Honda Accord LX Broadside Collision

With a Narrow Fixed-Object:

Foil Test Number 97S003

PUBLICATION NO. FHWA-RD-98-008

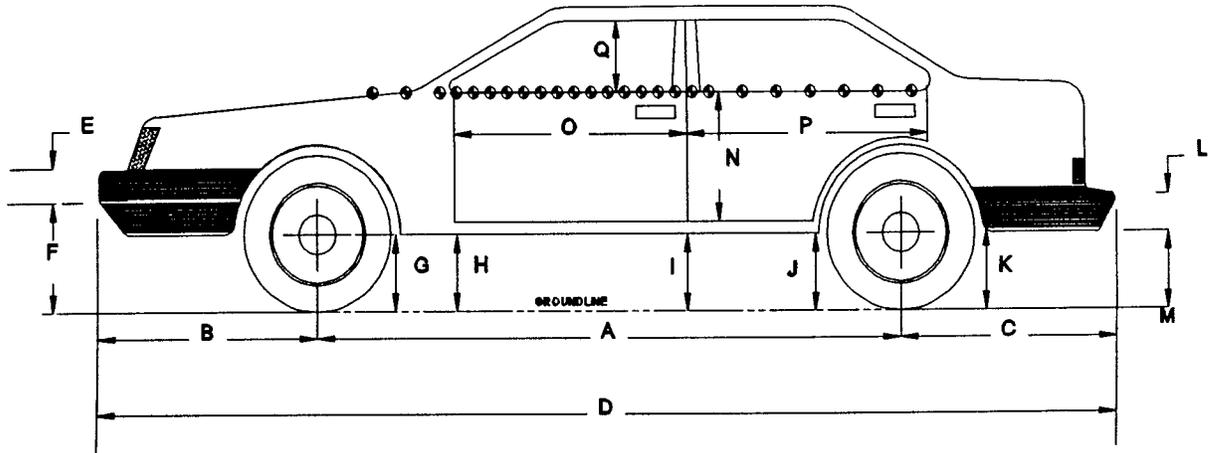
PRE-TEST	POST-TEST	△CHANGE
A	2,718	2,477	-241
B	921	895	-26
C	1,022	1,035	13
D	4,655	4,407	-248
E	121	121	0
F*	416 / 406	413	7
G*	283 / 267	254	-13
H*	283 / 267	257	-10
I*	284 / 267	273	6
J1*	210 / 194	298	104
J2*	284 / 267	248	-19
K*	352 / 311	337	26
L	241	241	0
M*	335 / 337	337	0
N	635	660	25
O	1,102	965	-137
P	972	864	-108
Q	438	391	-47

* These measurements were taken in the "as delivered" and in the "as tested" configuration, respectively.

Figure 1. Vehicle physical parameters in millimeters.

A list and sketches of the vehicle's physical parameters are shown in table 2 and figure 1, respectively. Figure 1 includes post-test damage measurements.

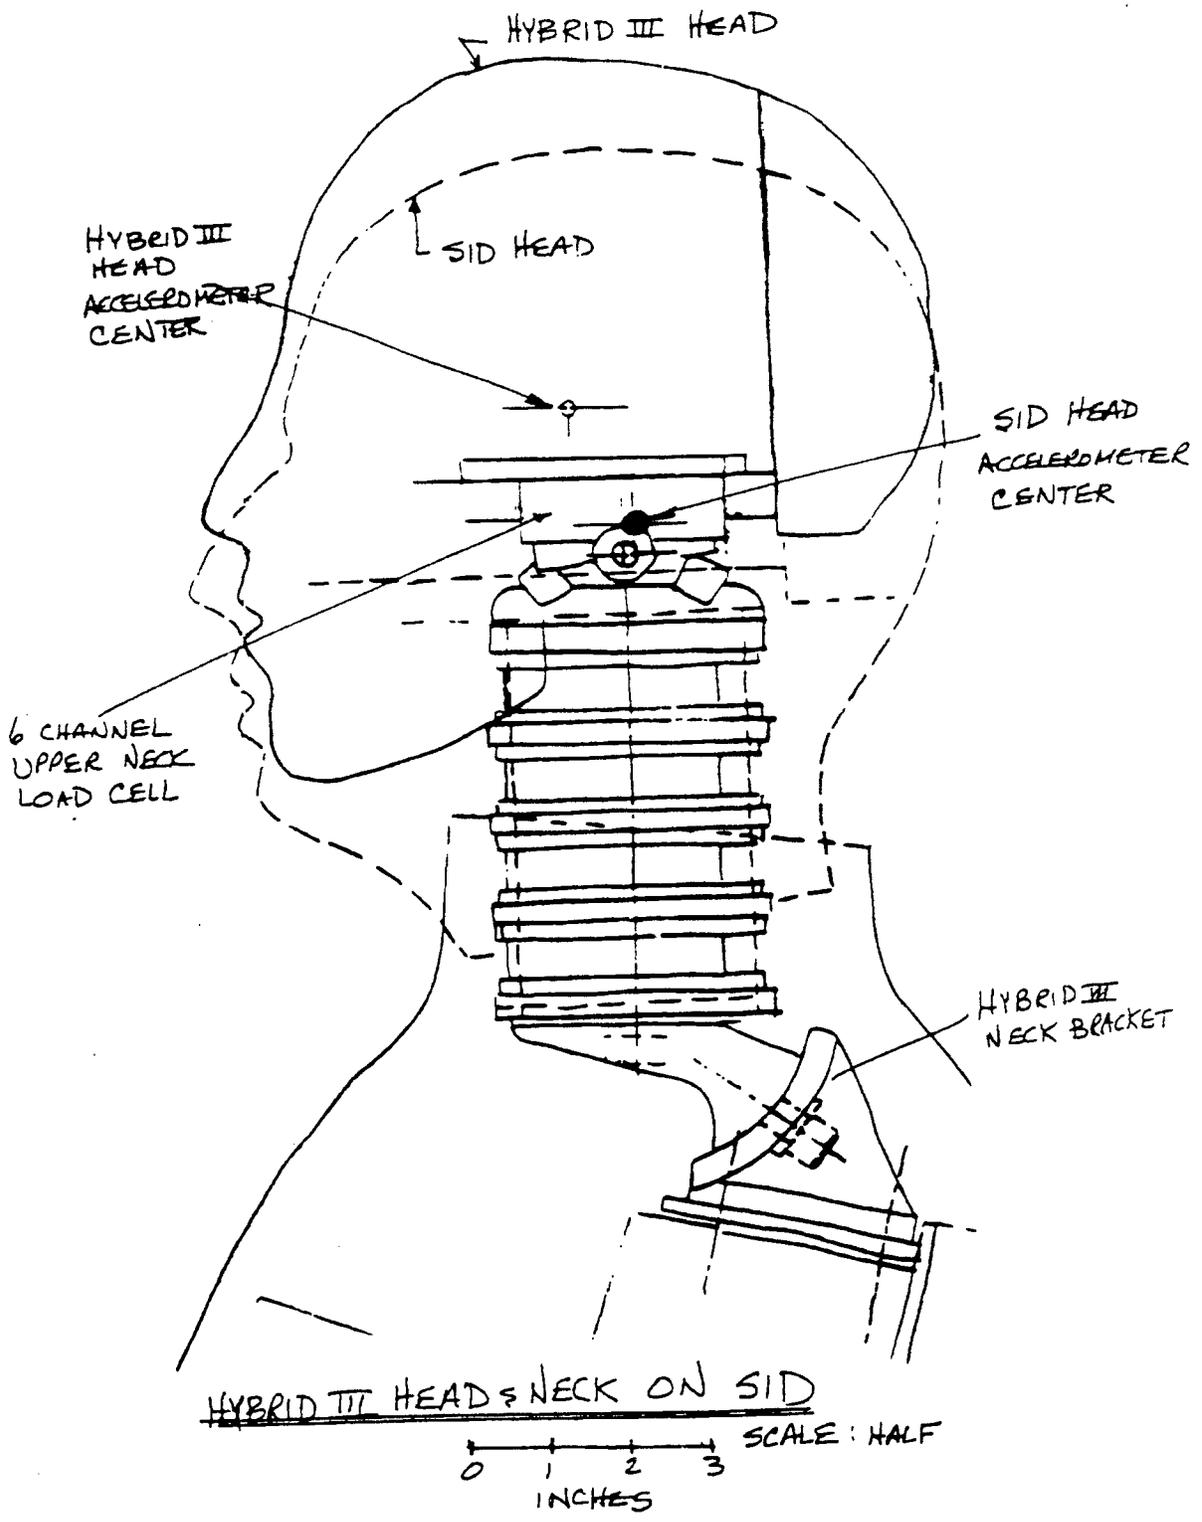
Figure 2. HYBRID III neck and head assembly on SIDH3 #26.

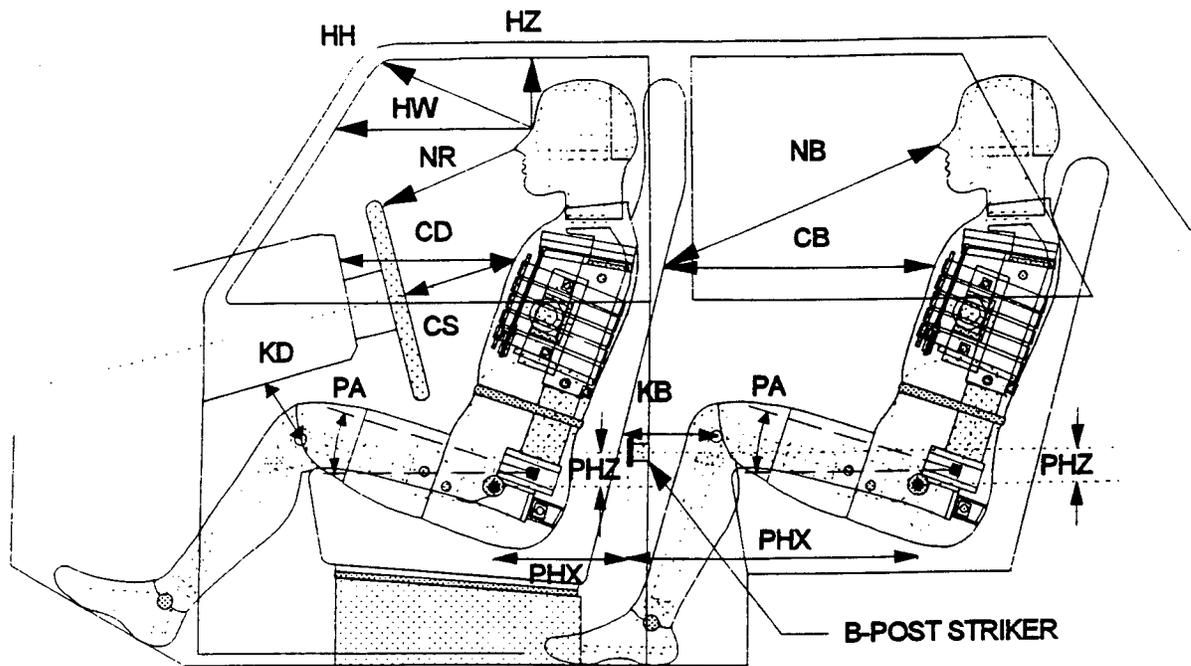
NOTE: 2-DOOR VEHICLE SHOWN.
 REAR DUMMY PHX & PHZ
 MEASUREMENTS FOR A 4-DOOR
 VEHICLE WOULD USE THE C-POST
 STRIKER AS A REFERENCE POINT

MEASUREMENT (mm)	DRIVER SIDH3 ID# 26
HH	485
HW	636
HZ	205
NR	560
CD	616
CS	390
KDL(KDA degrees)	190(24°)
KDR	210(21.3°)
PA degrees	25°
PHX	245
PHZ	160

Figure 3. SIDH3 longitudinal clearance and position measurements.

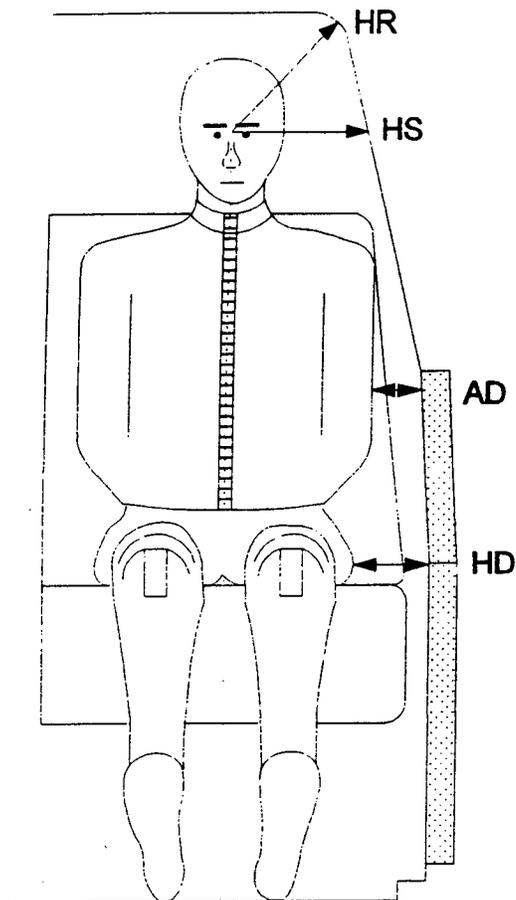
MEASUREMENT (mm)	DRIVER SIDH3 ID# 26
HR	220
HS	330
AD	92
HD	152

Figure 4. SIDH3 lateral clearance and position measurements.

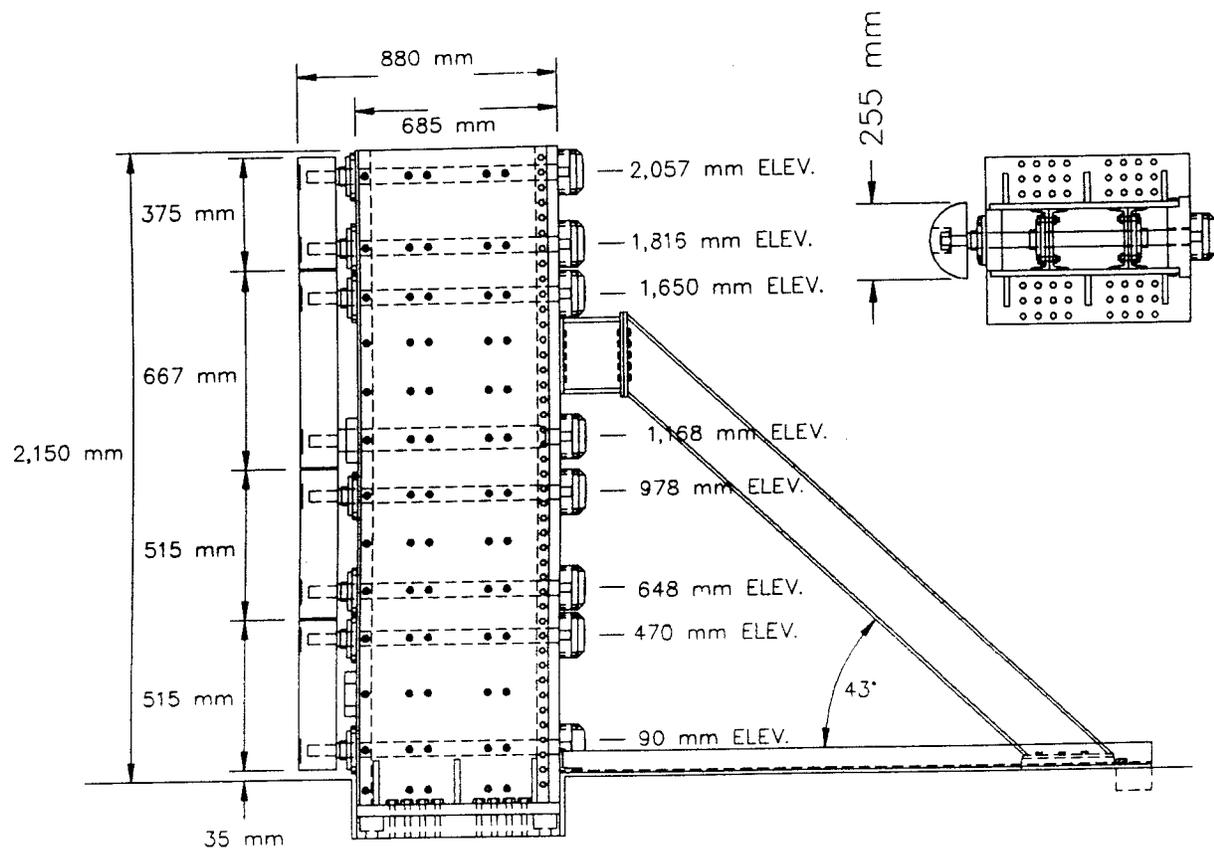
Figure 5. FOIL 300K instrumented rigid pole.

The FOIL instrumented 300K rigid pole was designed to measure vehicle frontal and side crush characteristics. The rigid pole was set up in the side-impact configuration. The rigid pole side-impact configuration consisted of four solid half-circle steel impact faces mounted to two load cells via two high-strength connecting rods per face (eight load cells total). The diameter of the pole impact faces was 255 mm. The load cells measured the forces exerted on the pole at each location. This provided insight into what structures on the vehicle produced the significant loads. The 300K rigid pole was mounted in line with the target impact location, aligned with the cg of the dummy's head.

A spike (e.g., sharpened welding rod) was affixed to one impact face to verify the impact location by physically puncturing the vehicle body. Figure 5 is a sketch of the FOIL 300K rigid pole (side-impact configuration).

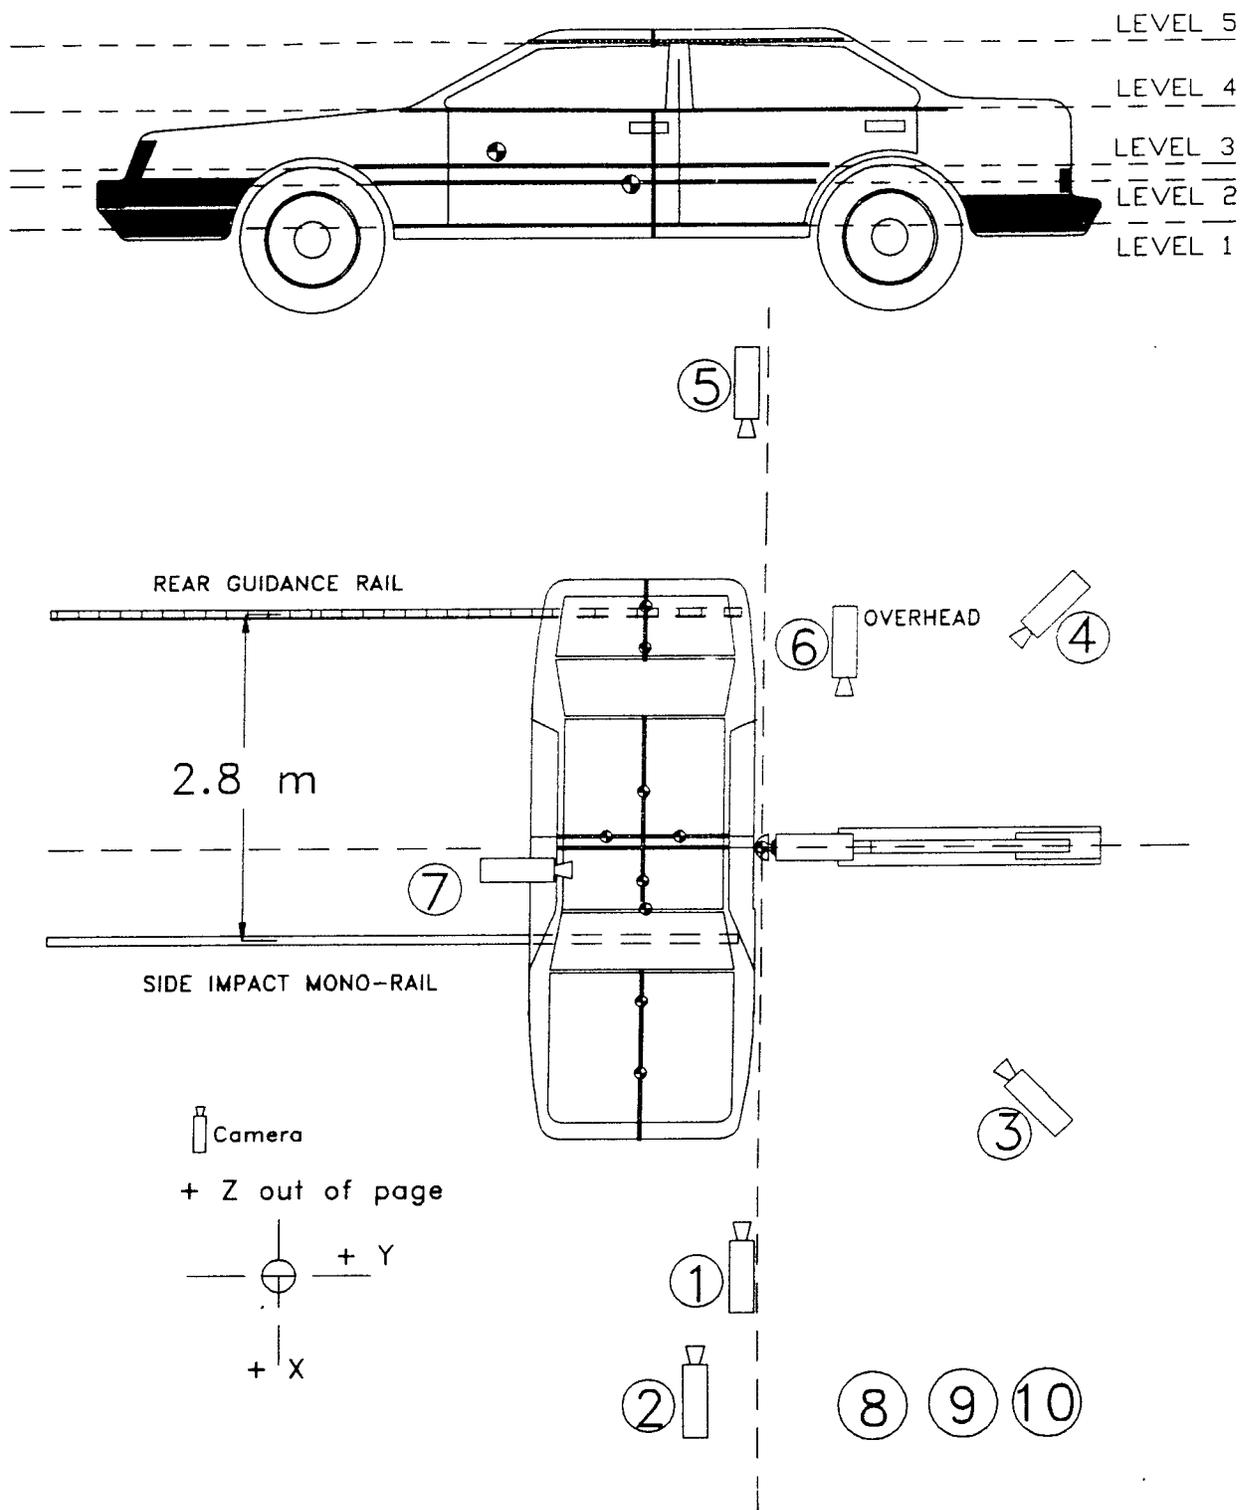
Figure 6. Camera locations and test setup.

Figure 6 presents a side view of the test vehicle, showing the target tape locations. Figure 6 also contains an overhead sketch of the facility depicting the setup of the vehicle, rigid pole, test track, and the location of each high-speed camera. Positioned in each camera's view was at least one strobe light. The lights flashed when the vehicle struck the pole. This synchronized the film with the electronic data.

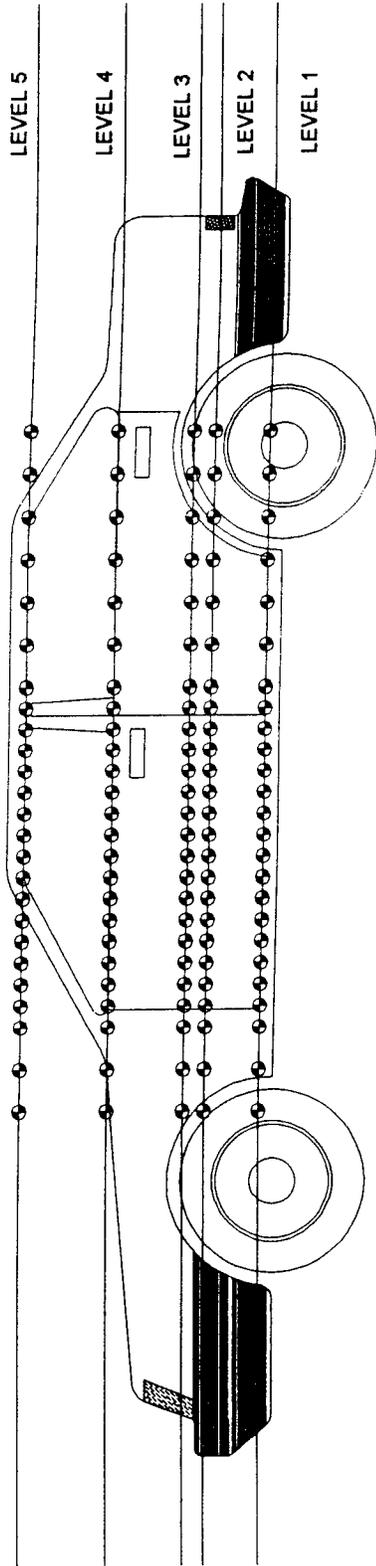
Level 1 - Sill height Level 2 - Occupant H-point Level 3 - Mid-door Level 4 - Window sill Level 5 - Window top

LEVEL	HEIGHT	1,067	-914	-838	-762	-686	-610	-533	-457	-381	-305	-229	-152	-76
1	273	835	841	848	848	848	845	848	848	851	845	848	851	848
	318	972	1,010	1,022	1,041	1,080	1,092	1,099	1,124	1,149	1,181	1,213	1,257	1,311
		CRUSH	137	169	193	232	267	251	276	298	336	365	406	453
2	457	794	797	803	810	810	810	810	811	810	810	806	803	806
	495	914	972	991	1,016	1,043	1,092	1,105	1,130	1,168	1,194	1,226	1,257	1,311
		CRUSH	120	175	206	233	282	295	319	358	384	420	454	505
3	584	794	797	803	810	810	810	810	811	810	810	806	803	810
	614	914	967	997	1,019	1,067	1,099	1,099	1,124	1,143	1,187	1,232	1,280	1,321
		CRUSH	129	170	209	257	289	289	313	333	377	426	477	511
4	883	851	848	857	854	854	857	864	864	870	867	867	867	860
	927	959	967	991	1,010	1,080	1,118	1,118	1,156	1,181	1,207	1,251	1,283	1,321
		CRUSH	106	119	156	226	261	254	292	311	340	384	416	461
5	1,340									1,140	1,130	1,133	1,137	1,133
	1,422									1,257	1,283	1,308	1,340	1,372

Target tape and circular targets were placed on the test vehicle in accordance with FMVSS 214. The 25-mm yellow and black target tape was placed along the struck side of the vehicle at five elevations. The elevations included the lower door sill, the mid-door height, occupant H-point height, top-door sill, and roof sill. The target tape was used to measure pre- and post-test side profile measurements to determine vehicle damage or crush. The FOIL used a 2.5 m long by 1.4 m high peg board placed along the driver (left) side of the vehicle to measure the vehicle profile. The board's position was referenced from two points directly across from the impact location on the right side of the vehicle. This was done to ensure that the reference location would not be severely damaged. The two points were chosen directly across from impact because the least amount of bowing occurs directly across from impact. It was necessary to position the board in the same position relative to the vehicle after the crash test to obtain accurate crush measurements. The pre- and post-test profile measurements are shown in figure 7 later in this report.

After the test a damage profile of the vehicle was produced. Figure 7 depicts the driver-side profile measurements before and after the test. The measurements were made using a reference line parallel to the driver side of the vehicle. The parallel line was drawn a certain distance from and perpendicular to a line formed by the passenger side sill across from the impact location. This allowed the same reference line to be drawn after the test to measure the post-test measurements. The measurements were made in 75-mm and 150-mm increments forward and aft of the impact point. After the test, measurements were taken at the same points forward and aft rather than measuring at the same increments. From the figure, the maximum static deflection recorded was 549 mm at mid-door height along the vertical impact target tape.

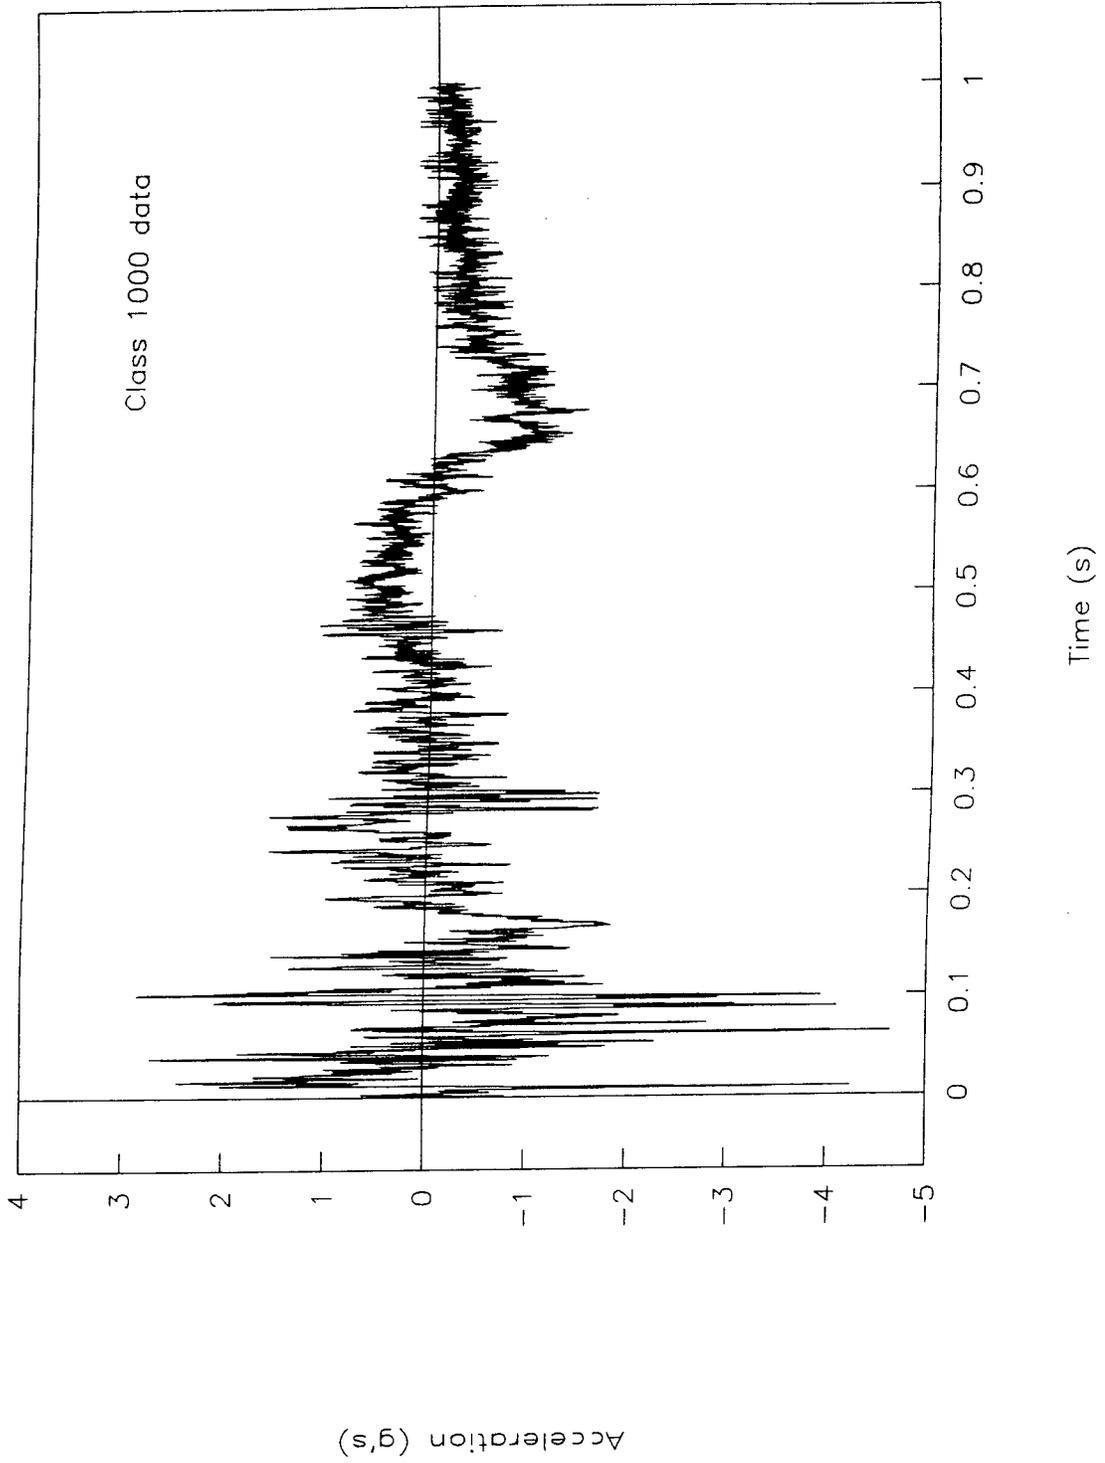
X-axis, acceleration vs. time cg data

Figure 8. Acceleration vs. time, cg X-axis, test 97S003.

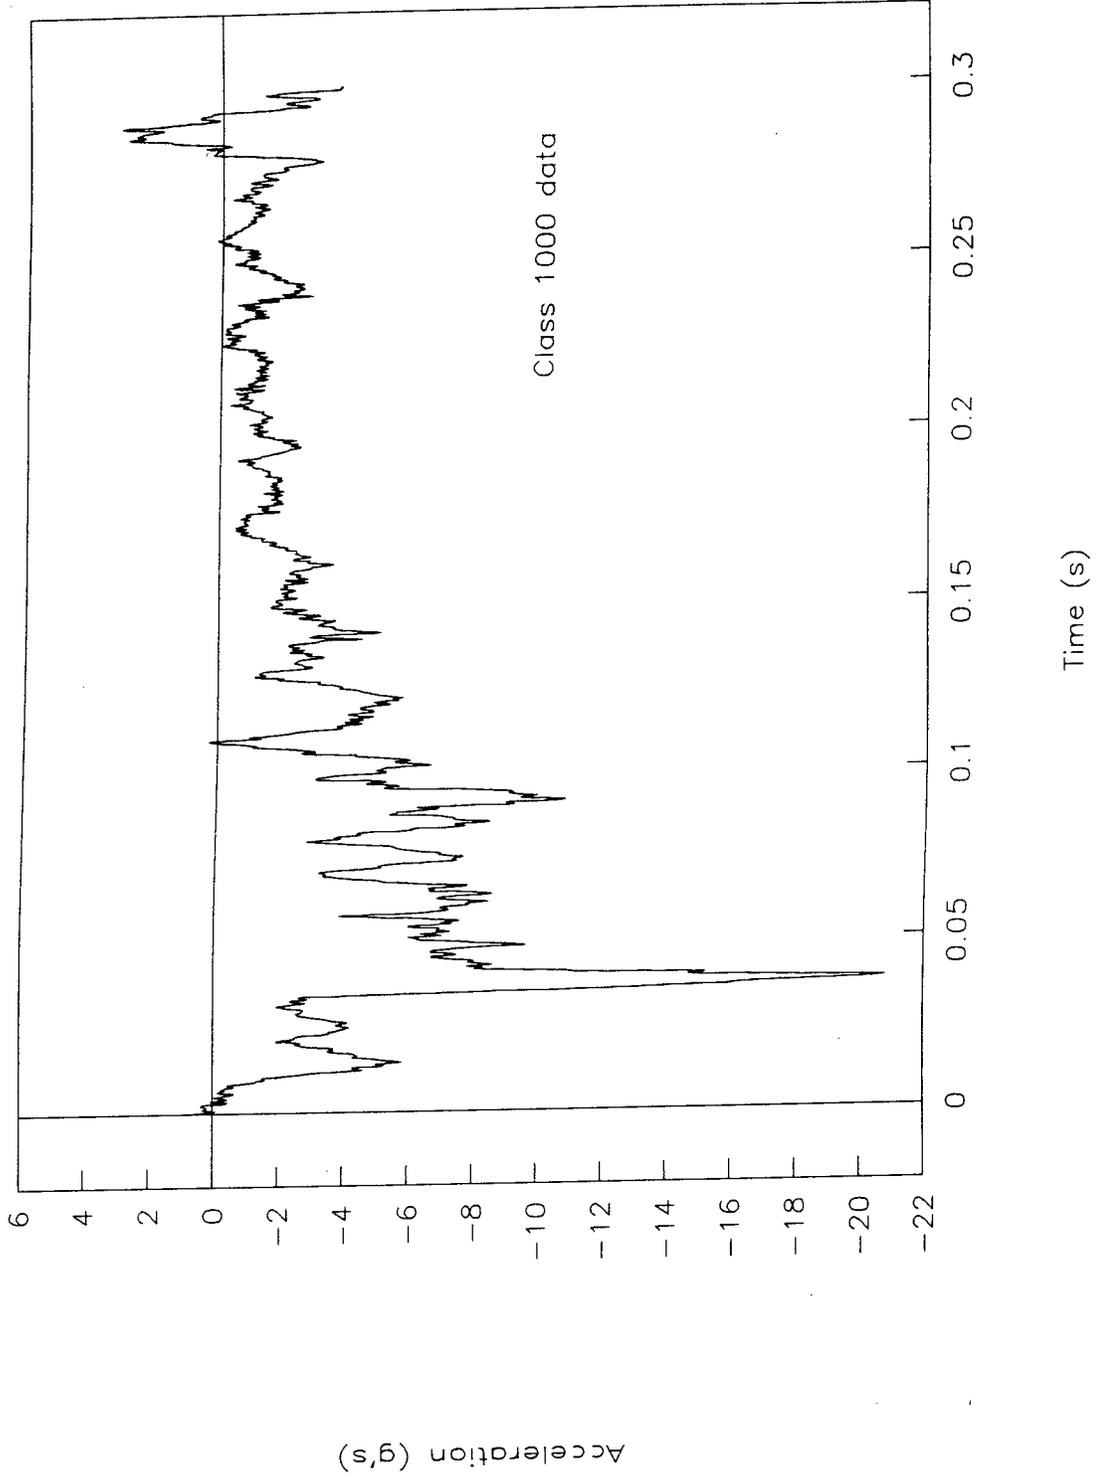
Y-axis, acceleration vs. time cg data

Figure 9. Acceleration vs. time, cg Y-axis, test 97S003.

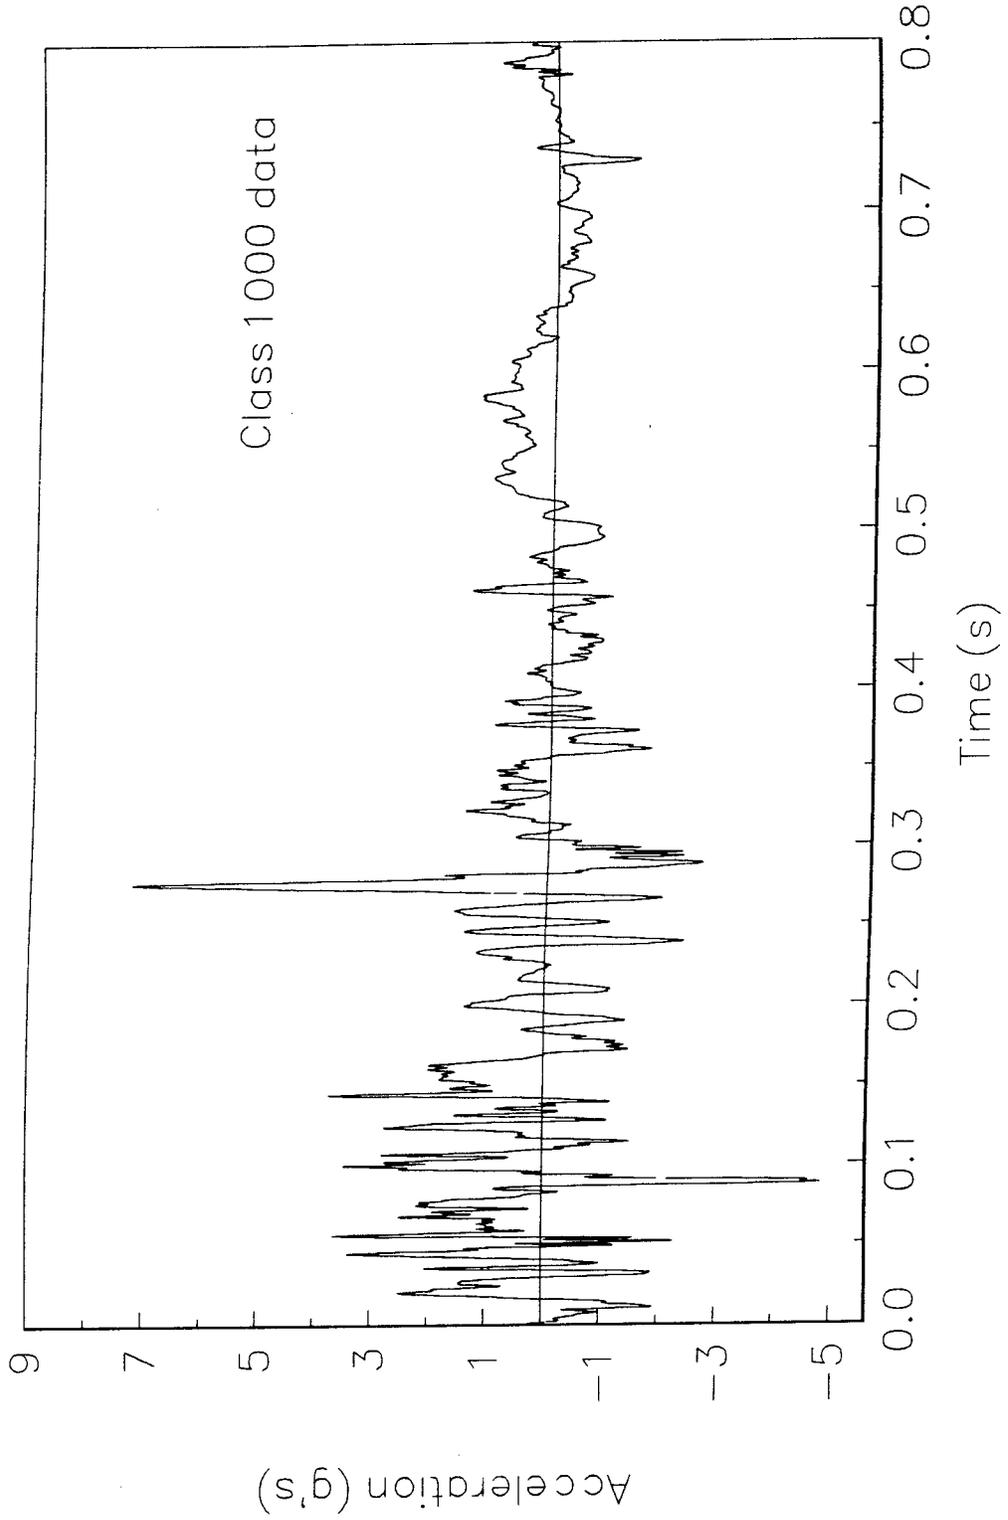
Figure 10. Acceleration vs. time, cg Z-axis, test 97S003.

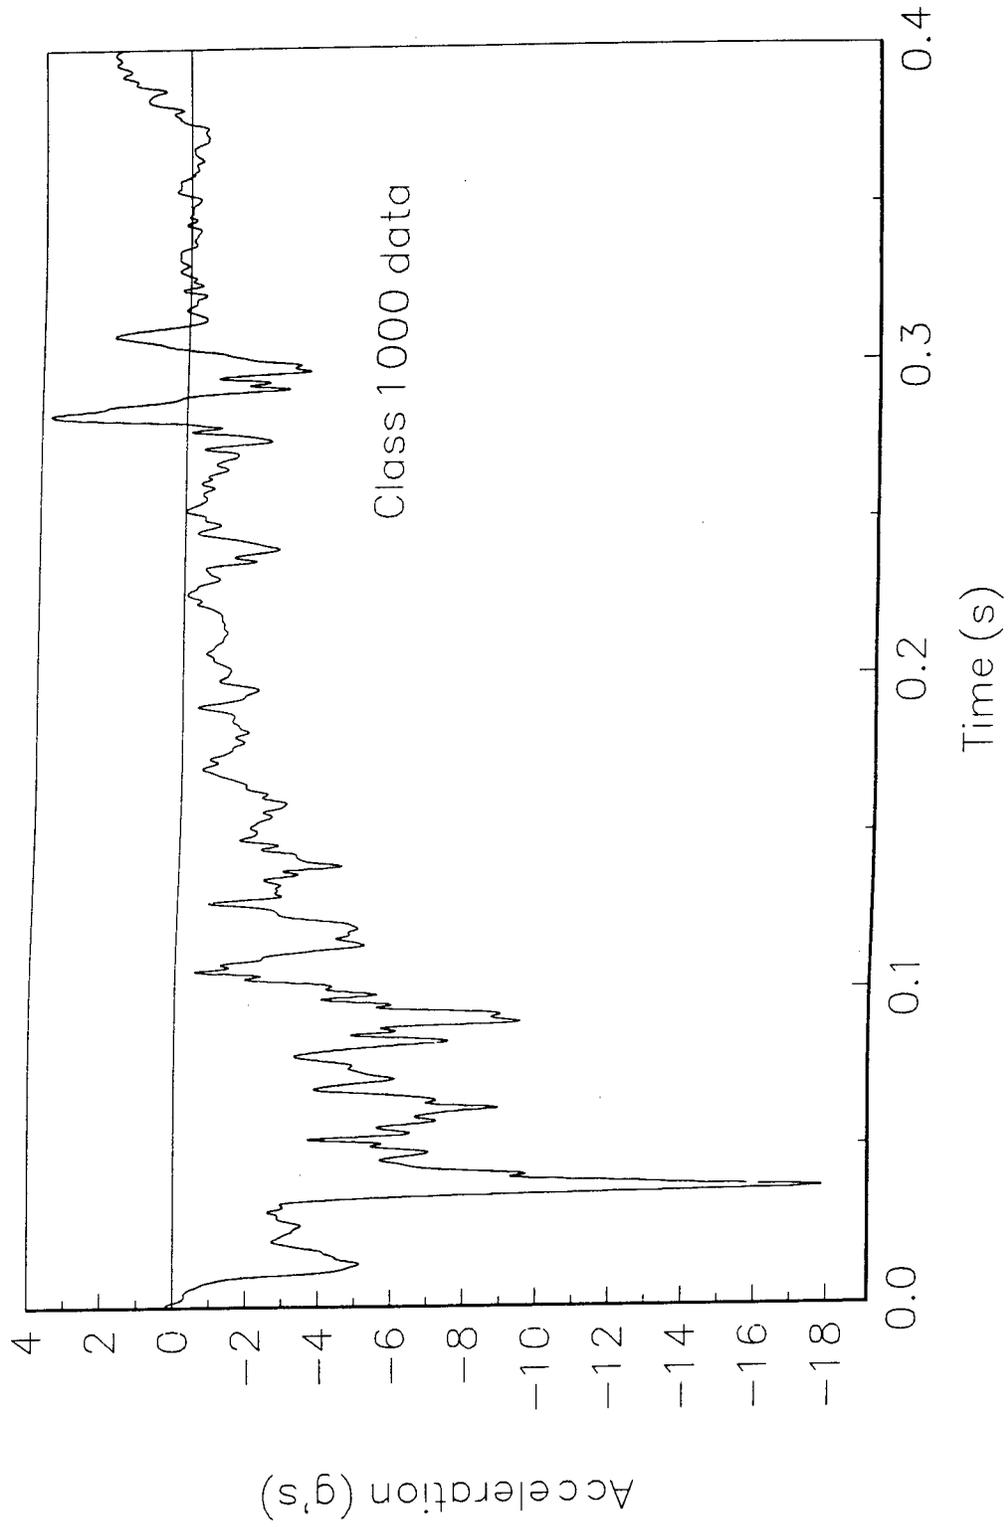
Figure 11. Acceleration vs. time, redundant Y-axis cg, test 97S003.

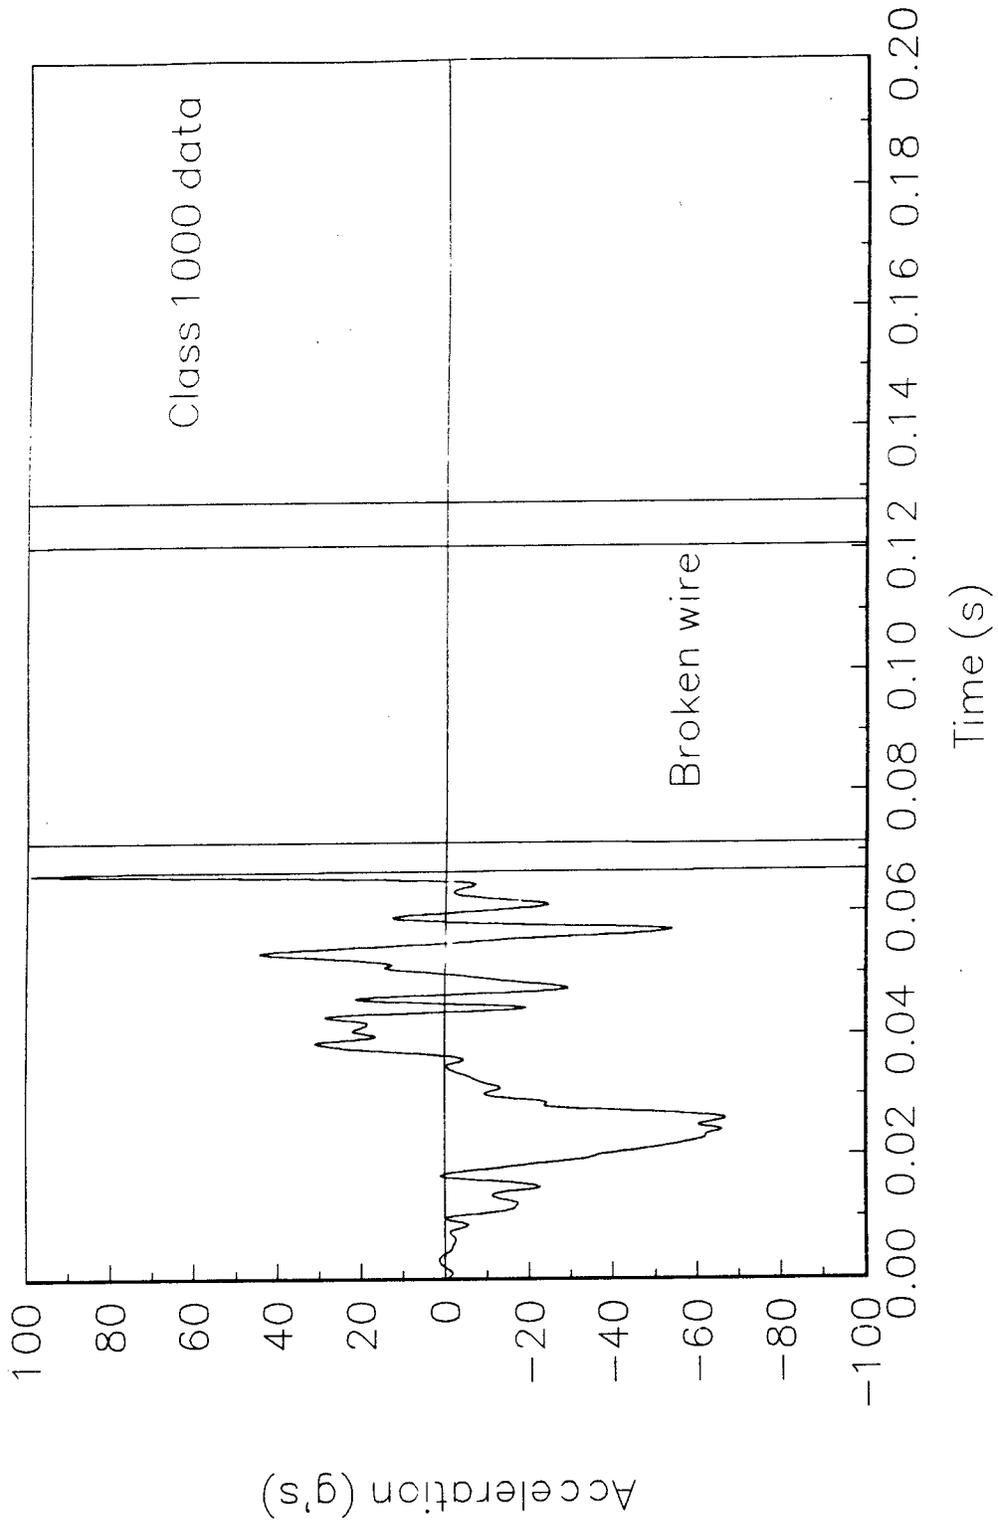
Figure 12. Acceleration vs. time, Y-axis driver seat track, test 97S003.

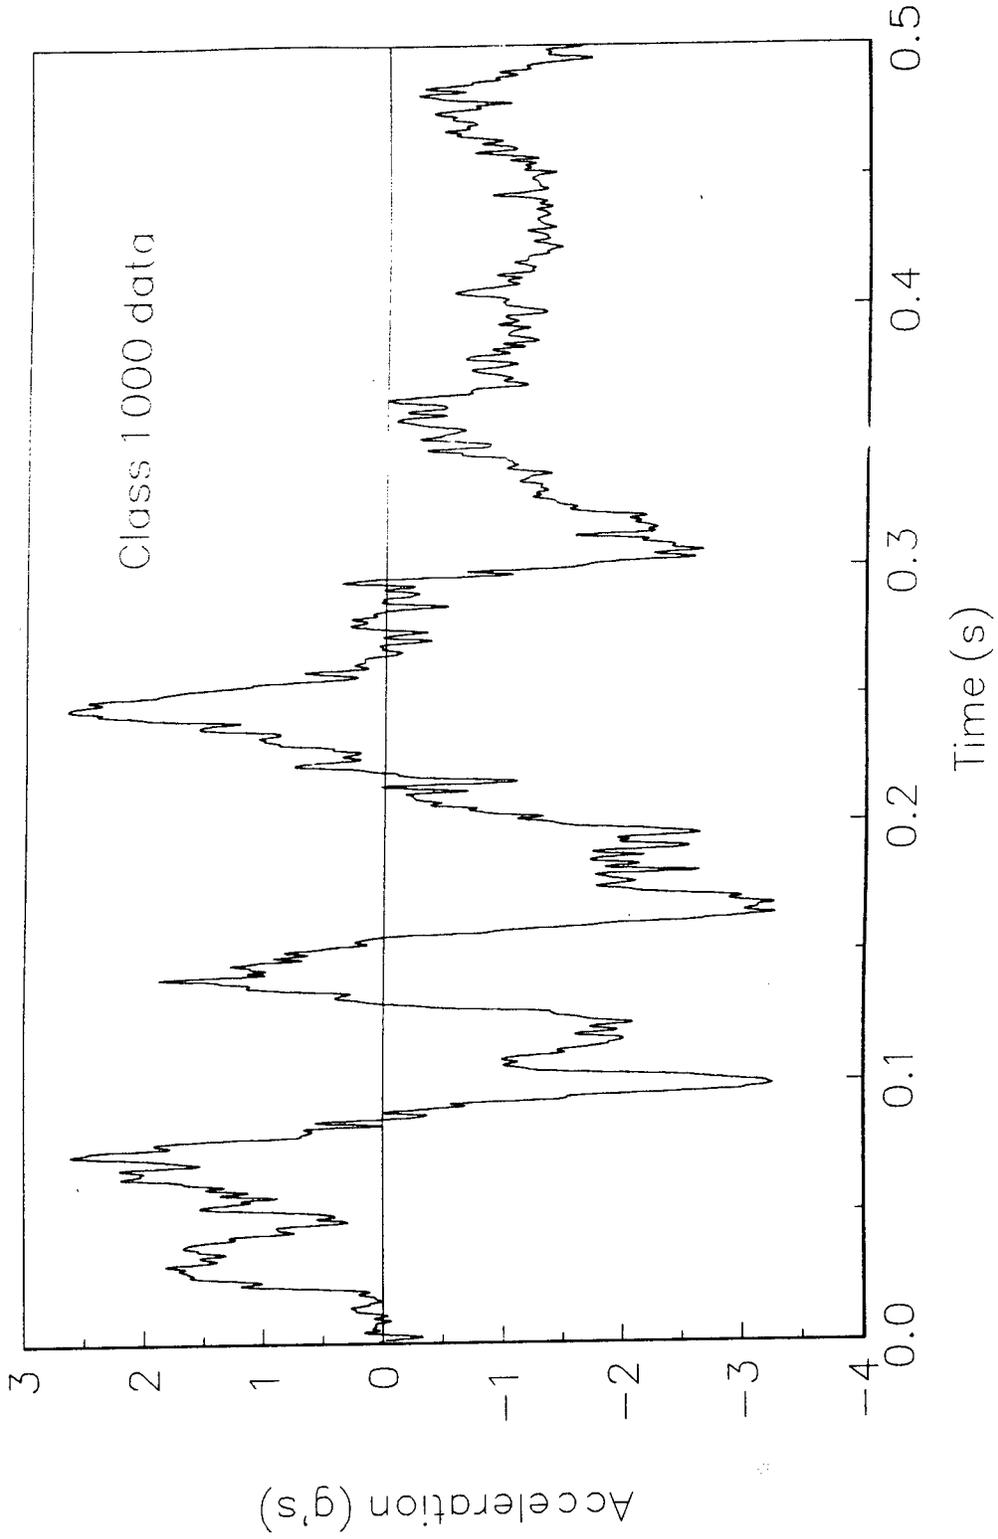
Figure 13. Acceleration vs. time, X-axis engine block, test 97S003.

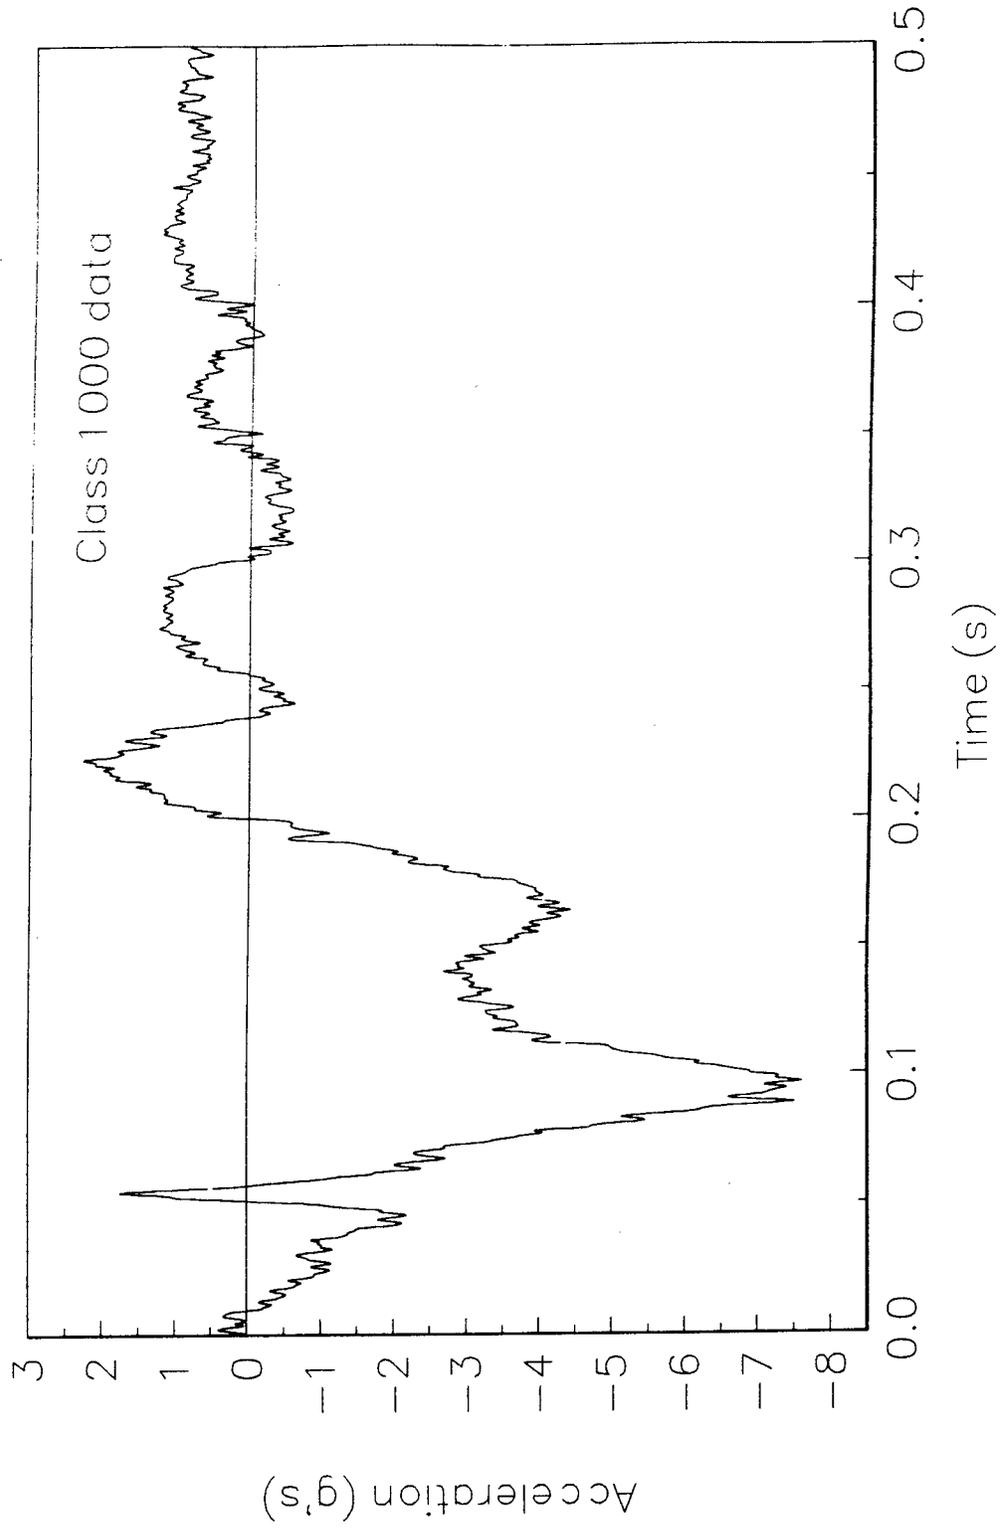
Figure 14. Acceleration vs. time, Y-axis engine block, test 97S003.

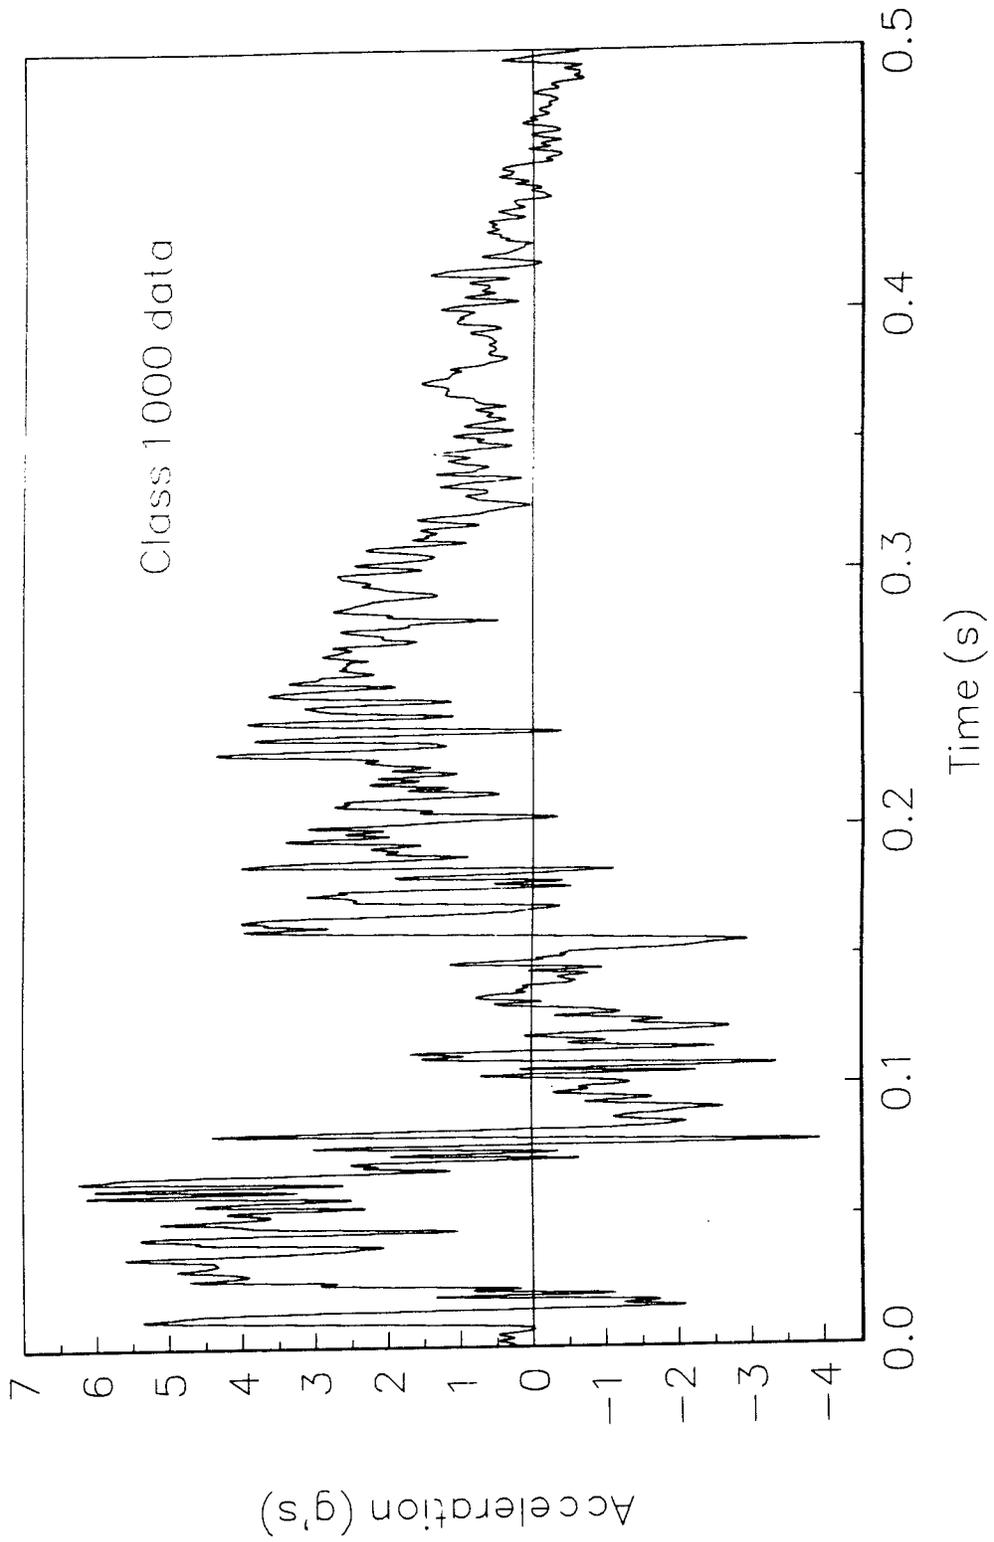
Figure 15. Acceleration vs. time, X-axis trunk, test 97S003.

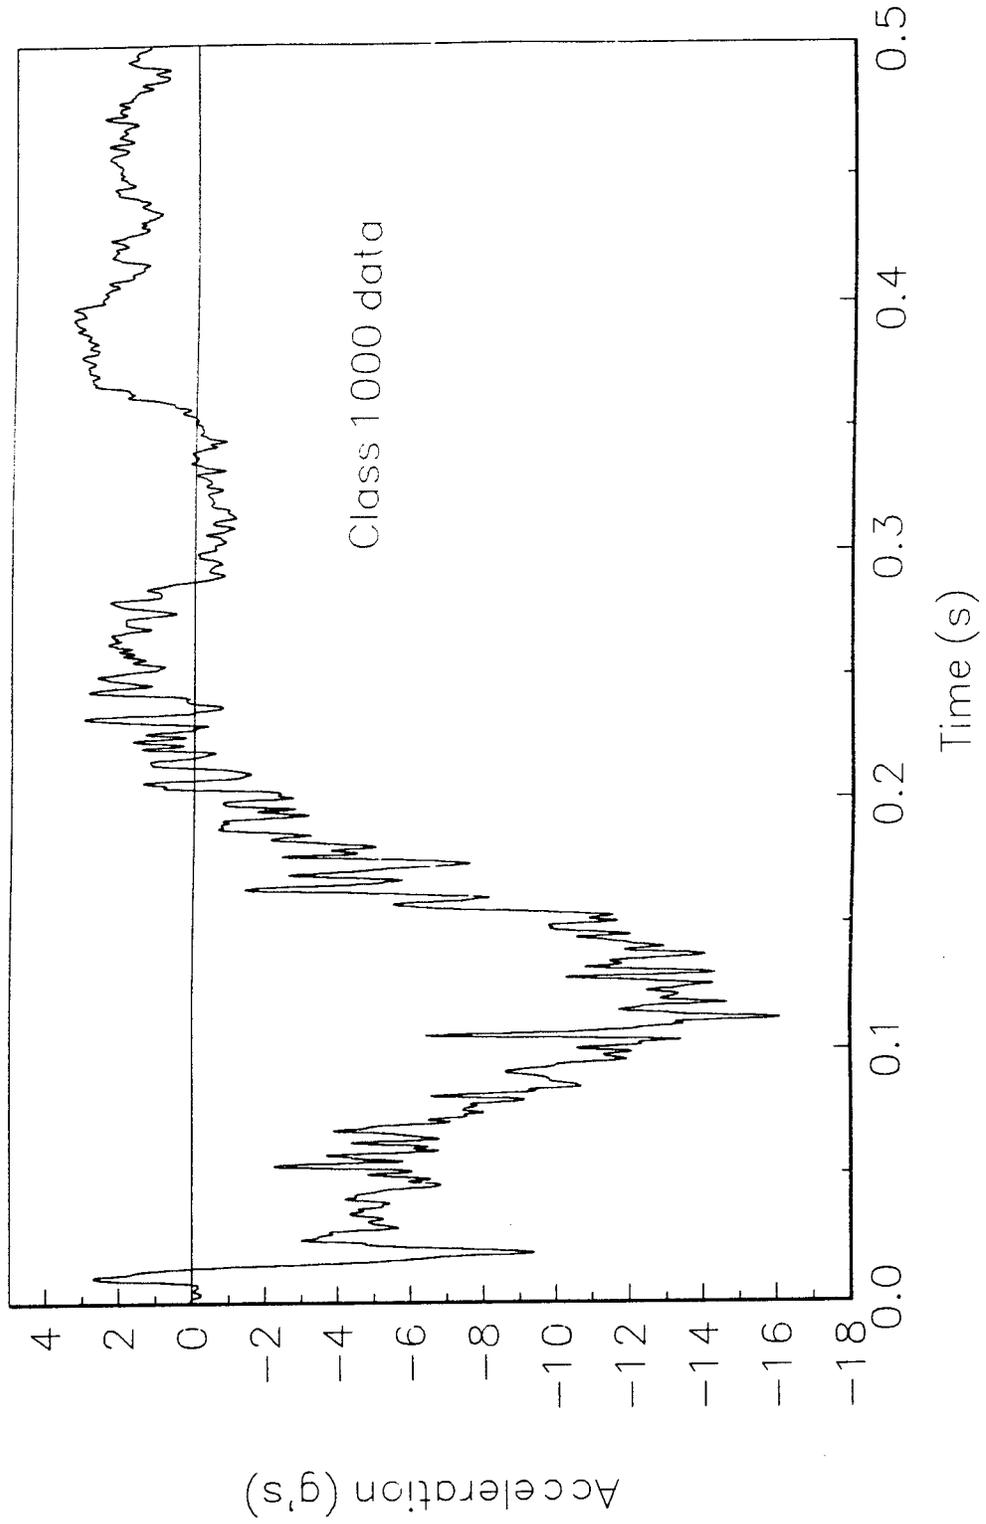
Figure 16. Acceleration vs. time, Y-axis trunk, test 97S003.
