Honda Accord LX Broadside Collision

With a Narrow Fixed-Object:

Foil Test Number 97S003

PUBLICATION NO. FHWA-RD-98-008

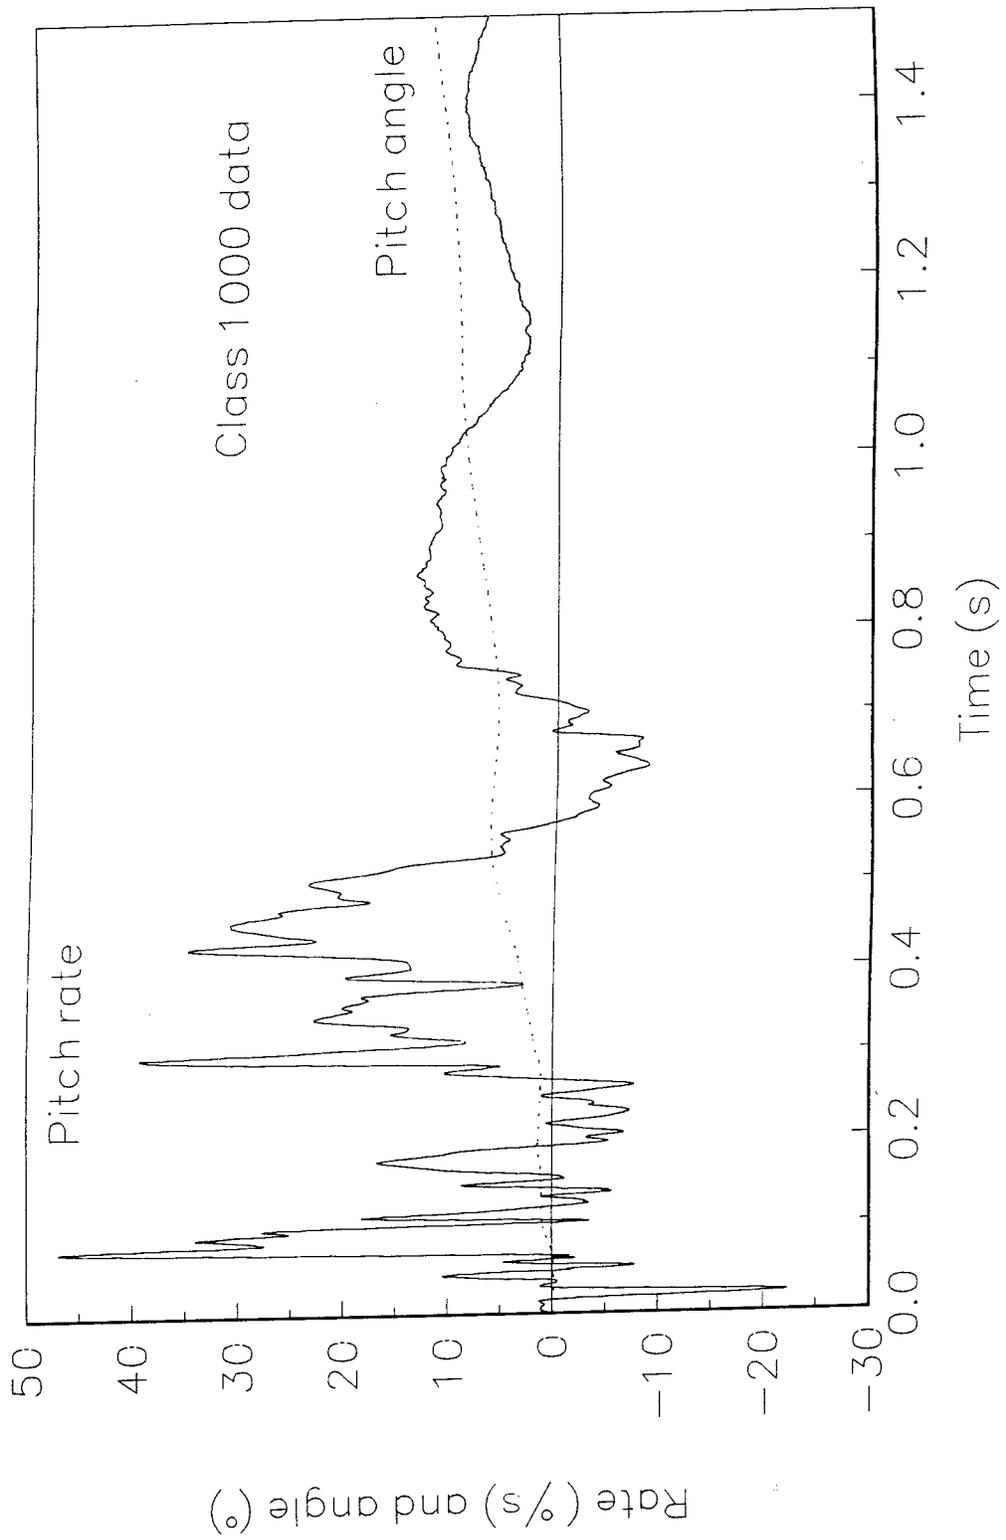
Figure 17. Pitch rate and angle vs. time, test 97S003.

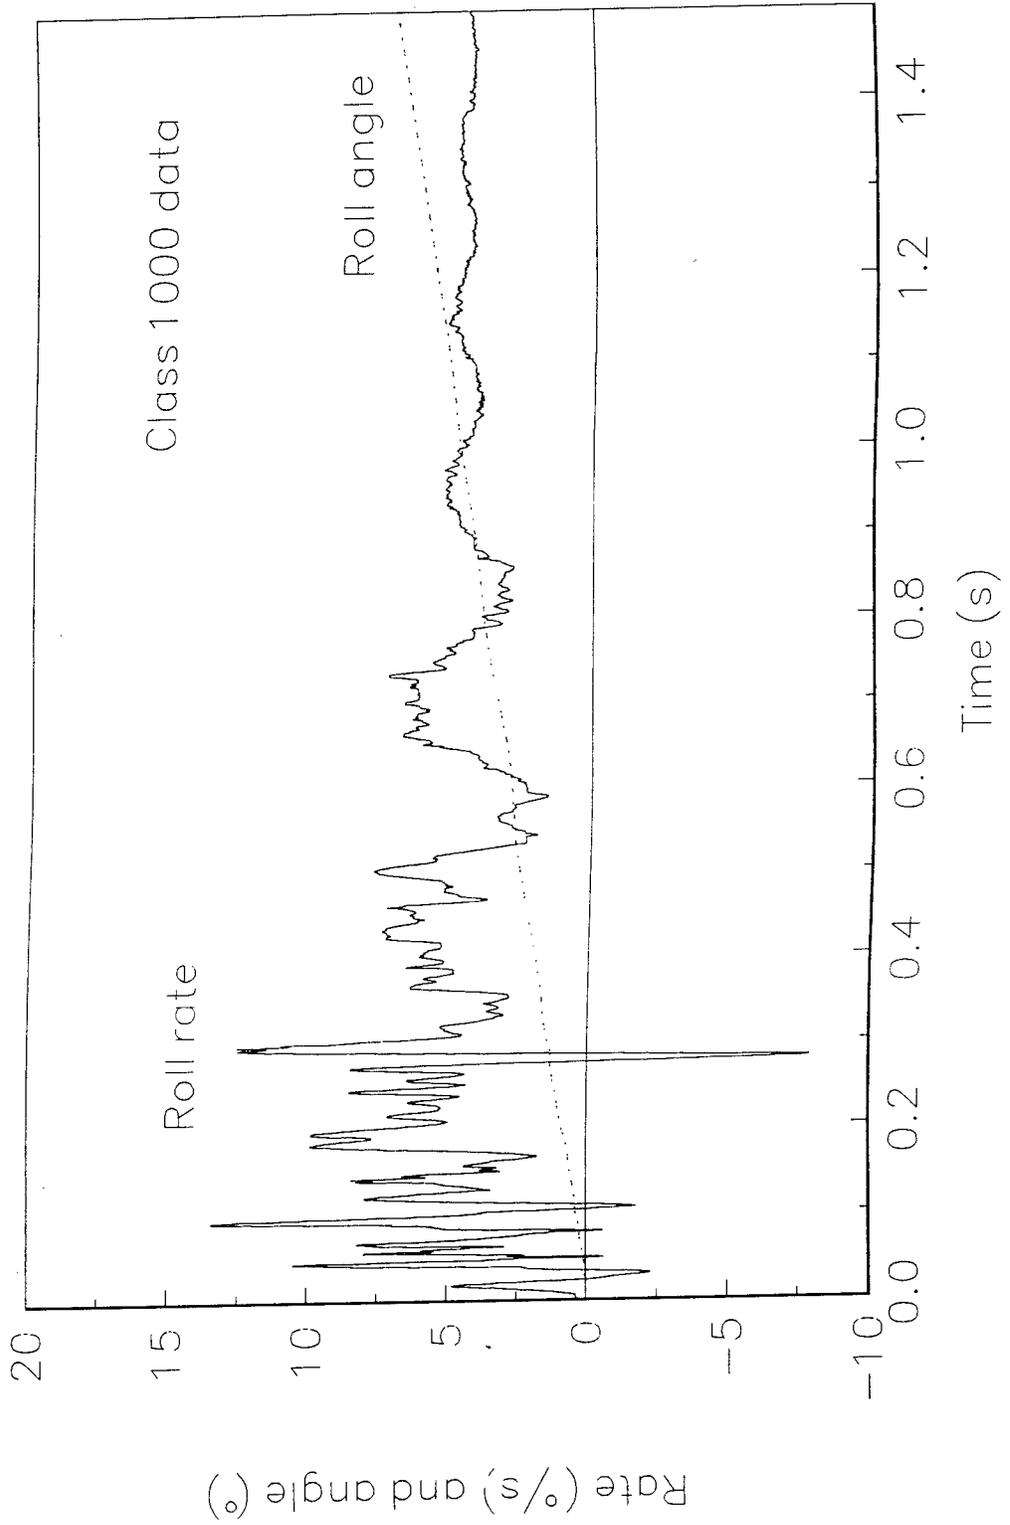
Figure 18. Roll rate and angle vs. time, test 97S003.

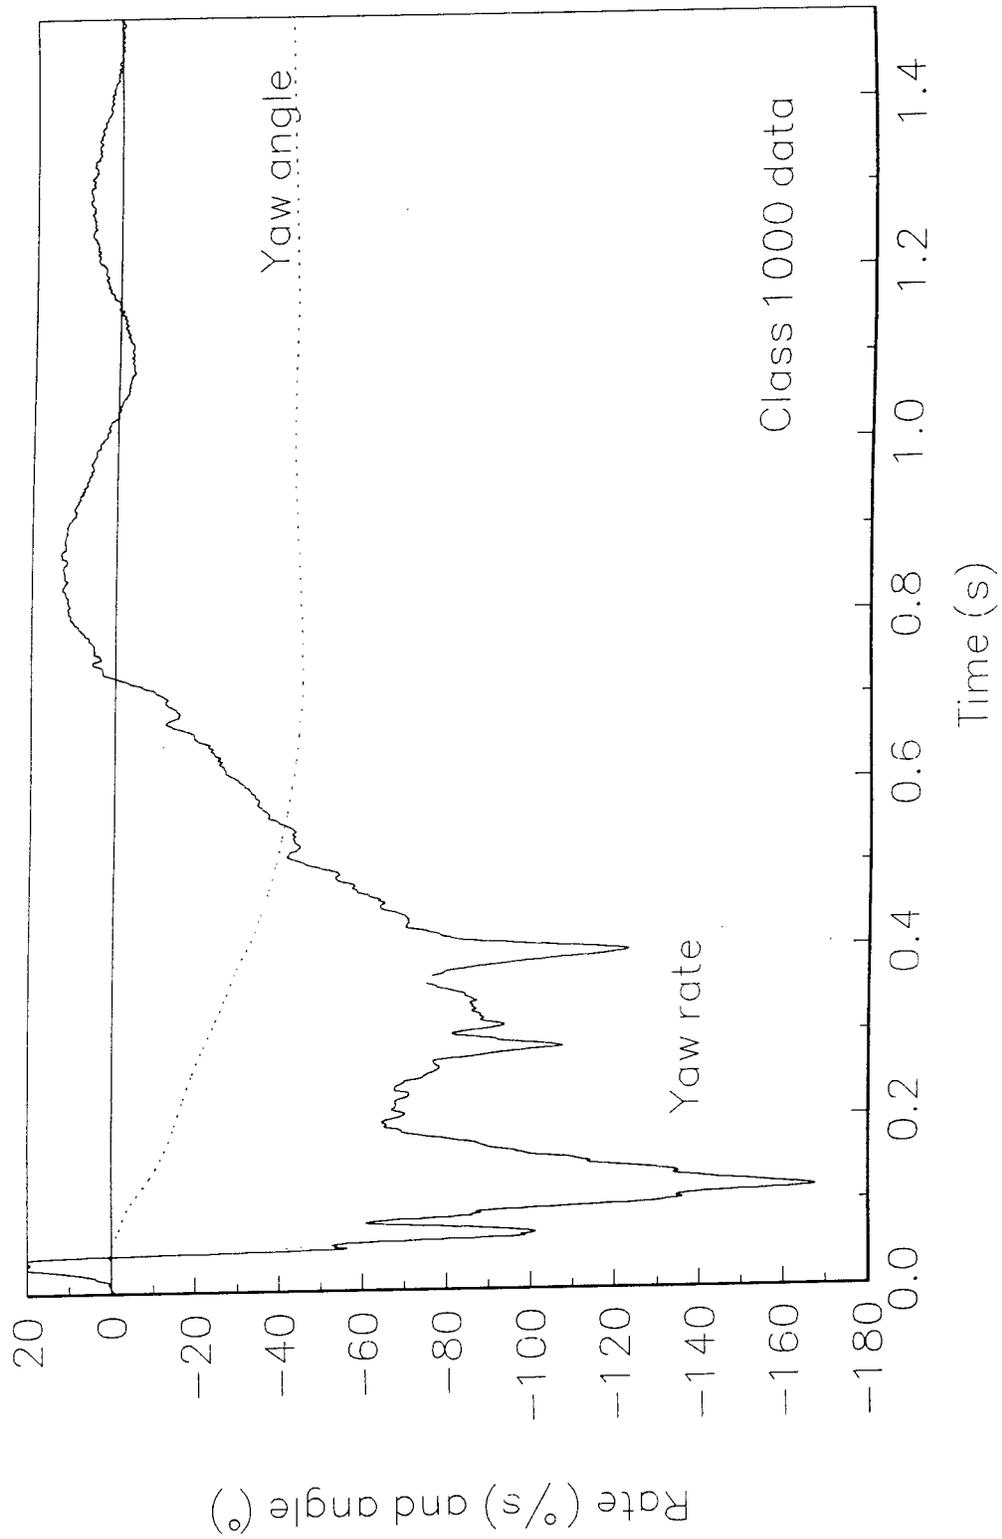
Figure 19. Yaw rate and angle vs. time, test 97S003.

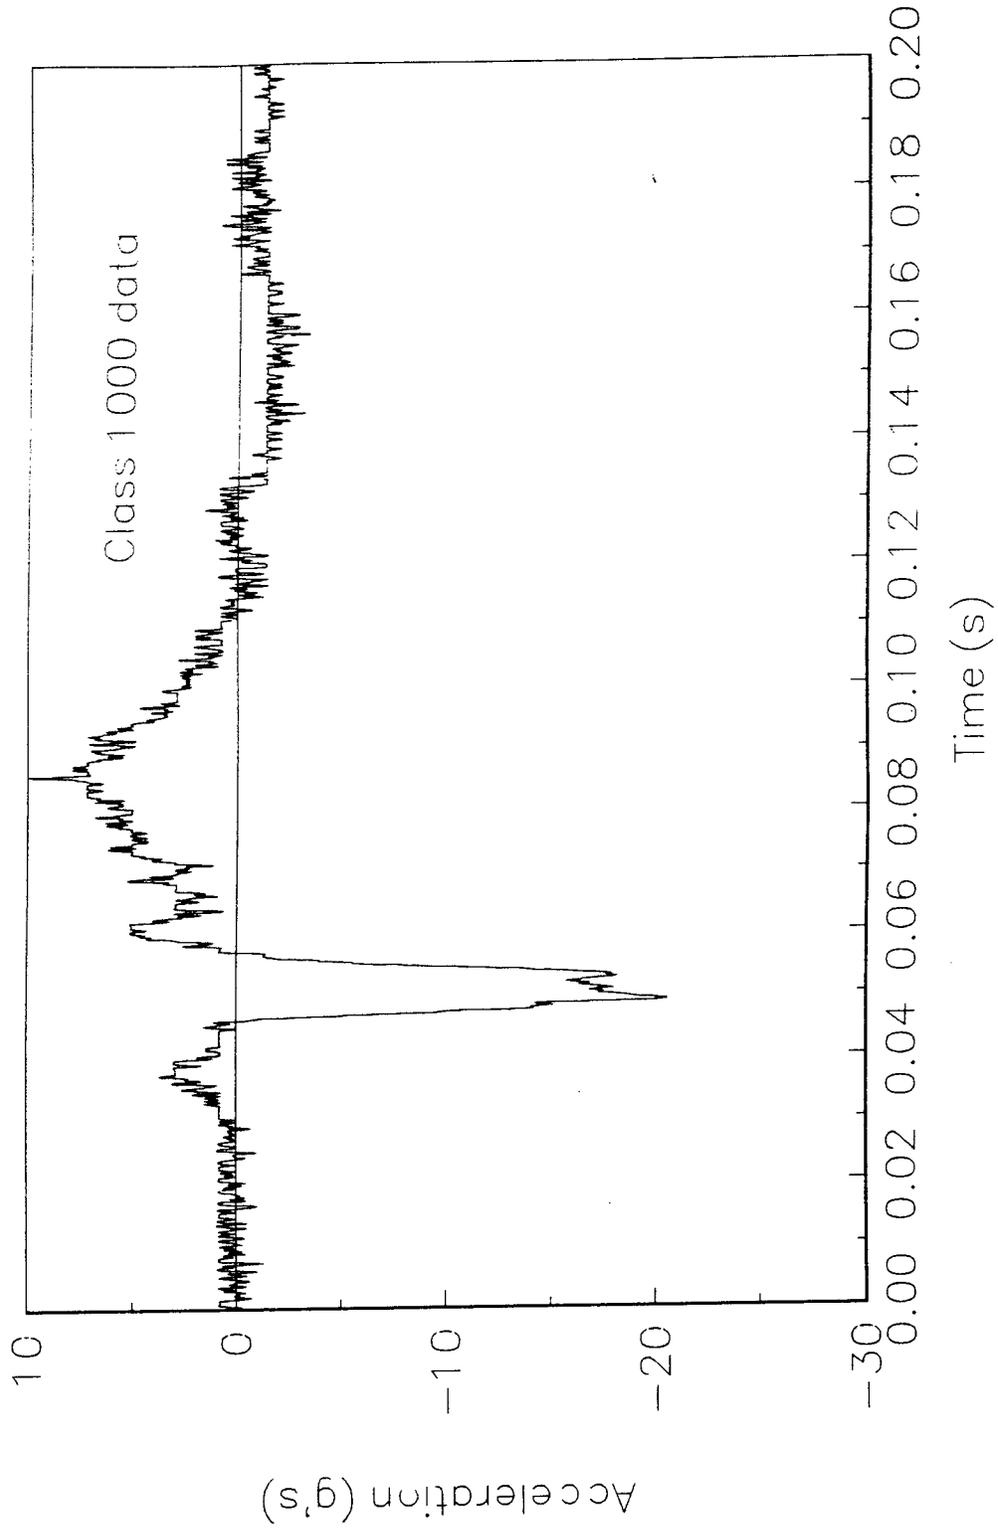
Figure 20. Acceleration vs. time, X-axis head, test 97S003.

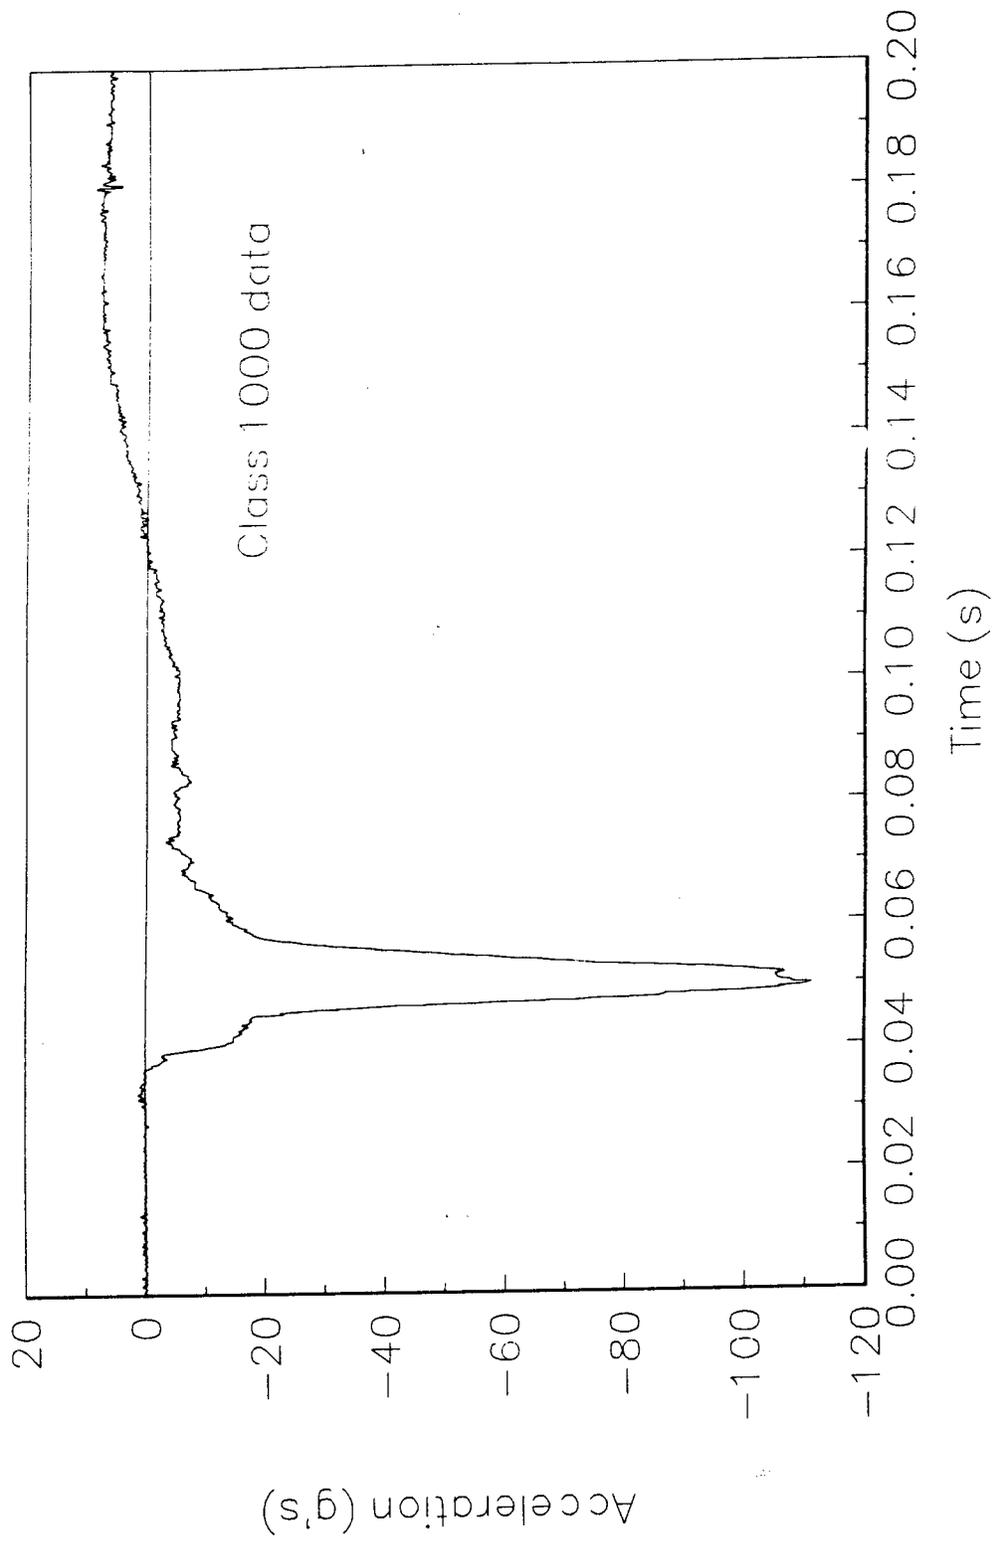
Figure 21. Acceleration vs. time, Y-axis head, test 97S003.

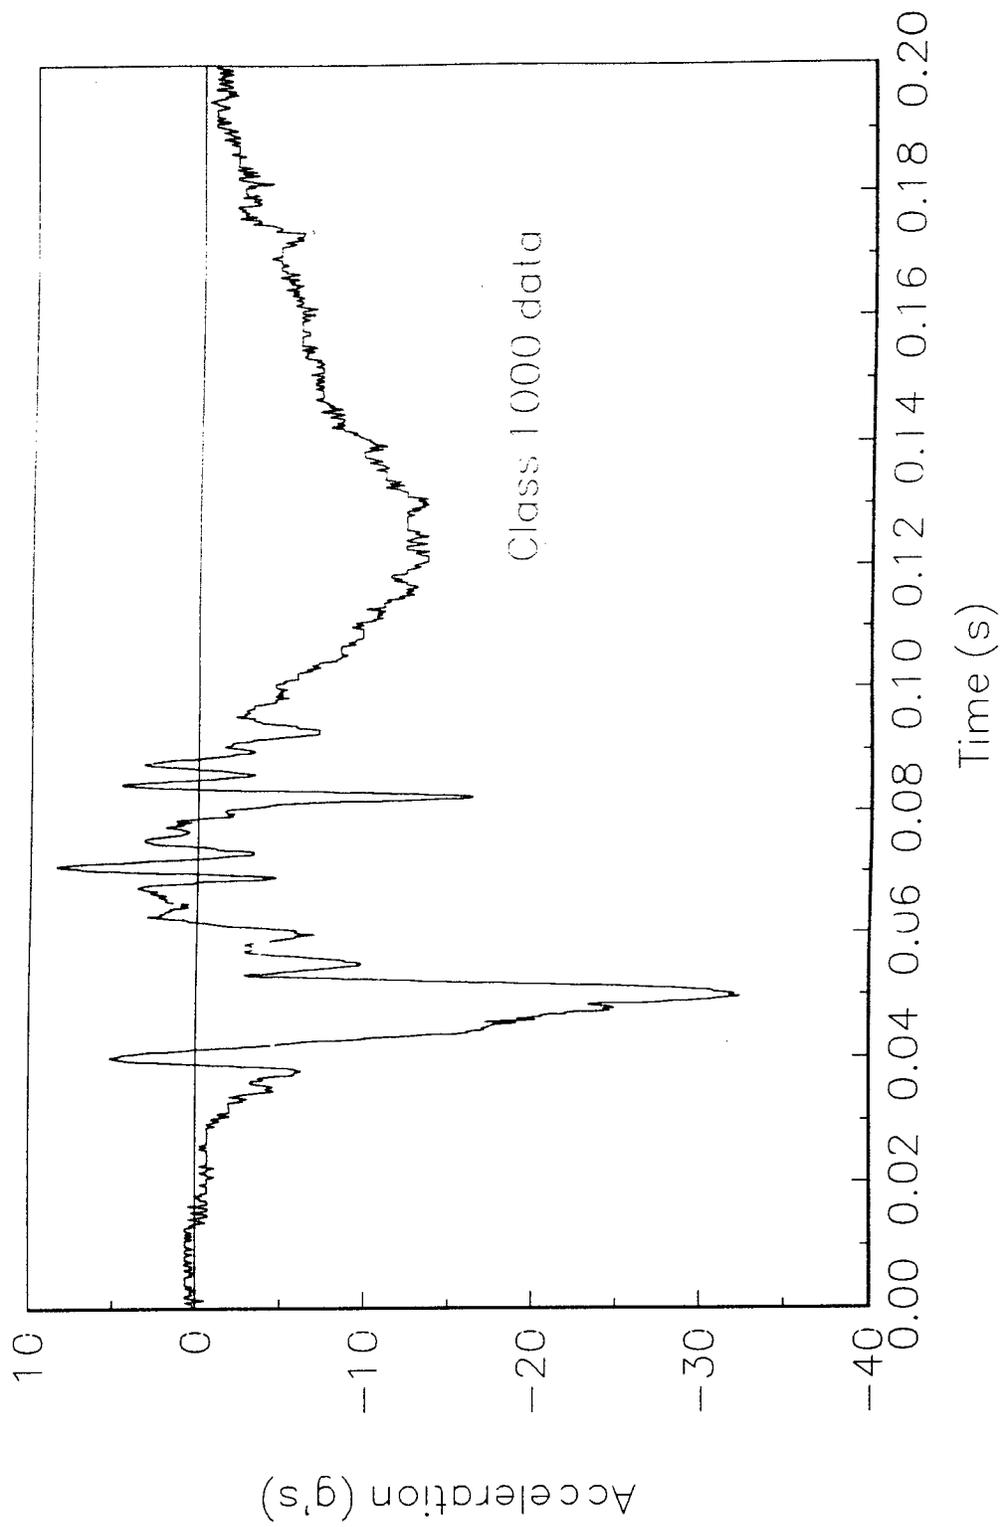
Figure 22. Acceleration vs. time, Z-axis head, test 97S003.

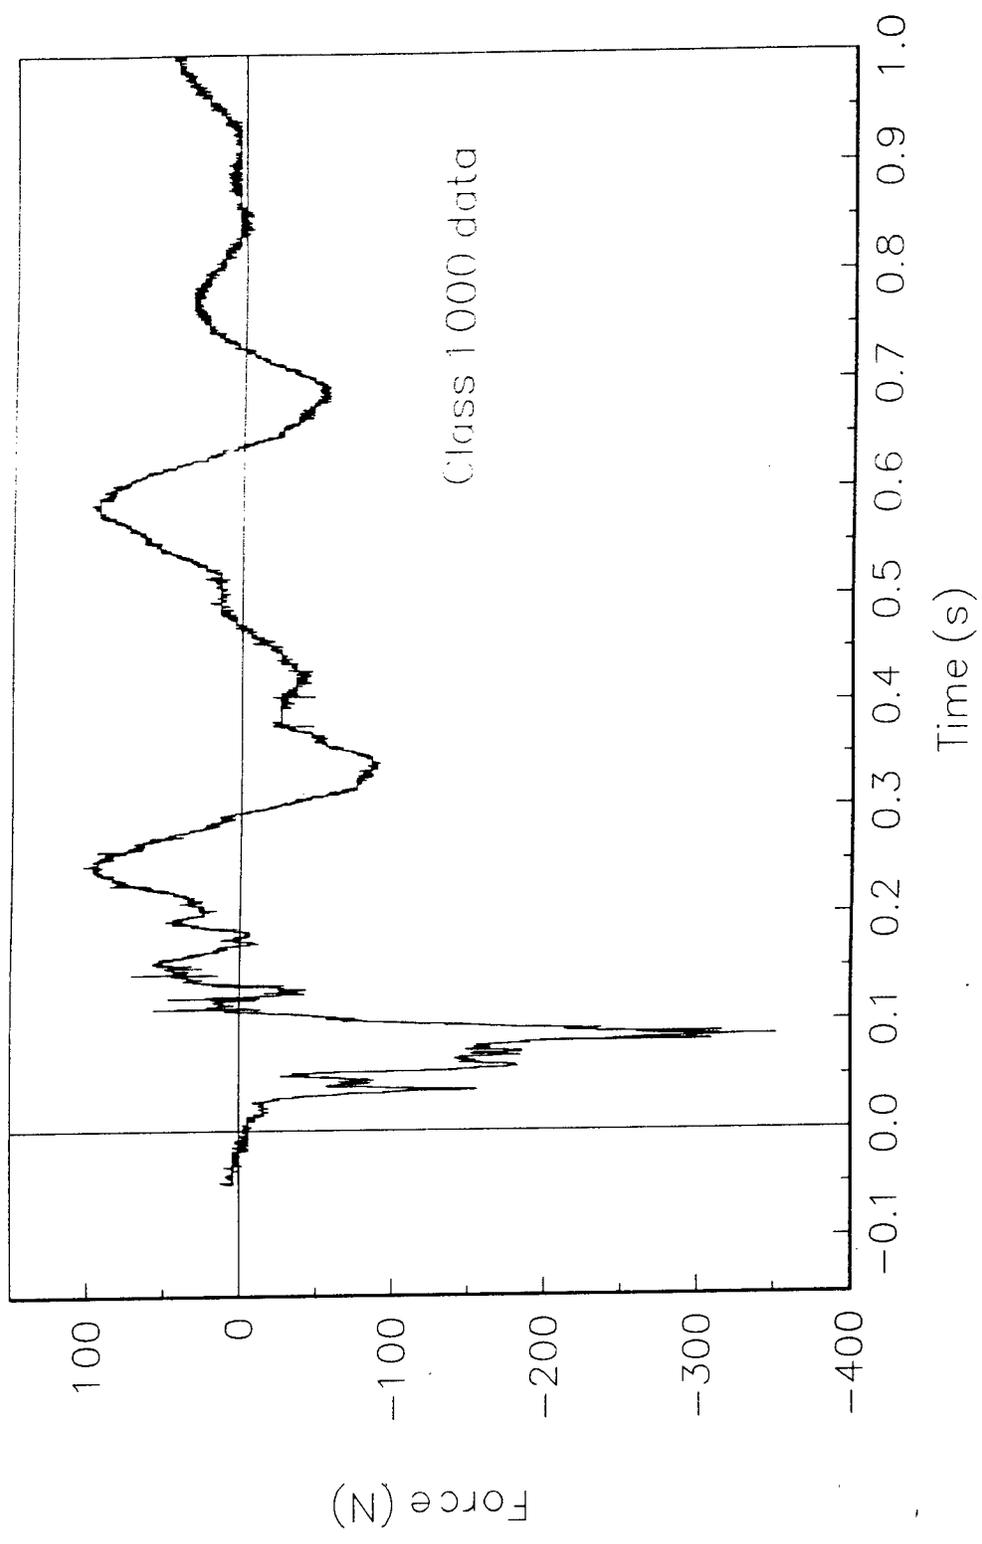
Figure 23. Force vs. time, X-axis neck, test 97S003.

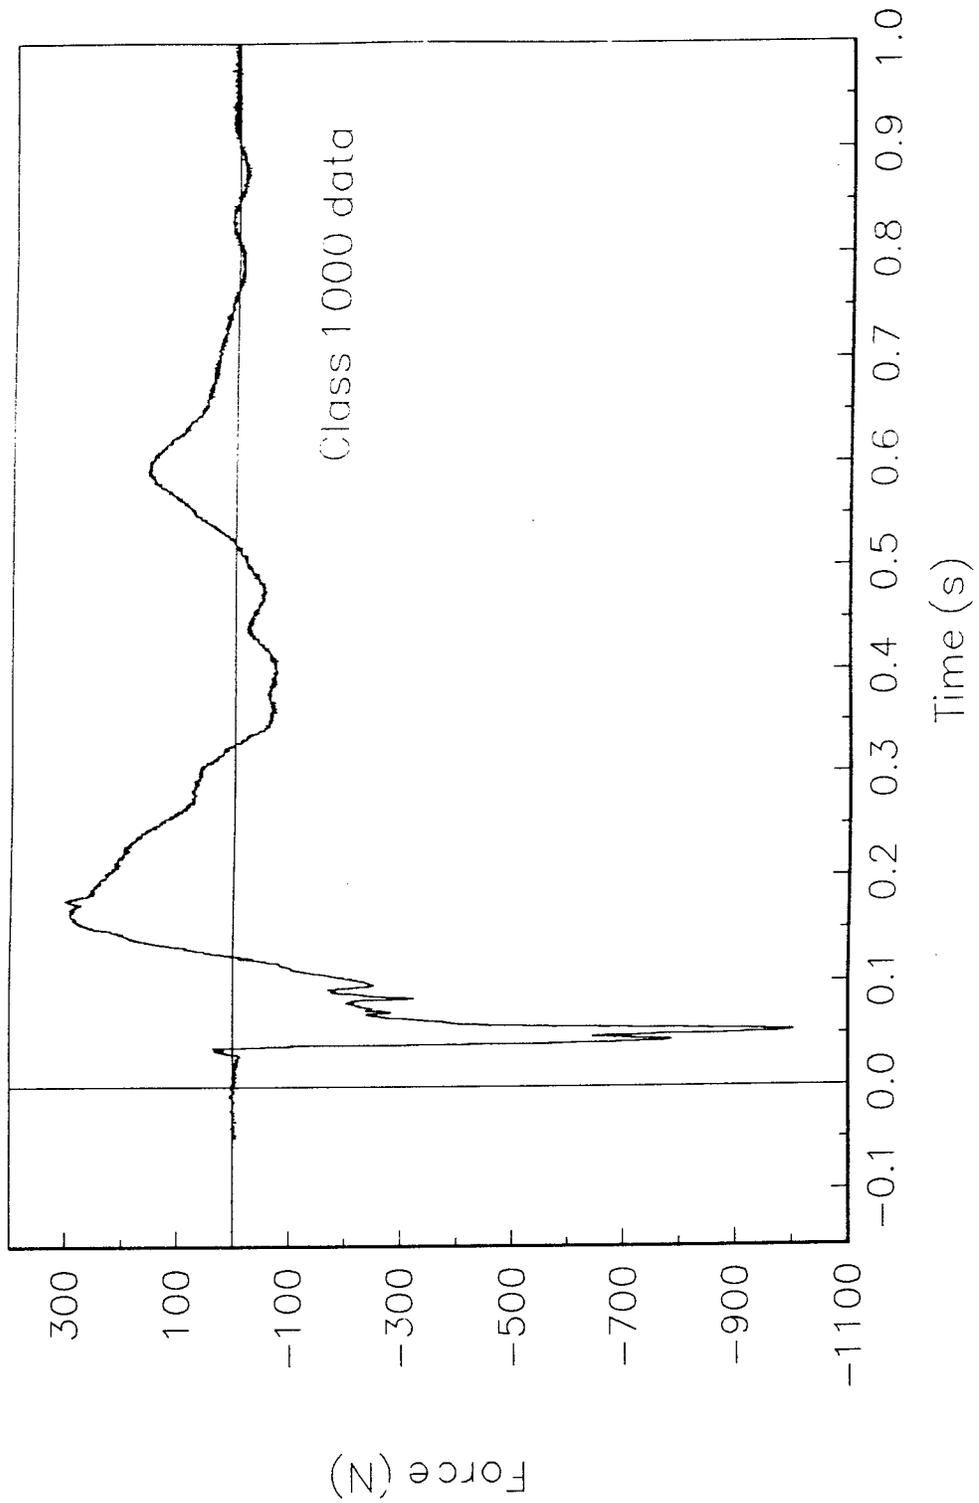
Figure 24. Force vs. time, Y-axis neck, test 97S003.

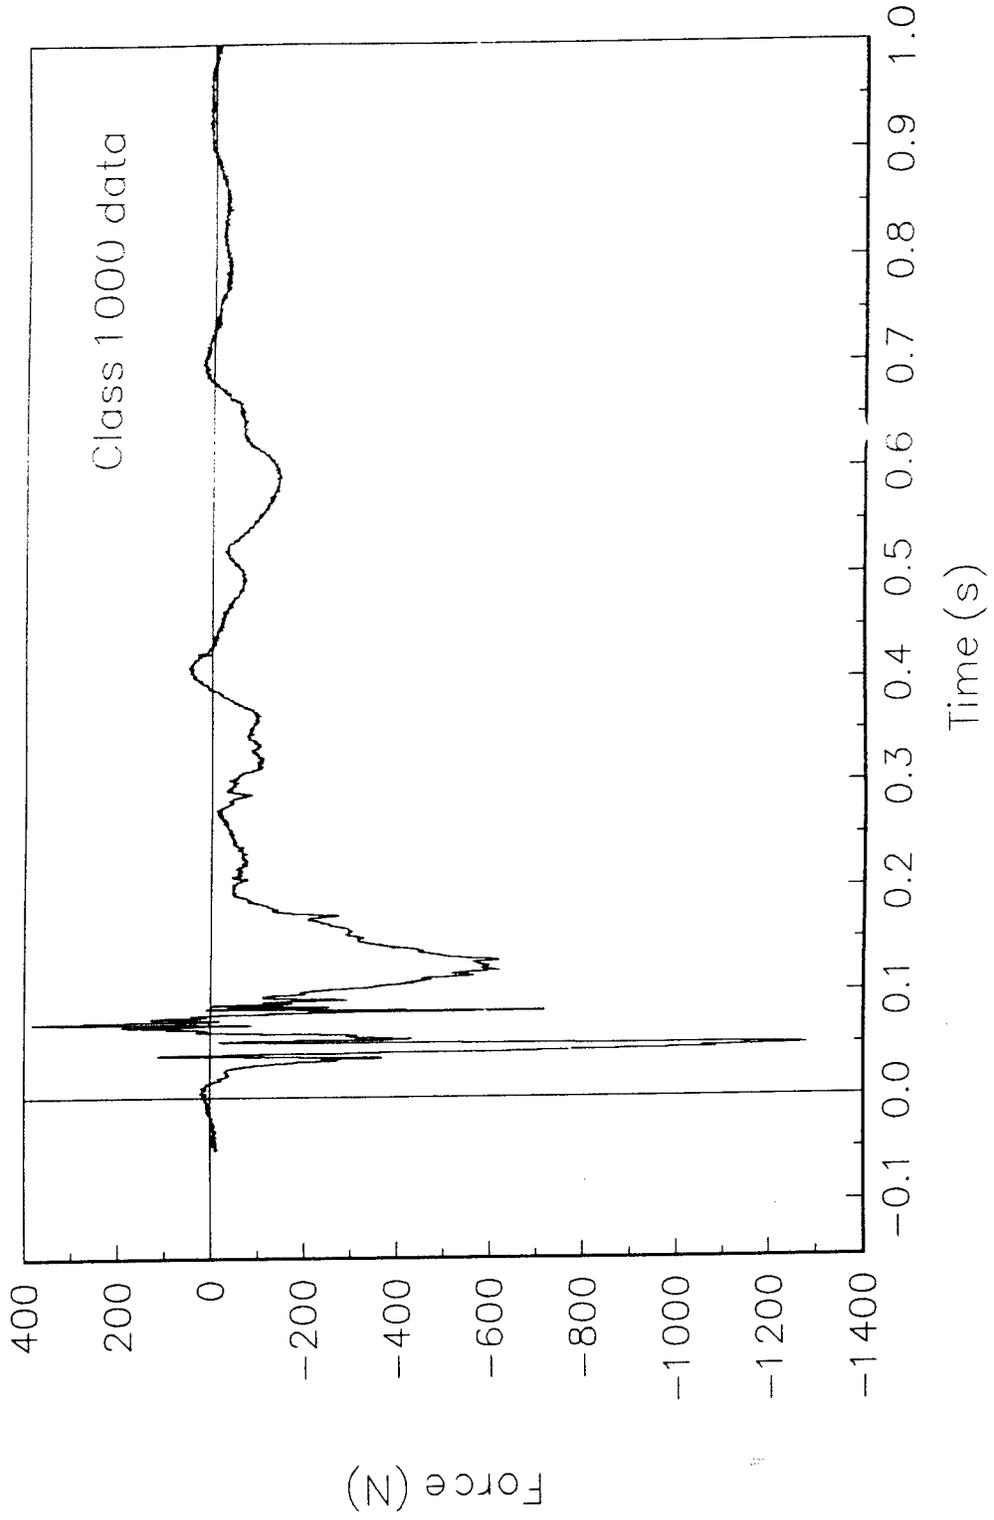
Figure 25. Force vs. time, Z-axis, neck, test 97S003.

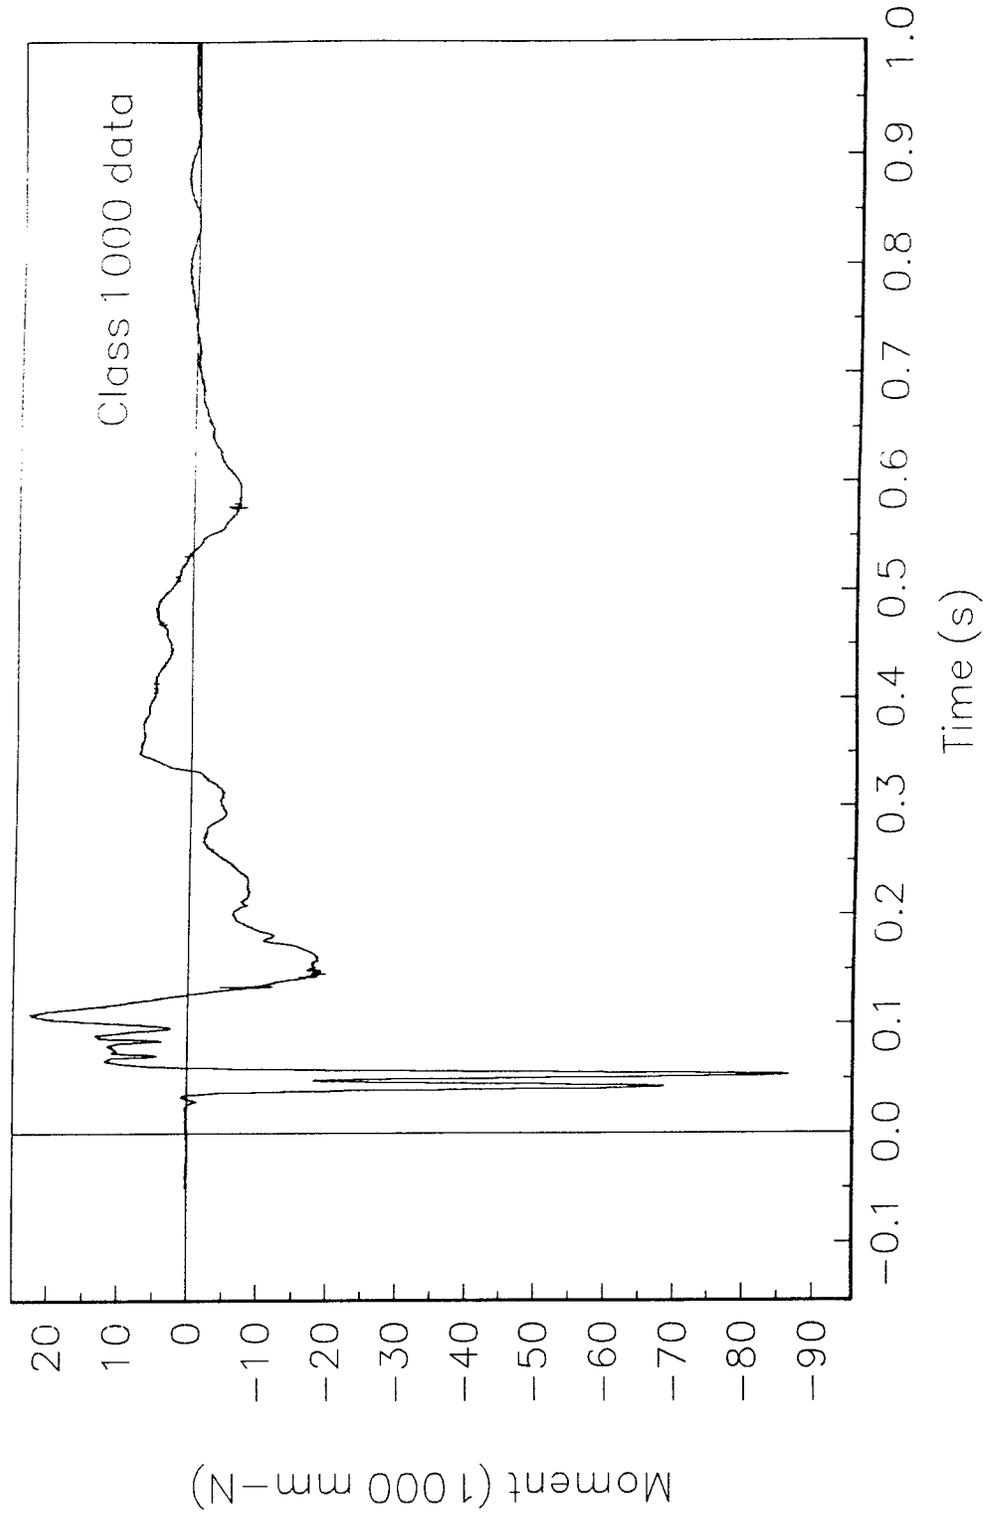
Figure 26. Moment vs. time, X-axis neck, test 97S003.

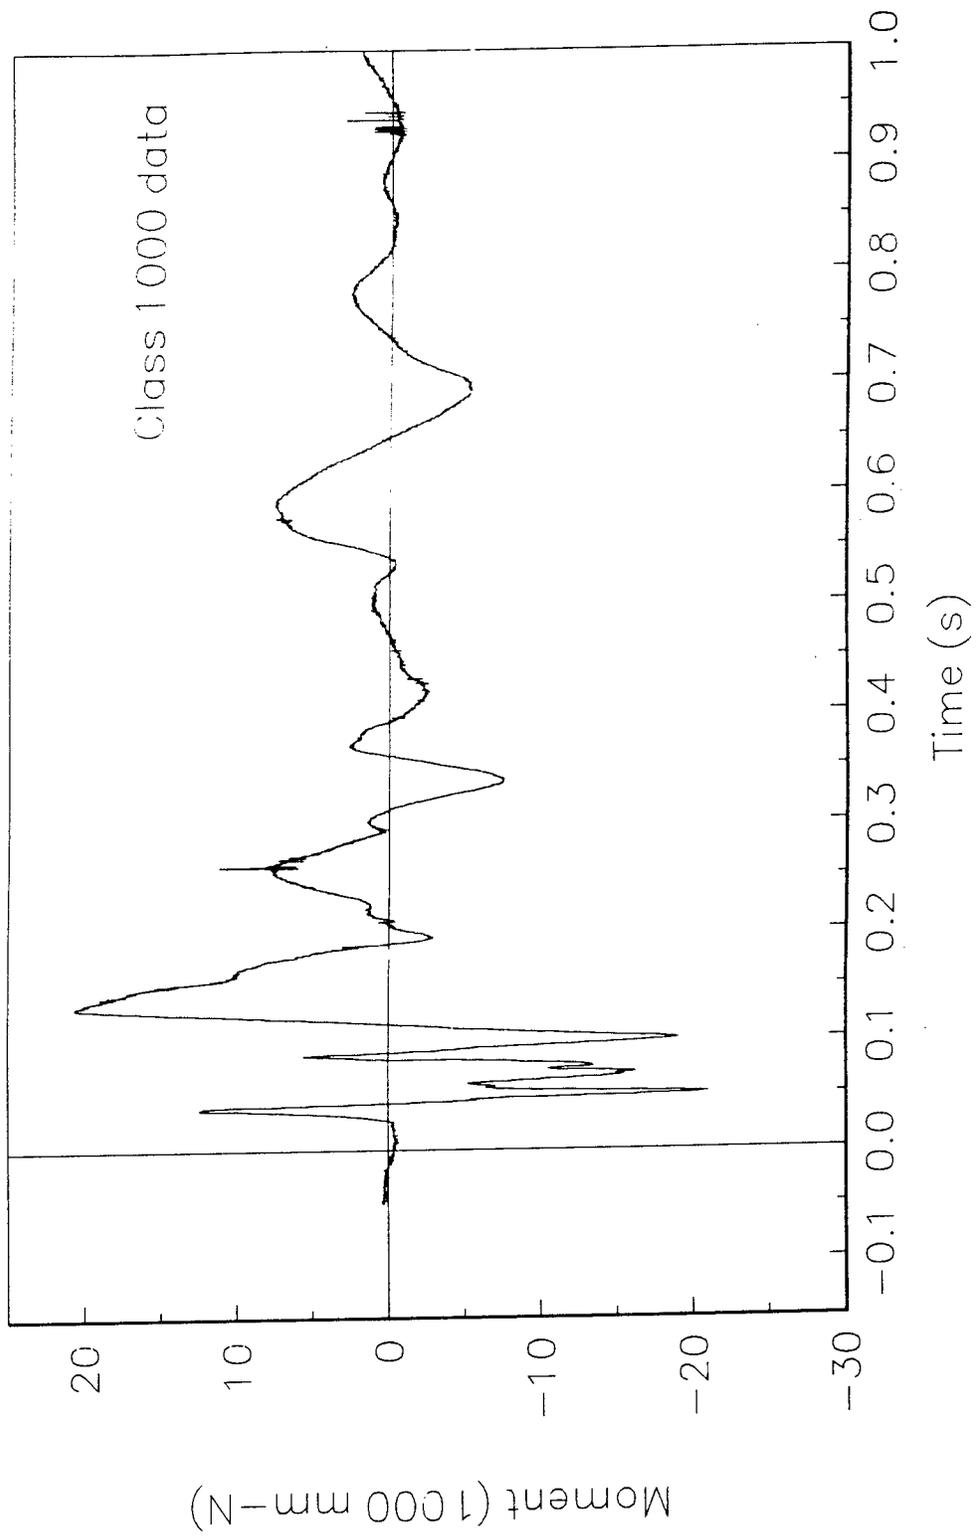
Figure 27. Moment vs. time, Y-axis neck, test 97S003.

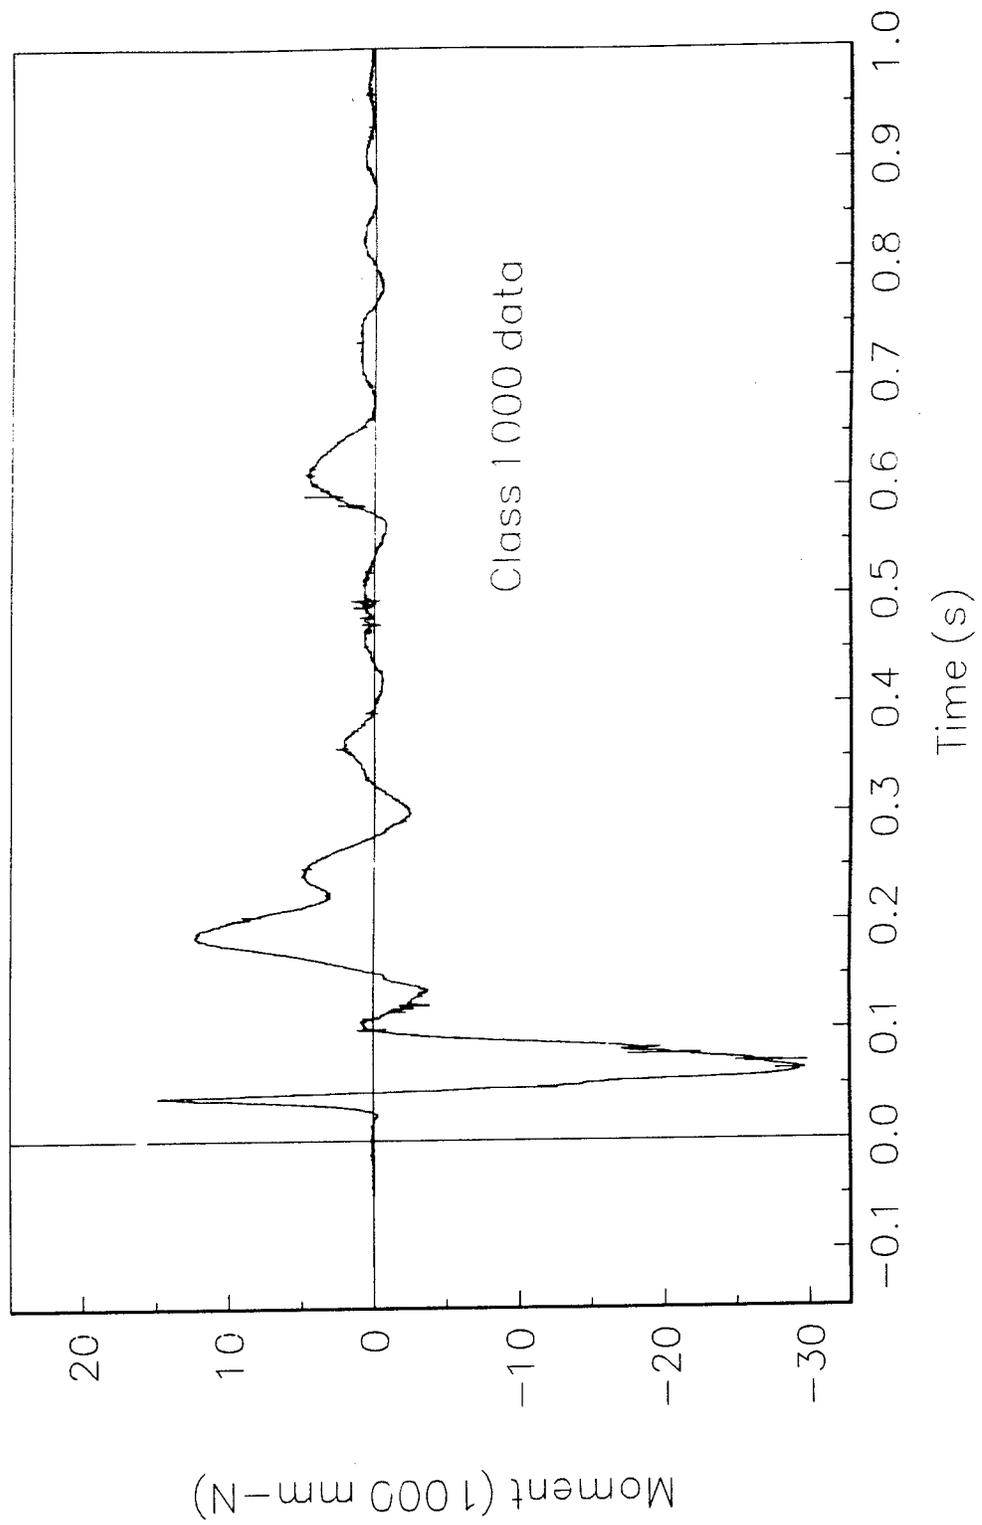
Figure 28. Moment vs. time, Z-axis neck, test 97S003.

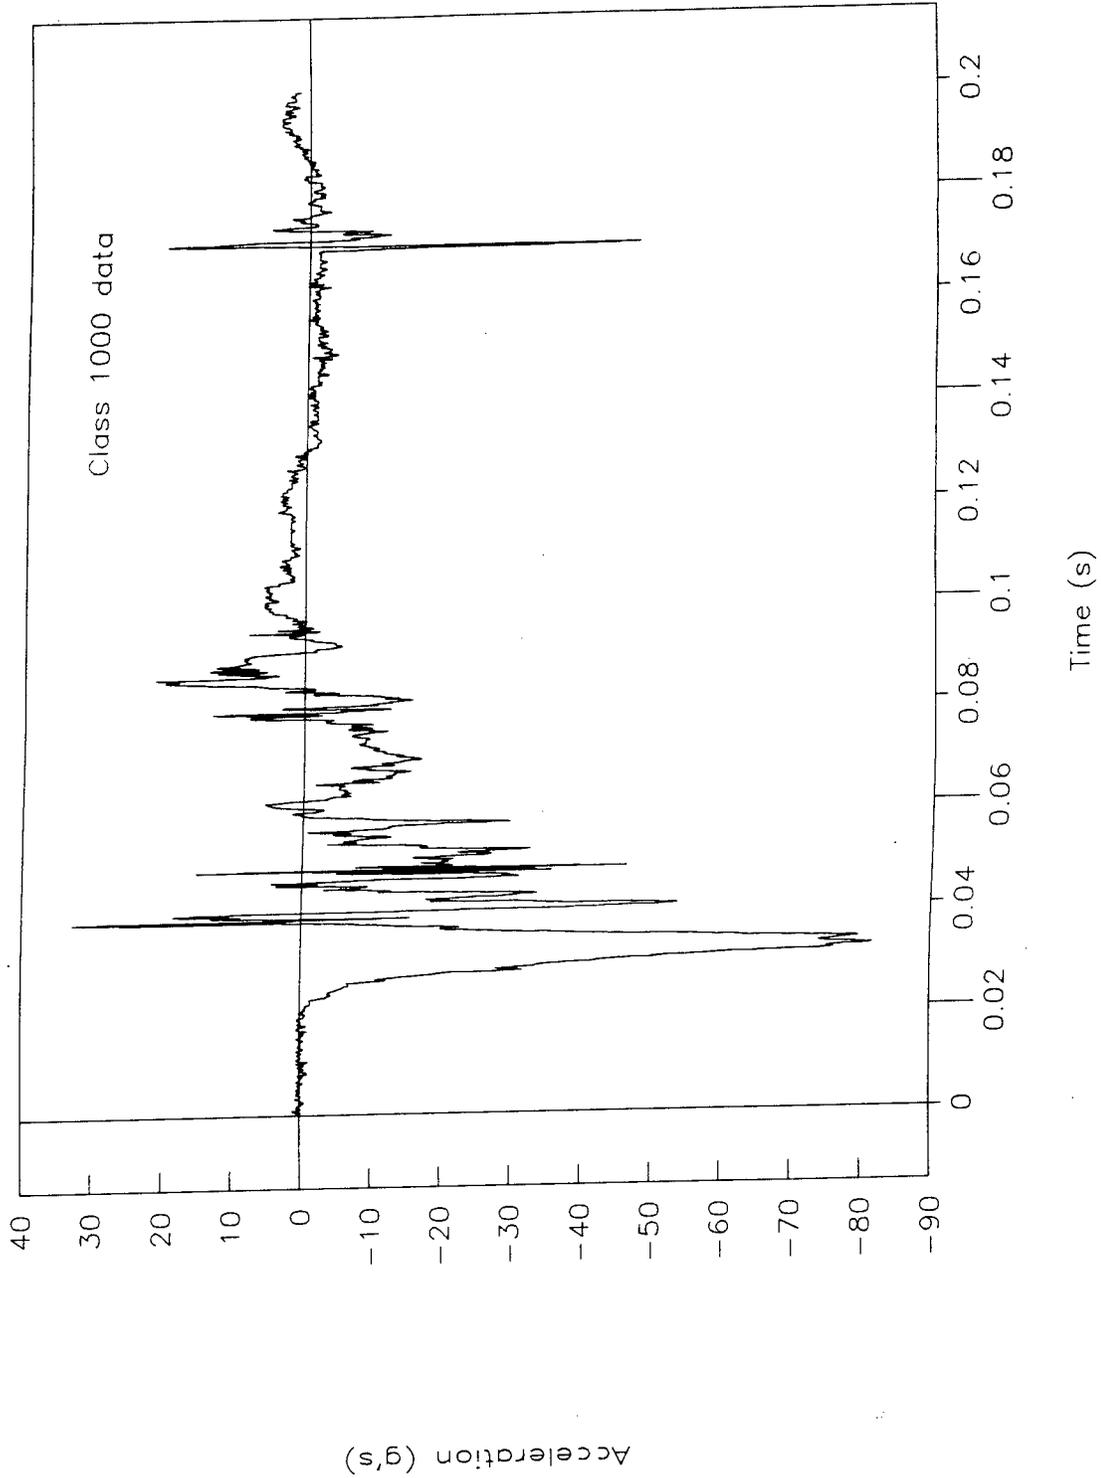
Figure 29. Acceleration vs. time, primary upper rib, test 97S003.

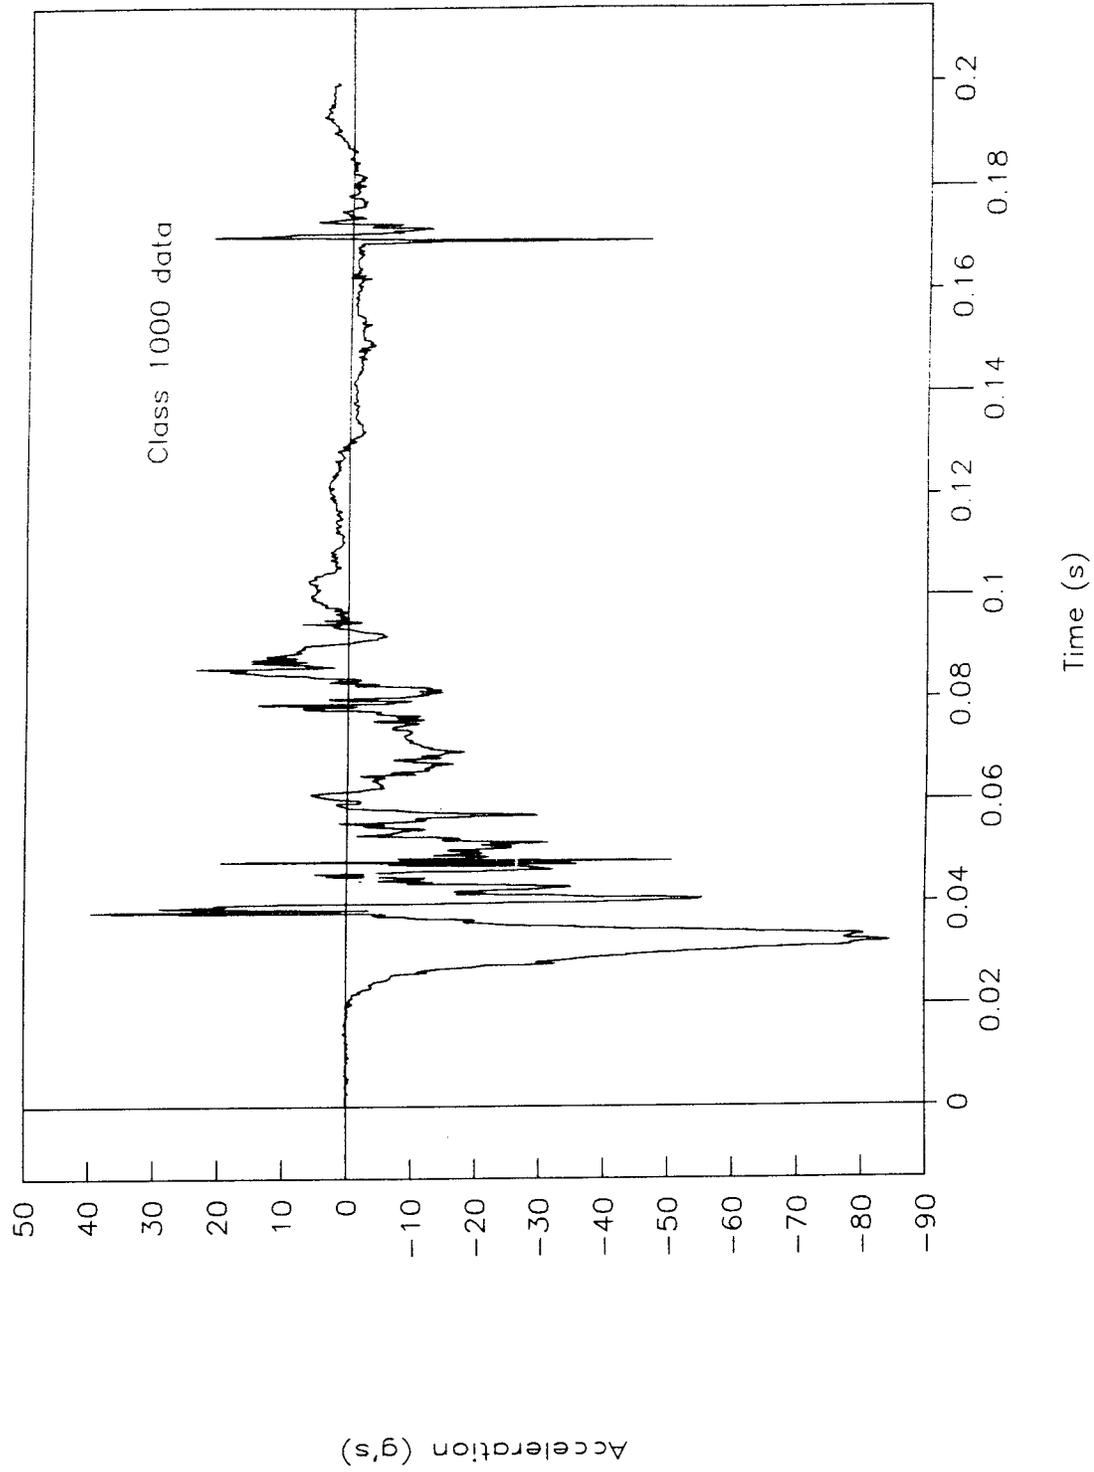
Figure 30. Acceleration vs. time, redundant upper rib, test 97S003.

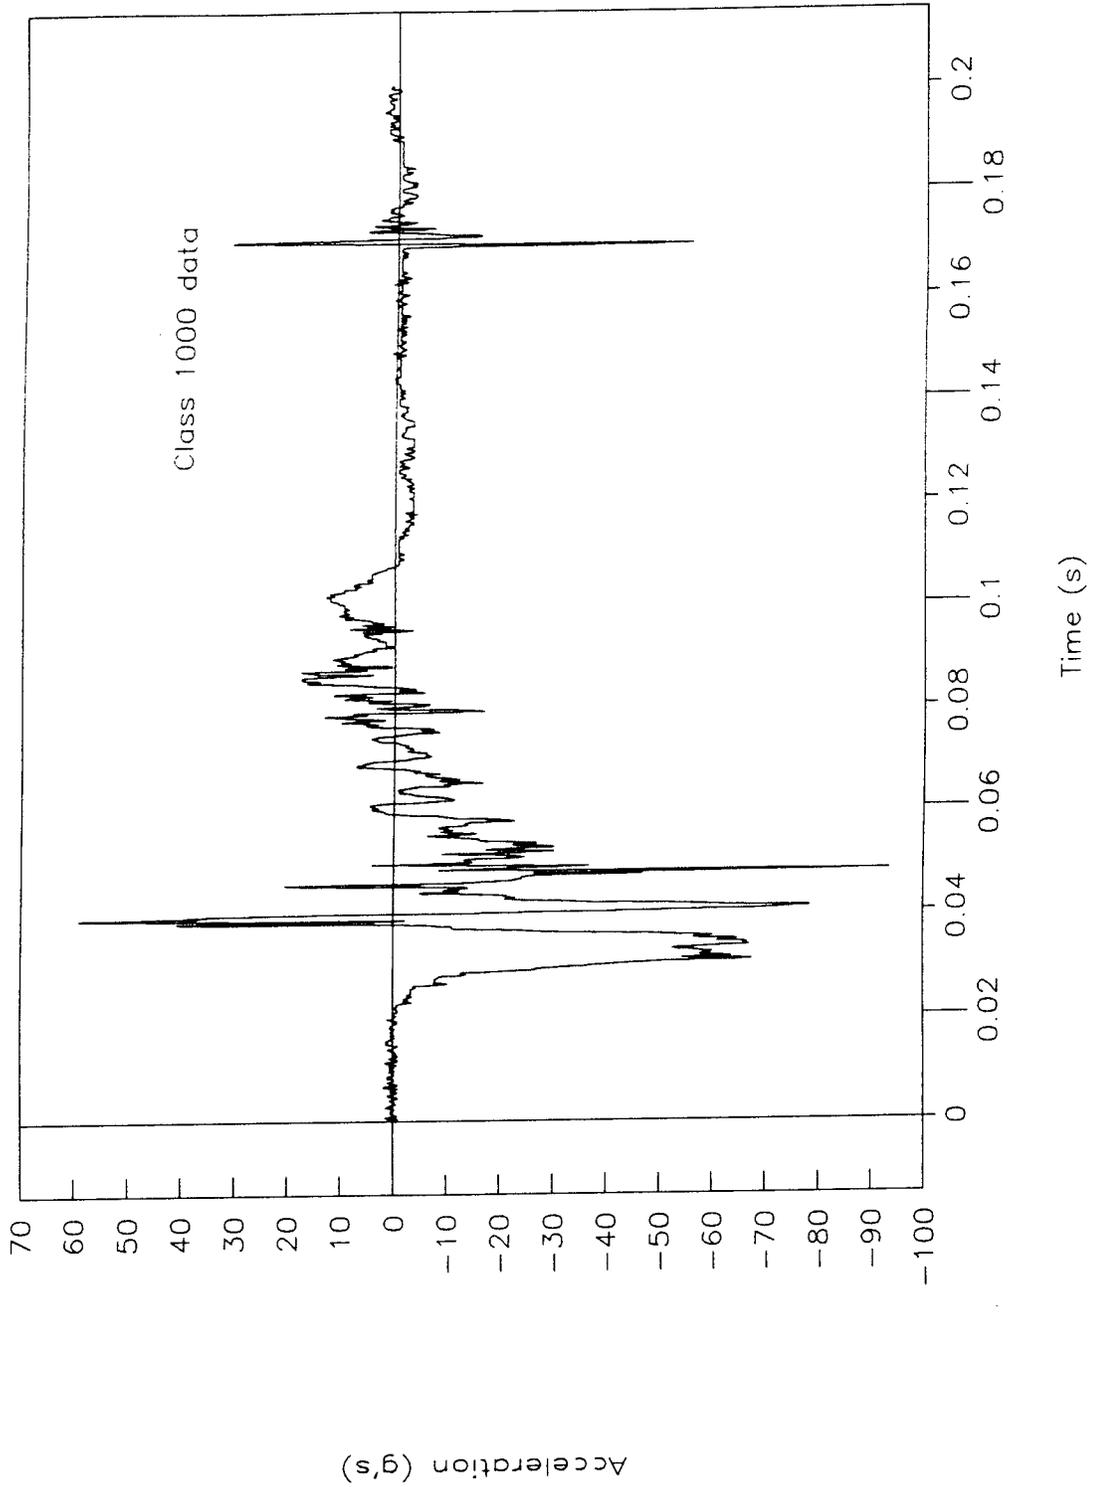
Figure 31. Acceleration vs. time, primary lower rib, test 97S003.
