Honda Accord LX Broadside Collision

With a Narrow Fixed-Object:

Foil Test Number 97S003

PUBLICATION NO. FHWA-RD-98-008

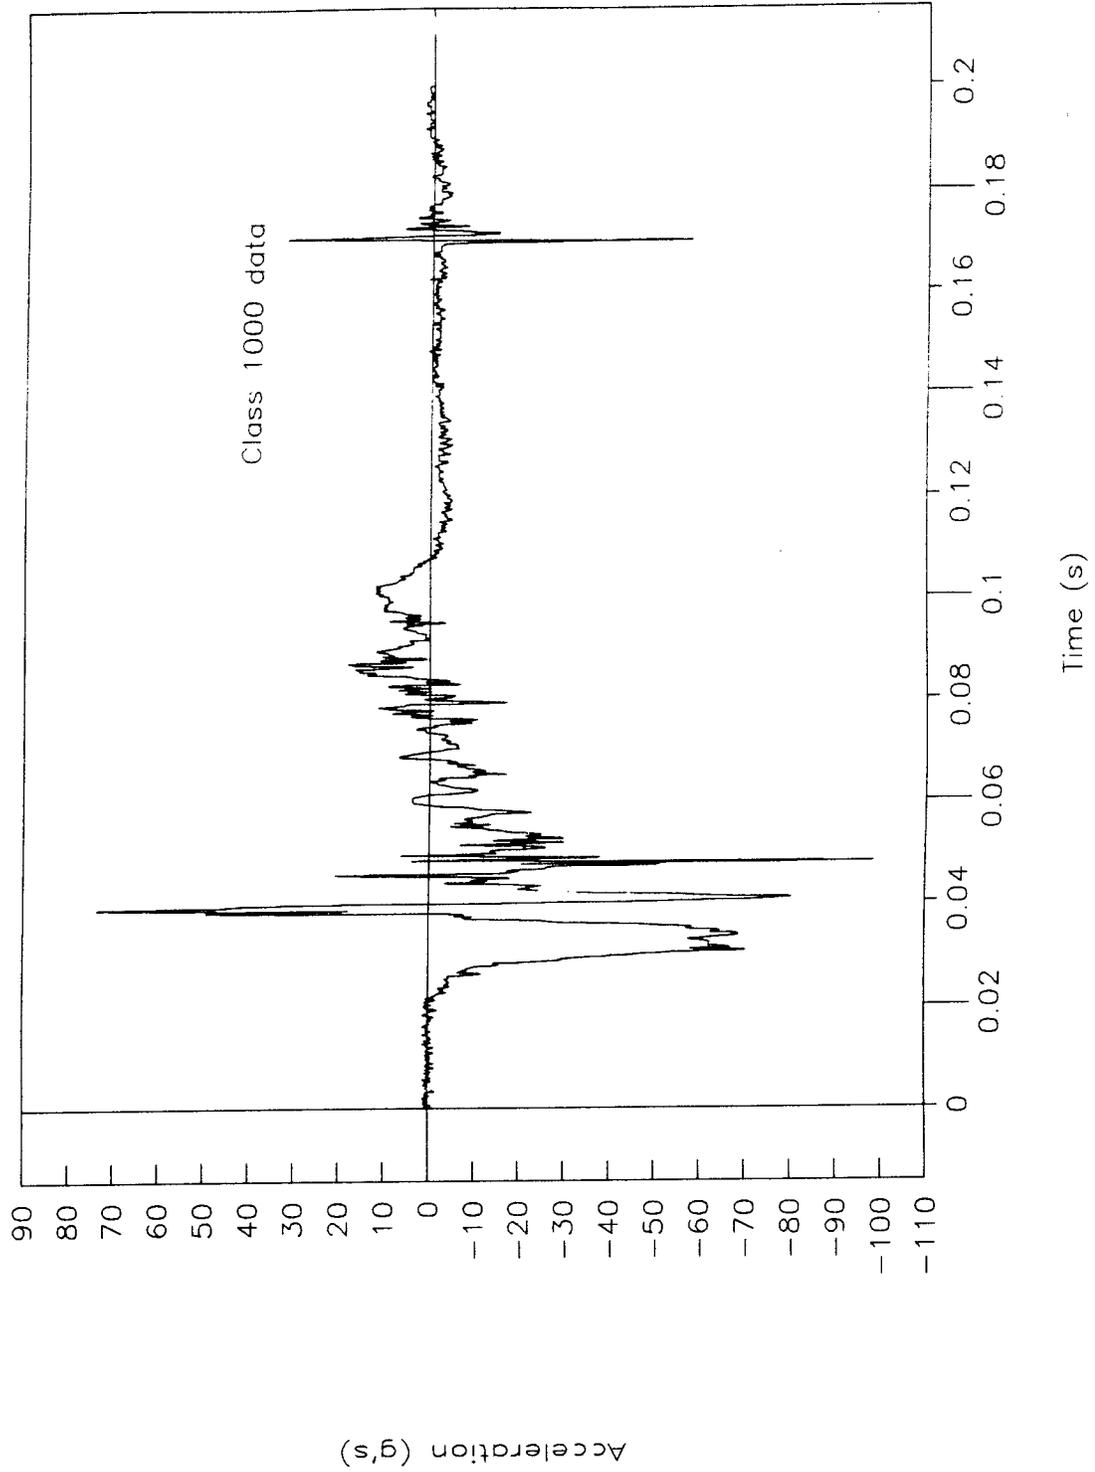
Figure 32. Acceleration vs. time, redundant lower rib, test 97S003.

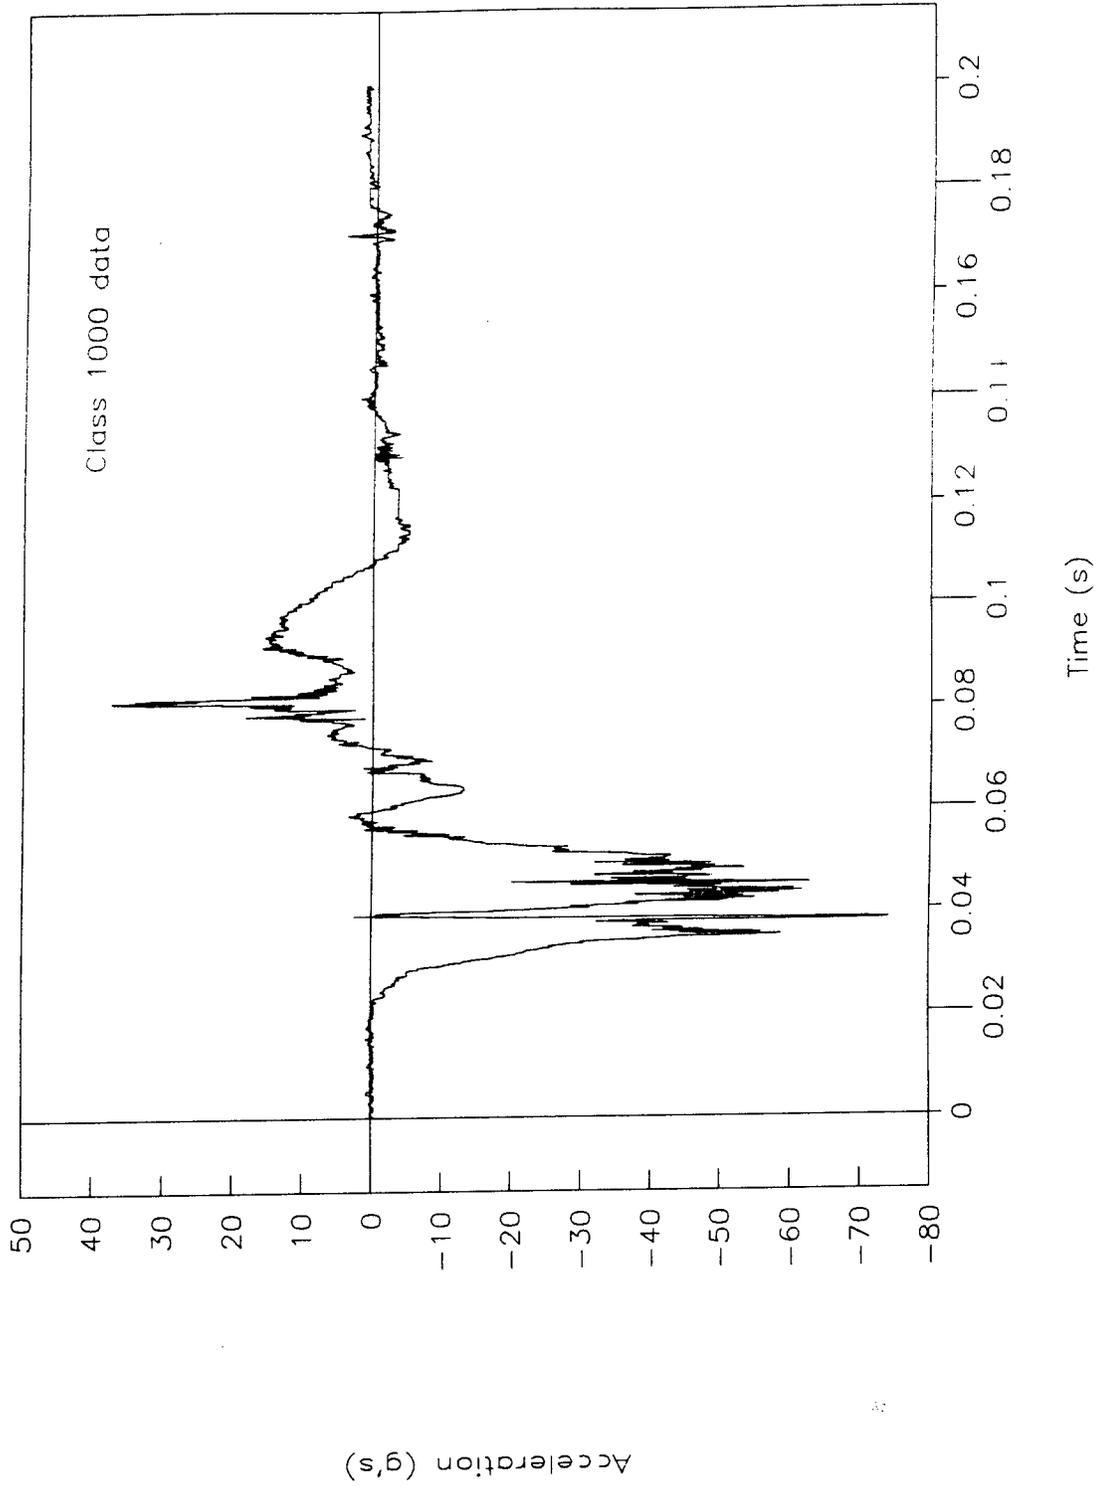
Figure 33. Acceleration vs. time, primary T12 spine, test 97S003.

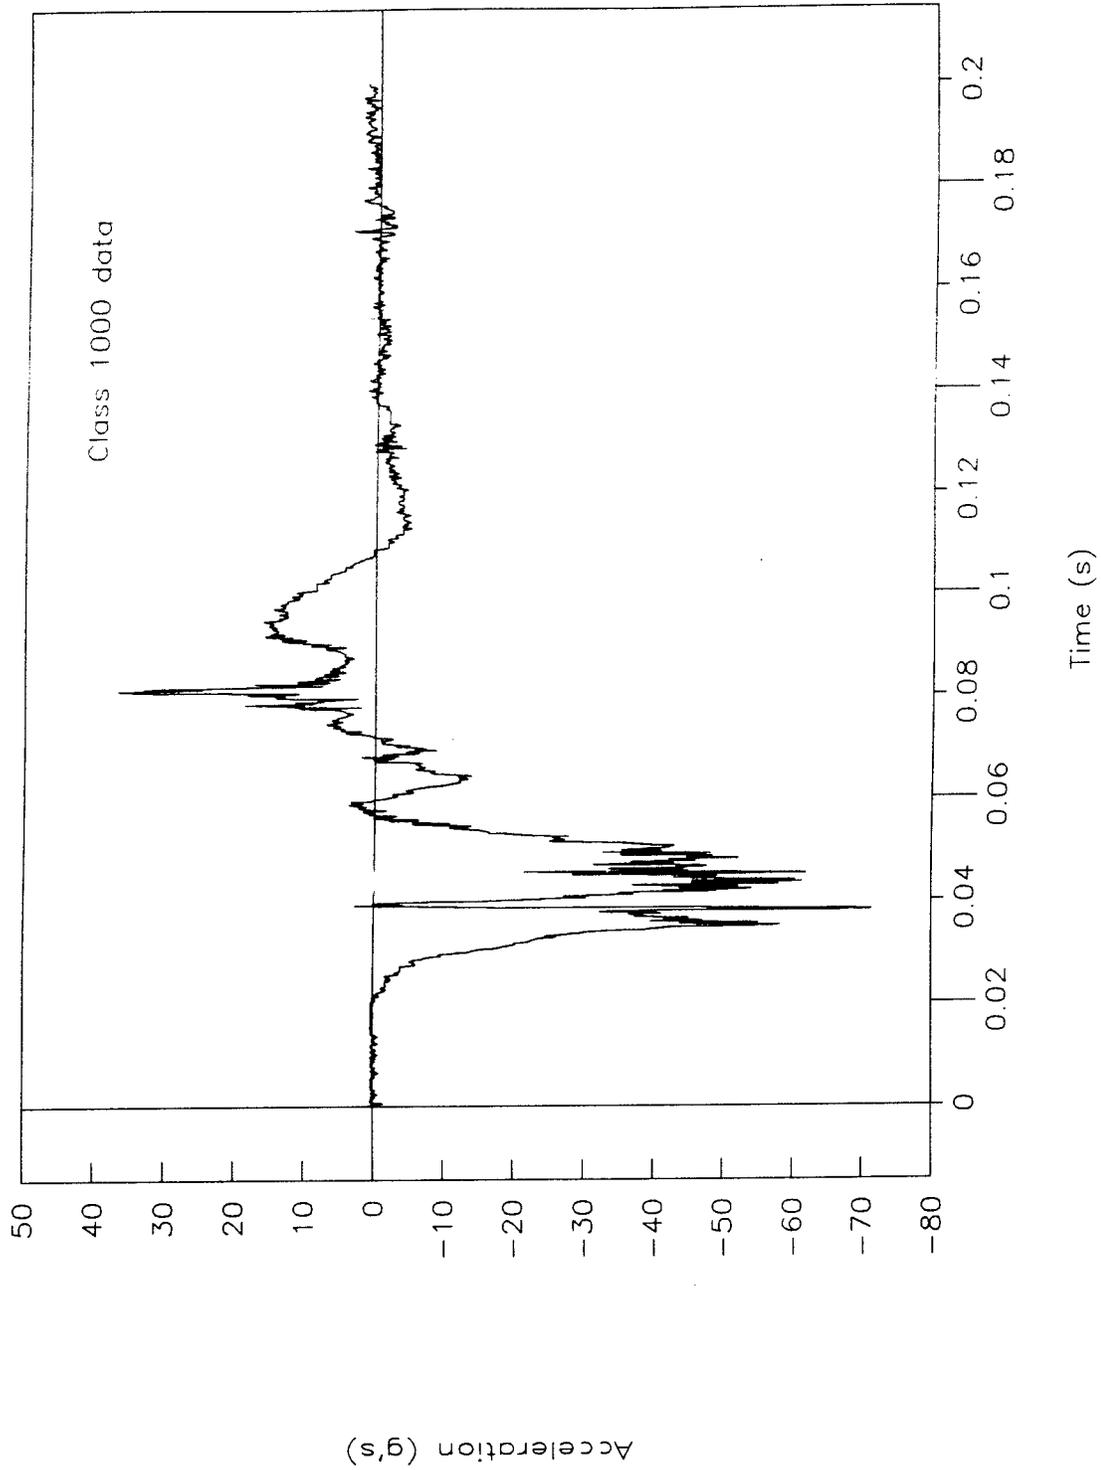
Figure 34. Acceleration vs. time, redundant T12 spine, test 97S003.

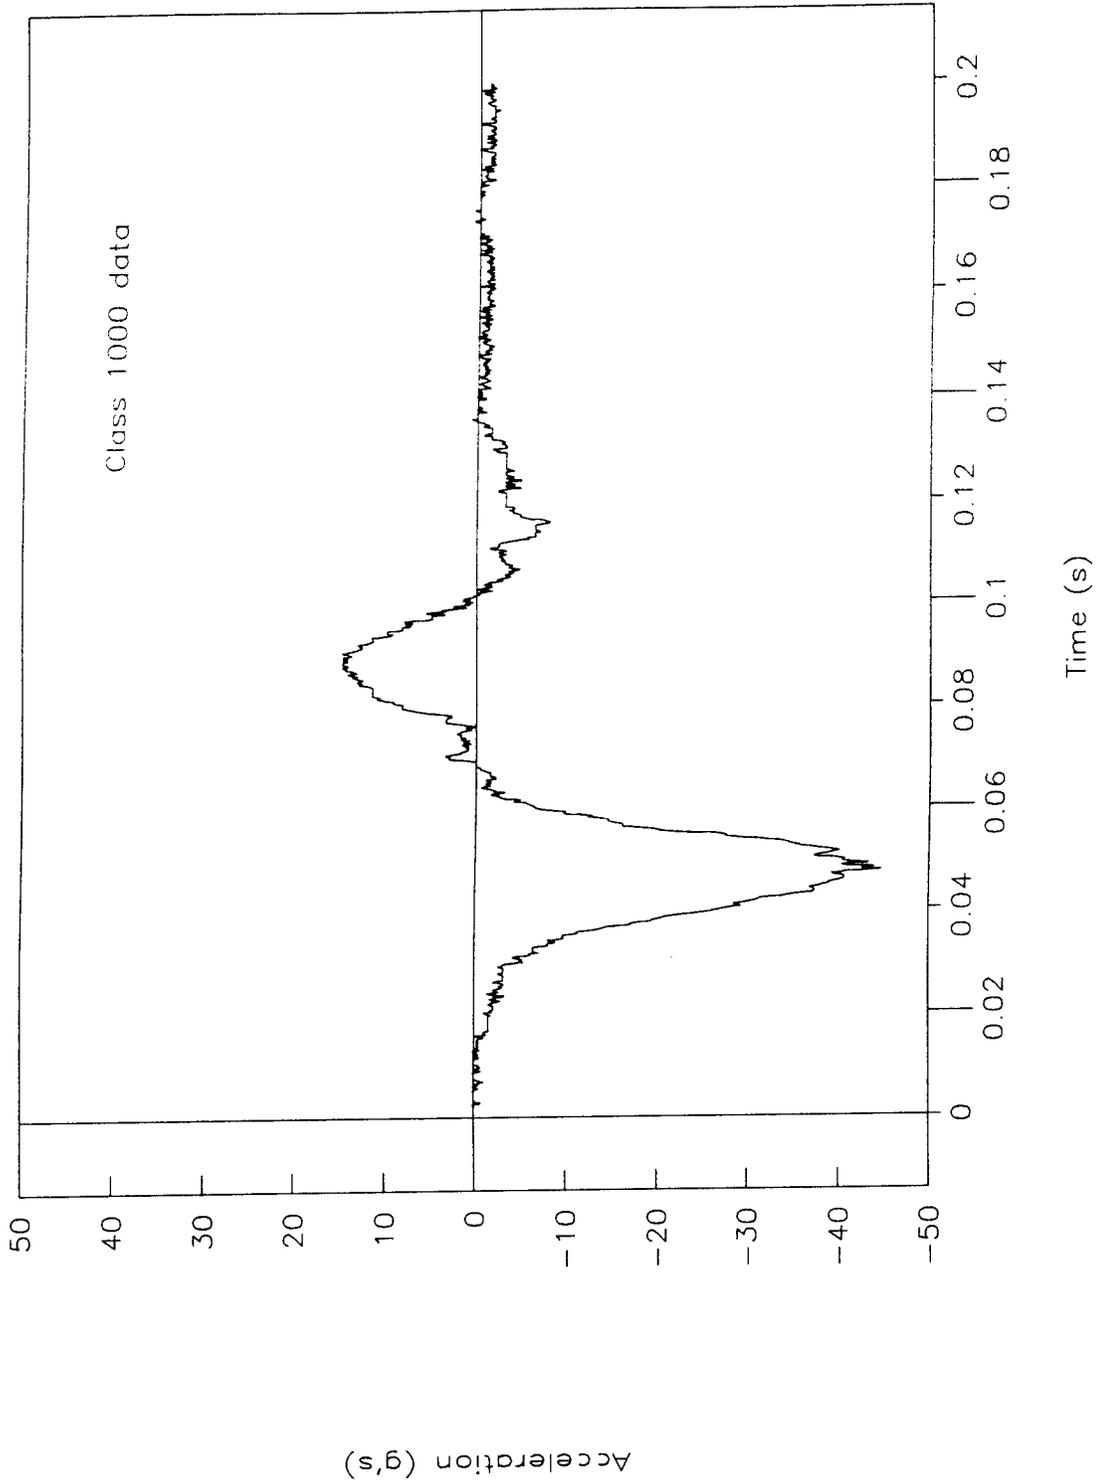
Figure 35. Acceleration vs. time, Y-axis pelvis, test 97S003.

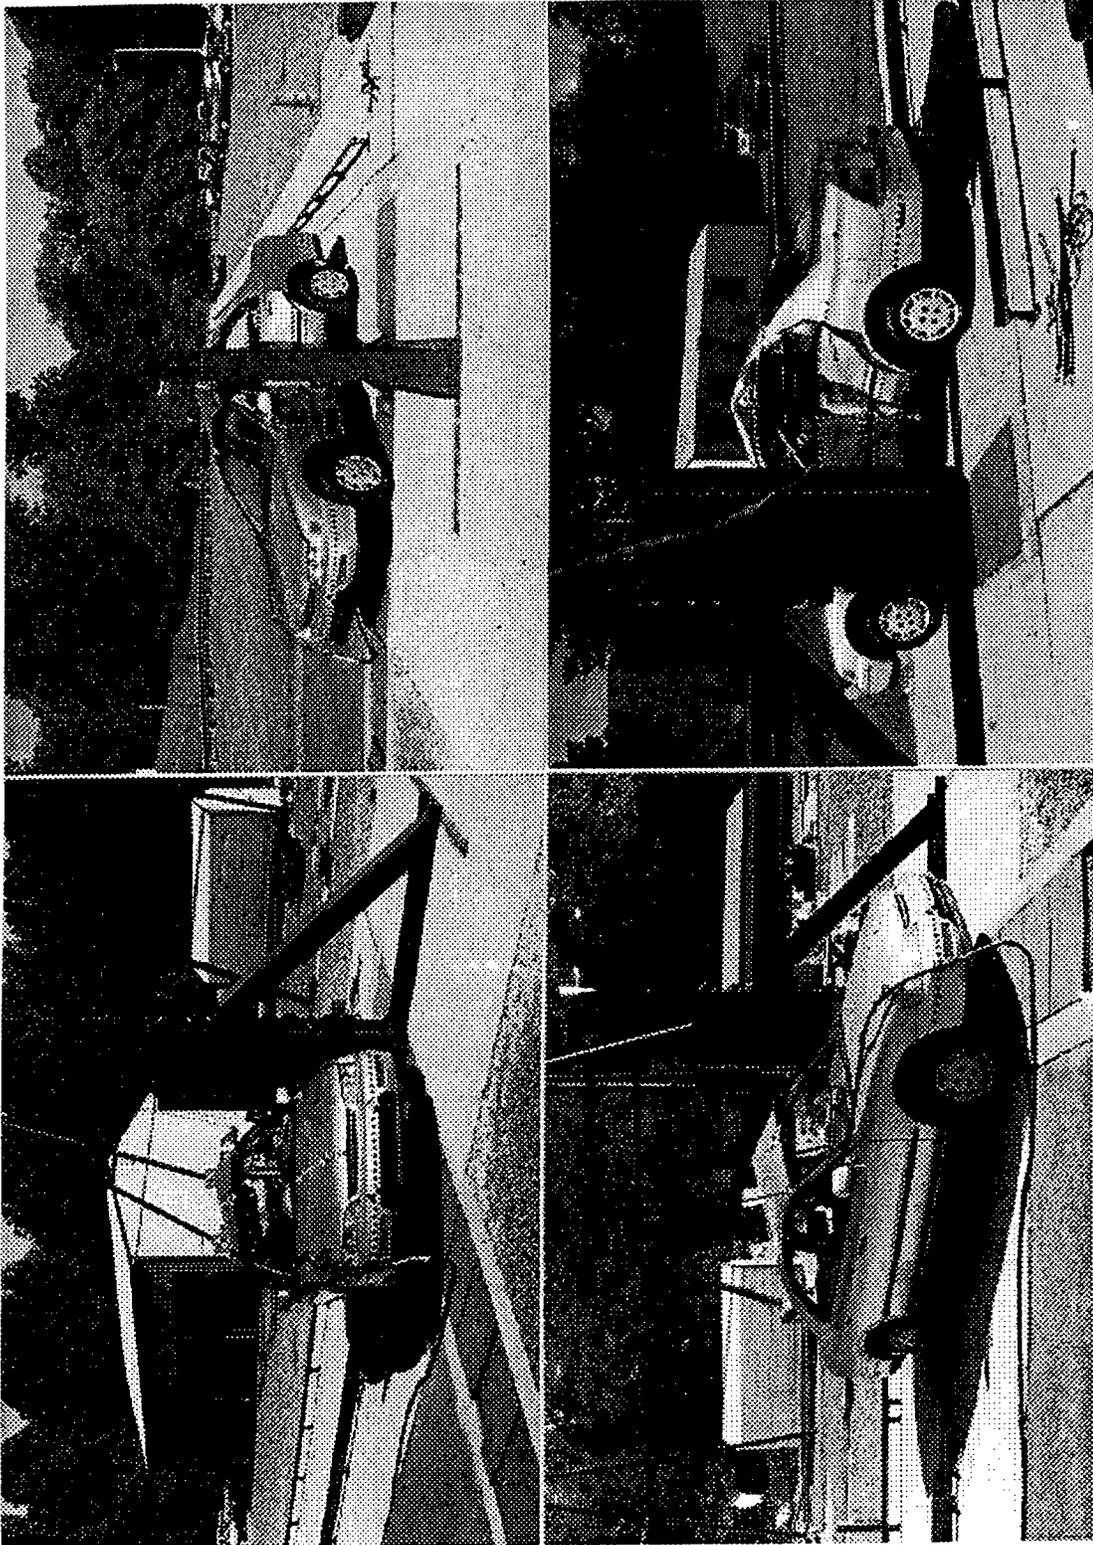
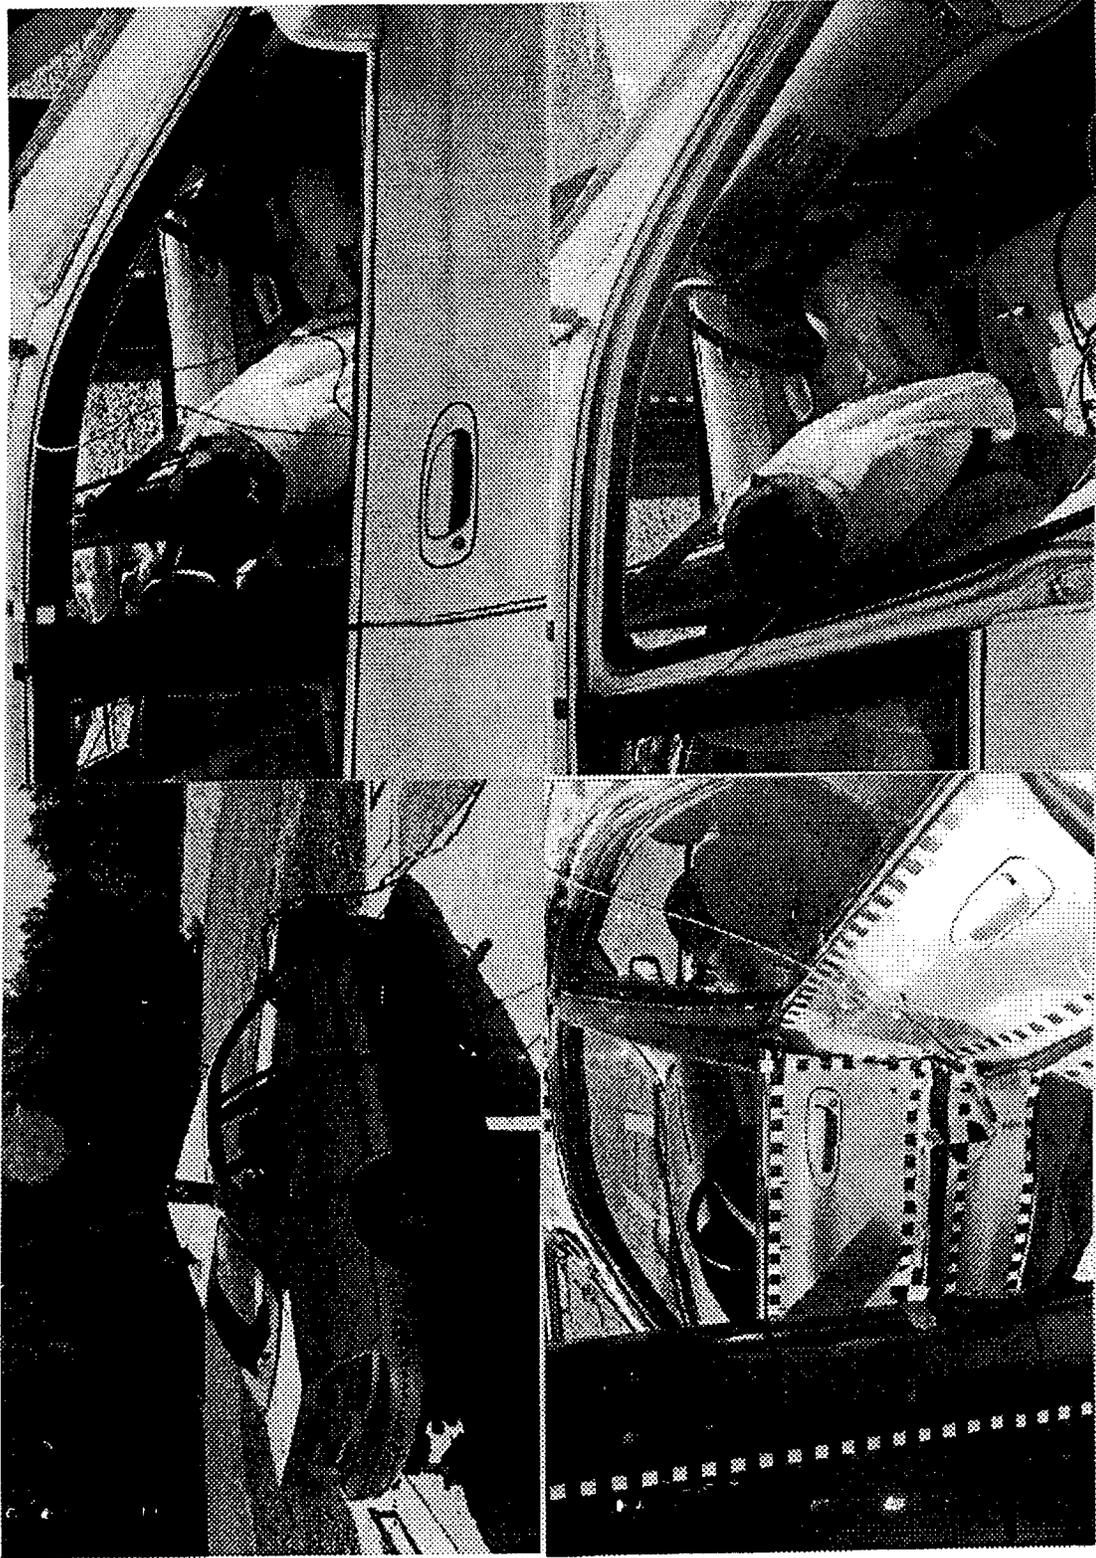
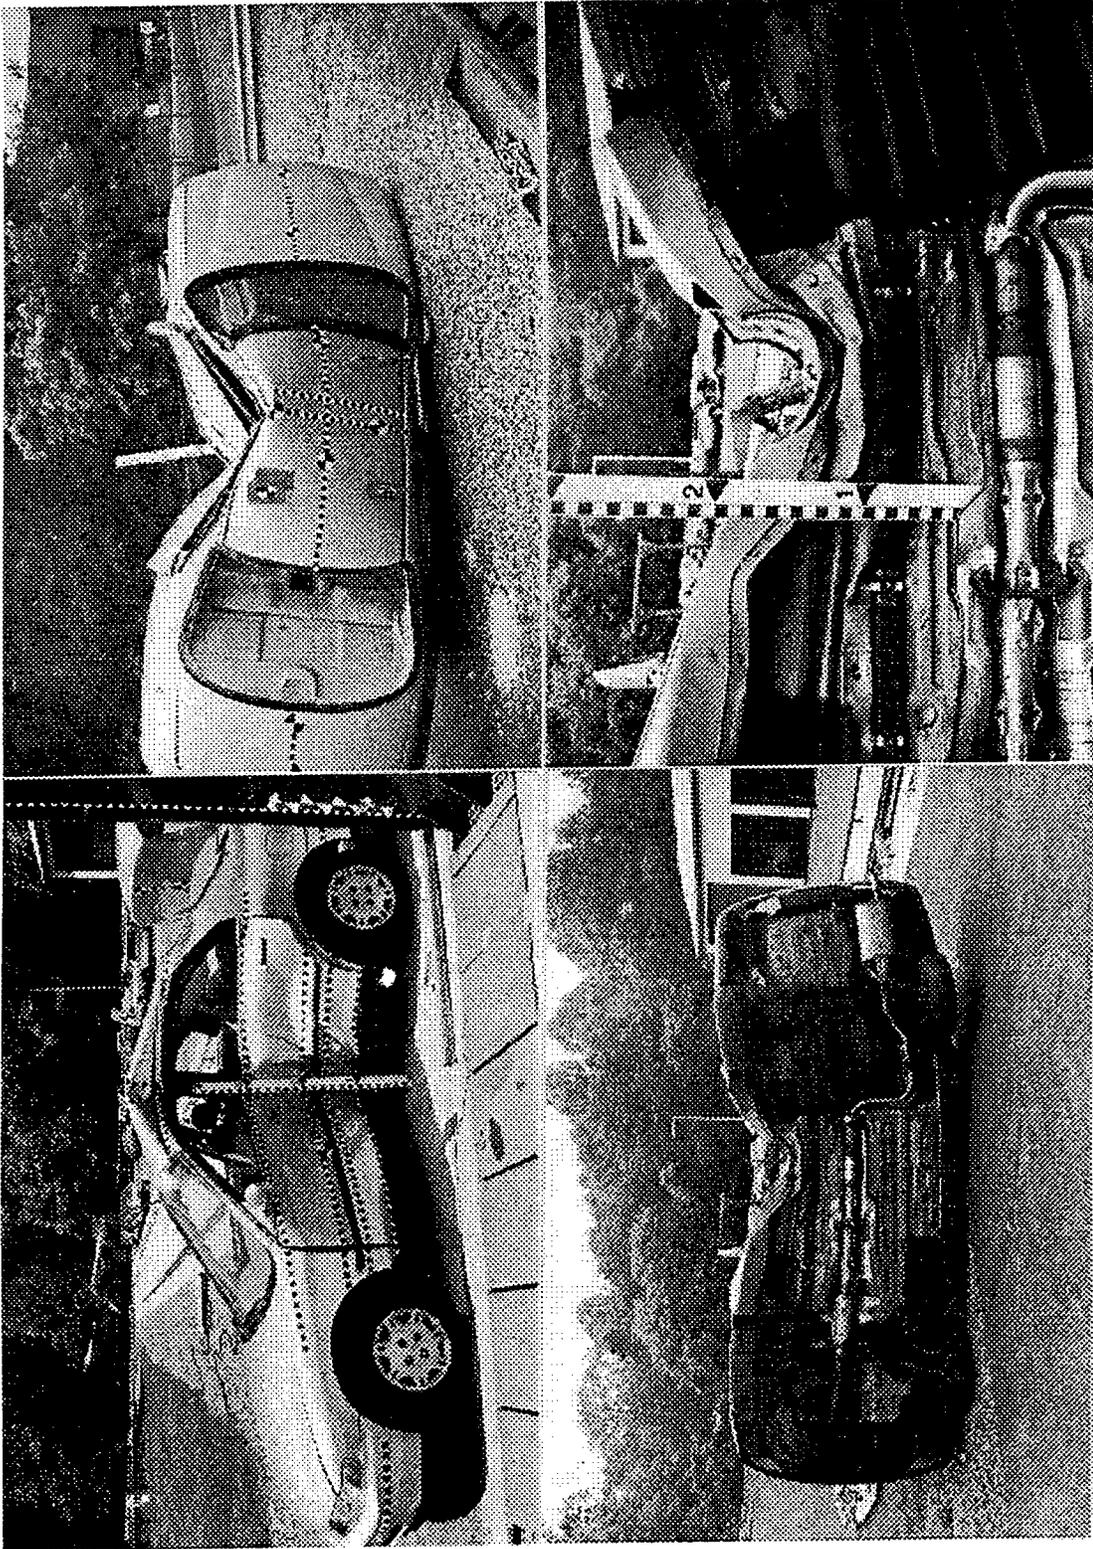
Figure 38. Post-test photographs, test 97S003.

Fuel system and door latch integrity were not breached by the broadside collision with the FOIL instrumented rigid pole (narrow-fixed object). Red, green, and yellow chalk on the B-pillar indicated significant contact between the B-pillar and the dummy's head (side, rear, and top). This contact caused the dummy to rotate away from the rigid pole, thus lowering contact with the rigid pole. The HIC value was below expected results for a broadside collision with a narrow object aligned with dummy's head cg. The test did not yield adequate results to show that a dynamic side-impact protection system would be of significant improvement. The injury criteria are below current safety standards without an air bag system present.

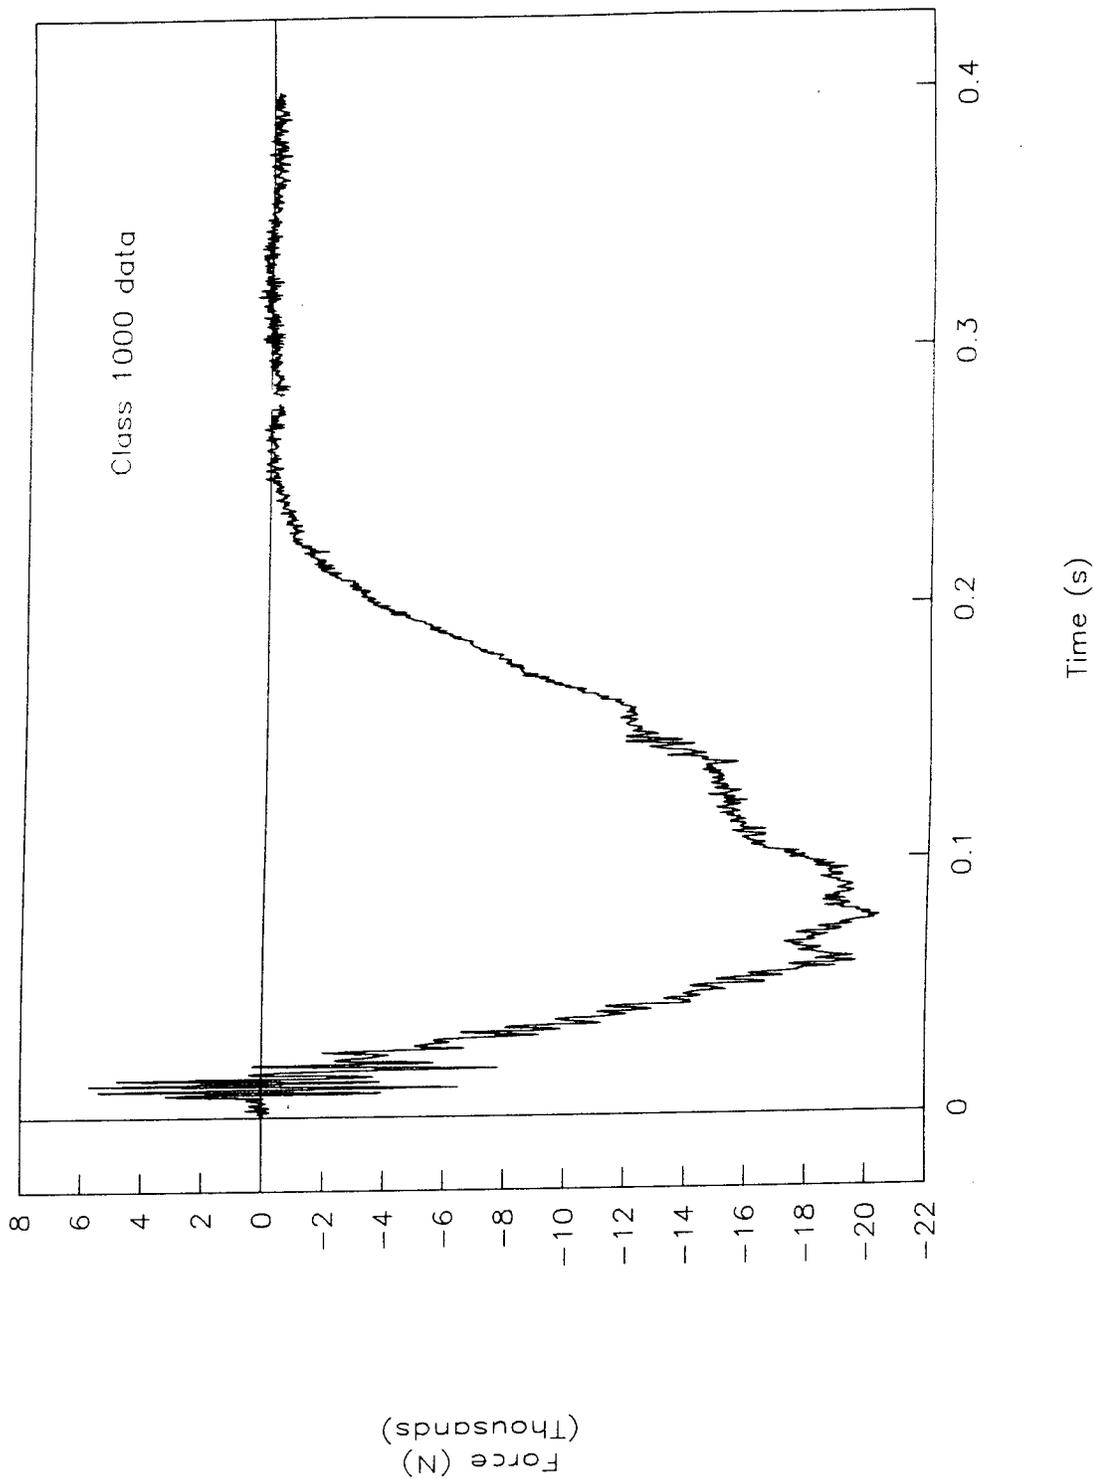
Figure 39. Rigid pole, force vs. time, bottom face lower load cell, test 97S003.

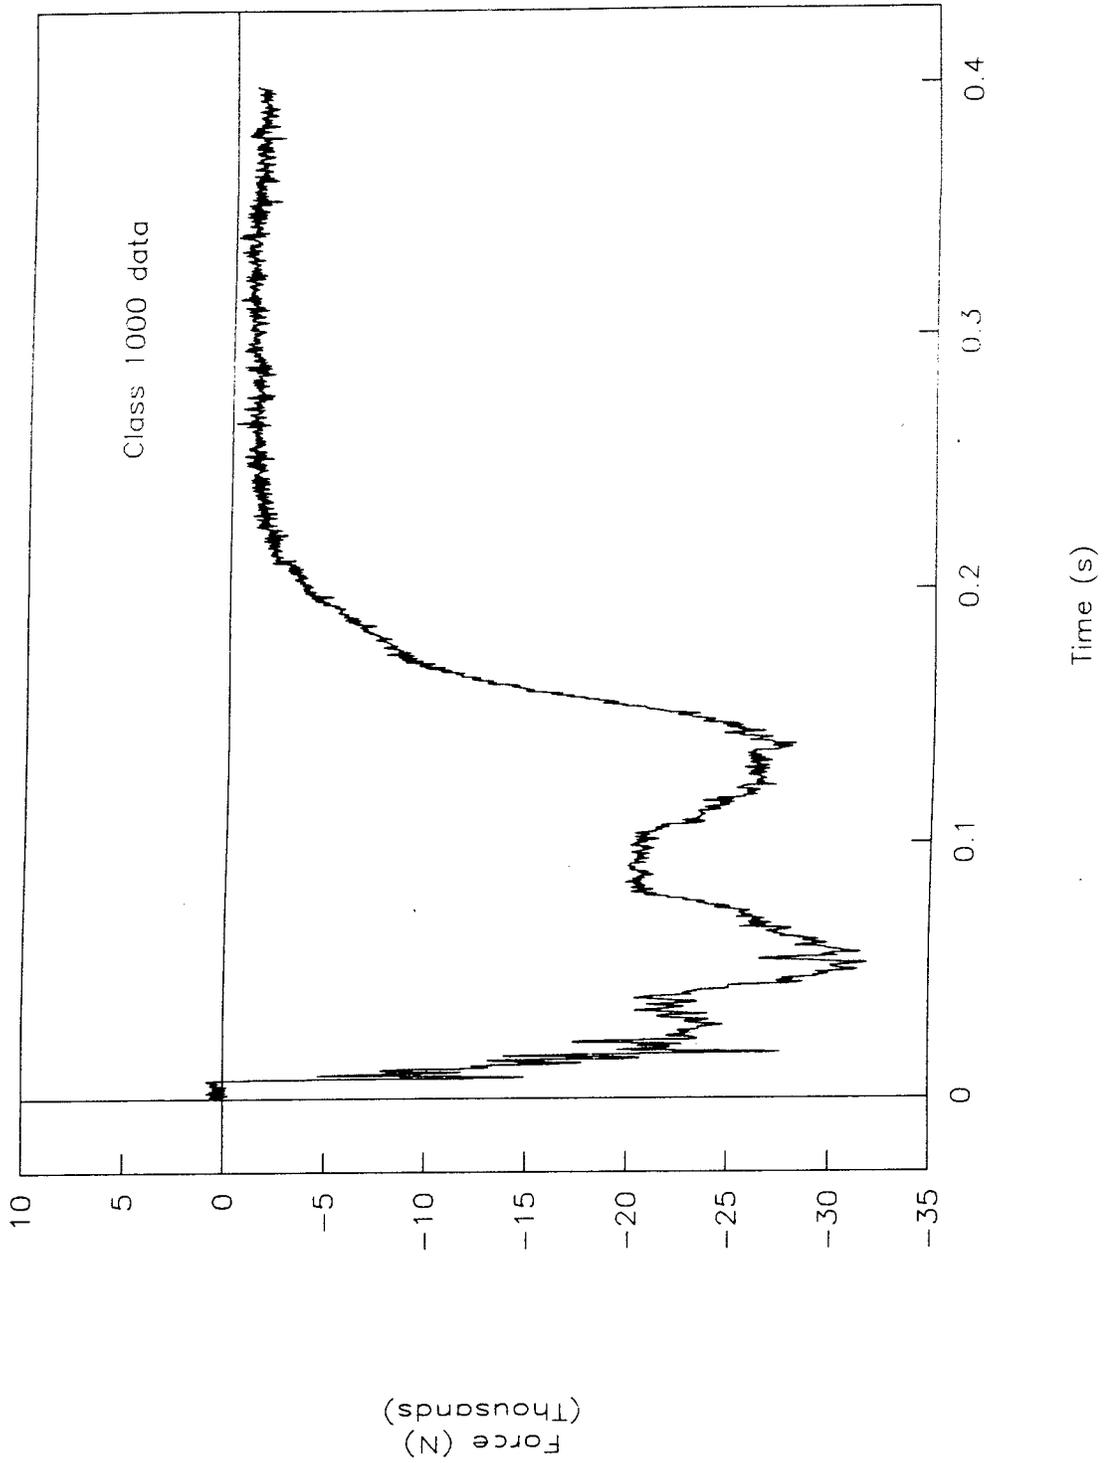
Figure 40. Rigid pole, force vs. time, bottom face upper load cell, test 97S003.

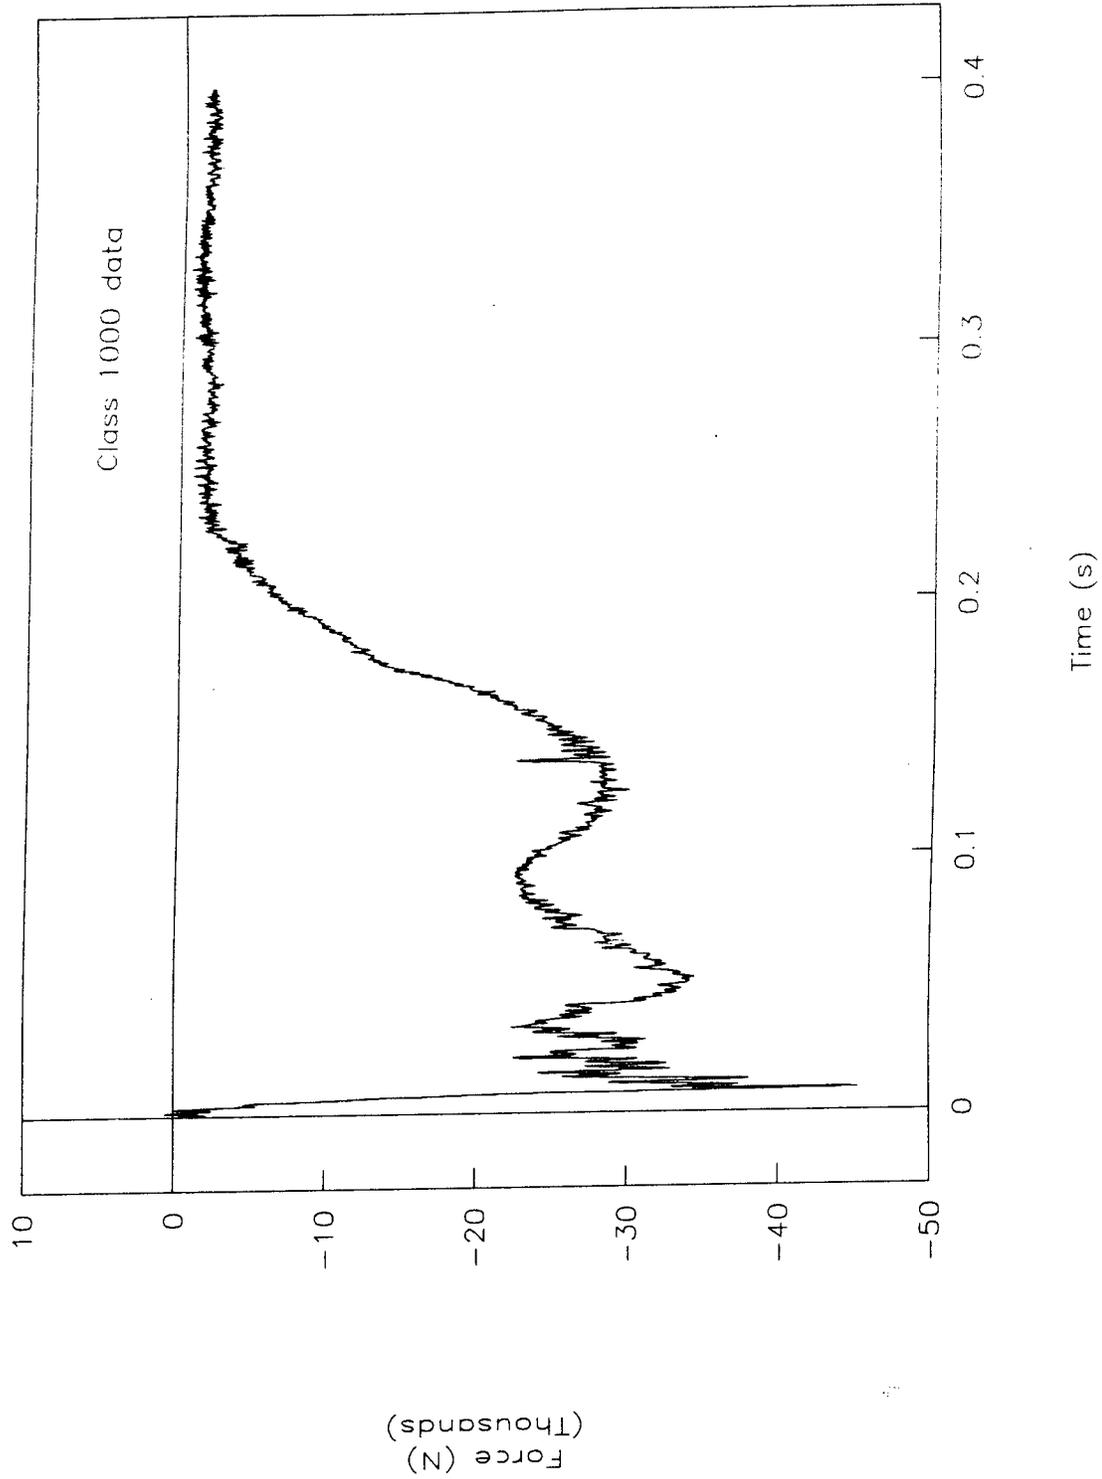
Figure 41. Rigid pole, force vs. time, lower-middle face lower load cell, test 97S003.

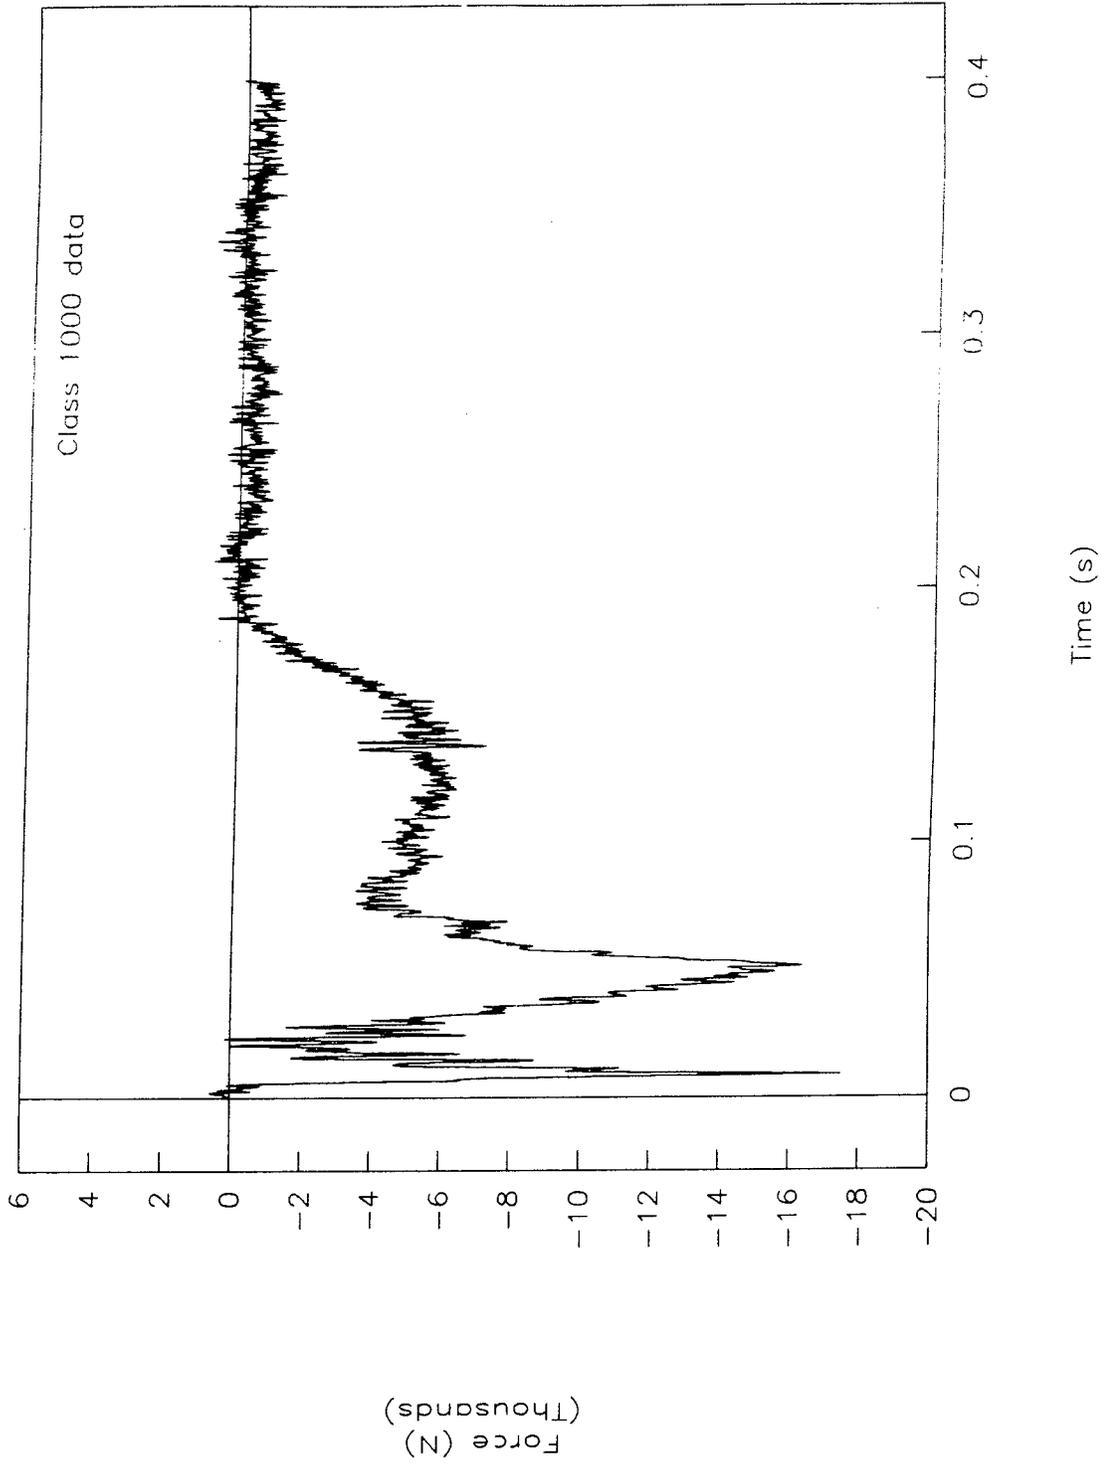
Figure 42. Rigid pole, force vs. time, lower-middle face upper load cell, test 97S003.

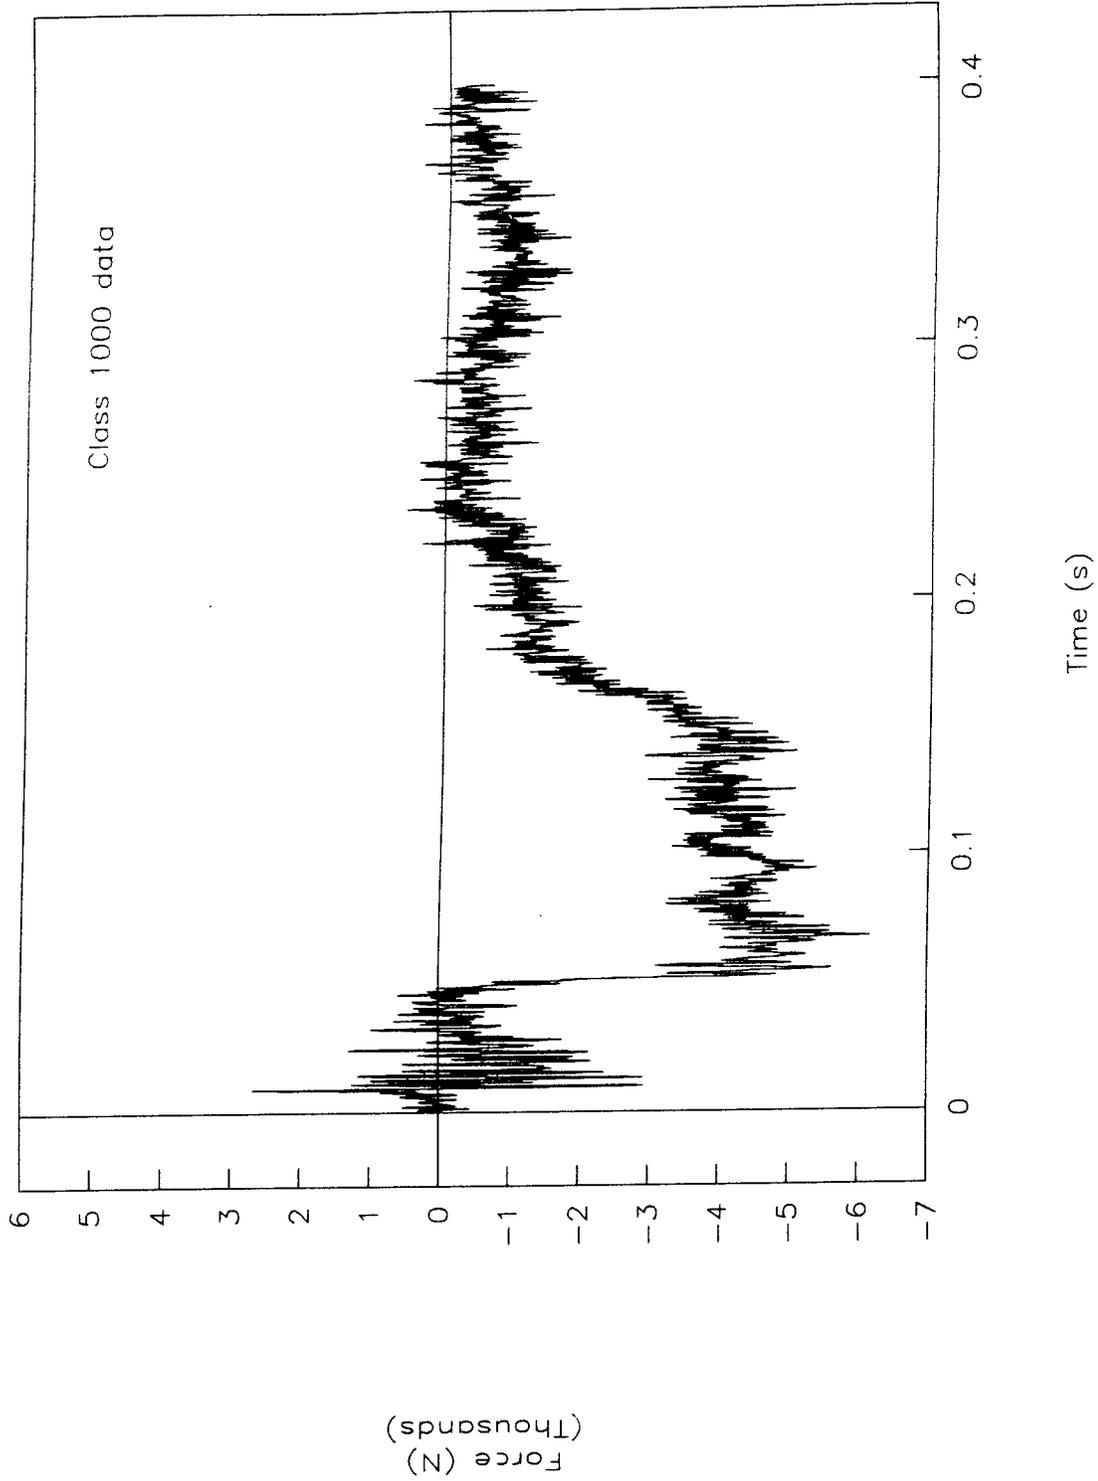
Figure 43. Rigid pole, force vs. time, upper-middle face lower load cell, test 97S003.

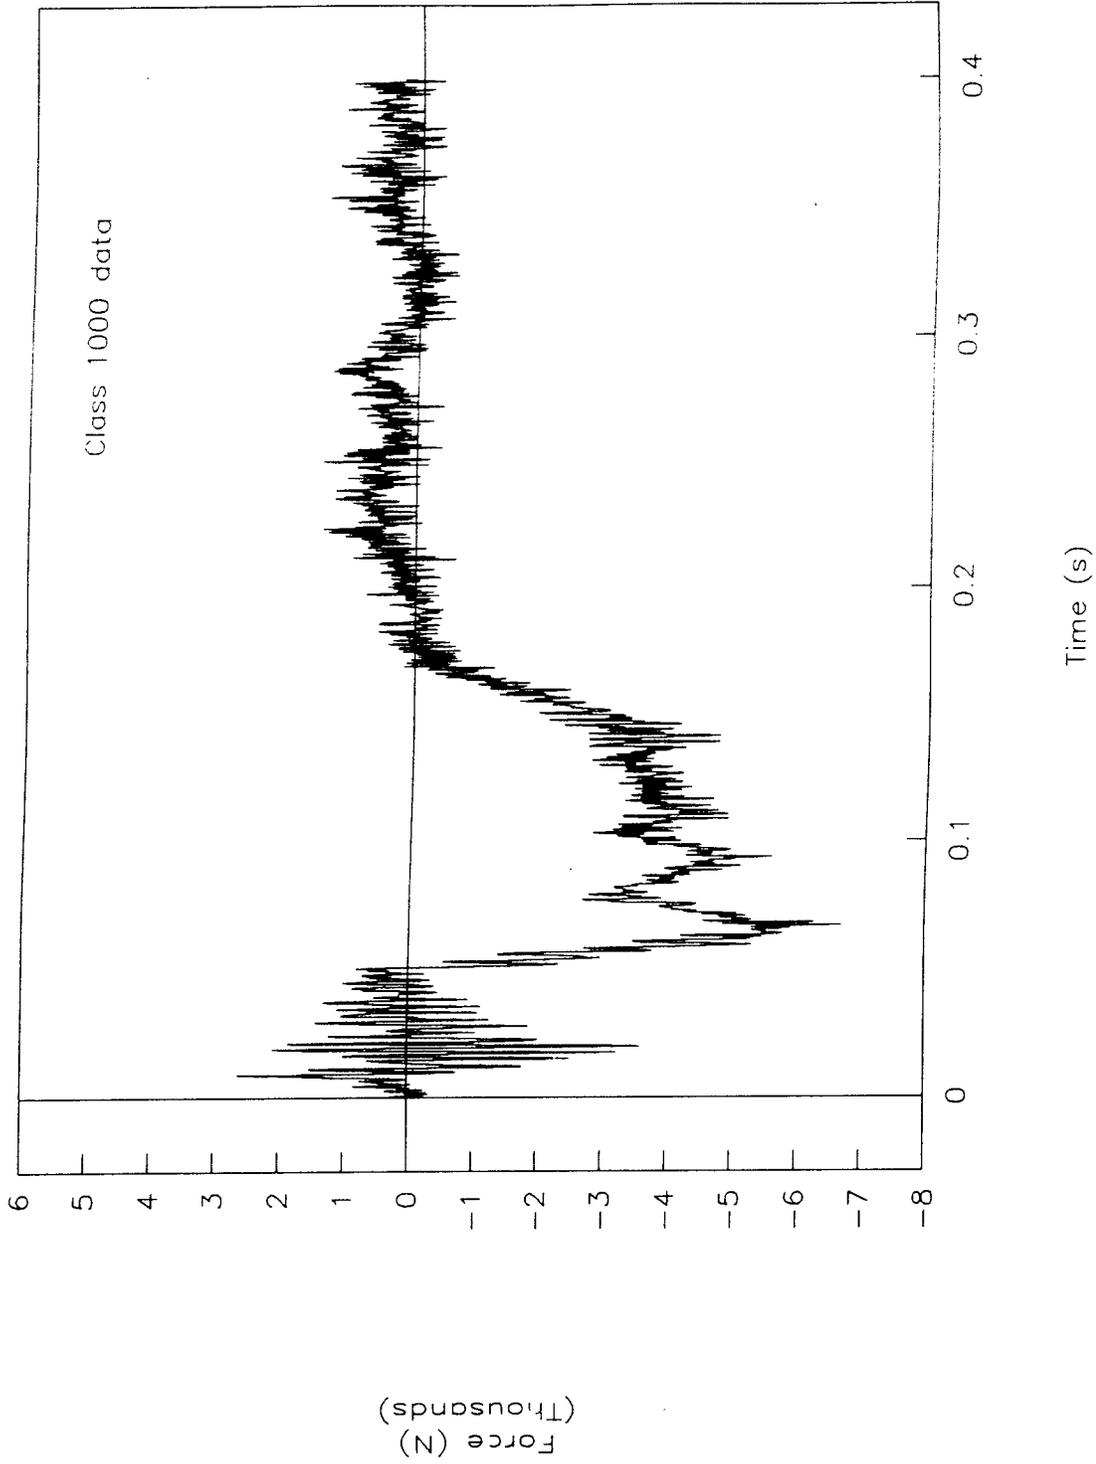
Figure 44. Rigid pole, force vs. time, upper-middle face upper load cell, test 97S003.

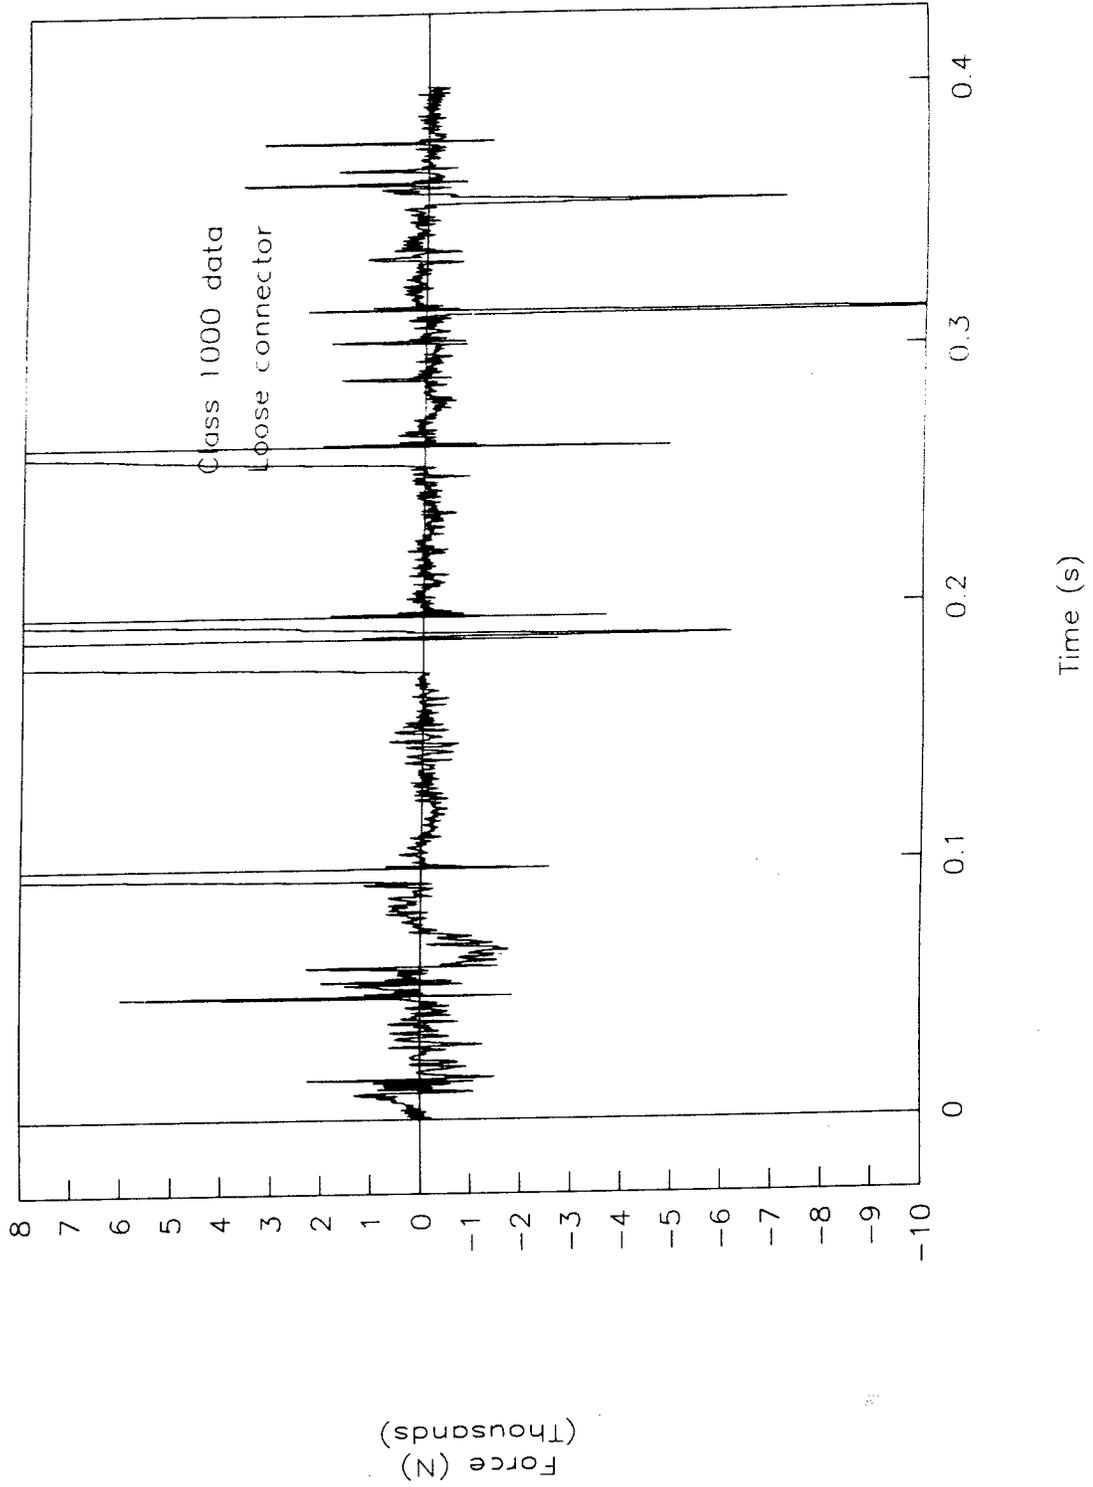
Figure 45. Rigid pole, force vs. time, upper face lower load cell, test 97S003.
