Honda Accord LX Broadside Collision

With a Narrow Fixed-Object:

Foil Test Number 97S003

PUBLICATION NO. FHWA-RD-98-008

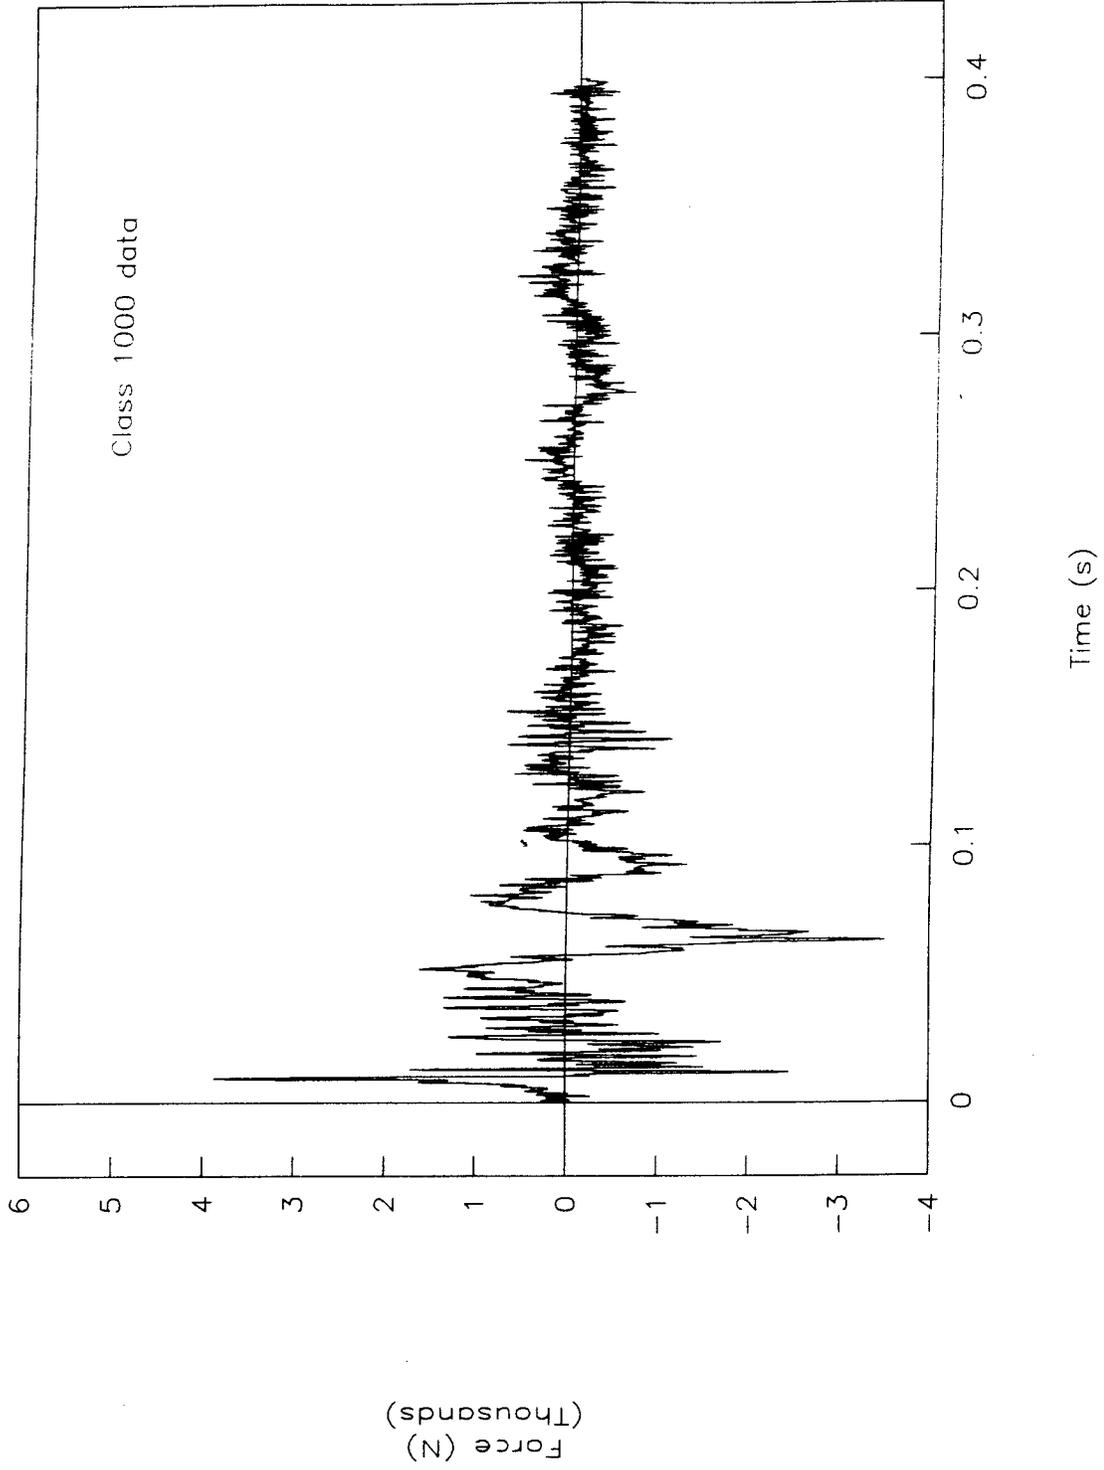
Figure 46. Rigid pole, force vs. time, upper face upper load cell, test 97S003.
