FINAL REPORT

FHWA-WY-98/02F

Improving the Wyoming Road Weather Information System

Tabler & Associates
P.O. Box 483
Niwot, Colorado 80544
(303) 652-3921

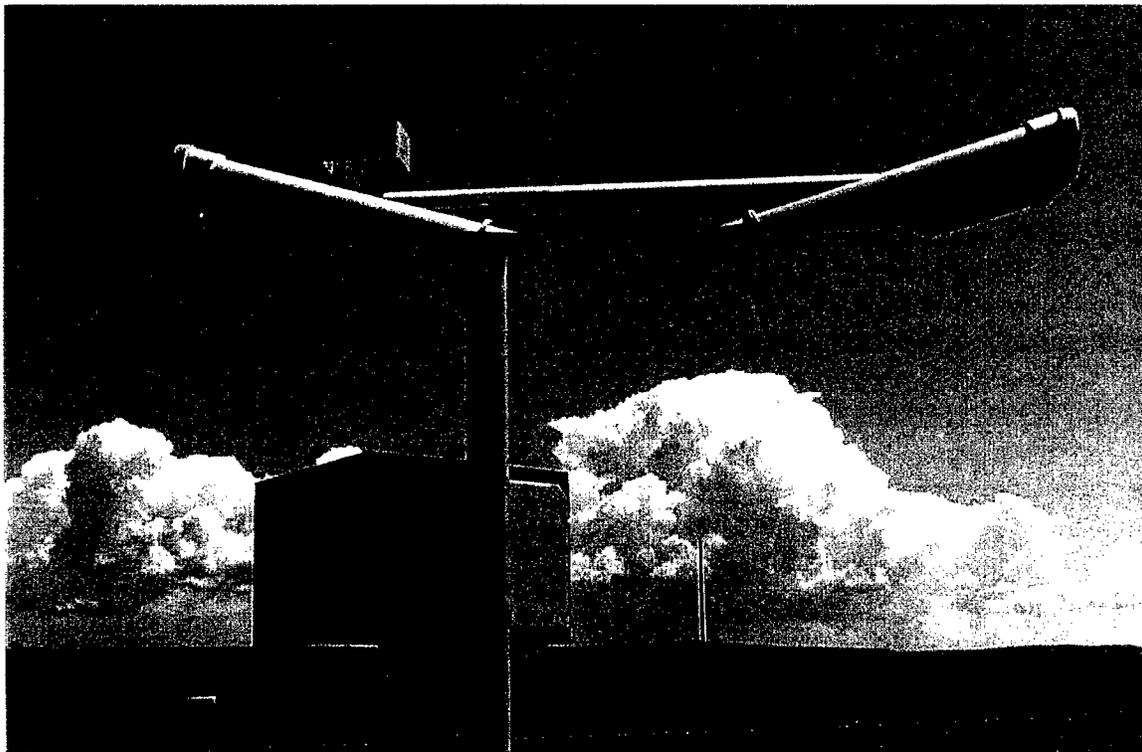
Figure 2.6. Vaisala Present Weather Detector FD12P. Box-like object on horizontal arm is the Model DRD11A Precipitation Detector (Skyline, 8/11/98).

Vaisala uses a rain detector (DRD11A) to estimate three intensities of precipitation--light (<2 mm/h), moderate (2 - 8 mm/h), and heavy (>8 mm/h)--based on the capacitance of a heated plate inclined at a 30° angle, and enclosed on four sides by a small rectangular wind screen (Figure 2.6). This device was not originally intended for snow, and data supporting its accuracy are apparently unavailable. Perhaps the greatest potential error of the device derives from the inevitable deflection of snow around the sensor when snowfall is associated with wind—a problem common to standard precipitation gauges (Tabler et al. 1990). Some users have installed a larger windscreen around the device to help reduce this problem, but again no quantitative data are available to indicate what improvement, if any, this modification makes. When the device is used in conjunction with the Vaisala visibility meter (FD12), the combination of instruments is called the FD12P weather sensor (Figure 2.6) or “Present Weather Detector,” Model PWD11. According to the manufacturer, analyses of the optical scattering signal makes it possible to identify precipitation type, and provide an analog estimate of precipitation intensity. The accuracy specified for accumulation in light and moderate *rainfall* is ± 30% for the PWD 11. No specification is given for intensity, although detection sensitivity is specified at 0.1 mm/h for liquid precipitation. No specifications are given for snowfall.

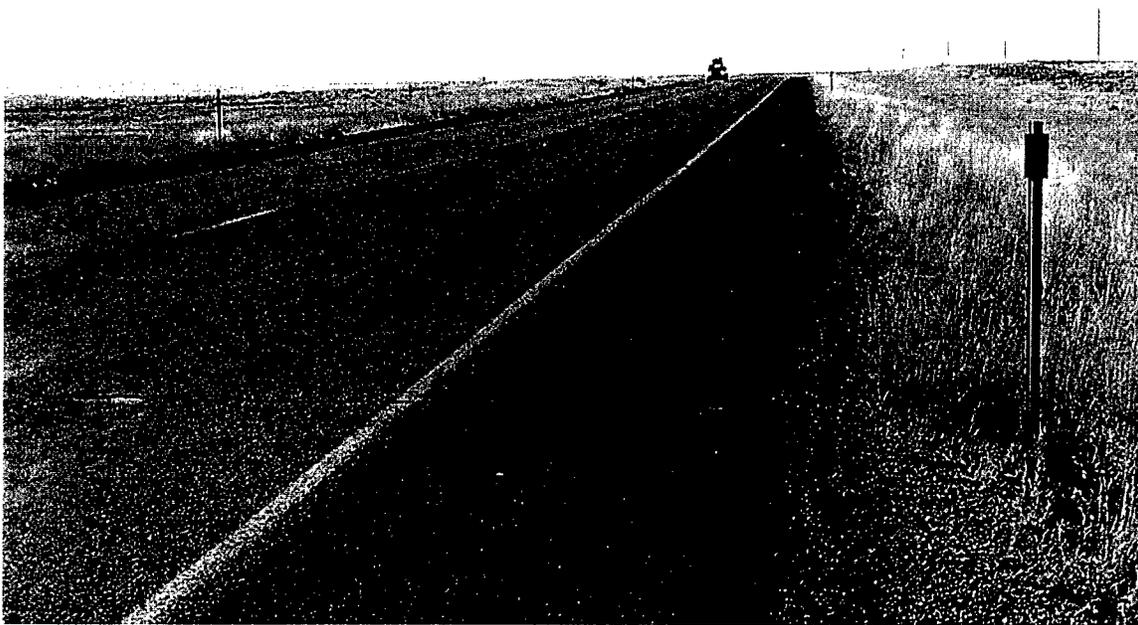
Figure 3.4. Example of proper marking of pavement sensor (Hiland, 8/15/98). The RPU is barely visible on the right side of the road 584 m in the distance—placement could have been much closer to the RPU. Note also the unavoidable depression around the sensor that results from chip sealing

- Pavement sensor locations are generally poorly marked. This makes them difficult to locate for routine inspections and maintenance, and makes it difficult for snow plow operators to properly evaluate sensor accuracy. Sensors are properly marked with distinctive amber reflectors at only three locations (Figure 3.4).

27. Improve marking of pavement sensor locations with posts and reflectors to facilitate finding them for inspection and service, and to allow plow operators and other personnel to compare actual surface conditions at the sensors with status reported by sensor.

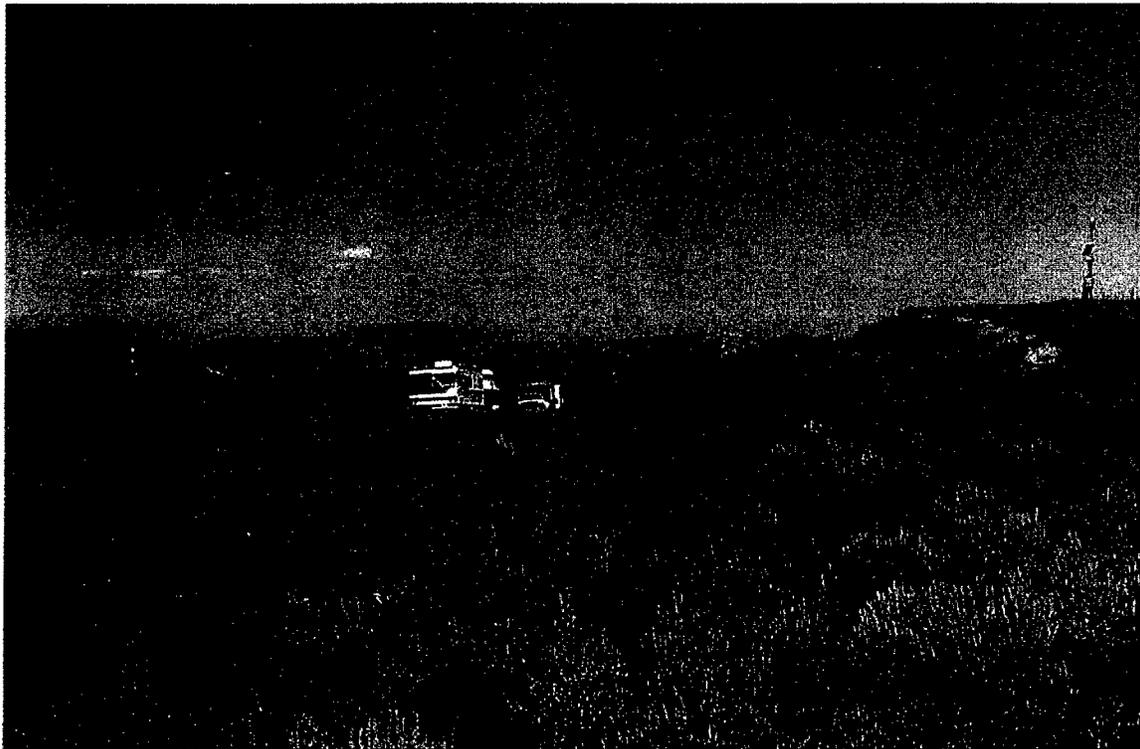
Figure 3.6. Meeteetse Rim site, looking north. Snow deposition in cut would significantly reduce blowing snow at tower when winds were westerly (from left) (8/13/98).

Exposed location on hill, strategically located for pavement condition. However, location on east side of road cut prevents RPU from being representative for blowing snow (Figure 3.6). Would have been better to locate RPU on west side of road—prevailing wind direction at this location is 325° (Tabler 1997). Wind vane orientation is 11° off (Table 3.1). Southern-most pavement sensor is much farther away from RPU than was necessary (652 m), and should be better marked.

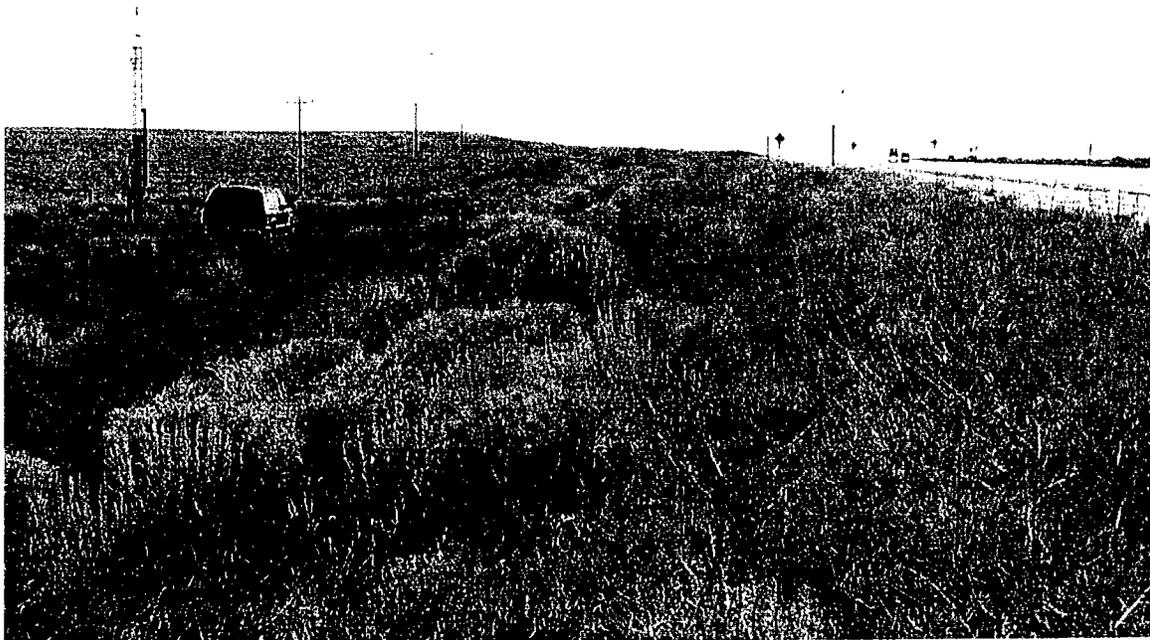
Figure 3.7. Pathfinder Hill RPU looking east. Note tower location relative to road elevation (8/15/98).

General location good, but on north side of road at 2.5-m fill (Figure 3.7). A perfect site exists about 100 m east, illustrating poor judgment in site selection. Mast is far enough off road that road cross-section probably has only minor effect on wind, but deposition on north side of fill would reduce snow arriving at site and affect vertical distribution of blowing snow, and thus visibility. East pavement sensor is installed about 5 mm above road surface (Figure 3.8). Sensor to west needs encapsulation repair, and is too close to turnout where more braking would be expected to occur. Sensors are adequately marked with posts and reflectors!

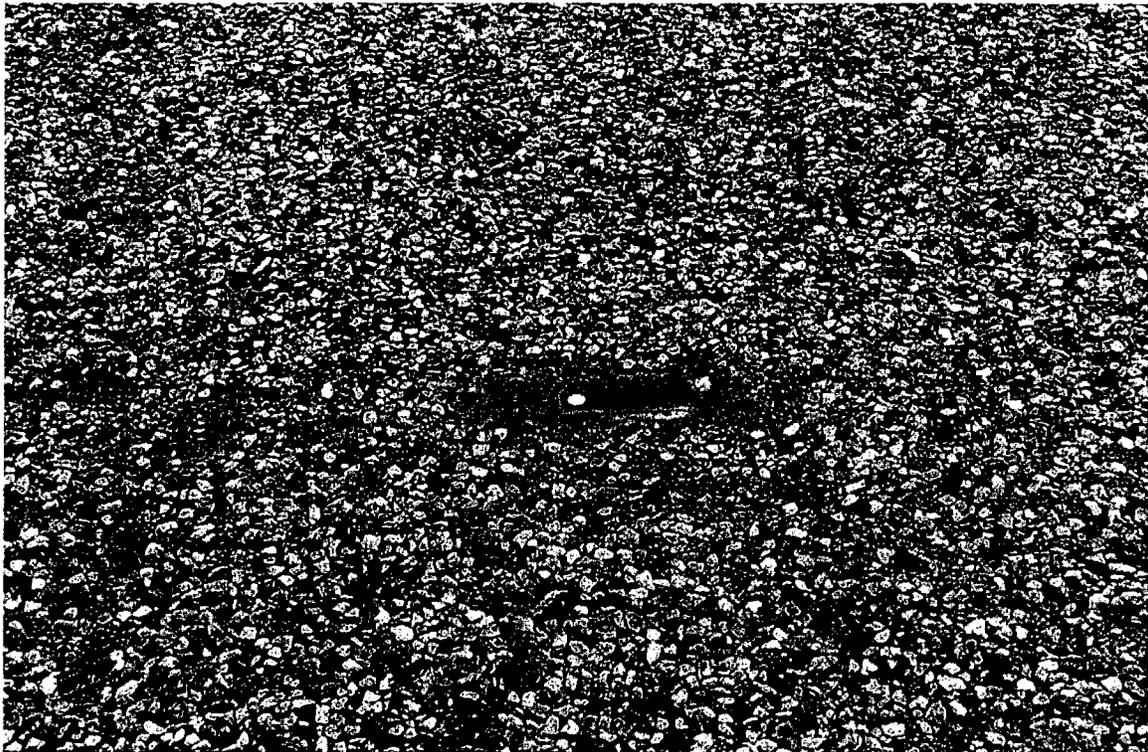
Figure 3.13. Pavement sensor at Skyline RPU showing depression formed by chip sealing (8/11/98).

This is a good site for all parameters. Although there are 3.8-m-tall snow fences located 142° to 172° from site, drifting from this direction would occur only rarely. The "Present Weather" detector is on a separate support mast 3.7 m southeast of the tower, with the result that the RPU enclosure would interfere with blowing snow when winds were from 315° or so. Prevailing wind direction at site is approximately 270° (Tabler 1997, Appendix B). Pavement sensors recessed about 5 mm as result of chip sealing, but unavoidable (Figure 3.13).

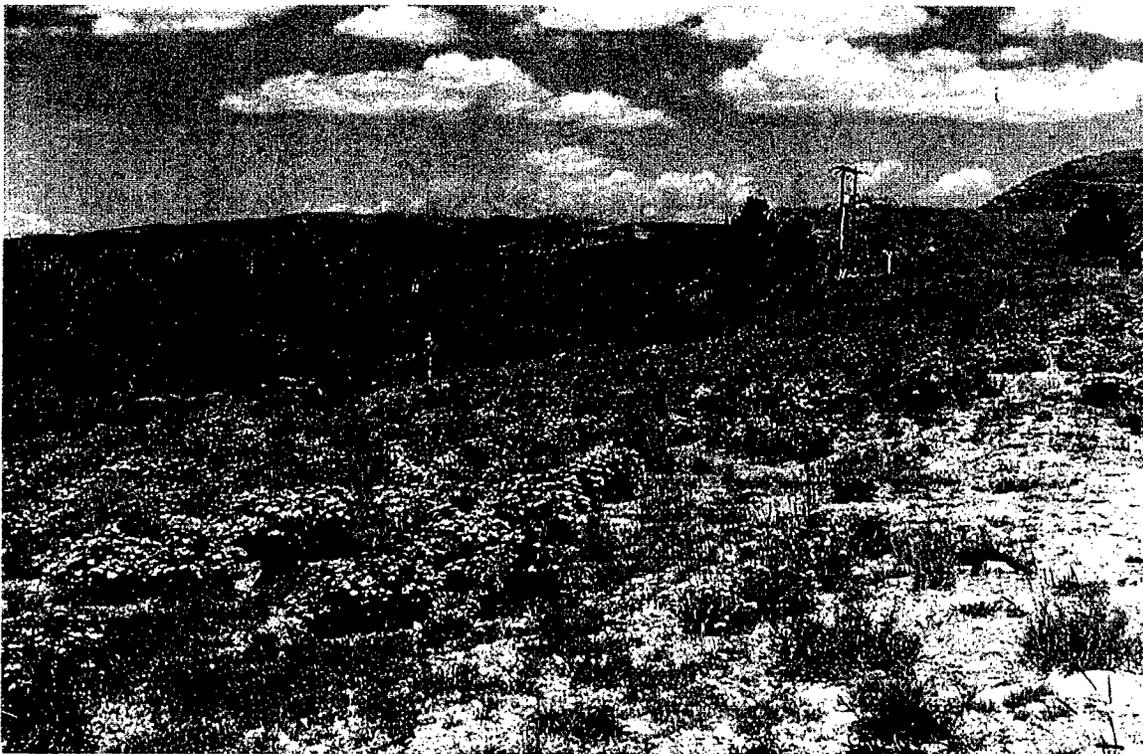
Figure 3.15. Looking north toward Chief Joseph RPU (8/13/98).

According to WYDOT personnel, this RPU is not presently useful because of contracted snow/ice control. Desirability of moving, however, depends on future plans for winter maintenance. Present location is poor for monitoring visibility in blowing snow because of limited fetch in all directions except from east. Blowing snow arriving at tower from east, however, is also reduced by a snow deposition area. Although tower barely protrudes above trees, this site is highly vulnerable to lightning strikes, which should have ruled out location in the first place. Location is suboptimal for wind measurement because of obstruction by 5- to 6-m-tall trees in some directions (Figure 3.15). This would be a good site for a precipitation gauge, as discussed in Section 4. Maintenance personnel have suggested moving to vicinity of Mile 110 on WY 120. Mile 109.9 appears to be an excellent site with AC power.
