**STRUCTURAL SYSTEMS
RESEARCH PROJECT**

Report No.
SSRP - 97/04

**THE EFFECT OF EXTERNAL
CONFINEMENT AND TRANSVERSE
REINFORCEMENT ON PLASTIC HINGES
IN CAST-IN-PLACE PILE SHAFTS
-- Experimental Results**

Final Report on a Research Project funded by Caltrans under
Contract No. DOT59V375

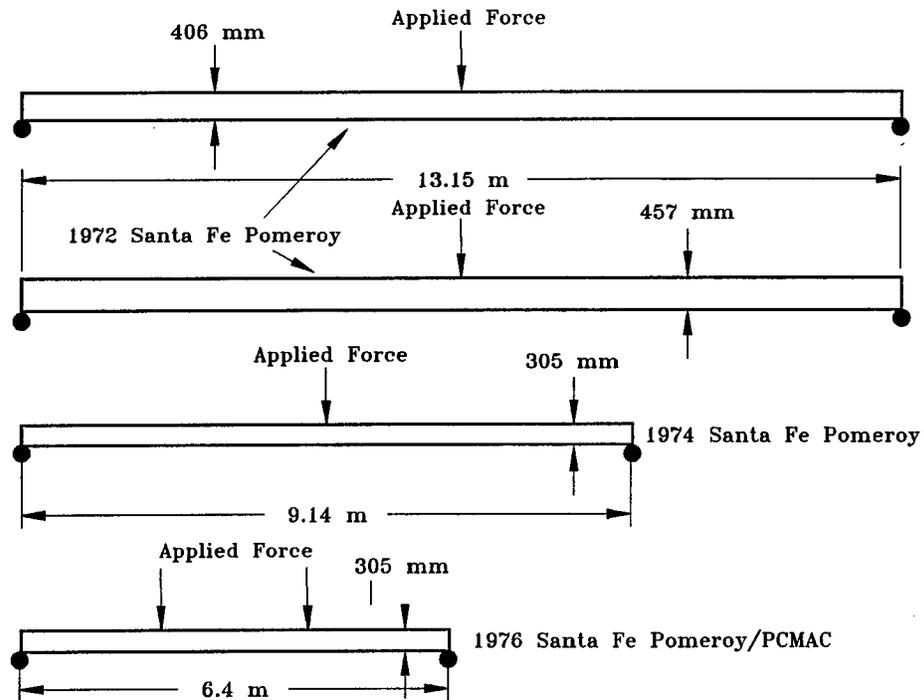
Fig. 2.1: Comparison of spans and loading points of pile tests described by Sheppard (drawings are to true scale)

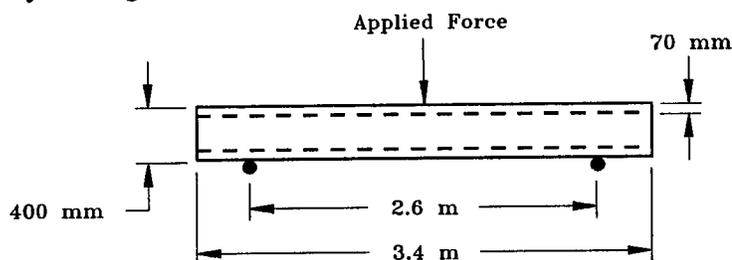
Fig. 2.2: Configuration of pile test units described by Ikeda et al (drawn to scale)

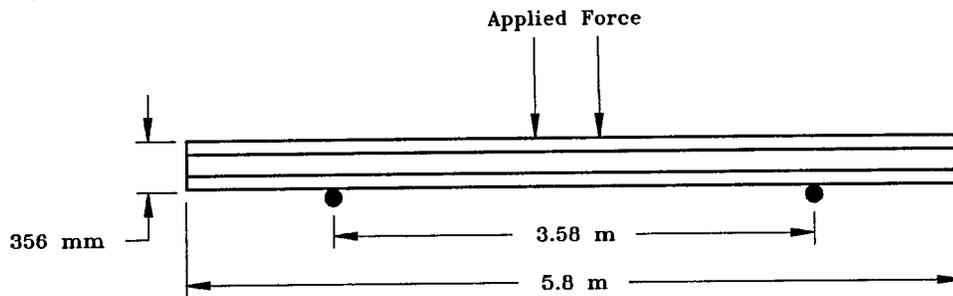
Fig. 2.3: Pile test configuration described by Banerjee et al (drawn to scale)

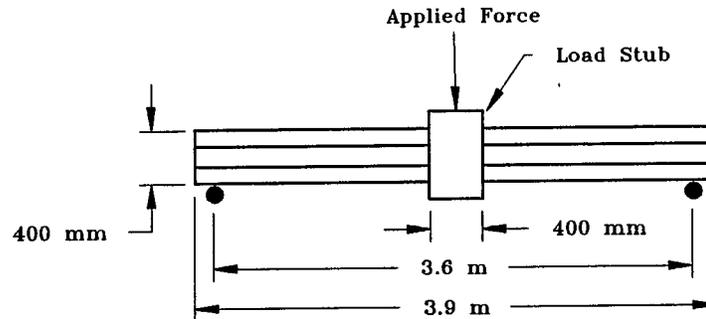
Fig. 2.4: Pile test configuration described by Falconer and Park (drawn to scale; piles tested by Pam, Park, and Priestley were similar)

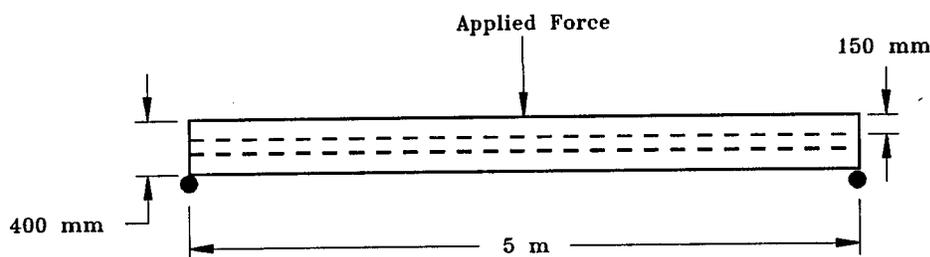
Fig 2.5: Pile test configuration described by Muguruma et al (drawn to scale)

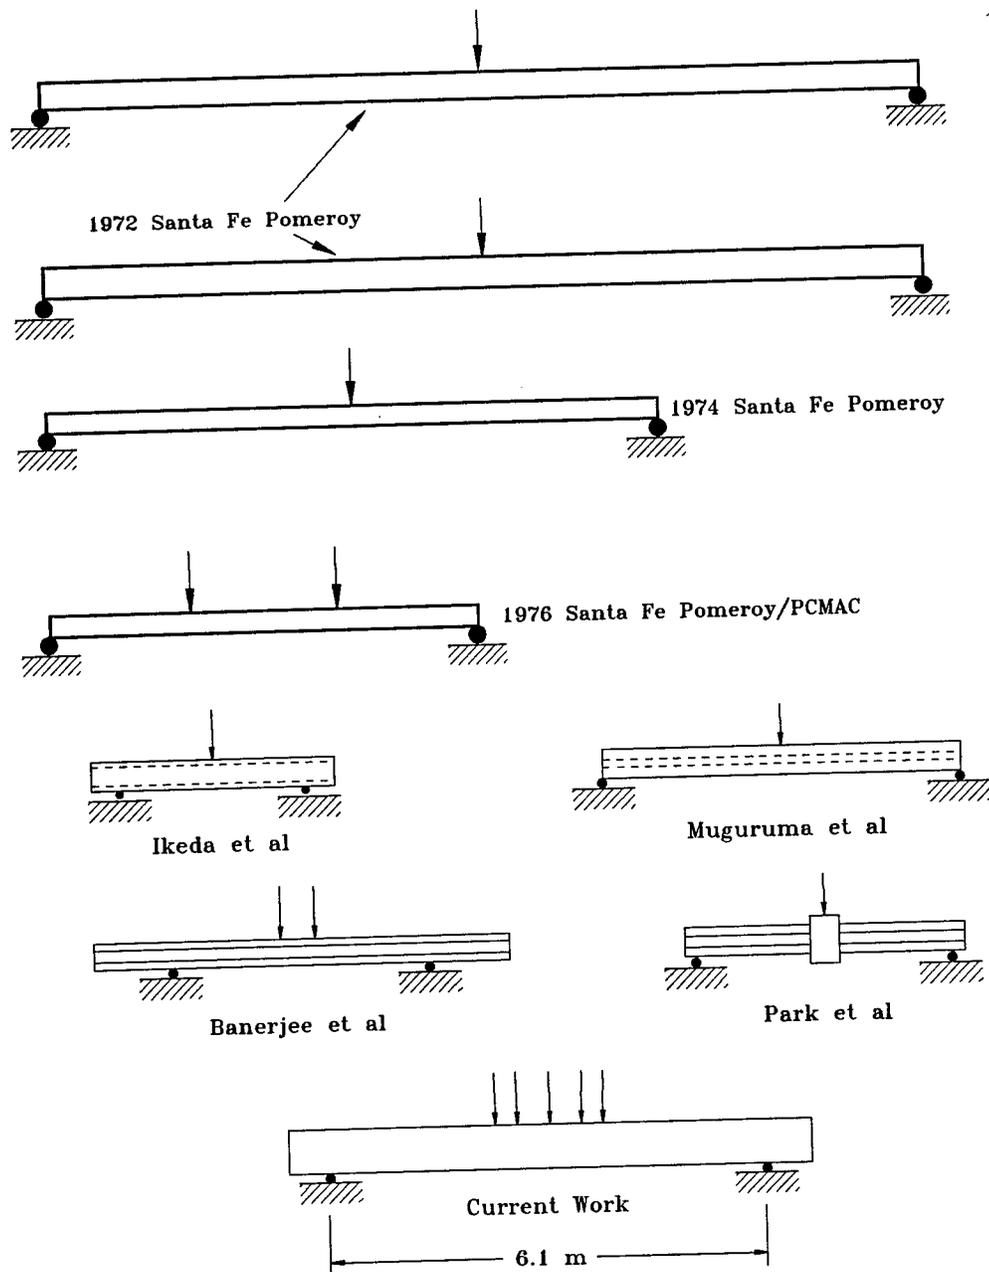
Fig. 2.6: Comparison of geometry and loading of previous pile body tests with present work (drawings do not necessarily imply unidirectional loading; axial loading, where present, omitted for clarity)

Shown in fig. 2.6 is a comparison of test loadings and spans, among the past work and the presently considered tests.

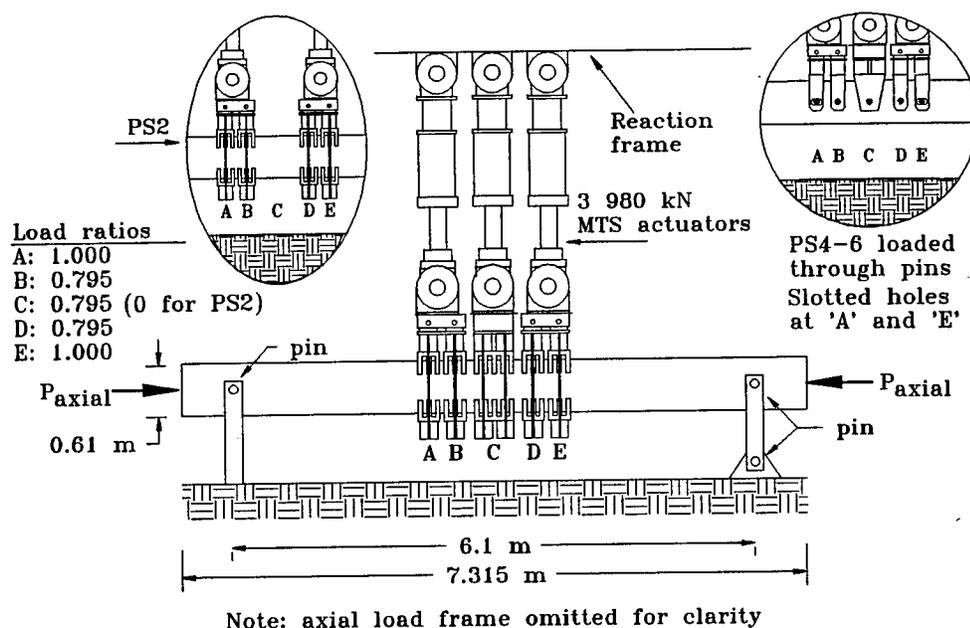
Fig. 3.1: General arrangement of test apparatus used for PS1-6 (scrap views: for PS2 the center actuator was removed, and load ratio C was thus zero; for PS 4-6 loading was via 50.8mm diameter pins passing through the unit midline at points A-E)

on a pile shaft. Basically a whiffle tree, the loading mechanism distributed the applied force from three (two, in the case of PS2) 980 kN MTS actuators through five (four for PS2) symmetrically arrayed load points. Shown in fig. 3.1 is the general configuration used for PS1-6.

Visual examination of PS1 during the test showed crushing to begin under the central load saddle (ref. fig. 3.1, point 'C') at $\mu=1.5$. This extended outboard on both sides to the adjacent saddles at $\mu=2$. Crack patterns observed during the test showed cracking to begin at a shear load of 150 kN; later in the course of the test, rotation seemed to be concentrated by a series of wide, evenly spaced tension cracks that first appeared at $\mu=1.5$. Flexural cracking was observed outboard of the quarter points to within 1.5 m of the pins. Shear (inclined) cracking first appeared at this level of ductility, in the area of the outboard load saddles.

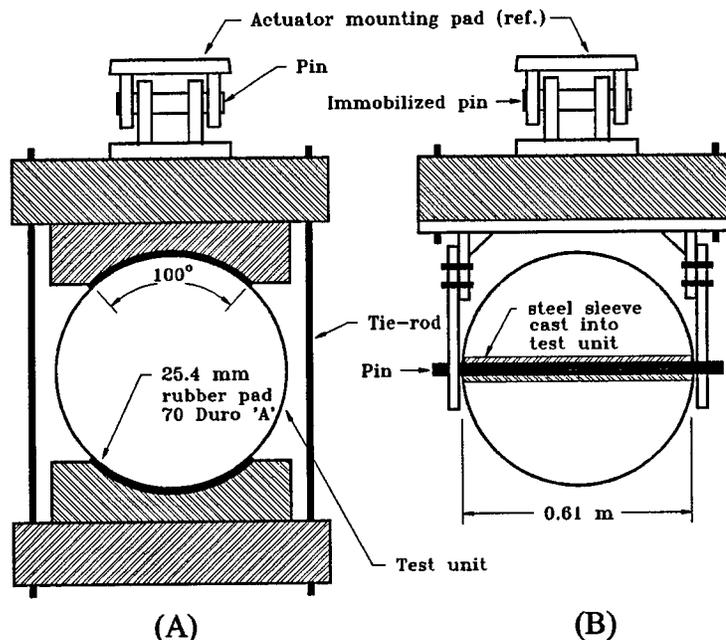
Fig. 3.3: Cross-section of loading apparatus: (A) used for pile shaft test units PS1-3, (B) used for PS4-6

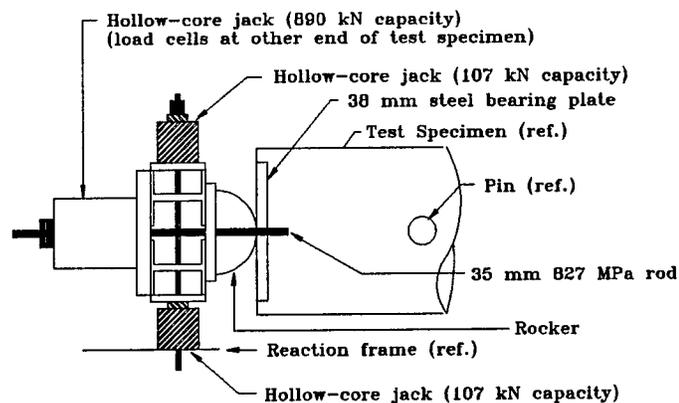
Fig. 3.5: Side view of axial load strongback and leveling mechanism

An axial load of 890 kN was maintained during the tests to give a nominal $P_{ax}=0.11f_cA_g$. Axial load was applied by strongbacks at either end of the test units, connected by high strength steel rods running down either side (fig. 3.4). Load was applied via hollow-core jacks, and monitored by load cells. The strongbacks were kept level through the tests by a manually-controlled system of jacks (fig. 3.5). A significant P- Δ effect was expected.

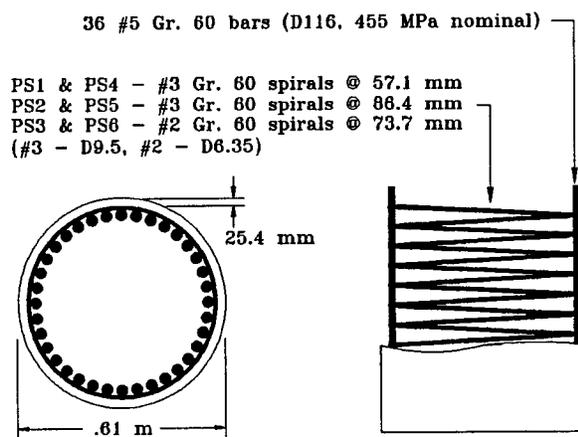
Fig. 3.6: Dimensional and reinforcement details of pile shaft test units PS1 - PS6

The test units were circular-section pile shafts of 0.6096 m diameter, with 25.4 mm cover to the main bars (fig. 3.6). Longitudinal reinforcement was provided by 36 #5 Grade 60 bars (455 MPa nominal), giving $\rho_l=0.022$. Transverse reinforcement (Grade 60, 455 MPa nominal) is shown in table 3.1; fig. 3.7 shows the reinforcing cage for PS2, which had the nominal recommended transverse reinforcement of $\rho_t=0.006$.

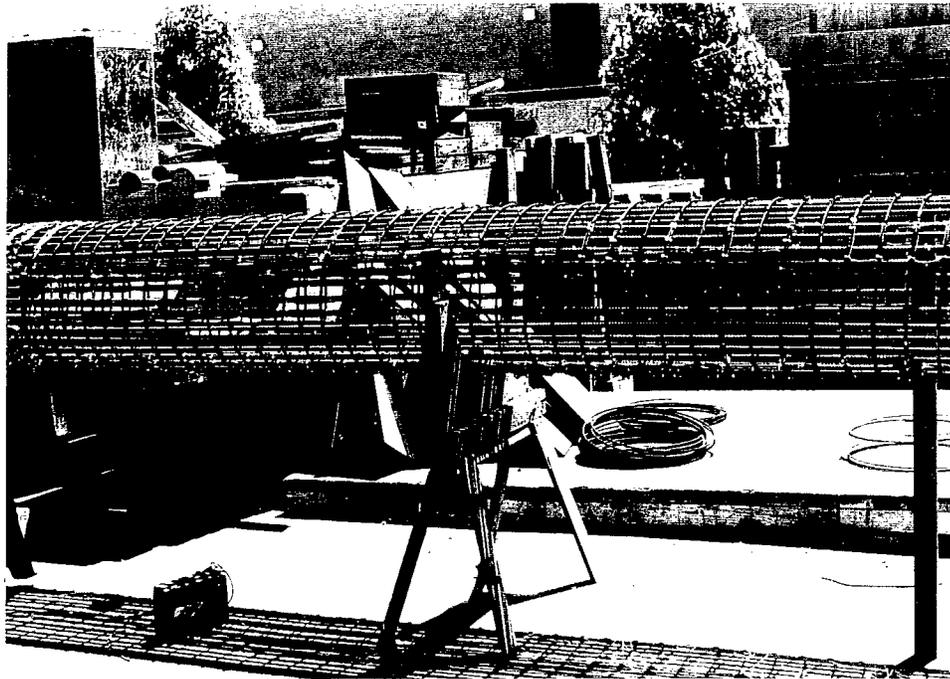
Fig. 3.7: Reinforcing steel cage for pile shaft test unit PS2 ($\rho_t=0.006$)

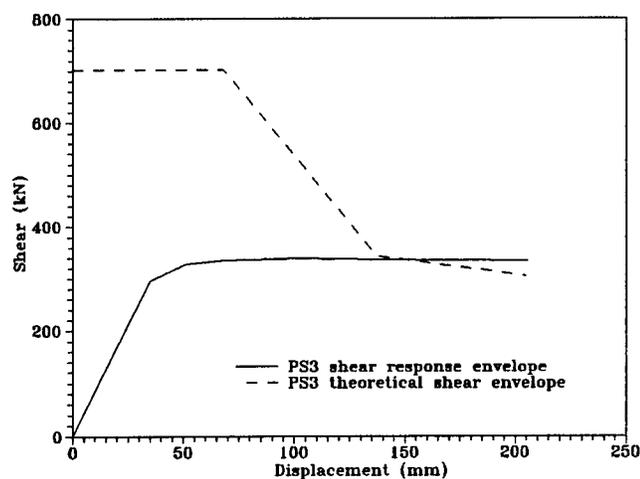
Fig. 3.9: Comparison of theoretical shear capacity with experimentally observed shear, pile shaft test unit PS3

Fig. 3.9 shows a comparison of experimentally observed shear vs. theoretical shear capacity for PS3 (in which the theoretical and response envelopes would have been

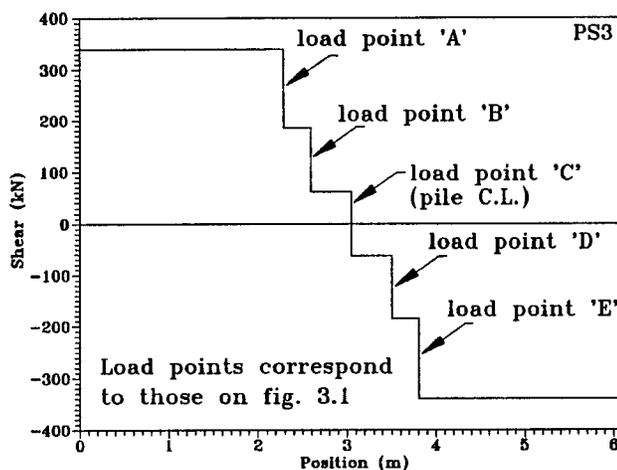
Fig. 3.10: Maximum shear plotted vs. position along the length of pile shaft test unit PS3

closest). While it would seem that PS3 was in danger of experiencing shear failure, fig. 3.10 shows that shear in the plastic hinge region (i.e., centered on load point 'C') was considerably below the maximum value plotted in the force-displacement envelope.

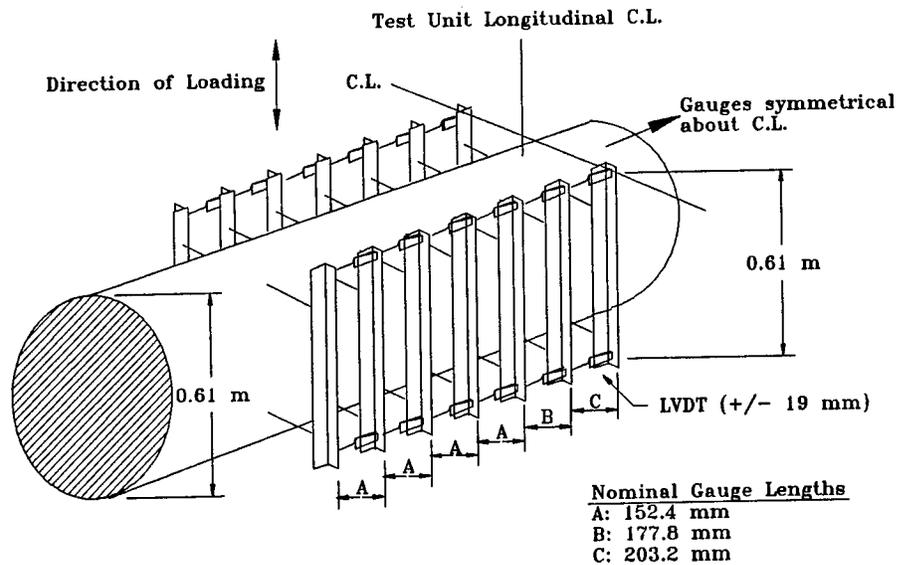
Fig. 4.2: Mounting of displacement transducers to measure curvature, test units PS1-3

Instrumentation used to measure curvature consisted of sets of linear displacement transducers (± 19 mm travel), paired in vertical planes; the relative difference in their displacements was used to calculate section curvature. Curvature was measured through the loading area over a length similar to that instrumented with strain gauges. The transducers were mounted on aluminum angle brackets, which were in turn attached to steel thread rod cast into the test unit. In the case of PS1-3, the loading system dictated the mounting of the curvature instrumentation along both sides of the test units (fig. 4.2); the results were averaged to eliminate errors caused by lateral 'sway' during test. The thread rod holding the bracketry was installed such that the rod on the compression side of each cycle would be in the forecast compression zone. In the case of PS4-6, the potentiometers could be mounted along the top and bottom longitudinal axes of the test unit (fig. 4.3).

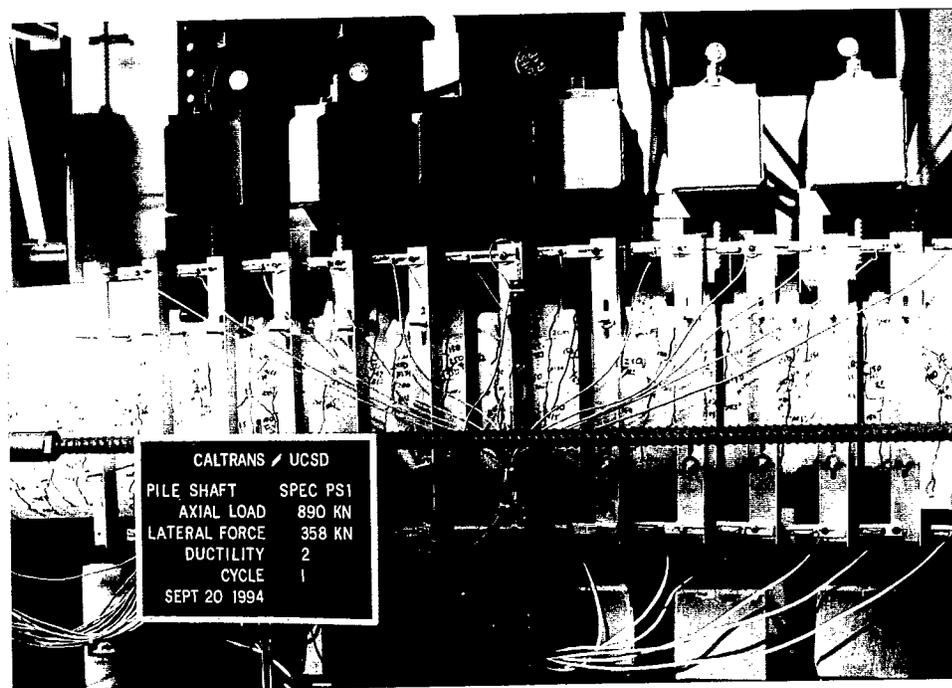
Fig. 5.1: Pile shaft test unit PS1 at $\mu=2$ (externally confined, high reinforcement)

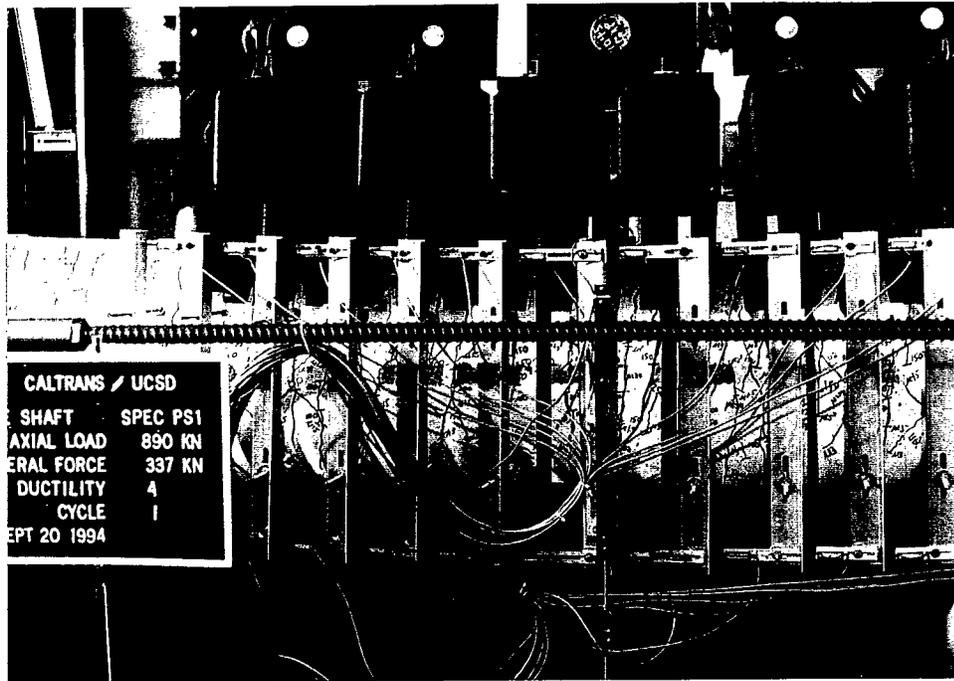
Fig. 5.2: Pile shaft test unit PS1 at $\mu=4$ (externally confined, high reinforcement)

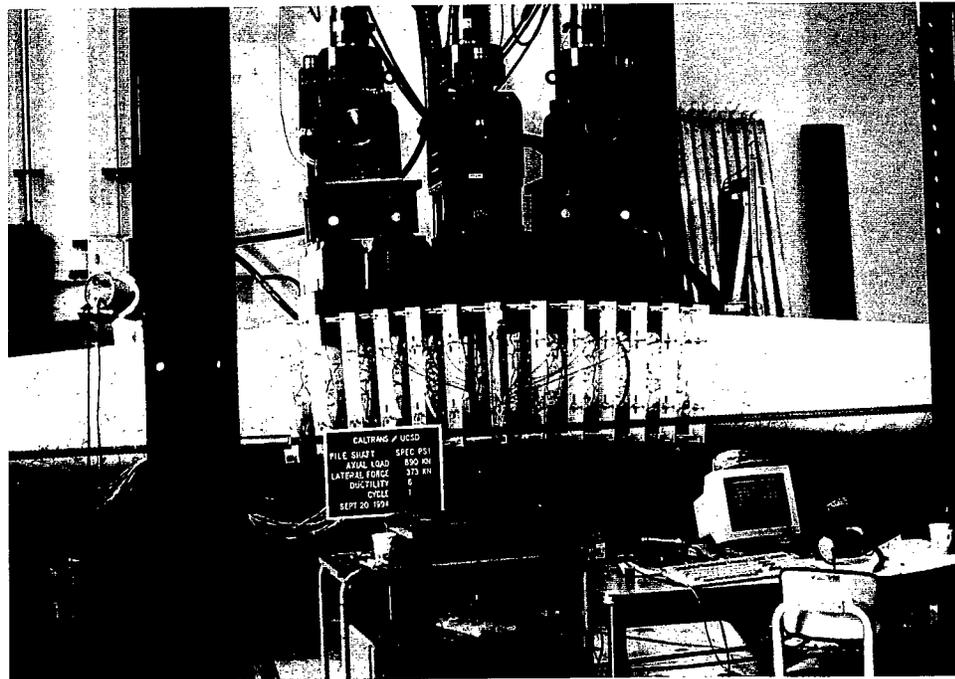
Fig. 5.3: Pile shaft test unit PS1 at $\mu=6$ (externally confined, high reinforcement)

Crushing was observed beyond the medial point of the central saddle at $\mu=6$, and there were significant extensions to existing shear cracks in the outboard regions of the loading area.

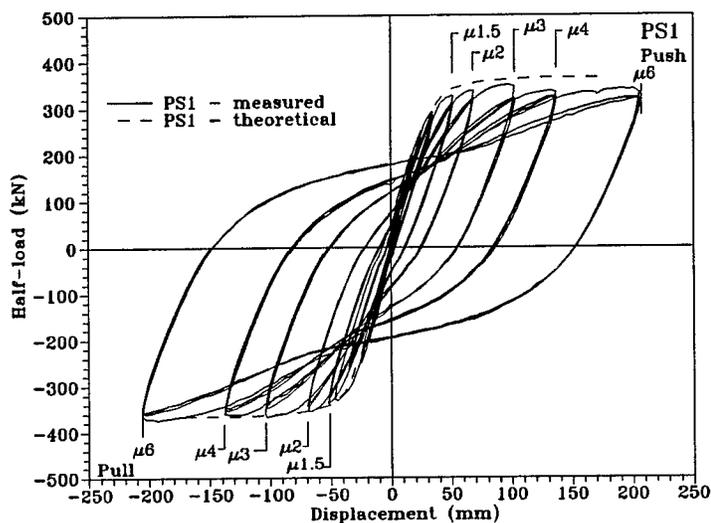
Fig. 5.4: Force-deflection hysteresis loops, pile shaft unit PS1 (externally confined, high reinforcement)

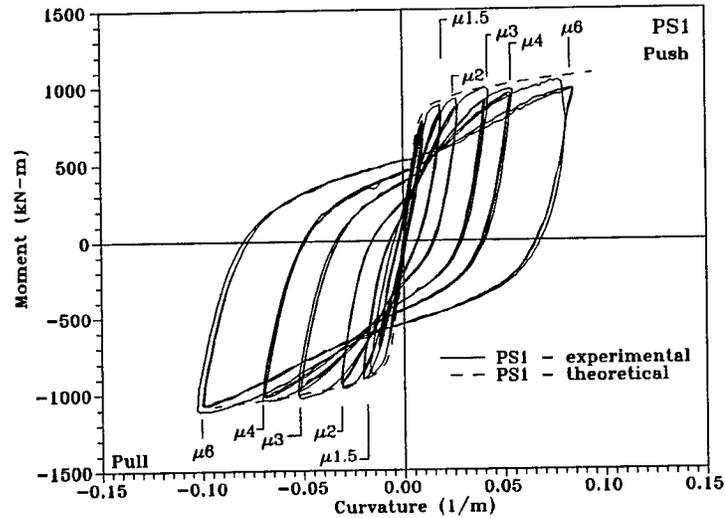
Fig. 5.5: Moment-curvature hysteresis loop (at test unit center), pile shaft test unit PS1 (externally confined, high reinforcement)

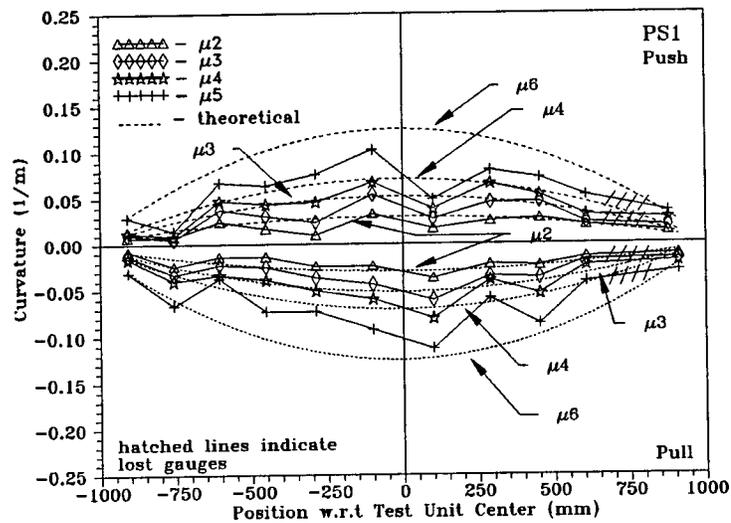
Fig. 5.6: Curvature profiles, pile shaft unit PS1 (externally confined, high reinforcement)

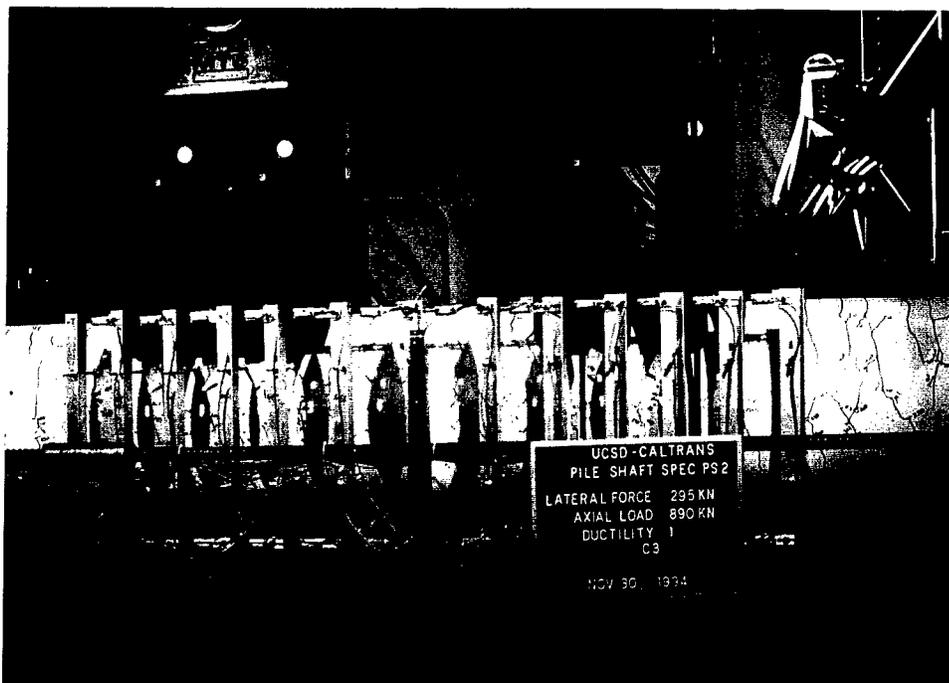
Fig. 5.9: Pile shaft test unit PS2 at $\mu=1$ (externally confined adjacent to hinge, medium reinforcement)

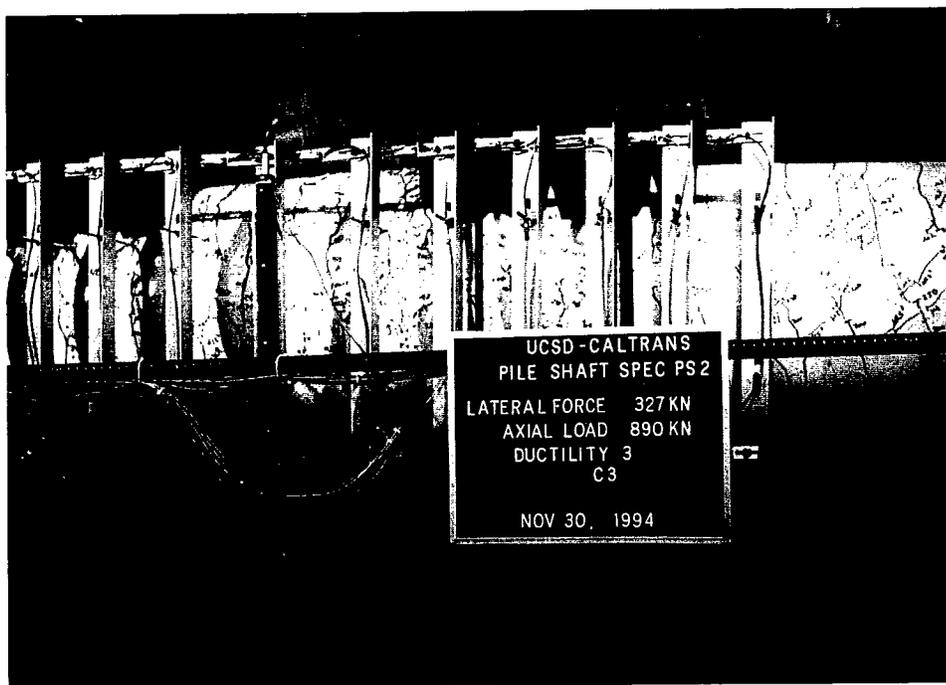
Fig. 5.10: Pile shaft test unit PS2 at $\mu=3$ (externally confined adjacent to hinge, medium reinforcement)

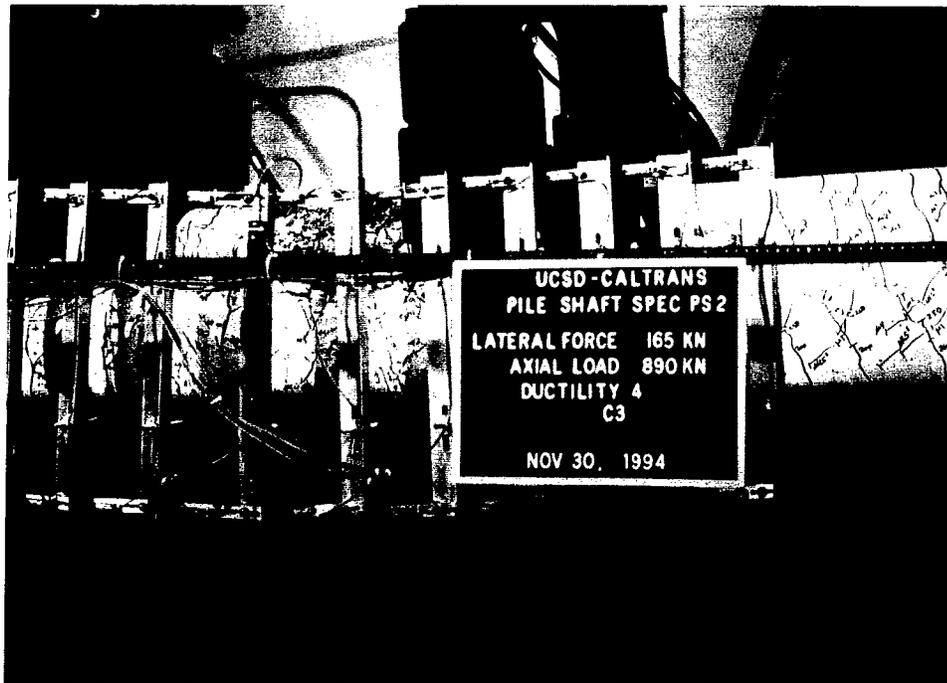
Fig. 5.11: Pile shaft test unit PS2 at $\mu=4$ (externally confined adjacent to hinge, medium reinforcement)

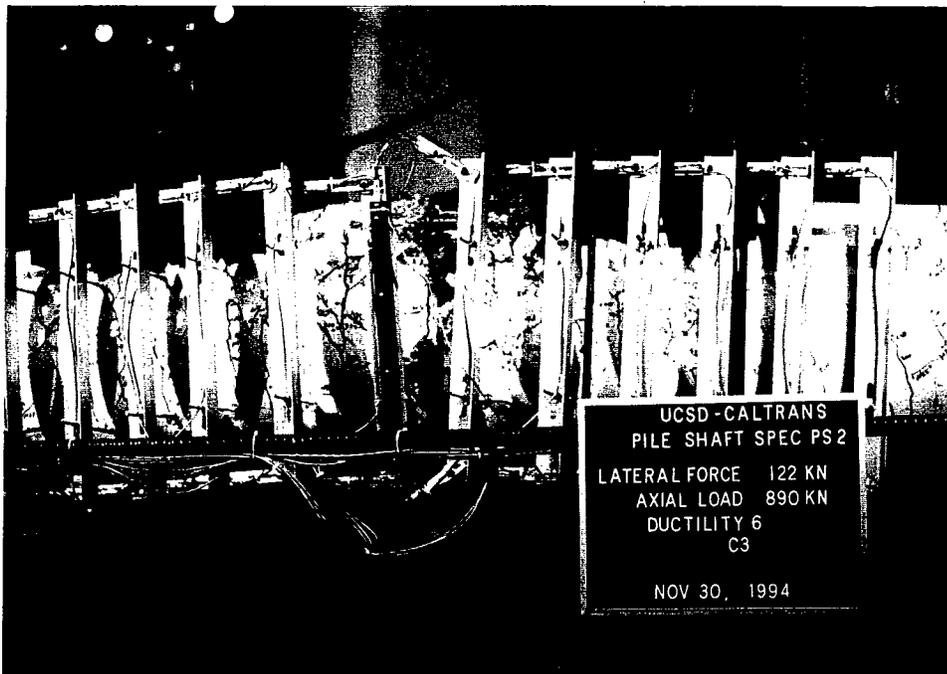
Fig. 5.12: Pile shaft test unit PS2 at $\mu=6$ (externally confined adjacent to hinge, medium reinforcement)

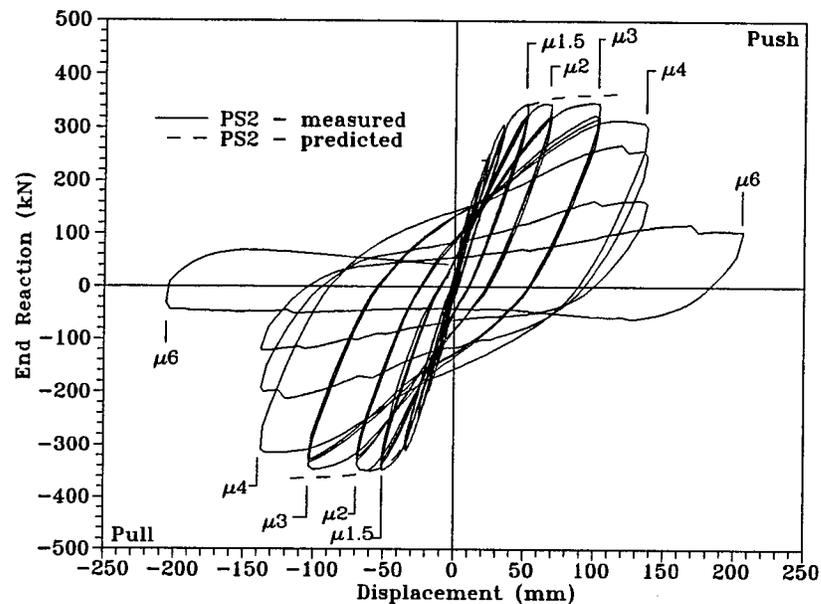
Fig. 5.14: Force-deflection hysteresis loops, pile shaft unit PS2 (externally confined adjacent to hinge, medium reinforcement)

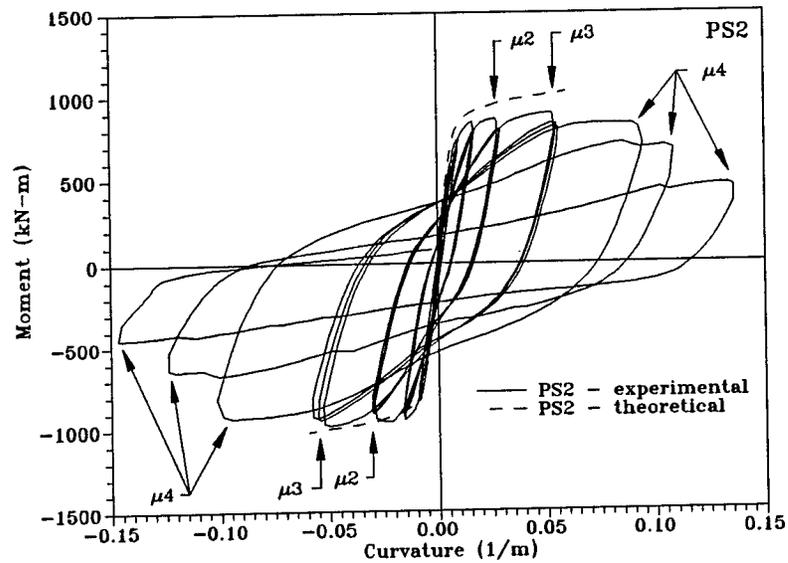
Fig. 5.15: Moment-curvature hysteresis loops, pile shaft unit PS2 (externally confined adjacent to hinge, medium reinforcement)

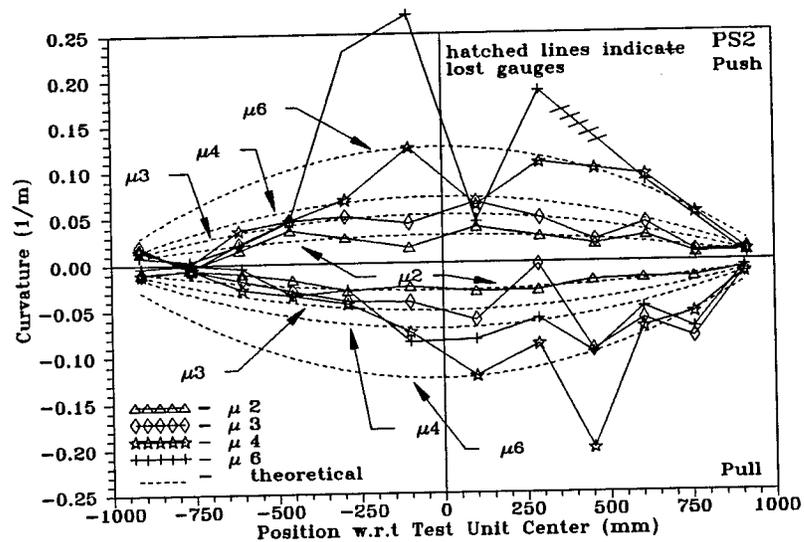
Fig. 5.16: Curvature profiles, pile shaft unit PS2 (externally confined adjacent to hinge, medium reinforcement)

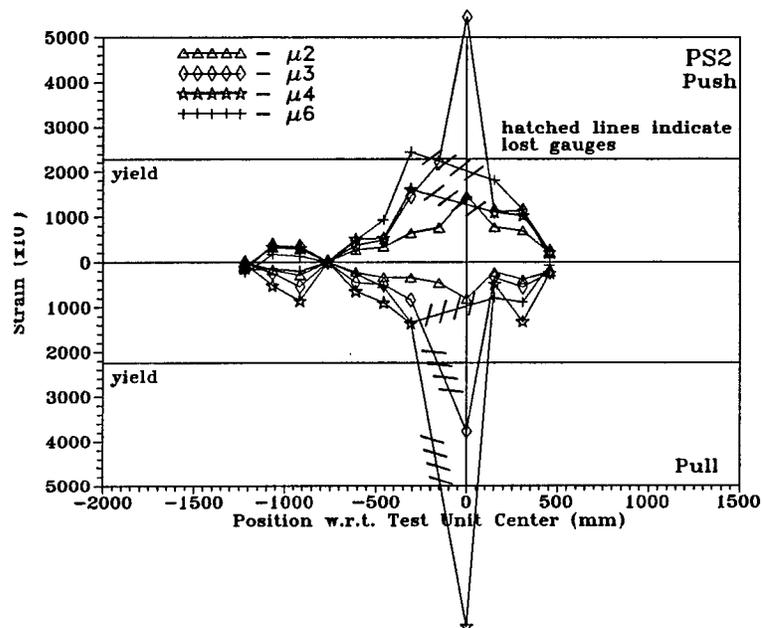
Fig. 5.17: Confining steel strain, pile shaft test unit PS2 (externally confined adjacent to hinge, medium reinforcement)

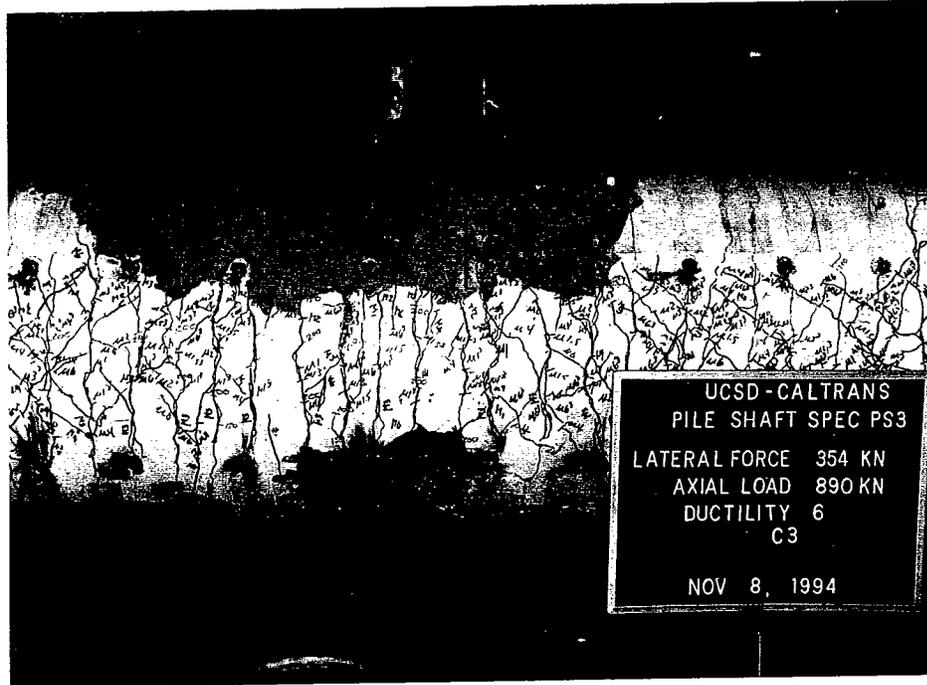
Fig. 5.21: Pile shaft test unit PS3 after removal of fixturing (externally confined, low reinforcement)

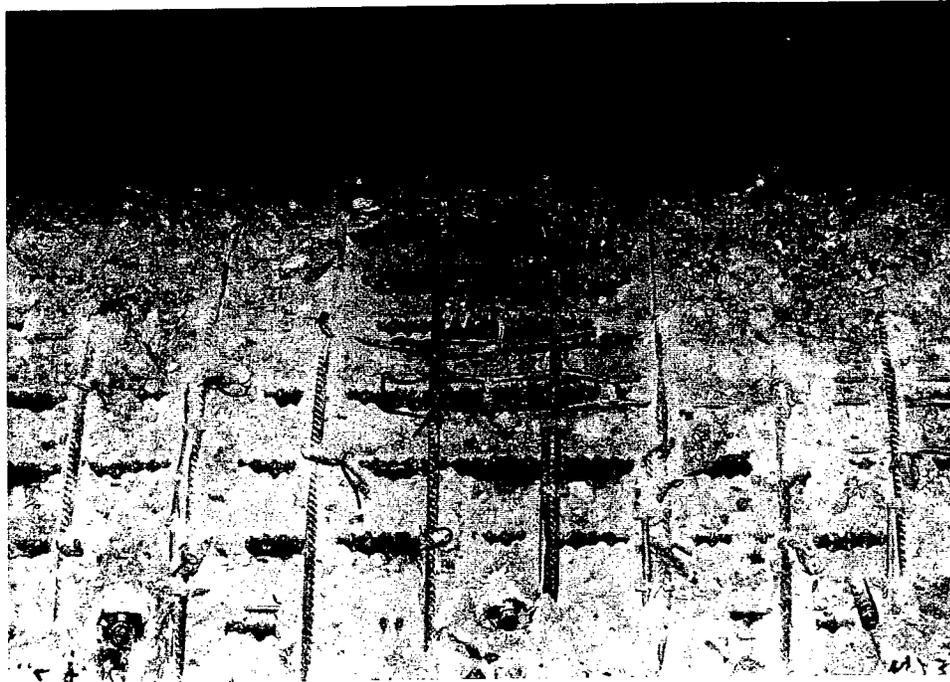
Fig. 5.22 Damage to reinforcing steel, pile shaft test unit PS3 (externally confined, low reinforcement)

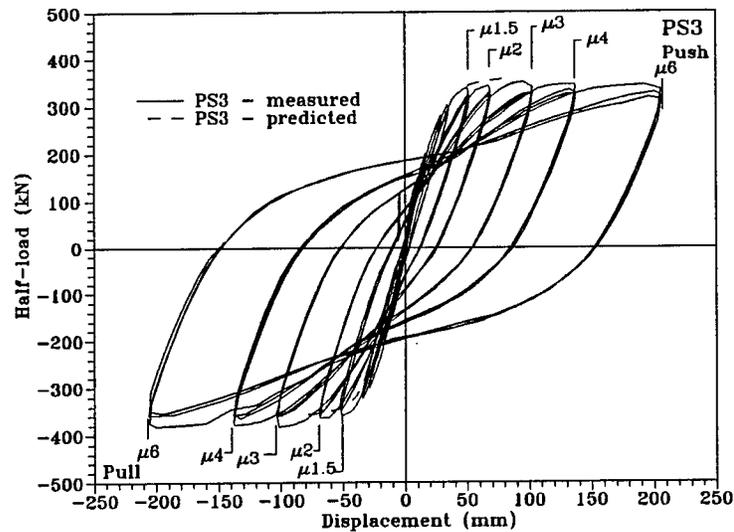
Fig. 5.23: Force-displacement hysteresis loops, pile shaft test unit PS3 (externally confined, low reinforcement)

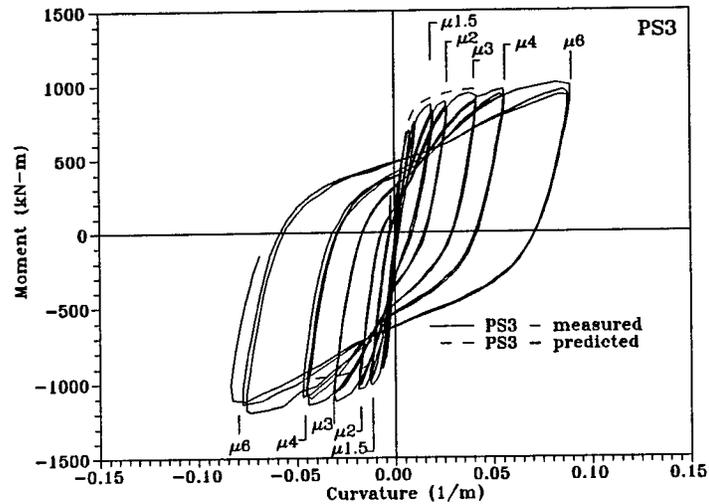
Fig. 5.24: Moment-curvature hysteresis loops at test unit midpoint, pile shaft test unit PS3 (externally confined, low reinforcement)

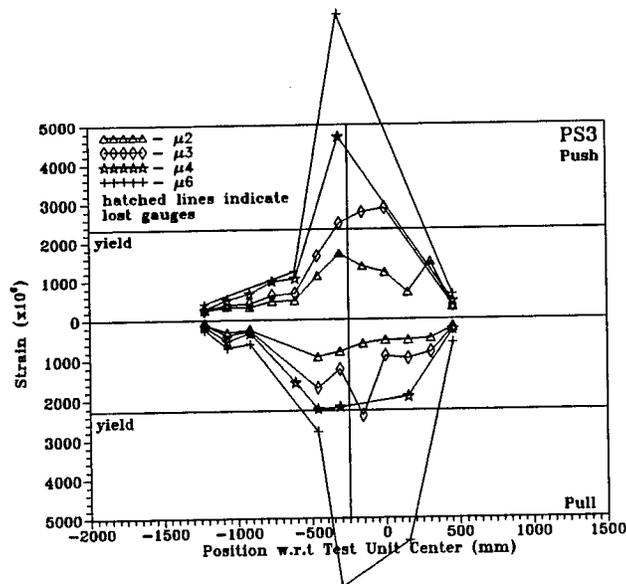
Fig. 5.26: Confining steel strain, pile shaft test unit PS3 (externally confined, low reinforcement)

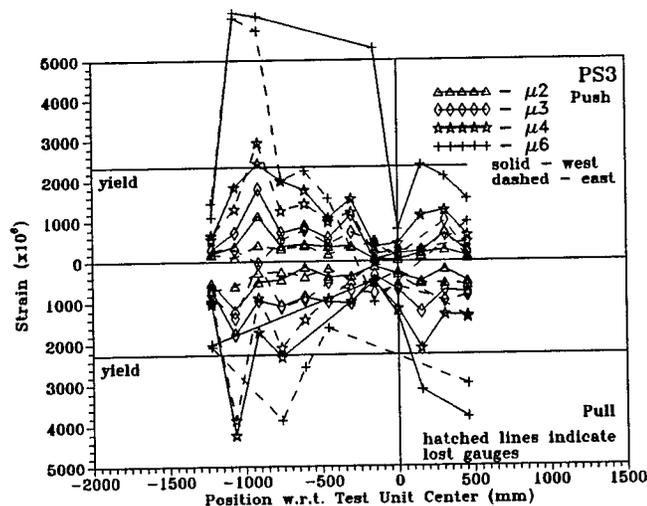
Fig. 5.27: Shear steel strain, pile shaft test unit PS3 (externally confined, low reinforcement)

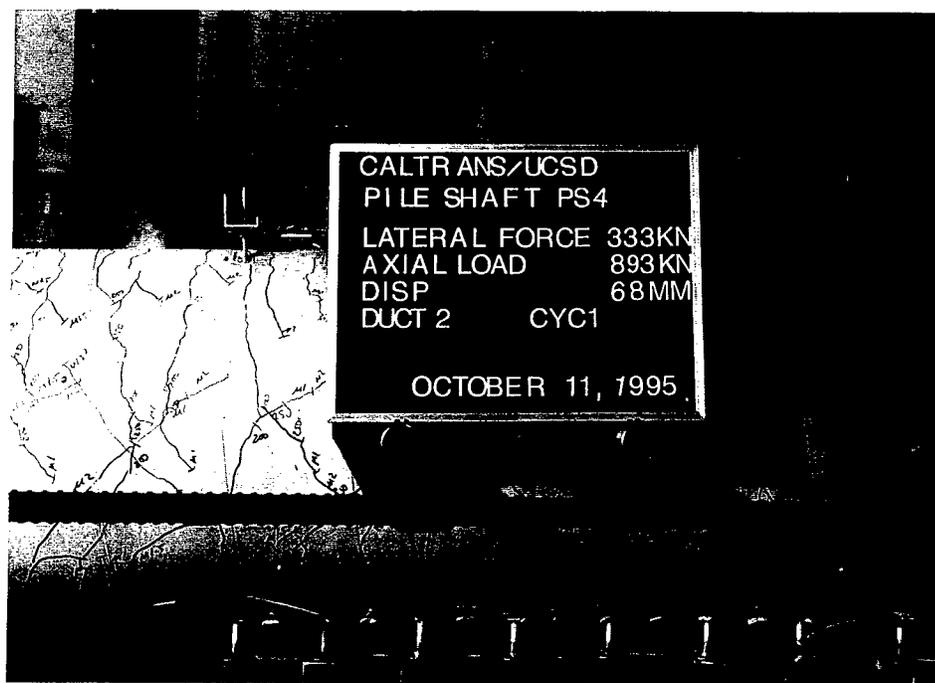
Fig. 5.28: Pile shaft test unit PS4 at $\mu=2$ (no external confinement, high reinforcement)

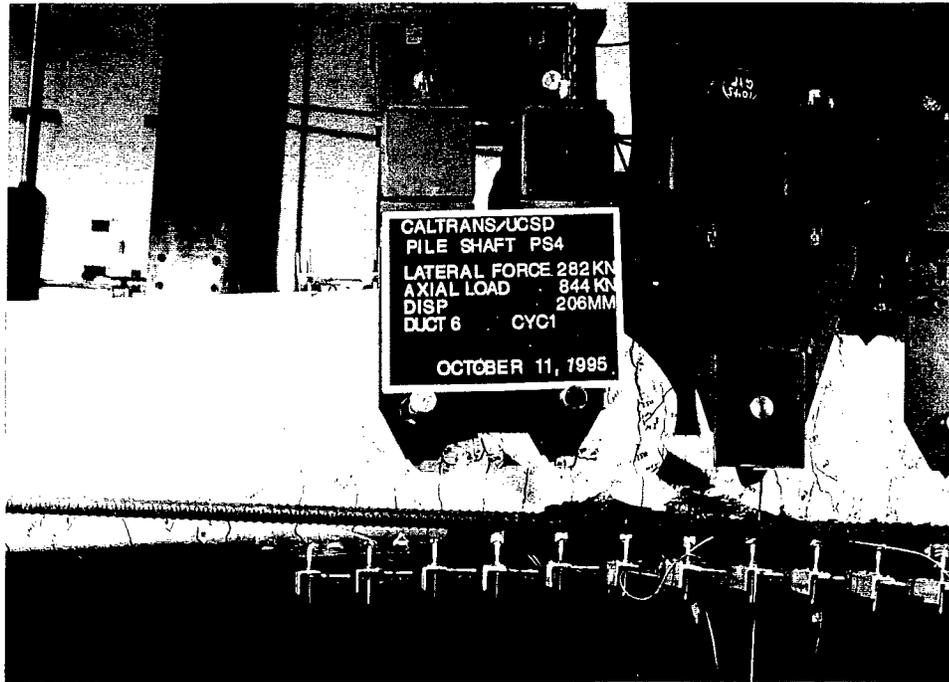
Fig. 5.31: Pile shaft test unit PS4 at $\mu=6$ (no external confinement, high reinforcement)

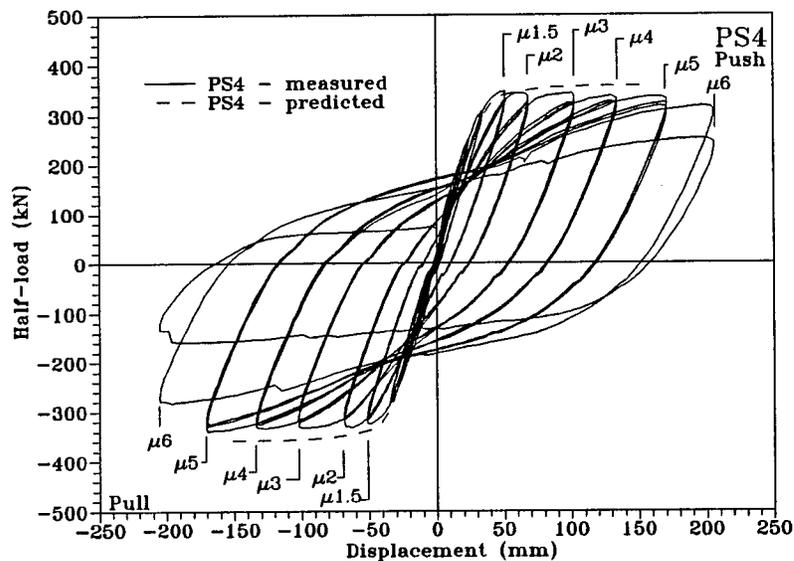
Fig. 5.33: Force-displacement hysteresis loops for pile shaft test unit PS4 (no external confinement, high reinforcement)

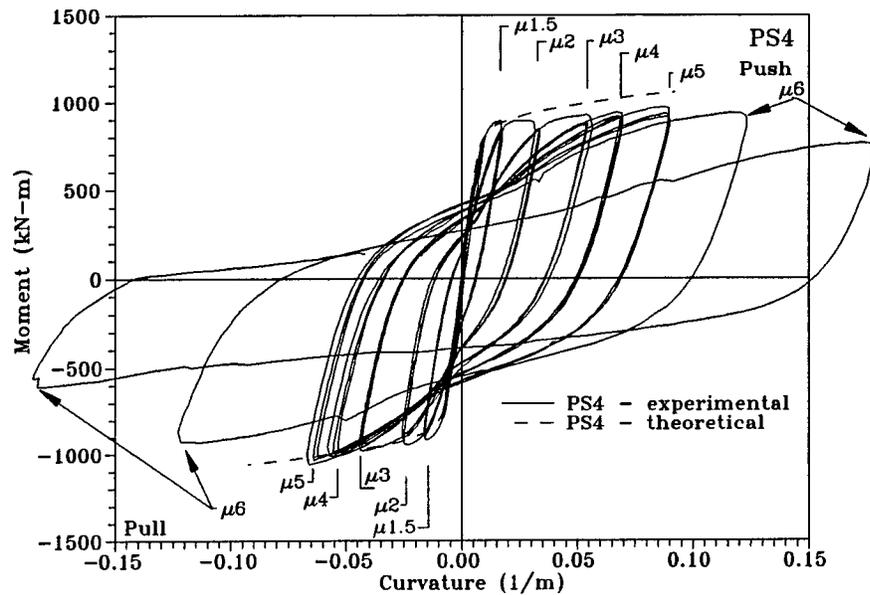
Fig. 5.34: Moment-curvature hysteresis loops, pile shaft unit PS4 (no external confinement, high reinforcement)

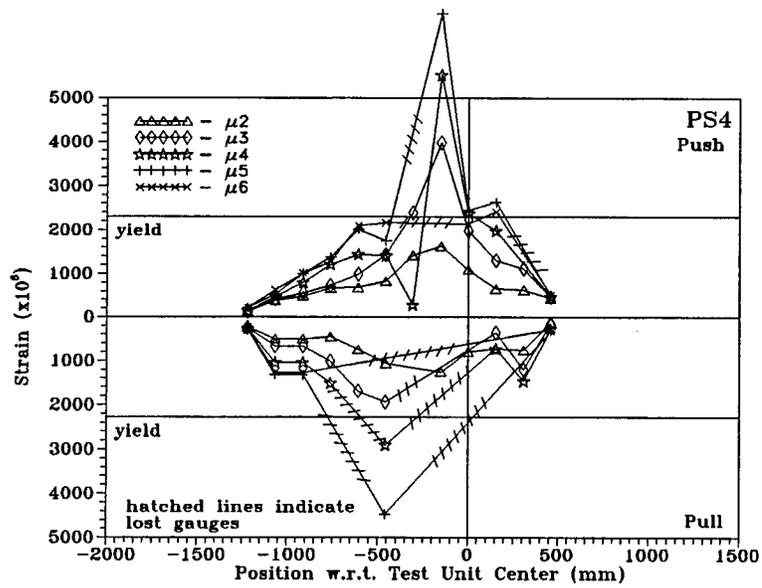
Fig. 5.36: Confining steel strain, pile shaft test unit PS4 (no external confinement, high reinforcement)

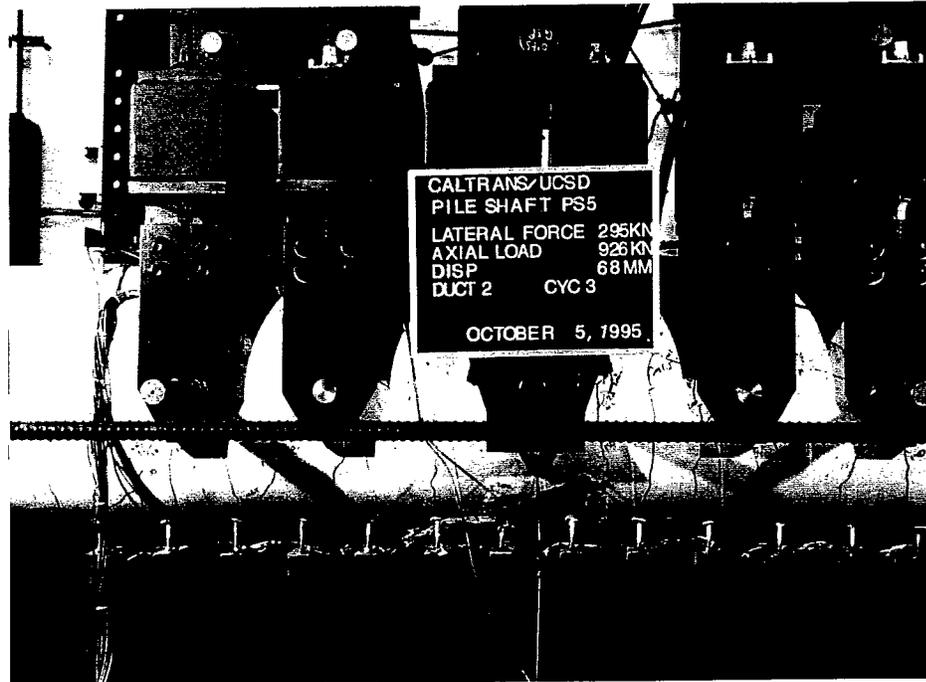
Fig. 5.38: Pile shaft test unit PS5 at $\mu=2$ (no external confinement, medium reinforcement)

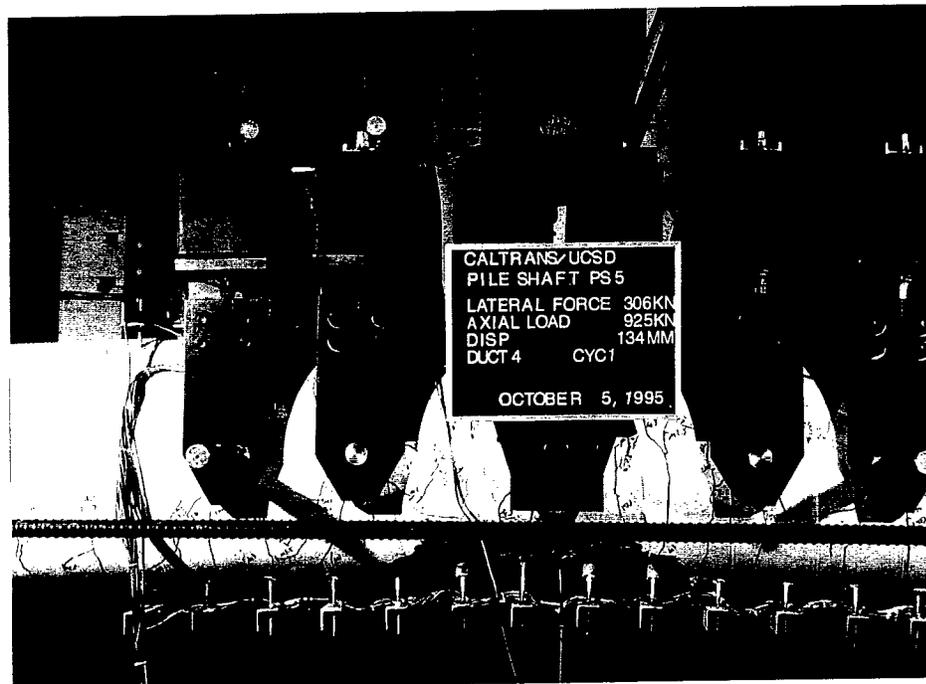
Fig. 5.39: Pile shaft test unit PS5 at $\mu=4$ (no external confinement, medium reinforcement)
