**STRUCTURAL SYSTEMS
RESEARCH PROJECT**

Report No.
SSRP - 97/04

**THE EFFECT OF EXTERNAL
CONFINEMENT AND TRANSVERSE
REINFORCEMENT ON PLASTIC HINGES
IN CAST-IN-PLACE PILE SHAFTS
-- Experimental Results**

Final Report on a Research Project funded by Caltrans under
Contract No. DOT59V375

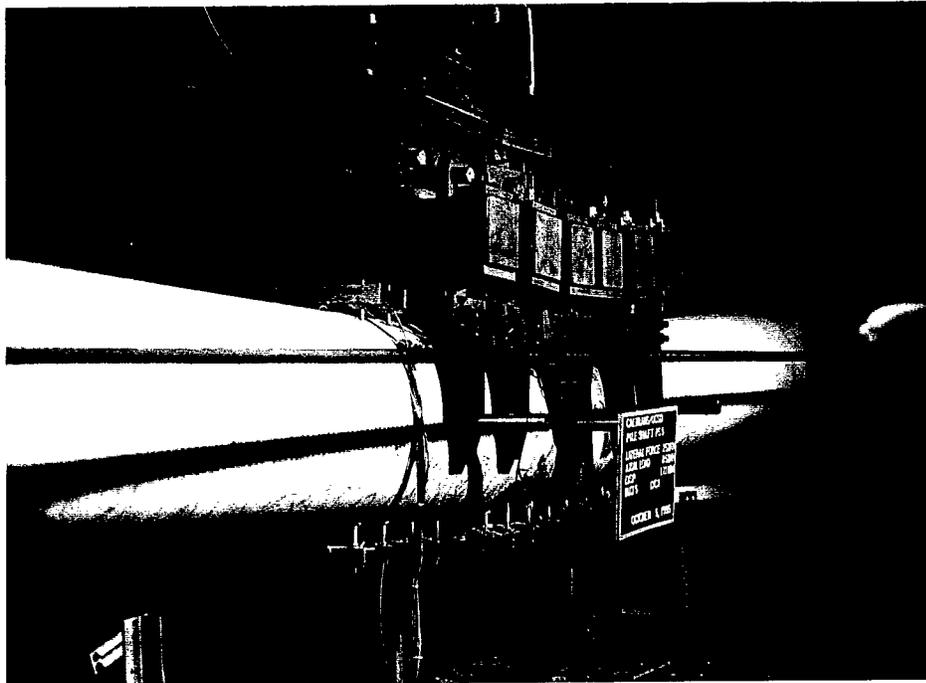
Fig. 5.40: Pile shaft test unit PS5 at $\mu=5$ (no external confinement, medium reinforcement)

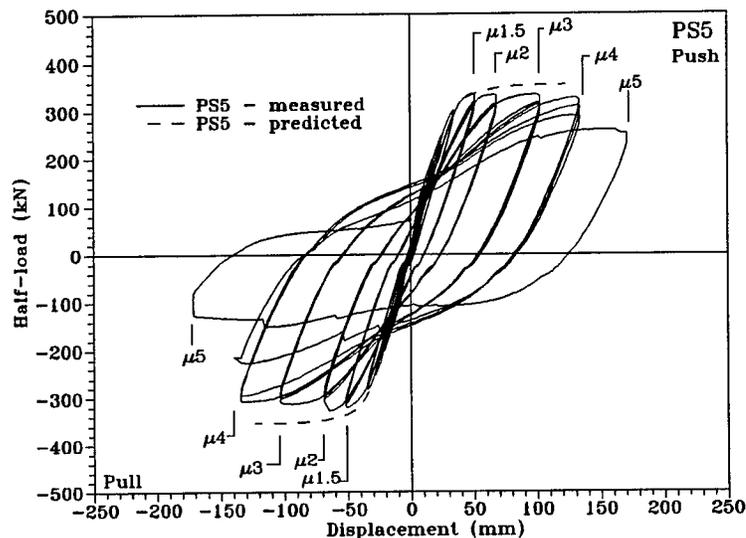
Fig. 5.42: Force-displacement hysteresis loops for pile shaft test unit PS5 (no external confinement, medium reinforcement)

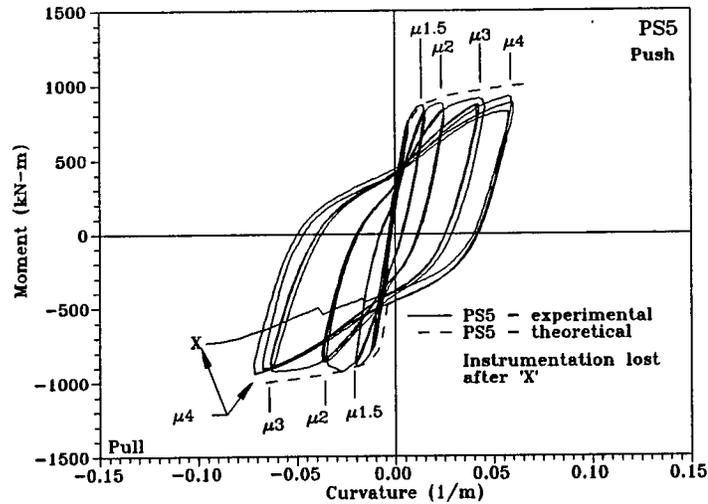
Fig. 5.43: Moment-curvature hysteresis loops for pile shaft unit PS5 (no external confinement, medium reinforcement)

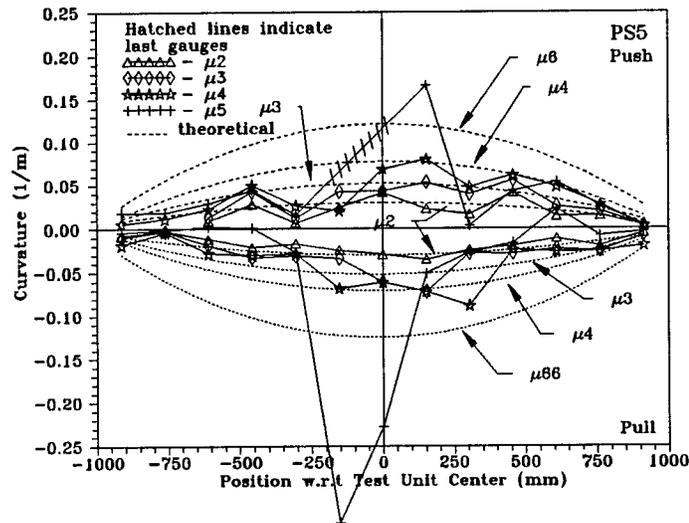
Fig. 5.44: Curvature profiles for pile shaft unit PS5 (no external confinement, medium reinforcement)

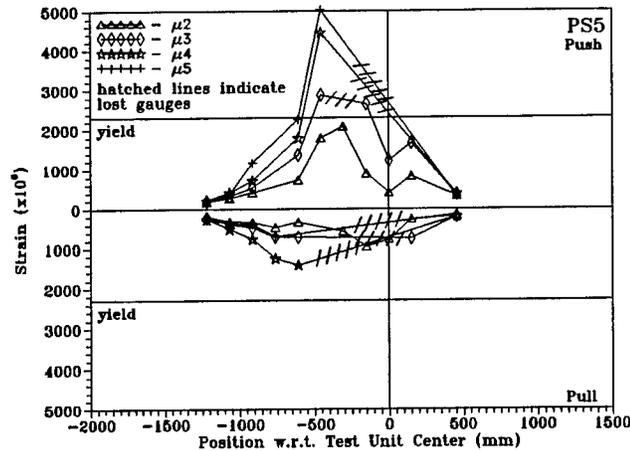
Fig. 5.45: Confining steel strain, pile shaft test unit PS5 (no external confinement, medium reinforcement)

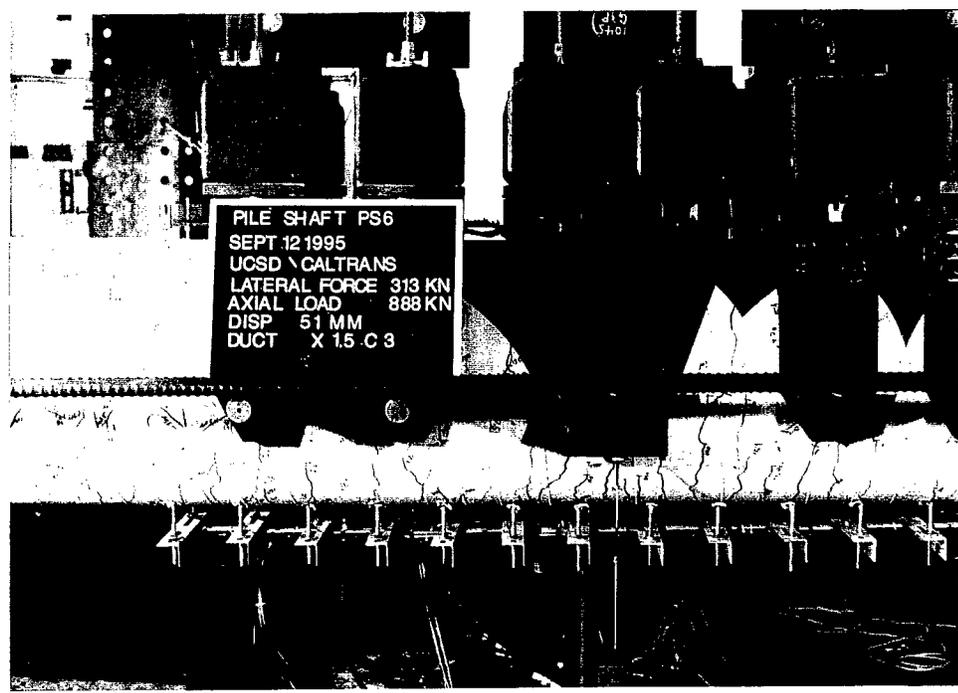
Fig. 5.47: Pile shaft test unit PS6 at $\mu=1.5$ (no external confinement, low reinforcement)

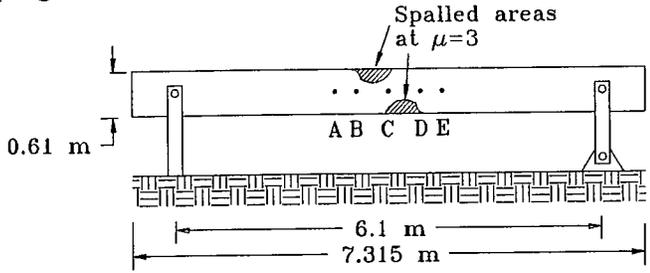
Fig. 5.48: Location of major spalling on pile shaft test unit PS6 (no external confinement, low reinforcement)

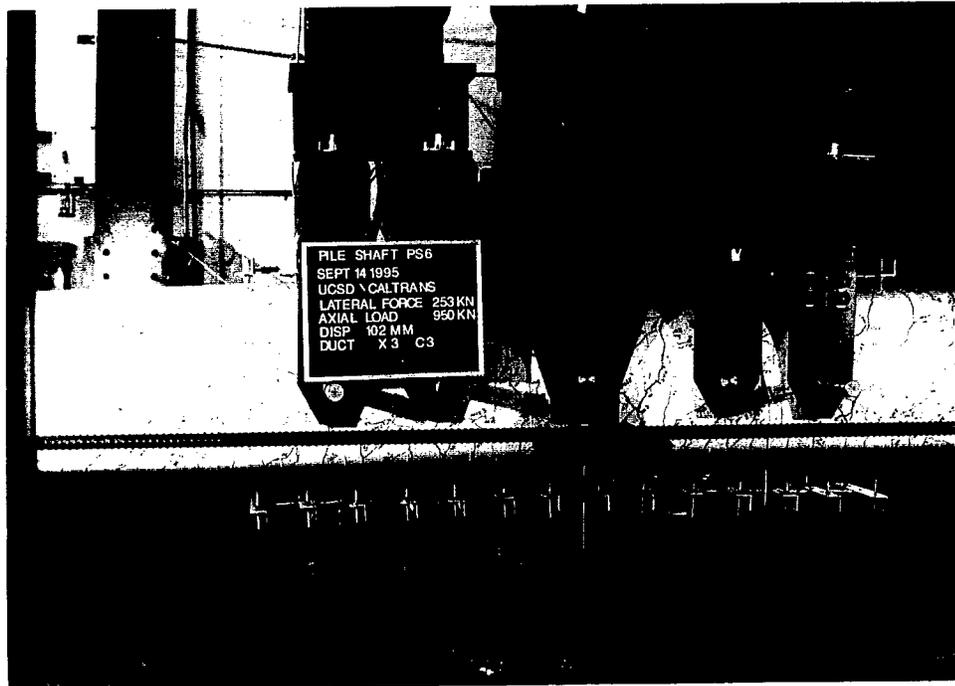
Fig. 5.49: Pile shaft test unit PS6 at $\mu=3$ (no external confinement, low reinforcement)

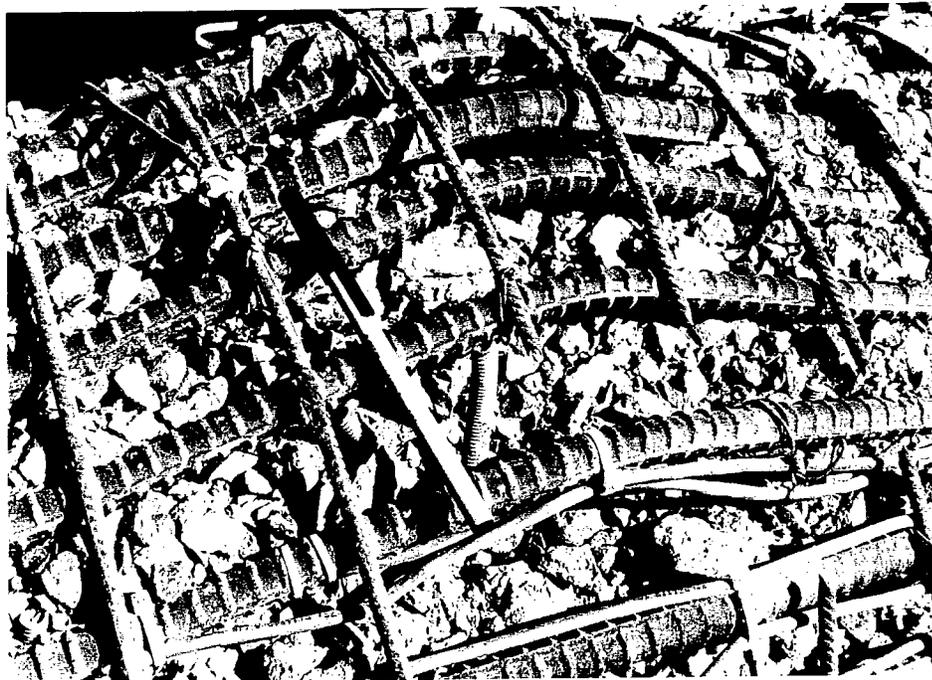
Fig. 5.50: Buckled longitudinal steel and fractured spirals after test of pile shaft test unit PS6 (no external confinement, low reinforcement)

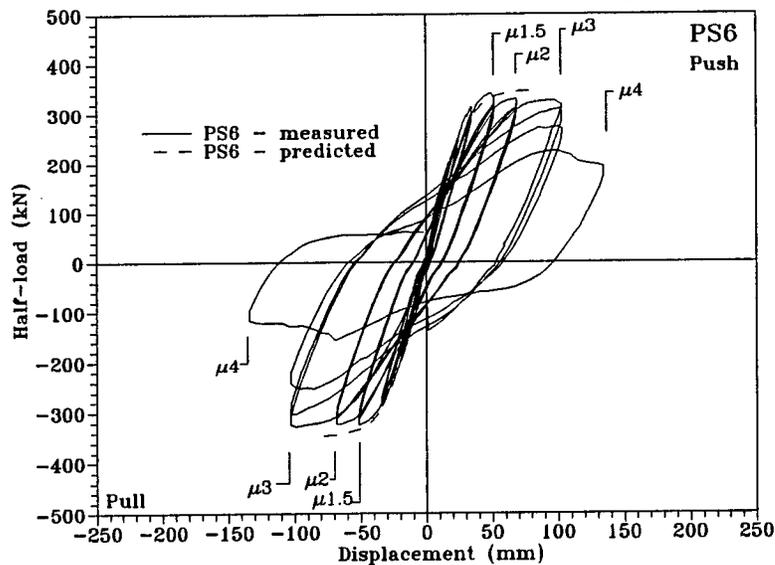
Fig. 5.51: Force-displacement hysteresis loops for pile shaft test unit PS6 (no external confinement, low reinforcement)

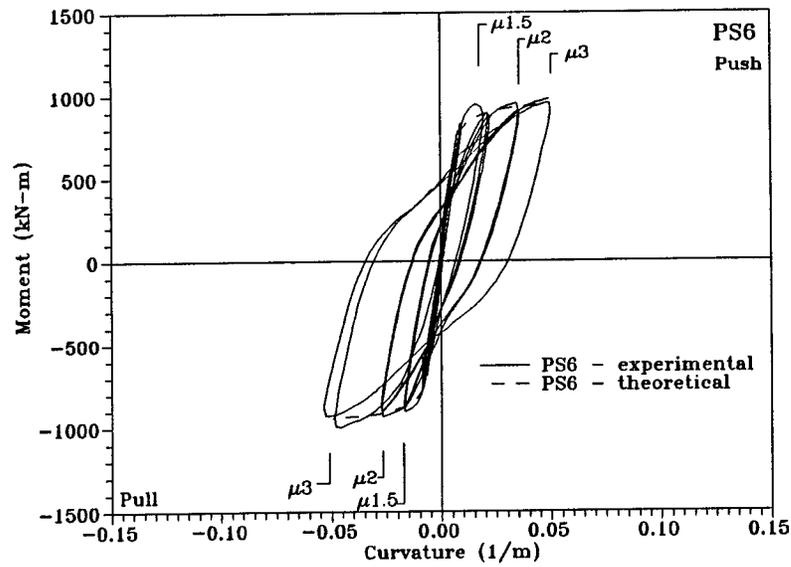
Fig. 5.52: Moment-curvature hysteresis loops for pile shaft test unit PS6 (no external confinement, low reinforcement)

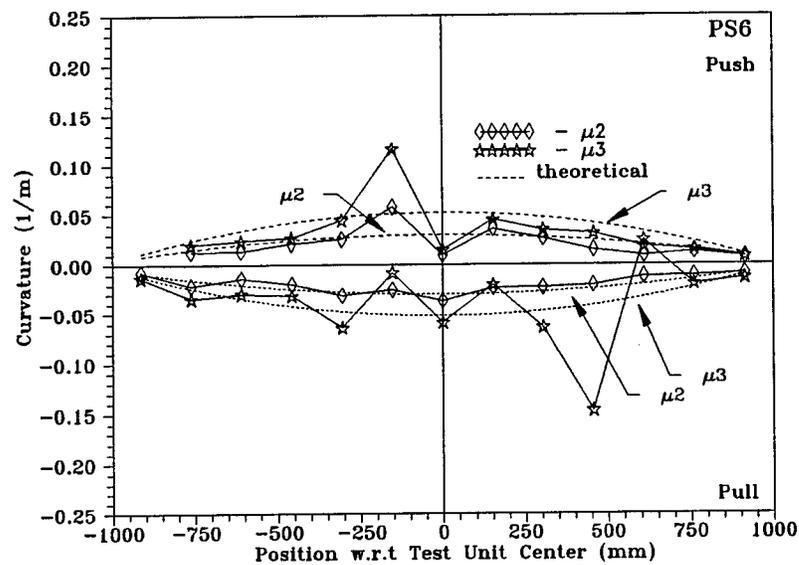
Fig. 5.53: Curvature profiles for pile shaft test unit PS6 (no external confinement, low reinforcement)

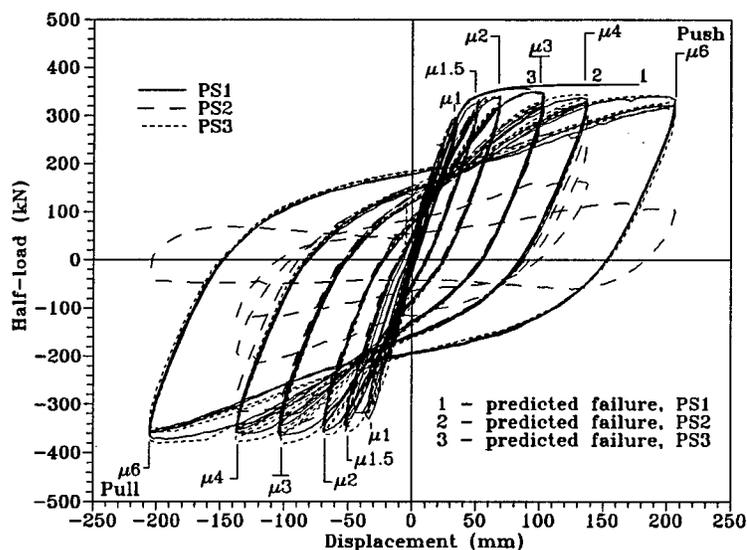
Fig. 5.56: Force-displacement hysteresis loops, PS1-3 (with external confinement; PS2 left center of plastic hinge region unconfined)

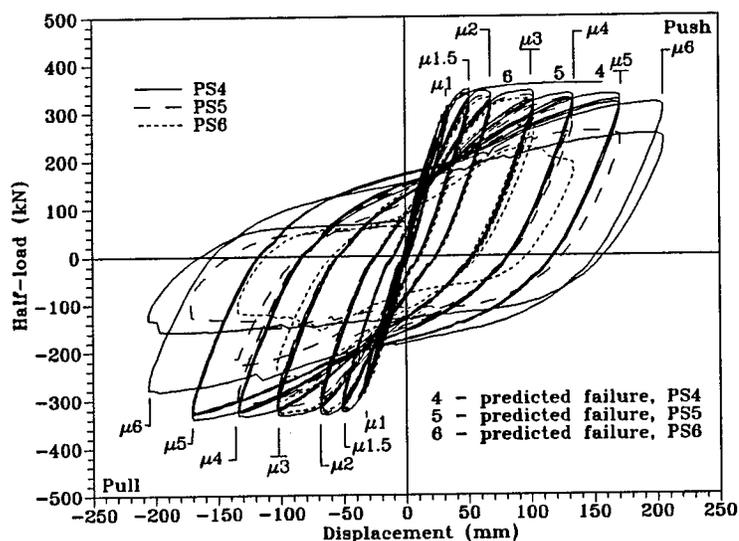
Fig. 5.58: Force-displacement hysteresis loops at longitudinal midpoint, PS4-6 (no external confinement)

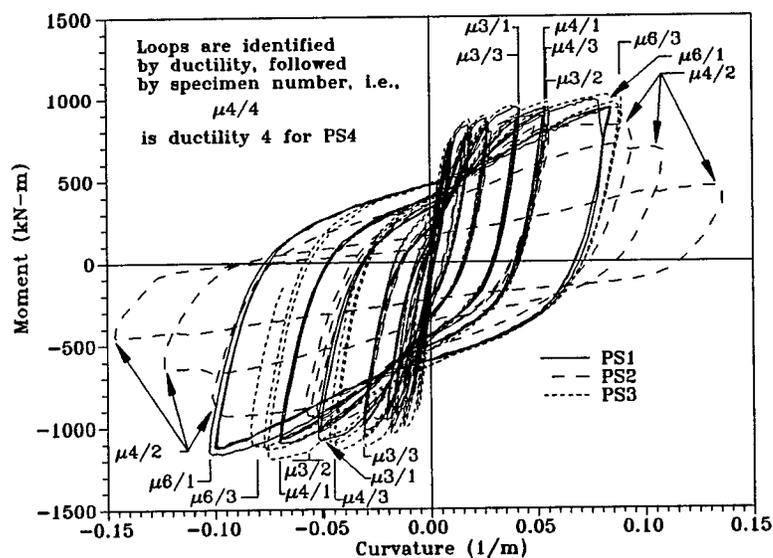
Fig. 5.59: Moment-curvature hysteresis loops at longitudinal midpoint, PS1-3 (with external confinement; PS2 left center of plastic hinge region unconfined)

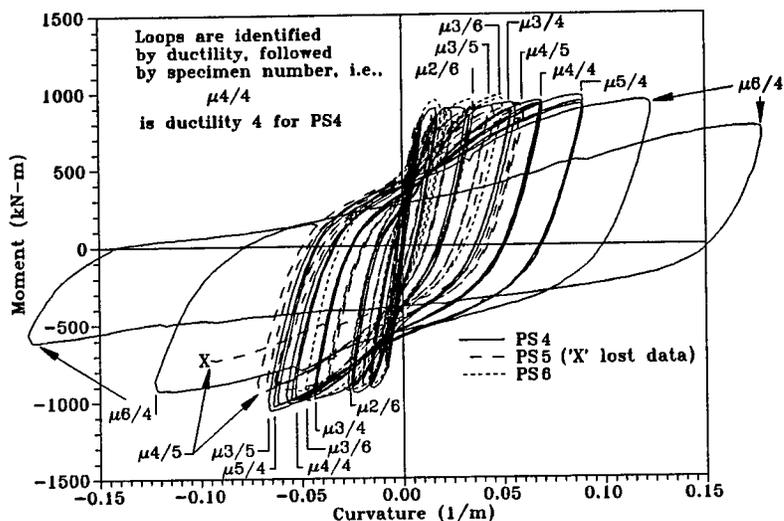
Fig. 5.60: Moment-curvature hysteresis loops at longitudinal midpoint, PS4-6 (no external confinement)

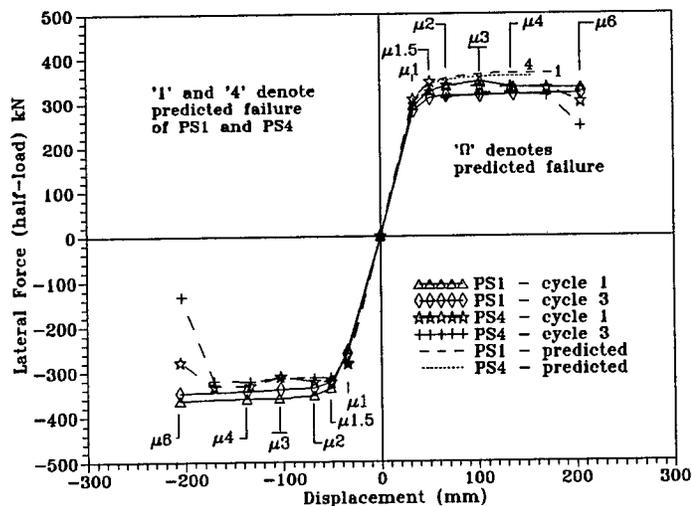
Fig. 5.61: Force-displacement envelopes for PS1 and PS4 (PS1 with external confinement, PS4 without)

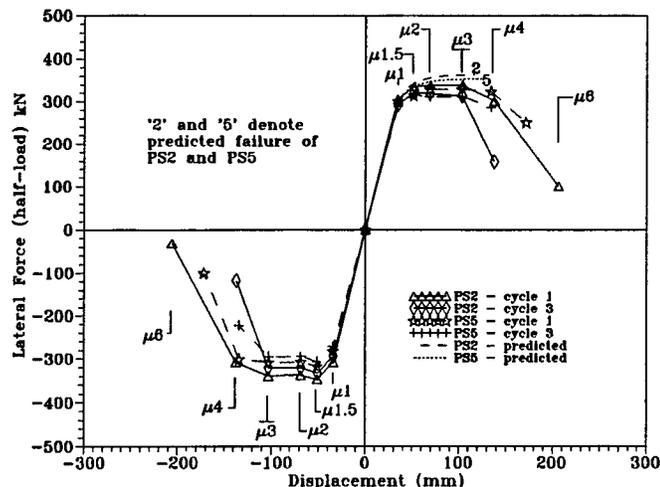
Fig. 5.62: Force-displacement envelopes for PS2 and PS5 (PS2 with external confinement adjacent to plastic hinge region, PS5 without external confinement)

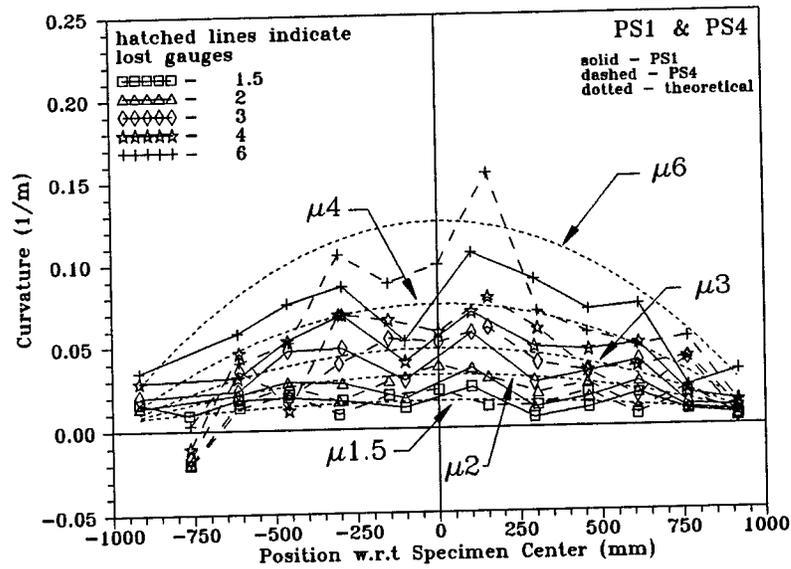
Fig. 5.67: Theoretical and experimental curvature profiles for PS1 and PS4, push cycles (PS1 with external confinement, PS4 without)

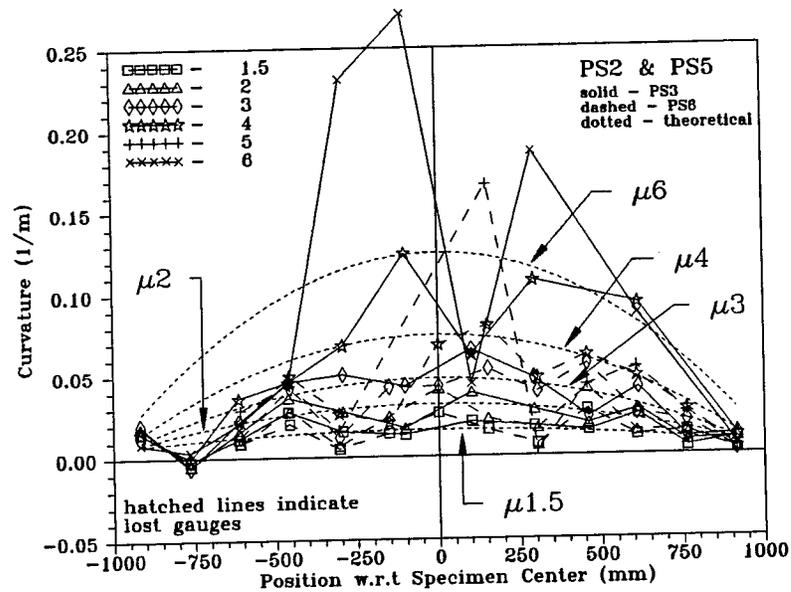
Fig. 5.68: Theoretical and experimental curvature profiles for PS2 and PS5, push cycles (PS2 with external confinement adjacent to plastic hinge, PS5 without external confinement)

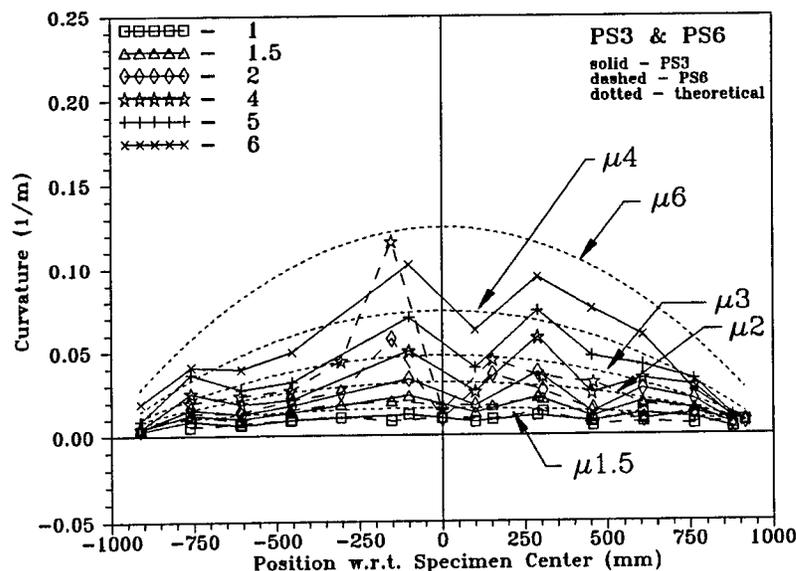
Fig. 5.69: Theoretical and experimental curvature profiles for PS3 and PS6, push cycles (PS3 with external confinement, PS6 without)
