Safety Performance Testing of a Modified Oregon Multidirectional Slip-Base Sign Support: FOIL Test Numbers 98F002 and 98F004

PUBLICATION NO. FHWA-RD-98-111

OCTOBER 1998

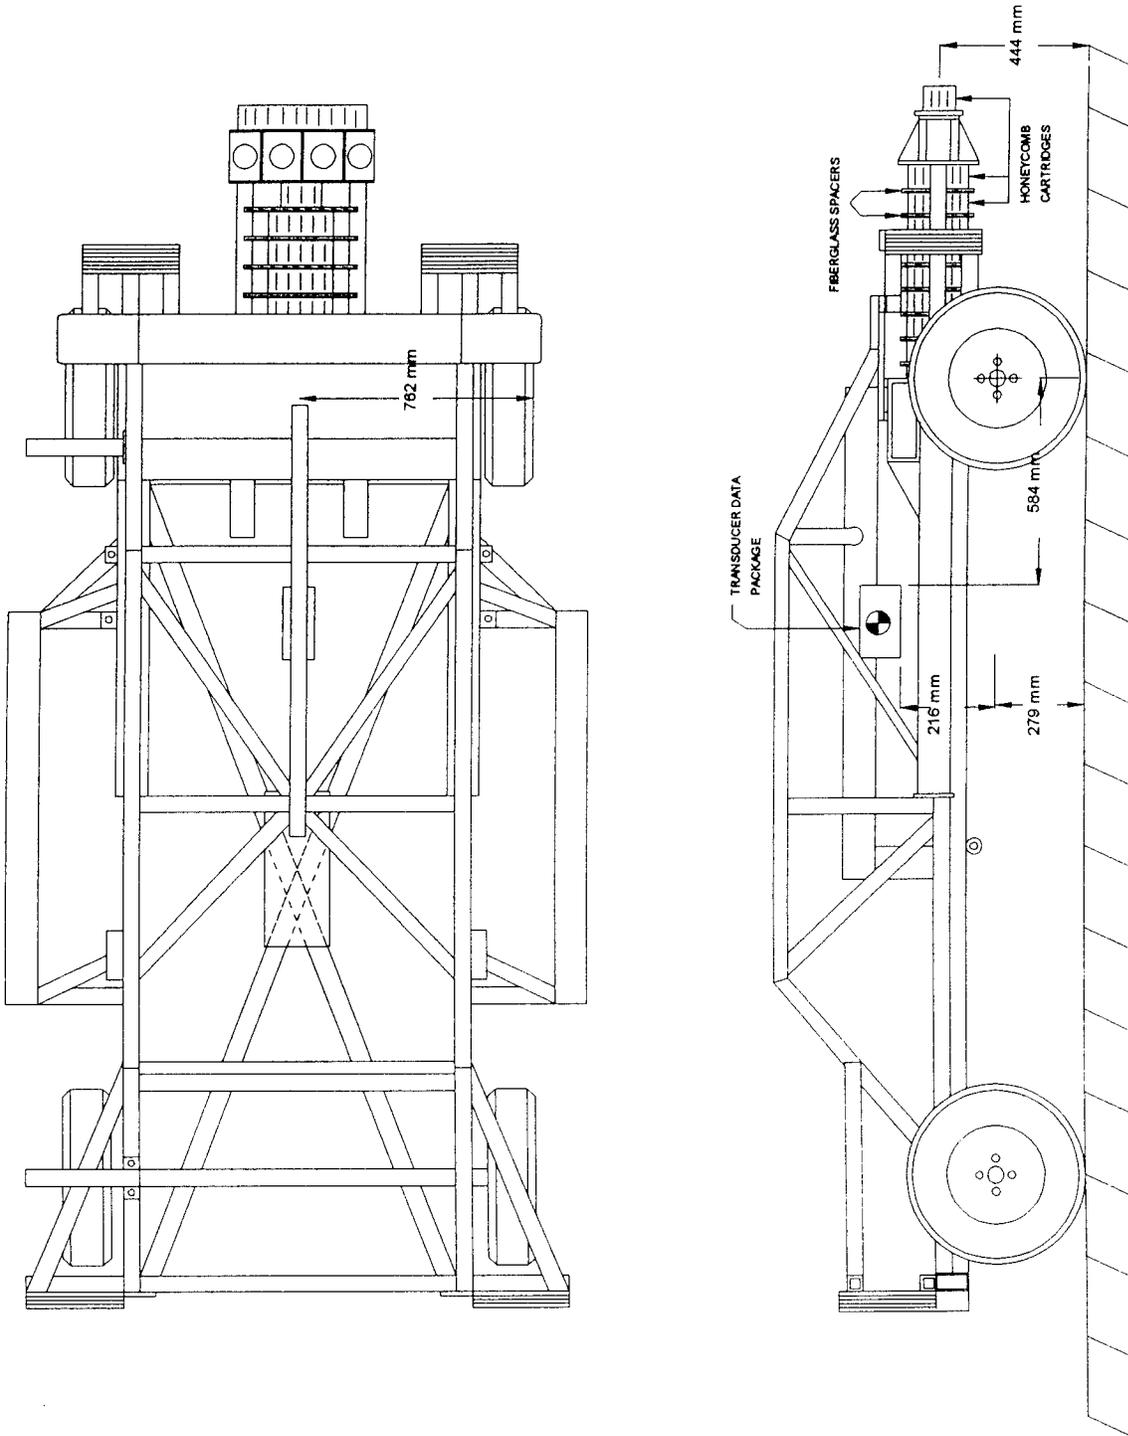
Figure 1. Sketch of the FOIL bogie vehicle.

The test vehicle was the FOIL's reusable breakaway bogie vehicle. The bogie vehicle uses a honeycomb material in a sliding nose to simulate the crush characteristics of an 839-kg small vehicle, more specifically a 1979 VW Rabbit.⁽⁴⁾ The height of the bogie vehicle's nose was 444 mm, which corresponds to the bumper height of a VW Rabbit. Figure 1 is a sketch of the bogie vehicle. Frontal crush of the bogie vehicle, which simulates the crush of an actual vehicle, is accomplished using multiple cartridges of expendable aluminum honeycomb material in the sliding nose. After each test, the honeycomb material was replaced and the vehicle reused for the next sign test. Figure 2 depicts the honeycomb configuration used in the low-speed test and figure 3 is a sketch of the honeycomb configuration for the high-speed test. The bogie vehicle had four 1.8-m 100-mm by 100-mm boards mounted on top of its frame to protect it from the falling support or other debris. Ballasted and instrumented the bogie weighed 839 kg. A dummy is not used in bogie vehicle tests.

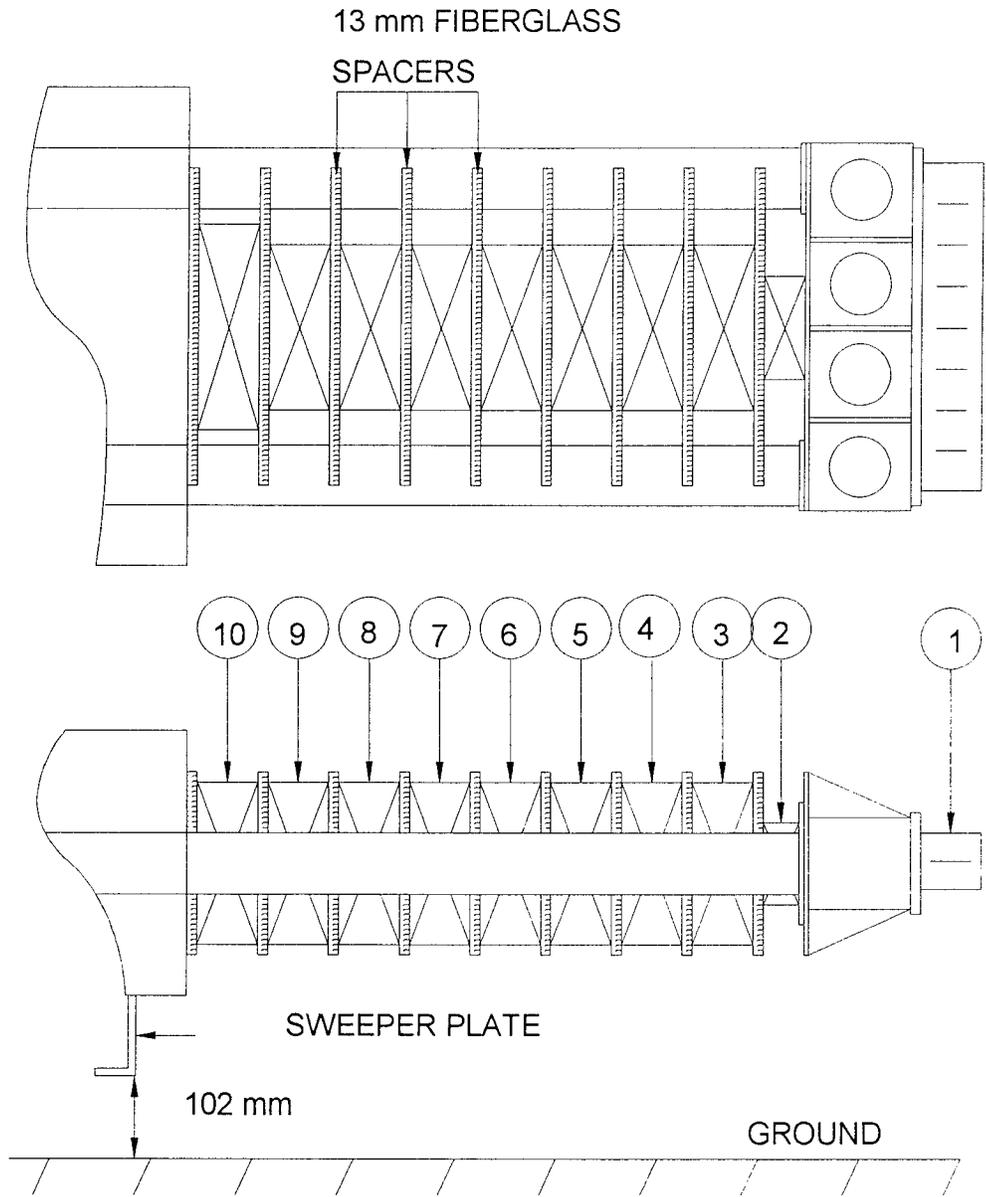
Figure 2. Sketch of low-speed honeycomb configuration.

<u>Cartridge Number</u>	<u>Size (mm) / punch (mm²)</u>	<u>Static Crush Strength(kPa)</u>
1	70 x 406 x 76	896
2	102 x 127 x 51	172
3	203 x 203 x 76 / 13,545	896
4	203 x 203 x 76 / 9,675	1,585
5	203 x 203 x 76 / 3,870	1,585
6	203 x 203 x 76	1,585
7	203 x 203 x 76 / 13,545	2,756
8	203 x 203 x 76 / 7,740	2,756
9	203 x 203 x 76	2,756
10	203 x 254 x 76	2,756

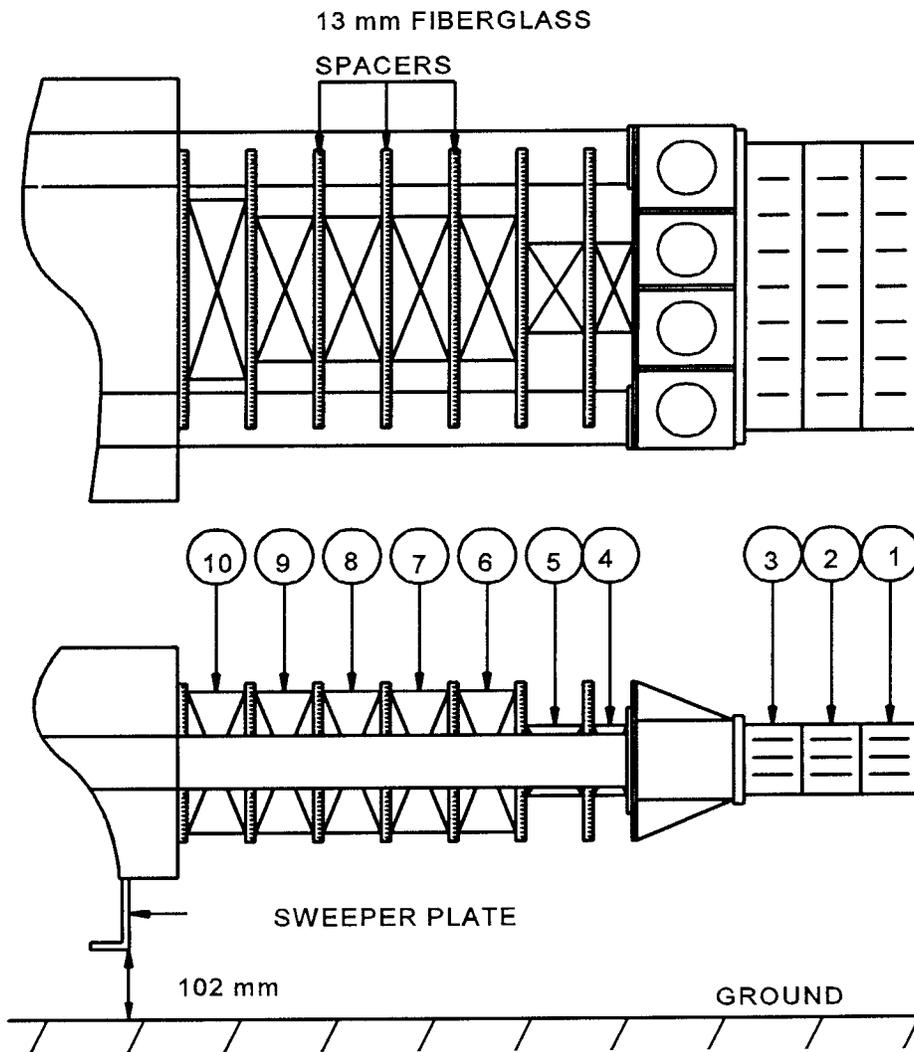
Figure 3. Sketch of high-speed honeycomb configuration.

<u>Cartridge Number</u>	<u>Size (mm) / punch (mm²)</u>	<u>Static Crush Strength(kPa)</u>
1	102 x 406 x 76	896
2	102 x 406 x 76	1,585
3	102 x 406 x 76	1,585
4	102 x 127 x 76	172
5	102 x 127 x 76	172
6	203 x 203 x 76	1,585
7	203 x 203 x 76 / 13,545	2,756
8	203 x 203 x 76 / 7,740	2,756
9	203 x 203 x 76	2,756
10	203 x 254 x 76	2,756

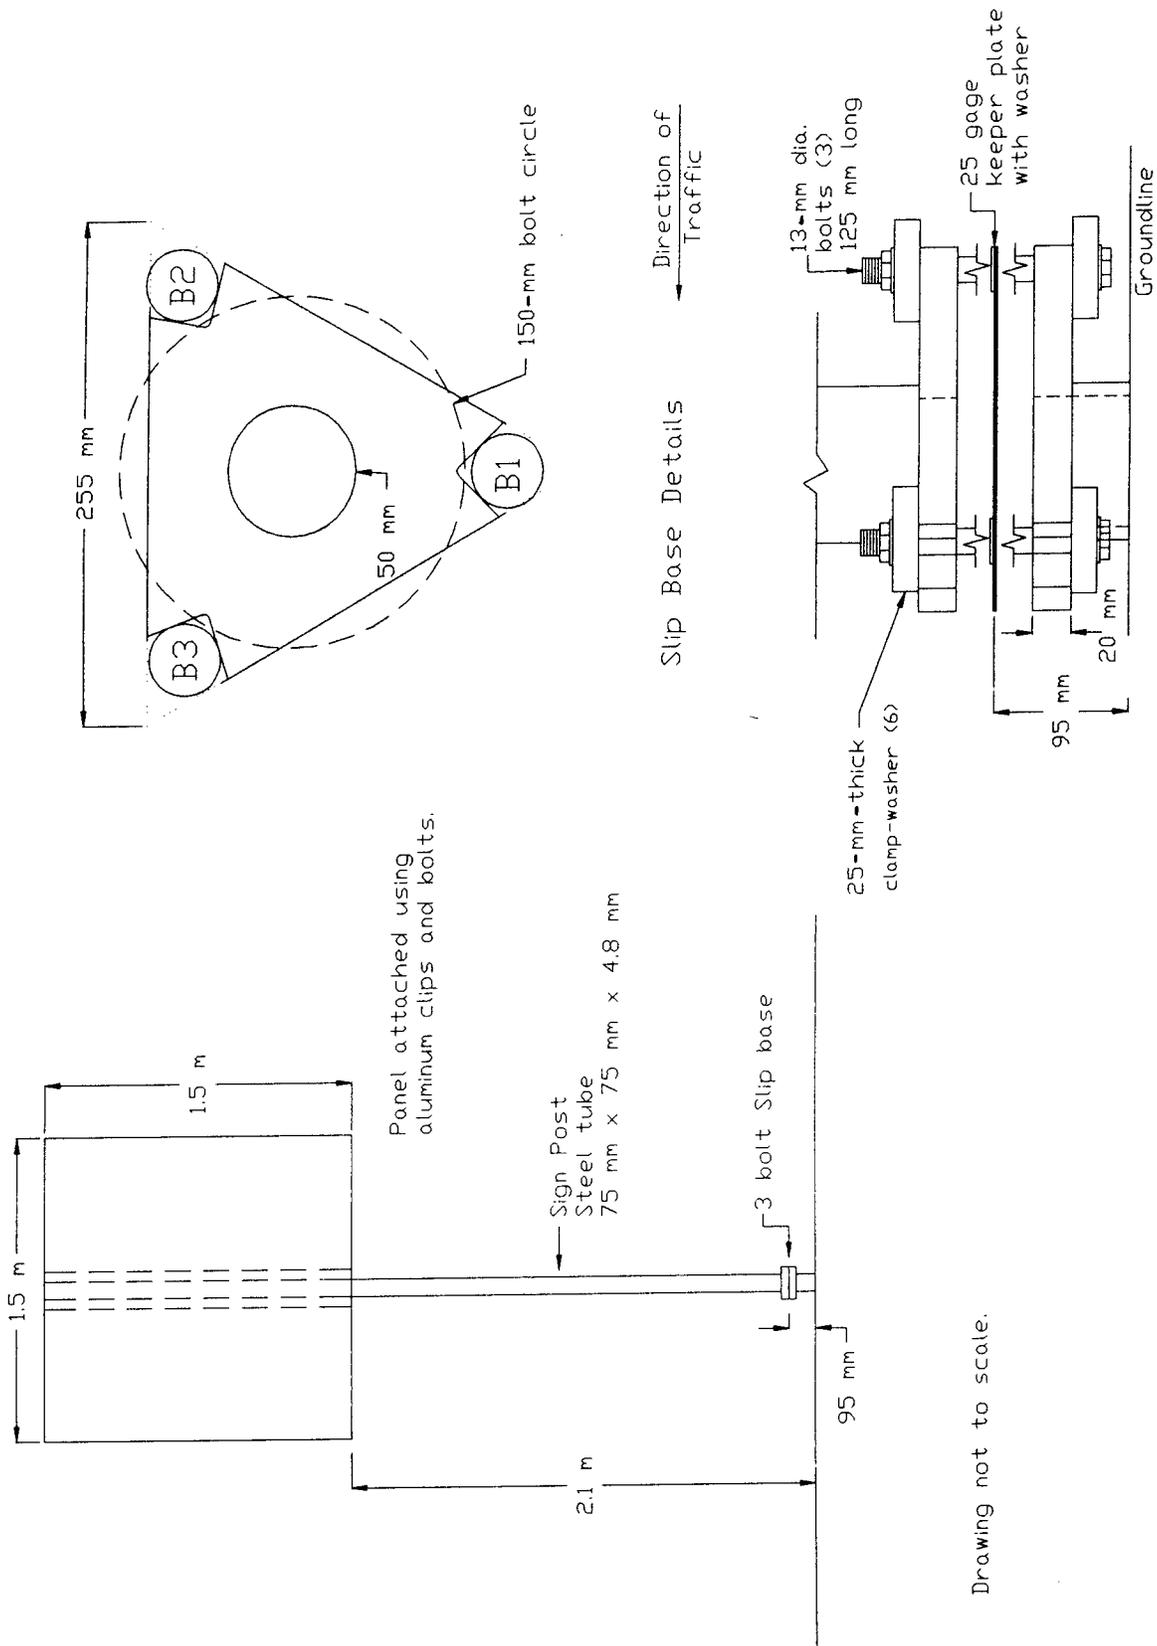
Figure 4. Sketch of the Oregon 3x3 TBB sign support.

Two multidirectional triangular slip-base sign supports were provided by the ODOT for testing. The sign supports consisted of a 75-mm by 75-mm box-tube post welded to a triangular slip-base. The base had three 90° notches to accept three 13-mm-diameter strain gage bolts. A 1.5-m by 1.5-m aluminum sign panel was attached to a 150-mm wide by 5-mm thick steel plate welded to the top 1.5-m of the sign stub. The extruded panel was clamped to the plate using eight aluminum sign panel clips supplied by the ODOT. The three bolts clamped the sign post to the sign stub (slip plane) and were torqued to the manufacturer's recommended torque value of 41 N·m. The increase in the bolt-notch size precipitated the need for longer and thicker clamp-washers. The washers used were 25 mm thick, 25 mm wide and 50 mm long. The thicker washers precipitated the need for 125-mm-long bolts. Strain gage bolts were used for tests 98F002 and 98F004 to measure the bolt tension during the crash tests. The bolts in these tests were pre-tensioned to a nominal tension of 22 kN each. This corresponds to 41 N·m torque. This relationship was derived from the results reported in the report *Slip-Base Clamping Force Tests*.⁽⁵⁾ The bolts in each test were lubricated before sign installation. A slip-bolt keeper plate was sandwiched between the sign post slip-base and the sign stub. The sign stub was bolted to the FOIL runway's foundation plate using 10 20-mm bolts. Table 2 summarizes the details of the sign support. Figure 4 is a sketch of the sign support system.

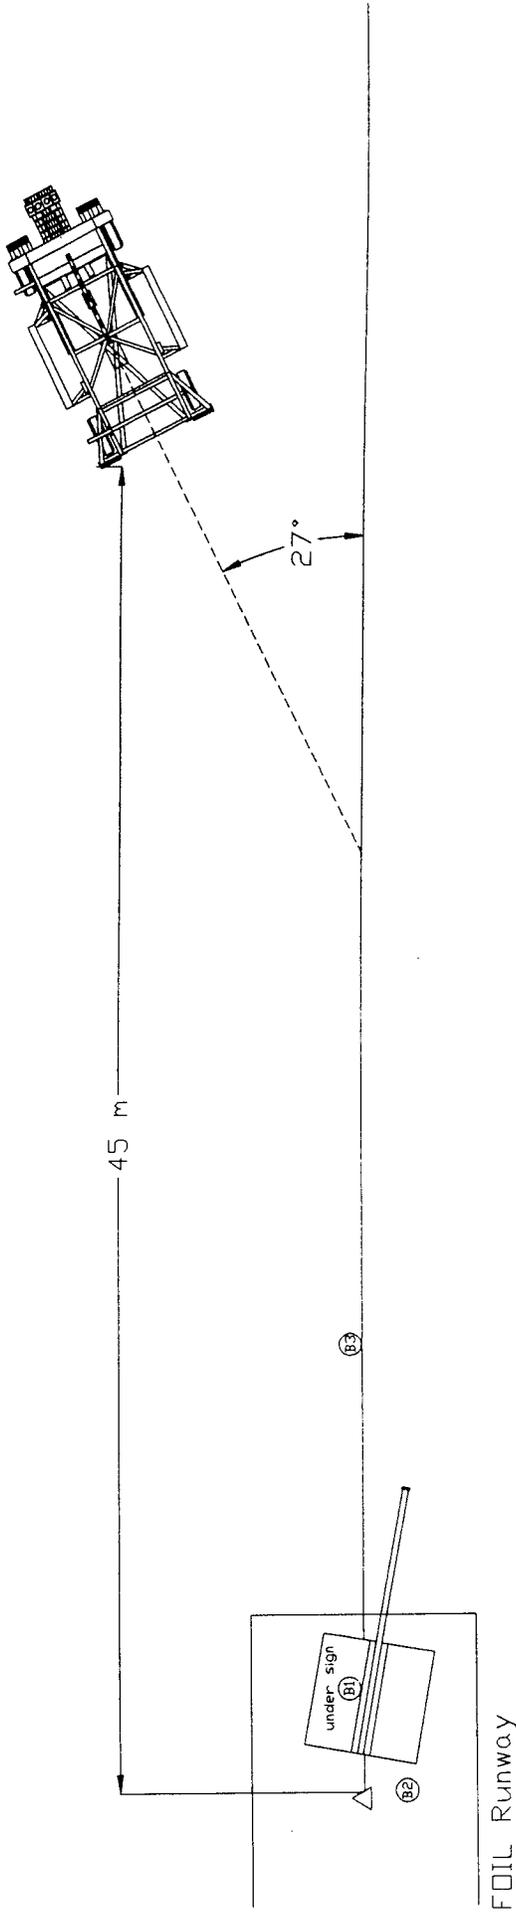
Figure 6. Summary of results, test 98F002.

Test number.....98F002	Impact location.....Single-leg center
Date.....January 26, 1998	Impact angle.....0 degrees
Test article.....Single-leg sign support	Vehicle front-end crush (honeycomb).....150 mm
Support.....3X3 TB on a triangular slip-base	Vehicle damage.....N/A
Total clamp load.....62.6 kN	Vehicle analysis
Sign panel.....Aluminum 1.5 m by 1.5 m	Longitudinal:
Foundation.....FOIL Universal Foundation	Vehicle Delta-V.....0.84 m/s
Vehicle.....FOIL Bogie	Occupant Delta-V at 0.6 m
Weight: Inertial.....839 kg	(acceptable 5.0 m/s).....0.84 m/s
Gross.....839 kg	Ridedown Acceleration
Impact speed.....35.3 km/h	(acceptable 15 g's).....0.3 g's
	Lateral:
	Occupant Delta-V at 0.3 m.....No contact
	Ridedown Acceleration.....No contact
	Vertical stub height (100-mm limit).....95 mm

Figure 5 is photographs of the sign support during the crash test. Figure 6 presents a summary of the test data and the location of the bogie vehicle and sign support after the test. Figures 7 through 14 present data plots of data obtained from accelerometers and strain gage bolts. Figure 15 is photographs taken before the crash test, and figure 16 shows photographs of the vehicle and sign system after the test.

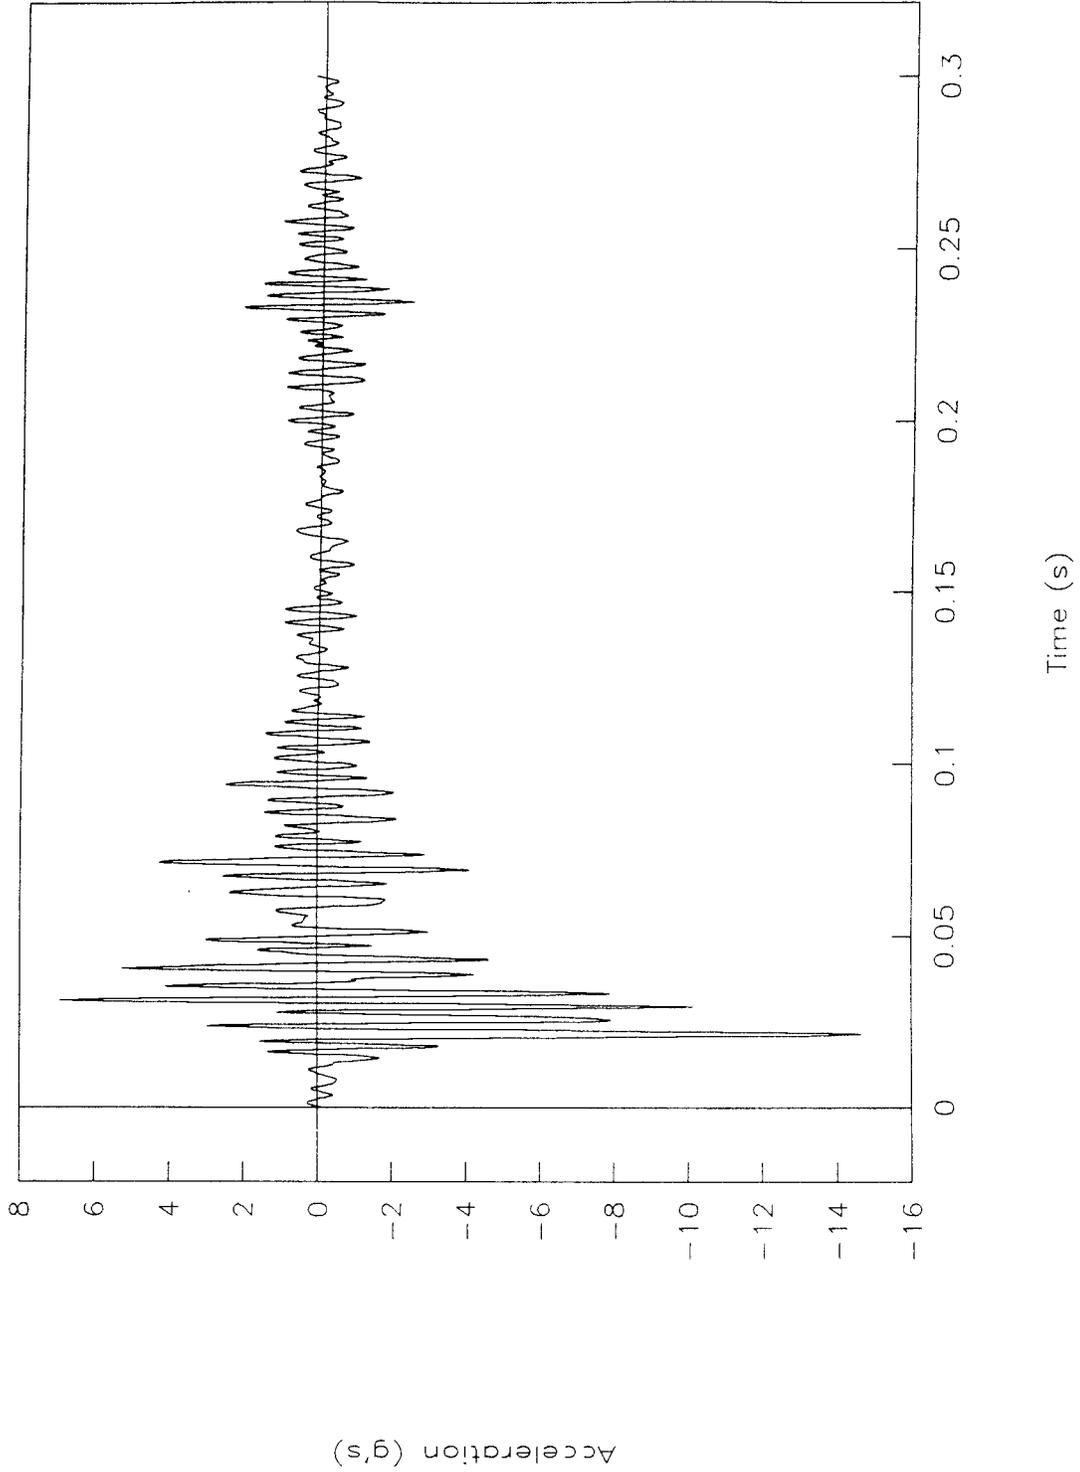
Figure 7. Acceleration vs. time, X-axis, test 98F002.

The longitudinal vehicle change in velocity was determined to be 0.84 m/s. The triaxial rate transducer measured no significant pitch, roll, or yaw rates during the test.

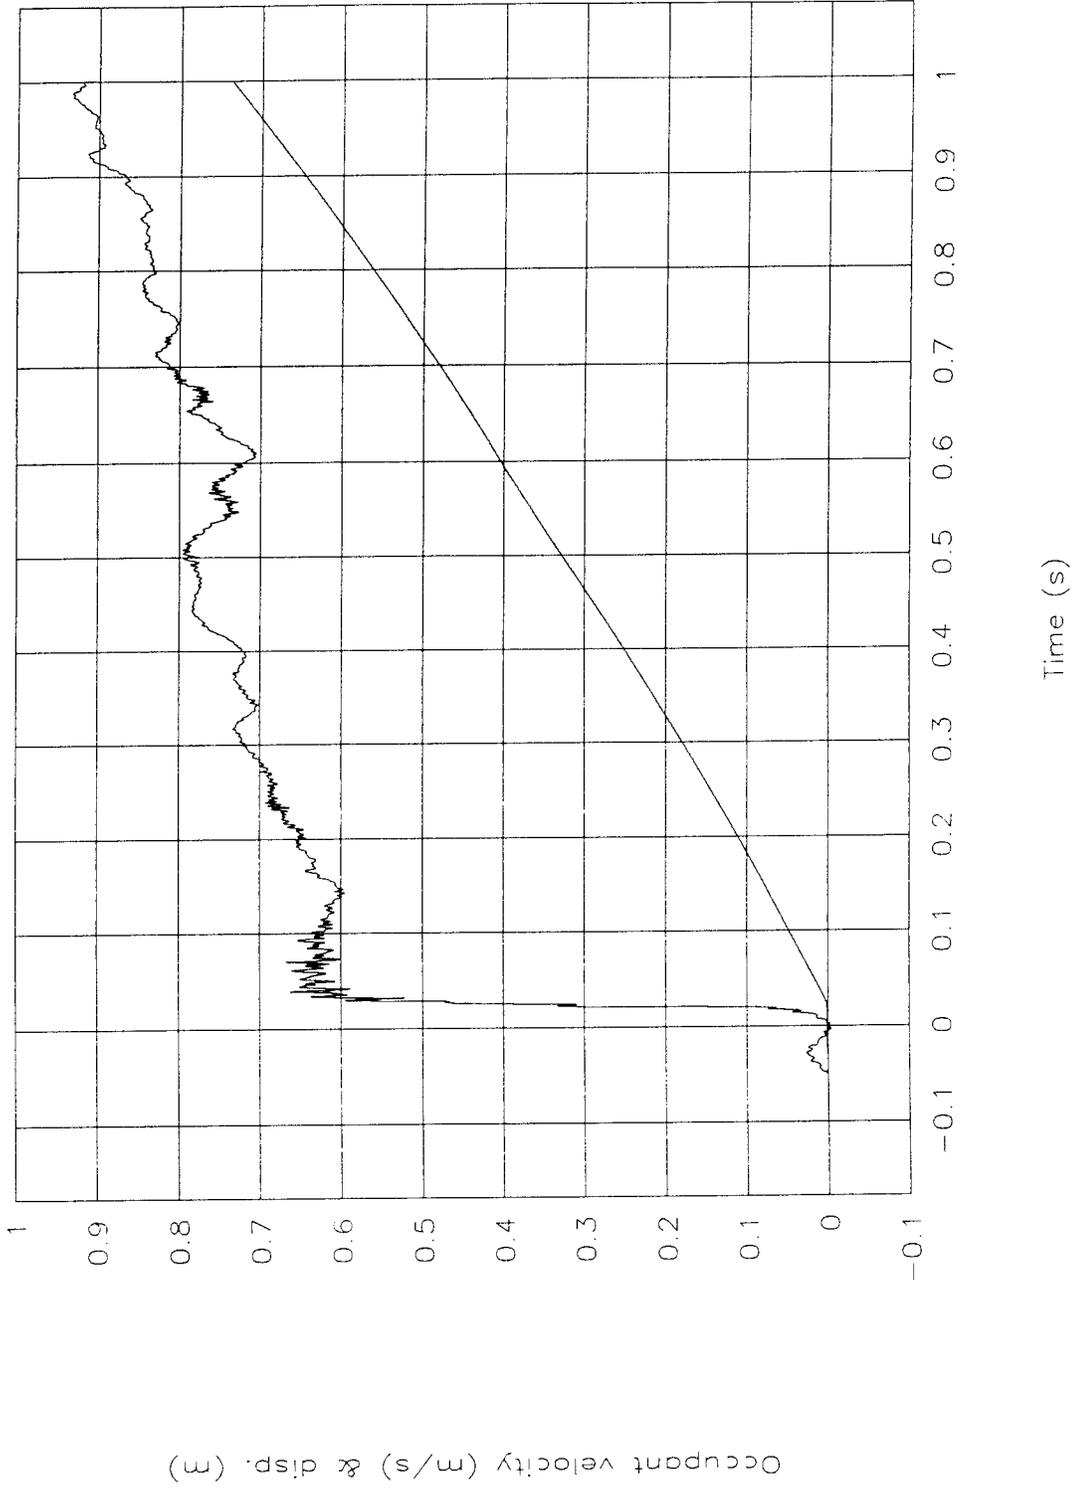
Figure 10. Occupant velocity and displacement vs. time, test 98F002.

b. Occupant Responses: The longitudinal occupant impact velocity for the test was determined to be 0.84 m/s and occurred 0.8 s after initial contact. The longitudinal 10-ms average ridedown acceleration was determined to be 0.3 g's. There was no lateral occupant impact during the bogie/sign interaction.

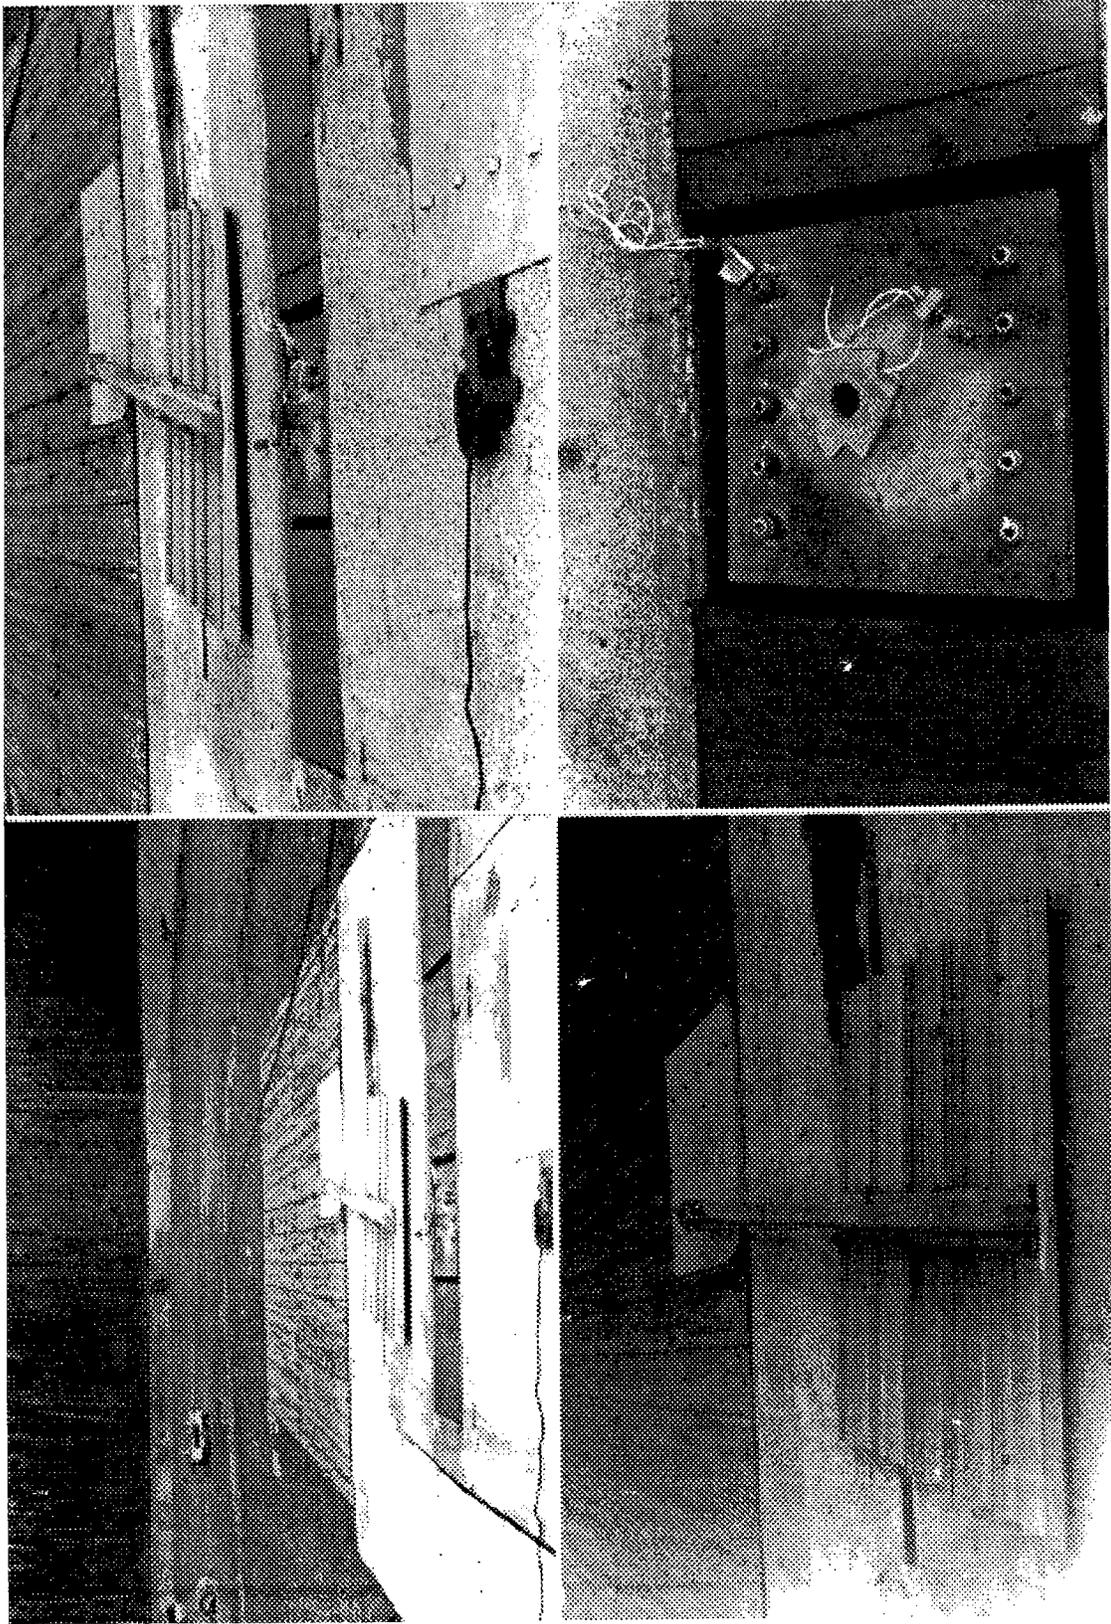
Figure 16. Post-test photographs, test 98F002.

d. Test Article Damage: Damage to the test article was minor. The post disconnected from the base and tore the keeper plate. The sign panel remained fastened to the sign post with no damage. The sign system could be used again after installation of a new keeper plate. The stub height was measured to be 95 mm.

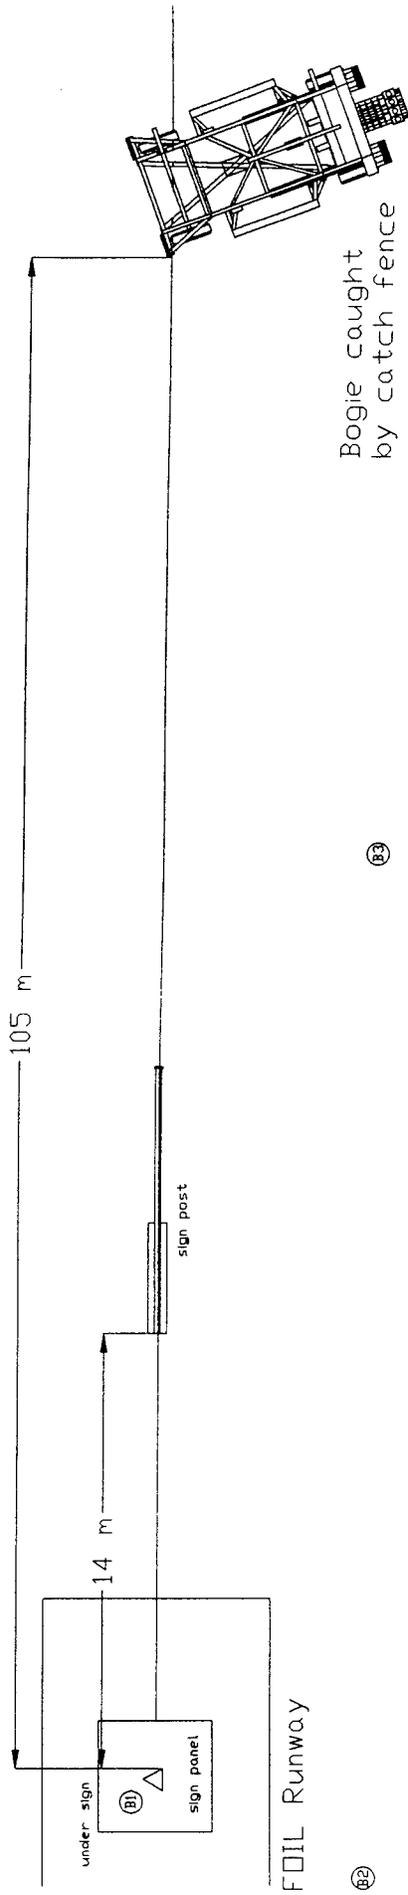
Figure 18. Summary of results, test 98F004.

Test number.....	98F004	Impact location.....	Single-leg center
Date.....	February 5, 1998	Impact angle.....	0 degrees
Test article.....	Single-leg sign support	Vehicle front-end crush (honeycomb).....	330 mm
Support.....	3X3 TB on a triangular slip-base	Vehicle damage.....	N/A
Total clamp load.....	62.5 kN	Vehicle analysis	
Sign panel.....	Aluminum 1.5 m by 1.5 m	Longitudinal:	
Foundation.....	FOIL Universal Foundation	Vehicle Delta-V.....	1.4 m/s
Vehicle.....	FOIL Bogie	Occupant Delta-V at 0.6 m	(acceptable 5.0 m/s)
weight: Inertial.....	839 kg	Ridedown Acceleration	(acceptable 15 g's)
Gross.....	839 kg	Lateral:	
Impact speed.....	99.9 km/h	Occupant Delta-V at 0.3 m.....	No contact
		Ridedown Acceleration.....	No contact
		Vertical stub height (100-mm limit).....	95 mm

Figure 17 contains photographs of the sign support during the crash test. Figure 18 presents a summary of the test data and the location of the test vehicle and sign system after impact. Figures 19 through figure 26 present data plots from data obtained from accelerometers and strain gage bolts. Figure 27 is photographs of the bogie and sign support taken before the test, and figure 28 shows photographs of the bogie and sign support after the test.

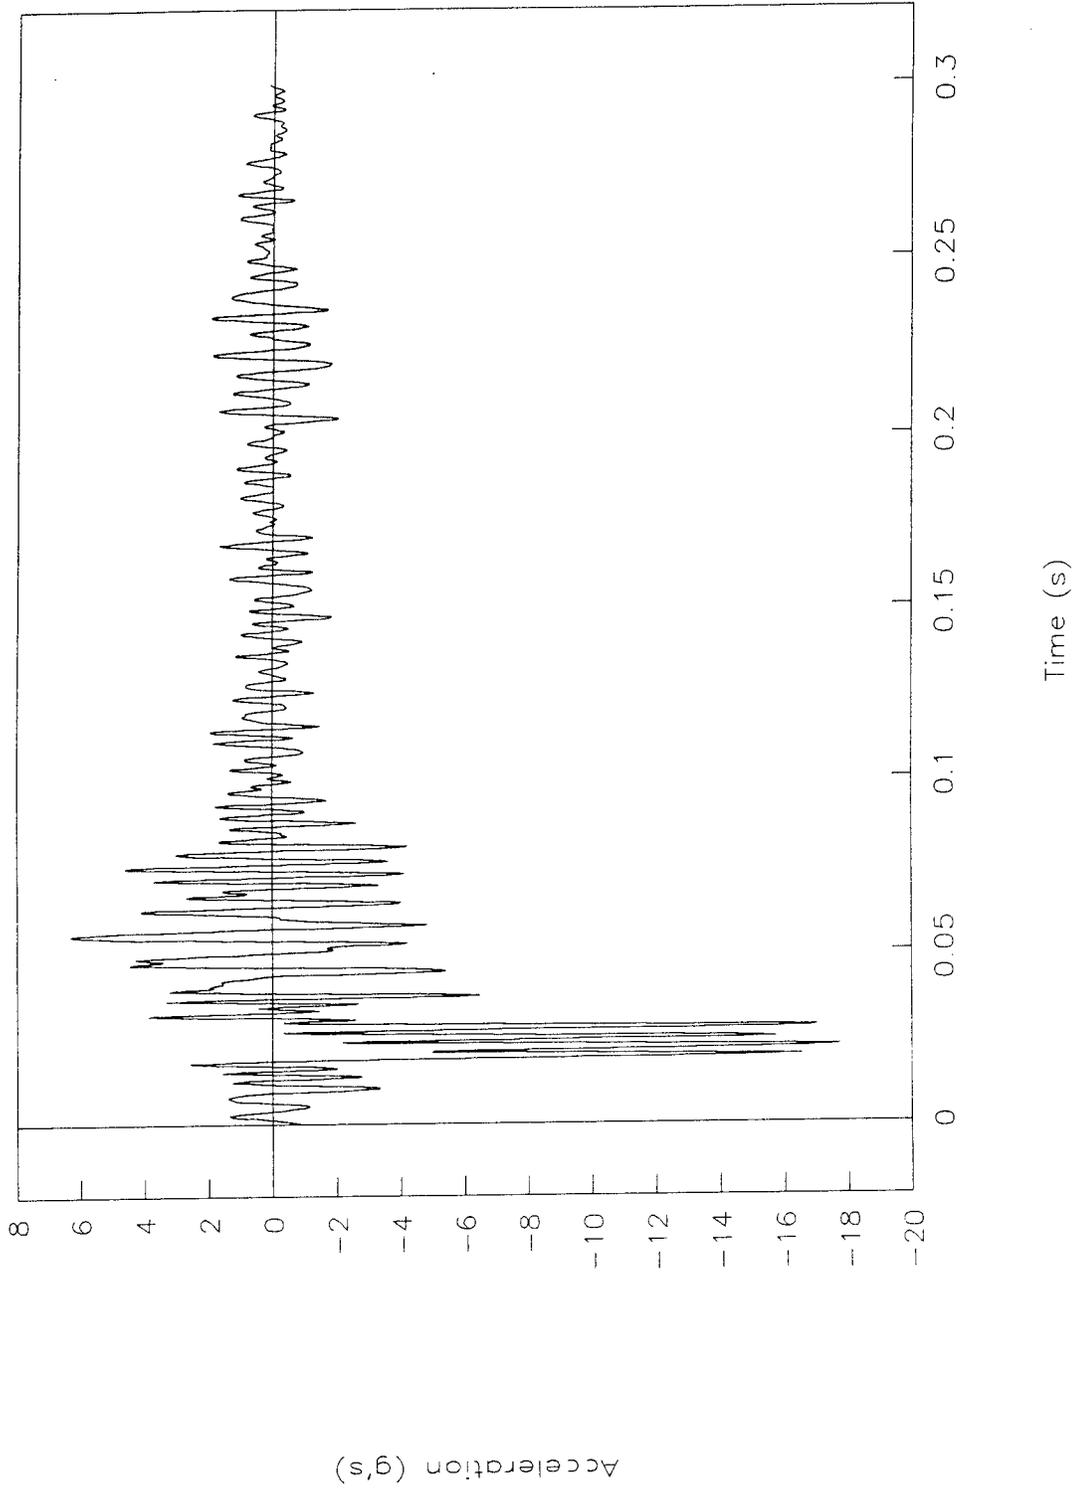
Figure 19. Acceleration vs. time, X-axis, test 98F004.

The longitudinal vehicle change in velocity was determined to be 1.4 m/s. The triaxial rate transducer measured no significant pitch, roll, or yaw rates during the test.

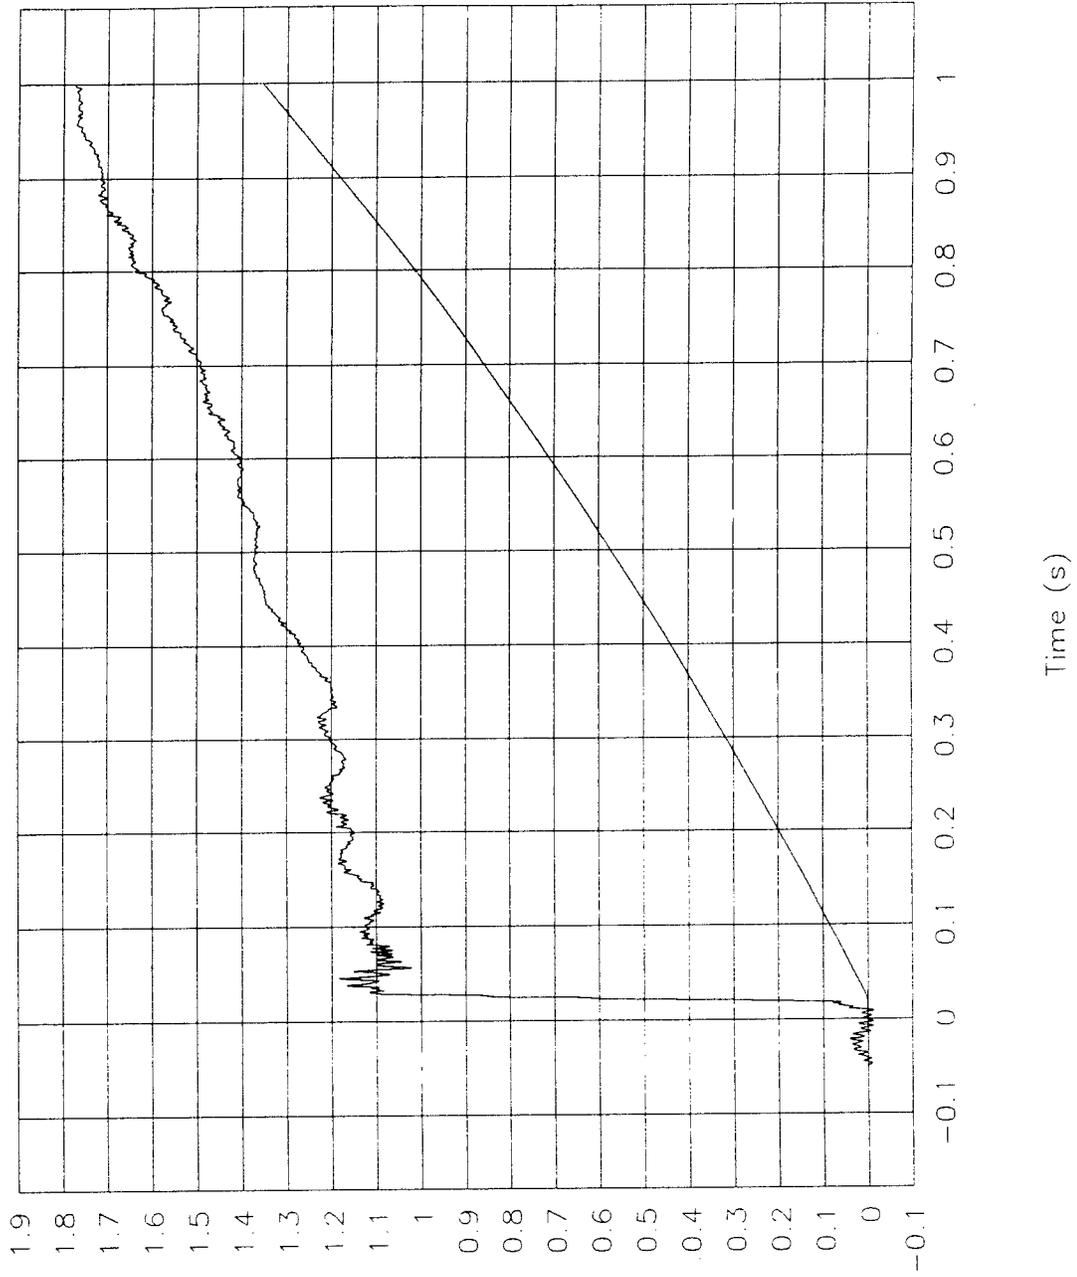
Figure 22. Occupant velocity and displacement vs. time, test 98F004.

b. Occupant Responses: The longitudinal occupant impact velocity for the test was determined to be 1.4 m/s and occurred at 0.519 s after initial contact. The longitudinal 10-ms average ridedown acceleration was determined to be 0.3 g's. There was no lateral occupant impact during the bogie/sign interaction.

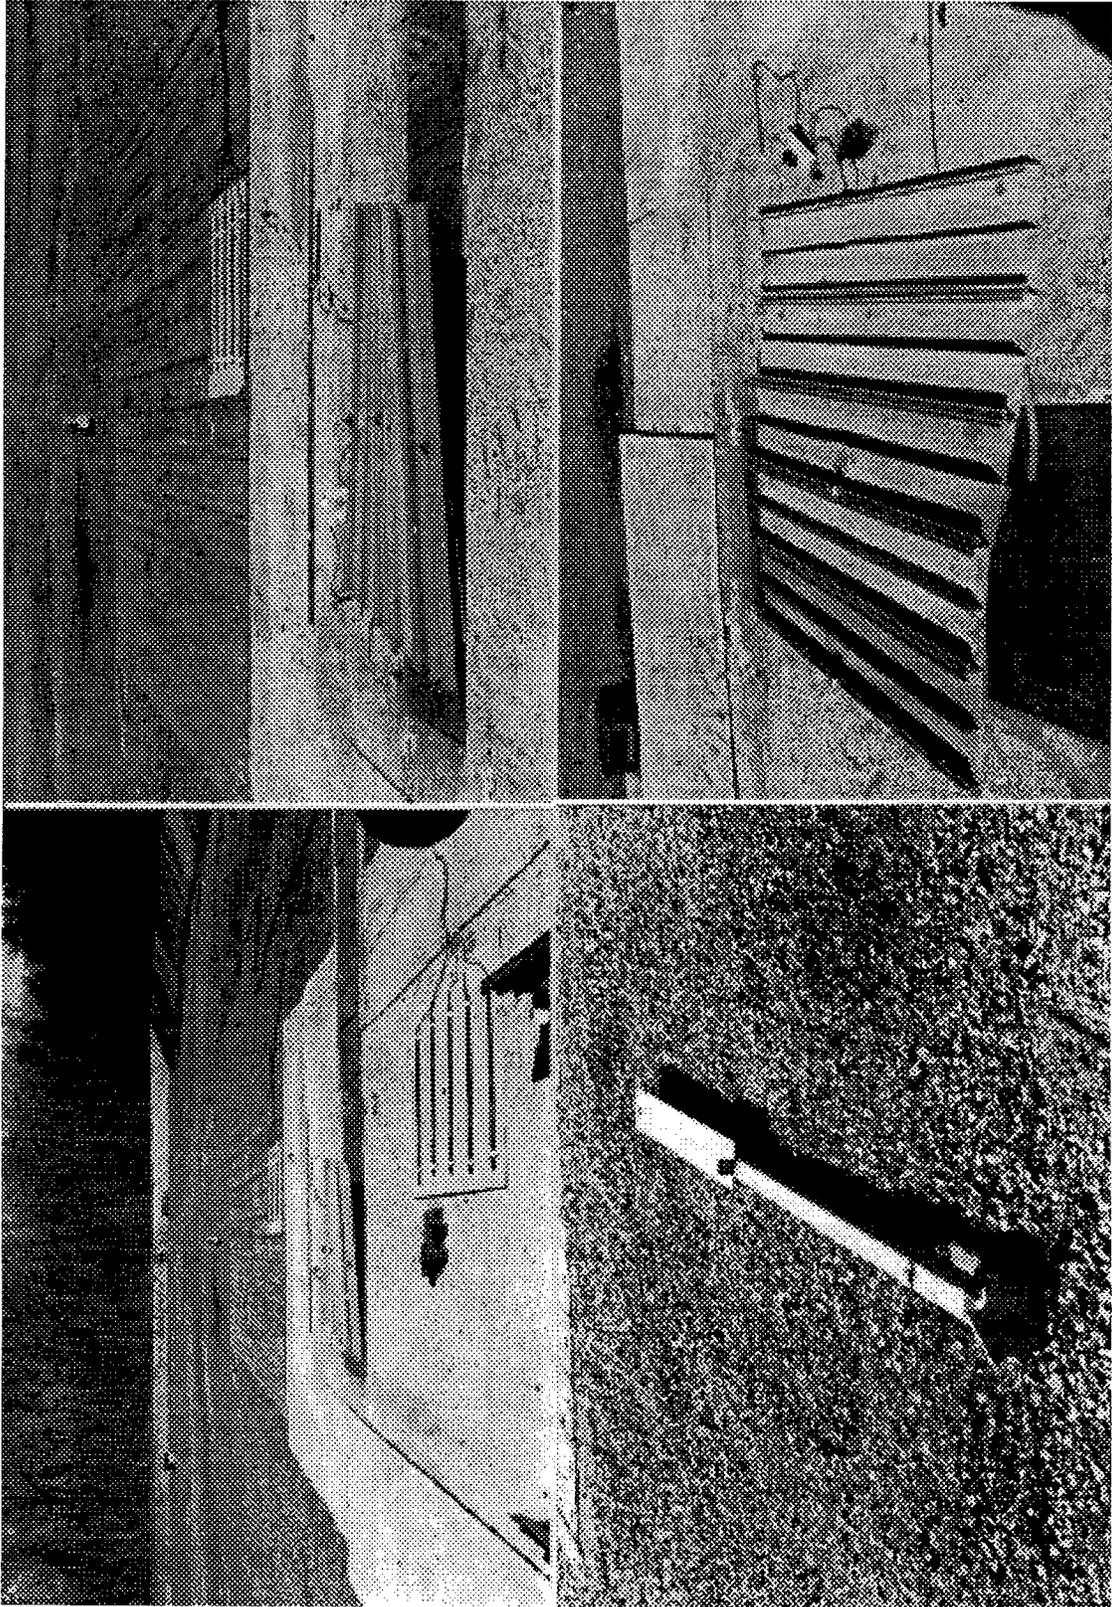
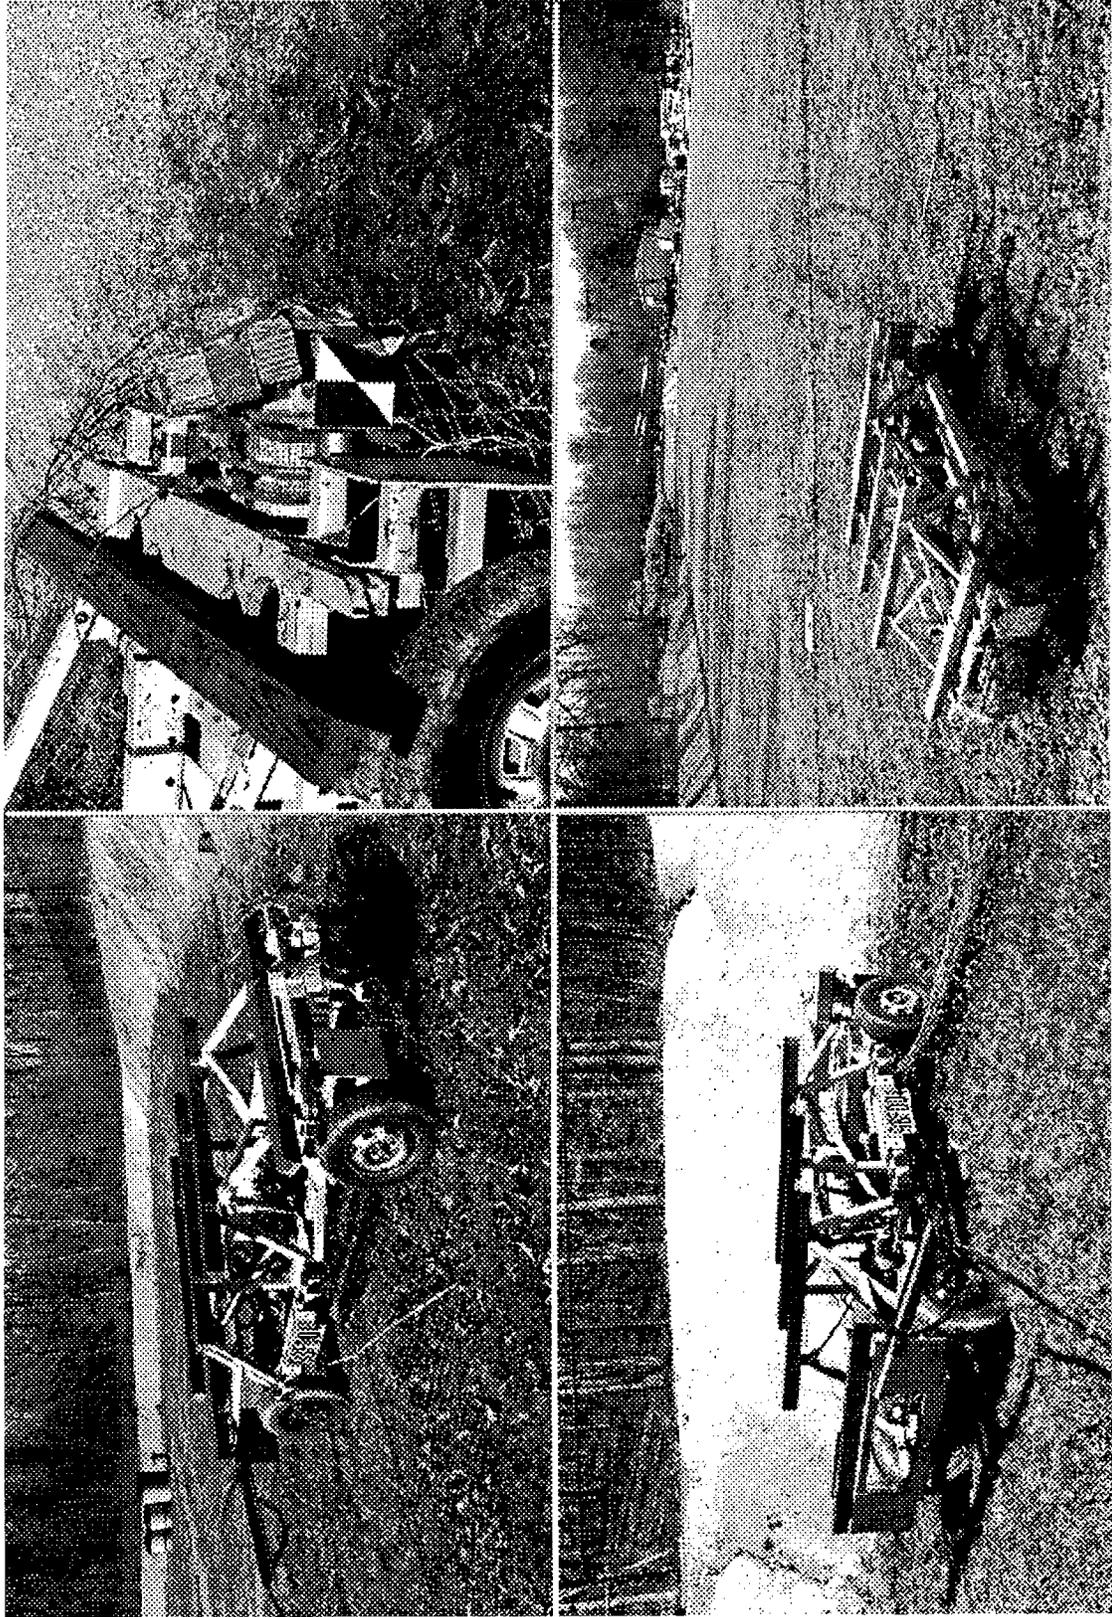
Figure 28. Post-test photographs, test 98F004.

d. Test Article Damage: There was no significant damage to the sign support system. The post disconnected from the base and tore the keeper plate. Although the sign panel slipped off the sign post, the sign support system could be reused after reattachment of the sign panel and installation of a new bolt keeper plate.
