MPC REPORT NO. 99-99A

**Cyclic Lateral Loading of a
Model Pile Group in Clay Soil**

February 1999

PHASE 2A

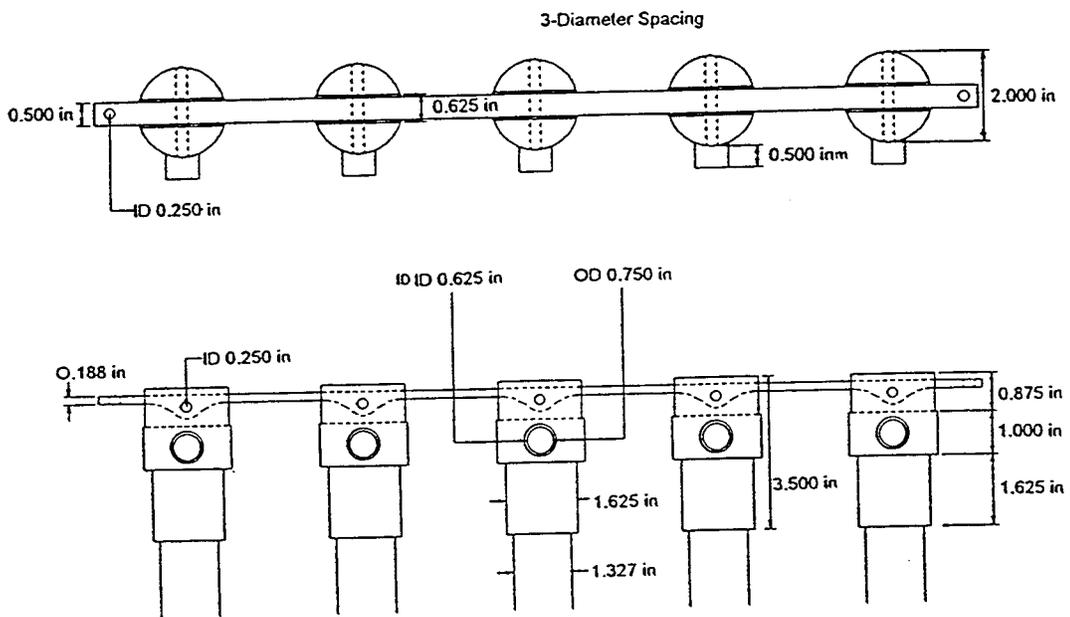
Figure 4. Pile cap assembly.

Aluminum pile crowns for sealing the tops of the piles and with a provision for pinning the piles together in a linear group were designed and fabricated. Figure 4 shows the pile crowns as part of the pile cap assembly. Strain gage wires exit the crown through a side port. To assure a tight fit between crowns and piles, the inside diameter of the crowns were designed to be slightly smaller than the outside diameter of the piles. The crowns were installed by first threading all of the strain gage lead wires up through the bottom of the crown and then out through the port. Reference lines on the crowns were aligned with the lines that had earlier been scribed on the piles for the strain gage installation work. The crowns were then driven onto the piles with a heavy rubber mallet until seated.

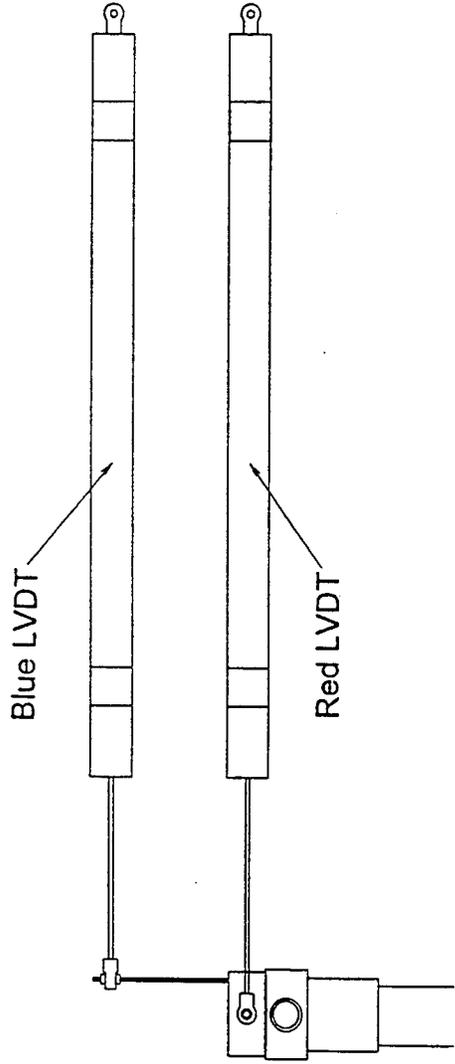
Figure 7. LVDT mounting configuration.

It was necessary to use two LVDTs during testing to record deflections that were used as boundary conditions in the data reduction process. One was mounted at the pinned load rod/pile crown connection elevation to measure group deflection, and the other was mounted 76.2 mm (3.0 in.) above the load application axis to record a second set of deflection data that was used in calculating the angle of rotation of the piles.

To connect the LVDT at the load rod-pile cap elevation, a 25.4 mm (1.0 in.), 10-24 flat head machine screw was glued onto the end of the stainless steel pin used to connect the load rod to the end pile in the group. The ball and socket end fitting on the LVDT slider was slid over the machine screw and held in place with wing nuts, which could be used to adjust the horizontal position of the LVDT.

Modifications had to be made to the pile crown on the end pile in the group in order to allow the second LVDT to be mounted in the elevated position necessary for calculating pile head slope. Figure 7 shows the mounting configuration of the LVDTs. The first step in the modification process was to drill a hole vertically down into the solid part of the pile crown, far enough away from the pin connection to not interfere with the pin. This hole was then tapped with a 10-24 thread. The head was cut off a 101.4 mm (4.0 in.) 10-24 machine screw, which was then screwed down into the hole. A nut was then screwed all the way down onto the machine screw until it tightened up against the top of the pile crown. This secured the machine screw and kept it from coming out or wiggling. The ball and socket fitting on the slider end of the LVDT was then slid down over the machine screw and held in position with wing nuts, which also were used to vertically align the LVDT.

A bracket was made from a piece of steel strap material 3.2 mm x 63.5 mm x 203.2 mm (0.125 in. x 2.5 in. x 8 in.) to which the nonmoving ends of the LVDTs were mounted by means of two 50.8 mm (2.0 in.) 10-24 machine screws. Holes were drilled in the steel strap at 12.7 mm (0.5 in.) intervals to allow the LVDTs to be spaced as conditions required. The machine screws were inserted through the holes and tightened down with nuts. Two wing nuts were used on these to allow horizontal LVDT adjustment and to fix LVDT position once they were aligned.

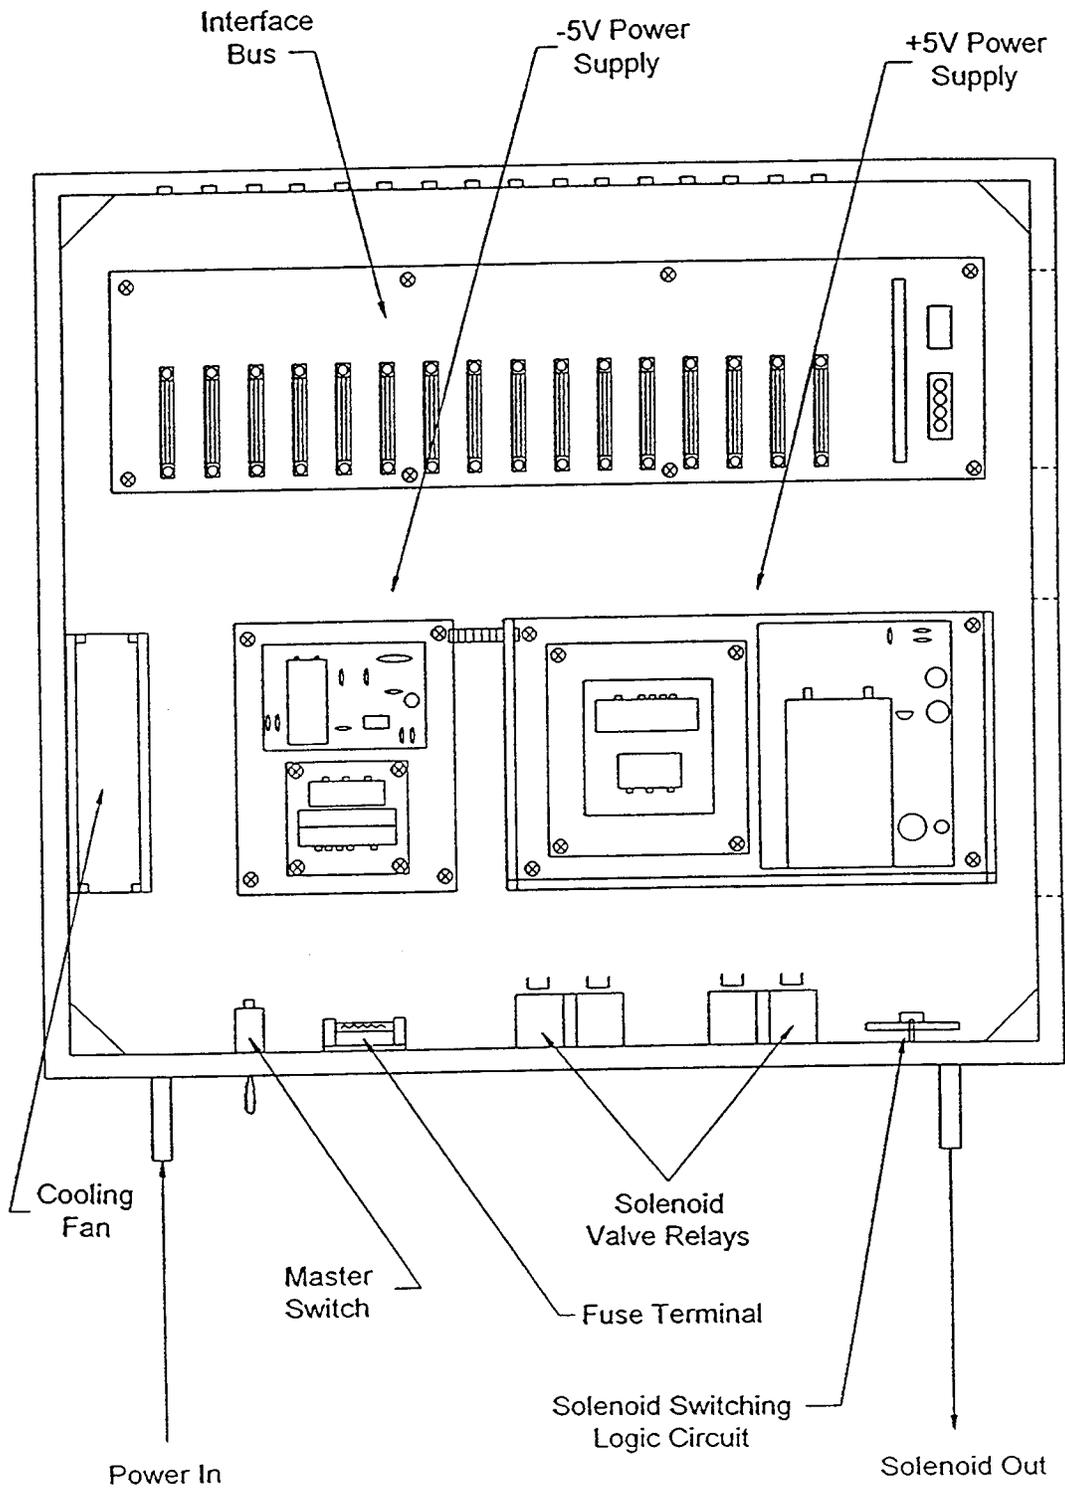
Figure 11. Data acquisition system box layout.

All of the components had to be housed, therefore a decision was made to bring all components external to the personal computer together in one box, including input boards, interface bus, power supplies, fuses, and all components necessary to control the pile group loading system. This would allow for easier management of all of the testing systems. Figure 11 shows the layout of the data acquisition system box.

The box was constructed of 4.8 mm (0.2 in.) thick plywood and is 476 mm (18.75 in.) long, 422 mm (16.6 in.) wide, and 178 mm (7.0 in.) high. The inside surface of one of the long sides was slotted with 16 3 mm (0.13 in.) slots spaced at 20.3 mm (0.8 in.) intervals to be used as guides for holding the input boards when plugged into the interface bus. A cooling fan was added to the box to provide the 0.57 m³/min (20 ft³/min) of convective cooling air required by the large power supply. A circular hole was cut in one of the short sides to accommodate the fan. Two slots were cut in the wall opposite the fan. Through one of the slots the ribbon cable passes in going from the interface bus to the A/D board in the computer. The second slot was positioned so cooling air could be drawn into the box and pass across the heat-sink resistors on the underside of the large power supply. Other holes were drilled in the box for power cords, one for bringing in power and the other for sending power to the pile group loading system. The component positions were laid out and holes were drilled for mounting bolts, after which the box was painted inside and out. Brass bushings were used as standoffs for the power supplies, interface bus, and the loading system switching relays and logic circuit.

The loading system logic circuit and relays were wired so they could be controlled by the A/D board in the computer and the LabVIEW software. Wires for power and signal passing were soldered to the proper pins for these functions on the interface bus underside where the 50-pin socket connector pins protruded.

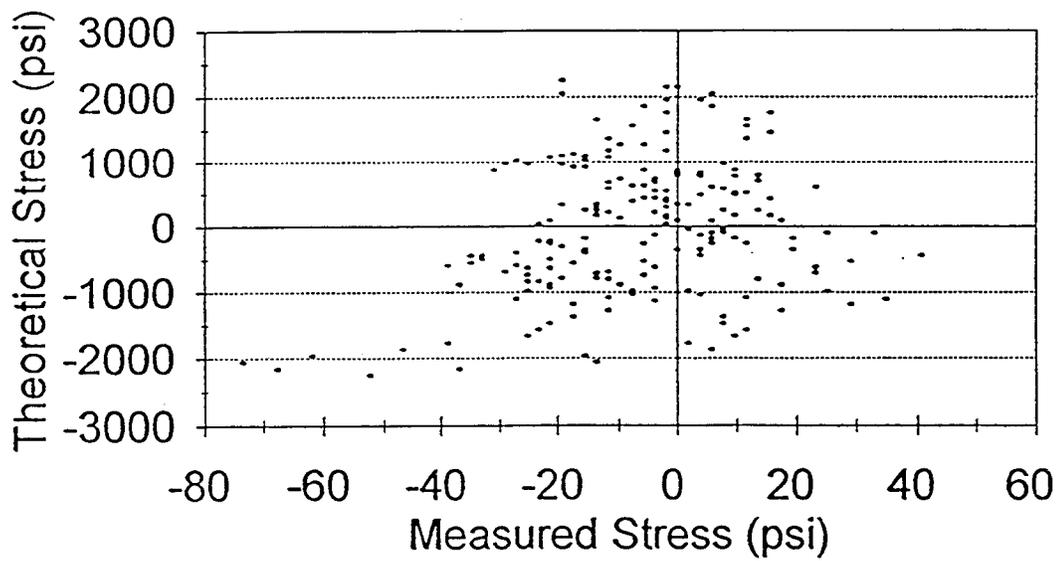
Figure 16. Calibration output for a defective gage.

Calibration also revealed that several gages, their connections, or lead wires were defective. These gages were Pile 1, Black 11, Pile 2, Red 2, and Pile 3, Red 1. These gages gave random output data, shown on their calibration graphs. Figure 16 shows the random output from a defective gage. The Black 14 gage in Pile 2 had a short circuit before calibration was started and was not even hooked up to its input board for calibration.

Pile 3 Red Gage 1

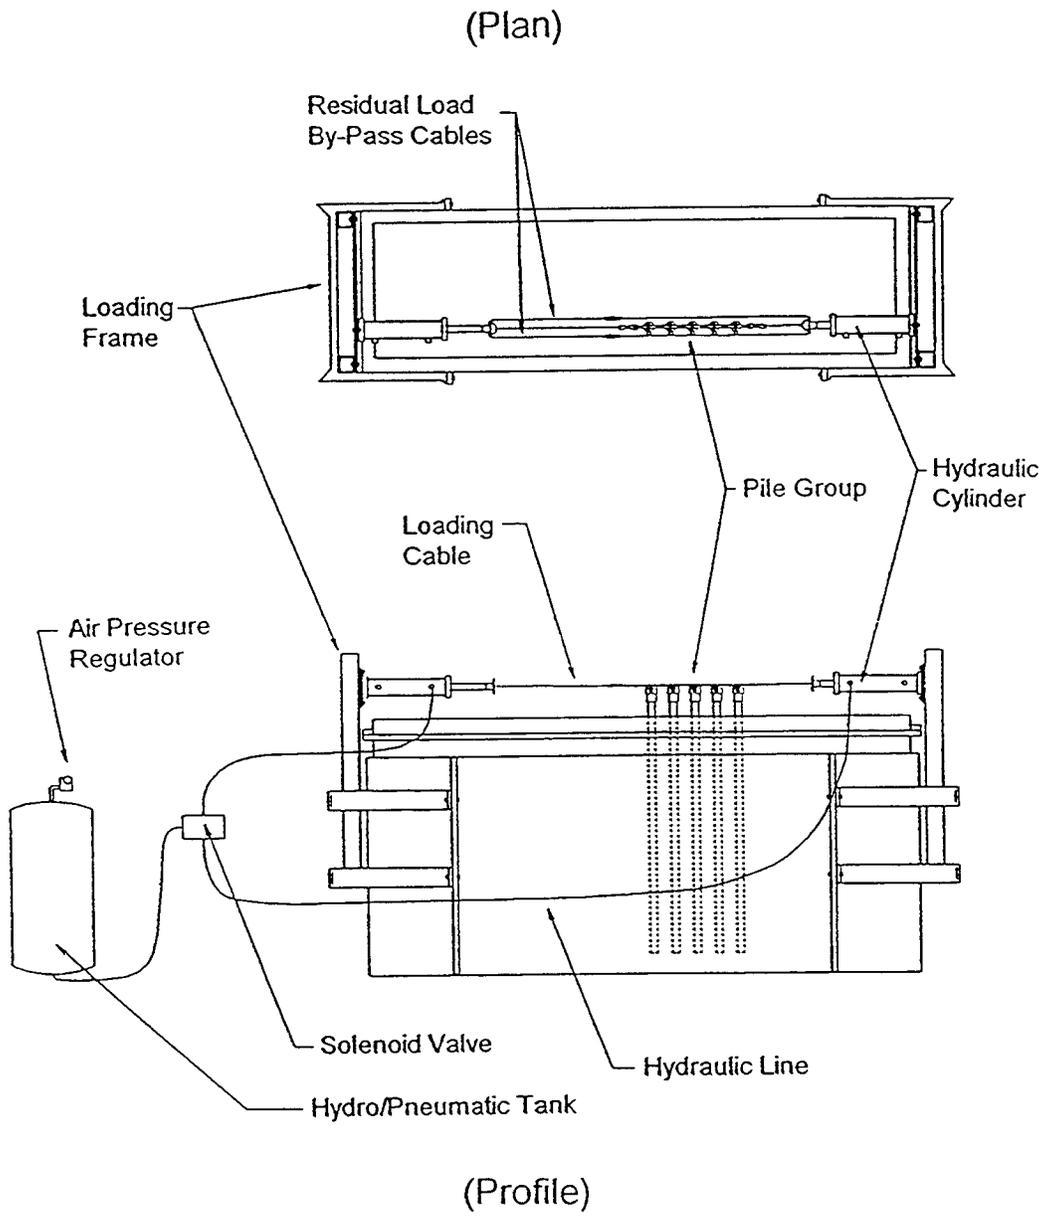
Figure 21. Loading system.

Measurements were made of the hydraulic cylinder base plates so that mounting frames could be fabricated, which would allow the cylinders to be mounted on the load frames. Steel channel 76.2 mm x 38.1 mm (3.0 in. x 1.5 in.) was cut into four lengths, each 0.965 m (38 in.) long, to span the width of the load frames. These channel lengths were slotted with six 17.5 mm (0.688 in.) wide slots of two different lengths oriented perpendicular and parallel to the axis of the channel to allow for vertical and horizontal adjustment of the cylinders when aligning them with the pile group before testing. Steel strap was welded to the ends of the channels to bind them together at the proper distance to match the bolt holes in the base plates of the cylinders. Grade 8 bolts were purchased for mounting cylinders to the mounting frames and for bolting the mounting frames to the load frames. Figure 22 shows a view of a mounting frame.

With the load frames in place, placement of the mounting frames and hydraulic cylinders with respect to the top of the pile group was laid out by measuring from the top of the soil to a string that had been strung between the load frames. This string was leveled at the proper elevation, measurements were made and markings placed at the proper locations on the load frames where the bolt holes for mounting the frames were to be drilled. A portable 12.7 mm (0.5 in.) electromagnetic drill press was used to drill the holes for the 15.9 mm (0.625 in.) diameter bolts. A C-clamp was used to bolster the electromagnetic base on the drill press, which allowed it to be attached to the frames in a horizontal position for drilling. The drill bit used for cutting holes was long enough to drill through both sides of the box beam without having to reposition the drill press. Grade 8 bolts were purchased for bolting the hydraulic cylinders to the mounting frames and the mounting frames to the load frames.

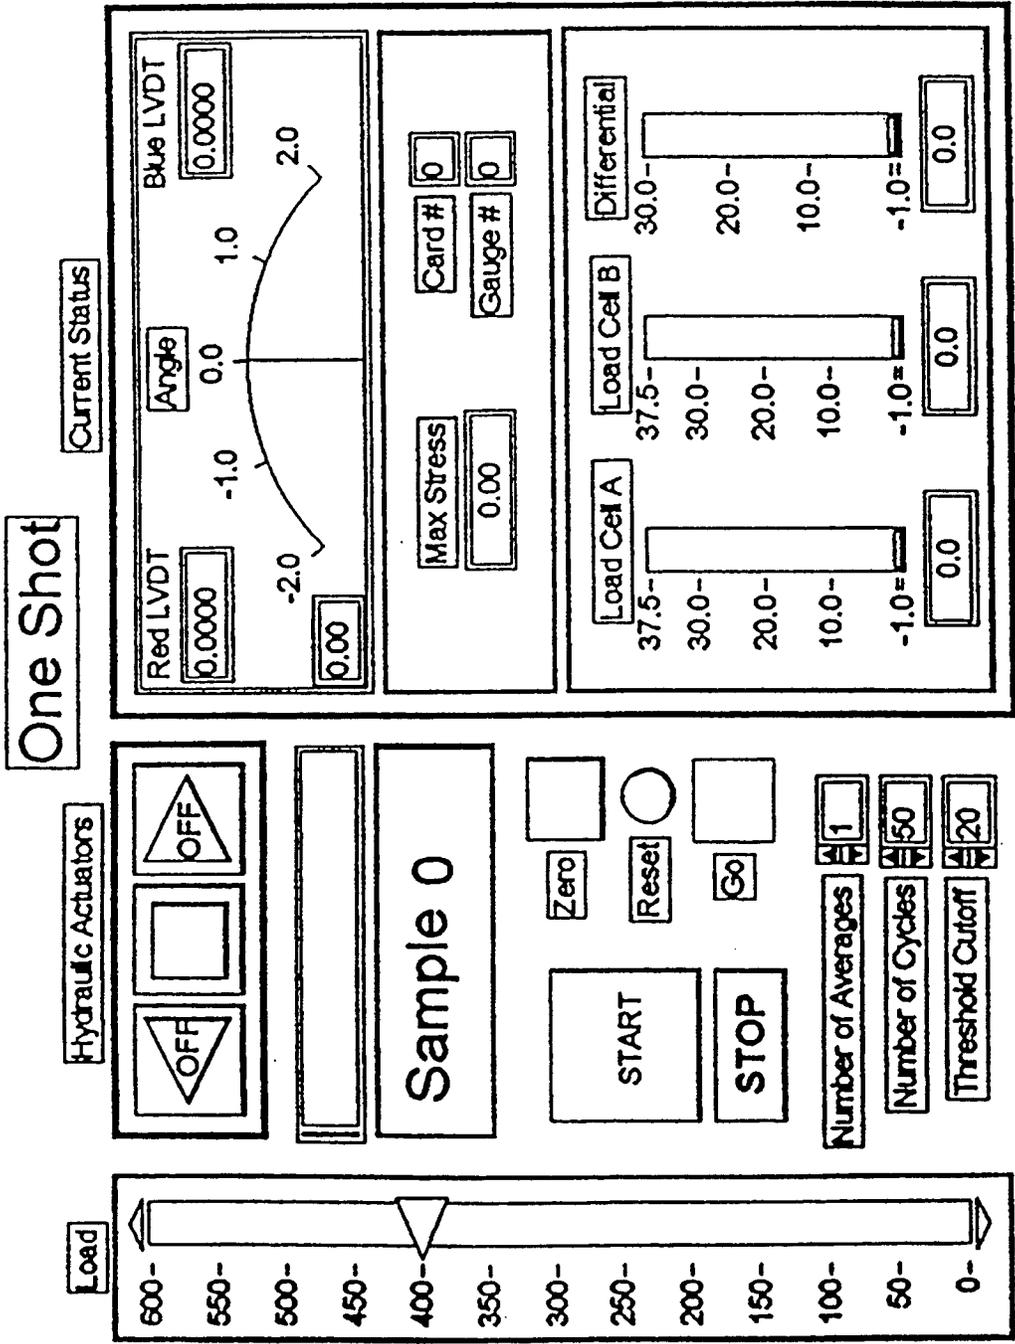
Figure 26. ONE SHOT. VI program panel.

computer and a baseline reading of all instruments was made. The program would not allow testing to begin without this initial reading. When this was accomplished, data acquisition was started by clicking the start button. Figure 26 shows the program control panel for One ShotVI. This started data acquisition and opened the solenoid valve. The air pressure regulator on the tank was slowly opened allowing the hydraulic fluid to be pressurized. As the cylinder being pressurized pulled on the pile group, the load, as monitored by the active load cell, was called out to help the person opening the regulator maintain a constant rate. The linkage on the inactive load cell was kept loose so that it would not register any load other than the weight of the linkage. As the load continued to rise, the pile group could be seen to deflect, and pile top displacement and angle were displayed on the computer. When the air pressure in the tank rose high enough to produce the desired 1779.3 N (400 lb.) load in the active load cell, the computer switched the solenoid valve, thus causing the hitherto unpressurized cylinder to pull the pile group in the opposite direction until the load on the active load cell fell below a given threshold, usually 89 N (20 lb.), at which point the solenoid valve was closed and data acquisition stopped. The pressure in the tank was released and the air regulator was reset in preparation for the next half-cycle.

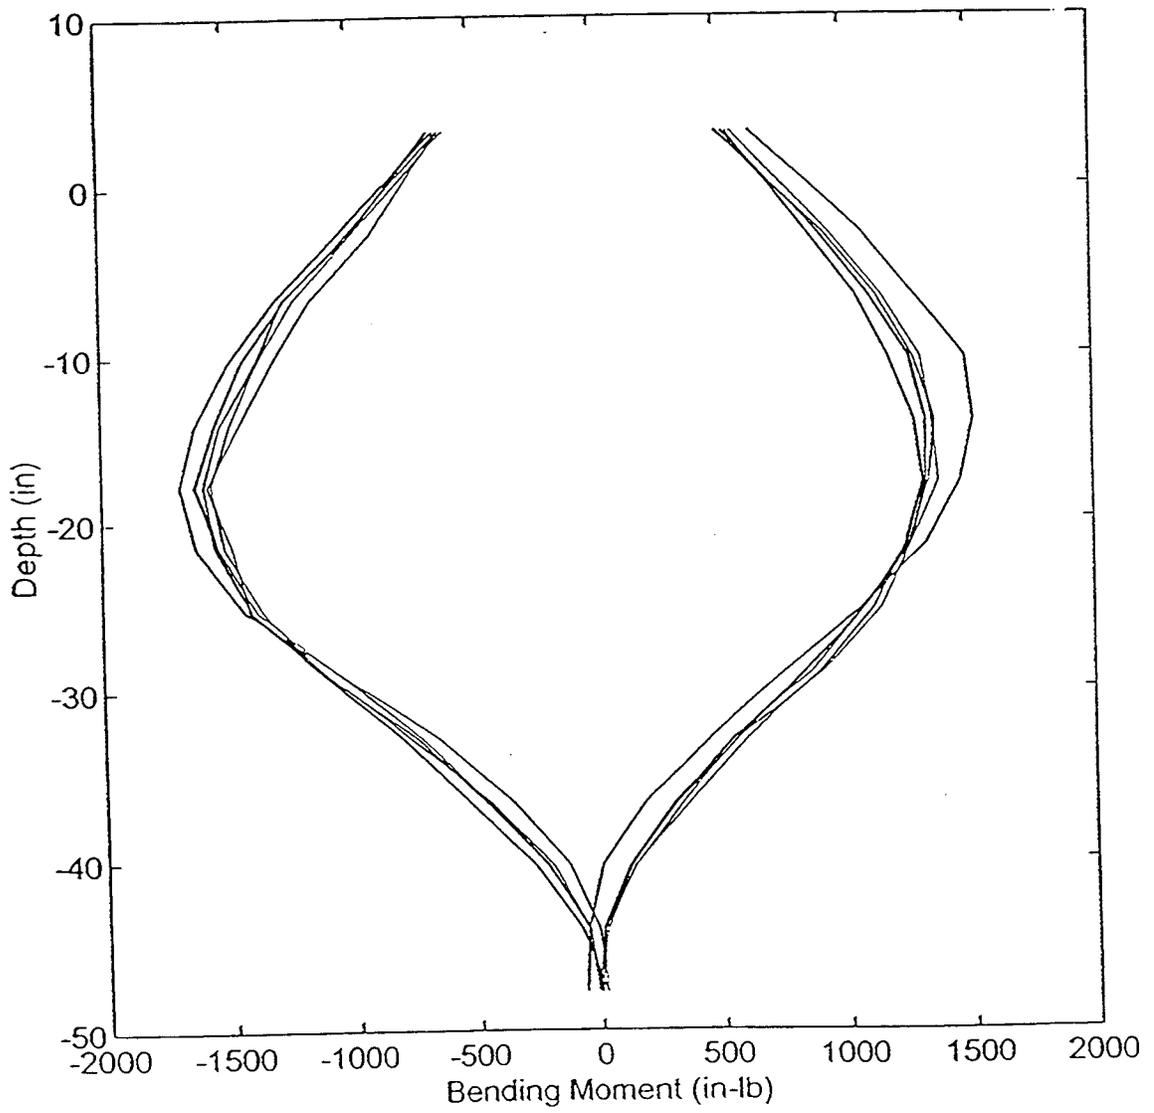
Figure 30. Pile group moment distribution for cycle 25 cycle 25 at 350 lb.

At a load of 1557 N (350 lb.) in cycle 25, the points of counter-flexure disappear altogether, and a moment of 0 is registered at the lowest strain gages in the piles, as seen in Figure 30. This demonstrates that the piles have become “short” piles. The points of counter-flexure occur in the loads lower than this in this cycle, but remain unseen in the loads higher than this. The depth at which the maximum moment occurs is again lower than in the previous cycles.

are no counter-flexure points at this or any other load in this cycle. Unlike the situation discussed for cycle 25 at the 1557 N (350 lb.) load, where the moment is 0 at the bottom of the piles, moment readings occur at all depths through this whole cycle. Because of this, it can be reasoned that even though the piles act as short piles, the bottoms of the piles are still fixed; otherwise, there would be no reaction to cause the bending that is registered at the pile tips.

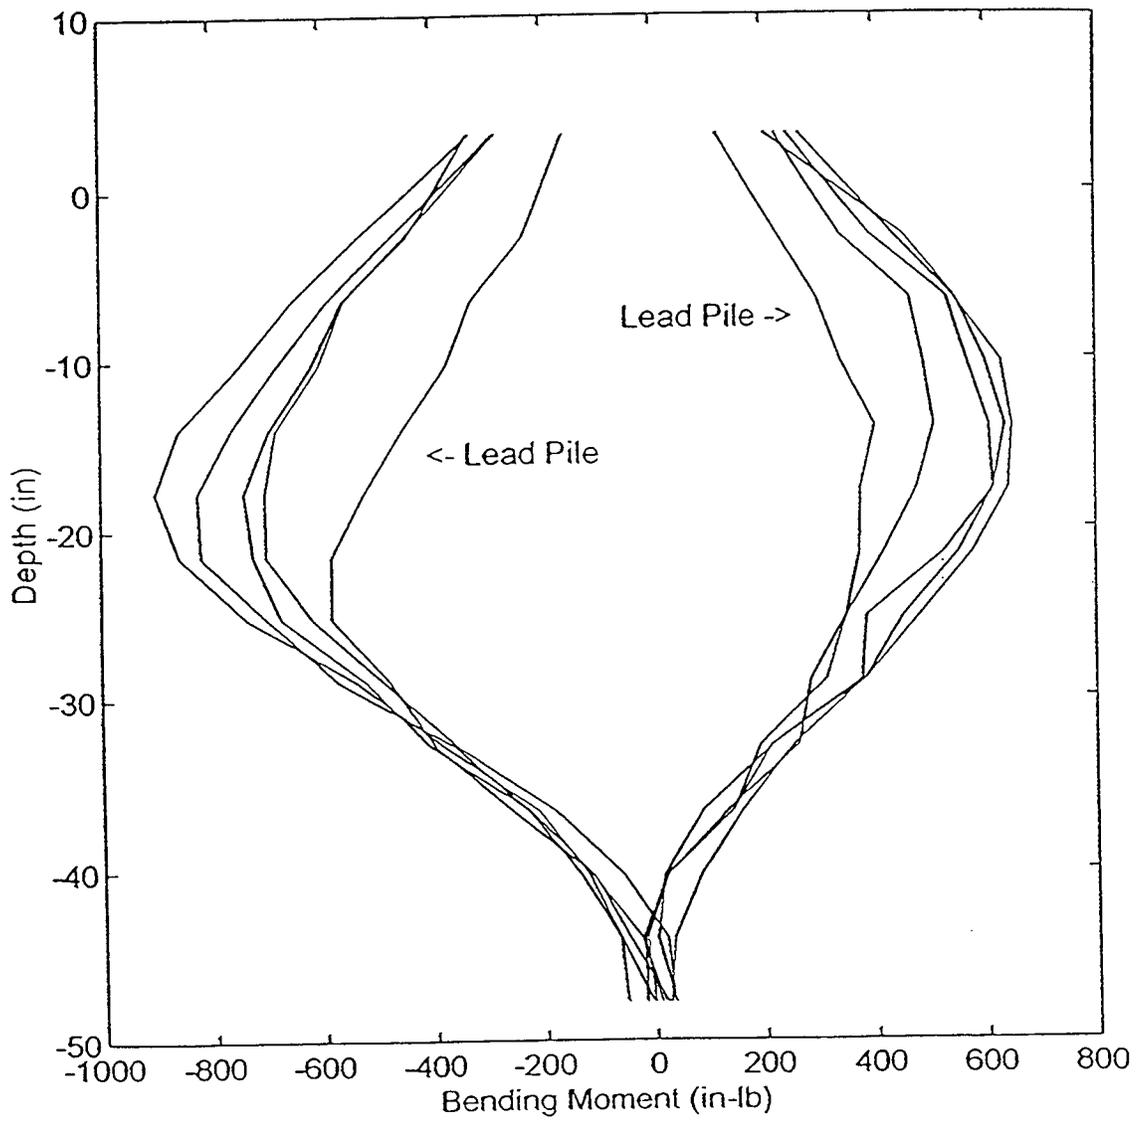
Figure 31. Pile group moment distribution for cycle 50 at 150 lb.

Cycle 50 shows some interesting results. At the load of 667 N (150 lb.), the bending moment output for the lead piles in each half-cycle is distinctly lower than that of the other piles as shown in Figure 31. This correlates well with the load distribution data for this same cycle and load. There also

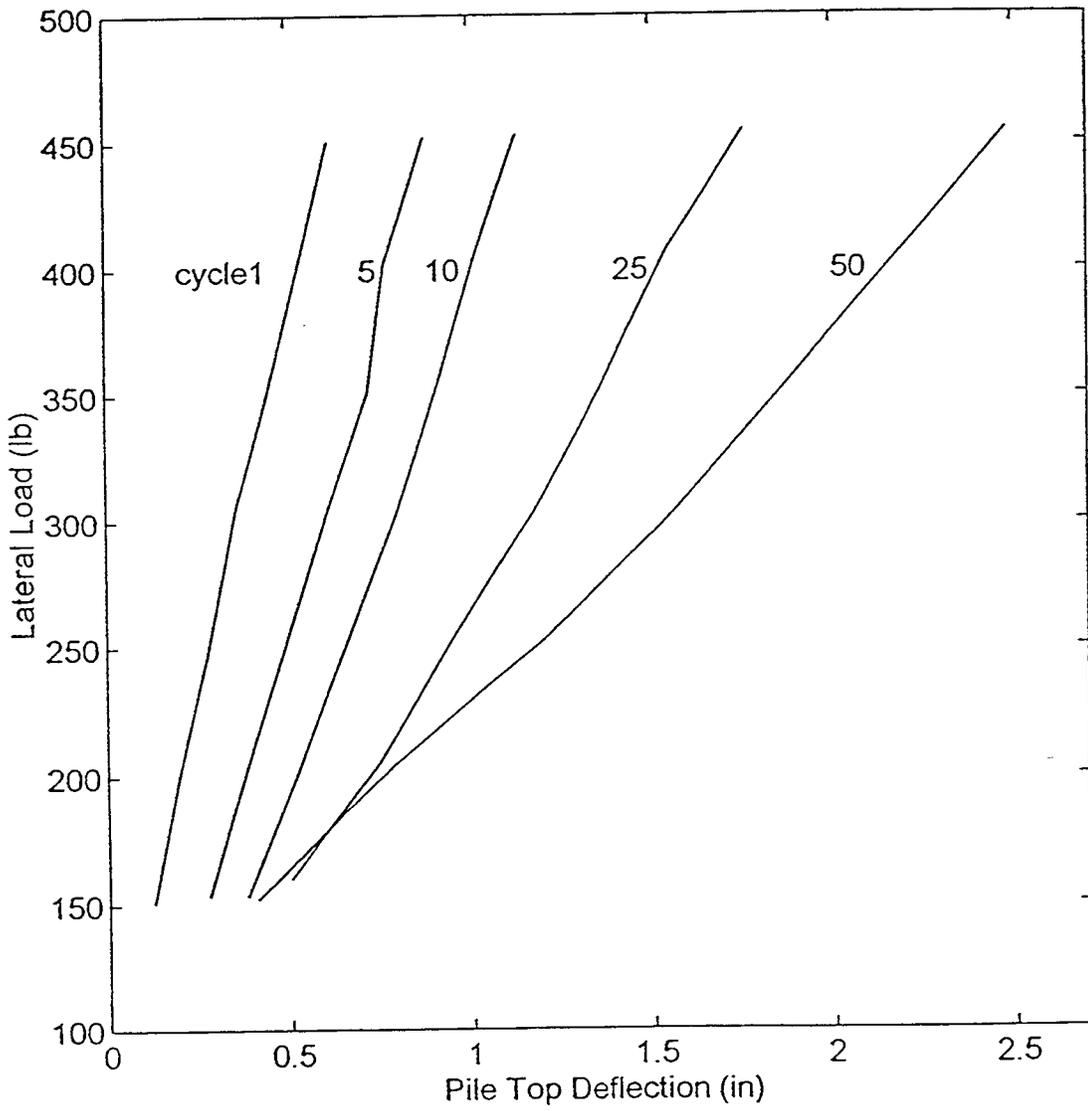
Figure 34. Load versus deflection.

The load versus deflection output was straight forward. As load magnitude increased in each of the five cycles, the deflection increased in a linear fashion. If the deflection at each load increment is compared from cycle to cycle, the deflection does not increase in a linear fashion. For example, deflection of the pile top at the maximum load of 2000 N (450 lb.) at cycle 10 was not 10 times greater than it was in cycle 1 at this same load. This can be seen in Figure 34.

The load versus deflection curve for cycle 50 showed a lesser deflection at a load of 667 N (150 lb.) than the deflection at this load for cycle 25. This can be explained by the conditions during testing. In the latter cycles of the test, when the target load was reached, the pile group was pulled back in the direction opposite the one in which it was being loaded, to unload it. It was pulled back until the load on the active load cell dropped below the cutoff threshold, whereupon the hydraulic cylinders stopped moving. Since the pile group had been pulled so far to one side, soil resistance continued to hold the pile group in a displaced position, and after the cutoff threshold was reached, the piles moved back slightly in the direction in which they had just been loaded. This produced a starting point for the next half-cycle that was slightly displaced in the direction opposite to the one in which the next loading would occur. For complete load versus deflection output, refer to Figure B-16.

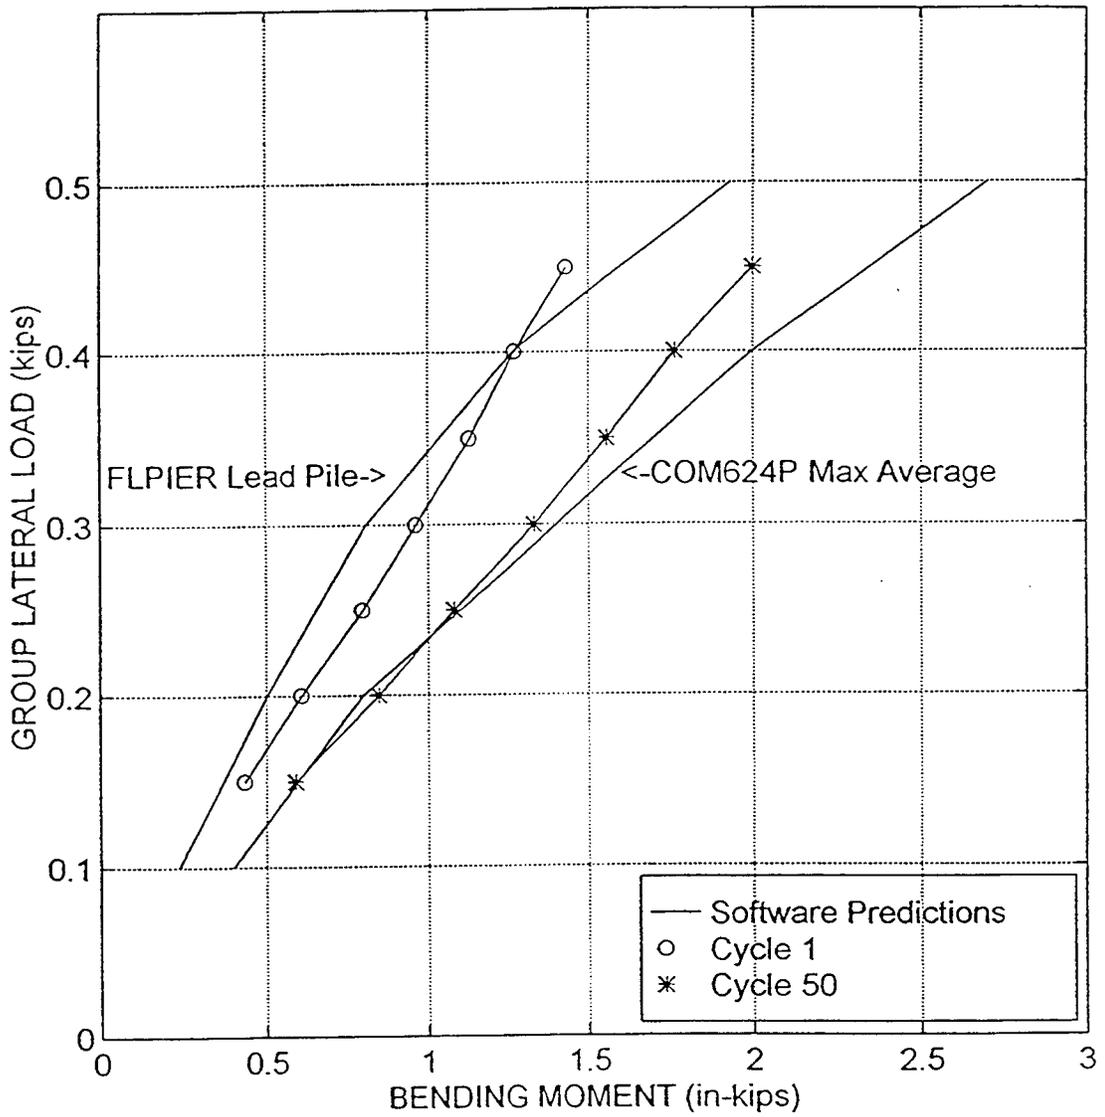
Figure 35. Maximum bending moment: predicted versus measured.

As a matter of interest, the measured results for the lead piles from cycle 1 also were compared with predictions. Maximum measured bending moment reached just under 170 N-m (1500 in-lb.), and was quite close to the prediction made using Florida Pier. Displacement measured 15.7 mm (0.62 in.), and was close to the prediction made by COM624P up to the 1334 N (300 lb.) load increment.
