FHWA/IN/JTRP-98/15

**METHODS OF CORROSION PROTECTION AND
DURABILITY OF CONCRETE BRIDGE DECKS
REINFORCED WITH EPOXY-COATED BARS - PHASE I**

**Lisa M. Samples
Julio A. Ramirez**

Joint Transportation Research Project

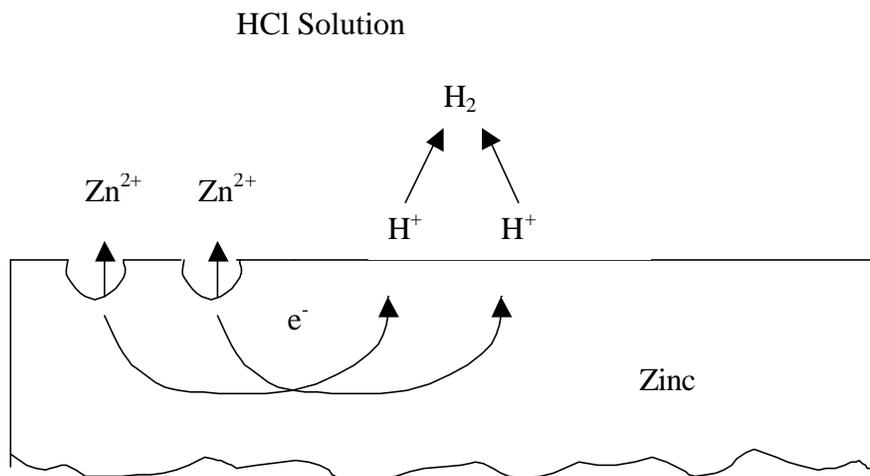
Figure 2.1 Corrosion of Zinc in Hydrochloric Acid¹

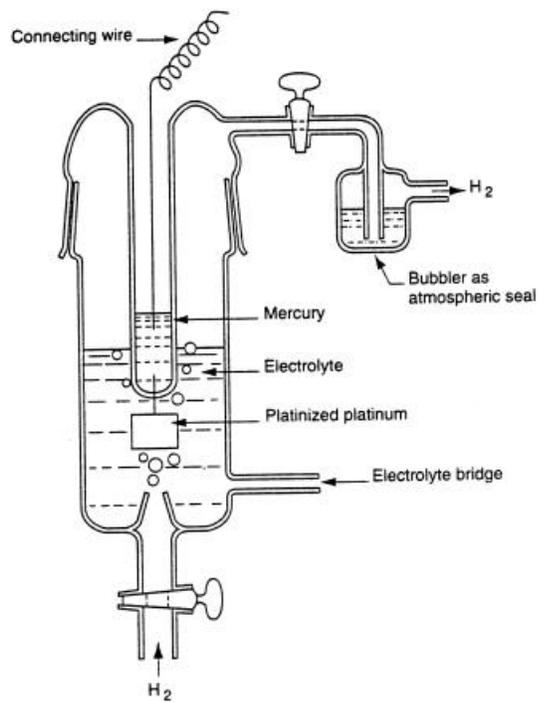
Figure 2.2 Standard Hydrogen Electrode (SHE)²

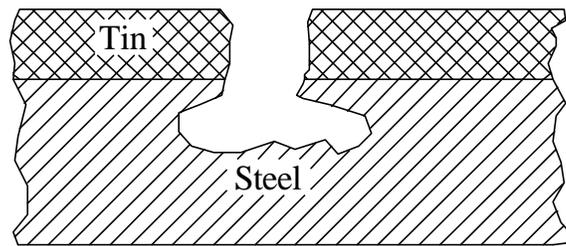
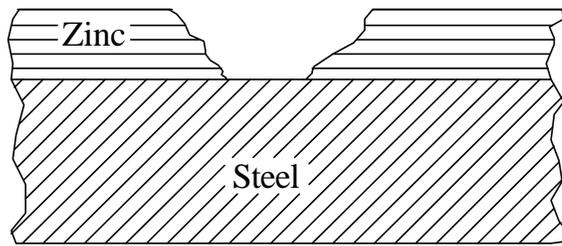
Figure 2.4 Galvanic Corrosion at Damaged Site in Tin and Zinc Coated Steel⁴

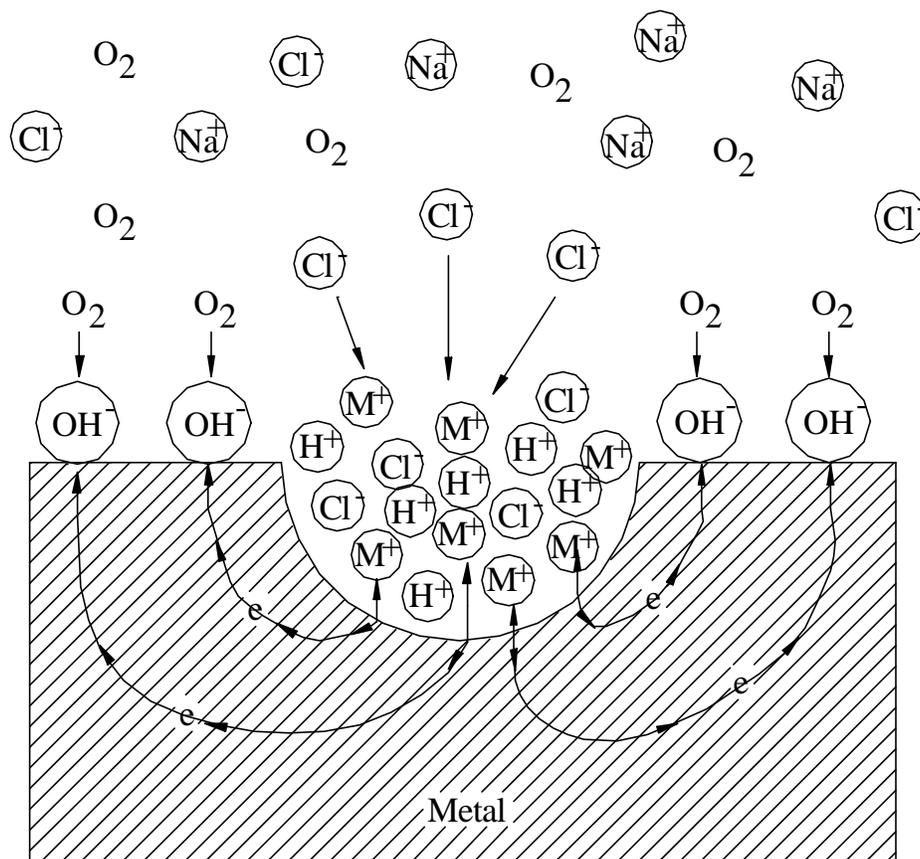
Figure 2.5 Process of Growing Pit¹

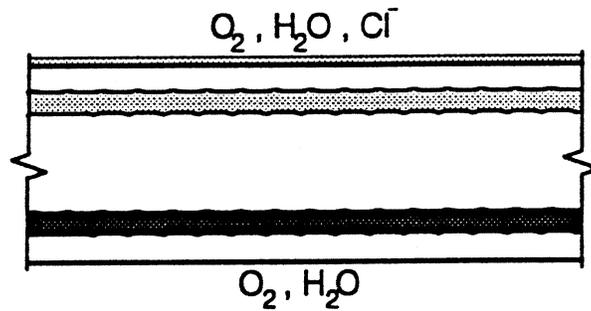
Undamaged, Electrically Isolated Coated Bars
No Corrosion

Figure 2.6 Effect of Damage and Electrical Continuity on Corrosion Activity⁶

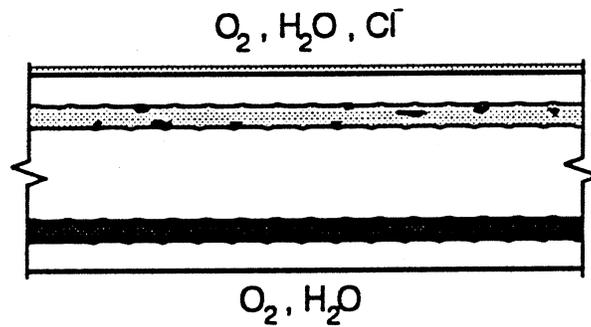
Damaged, Electrically Isolated Coated Bars
Microcell-Insignificant Corrosion

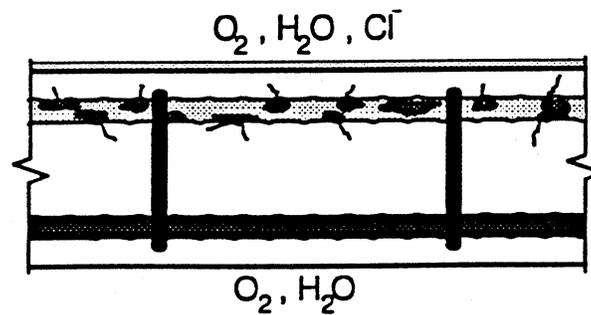
Damaged, Electrically Continuous Reinforcing Bars
Macrocell-Severe Corrosion

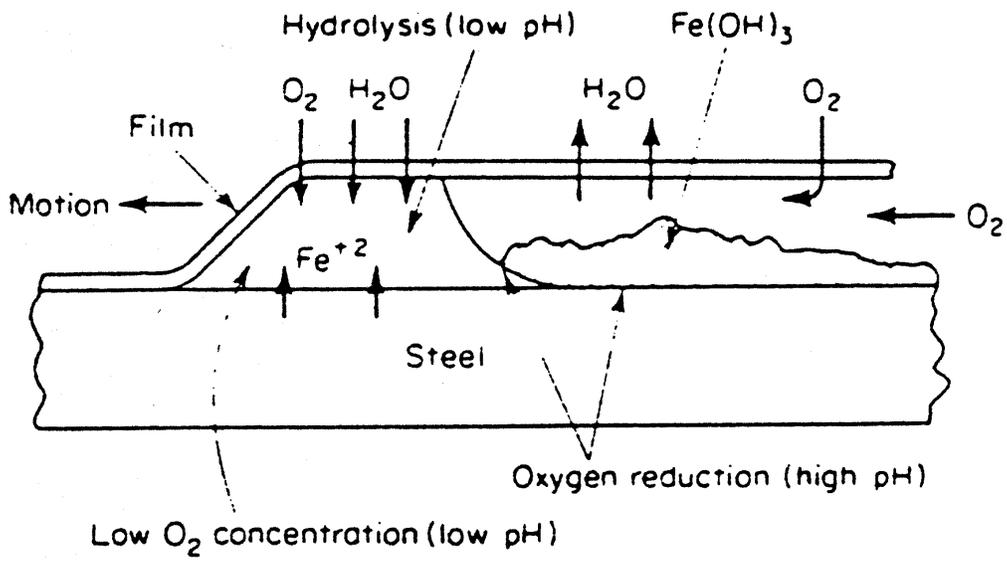
Figure 2.7 Underfilm Corrosion¹

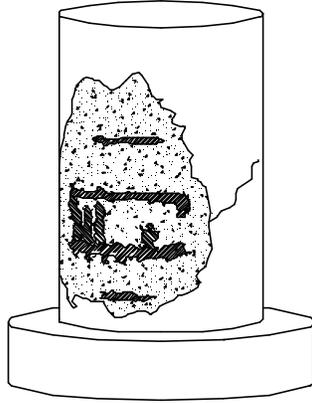
Figure 3.1 Typical Delamination Found on the Seven Mile Bridge in 1987¹¹

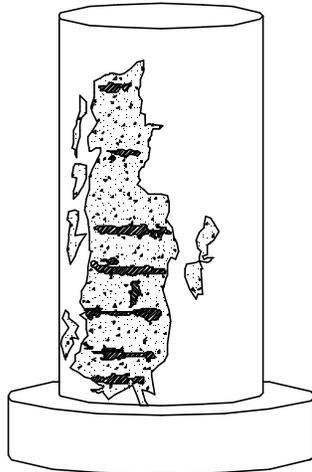
Figure 3.2 Typical Delamination Found on the Nile Channel Bridge in 1987¹¹

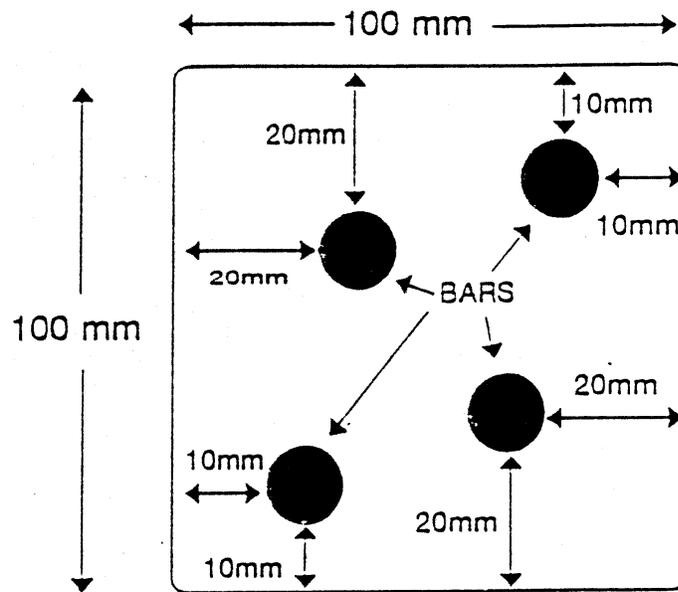
Figure 3.3 Cross-Section of Beam Specimens¹⁸

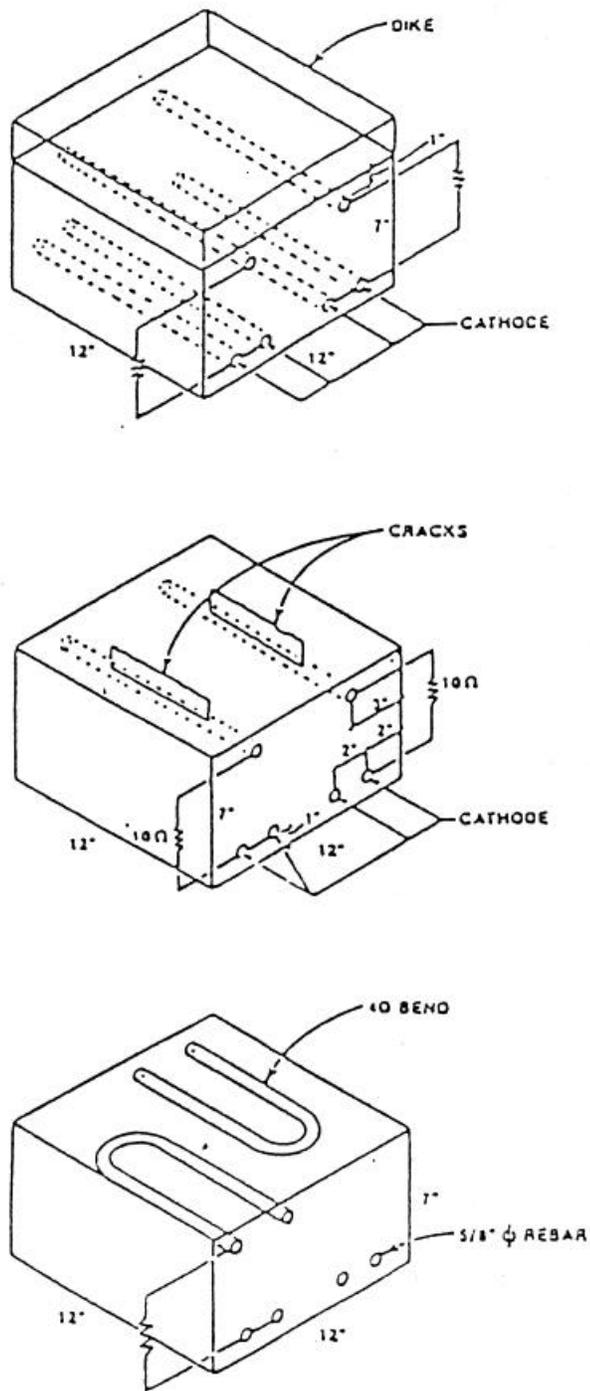
Figure 3.5 Diagram of Concrete Test Slabs²¹

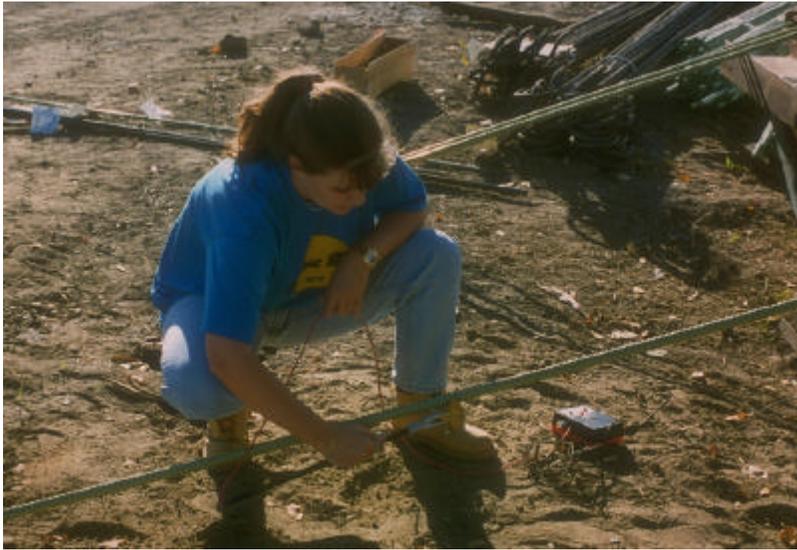
Figure 4.1 Holiday and Defect Testing after Arriving on Site

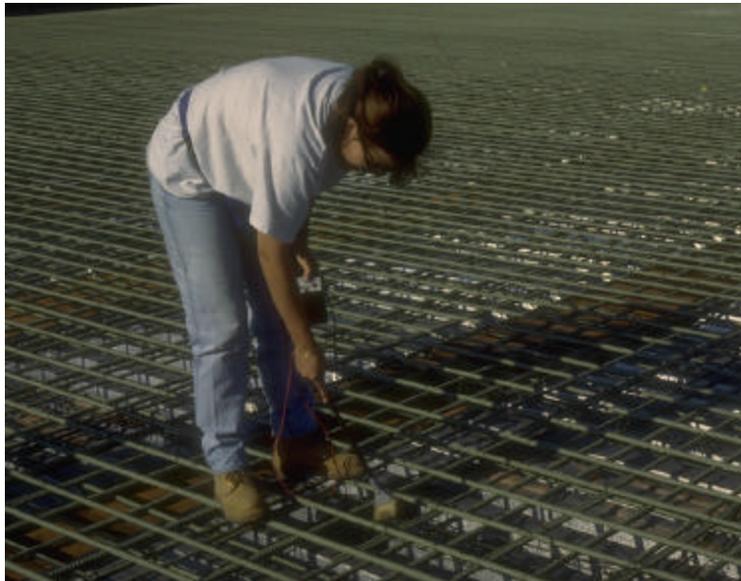
Figure 4.2 Holiday and Defect Testing after Placement in Bridge Deck

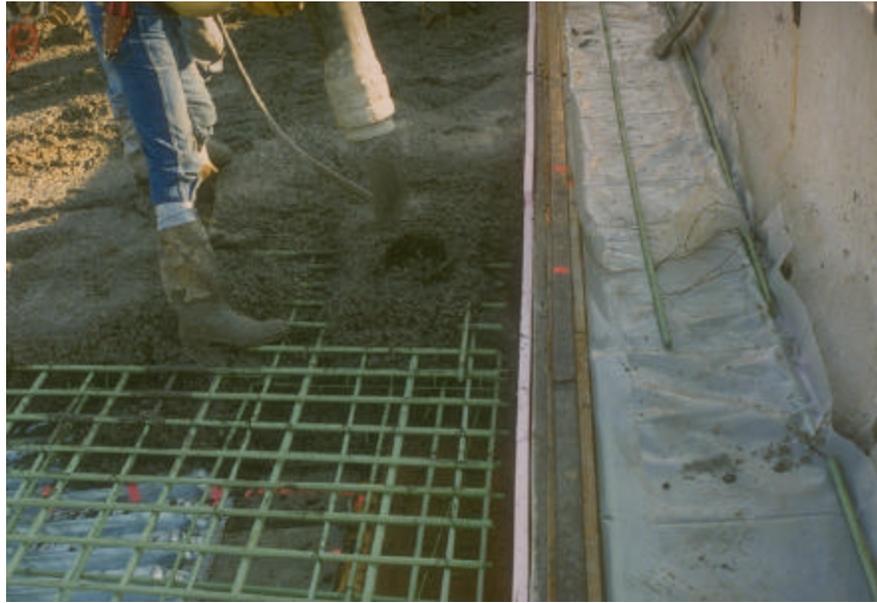
Figure 4.3 Concrete Pumping Operation over Test Bar

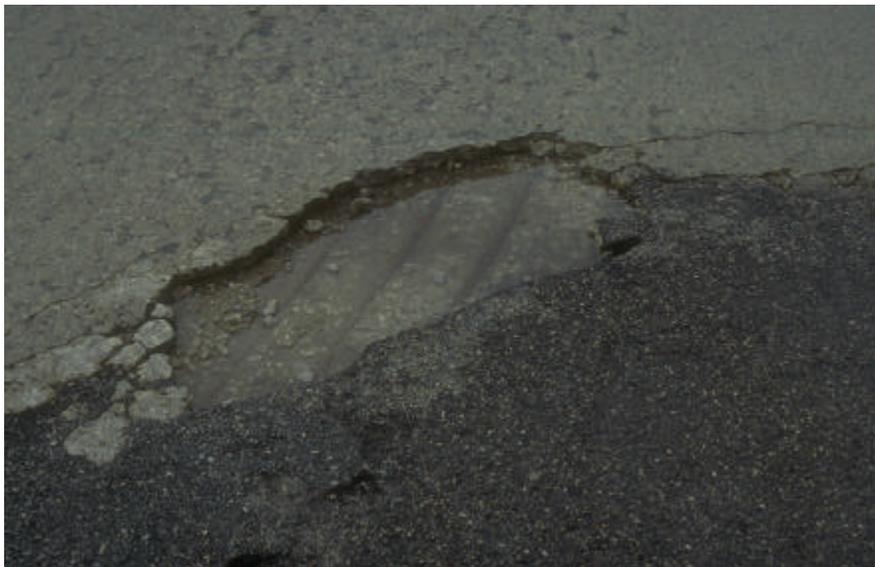
Figure 4.6 Spall with Reinforcement Exposed

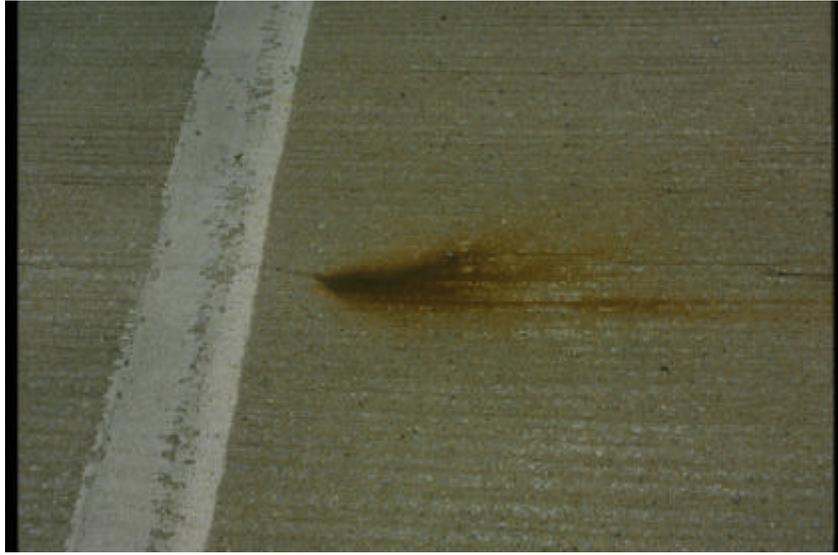
Figure 4.7 Rust Stain in Area of Cracking

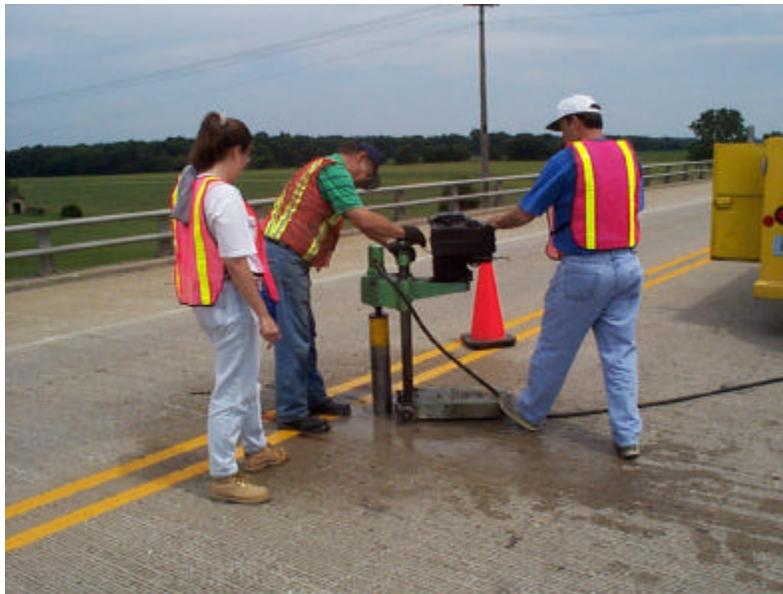
Figure 4.8 Coring Machine used to Extract Cores from Bridge Deck

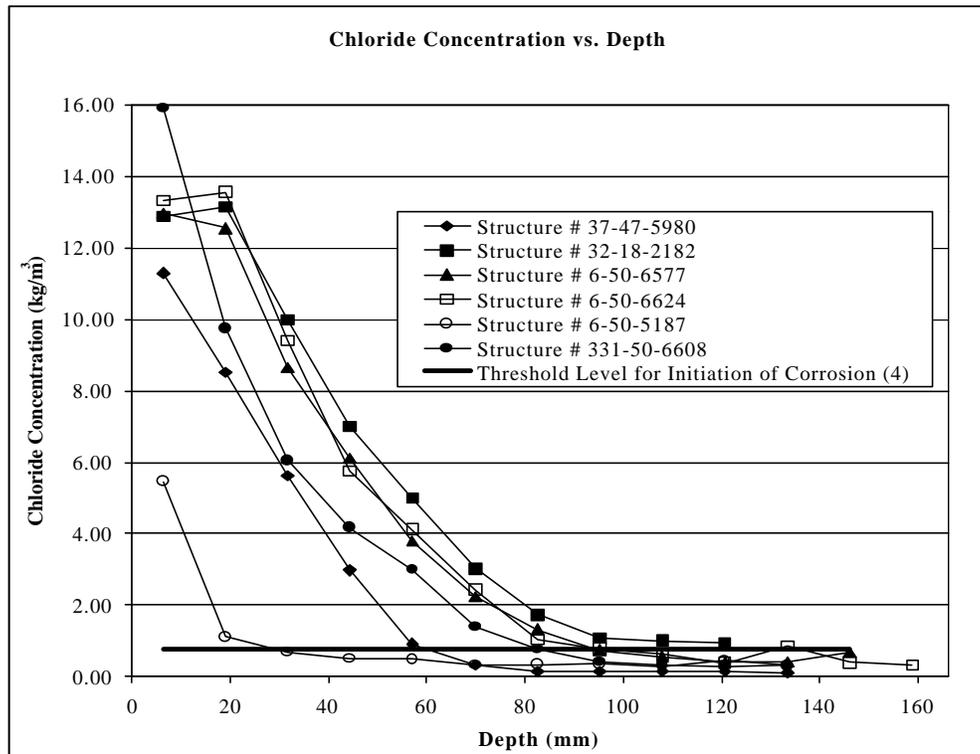
Figure 4.10 Chloride Concentration Profiles

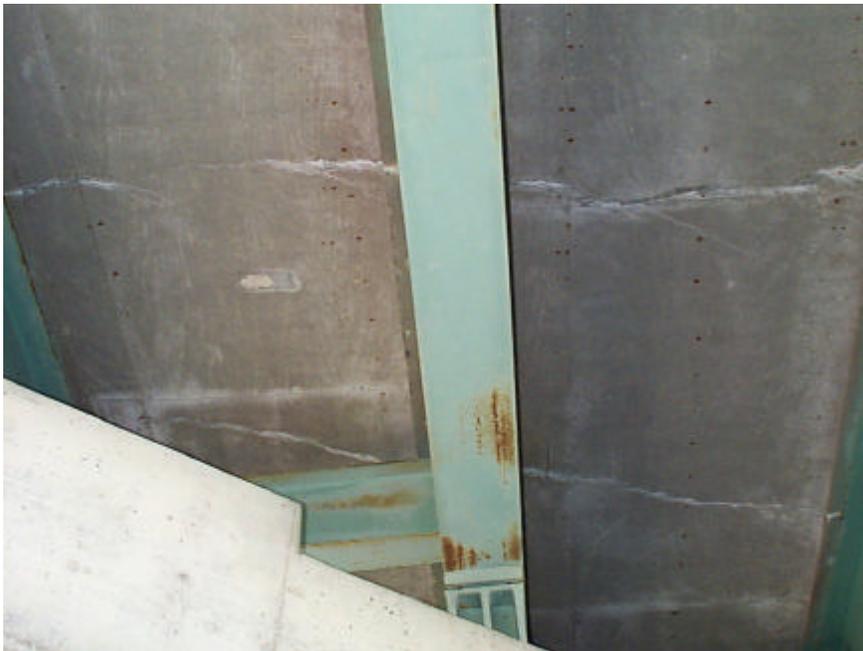
Figure 4.12 Cracking seen on Underside of Bridge Deck (Structure #37-47-5980)

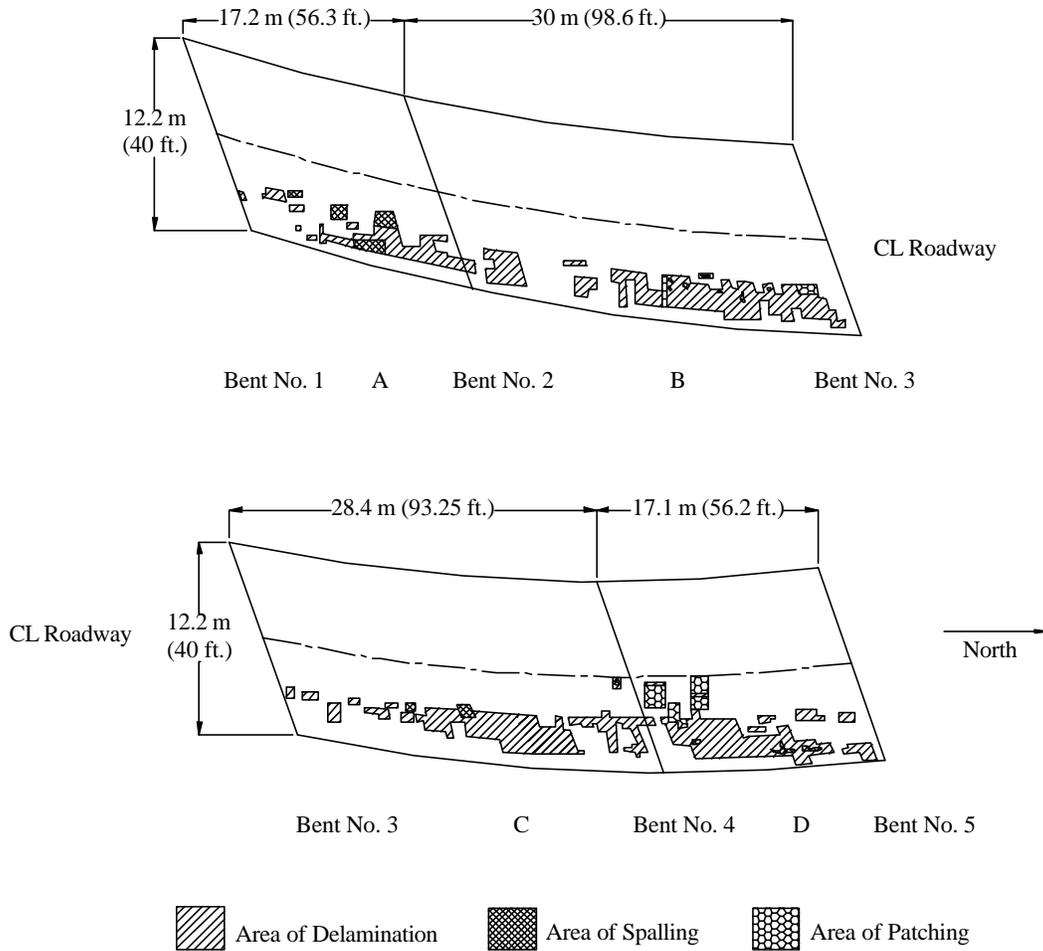
Structure #37-47-5980 Northbound Lane
 Black Rebar with Class A Concrete
 Lawrence County, Vincennes District
 Built 1973

Figure 4.13 Delaminations, Spalls, and Patching Found on Structure #37-47-5980

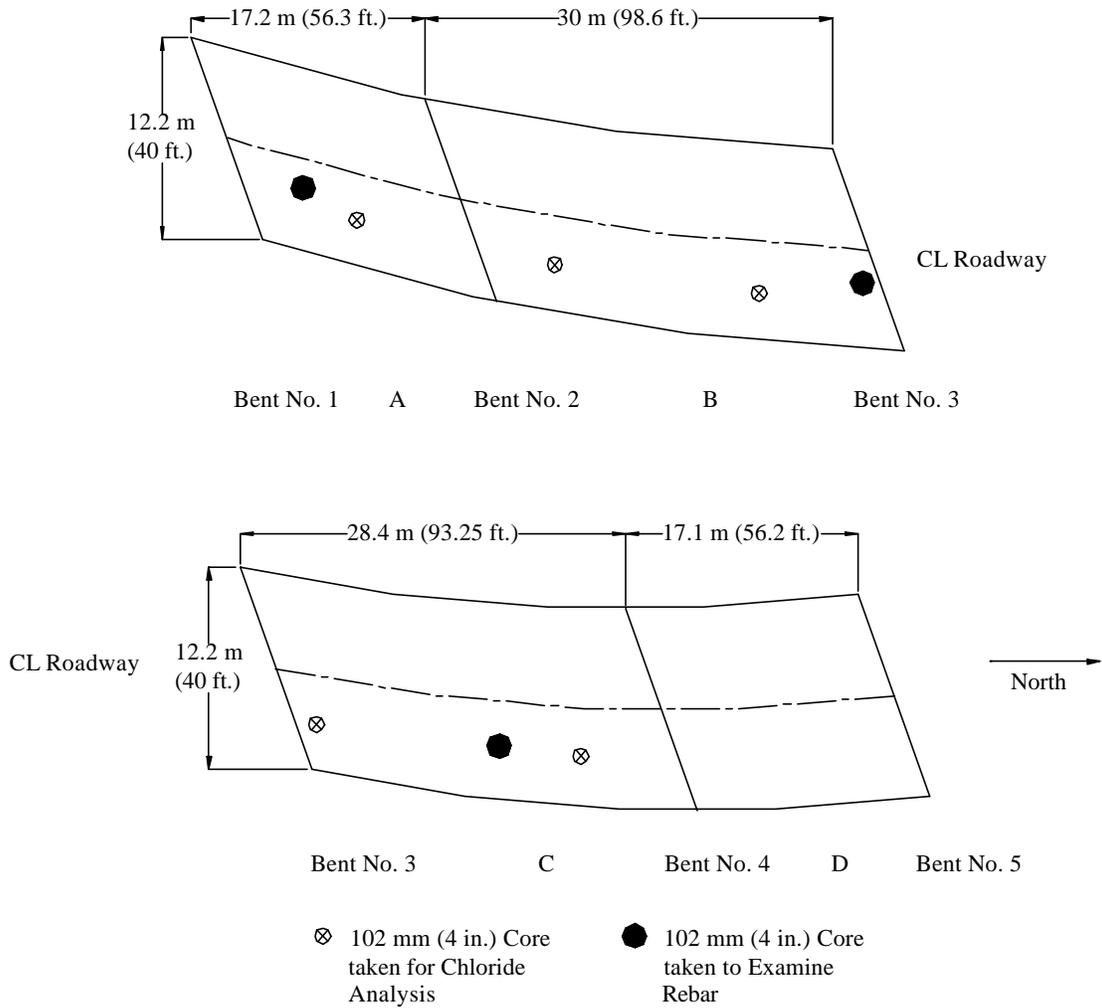
Structure #37-47-5980 Northbound Lane
 Black Rebar with Class A Concrete
 Lawrence County, Vincennes District
 Built 1973

Figure 4.14 Location of Cores Taken From Structure #37-47-5980

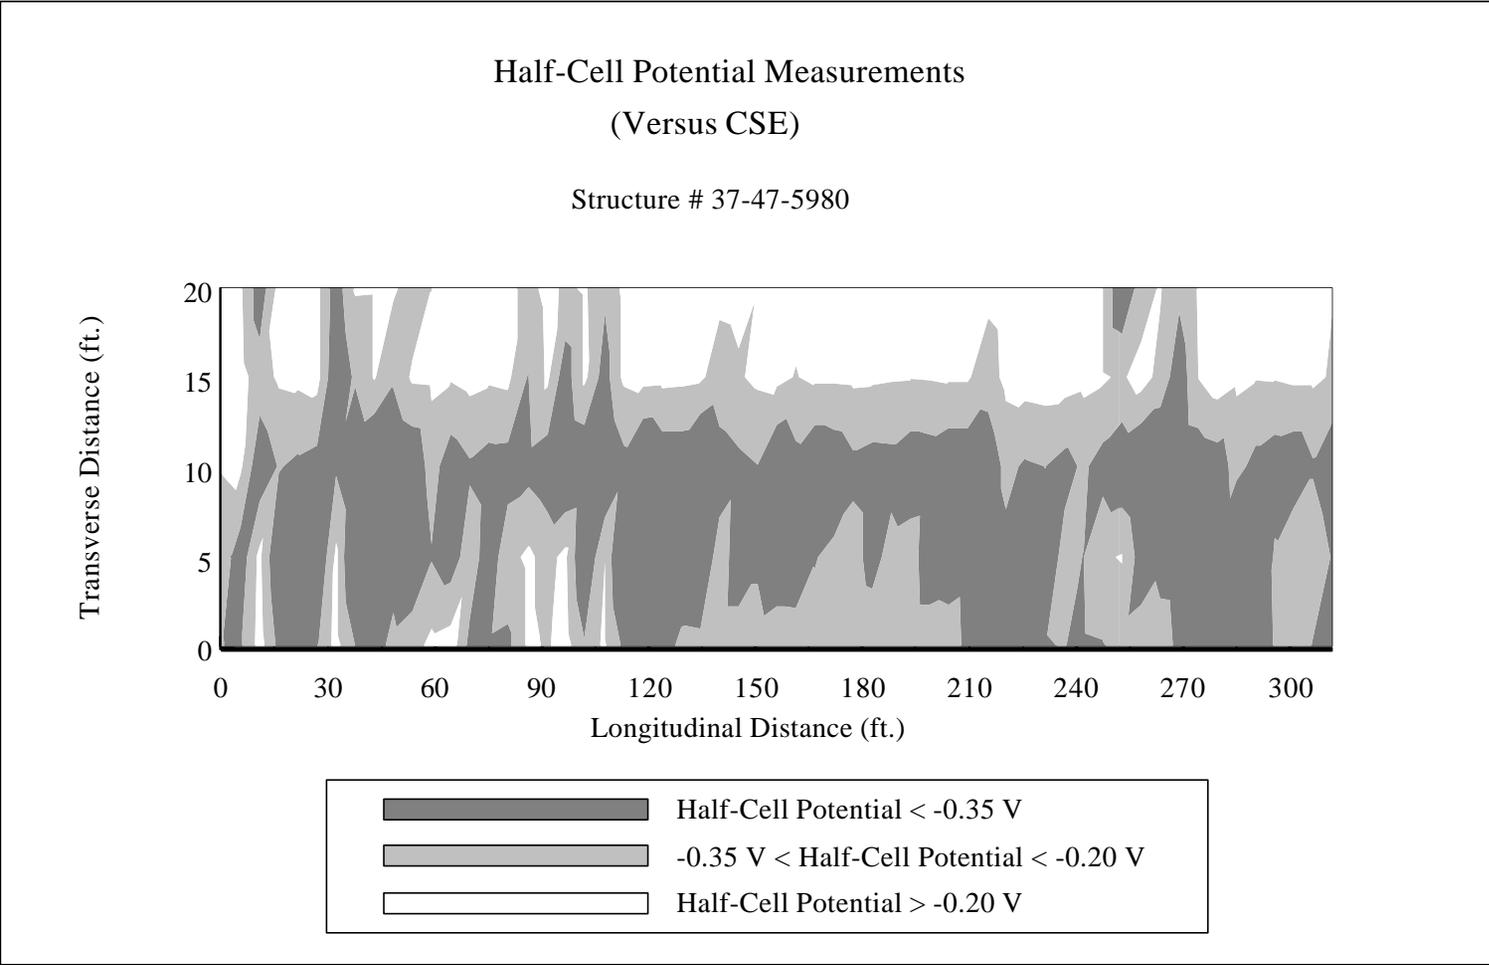
Figure 4.15 Half-Cell Measurements for Structure #37-47-5980

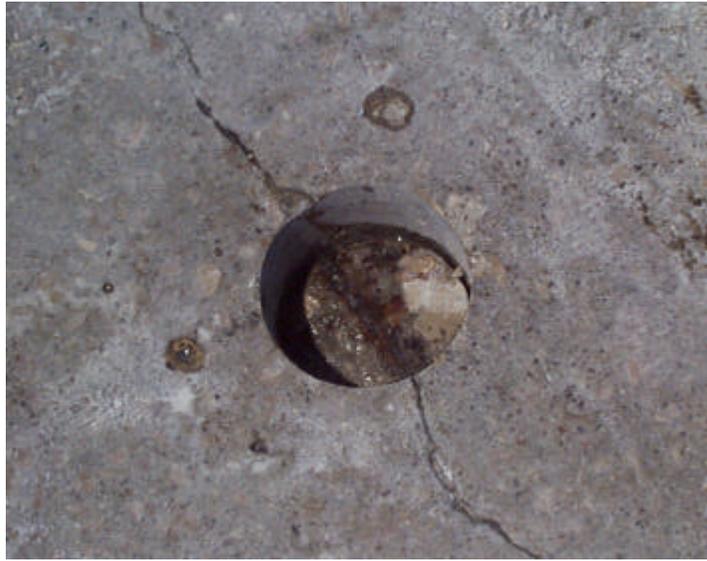
Figure 4.16 Core Taken in Cracked Region (Structure #37-47-5980)

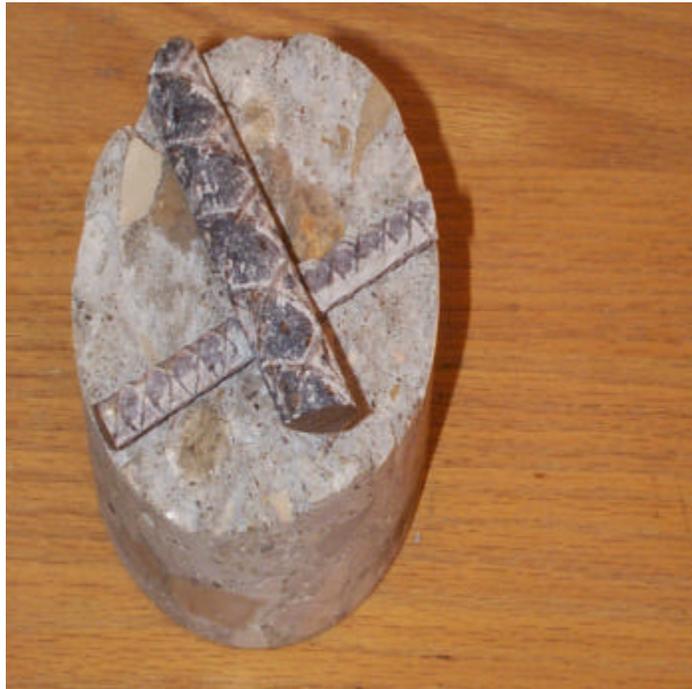
Figure 4.17 Reinforcement from Core Taken in Sound Area of Deck (Str. #37-47-5980)

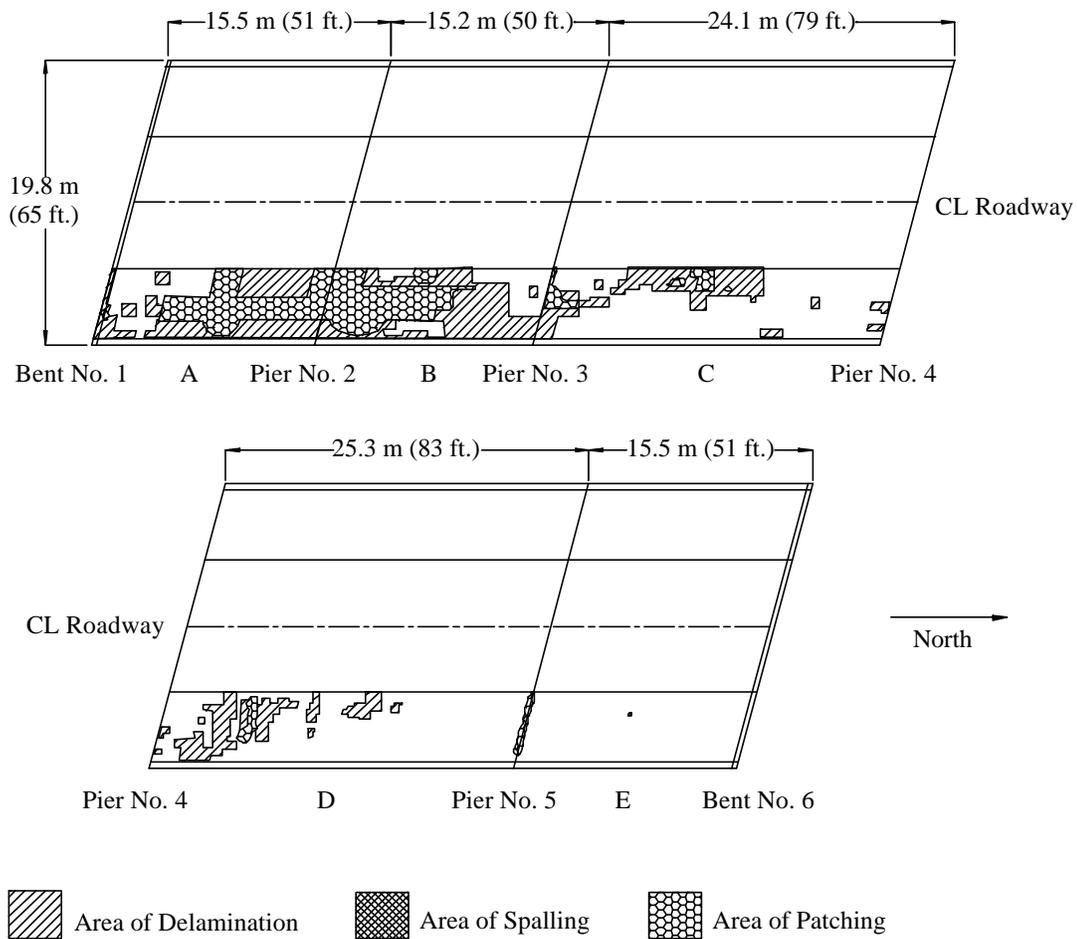
Structure #32-18-2182 Northbound Lane
 Black Rebar with Class C Concrete
 Delaware County, Greenfield District
 Built 1975

Figure 4.20 Delaminations, Spalls, and Patching Found on Structure #32-18-2182

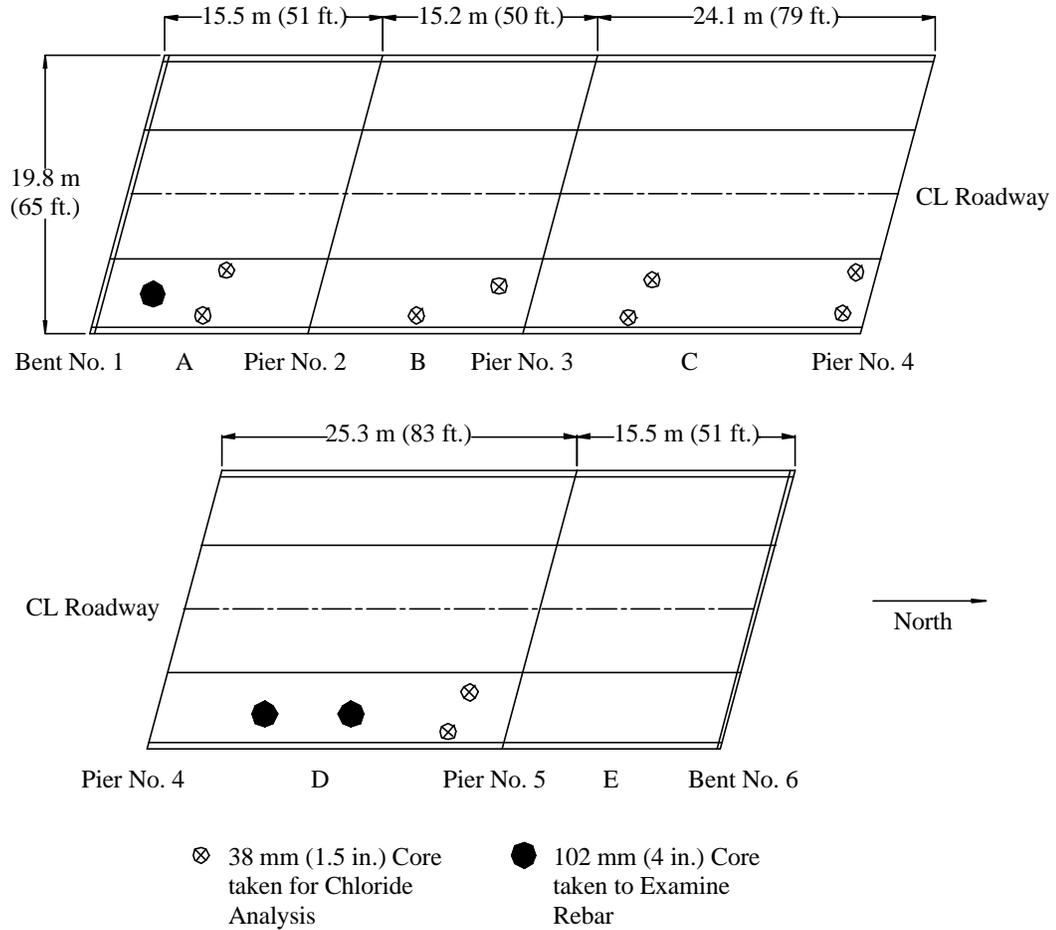
Structure #32-18-2182 Northbound Lane
 Black Rebar with Class C Concrete
 Delaware County, Greenfield District
 Built 1975

Figure 4.21 Location of Cores Taken From Structure #32-18-2182

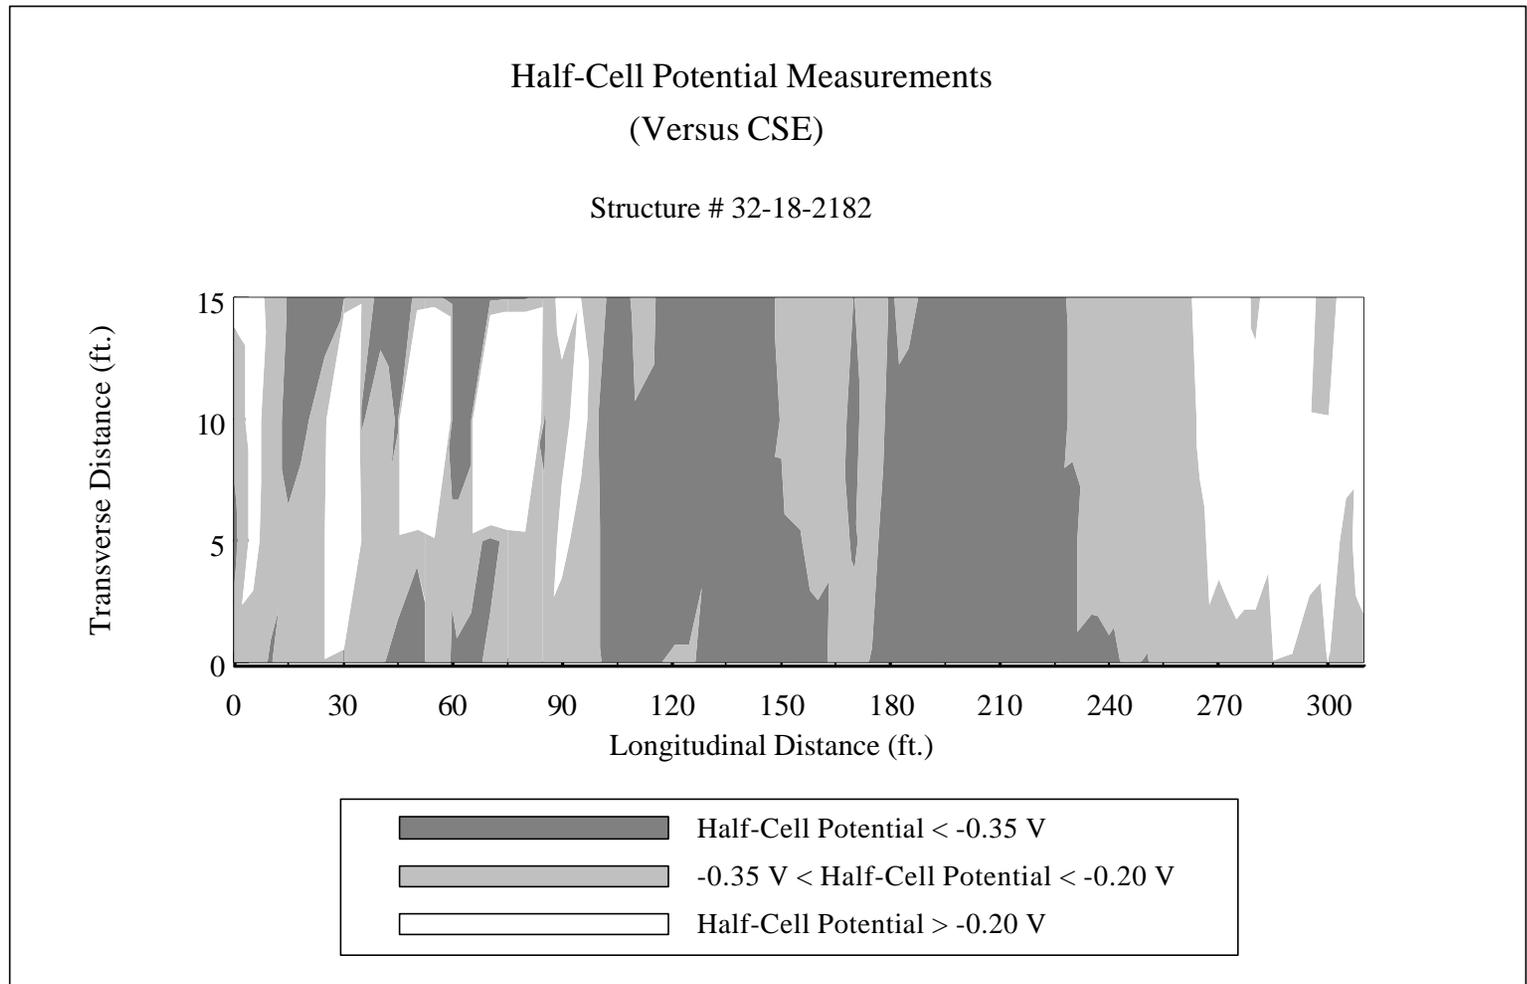
Figure 4.23 Half-Cell Measurements for Structure #32-18-2182

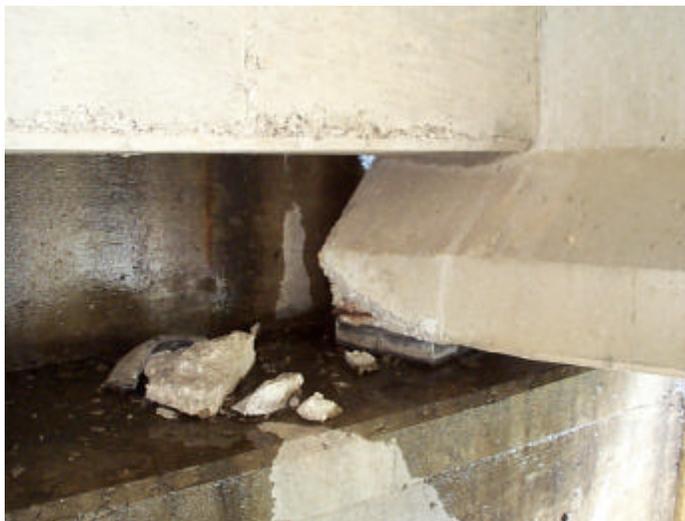
Figure 4.25 Corrosion Damage to Interior Prestressed Member (Structure #32-18-2182)

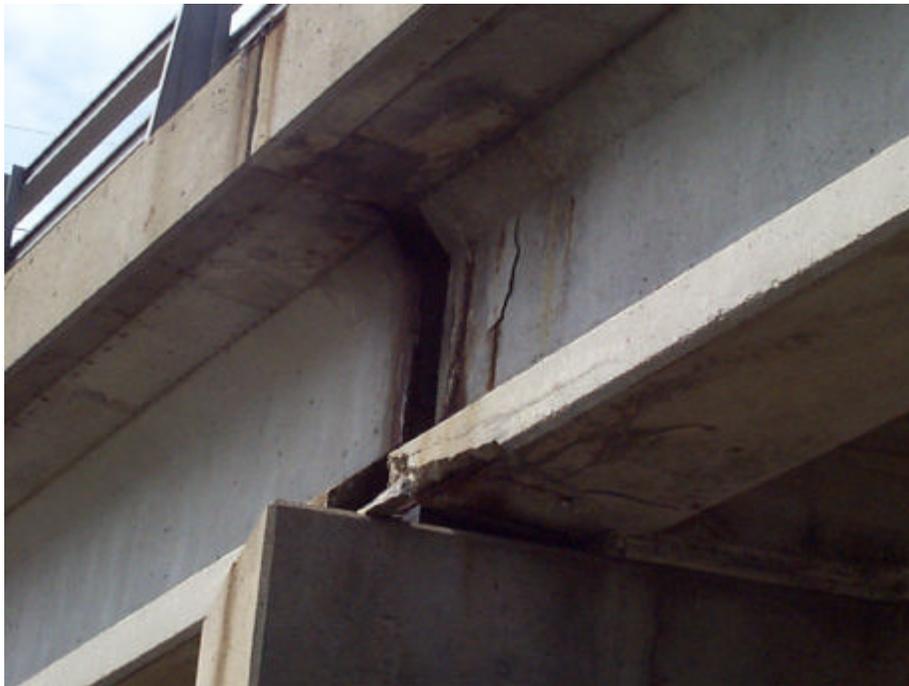
Figure 4.26 Damage to Exterior Prestressed I-Beam (Structure #32-18-2182)

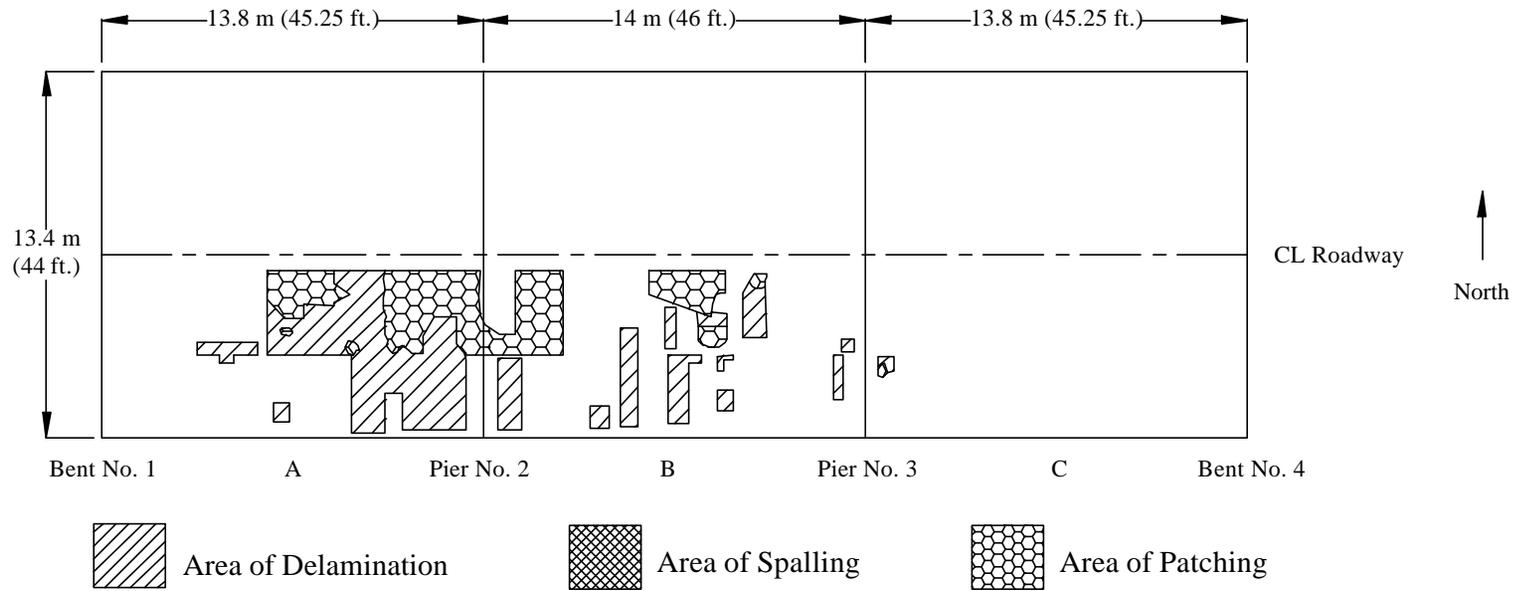
Structure #6-50-5187 Eastbound Lane
 Black Rebar with Class C Concrete and 38 mm (1.5 in.) LMO
 Marshall County, Laporte District
 Built 1980

Figure 4.28 Delaminations, Spalls, and Patching Found on Structure #6-50-5187

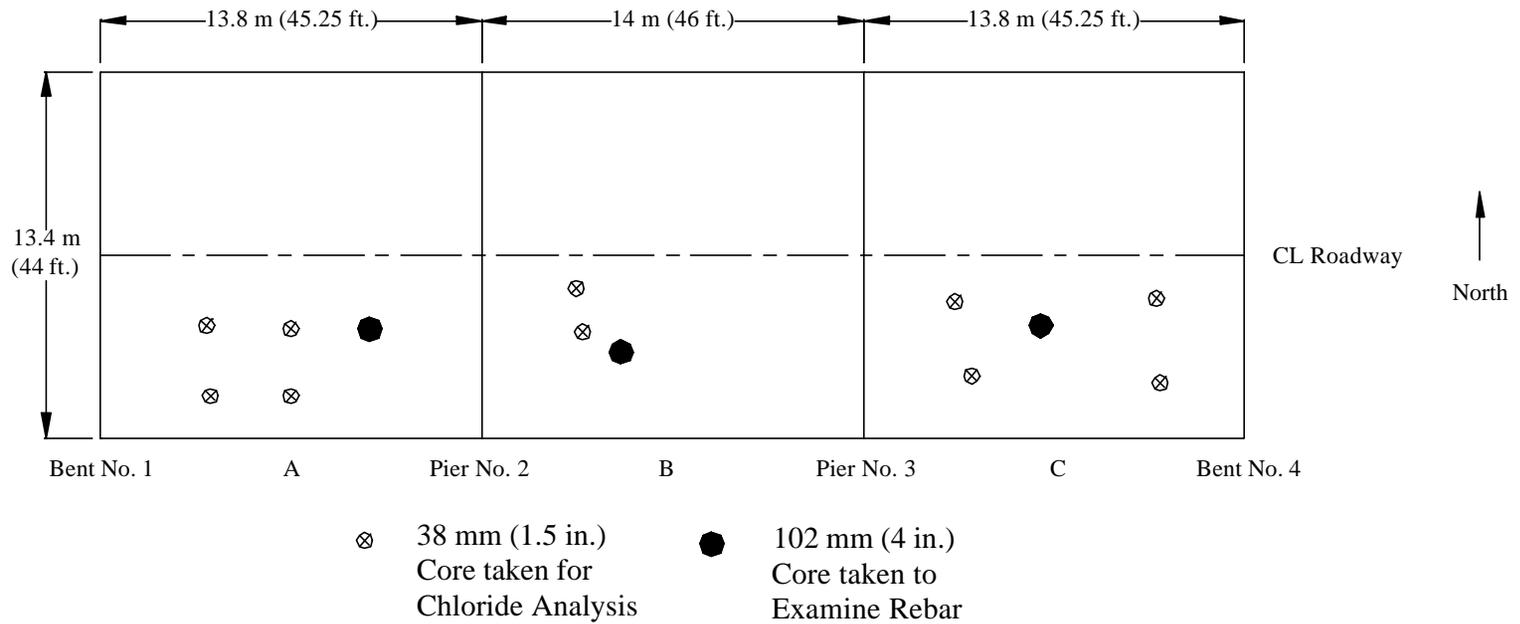
Structure #6-50-5187 Eastbound Lane
 Black Rebar with Class C Concrete and 38 mm (1.5 in.) LMO
 Marshall County, Laporte District
 Built 1980

Figure 4.29 Location of Cores Taken From Structure #6-50-5187

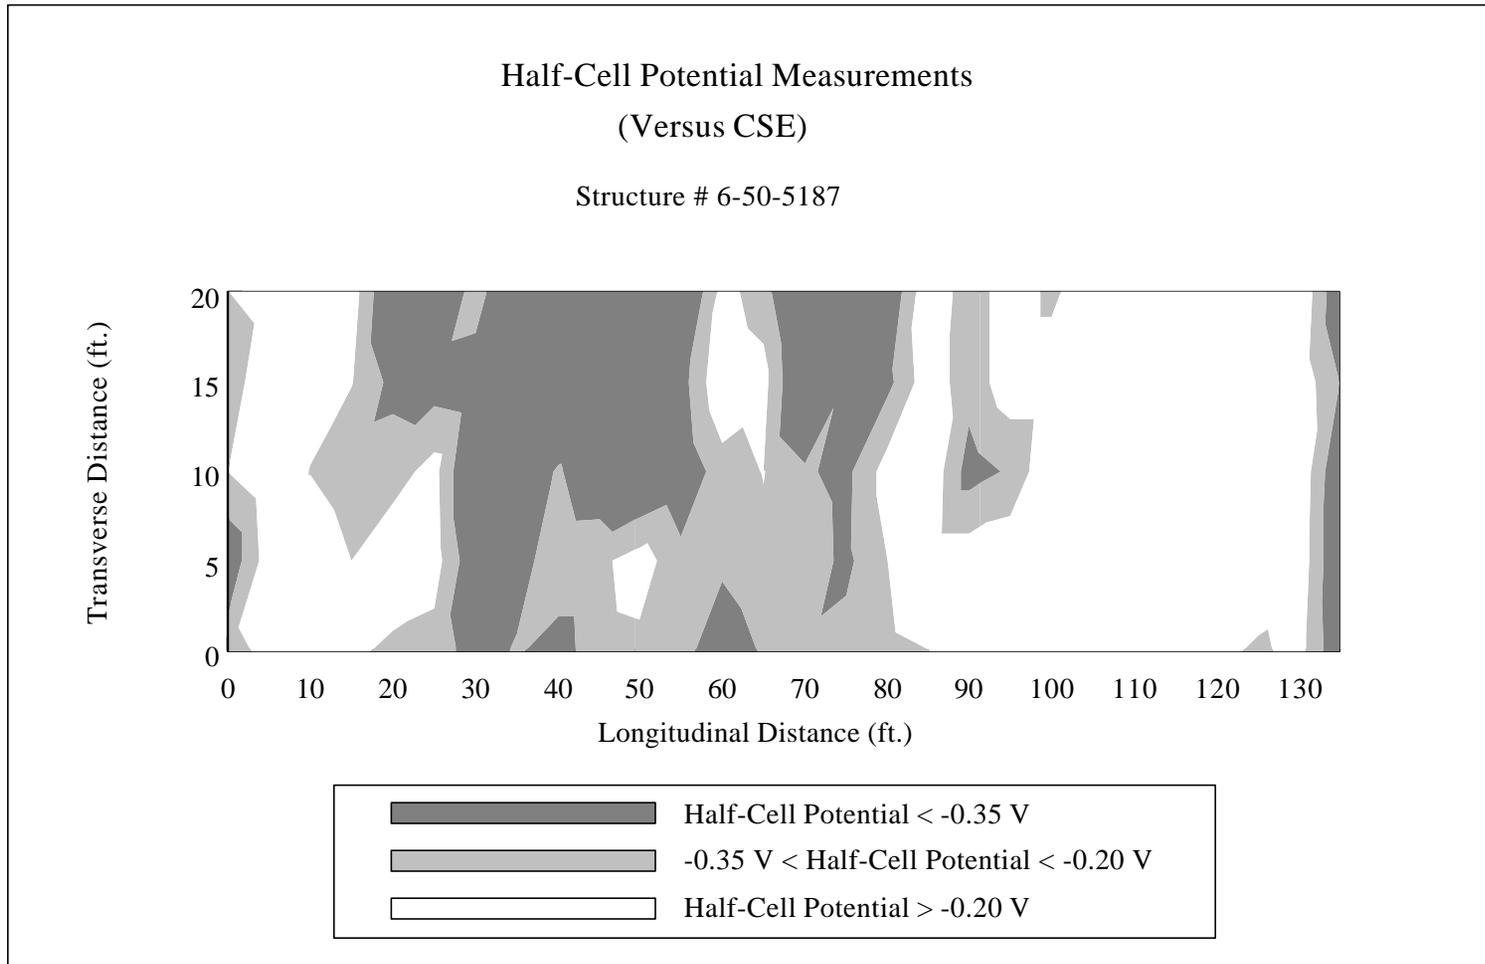
Figure 4.30 Half-Cell Measurements for Structure #6-50-5187

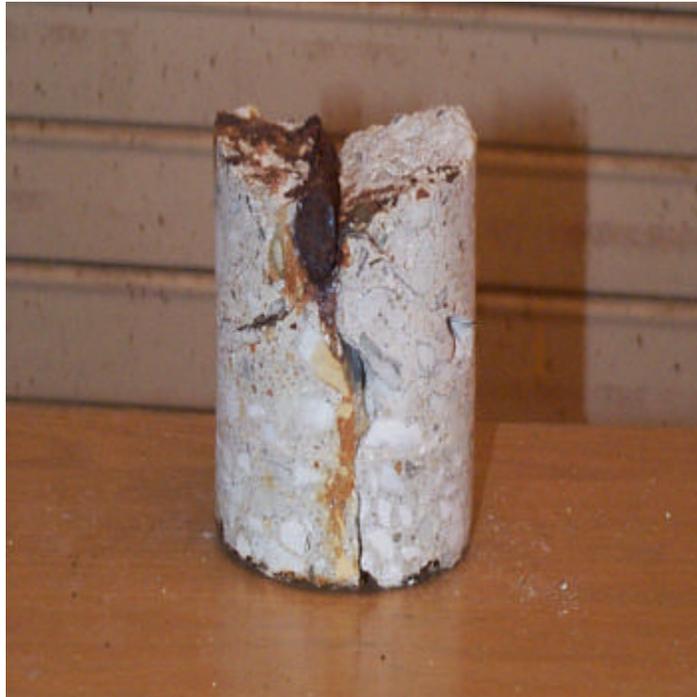
Figure 4.31 Core Taken in Cracked Area (Structure #6-50-5187)

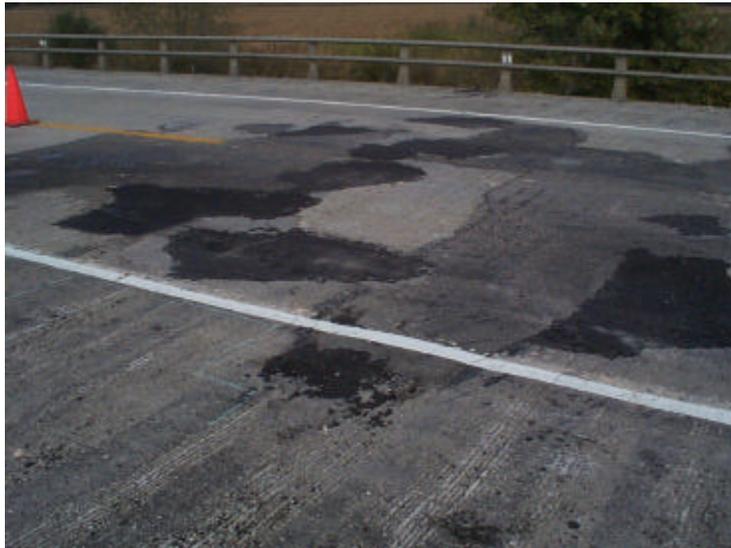
Figure 4.32 Extensive Patching of Bridge Deck (Structure #6-50-5187)

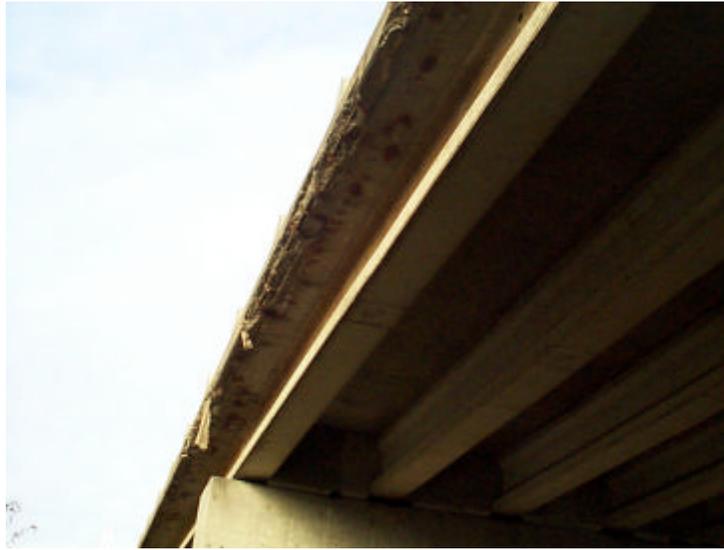
Figure 4.33 Corrosion Damage to Underside of Deck (Structure #6-50-5187)
