FHWA/IN/JTRP-98/15

**METHODS OF CORROSION PROTECTION AND
DURABILITY OF CONCRETE BRIDGE DECKS
REINFORCED WITH EPOXY-COATED BARS - PHASE I**

**Lisa M. Samples
Julio A. Ramirez**

Joint Transportation Research Project

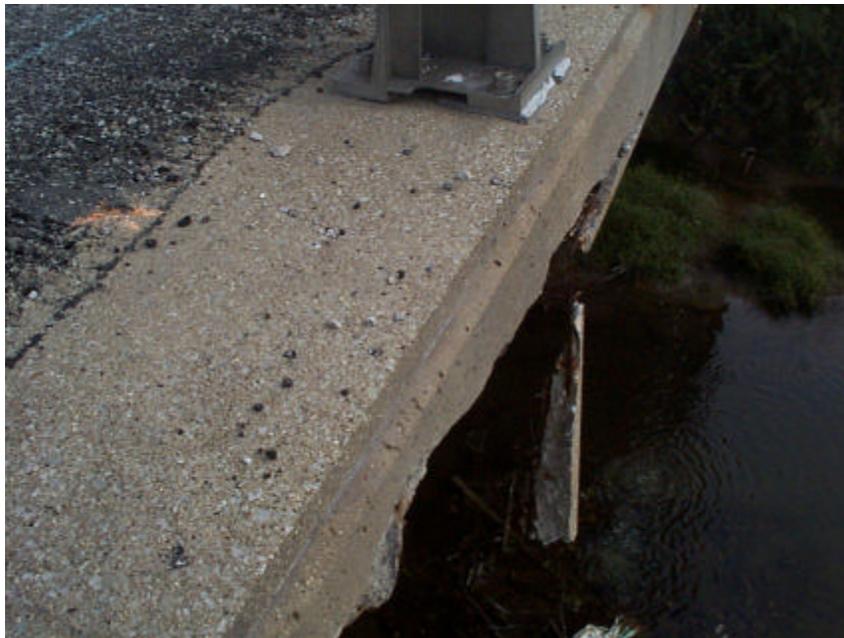
Figure 4.34 Concrete Spalling from Underside of Deck (Structure #6-50-5187)

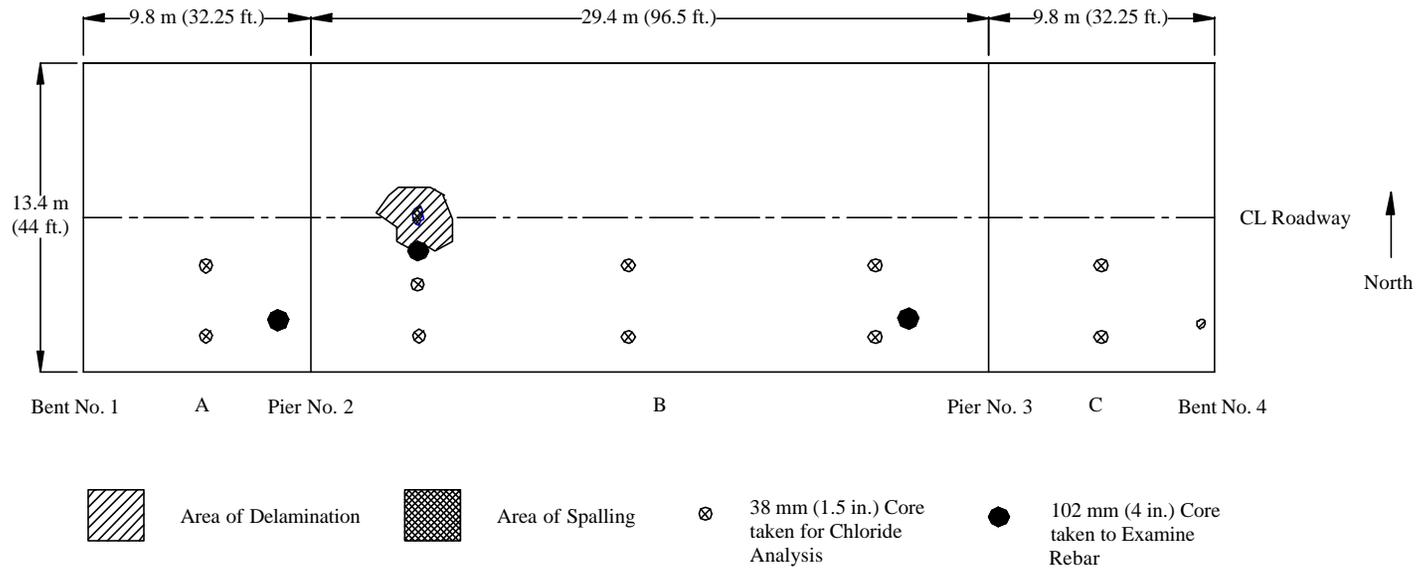
Structure #6-50-6624 Eastbound Lane
 Epoxy-Coated Rebar with Class C Concrete
 Marshall County, Laporte District
 Built 1980

Figure 4.36 Delaminations, Spalls, and Location of Cores for Structure #6-50-6624

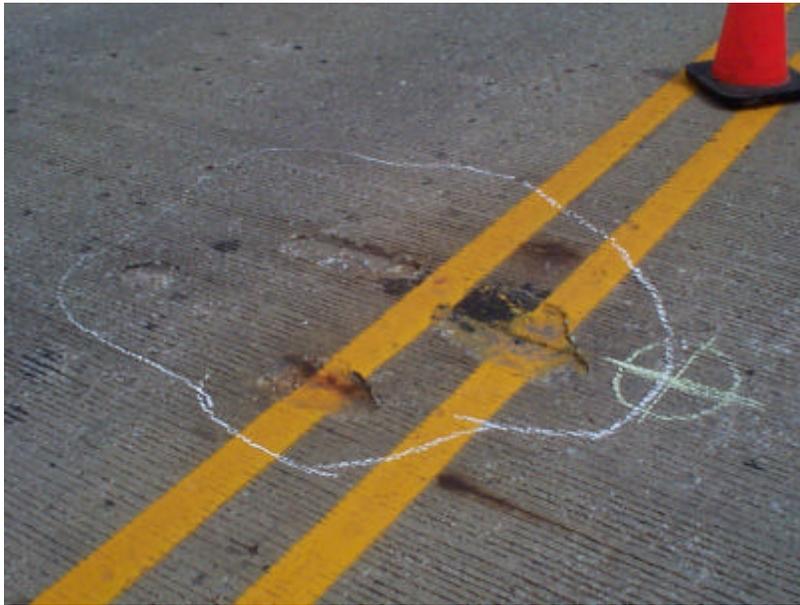
Figure 4.37 Delaminated Area with Spalls and Exposed Reinforcement (Structure # 6-50-6624)

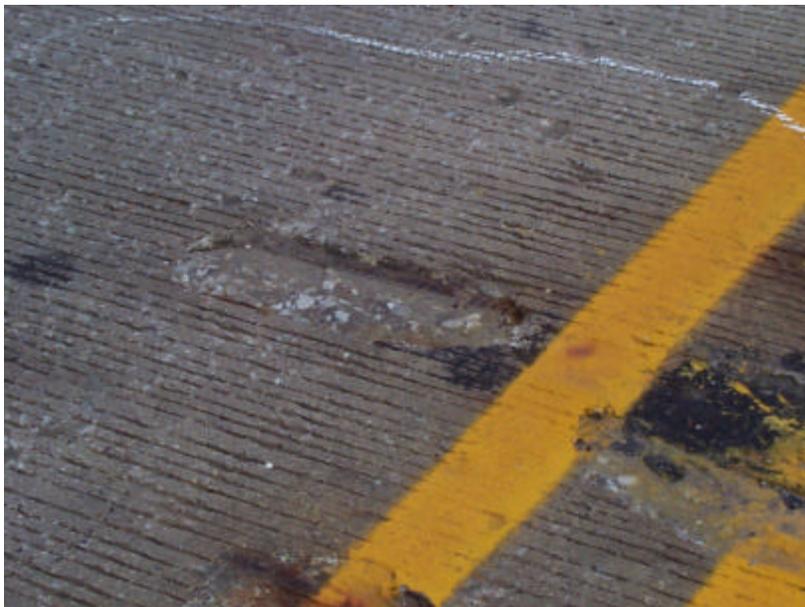
Figure 4.38 Exposed Rebar with Epoxy Coating Removed (Structure #6-50-6624)

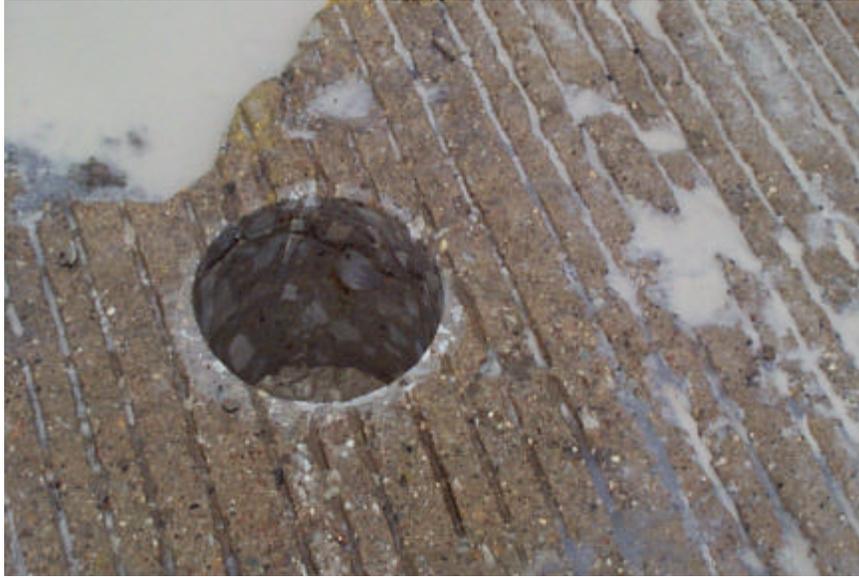
Figure 4.39 Delamination from Corrosion of Rebar (Structure #6-50-6624)

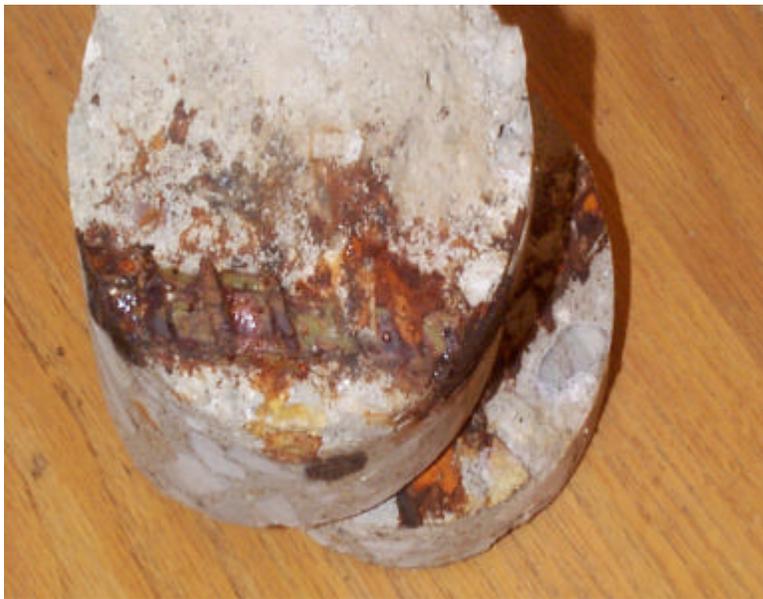
Figure 4.40 Core Removed from Delaminated Area of Deck (Structure #6-50-6624)

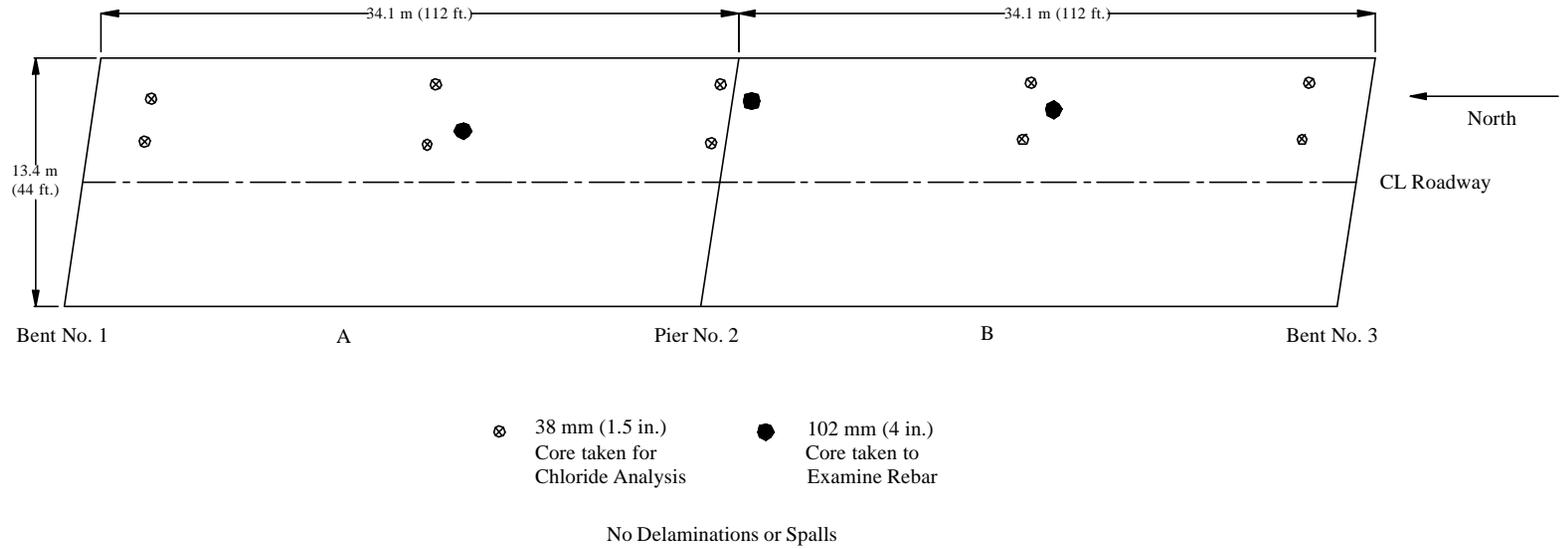
Structure #331-50-6608 Northbound Lane
 Epoxy-Coated Rebar with Class C Concrete
 Marshall County, Laporte District
 Built 1976

Figure 4.45 Location of Cores for Structure #331-50-6608

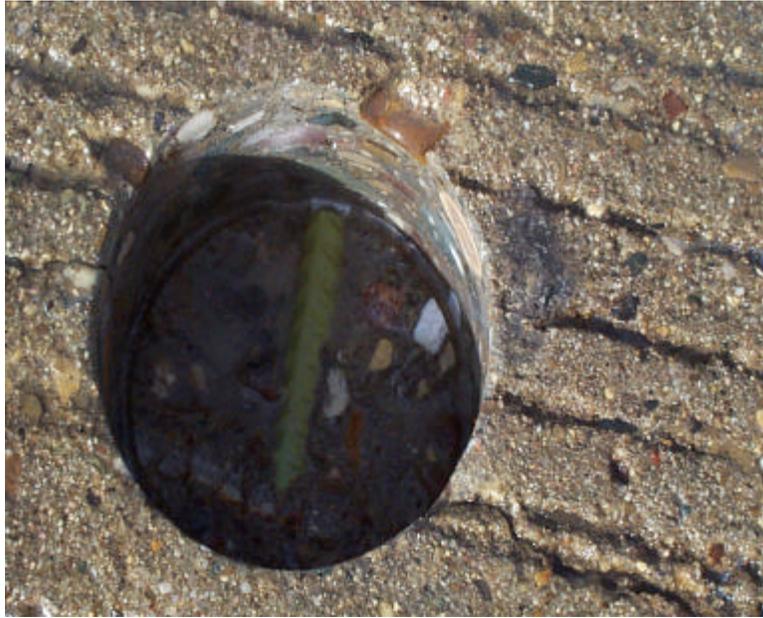
Figure 4.46 Core Taken in Cracked Location (Structure #331-50-6608)

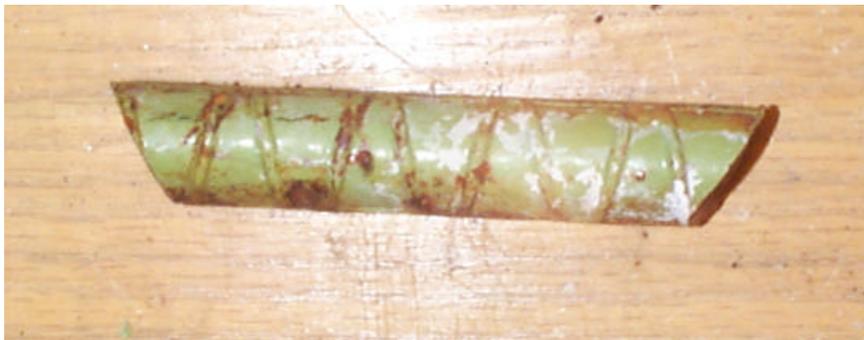
Figure 4.47 Rebar Removed from Cracked Location in Deck (Structure #331-50-6608)

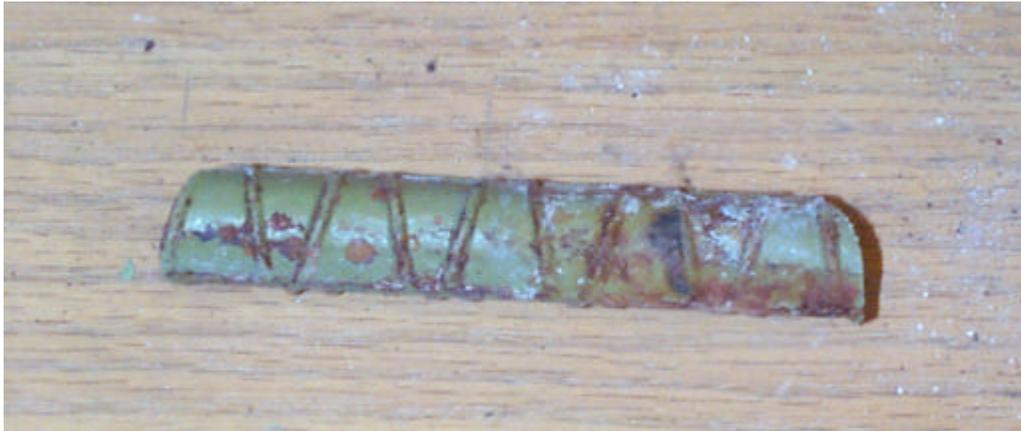
Figure 4.48 Alternate Side of Rebar Removed from Cracked Area
(Structure #331-50-6608)

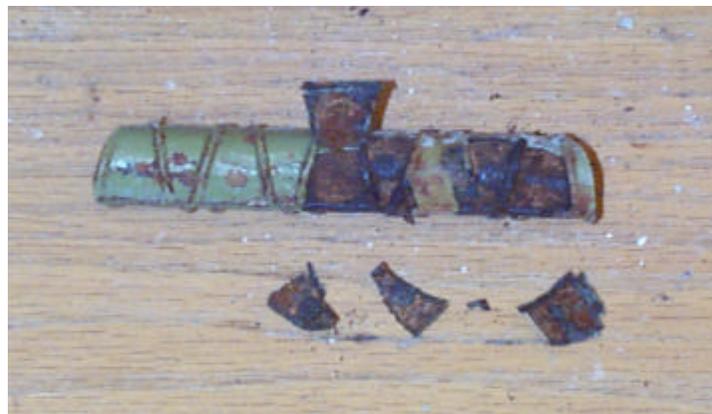
Figure 4.49 Underfilm Corrosion Found after Removing Coating
(Structure #331-50-6608)

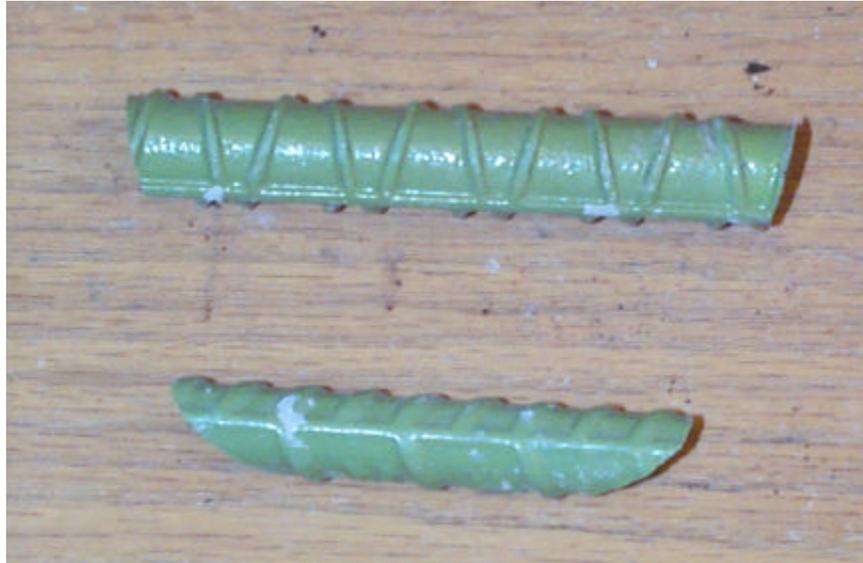
Figure 4.50 Rebars Removed from Sound Area of Deck (Structure #331-50-6608)

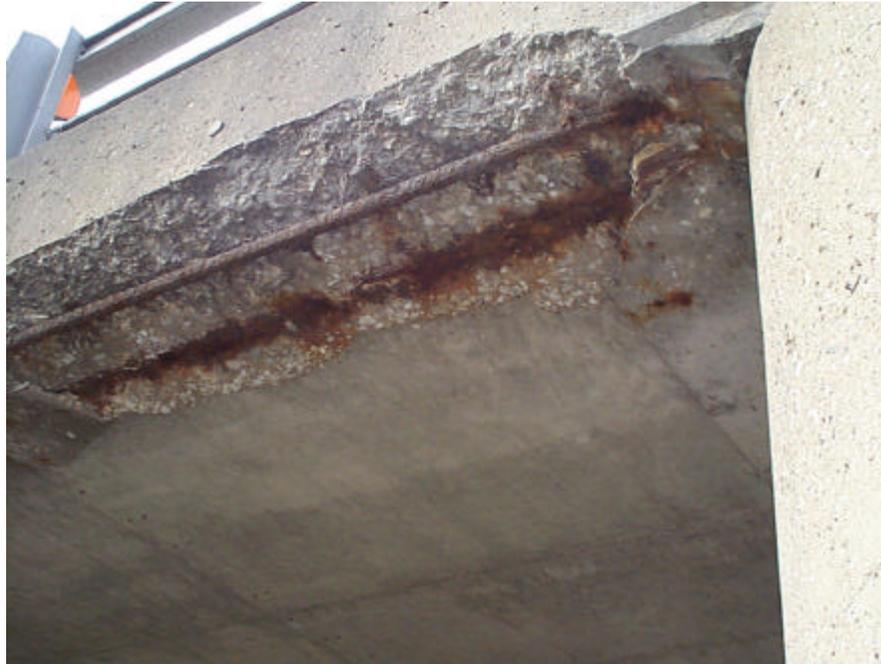
Figure 4.53 Concrete Spalling on Underside of Deck (Structure #6-50-6577)

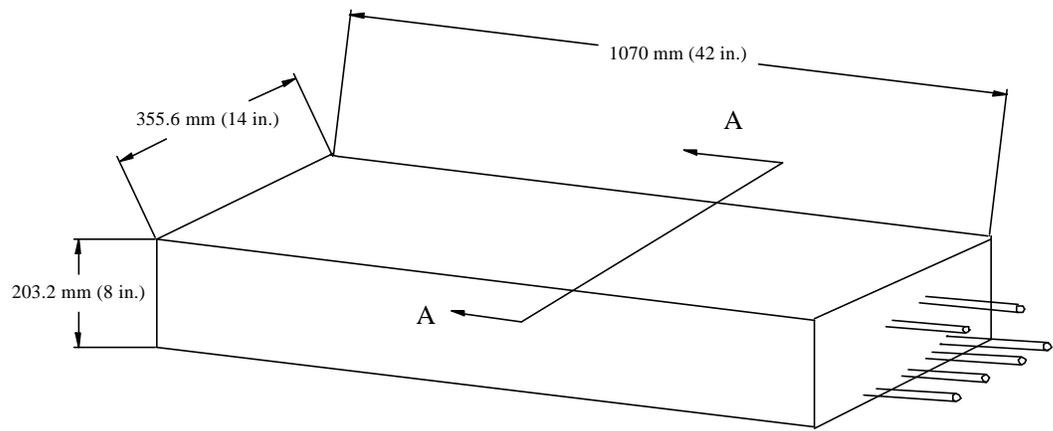
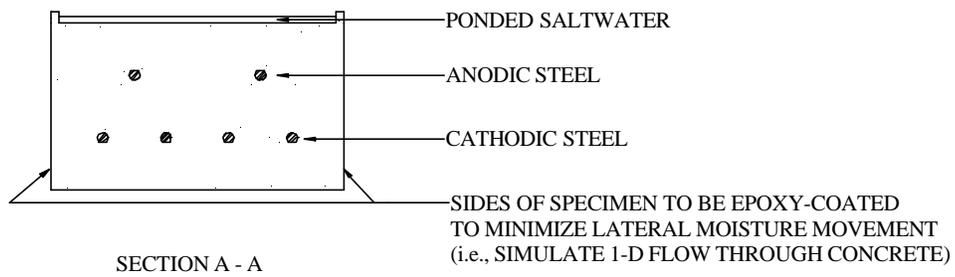
Figure 5.1 Durability Specimens

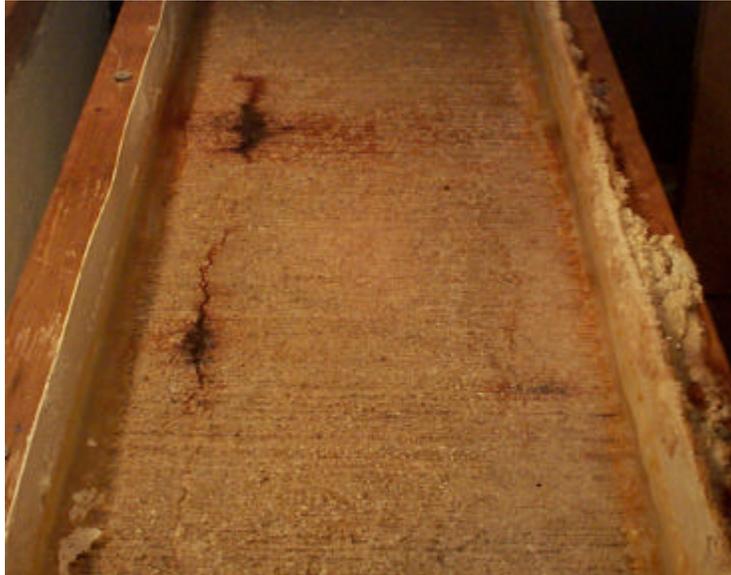
Figure 5.2 Cracking over Reinforcement

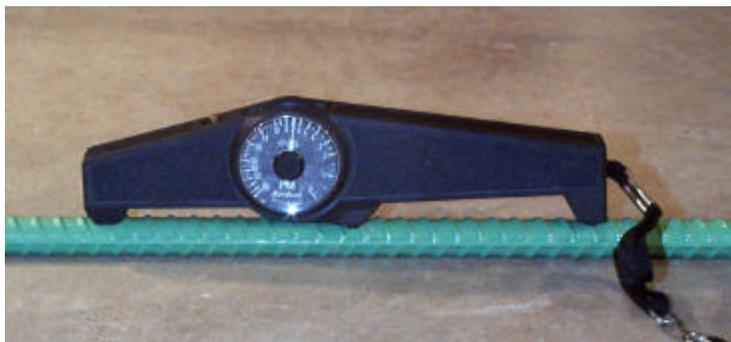
Figure 5.3 Coating Thickness Measurements

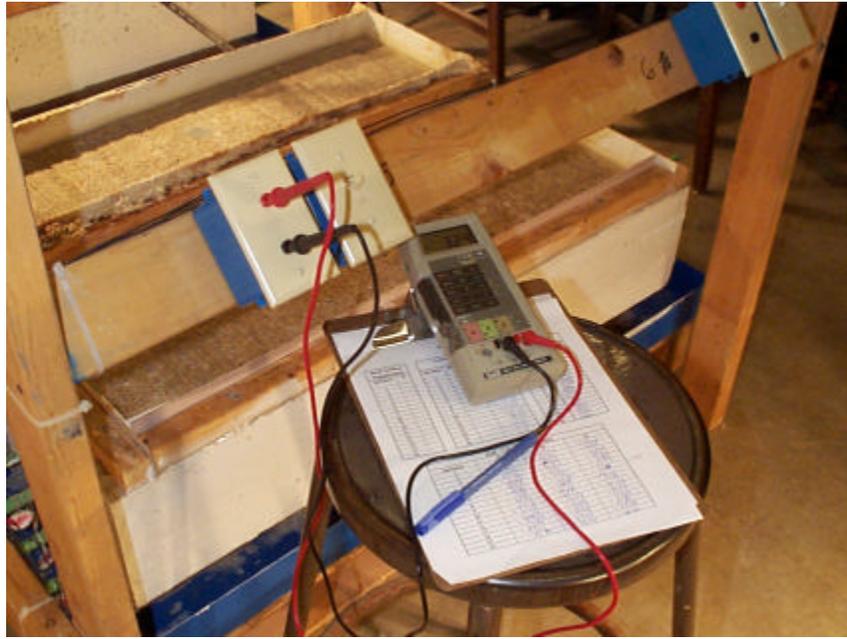
Figure 5.8 Corrosion Current Measurements

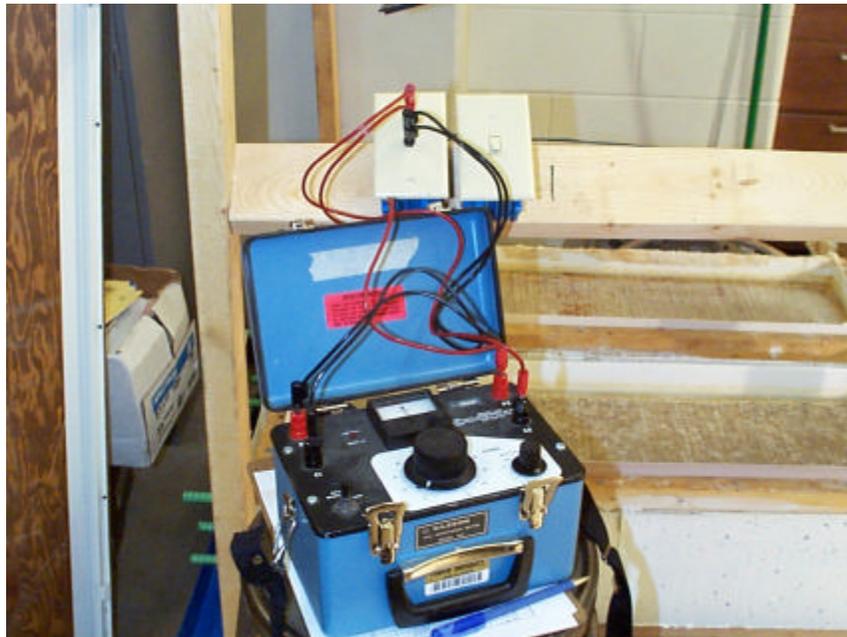
Figure 5.9 AC Mat to Mat Resistance Measurements

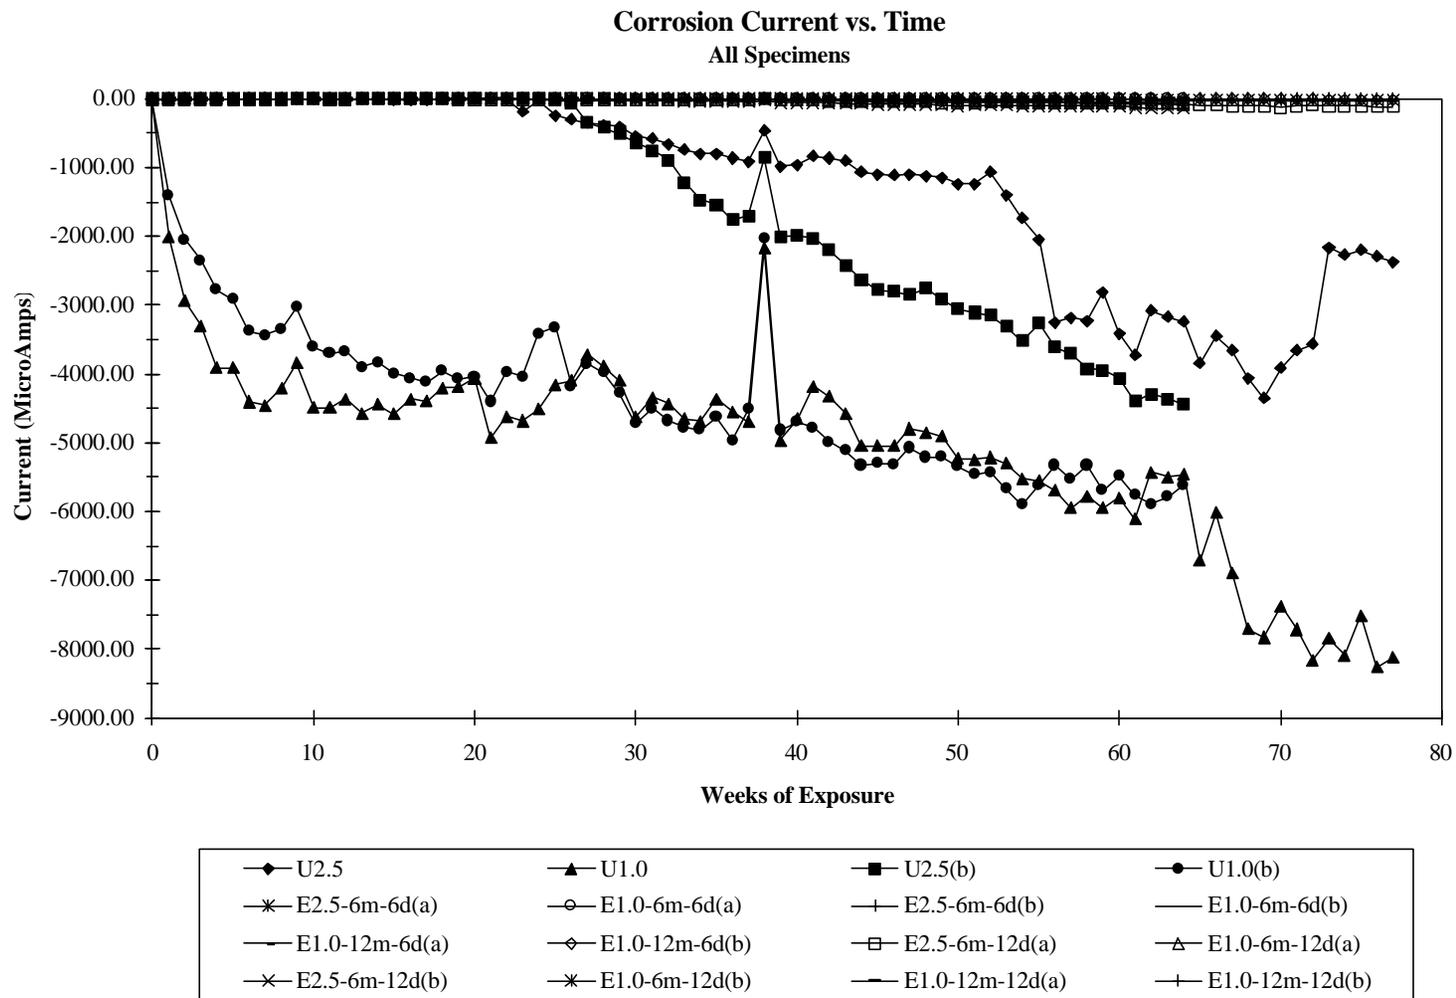
Figure 5.11 Corrosion Current Measurements for all Specimens

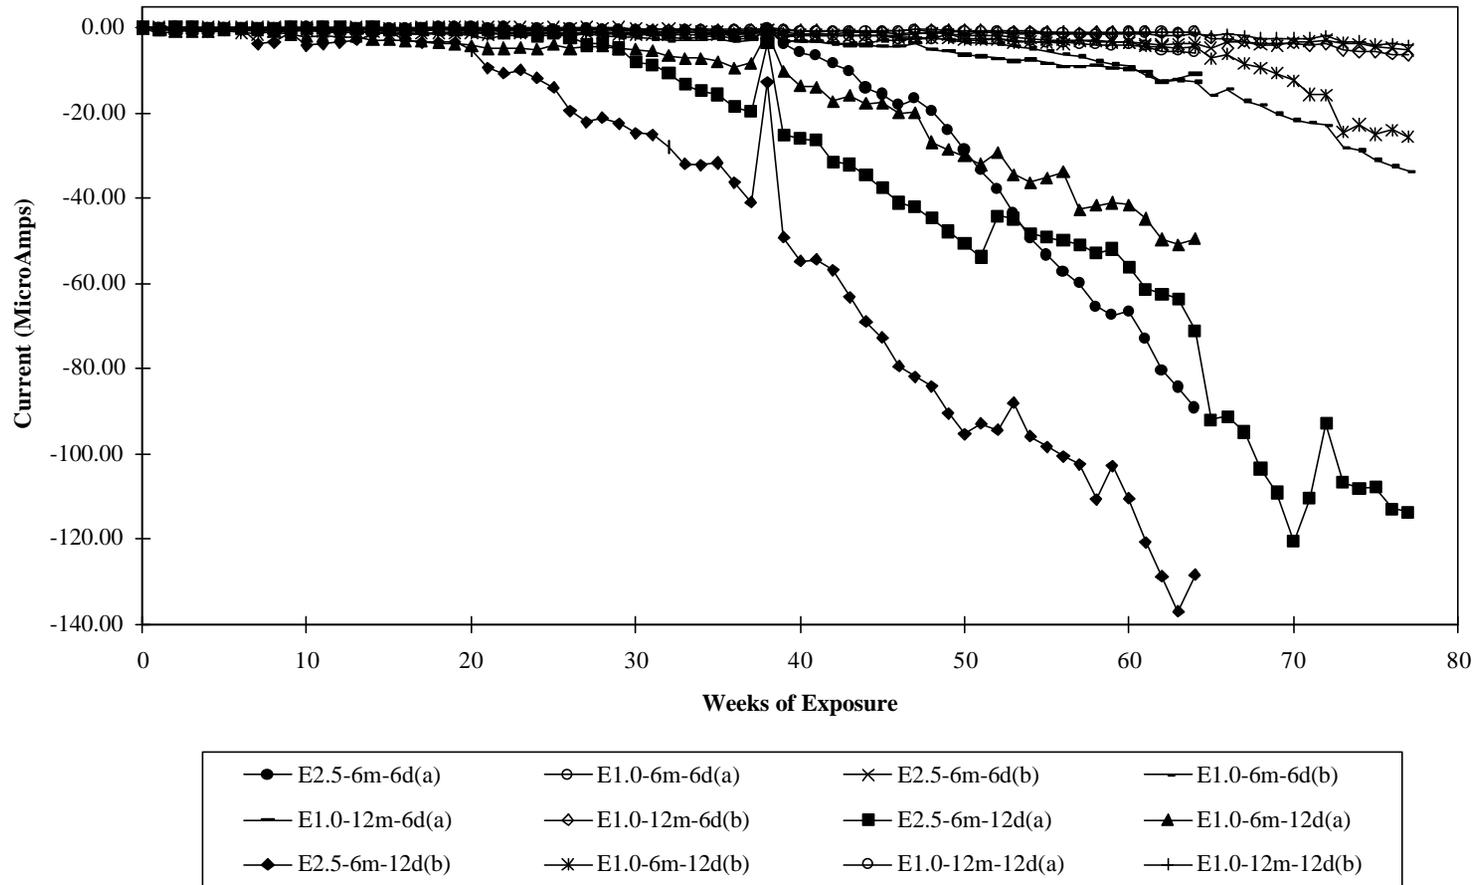
Figure 5.12 Corrosion Current Measurements for Epoxy-Coated Specimens Only

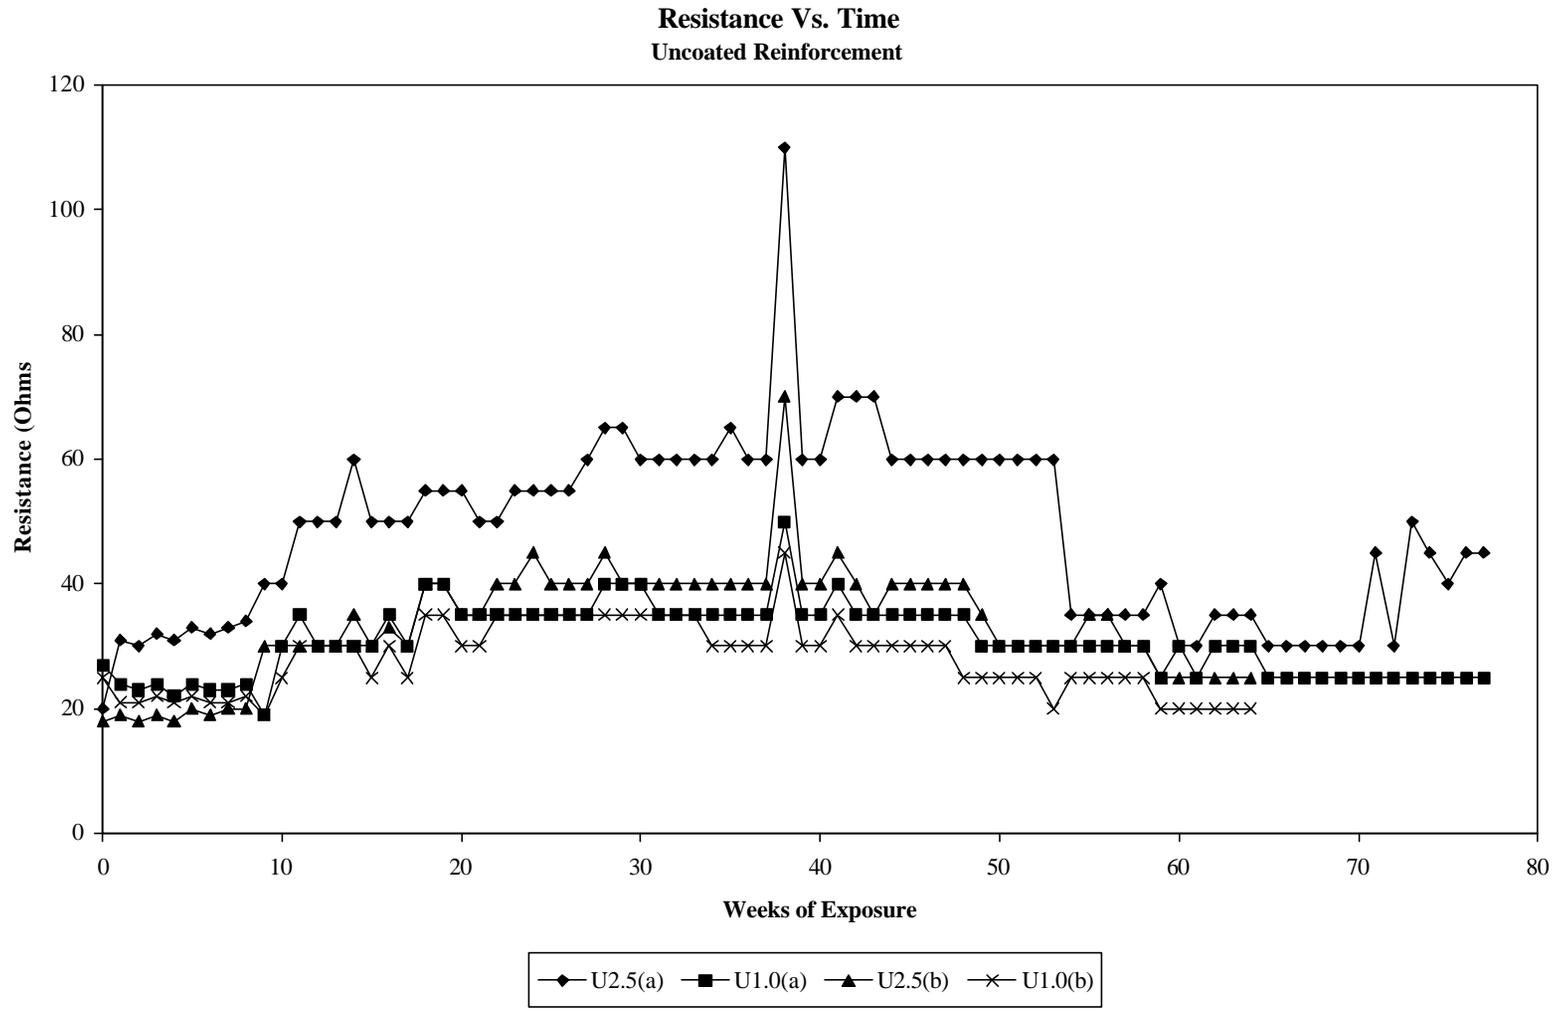
Figure 5.13 Resistance Measurements for Specimens Containing Uncoated Reinforcement

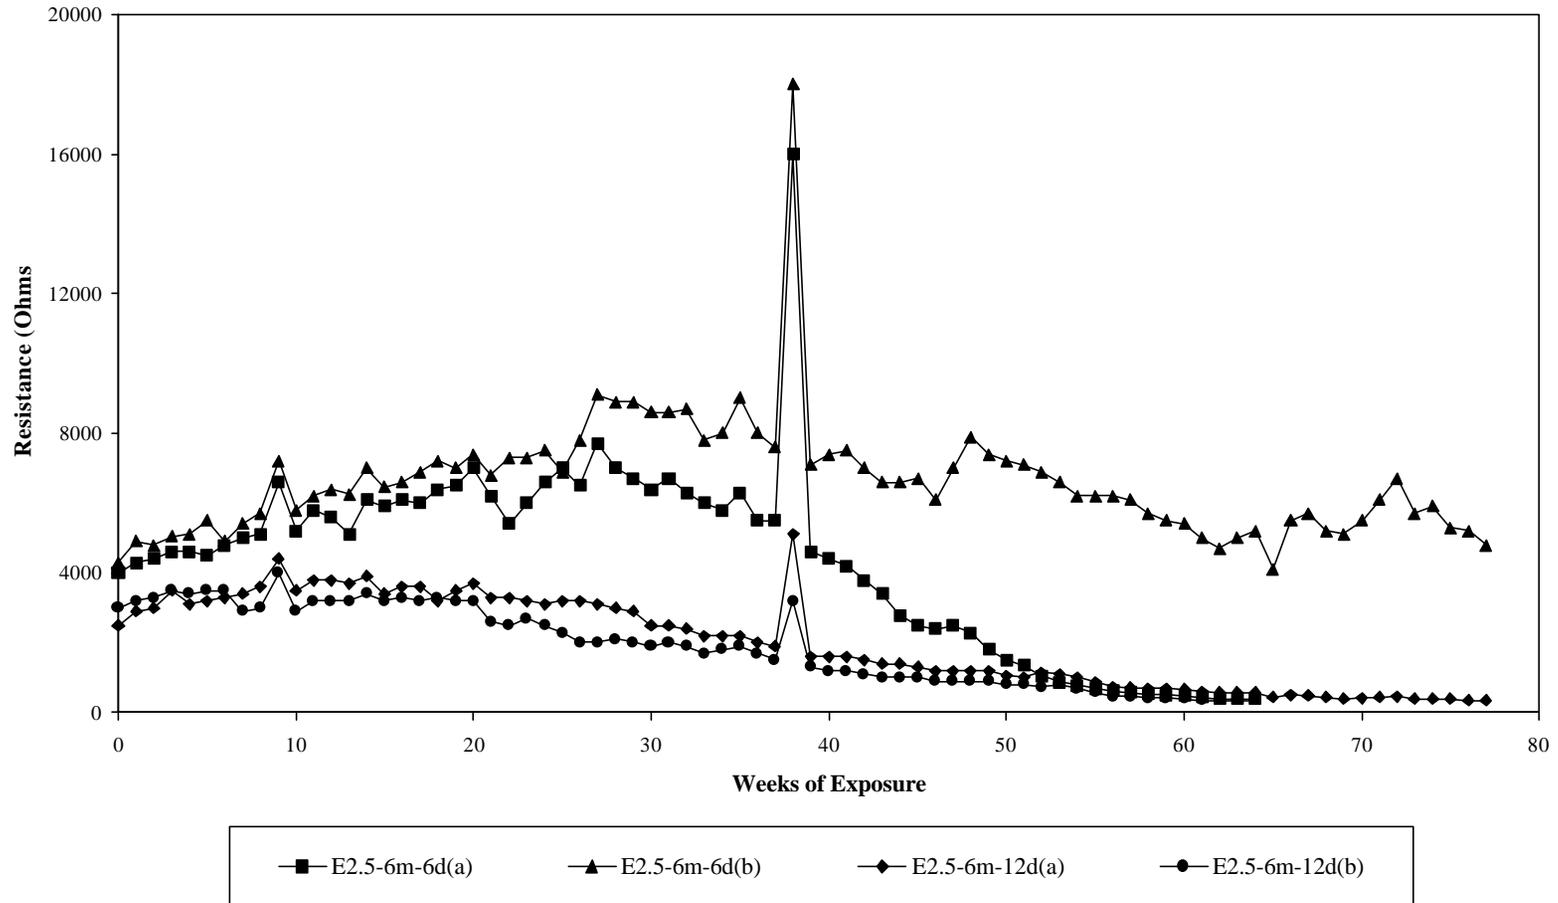
Figure 5.14 Resistance Measurements for Specimens with Epoxy-Coated Reinforcement and 63.5 mm (2.5 in.) Cover

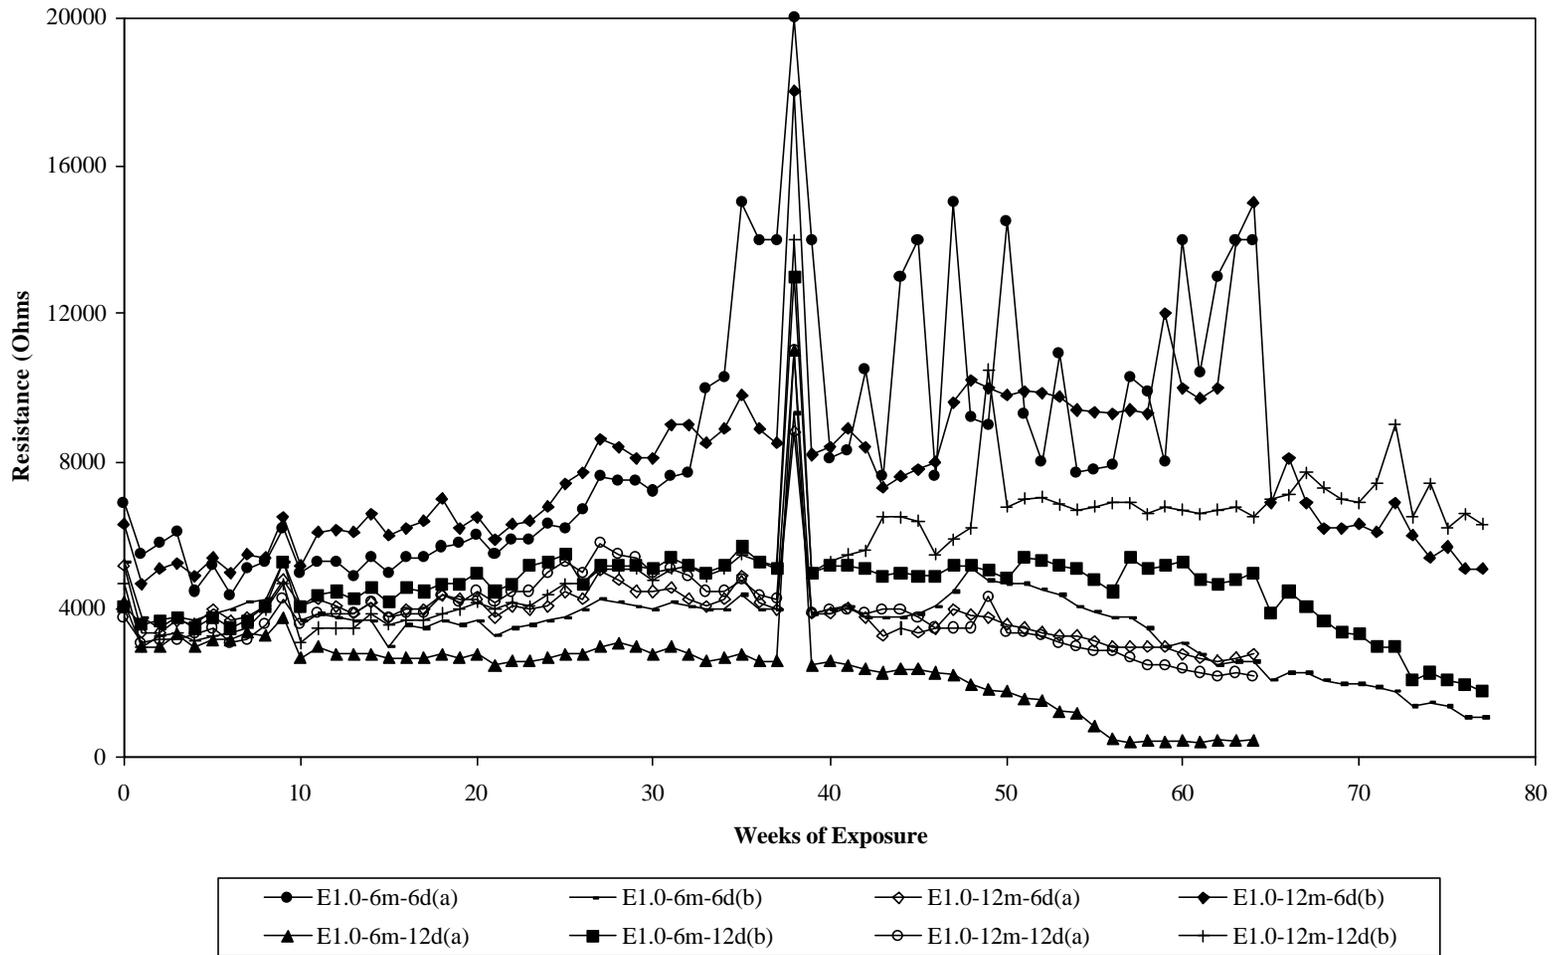
Figure 5.15 Resistance Measurements for Specimens with Epoxy-Coated Reinforcement and 25.4 mm (1.0 in.) Cover

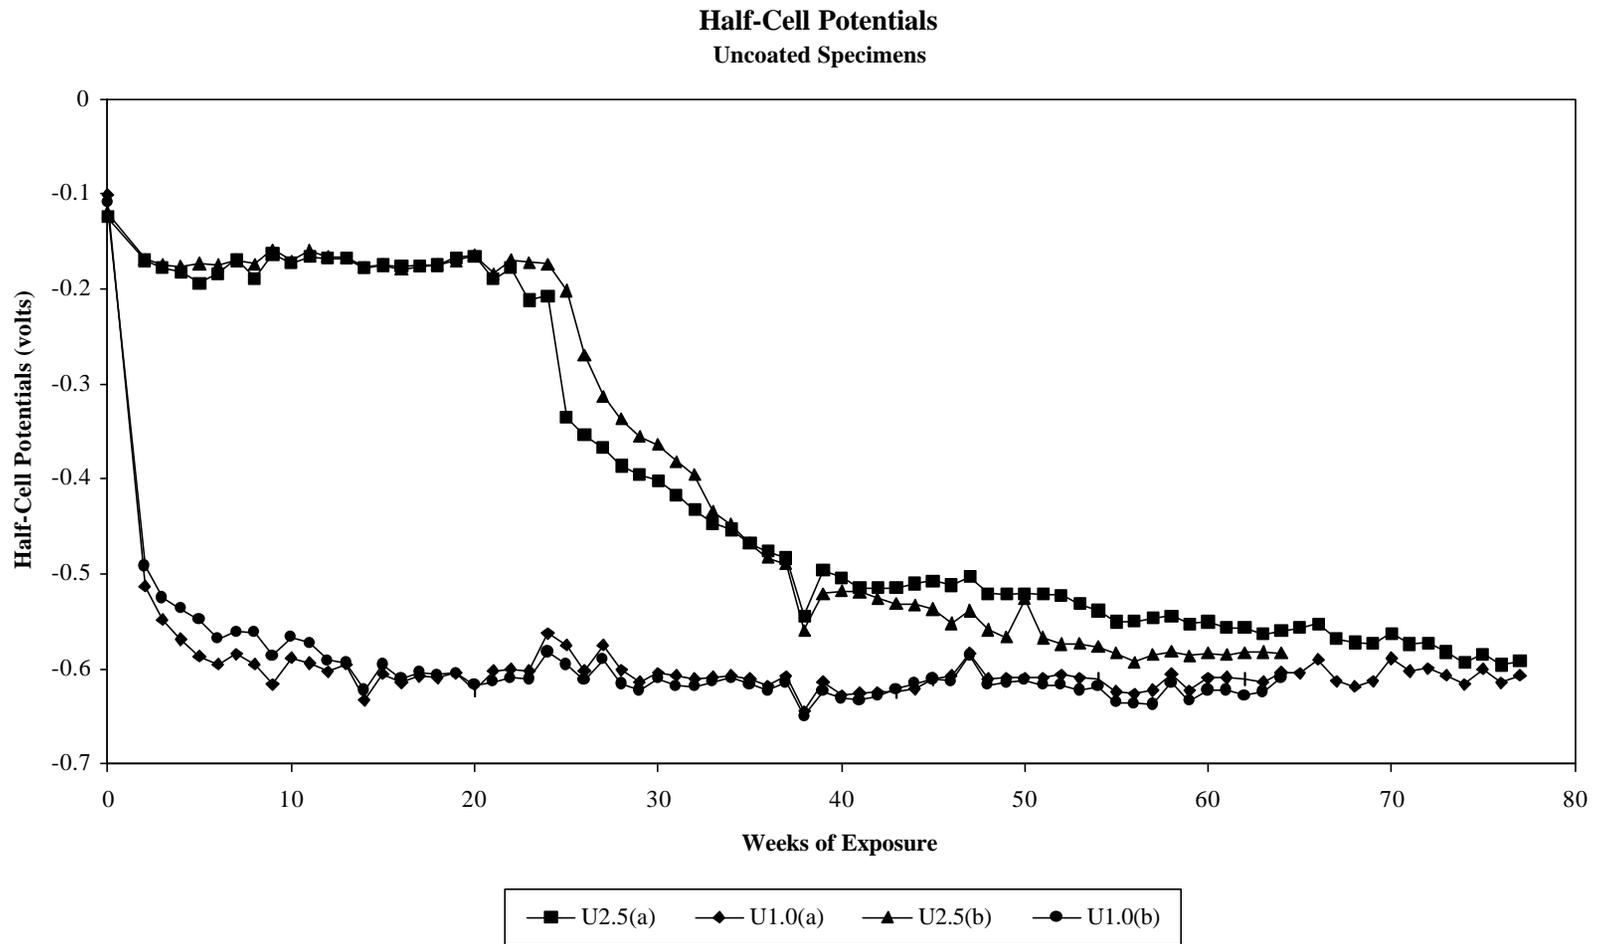
Figure 5.16 Half-Cell Potential Measurements for Specimens Containing Uncoated Reinforcement

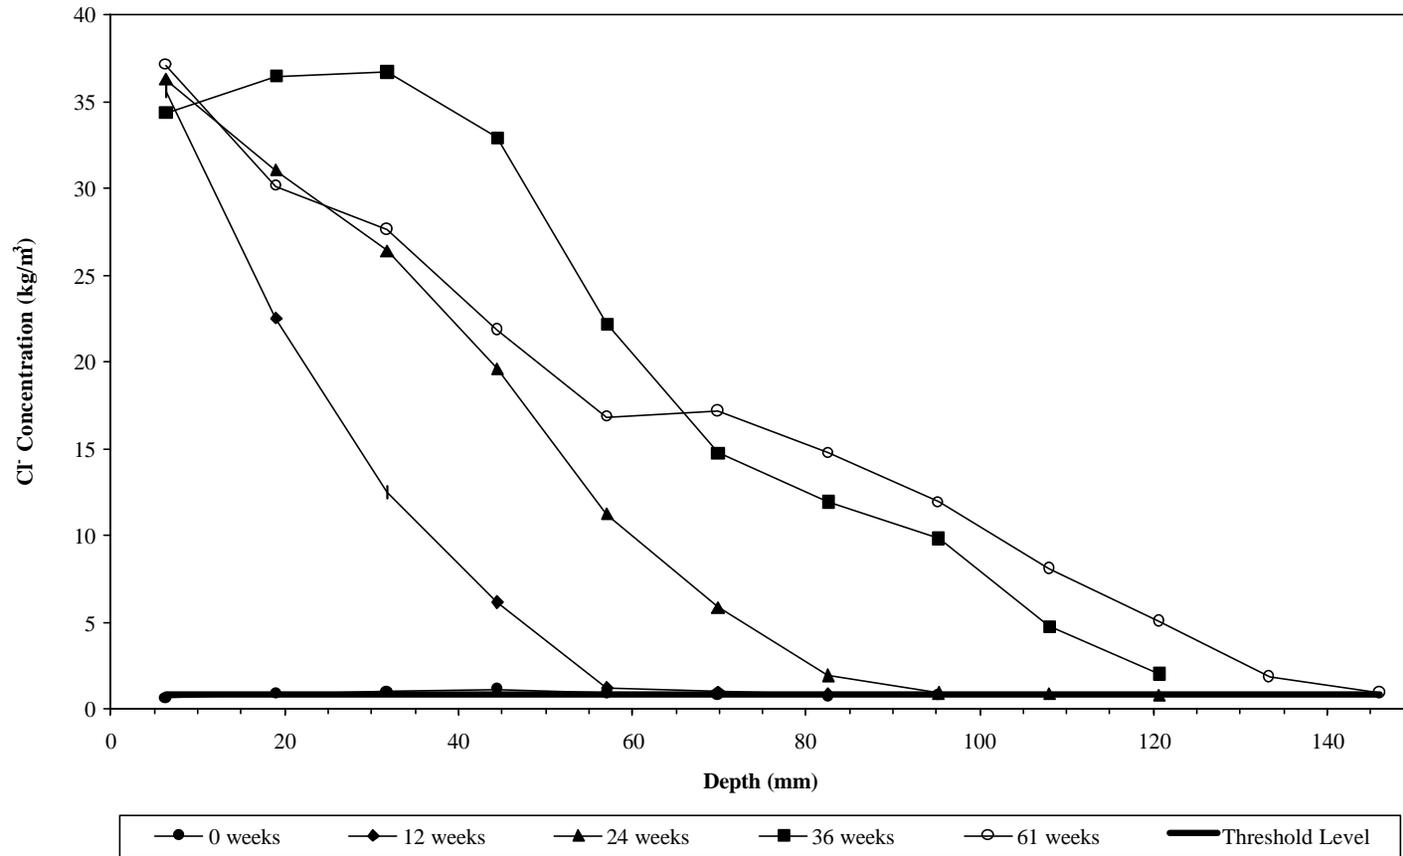
Figure 5.17 Powder Sample Results

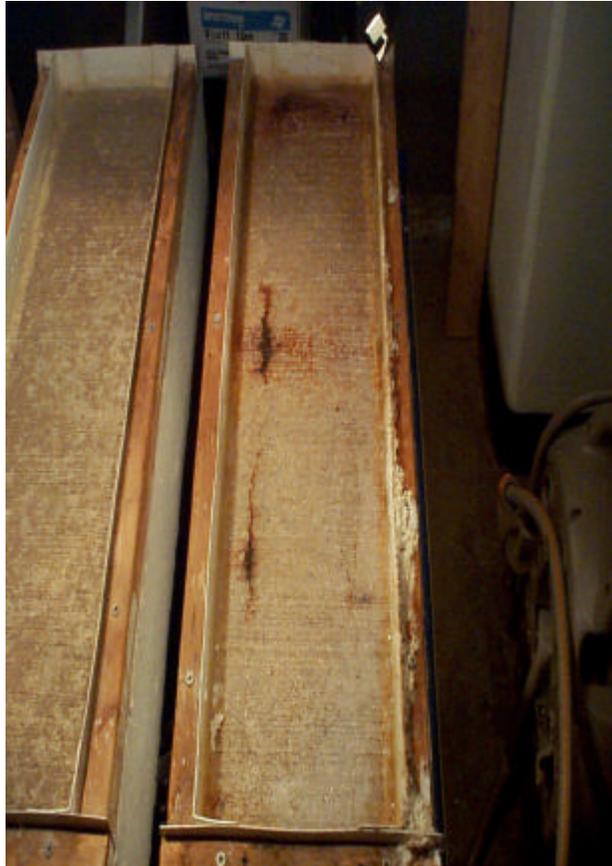
Figure 5.18 Rust Stains at Week 10

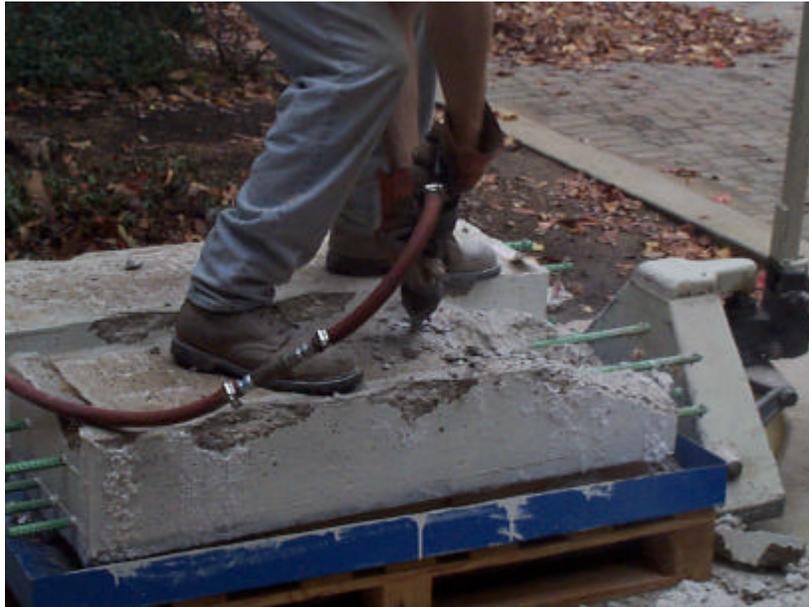
Figure 5.19 Removal of Reinforcement from Specimens

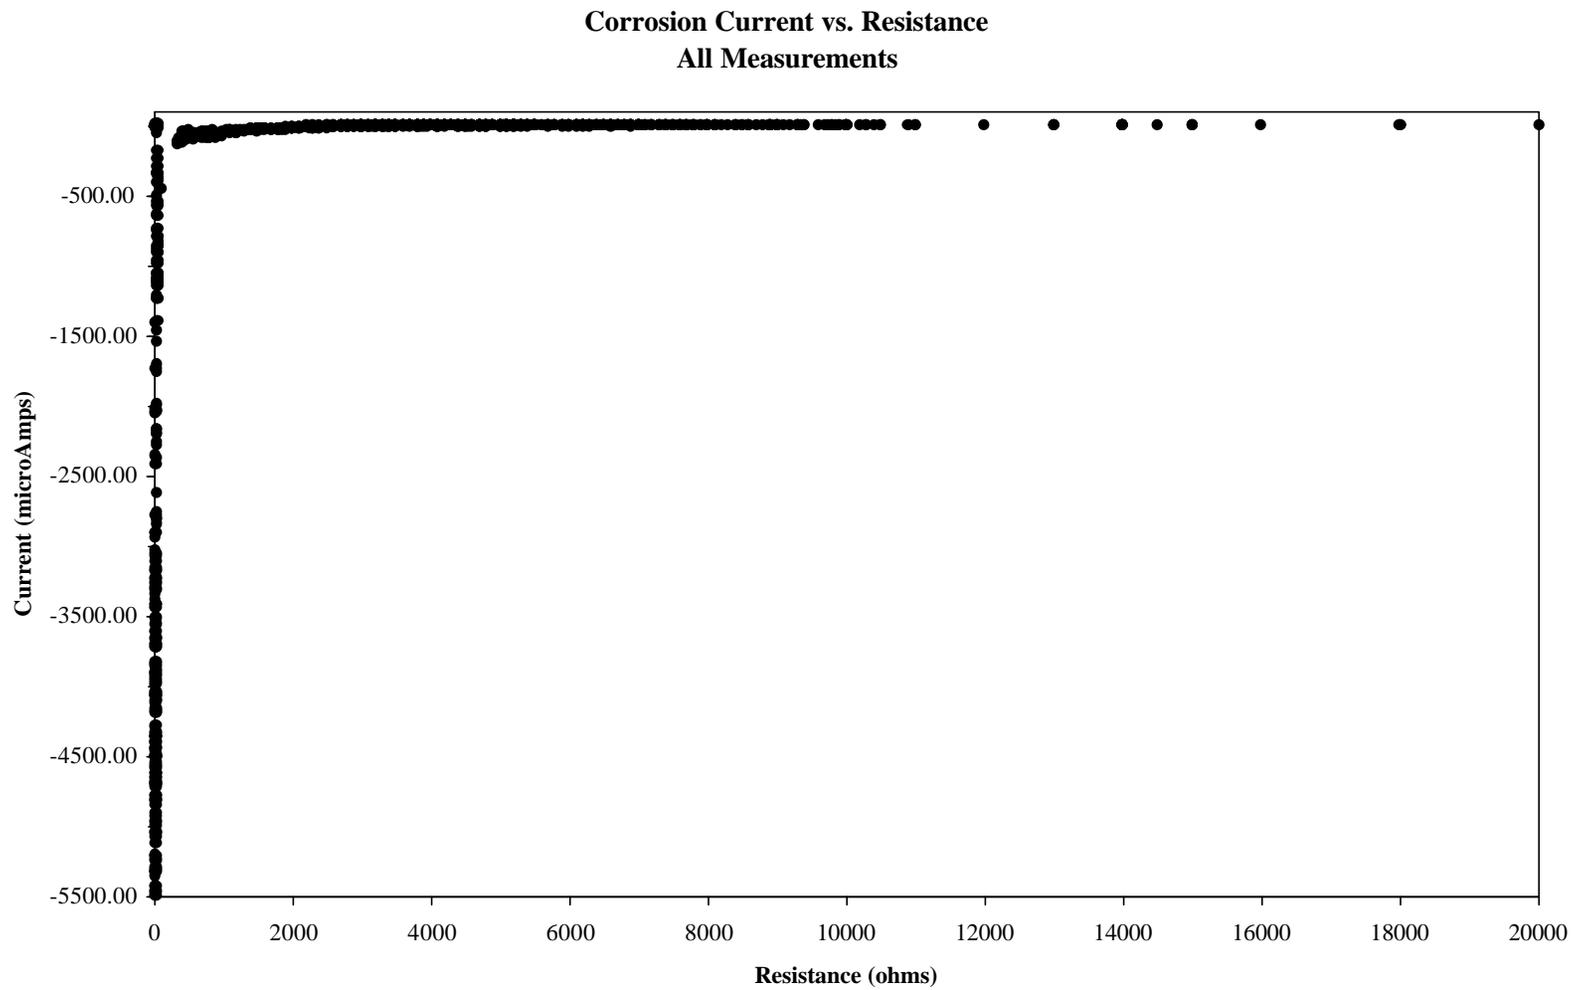
Figure 5.37 Corrosion Current versus Resistance, All Measurements
