FHWA/IN/JTRP-98/15

**METHODS OF CORROSION PROTECTION AND
DURABILITY OF CONCRETE BRIDGE DECKS
REINFORCED WITH EPOXY-COATED BARS - PHASE I**

**Lisa M. Samples
Julio A. Ramirez**

Joint Transportation Research Project

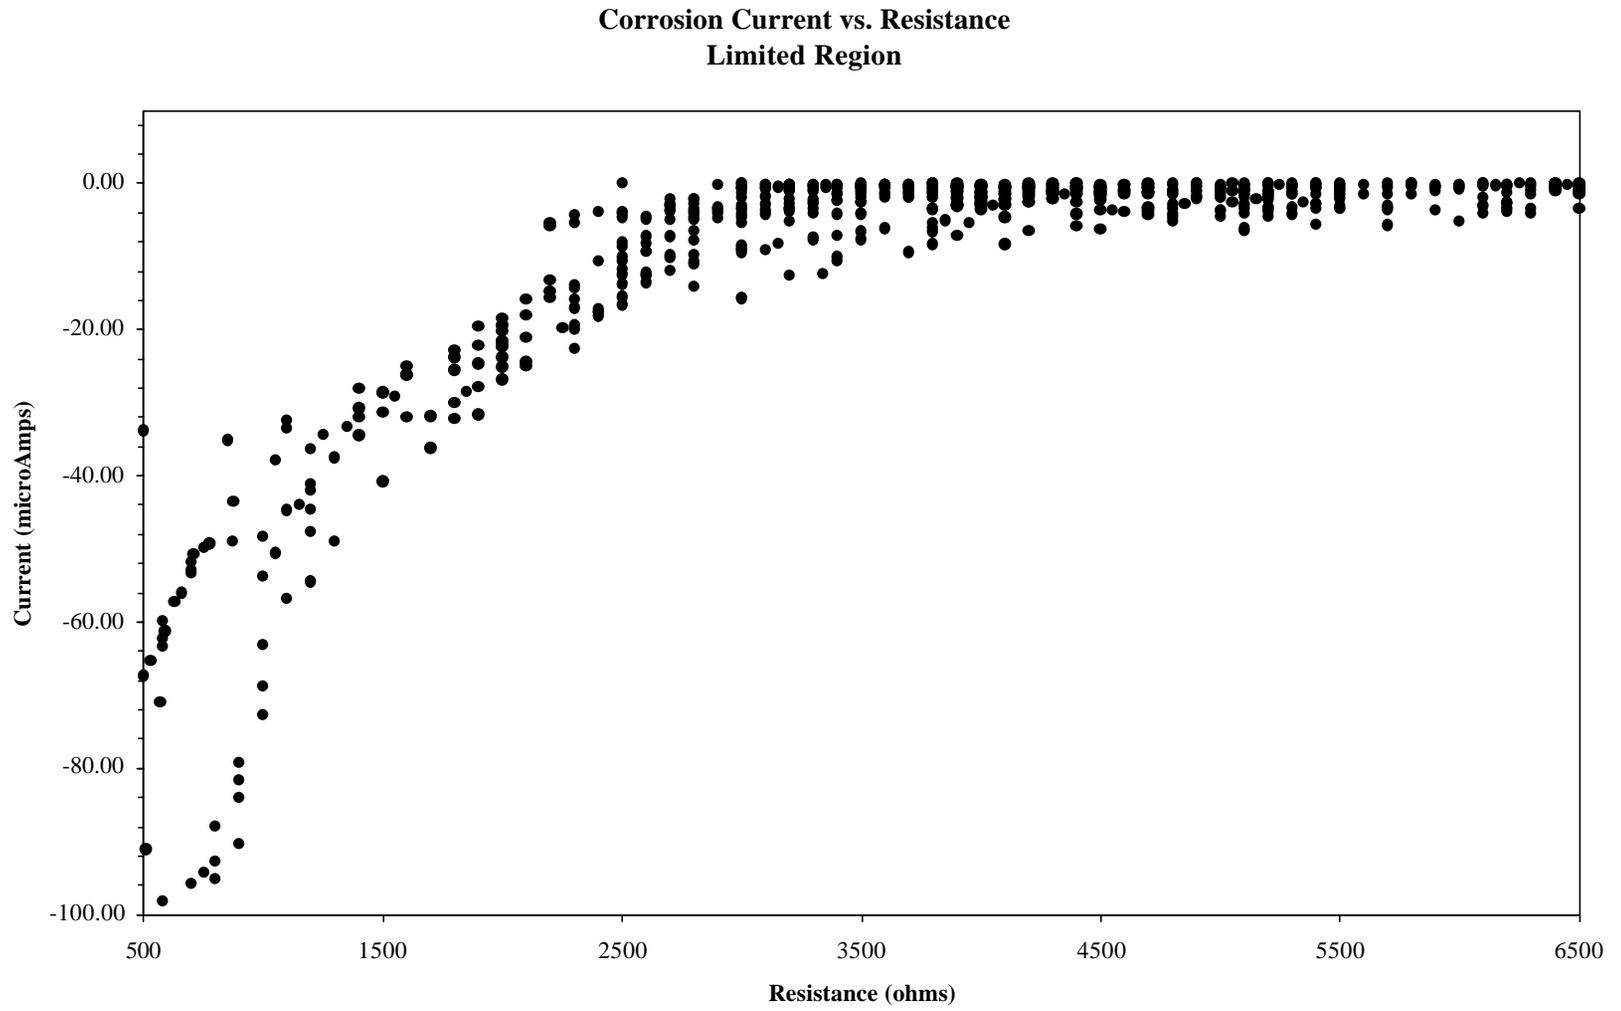
Figure 5.38 Corrosion Current versus Resistance, Limited Region
