# Testing of State Roadside Safety Systems Volume II: Appendix A— Crash Testing and Evaluation of a Michigan Thrie-Beam Transition Design

PUBLICATION NO. FHWA-RD-98-037

The Michigan Department of Transportation has designed a thrie-beam transition for use in transitioning from a standard W-beam guardrail to a safety-shaped concrete parapet bridge rail. This report presents the details of a full-scale crash test and the performance of this transition design when impacted by a 2043-kg (4500-lb) passenger car traveling at a nominal speed and angle of 96.5 km/h (60 mi/h) and 25 degrees. Testing and evaluation was performed according to guidelines outlined in National Cooperative Highway Research Program (NCHRP) Report 230.<sup>(1)</sup>

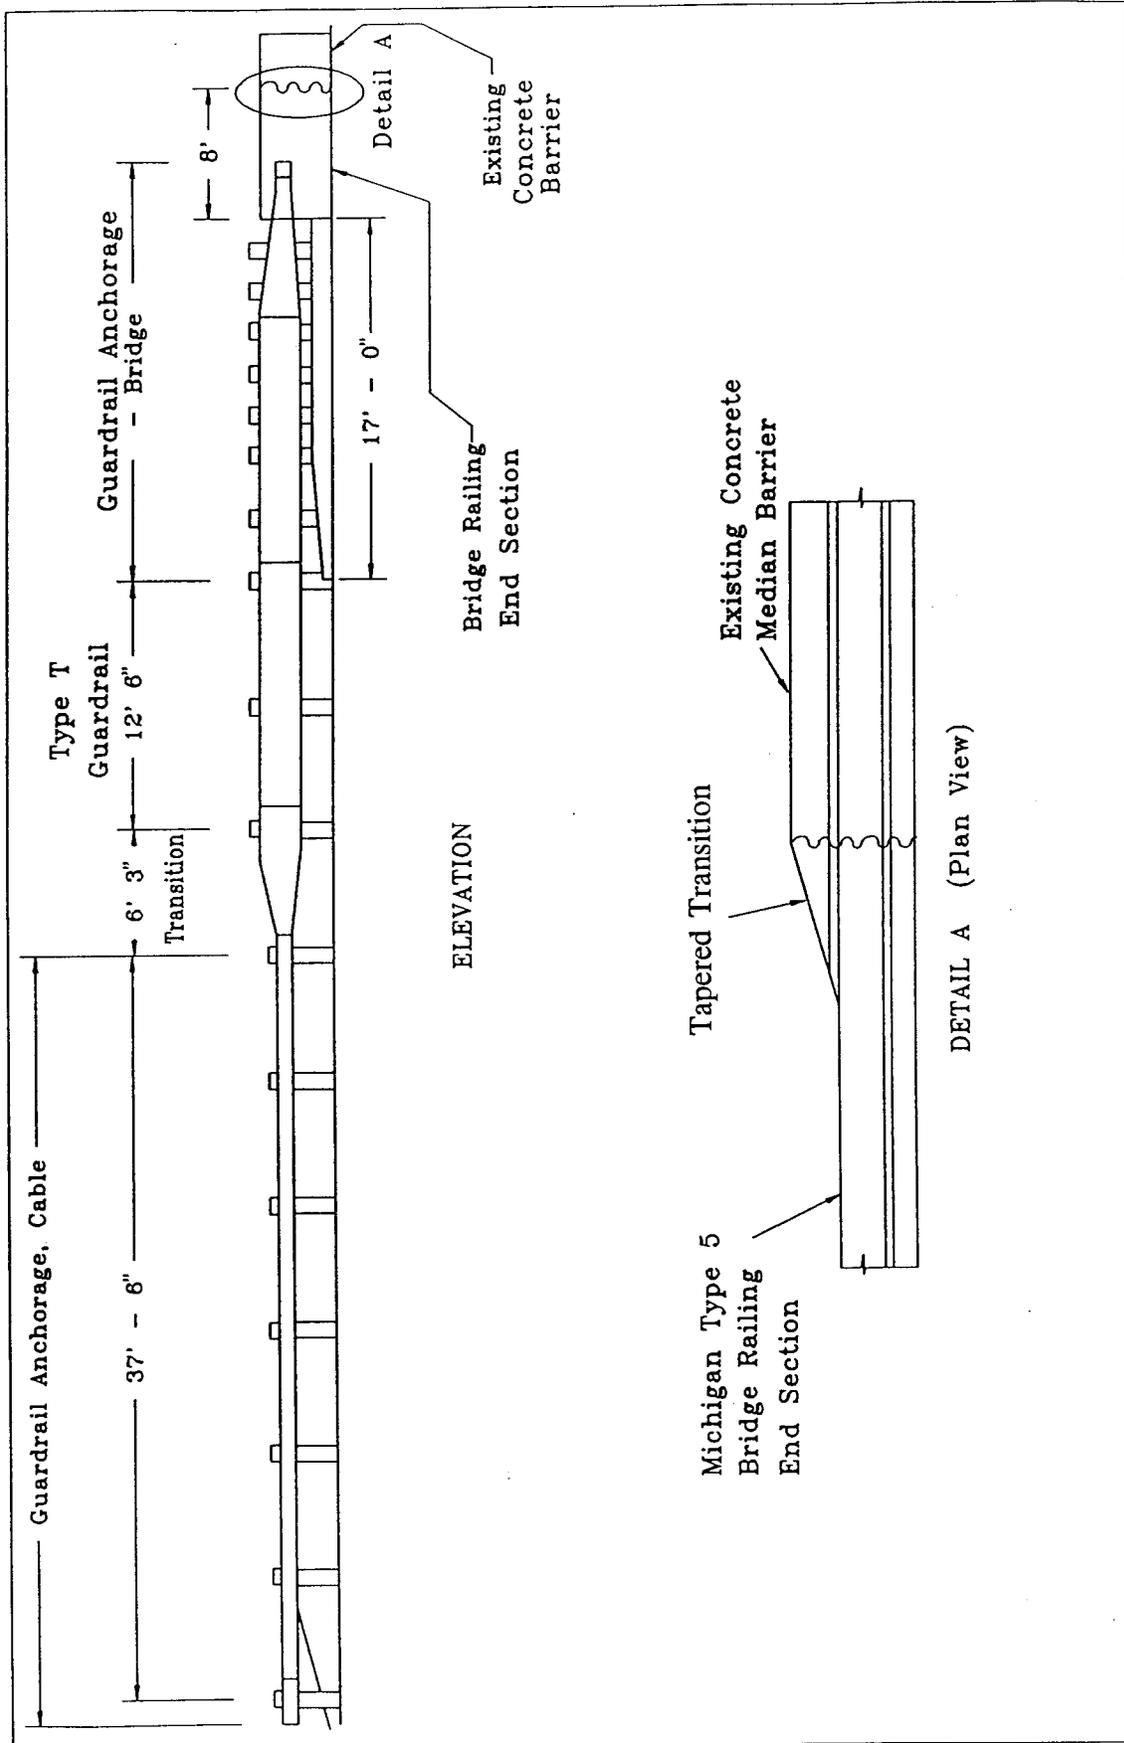
Figure 1. Details of Michigan transition.

A 2.44 m (8-ft) section of Michigan Type 5 (concrete safety-shaped) bridge railing was constructed and tied into an existing 864-mm- (34-in-) high concrete safety-shaped median barrier, as shown in figure 1. Approximately 22.9 m (75 ft) of approach guardrail was constructed, including a Detail T-4 guardrail to bridge rail transition section, one 3.81-m (12-ft, 6-in) section of standard Type T (thrie-beam) guardrail, one 1.91-m (6-ft, 3-in) transition section from thrie-beam to W-beam guardrail, and a 11.4-m (37-ft, 6-in) section of a Breakaway Cable Terminal (BCT) guardrail anchorage. The Detail T-4 guardrail to bridge rail transition consisted of one 3.81-m (12-ft, 6-in) section of thrie beam, one 1.91-m (6-ft, 3-in) transition from thrie-beam to W-beam, and a W-beam end section anchored to the concrete bridge rail. There was also a 5.18-m- (17-ft-) long curb and gutter section with backfill to the top of the curb in the transition area.

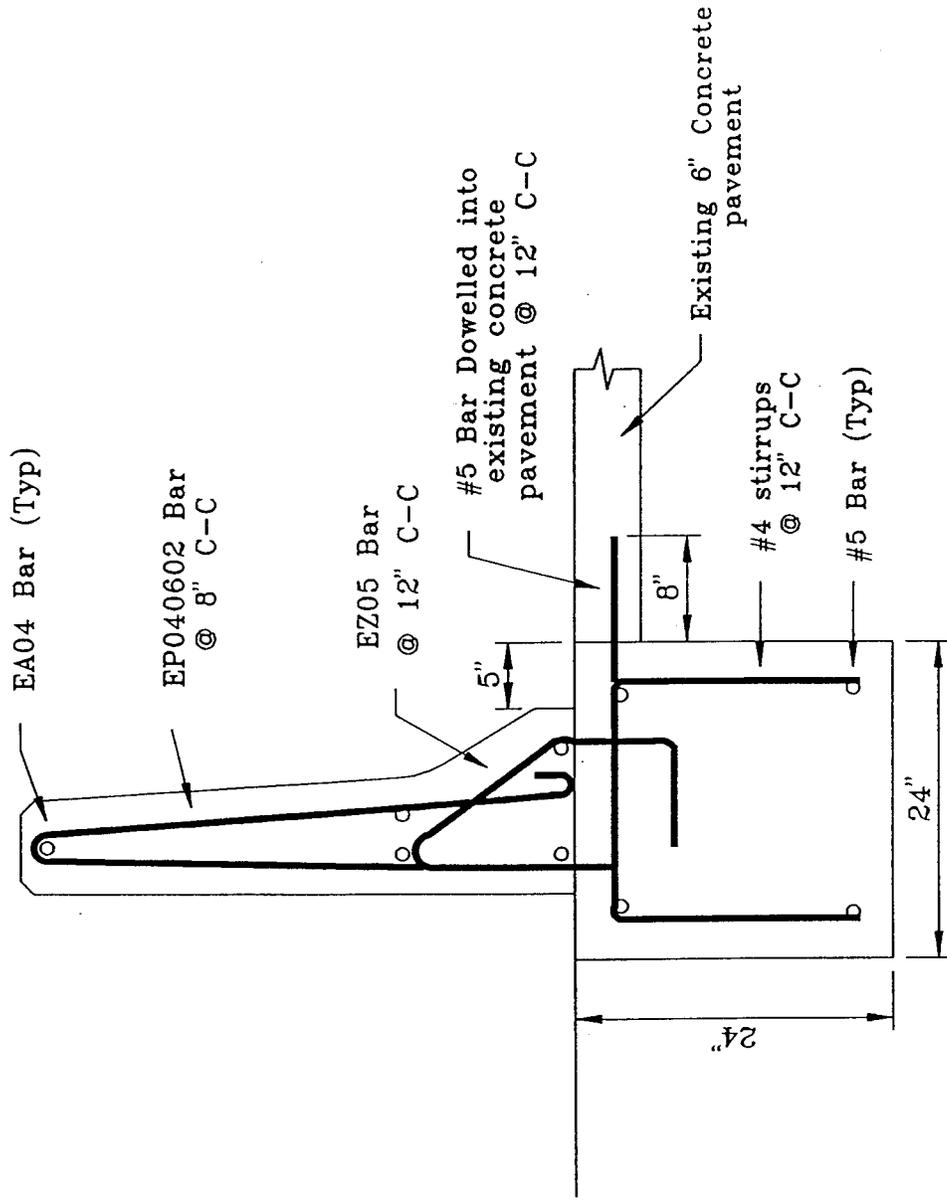
Figure 2. Foundation and reinforcement details.

Foundation and steel reinforcement details for the simulated bridge railing end section are shown in figure 2. Details of the transition section are shown in figure 3, and figure 4 illustrates the details of the approach curb and gutter section. Photographs of the completed Michigan thrie-beam transition system prior to the full-scale crash test are shown in figures 5 and 6.

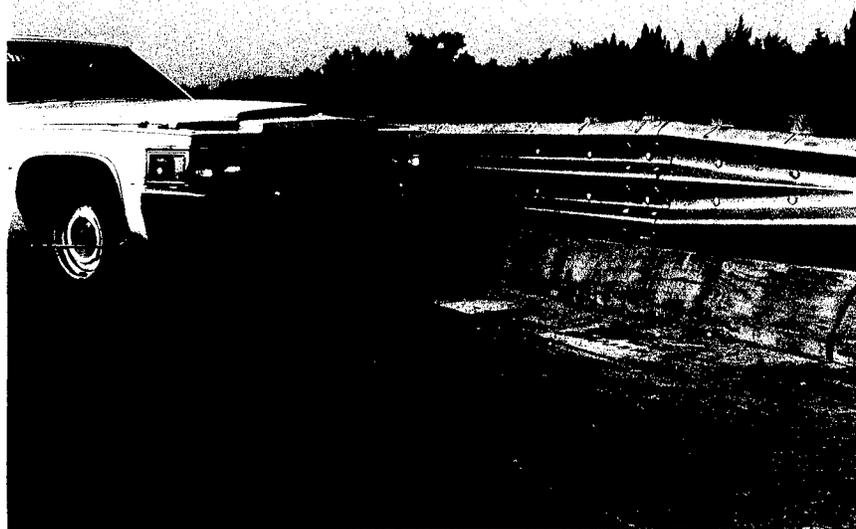
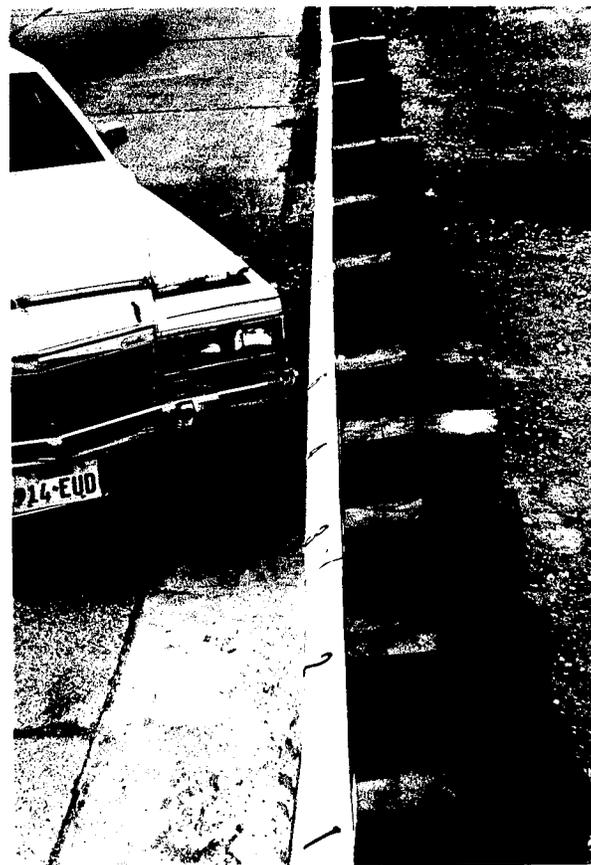
Figure 7. Vehicle/transition geometry for test 7147-1.

A 1979 Cadillac Coupe de Ville, shown in figures 7 and 8, was directed into the Michigan thrie-beam transition system. Test inertia weight of the vehicle was 2043 kg (4500 lb) and its gross static weight was 2118 kg (4666 lb). The height to the lower edge of the vehicle bumper was 343 mm (13.5 in) and it was 584 mm (23.0 in) to the upper edge. Additional dimensions and information on the vehicle are given in figure 9. The vehicle was directed into the transition using the cable reverse tow and guidance system, and was released to be free-wheeling and unrestrained just prior to impact.

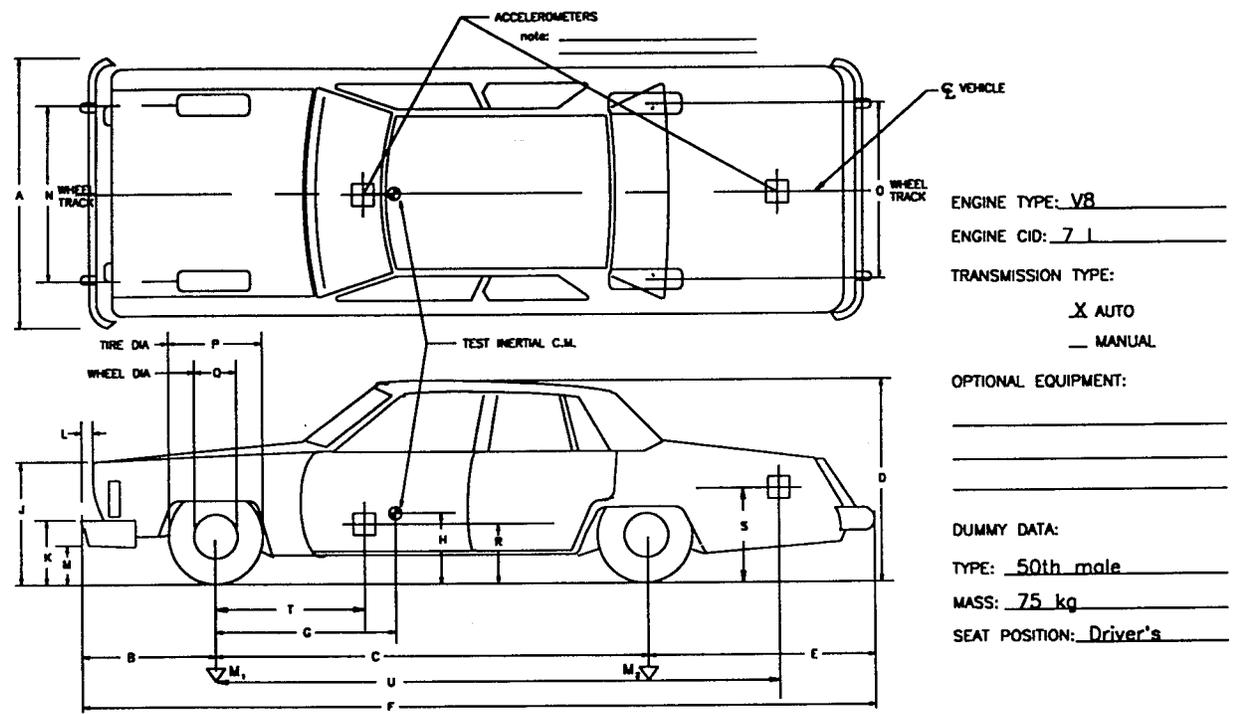
Figure 9. Vehicle properties (test 7147-1).

DATE: 07/31/90 TEST NO.: 471470-1 VIN NO.: 6D4759C362215  
 YEAR: 1979 MAKE: Cadillac MODEL: Coupe deVille  
 TIRE INFLATION PRESSURE: \_\_\_\_\_ ODOMETER: 97812 TIRE SIZE: \_\_\_\_\_

MASS DISTRIBUTION (kg) LF 549 RF 558 LR 465 RR 471

A <u>1937</u>	E <u>1397</u>	J <u>914</u>	N <u>1575</u>	R <u>495</u>
B <u>1080</u>	F <u>5550</u>	K <u>584</u>	O _____	S <u>597</u>
C <u>3073</u>	G <u>1407</u>	L <u>121</u>	P <u>686</u>	T <u>978</u>
D <u>1403</u>	H _____	M <u>343</u>	Q <u>413</u>	U <u>4039</u>

MASS - (kg)	CURB	TEST INERTIAL	GROSS STATIC
M <sub>1</sub>	<u>1092</u>	<u>1107</u>	<u>1145</u>
M <sub>2</sub>	<u>763</u>	<u>936</u>	<u>973</u>
M <sub>T</sub>	<u>1856</u>	<u>2043</u>	<u>2118</u>

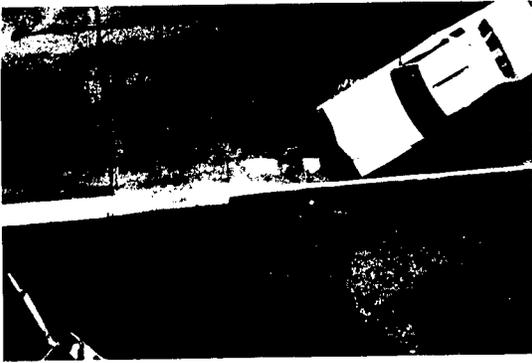
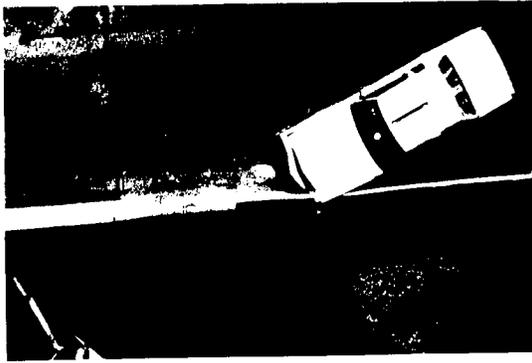
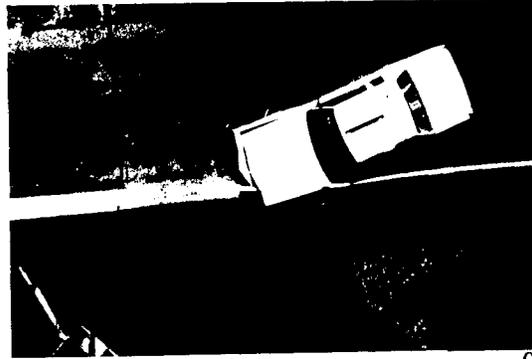
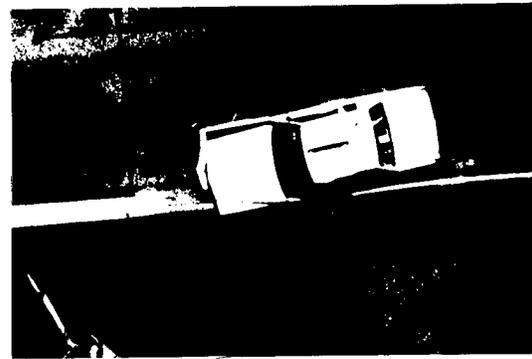
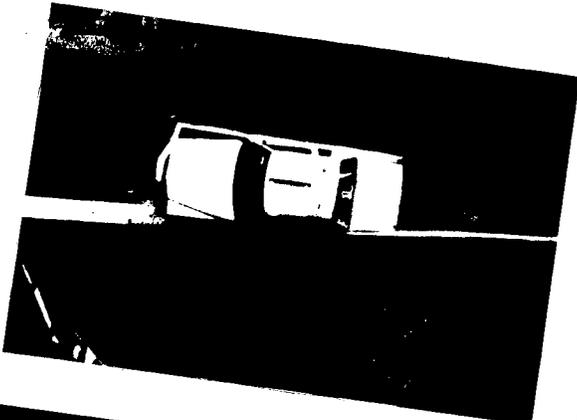
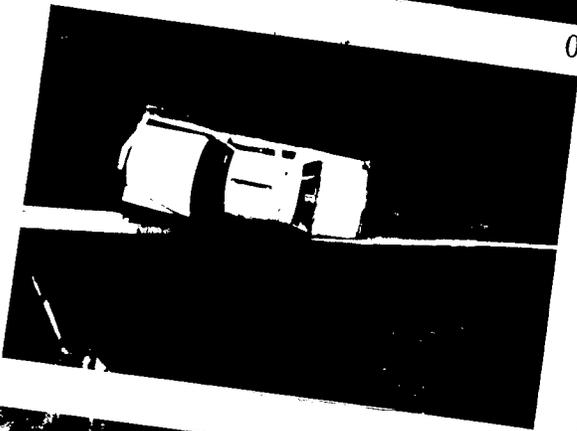
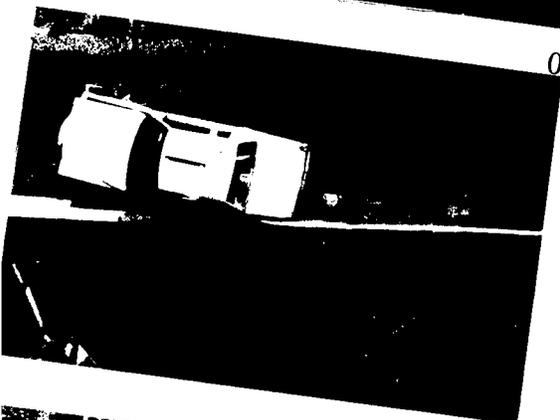
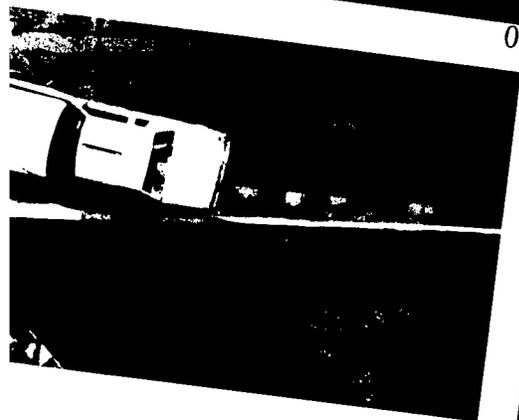
Figure 10. Sequential photographs for test 7147-1 (overhead and behind the rail views).

The vehicle was traveling at a speed of 100.1 km/h (62.2 mi/h) when it impacted the transition approximately 2.9 m (9.4 ft) from the end of the concrete bridge railing. The impact angle was 26.0 degrees. At 0.041 s after impact, the vehicle slowly began to redirect. As the vehicle continued forward, it began to deform at the A-pillar at 0.075 s and then began to redirect significantly at 0.082 s. The dummy hit the side window and shattered it at 0.143 s. At 0.167 s, the vehicle was traveling parallel to the transition at a speed of 81.4 km/h (50.6 mi/h) and, almost immediately afterwards, the rear of the vehicle impacted the transition. The vehicle exited the transition at 0.324 s, traveling at a speed of 77.7 km/h (48.3 mi/h), with an exit trajectory of 14.1 degrees. The brakes were applied after the vehicle cleared the test installation and the vehicle came to rest 66 m (218 ft) down and 27 m (88 ft) in front of the point of impact. Sequential photographs of the test sequence are presented in figures 10 and 11.

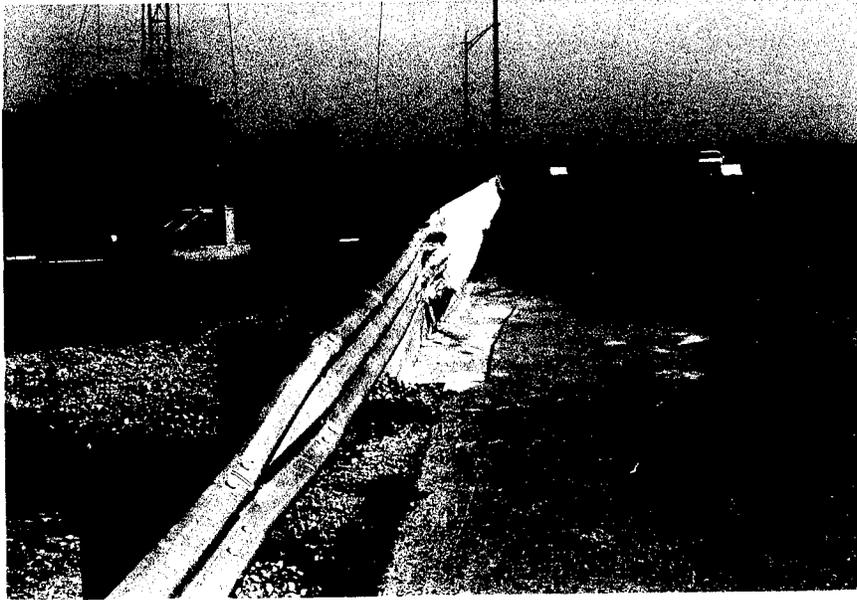
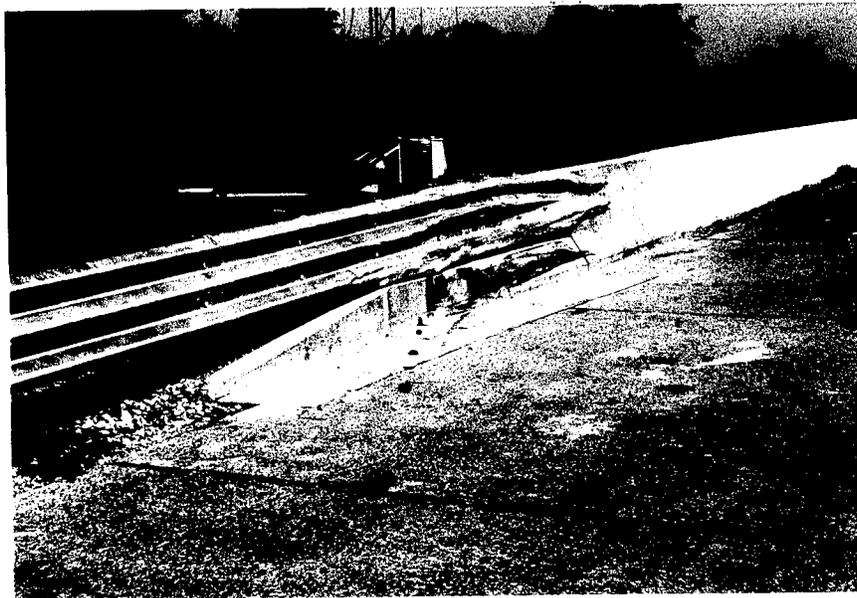
Figure 12. Michigan transition after test 7147-1.

The transition received moderate damage to the thrie beam, as shown in figures 12 through 14. As also can be seen in the photographs, the curb was chipped and there were tire marks along the contact area. There was also some slight movement in the curb and gutter section. Total length of contact with the transition was 4.3 m (14 ft) and the maximum permanent deformation was 102 mm (4.0 in) at post 4.

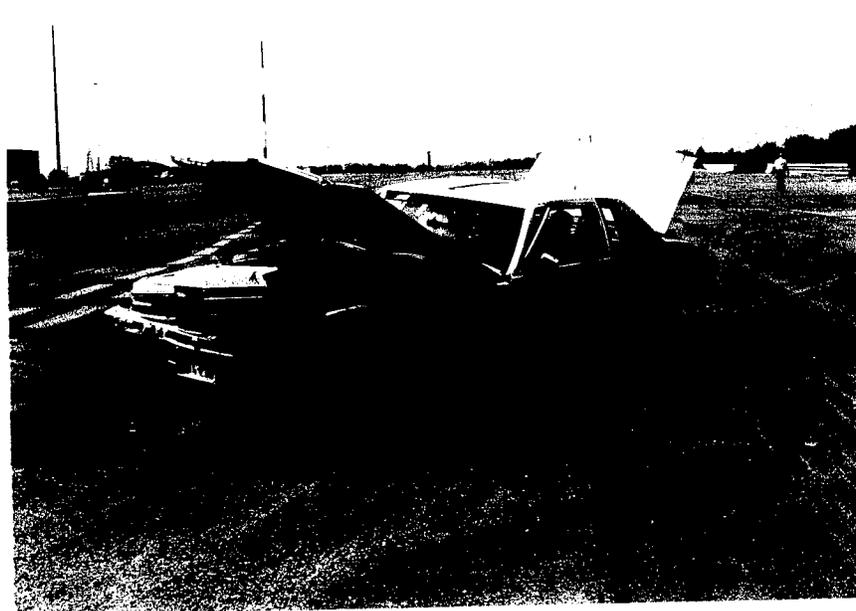
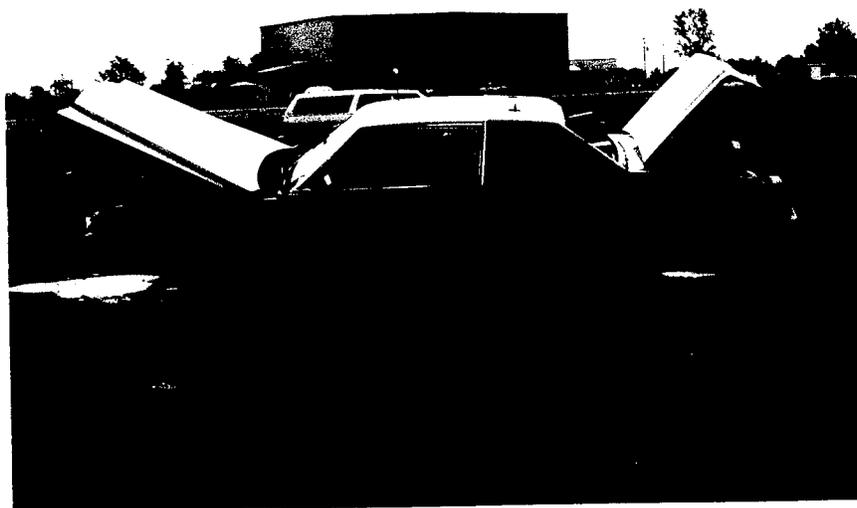
Figure 15. Damage to vehicle, test 7147-1.

The vehicle (shown in figure 15) sustained severe damage to the left side. The tie rod was bent and the windshield and left door glass were broken. There was damage to the front bumper, hood, grill, radiator and fan, left front quarter panel, left door, left rear quarter panel, and rear bumper. The left front wheel rim was split, the welds were broken, and the tire was cut. The left rear rim and tire were also damaged. Maximum crush to the vehicle was 432 mm (17.0 in) at the left front corner at bumper height.

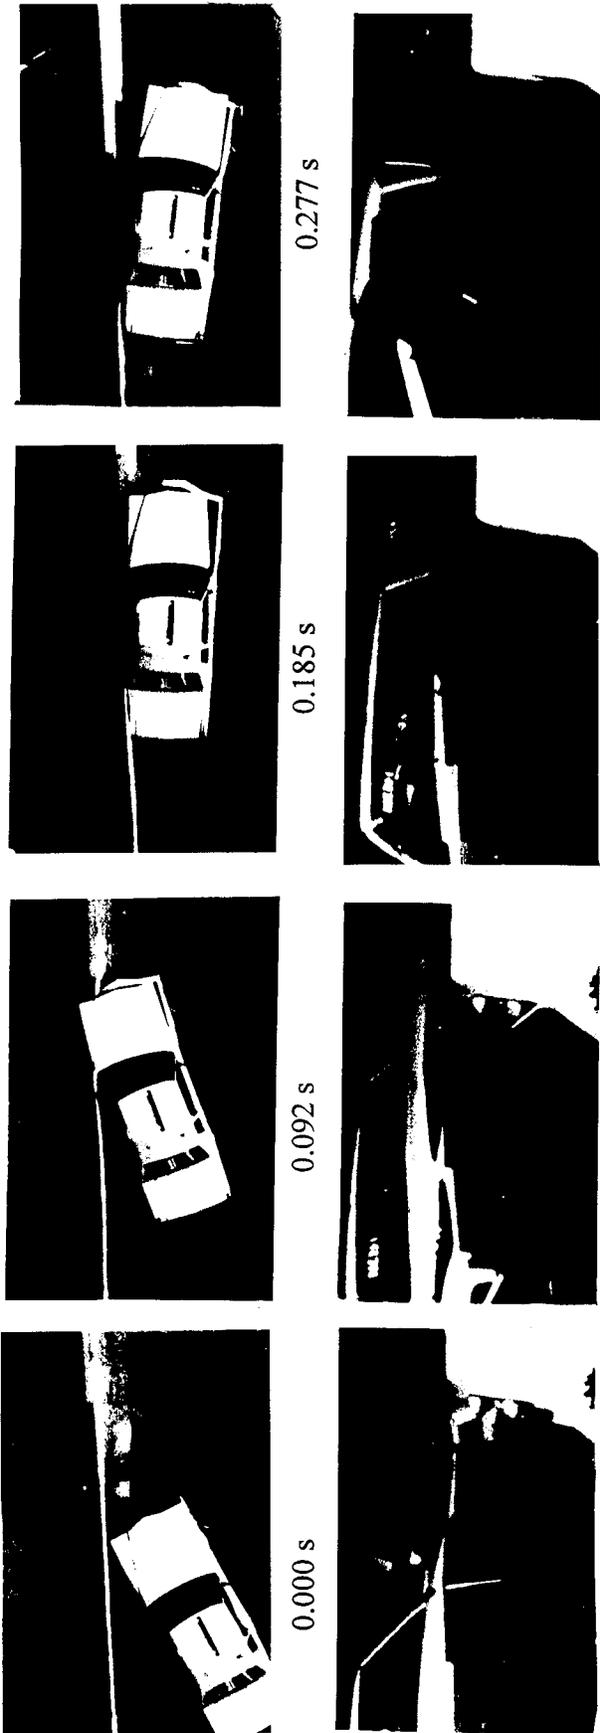
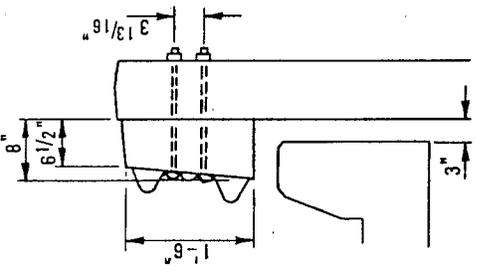
Figure 16. Summary of results for test 7147-1.

A summary of pertinent data from the electronic instrumentation, high-speed film, and field measurements is given in figure 16. Vehicle angular displacements are displayed in figure 17, and vehicular accelerations versus time traces filtered at 300 Hz are presented in figures 18 through 20.

Test No. ....	7147-1	Impact Speed .....	100.1 km/h (62.2 mi/h)
Date .....	07/31/90	Impact Angle .....	26.0 deg
Test Installation .....	Michigan Transition with 12-Gauge Thrie Beam	Speed at Parallel .....	81.4 km/h (50.6 mi/h)
Installation Length .....	23 m (75 ft)	Exit Speed .....	77.7 km/h (48.3 mi/h)
Max. Dynamic Deflection .....	Not Attainable	Exit Trajectory .....	14.1 deg
Max. Perm. Deformation .....	0.1 m (0.3 ft)	Vehicle Accelerations (Max. 0.050-s avg)	
Test Vehicle .....	1979 Cadillac Coupe de Ville	Longitudinal .....	-7.5 g's
Vehicle Weight .....		Lateral .....	-13.7 g's
Test Inertia .....	2043 kg (4500 lb)	Occupant Impact Velocity	
Gross Static .....	2118 kg (4666 lb)	Longitudinal .....	7.2 m/s (23.6 ft/s)
Vehicle Damage Classification		Lateral .....	8.7 m/s (28.7 ft/s)
TAD .....	11FL6 & 11LD6	Occupant Ridedown Accelerations	
CDC .....	11FLEK2 & 11LDES3	Longitudinal .....	-7.9 g's
Maximum Vehicle Crush .....	432 mm (17.0 in)	Lateral .....	-12.2 g's

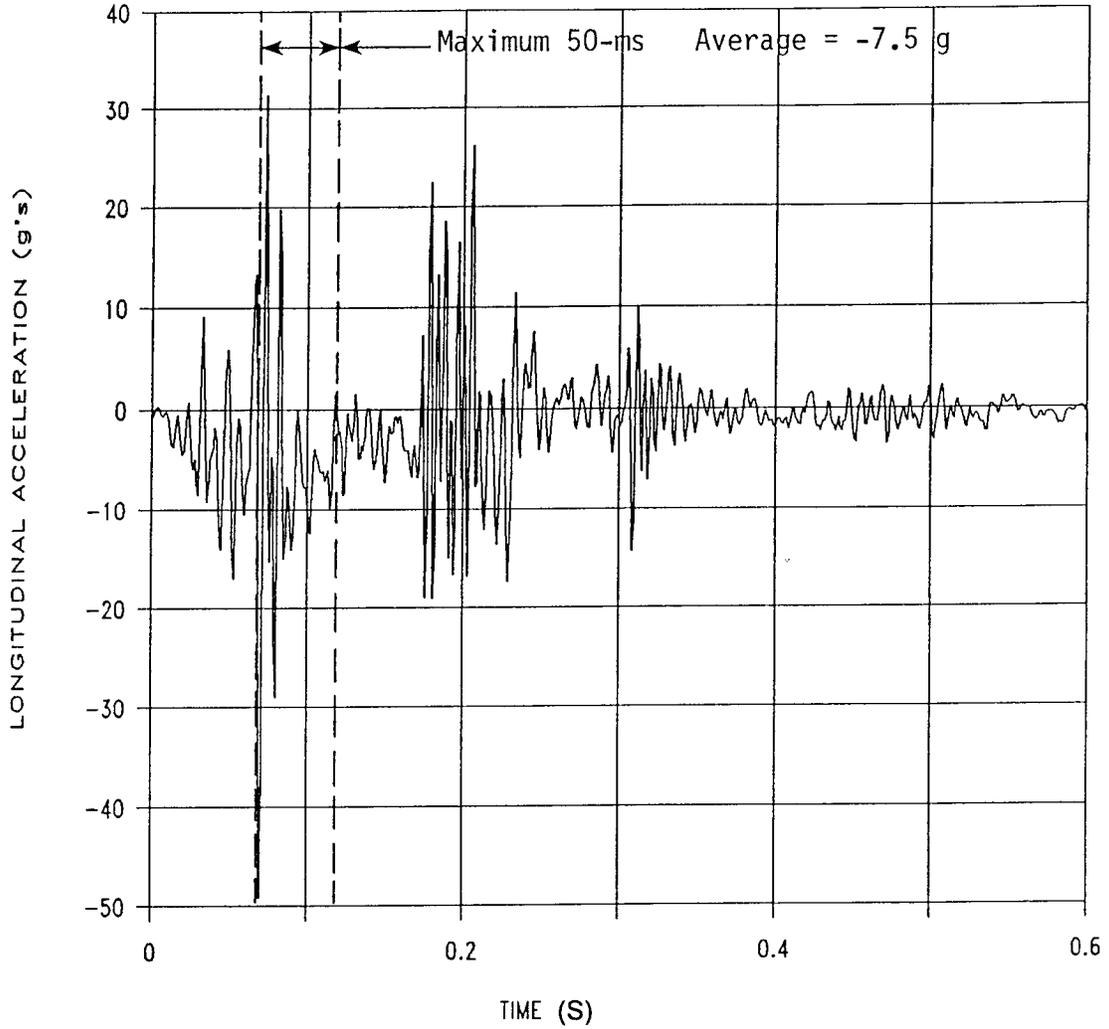
Figure 18. Longitudinal vehicle accelerometer trace for test 7147-1.

Data from the electronic instrumentation were digitized for evaluation, and occupant risk factors were computed as follows. In the longitudinal direction, occupant impact velocity was 7.2 m/s (23.6 ft/s) at 0.176 s; the highest 0.010-s average ridedown acceleration was -7.9 g's from 0.221 to 0.231 s; and the maximum 0.050-s average acceleration was -7.5 g's between 0.068 and 0.118 s. Lateral occupant impact velocity was 8.7 m/s (28.7 ft/s) at 0.106 s, the highest 0.010-s average ridedown acceleration was -12.2 g's from 0.106 to 0.116 s; and the maximum 0.050-s average acceleration was -13.7 g's between 0.067 and 0.117 s. The change in vehicle velocity at loss of contact was 22.4 km/h (13.9 mi/h) and the change in momentum was 12 672 N-s (2849 lb-s).
