# Preliminary Evaluation of LTPP Continuously Reinforced Concrete (CRC) Pavement Test Sections

PUBLICATION NO. FHWA/RD-99-086

JULY 1999

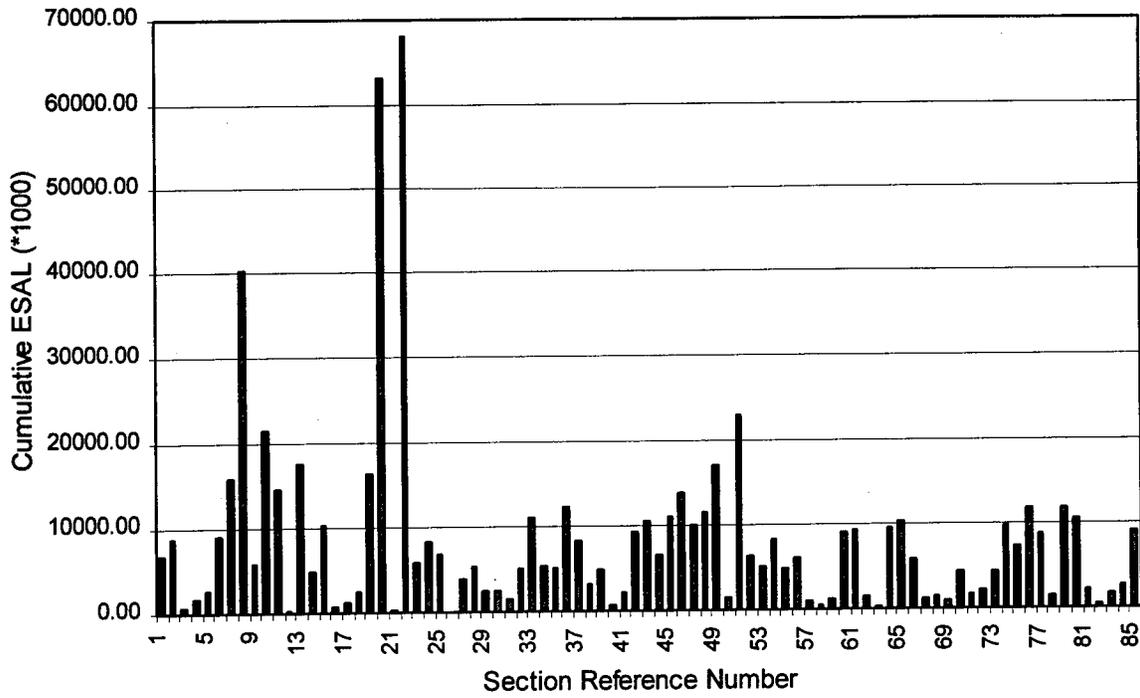
Figure 11. Cumulative ESAL summary.

The cumulative 80-kN equivalent single-axle load (ESAL) was used to characterize traffic loading. The cumulative 80-kN ESALs to the date of the distress survey were evaluated by summing the estimated annual 80-kN ESALs over the years the sections were in service up to the time of the latest distress survey. In the cases where some ESAL values were missing for a few years, regression analysis was used to estimate the annual total ESALs for these years.

Section 24-5807 had no traffic data and was therefore not considered in subsequent analyses. A summary of the ESAL data is given in figure 11.

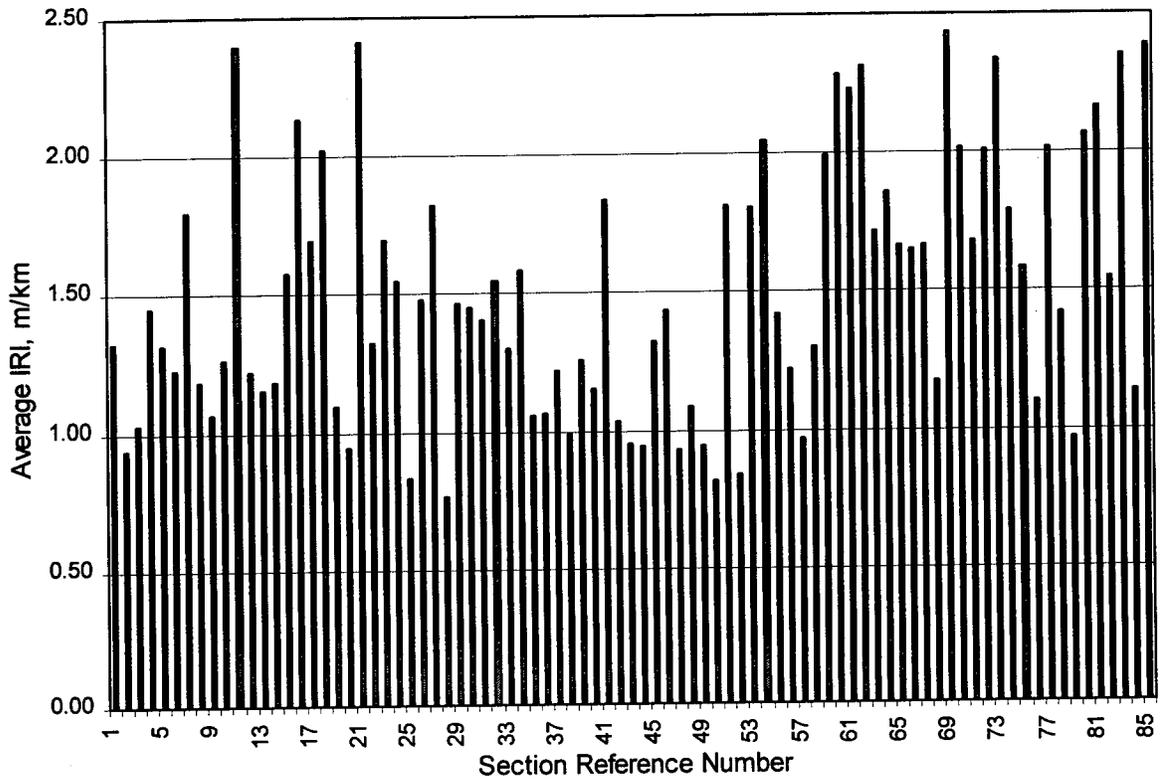
Figure 12. Average IRI summary.

International Roughness Index (IRI) is one of the indices used in the LTPP program for characterization of pavement section roughness. IRI values determined at different test times over the years are available in the database. Values at times that correspond to the latest distress survey dates were used for characterization of profile condition of pavement sections. A summary of IRI data is given in table 5 and figure 12. The IRI values for GPS-5 sections ranged from about 0.7 to 2.4 m/km, with a large number of sections exhibiting IRI values less than 1.8 m/km. Considering the service lives of the CRC sections in the GPS-5 experiment, the CRC pavements are exhibiting good ride characteristics.

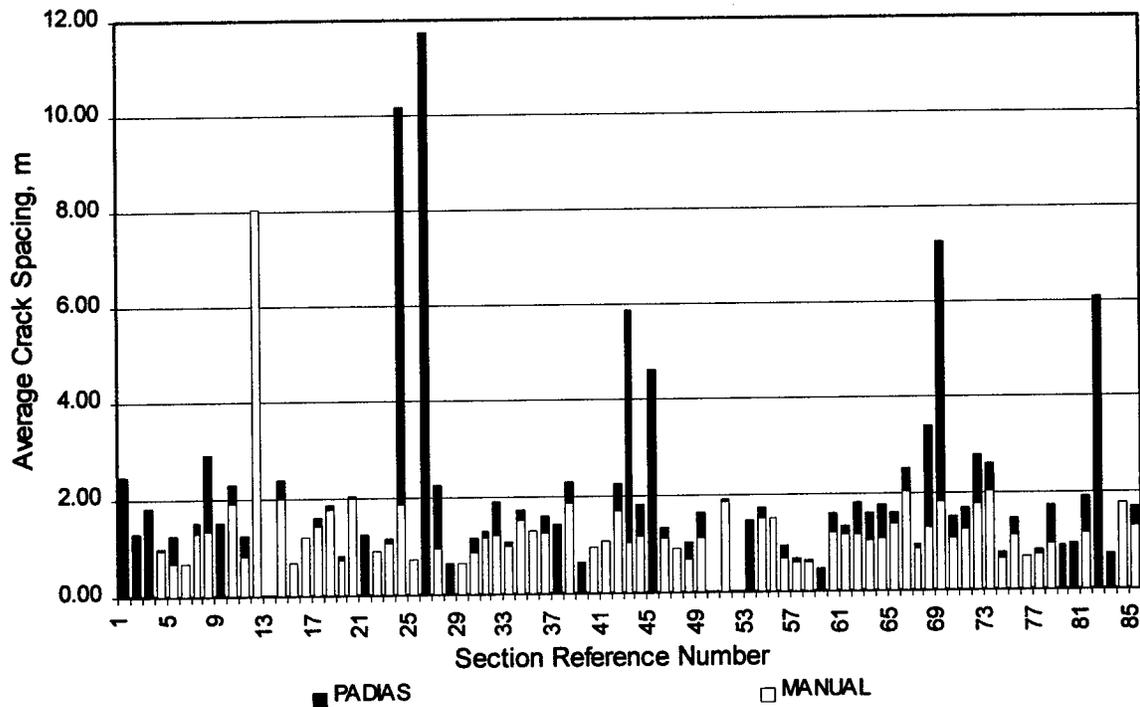
Figure 13. Average crack spacing.

Average transverse crack spacing was calculated by dividing the length of the section by the total number of cracks. The total number of localized failures was found as a summation of the total number of rigid and flexible patches and punchouts. Table 5 gives a summary of GPS-5 distress survey data. Generally, PADIAS surveys predicted larger crack spacings compared to the manual survey, as shown in figure 13. The crack spacing shown in figure 13 is based on the most recent surveys listed in table 5. Overall, the average crack spacing for the GPS-5 test sections was found to be about 1.2 m (4 ft) based on manual surveys. It appears that the photographic procedure fails to adequately identify all low-severity transverse cracking.

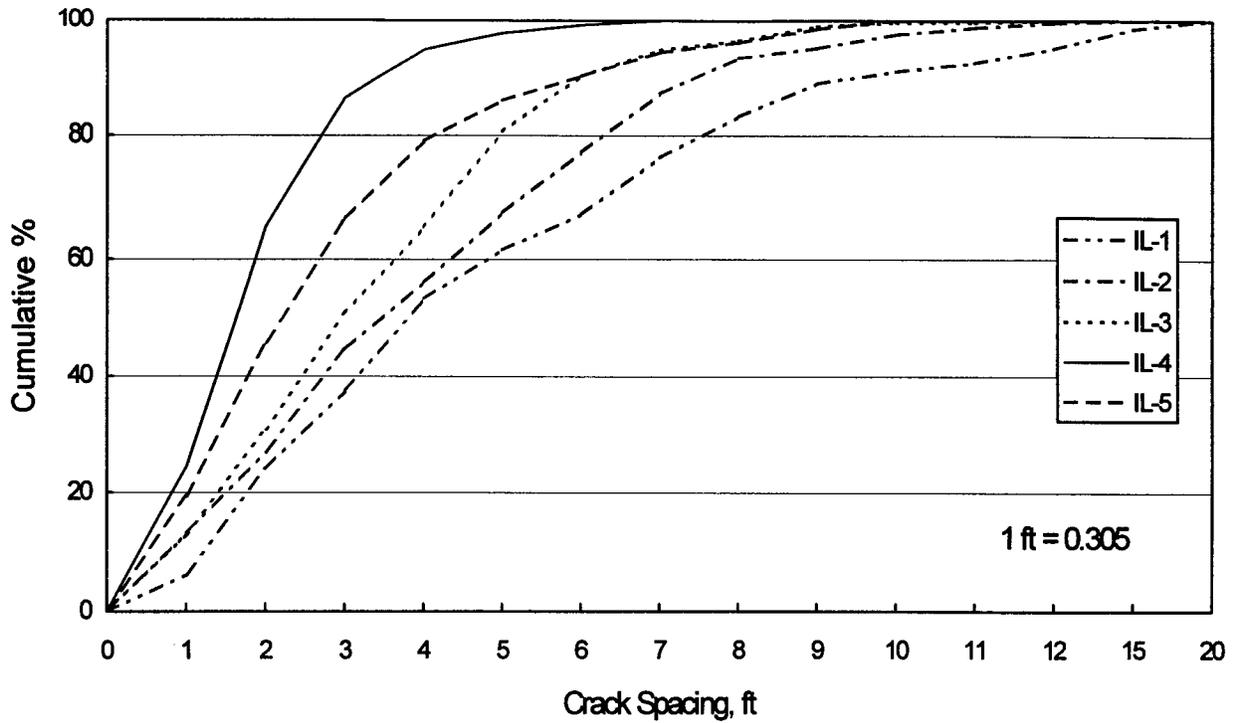
Figure 14. Typical crack spacing distribution plot for a CRC pavement<sup>3</sup>.

Another data type that is currently not available is the data on individual crack spacing. Without this data, analysis of the characteristics of the crack spacing pattern is not possible. Previous studies have shown that frequency distribution curves for crack spacing and plots of “average spacing of the closest five cracks” (ASCFC) can be useful in understanding the behavior of CRC pavements and in determining potential areas of future localized failures. The ASCFC plots can identify poor crack spacing patterns within a section of CRC pavements. Cluster cracking areas and areas with large crack spacings can be easily identified. Wide crack spacing can result in premature crack spalling and “companion” punchouts at the location of wide cracks. Typical frequency distribution curves and the plots of ASCFC are shown in figures 14 and 15. It is believed that in the future, the interpretation of distress data will also include data on individual crack spacing along the 152.4-m length of each GPS-5 test section. Future analysis of the CRC pavements will also benefit if actual distress survey maps are made available to the analysts. Then it would be possible to relate the locations of the failures to crack spacing characteristics at these locations.

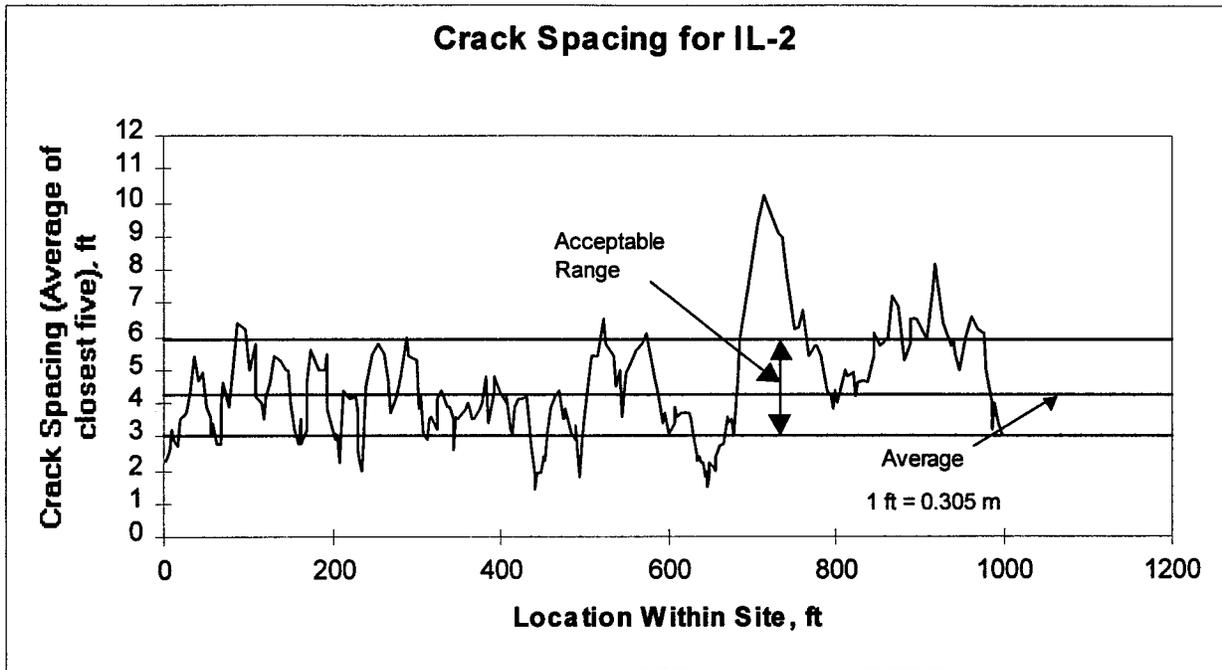
Figure 15. Typical plot of ASCFC for a CRC pavement<sup>3</sup>.

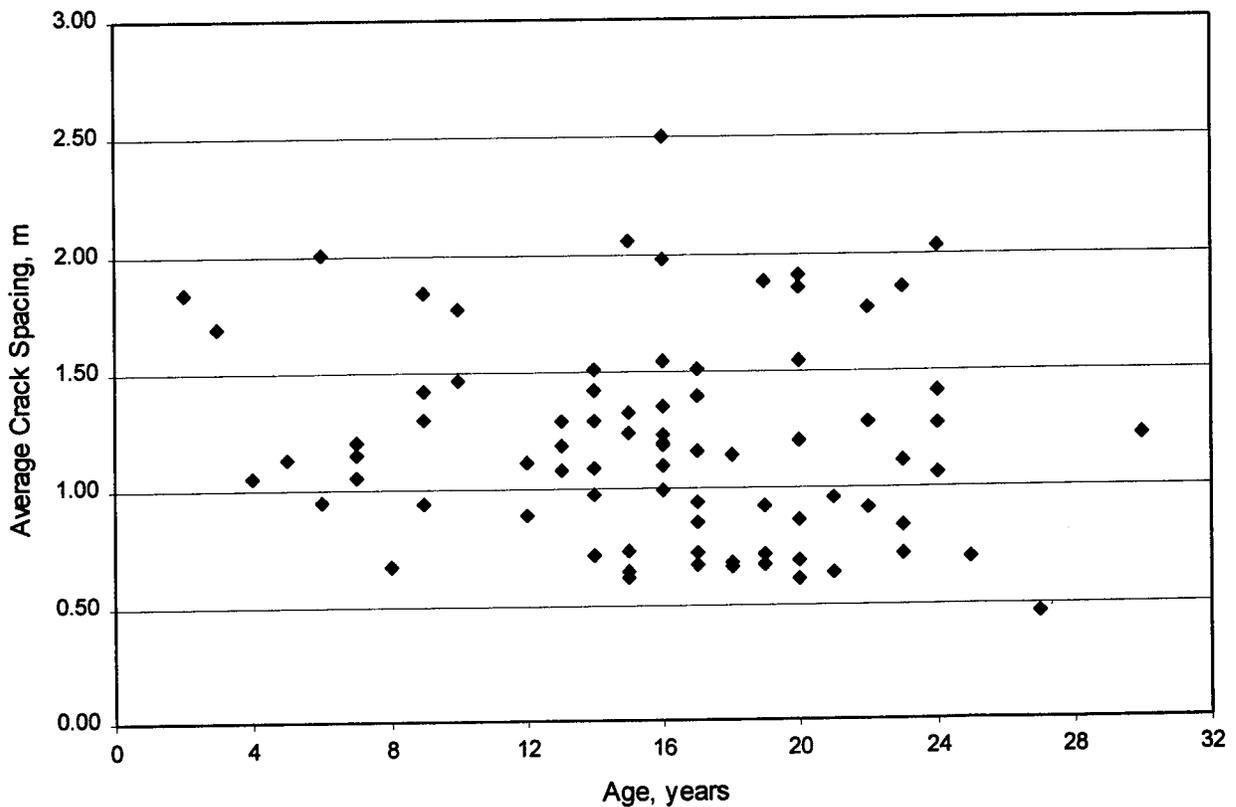
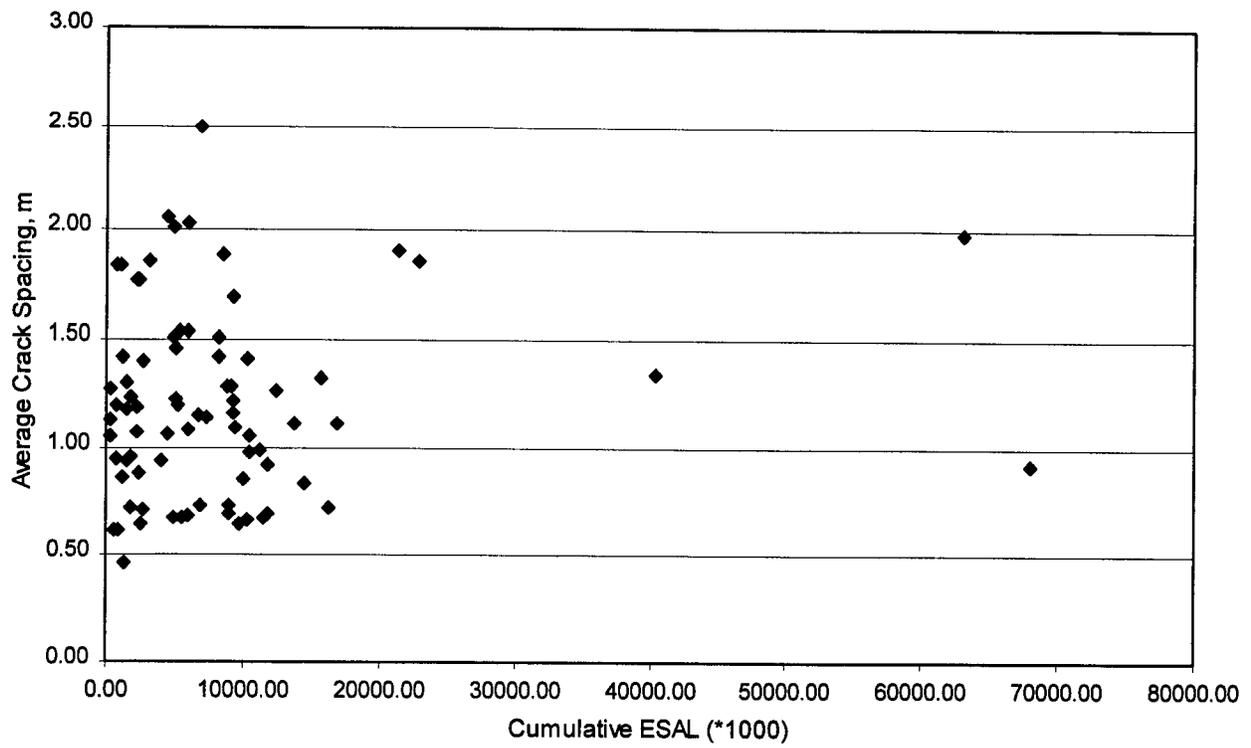
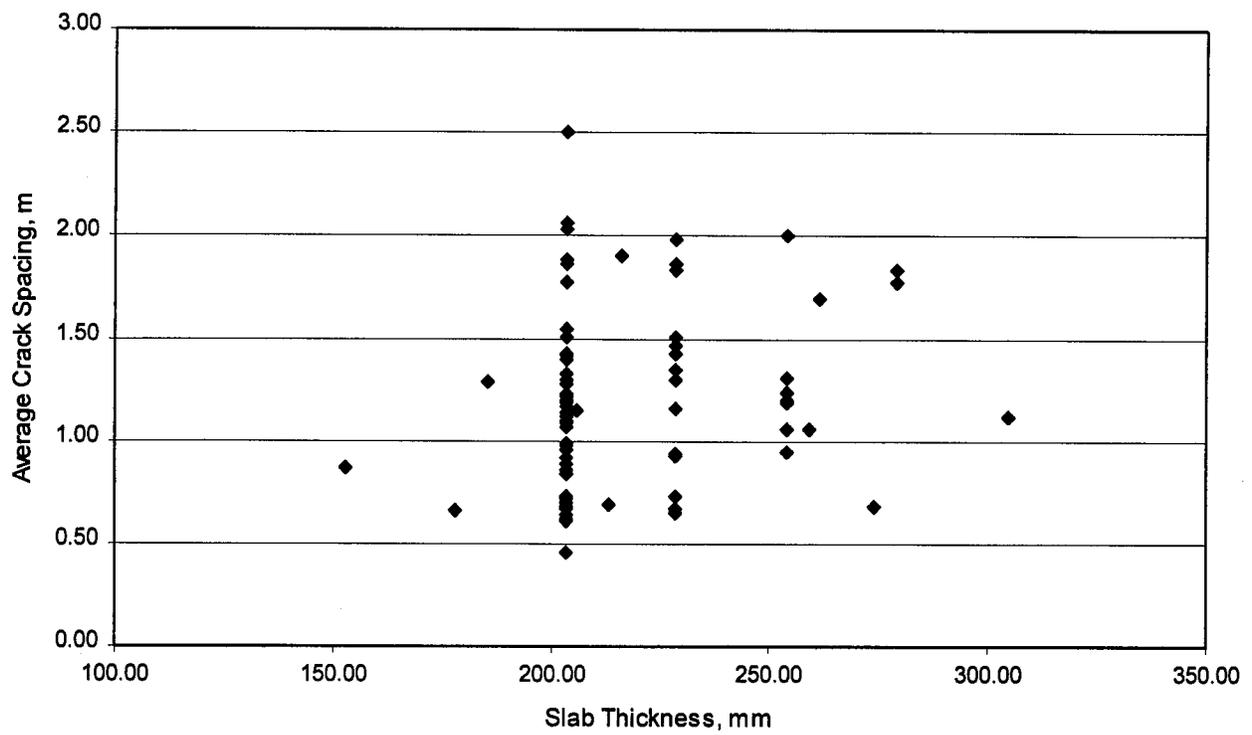
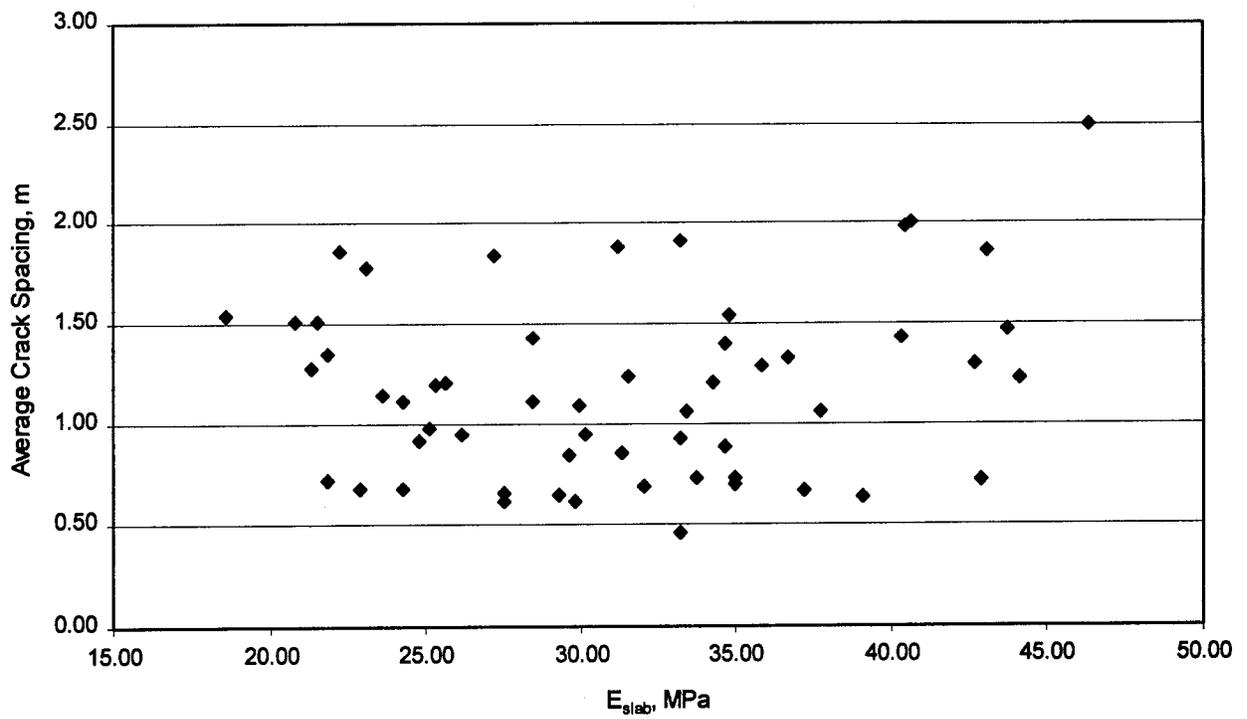
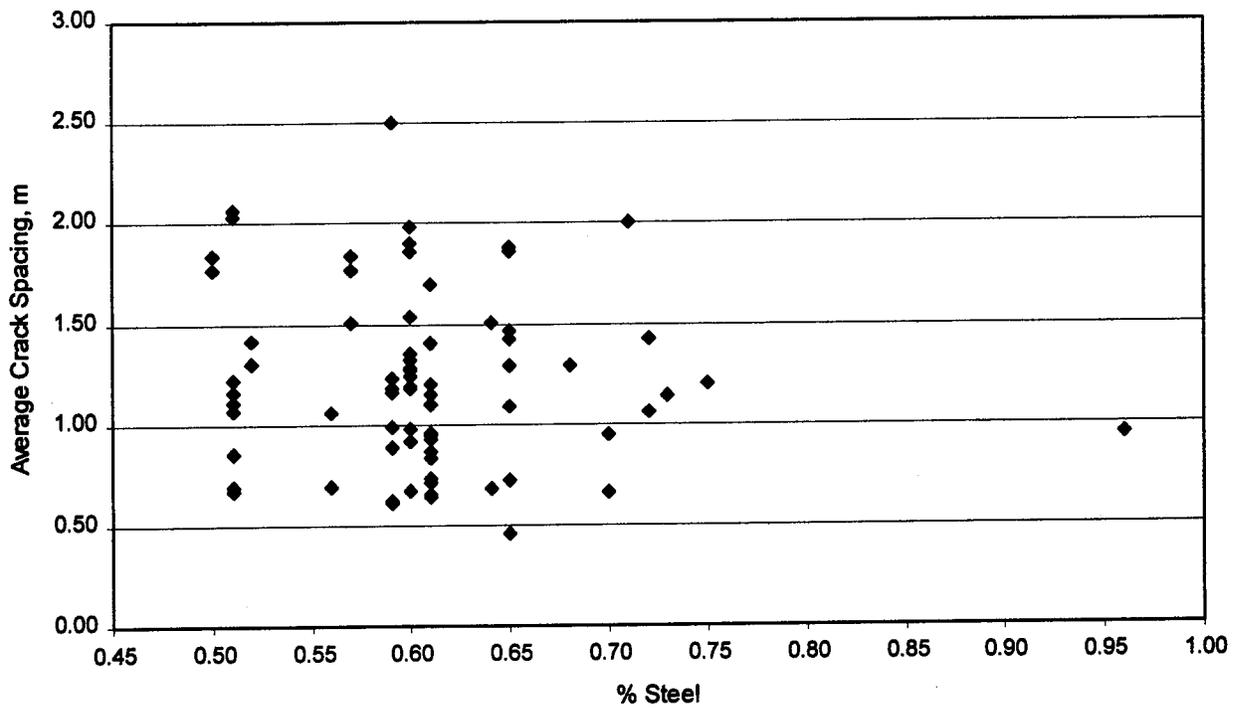
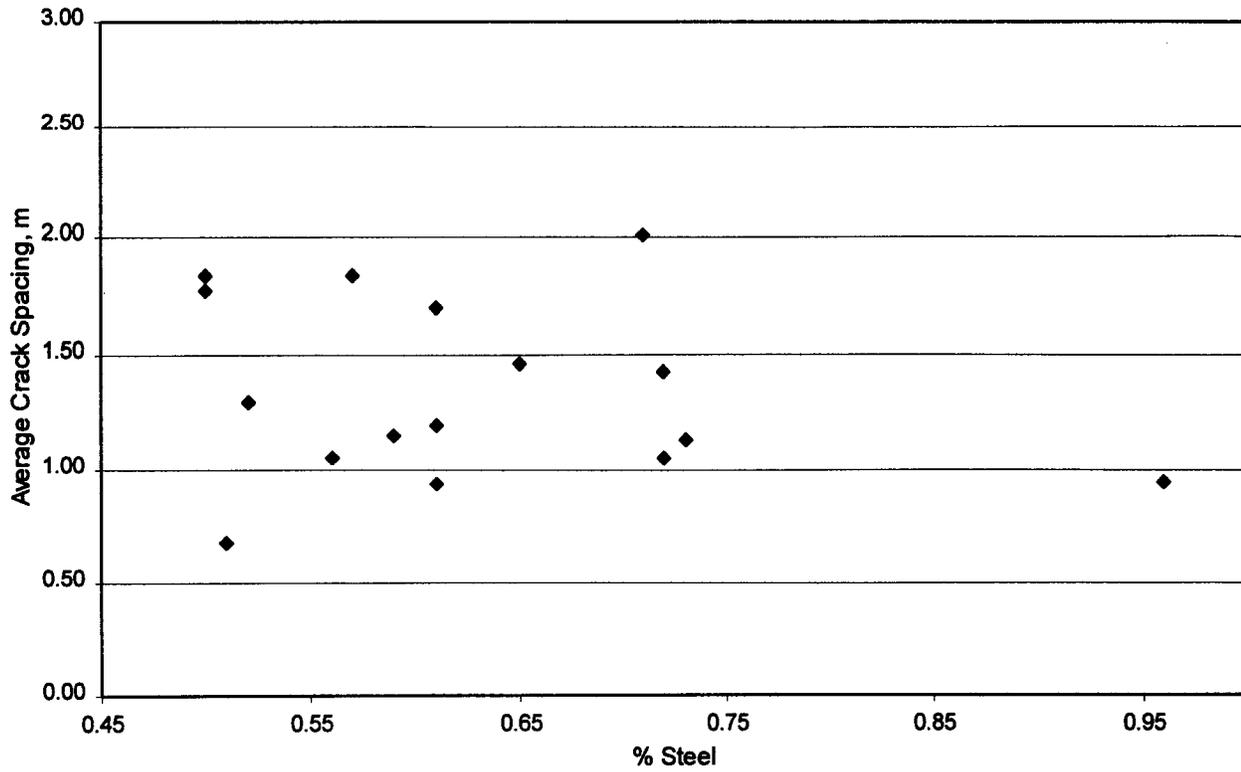
Figure 16. Crack spacing versus age.

Figure 17. Crack spacing versus cumulative ESALs.

Figure 18. Crack spacing versus slab thickness.

Figure 19. Crack spacing versus concrete modulus of elasticity,  $E_{slab}$ .

Figure 20. Crack spacing versus percent longitudinal steel.

Figure 21. Crack spacing versus percent longitudinal steel (age < 10 years).

It is seen from a review of figures 16 through 27 that no clear trends are evident on the basis of bi-variate analysis of the data. The long-term crack spacing pattern, as represented by average crack spacing, is dependent on the interactions of possibly all of the independent variables considered together with the ambient conditions during the first few days of construction. As such, an understanding of the effect of the variables noted would have to consider the interactions and the confounding effects of each of the variables. One method to account for these effects is to use multiple regression analysis. A limited effort was made to determine if robust explanatory models could be developed for crack spacing using linear regression analysis. However, the results were not promising (low coefficient of correlations) and no further effort was devoted to this activity. Use of empirical analysis was not part of the scope of the study and the results are therefore not reported here.

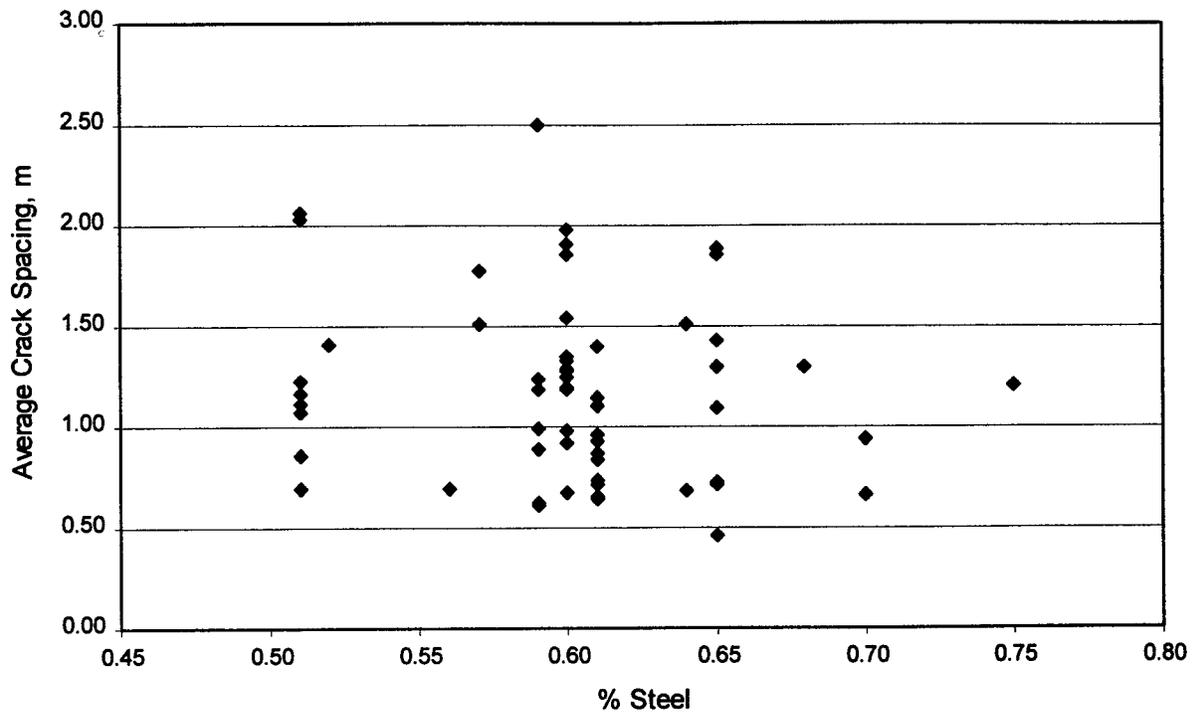
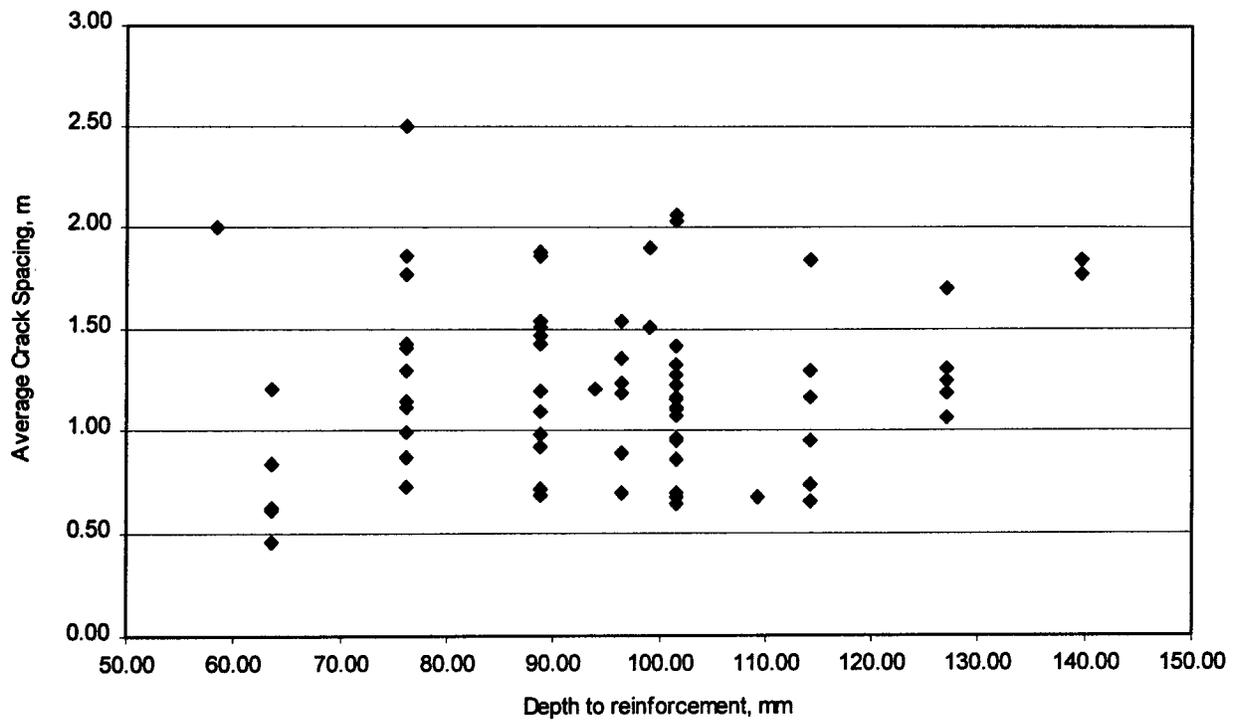
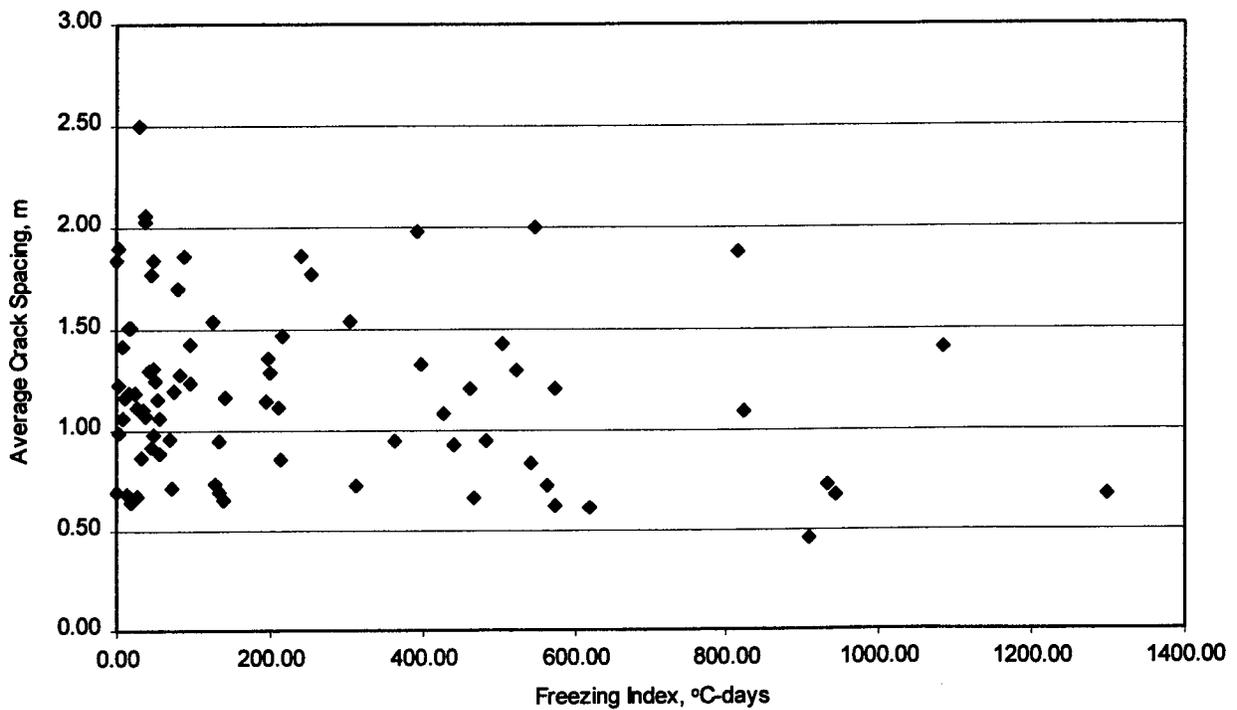
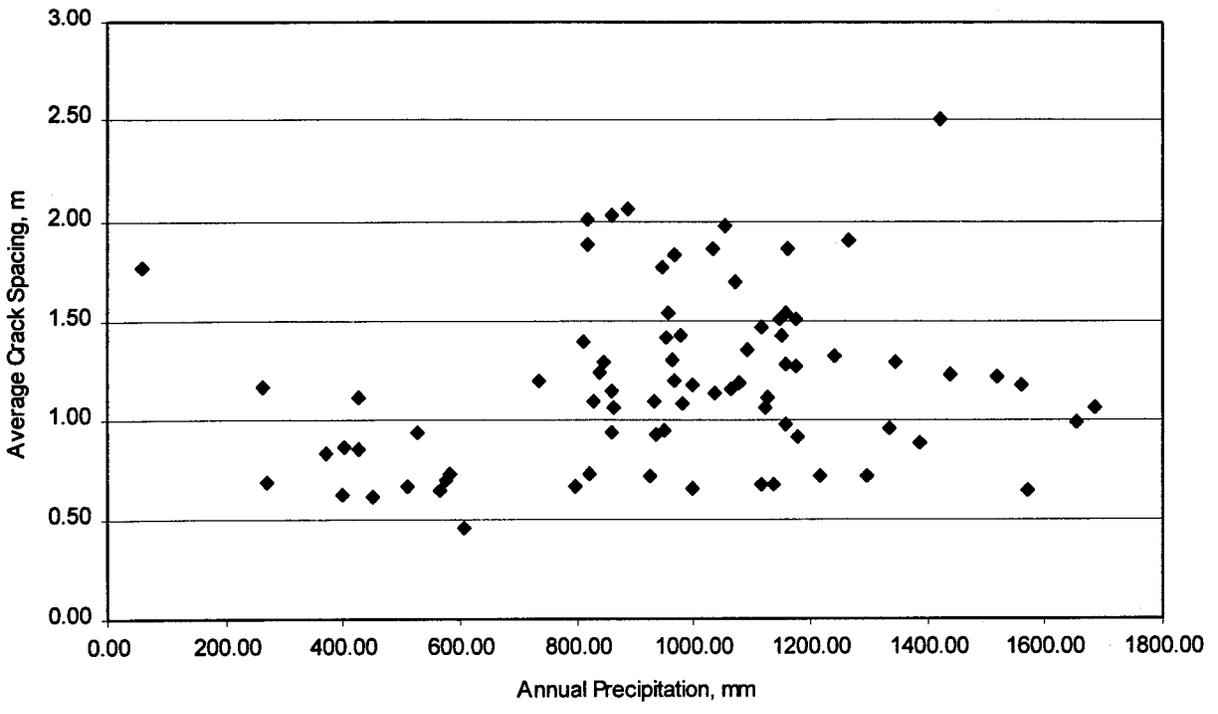
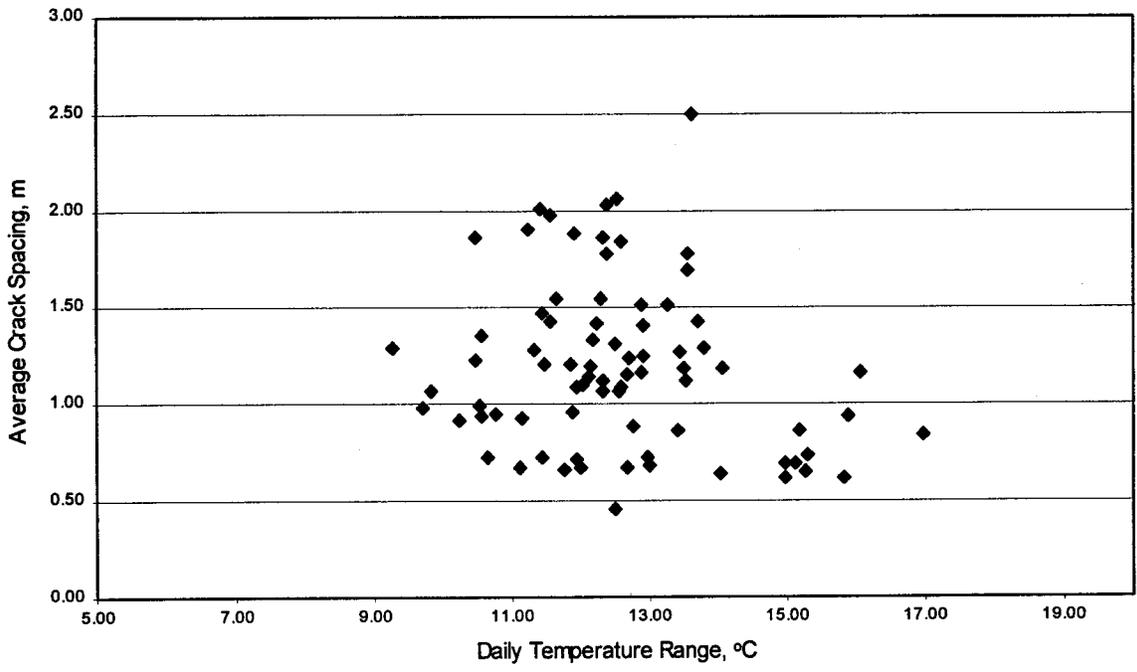
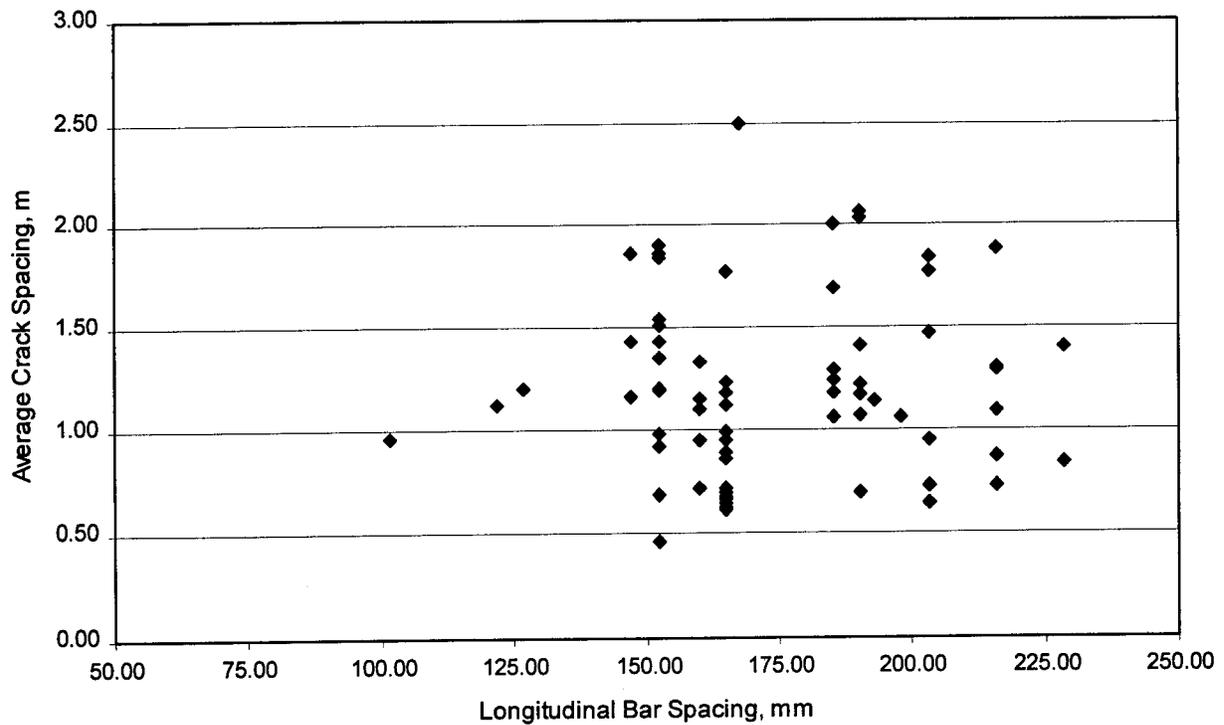
Figure 22. Crack spacing versus percent longitudinal steel (age > 10 years).

Figure 23. Crack spacing versus depth to longitudinal reinforcement.

Figure 24. Crack spacing versus annual air freezing index.

Figure 25. Crack spacing versus annual precipitation.

Figure 26. Crack spacing versus average daily temperature range.

Figure 27. Crack spacing versus longitudinal bar spacing.

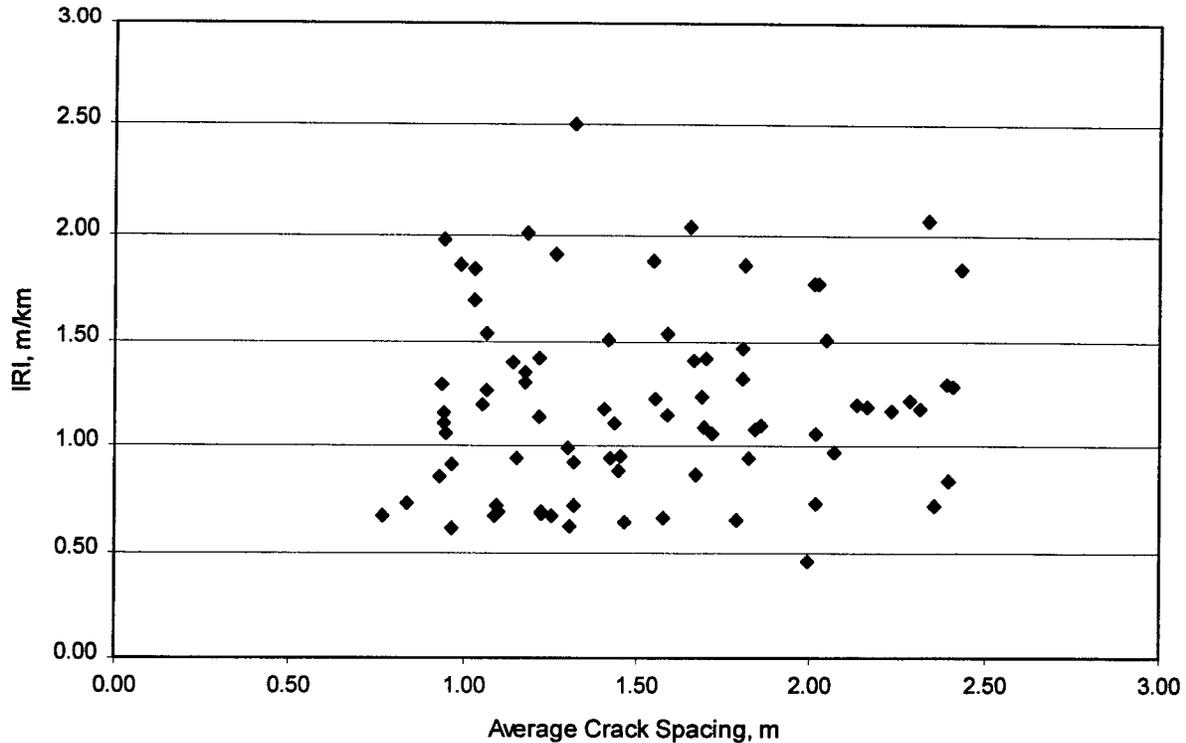
Figure 28. Effect of crack spacing on IRI.

The effect of transverse cracking on ride is shown in figure 28. No clear trends are apparent. This is possibly due to not considering the influence of initial roughness. It should be noted that previous studies have indicated that initially smooth (as-constructed) CRC pavements generally remain smooth, and rough (as-constructed) CRC pavements tend to become rougher with time.

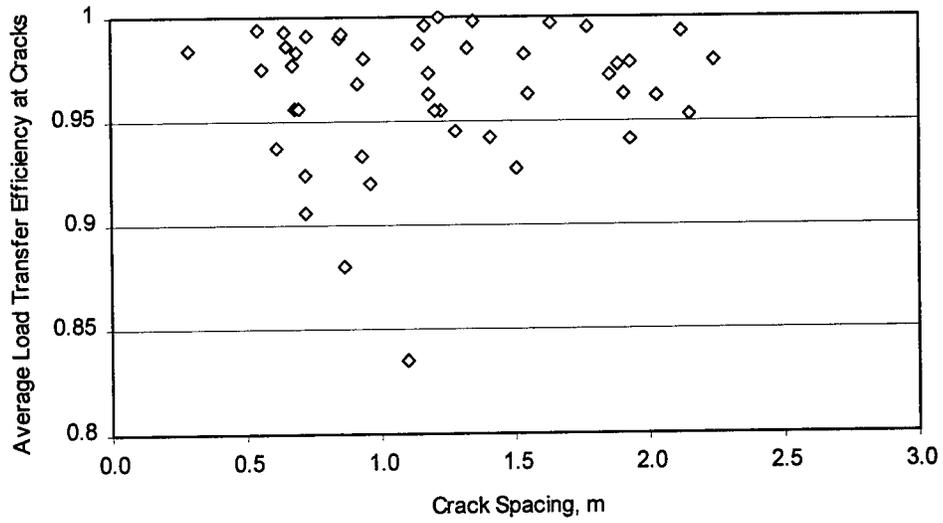
Figure 29. Average load transfer efficiency at cracks versus crack spacing.

To determine the relationship between crack spacing and deflections as measured by the falling-weight deflectometer (FWD), average crack spacing was plotted versus load transfer efficiency and the ratio of the edge deflection and the corresponding interior deflection for sections having FWD data in the database, as shown in figures 29 and 30, respectively. No clear trends in the data can be observed. It is seen that most of the sections exhibited load transfer efficiency at cracks of 90 percent or more. The ratios of the edge deflection and the corresponding interior deflection ranged from 1 to about 2. The variability within the range is possibly due to the time of testing (curling effects), slab warping effects, and the type of shoulder.

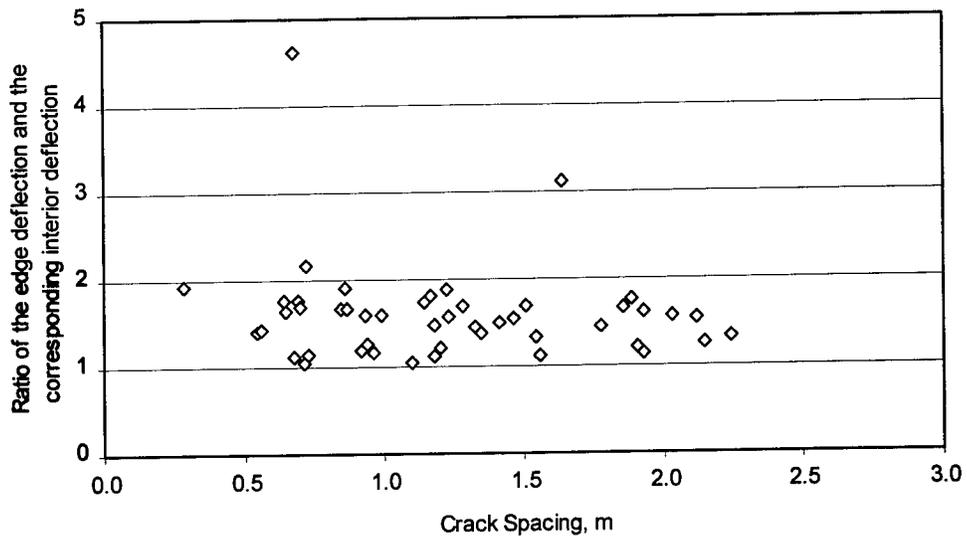
Figure 30. Ratio of maximum edge and interior deflections versus crack spacing.
