# 3M Microloop Field Evaluation Report

1. Report No. <b>MN/RC - 1999-15</b>	2.	3. Recipient's Accession No.	
4. Title and Subtitle <b>3M MICROLOOP FIELD EVALUATION REPORT</b>		5. Report Date <b>April 1999</b>

## Comparison of 3M™ Canoga™ M701 Microloops and 1.7 m X 1.7 m Loops in an Intersection Advance Detection Application

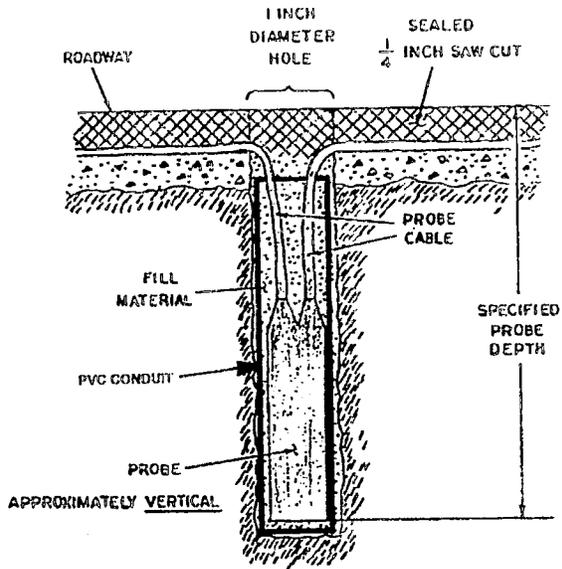
3M offers two models of microloops. The M701 microloop probe is installed in small diameter hole that is typically 460 millimeters deep (see Figure 1 and Figure 2). Its lead-in wire is placed into a saw cut that is filled in with a loop sealant and extends to the conduit at the side of the road. The M702 non-invasive microloop probe (see Figure 4) is placed in a protective, 76 mm diameter PVC or seamless polyethylene conduit located 530 mm below the pavement surface (see Figure 3). This standard conduit is typically installed using horizontal directional drilling which leaves the road surface intact (see Figure 5). Some traffic control is needed during the horizontal directional drilling process to allow a worker to periodically walk onto the road surface to measure the drill head depth. The conduit terminates in a handhole. Interlocking carriers are used to install the probes into the conduit. These 305 mm long carriers have receptacles to hold the non-invasive microloop probes firmly in place. The carriers are easily inserted into the conduit from the handhole at the roadside (see Figure 6). A locking mechanism prevents the carriers from rotating. With the M702 non-invasive microloop, there are no sensor components in the pavement. The non-invasive microloops can be inserted, removed, replaced or adjusted without disrupting the traffic flow.

Figure 1 M701 Microloop Installation

Based on these recommendations the plans shown in Figure 7 were prepared. A contractor installed the sensors in the summer of 1995 according to these plans. The M701 microloop probes were installed at the recommended depth of 460 mm from the pavement surface to the bottom of the probe. The microloop lead-in cables were buried at a depth of 100 mm below the pavement surface in an attempt to permit future resurfacing without cutting the lead-in cables.

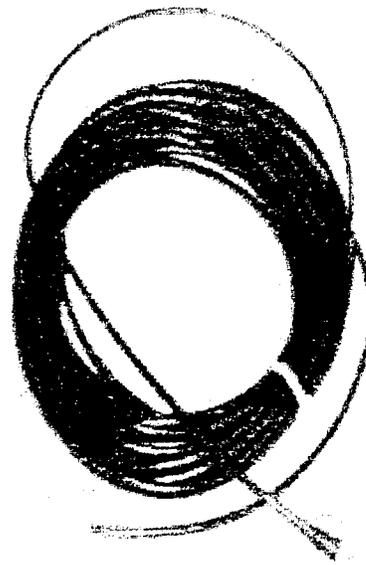
Figure 2 M701 Microloop Probe

The M701 microloop is a low Q inductor with a  $Q = 3$ . Inductive wire loops typically have a  $Q > 5$ . Inductive loop detectors must be capable of driving low Q inductors to be used with M701 microloops. M702 non-invasive microloops typically have a  $Q > 5$  and can be more readily interfaced with inductive loop detectors.

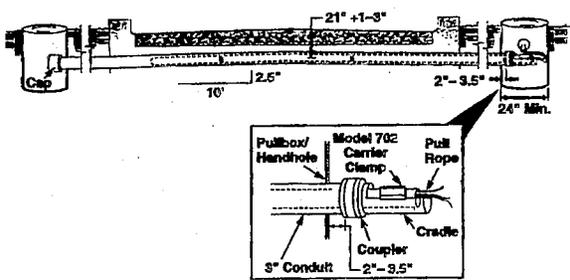
Figure 3 M702 Non-invasive Microloop Installation

Only the M701 microloop was available when the evaluation was started. Results reflect the performance of this microloop. The M702 non-invasive microloop is smaller in size compared to the M701 microloop, but its sensitivity to changes in the earth's magnetic field is very similar. Subsequent evaluations of the M702 non-invasive microloop have indicated that its performance is similar to that of the M701 microloop when both are used with a matched Canoga C800 series vehicle detector.

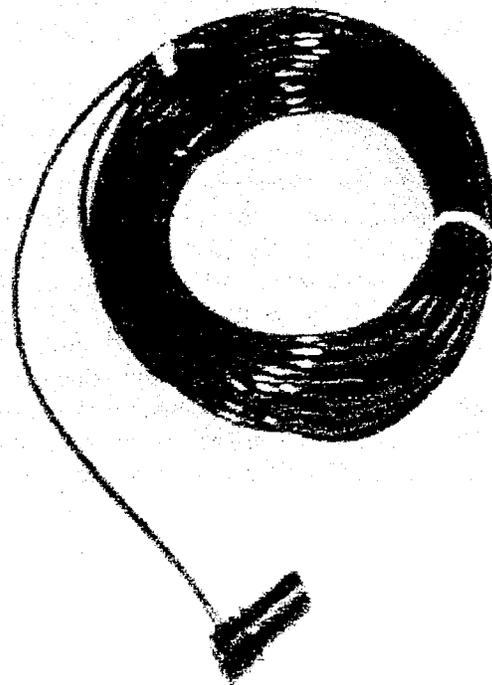
Figure 4 M702 Non-invasive Microloop

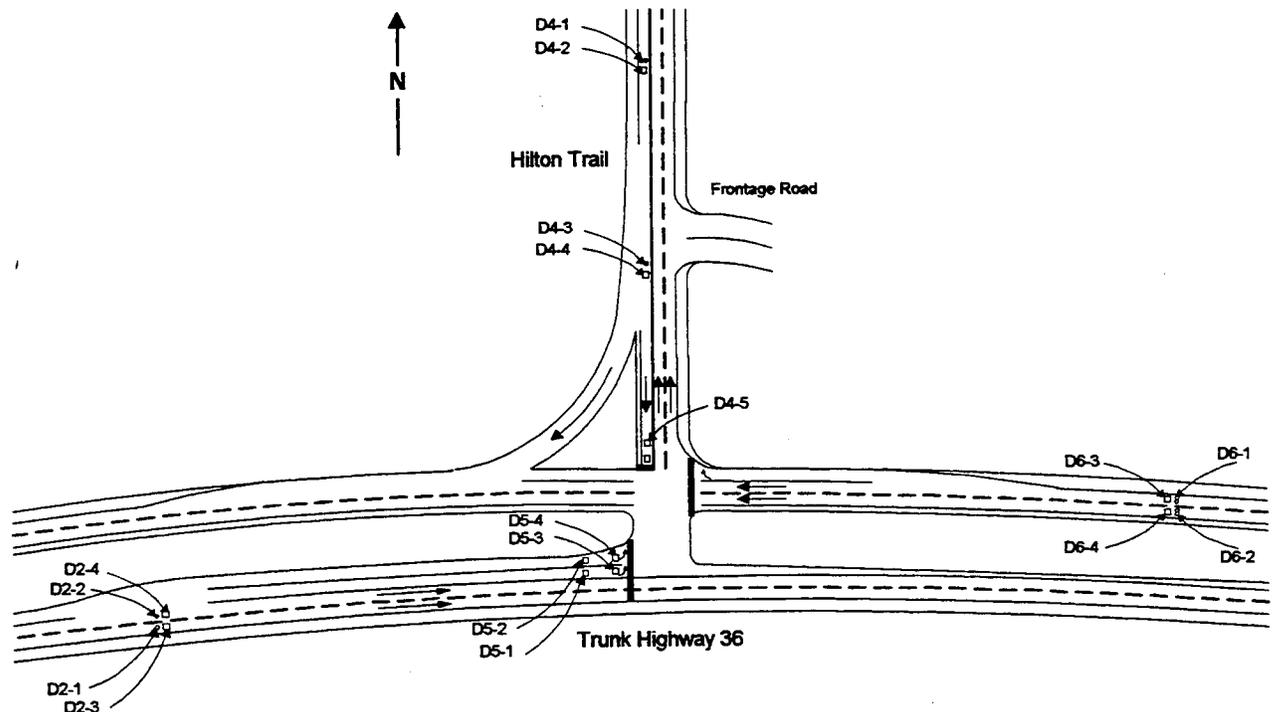
Figure 7: Intersection Layout - TH 36 at Hilton Trail, Pine Springs, Washington County (not to scale)

This test site has geometric situations that are likely to cause deviations in the count comparisons between the loops and microloops:

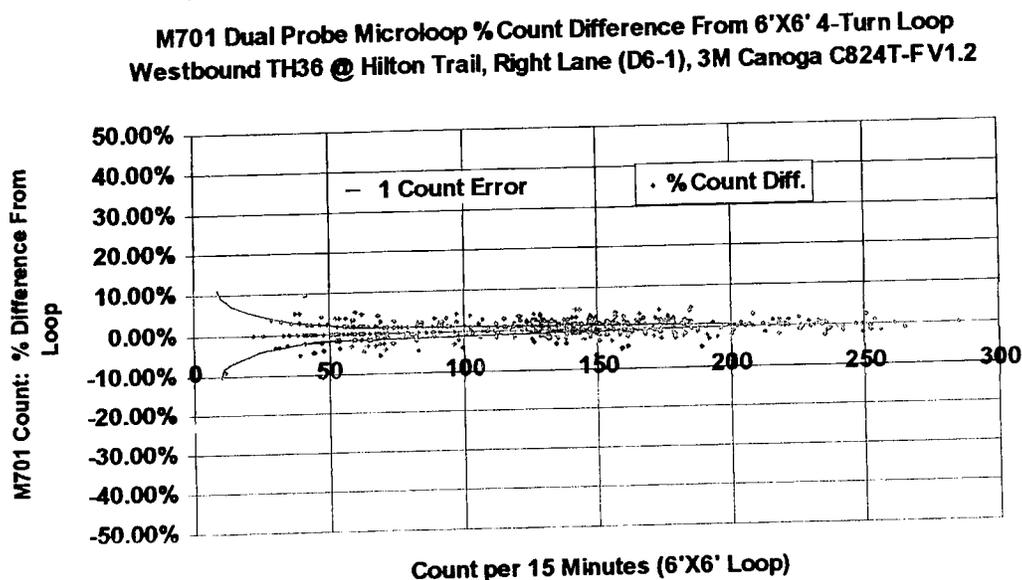
Figure 9: Microloop Count versus Loop Count for Right through Lane of Eastbound TH 36

The red line in Figure 9 represents the percent difference that can result from one-count differences at the crossover from the current to the next 15-minute interval (interval boundary): a vehicle count may be assigned to one 15-minute interval for one detector and to the next 15-minute interval for the other detector.

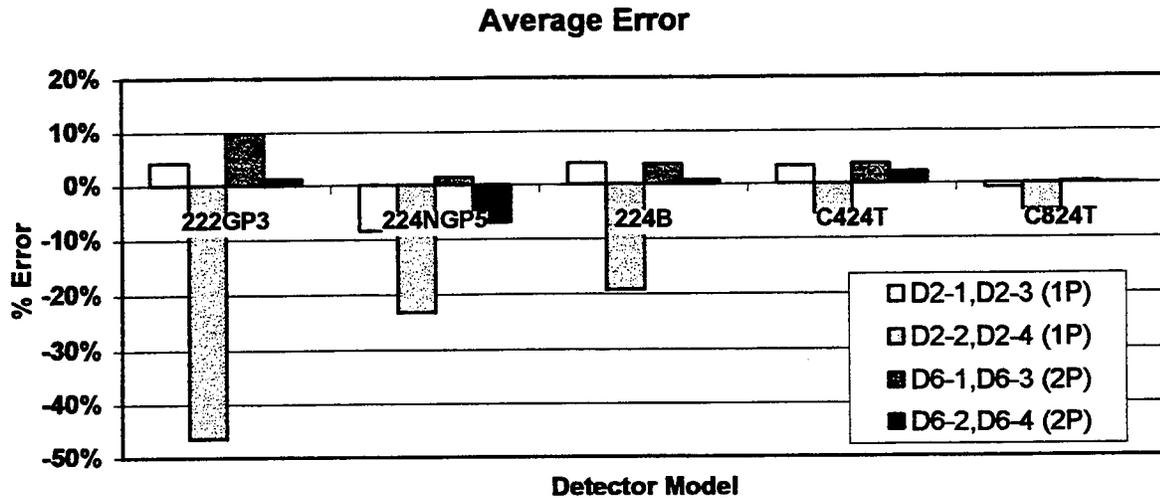
To compare the performance of different detector models attached to the microloops, the average error and the standard deviation of the errors were calculated. This analysis also compared count accuracy of a detector with either one (1P) or two probes (2P). The data from the one-probe microloops is represented by the orange hue (light shading) while the data from the two-probe microloop by the green hue (dark shading). The results are shown in Figure 10 and Figure 11.

Figure 10: Average Error for Each Detector Model (1P = one-probe microloop, 2P = two-probe microloop)

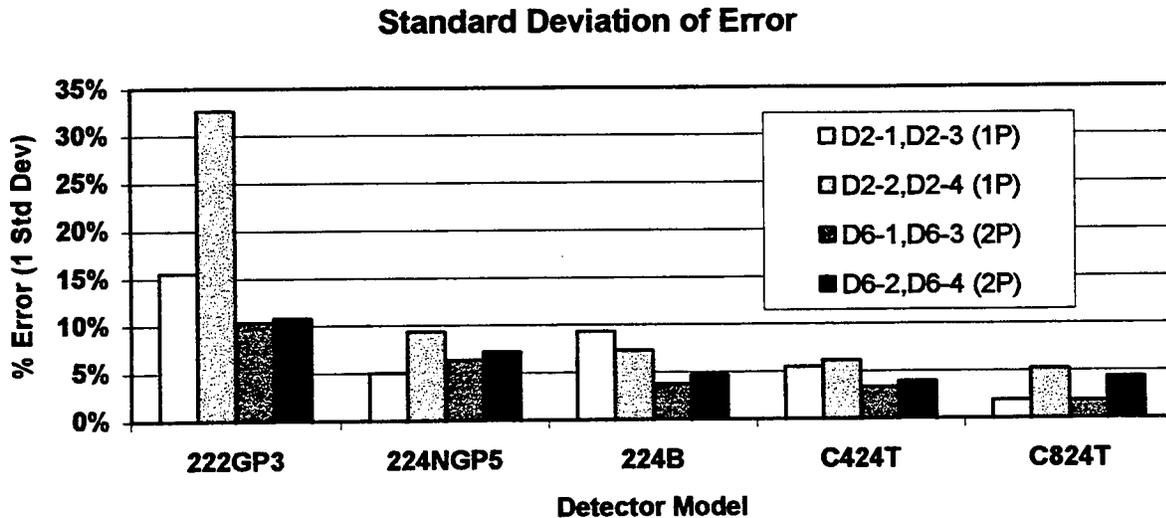
Figure 11: Standard Deviation of Percent Count Error for Each Detector Model (1P = one-probe microloop, 2P = two-probe microloop)

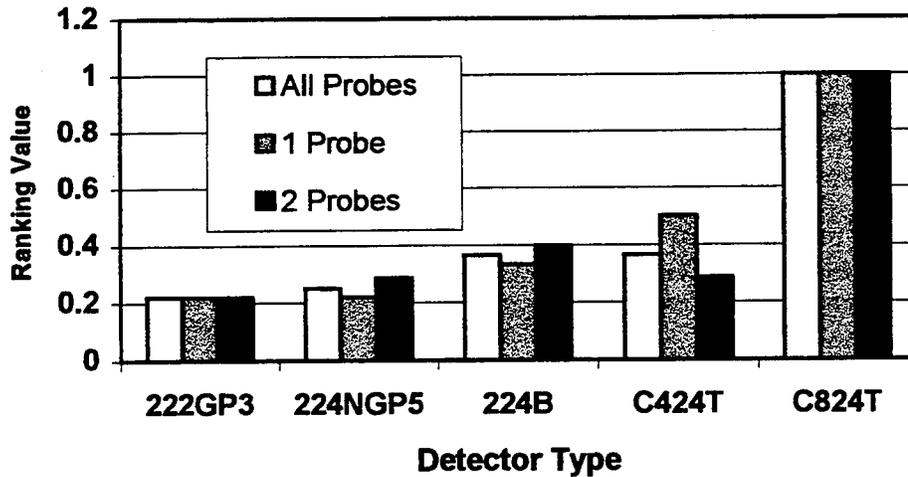
detector having the lowest percent error as compared to the reference loop count. The lowest rank (Rank = 5) was given to the detector with the largest percent error as compared to the reference loop count. The overall rank for a detector was obtained by dividing the sum of the ranking at each of the sensing stations by the number of sensing stations and then calculating the reciprocal of that number. A "perfect" score is a rank of 1 and the lowest possible score a rank of 0.20.

**Ranking of Detector Types by Average Bin Difference Between Loop and Microloop**

**Figure 12: Ranking of Detector Models According to Average Count Error with Respect to Loop Count**

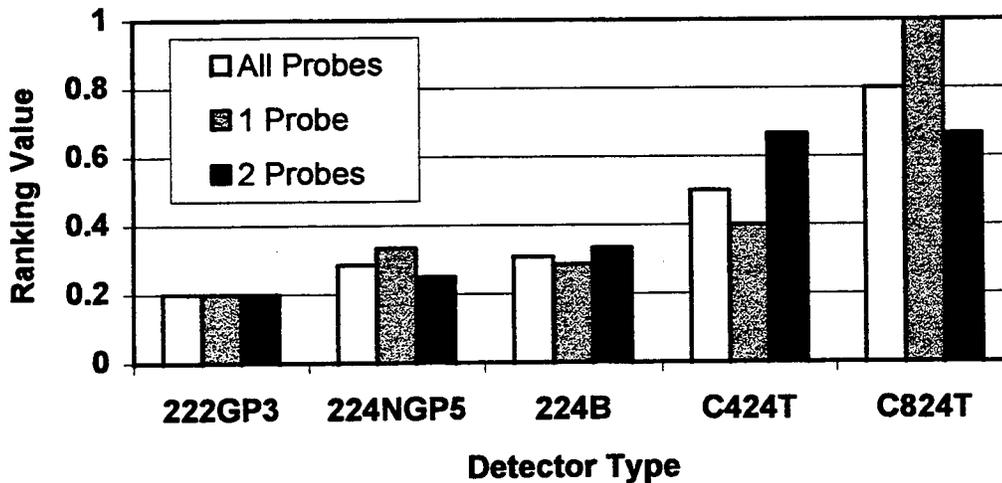
**Ranking of Detector Type by Standard Deviation of Bin Difference Between Loop and Microloop**

**Figure 13: Ranking of Detector Models According to Standard Deviation of Count Error with Respect to Loop Count**

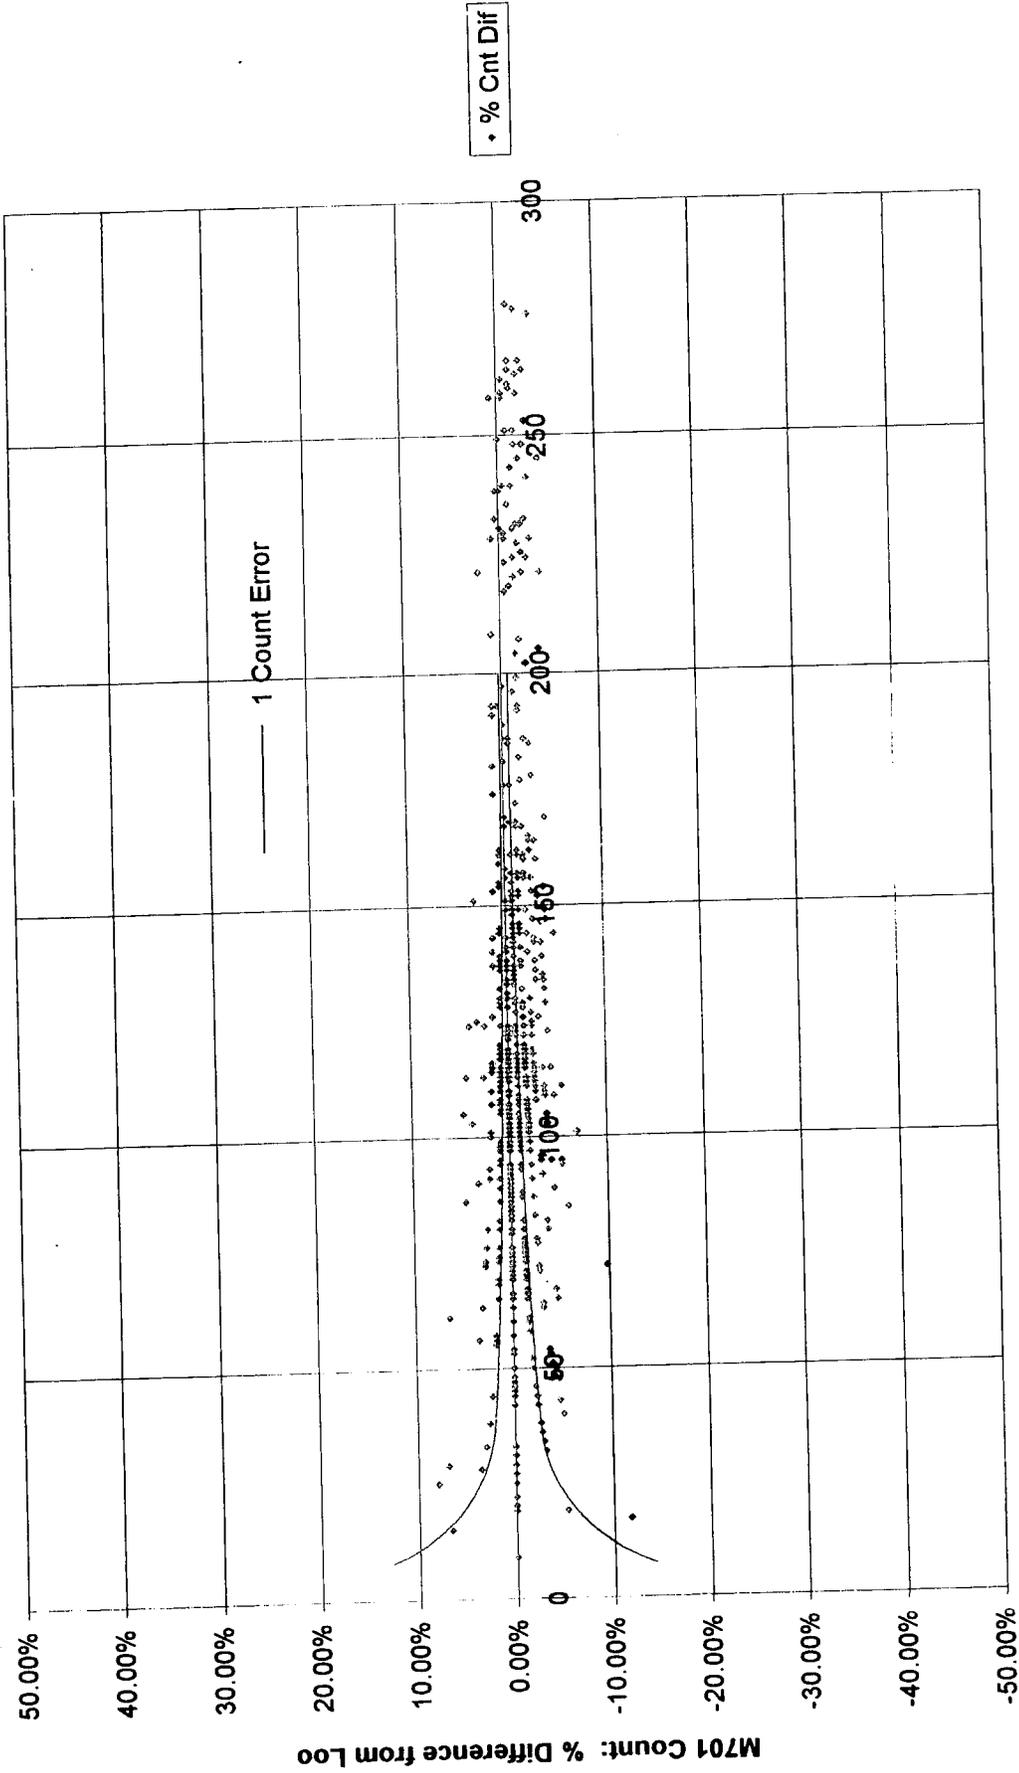
Single Probe M701 Microloop Count Difference From 6'X6' 4 Turn Loop  
 Eastbound TH36 @ Hilton Trail, Right Lane (D2-1), 3M Canoga C824T-F V1.2

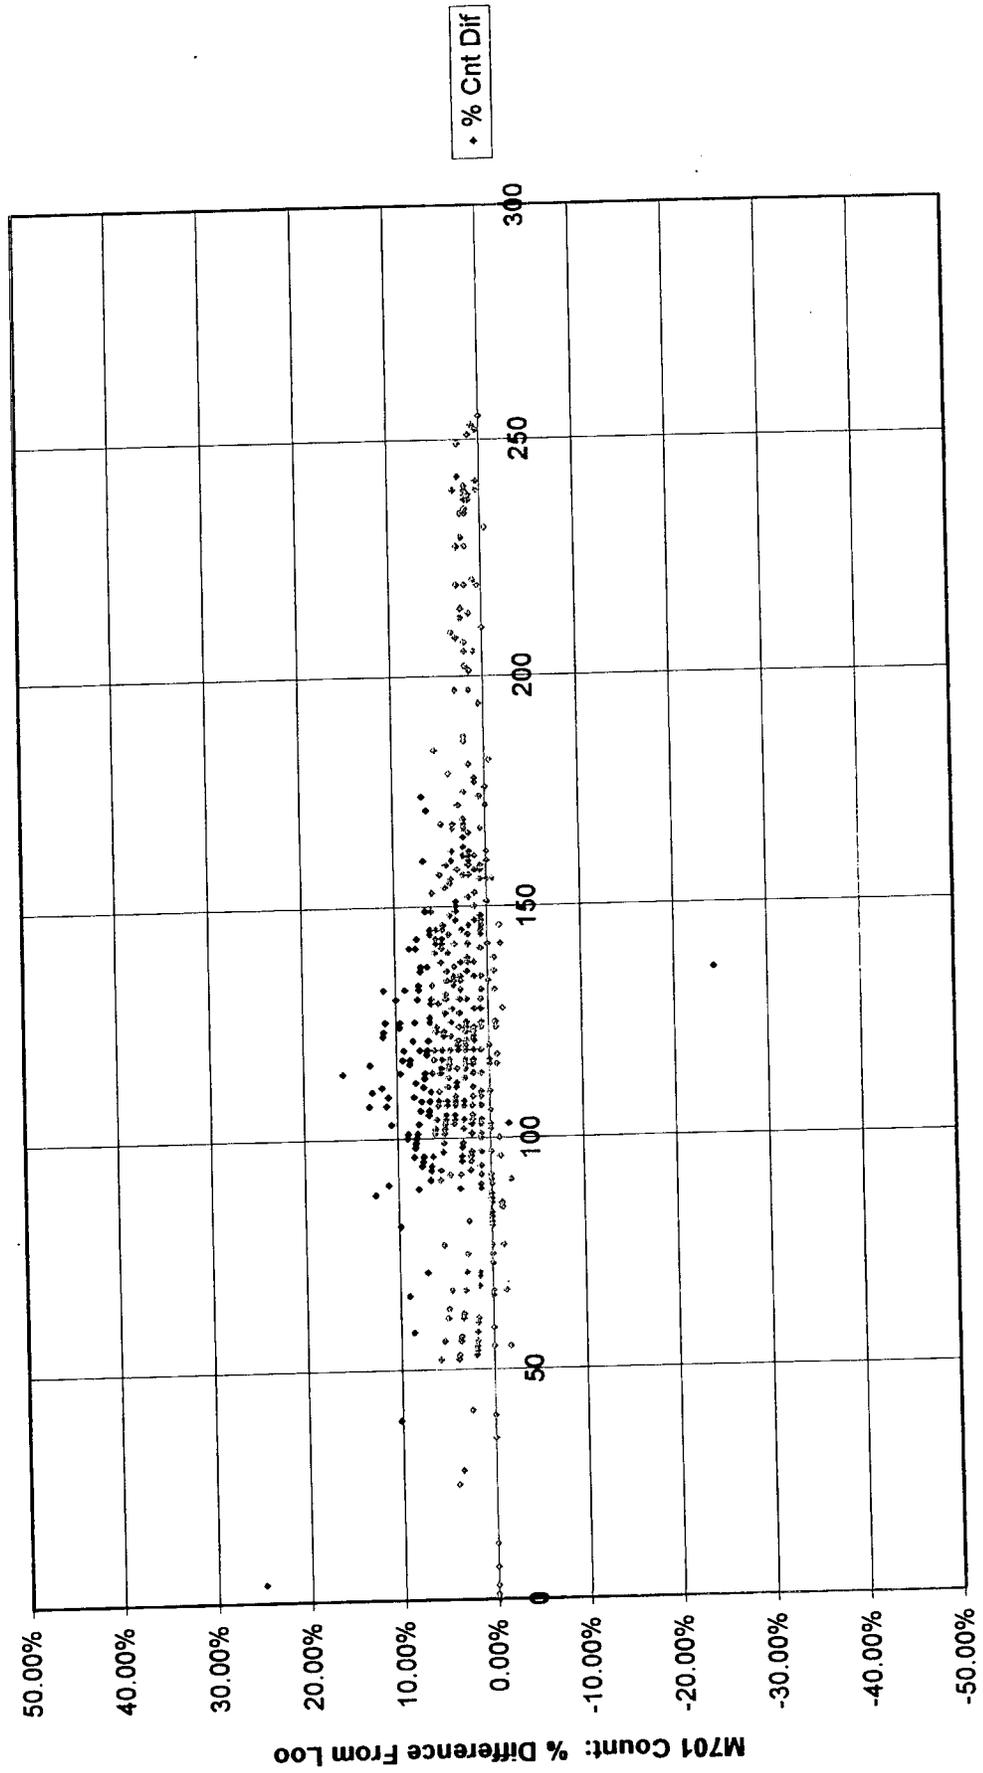
M701 Single Probe Microloop % Count Difference From 6'X6' 4-Turn Loop  
 Eastbound TH36 @ Hilton Trail, Right Lane (D2-1), 3M Canoga C424T Detector

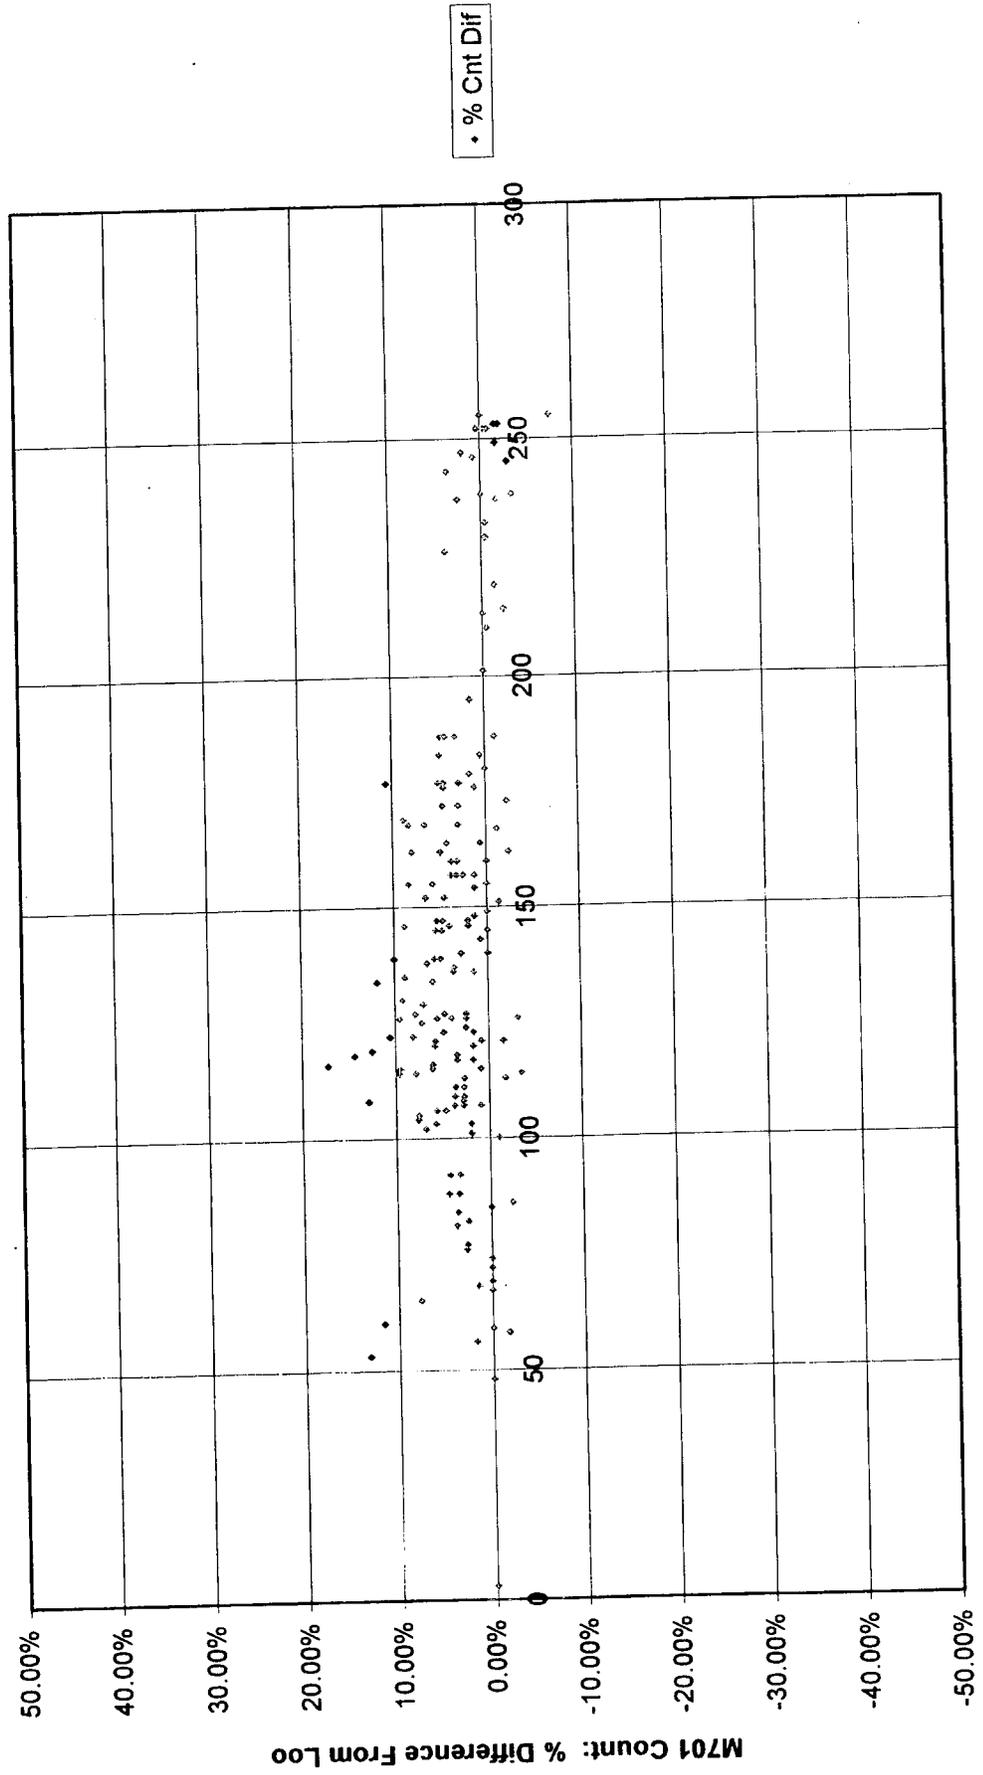
M701 Single Probe Microloop % Count Difference From 6'X6' 4-Turn Loop  
 Eastbound TH36 @ Hilton Trail, Right Lane (D2-1), Detector Systems 224B Detector

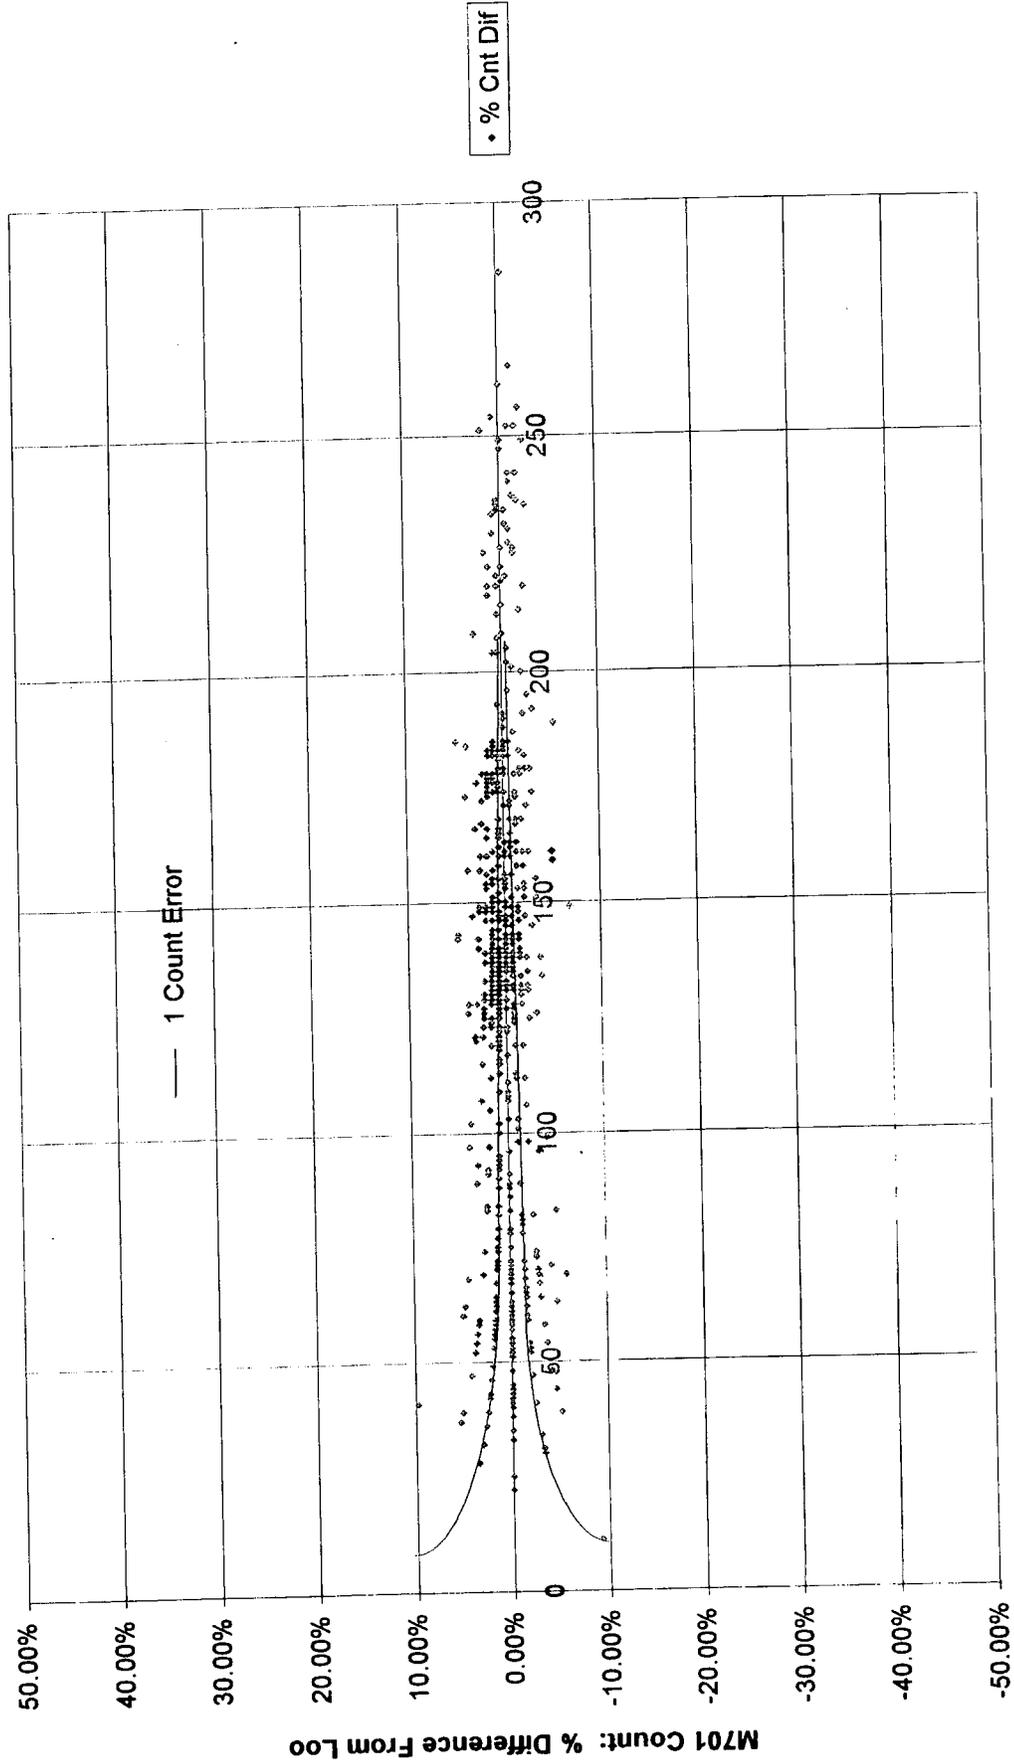
M701 Dual Probe Microloop % Count Difference From 6'X6' 4-Turn Loop  
 Westbound TH36 @ Hilton Trail, Right Lane (D6-1), 3M Canoga C824T-F V1.2

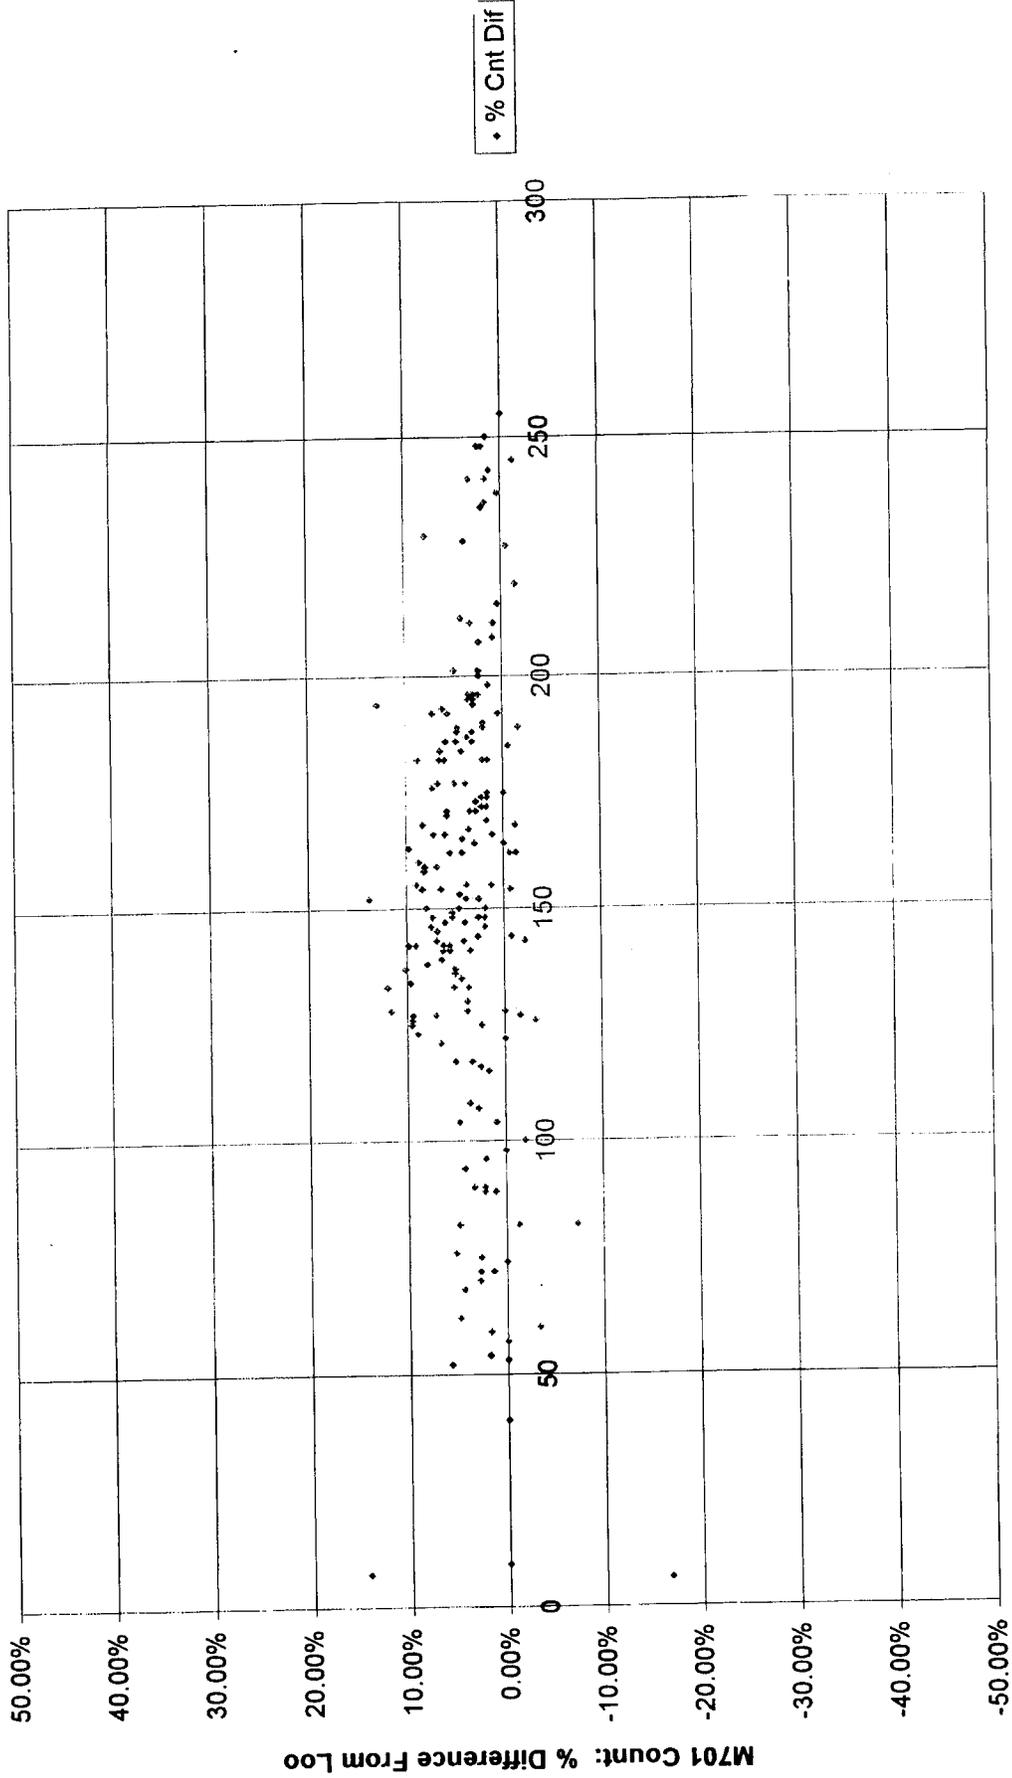
M701 Dual Probe Microloop % Count Difference From 6'X6' 4-Turn Loop  
 Westbound TH36 @ Hilton Trail, Right Lane (D6-1), Detector System 224B Detector

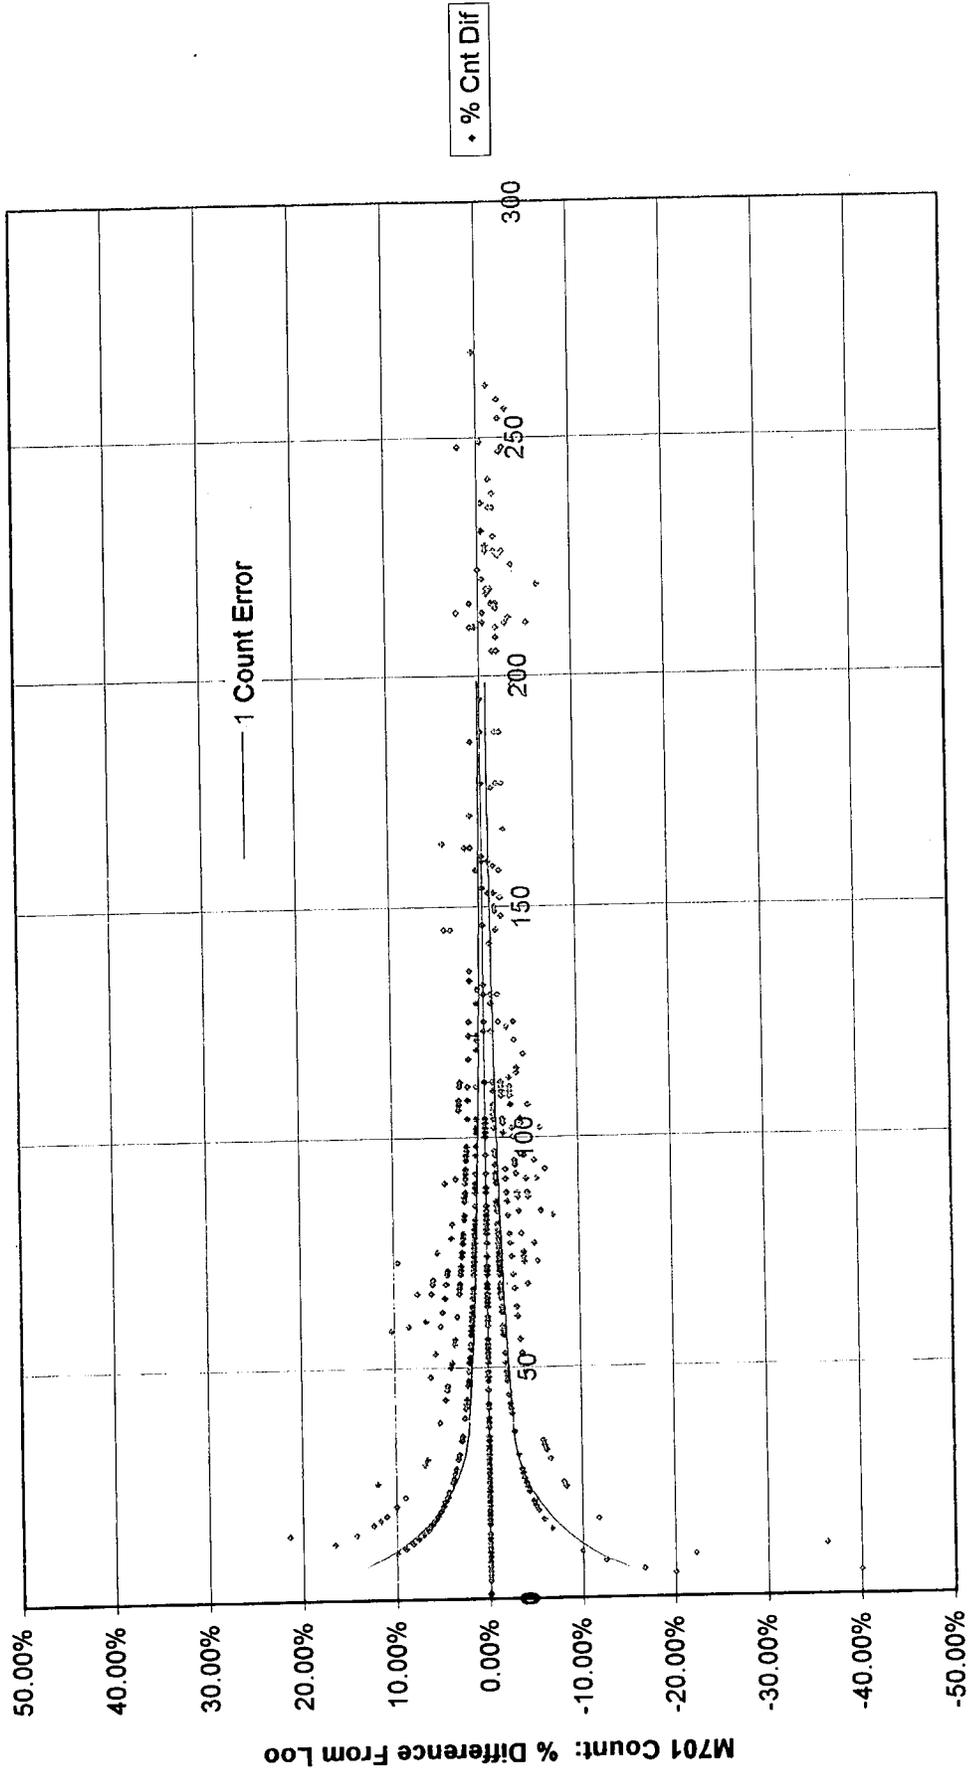
M701 Dual Probe Microloop % Count Difference From 6'X6' 4-Turn Loop  
 Westbound TH36 @ Hilton Trail, Left Lane (D6-2), 3M Canoga C824T-F V1.2 Detector

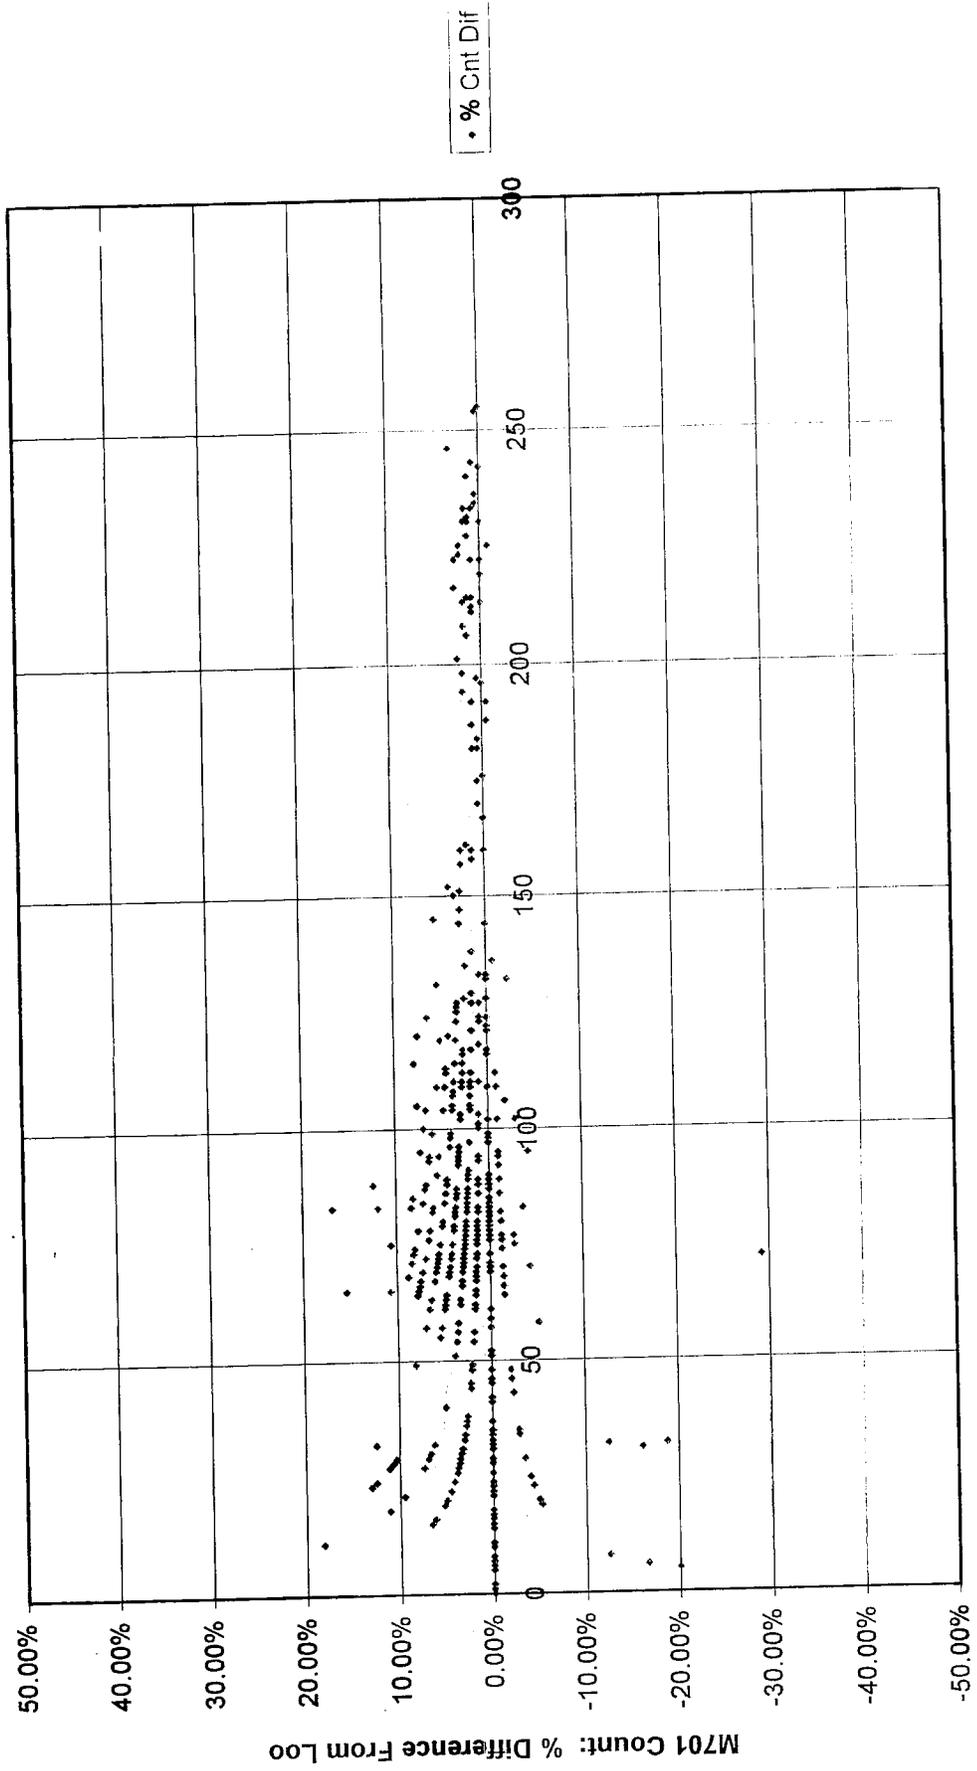
M701 Dual Probe Microloop % Count Difference From 6'X6' 4-Turn Loop  
 Westbound TH36 @ Hilton Trail, Left Lane (D6-2), 3M Canoga C424T Detector

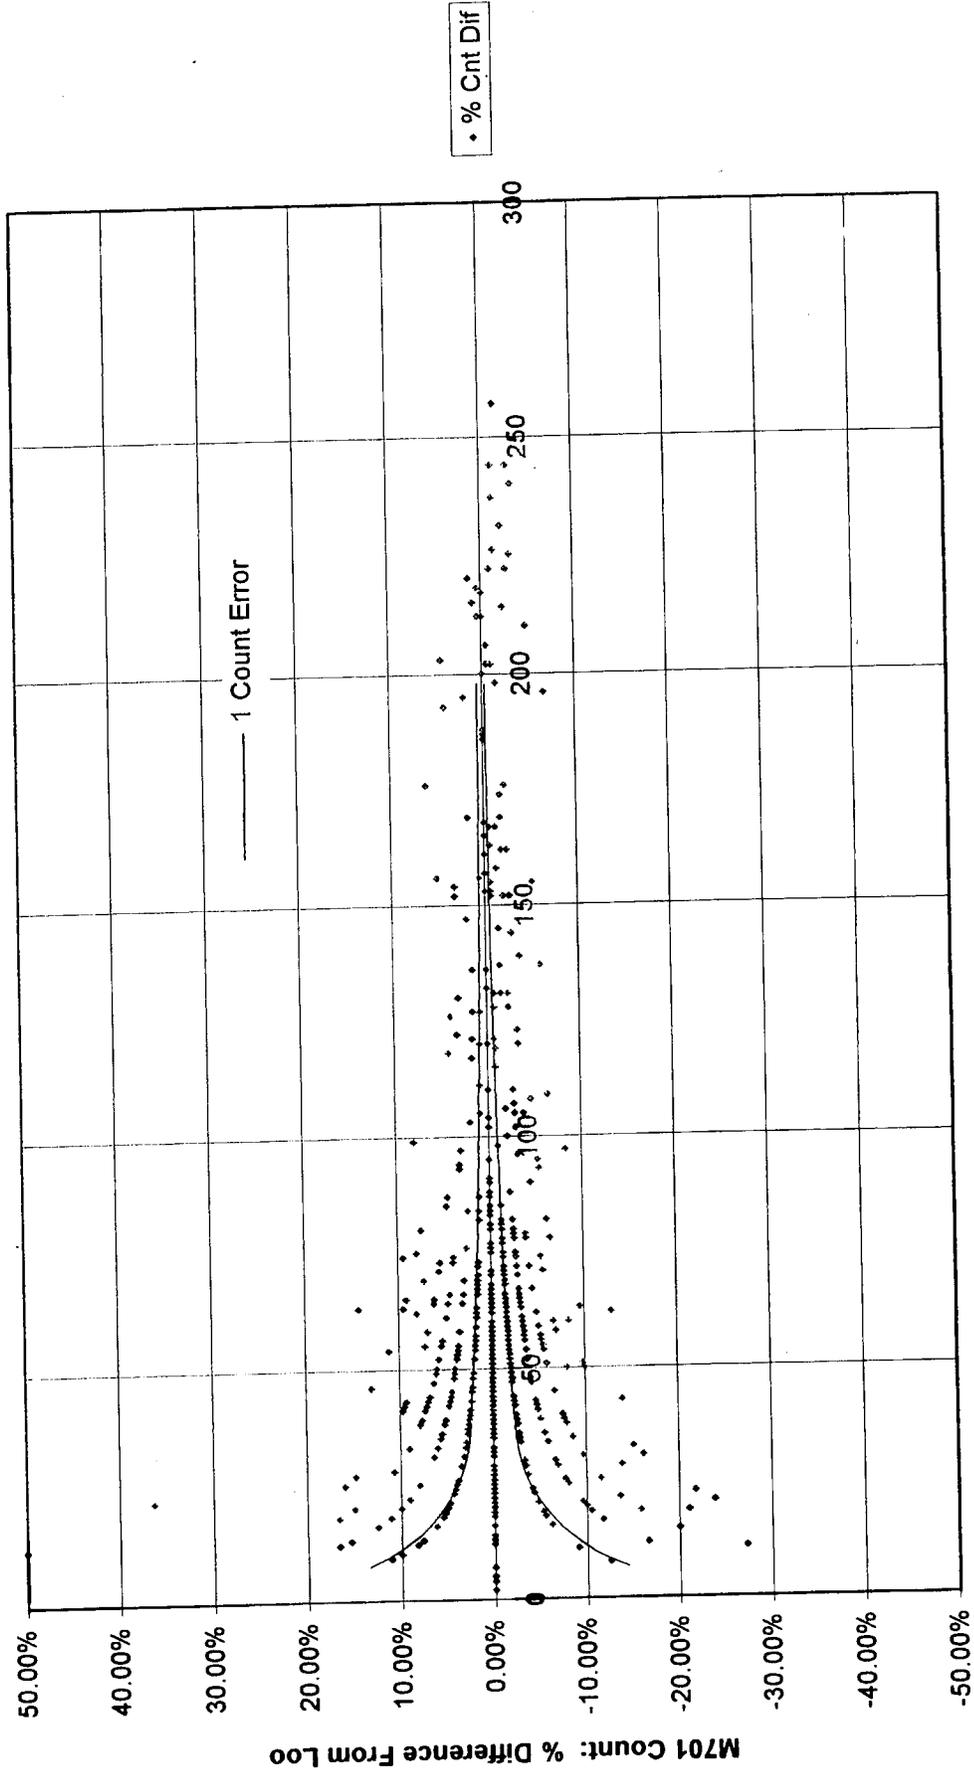
**M701 Double Probe Microloop % Count Difference From 6'X6' 4-Turn Loop  
 Southbound Hilton Trail, Far Advance (D4-1), 3M Canoga C824T-F V1.2 Detector**
