Laboratory and Field Evaluation of Piezoelectric WIM Sensors

ICWIM 3, Orlando

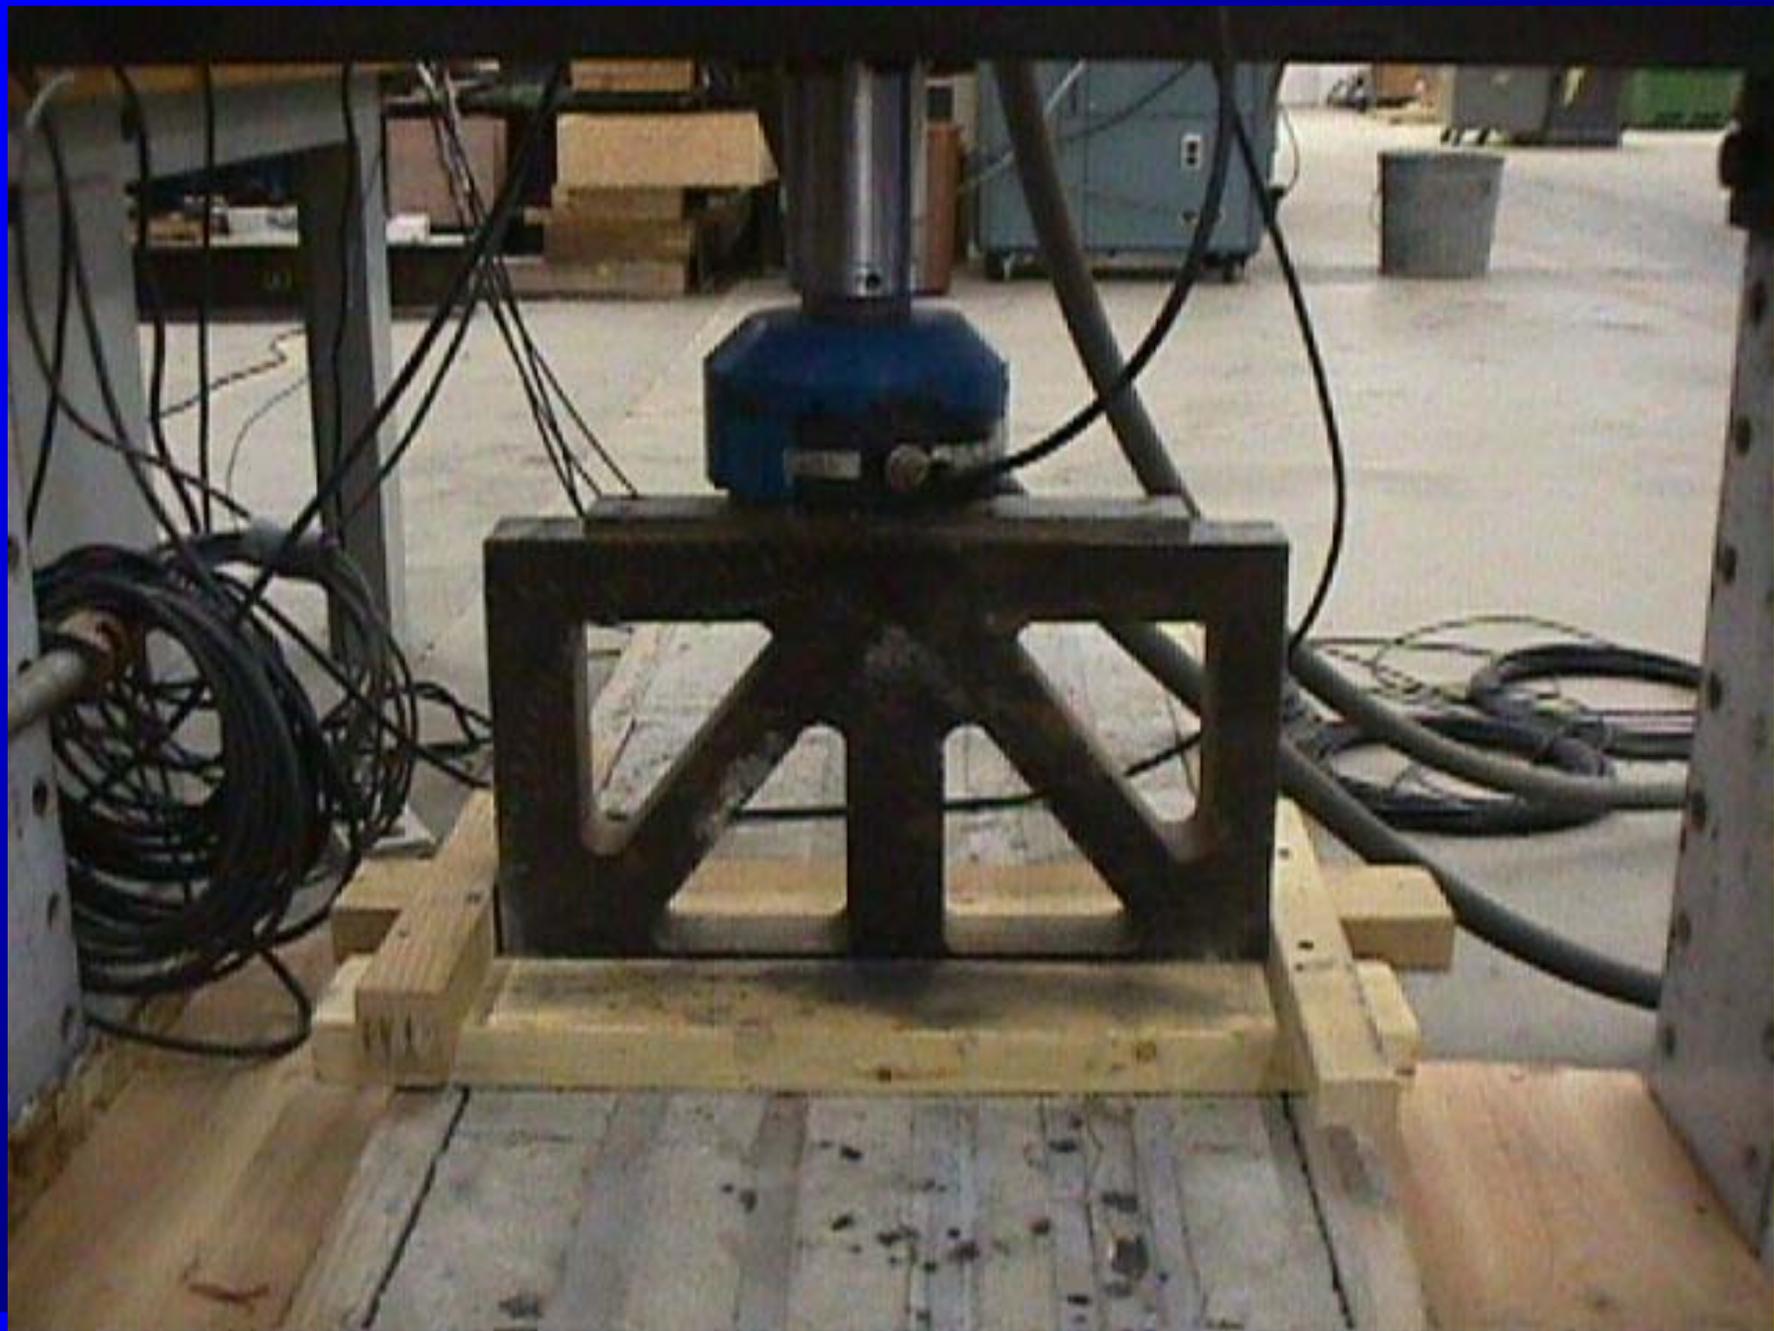
VC-encapsulated; 860 kPa, Dry.

Manufacturer A- Encapsulated

- ☞ Some short-term changes in voltage output.
- ☞ Under 860 kPa/dry:
 - both types of VC sensors exhibited an increase in peak voltage output, while,
 - both types of MSI sensors exhibited a decrease in peak voltage output.
- ☞ Under 860 kPa/wet:
 - both makes of encapsulated sensors outperformed the bare sensors
- ☞ Under 200 kPa/dry:
 - No apparent fatigue damage for any of the sensors

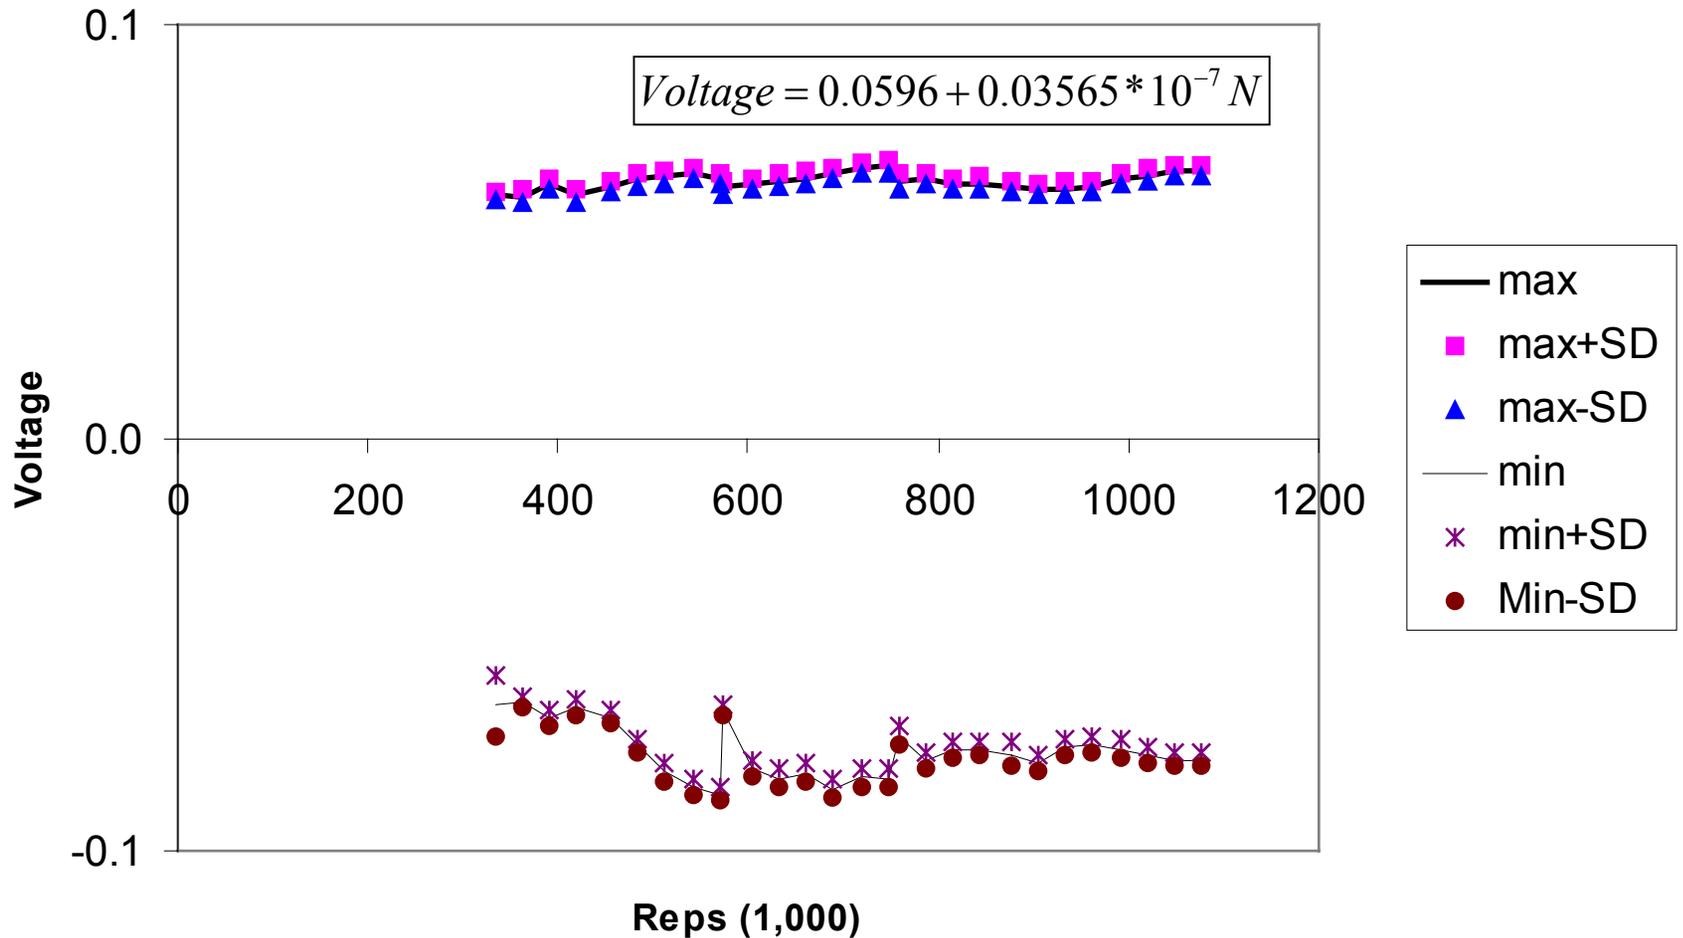
MSI-encapsulated; 860 kPa, Dry

Manufacturer B- Encapsulated

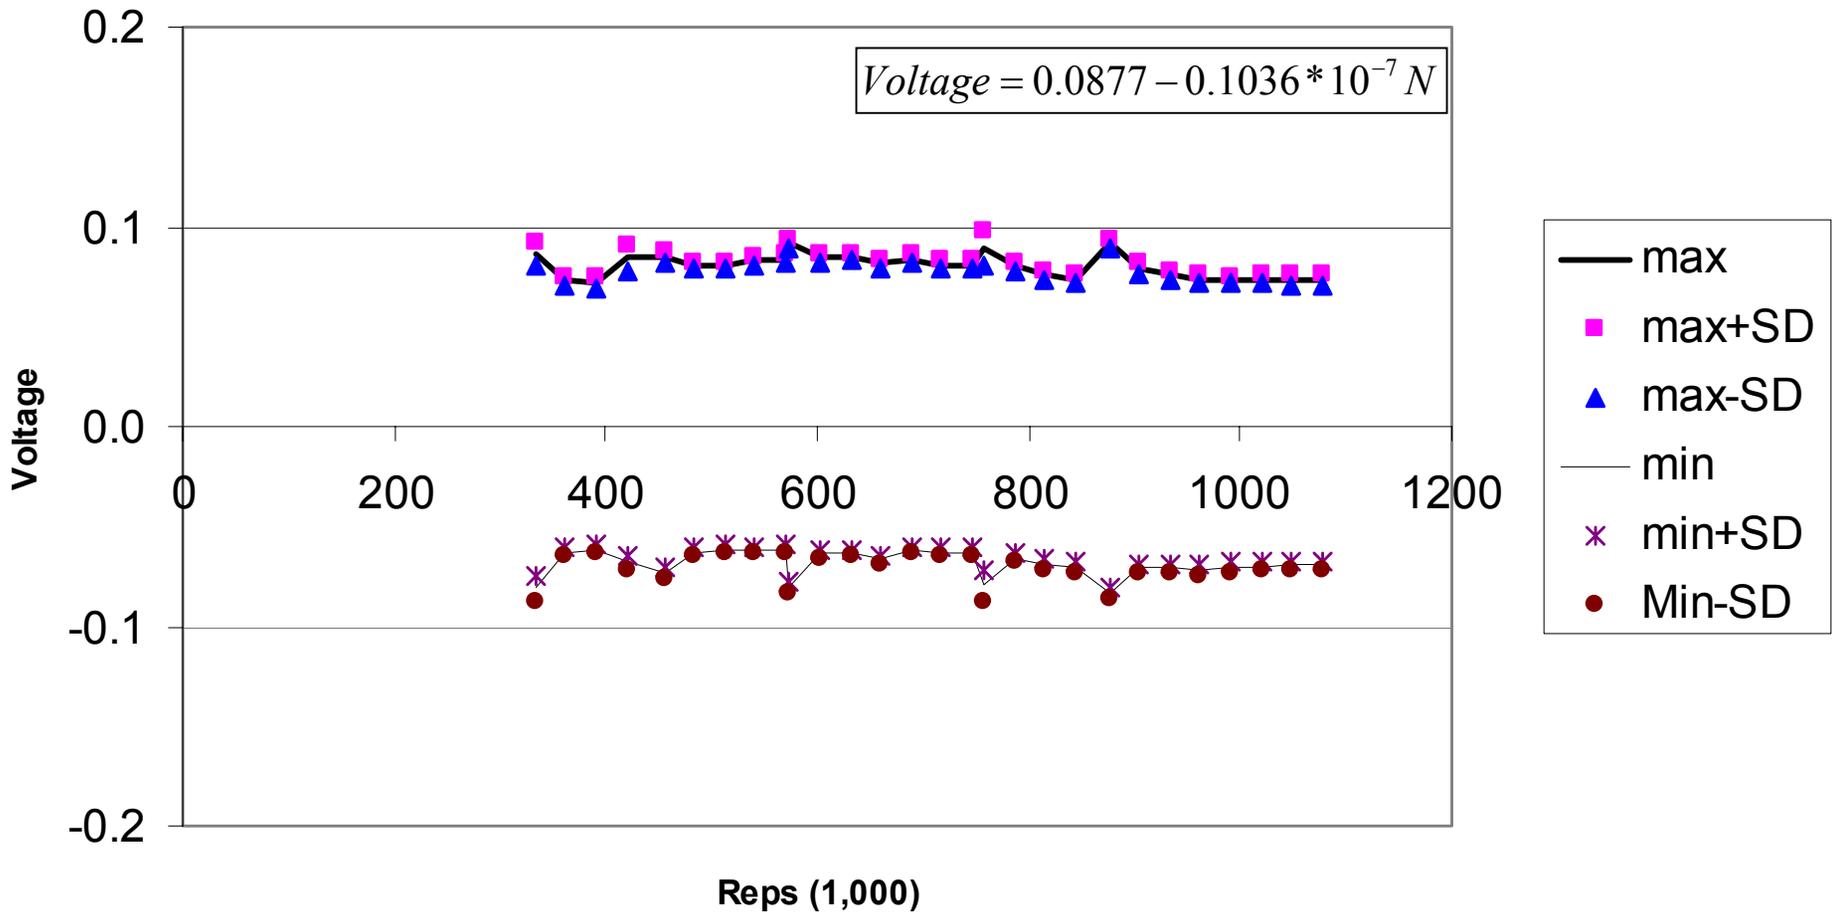
VC-encapsulated; 860 kPa, Wet

Manufacturer A- Encapsulated

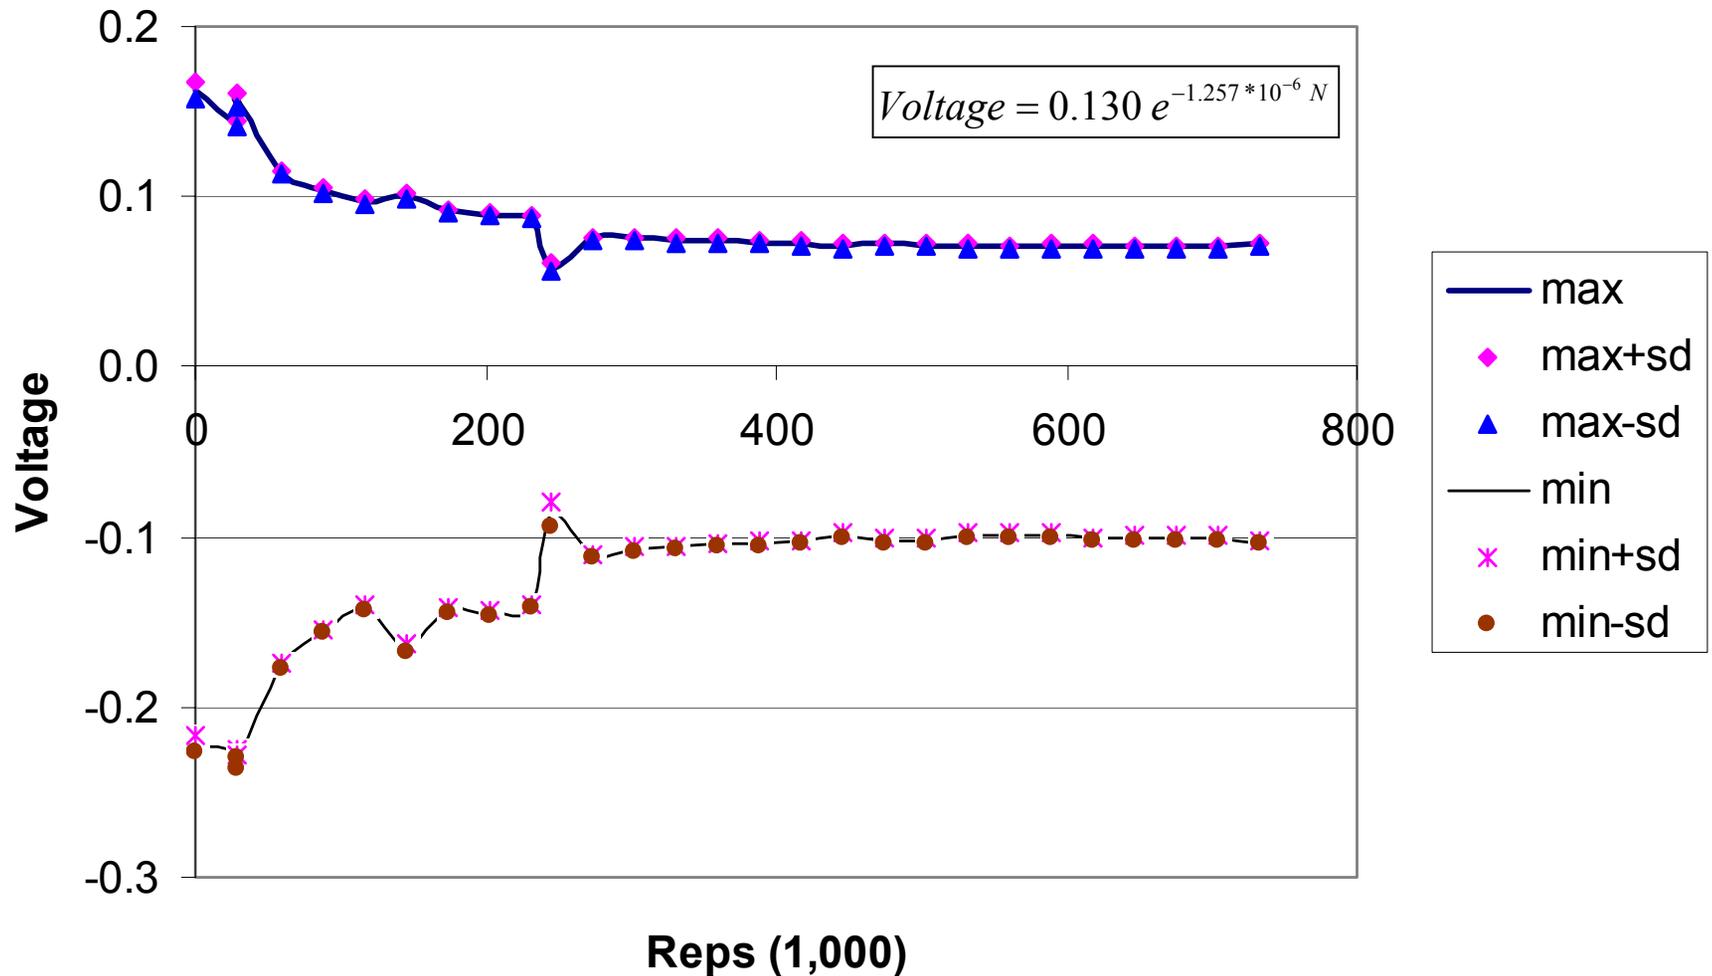
MSI-encapsulated; 860 kPa, Wet

Manufacturer B- Encapsulated

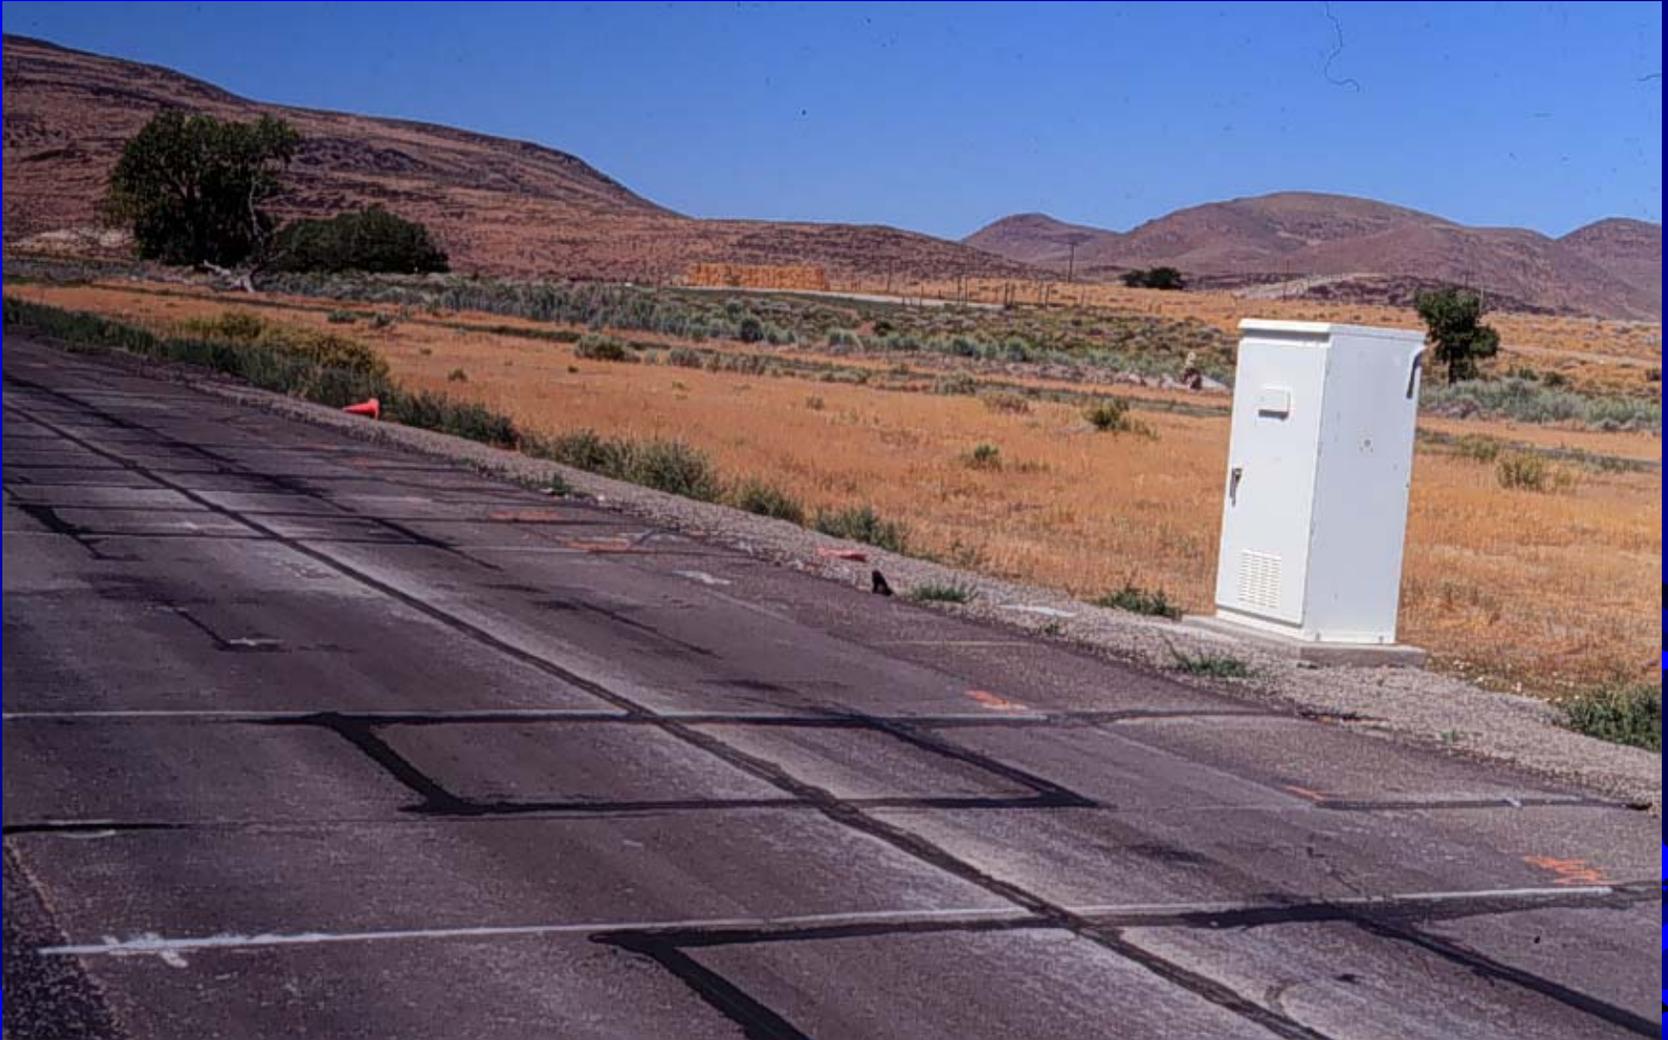
WesTrack Installation:

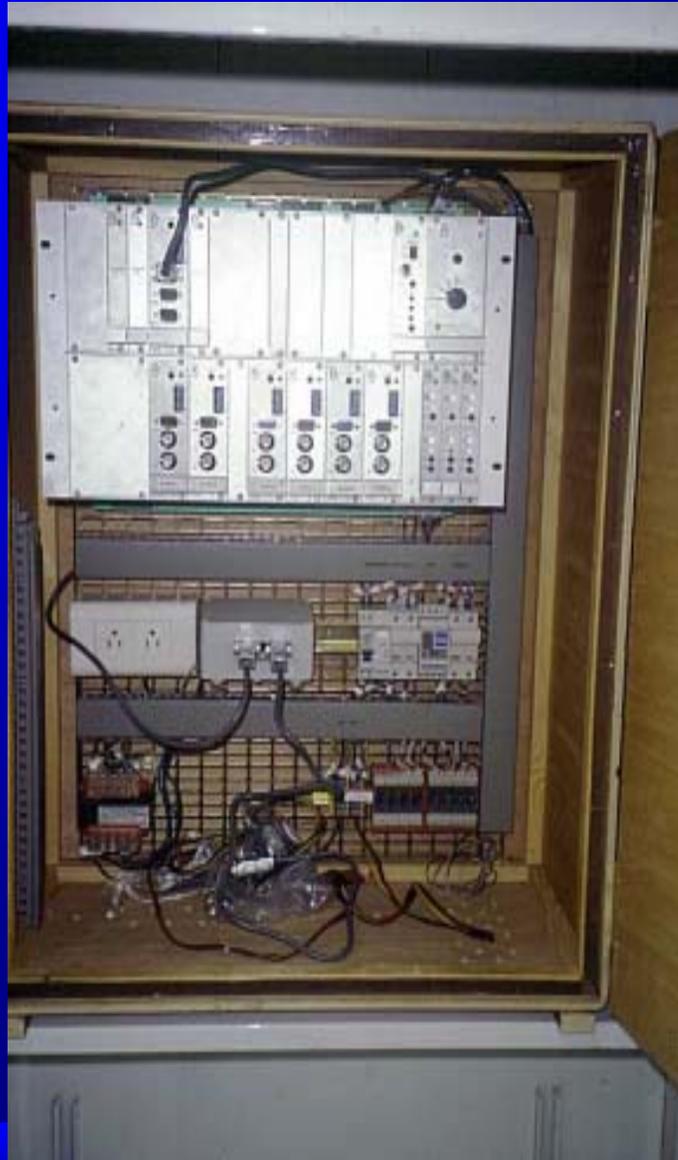
Hestia Data Acquisition System

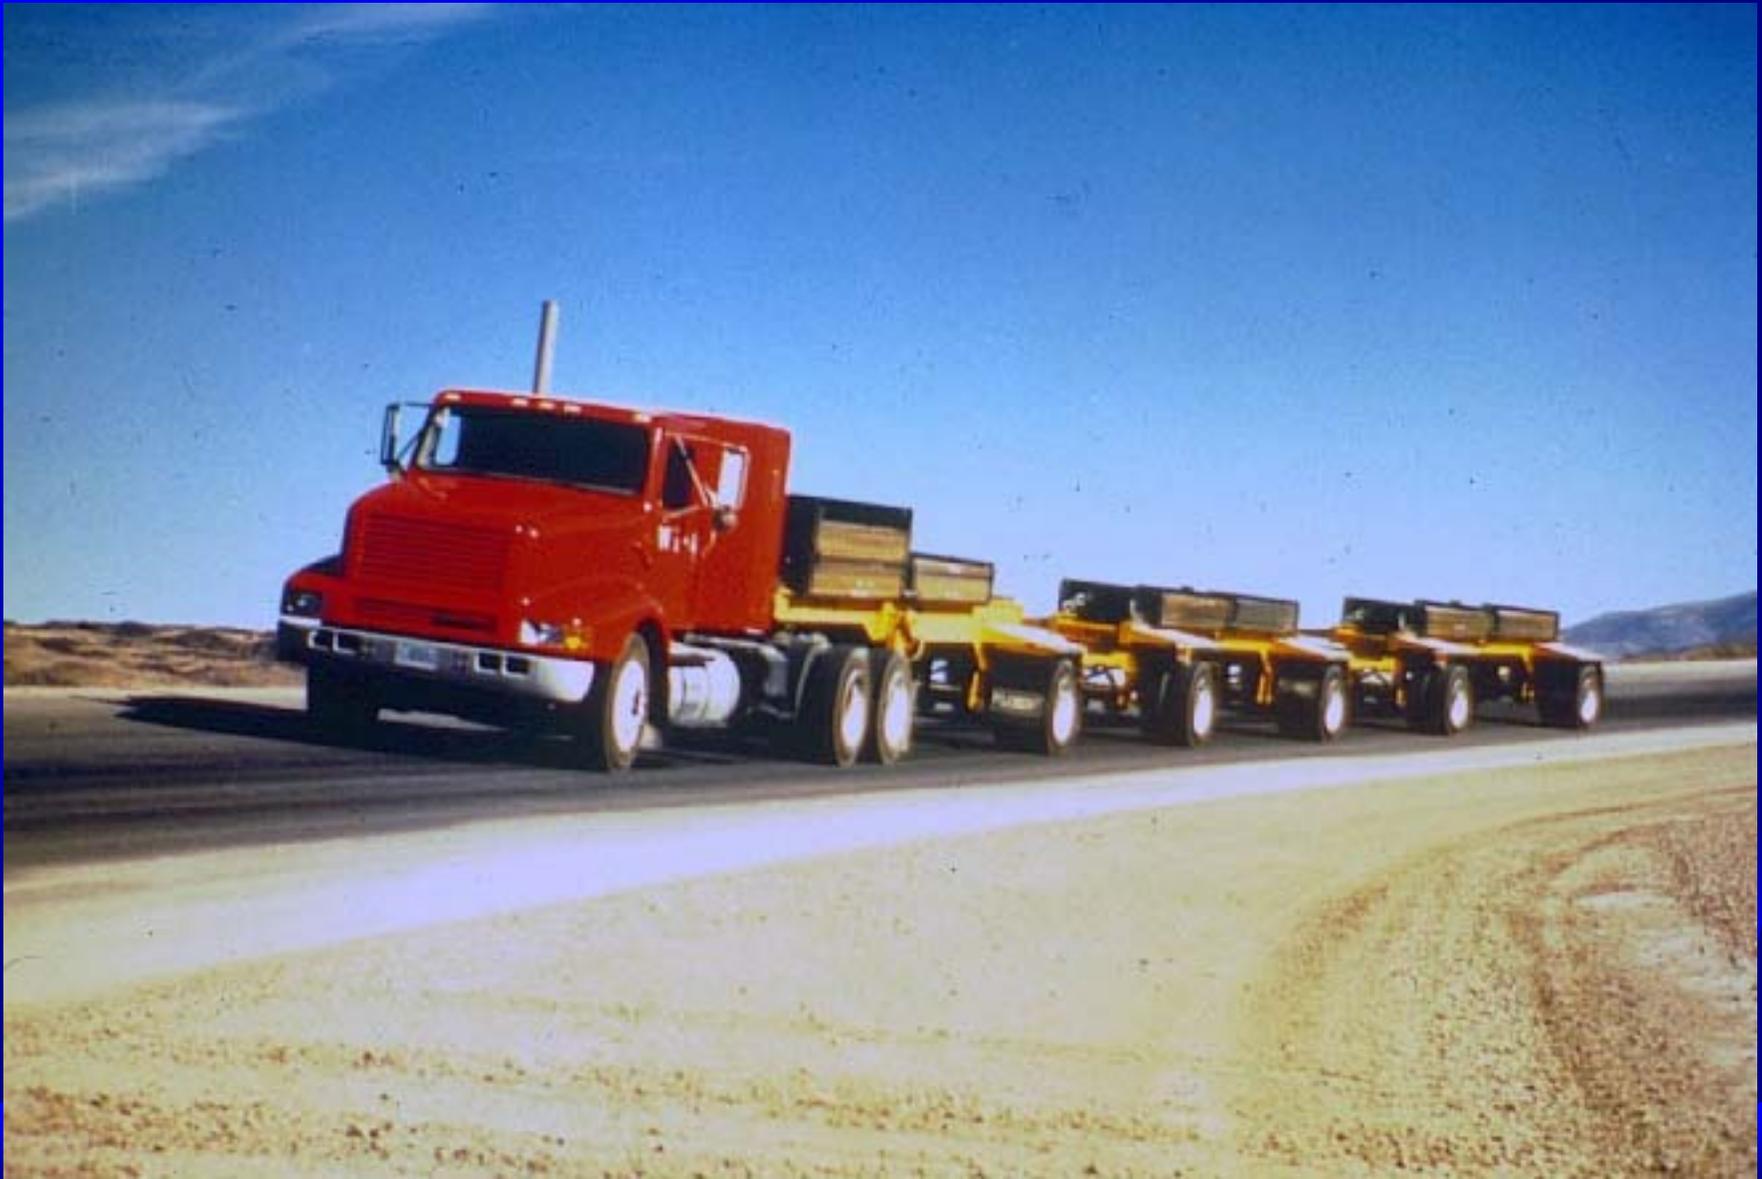
WesTrack Vehicle: 7x89 kN axles

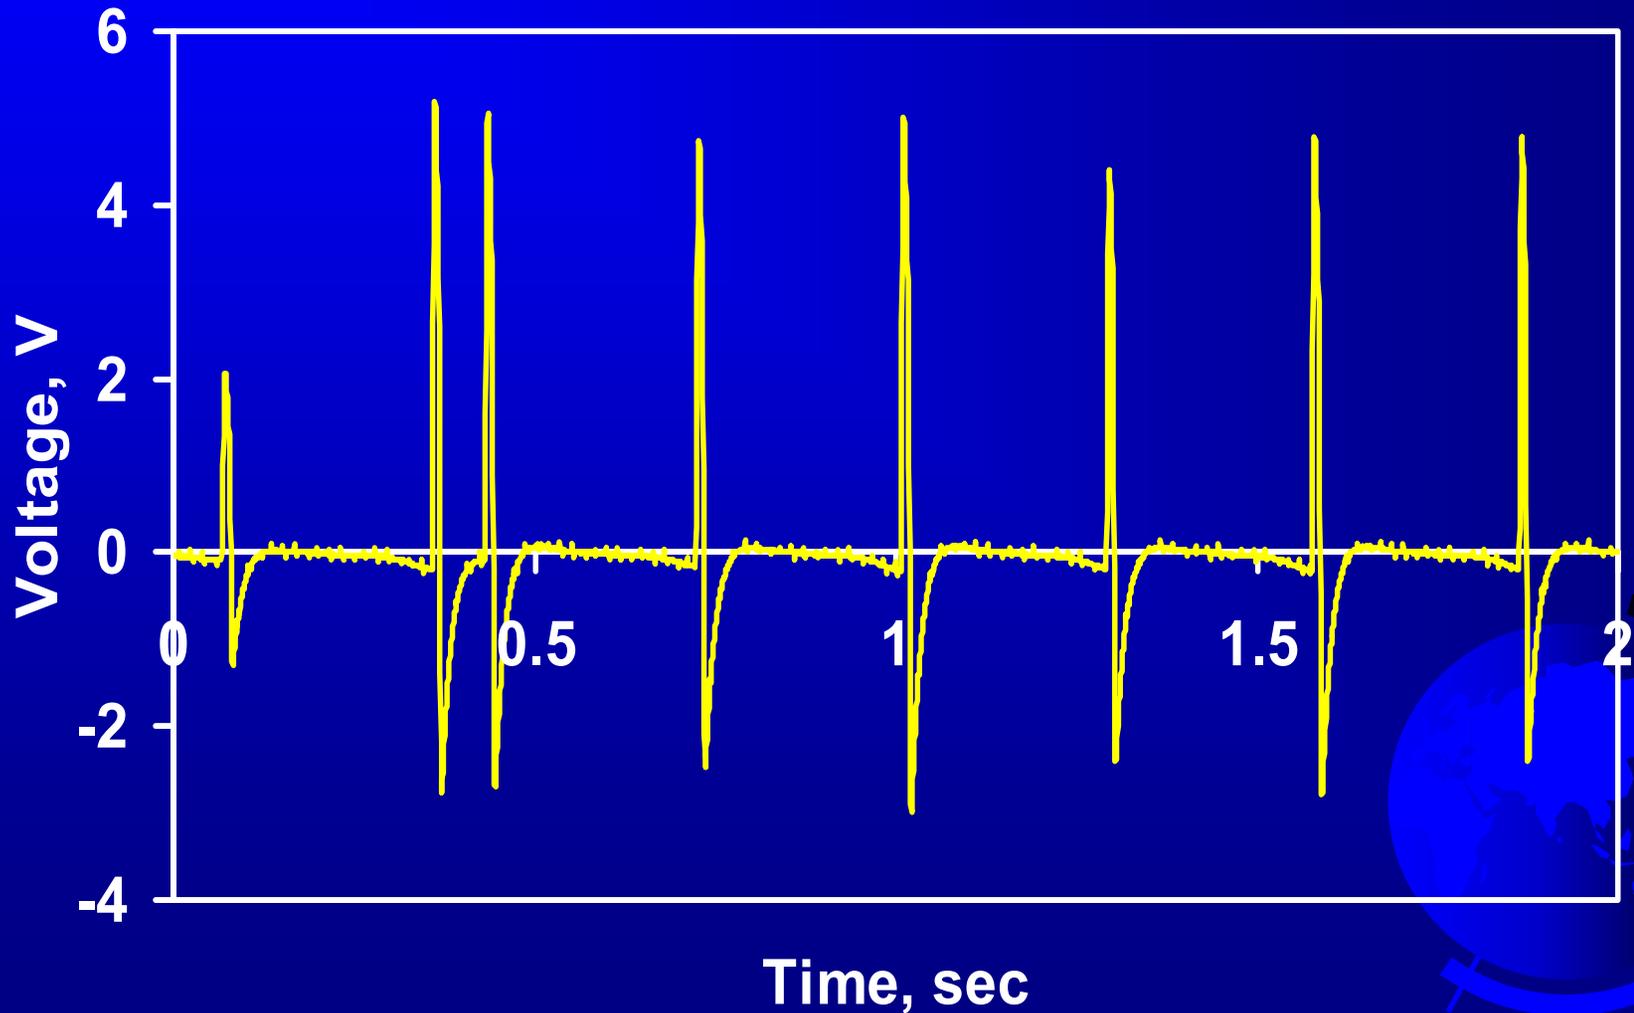
Raw Signal Example; MSI

Sensor 11 Roadtrax BL, 12/18/98

- Raw signal was very precise over the short-term but appeared to be temperature sensitive. For increasing temperature:
 - it decreased for the VC sensors, while,
 - it increased for the MSI sensors.
- Fine-tuning the raw signal reduction routine in the DAQ to compute WIM weight required several iterations.
- After fine-tuning, WIM data was very precise.

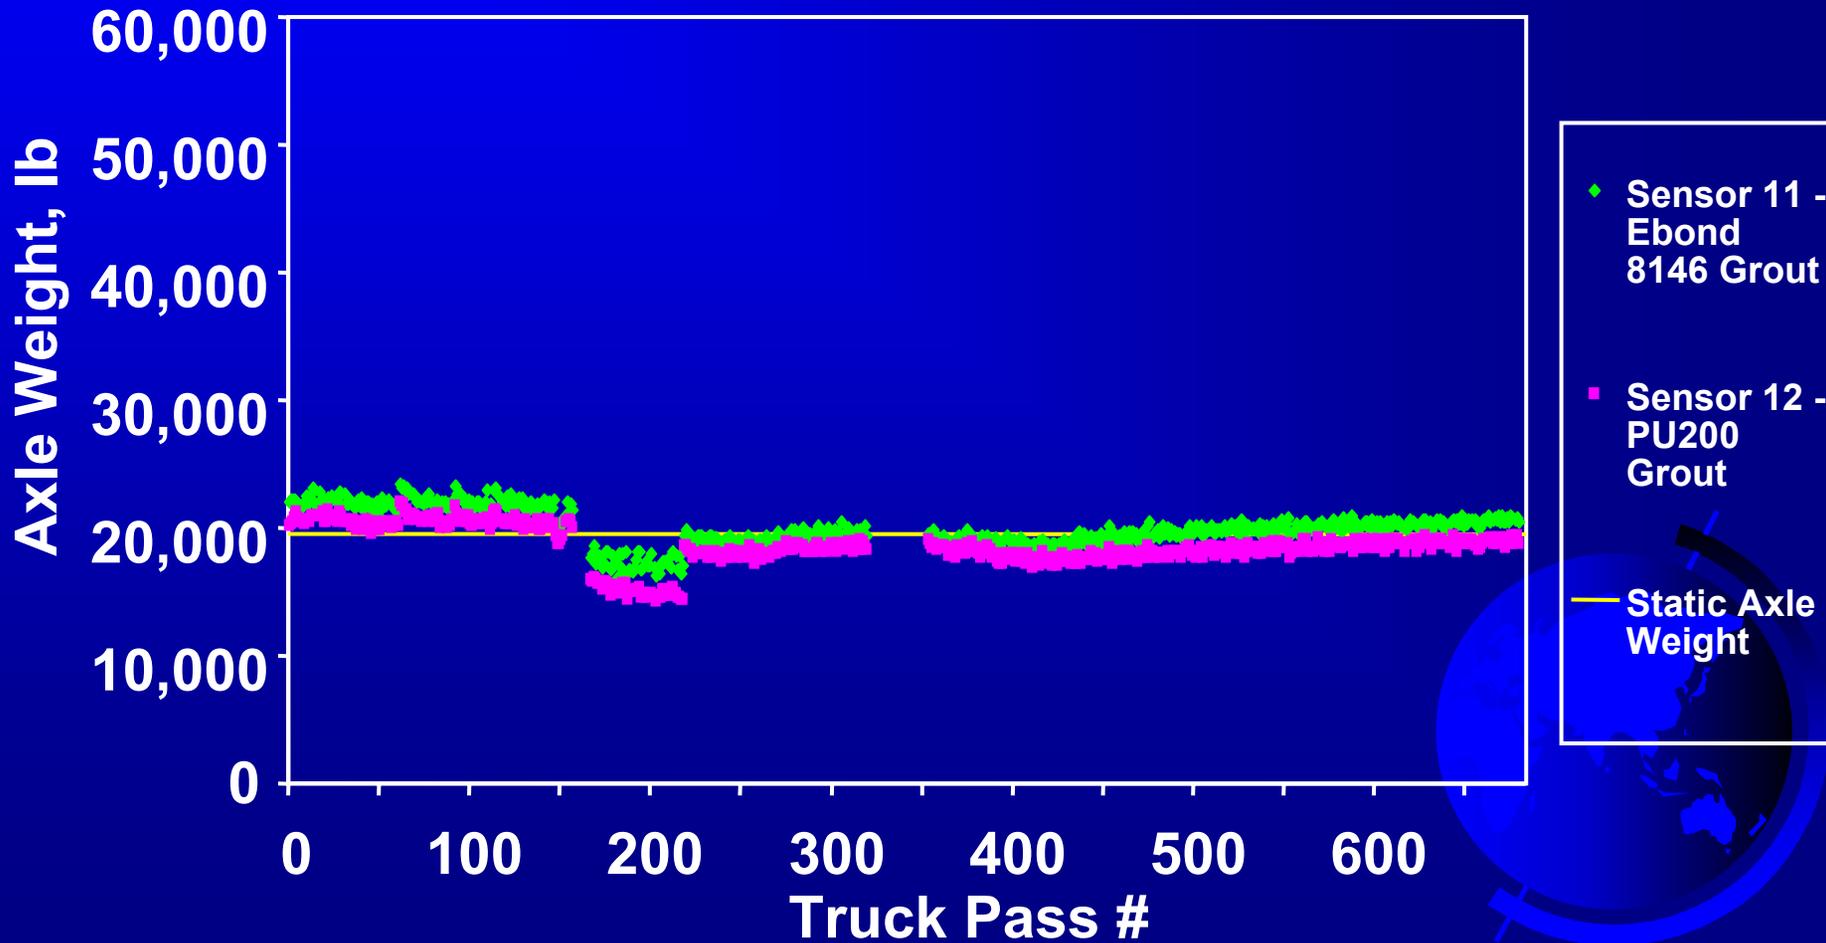
WIM Measurement Example, MSI

WIM Measured Axle 3 Weight, Roadtrax BL

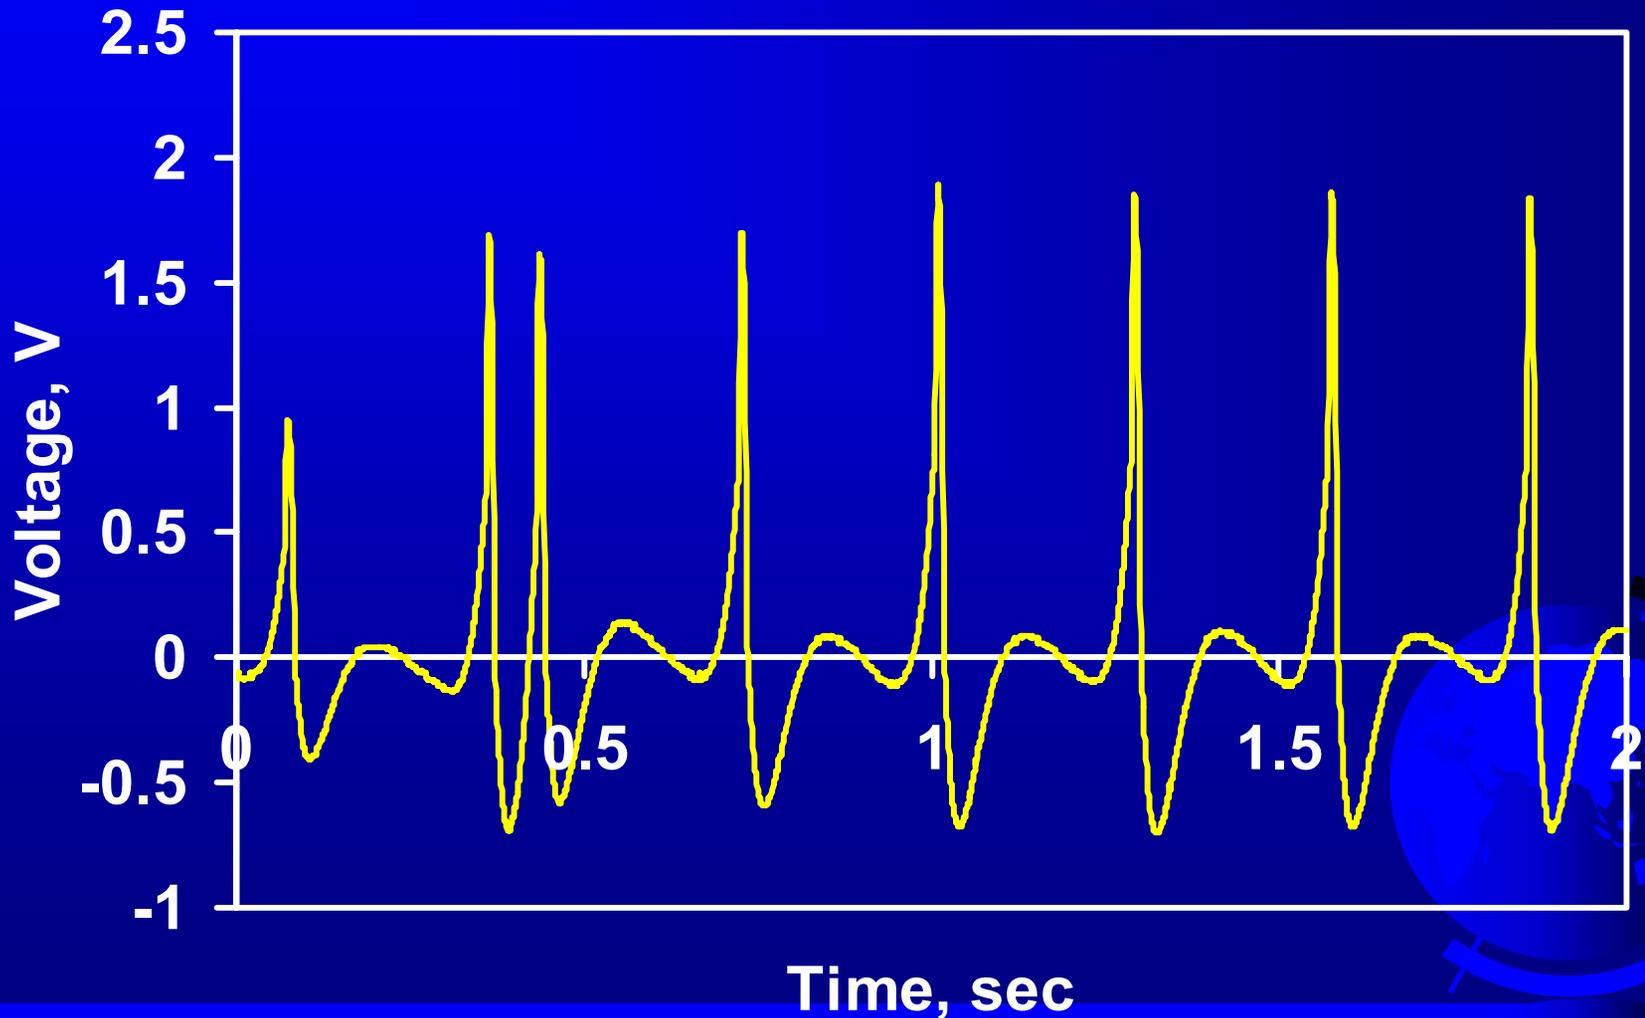
Raw Signal Example, VC

Sensor 1 Vibracoax Bare, 12/17/98

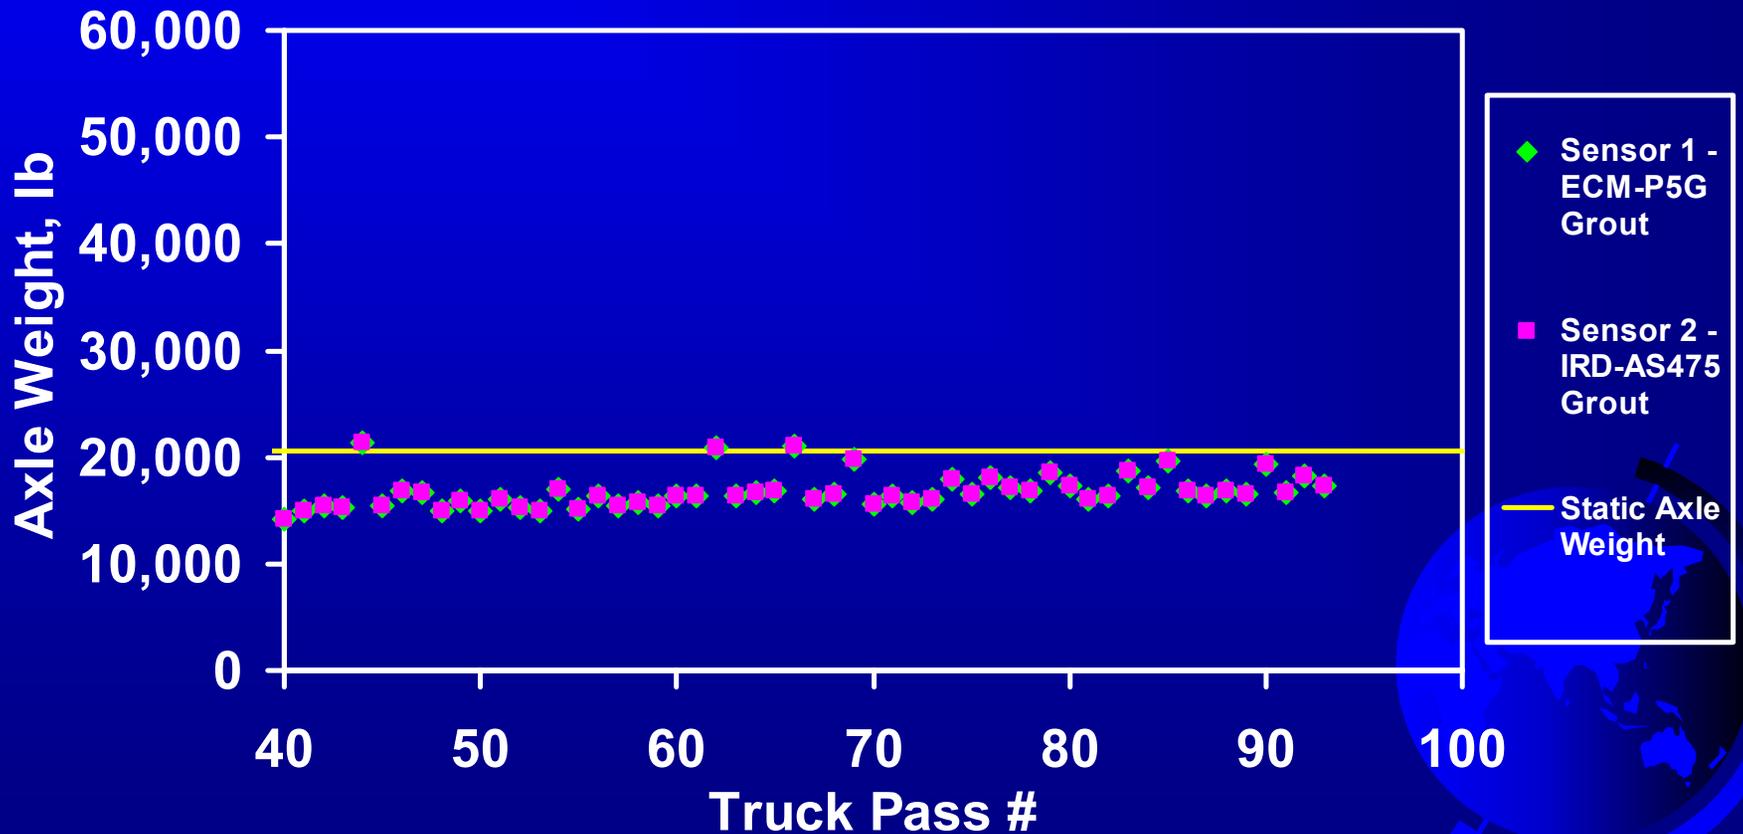
WIM Measurements Example; VC

WIM Measured Axle 2 Weight, Vibracoax 3mm Bare
(After Hestia Adjustment)

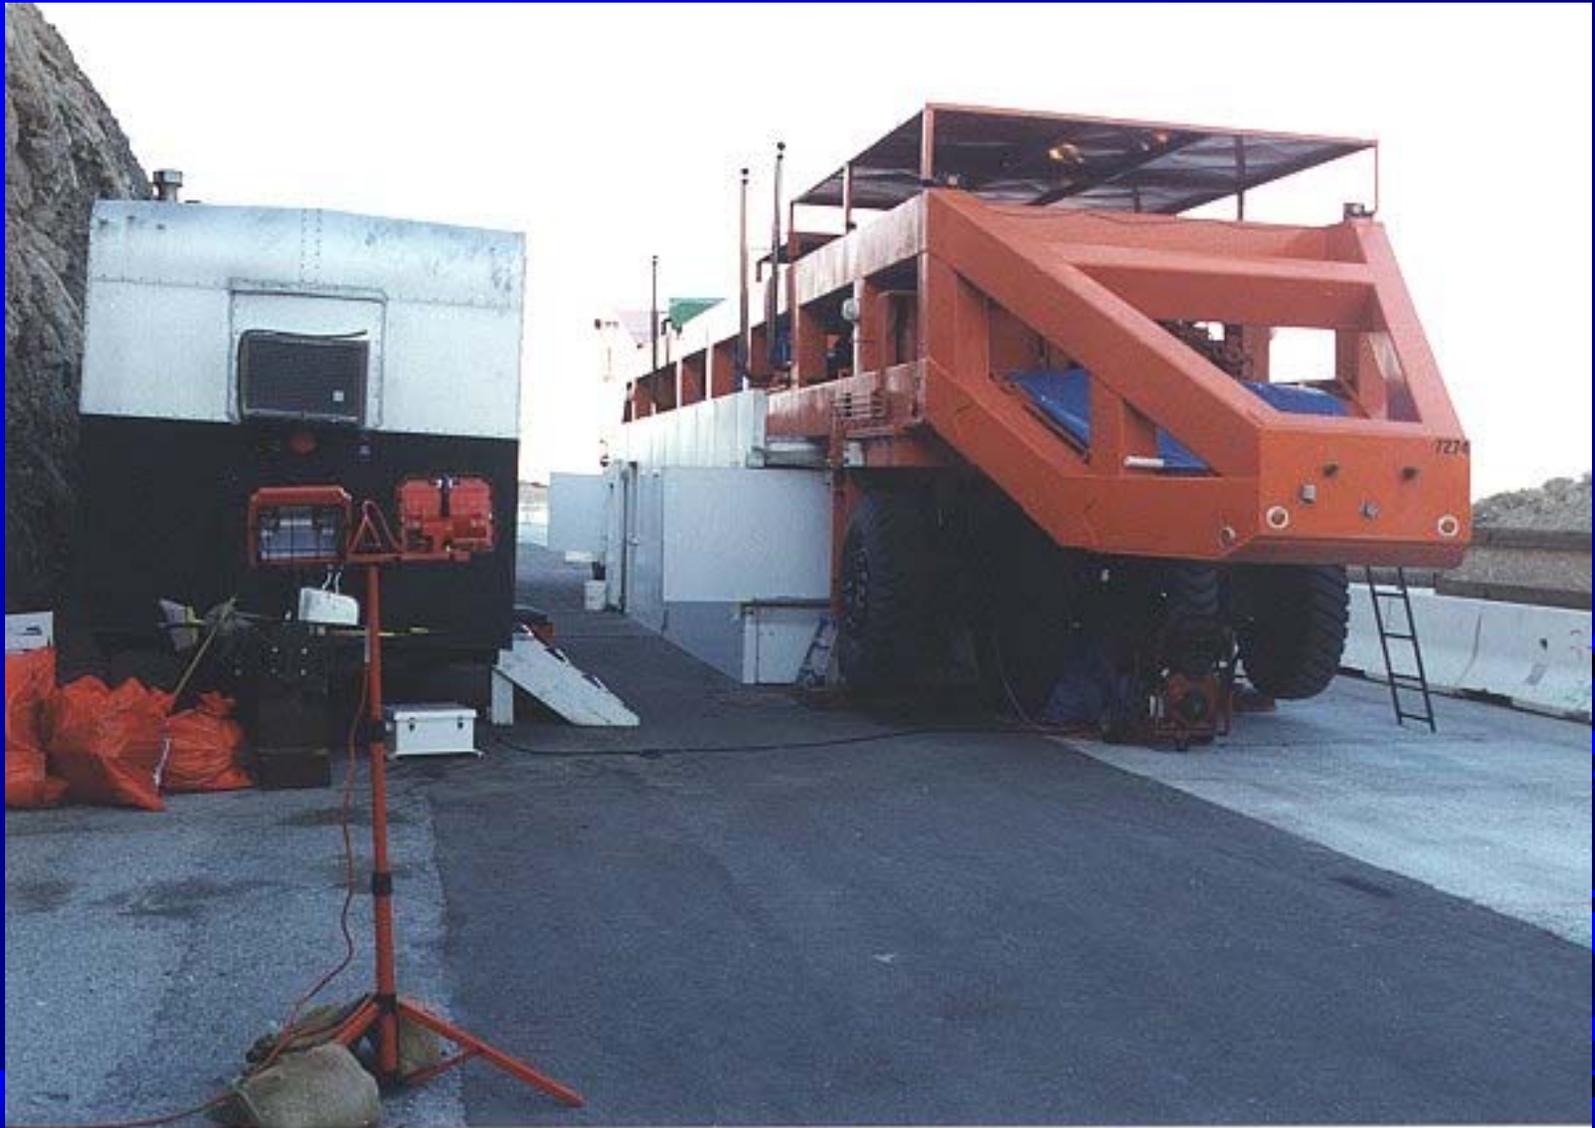
The HVS:

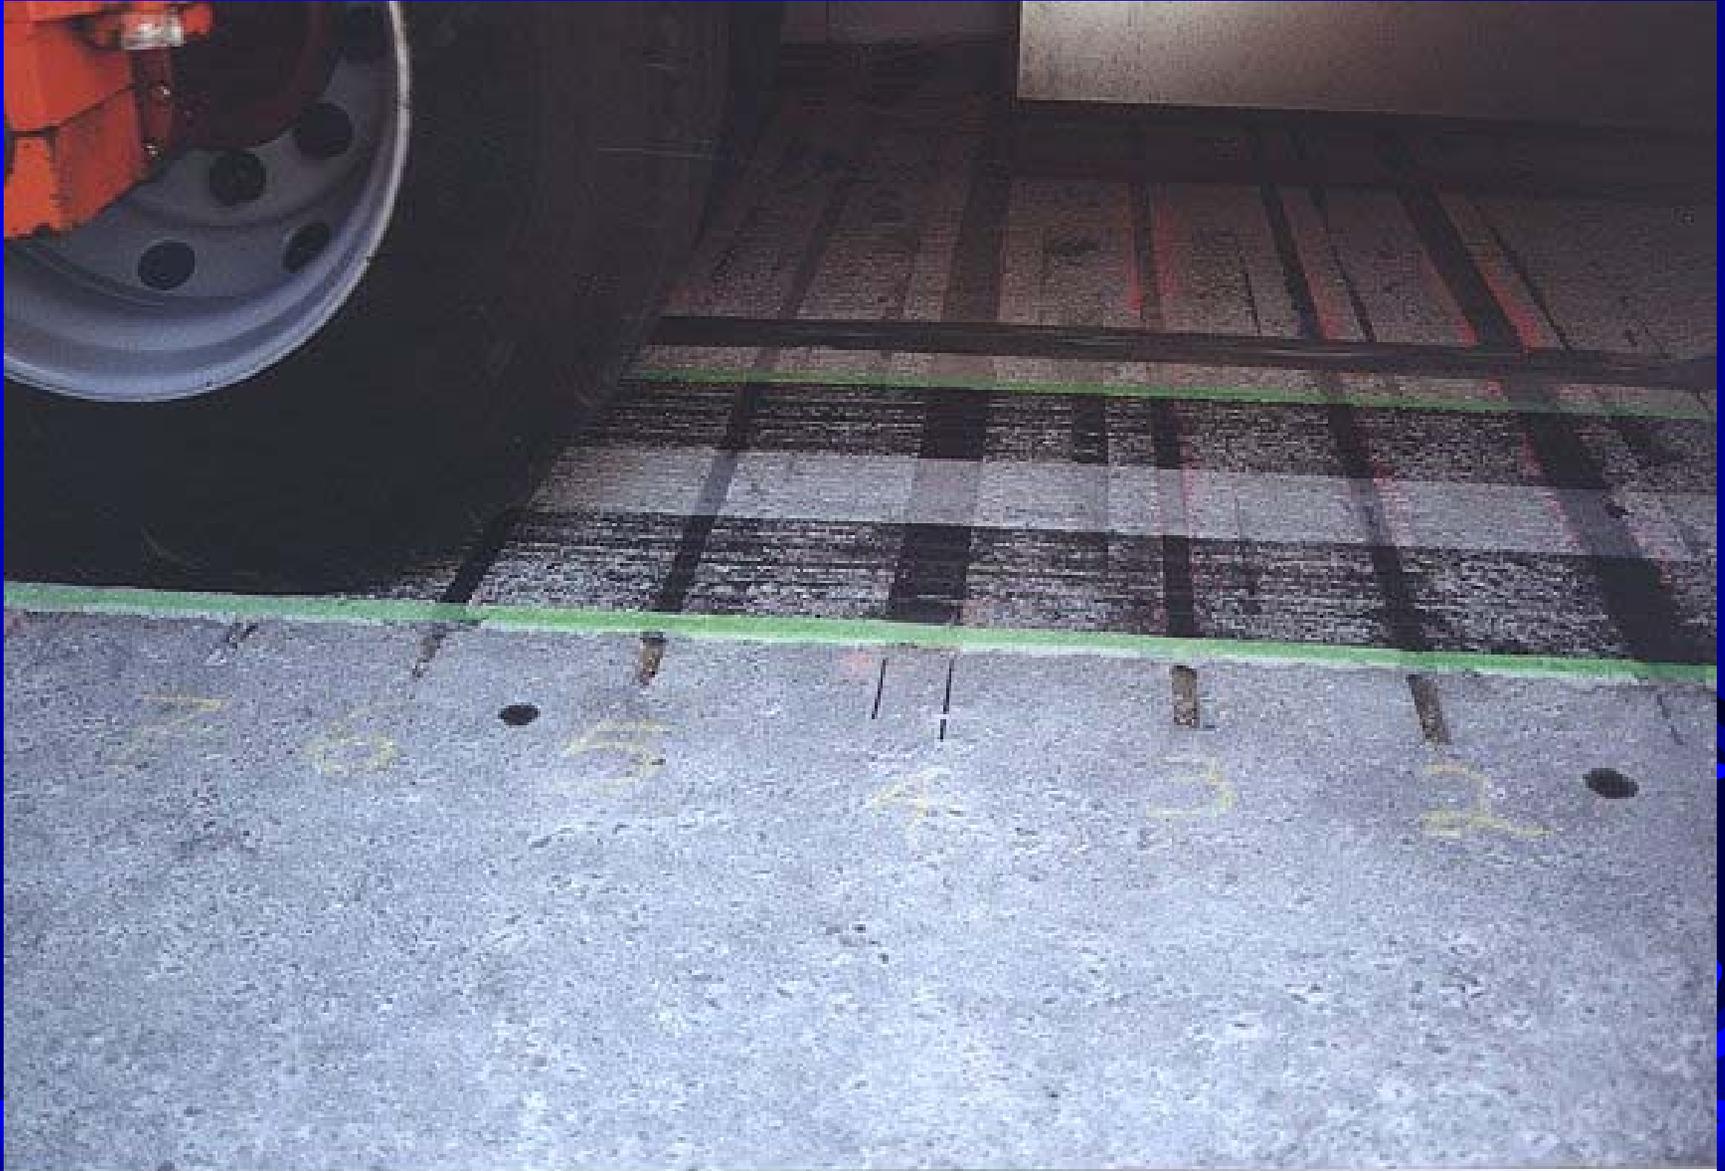
Sensors under HVS loading:
