Laboratory and Field Evaluation of Piezoelectric WIM Sensors

ICWIM 3, Orlando

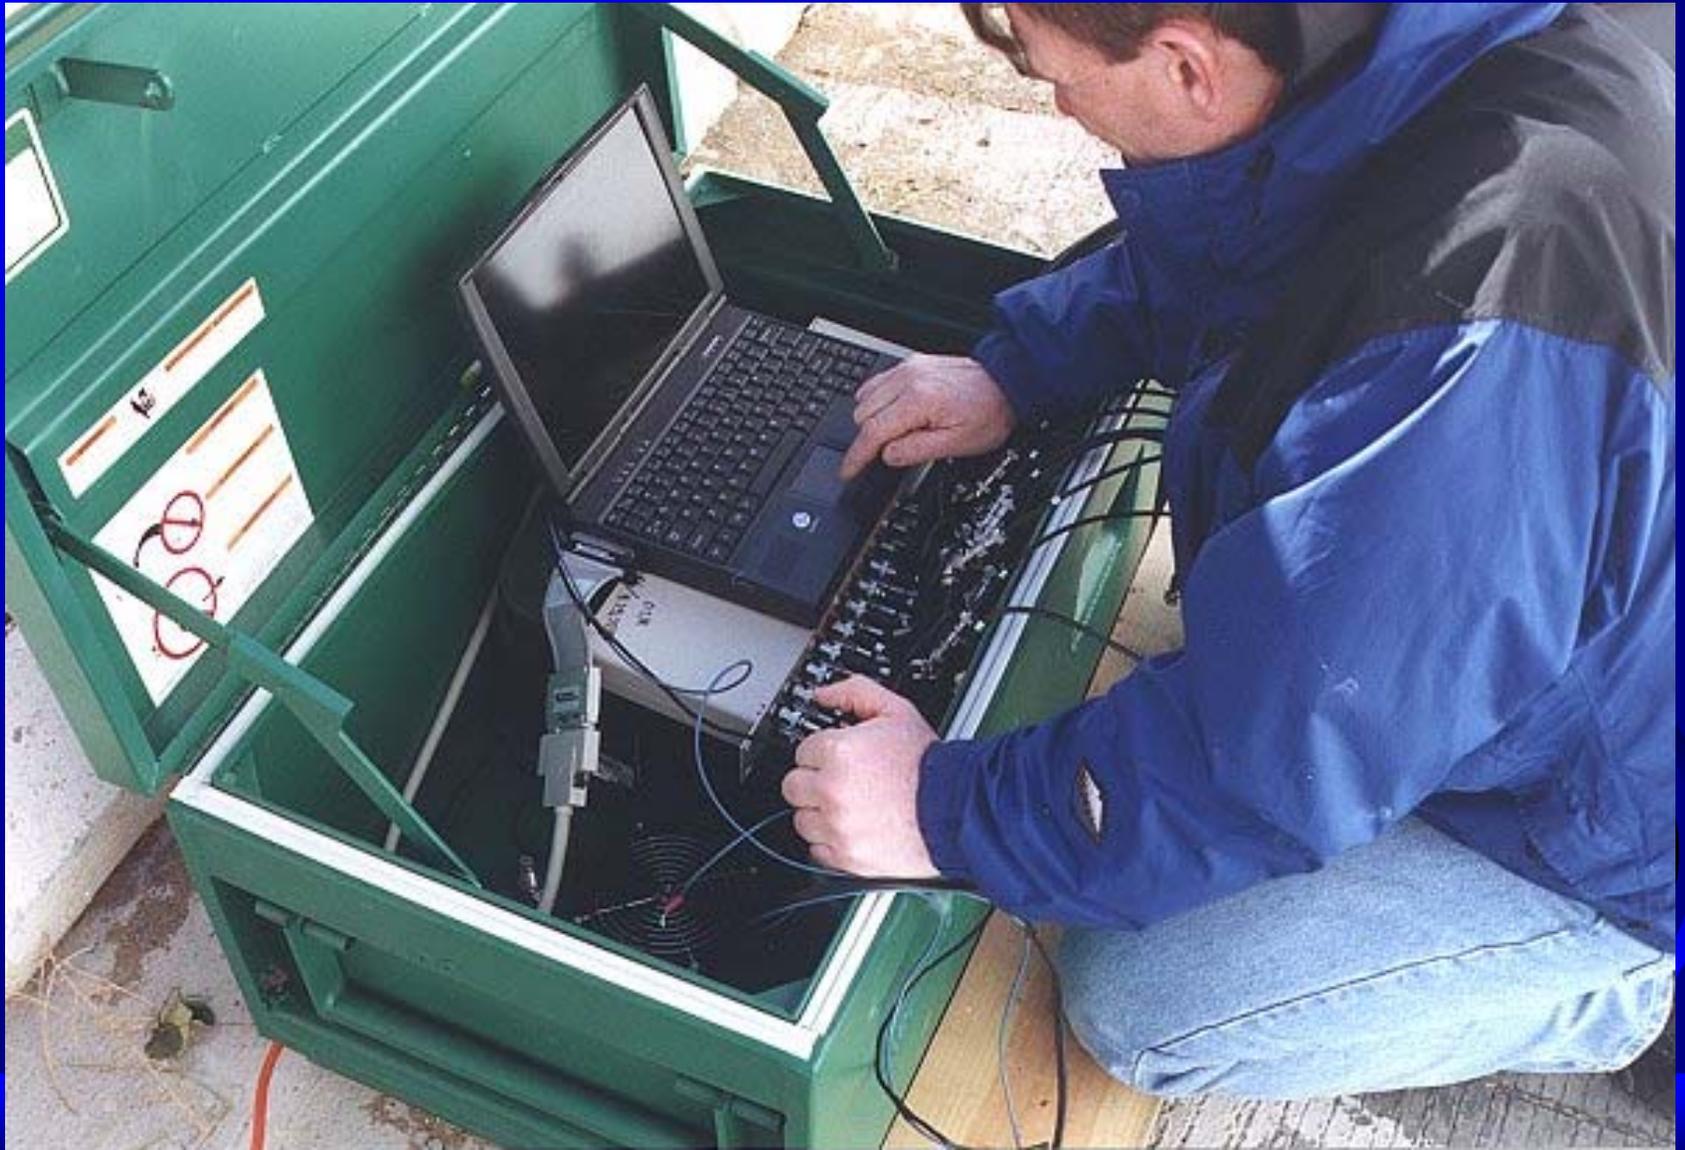
The Data Acquisition System
