## XI. ON-BOARD SYSTEMS: 2002-03 OPERATIONS

### REAL-WORLD TESTING

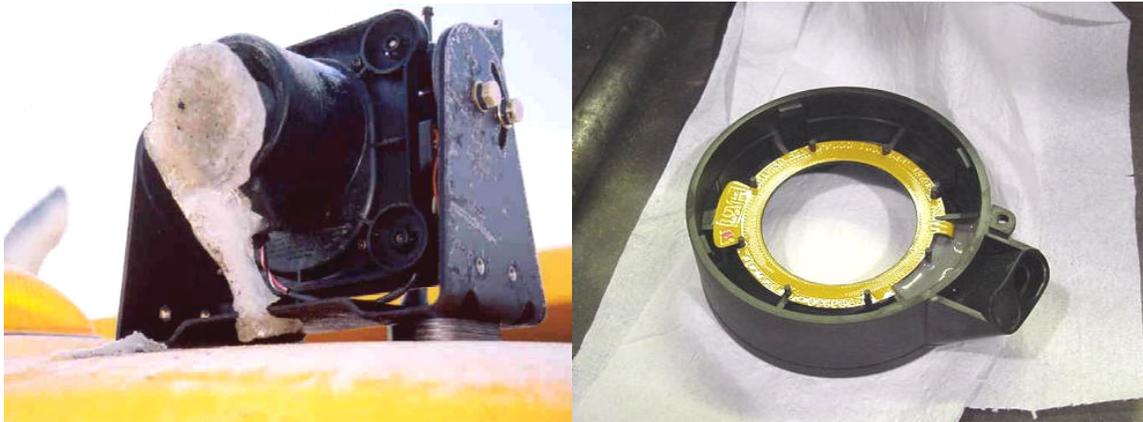
**Figure 24. Freeze, Thaw, and Refreeze: the Camera Window Heating Element**

The primary problem had to do with the lens heater element, as the single biggest complaint was snow being packed into the lens of the camera. While the drivers expected to clean the infrared camera whenever they stopped to clean their wipers and lights, they also expected the heater to be effective. On some plow routes there were few opportunities to pull off safely to clean the IR camera – which was masked by snow more rapidly than the driving lights and wiper blades.

With regard to the heater performance, the two new off-the-shelf XVision units did not seem to have problems as frequently as did the F235 prototype, for which Bendix exchanged several heating elements over the winter season. On occasion the lens temperature was measured at over 110 degrees (F), but at other times the drivers said it simply would not heat up to the touch. As shown in Figure 24, the heater did melt snow that built up within the recessed lens barrel, but it was unable to keep up with rapid accumulations. This picture also shows the threat of ice buildup to the exposed camera wiring.

The source of the problem was not identified, but it may have been the calibration of individual thermostats or the capacity of the heating element. The larger issue was the combination of cold, moisture and wind effects, which were more than the heater unit could effectively deal with. Driving into the wind in an oncoming storm aggravated the problem, and driving with the wind reduced it somewhat. The moisture level of the snow and the wind speed and direction were other significant factors. Slush spray from the plow blade was also a key problem area.

Other issues with the system were also generally related to the design of the camera window and lens barrel assembly. As Figures 19 and 24 show, the lens window is recessed, which creates a pocket for snow to quickly accumulate. Road film may also accumulate there; Figure 19 shows a gradual buildup of deicing chemical on the silicon disk of the lens window. The focal length of the XVision camera is approximately 80 feet, so dirt and bug parts do not block the image, but the lens pocket design seems to collect airborne material. ADOT drivers also reported problems in the rain; they experimented with commercial dispersant products but saw little improvement.
