XIII. DEFERRED RESEARCH TASKS: RESOLUTIONS

OTHER GOALS: SMARTCRUISE BY EATON VORAD

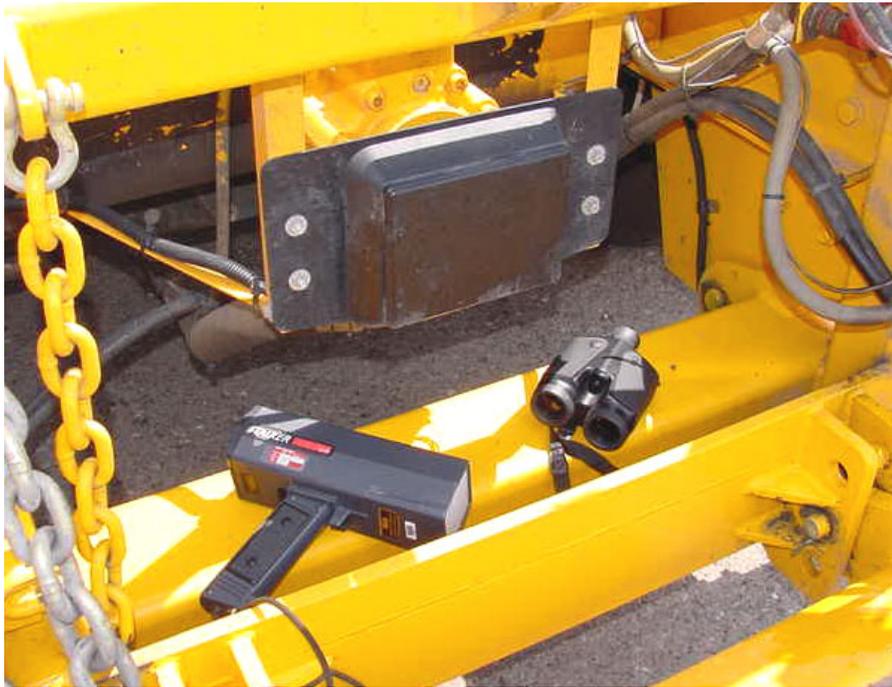
Figure 25. SmartCruise Antenna and Hand-Held Test Equipment

ATRC staff received valuable support from TAC members for the tests, including the Flagstaff District of the DPS, which provided a Stalker speed radar gun to verify both the snowplow and target vehicle travel speeds. ATRC obtained a Bushnell Lytespeed 400 Infrared rangefinder from ADOT Natural Resources to confirm the target distances.

The Flagstaff Shop provided its ProLink portable diagnostic system as the primary in-cab tool to display real-time SmartCruise performance data from the EVT-300's onboard computer. The hand-held systems provided crucial backup data when the ProLink unit failed during the testing.

The ATRC used the ProLink display to record the EVT-300's speed and distance measurements, and also confirmed them with the hand-held radar gun and rangefinder. This was eminently

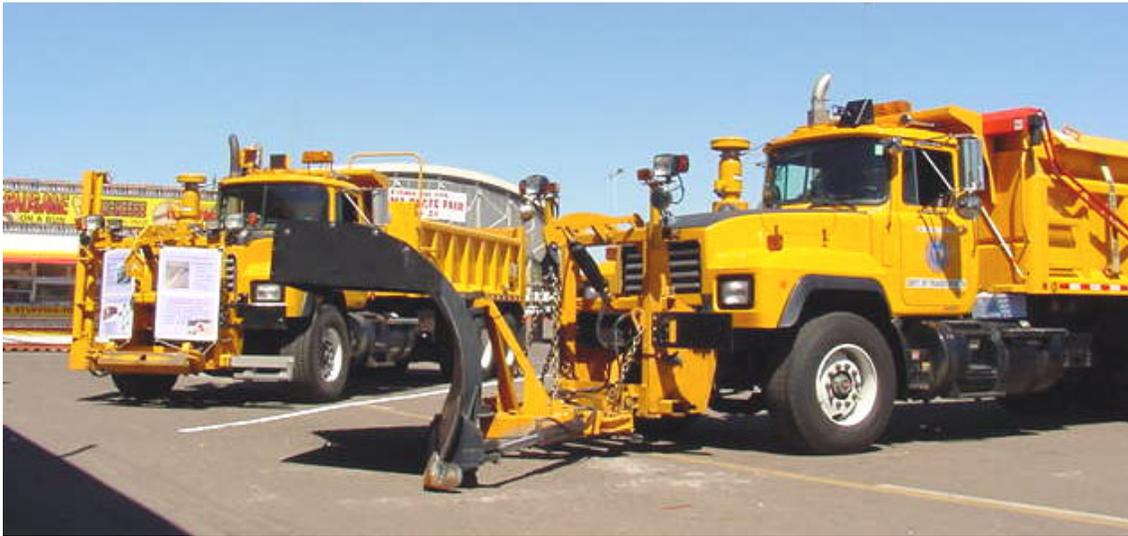
Figure 26. Gray Mountain and Kingman Plows: ADOT Equipment Roadeo

Two of the project's research snowplows were also exhibited during the Rodeo, as shown in Figure 26. Snowplow F277 was driven down from Kingman to display the XVision system. The second plow was F342 from Gray Mountain, equipped with both the EVT-300 radar and the 3M tape guidance system. ATRC also laid out 80 feet of magnetic tape to illustrate Lane Awareness System concepts to the event visitors.

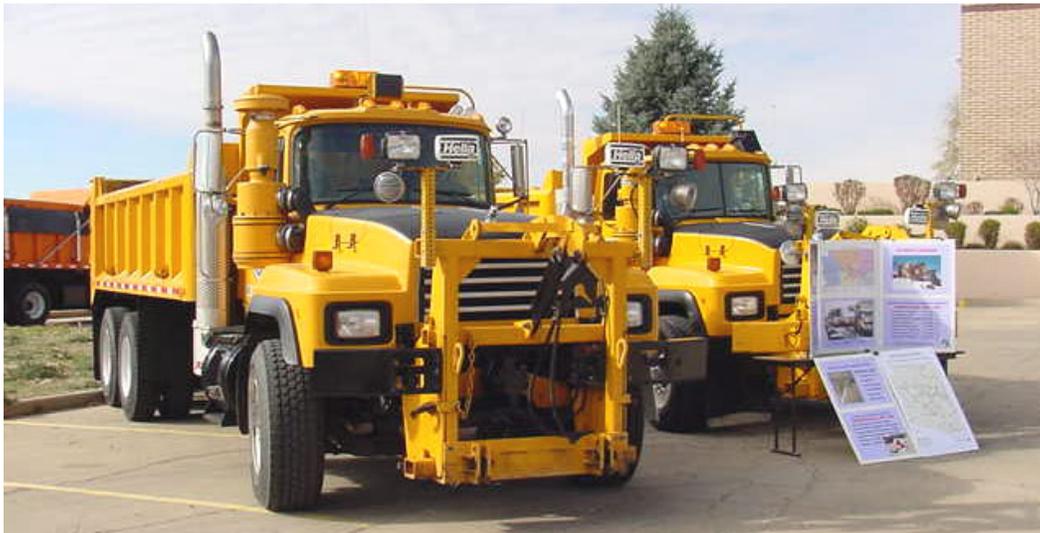
Figure 27. Chambers and Winslow Plows: Four Corners Conference

The second significant outreach event was the annual Four Corners Maintenance Conference, held in Cortez, Colorado in early November. The ADOT Holbrook District was the conference host for 2003. As a core partner in this research project, the district provided its two research snowplows for the event. These were F269 from Chambers, with the Eaton VORAD CWS radar system, and F340 from Winslow, with the Bendix night vision system.

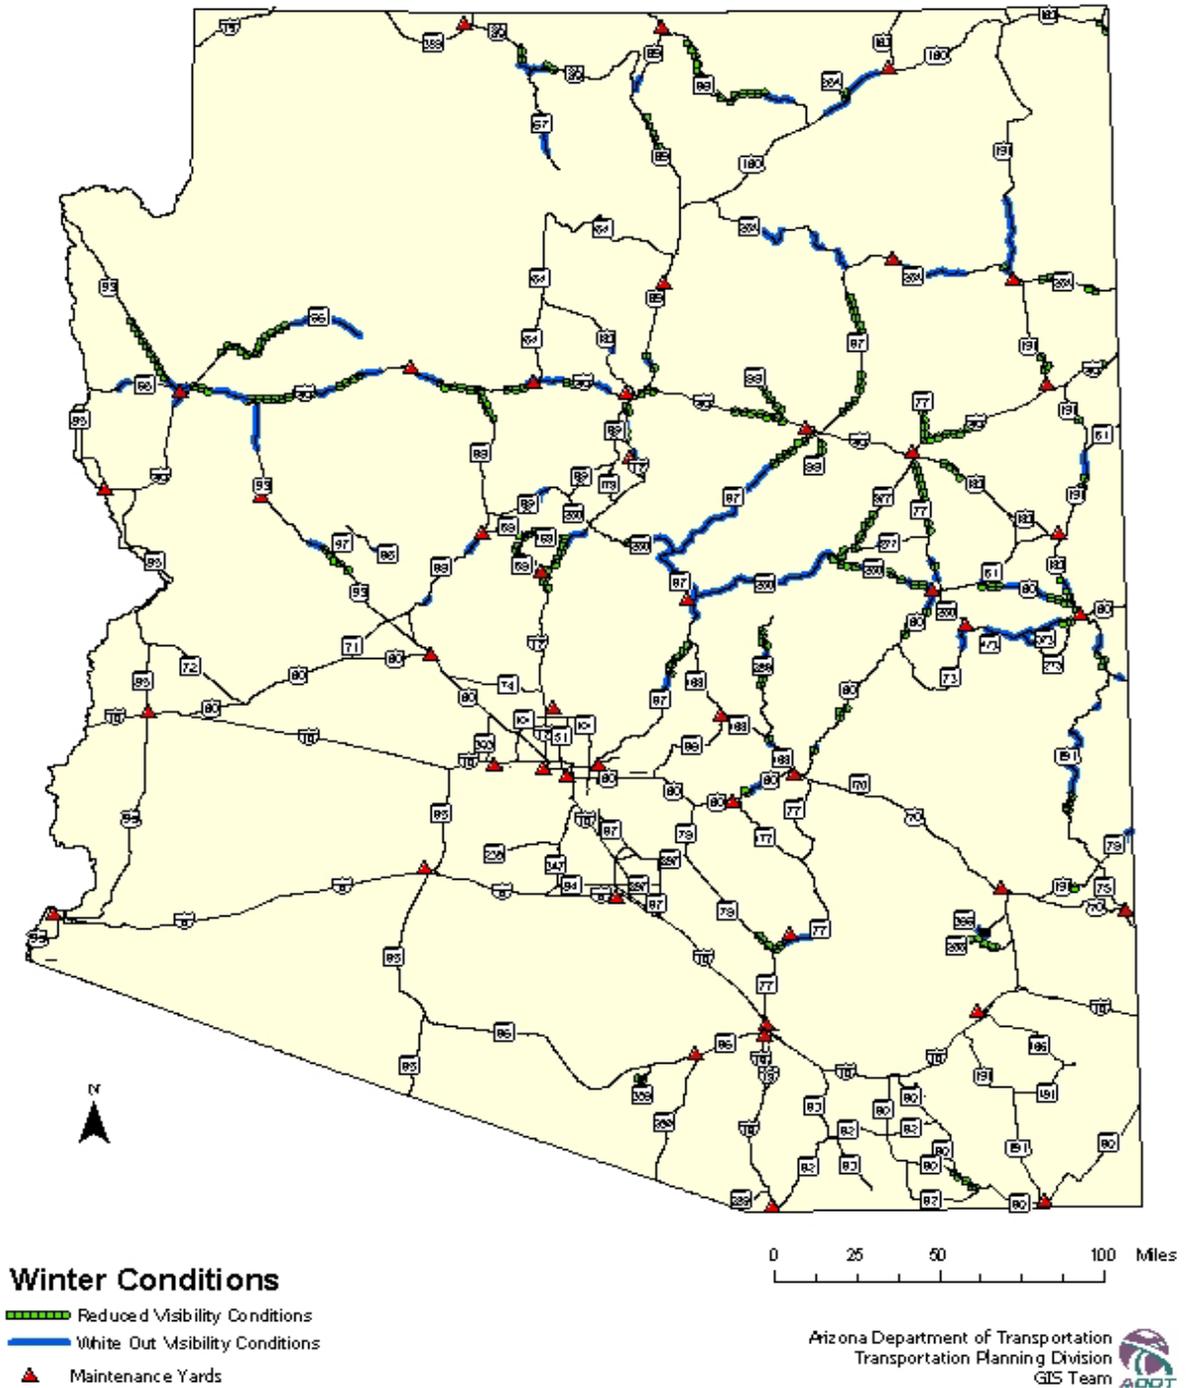
Arizona State Highway System

Winter Conditions Visibility Survey by Route Corridor Miles

Figure 28. Impaired Visibility Snowplow Routes

As noted above, each district was given large maps to help work out their impaired and whiteout visibility zones on each highway corridor in their area. These maps supported the tabulation of the milepost limits for each low-visibility route segment, and the color-coding clearly showed regional trends based on terrain or storm weather patterns as well.

While the scale reduces its clarity, a statewide map (Figure 28) was created to illustrate the extent of the visibility problems for the ADOT snowplow operators across Arizona.

The complete tabular and graphic results of the project's snowplow impaired-visibility survey are included in Appendix K of this report. Both a visibility classification map and a route summary table are provided for each of the ADOT maintenance districts.
