Report No. K-TRAN: KSU-06-6  
FINAL REPORT

## **EVALUATION OF LONGITUDINAL CONSTRUCTION JOINTS ON TRAFFIC OPERATIONS AND SAFETY**

E. Dean Landman  
Sunanda Dissanayake, Ph.D., P.E.  
Vikranth S. Manepalli  
Eugene R. Russell, Professor Emeritus  
Kansas State University  
Manhattan, Kansas

January 2009

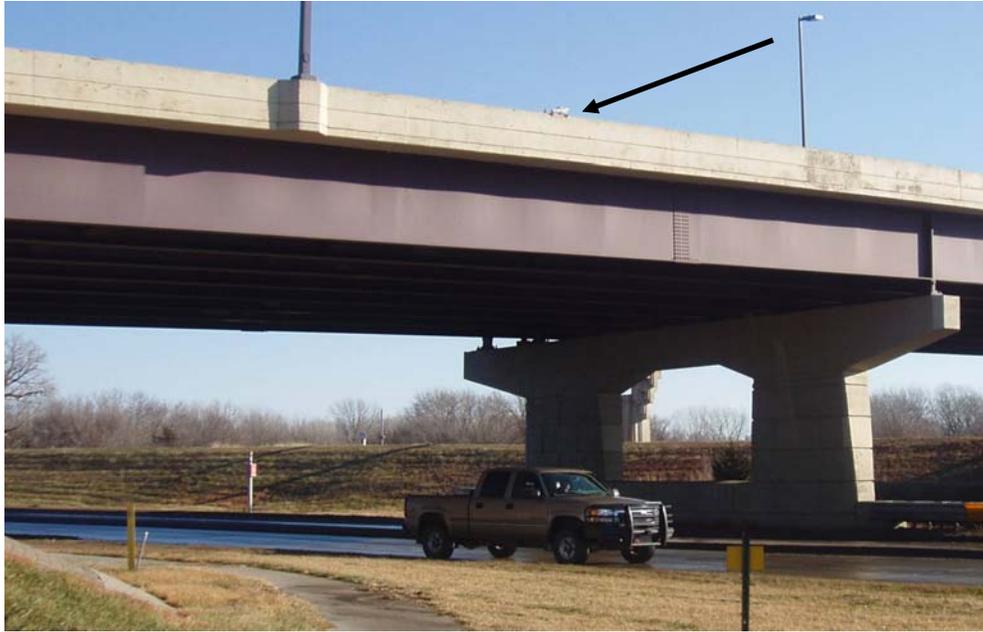
**Figure 4.2: Security Camera on Handrail of Kansas River Bridge**

The observations at Ft. Riley Blvd. were recorded twice, during the project. An outdoor security camera was used to record the vehicles at this location, to conduct a before and after study. The camera was fixed to the handrail of the Kansas River Bridge, near the site. The position of the camera installed on the Kansas River Bridge is shown by an arrow mark in Figure 4.2.

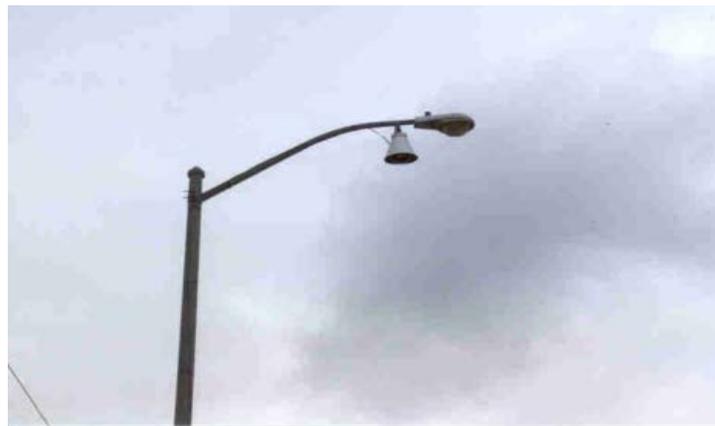
**Figure 4.3: Camera with fish-eye lens mounted on a utility pole at Ft. Riley Blvd**

A camera with a fish-eye lens was also used at the site for recording the observations. It was mounted on a utility pole as shown in Figure 4.3 for capturing the vehicular position/location for longer durations.

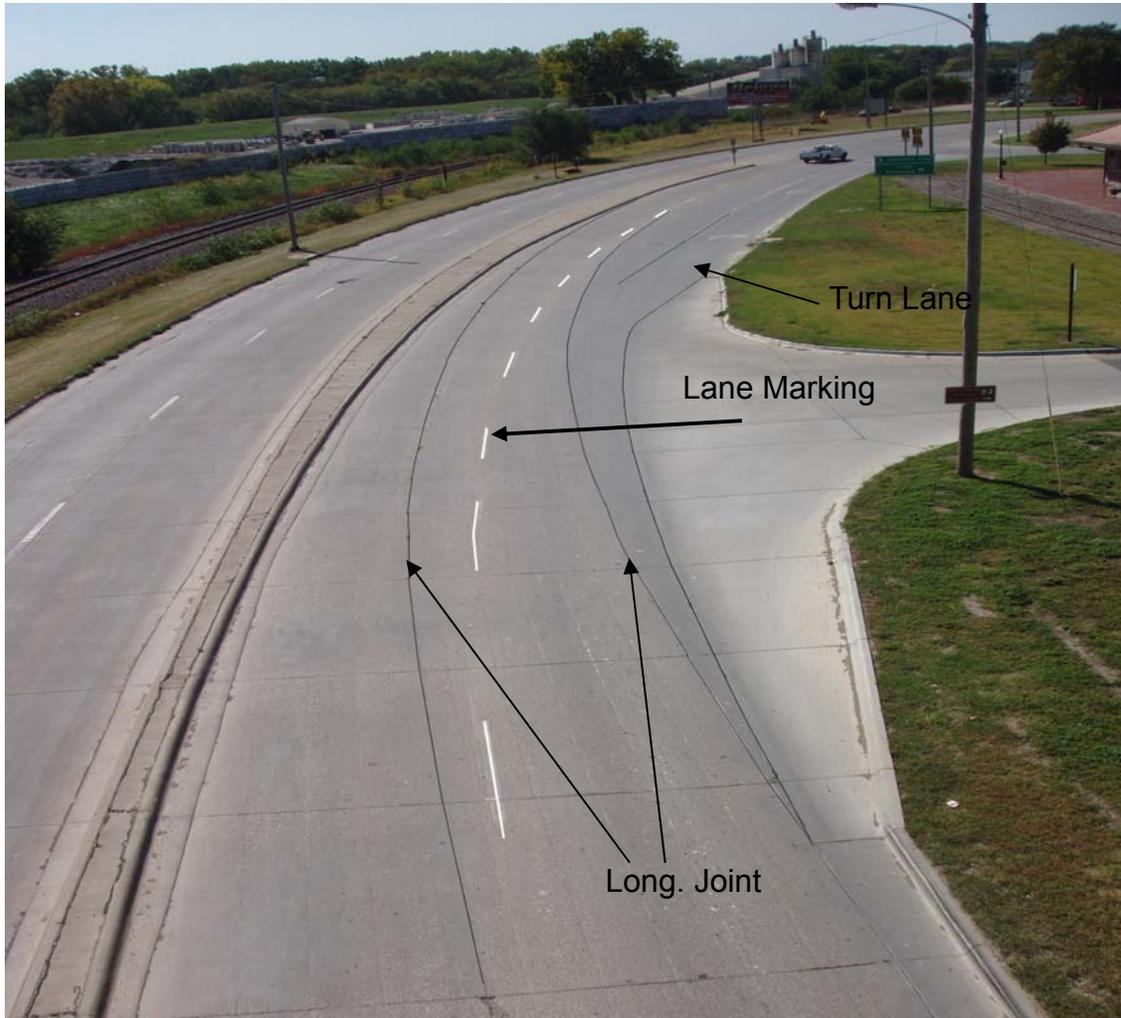
**Figure 4.4: Westbound K-18 (fort Riley Blvd.)**

Figure 4.4 shows a picture taken from the Kansas Avenue Bridge. The view of the joints has been enhanced by the addition of black lines on the above photo as indicated by the black arrow heads. The lane markings have also been enhanced in the photo by the addition of a broken white line.

This figure complements Figure 4.4 showing the locations and dimensions for the longitudinal joint that was concurrent to the centerline stripe to near the beginning of the horizontal curve. The distance between the joint and the inside curb gradually decreases until disappearing.

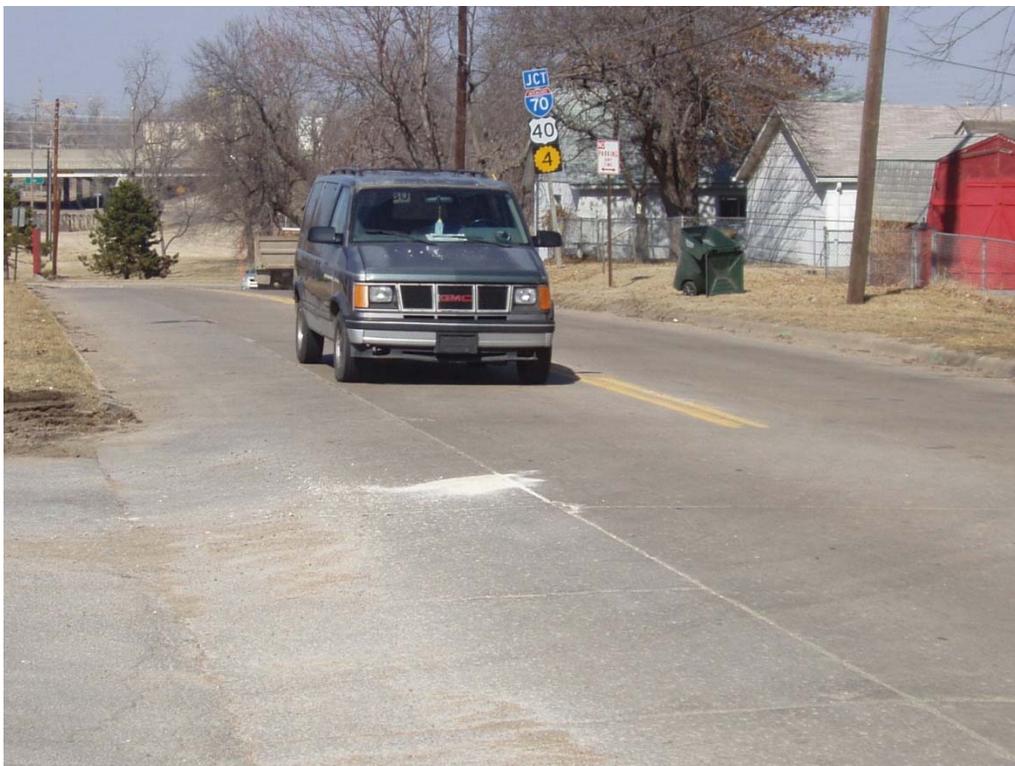
**Figure 4.7: MacVicar, looking North toward I-70**

line joint is near the center of the southbound lane. The effect of the location of this joint was the reason this location was included in the research project.

Data was gathered at this location for two hours. The data from the video camera was recorded on a DVD recorder and the video was viewed on a TV. A clear sheet of material with a grid drawn on it was placed on the screen. The grid was calibrated to the distance from near the west curb-line to the longitudinal joint. Because the asphalt curb was badly deteriorated, there was no clear-cut line from which to measure.

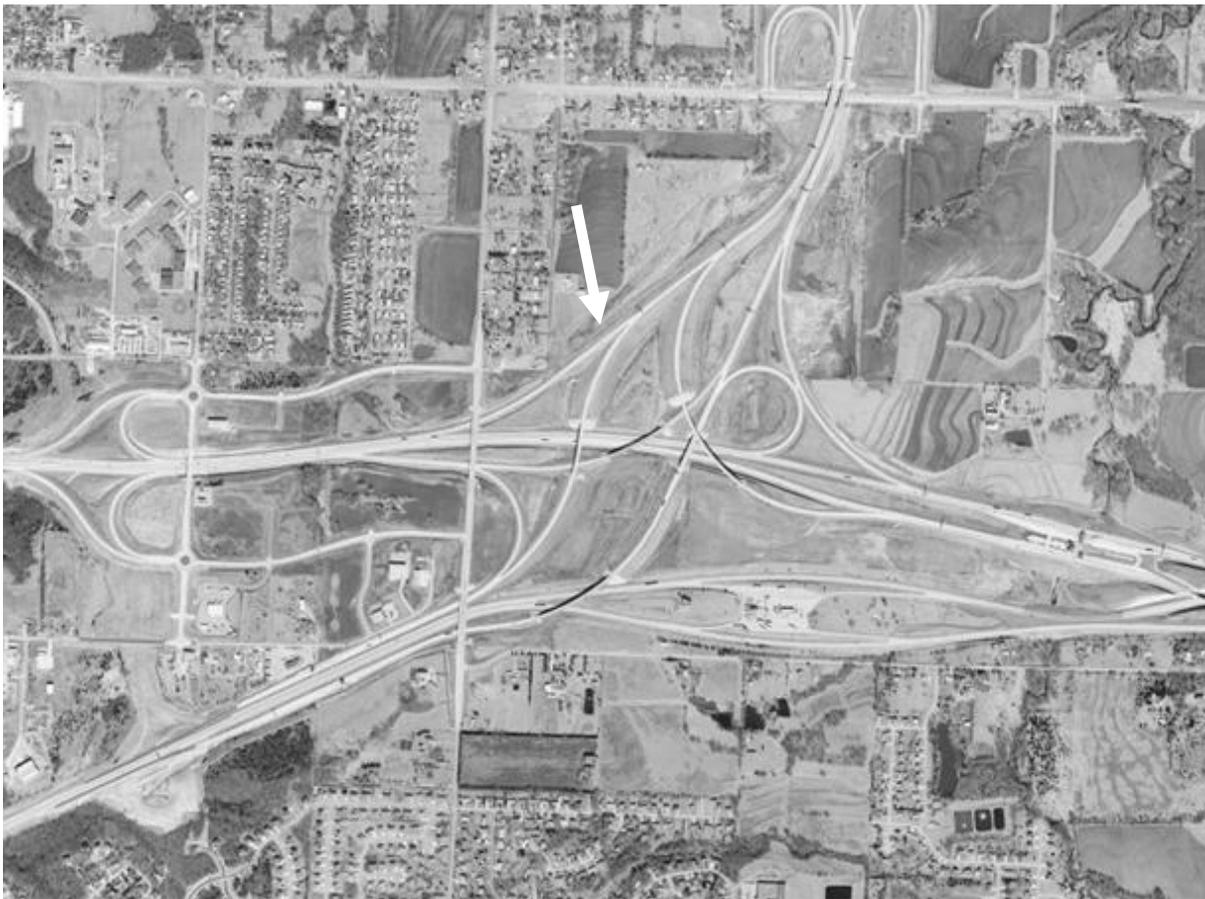
**Figure 4.10: I-70/K-4/KTA Interchange, East Side of Topeka**

locate themselves on a newly constructed section of roadway with a noticeable longitudinal joint within the driving lane. The I-70/K-4/Kansas Turnpike (KTA) Interchange is a well-marked, complex interchange with numerous ramps at various locations. Photos were taken on the southwest bound K-4 to I-70 ramp, a fairly straight section of roadway, just beyond where a ramp exits to the left toward westbound KTA, as shown in Figure 4.10.

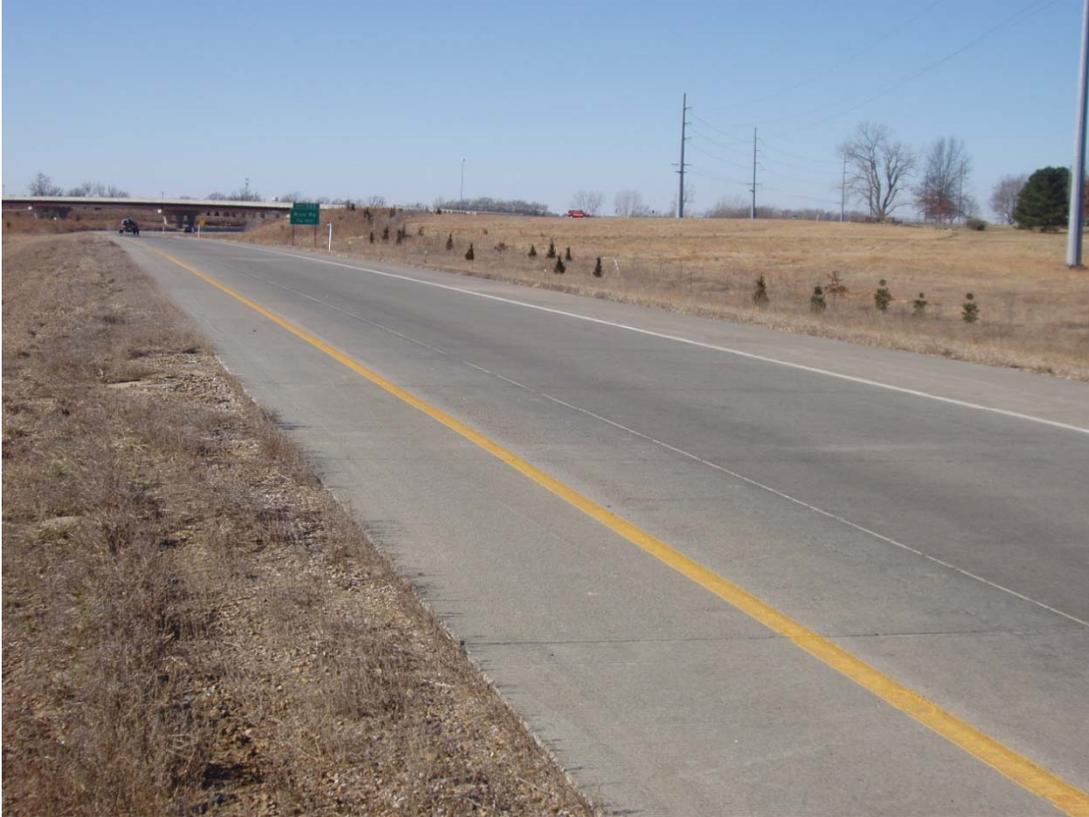
**Figure 4.12: View of joints and pavement markings on K-4 WB Ramp**

The ramp included a 14 foot lane and a left and right shoulder. Figure 4.12 shows the configuration of the joints and shoulder striping at this location. At this location, measurements were made from the yellow strip at the left side of the lane to the outside of the tire on the driver's side (left) of the vehicles.

The longitudinal joint was located 4 feet away from the left stripe of the pavement. A total of 100 vehicles were observed to be traveling under both the daytime and nighttime conditions. Under the daytime conditions, 51 vehicles were seen traveling with a mean and standard deviation of 5.9 feet and 1.24 feet, respectively. Figure 4.13 shows the distribution of vehicles across the ramp. Four of the 51 vehicles were driving with the left tire directly on the joint. Assuming a vehicle width of 5.5 to 6.0 feet, those four vehicles were driving in the center of the marked lane. The remaining 47 were driving to the right of the center of the marked lane. This would indicate that the drivers were either influenced by the longitudinal joint or they tend to drive closer to the right

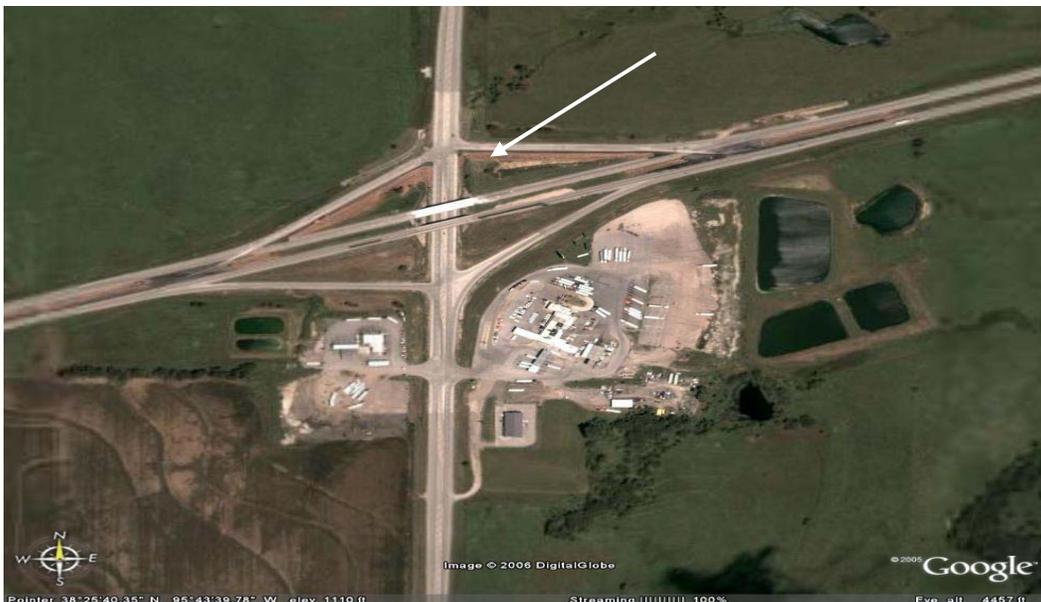
**Figure 4.15: I-35/US-75 Interchange showing truck stop**

The ramps at this interchange have been reconstructed and paved as part of an interstate reconstruction project on I-35. During construction, KDOT’s field personnel approved a request by the contractor to construct the longitudinal joints down the center of the ramps. By placing a joint in the middle of the ramp, the paving operation could be accomplished in one pass, thus saving the contractor time and money. There is a large and very busy truck stop just south of I-35, on the east side of US-75. The volume of trucks entering and exiting at this interchange is extra-ordinarily high for a rural diamond interchange. Judging from the current traffic count map, approximately 750 heavy commercial vehicles (trucks) are exiting I-35 on the westbound ramp and 450 of these trucks are entering and leaving the truck stop. The trucks using the westbound off-ramp,

indicated by the white arrow on the photograph below, must make a left turn to proceed to the truck stop. The reconstruction of pavement to the east was completed before the resurfacing was complete west of the interchange. The striping of the ramps was not undertaken until the project to the west was completed. The first series of pictures taken at this location were taken after a right-shoulder rumble strip was added but before the final lane striping was complete. A second series of pictures was taken after the striping was completed.

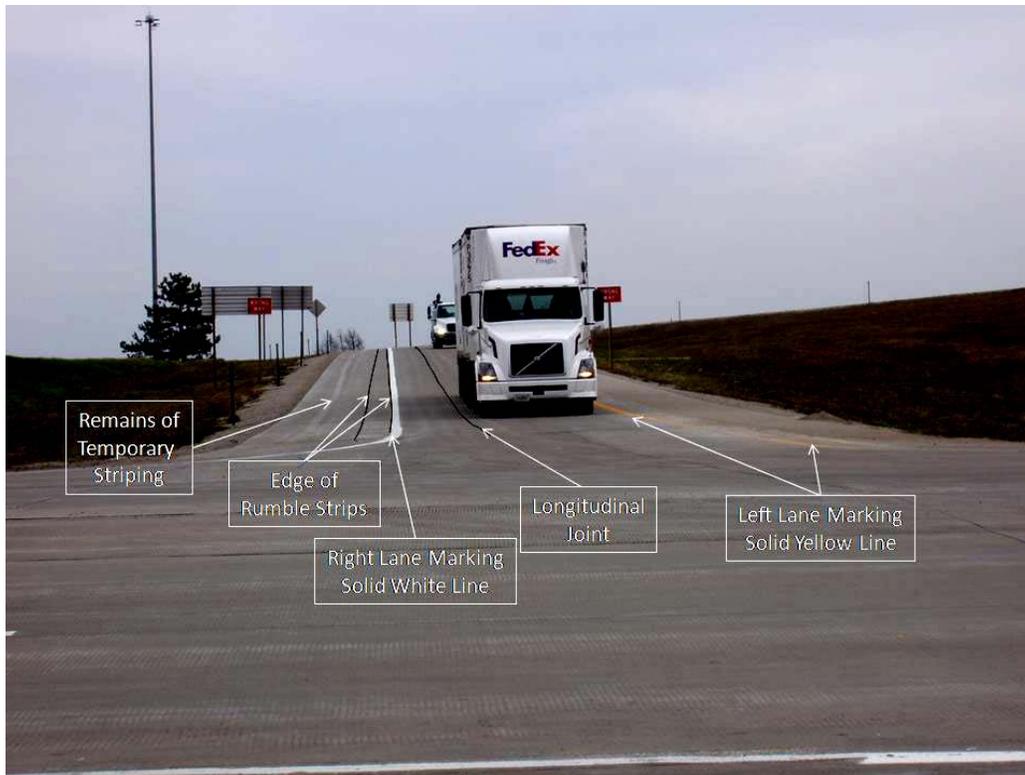
**Figure 4.16.1: Ramp before final striping**

**Figure 4.16.2: Ramp after final striping**

The research was carried out to observe the position of vehicles before and after the application of pavement markings. As can be seen in the photograph taken before the permanent marking was applied, the temporary striping is almost completely worn away, except for one strip outside of the rumble strip, near the outside of the slab. In the lower photograph, taken after the permanent striping was applied, the right hand strip is white and placed just inside the rumble strip. However, the faded strip, farther to the outside is still barely visible and was used for measurement.

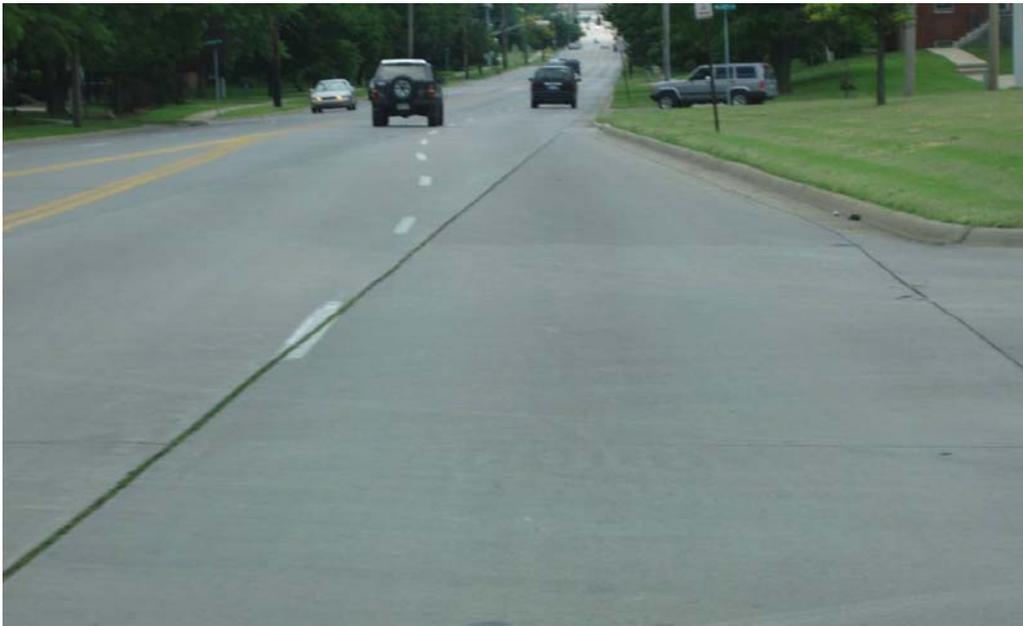
**Figure 4.19 Photograph of Fairlawn South at 21st Street**

Driving patterns were observed at several other locations that were identified as having longitudinal joints that might cause confusion to drivers. The southbound leg of the intersection of Fairlawn Rd. at 21<sup>st</sup> Street in Topeka was studied because the joint crosses the outside lane just beyond an entrance to a shopping center. A photograph of the site is shown in Figure 4.19.

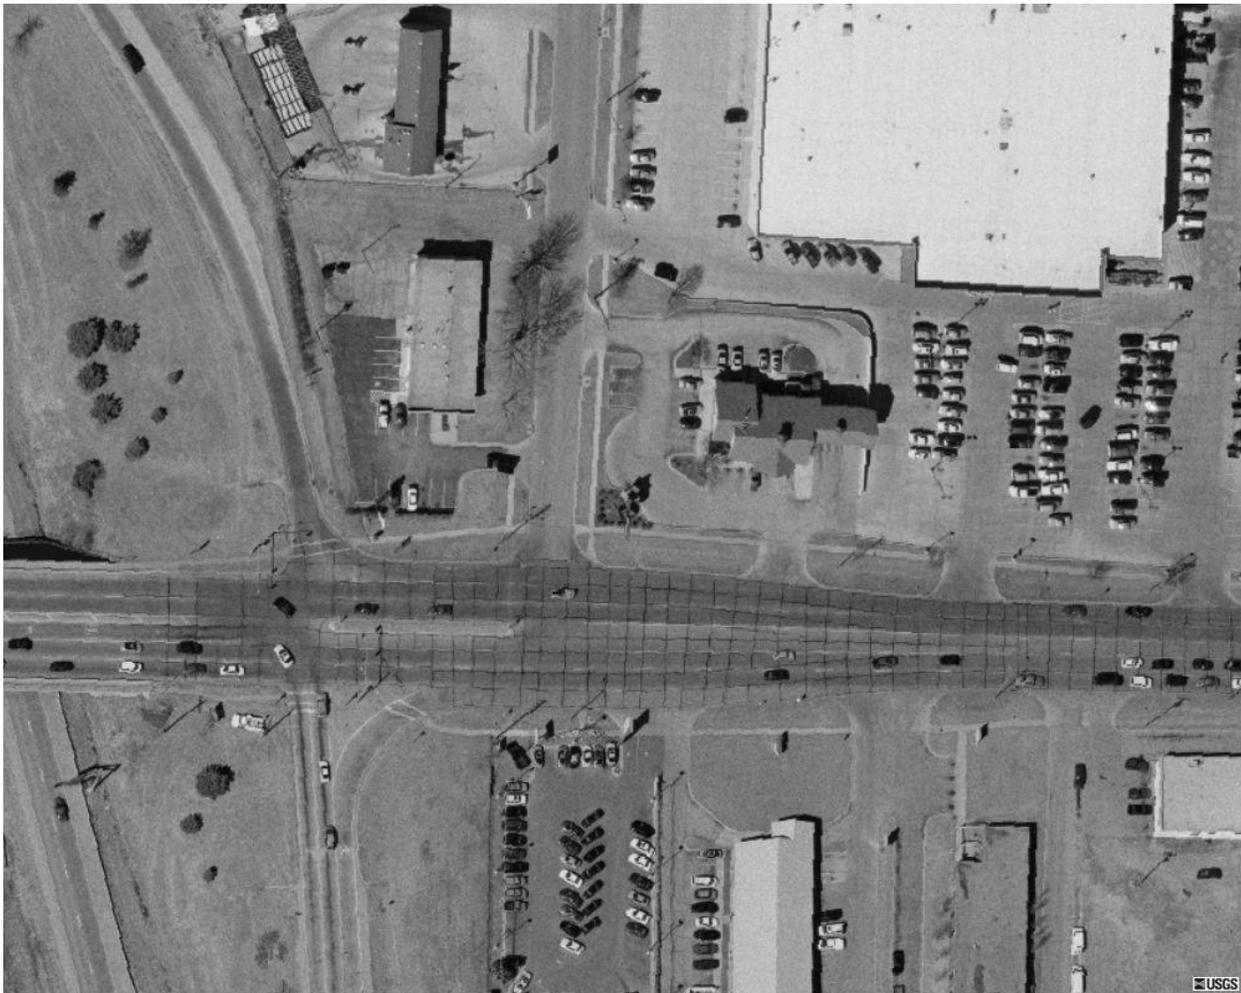
**Figure 4.21: WB 21st Street to NB I-470, Topeka, KS**

The following USGS aerial photograph (Figure 4.21) shows the large amount of joint sealant in both the transverse and longitudinal joints at this location. As can be seen from the location of the joints, the westbound outside lane near the right side of the photograph continues as the exit lane that turns right onto northbound I-470. The westbound traffic was observed for one hour and no problems were observed. However, while driving in the outside lane, the researcher observed a vehicle directly in front move into the exit, without signaling. When the front vehicle reached the end of the exit lane, he or she suddenly swerved back into the outside through lane, nearly clipping

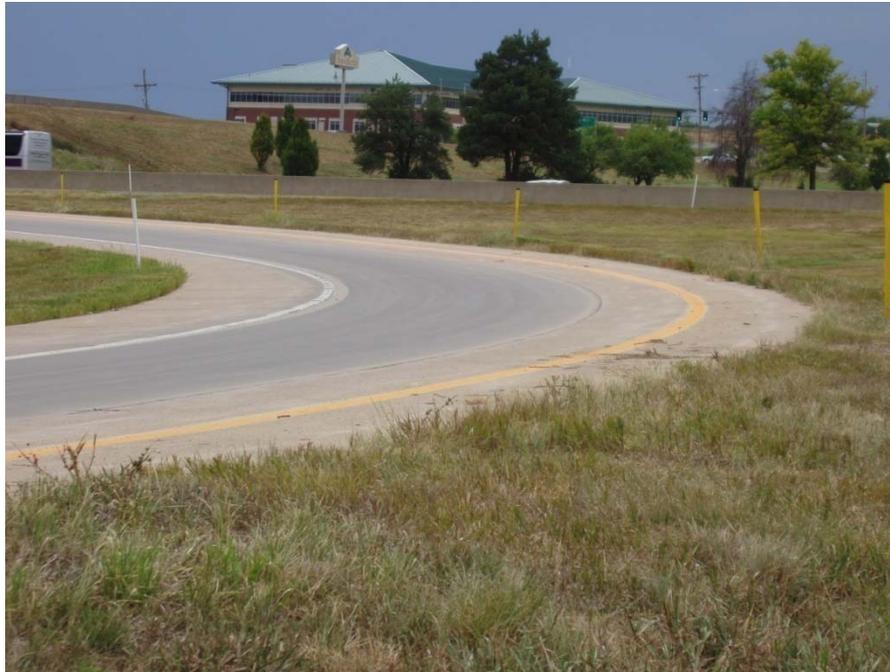
**Figure 4.22: East bound off-ramp, I-70 & Wanamaker, Topeka**

The picture below (Figure 4.22) shows the eastbound off-ramp from I-70 to Wanamaker. As can be seen from the tire rubber that has been deposited on the pavement, very few vehicles travel beyond the joint on the outside of the curve. While this picture does not prove that the driver's path was influenced by the location of the

longitudinal joint, it does support the recommendation that the joint should be placed on the outside of a curved ramp, if at all possible, to minimize joint deterioration.

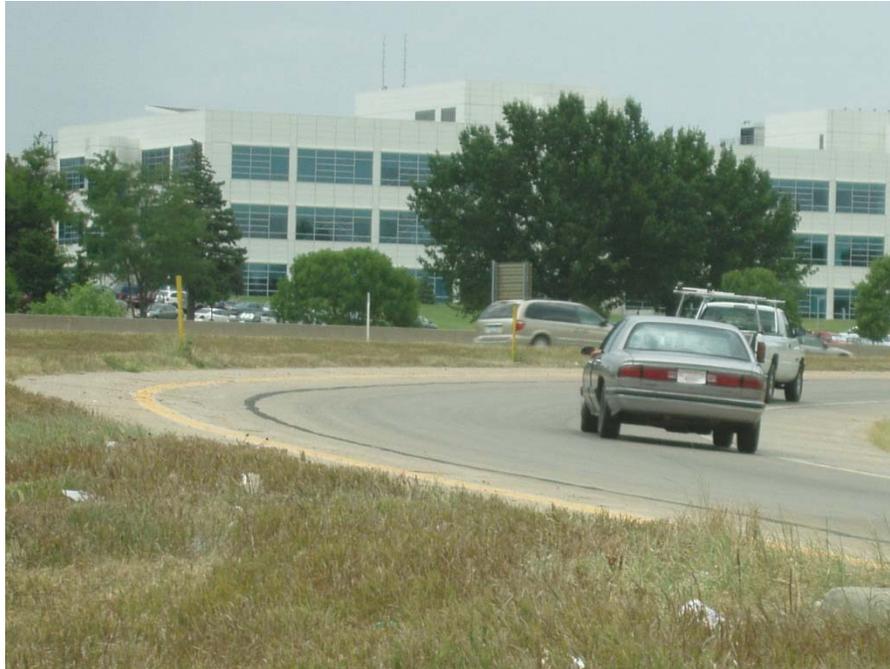
**Figure 4.23: Eastbound on-ramp, I-70 & Wanamaker, Topeka**

The next picture (Figure 4.23) is the eastbound entrance on-ramp at the same interchange. Because of its geometry, ramp first curves to the left and then to the right, making it impractical to put the joint on the outside of the curve. The tire marks on the pavement indicates little if any use to the outside of the outside joint. However, it was observed that most vehicles put their right-side wheels on or near the right-hand stripe and joint. This was especially true for combination vehicles.

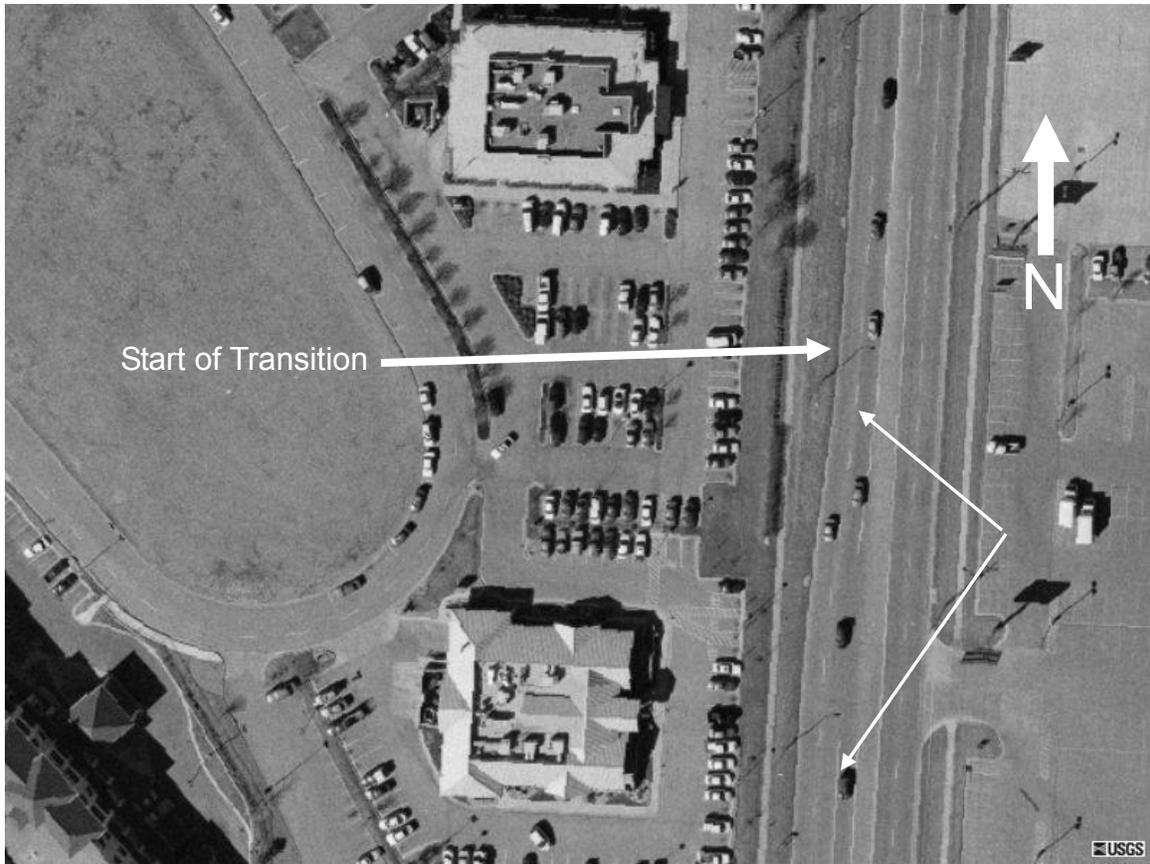
**Figure 4.24: Wanamaker, North of 21st Street, Topeka**

There is a two-lane left turn approach from southbound to eastbound at the 21<sup>st</sup> and Wanamaker intersection. The approach widens to accommodate the 2<sup>nd</sup> lane approximately 300 feet north of the intersection. It is indicated on Fig. 4.24 by two white arrows. The joints through the transition continue straight into the intersection. The approach was widened at the beginning of the transition, making a new outside through lane. The outside lane north of the transition becomes the inside through lane and the inside lane becomes the outside left-turn lane.

It was observed that most of the left-turning vehicles continued straight within the longitudinal joint to the inside lane to make a left turn and later moved another lane to the inside turning lane if desired. This location was observed during an off-peak period and during heavy traffic during the Christmas shopping period, when a larger number of drivers might be unfamiliar with the features of this intersection. At no time did the research team witness any confusion on the part of drivers in the traffic stream.

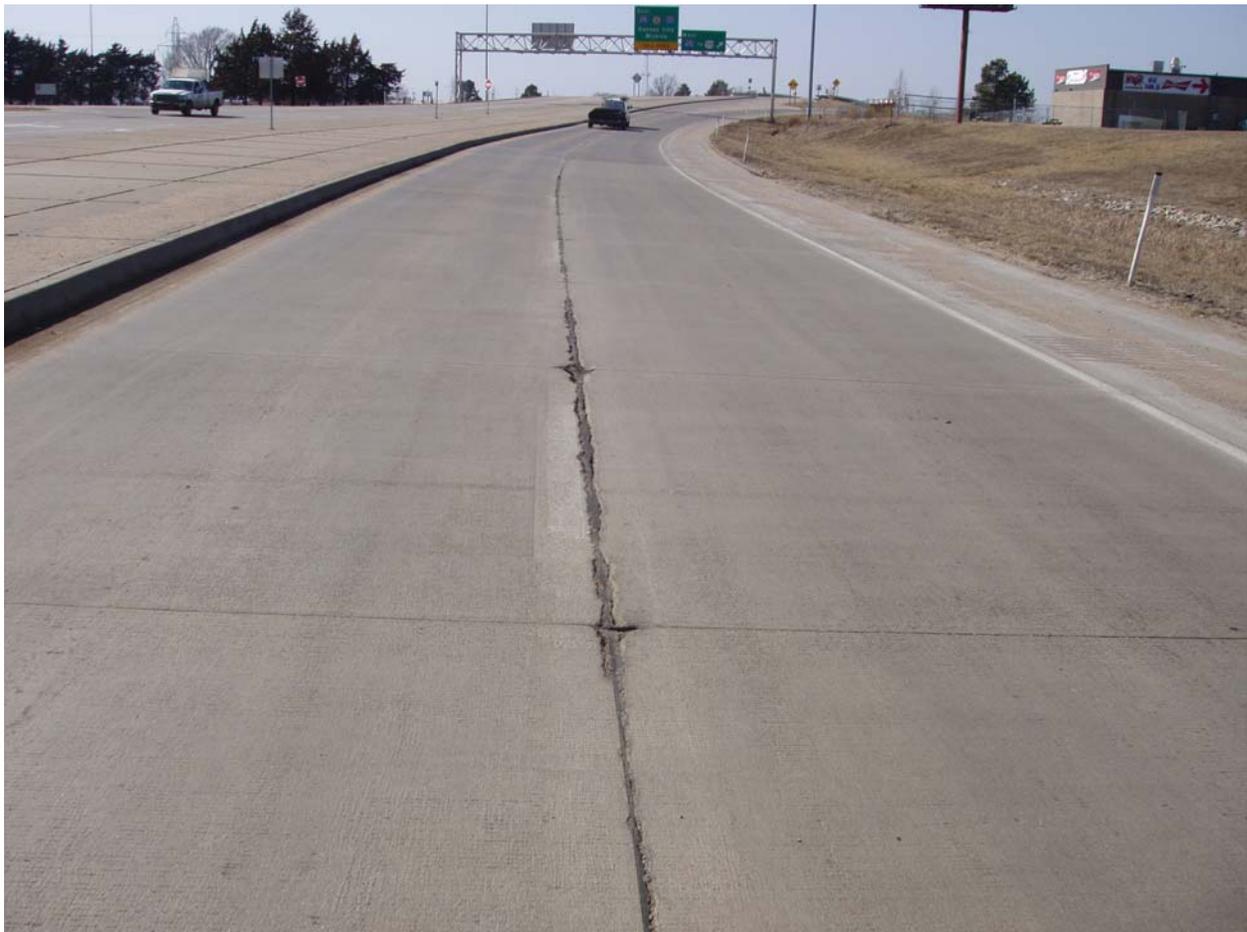
**Figure 4.25: Ramp to I-470 & KTA at S Topeka Blvd**

the Kansas Turnpike and left turning traffic from Northbound Topeka Blvd and I-470. The weaving traffic must cross the longitudinal joint that is located between the lanes. Figure 4.25, below, shows that there is considerable deterioration in the joint. Although the deterioration may not be entirely attributed to the loads on the joints, it is the author's judgment, that the loads on the joints accelerated the wear that can be observed.
