# PERFORMANCE OF I-57 RECYCLED CONCRETE PAVEMENTS

Research Report ICT-09-032

**Performance of I-57 Recycled Concrete Pavements**

Illinois Center for Transportation

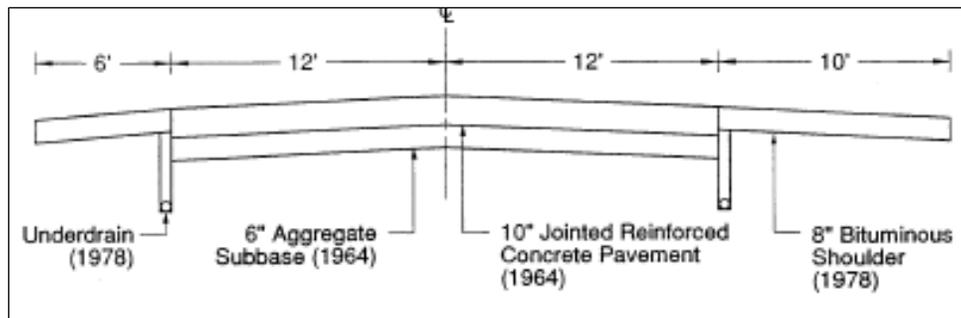
The new concrete pavement with RCA was designed to replace a 10-in-thick JRC pavement with 100-ft joint spacing built in 1964. The JRC was placed on top of a 6-in aggregate subbase layer, as shown in Figure 1. In 1978, the 8-in bituminous shoulders were reconstructed, along with the installation of underdrains.

Figure 1. Original pavement cross section (Schutzbach, 1993)

The original JRC pavement section did not show any signs of D-cracking which was prevalent on many distressed concrete pavements in Illinois. However, two to three transverse cracks existed per slab panel. These cracks and most of the joints were badly faulted and spalled. The shoulders and underdrains were still in excellent condition at the time of reconstruction.

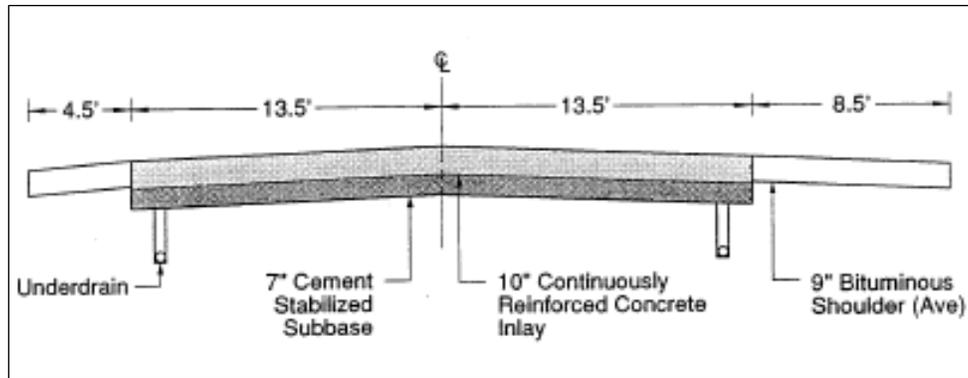
During the design phase of the recycled CRCP in 1984, the average daily traffic was 10,000 vehicles with 2,000 trucks. A 20-year design life was selected for the traffic estimation and material specifications. An inlay was specified because of the excellent condition of the existing shoulders and underdrains. The final design was a 27-ft-wide, 10-in-thick CRC pavement on a 7-in cement-stabilized subbase, as seen in Figure 2. The subbase was designed 3 in higher than the standard IDOT subbase to allow for a crown change and because of a desire to have stabilized materials in place over the subgrade.

Figure 2. Cross section of I-57 CRC pavement inlay with RCA (Schutzbach, 1993)

Several unique features of this project were the 1.5-ft extended (widened) lane and the use of RCA as the primary aggregate source for the surface concrete mixtures. RCA has not been used subsequently and widened lanes only infrequently. The amount of longitudinal reinforcing steel was 0.7 percent. Longitudinal reinforcing steel was #7 without epoxy coating placed on 8-5/8 inch centers. The longitudinal contraction joint was tied together with 30-in-long #5 bars placed at 2.5-ft centers.

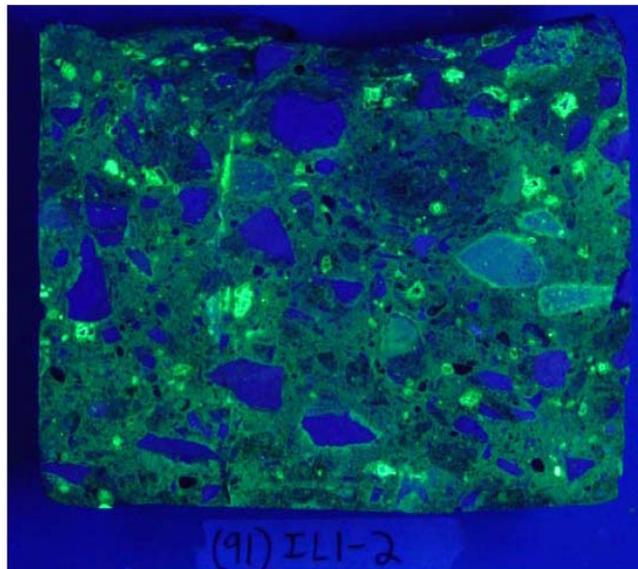
Figure 3. I-57 fractured core under ultra-violet light and coated with uranyl acetate dihydrate (Sturtevant, 1997)

Alkali silica reactivity (ASR) was suspected due to the positive results from the uranyl acetate test (Figure 3), a modified ASTM C1293 test (Figure 4), and petrographic analysis of the cores under a stereo microscope (Figure 5). This is contrary to a petrography study of several I-39 and I-57 cores done by Construction Technology Laboratories, Inc. for the Roesler and Ulreich (2002) study, which showed no deleterious reactions, such as ASR, were present. Due to several discrepancies between the work of Sturtevant (2007) and previous studies on this I-57 section on D-cracking, CRCP transverse cracking, and ASR, the validity of some of the data reported by Sturtevant for this section is somewhat questionable. Further cores were extracted from I-57 in 2008 to conduct another independent petrographic analysis for ASR. The results are discussed later in this report in section 4.2.3.

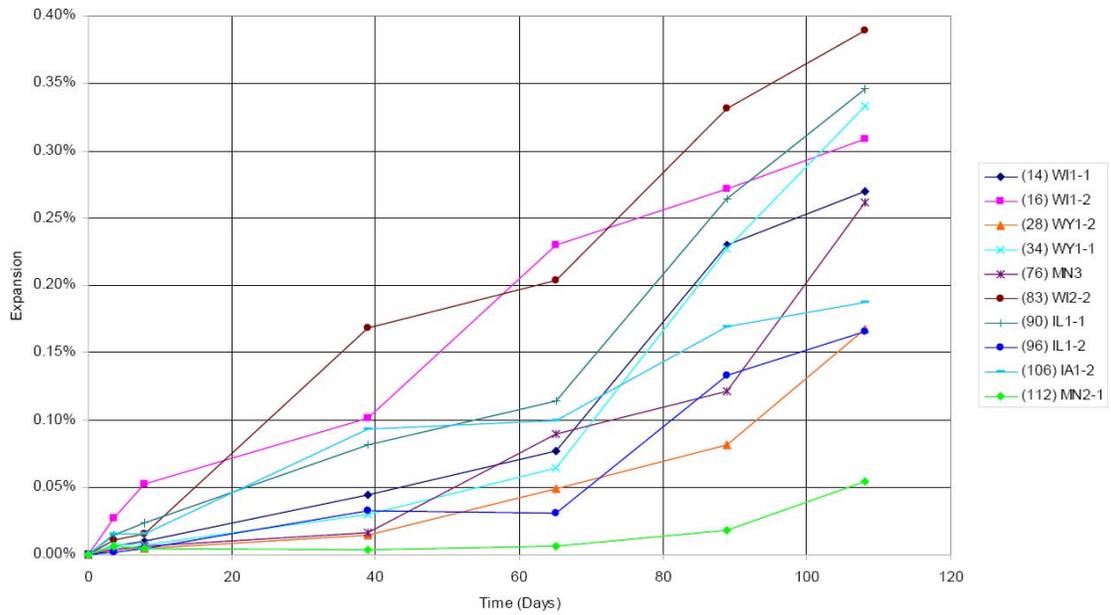
Figure 4. Expansion versus time for modified mortar bar expansion – ASTM C1293 (Sturtevant, 2007)

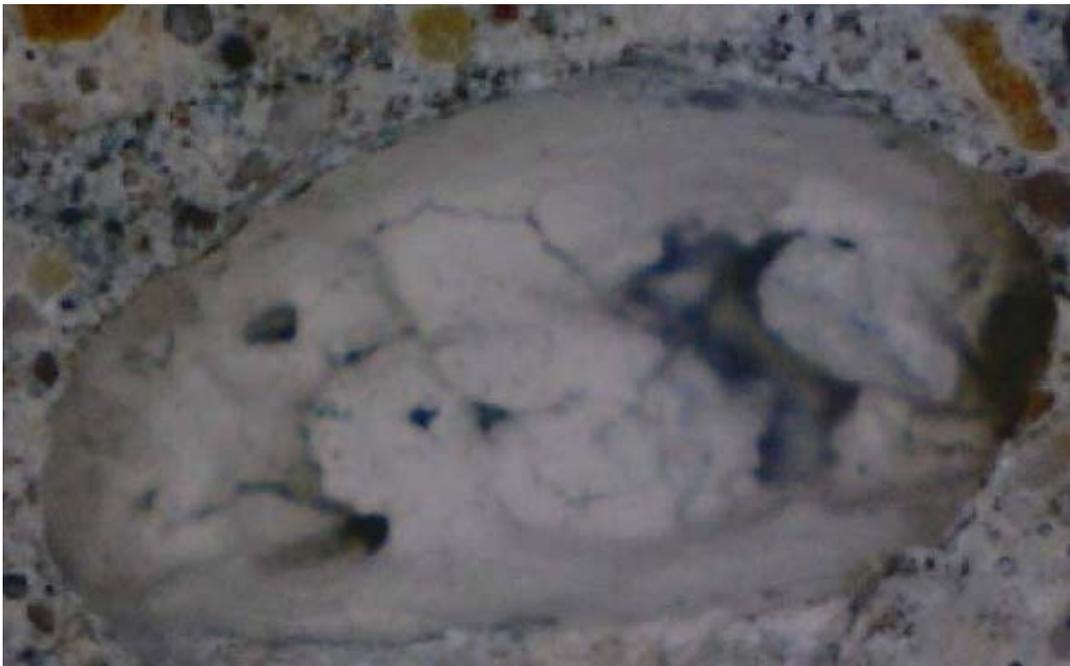
Figure 5. Photo of void filled with ASR gel from Illinois CRCP test section (Sturtevant, 2007)

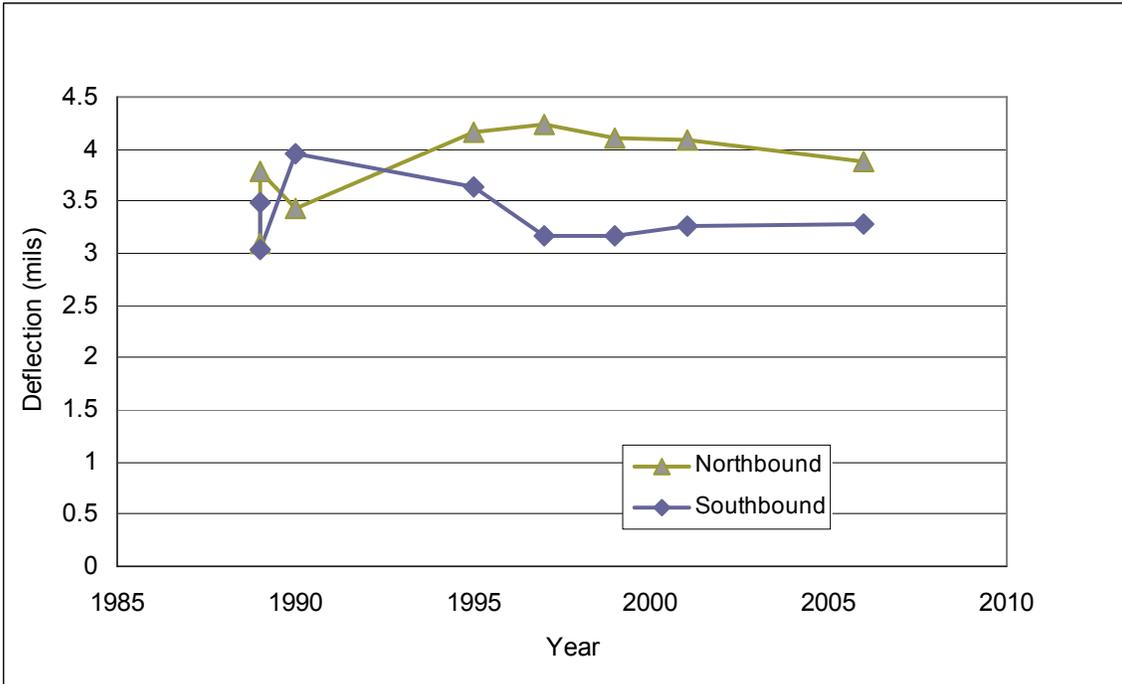
Figure 6. Average center of the driving lane deflection per direction per year

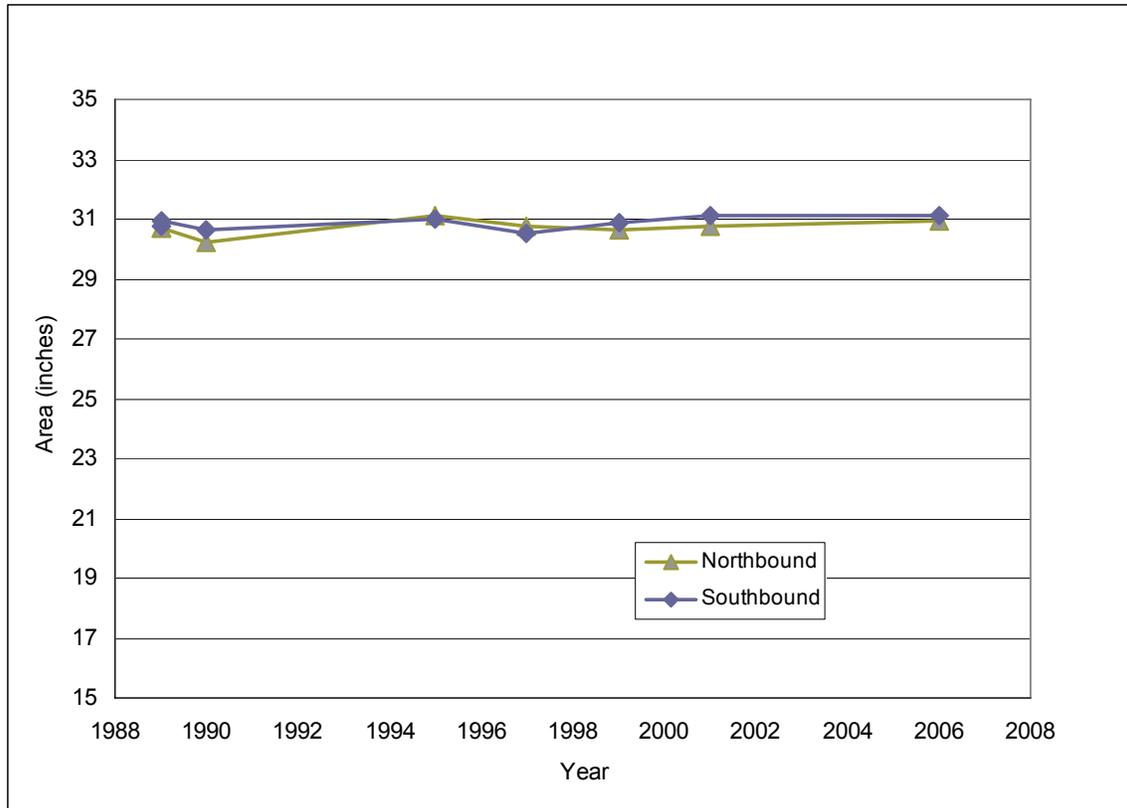
Figure 7. Average center of the driving lane AREA per direction per year

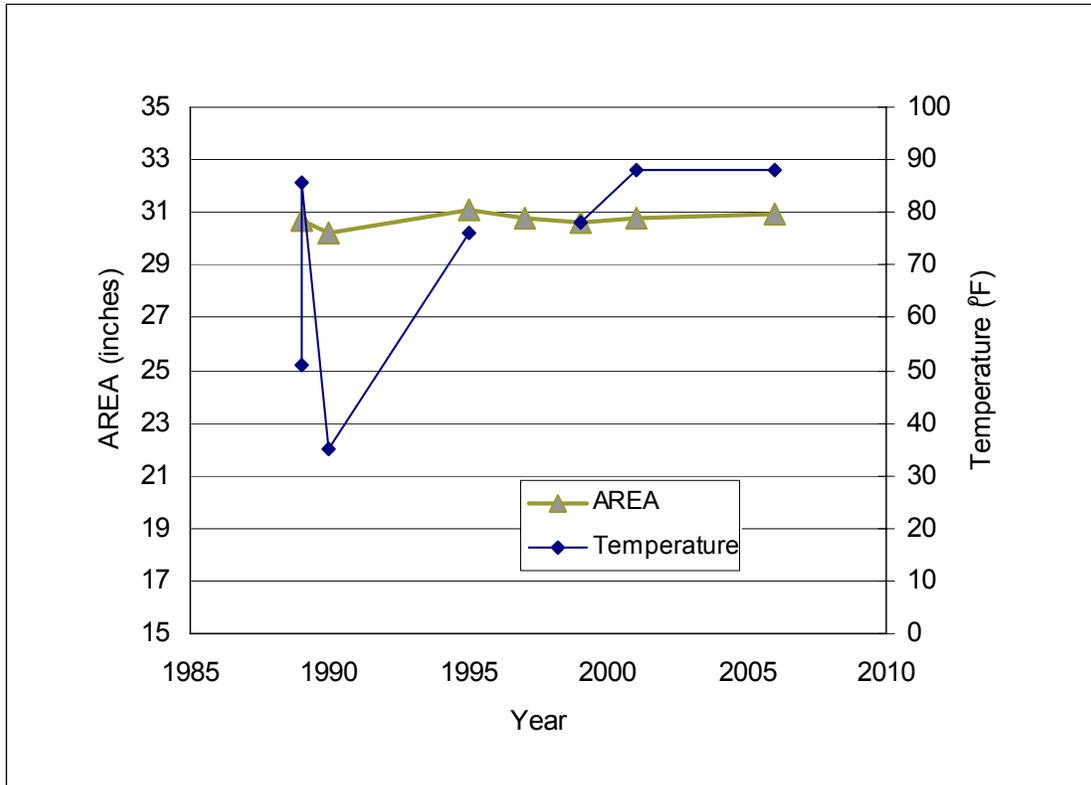
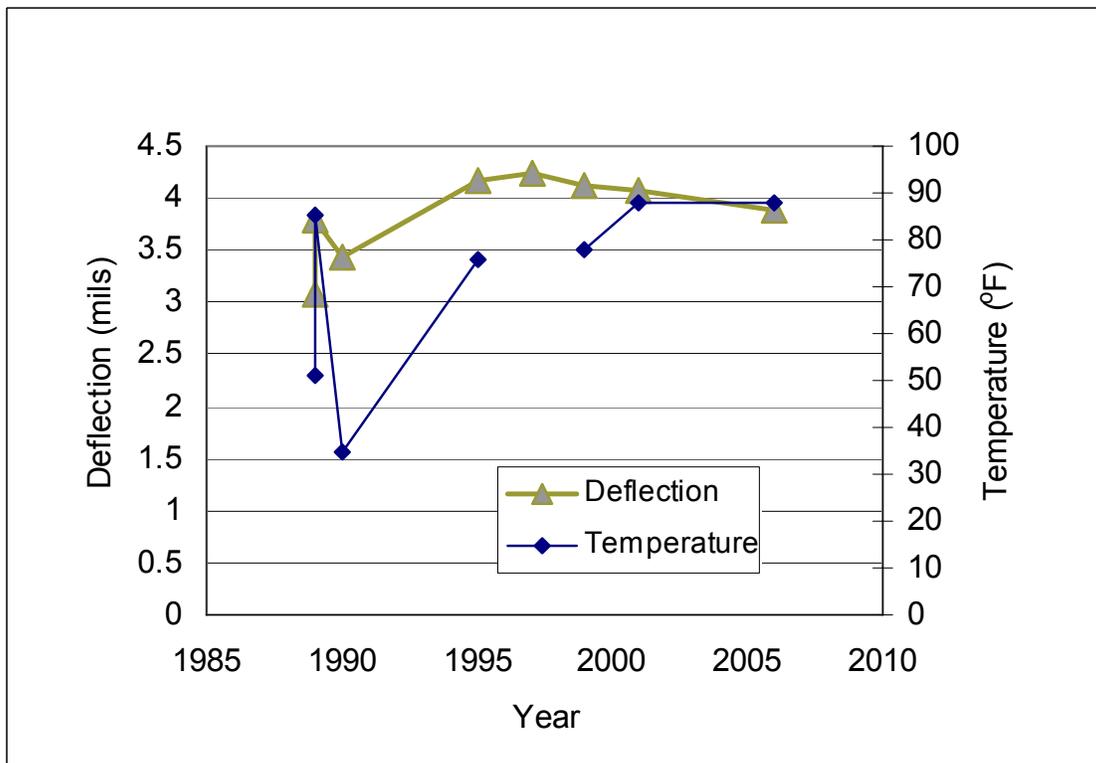
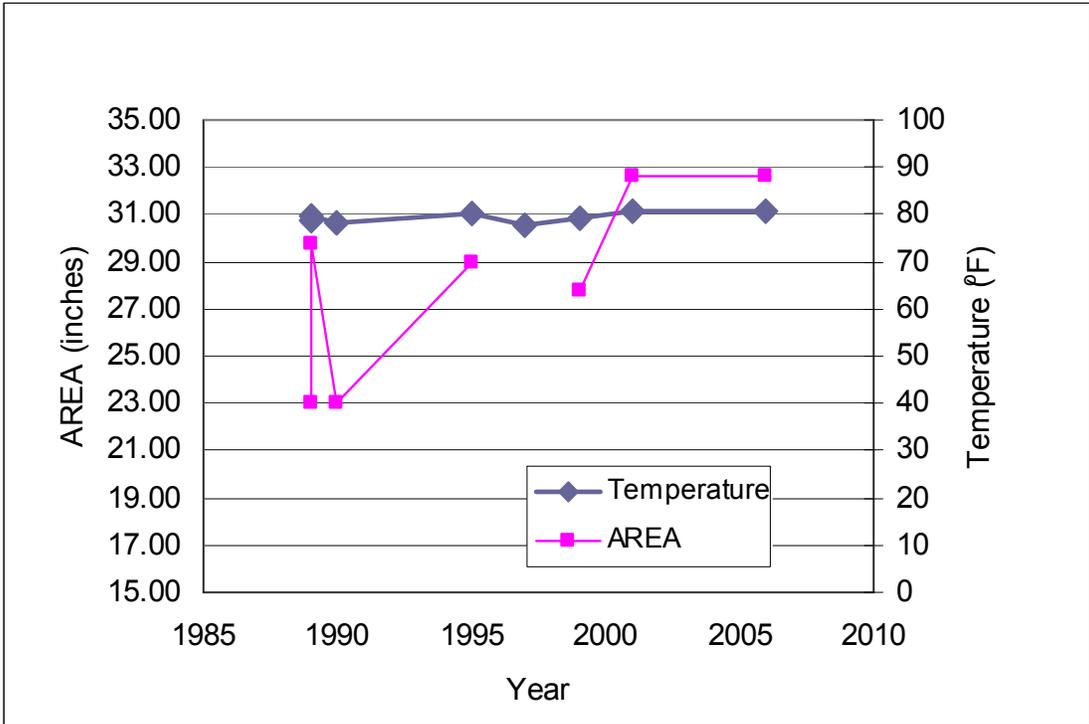
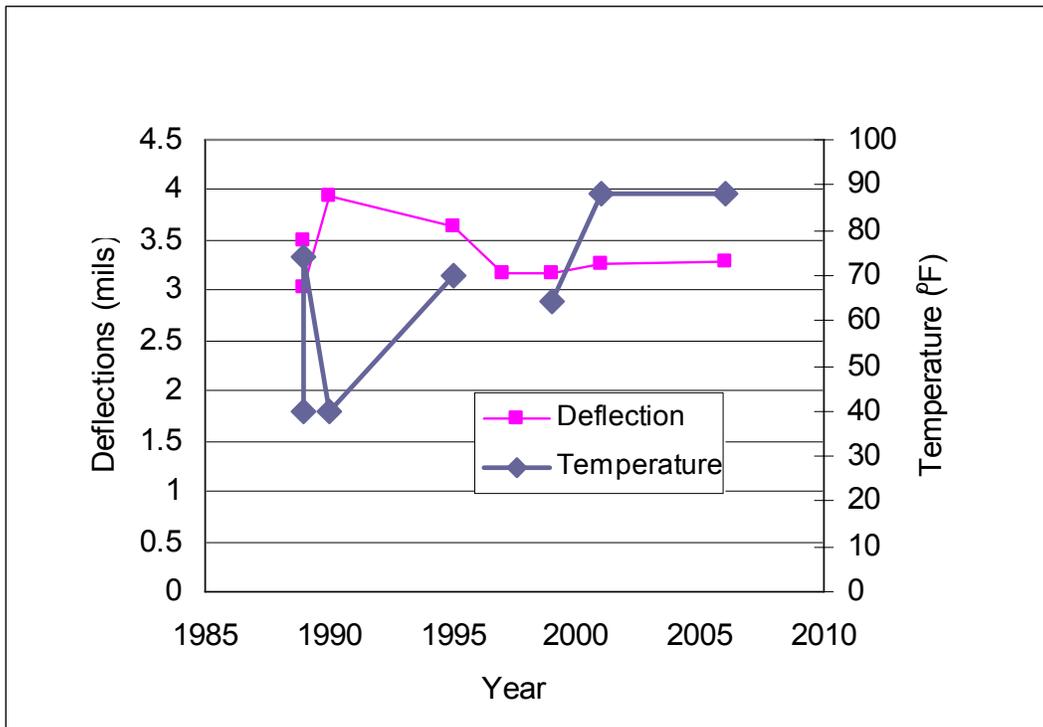
Figure 8, Figure 9, Figure 10, and Figure 11 show the average center of the driving lane deflection and AREA relative to the temperature for both directions. As the temperature decreases, the general trend is for the deflection and AREA to decrease also. This is somewhat counterintuitive, since lower temperatures should open the transverse cracks and result in higher deflections. Another factor that influences the deflection is the temperature differential through the slab thickness, which was not available for these test data and therefore no conclusions can be made with respect to temperature behavior and deflection.

Figure 8. Average northbound center of the driving lane AREA per year

Figure 9. Average northbound center of the driving lane deflection per year

Figure 10. Average southbound center of the driving lane AREA per year

Figure 11. Average southbound center of the driving lane deflection per year

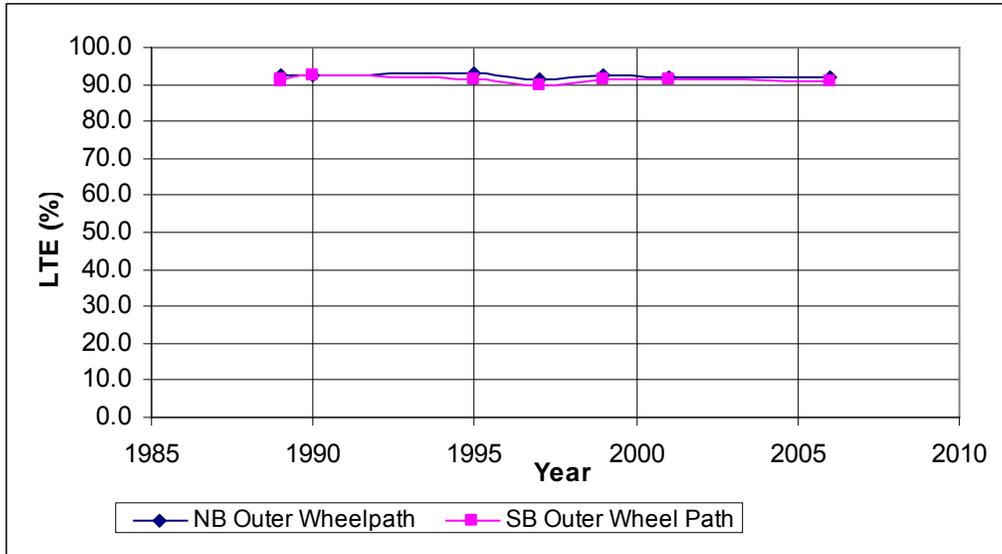
The load transfer efficiency can also be affected by temperature, similar to deflections and AREA, but as seen in Figure 12, the load transfer efficiency for these CRC sections have held constant over time.

Figure 12. Load transfer efficiency at leave crack of outer wheel path

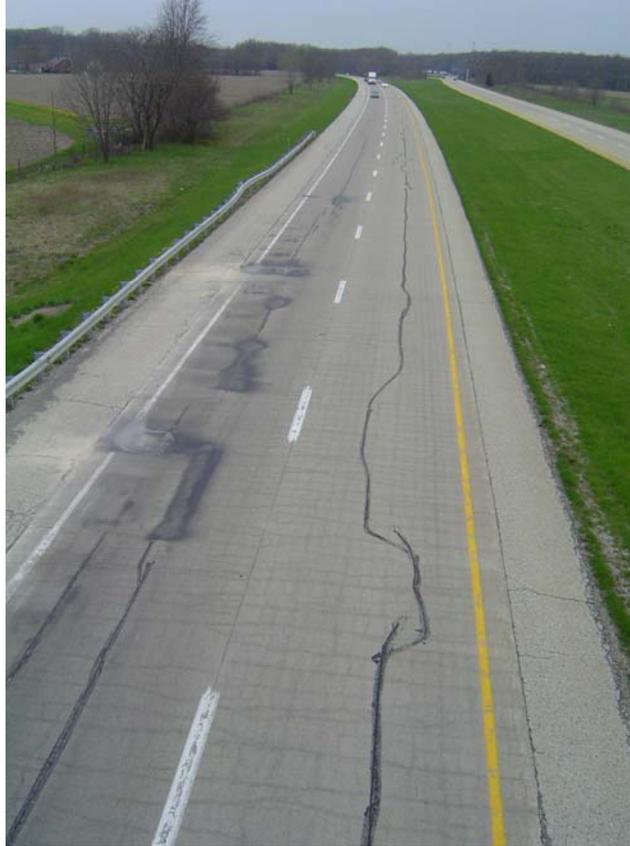
As discussed earlier, longitudinal cracks run parallel to the flow of traffic in both the driving and passing lanes. Based on distress surveys, longitudinal cracking has been visible since the first visual survey in 1990, and is currently very prevalent on both northbound and southbound sections. In recent visual inspections conducted by Roesler et al. (2002) and Sturtevant (2007), longitudinal cracking was present on 100 percent of the experimental CRCP section. Figure 13 shows a picture of the longitudinal cracking on the northbound lanes, while Figure 14 shows the longitudinal cracking and associated distresses in the northbound driving lane. From these photos, it is apparent that much of the subsequent distresses (popouts, localized distresses, spalls, and patches) that have developed on these CRCP sections have emanated from deteriorating longitudinal cracks.

Figure 13. Longitudinal cracking in the northbound lane

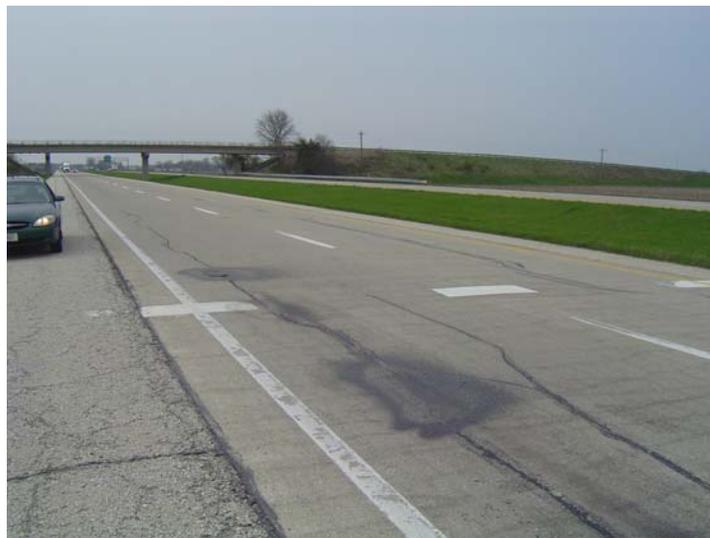
Figure 14. Longitudinal cracking and distress in the northbound driving lane

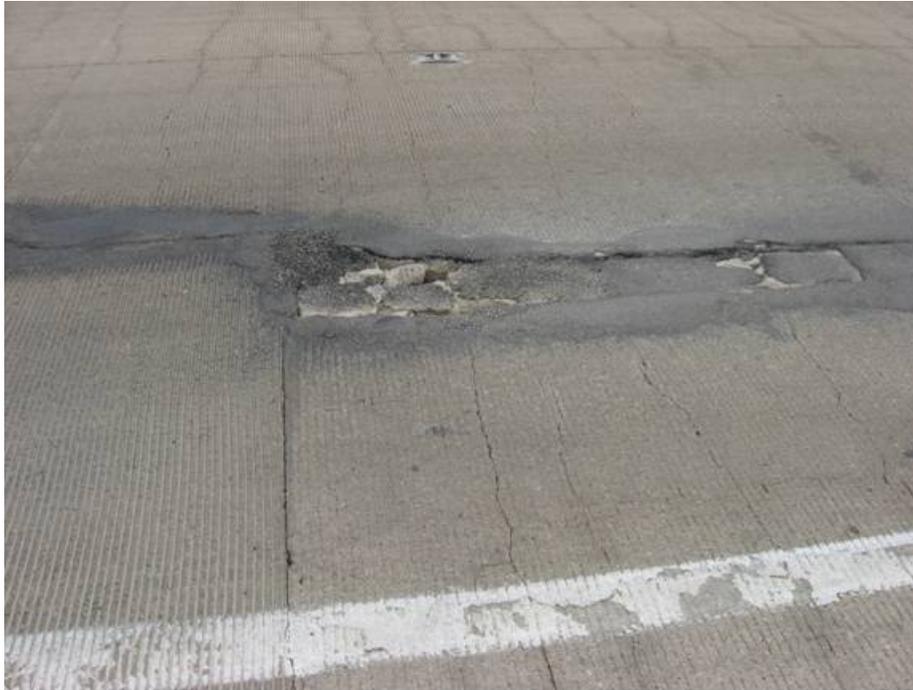
Given the difficulty of differentiating among the various localized distresses (popouts, potholes, or spalls) on the video surveys of 2002 and 2007, and for ease of analysis, all these distresses (see Figure 15) were classified as localized distresses. Table 22 shows the numbers of each distress identified with the video survey. Due to the level of longitudinal cracking present, it was highly unlikely that any classic punchouts had developed, and that the patches were a result of the longitudinal cracks deteriorating as a result of repeated traffic loading.

Figure 15. Localized distress in the southbound driving lane

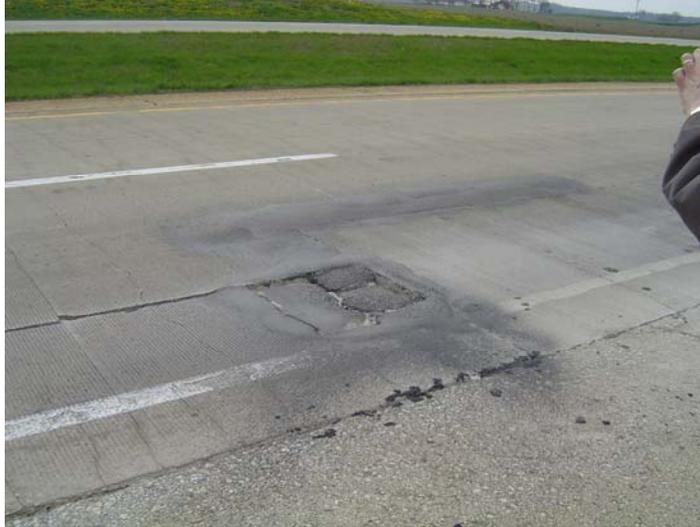
Using data from both visual and video surveys, it can be seen that for the first 10 years, only a few distresses were identified, with most of those being classified as low severity with a slow deterioration rate. But, over the past 5 years as seen in Table 22, a significant rise has taken place in the number of patches and localized distresses. The localized distresses and patches almost always emanate from existing longitudinal cracks. Figure 16 and Figure 17 demonstrate that many of the distresses and patches that subsequently develop occur near previous patches.

Figure 16. Deteriorating patch in the southbound driving lane

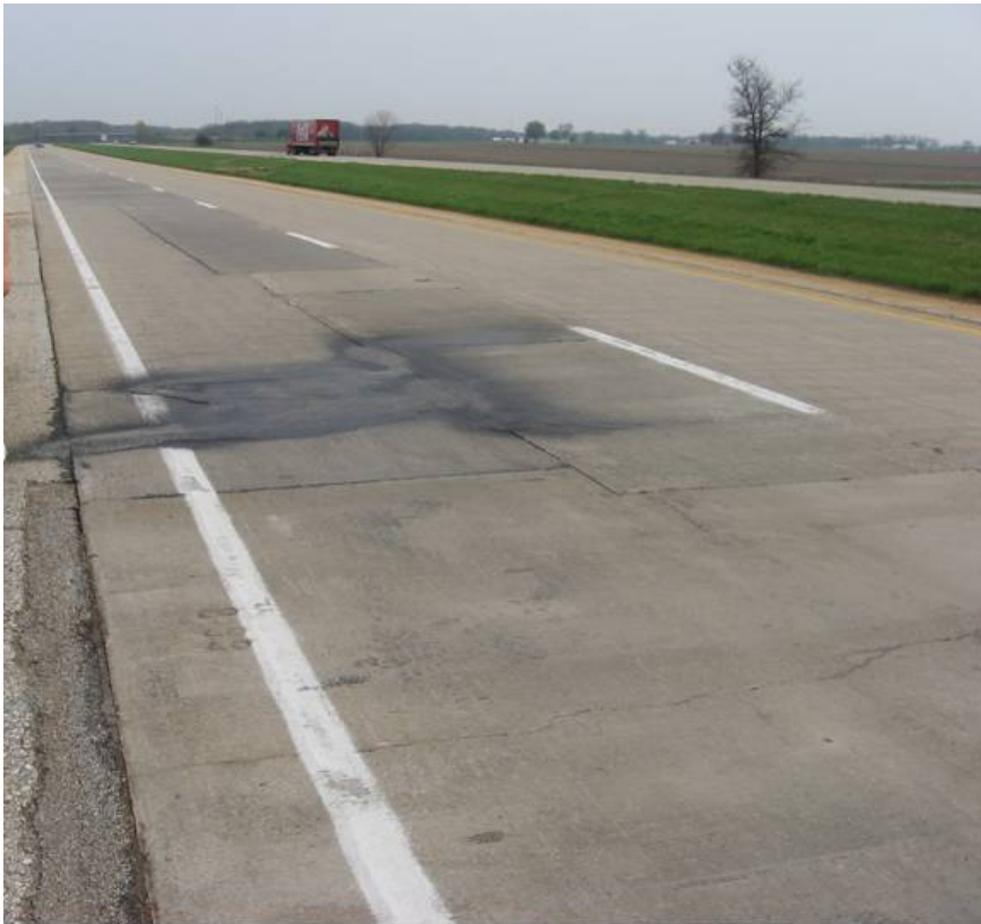
Figure 17. Multiple CRCP patches in the southbound driving lane

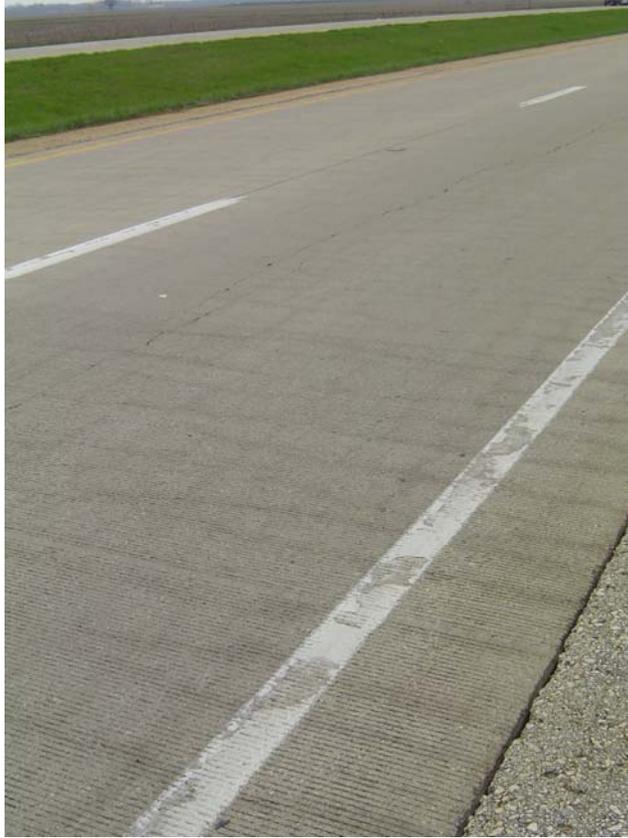
Figure 18. Transverse cracking northbound lanes

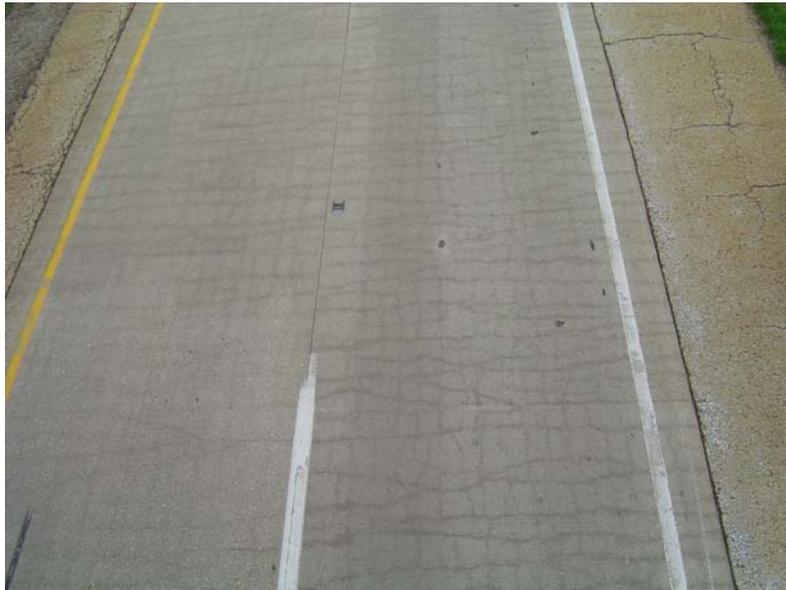
Figure 19. Transverse and longitudinal cracking northbound lanes

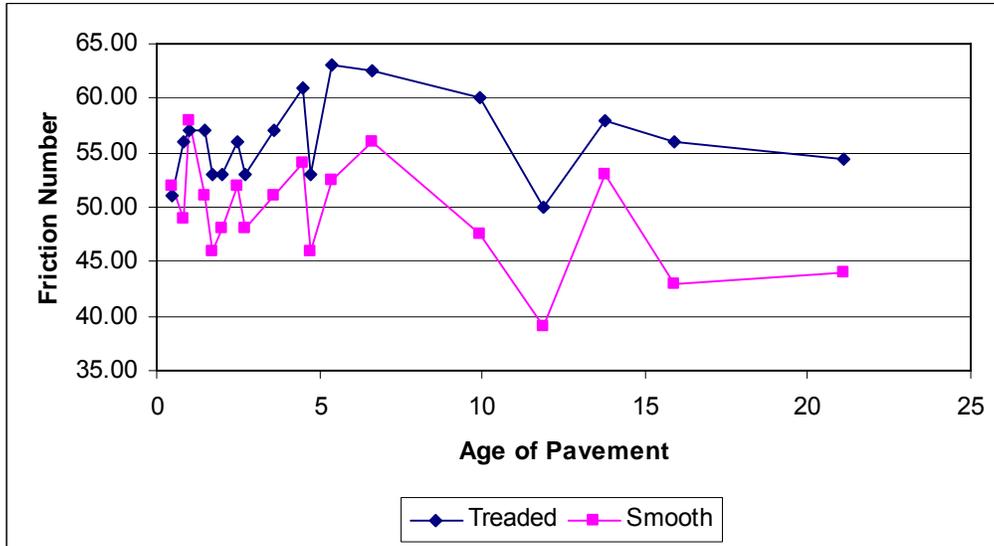
The southbound section was not completed until late in 1987; thus no data exists for the spring of that year. The treaded tire results show that the friction number has varied little over the 20-year life of the pavement, which can be seen in Figure 20. The smooth tire data show a 10-point decrease on the northbound and an approximately 15-point decrease on the southbound after 20 years. IDOT considers friction values above 35 for the treaded tire and 25 for the smooth tire tests to be good and to not be a factor in contributing to wet weather accidents. Thus, the northbound and southbound lanes meet the criteria for adequate friction values.

Figure 20. Changes in treaded and smooth friction data over time

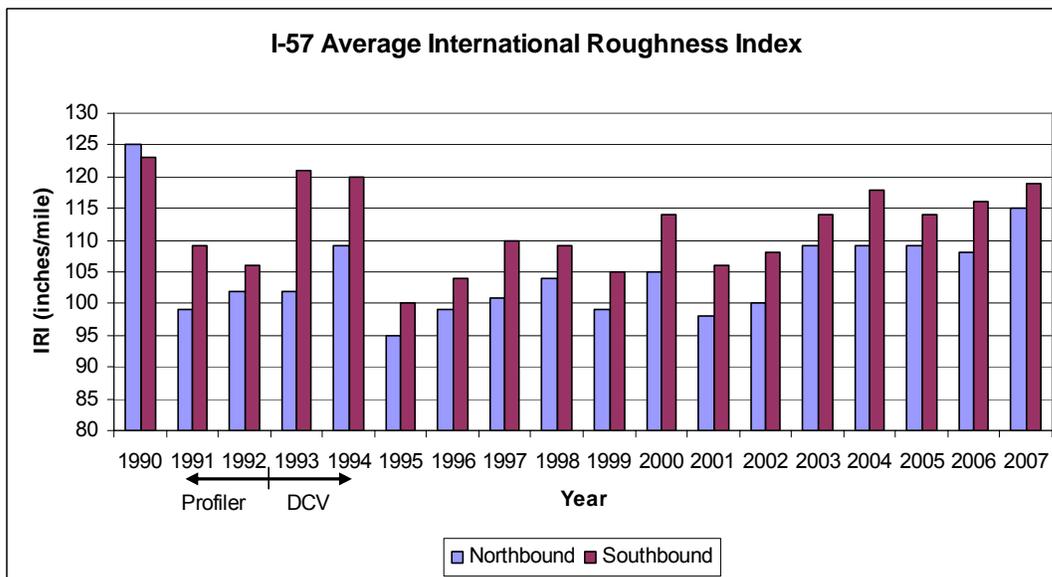
Figure 21. I-57 average IRI per year per direction

Figure 21 plots the average IRI values for I-57 with northbound and southbound directions shown separately. The data shows IRI values from 95 to 125 in per mile for northbound and 100 to 122 in per mile for southbound. A change in testing devices occurred in 1993; thus, the possible increase in IRI values for 1993 and 1994 could be attributed to the new equipment. A typical new concrete pavement has an IRI of around 60 in per mile. The initial IRI values for these sections were high but have not significantly increased over the past 15 years.

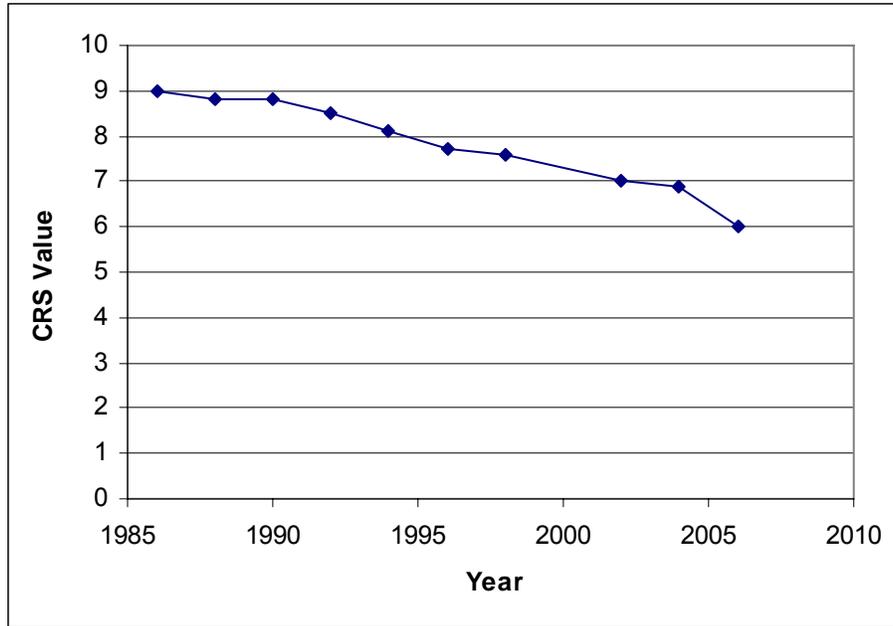
Figure 22. CRS values of pavement life

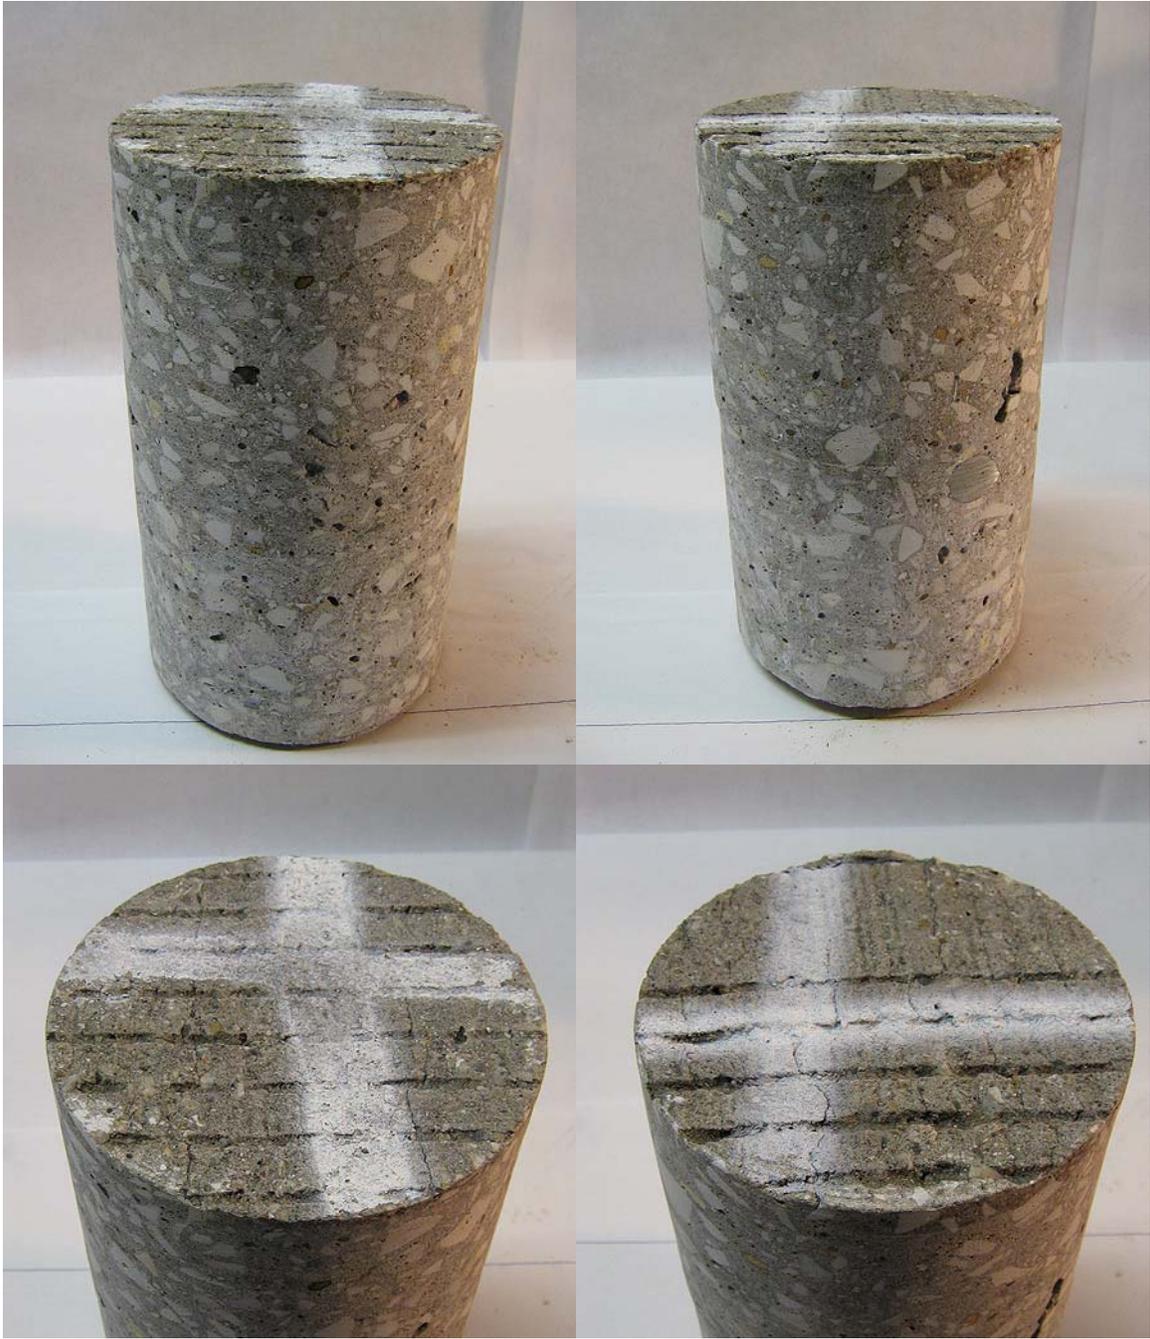
Figure A.1: 6" diameter cores I-57 NB-2 and I-57 NB-4 as-received.

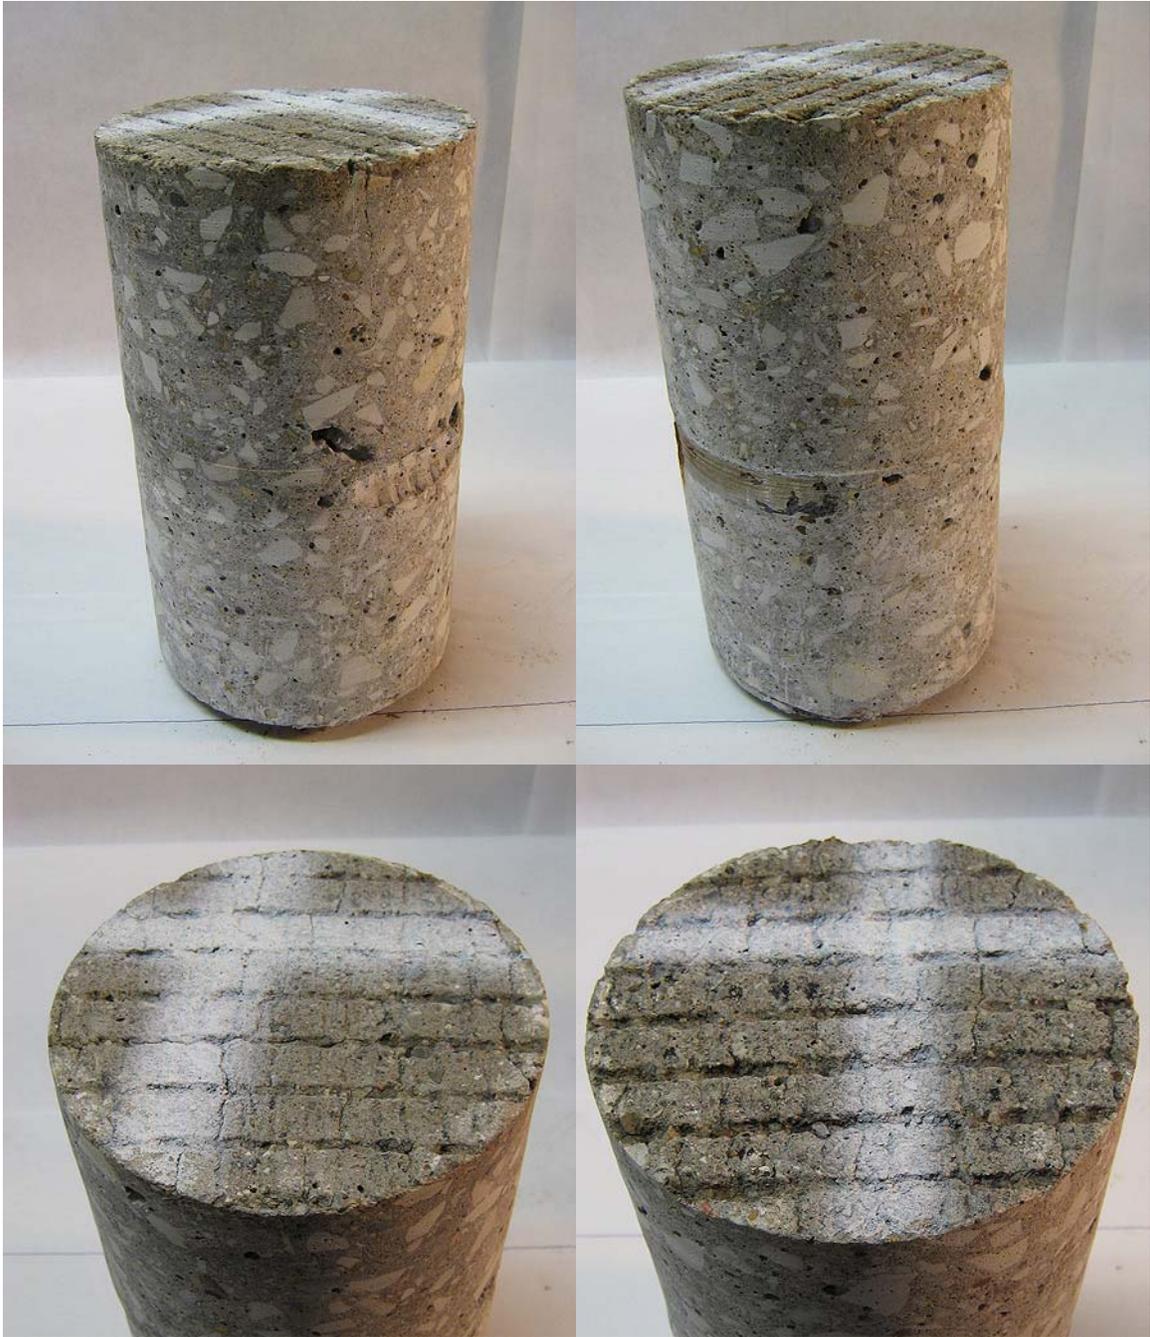
Figure A.2: 6" diameter cores I-57 SB-2 and I-57 SB-4 as-received.

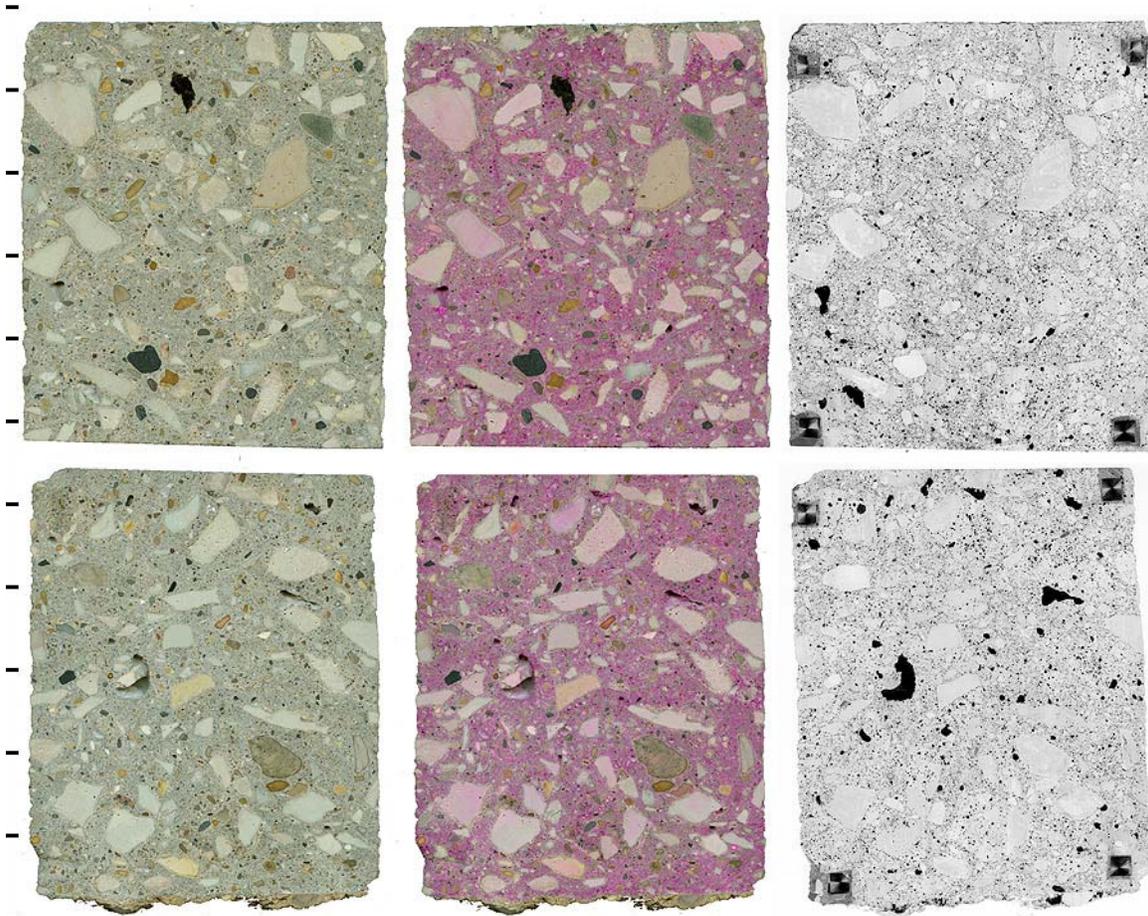
Figure A.3: First set of slabs from core NB-2, from left to right: as polished, phenolphthalein stained, and after treatment to enhance visibility of cracks and air voids, tic marks along left-hand side spaced at 1" intervals.

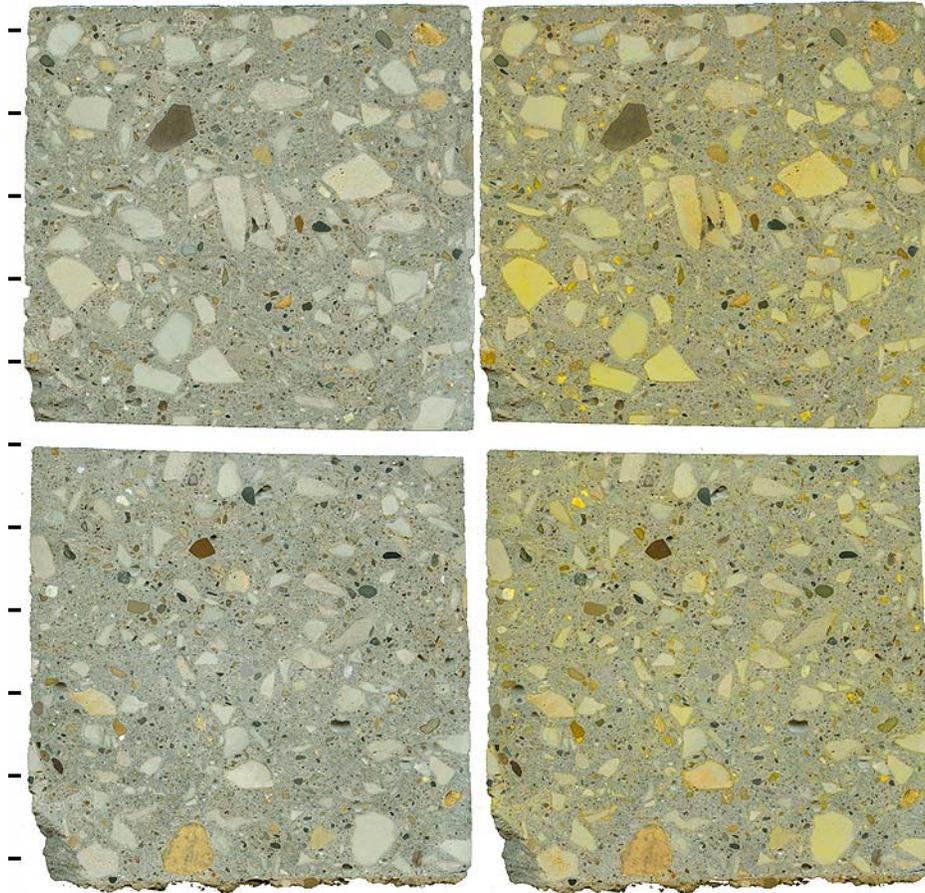
Figure A.4: Second set of slabs from core NB-2, from left to right: as polished, and sodium cobaltinitrite stained, tic marks along left-hand side spaced at 1" intervals.

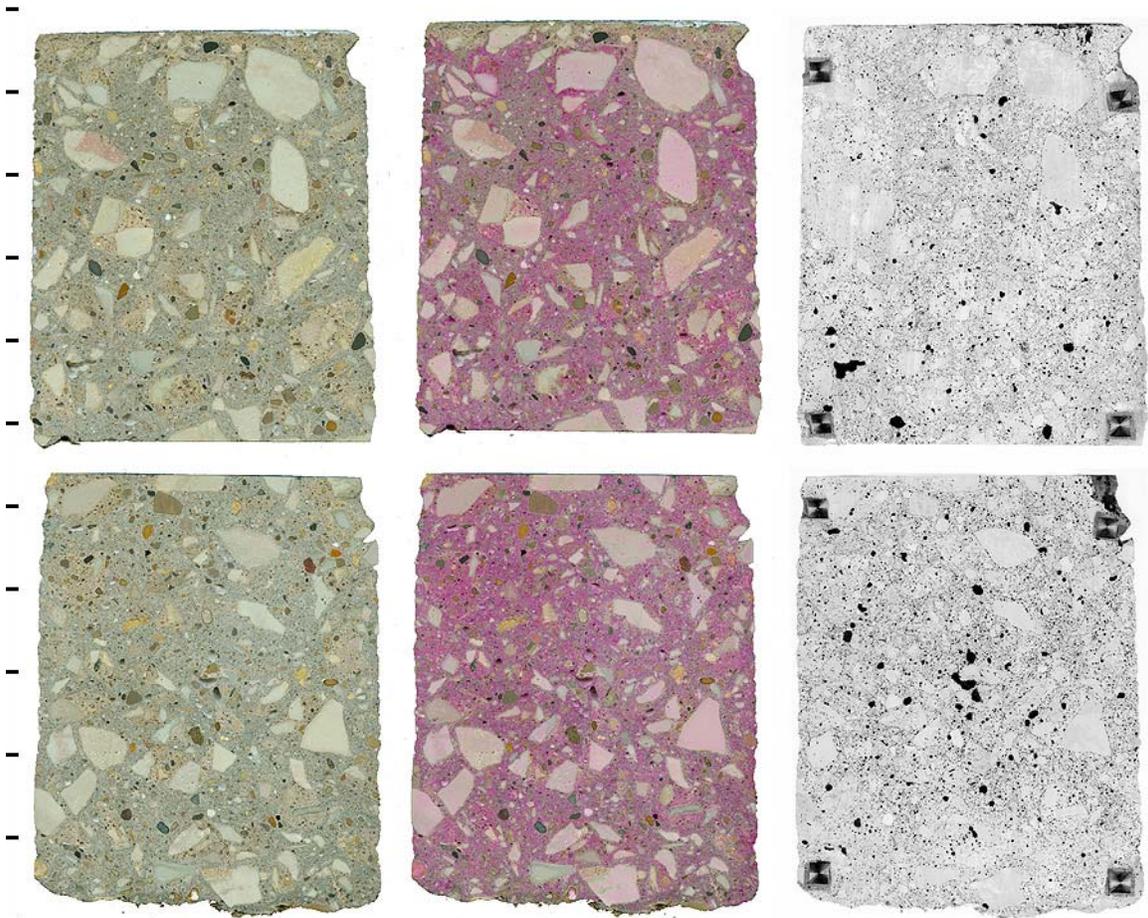
Figure A.5: First set of slabs from core SB-2, from left to right: as polished, phenolphthalein stained, and after treatment to enhance visibility of cracks and air voids, tic marks along left-hand side spaced at 1" intervals.

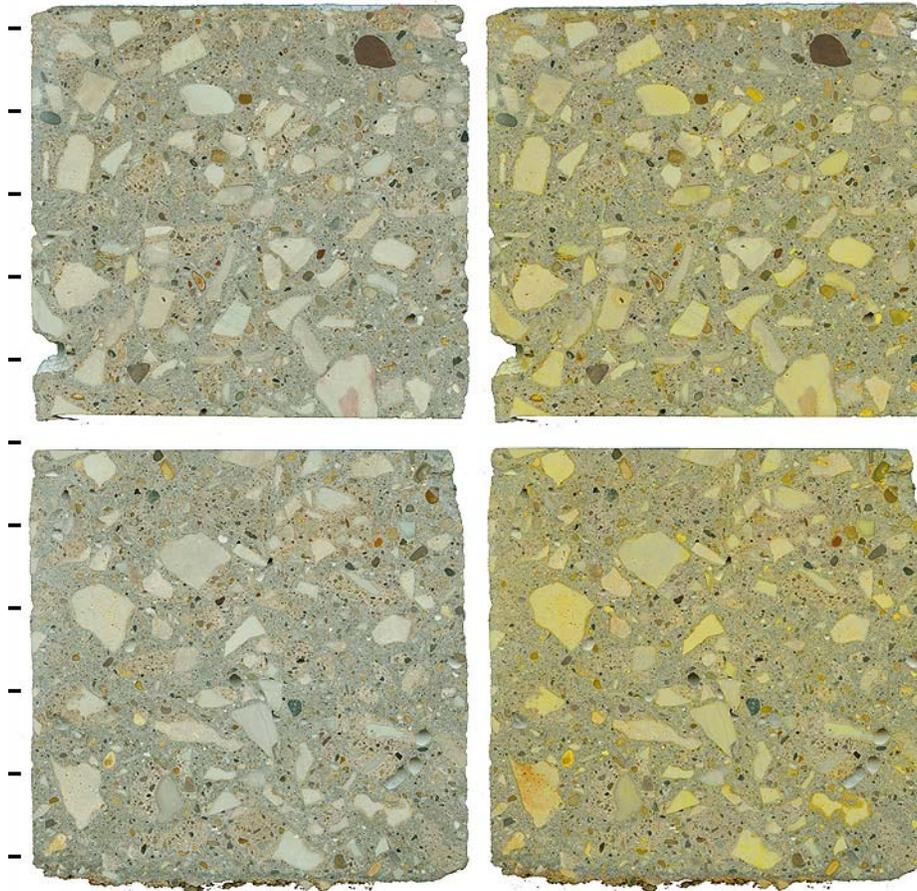
Figure A.6: Second set of slabs from core SB-2, from left to right: as polished, and sodium cobaltinitrite stained, tic marks along left-hand side spaced at 1" intervals.
