# PERFORMANCE OF I-57 RECYCLED CONCRETE PAVEMENTS

Research Report ICT-09-032

**Performance of I-57 Recycled Concrete Pavements**

Illinois Center for Transportation

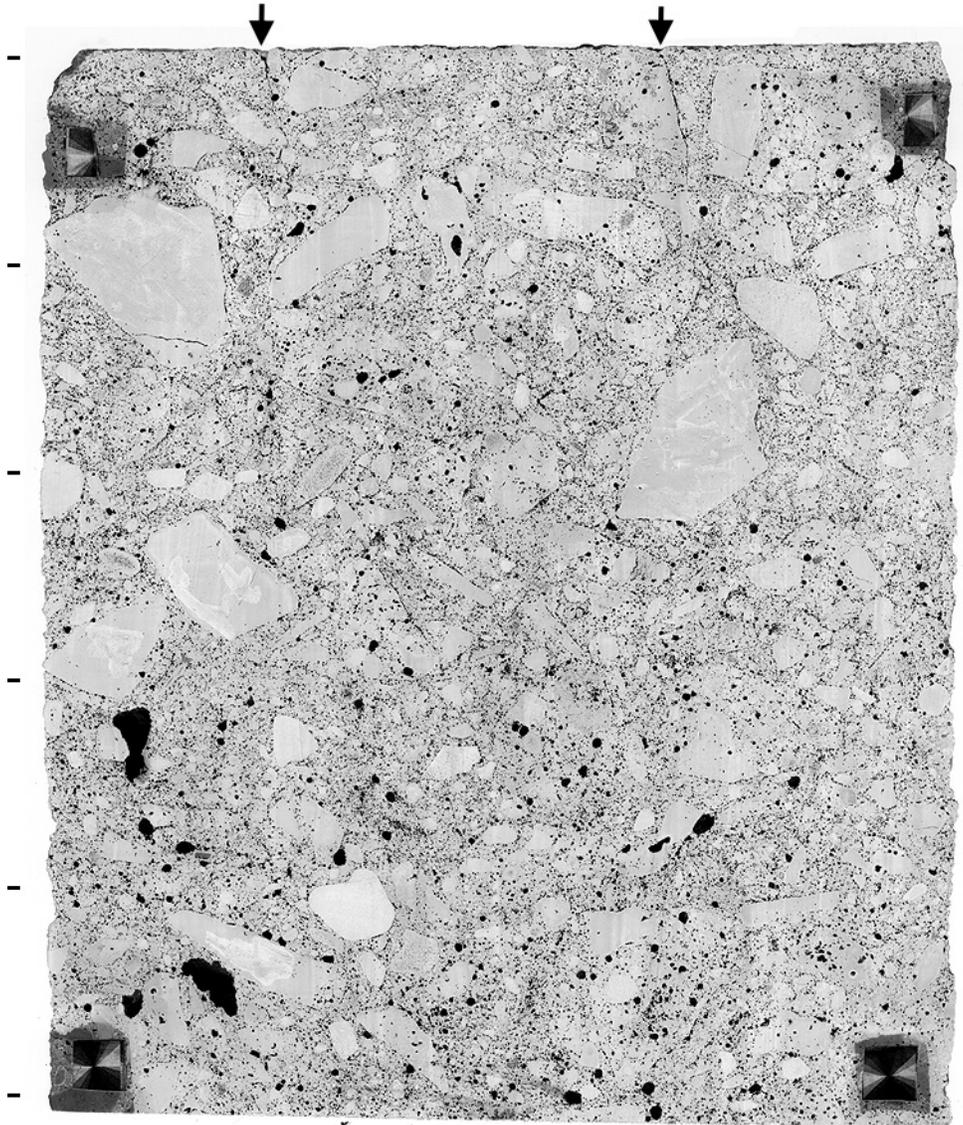
The cracks observed at the pavement surface likely originated from drying shrinkage. The alkali-silica reactivity observed in the coarse aggregate particles does not appear to have resulted in expansion, as no related cracking was observed. Cracking (only two instances) was observed in reactive fine aggregate particles, but the cracks were limited to the particles themselves, without any cracking of the surrounding cement paste matrix. For the most part, reactive fine aggregate particles did not exhibit any signs of cracking or expansion. Since alkalis in concrete tend to be mobile, there is often a potassium-gradient at the pavement surface, and it is normal for the sodium-cobaltinitrite stain to be picked-up just below the pavement surface. The entrained air parameters appeared sufficient for freeze-thaw durability, with spacing factor values in the range of 0.106 – 0.143 mm, and specific surface values in the range of 25.6 to 32.5 mm<sup>-1</sup>. The carbonation depth of 1/4" is deeper than is generally expected for a concrete pavement. Carbonation depths on the order of 1/10" are more common. The deep carbonation suggests a hardened cement paste that might be slightly more permeable than would generally be expected for concrete pavement.

Figure A.7: Detailed scanned image from slab representing top-half of core NB-2 to illustrate cross-section of cracks observed at pavement surface, (black arrows) tic marks along left-hand side spaced at 1" intervals. Prismatic stickers at the four-corners were applied to assist with automated air void analysis.

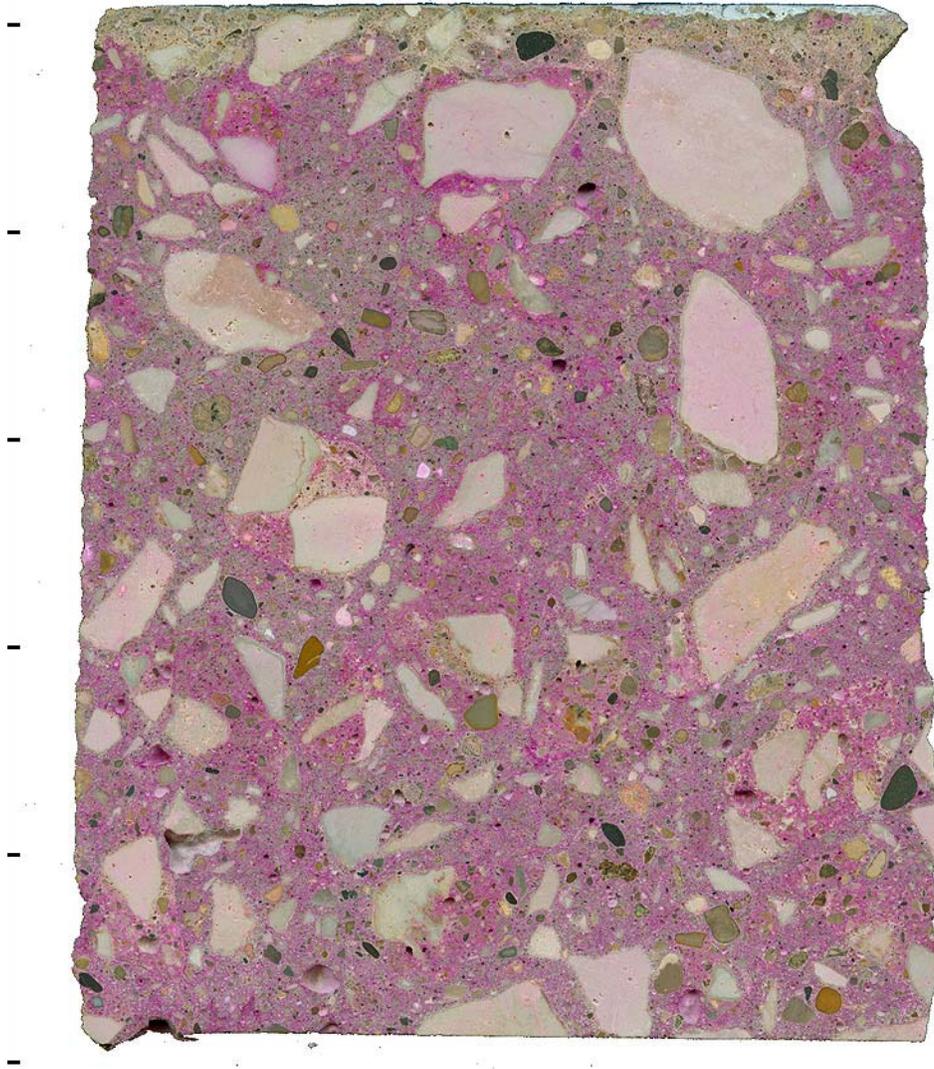
Figure A.8: Detailed scanned image from slab representing top-half of core SB-2 to illustrate depth of carbonation (approximately 1/4").

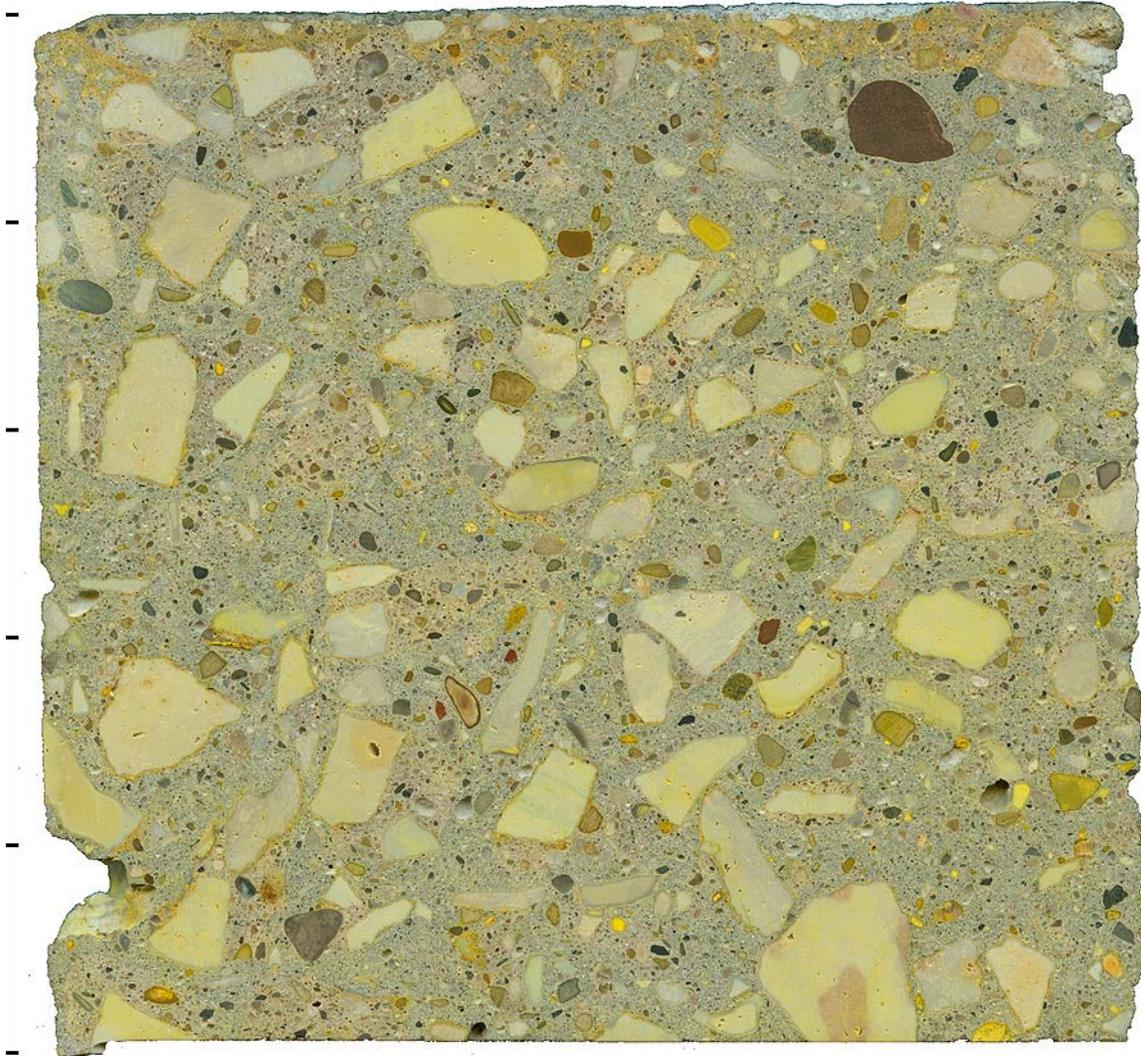
Figure A.9: Detailed scanned image from slab representing top-half of core SB-2 to illustrate extent of yellow sodium cobaltinitrite stained regions.

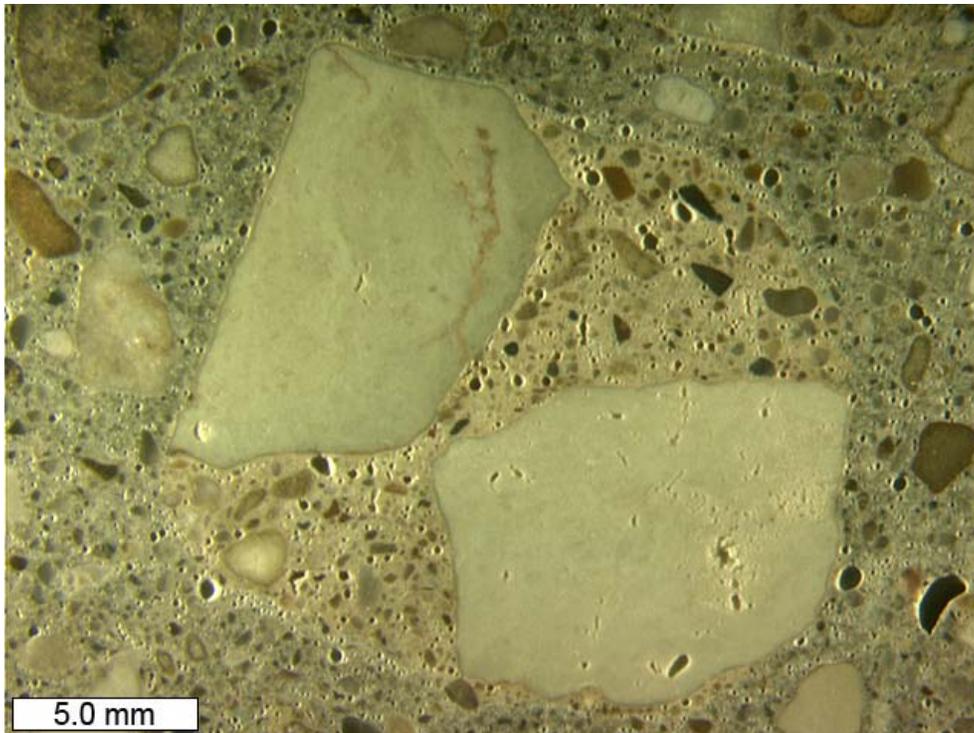
Figure A.10: Example of large recycled coarse aggregate particle in polished cross-section, core NB-2.

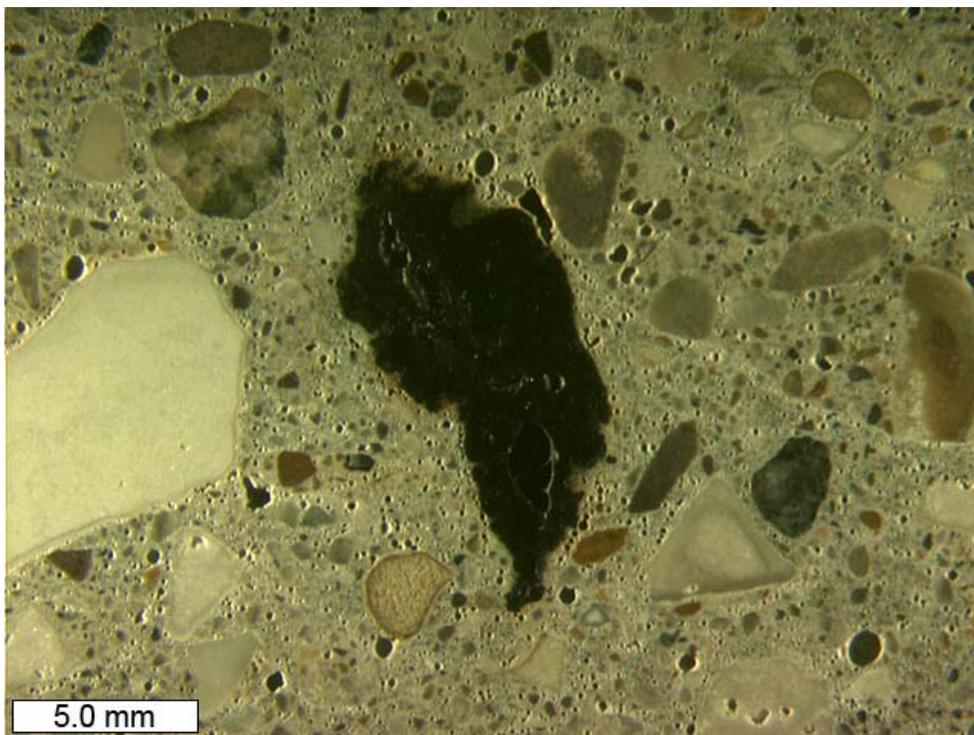
Figure A.11: Lump of asphalt observed in polished cross-section, core NB-2.

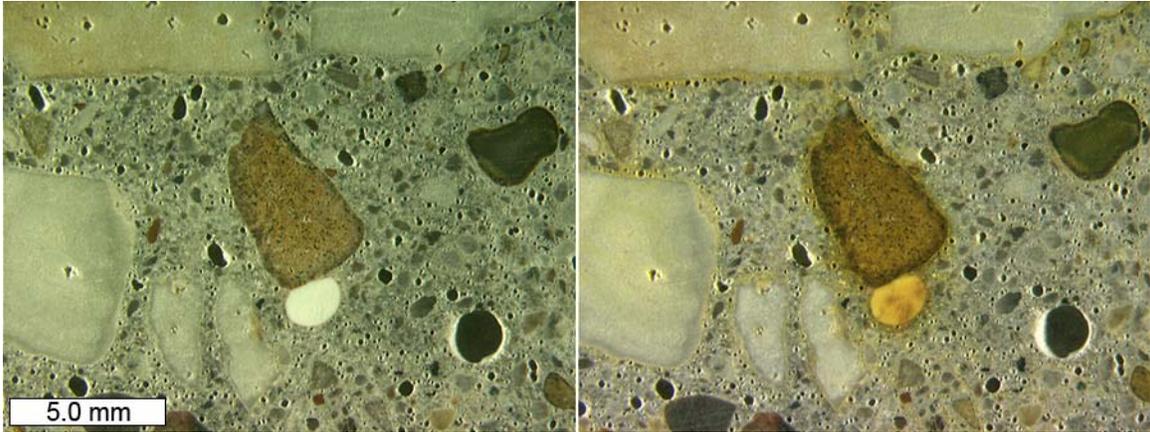
Figure A.12: Reactive fine aggregate particle with adjacent blob of alkali-silica reaction product, core NB-2, both before, (left) and after sodium cobaltinitrite stain, (right).

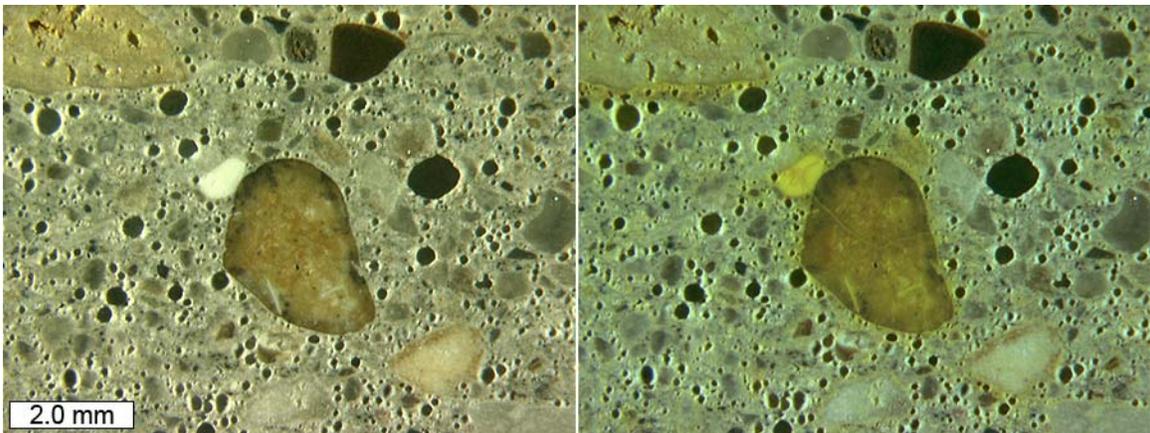
Figure A.13: Reactive fine aggregate particle with fine cracks and adjacent blob of alkali-silica reaction product, core SB-2, both before, (left) and after sodium cobaltinitrite stain, (right).

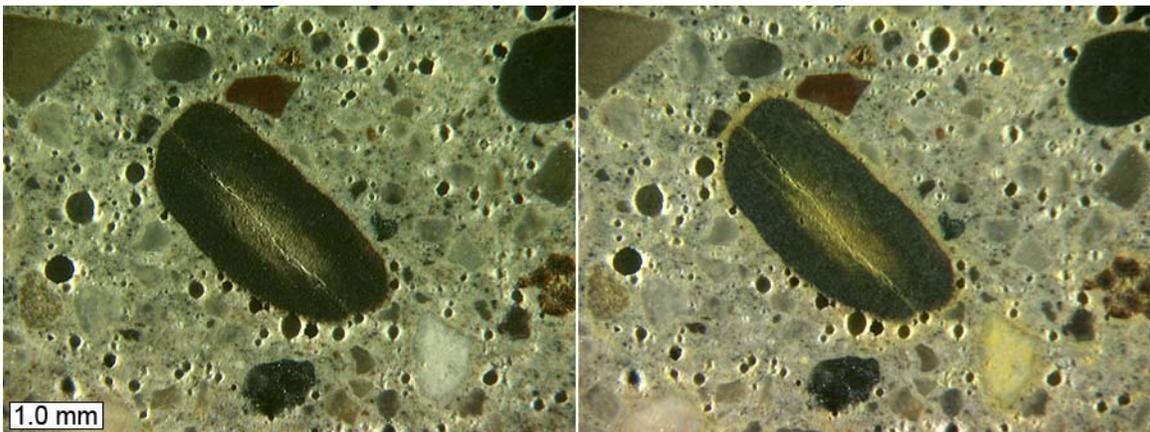
Figure A.14: Reactive fine aggregate particle with fine cracks, core SB-2, both before, (left) and after sodium cobaltinitrite stain, (right).

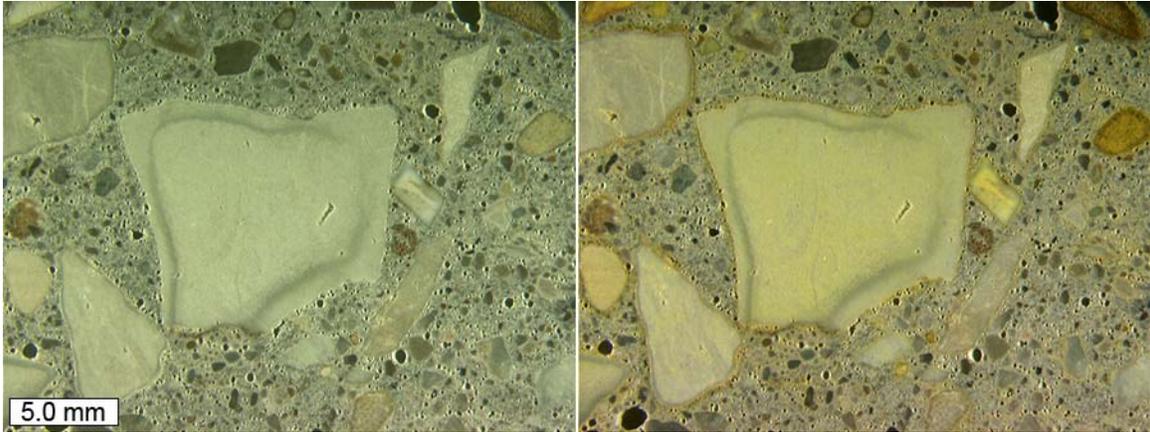
Figure A.15: Carbonate fraction of recycled coarse aggregate particles, core NB-2, both before, (left) and after sodium cobaltinitrite stain, (right).

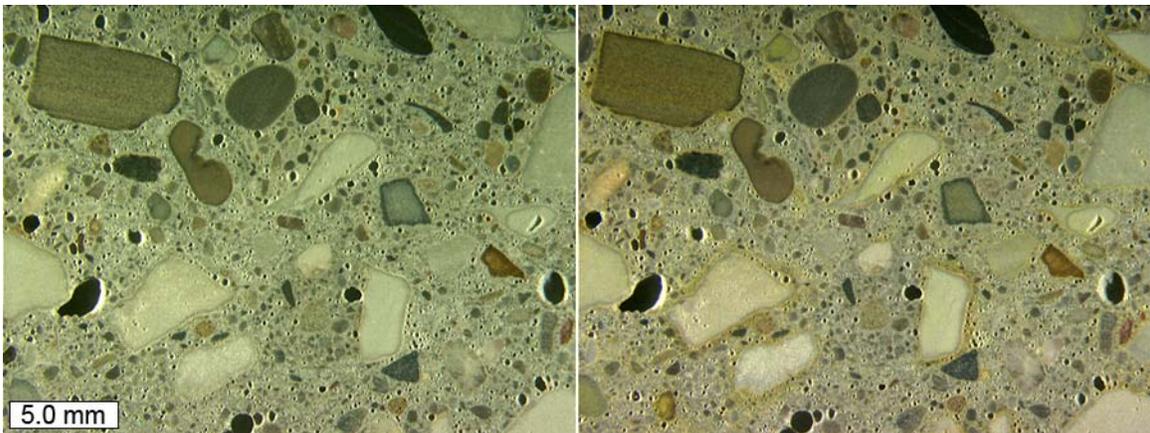
Figure A.16: Carbonate fraction of recycled coarse aggregate particles, core NB-2, both before, (left) and after sodium cobaltinitrite stain, (right).

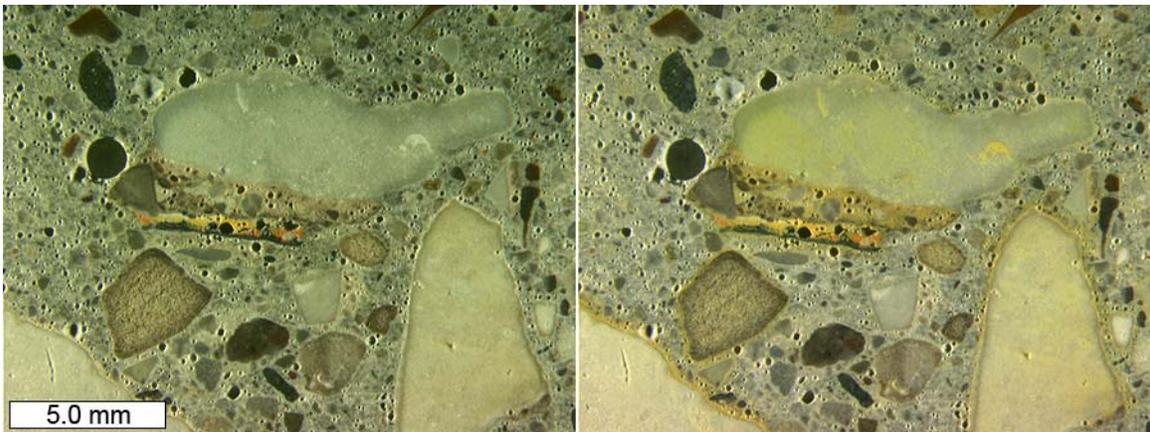
Figure A.17: Carbonate fraction of recycled coarse aggregate particles, one with adhered paint from original concrete surface, core SB-2, both before, (left) and after sodium cobaltinitrite stain, (right).

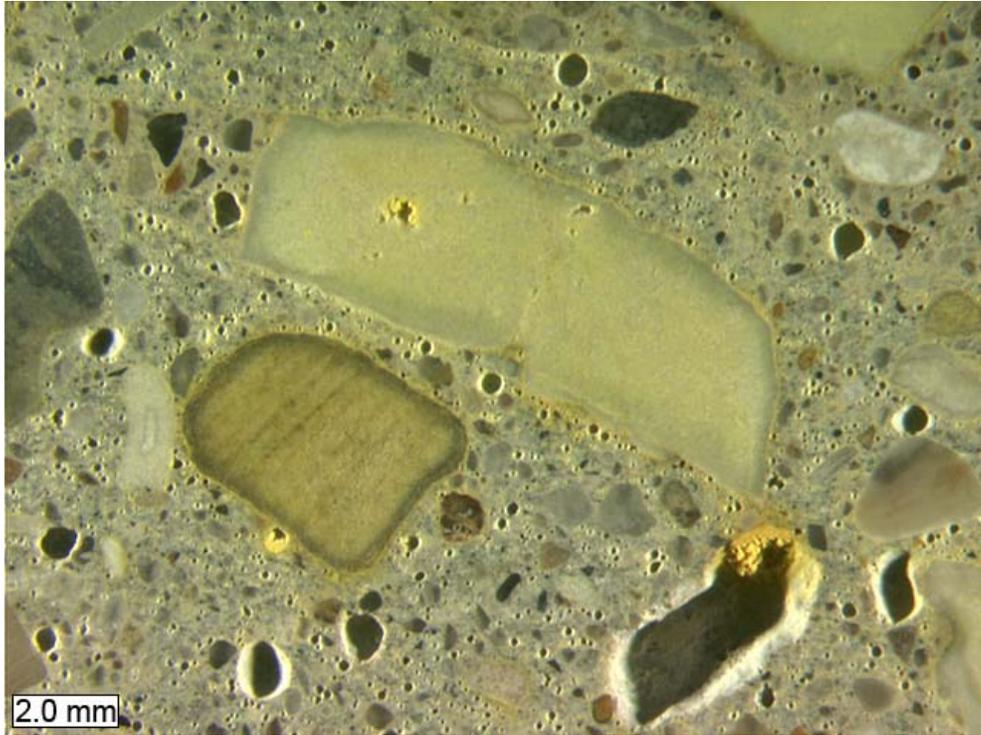
Figure A.18: Examples of alkali-silica reaction product filling voids near reactive aggregate particles, after application of sodium cobaltinitrite stain, core SB-2.

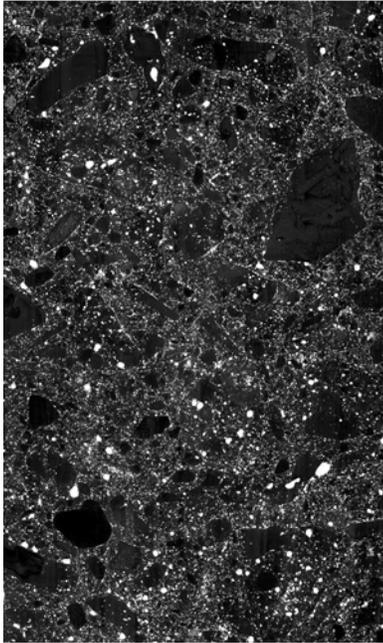
**Air Void Analysis of Hardened Concrete**  
**Calculated According to ASTM C 457**

Scanned Black and White Image

Scanned Image After Thresholding

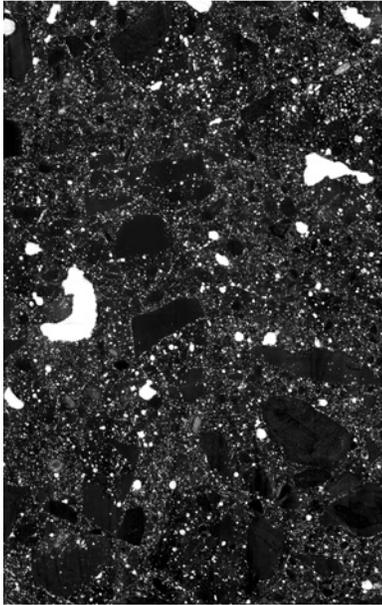
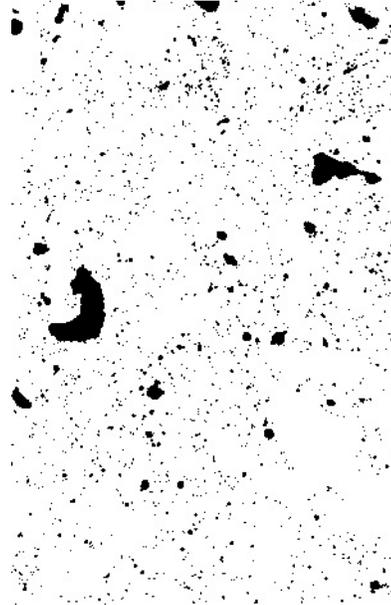
**Air Void Analysis of Hardened Concrete**  
**Calculated According to ASTM C 457**

Scanned Black and White Image

Scanned Image After Thresholding

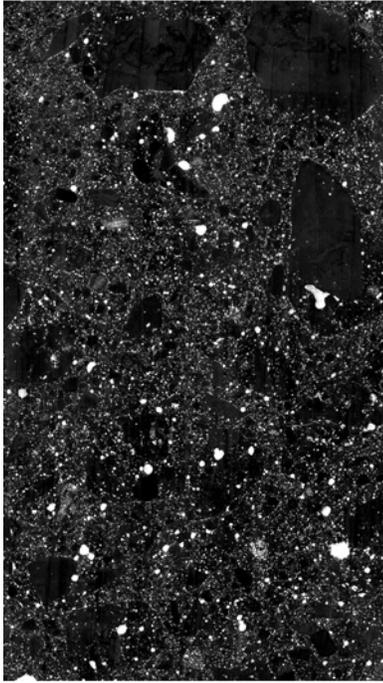
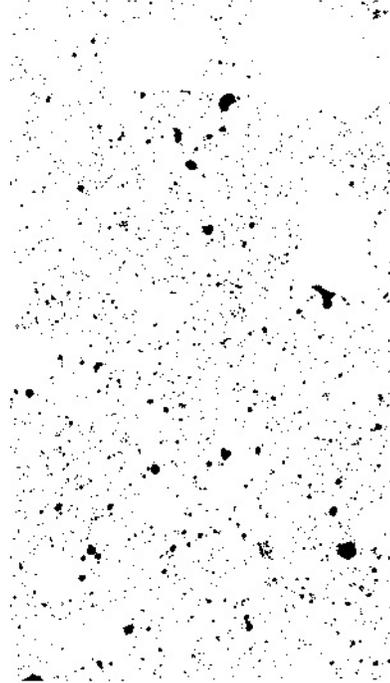
**Air Void Analysis of Hardened Concrete**  
**Calculated According to ASTM C 457**

Scanned Black and White Image

Scanned Image After Thresholding

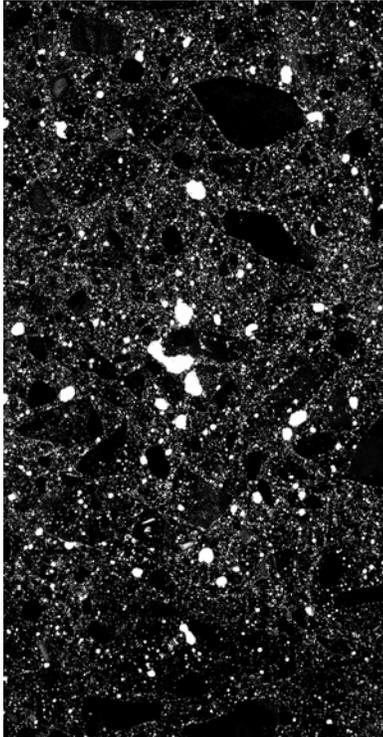
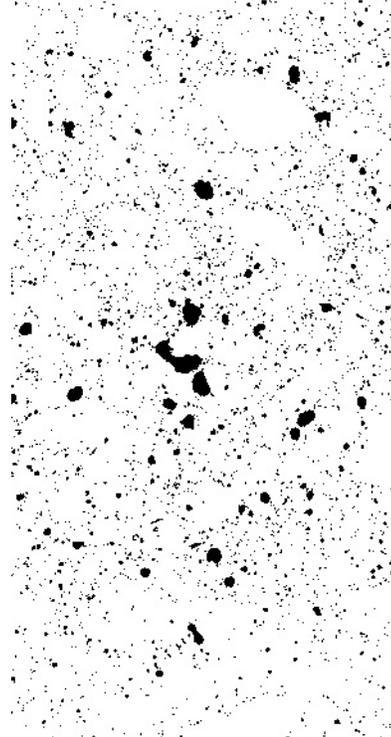
**Air Void Analysis of Hardened Concrete**  
**Calculated According to ASTM C 457**

Scanned Black and White Image

Scanned Image After Thresholding
