Project 0-4588
Seminar: 0-4588-P2
Effect of Voids in Grouted, Post-Tensioned
Concrete Bridge Construction

Texas Department of Transportation, Austin, Texas
February 26, 2009

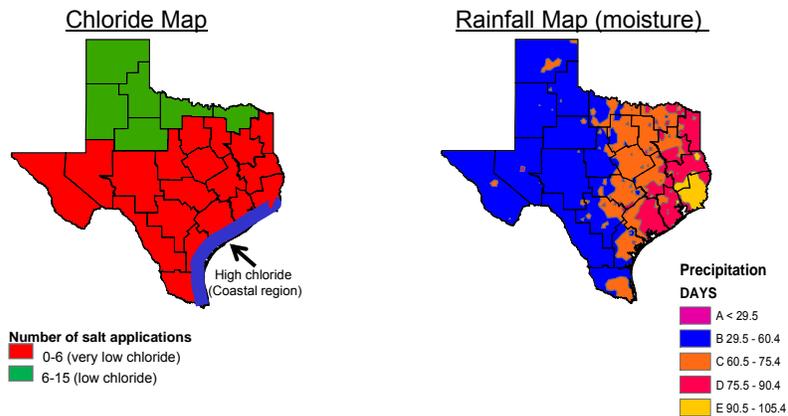
Northern, eastern, and coastal regions in Texas have potentially moderate to severe environmental conditions for PT bridges

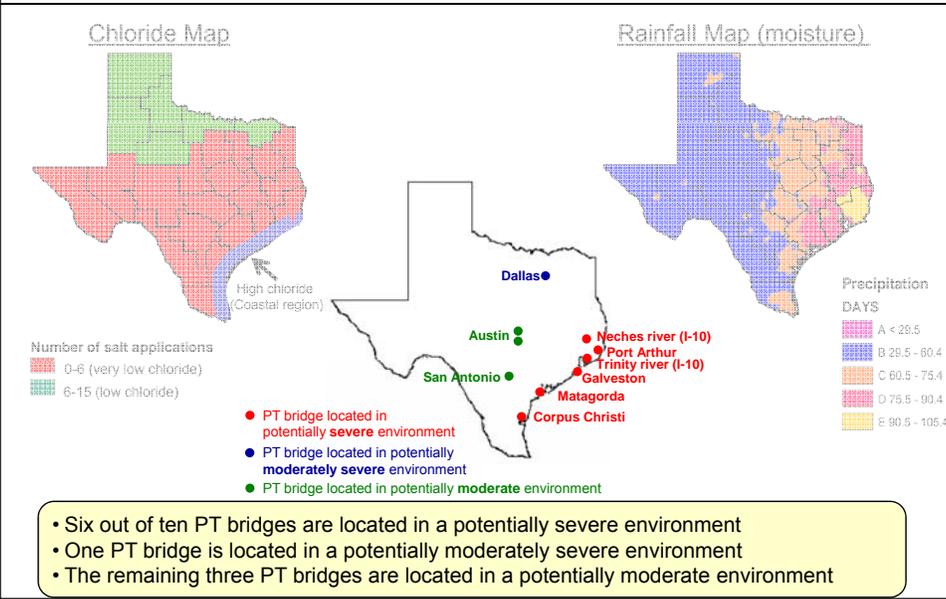
Major PT bridges are located in potentially severe environmental conditions

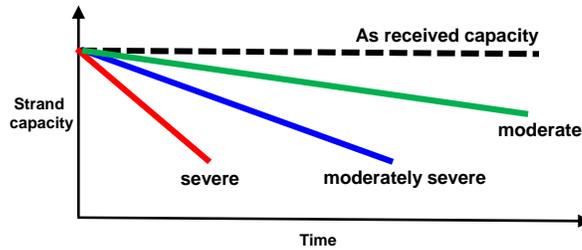
A conceptual schematic showing the capacity loss of strands

The rate of corrosion and tension capacity loss of strands vary depending on the exposure conditions

- Strand exposure conditions are affected by the presence of voids and tendon damage
- The rate of corrosion and the tension capacity loss of the strands increase as the severity of the exposure conditions increase

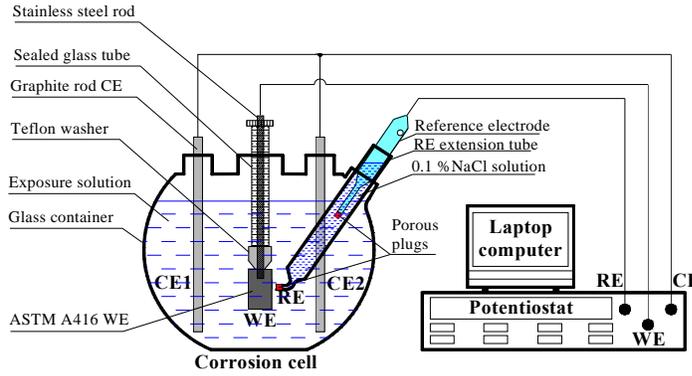
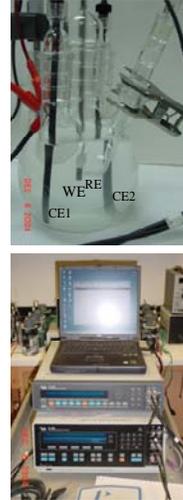
- The cyclic polarization test setup is shown below

Notes
 CE - Counter electrode (Graphite rod)
 RE - Reference electrode (Saturated Calomel electrode with 0.241 V vs SHE)
 WE - Working electrode (ASTM A416 steel wire)

Cyclic polarization tests indicated that the presence of chlorides significantly influences the electrochemical behavior of strands

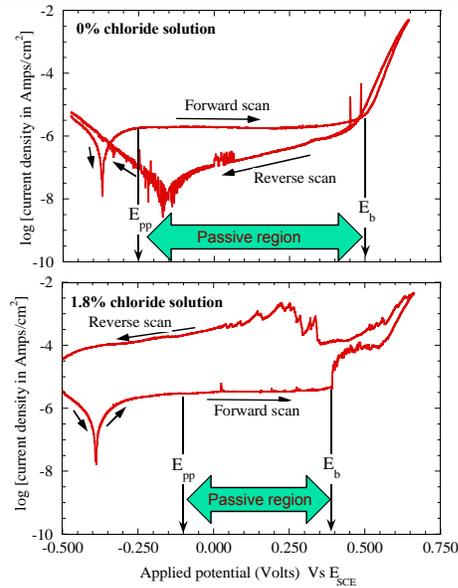
- As the chloride concentration increases, the breakdown potential, E_b , decreases and the passivation potential, E_{pp} , increases.
- Negative and positive hysteresis were observed with 0 and 1.8% chloride solutions, respectively.

- The passive region decreases as the chloride concentration increases
- The presence of chlorides can cause an increase of ~ 3 orders of magnitude in the corrosion rate
- Repassivation does not occur when chlorides are present

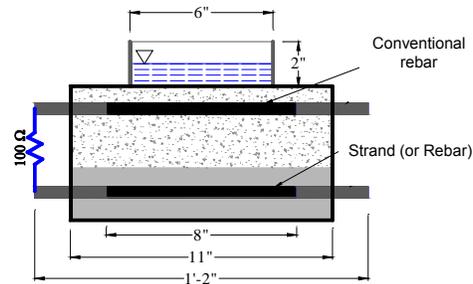
Modified ASTM G109 Test shows that no significant galvanic corrosion occurs between the conventional reinforcement and strands

- 20 specimens with strands at bottom and 20 specimens with conventional rebar at bottom were prepared and evaluated
- These specimens were then exposed to wet-dry cycles with 0 and 9% chloride solutions for 10 months

• No significant galvanic corrosion occurs between the conventional reinforcement and prestressing strands

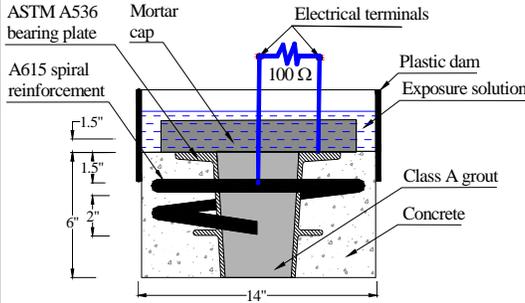
Bearing-plate Test shows that significant galvanic corrosion can occur between the conventional reinforcement and bearing plates

- 20 specimens with conventional spiral reinforcement and cast iron bearing plates were prepared
- These specimens were then exposed to wet-dry cycles with 0 and 9% chloride solutions for 10 months

- Galvanic corrosion can occur between the conventional reinforcement and bearing plate and between the prestressing strand and bearing plate.
- Coating the bearing plate surface with a dielectric material may be beneficial

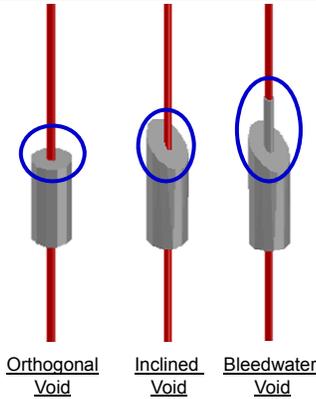
Void types were simulated by forming grout-air-strand interfaces that represent field conditions

- **Parallel voids** - typically found in the horizontal portion of a tendon in a PT girder
- **Orthogonal voids** - typically found in the PT columns with vertical profile
- **Inclined and bleedwater voids** - typically found in the inclined tendons at the anchorage zones of a PT girder

- Orthogonal, inclined, bleedwater void types have statistically similar effects on the tension capacity of strands
- The localized corrosion associated with these void types (typically located at girder anchorages and columns) are more severe than the parallel void type (typically located at the midspan of a girder)

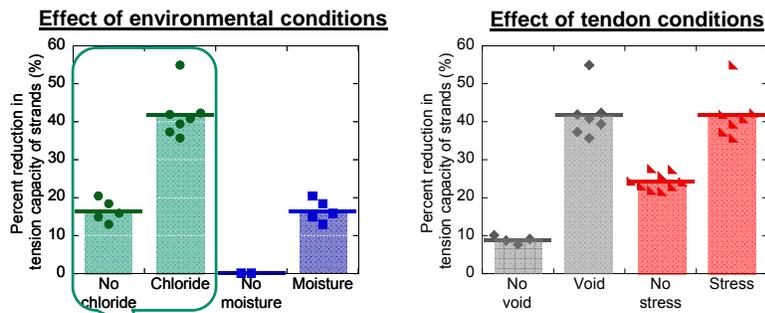
The presence of chlorides can reduce the strand capacity by an additional ~25% in 21 months

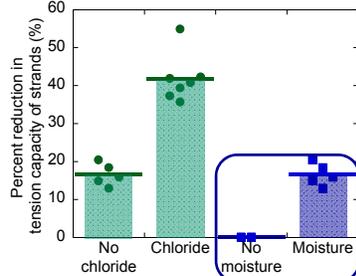
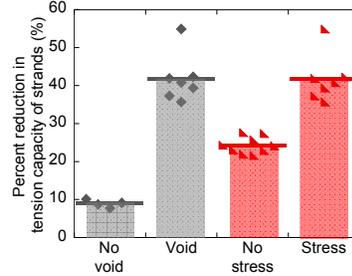
The presence of moisture can reduce the strand capacity by an additional ~17% in 21 months

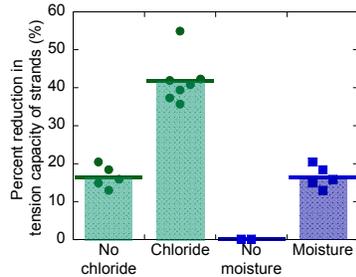
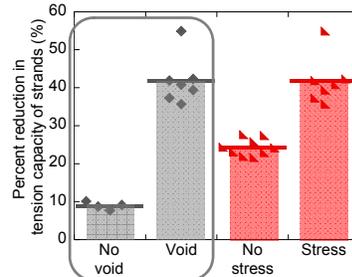
The presence of voids can reduce the strand capacity by an additional ~33% in 21 months

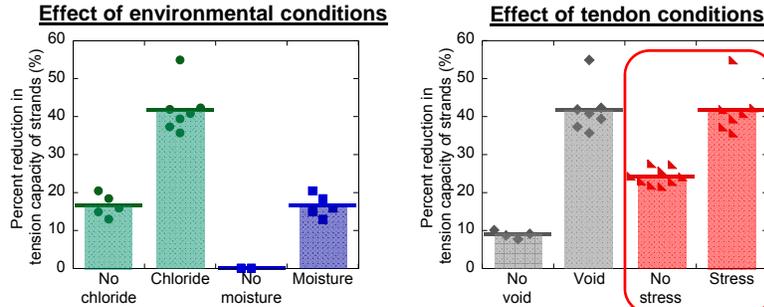
The presence of stress can reduce the strand capacity by an additional ~17% in 21 months

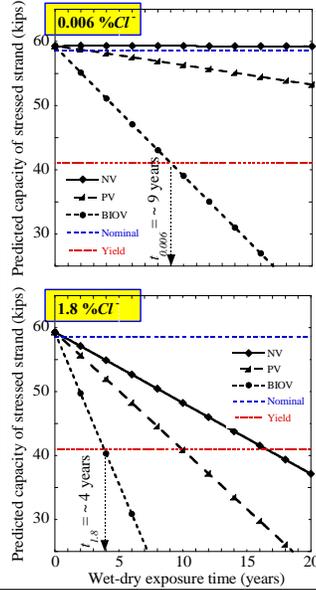
- The presence of chlorides can cause significantly reduce the tension capacity of strands even under No Void (NV) conditions
- Bleedwater, Inclined, or Orthogonal Void (BIOV) types are more corrosive than the Parallel Void (PV) types

- Tension capacity of tendons can drop below the yield capacity in very young ages, if voids, water, or chlorides are present inside the tendons
- The time estimates obtained from the capacity models are consistent with the tendon failures observed in Florida and Virginia
- The effects of this tension capacity loss on the structural reliability were assessed

The plots shown are based on the assumption that there is a 2 months of wet time in every year

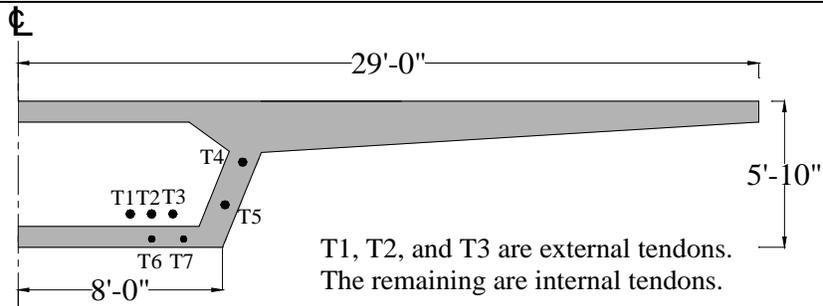
Cross-section of a typical segmental box girder with 14 tendons and a span of 100 feet

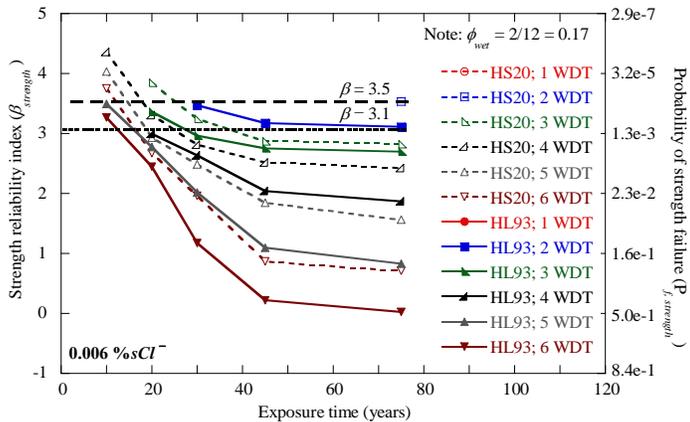
Safety can decrease if water infiltrate the voided tendons

- Bridge tendons with voids exposed to severe moisture conditions lead to a severe reduction in strength reliability

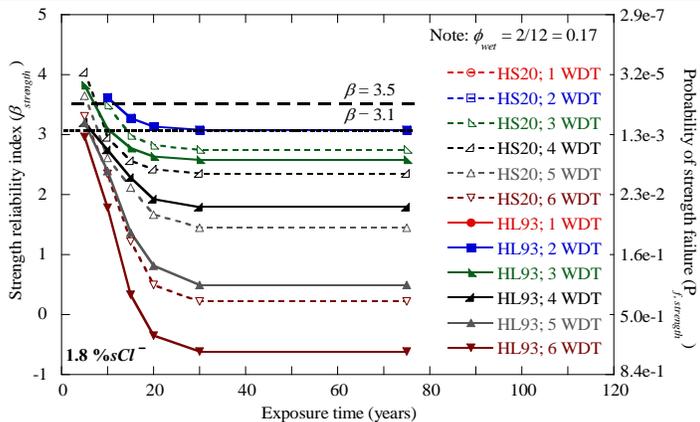
Safety can further decrease if water and chlorides infiltrate the voided tendons

- Bridge tendons with voids exposed to severe moisture and chloride conditions lead to a severe reduction in strength reliability

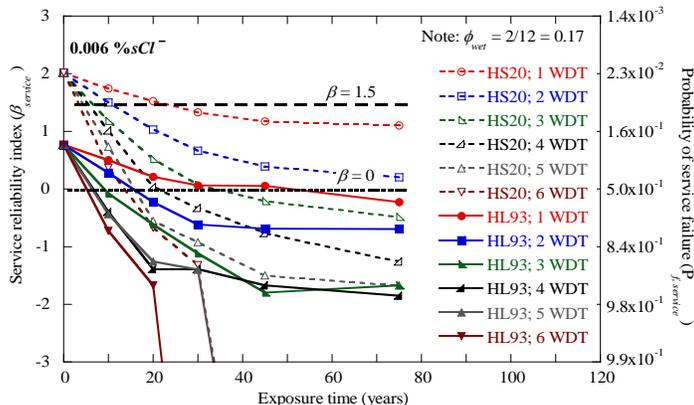
Serviceability can decrease if water infiltrate the voided tendons

- Bridge tendons with voids exposed to severe moisture conditions lead to a severe reduction in service reliability

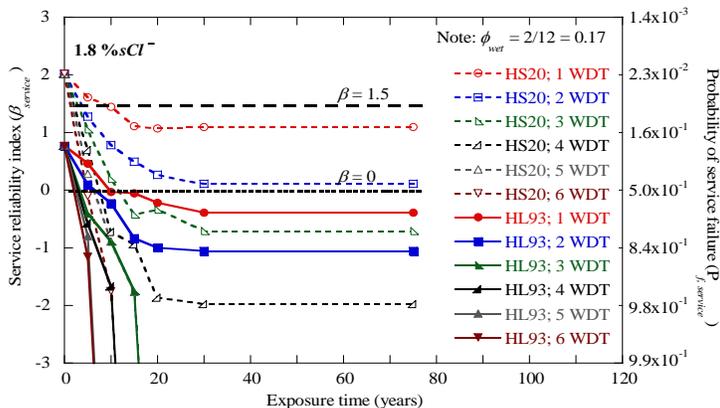
Serviceability can further decrease if water and chlorides infiltrate the voided tendons

- Bridge tendons with voids exposed to severe moisture and chloride conditions lead to a severe reduction in service reliability

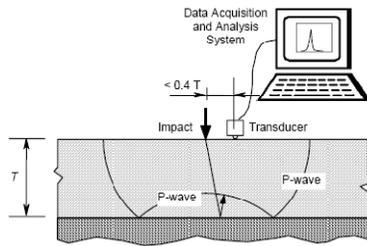
Tinkey and Olson (2007)

- It is difficult to identify voids using IE methods when conditions include small, round elements such as tendons and is not applicable for external tendons

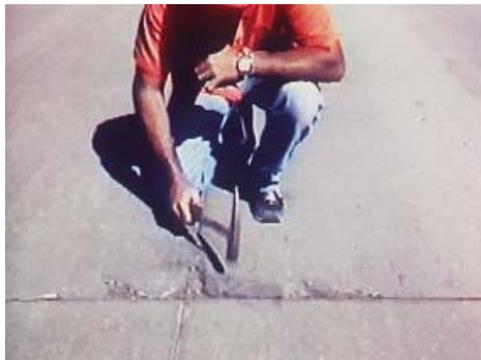
- The literature shows that the sounding inspection method is commonly used to detect delaminated areas in concrete structures
- The sounding inspection method is subjective

Detecting delaminated areas in concrete bridge decks

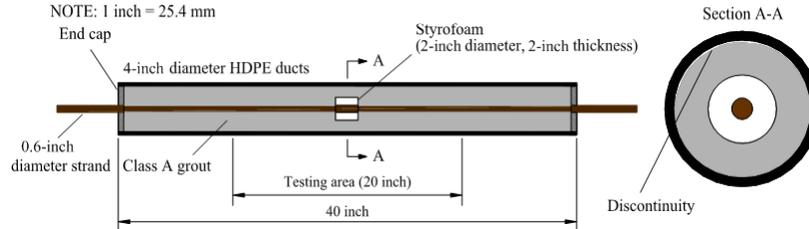
- 16 specimens were designed and fabricated
- Voids were simulated using different size of plastic balls and styrofoam

The schematic of small scale specimen including styrofoam void and strand

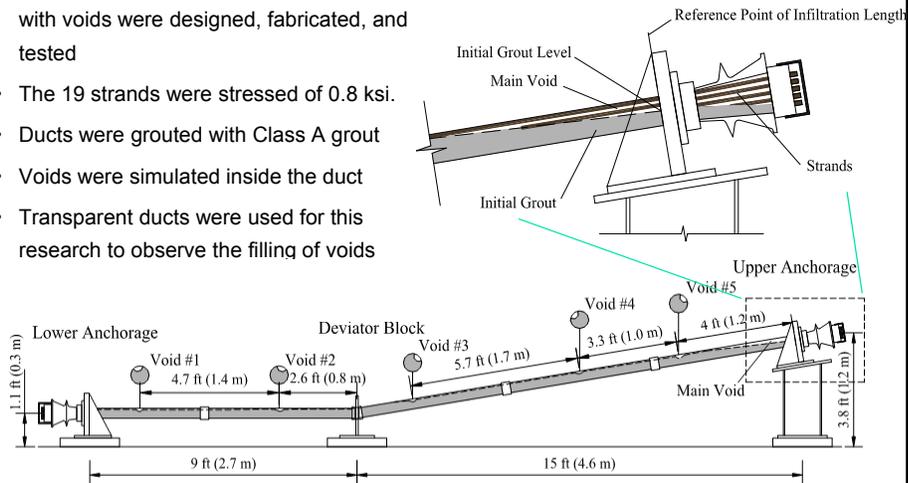
- 16 prototype external tendon specimens with voids were designed, fabricated, and tested
- The 19 strands were stressed of 0.8 ksi.
- Ducts were grouted with Class A grout
- Voids were simulated inside the duct
- Transparent ducts were used for this research to observe the filling of voids

Note: For clarity the 19 strands inside the acrylic duct are not shown.

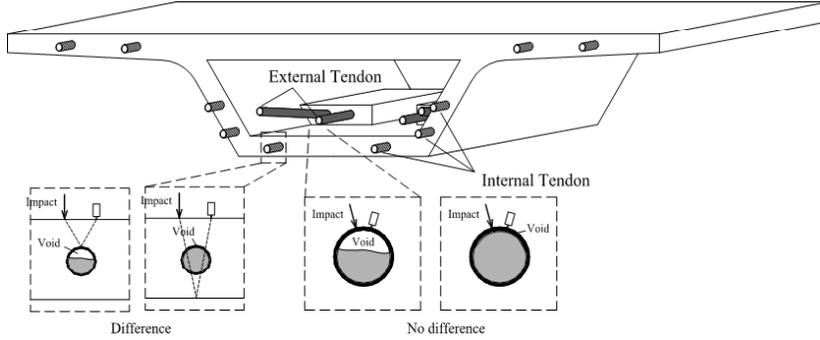
- The results obtained from the IE method were not repeatable
- It is difficult to apply the IE method without a medium for transmitting impact waves

- The IE method is not effective for identifying voids in external tendons
- The IE method is sensitive to vibration and is difficult to use in the field

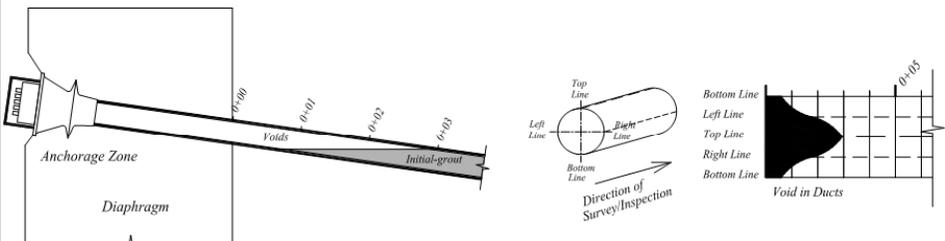
- The test methodology
 - uses a steel tapping hammer to identify the presence of voids in PT ducts
 - identifies voids by detecting a high pitch sound while tapping
 - uses subjective assessment of noise pitch
- The information is recorded on the “unrolled drawing” as shown:

Marking void profiles using sounding inspection on unrolled drawing form

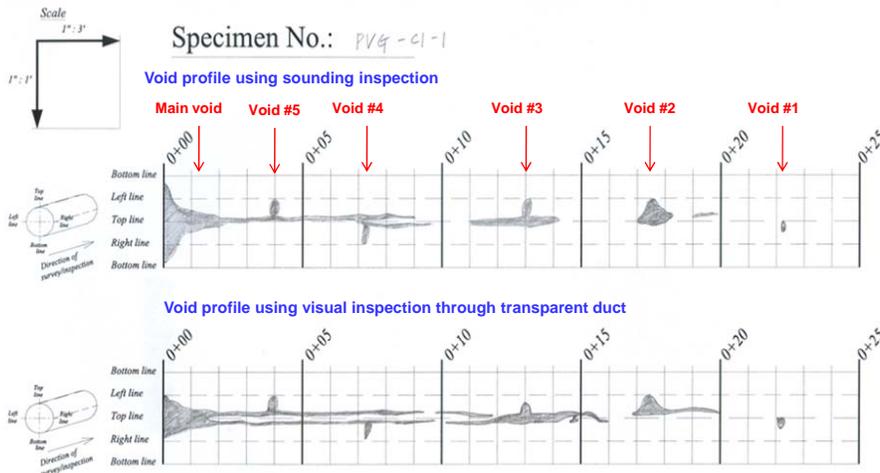
The void profiles obtained using sounding and visual inspections were compared

- The sounding inspection method can identify voids

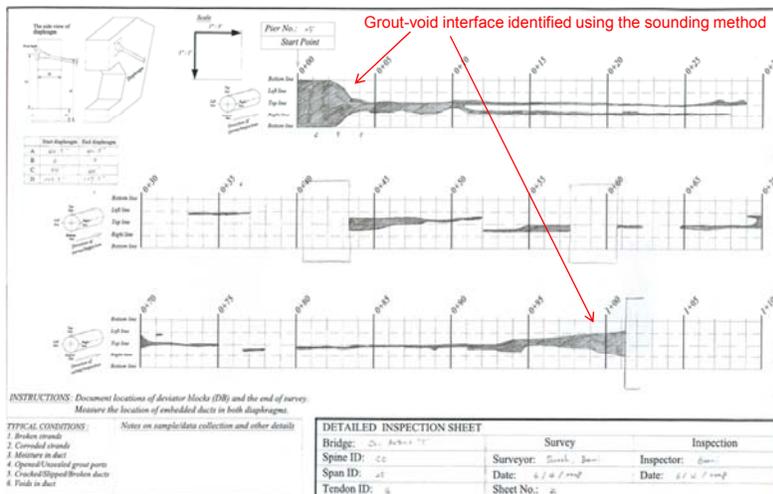
Sounding inspection method was used to assess the presence of voids in the San Antonio “Y” bridge

- The void profile in the bridge show the same trends as the laboratory sample and can be used to identify the grout-void interface in external tendons

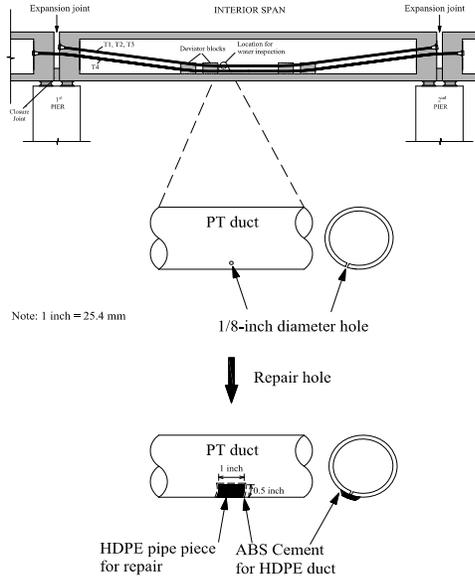
- Test procedure
 - **Using a dremel tool with a copper wire bit (1/8-inch diameter),** drill the duct at the bottom of the lowest point of tendon
 - If water drains from the hole in the tendon, the solution can be collected to assess chlorides or other aggressive ions
 - Repair the hole
 - For more in-depth assessment, additional holes can be selected to identify water and/or chlorides in external tendon

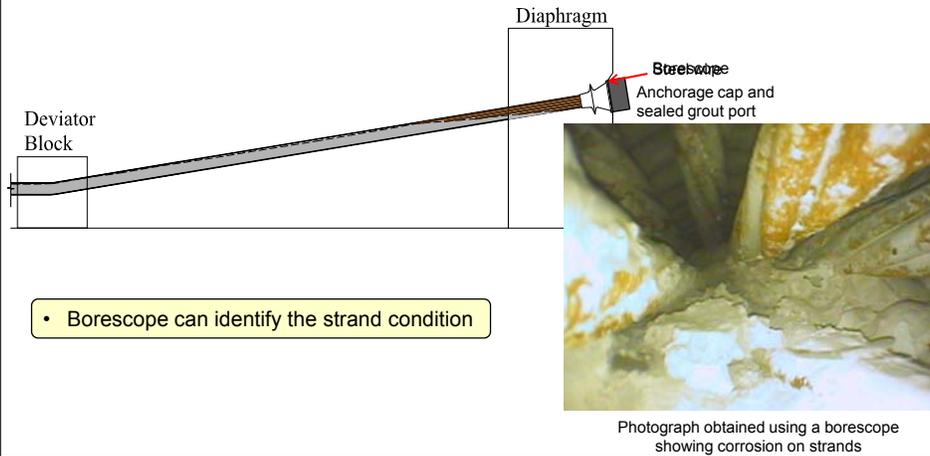
To identify the condition of the strands a borescope can be used

- Test procedure
 - Open the sealed grout port at anchor plate
 - Check the existence of voids inside the anchor plate using steel wire
 - Identify strand conditions inside the anchor plate using borescope

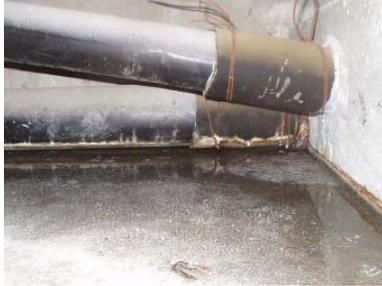
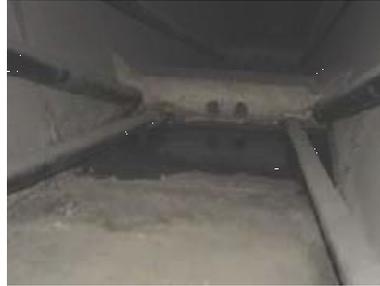
To identify potential damaging conditions in PT systems, the presence and source of water should be identified

- Standing water/moisture inside the box girder

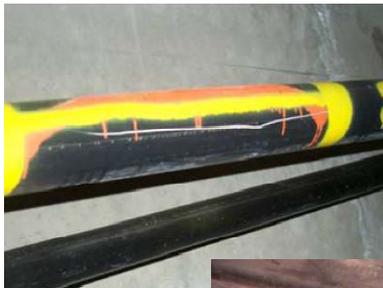
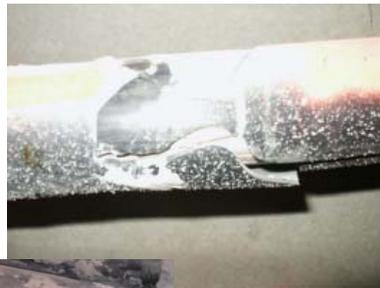
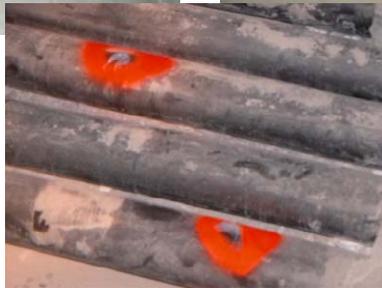
To identify potential damaging conditions in PT systems, the presence of cracked ducts should be identified

- Cracked/broken PT duct and holes on duct

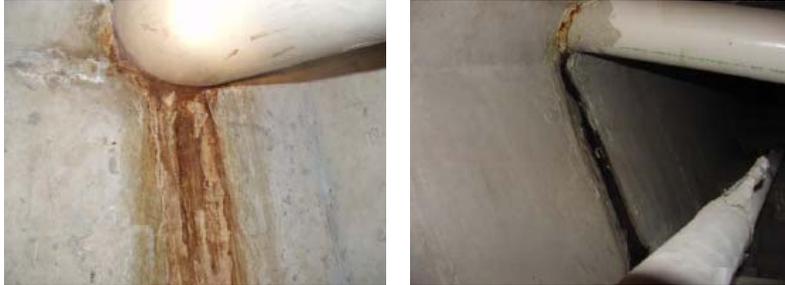
To identify potential damaging conditions in PT systems, the presence of broken drainage pipes should be identified

- Cracked/broken drainage pipe

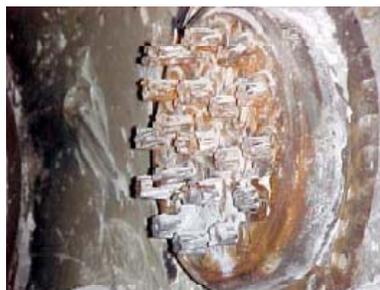
To identify potential damaging conditions in PT systems, the presence of exposed anchorage plates should be identified

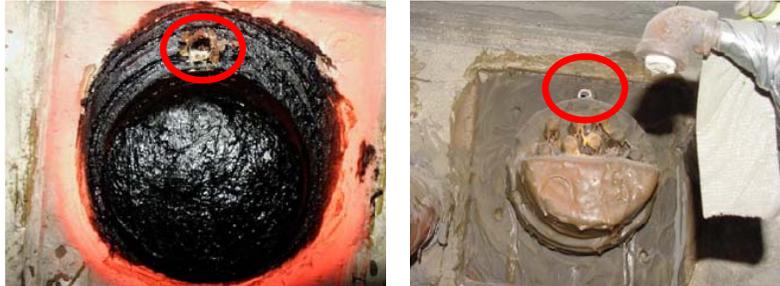
To identify potential damaging conditions in PT systems, the presence of open grout ports should be identified

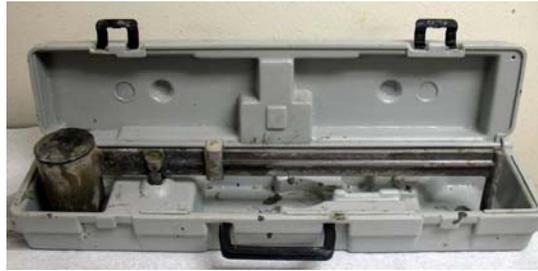
Baroid Mud Balance Apparatus

Mud balance test needs to be included in DMS-4670 specification to ensure field quality of repair grouts

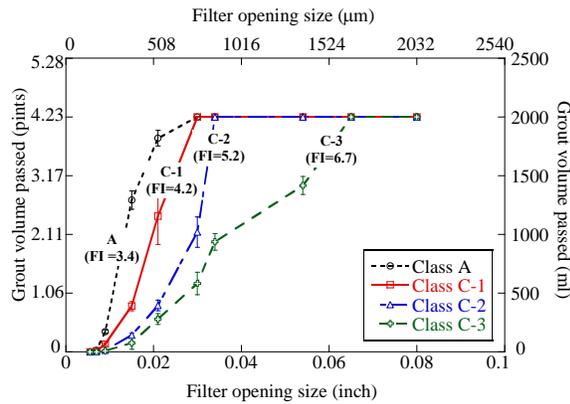
A method was determined to assess the fillability of repair grout

- Different commercially available Class C grouts can have different fillability indices
- It is recommended to include fillability test in DMS-4670 specification to well characterize the Class C grouts

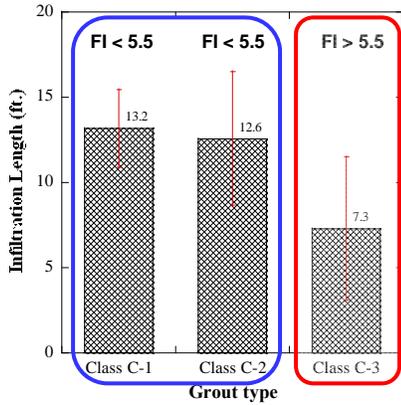
- C-3 grout does not meet Fillability Index (FI) requirement
- C-1 and C-2 grouts with larger FI can infiltrate deeper into the voids than C-3 grout

- Based on the analysis of variance (ANOVA), at a 0.05 level of significance (which is the probability of erroneously rejecting the hypothesis), the hypothesis that the mean infiltration lengths are all the same as different repair grouts can be rejected
- That is, there are statistically significant evidences to conclude that different repair grouts have different infiltration lengths
- From the Student-Newman-Keuls (SNK) test, the infiltration length of the Class C-3 grout have less infiltration length than others
- Therefore, the different repair grouting methods are assessed while considering the Class C-1 and C-2 grouts

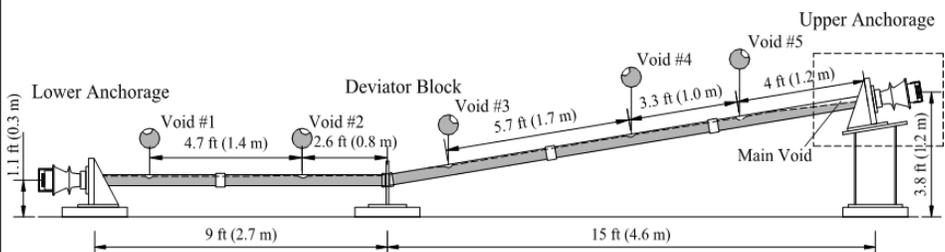
Three repair grouting methods were assessed for their filling capability, repair performance, and economic feasibility

Note: For clarity the 19 strands inside the acrylic duct are not shown.

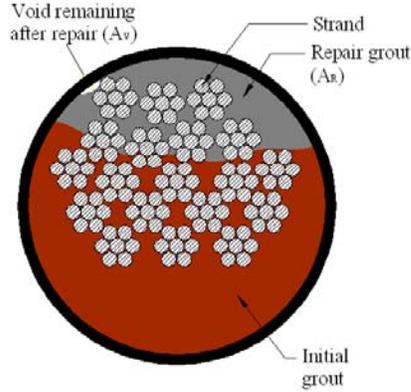
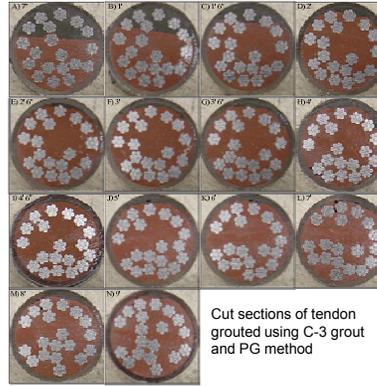
- Sections were cut at every 6 inches up to 5 ft from reference point and at every 12 inches thereafter
- Void percent $(A_v/A_R) \times 100$ was estimated to compare the performance of repaired grout
- The minimum values of the repaired area in cut sections were evaluated to compare filling capability

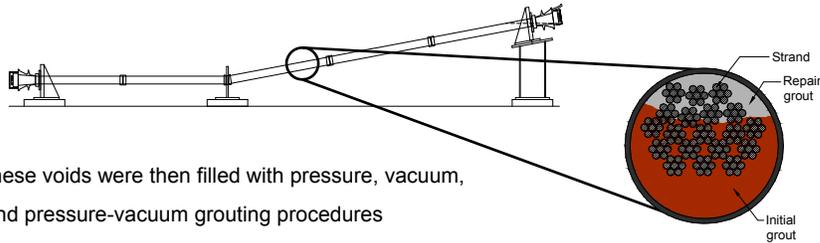
- These voids were then filled with pressure, vacuum, and pressure-vacuum grouting procedures
- **Pressure grouting** requires less preparation time (more constructable) but was found to leave voids unfilled (lower fillability)

Tendon cross-section showing strands, possible remaining voids, and initial and repair grout
(LOWER FILLABILITY)

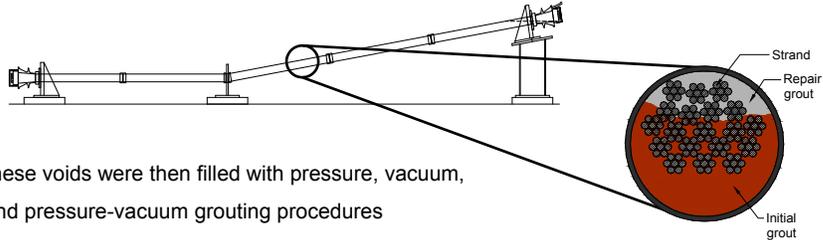
- These voids were then filled with pressure, vacuum, and pressure-vacuum grouting procedures
- **Pressure grouting** requires less preparation time (more constructable) but was found to leave voids unfilled (lower fillability)

Tendon cross-section showing strands, and initial and repair grout
(BETTER FILLABILITY)

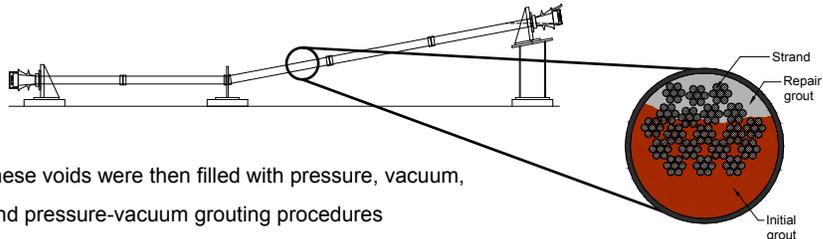
- These voids were then filled with pressure, vacuum, and pressure-vacuum grouting procedures
- **Pressure grouting** requires less preparation time (more constructable) but was found to leave voids unfilled (lower fillability)
- **Vacuum grouting** results in better fillability but is less constructable
- **Pressure-vacuum grouting** was found to be both constructable and to have better fillability

Tendon cross-section showing strands, and initial and repair grout (BETTER FILLABILITY)

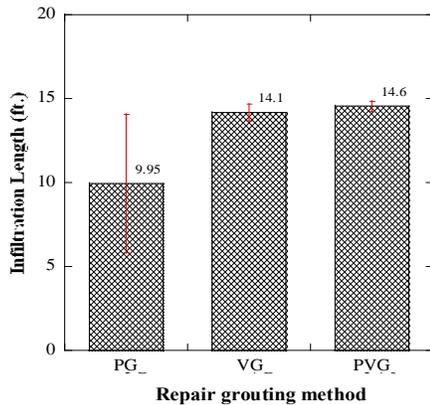
- Based on the ANOVA, at a 0.05 level of significance, the hypothesis that the mean infiltration lengths are all the same as different repair grouting method cannot be rejected
- That is, there is no statistically significant evidence to conclude that different repair grouting methods have different infiltration lengths
- However, the PG method seems to have less infiltration length than others

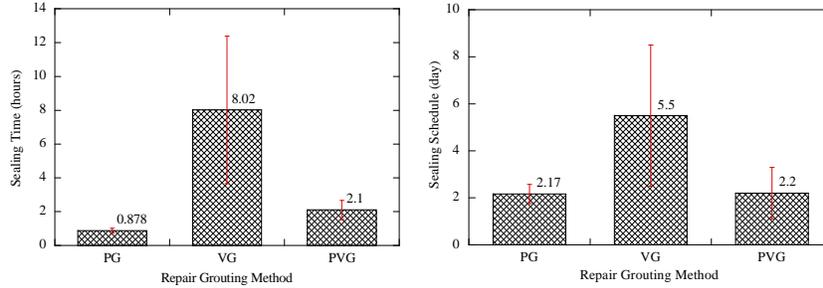
- Voids after repair are assessed in cut sections
 - Based on the ANOVA, at a 0.05 level of significance, the hypothesis that the mean sealing time is all the same as different repair grouting methods can be rejected.
 - That is, there is statistically significant evident to conclude that different grouting methods need different sealing time.
 - From the SNK test, the sealing time of the VG method have more preparation time than others.
