# **DEVELOPMENT AND LAYOUT OF A PROTOCOL FOR THE FIELD PERFORMANCE OF CONCRETE DECK AND CRACK SEALANTS**

Project 07-13  
August 2009

Midwest Regional University Transportation Center  
College of Engineering  
Department of Civil and Environmental Engineering  
University of Wisconsin, Madison

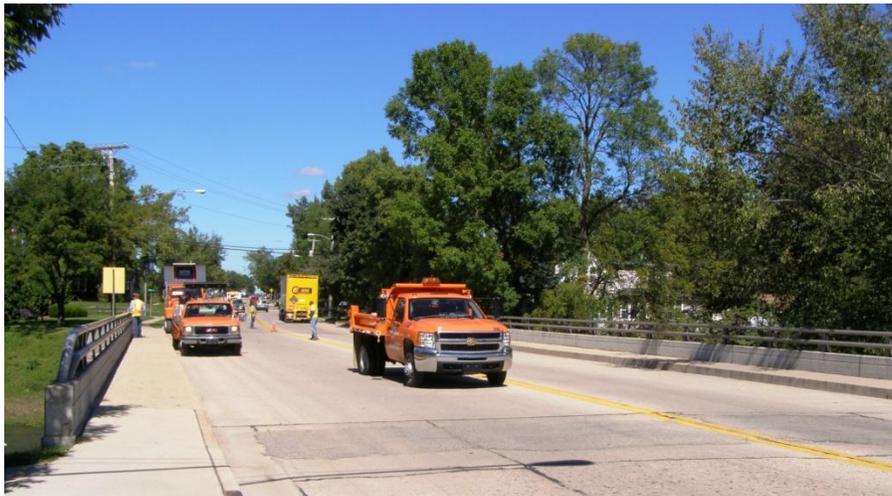
This bridge, built in 1979, is a two lane, three span continuous haunched slab over the Sugar River in Dane County with an overall length of 142 ft. 10 in. (see Fig. 3.2). It was built in 1979 and, according to inspection reports, it has undergone only minor repair work. The deck was reinforced with black bars. For the purposes of this study, the southbound lane was closed and visually inspected. Overall, the deck was in good condition (NBI rating of 7 in 2007), but it presented several longitudinal and transverse cracks that varied in length, as shown in Figure 3.3. The crack depth was unknown, but inspection of the underside of the deck

**Figure 3.2** Overall view of bridge B-13-0337.

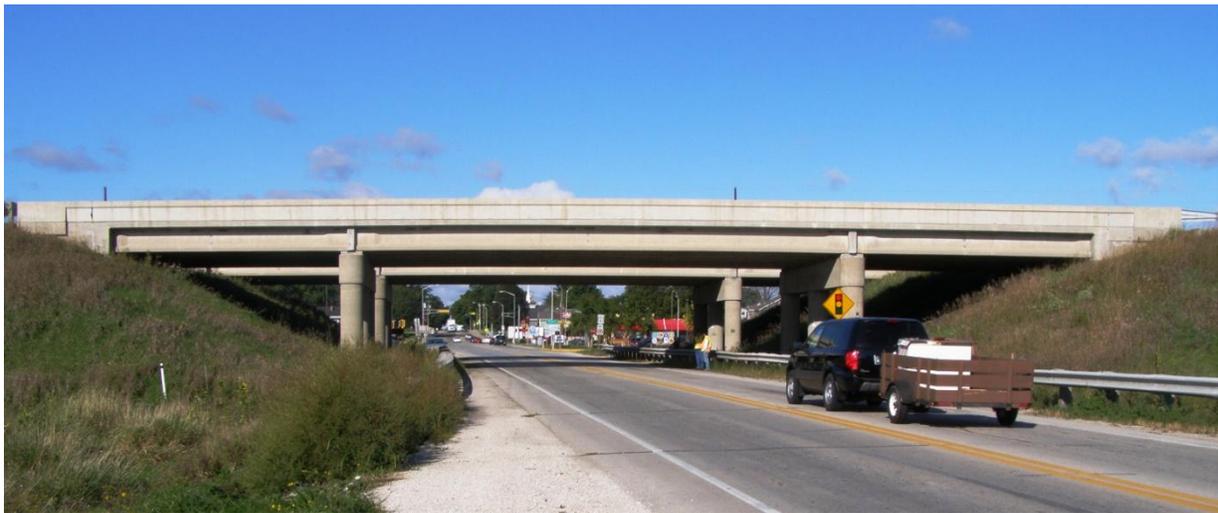
This bridge is a two lane on USH 151 NB originally built in 1961, but was provided with a new deck in 1997. The bridge is a three span concrete deck supported on prestressed concrete girders with an overall length of 132 ft, as shown in Fig. 3.6. Deck reinforcement consisted of epoxy-coated bars. The deck was in very good condition (NDI rating of 7 in 2006)

Figure 3.6 Overall view of bridge B-13-0034.

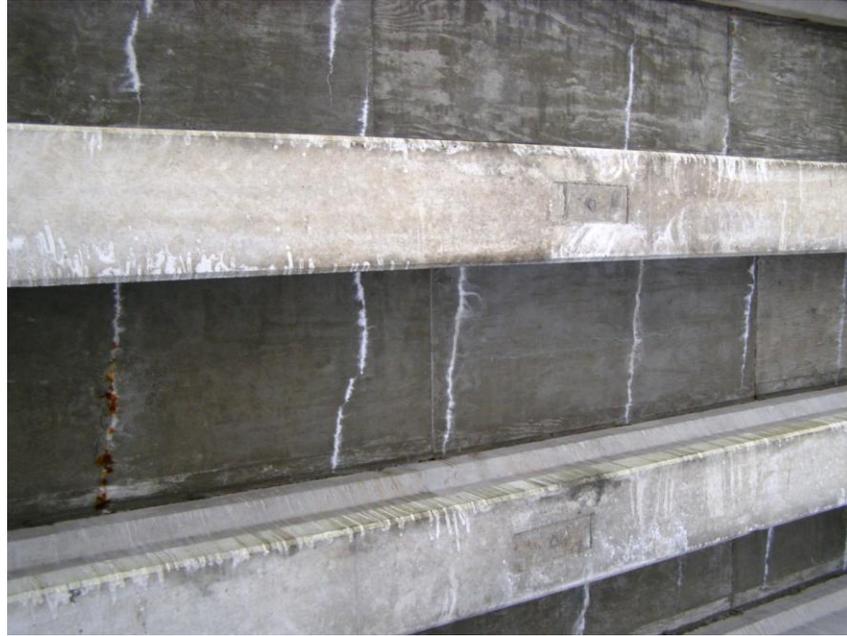
**Figure 3.8** Evidence of efflorescence and rust stains on the underside of the deck of bridge B-13-0034.

but it had a few transverse cracks and a few longitudinal cracks in all three spans, as shown in Fig. 3.7 for the left lane. Some of these cracks extended through the depth of the deck, as evidence by efflorescence and rust stains on the underside of the deck (see Fig. 3.8).

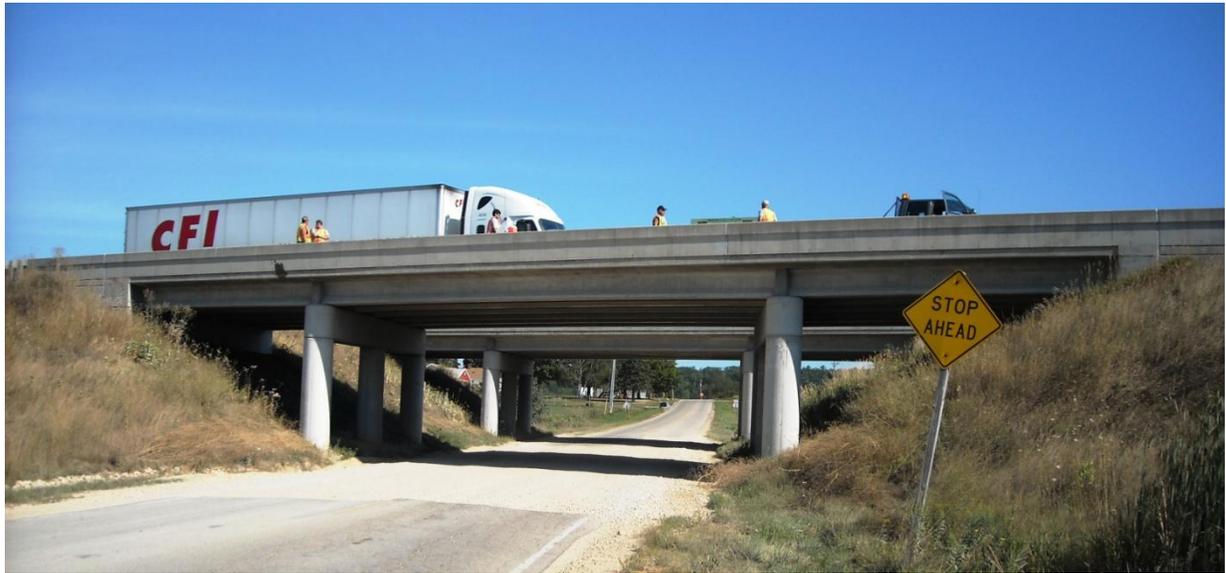
This bridge is a two lane on STH 29 EB built in 1997. The bridge is a three span concrete deck reinforced with epoxy coated bars. The deck is supported on prestressed concrete girders with an overall length of 102 ft. as shown in Fig. 3.9. The deck was in very good condition (NDI rating of 7 in 2007) but it had longitudinal, transverse and diagonal cracks, as shown for the right lane in Fig. 3.10. These cracks, however, are believed to be superficial as visual inspection showed no evidence of cracking on the bottom of the deck.

Figure 3.9 Overall view of bridge B-58-0080.

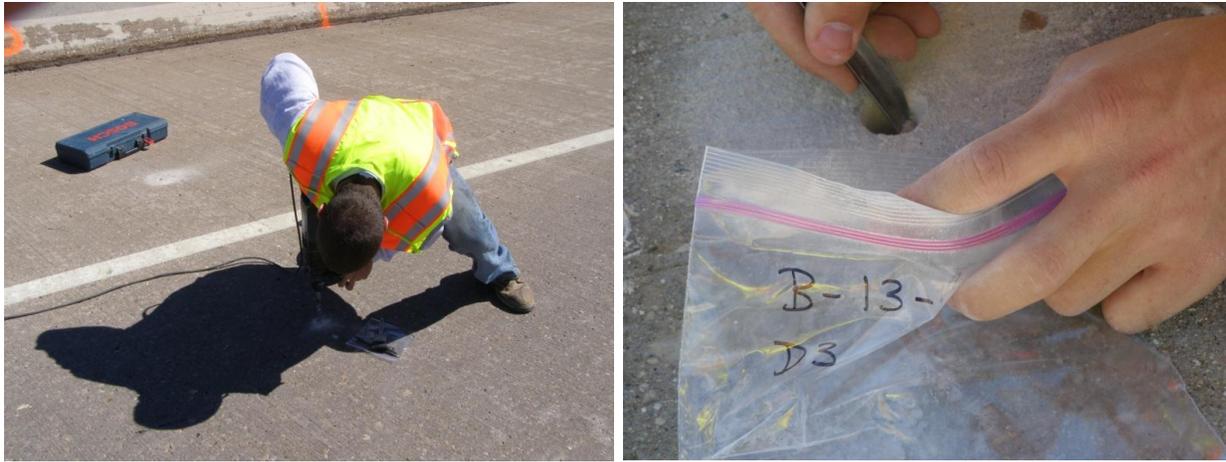
**Figure 4.2** Extraction of powder samples in the field.

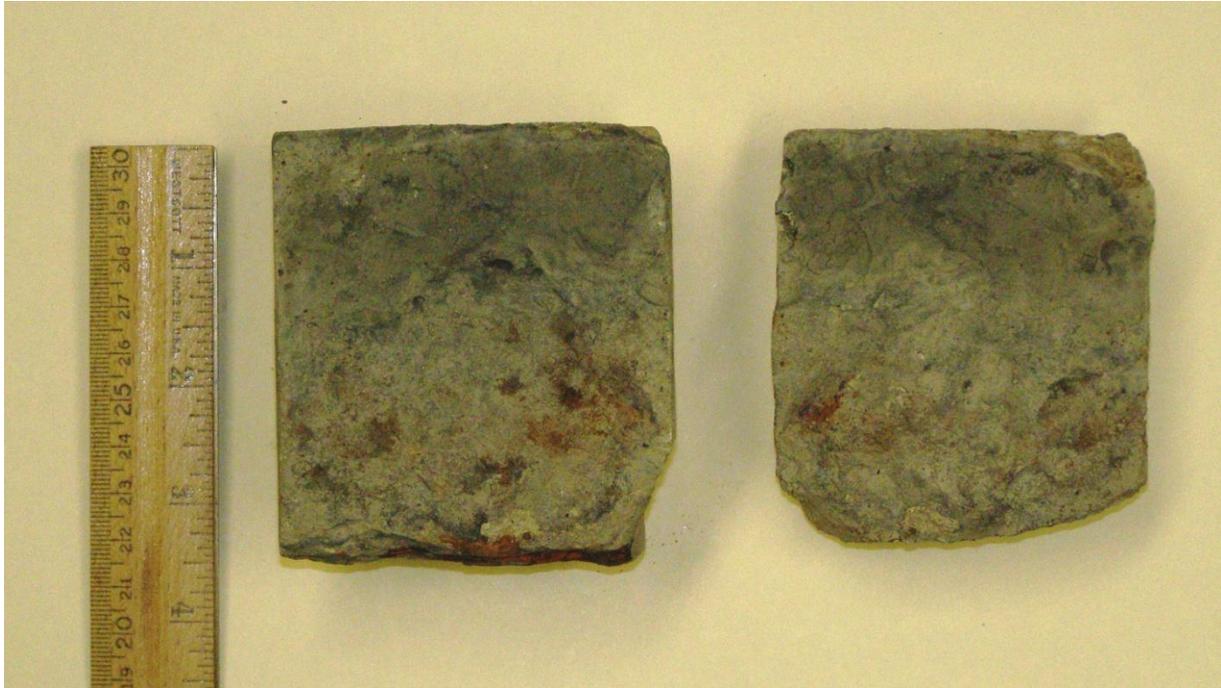
**Figure 4.3** Evidence of carbon dioxide penetration through cracks in bridge B-13-0337.

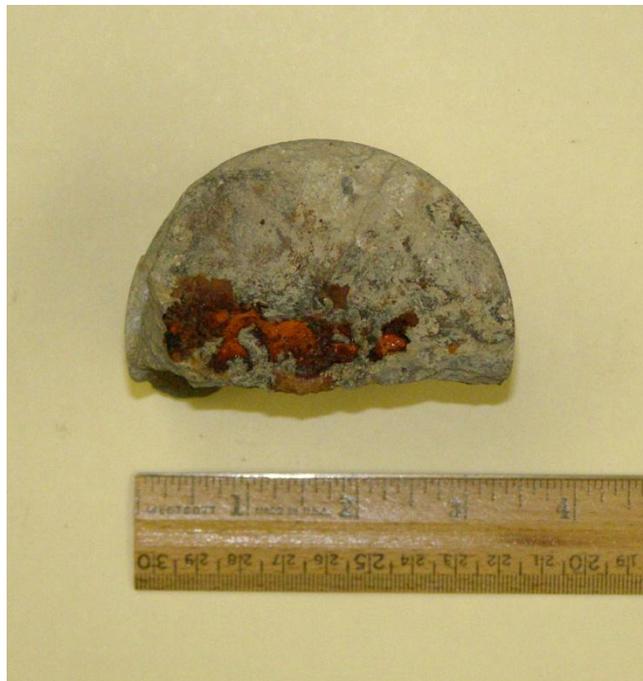
approximately 3-1/2 in., i.e. the full depth of the core. Although no bars were severed with the core, rust stains on the bottom of the core at the bar level (see Fig. 4.4) show that bar corrosion activity is present. This result was expected since the chloride ion content level at the bar level in a crack should be about the same as that at the surface (Pincheira et al., 2008). For bridge B-13-0337, the average chloride ion content near the surface was measured at about 21 lb/cy which far exceeds the corrosion threshold content level of 1 to 1.5 lb/cy commonly for black bars (Pincheira et al., 2008).

**Figure 4.4** Rust stains on the bottom of a core extracted from B-13-0337.

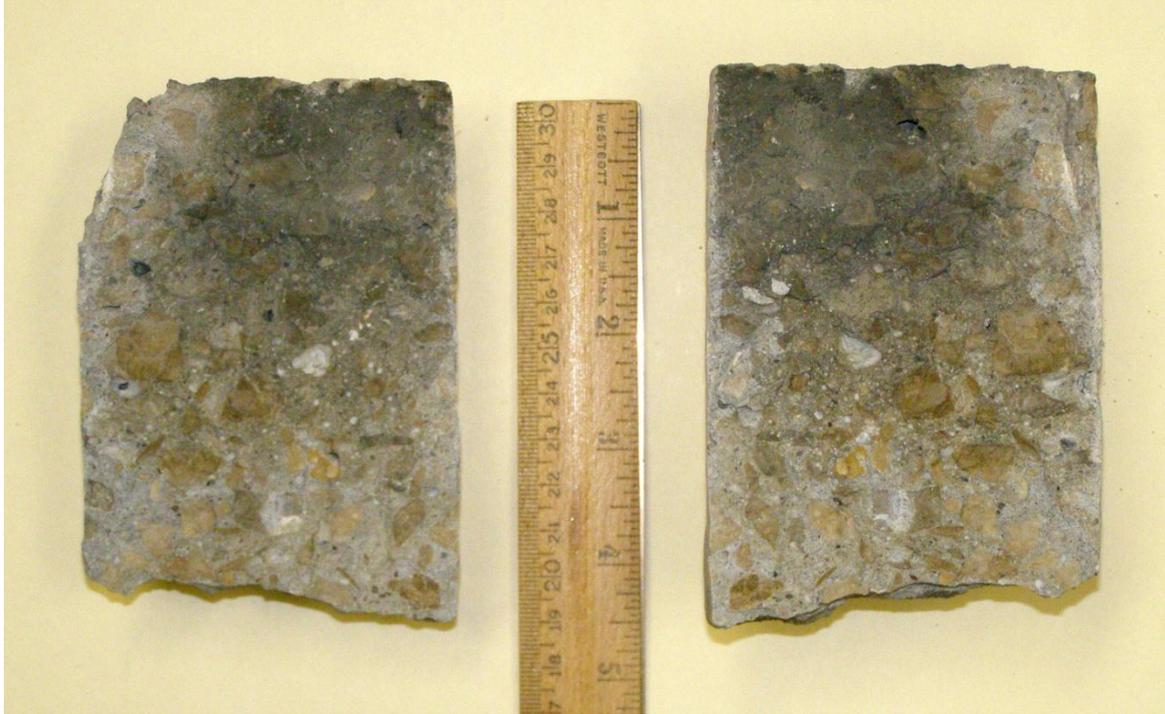
Fig. 4.5 shows a photograph through a crack in a core extracted from bridge B-14-0034. Again, the penetration of carbon dioxide through the crack is evident (approximately 3-1/2 in.). This deck, however, is newer than that of B-13-0034 and is reinforced with epoxy coated bars. No bars were extracted with the core shown in Fig. 4.5. However, a second core extracted from this bridge severed a portion of the top bar of the top mat. In addition, the bar markings of the bottom bar of the top mat could be clearly seen on the bottom face of the core as shown in Fig. 4.6. As can be seen, there was no evidence of corrosion in this case, despite the fact that this bridge had a chloride ion content near the surface of about 14 lb/cy and significant carbon dioxide penetration through cracks.

**Figure 4.5** Evidence of carbon dioxide penetration through cracks in bridge B-14-0034.

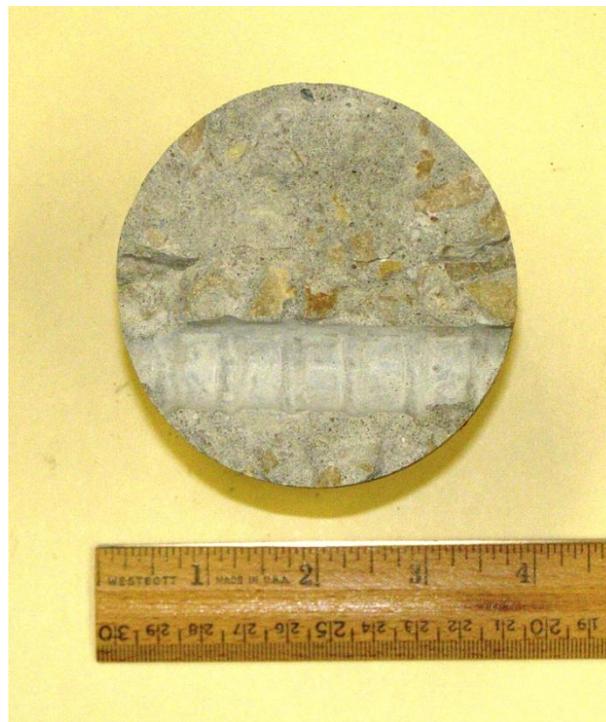
**Figure 4.6** Bar markings (clean) on the bottom of a core extracted from bridge B-14-0034.
