**HYBRID FRP-CONCRETE BRIDGE  
DECK SYSTEMS  
Project No.: C-02-07**

**FINAL REPORT II:  
LONG TERM PERFORMANCE OF HYBRID FRP-  
CONCRETE BRIDGE DECK SYSTEM**

October 2009

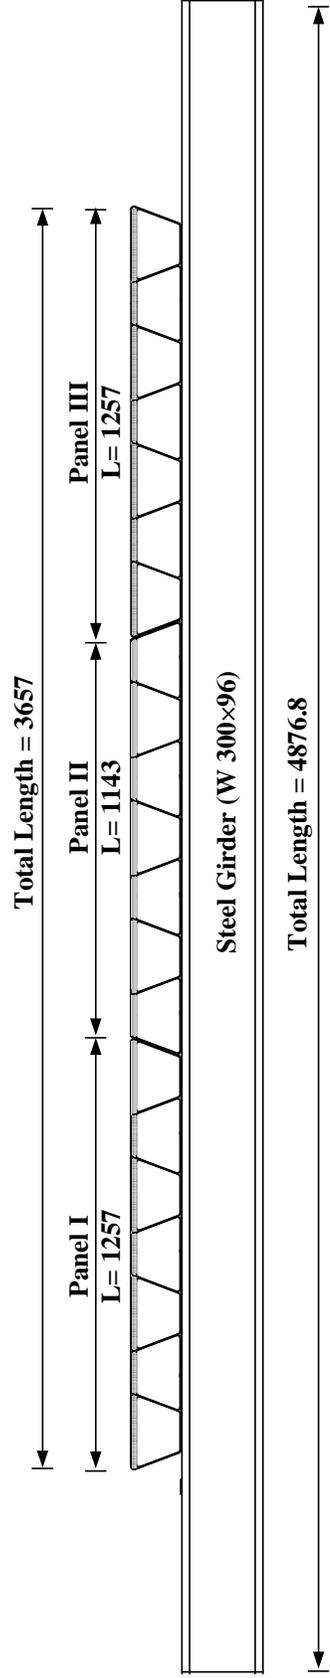
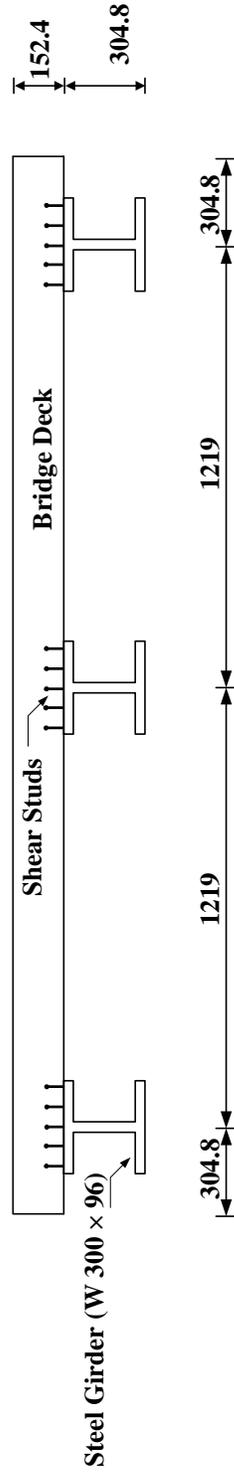
a. Elevation

b. Side View

Fig. 2.1 3/4 Scale Model of Steel Bridge with a Hybrid FRP-Concrete Bridge Deck (units in mm)

the proposed bridge deck system. To evaluate the efficiency of the proposed bridge deck system, a prototype bridge system (6.5 m long and 4.06 m wide) was designed as a simply supported steel bridge with a hybrid FRP-concrete deck. The height of the hybrid deck was limited to 200 mm so that the proposed deck can be used for deck renewal projects. This proposed bridge system has several inherent advantages over an all-composite bridge, which can be summarized in the following points:

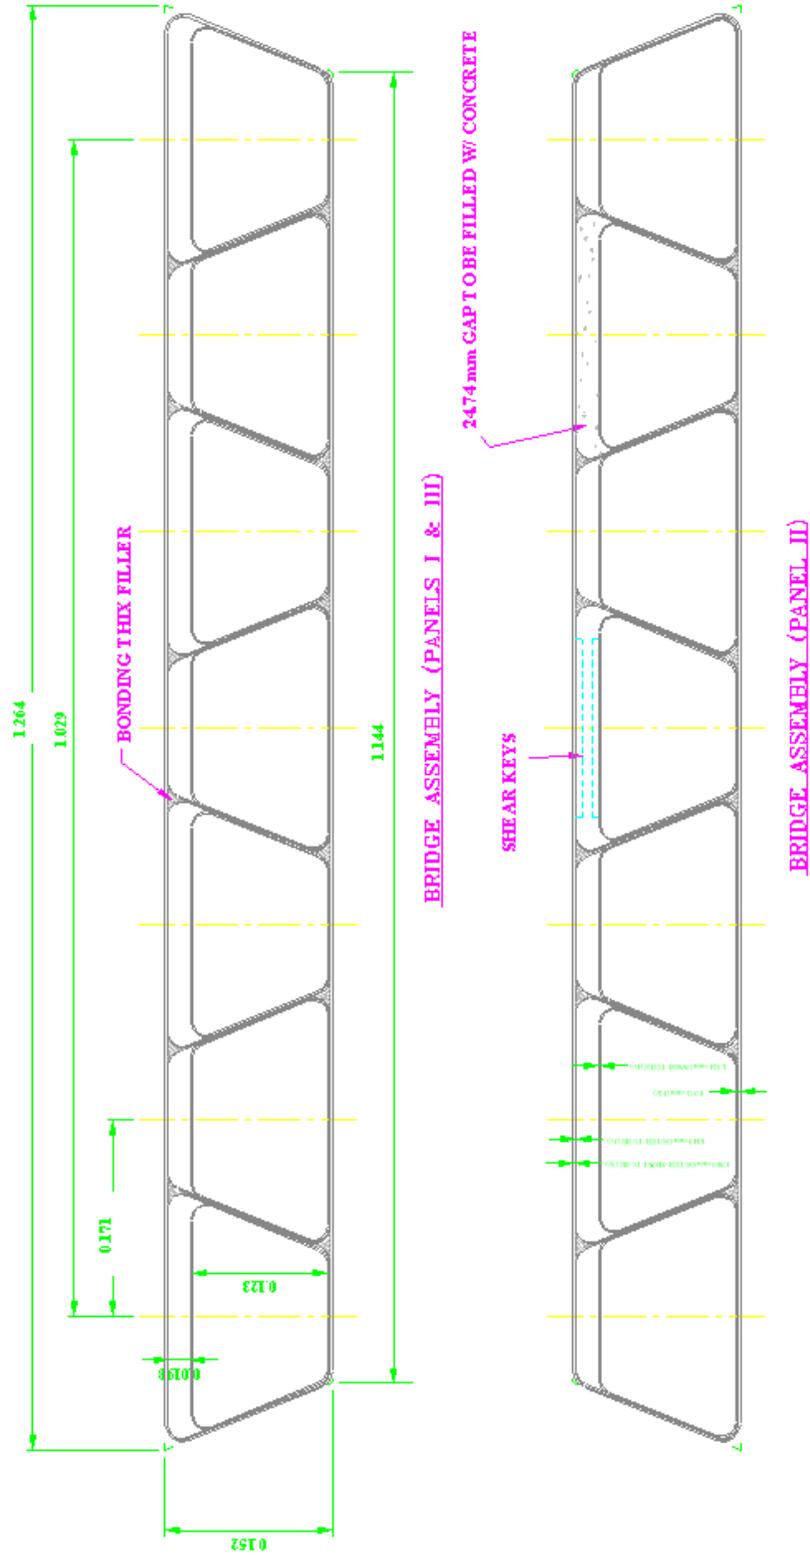
Fig. 2.2 Cross Section of the 3/4 Scale Model of a Hybrid FRP-Concrete Bridge Deck Panels (units in mm)

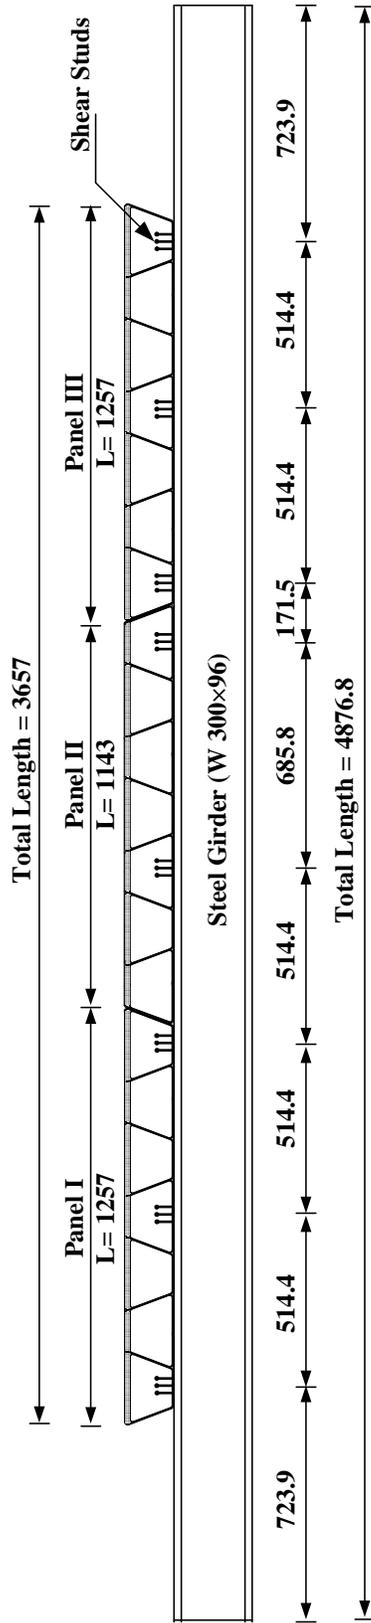
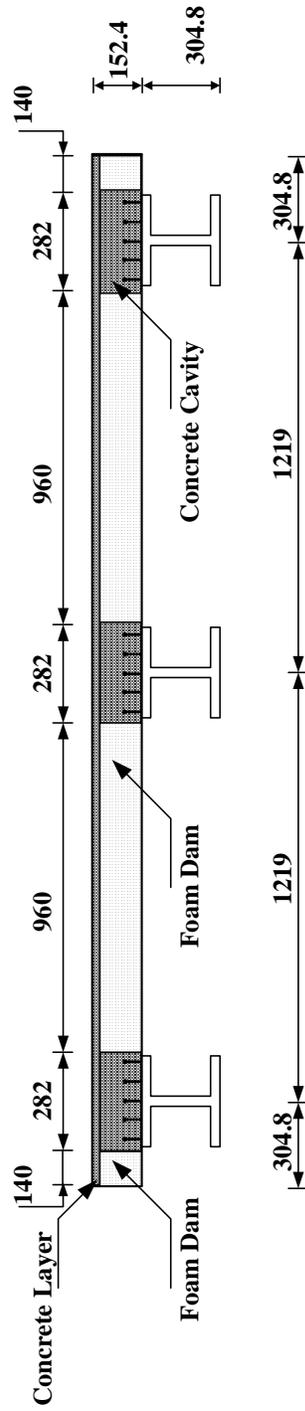
a. Elevation

b. Cross Section

Fig. 2.3 Shear Stud Configuration (units in mm)

To achieve good composite action between GFRP laminates and concrete, shear keys, were installed in staggered positions at the interface of the GFRP laminates and concrete. Each shear key had a length of 0.155 m for the side trapezoidal section and 0.076 m for the middle trapezoidal section in the transverse direction to effectively transfer the shear stress across the concrete-FRP interface. The shear keys were installed on the top surface of the inner tube laminate and on the bottom surface of the outer tube laminate with an interval of 0.508 m. These shear keys were also made of GFRP composites.

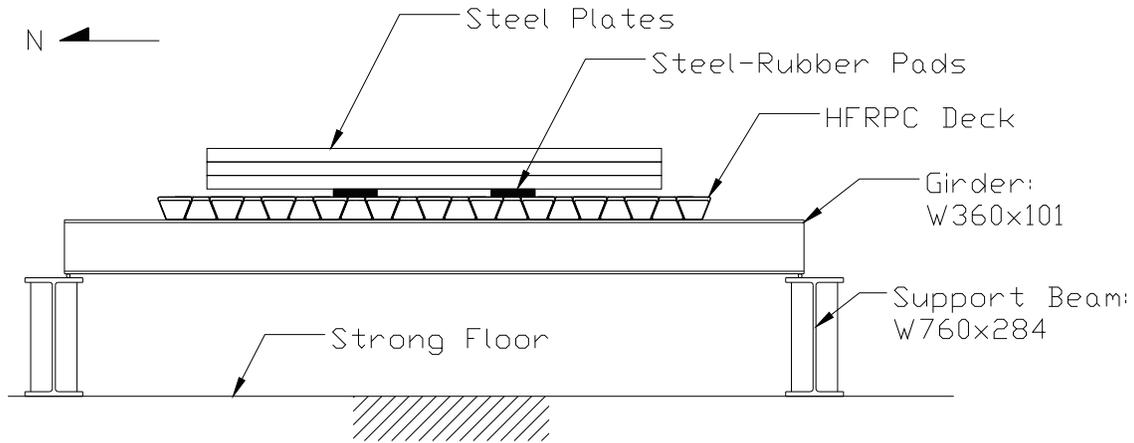
**Fig. 3.1 Elevation view of creep test setup**

The test setup consisted of the HFRPC specimen (including HFRPC deck and steel girders), two W760x284 support beams, four 383 mm by 290 mm steel plates with bonded rubber pads and three steel “load” plates each measuring, approximately, 3000 mm long by 2000 mm wide and 90 mm thick. Figure 3.1 presents a schematic of the elevation view of the HFRPC creep test setup. Each steel plate weighted approximately 38 kN providing a total load of 114 kN that was intended to represent the scaled design tandem load of 124 kN (Alnahhal 2007). The three steel plates were stacked atop four steel-rubber pads on the HFRPC deck each pad intended to simulate the area of a scaled truck tire. Each steel-rubber pad consisted of a steel plate 25 mm thick bonded to a rubber pad 12.5 mm thick each with plan dimensions of 383 mm by 290 mm and arranged in a two-axle truck configurations with 0.9 m between each axle and a width of 1.35 m.

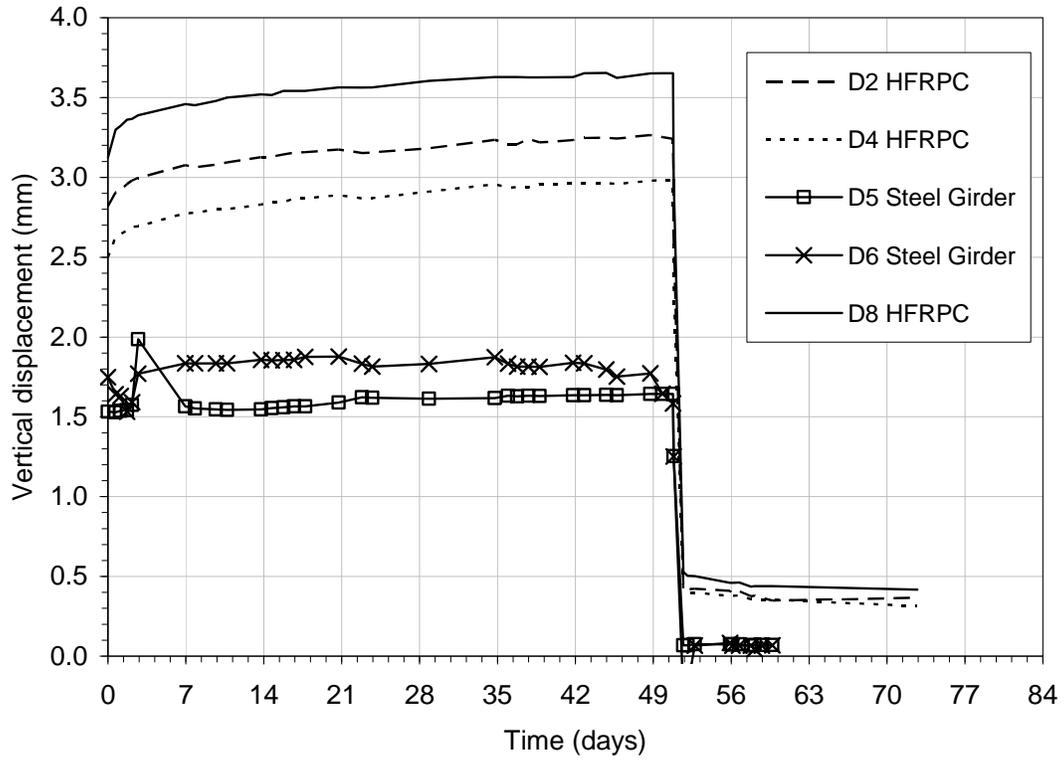
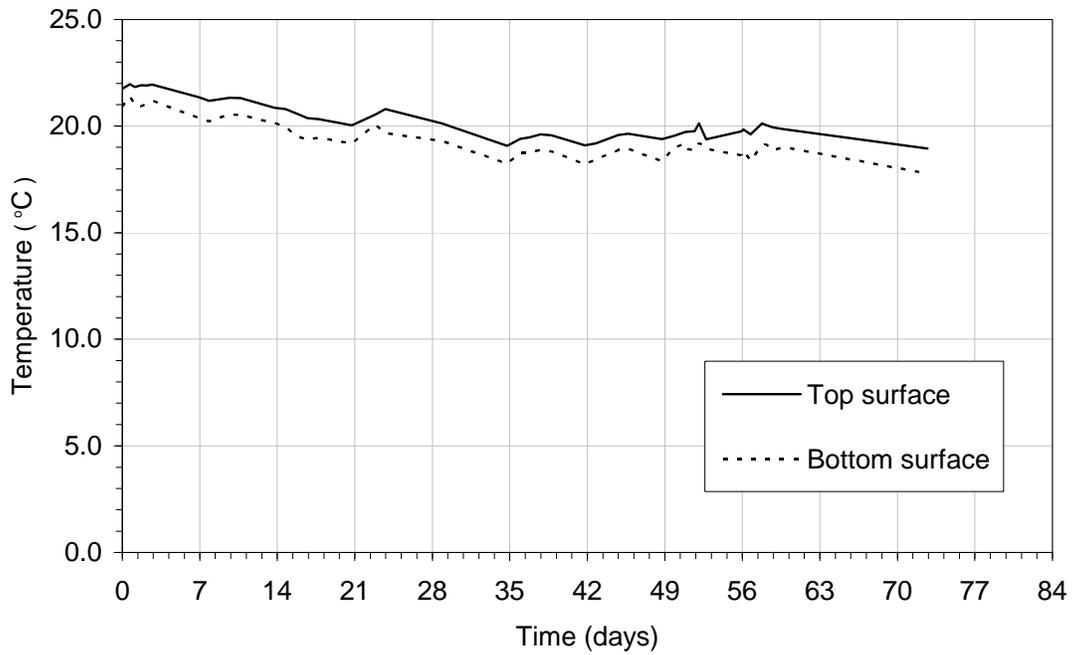
a. vertical displacement

b. temperature

**Fig. 3.3 Results of creep testing**

Figure 3.3a presents the vertical displacement results for the HFRPC deck (denoted HFRPC) and the steel girders. In this figure average daily vertical displacement results are plotted against time where zero on the time axis represents the initial vertical displacement of the specimen after being loaded. Creep in the HFRPC deck is evident in Fig. 3.3a from the increase in vertical displacement observed at the points of loading (transducers D2, D4 and D8) up to day 51 (unloading). Transducer D7 malfunctioned during the creep test and therefore results from this transducer are not presented. Creep displacements in the HFRPC ranged from 15 (D2) to 20 (D4) percent of the initial vertical displacement. The vertical displacement of the steel girders (D3, D5 and D6) provide an idea of the creep behavior of the HFRPC system, that is the HFRPC deck and steel girders. The results presented in Fig. 3.3a show the vertical displacement of the steel girder (D5 and D6) remained relatively constant for the 51 day period while the specimen was loaded then rapidly decreased on day 51 when the specimen was unloaded. This result suggests the creep behavior of the HFRPC deck had a negligible effect on the global creep behavior of the specimen. Upon unloading the specimen, approximately 95 percent of the initial vertical displacement in the steel girders (D5 and D6) was recovered. In the HFRPC deck between 82 and 84 percent of the initial vertical displacement was recovered upon unloading representing the elastic recovery of the HFRPC system. The vertical displacement of the HFRPC continued to recover until the conclusion of the creep test at which time the vertical displacements in the HFRPC deck were approximately 0.5 mm.

Figure 3.3b present average daily temperature data for the duration of the creep test. From Fig. 3.3b the temperature of the top surface ranged from, approximately, 22 °C to 19 °C for the duration of the test and can be attributed to the change in the ambient

temperature of the testing laboratory over the 73 day test. The temperature of the bottom surface of the HFRPC deck ranged from 21 °C to 18 °C, a three degree change that again can be attributed to the change in ambient temperature of the testing laboratory. Also from, Fig. 3.3b the temperature value of the top and bottom thermocouples differs by approximately 1 °C throughout the duration of the test. This difference is due to error in the calibration of the thermocouple and does not represent a true physical difference. The results presented show that the HFRPC specimen was subjected to only a minor deviation in ambient temperature (approximately 3 °C) and that throughout the duration of the test the temperature of the specimen remained well below a temperature at which the mechanical properties of the GFRP (Glass Fiber Reinforce Polymer) would be affected.

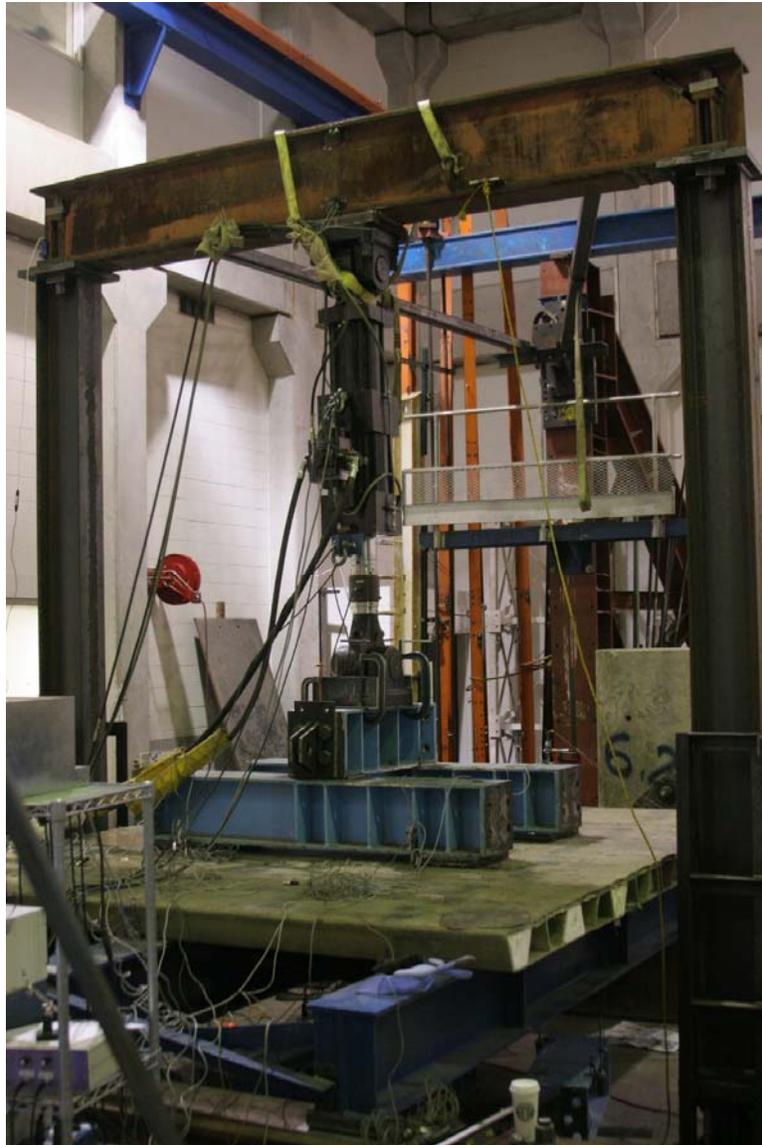
**Fig. 4.1** Photograph of fatigue test setup

pads were designed to simulate the dimensions and loading of the tandem load specified in the 1998 AASHTO LRFD Bridge Design Specifications (AASHTO 1998) scaled according to the 3/4 model length scale factor. Each steel-rubber pad consists of a steel plate 25 mm thick bonded to a rubber pad 12.5 mm thick each with plan dimensions of 383 mm by 290 mm and arranged in a two-axle truck configuration with 0.9 m between each axle (north-south) and a width of 1.35 m (east-west).

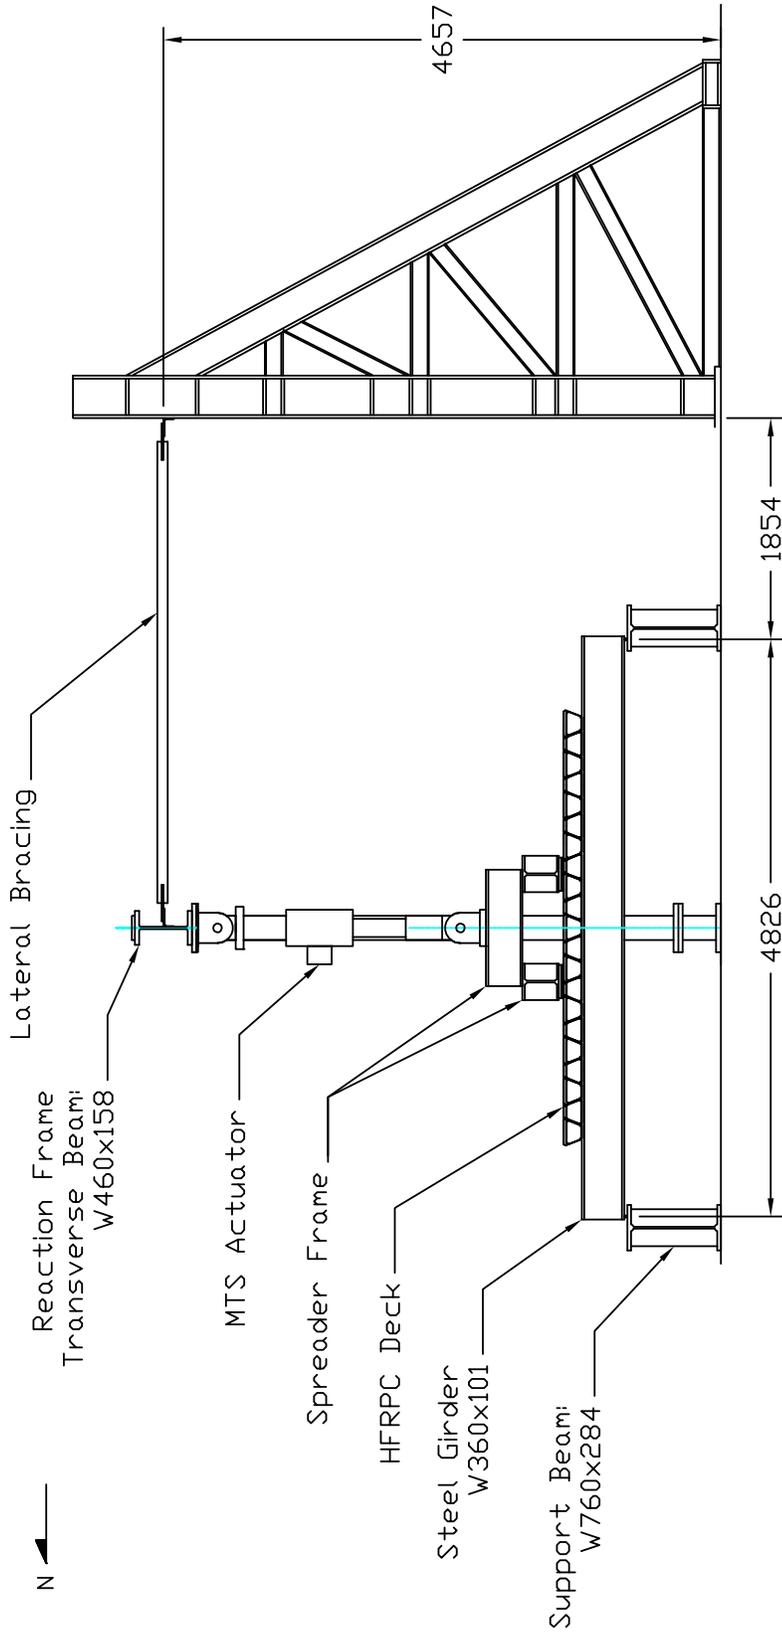
Fig. 4.2 Schematic showing side view of fatigue testing setup (dimensions in mm)

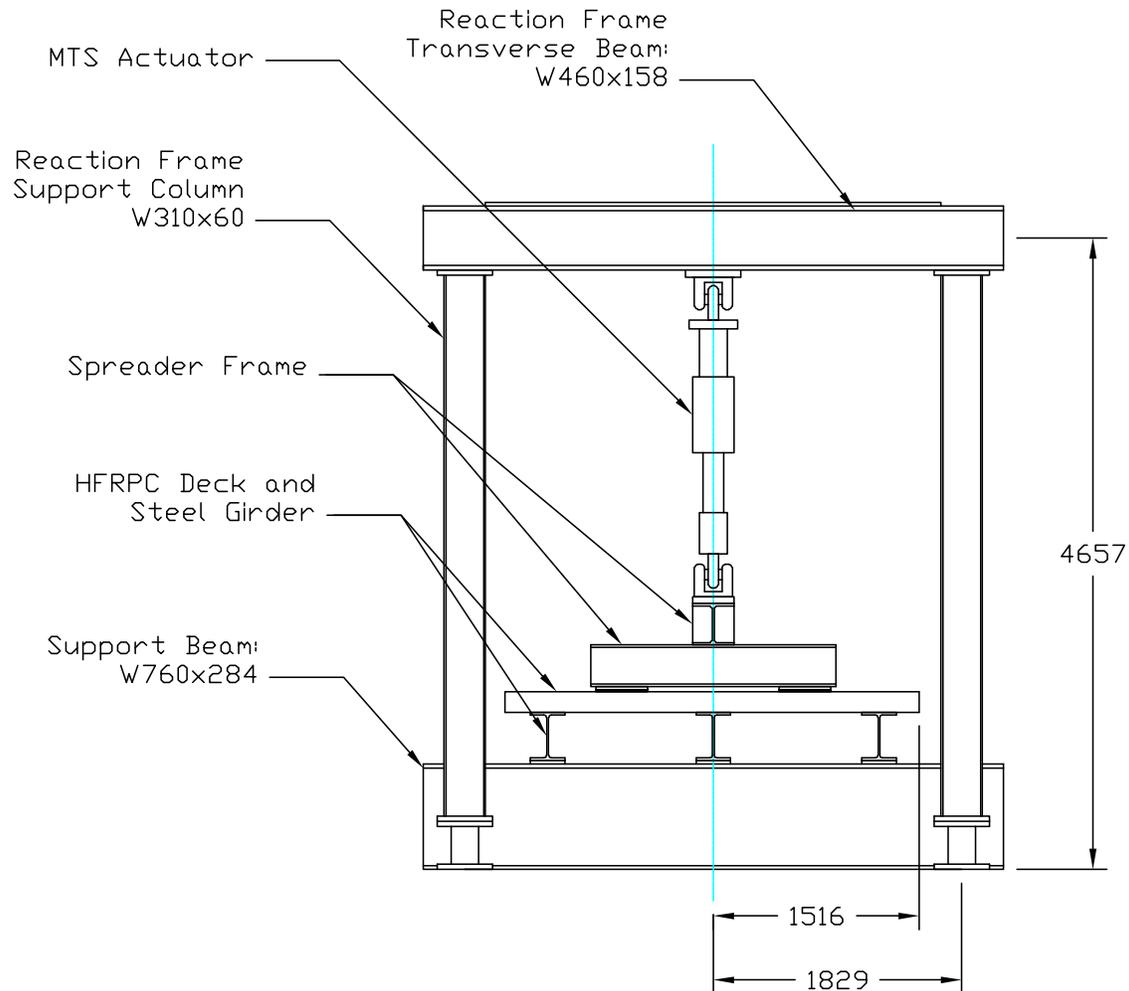
**Fig. 4.3 Schematic showing elevation view of fatigue testing setup (dimensions in mm)**

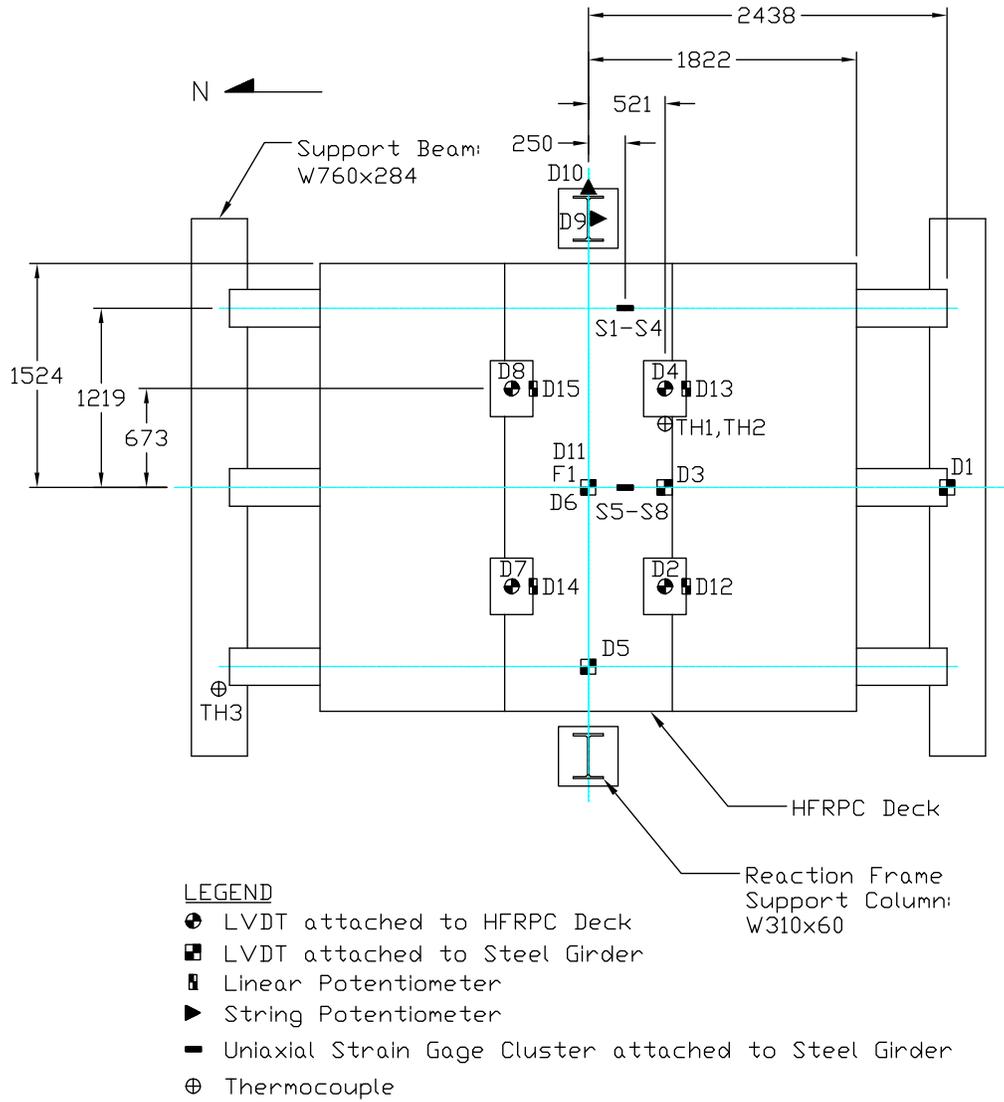
**Fig. 4.4 Plan view of specimen showing instrumentation layout (dimensions in mm)**

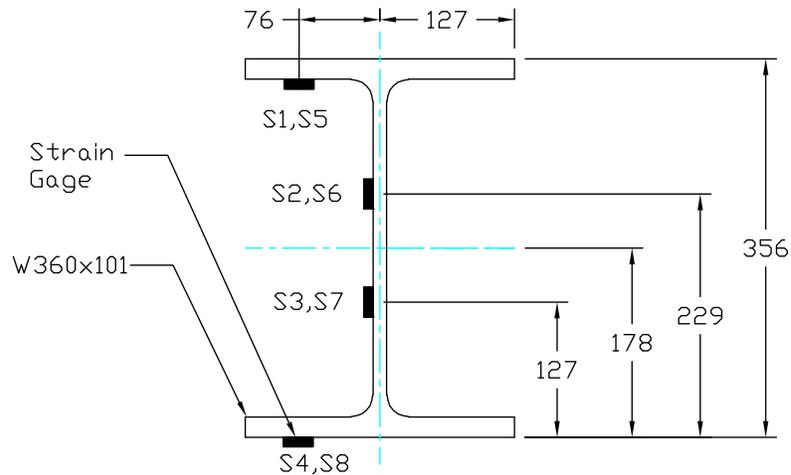
**Fig. 4.5 Uniaxial strain gage cluster attached to steel girder (dimensions in mm)**

Strain gages installed at two locations were used to measure and record longitudinal strain at various heights on the steel girders so that strain profiles could be used to determine and monitor the location of the neutral axis – an indicator of composite action between the HFRPC bridge deck and supporting steel girders. Two clusters of four uni-axial gages were installed approximately 250 mm from the centerline of the interior (S5-S8) and east exterior girder (S1-S4) as illustrated in Fig. 4.4. The uni-axial strain gages were installed at various heights on the steel girders and oriented to measure longitudinal strain. Figure 4.5 presents a cross-sectional view of a steel girder illustrating the location of the individual strain gages on the girder cross-section.

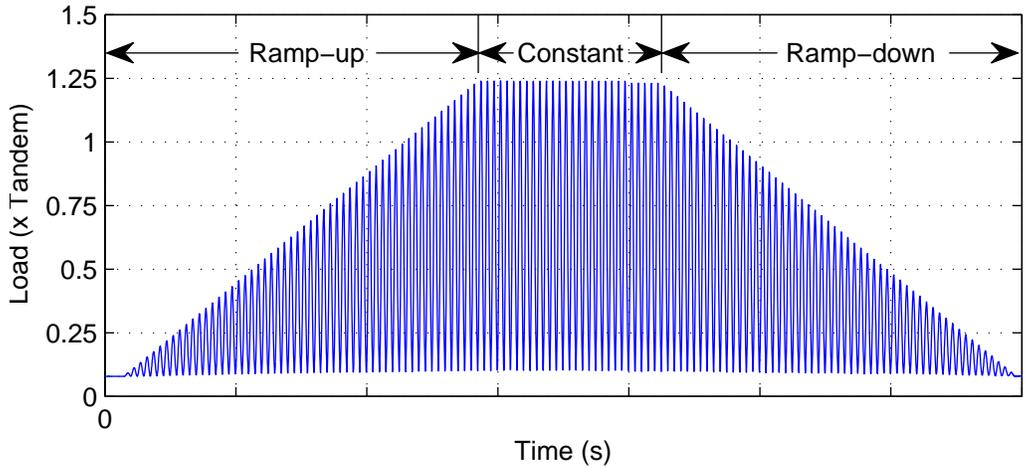
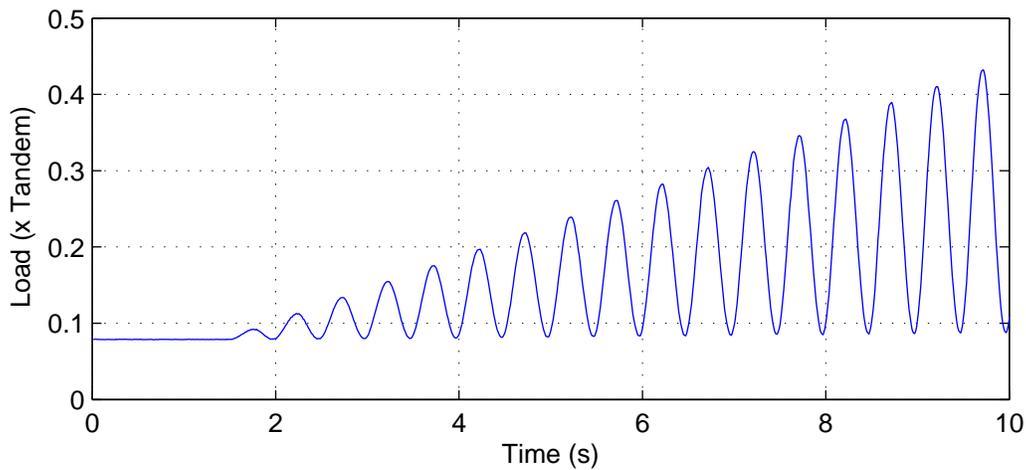
a. Three-phase loading scheme

b. Portion of the Ramp-up phase

**Fig. 4.6 Three phase loading scheme used for fatigue testing**

consisted of sinusoidal loading with amplitude of 156 kN for the daily duration of testing (ranging from 3-1/2 hours to 13 hours). The Ramp-down phase consisted of 54 cycles of decreasing amplitude sinusoidal cycles until the structure was effectively un-loaded. For the purpose of cycle counting the Ramp-up and Ramp-down phases were ignored using only the Constant amplitude duration and the 2 Hz frequency to determine the daily number of cycles conducted. At intervals of 200,000 cycles, a static test was performed to collect data and to determine the stiffness and composite behavior of the HFRPC-SG systems. Each static test consisted of loading the HFRPC-SG specimen from a preload of approximately 9 kN up to 156 kN (1.26 x Tandem Load) and back to the 9 kN preload. Results of the static tests were used to investigate the fatigue resistance of the HFRPC-SG specimen and are presented in the subsequent results section.

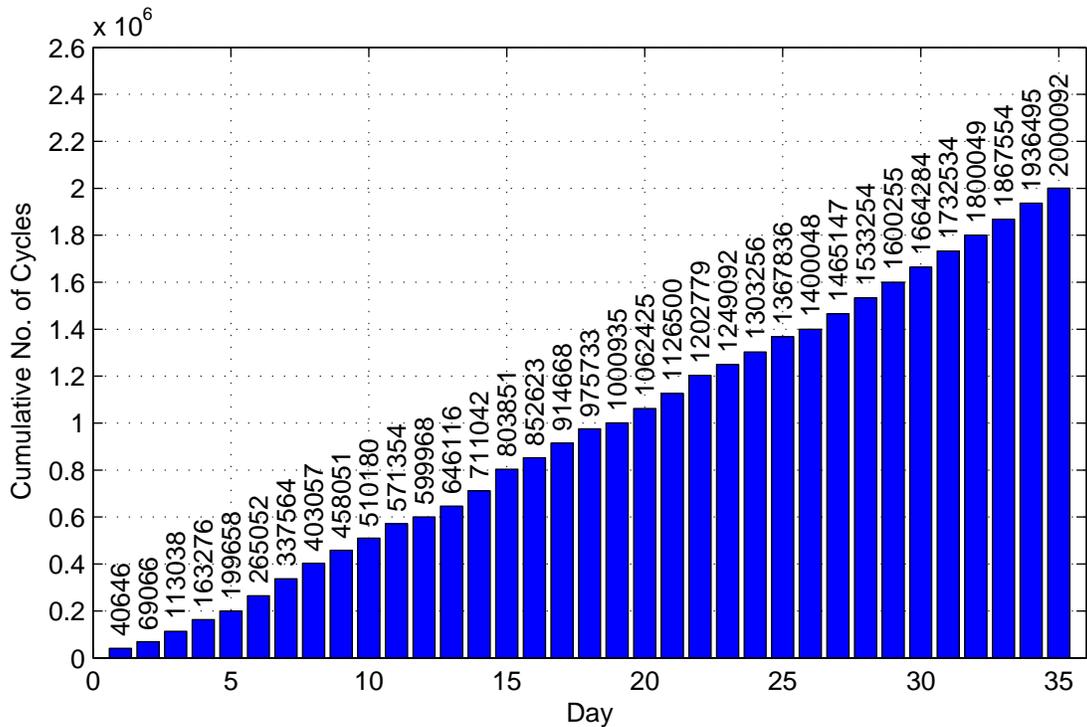
**Fig. 4.7 Loading history of fatigue test**

The peak load amplitude for the fatigue testing was decreased from the target value of 1.33 times the scaled tandem load (165 kN) to approximately 1.26 times the scaled tandem load (156 kN) to ensure the 2 Hz loading frequency could be maintained by the hydraulic actuator in a stable manner throughout the duration of testing. For consistency the static “benchmark” tests were also conducted to a peak load amplitude of 1.26 times the scaled tandem load or 156 kN. Although the load amplitude of 1.26 times the scaled tandem load is less than the desired 1.33 times the scaled tandem load that was chosen to account for the AASHTO impact factor the achieved load level of 156 kN is significantly (26 percent) larger than the scaled tandem load of 124 kN.

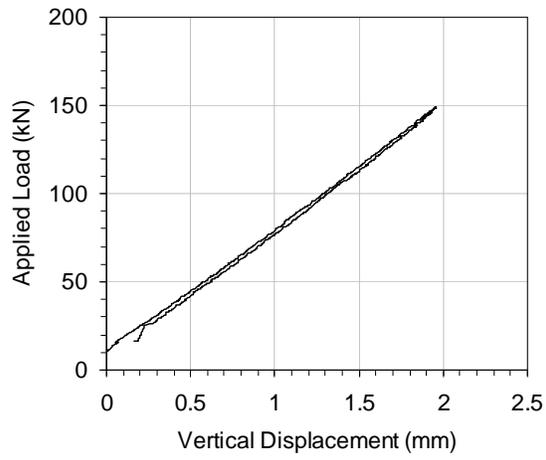
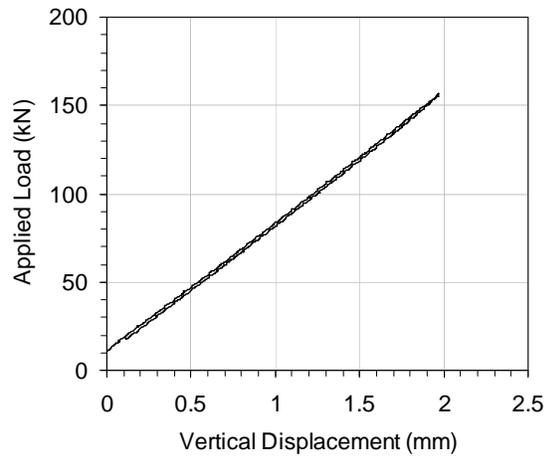
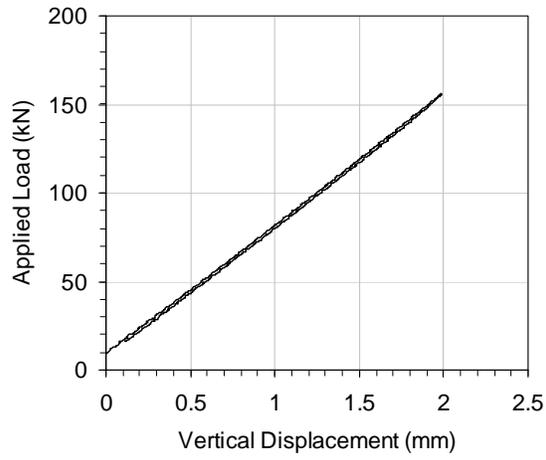
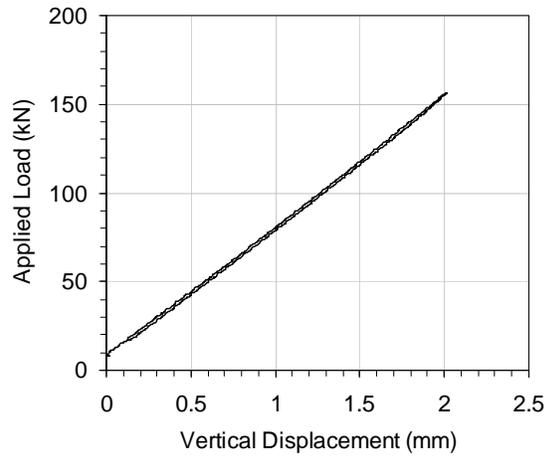
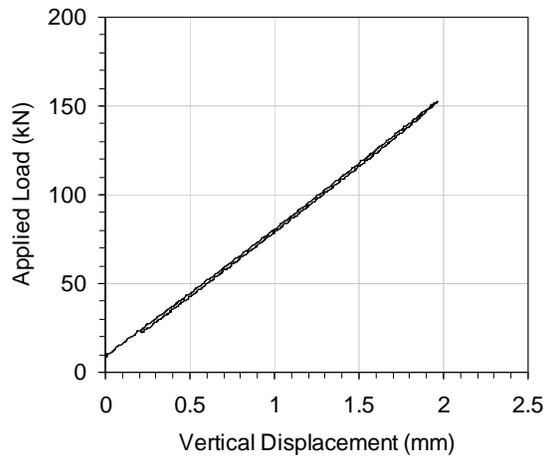
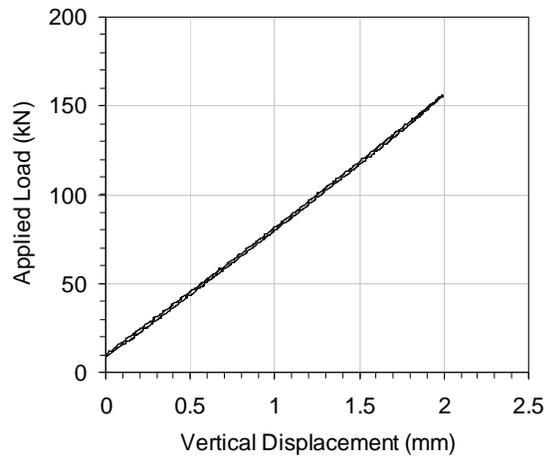
**Fig. 4.8 Global HFRPC-SG force-displacement results from various static test performed throughout the fatigue testing program**

To further verify that the global stiffness remained constant and that degradation of the HFRPC-SG was not observed after 2 million cycles, the global vertical stiffness of the HFRPC-SG was calculated from the static benchmark data (D6 and F1) for each 200,000 cycle interval. From each 200,000 cycle static benchmark test the vertical stiffness of the HFRPC-S G system was calculated using linear regression analysis of the data on the ascending branch of the load curve between 0.2 and 0.8 times the maximum load (approximately 156 kN).

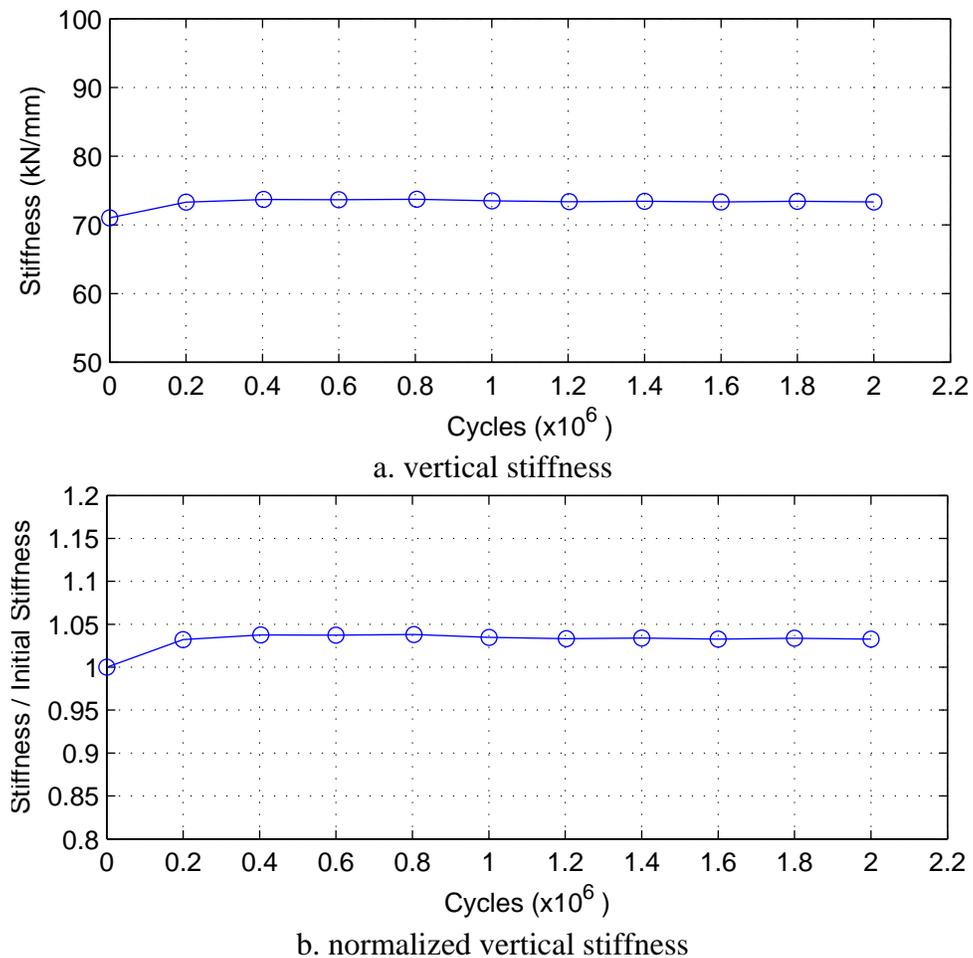
**Fig. 4.9 Vertical stiffness results for the HFRPC-SG specimen**

The results of the vertical stiffness calculation for each of the eleven static benchmark tests performed throughout the fatigue test are plotted in Fig. 4.9.a. The initial (0 cycles) vertical stiffness of the HFRPC-SG system was determined to be 73 kN/mm. Figure 4.9b presents vertical stiffness results for each benchmark test normalized by the initial vertical stiffness (73 kN/mm). The normalized results provide an indication of the percent change in vertical stiffness over the course of the fatigue test. From Fig. 4.9b an approximate 3 percent increase in stiffness is observed from 0 cycles to 200,000 cycles then remains relatively constant between 1.03 and 1.04 through to 2 million cycles. The 3 percent increase observed between 0 and 200,000 cycles is likely due to the replacement of the D6 LVDT displacement transducer that malfunctioned sometime between these two static benchmark tests. If the initial value is neglected the change in stiffness for the remaining 1.8 million cycles was observed to be less than 1 percent.

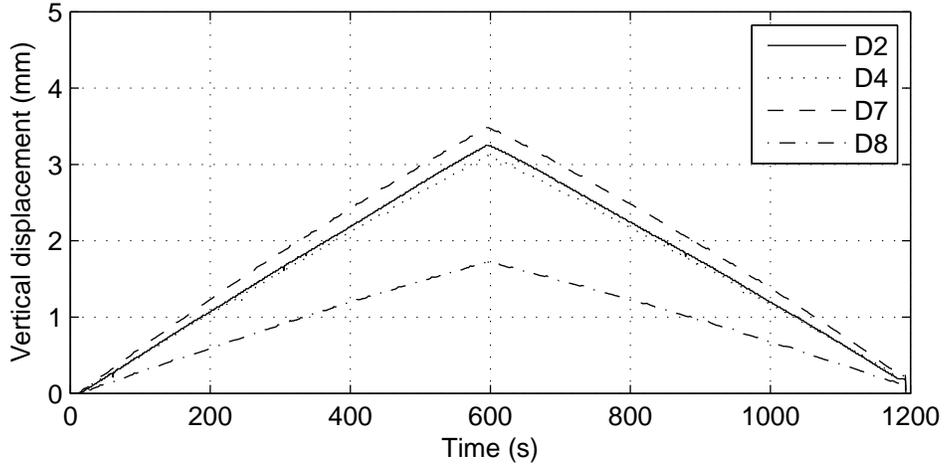
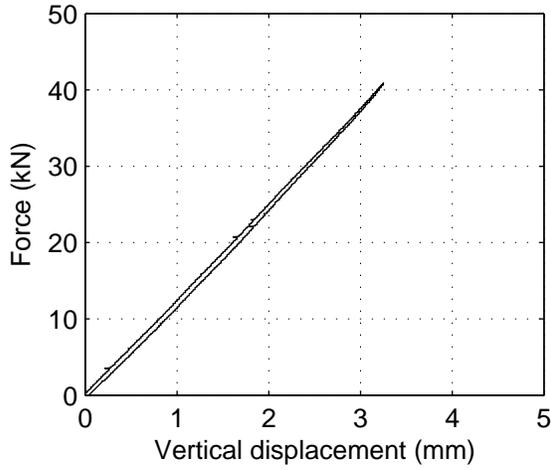
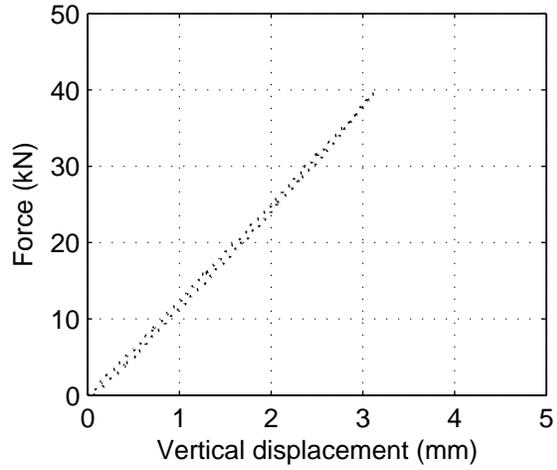
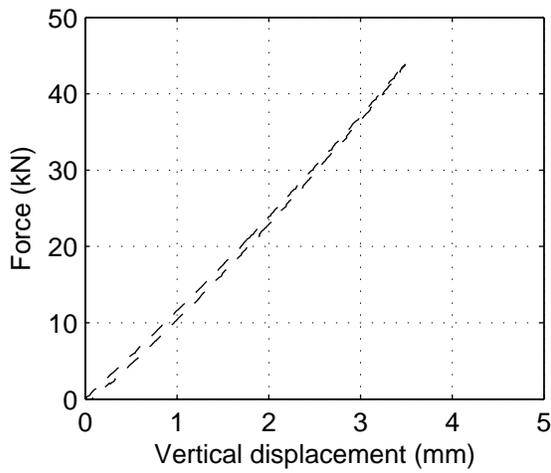
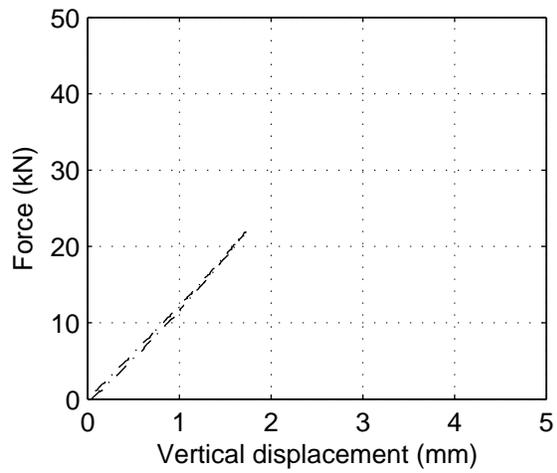
**Fig. 4.10 Vertical displacement and force-displacement response of HFRPC deck after 2,000,092 cycles**

Using Eq. 4-7 and the vertical displacement data from the 2 million cycle static test the proportion of load transmitted to each of the four loading points were determined to be:  $F_{D2}/P = 0.28$ ,  $F_{D4}/P = 0.27$ ,  $F_{D7}/P = 0.3$  and  $F_{D8}/P = 0.15$ . These ratios were then used to determine the proportion of total load transmitted to each load point and to facilitate the calculation of the local HFRPC bridge deck stiffness. The force-displacement response of the HFRPC bridge deck at each point of loading from the 2 million cycle static test are presented in Fig. 4.10b – 4.10e. Although not presented in this report an analysis of a simple four spring idealization of the HFRPC bridge deck with the displacement data suggested that eccentricities of the applied loading as small as 3 mm in the north-south direction and 0.1 mm in the east-west direction could have produced the observed difference in load transmitted to each loading point and resulting vertical displacement.

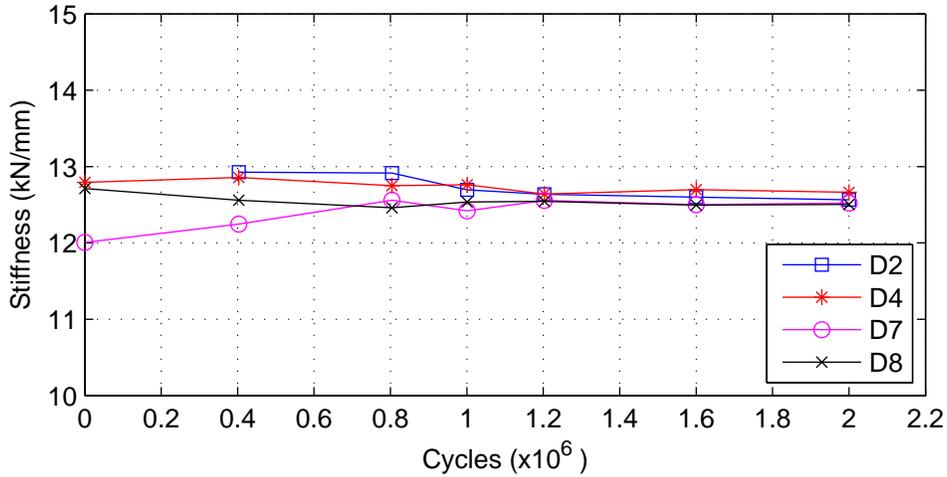
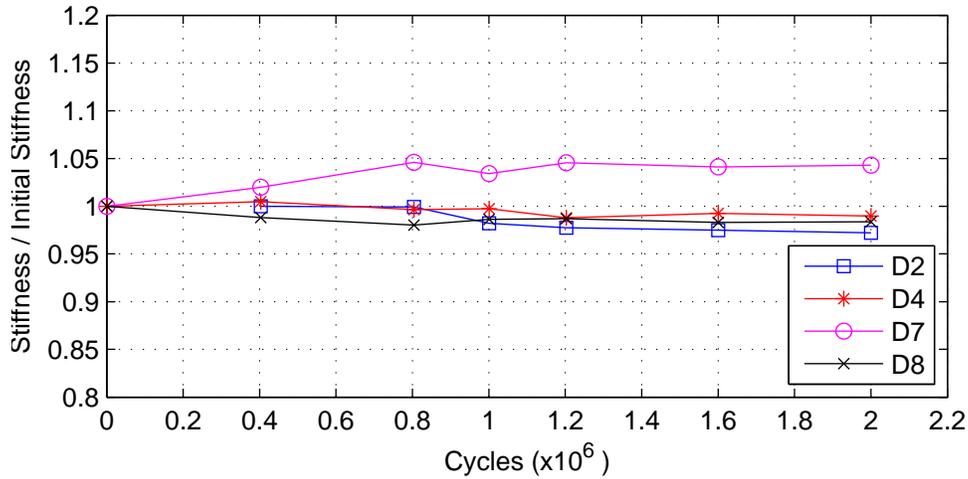
**Fig. 4.11 Vertical stiffness results for the HFRPC bridge deck**

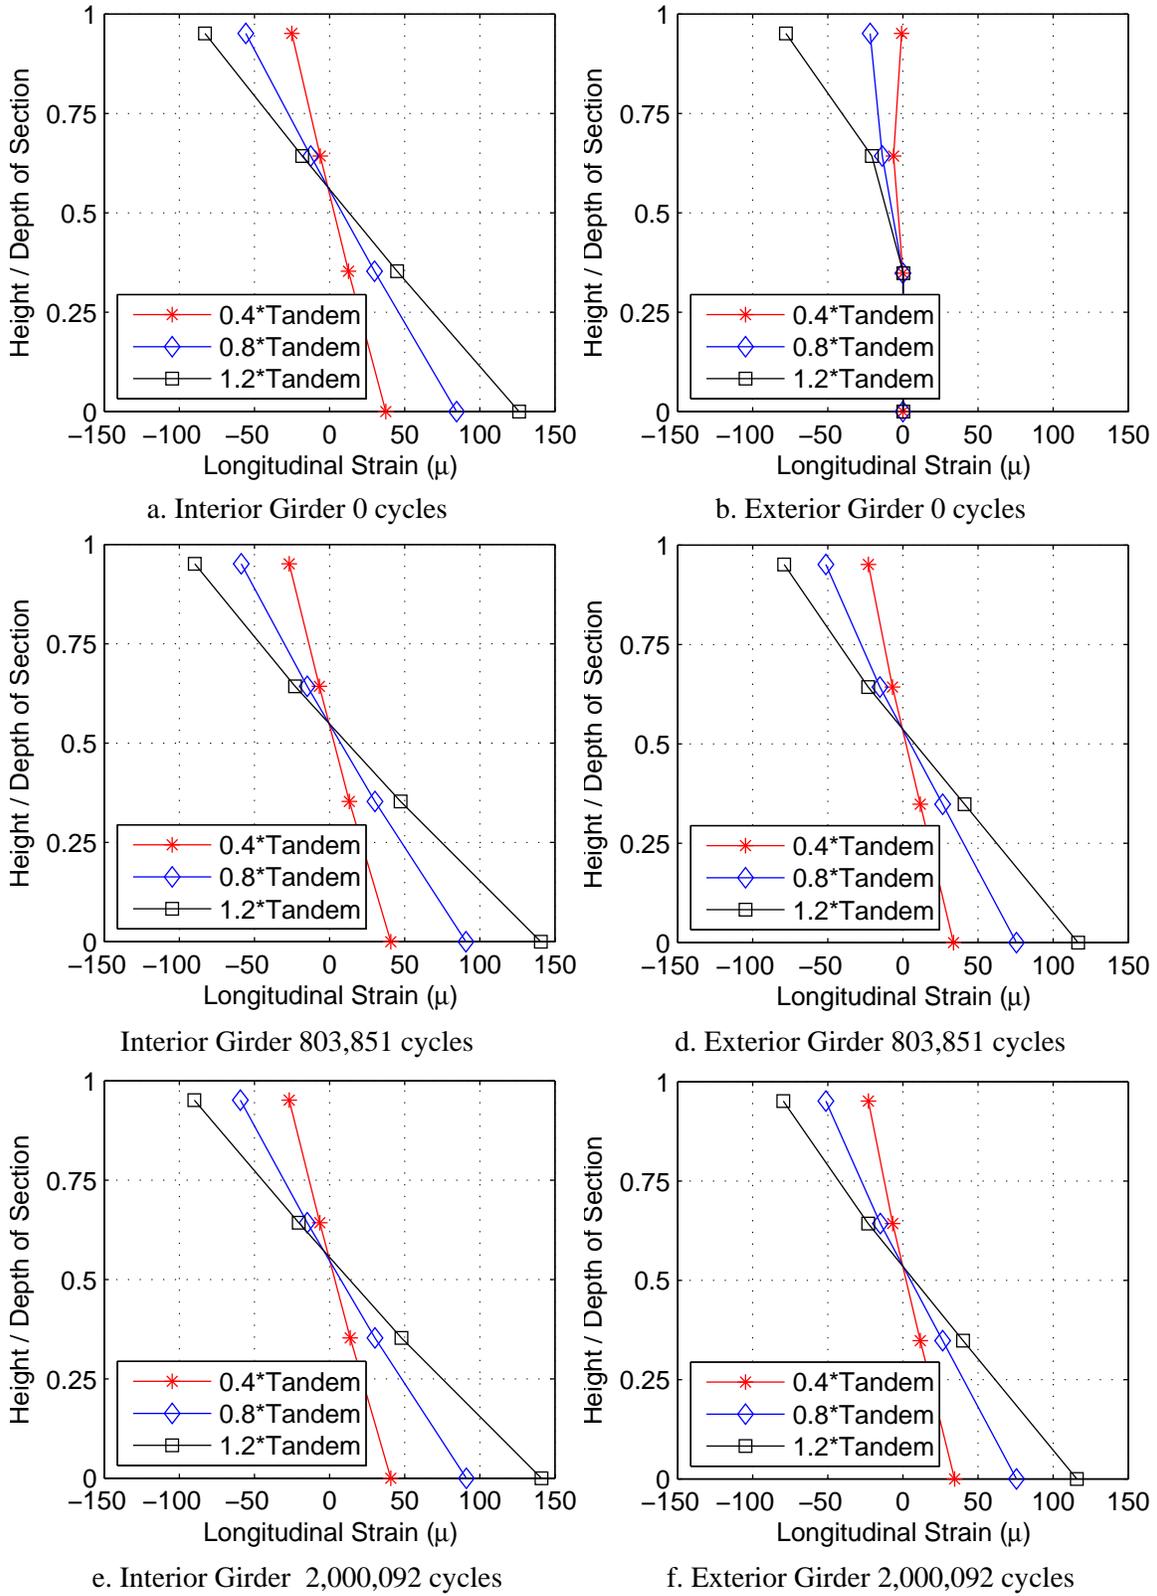
**Fig. 4.12 Strain profiles across girders from various static benchmark tests**

The location of the neutral axis was calculated by linearly interpolating the strain data for all eleven static benchmark tests at each of the three load levels and was observed to range from  $0.55d$  to  $0.58d$  for all profiles. The approximate normalized neutral axis location of  $0.57d$  being greater than half the section depth indicates the presence of composite action between the HFRPC deck and steel girders and the consistency of the location of the neutral axis ( $0.55d$  to  $0.58d$ ) at both locations throughout the fatigue test indicates the shear stud connection sufficiently resisted fatigue induced degradation.

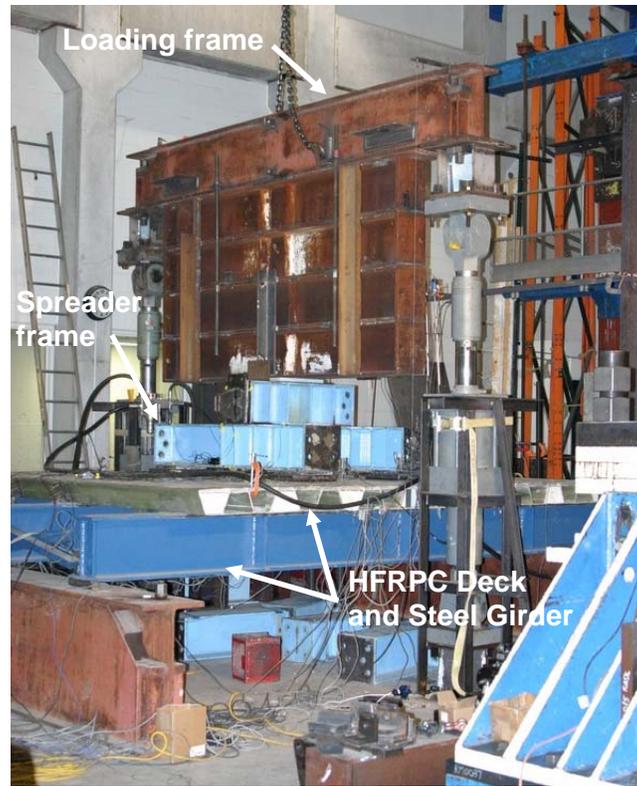
**Fig. 5.1 Photograph of destructive test setup**

The fatigue testing experimental setup (see Section 4) was designed specifically for the fatigue testing protocol (high frequency low amplitude loading) and therefore does not have sufficient capacity to reach the anticipated load level required to fail the HFRPC deck. To facilitate destructive testing of the HFRPC bridge deck an experimental setup with sufficient capacity used in previous verification tests performed on the HFRPC-SG specimen was utilized. A photograph of the experimental setup is presented in Fig. 5.1 showing the HFRPC-SG specimen, the loading frame, spreader frame and the two hydraulic actuators used to load the specimen.
