**HYBRID FRP-CONCRETE BRIDGE  
DECK SYSTEMS  
Project No.: C-02-07**

**FINAL REPORT II:  
LONG TERM PERFORMANCE OF HYBRID FRP-  
CONCRETE BRIDGE DECK SYSTEM**

October 2009

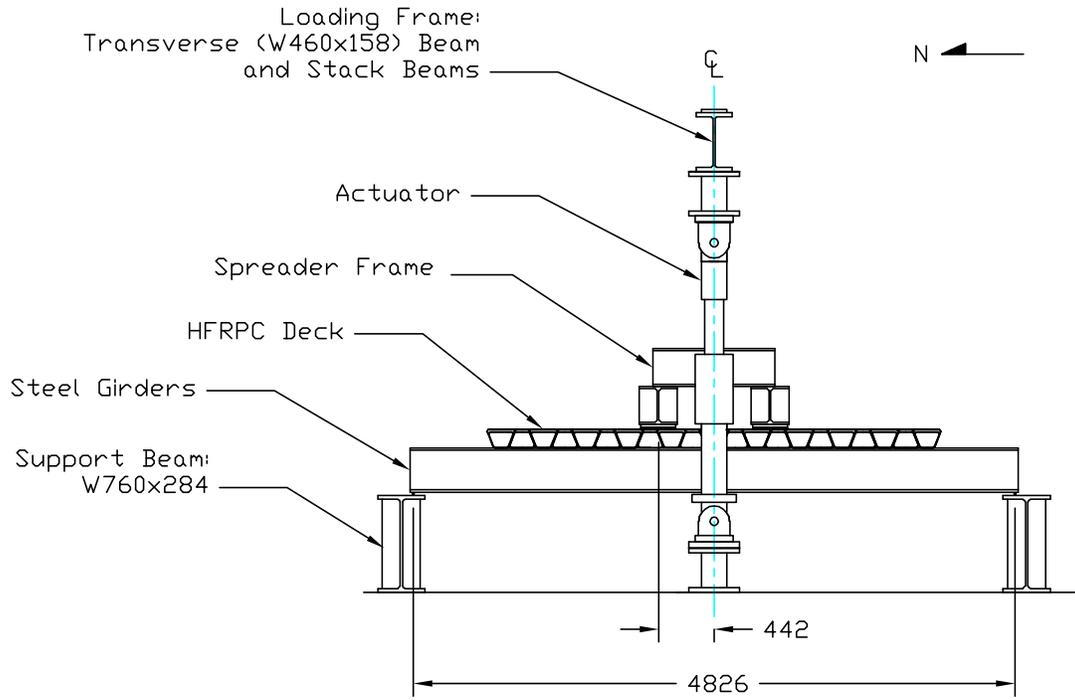
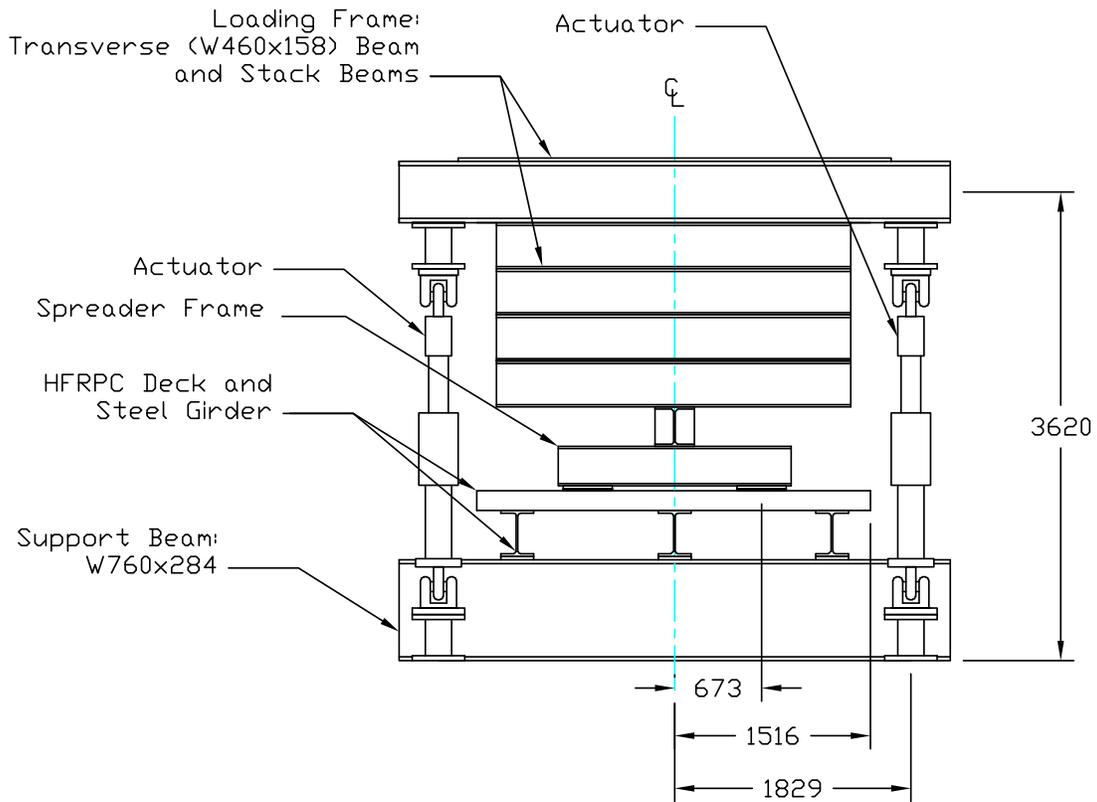
**Fig. 5.2 Schematic showing destructive test setup (dimensions in mm)**

Schematics of the side and elevation view of the destructive testing setup are presented in Fig. 5.2. Again, the HFRPC-SG specimen was simply supported on two W760x284 support beams tied to the SEESL strong floor providing a span length of 4826 mm. Two Miller servo-hydraulic actuators each with 1110 kN of force capacity and  $\pm 203$  mm of displacement capacity were connected to the strong floor and the loading frame via steel pedestal fixtures and hardware. In this configuration, contraction of the actuators would apply downward vertical loading to the HFRPC-SG specimen. The loading frame consists of a transverse (W460x158) beam with various web stiffeners and flange double plates attached to four stack beams each with web stiffeners at various locations. Similar to the fatigue testing setup, load is applied to the HFRPC-SG specimen at four points via a steel spreader frame and four 383 mm by 290 mm steel-rubber pads to simulate a two axle truck and the load applied by a truck tire. However for destructive testing the steel-rubber pads were rotated 90 degrees so that the 383 mm dimension was aligned with the north-south direction. This was done so that the edge of the pad did not coincide with the location of minor damage of the HFRPC deck that occurred during setup and is reflected in the instrumentation layout presented in the subsequent section.

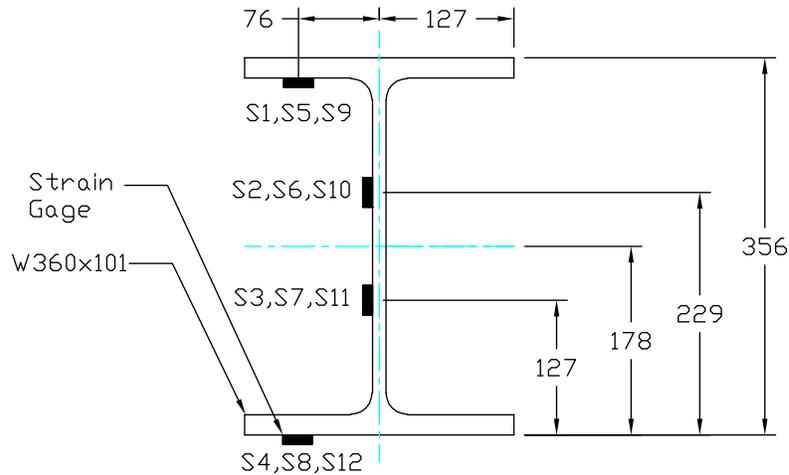
**Fig. 5.4 Uniaxial strain gage cluster attached to steel girder (dimensions in mm)**

Figure 5.4 presents the location of the individual uniaxial strain gages for each of the three strain gage clusters, specifically S1-S4 located at the approximate centerline of the east exterior girder, S5-S8 located at the approximate centerline of the interior girder and S9-S12 located approximately at the north quarter point of the HFRPC deck (see Fig. 5-3). Specifics pertaining to the placement of the instruments and data acquired are discussed in the subsequent sections.

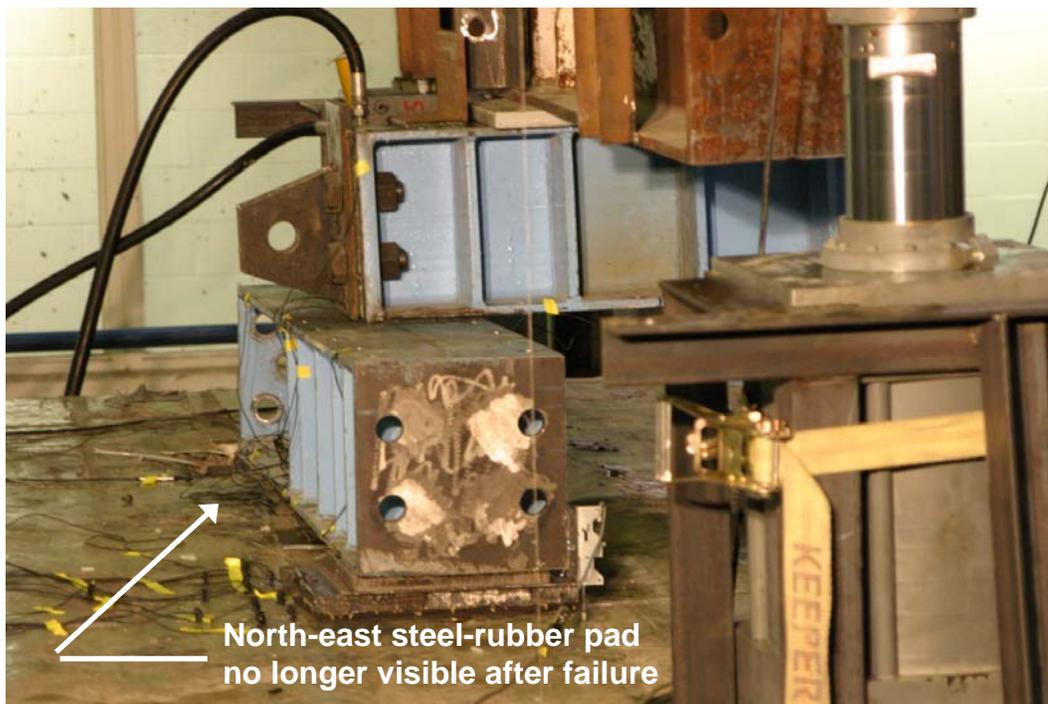
**Fig. 5.5 Photograph of spreader frame and failure at north-east load point**

9. At 7,500 seconds and a load of 623 kN (5xTandem) significant rotation of the loading frame about the east-west axis was observed accompanied by severe twisting and rotation of the spreader frame about the north-south axis due to failure of the HFRPC bridge deck at the north-east location as shown by the photograph presented in Fig. 5.5.

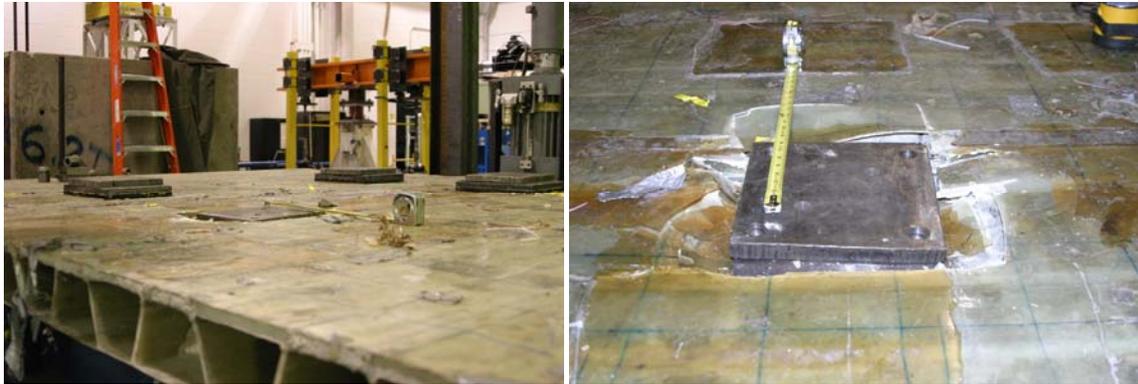
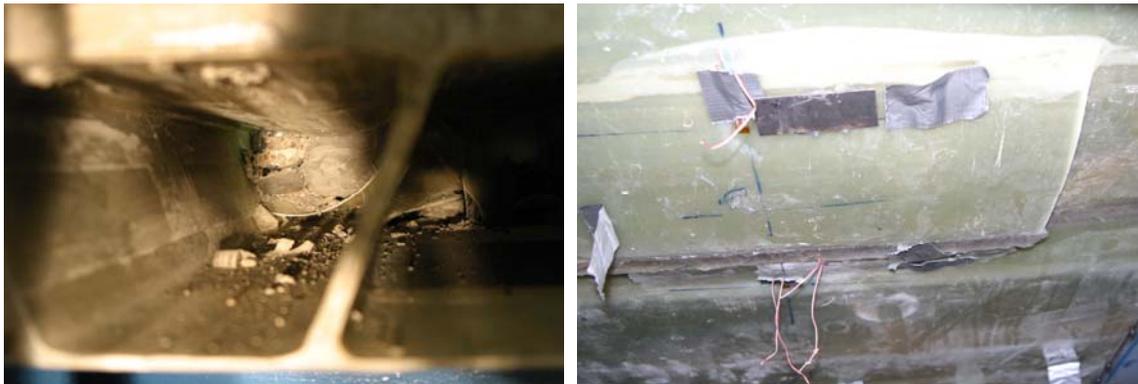
a. HFRPC deck surface

b. failure of deck at north-east location

c. failure of inclined web

d. underside of HFRPC deck

**Fig. 5.6 Photographs of HFRPC failure at north-east point of loading**

7. At 6,300 seconds with a load of 761 kN (6.2x Tandem) a series of loud bangs followed by failure at the north-east load point. The failure appeared to be a combination of punching-shear and web-buckling of the HFRPC deck as evidenced by the steel-rubber pad dropping into the HFRPC deck and rapid extension of the linear potentiometer (D14) at the north-east point of loading. A sudden drop in load followed the observed failure.

Following the conclusion of the destructive test the loading frame and spreader frame were removed to facilitate post-test inspection of the HFRPC deck and steel girders. No noticeable global residual deformation was observed suggesting that the girders remained elastic or nearly elastic. The most notable failure occurred in the HFRPC deck at the north-east loading point where the rubber-steel pad punched through the HFRPC top flange into the HFRPC deck cavity as shown in the photographs presented in Fig. 5.6a and Fig. 5.6b. Figure 5.6a also shows the rubber-steel pads at the other three loading locations remained atop the HFRPC deck. Closer inspection revealed crushing of the concrete and failure of the inclined web at the north-east location over a length approximately equal to the width of the steel-rubber pad (250 mm) that is shown in the photograph presented in Fig. 5.6c. Further inspection of the underside of the HFRPC deck showed impending punching shear failure of the bottom FRP flange of the deck that is shown by photograph presented in Fig. 5.6d.

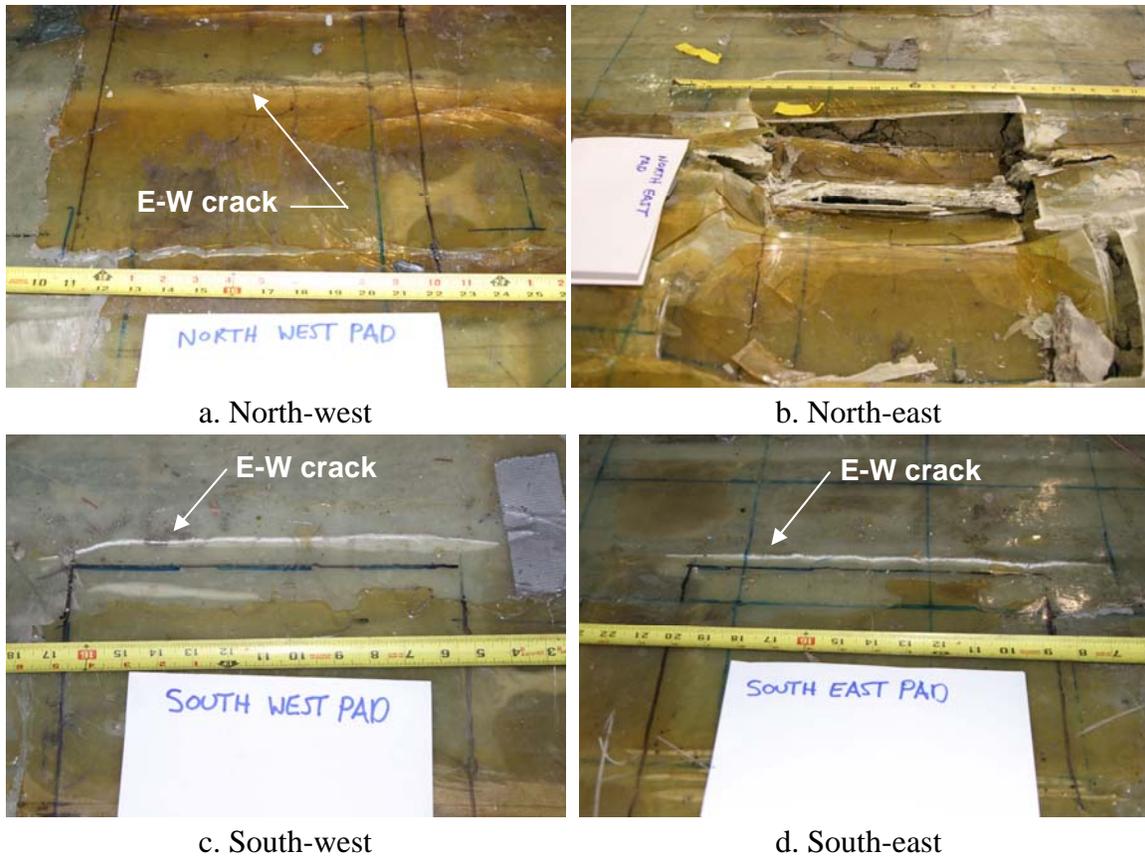
**Fig. 5.7 Photographs of HFRPC deck surface at points of loading**

Figure 5.7 presents photographs of the HFRPC deck surface at the four points of loading. With the exception of the north-east location (Fig. 5.6b), noticeable east-west cracks were observed at each of the other three locations with the most severe cracking observed at the south-east location. Although the top FRP layer of the HFRPC deck was not removed for inspection, likely significant crushing of the concrete in the top flange would have been observed at each location as suggested by the several loud audible “bang” sounds heard throughout the destructive test indicative of the crushing of confined concrete.

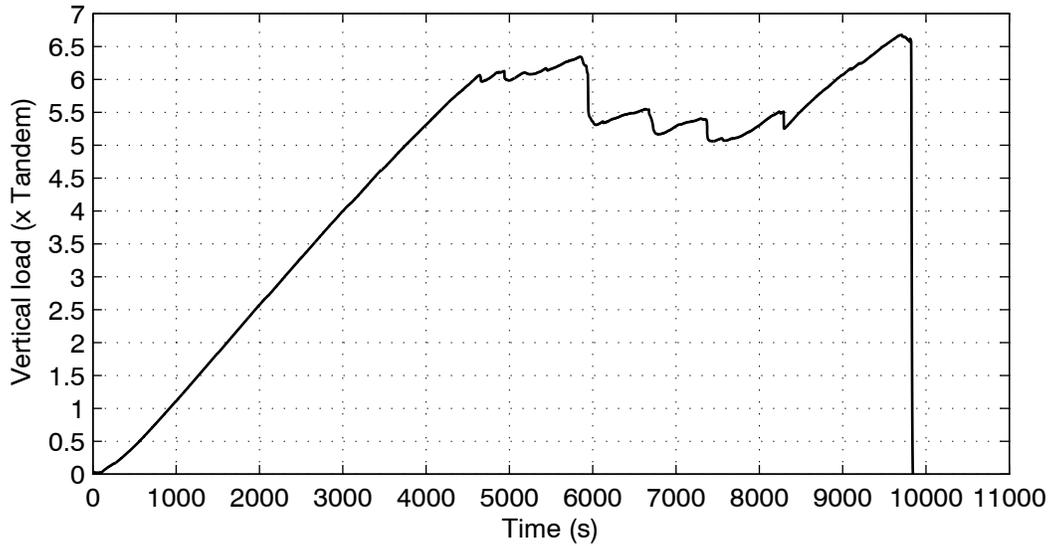
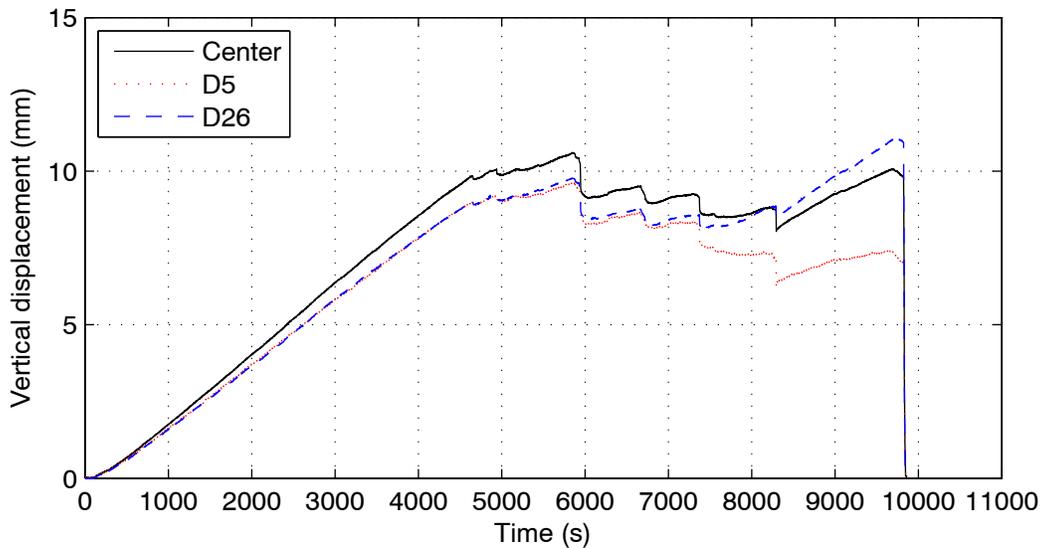
**Fig. 5.8 Applied load and vertical displacement results of HFRPC-SG specimen**

Figure 5.8 presents vertical load (Fig. 5.8a) and vertical displacement (Fig. 5.8b) data as a function of time. The vertical load presented in Fig. 5.8a has been normalized by the scaled tandem load (equal to 124 kN). Figure 5.8b presents displacement data from D5 and D26 along with the calculated displacement at the center (shown by a solid line). From Fig. 5.8 the load and vertical displacements are observed to increase approximately linearly up to an applied load of approximately 6 times the tandem load at 4,600 seconds corresponding to the onset of punching shear failure at the north-east point of loading. The load and displacement increased up to approximately 6.3 times the tandem load and a vertical displacement at the center of 11 mm at 6,000 seconds followed by a rapid drop in load corresponding to failure of the inclined FRP web at the north-east point of loading. Up to 6,000 seconds the vertical displacement at the center was larger than the vertical displacements at D5 and D26 however failure of the north-east pad lead to significant rotation of the spreader and loading frame that resulted in redistribution of load from 6,000 seconds to approximately 8,200 seconds as is evidenced by the divergence of the vertical displacements measured at D5 and D26 in this period of time. At approximately 8,000 seconds the north lateral beam of the spreader frame began bearing on the HFRPC deck directly over the interior girder as indicated by the increase

in applied load however the applied load was no longer being applied symmetrically to the HFRPC-SG specimen as is evidenced by the divergence of vertical displacements at D5 and D26 and the vertical displacement at D26 (located on the north side of the loading frame) beginning to exceed the vertical displacement at the center of the interior girder.

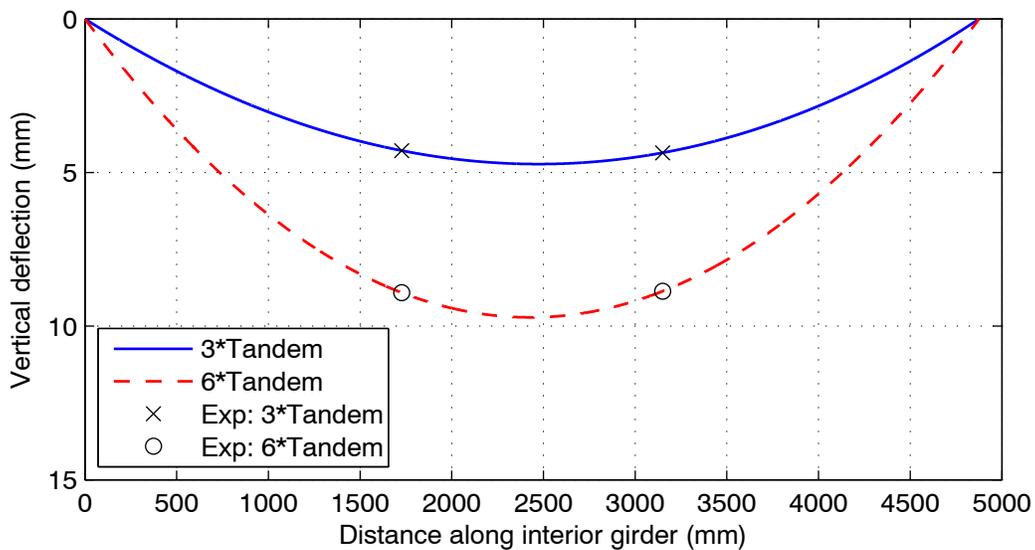
**Fig. 5.9 Deformed shape of the interior girder**

To verify the Rayleigh-Ritz method was generating reasonable deformed shapes, i.e. shapes that conform to the boundary conditions and specified displacements, the deformed shape profile of the interior girder was plotted for two load levels, specifically 3 and 6 times the tandem load. Figure 5.9 presents the deformed shape for 3 and 6 times the tandem load determined using the Rayleigh-Ritz method shown by solid and dashed lines respectively along with vertical displacement data from D5 and D26 shown by an x-shaped marker and a circle marker. The profiles plotted in Fig. 5.9 indicate that the Rayleigh-Ritz method appears to have provided reasonable estimates based on the zero displacement boundary conditions and the agreement between the measured and calculated displacements at the D5 and D26 locations as would be expected. Further verification of the Rayleigh-Ritz method is provided in the subsequent section when the elastic stiffness of the HFRPC-SG specimen determined from destructive testing is compared with the elastic stiffness determined from fatigue testing (see Section 4) where the vertical displacement of the center of the interior girder was measured directly.

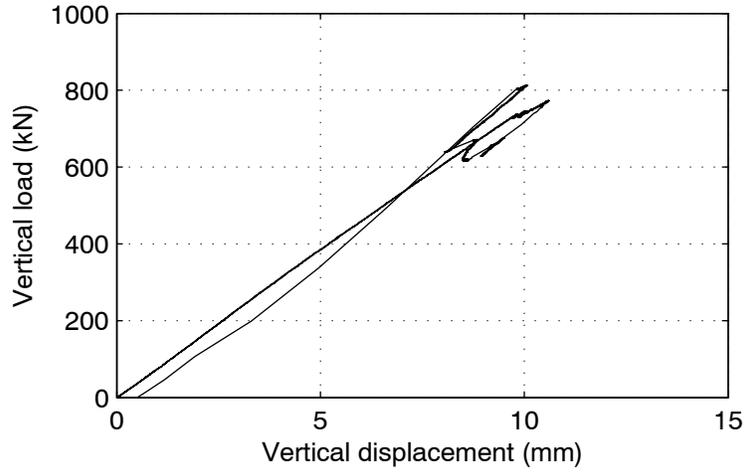
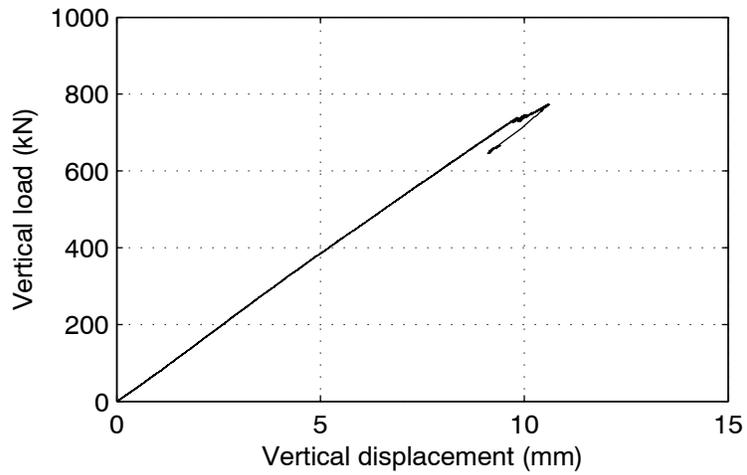
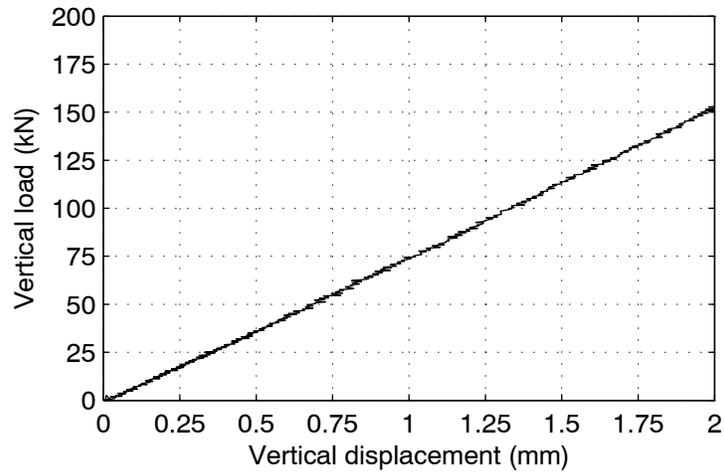
**Fig. 5.10 Force-displacement response of the HFRPC-SG specimen**

The global force-displacement response of the HFRPC-SG specimen determined from the load cell data (F1 and F2) and the calculated vertical displacement at the center of the interior girder is presented in Fig. 5.10. Figure 5.10a presents a plot of the complete force-displacement response of the HFRPC-SG specimen however following failure of the HFRPC deck at the north-east location there was a redistribution of loading resulting in decreasing vertical displacement at the center of the interior girder obscuring the results. Figure 5.10b presents the force-displacement response up to just after failure of the HFRPC deck at the north-east location. From Fig. 5.10b the force displacement response is approximately linear up to 727 kN (5.9xTandem) and a vertical displacement of 9.7 mm. After this point the force-displacement response becomes nonlinear continuing to increase to a load of 764 kN (6.25xTandem) and a vertical displacement of 10.5 mm at which point the inclined web of the HFRPC deck at the north-east load point failed resulting in a drop in load and recovery of a portion of the total vertical displacement. Figure 5.10c presents the force-displacement response over the range of load that was applied during the fatigue testing portion of the experimental study. From Fig. 5.10c the force-displacement response again appears linear, or nearly linear, with an applied load of 74 kN at a vertical displacement of 1 mm corresponding to a vertical stiffness of 74 kN/mm. This value agrees very well with the average vertical stiffness of 73.2 kN/mm determined from the static benchmark tests performed through the fatigue testing program (see Section 4) using displacement data measured directly at the center of the interior girder. The close agreement between the vertical stiffness from fatigue testing and destructive testing further suggest that the Rayleigh-Ritz method was a reasonable approach to indirectly determining the vertical displacement at the center of the interior girder.

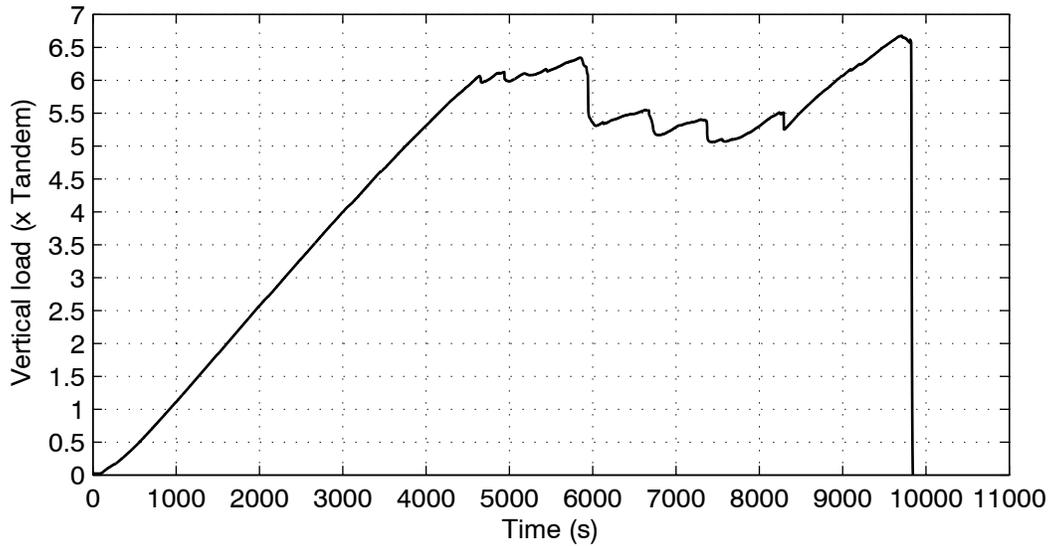
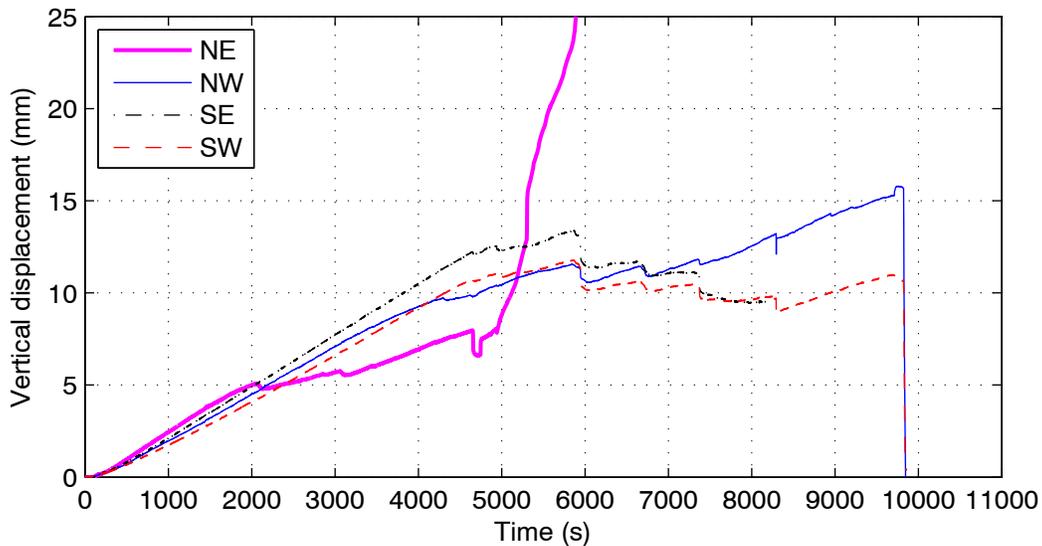
**Fig. 5.11 Applied load and vertical displacement results of HFRPC deck**

further, accompanied by a rapid drop in the applied load, as a result of the failure of the HFRPC deck at the NE location. The rapid increase in vertical displacement at the NE location at 6,000 seconds is due to crushing of the FPR inclined web allowing the steel-rubber pad and loading frame to punch into the HFRPC deck cavity and does not reflect the actual vertical displacement of the HFRPC deck at this point.

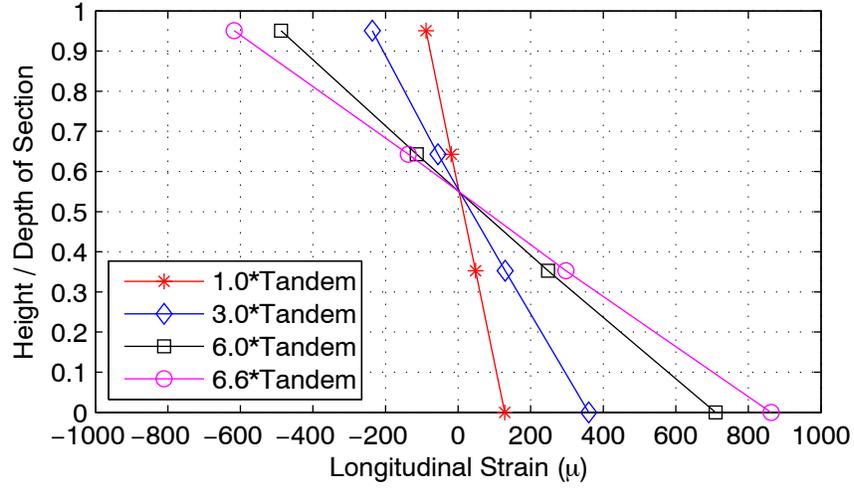
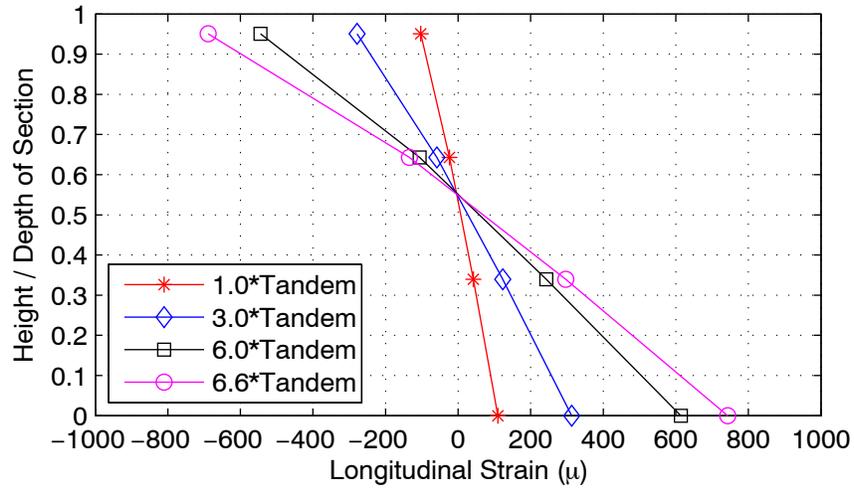
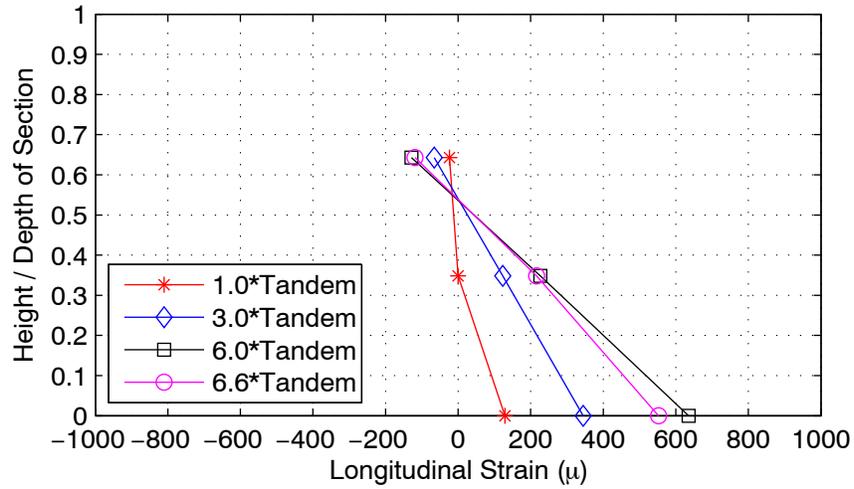
**Fig. 5.12 Strain profiles across girders at various locations**

The composite action between the HFRPC deck and steel girders was monitored using the position of the bending neutral axis at three locations. The neutral axis location was determined using longitudinal strain data from the strain gage sets installed at two locations on the interior (S5-S8 and S9-12 see Fig. 5.3) and exterior (S1-S4) girders collected throughout the destructive test. Figure 5.12 presents strain profiles for the approximate centerline of the interior girder (Fig. 5.12a), approximate quarter point of the HFRPC deck (Fig. 5.12b) and approximate centerline of the east exterior girder (Fig. 5.12c) for applied load levels of 1.0, 3.0, 6.0 and 6.6 times the scaled tandem load. Each plot in Fig. 5.12 presents the longitudinal strain, in units of micro-strain ( $\mu$ ), plotted at four different heights of the (W360x101) girder section (see Fig. 5.4) presented as the height of the gage normalized by the depth of the section ( $d = 356\text{mm}$ ). From Fig. 5.12a, for each applied load level (up to 6.6 times the tandem representing the maximum applied load) each strain profile passes through zero strain at an approximate normalized height of 0.56 -representing the position of the neutral axis. These results suggest that composite action between the HFRPC deck and steel girder was present (indicated by position of the neutral axis that is greater than  $0.5d$ ) and that the composite action at this location (approximate center of interior girder) was maintained at an applied load of 6.6 times the scaled tandem load. Also shown by the results presented in Fig. 5.12b is that the section remained elastic since all strain values were less than the expected yield strain of  $2070\ \mu$ : assuming a yield strength of 414 MPa and a Young's modulus of 200 GPa. Similar results are shown in Fig. 5.12b for the approximate quarter point of the HFRPC deck where the strain profiles pass through a value of zero strain at a normalized height of approximately  $0.56d$  indicating that composite action was maintained throughout the destructive test at this location and that the section remained elastic with all strain values less than the expected yield strain. Although the malfunction of S1 at the approximate centerline of the east exterior girder prevents plotting the full profile the results that were obtained seem to agree with the other locations in that composite action was present and maintained through the test and that the section at this location remained elastic.
