Transportation Elements Assessment Town of Milton, Delaware

September 29, 2009

Transportation Elements Assessment – Town of Milton, Delaware

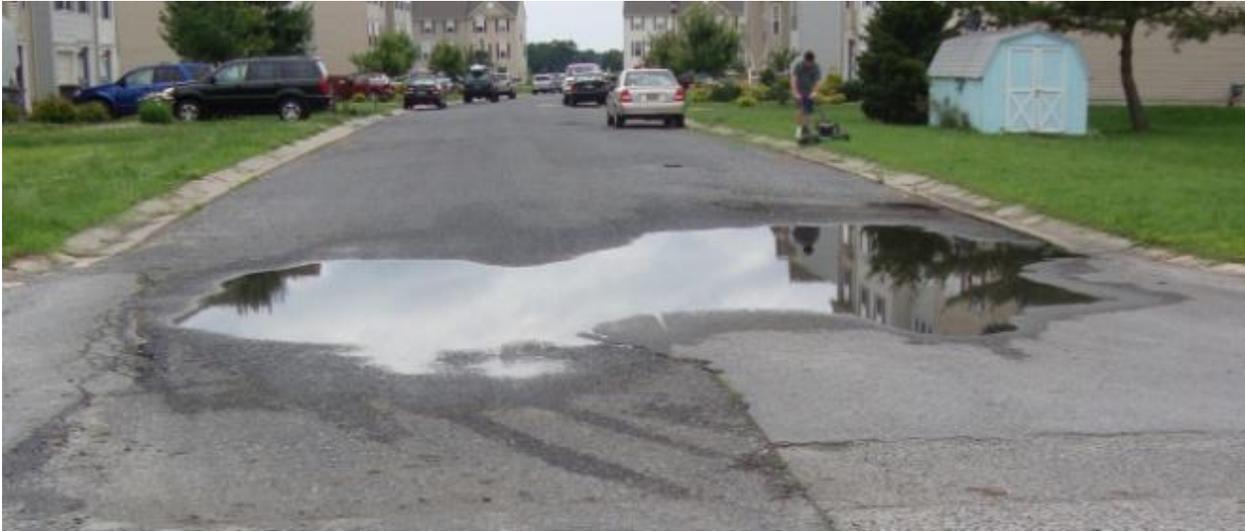
Figure 4 Intersection ponding in Main-sail Lane

Evidence of stormwater ponding at sidewalk ramps was noted, together with other elements that might limit the effectiveness of the ramp or sidewalk, particularly for disabled persons. For example, utility poles, sign posts, hydrants or other fixed objects that limited the clear path to less than desired or required widths were noted and/or photographed for further analysis.

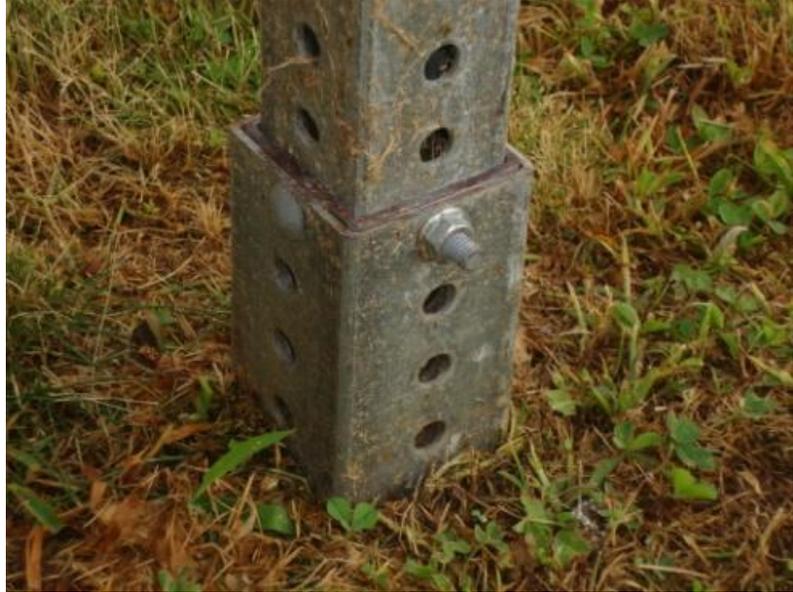
Figure 5 Breakaway Anchor at Mainsail Drive

For each sign, its height and width were measured, as well as its height above the pavement elevation, its distance from the pavement edge, and the retroreflectivity of the legend and background colors.⁹ Significant physical defects (such as graffiti, bullet holes, washing out, mold, etc.) were also noted, as well as limitations on viewable distances. The presence or absence of breakaway anchors was noted.

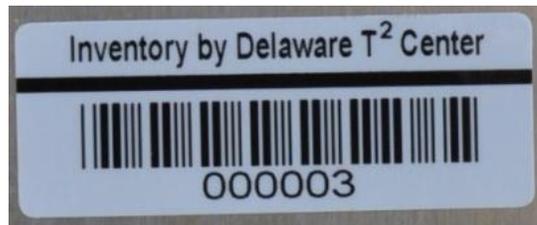
Figure 6 Typical barcode used by the team

Retroreflectivity was measured with a RoadVista 922 retroreflectometer. With this instrument the team was able to record multiple readings of a legend (lettering) or background color for each sign, the instrument would average the readings for each set (legend or background), and then store the data. The instrument's internal Geographical Information System (GIS) also records the physical location via latitude and longitude coordinates for later mapping and also reads barcodes that the team placed on the back of signs for cross-reference of data over time.

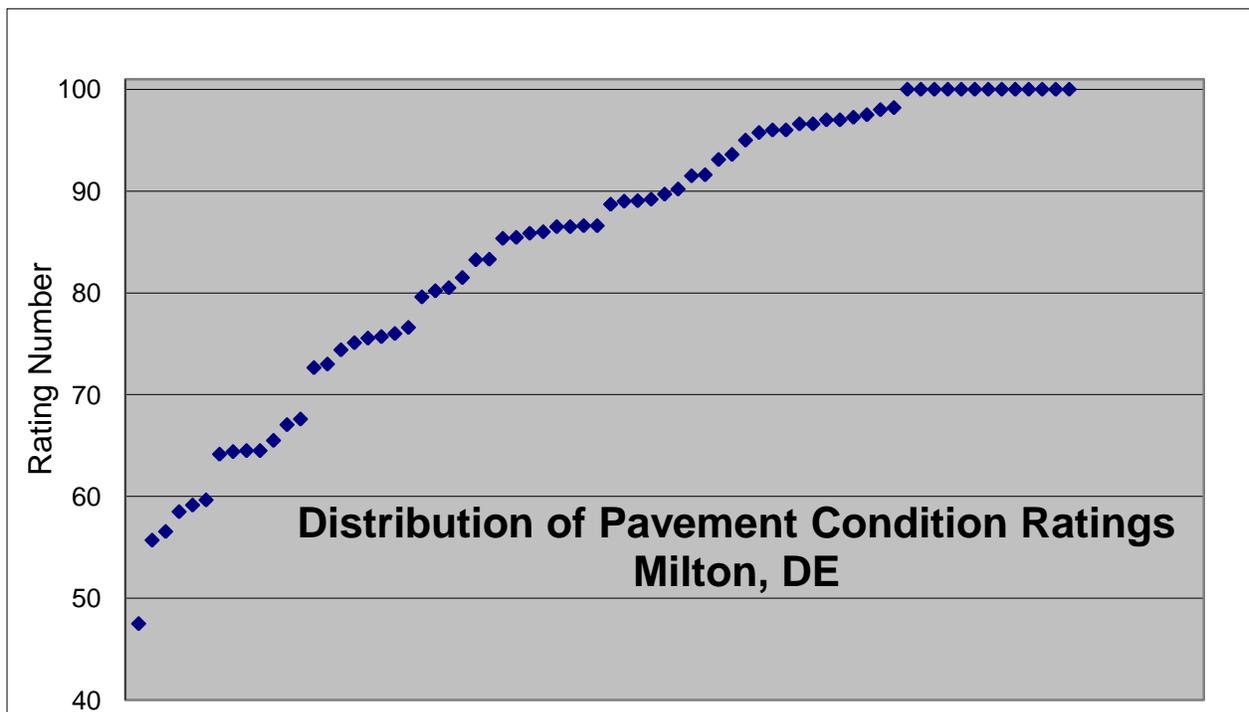
Figure 7 Milton PCR Distribution

Pavement condition ratings, using the PCR system, ranged from a low of 47.5 to ratings of 100 for several streets. Figure 7 shows the system-wide distribution of pavement ratings and illustrates that the range of street conditions are somewhat uniformly represented.

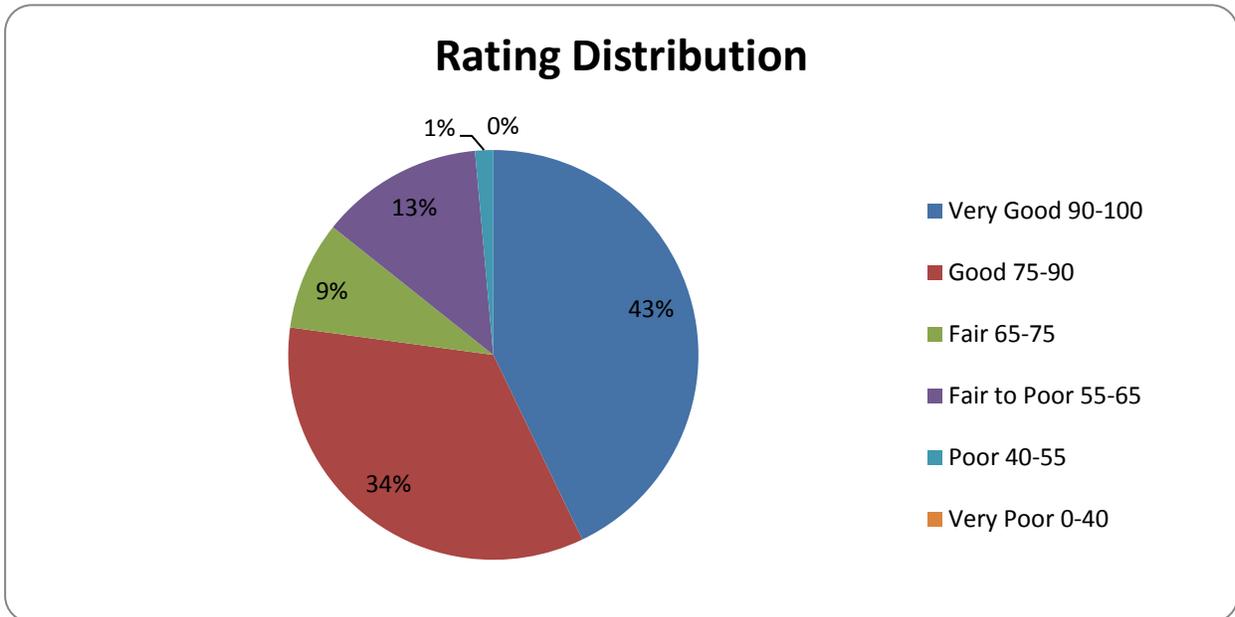
Figure 8 PCR Rating Distribution

Similarly, Figure 8 shows the majority of streets are between 75 and 100 on the pavement condition rating scale. The relatively high rating that many of these streets have is not surprising, given that many of these streets are relatively new or have been recently repaved.

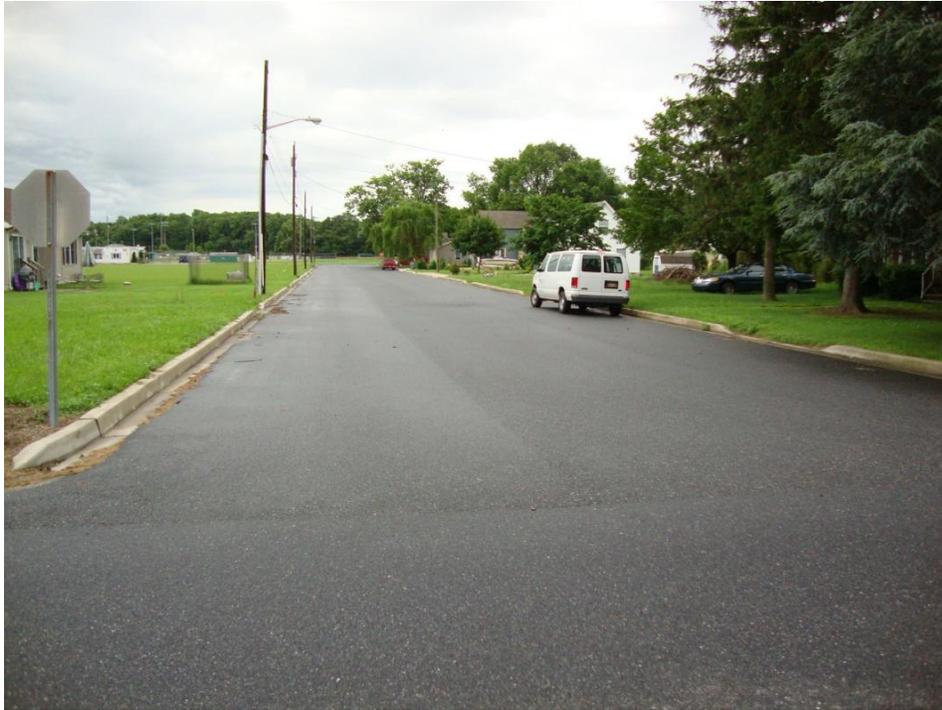
Figure 9 Sussex Street

Sussex Street, for example, has been repaved in the last few years, has cross slopes in the 1%-3% range, and has a pavement condition rating of 100, meaning that no substantive surface distresses are evident at this time.

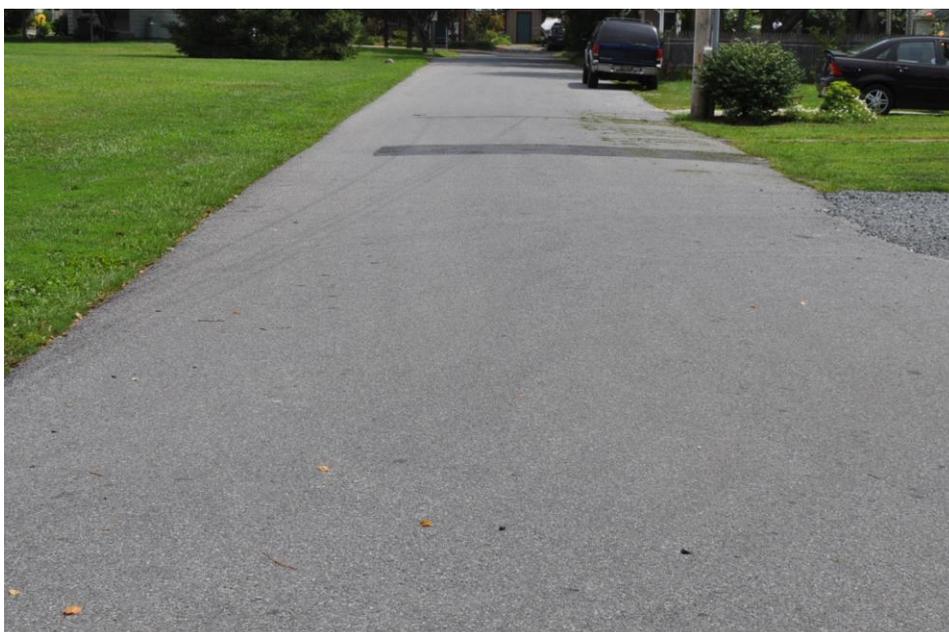
Figure 10 Tilney Street

Tilney Street has a PCR of 95 with cross slopes between 1% and 3%. The predominant distress found was patching with some random cracking.

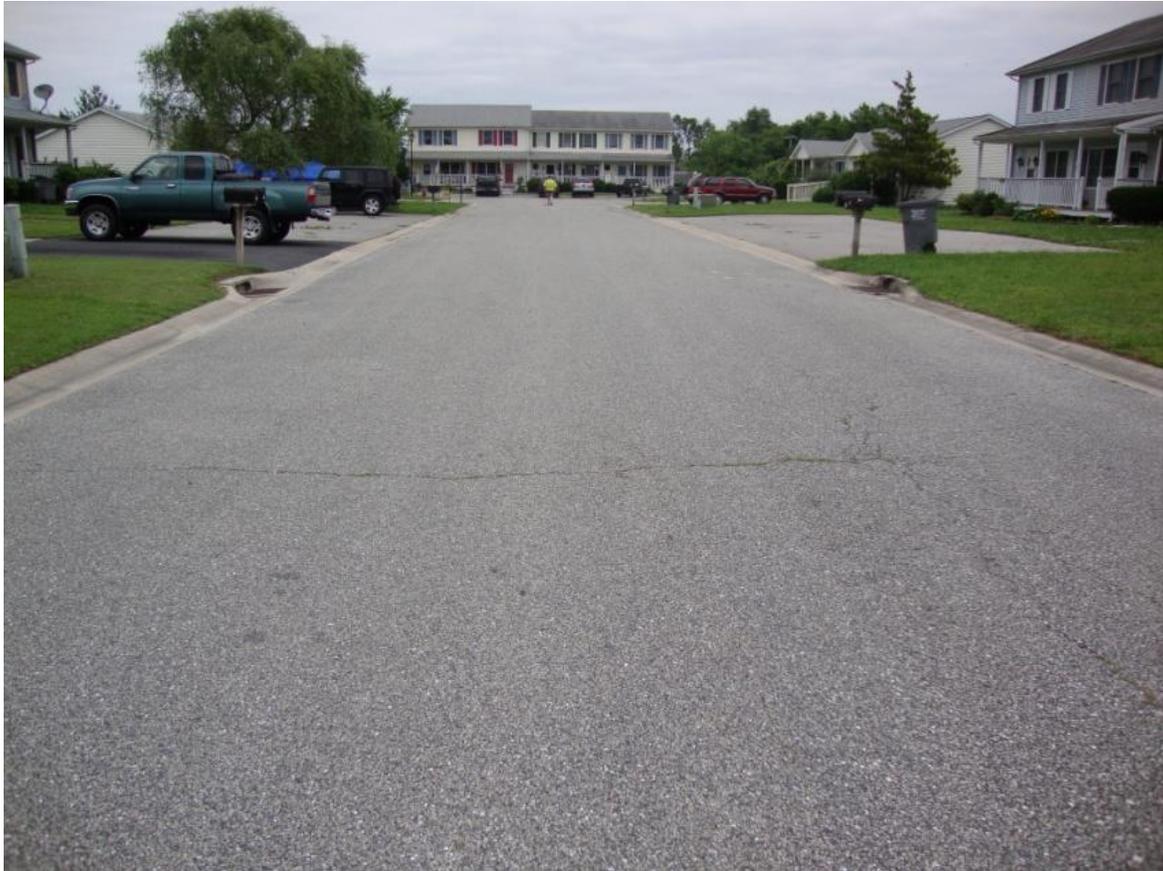
Figure 11 Bay Court

With a lower PCR rating of 86, Bay Court has cross slopes between 1% and 3% but longitudinal slopes typically below 1%, with only fair drainage characteristics. The major distresses along this road are block and transverse cracking as well as alligator cracking, perhaps due to the moderate longitudinal slopes.

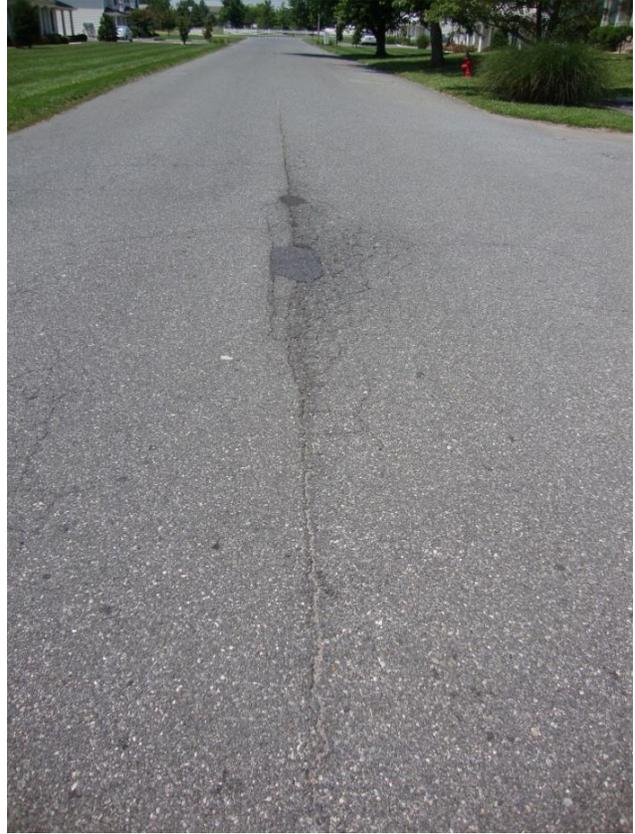
Figure 12 Tobin Drive

A still more severe example is Tobin Drive with a PCR of 67.6. Both cross slopes and longitudinal slopes were measured to be less than 1%. In fact, the section nearest Union Street is sloped inward at places towards the centerline, which exacerbates crack formation and

alligator cracking, longitudinal joint cracking, and block and transverse cracking are major distresses for Tobin Drive along with patching and potholes.

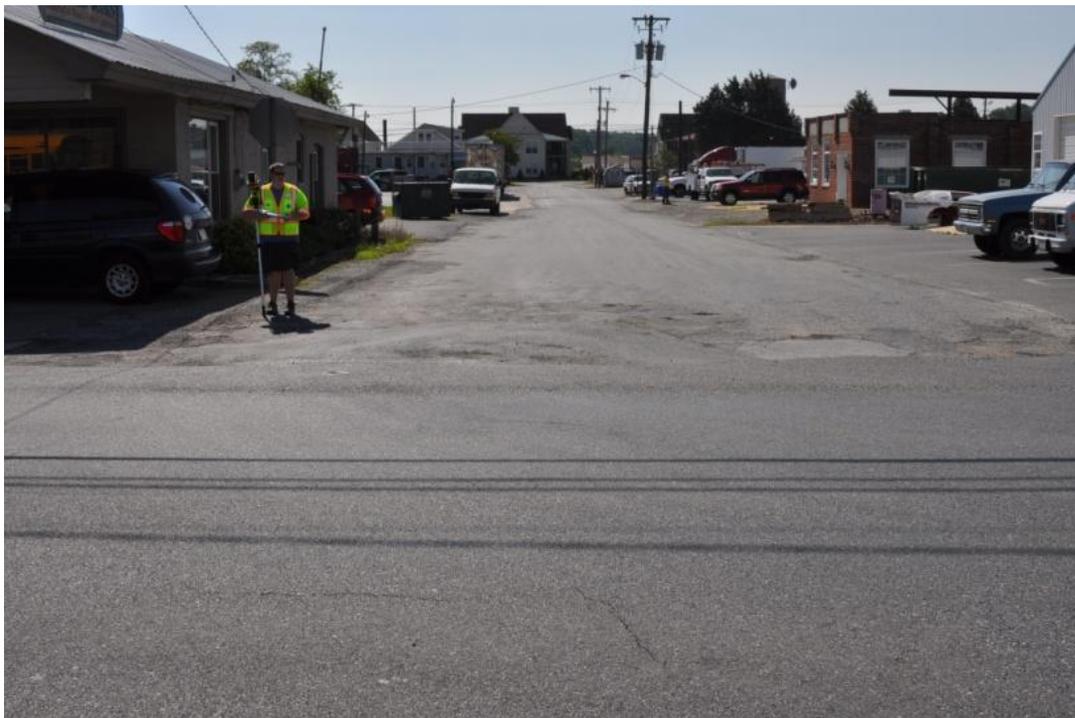
Figure 13 New Street

New Street is a rarity of sorts for Milton maintained streets in that it is a significant industrial street. While the cross slopes typically exceed 3%, the longitudinal slopes are generally less than 1%, resulting in compromised drainage as evidenced by the several distress categories. These include alligator cracking, settlement, potholes, and edge cracking, resulting in a PCR of 64.

- Atlantic Avenue – bleeding
- Main-Sail Lane – lack of surface course coupled with damaged base course
- Portions of South Spinnaker Lane – lack of surface course coupled with damaged base course
- Rudder Lane – extensive alligator cracking
- New Street – variety of severe and extensive distresses

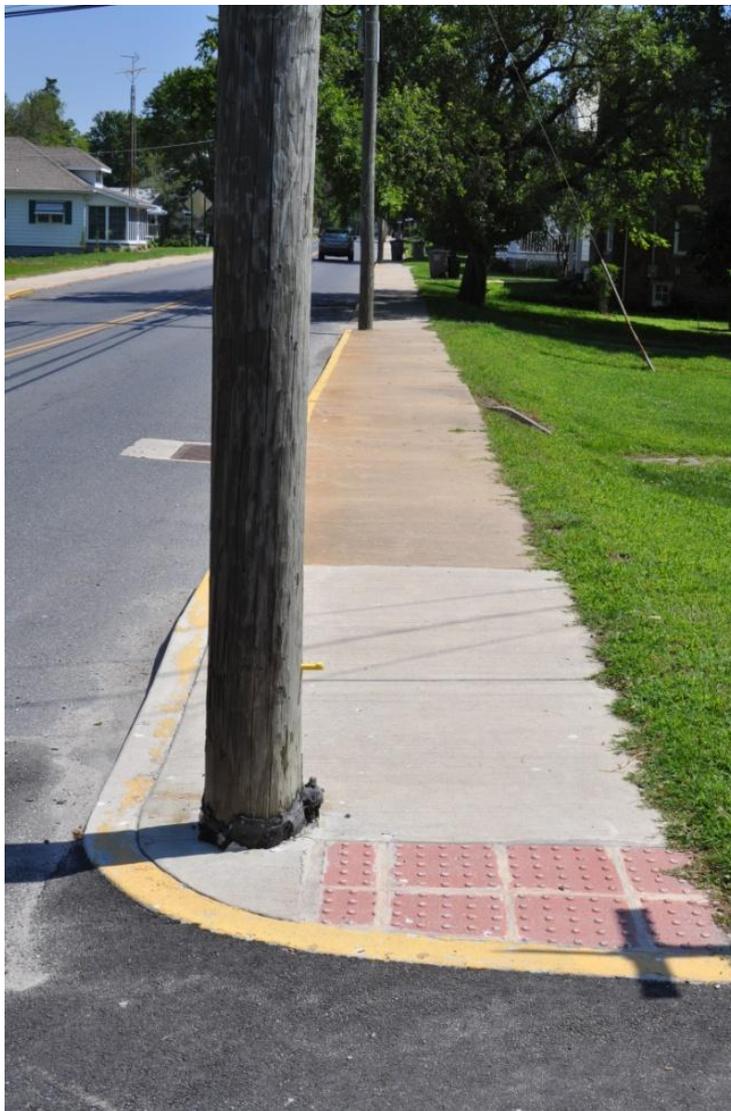
Figure 14 Federal Street and Church Street

The presence of utility poles and other obstructions in the ramp area can pose an additional challenge for disabled pedestrians. The ramp shown here at Federal Street and Church Street is a common condition in municipal environments like Milton and there are often no simple relocation alternatives, making it all the more important that the ramps' cross and longitudinal slopes accommodate navigation by disabled persons. Here the longitudinal slope is mild but the cross slope exceeds 3%. Compounding the problem here, a surveyor's benchmark has been placed on the utility pole in the pathway of pedestrians. When an obstruction such as this utility pole is not readily

relocated, making the cross and longitudinal slopes consistent with ADAAG guidelines and avoiding unnecessary obstructions such as a surveyor's benchmark, will make it easier for handicap persons to navigate around the obstruction.

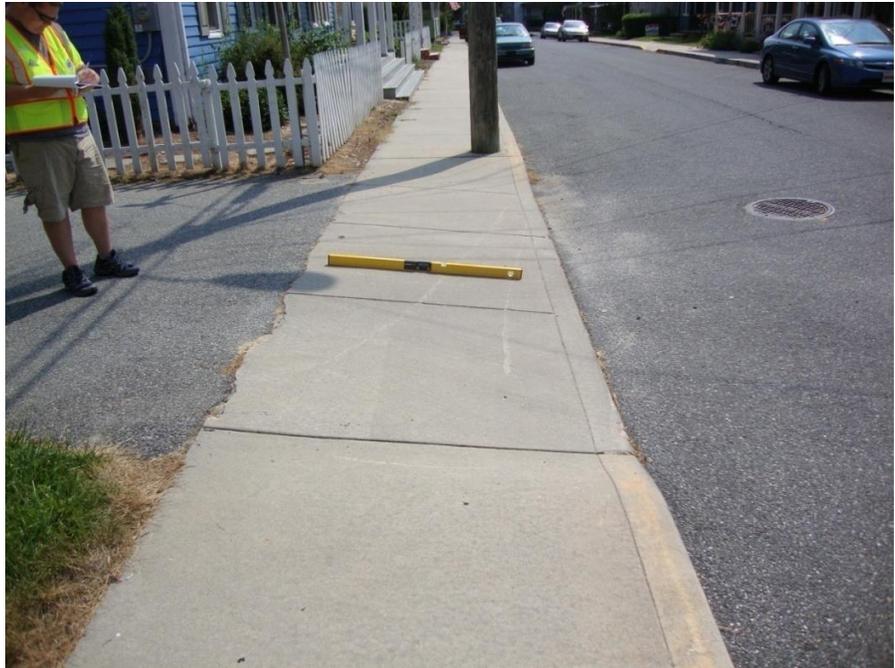
Figure 15 Reed Street and Broad Street

Broad Street the ramp system actually resembles a driveway entrance design and, coupled with the 13% cross slope, it can propel a disabled pedestrian (either in a wheel chair or crutches/walker) directly into the Broad Street travel way. This can affect pedestrians traveling along either Broad Street or Reed Street and reduce safety for both pedestrians and motorists.

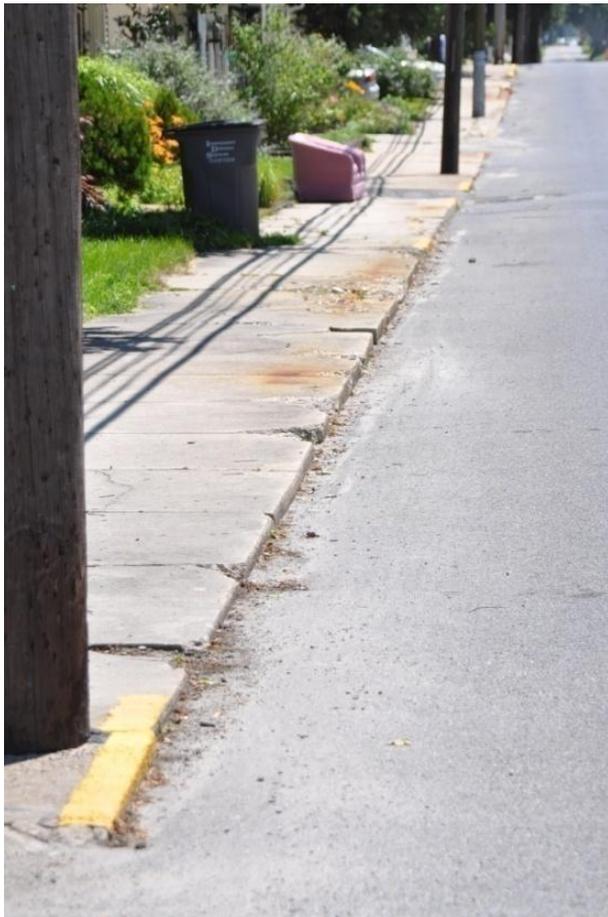
Figure 16 Along Chestnut Street

Even when sidewalks have adequate widths, cross slopes, and other physical features, they are often encumbered by temporary obstructions. These can be trash cans, parked cars, vegetative encroachment, etc. These ad hoc and/or intermittent obstructions minimize the effectiveness of what may already be a limited sidewalk system.

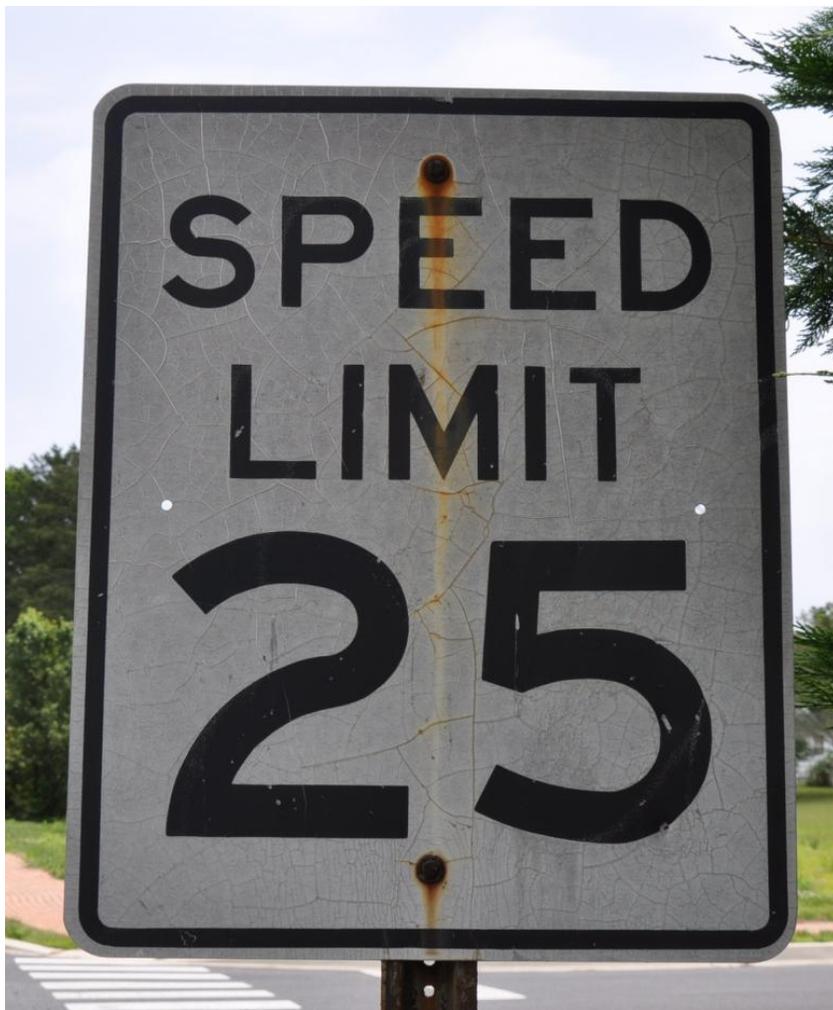
Figure 18 Cracked Speed Limit sign on Atlantic Ave

The Speed Limit sign found on Atlantic Avenue is very old, cracked, and rusted. It is an example of the signs that do not meet retroreflectivity levels. Although this sign is clearly degraded and needs to be replaced, there are other signs around the town that look like they are in good condition in the day light, but cannot be seen at night because they do not meet retroreflectivity levels.

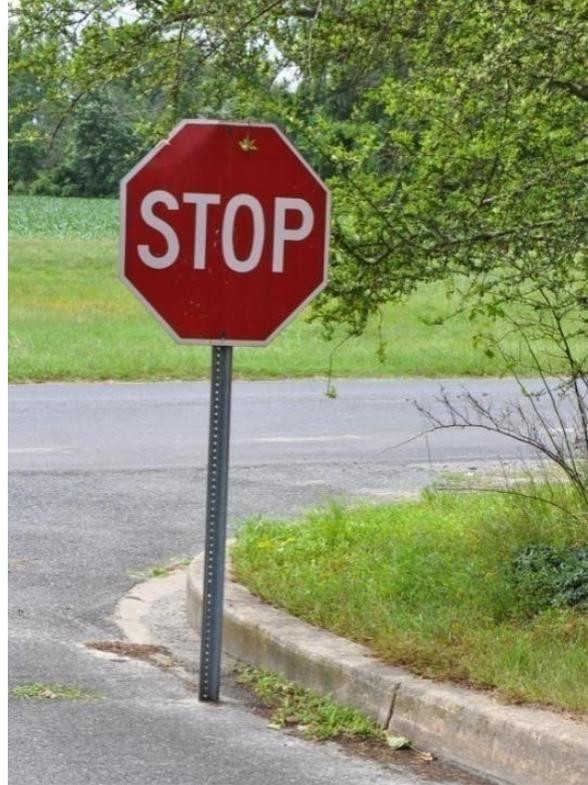
Figure 19 Sign in road on Yew Street

Yew Street is an example of a few signs found around Milton that is placed directly in the roadway, creating potential safety issues. In the case of this Stop sign on Yew Street, it is evident that the sign was placed there to be seen from further away because it would be hidden by some vegetation if placed in the grass behind the curb. The lack of

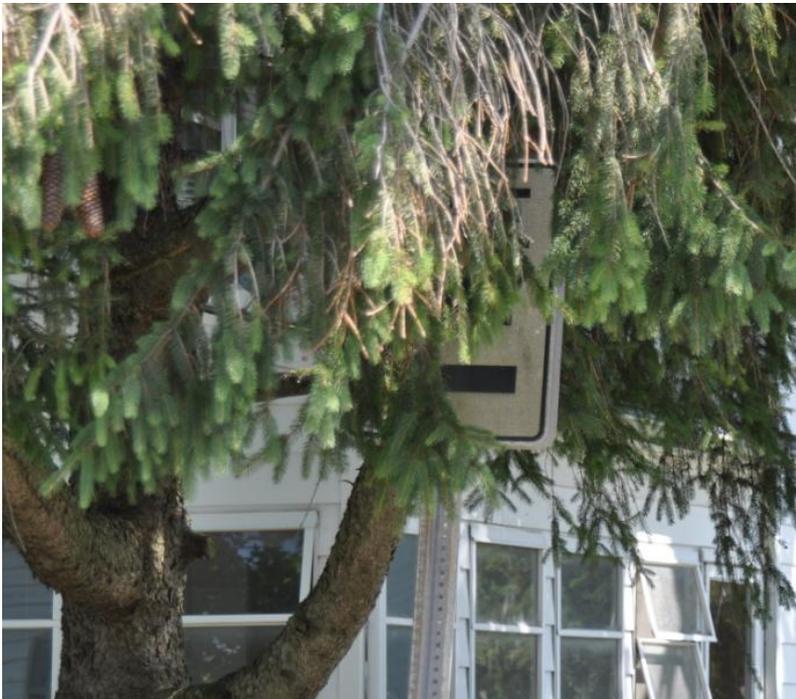
Figure 20 Can you spot the One Way sign?

Signs can be hidden by many obstacles such as trees, other vegetation, fences, houses, cars, etc., further contributing to safety concerns for motorists and pedestrians. Some examples were found in Milton, such as the picture to the right. This One Way sign can be detected only when it is likely too late to avoid a possible collision.

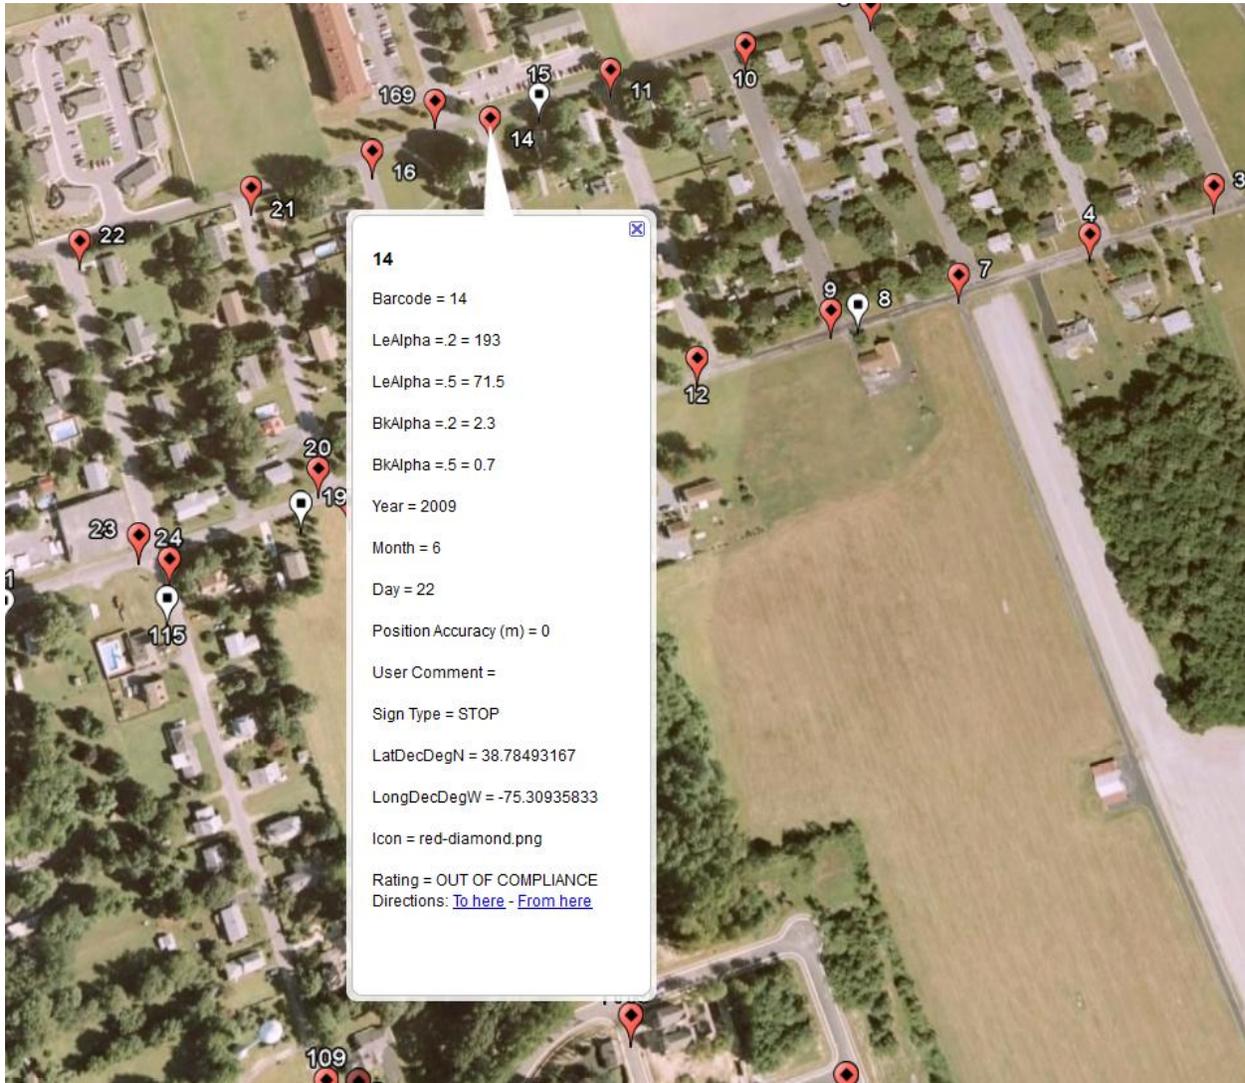
Figure 21 Google Earth overlay of sign locations and information

In addition to the Excel spreadsheets in Appendix A4, the team developed overlay files for Google Earth that allow visual browsing of sign locations, along with information about each individual sign. Other layers provide photographs of physical sign damage locations. These are considered layers in Google Earth

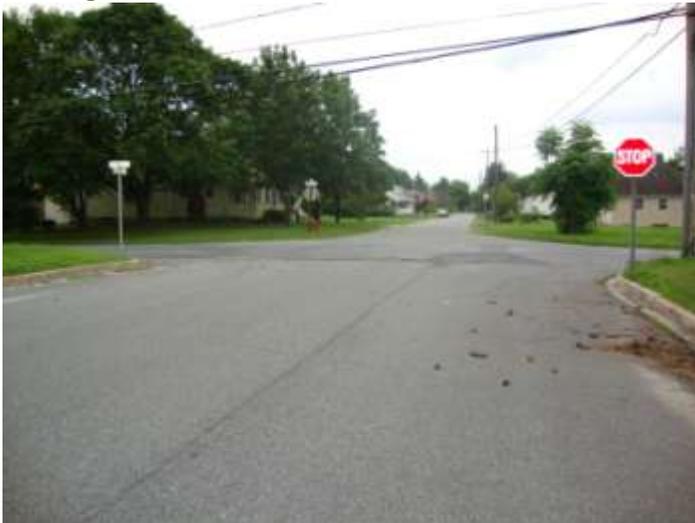
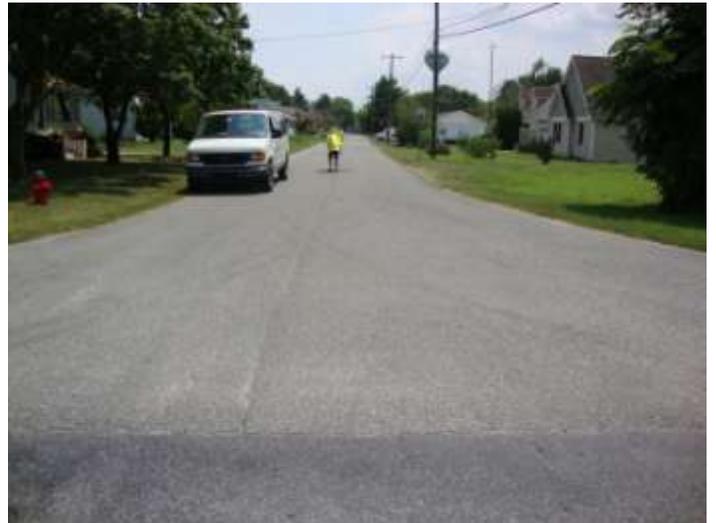
Drainage conditions for most streets are generally good. However, the existing cross slopes for a number of streets are less than 1%. Behringer Avenue and Chandler Street are both examples that have adequate drainage despite very moderate cross and longitudinal slopes.

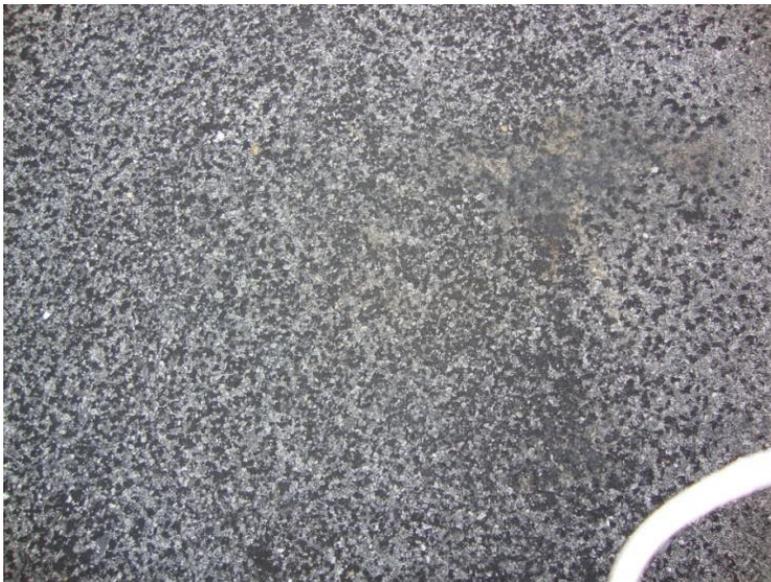
Causes: Bleeding occurs when asphalt binder fills the aggregate voids during hot weather, then expands onto the pavement surface. Since bleeding is not reversible during cold weather, asphalt binder will accumulate on the pavement surface over time. This can be caused by an excess amount of asphalt binder in the flexible pavement mixture and/or low air void content. Bleeding typically originates from poor hot mix production or transportation (i.e., segregation of aggregate and binder).

Leads to: Bleeding reduces the friction characteristics of the road surface. As the skid resistance of the roadway decrease, the likelihood of crashes increases.

Typical Repair Methods: When bleeding is minor, coarse sand can be applied to the pavement in order to absorb the excess asphalt binder. When much of the pavement surface is affected by bleeding, the surface may need to be removed (i.e., milled) and the surface wearing course replaced.

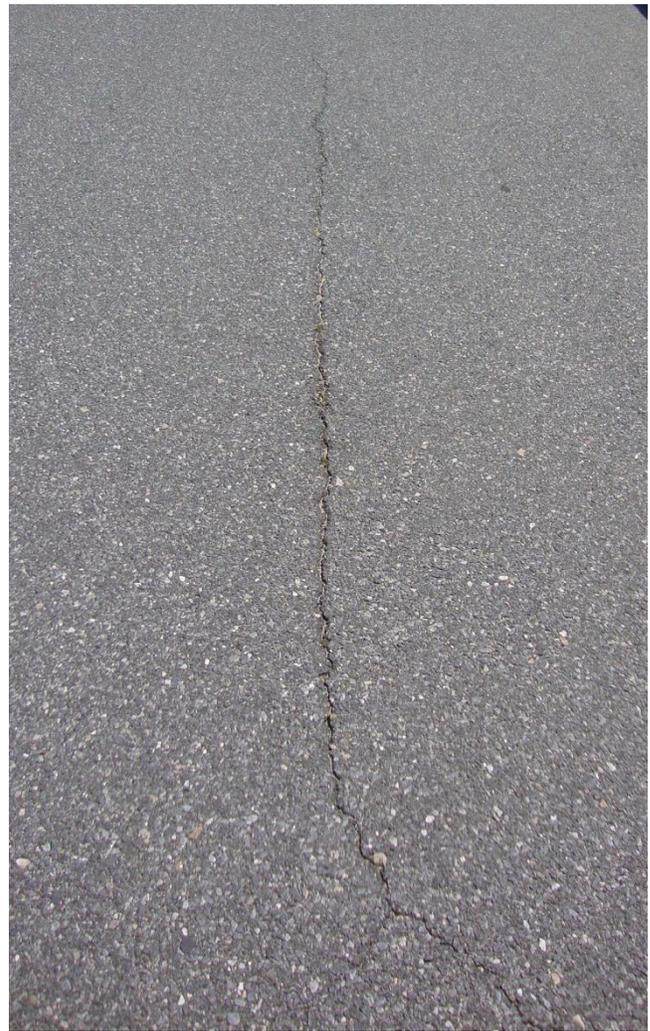
Crack Sealing Deficiency

Description: Cracks that have developed and begun to expand unabated. These may be cracks that have been sealed before but are no longer effective in preventing water intrusion or they may be newer cracks that have never been treated.

Causes: Cracks, to some extent, are inevitable in pavements. Crack sealing deficiency is when cracks have been allowed to expand, unabated, in both length and width or have not been monitored for recurrence of open conditions or expanded reach.

Leads to: Cracks allow water intrusion into the pavement, which causes more cracks and debonding and allows accelerated development of

other pavement distresses. Ultimately, the unmaintained roads have to be replaced more often, increasing the life cycle costs of the roadway.

Typical Repair Methods: Crack seal large cracks in pavement periodically to maintain a sealed surface condition and minimize pavement rehabilitation costs over time.

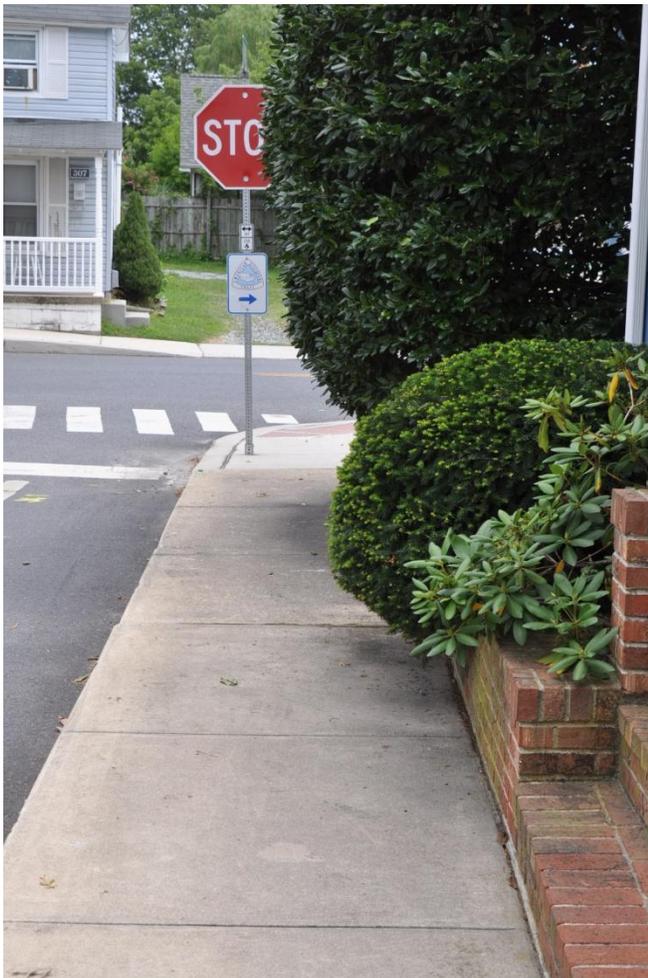
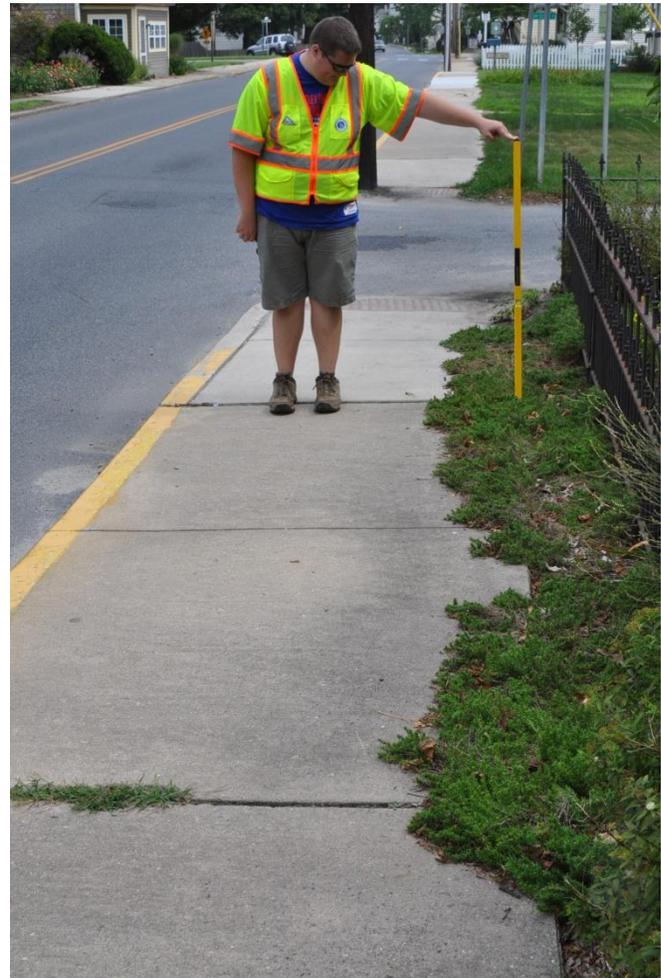
Pedestrian Passage Corridors for Sidewalks

A successful, ideal sidewalk system would be 60" wide throughout its length, would be free of obstructions, and meet all cross slope and longitudinal slope requirements. But even when such a sidewalk system is constructed, it often falls victim to temporary or incremental encroachments that limit its available capacity for pedestrians, particularly those in the disabled community. For example, available sidewalk widths can be lost to trash cans, expanding trees and shrubs, encroaching grass or ground covers, or low mounted signage.

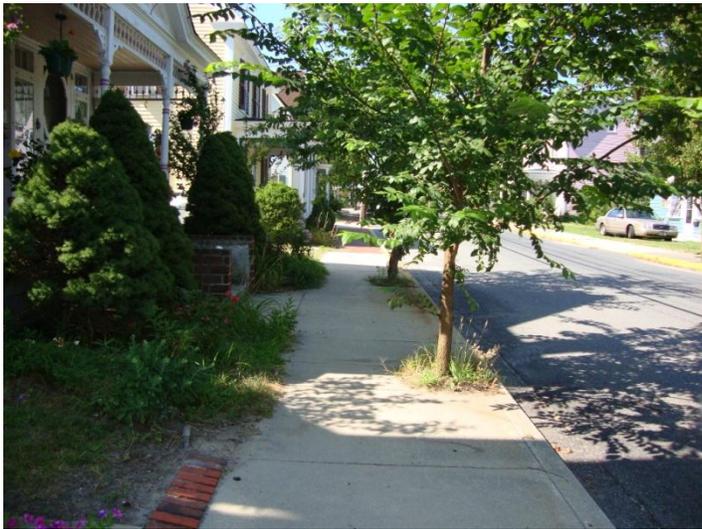
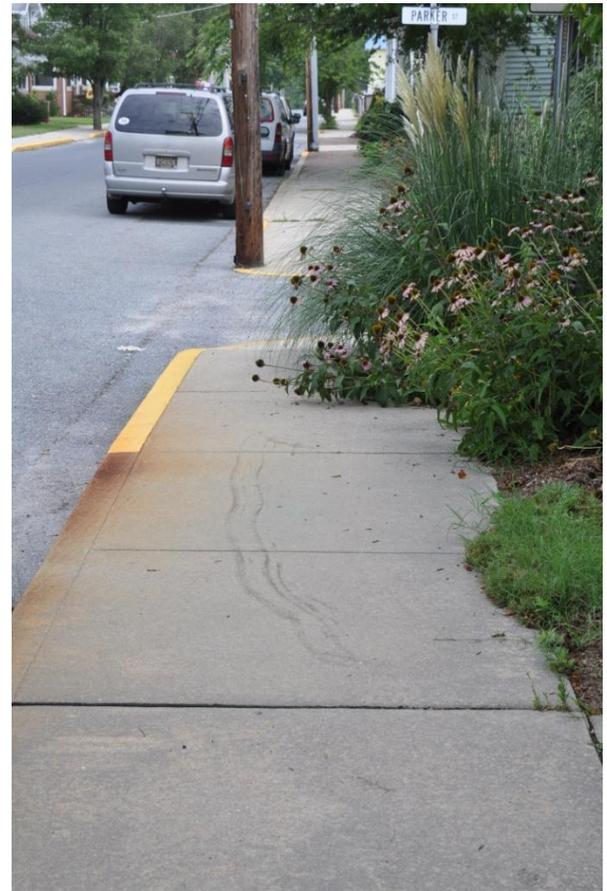
Vegetative encroachments take the form of shade trees, shrubs, ground cover, flowers, and grass. They are often benign when first planted, but over time, they increasingly cover more of the sidewalk or, in the case of grass and flowers, may present a seasonal disruption. Because these happen gradually, they tend to go unnoticed until they are more difficult to manage because they have been entrenched for so long.

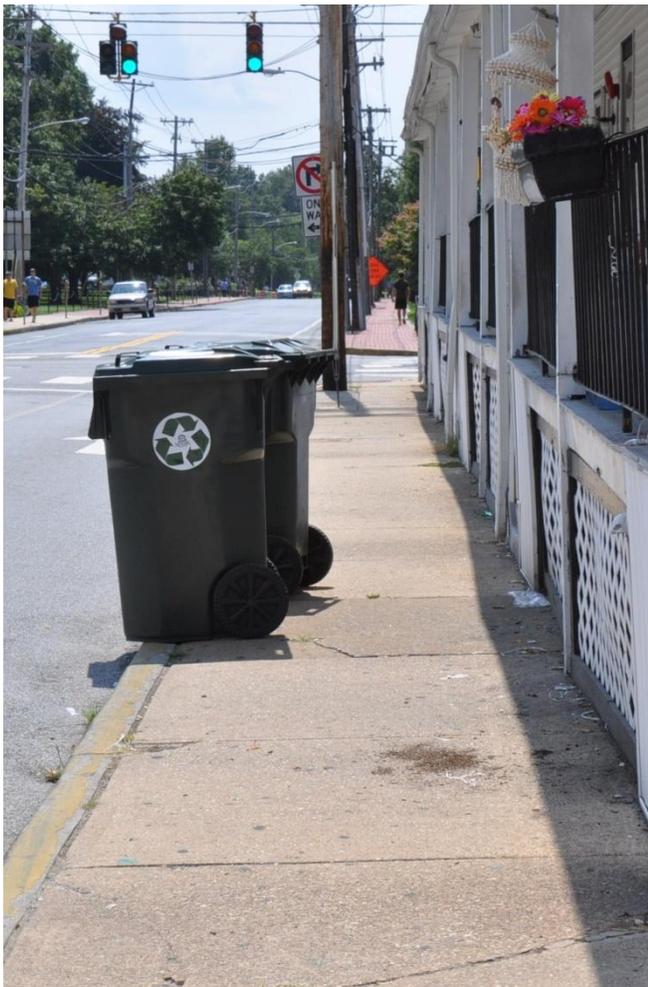
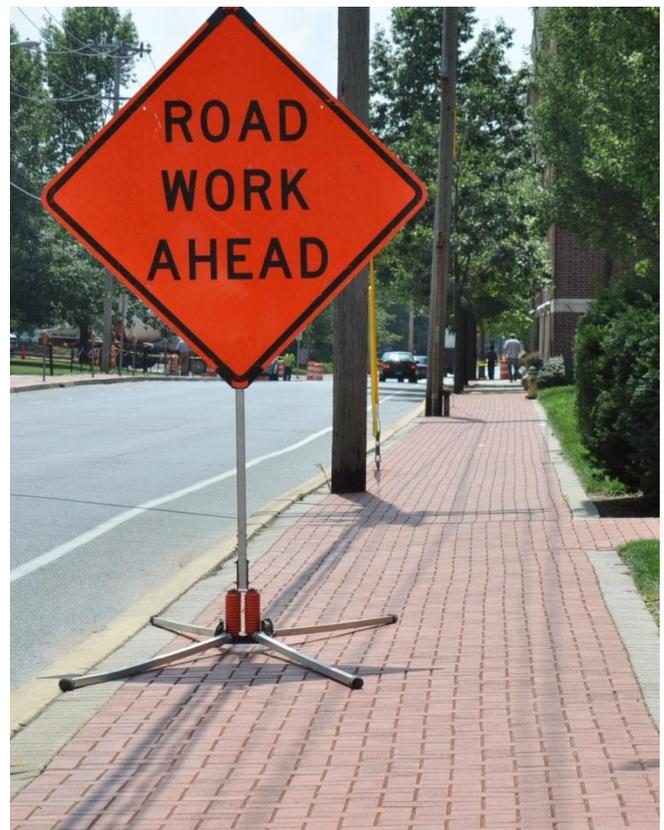
Other encroachments are temporary or intermittent, as in the case of trash cans or work zone signage. These can be even less anticipated than some of the vegetative encroachments and can be frustrating to disabled pedestrians who anticipate a clear pathway.

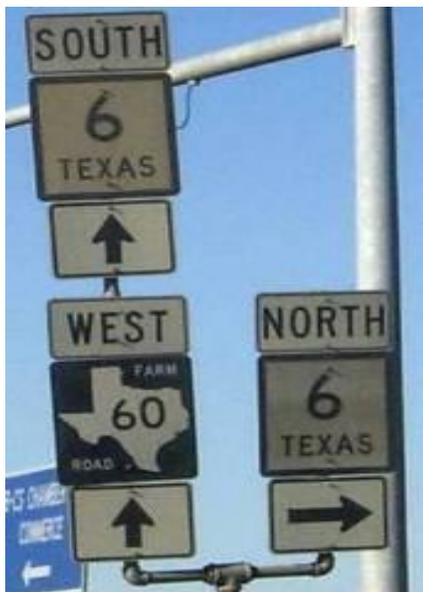
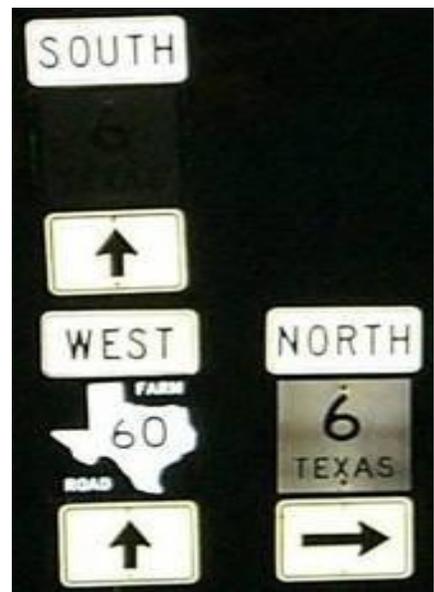
The importance of sign retroreflectivity is seen in these two photographs of the same sign array during the day and then again at night. Notice the variable clarity of the different signs and how one sign has disappeared altogether.

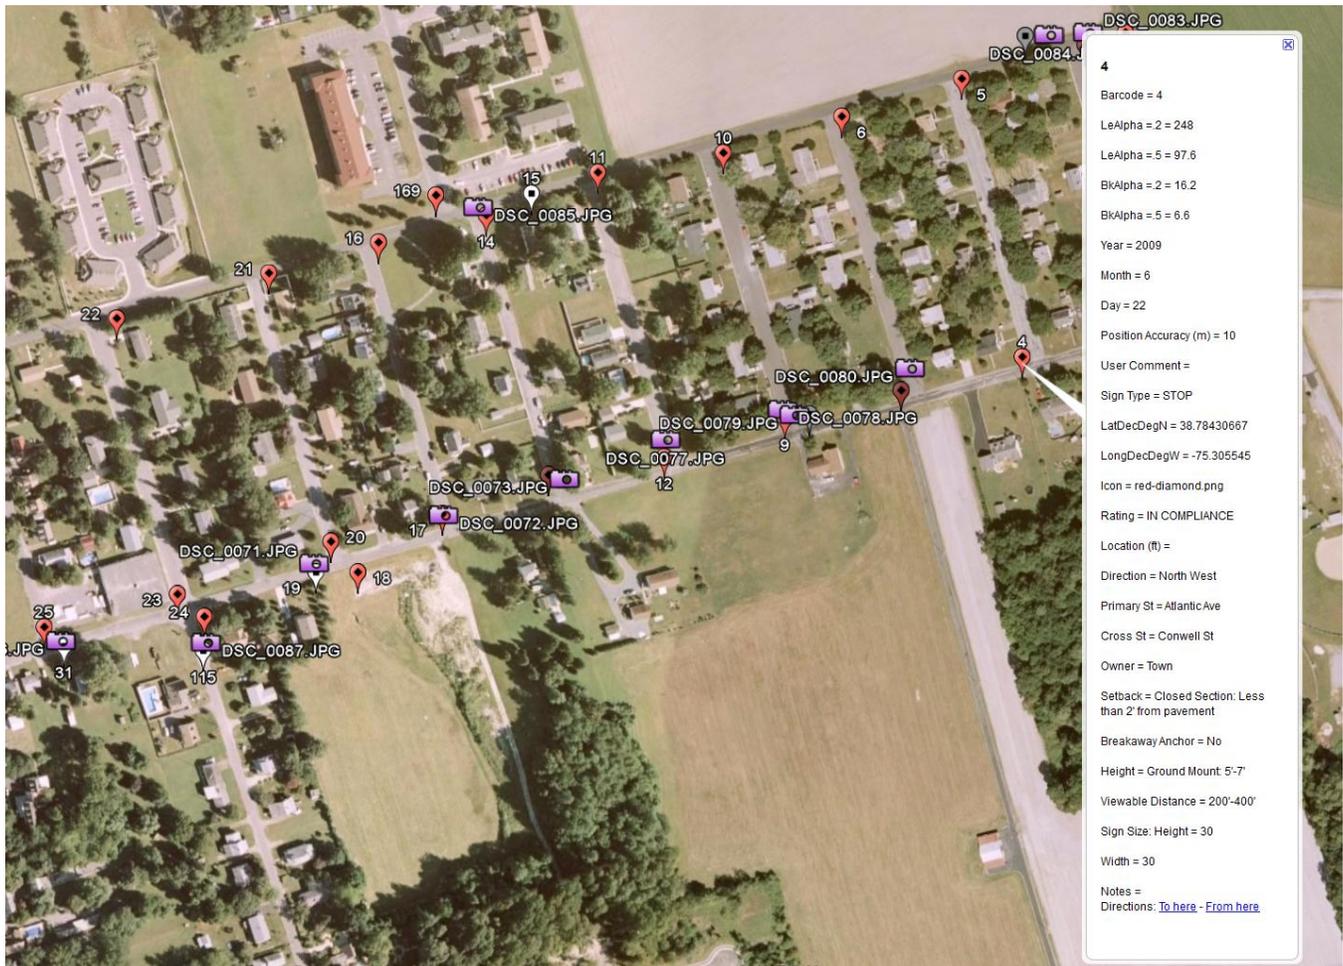
The screen shot above shows:

- Barcode. The barcode number scanned for that specific sign.
- LeAlpha=.2, LeAlpha=.5, BkAlpha=.2, and BkAlpha=.5. These are the retroreflectivity readings from two different observation angles; the federal MUTCD requires the use of an observation angle $\alpha=0.2$.

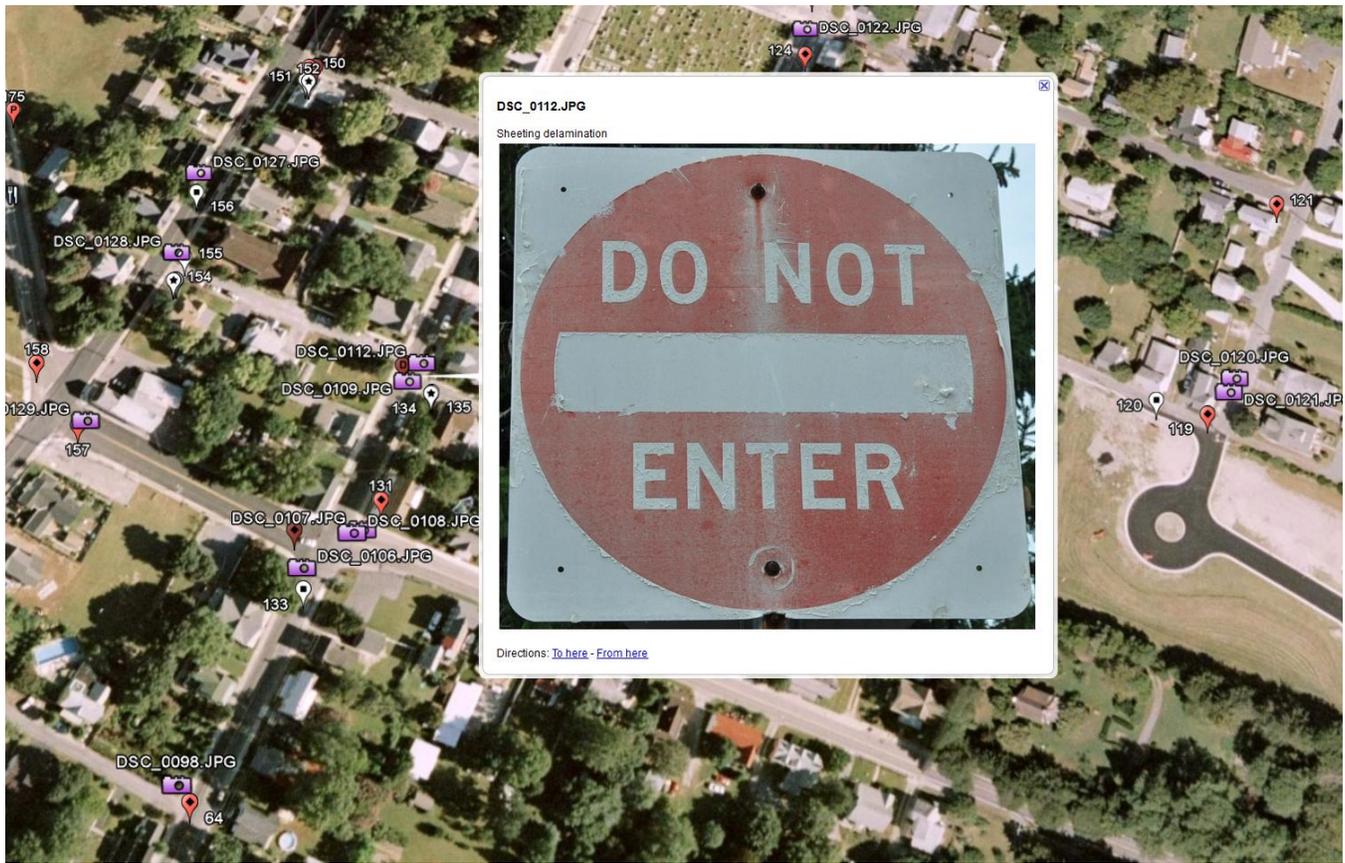
Clicking on a camera icon, the user would see a picture like the following, which includes the file name at the top and a small description underneath of what the picture is showing:
