Transportation Elements Assessment Town of Milton, Delaware

September 29, 2009

Transportation Elements Assessment – Town of Milton, Delaware

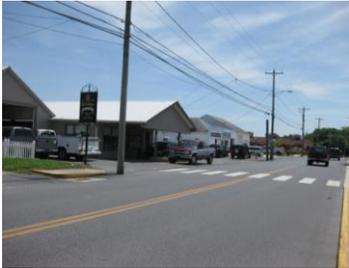
On the east side of Federal Street, several driveways interrupt the sidewalk. This creates conflict points between pedestrians and drivers.	Close of the driveways and continue the sidewalk along the west side of Federal Street between the medical center and Church Street.	Long term
B	Federal Street/ School site

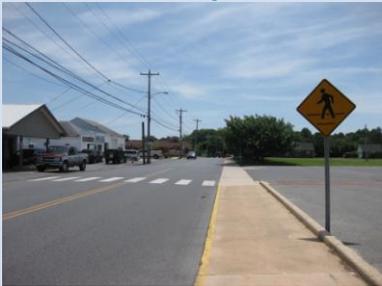
Driveway entrances to school parking lot are relatively wide. Vehicles were observed entering and exiting the parking lot at relatively high speeds from both driveways. The unpredictable travel pattern, combined with the vehicle speeds, increases the potential for conflicts with pedestrians entering the school campus.	Reduce the crossing distance across the driveways and designate specific entrances and exits for vehicles.	Consider for early action <ul style="list-style-type: none"> - Would need to know the width of the driveways to ensure that buses are able to still enter/exit the parking lot - Solution may be procedural rather than engineering (still researching feasibility)

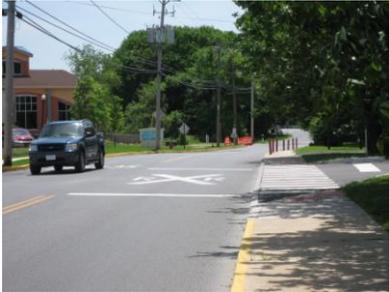
Map ID	Location	Issue	Recommendation	Phasing/Comments
Q	Intersection of Chestnut Street and Dogfish Head Brewery (6 Cannery Village Center)	Students living in the new development, Cannery Village, will most likely use this driveway to access Chestnut Street and Church Street. This is a direct pathway from the neighborhood and the community center to the school site.	<ul style="list-style-type: none"> - Install high visibility crosswalks across Chestnut Street - Install curb ramps on west side of Chestnut Street to line up with the crosswalks. - Install curb extensions on northeast and southeast sides of Chestnut Street to provide more gathering space and do reduce the crossing distance across the driveway. - Repair sidewalks on either side of the intersection where needed and where possible 	Early Action
R	Intersection of Federal Street and Medical Center driveway	The now obsolete road markings for the non-functioning rail road is confusing for drivers and may be distracting from the stop bars and other pedestrian crossing infrastructure.	<ul style="list-style-type: none"> - Remove the railroad lane markings - Install high visibility crosswalks across Federal Street 	Early Action
