EVALUATION OF THE
BUCKEYE CROSSBUCK
AT PUBLIC, PASSIVE
RAILROAD/HIGHWAY
GRADE CROSSINGS IN
OHIO

Final Report

December 2000

1. Report No. FHWA/OH-2000/021	2. Government Accession No.	3. Recipient's Catalog No.	
4. Title and Subtitle EVALUATION OF THE BUCKEYE CROSSBUCK AT PUBLIC, PASSIVE RAILROAD/HIGHWAY GRADE CROSSINGS IN OHIO		5. Report Date December 2000

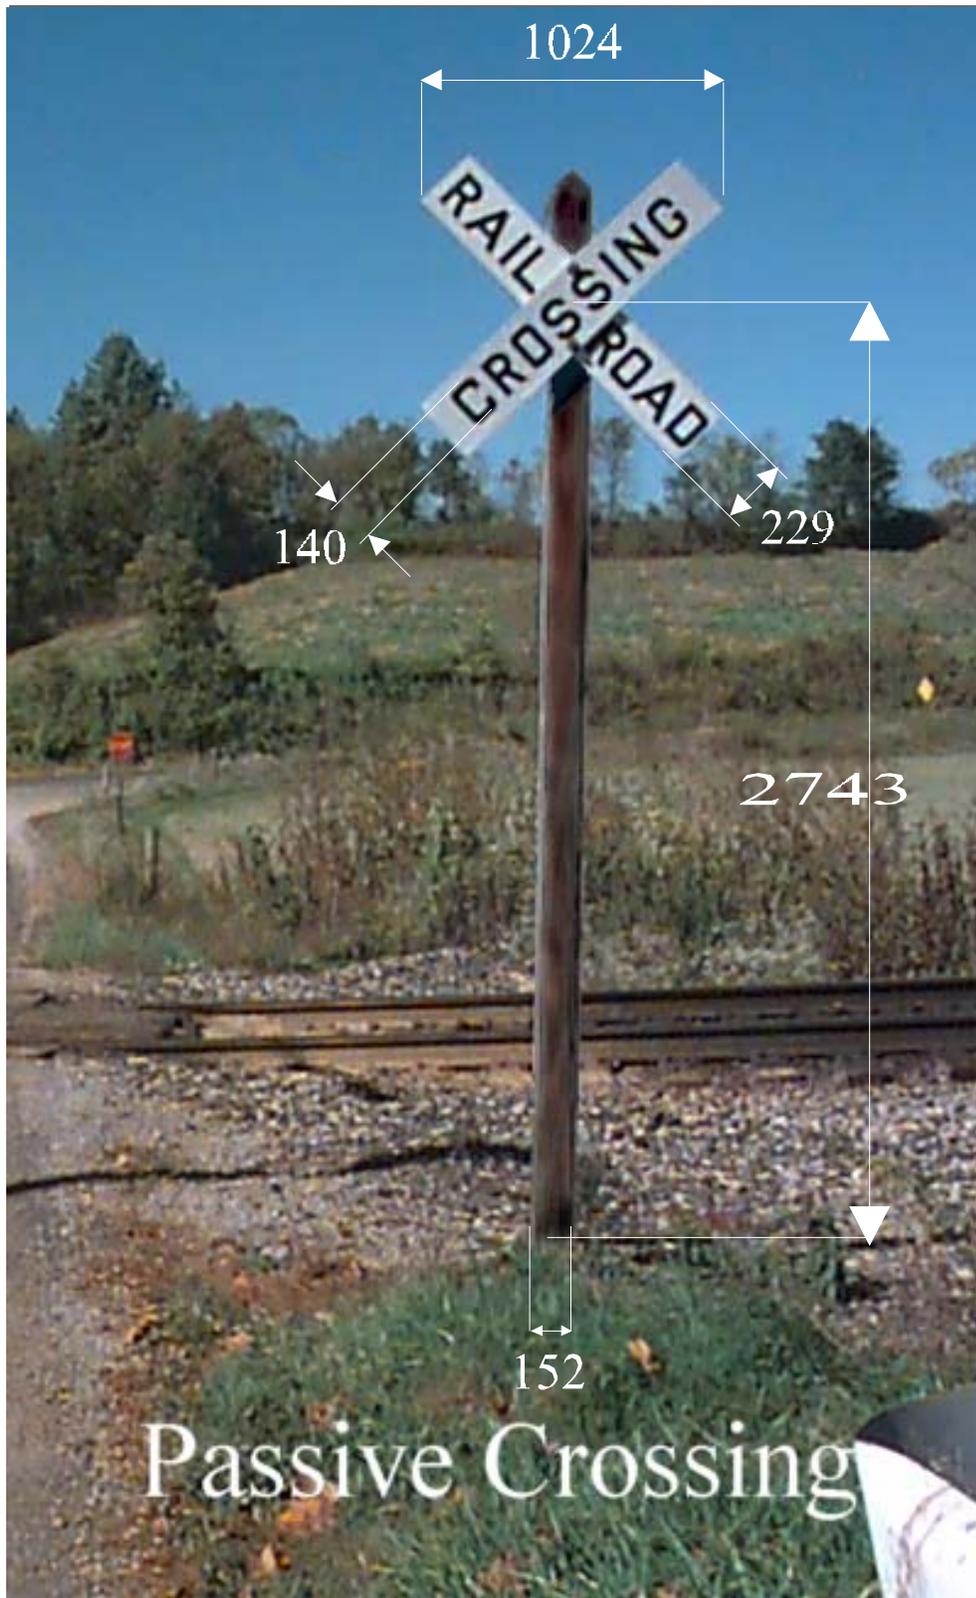
Figure 1. Current Standard Crossbuck Design

all values in mm

Motorist near-collision and violation video data was collected along four selected rail corridors during 1995 under the before-condition (Current Standard Crossbuck, Figure 1). A total of 3,833 passive railroad crossing approaches were recorded under both the before and the after condition. The video taping runs were repeated along the exact same rail corridors under the after condition during late 1996 and early 1997. Half of the Current Standard Crossbucks in Ohio were replaced with the Buckeye crossbuck (Figure 2, all even crossing numbers) and the other half was replaced with the Standard Improved crossbuck (Figure 3, all odd crossing numbers) prior to the after condition. It should be noted, that Conrail had already replaced all of their Current Standard Crossbucks in Ohio with either the Standard-improved or the Buckeye Crossbuck between May and October 1993. Therefore, no Conrail lines could be included in the before/after near-collision/violation study. As an initial step in the analysis, the Railroad/Highway Grade Crossings crash analysis was performed separately for Conrail and for all other railroad companies in Ohio.

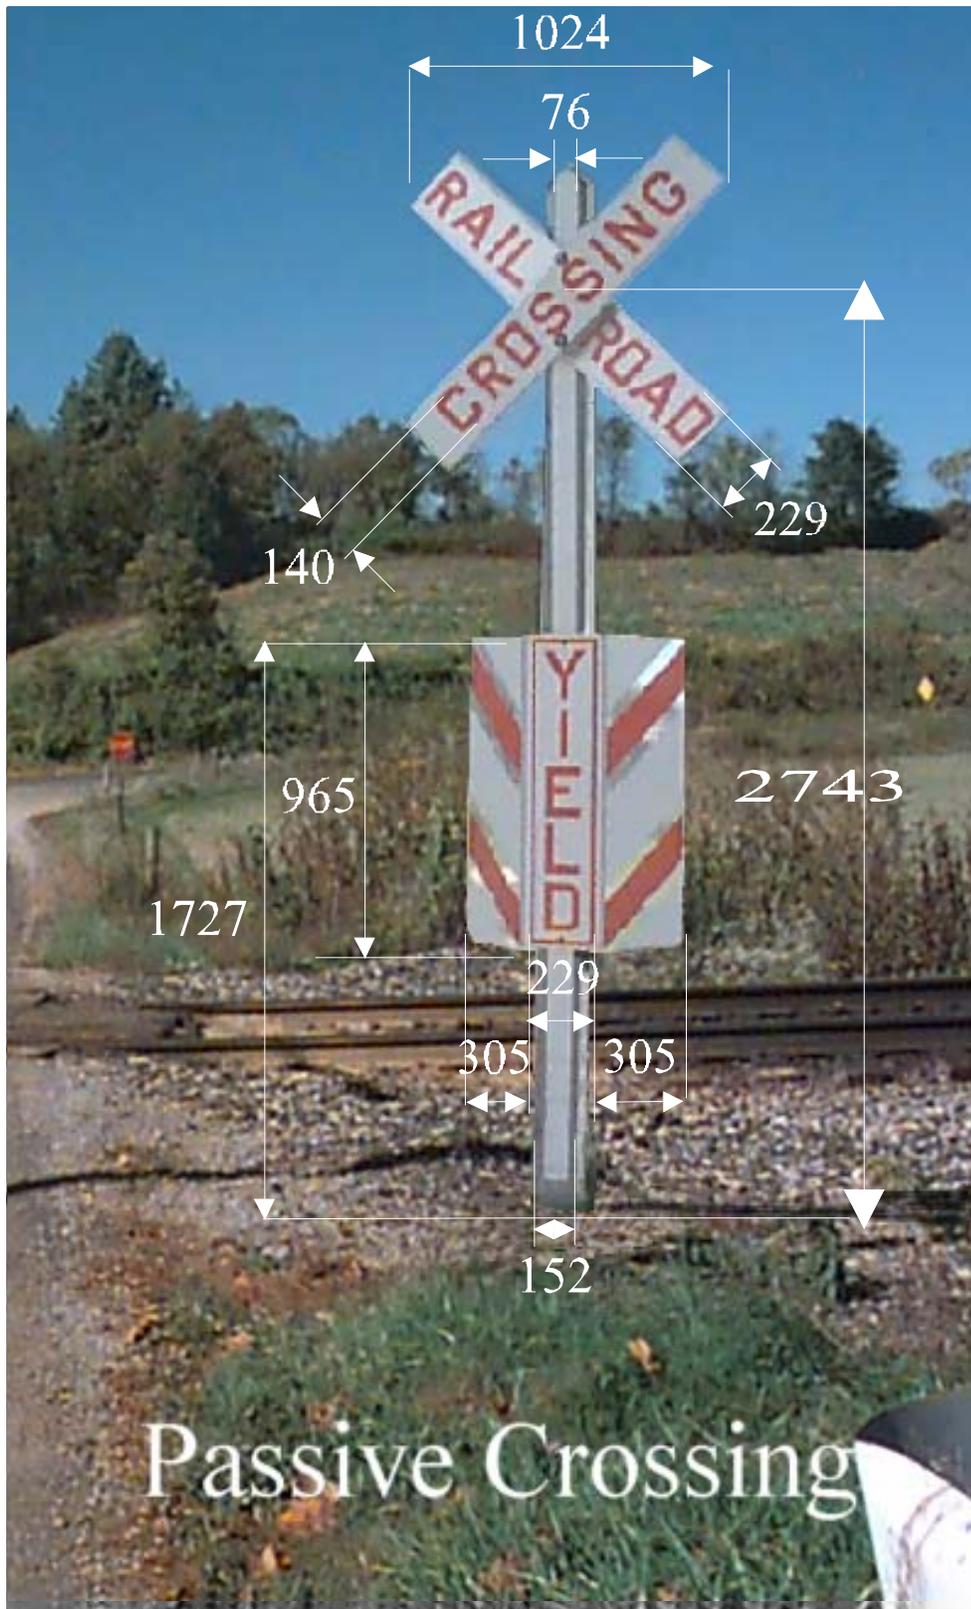
Figure 2. Buckeye Crossbuck Design

all values in mm

Conrail, through the efforts of their Project 50 Labor-Management Committee under the leadership of Marty Joyce, in conjunction with ODOT has devised a modification of the standard crossbuck which is designed to improve driver recognition and awareness of the potential dangers at Railroad/Highway Grade Crossings without active warning devices. The new crossbuck concept has been shown to various Transportation Research Board (TRB) Committees, and has been demonstrated to many others from various states. The Current Standard Crossbuck (Figure 1) consisted of a non-reflectorized wooden post and extruded aluminum blades with a black Railroad/Highway Grade Crossing legend. In its latest upgrade, the blades of the Current Standard Crossbuck were usually equipped with white encapsulated retro-reflective (type III) sheeting material. The Standard-Improved crossbuck (Figure 3) which consists of a wooden post which is reflectorized on all 4 sides and aluminum blades that are reflectorized front and back with white micro-prismatic (type VII, LDP long distance performance) sheeting, represents a first level of improvement over the Current Standard Crossbuck. The Railroad/Highway Grade Crossing legend is black and the wooden post is equipped with a safety break-away hole just above the ground. The Buckeye crossbuck (Figure 2) features a shield made of 2mm (0.081") thick 6061-T6 aluminum. This aluminum shield is fully reflectorized with white micro-prismatic sheeting on both sides and consists of a 0.22m (9") wide center section showing a framed red YIELD legend and two 0.304m (12") wide side panels that are bent away 45° from the approaching motorist. The side panels feature red diagonal retro-reflective stripes and specularly reflective mylar stripes, pointing down towards and emphasizing the YIELD legend. The specular mylar stripes are designed with the purpose of being most useful during nighttime as they have the potential (under certain angular conditions) to redirect a portion of the light of an oncoming train towards an approaching motorist and a portion of the light from the automobile headlights towards the approaching train, thus providing additional presence information to both the motorist and the train engineer.

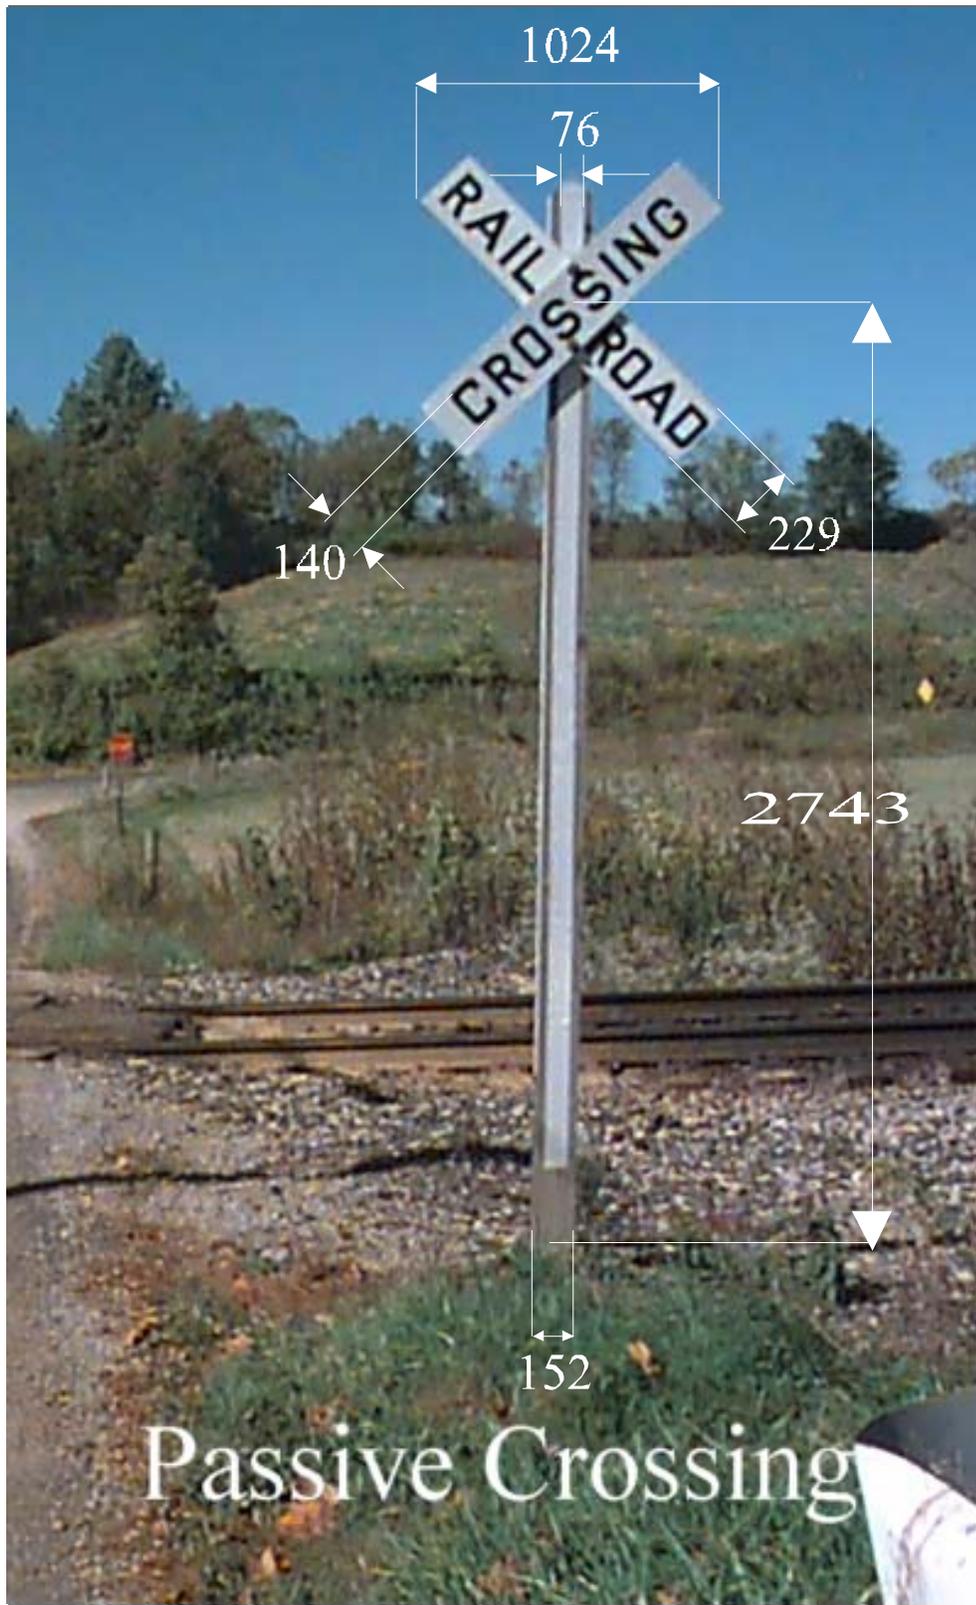
Figure 3. Standard Improved Crossbuck Design

all values in mm

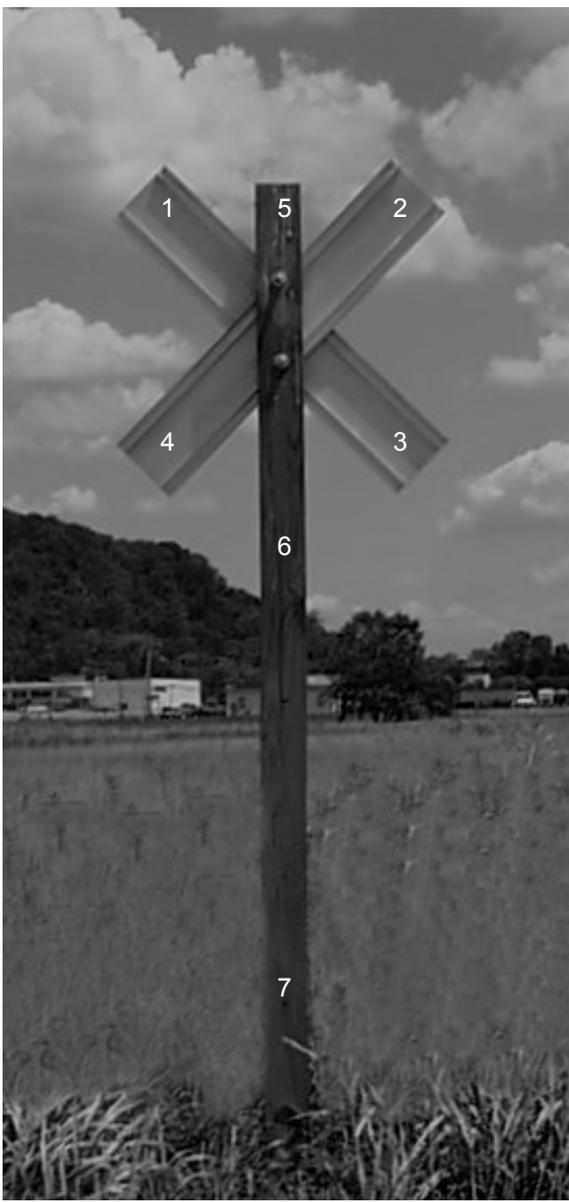
Figure 8. Current Standard Crossbuck Luminance Measurement Point Legend

Front Corresponds to Right Shoulder Location

Back Corresponds to Left Shoulder Location

Note: Images shown at daytime for illustration purposes only.

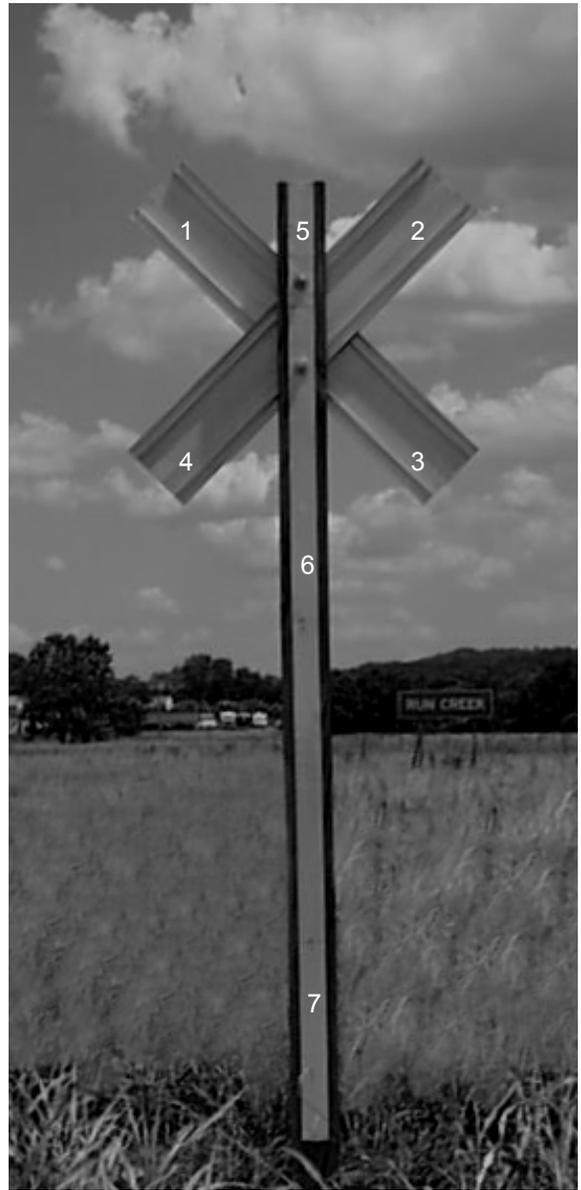
Figure 9. Standard Improved Crossbuck Luminance Measurement Point Legend

Front Corresponds to Right Shoulder Location

Back Corresponds to Left Shoulder Location

Note: Images shown at daytime for illustration purposes only.
