FHWA-WY-09/03F

EVALUATION OF AN ACTIVE WILDLIFE- SENSING AND DRIVER WARNING SYSTEM AT TRAPPER'S POINT

**Department of Civil and Architectural Engineering
University of Wyoming
1000 E. University Way
Laramie, Wyoming 82071**

April 2009

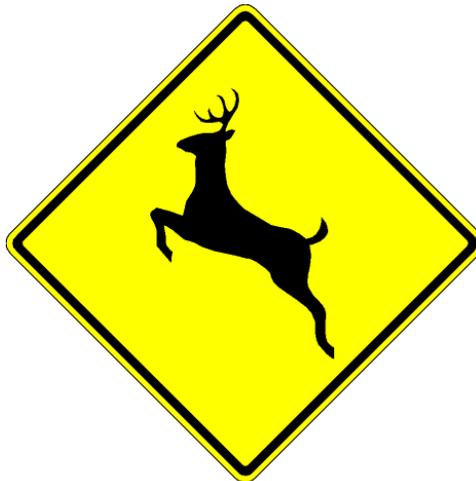
today (Hughes, Saremi and Paniati 1996). The signs are erected primarily for public relations and liability reasons, in addition to being cheap and easy to install (Jackson Hole Wildlife Foundation 2003). The *Manual on Uniform Traffic Control Devices, 2003 Edition (MUTCD)* explains that these signs may be used to alert road users in advance of locations where unexpected entries into the roadway or shared use of the roadway by animals might occur (Federal Highway Administration 2003). Unfortunately, unless the movement of deer is known to follow a predictable path, such as annual migration routes, or is somehow restricted by roadway design, the exact location where a driver will encounter a deer is unknown. The *MUTCD* further explains that these conflicts might be confined to a limited area, or might occur randomly over a segment of roadway. Deer crossing signs use the standard diamond shape and fluorescent yellow-green color for warning signs and are generally found in four sizes, ranging from 24” square to 48” square.

Figure 2-3: Advance Warning Sign

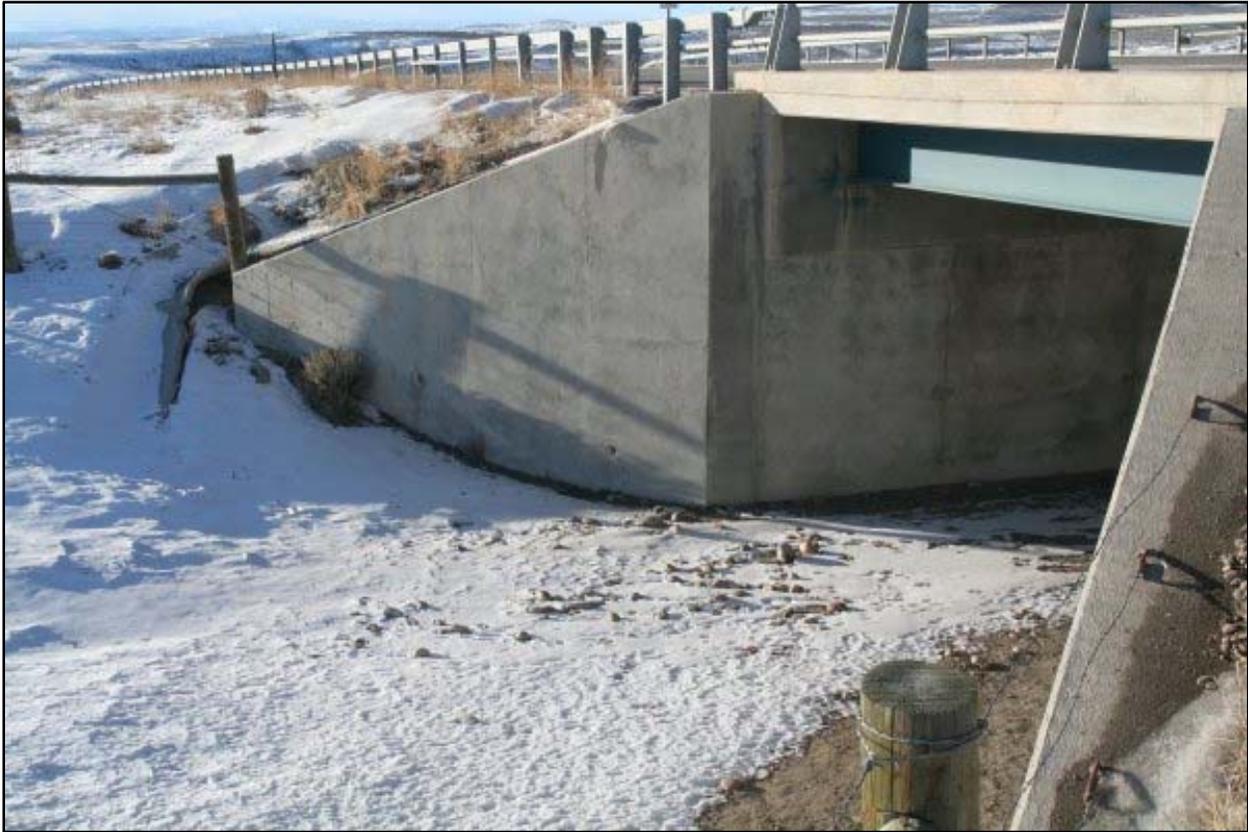
Figure 3-2: Photo of the stock pass along the project's length

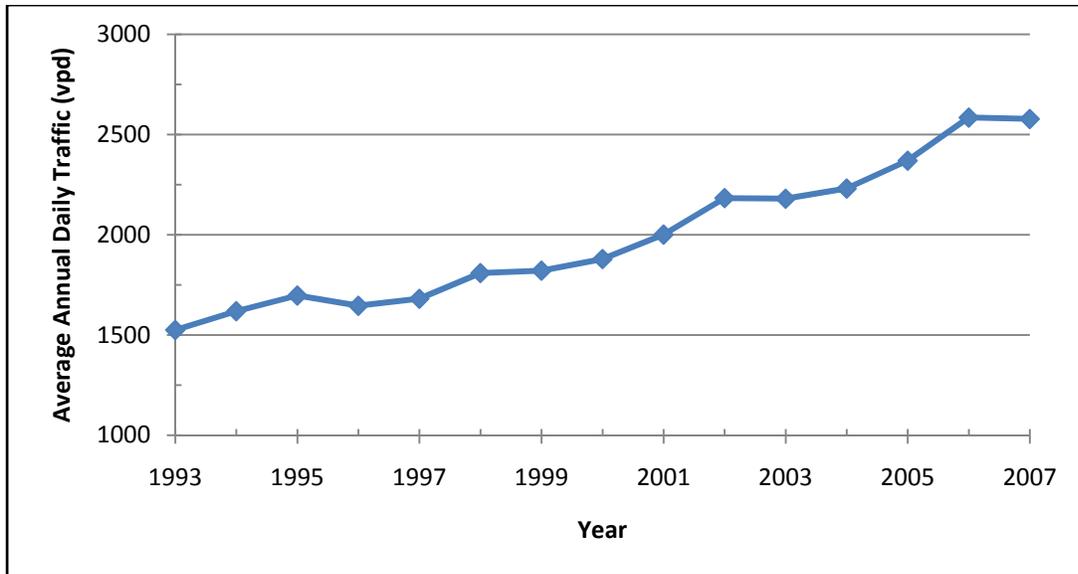
Figure 3-3 shows the average annual daily traffic (AADT) of US 191 from WYDOT's permanent counter at milepost 110.47, which measures traffic on the east leg of Daniel junction. This counter is less than four miles north of the project area. Traffic volumes appear to have been increasing steadily since 1993. In 2007, the AADT on this stretch of US 191 (both directions combined) was 2,578 vehicles per day. For 2004, the month with the highest average daily traffic (ADT) was July, with an average of 3,376 vehicles per day and the month with the lowest ADT was January, with an average of 1,545 vehicles per day.

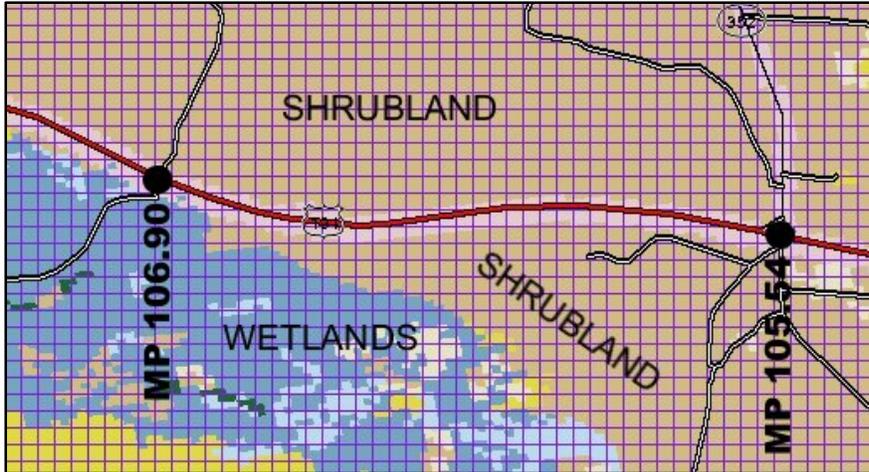
Vegetation is sparse, short, and not sufficient to hinder drivers’ view of approaching wildlife. In addition, side slopes are gradual enough to provide for a reasonable clear zone distance along the road.

Figure 3-4: Land Cover Types of Adjacent Area

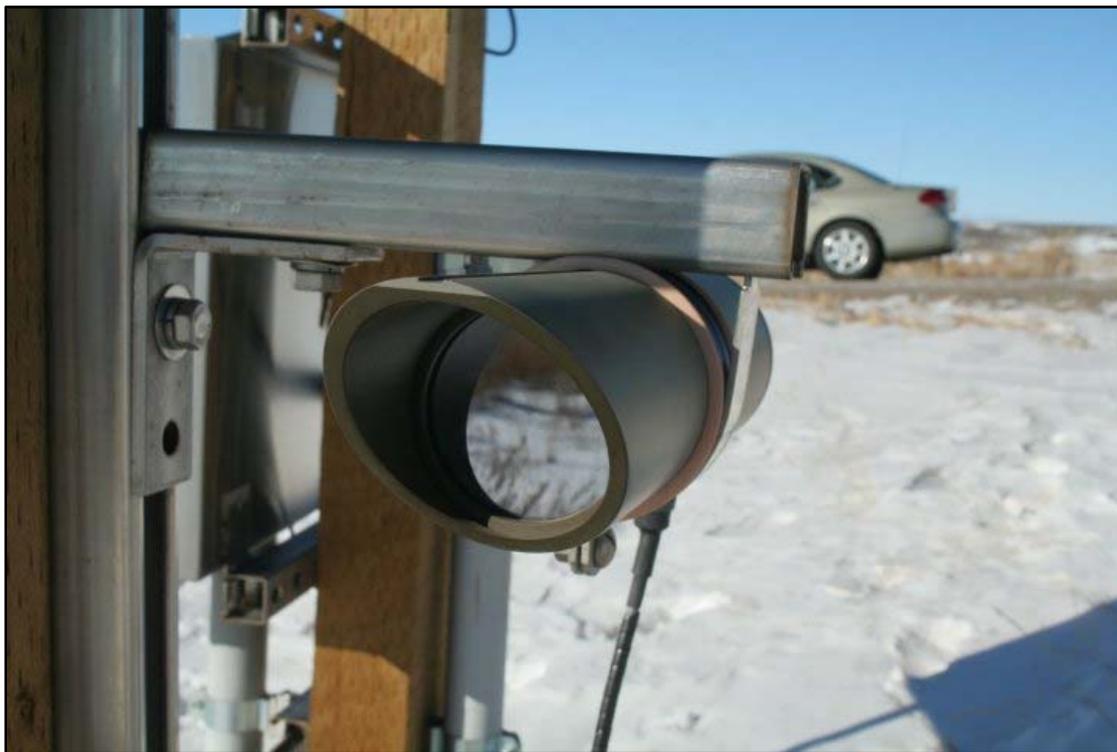
infrared sensor is mounted 28 inches from the ground to the center of the sensor. The upper sensor is mounted 33 inches from the ground to the center of the sensor. Each sensor unit is attached to a 10-inch-long stainless steel strut with a 3 $\frac{3}{4}$ inch diameter steel clamp. The steel strut is connected to the wooden pole via a $\frac{1}{4}$ " steel 90 degree bracket. One $\frac{1}{2}$ inch diameter bolt attaches the bracket to the pole and one $\frac{1}{2}$ inch diameter bolt attaches the bracket to the strut. This means that one bolt prevents the sensor from tilting up and down and one bolt prevents the sensor from rotating side to side. This was done to allow for easier aiming of the sensors. With a single bolt in each direction, an adjustment can be made in the aim of the sensors without drilling additional holes into the wooden pole.

Figure 3-7: Close-up photo of an IF-540 passive infrared sensor installed on-site

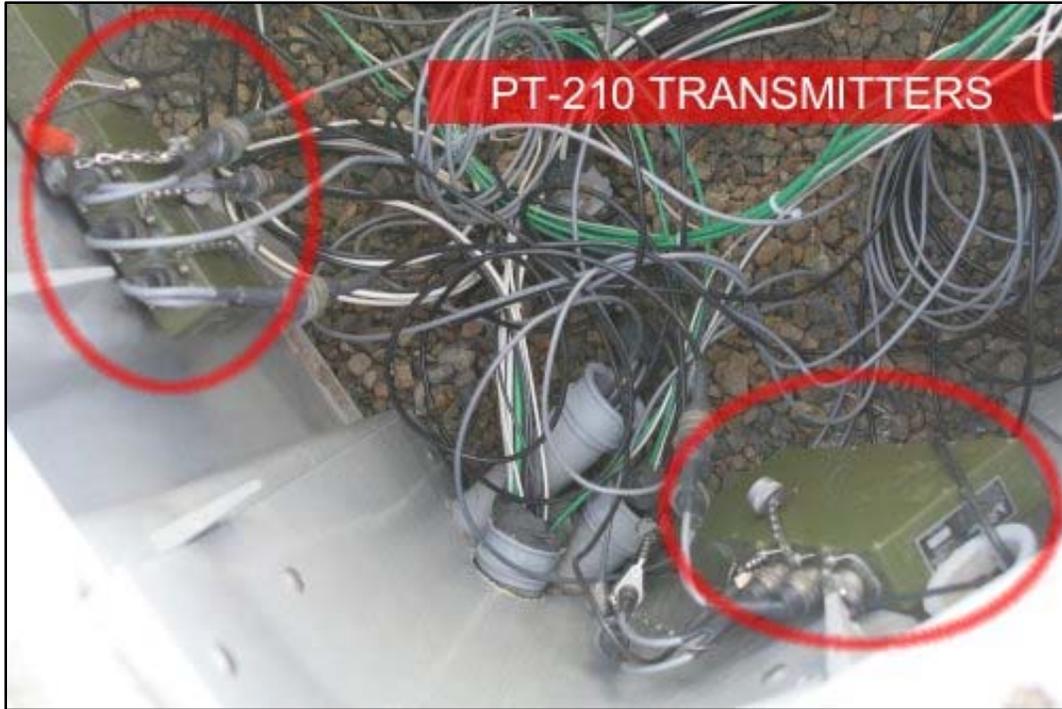
SP-500P geophone strings and the IF-540 passive infrared sensors are attached to a model PT-210M processor / transmitter buried in a pull box at the base of the wooden poles supporting the infrared. Initially, two geophone strings and two infrared sensors were attached to each PT-210M. Later, as described in Chapter 5, this setup was modified so that only one infrared sensor and one geophone string was attached to each PT-210M. Figure 3-8 is a photograph of one of the pull boxes after this modification was made. The photo shows two PT-210 processor / transmitter boxes and all of the necessary wiring. Despite the manufacturer's claim that the units are waterproof to a depth of three feet, the units were mounted to the wall of the pull box to prevent complications caused by water intrusion (Telonics, Inc. 2007).

Figure 3-8: Photo of PT-210M transmitters installed in pull boxes on-site

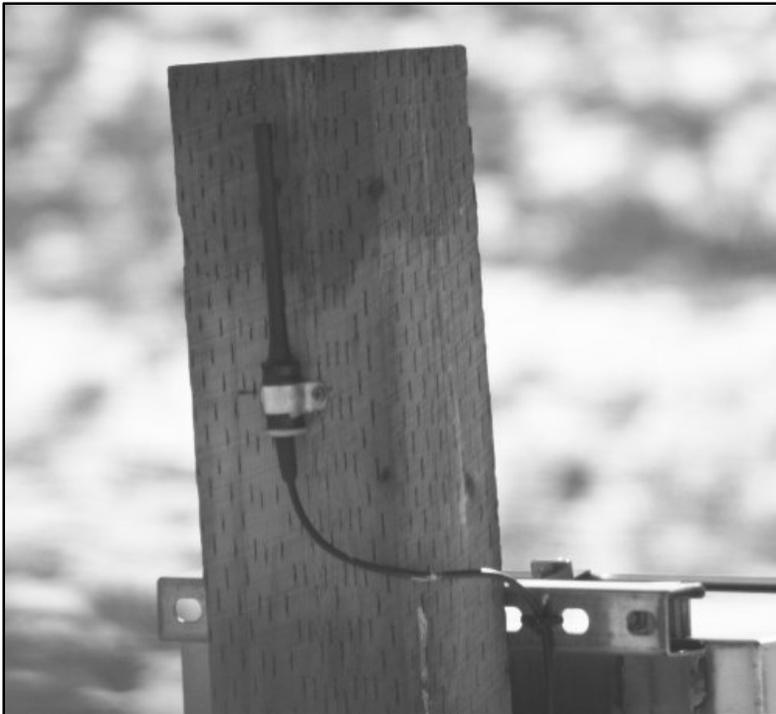
flexible handheld antenna is mounted on each of the wooden poles supporting the infrared sensors and is attached to the PT-210M transmitters in the pull box below. Figure 3-9 is a photograph of one of these remote antennas. The transmitters at Trapper’s Point are all set to transmit on a frequency of 154.60 MHz. Each transmitter can be set up with a unique ID number that is transmitted along with the signal. This information is used for recording and tracking purposes.

Figure 3-9: Photo of PT-210M external antenna installed on-site

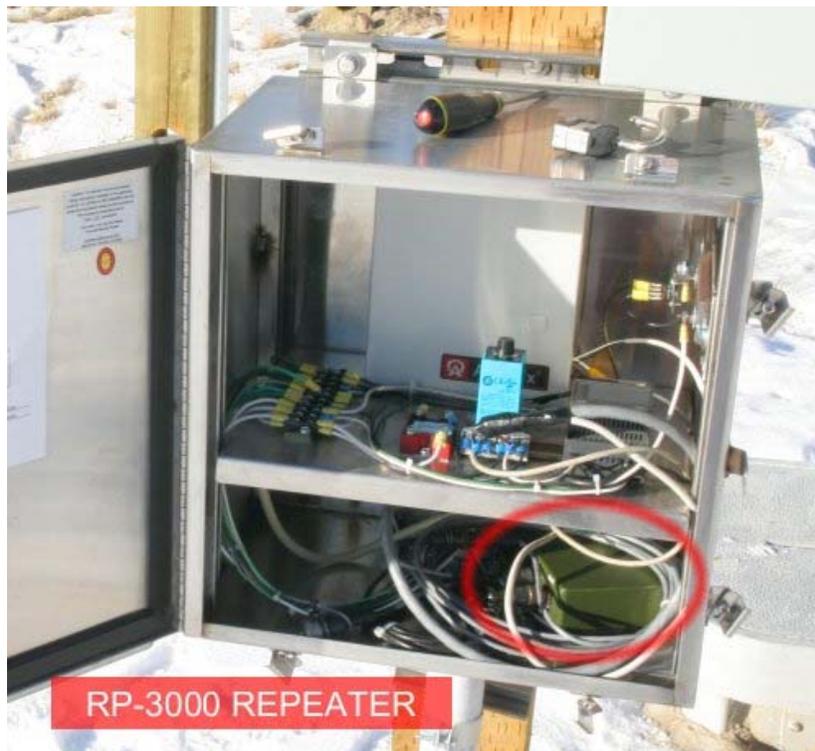
Each of the six “DEER ON ROAD WHEN FLASHING” signs is equipped with an RP-3000 repeater, enclosed in the sign’s above-ground cabinet. Figure 3-10 is a photograph of the interior of one of these cabinets. The RP-3000 can be seen on the bottom shelf and the necessary equipment to run the sign’s flashing lights can be seen on the top shelf. When the RP-3000 receives a signal from one of the PT-210M transmitters, the unit sends a signal to the flash timer and causes the lights to flash for a specified amount of time. The RP-3000 can be set up to react only to signals from specific PT-210M ID numbers. For example, if the user wanted a particular road sign to flash only when wildlife is detected in the immediate vicinity of the sign, the user could program the RP-3000 with the ID numbers of the appropriate PT-210M units.

Figure 3-10: Photo of an RP-3000 Repeater installed on-site

purposes and is discussed in Chapter 4. The controls for the flashing lights are enclosed in the same cabinet as the RP-3000 repeater, shown in Figure 3-10. Each sign is located approximately 20 feet from the edge of pavement.

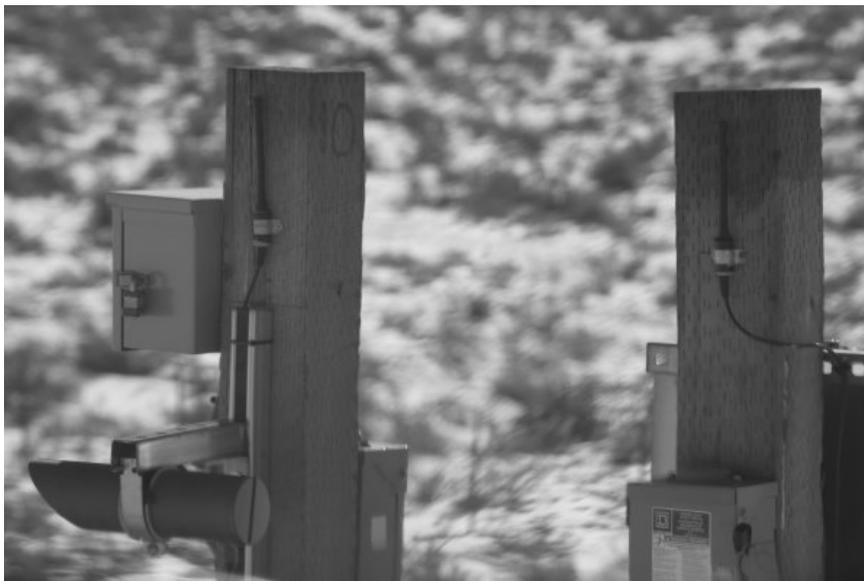
Figure 3-11: Photo of PT-210M and RP-3000 antennas

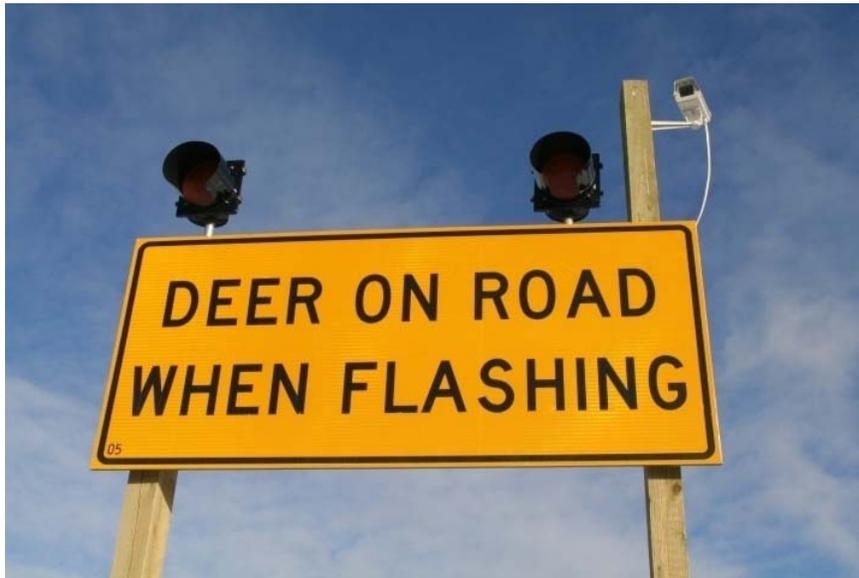
Figure 3-12: Close-up photo of Trapper's Point road sign (Sign D)

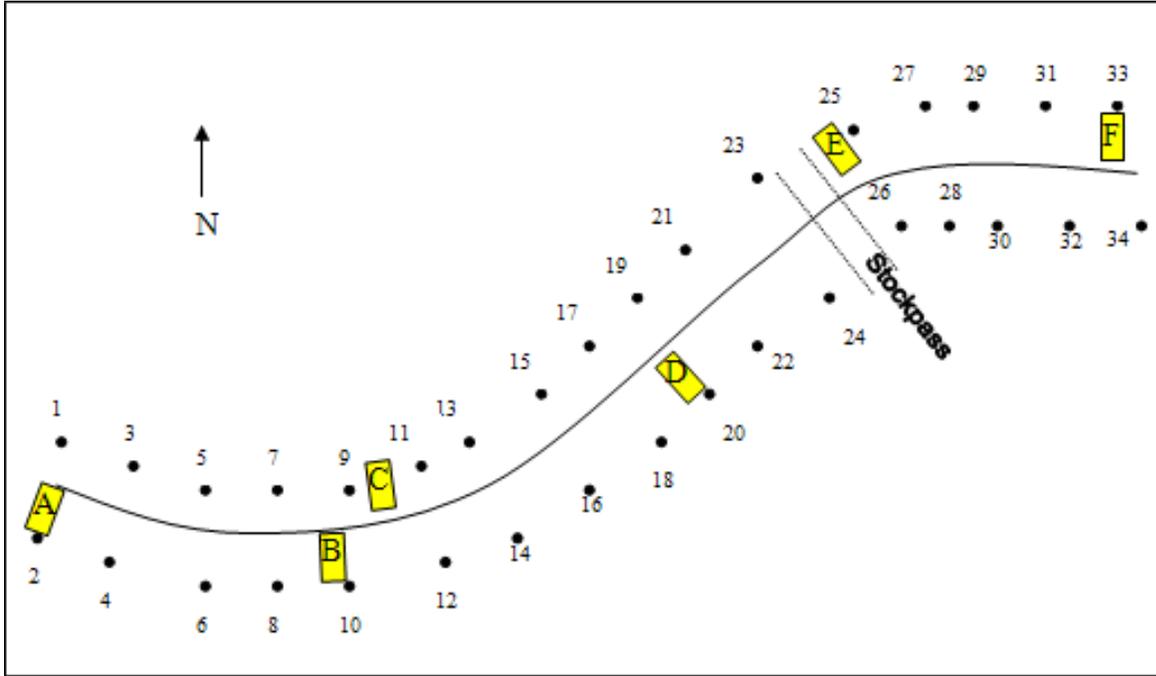
instead, they moved units from the outside edges of the project to posts in the center. This shortened the length of the road that was covered by sensors from 1.36 miles to approximately 1.00 mile. The new configuration begins at sensor number 7 on Figure 3-13 and ends at sensor number 23.

Figure 3-13: Original Layout of sensors and road signs

The camera is mounted on sign D and faces west. Southbound traffic heads towards the camera, northbound traffic travels away from the camera. Figure 4-3 is a screenshot captured by the DVR. Sign C is visible in the upper-right corner of the frame. The rear of sign B is visible across the road from sign C. The beginning of the southbound climbing lane taper can be seen in the center of the photo. All of the sensor detection zones between sensor numbers 17 and 7, and 18 and 8 (See Figure 3-13) are visible by the camera.

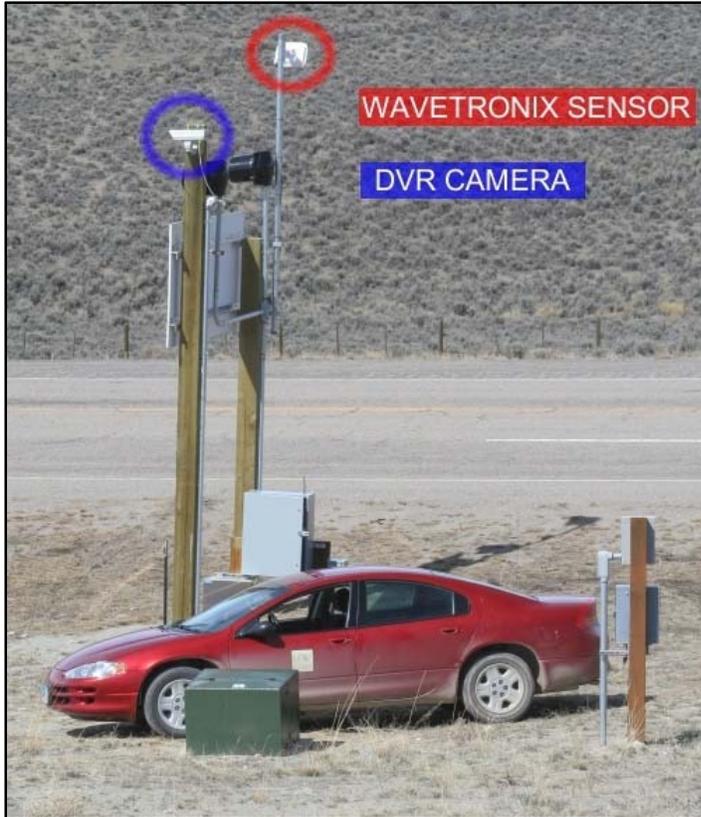
Figure 4-2: Photo of Wavetronix sensor and camera on road sign

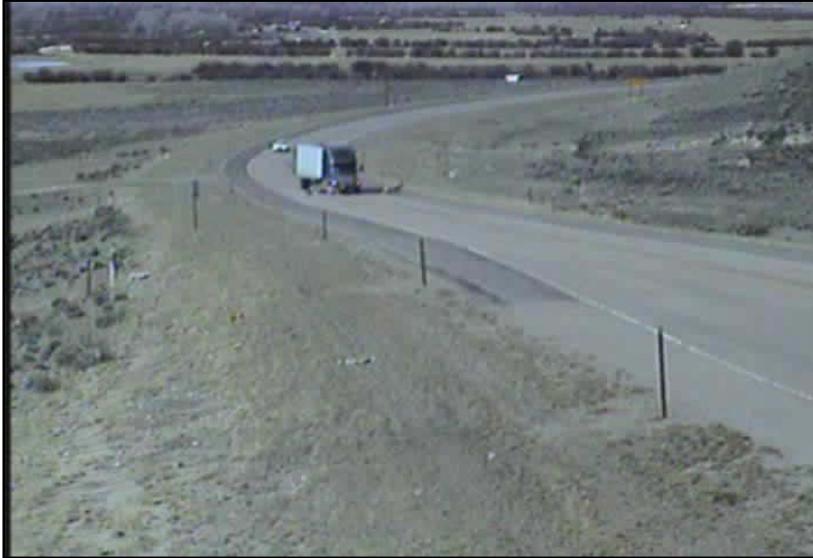
Figure 4-3: Screenshot of video recorded by the DVR

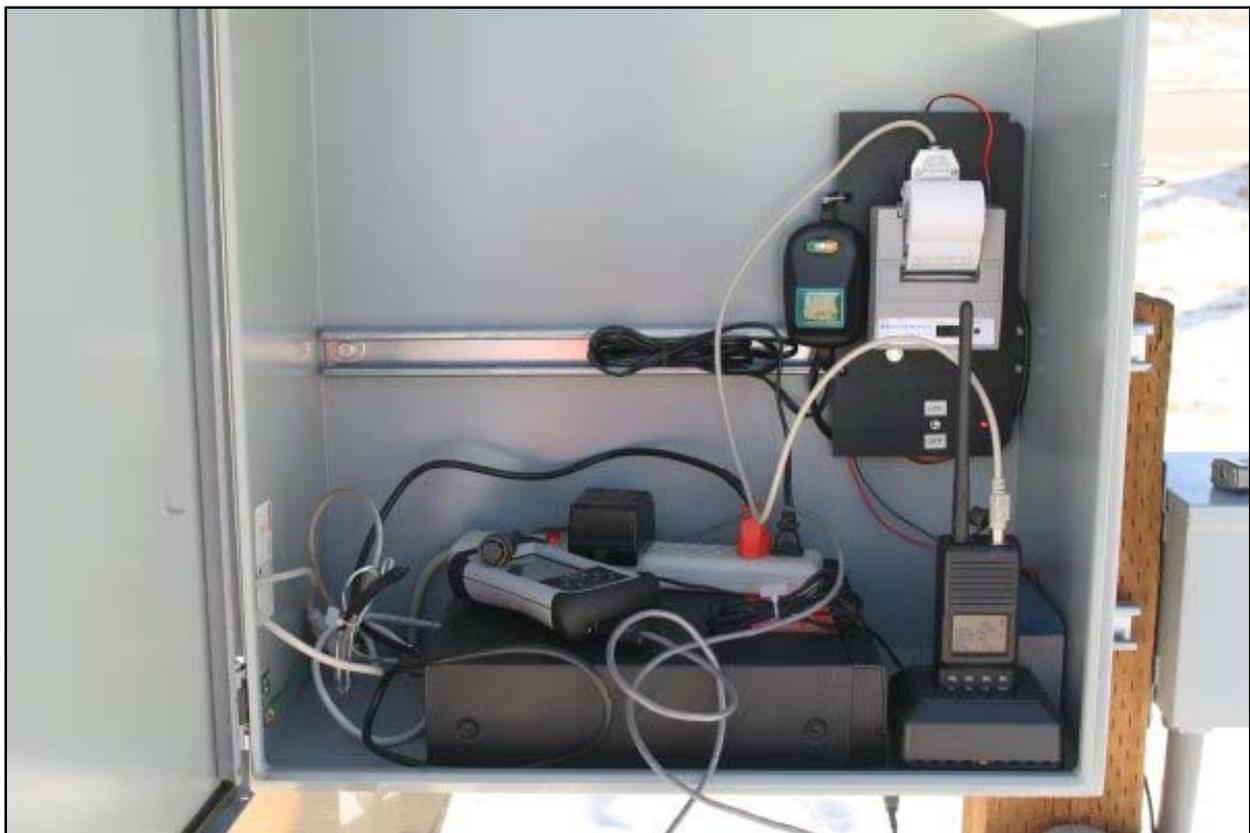
The RM-2000 receiver / monitor is a handheld radio that is kept in a cabinet near sign D to record details of each event whenever a PT-210M reports a detection. Figure 4-5 is a photograph of the interior of the cabinet, and shows the DVR, the RM-2000, a receipt-tape printer attached to the RM-2000, and the Pocket PC used to communicate with the Wavetronix SmartSensor HD units, PT-210M units, and RP-3000 units. The RM-2000 was kept in its charging cradle. It was commonly referred to as the “handheld radio” throughout this project.

Figure 4-5: Photo of RM-2000, printer, Pocket PC, and digital video recorder at sign D

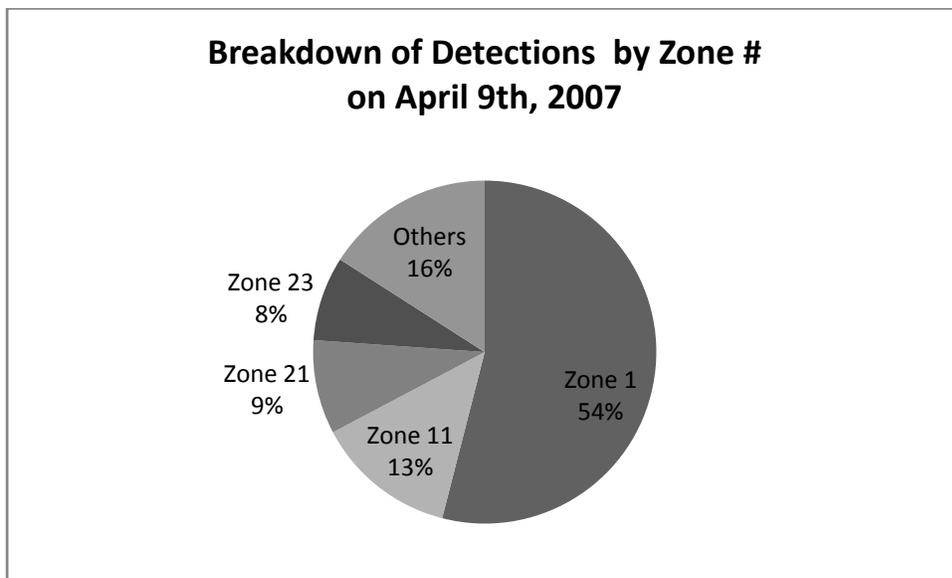
Many false positives were immediately recorded from transmitters 1, 11, and 5 (Figure 5-1) and appeared to be caused by passing tractor-trailers. The qualify time on these three sensors was reduced from 5 seconds to 2 seconds, as recommended by the site visit team on August 30th. A site visit on April 10th, 2007, found that reducing the qualify time on these sensors was not enough to prevent frequent false positives, since over half of the detections during the entire day of April 9th, 2007, had been caused by transmitter number 1 (Figure 5-3). Transmitter 11 had been responsible for 13% of the detections during the day. Since the qualify times on these transmitters had already been set to the minimum, 2 seconds, the sensitivities of the sensors were reduced to 3 for the infrared sensors and 3 for the geophone sensors.

Figure 5-3: Breakdown of detections by zone number, April 9th, 2007

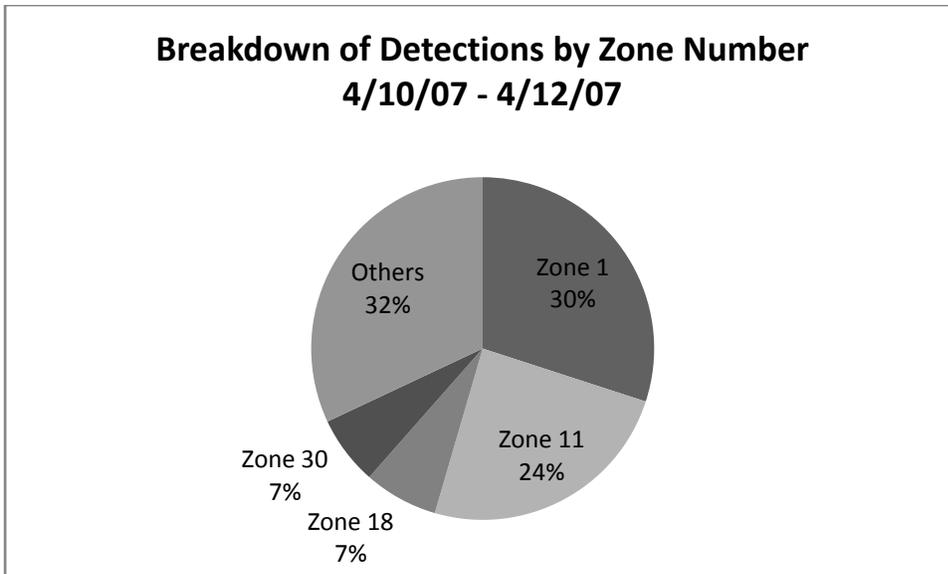
The modifications made to the PT-210M configurations on April 10th, 2007 appear to have had an effect on the breakdown of detections by zone number, as shown in Figure 5-5. Before those modifications were made, more than half of the detections came from zone number 1 (Figure 5-3). After the sensitivities of the geophones and infrared sensors were lowered to 3 on units 1, 11, and 5, however; only 30% of the detections between April 10th and April 12th (Figure 5-5) and 9% of the detections between April 26th and May 16th (Figure 5-6) came from zone number 1.

Figure 5-5: Breakdown of detections by zone number, 4/10/07 through 4/12/07

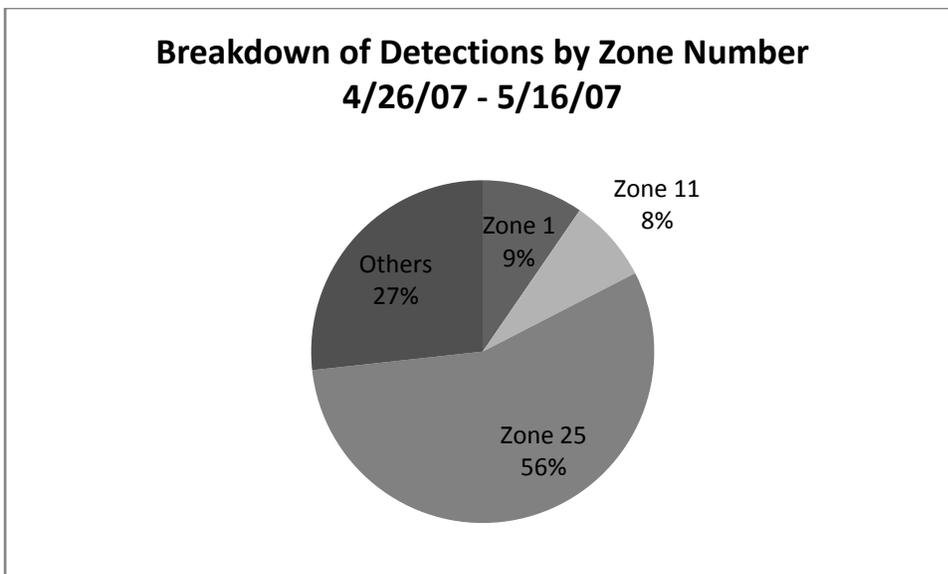
Figure 5-6: Breakdown of detections by zone number, 4/26/07 through 5/16/07

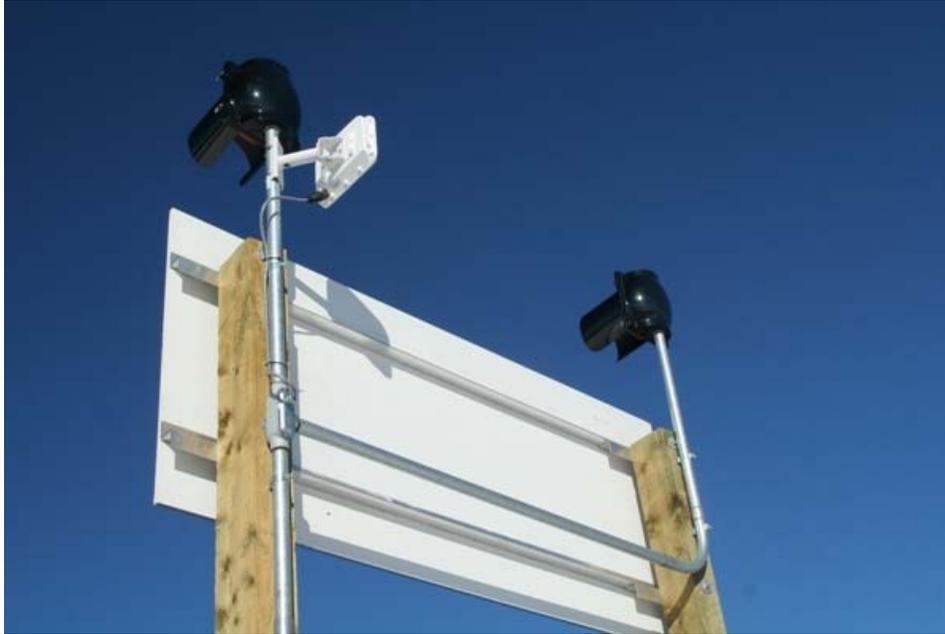
Figure 5-7: Photo of original Wavetronix SmartSensor HD mount

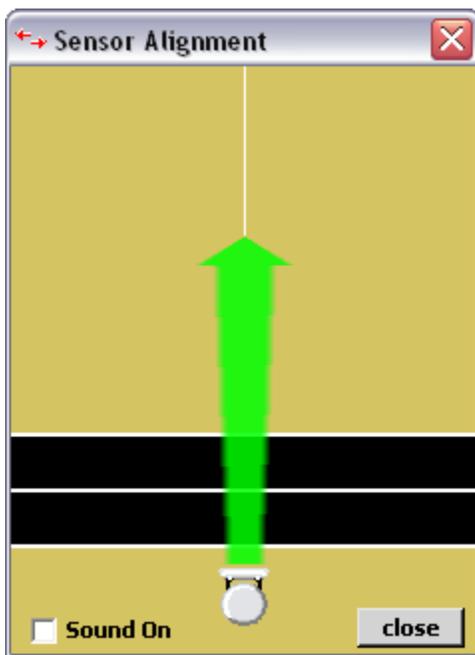
Figure 5-8: Screenshot of the SmartSensor software's sensor alignment feature

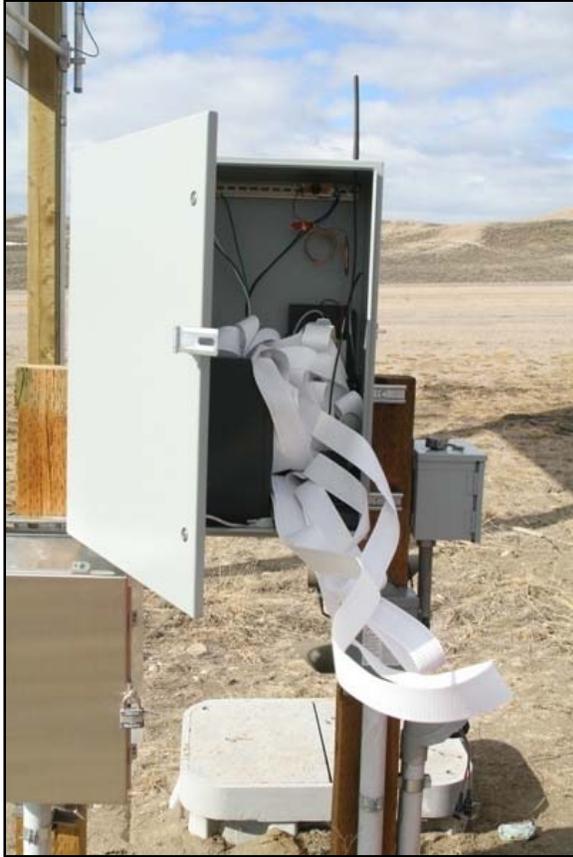
Figure 5-9: Photo of RM-2000 after installation of external antenna

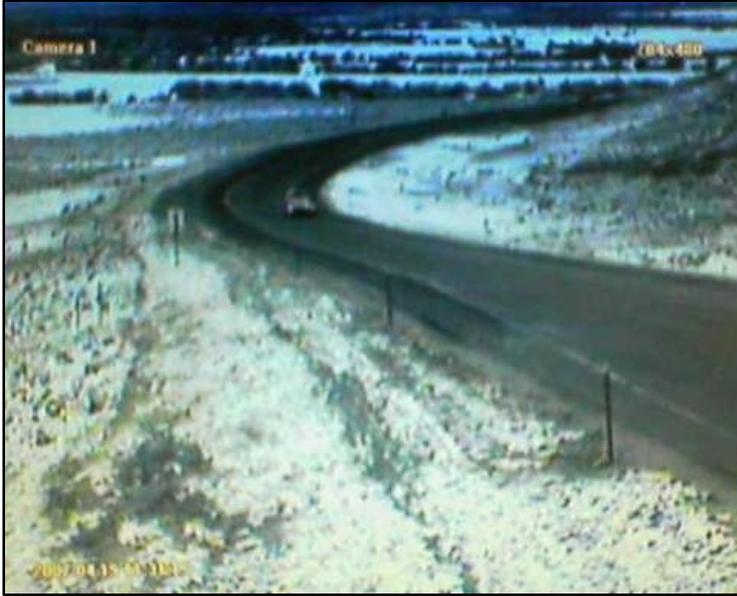
Figure 5-12: Video-capture from camera after modifications were made

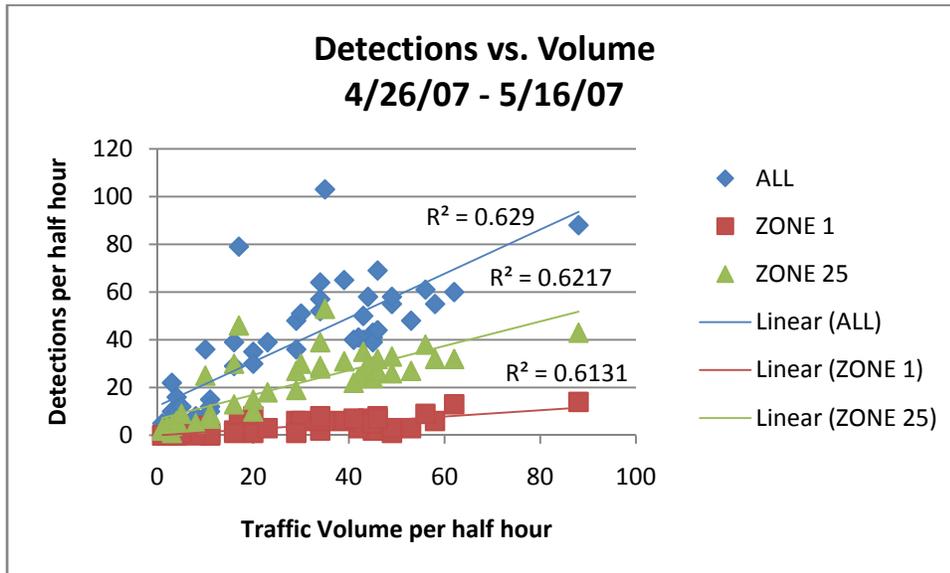
Figure 6-1: Number of Detections vs. Traffic Volume

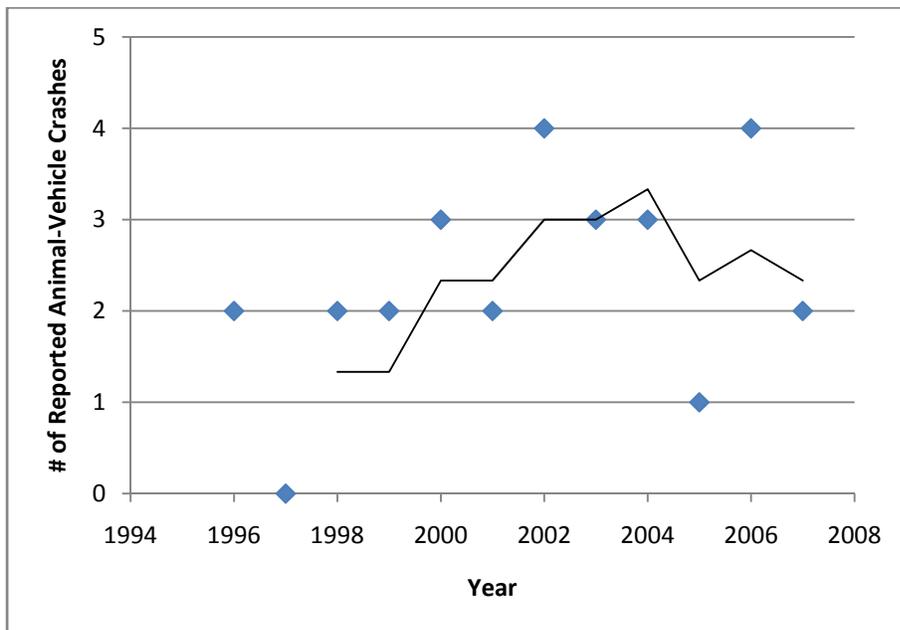
Figure 6-2: Number of Reported Animal-Vehicle Crashes on US 191 between MP 105.54 and 106.90

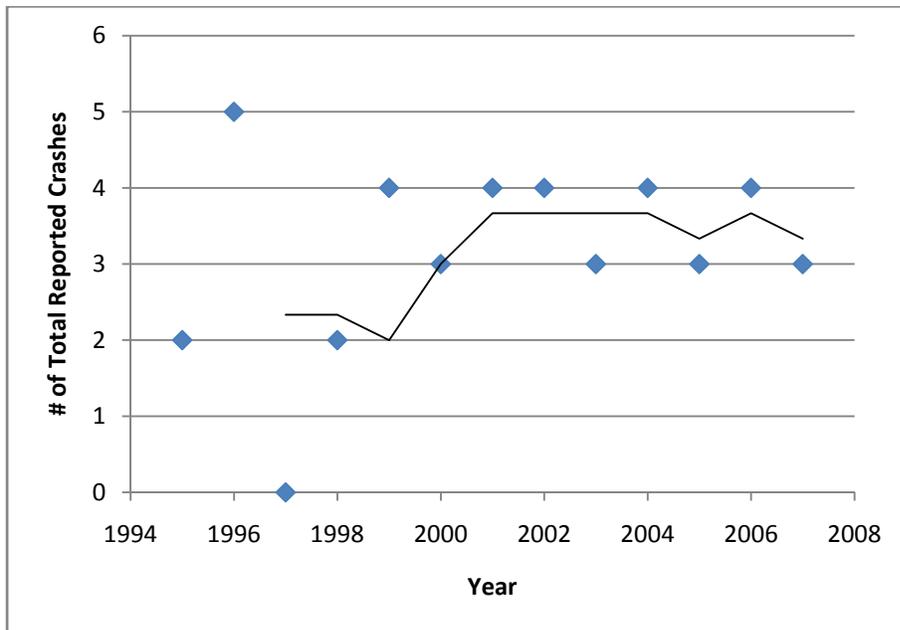
Figure 6-3: Number of Total Reported Crashes on US 191 between MP 105.54 and 106.90

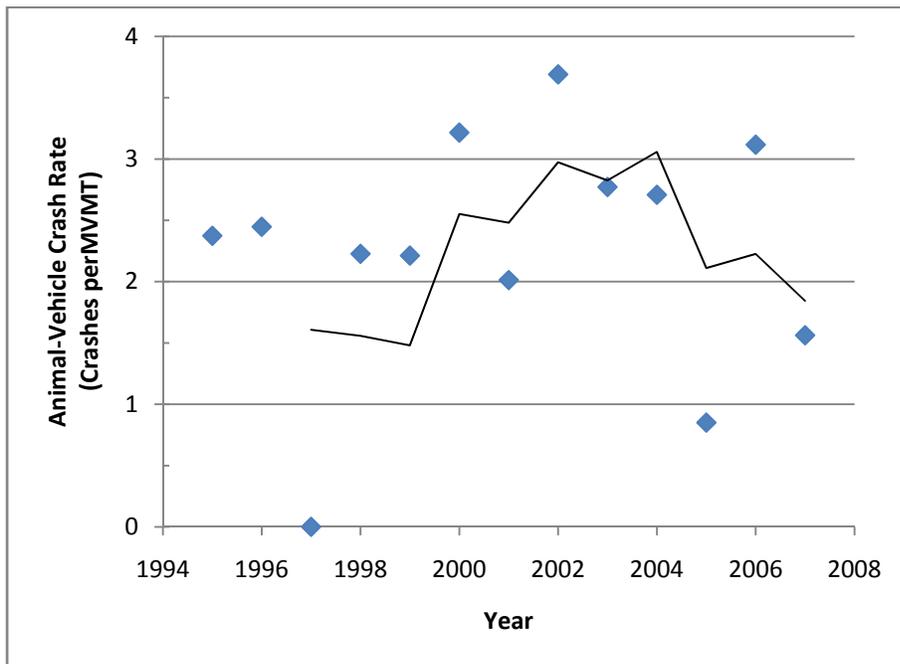
Figure 6-4: Animal-Vehicle Crash Rates on US 191 between MP 105.54 and 106.90

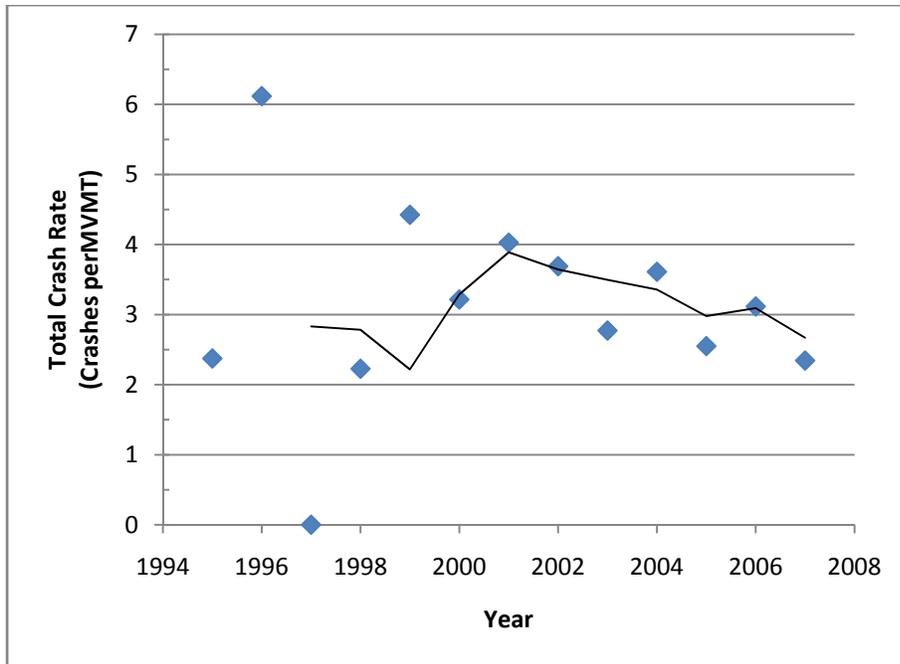
Figure 6-5: Total Crash Rates on US 191 between MP 105.54 and 106.90

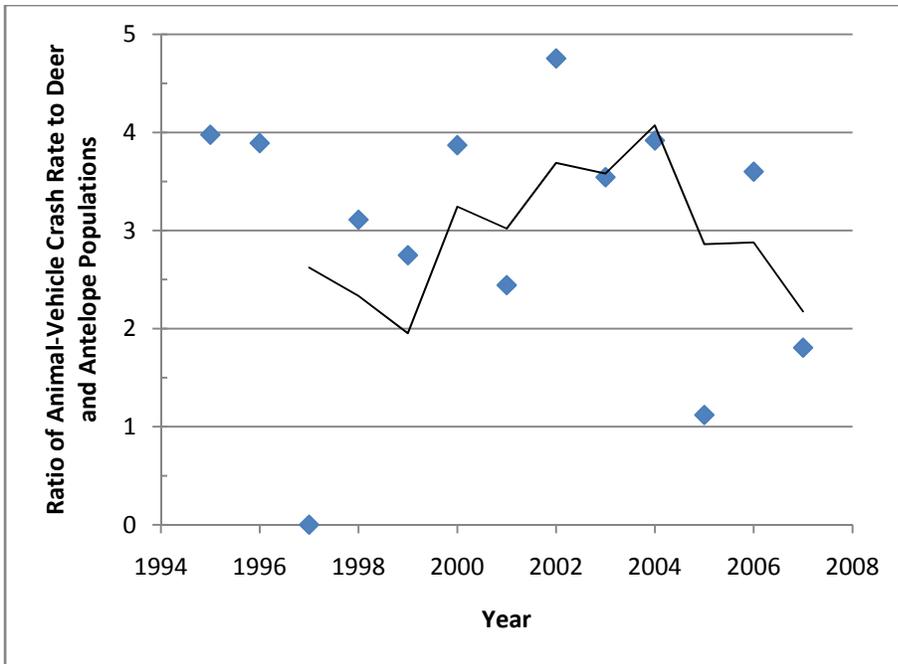
Figure 6-6: Ratio of Animal-Vehicle Crash Rate to Herd Population on US 191 between MP 105.54 and 106.90

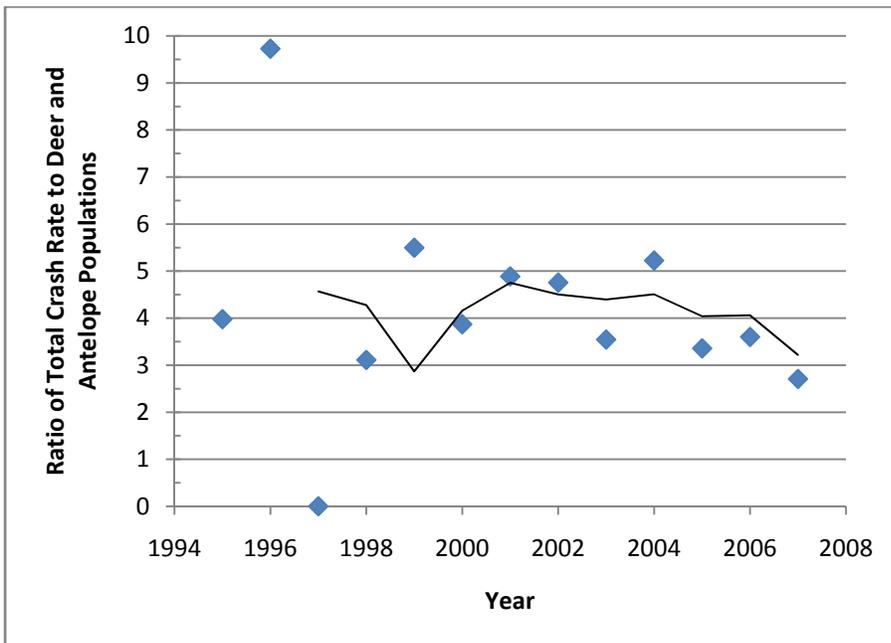
Figure 6-7: Ratio of Total Crash Rate to Herd Population on US 191 between MP 105.54 and 106.90

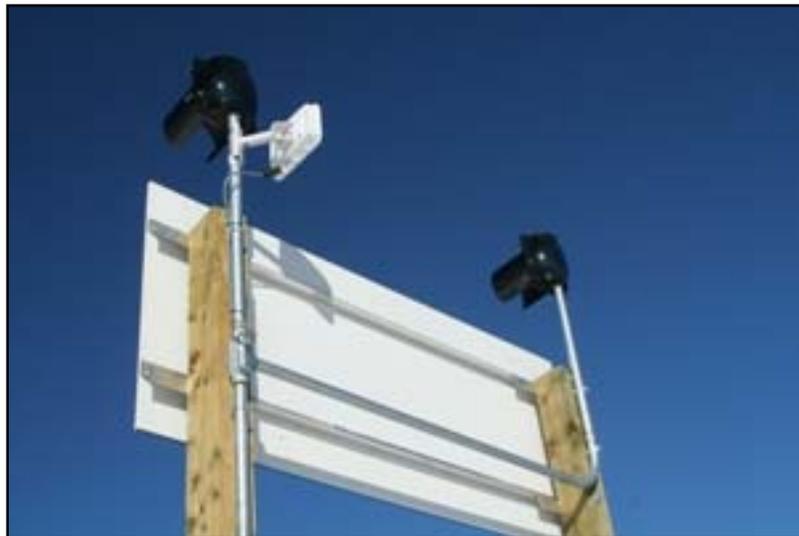
Figure1: Speed Sensor Mounting Location

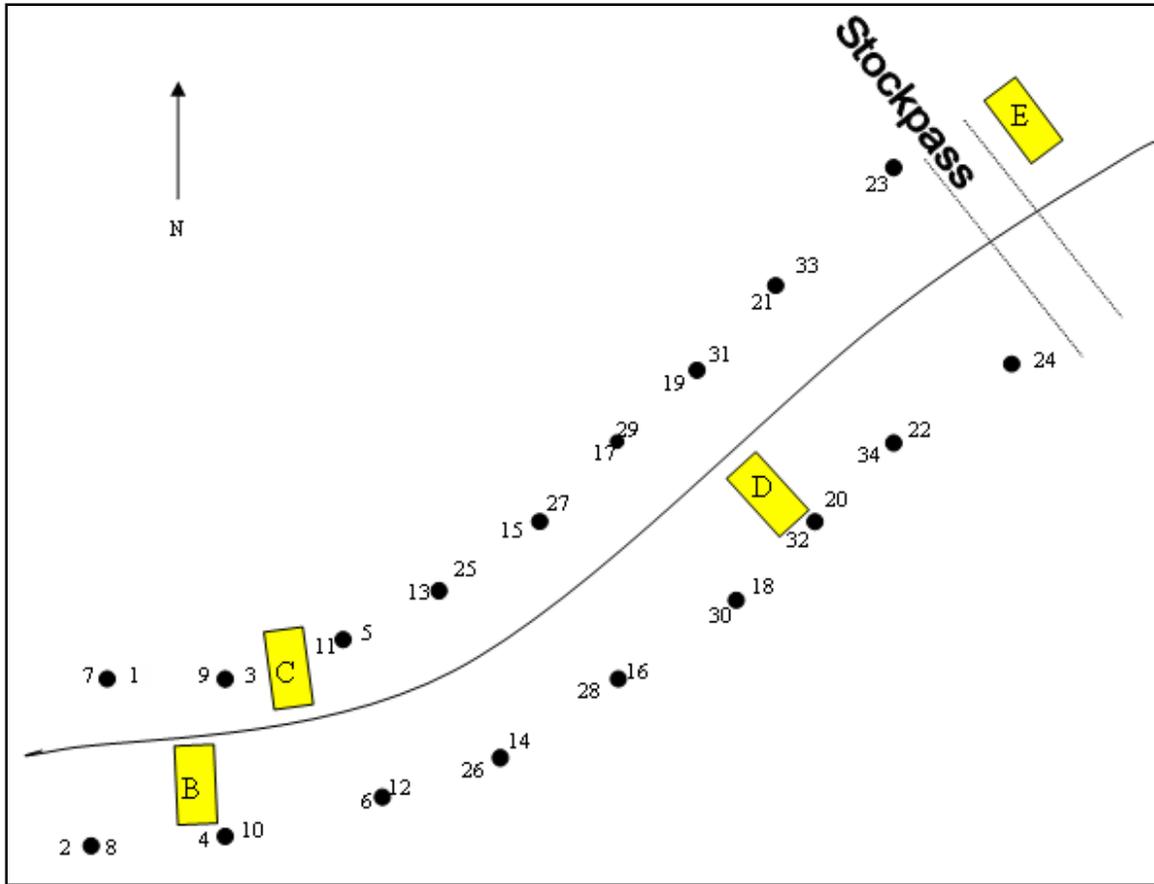
Figure 4: Site Layout

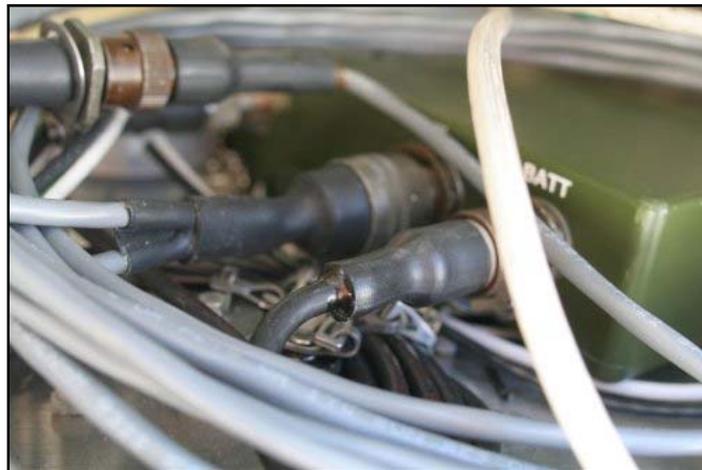
Figure 3: Typical radio receiver inside each sign's cabinet

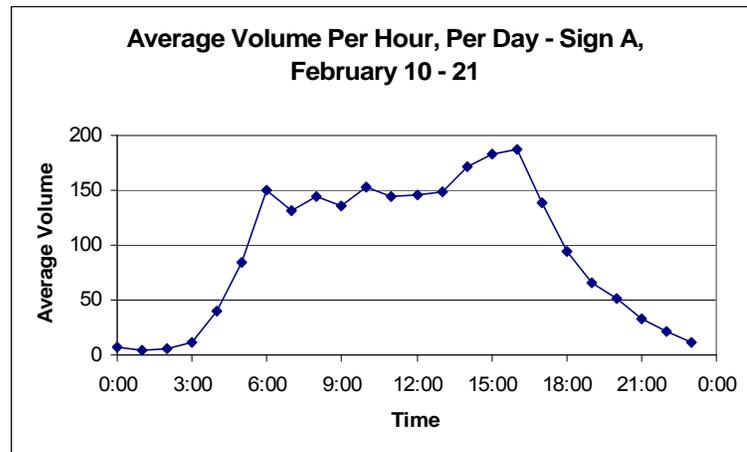
Figure 4: Average Volume Per Hour, Per Day

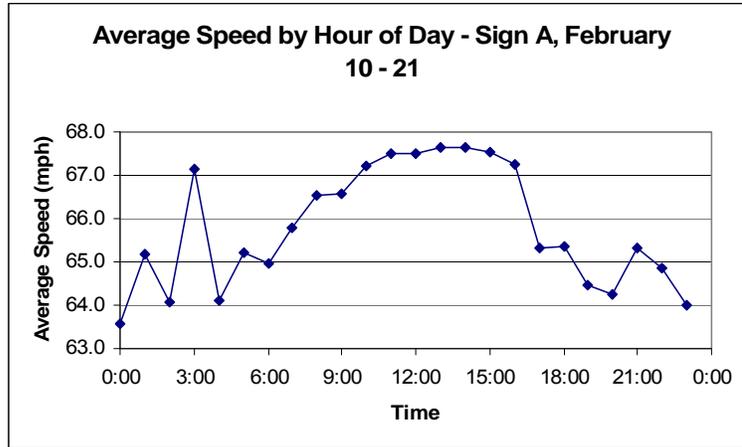
Figure 5: Average Speed by Hour of Day

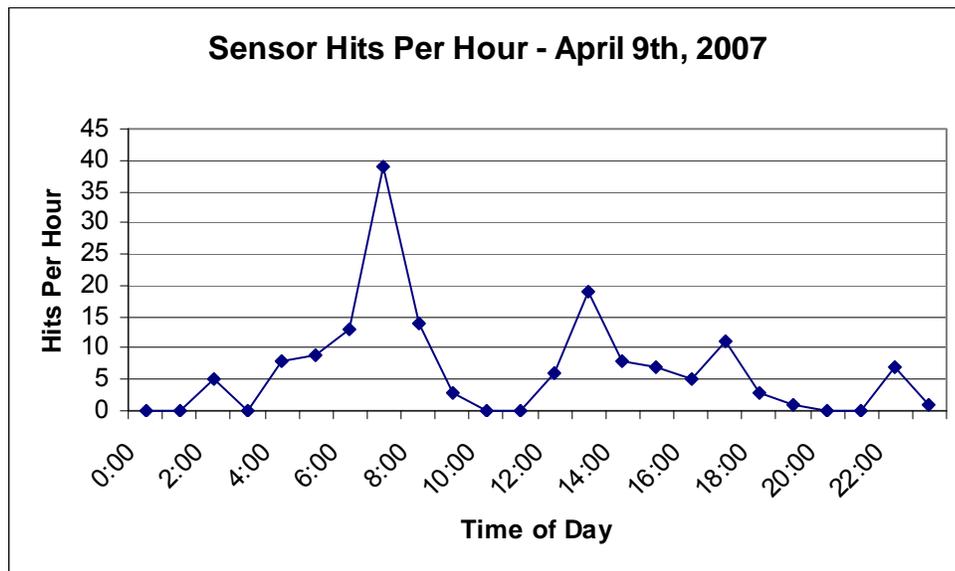
Figure 1: Sensor Hits Per Hour

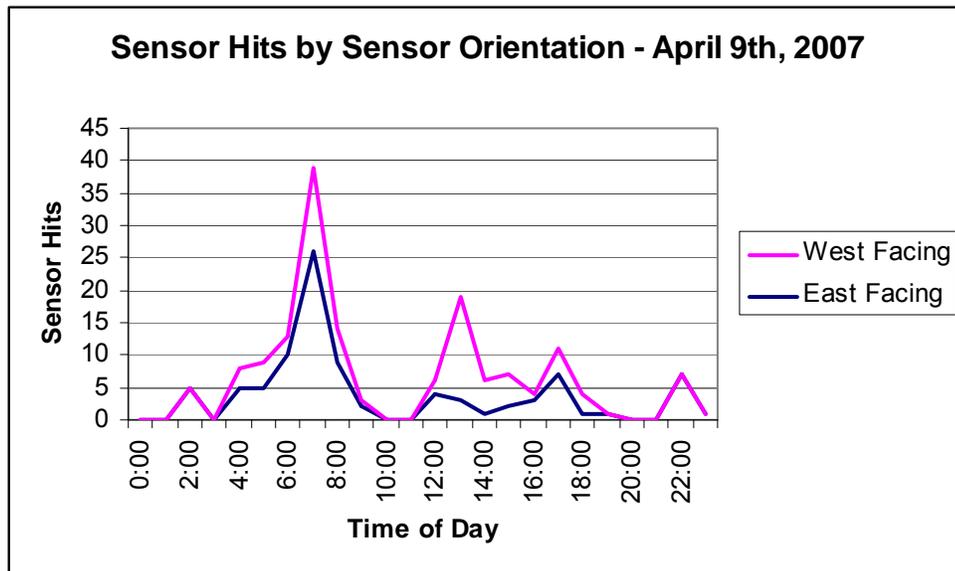
Figure3: Sensor Hits by Sensor Orientation
