FHWA-WY-09/03F

EVALUATION OF AN ACTIVE WILDLIFE- SENSING AND DRIVER WARNING SYSTEM AT TRAPPER'S POINT

**Department of Civil and Architectural Engineering
University of Wyoming
1000 E. University Way
Laramie, Wyoming 82071**

April 2009

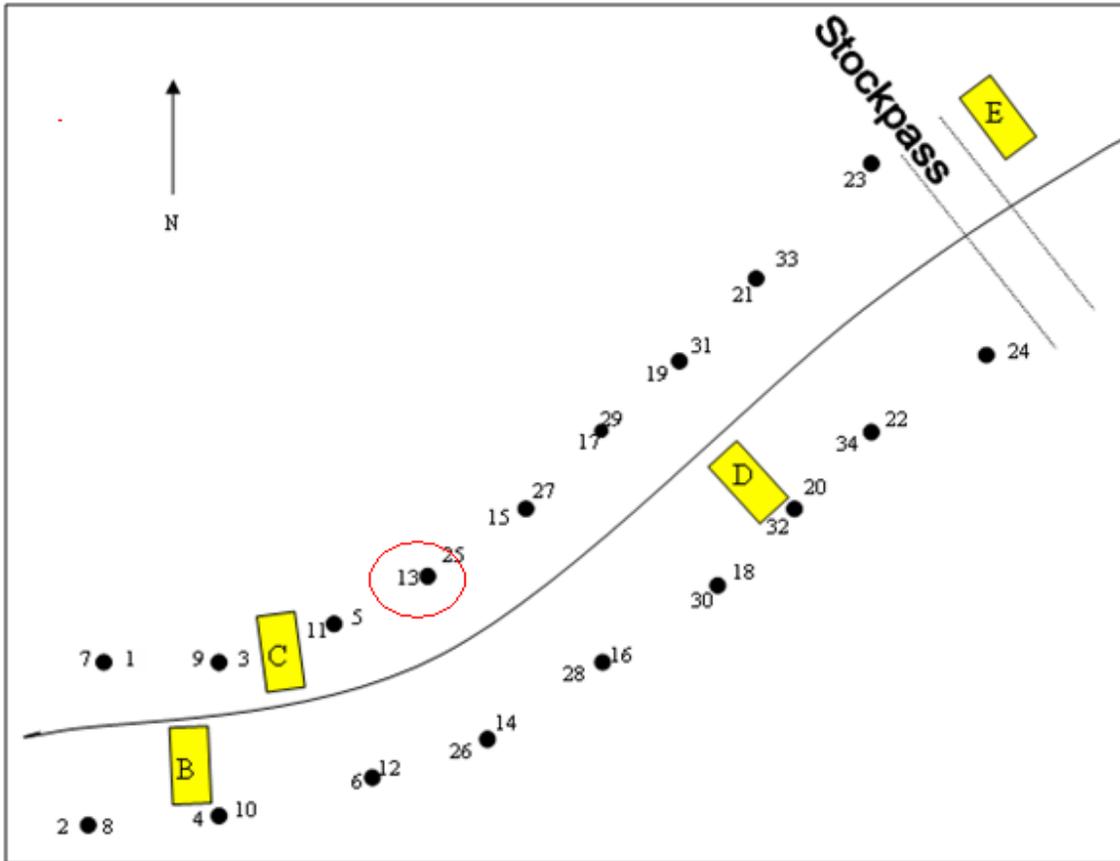
Figure 1: Site Layout
