# Determining More Effective Approaches for Grouting Shear Keys of Adjacent Box Beams

FINAL REPORT

COMMONWEALTH OF PENNSYLVANIA  
DEPARTMENT OF TRANSPORTATION

CONTRACT No. 510602  
PROJECT No. PSU 014

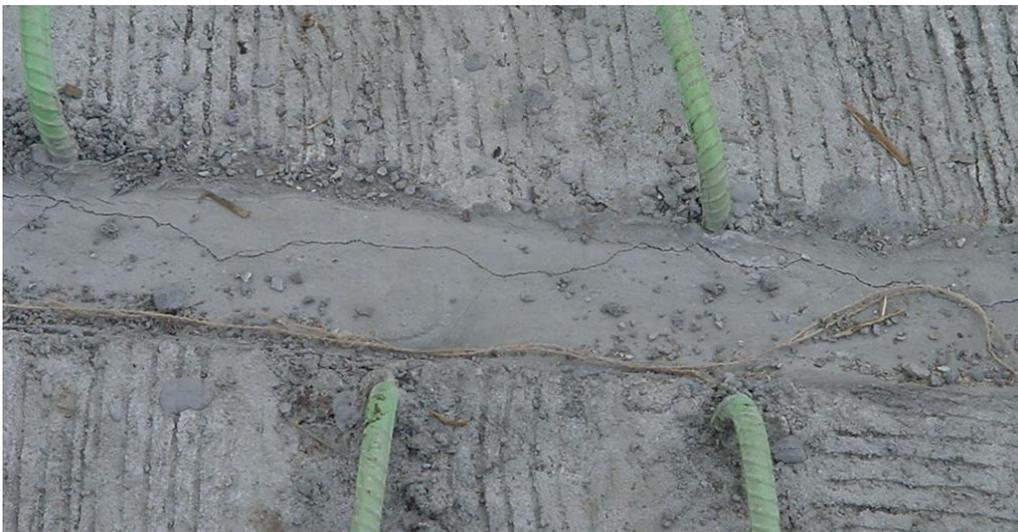
Figure 1.1 Shear key cracking during construction (Koller 2008)

The use of bridges built with adjacent precast, prestressed concrete box girders has been favored by several state Departments of Transportation, including the Pennsylvania Department of Transportation (PennDOT), due to the efficiency of their construction and the elimination of deck formwork (Miller et al. 1999). Box beams are typically connected by shear keys with some type of transverse reinforcement (mild or prestressed) and are typically grouted. Although the structural performance of such bridges has been successful, a common problem that has been observed is shear key grout failure at early stages, as shown in Figure 1.1. In many cases this cracking has resulted in water leakage, which could lead to corrosion problems on both the mild and prestressed reinforcement (Lall et al. 1998; Hawkin and Fuentes 2003). The Pennsylvania Department of Transportation is interested in evaluating improved design, construction, and repair practices that have the potential to reduce shear key grout failure in PennDOT's precast box beam bridges.

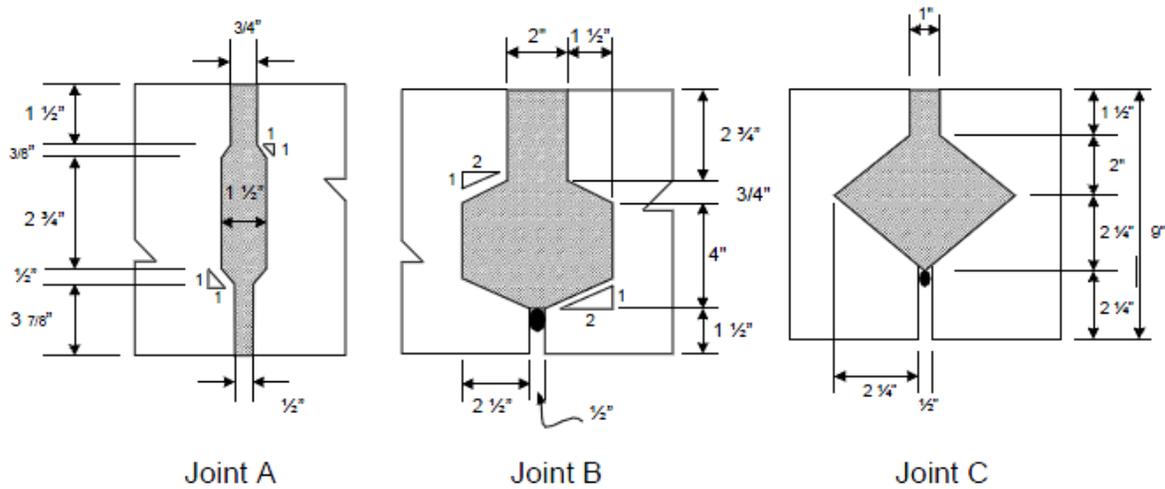
Figure 1.3 Different shear key geometries (Dong et al. 2007)

Only one study has been found that examines the effect of the geometry of the shear key. Dong et al. (2007) analytically compared the performance of the three types of shear key geometries using the finite element method. Their results indicated that joint A in Figure 1.3 performed better than the other two configurations: at the same load level, joints B and C had stresses at the top portion of the shear key exceeding the tensile strength of the grouting materials, whereas joint A showed principal stresses below that threshold. The analytical models used in this study showed the sensitivity of the shear key geometry on the magnitude of the stresses developed in this region. Different shear key grouting depths were also evaluated; it was found that full-depth shear keys behave better by reducing the number of locations where cracking

could occur. When the same load was applied to the FE models, a full-depth shear key developed lower stress levels compared to a partial-depth shear key.

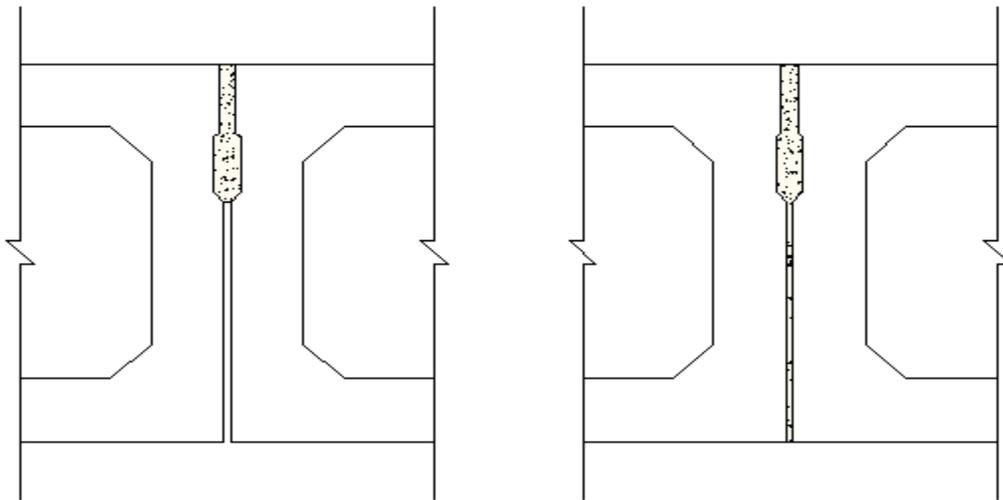
Figure 1.4 a) partial depth shear key b) full depth shear key

Grouting practices significantly affect the structural behavior of shear key. Two types of shear key grouting depth are used: partial depth and full depth. In a partial-depth shear key, the grout only covers a portion of the total height of the box girder. It usually coincides with the size of the shear key when it is located on the top tier of the box girder, as shown Figure 1.4 a). Full-depth shear keys have the entire space between two girders grouted, as shown in Figure 1.4 b).

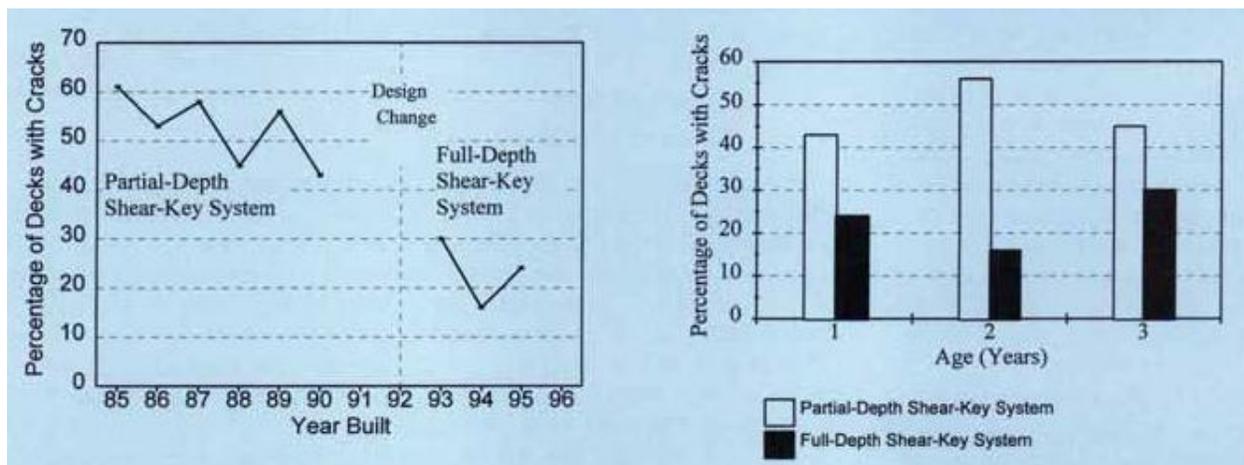
Figure 1.5 Frequency of Longitudinal Deck Cracking a) by year built b) by age at time of inspection (Lall et al. 1998)

A study was conducted by the New York State Department of Transportation in 1996 to evaluate the performance of the full-depth shear key configuration in adjacent box girder bridges (Lall et al., 1998). Inspections were performed to 91 box girder bridges with full-depth shear keys, built after 1992. The results from this study were compared to the results from a previous study conducted on box girder bridges using a partial-depth shear key (Tang 1992). Shear key with longitudinal cracking was found on 21 (23%) of the 91 inspected bridges with full-depth shear key. In contrast, 54% of the bridges with partial depth shear key were found to have longitudinal cracking. Moreover, only 47 out of a total of 874 full-depth shear keys were associated with deck cracking. Therefore, it was concluded that full-depth shear keys significantly reduced shear key cracking. Figure 1.5 shows the categorized frequency of longitudinal deck cracking observed in this study.

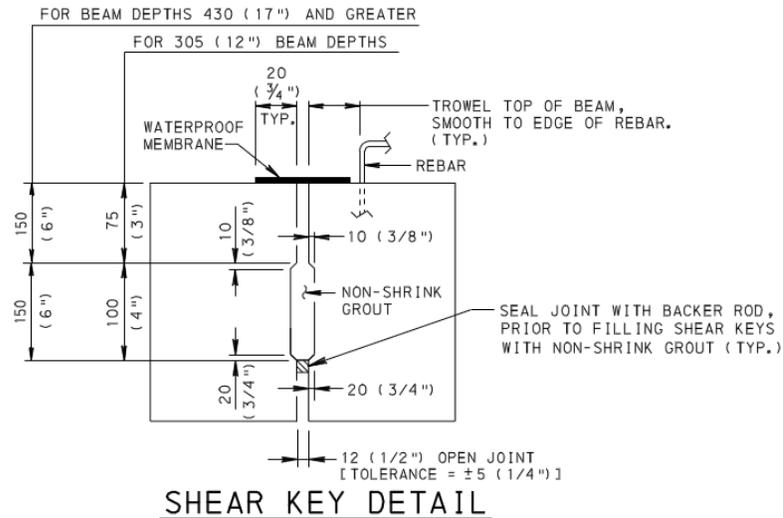
Figure 1.6 PennDOT partial-depth shear key details (PennDOT 2007)

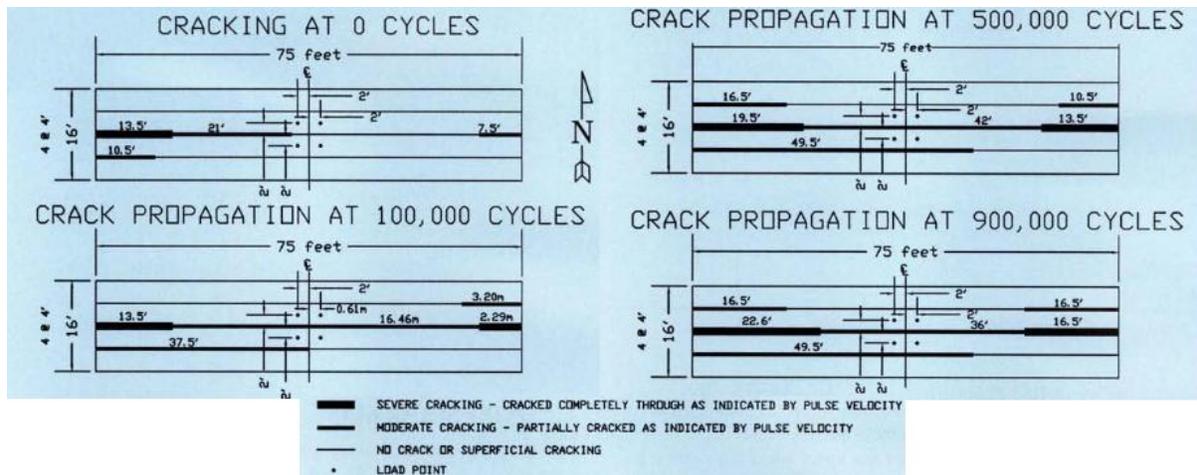
Figure 1.7 Shear key cracking propagation in the full-scale testing (Miller et al. 1999)

Bearing pads seem to be another contributor to shear key cracking. Two sources have noted the effects of bearing pad details on the relative deflection between girders. In a reflective cracking history graph provided by William Koller from PennDOT (2008), it is clear that shear key cracking is initiating near the two ends of the box beams and propagating toward the mid span. Miller et al.'s full-scale testing of a box beam bridge (1999) showed a similar crack pattern is observed, as seen in Figure 1.7.

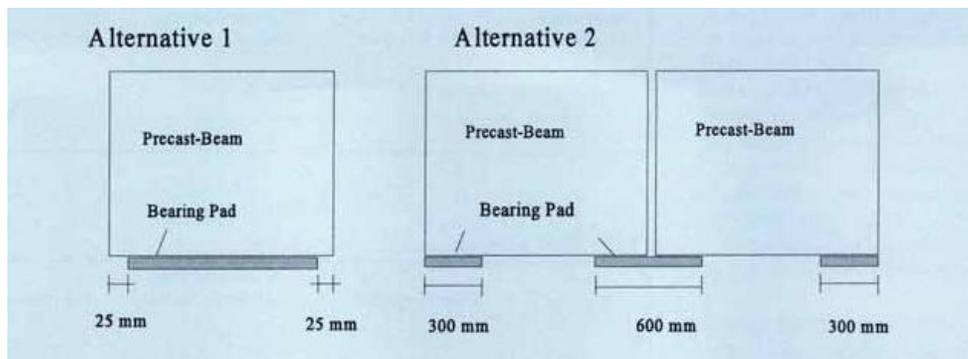
Figure 1.8 Bearing pad alternatives (Lall et al. 1998)

The New York State DOT requires the bearing pad to be at least half the width of the box beam. However, at least one study (Lall et al. 1998) has suggested that one half width of box beam is not adequate to provide lateral stability because the box beam can rotate along its longitudinal axis without restriction from such a short bearing pad. Therefore, the study proposed two alternative bearing pad details, as shown in Figure 1.8. The first alternative gives the box beam more restriction to rotate. The second alternative is to reduce the relative deflection between the two adjacent box beams as the bearing pad deforms. More in-depth analysis is necessary to verify the effectiveness of the two alternatives.

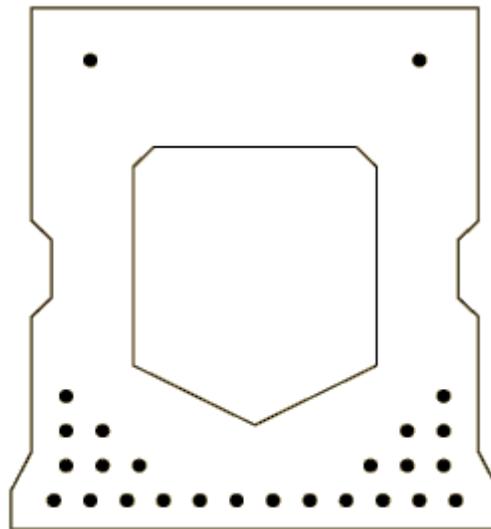
Figure 1.10 Typical Box Beam in South Korea (Kim et al. 2008)

A study was conducted in 1994 by Yamane et al. to evaluate the behavior of multi-box beam bridges in Japan. It was found that Japanese bridges typically had heavy transverse post-tensioning reinforcement at different elevations. Also, cast-in-place concrete is used to grout the full-depth shear keys instead of normal grout. In order to pour concrete, the Japanese box girder bridge has a wider (2-in wide minimum) and deeper shear key, allowing the coarse aggregate to disperse uniformly. The concrete mixture used for this grouting application has a much higher strength than the normal grouting material. This study suggested that the use of these design and construction practices reduced shear key cracking significantly. A similar design approach has been taken in South Korea (Kim et al. 2008): heavy transverse post-tensioning, combined with a mid-depth shear key fully filled with cast-in-place concrete; see

Figure 1.10. Detailed analysis and full-scale testing have been performed by Kim et al. (2008) to verify the effectiveness of this practice.

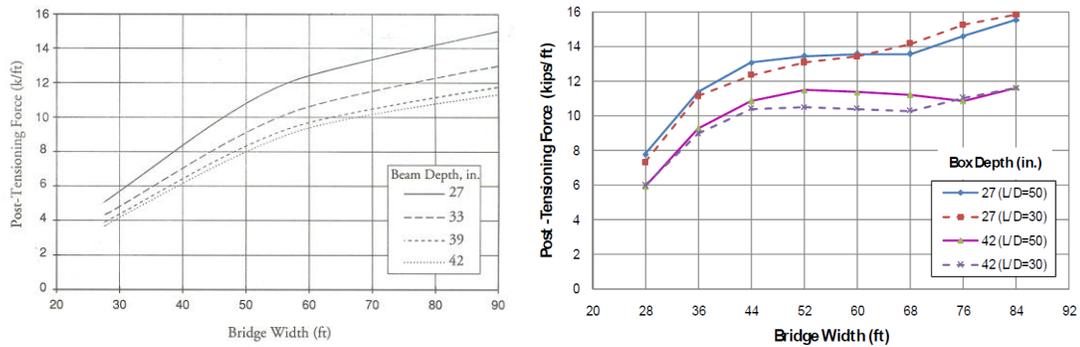
Figure 1.11 a) PCI BDM post-tension force design chart  
b) Proposed post-tensioning force design chart (Hanna et al. 2007)

Hanna et al. (2007) studied the different factors that are crucial to the calculation of post-tensioned tendon force using grillage analysis: A series of longitudinal beam elements along the center line of box girder is used to represent the girders; transverse beam elements at quarter points of the span are used to represent the transverse reinforcement. Connections between elements are assigned to resist shear, bending, and torsion to represent the full-depth shear key behavior. To prevent possible cracking, the concrete allowable stress limit is set as tension equal to 0 and compression equal to  $0.6f'_c$ . They identified the bridge width as the most influential parameter in calculating the post-tensioning force. Figure 1.11 shows two charts that relate bridge width to the amount of post-tensioning force required. Figure 1.11a) refers to the

2004 PCI Bridge Design Manual chart with AASHTO HS25 truck for calculating post-tensioning force. Figure 1.11b) is the proposed chart from the grillage analysis. It shows that the required post-tensioning force, based on their analysis, is significantly greater (more than 50%) than what's required by the 2004 PCI Bridge Design Manual.

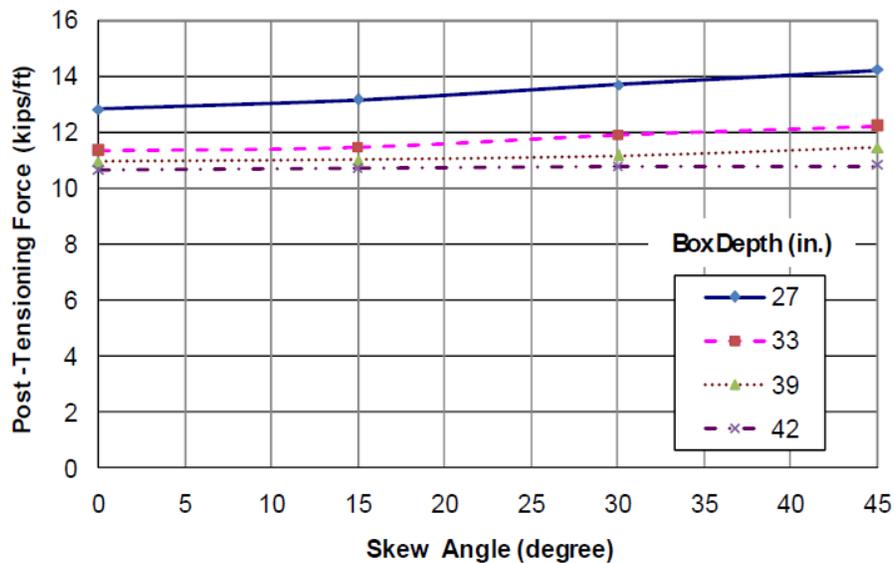
Figure 1.12 Required post-tensioning force vs. skew angle of bridge (Hanna et al. 2007)

This study also considered the effect of skew angle (Hanna et al. 2007). Figure 1.12 shows the relationship between required post-tensioning force and skew angle. It shows that the differences in the post-tensioning force between different skew angles are small and can be neglected except when shallow girder is used.

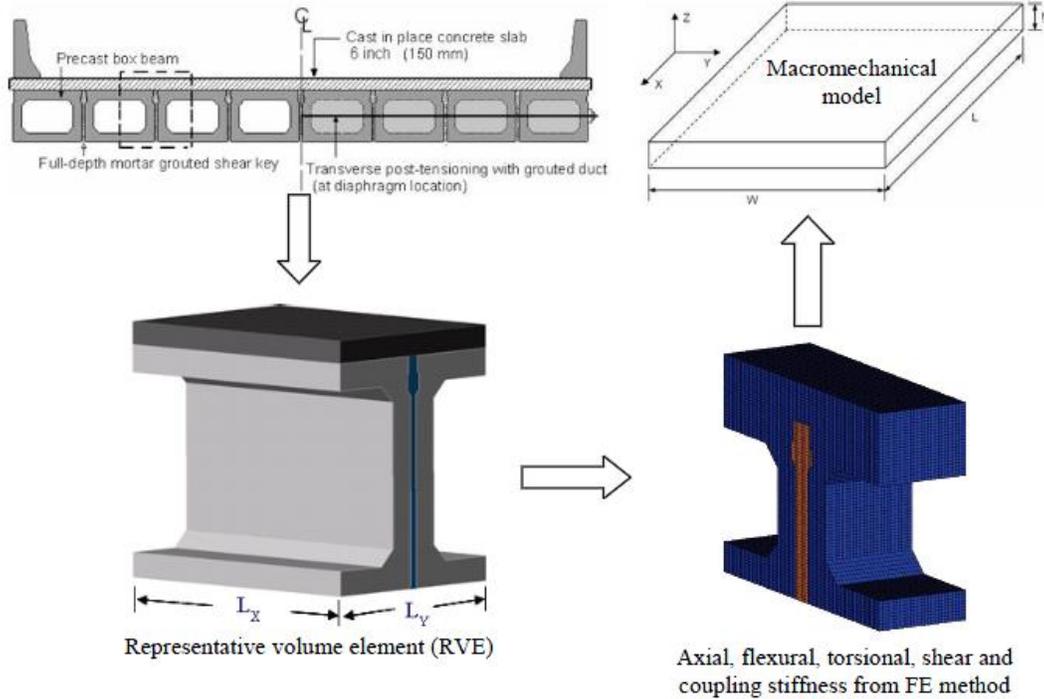
Figure 1.13 Macromodeling of an adjacent box girder bridge superstructure system (Attanayake and Aktan, 2009)

Attanayake and Aktan (2008, 2009) also used a grillage analysis to calculate the amount of the transverse post-tensioning required to keep box girders behaving as one unit. They proposed a new modified grillage analysis method to solve the shear key cracking problems. This proposed analytical tool gives a more accurate prediction of the amount of reinforcement required to prevent shear key cracking. Figure 1.13 shows the overall procedure of the analysis tool.

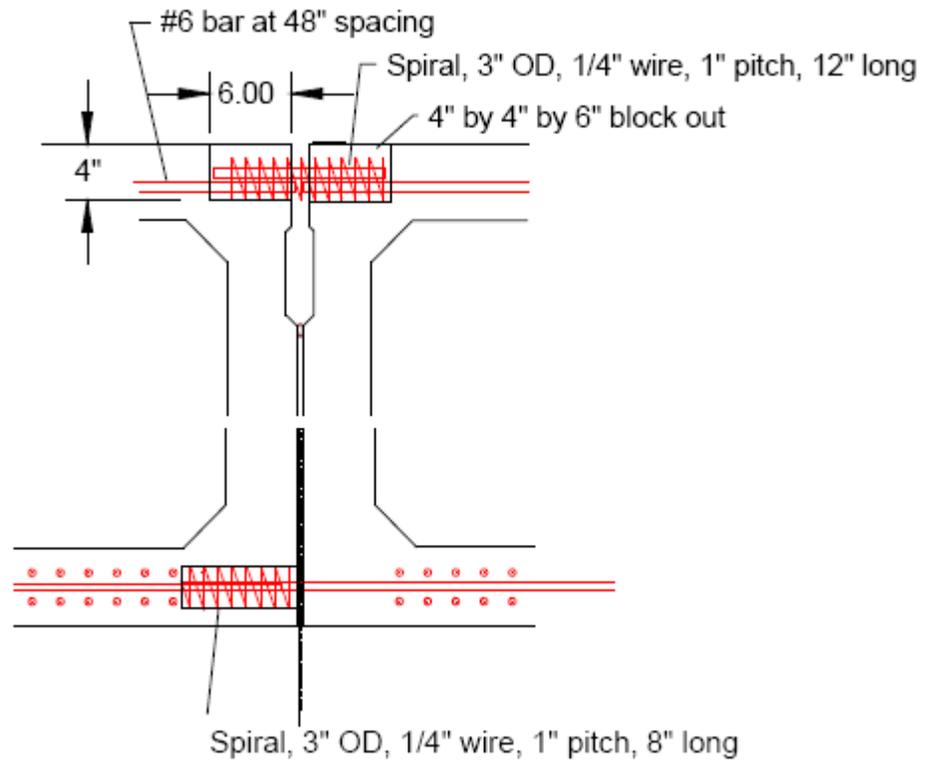
Figure 1.14 Alternative non-post-tensioning details of box beam shear key (Hanna et al. 2007)

Even though transverse post-tensioning is an effective practice to reduce the shear key cracking problem, it has disadvantages. For example, it is difficult to conduct post-tensioning on a skewed bridge. Hanna et al. (2007) proposed two non-post-tensioning connection details to prevent cracking of the shear key and eliminate the problems associated with post-tensioning and shear keys in general. The first alternative requires significant changes to the geometry of the box beam; therefore, it will not be shown in this report. The second alternative is shown in Figure 1.14. The specific details of this alternative are still under development at the University of Nebraska-Lincoln.

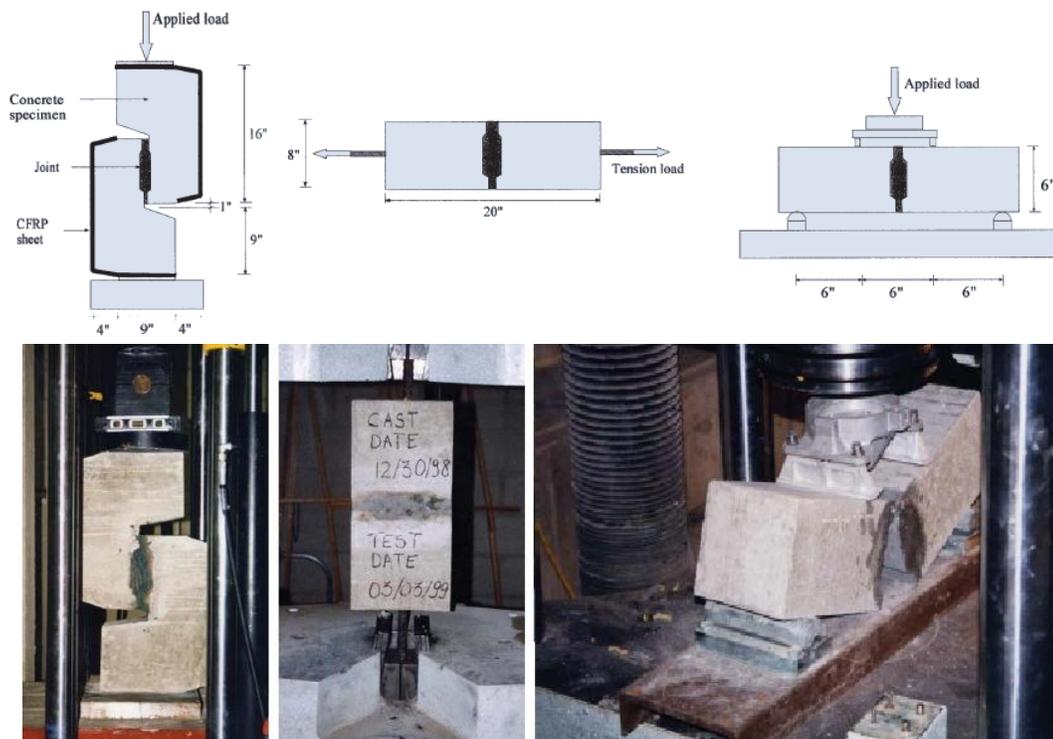
Figure 1.15 Composite testing methods: a) direct shear test b) direct tensile test c) flexural test (Issa et al. 2003)

Test methods have been developed to study the effects of grouting materials on the shear key performance in small-scale specimens. Issa et al. (2003) investigated the effect of three different grouting materials. They proposed and tested three composite testing methods for obtaining relevant properties of the shear key grout materials, specifically shear, tensile, and compressive strength. Figure 1.15 shows photographs of the three test methods developed: a) direct shear test, b) direct tensile test, and c) flexural test.

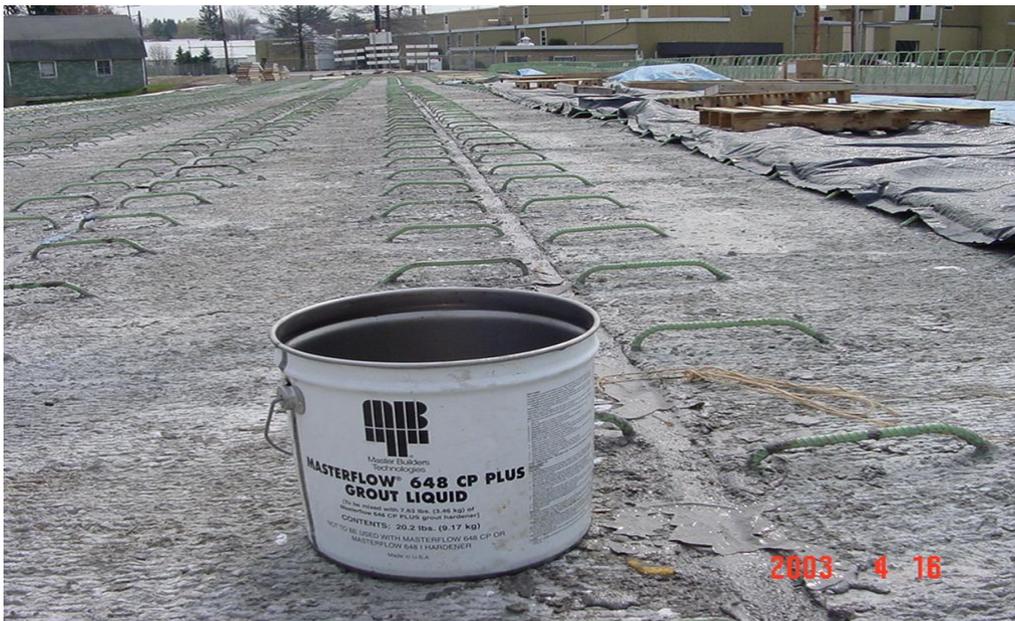
Figure 1.16 Photograph of the field application of an epoxy-based grout (Koller 2008)

Currently, PennDOT District 1 is experimenting with epoxy-based grout in eight precast box bridges. Their district standard specification for epoxy-based grout has a list of four commercially available products. One of the epoxy-based grouts used in their pilot study is Masterflow 648 CP. Figure 1.16 shows a field application of this grout on a PennDOT bridge in District 1 (Koller 2008). This epoxy-based grout is made of three components: two epoxy resins and aggregates. The advantage of this type of grout material is that it has excellent resistance to creep, high compressive strength (good even at high temperatures), high modulus of elasticity, and excellent resistance to cracking. It also has good adhesion to concrete. Its working time is 50-60 minutes at 32 °C, 90-120 minutes at 21 °C, and 120-150 minutes at 10 °C. The compressive strength of this grout is 14.5 ksi at 40 °C. and its average tensile strength is 2,000 psi.

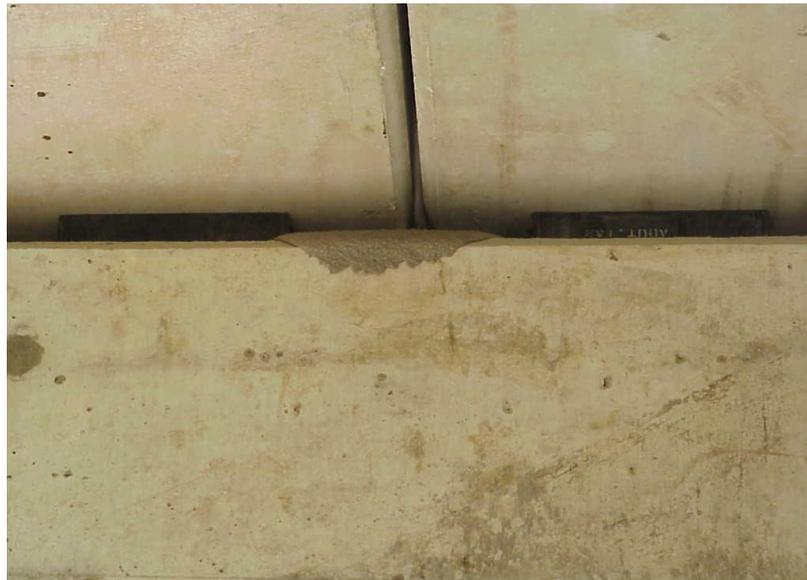
Figure 1.17 Grouting material leaking from the joint during the construction (Koller 2008)

- 1) Use prepackaged grout mix to obtain high-quality joints with more consistency.
- 2) Sand blast the surface of the shear key to ensure better bonding of grouting material onto the concrete surface of box beams.
- 3) Use seal block to prevent grout leaking down from the shear key. Figure 1.17 illustrates the potential problems.

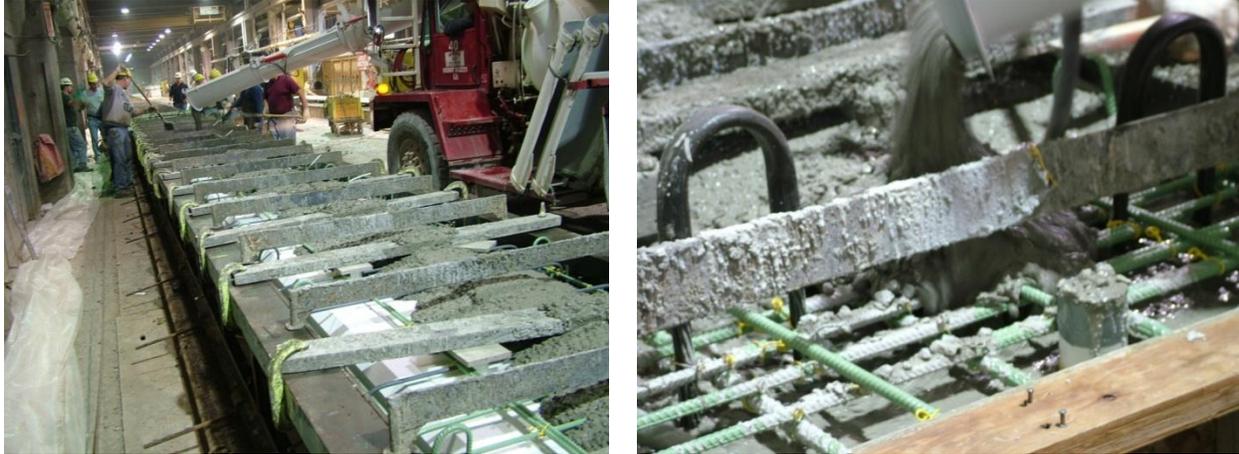
Figure 2.1 Casting of precast box girders using self-consolidation concrete (Newcrete Products, a division of New Enterprise Stone & Lime Co. Inc., Roaring Springs)

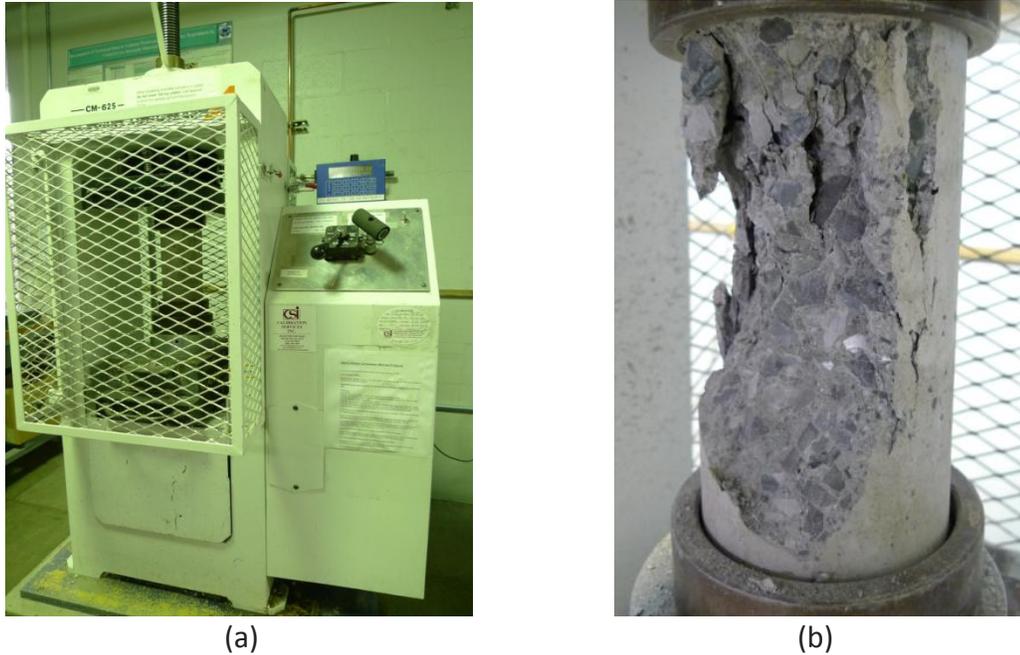
Figure 2.2 Concrete compression test: (a) Equipment used (b) typical failure mode

Concrete compressive strength was determined at 3, 7, and 28 curing days. Tests were performed following ASTM C 39. This test method consists of applying a compressive axial load to molded cylinders (6-in diameter x 12-in height) at a loading rate of 35±7 psi/sec until failure occurs. The compressive strength of the specimen is calculated by dividing the maximum load obtained during the test by the cross-sectional area of the specimen (ASTM C 39, 2005). Figure 2.2 shows photographs of the cylindrical specimen fitted in the testing machine before and after failure. Results from specimens were recorded and averaged (3 specimens per test) to obtain a representative compressive strength at a certain curing day.

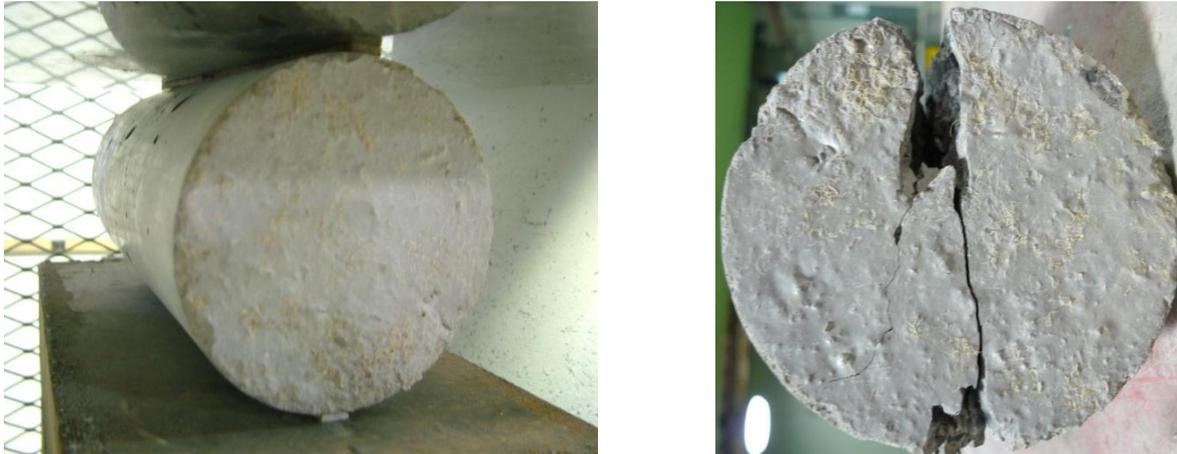
Figure 2.3 Splitting tensile test of a concrete specimen; photograph on the right shows typical failure mode

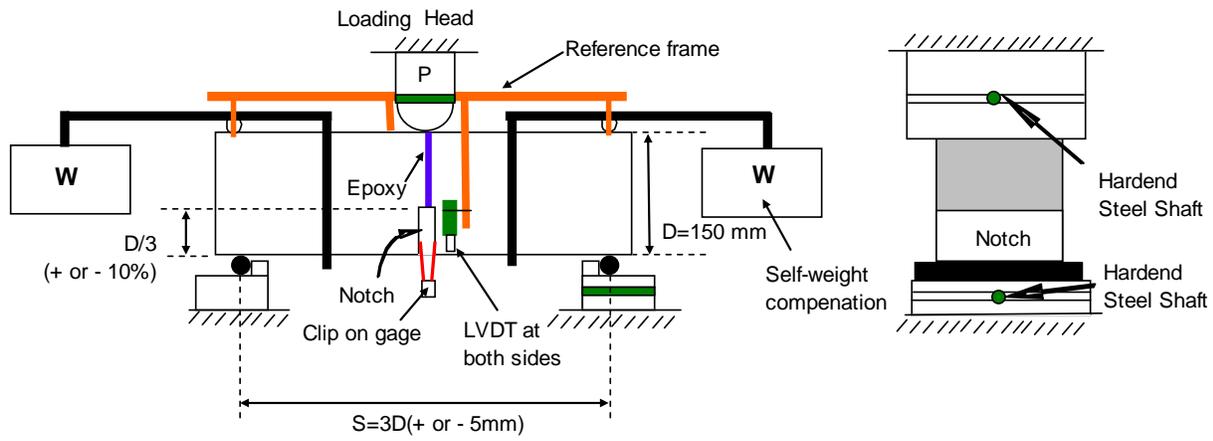
Figure 2.4 Sketch of a loading apparatus

sides of the bottom notch. A sketch of the specimen and test loading is shown in Figure 2.4. Figure 2.5 shows photographs of the test setup and concrete fracture surfaces.

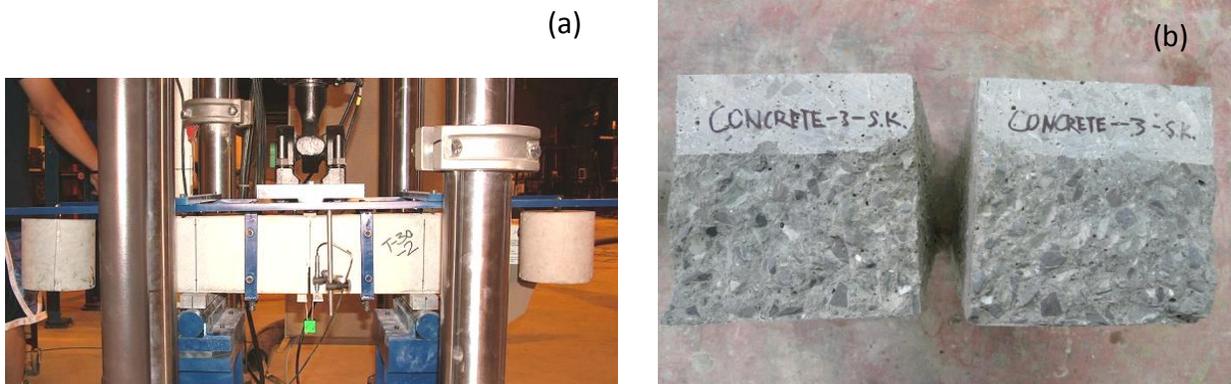
Figure 2.5 Photographs of fracture test: (a) test setup and (b) fractured specimens

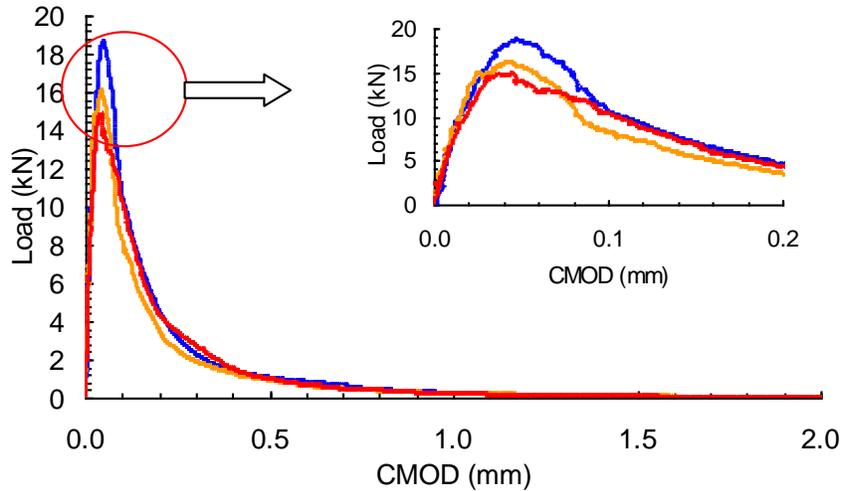
Figure 2.6 Load-CMOD curves of plain concrete (three specimens tested)

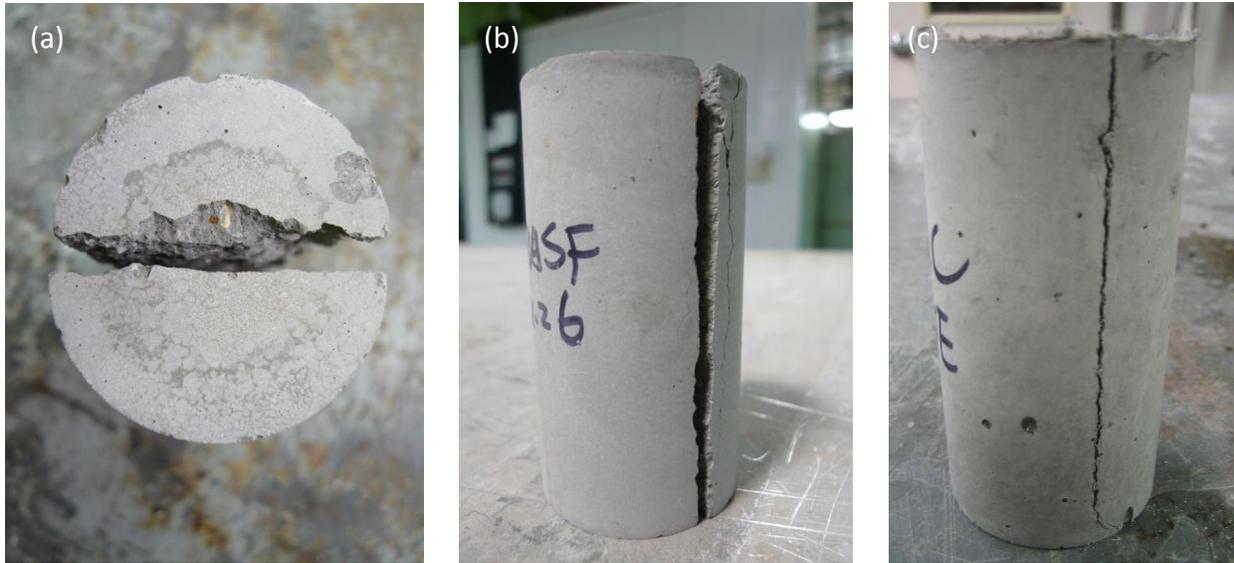
Figure 2.9 Cementitious grout specimen after the splitting tensile test: (a) top view of the specimen, (b) side view of the specimen, (c) side view of the specimen with fibers

was observed that fibers bridged the main crack, preventing a split failure of the specimen (shown in Figure 2.9c), as opposed to the failure mode exhibited by the non-fiber grout specimens.

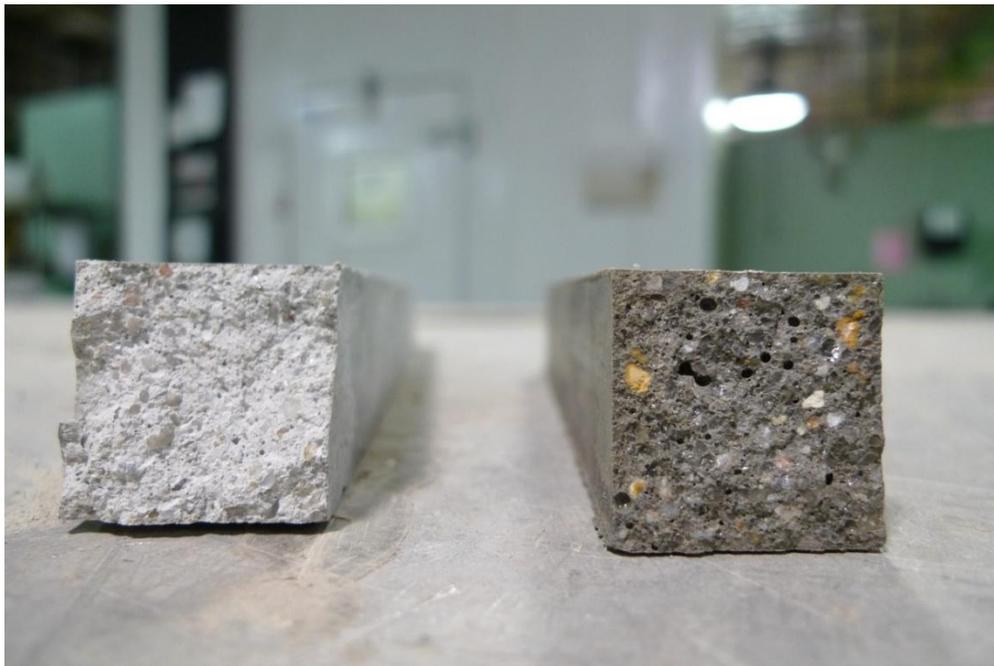
Figure 2.11 Fracture surfaces of the cementitious grout (left) and the epoxy grout (right)

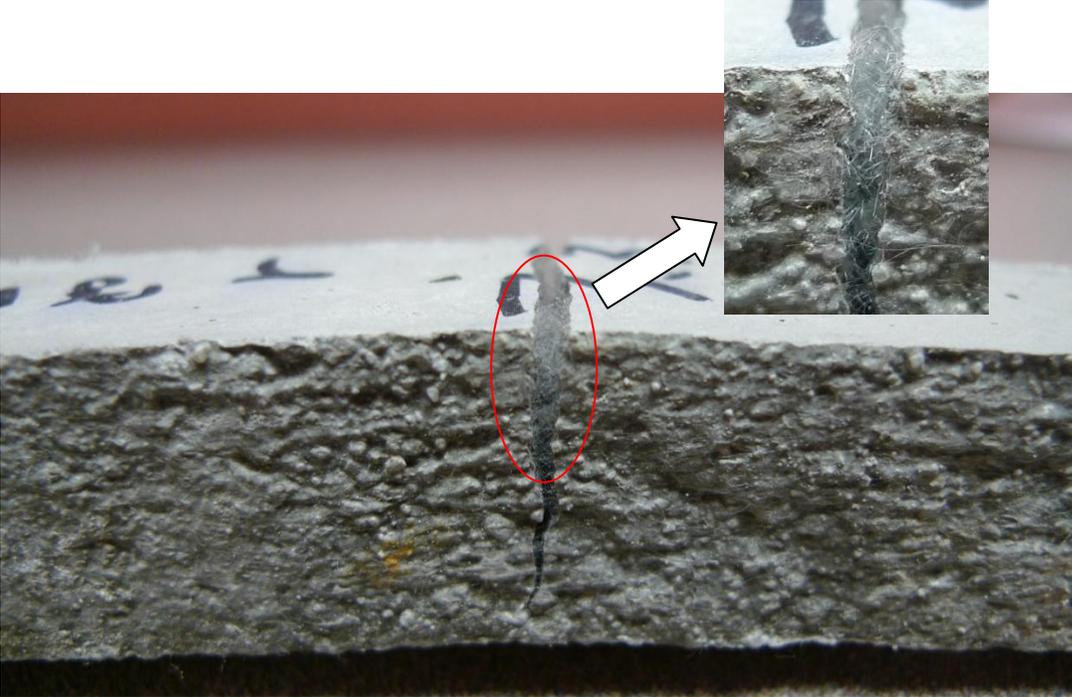
Figure 2.12 A flexural crack in a fiber-reinforced grout specimen

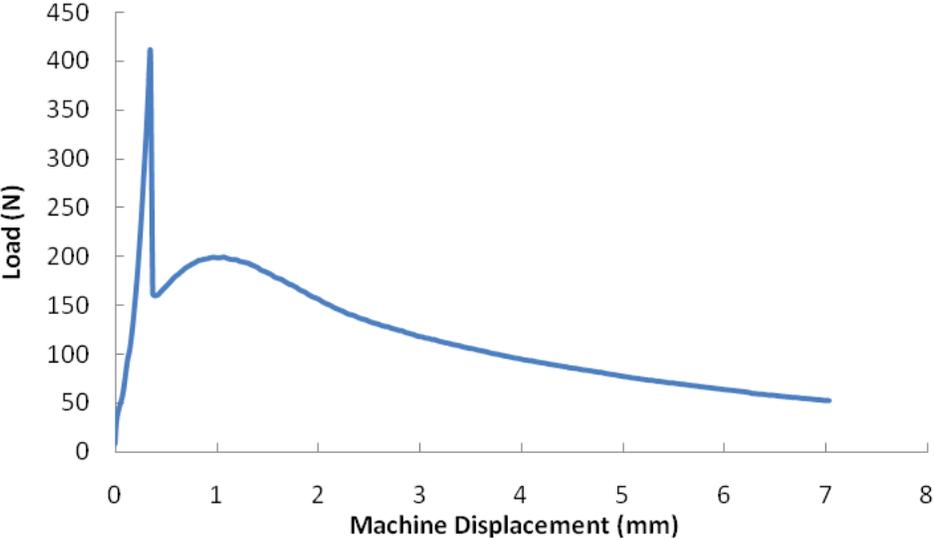
Figure 2.13 Load-machine displacement curve for a fiber-reinforced cementitious grout specimen

appearance of the second peak indicates that the fibers could provide some residual strength to the beam specimen after the peak flexural capacity is reached.

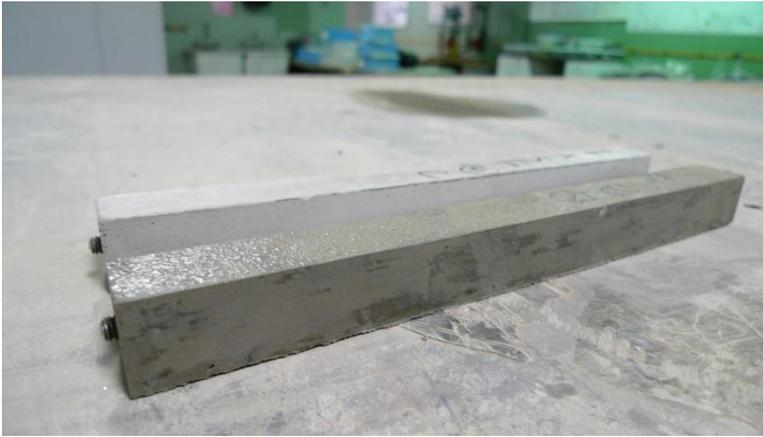
Figure 2.15 Photographs of the test setup and specimens used to determine linear shrinkage

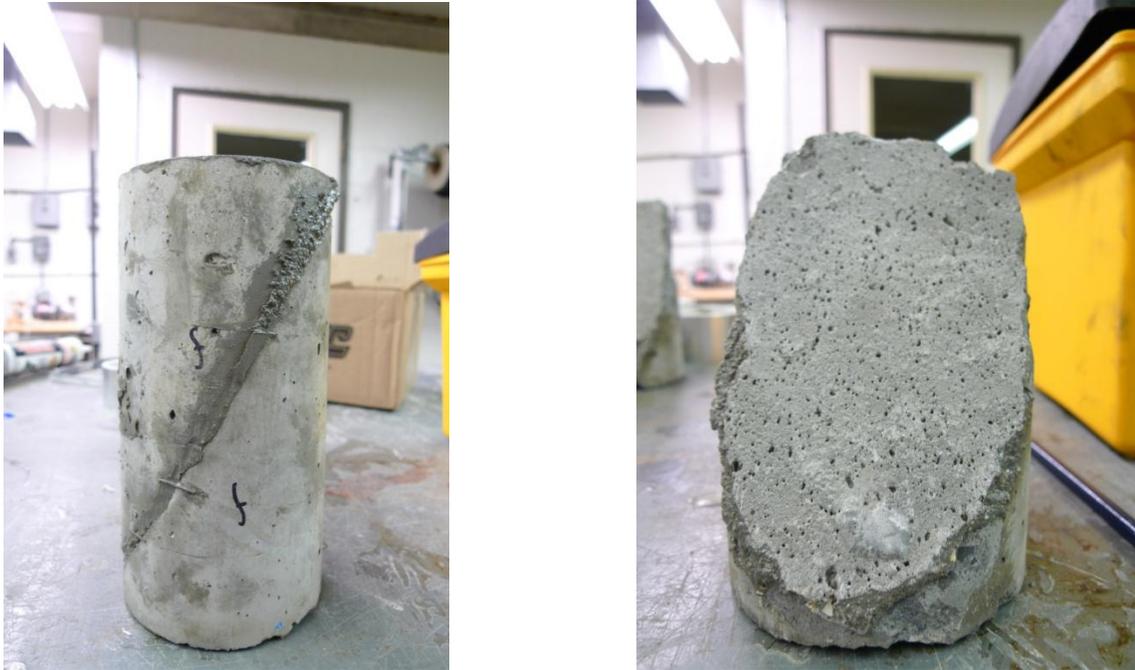
Figure 2.16 Photograph of typical concrete-epoxy bond strength specimen and fracture surface

attributed to epoxy grout's higher strength. Bond strength was calculated by dividing the load carried by the specimen at failure by the bonded surface area (25.13 in<sup>2</sup>). The average bond strength between epoxy grout and concrete is 5,019 psi.

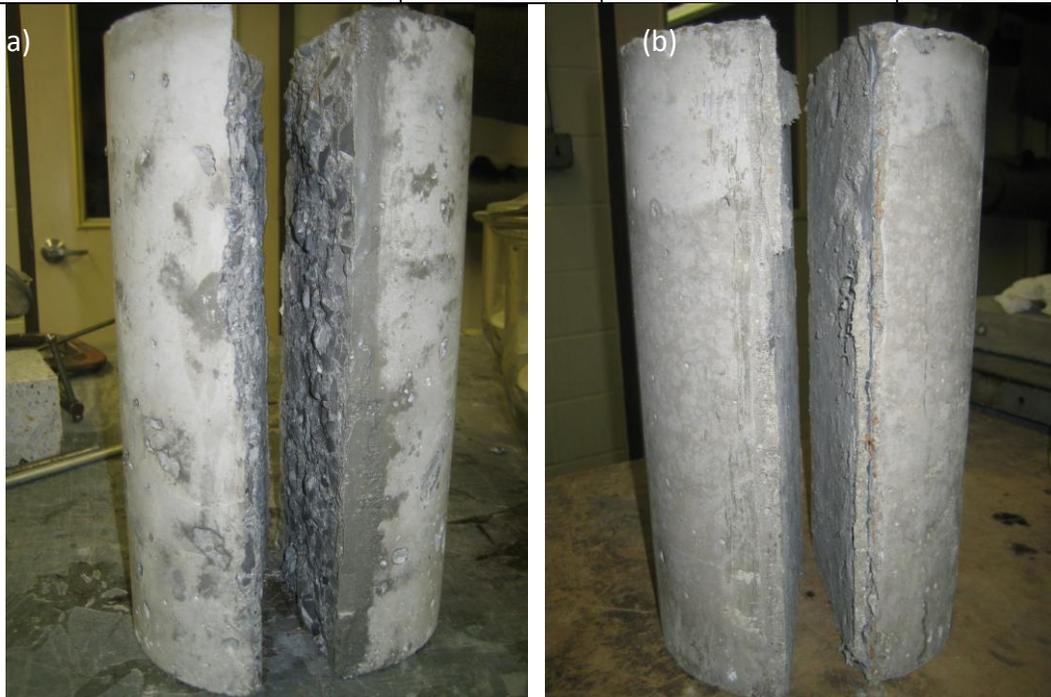
Figure 2.17 Failure mode of the splitting tensile test for (a) concrete-epoxy grout specimen  
(b) concrete-cementitious grout specimen

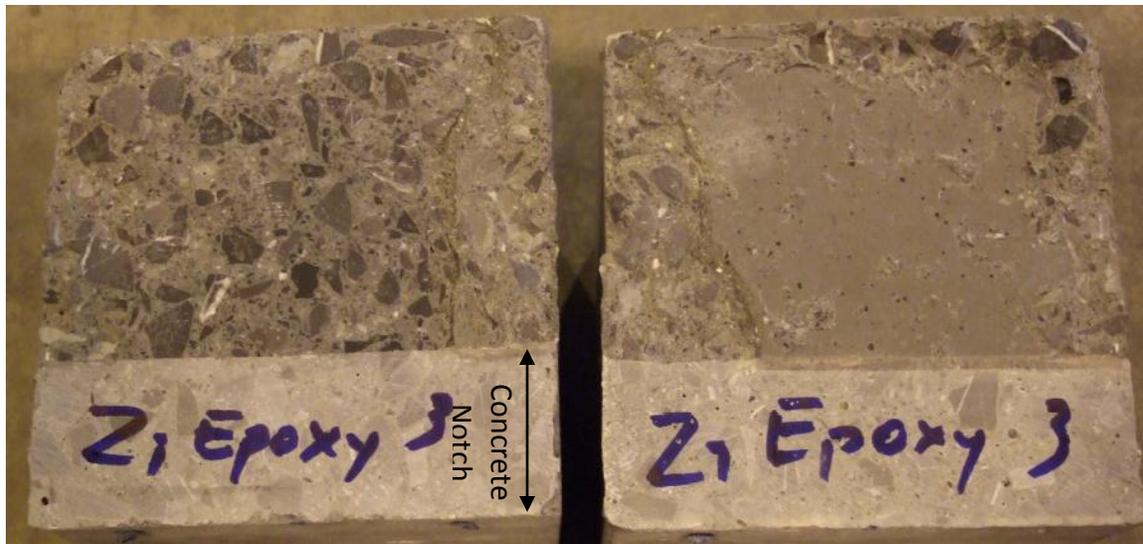
Figure 2.18 Fracture surfaces of the epoxy bonded specimen

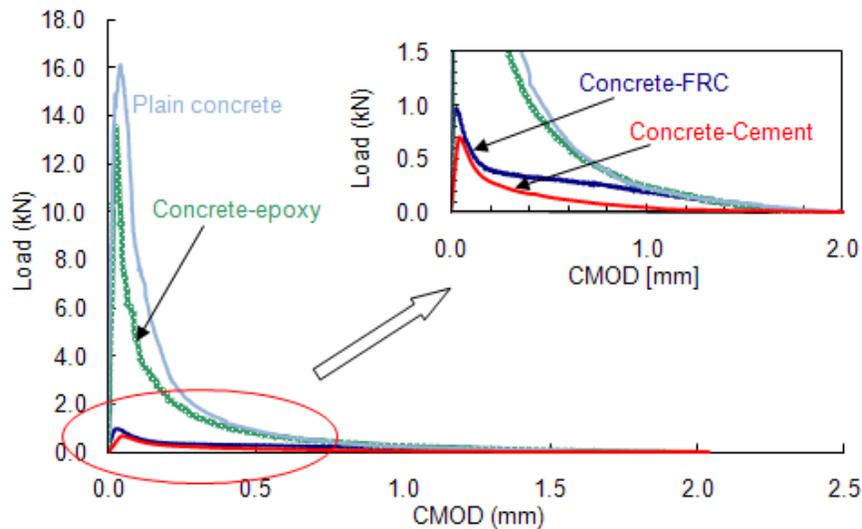
Figure 2.19 Load-CMOD curves for plain concrete and concrete-grout interfaces

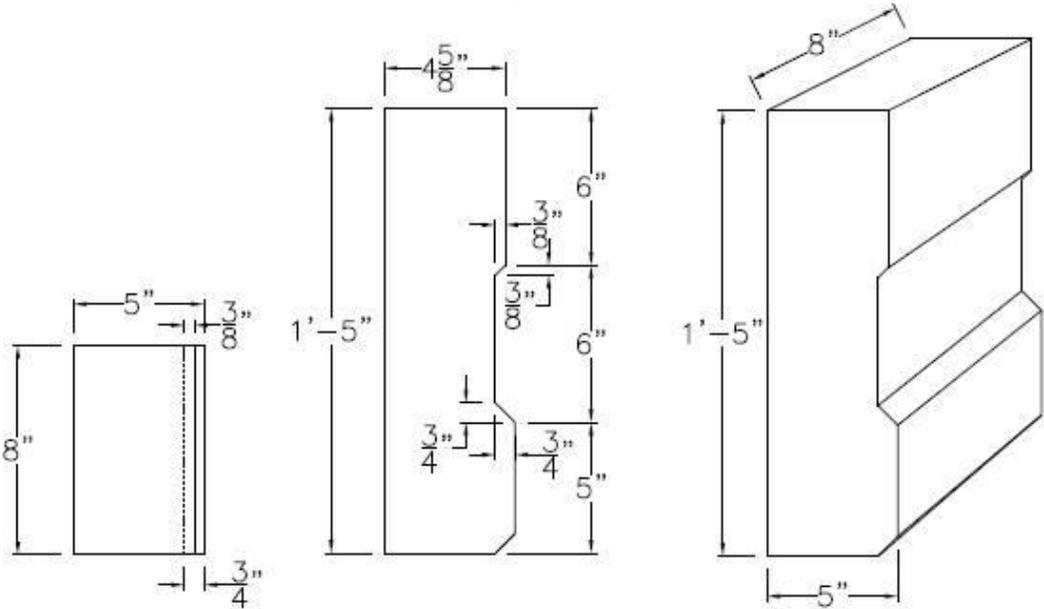
a) Specimen geometry

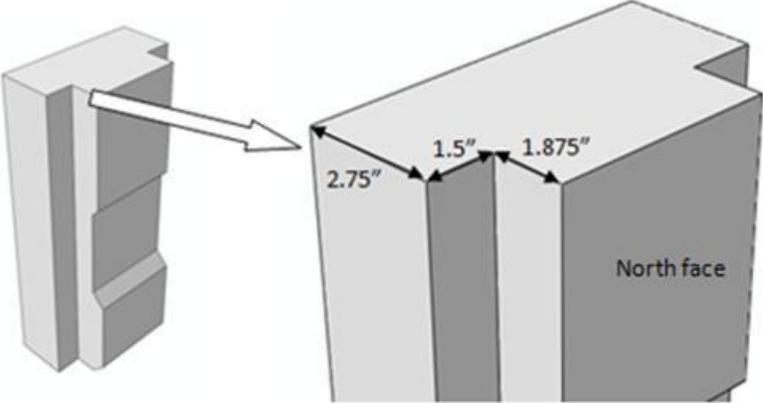
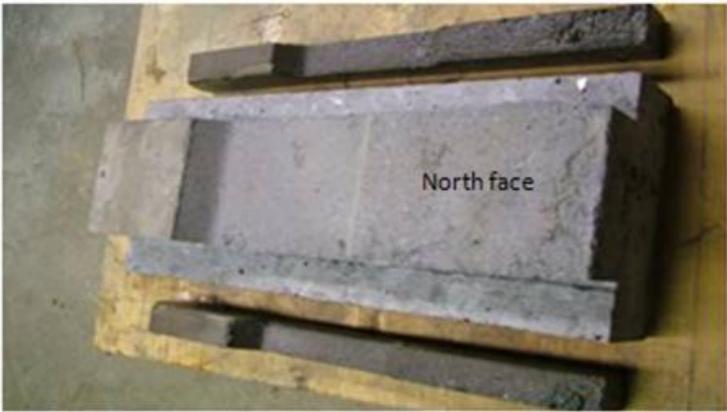
a) Modified shear key specimen geometry

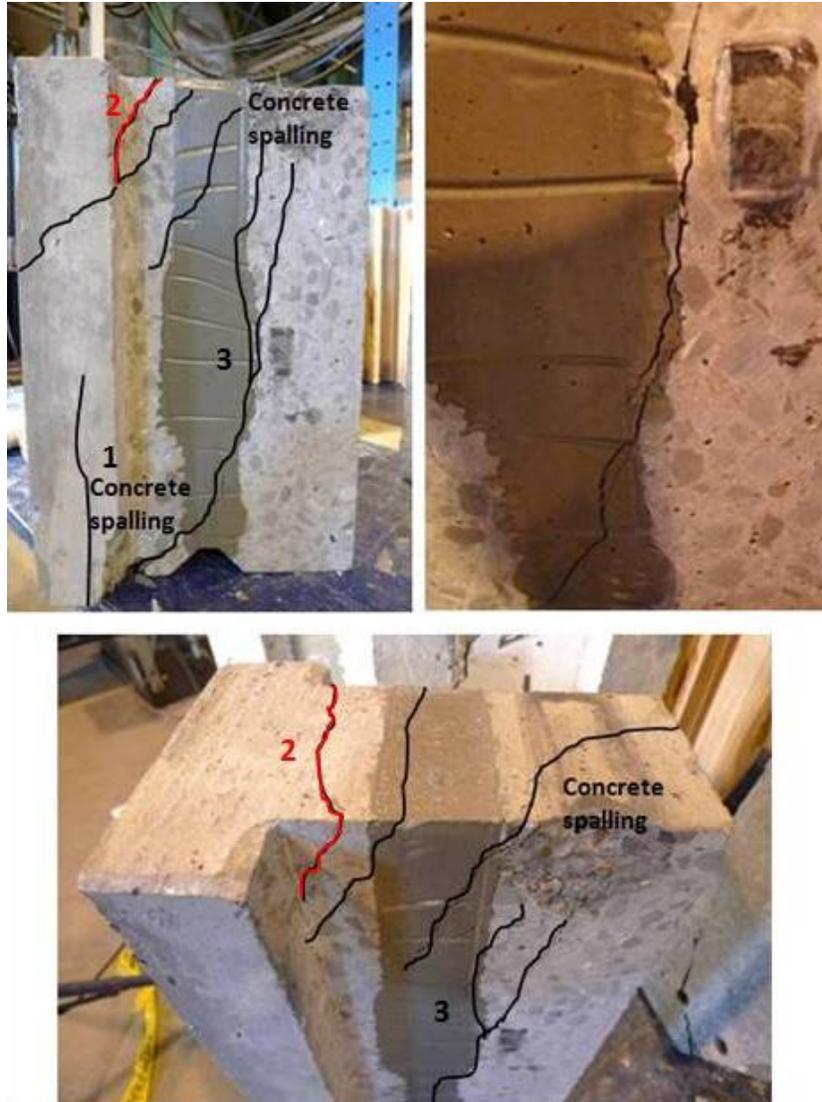
Figure 2.25 Crack patterns of a typical epoxy-based grout shear key specimen tested in shear
