# Determining More Effective Approaches for Grouting Shear Keys of Adjacent Box Beams

FINAL REPORT

COMMONWEALTH OF PENNSYLVANIA  
DEPARTMENT OF TRANSPORTATION

CONTRACT No. 510602  
PROJECT No. PSU 014

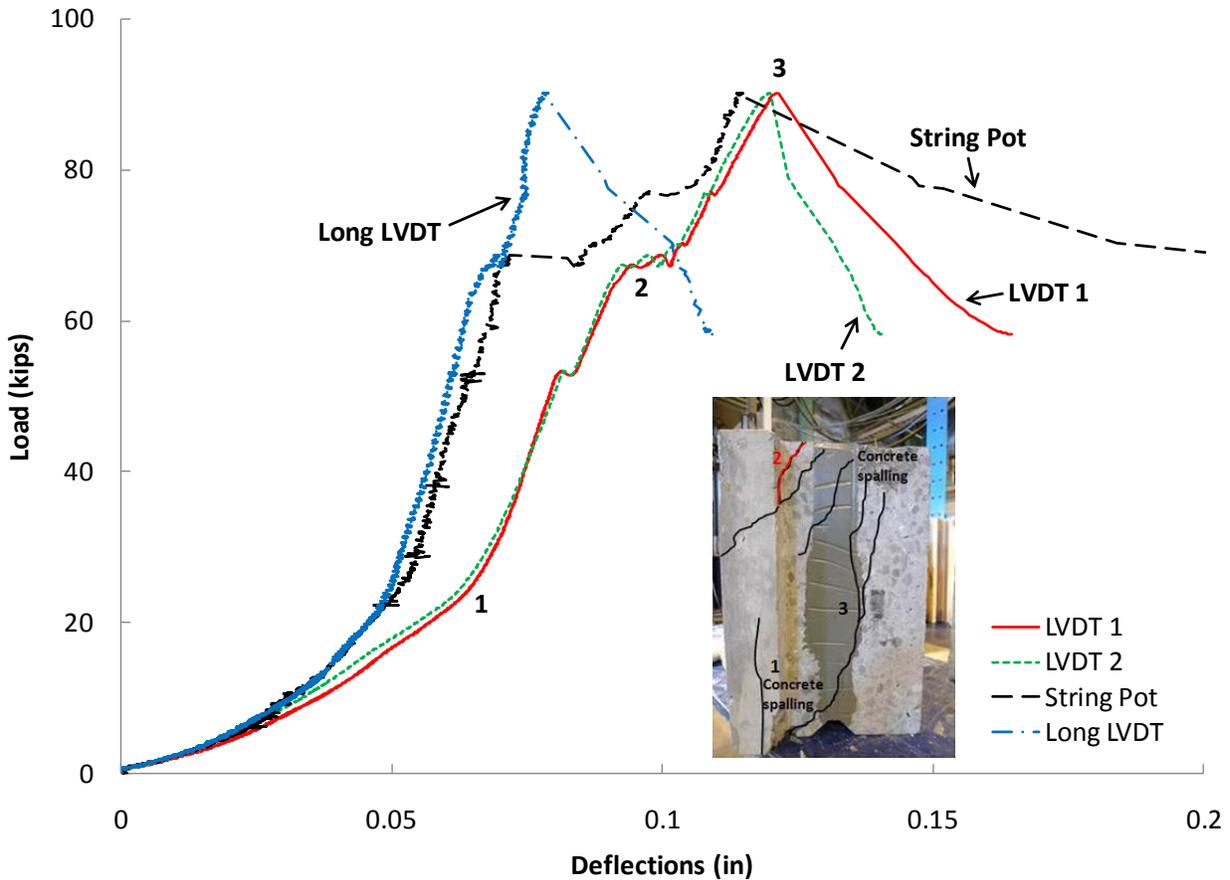
Figure 2.26 Load-deflection of the epoxy-based grout shear key specimen tested in shear

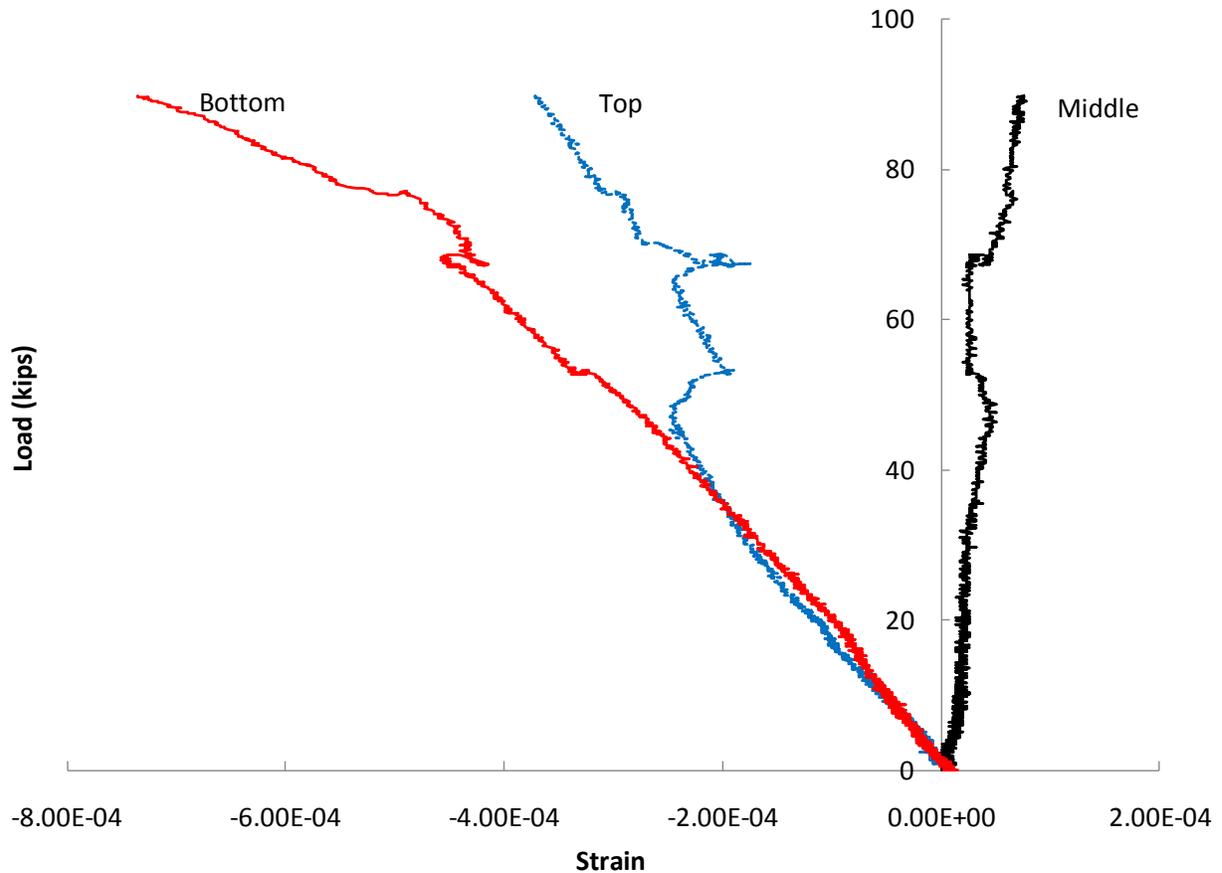
Figure 2.27 Load-strain curves of the epoxy-based grout shear key specimen

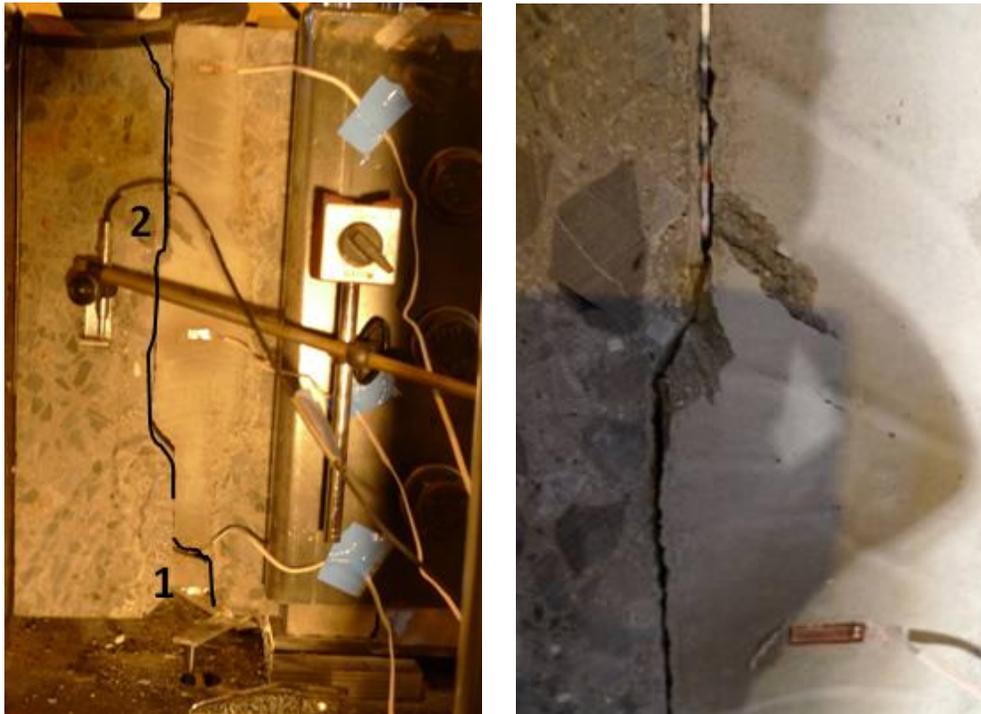
(a) cracks along the shear key interface      (b) bearing failure between two surfaces  
Figure 2.28 Crack patterns of a typical cementitious-grout shear key specimen tested in shear

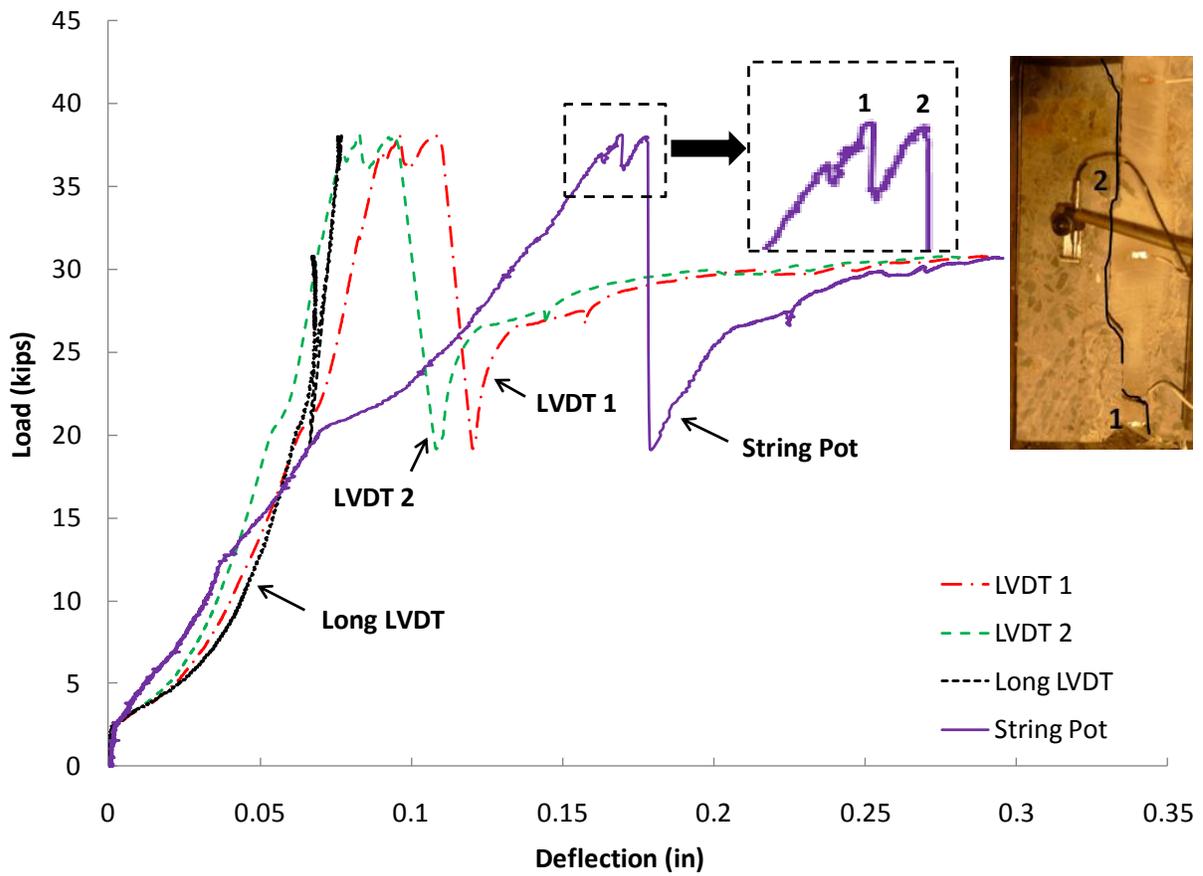
Figure 2.29 Load-deflection of the cementitious grout shear key specimen tested in shear

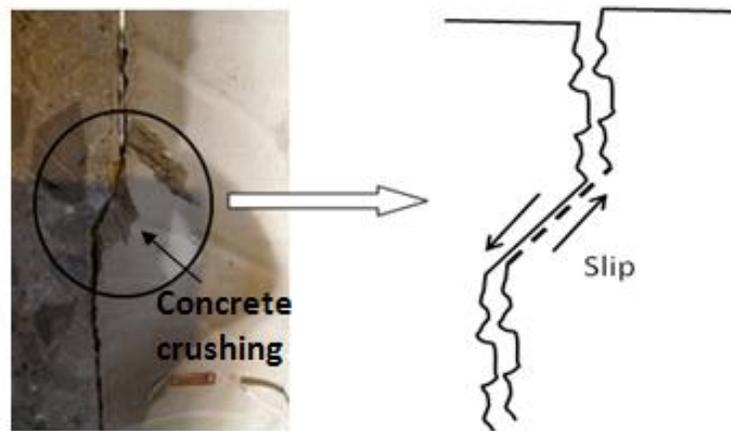
Figure 2.30 Bearing and slip failure mechanisms at the shear key interface

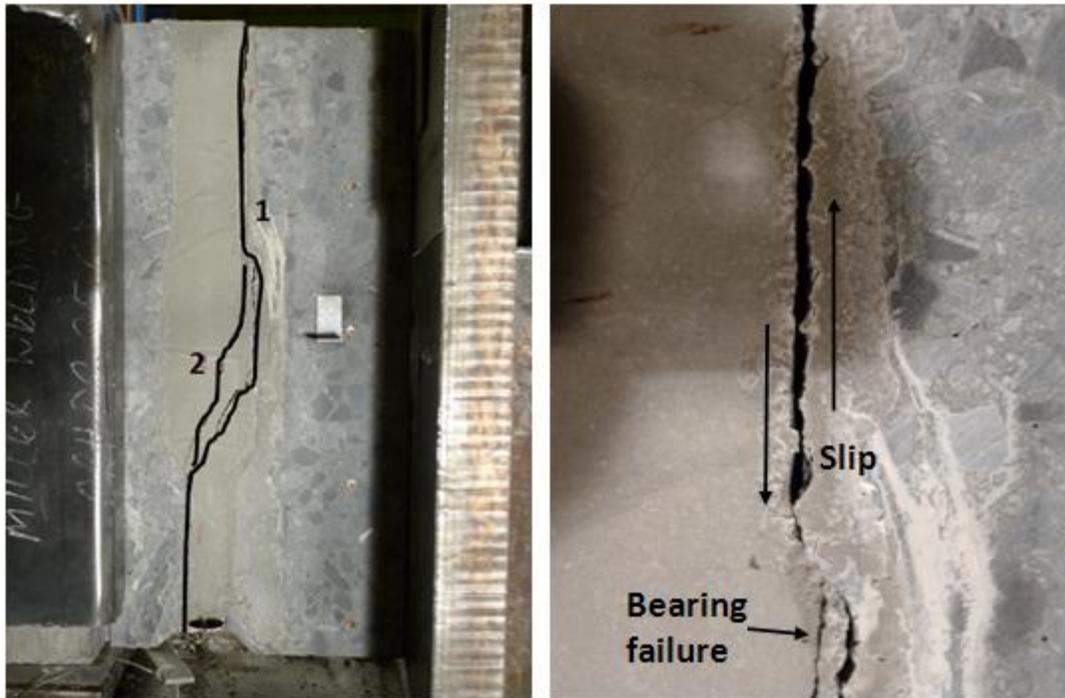
Figure 2.31 Photographs of the crack pattern observed in the second cementitious grout specimen

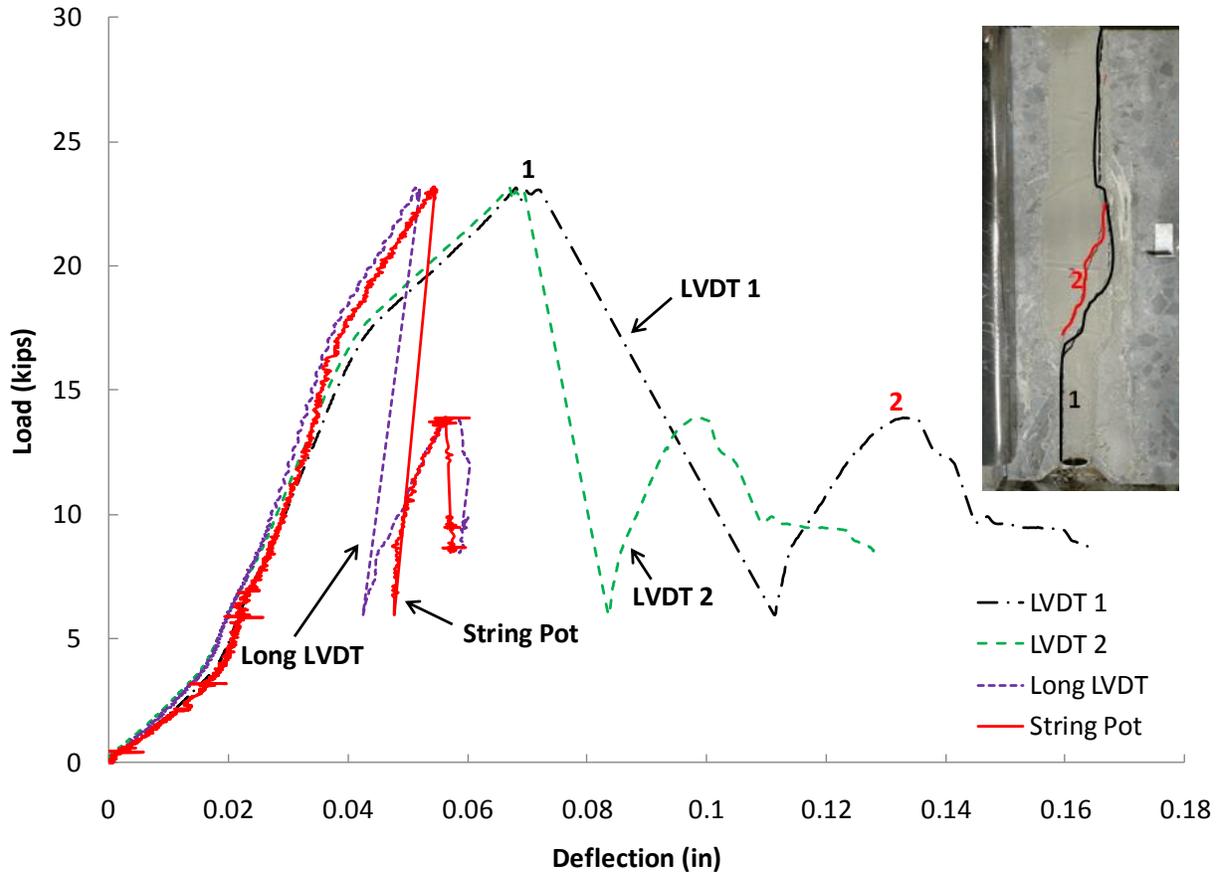
Figure 2.32 Load deflection plot of the second cementitious grout specimen

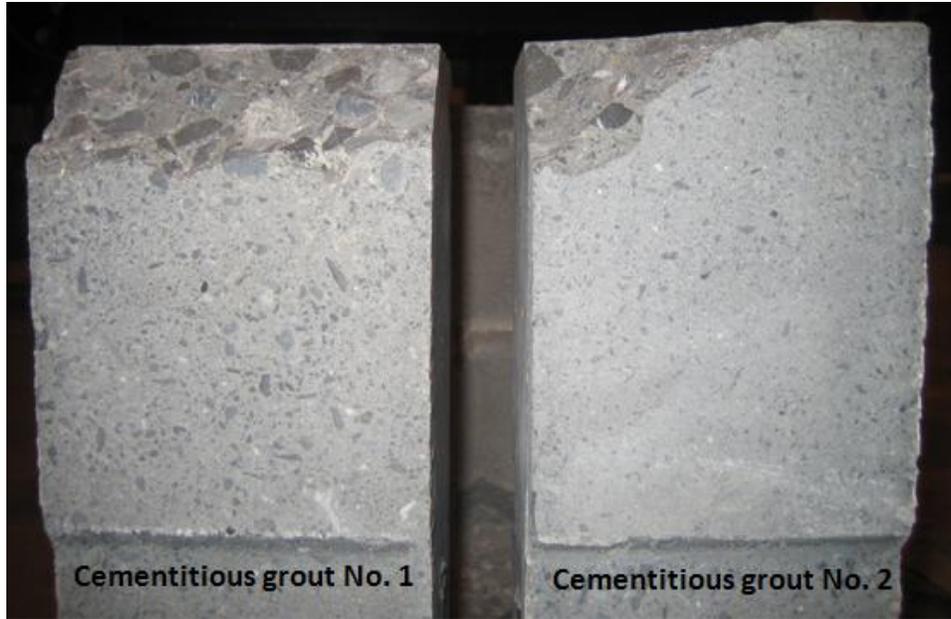
Figure 2.33 Differences in sand-blasted surfaces between two cementitious grout shear key specimens

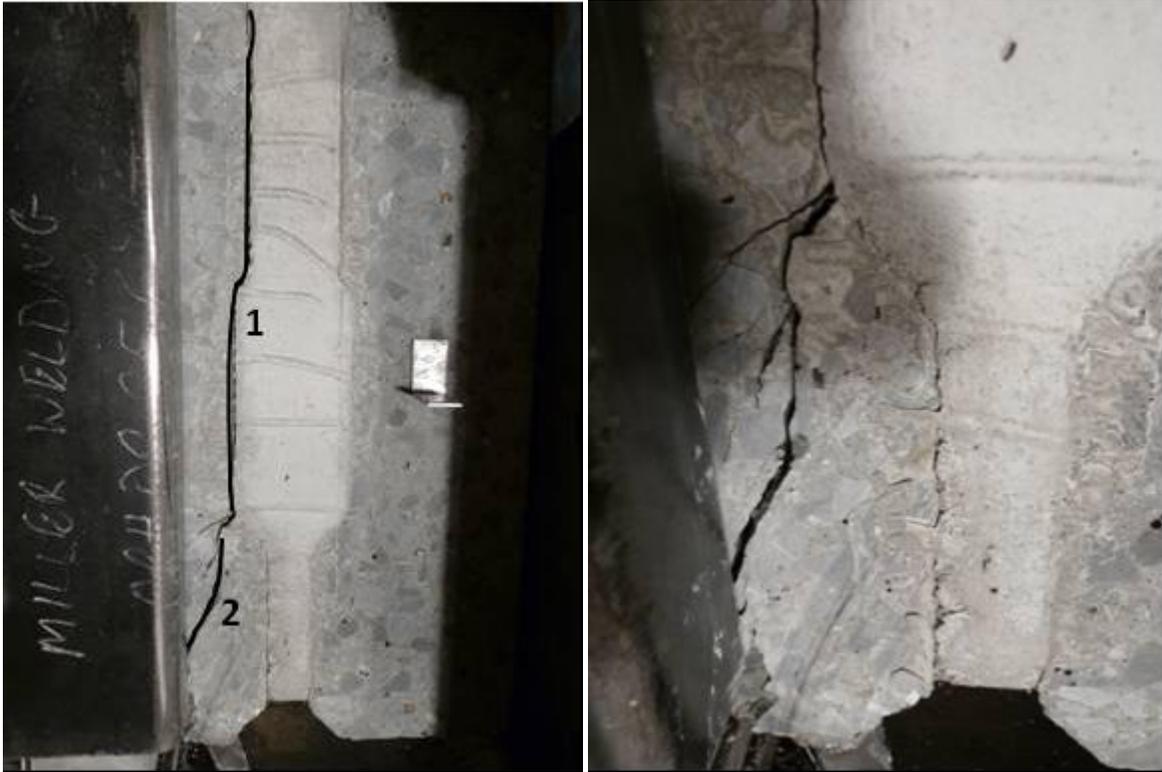
Figure 2.34 Failure of fiber-reinforced cementitious grout specimen

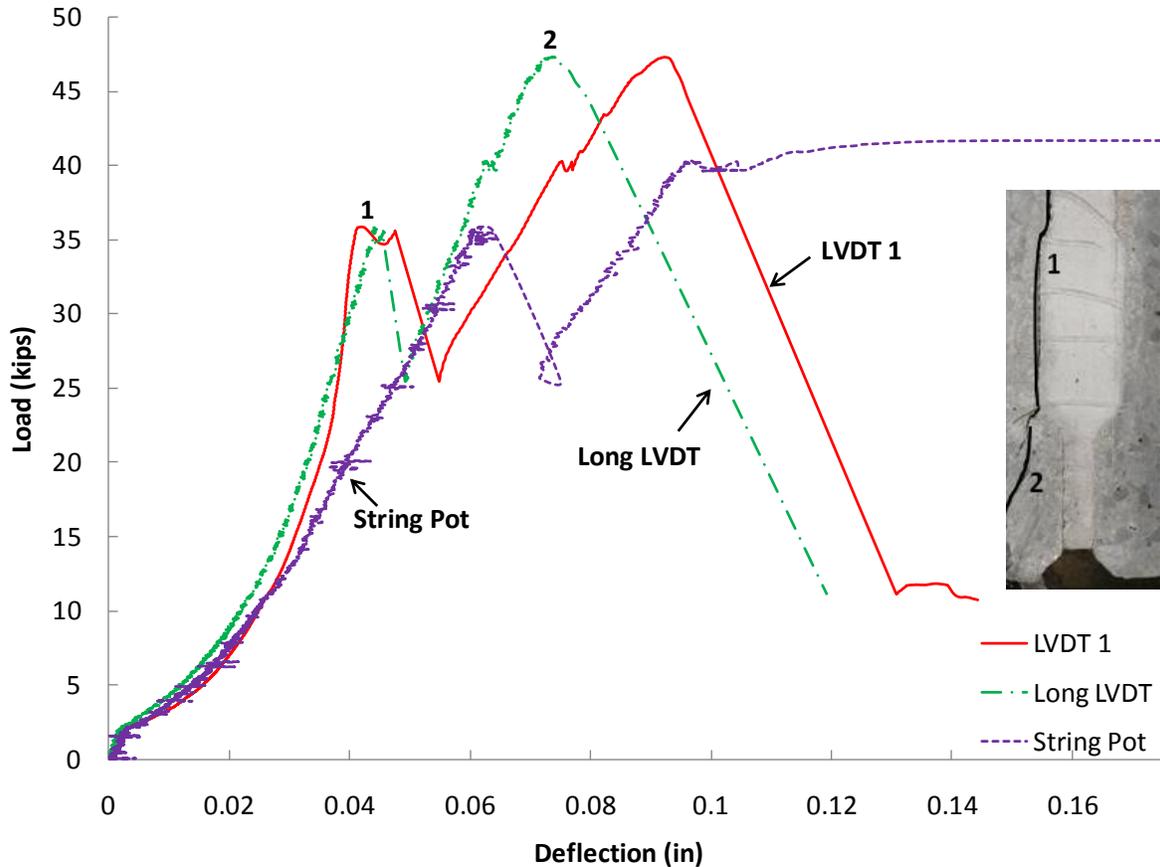
Figure 2.35 Load deflection plot of the fiber-reinforced cementitious grout specimen

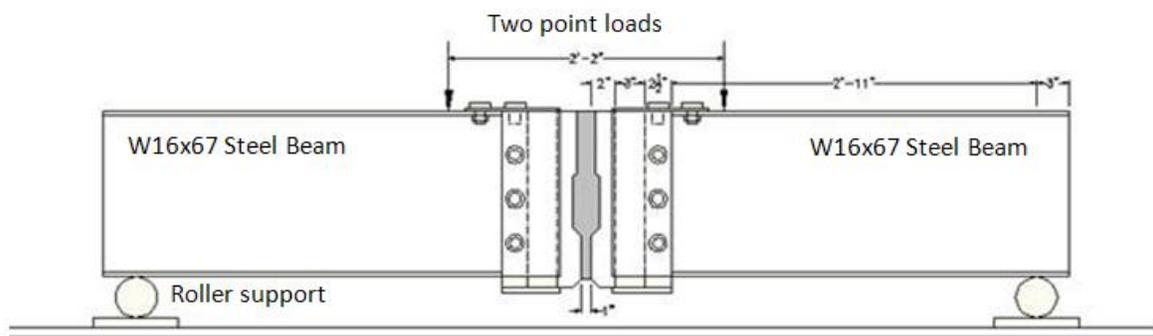
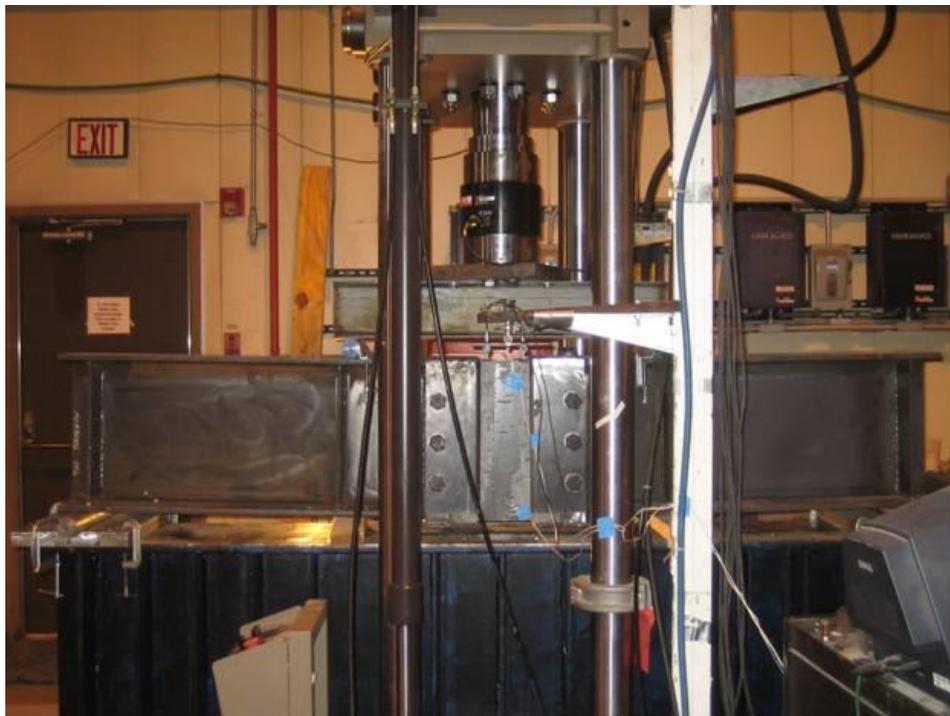
Figure 2.36 Flexure test setup

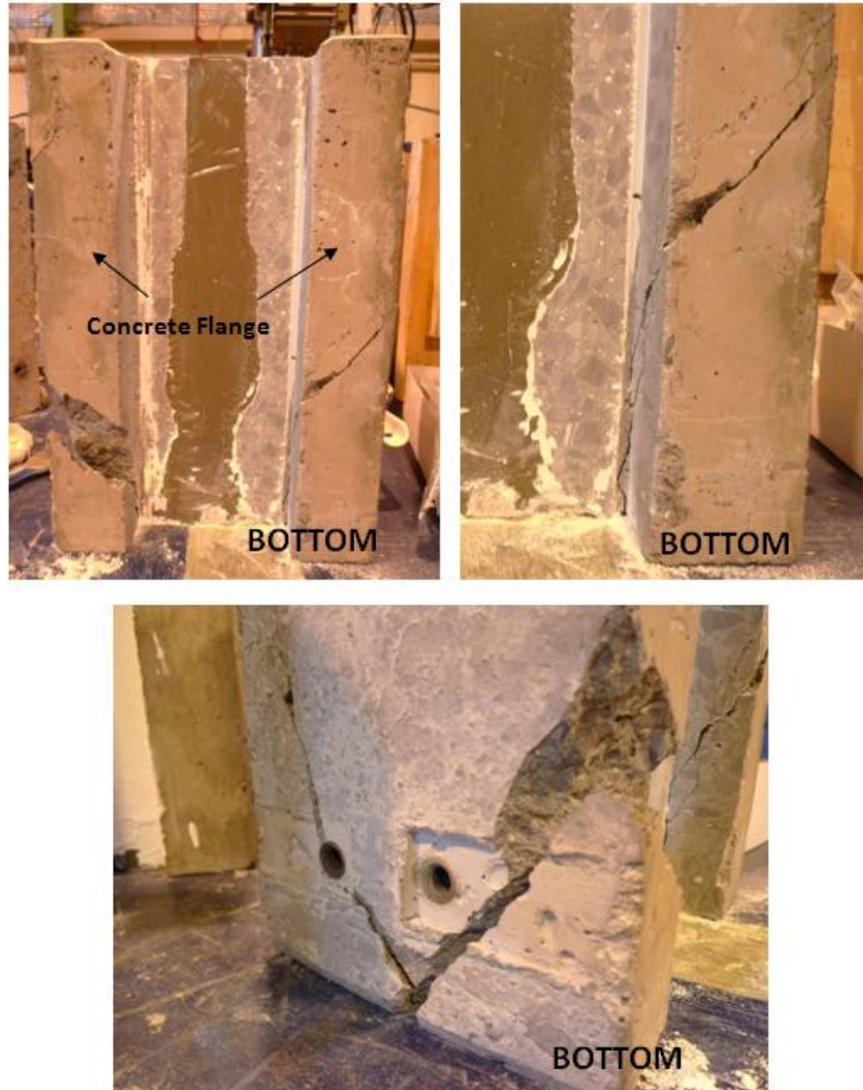
Figure 2.38 Failure mode of the epoxy grout specimen tested in flexure

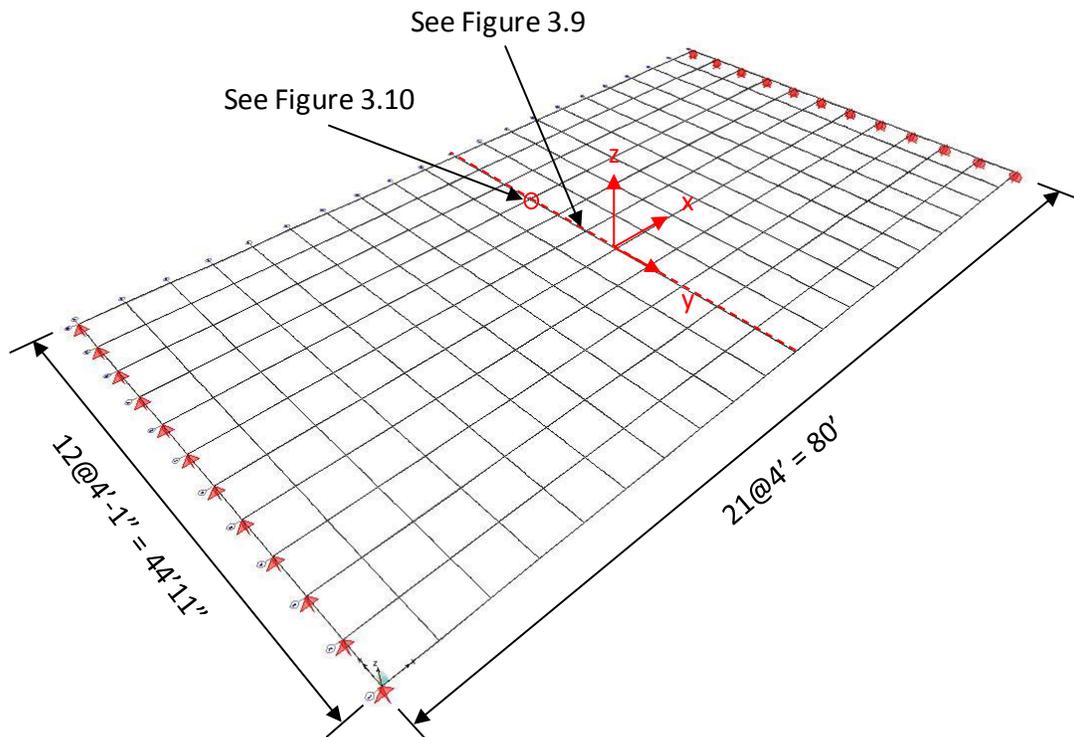
Figure 3.3 Grillage analysis model

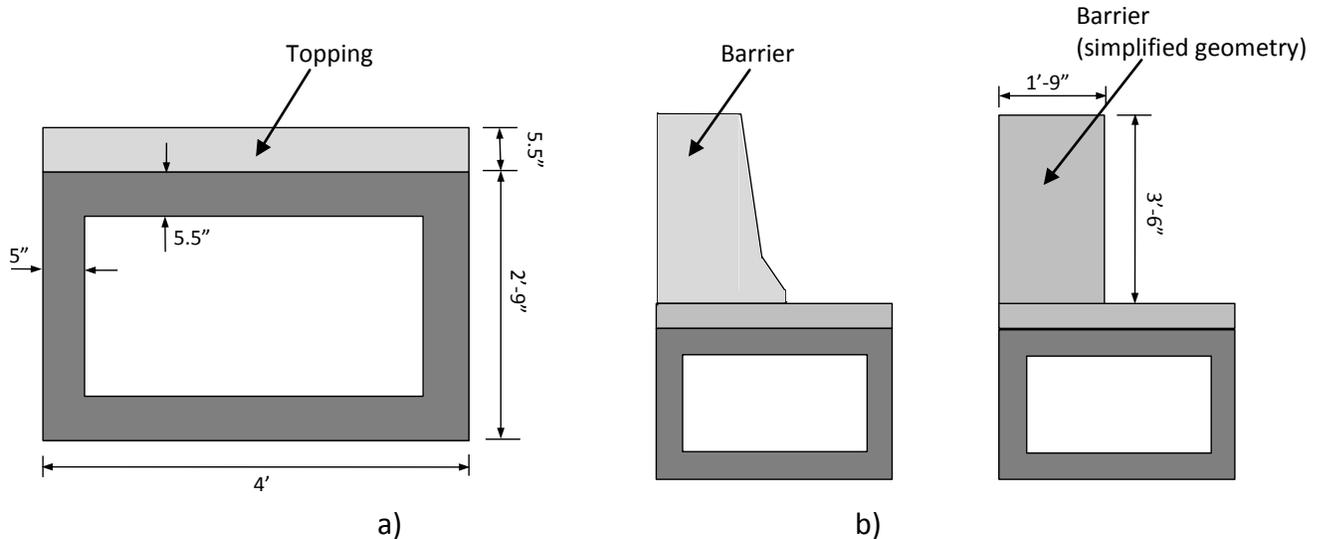
Figure 3.4 Cross section of typical longitudinal members in the grillage analysis:  
a) Interior box beam; b) Exterior box beam (as-is and simplified rectangular section)

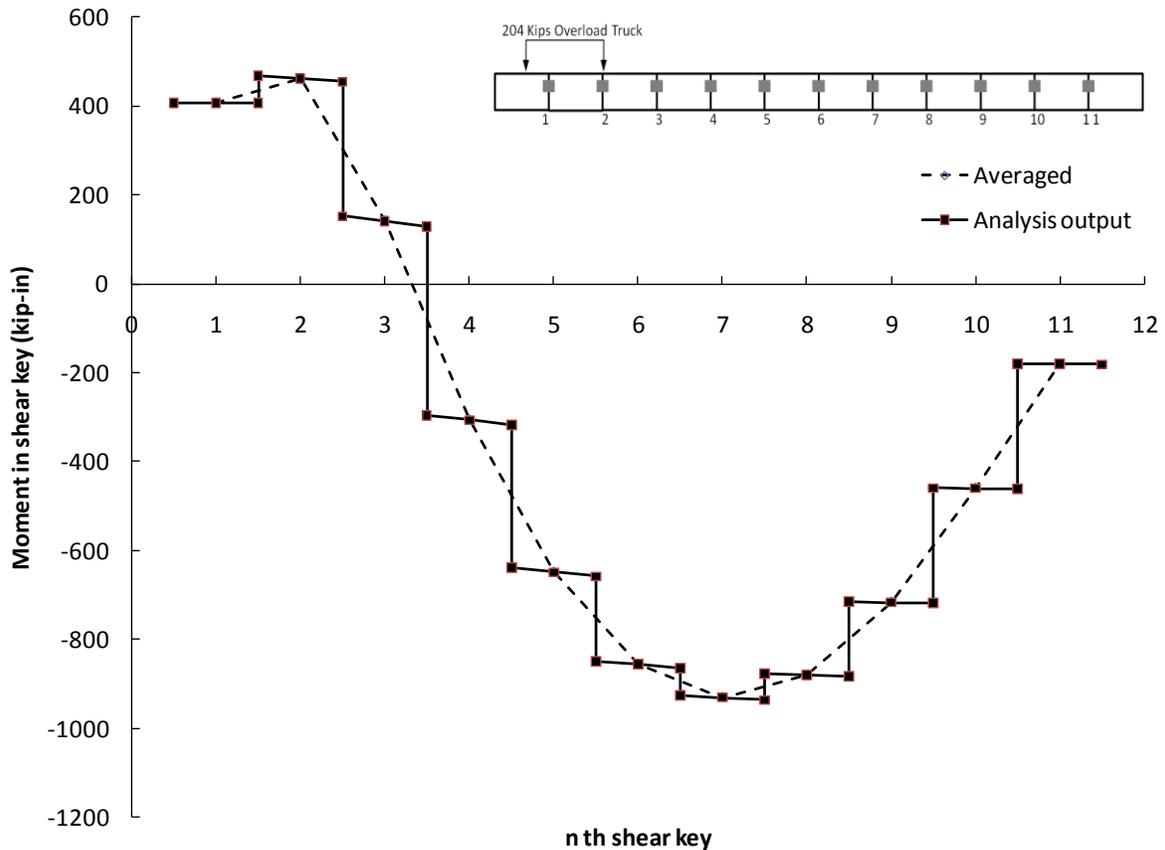
Figure 3.10 Transverse moments in shear key regions

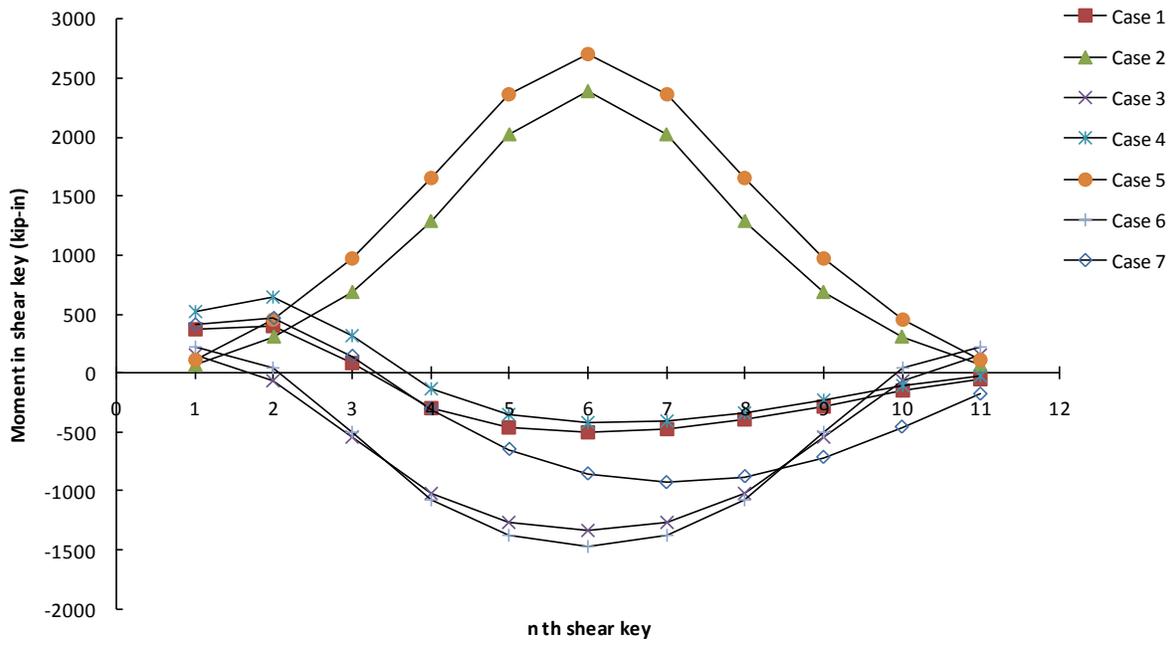
Figure 3.11 Average moment in shear keys for all load cases

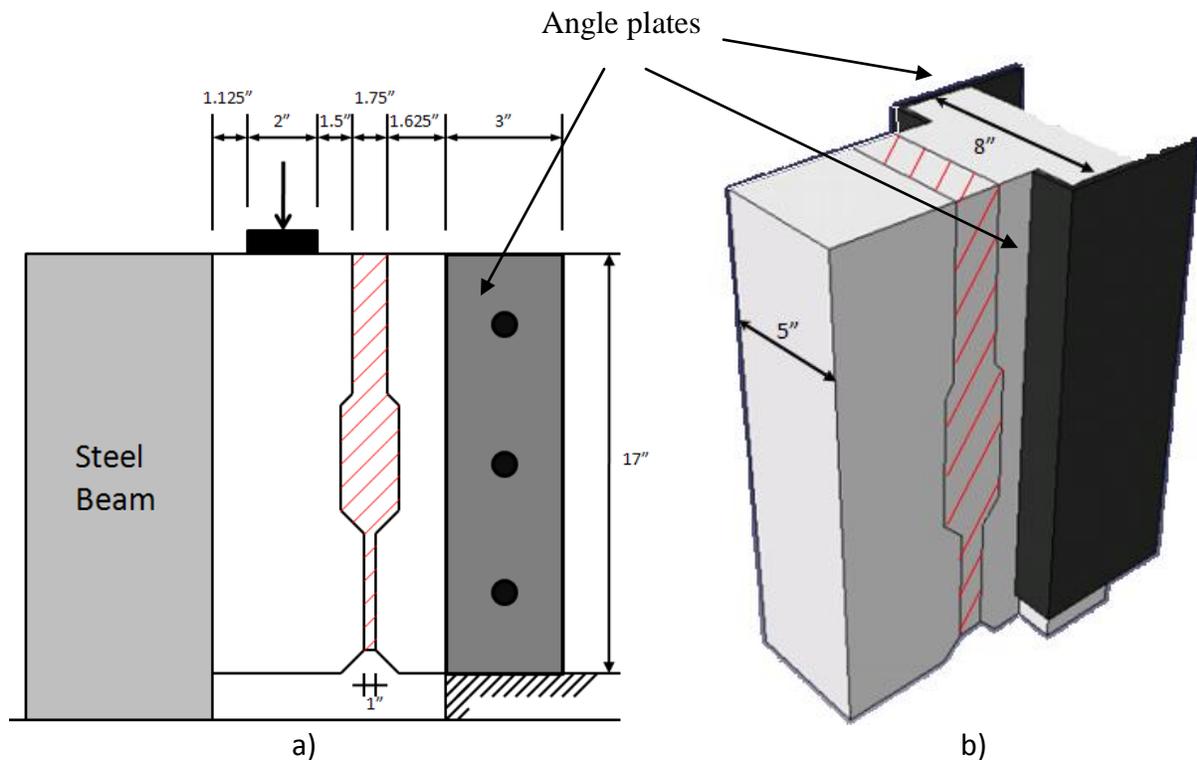
Figure 4.1 a) Front view and b) 3-dimensional rendering of the experimental shear test

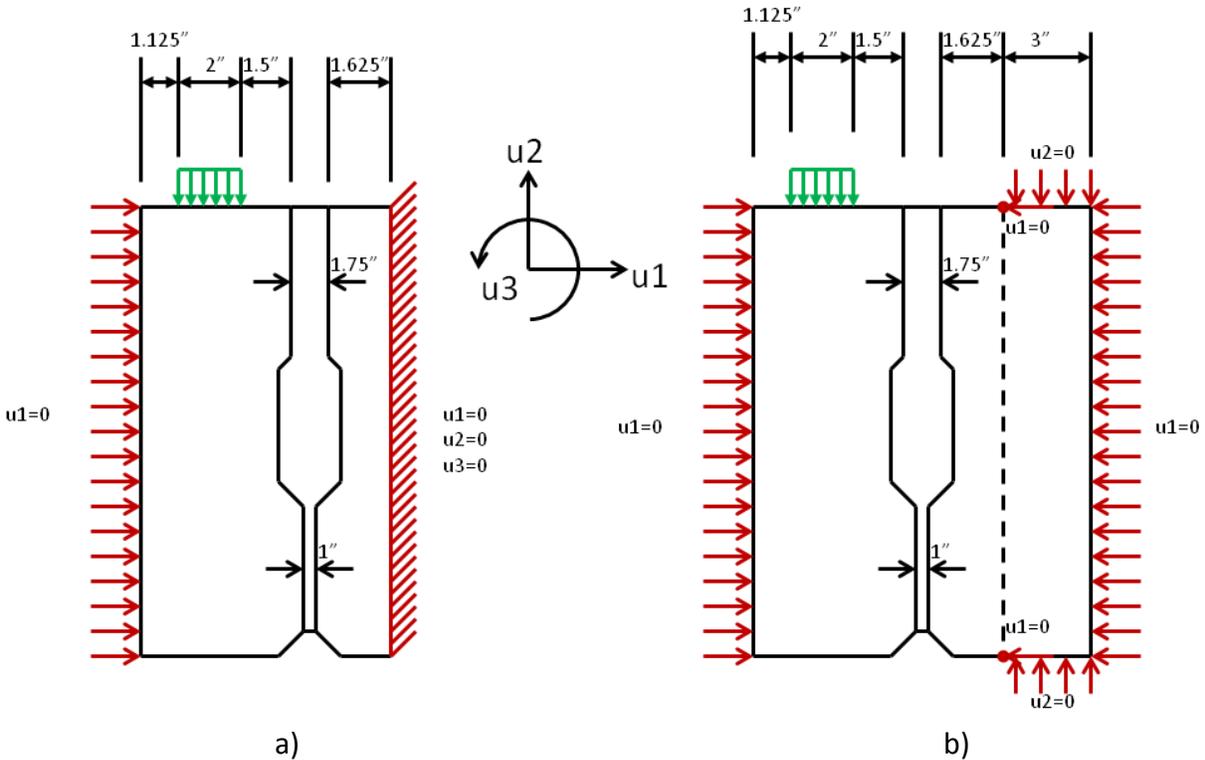
Figure 4.2 Two FE models of the shear test (boundary conditions differ)

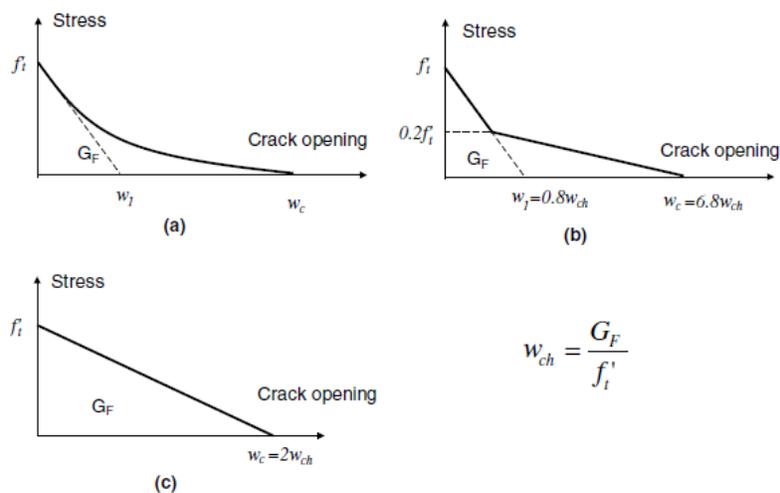
Figure 4.4 Softening model for concrete (Coronado and Lopez 2006)

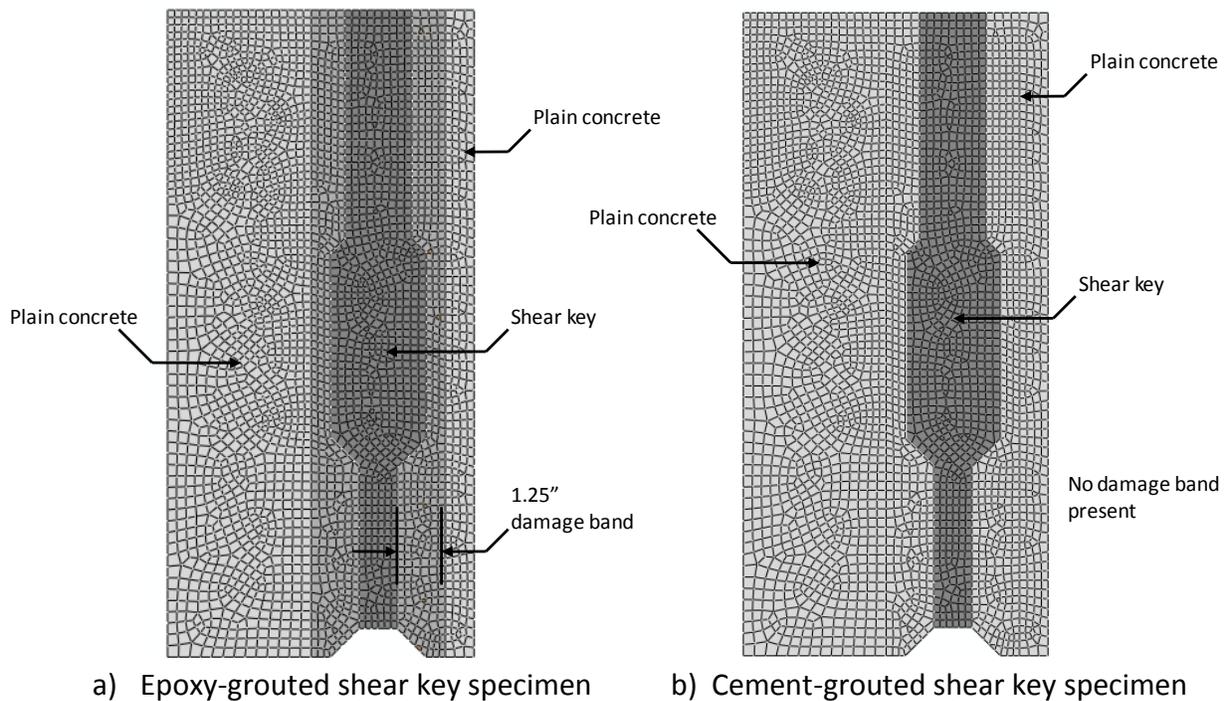
Figure 4.5 Material property assignments in the epoxy grout models

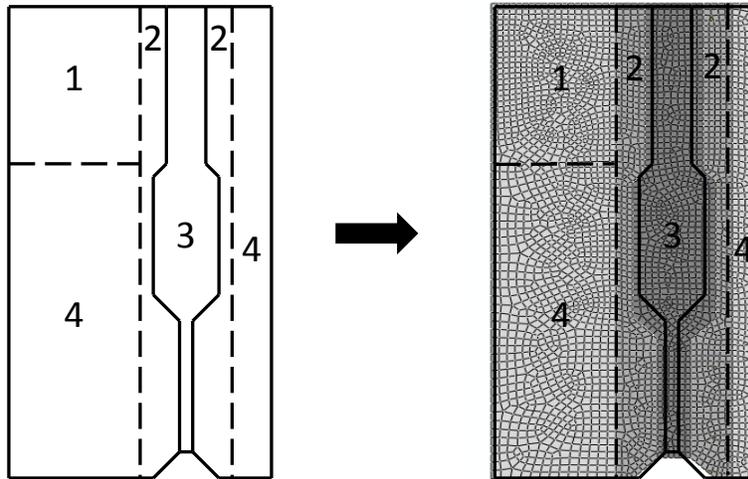
Figure 4.7 Mesh configurations for the FE model of the concrete-grout shear key specimen

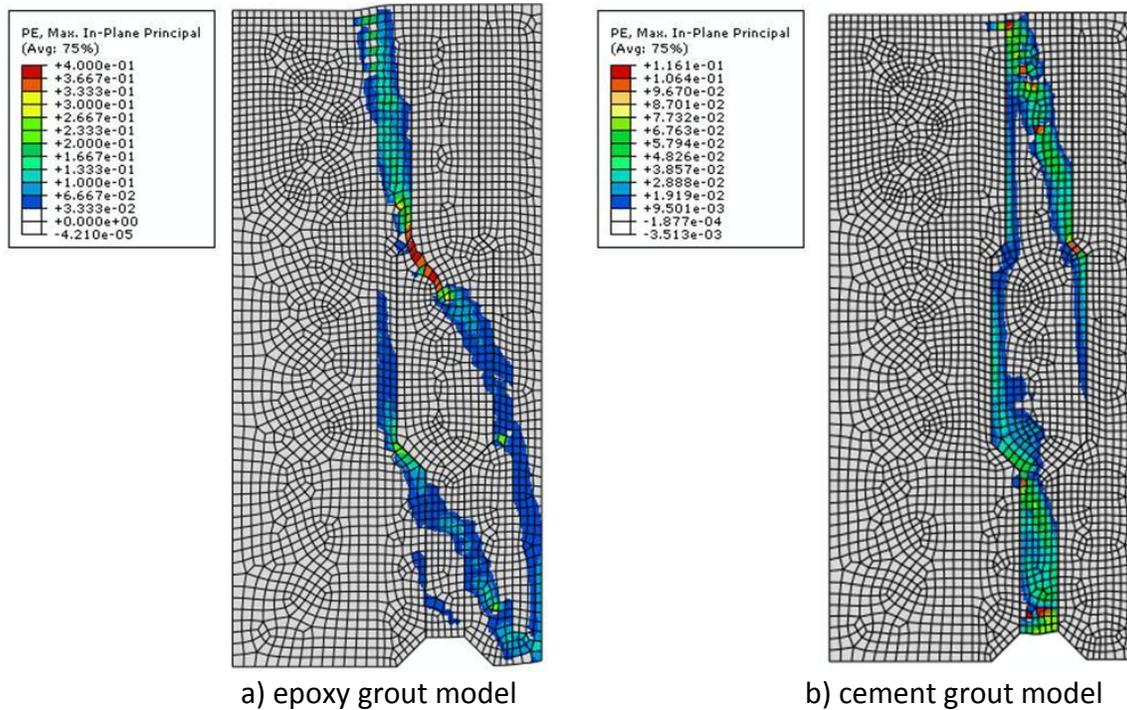
Figure 4.8 Damage regions at failure for epoxy and cement grout models

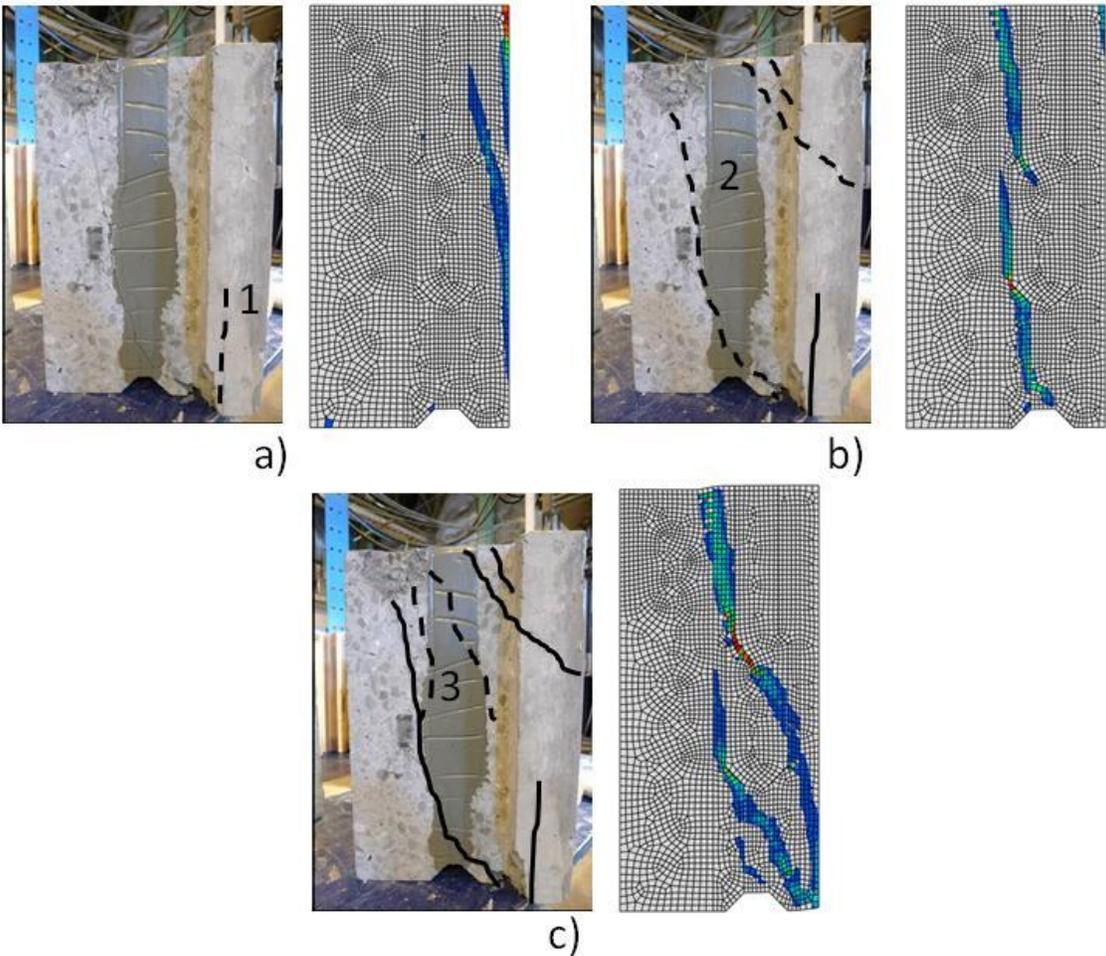
Figure 4.9 Crack sequence of the experimental and numerical shear test of epoxy grout:  
a) Step 1; b) Step 2; c) Step 3

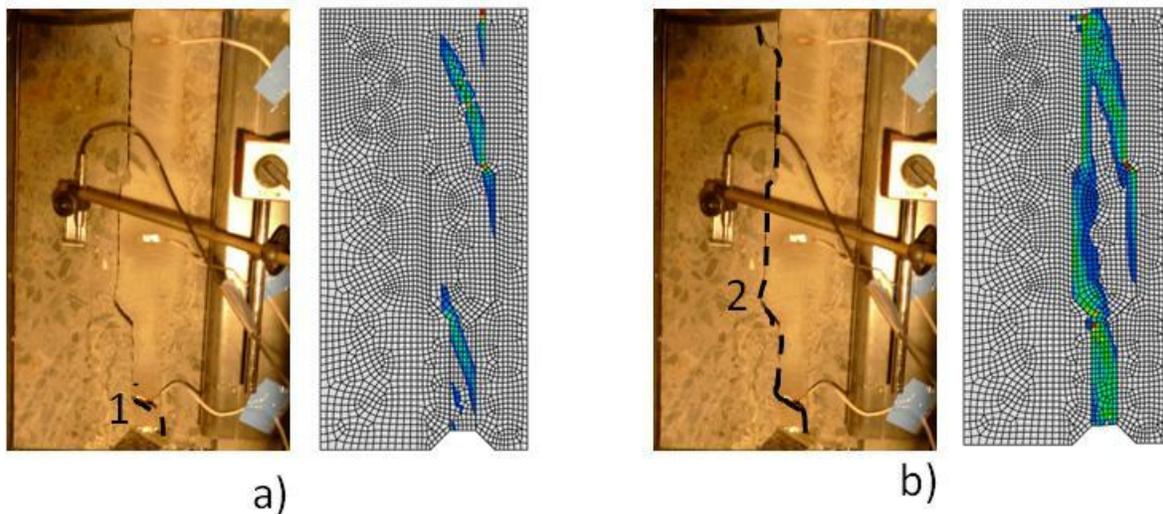
Figure 4.10 Crack sequence of the experimental and numerical shear test of cementitious grout: a) Step 1; b) Step 2

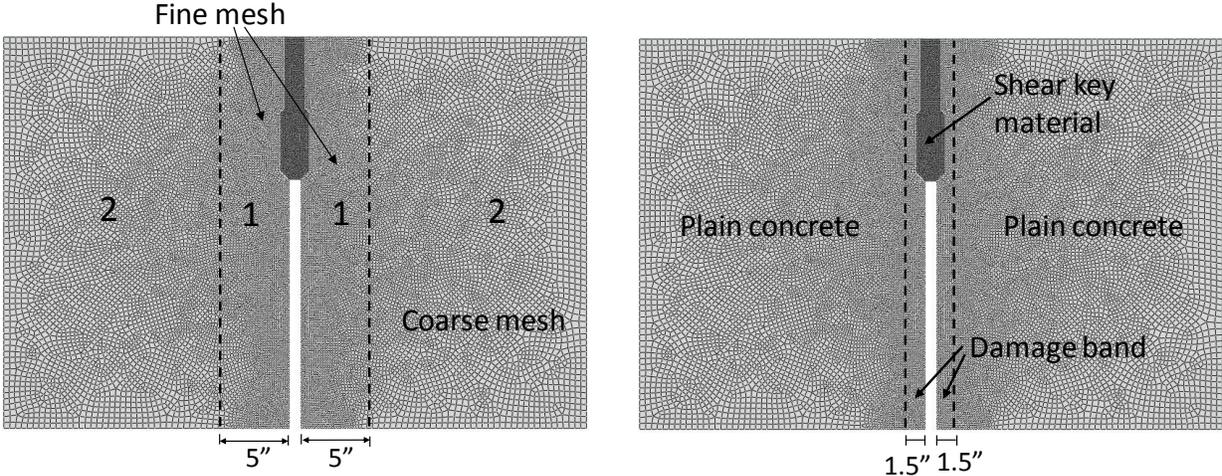
Figure 4.12 a) Mesh configuration of the shear key FE model; b) Material used in the shear key FE model

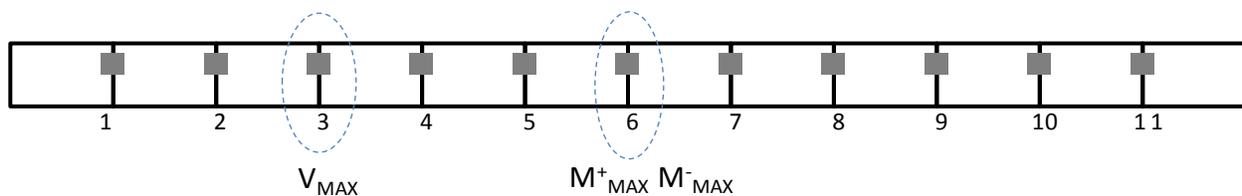
Figure 4.13 Location of shear keys along the transverse direction of the bridge

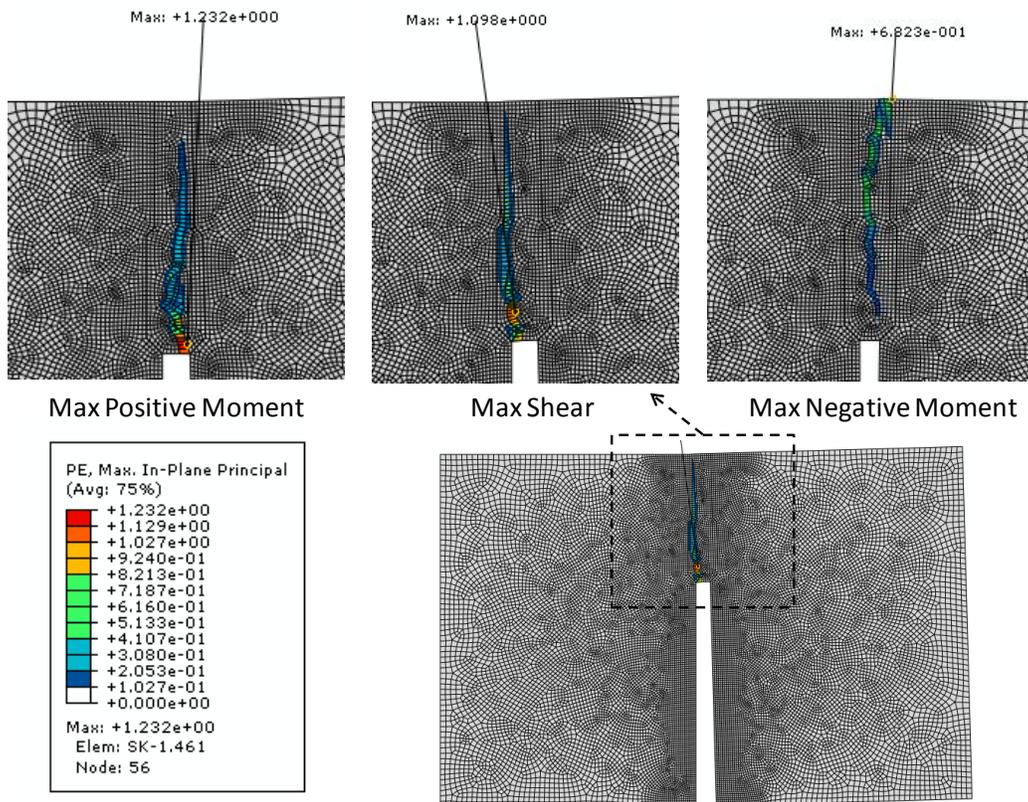
Figure 4.14 Crack patterns of a partial depth shear key with cementitious grout under the three maximum load cases

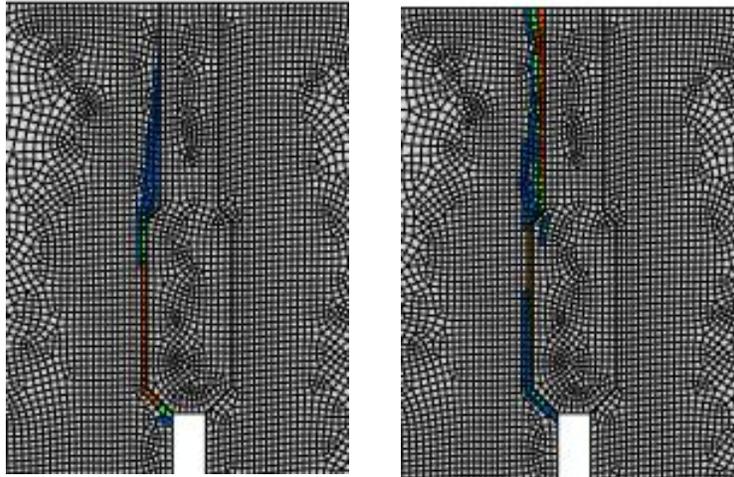
a) maximum positive moments    b) maximum negative moments  
 Figure 4.15 Crack patterns of partial-depth epoxy grout shear key

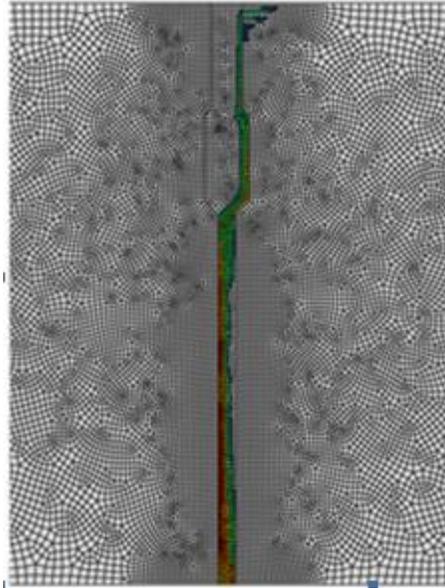
Figure 4.16 Plastic strain (crack patterns) of cementitious grout full-depth shear key

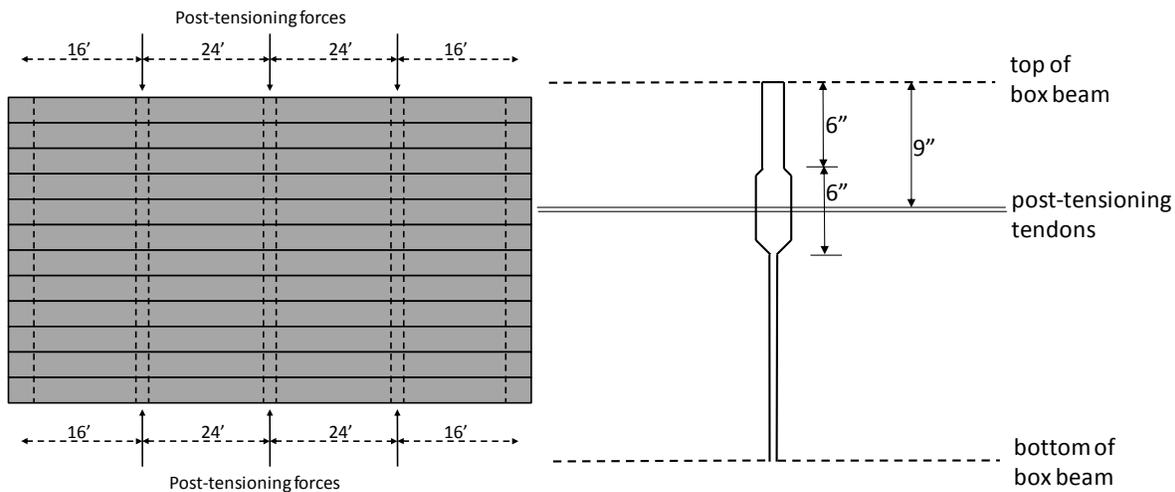
Figure 4.17 a) Transverse post-tensioning layout for the prototype bridge, b) Location of post-tensioning in the shear key area
