# Determining More Effective Approaches for Grouting Shear Keys of Adjacent Box Beams

FINAL REPORT

COMMONWEALTH OF PENNSYLVANIA  
DEPARTMENT OF TRANSPORTATION

CONTRACT No. 510602  
PROJECT No. PSU 014

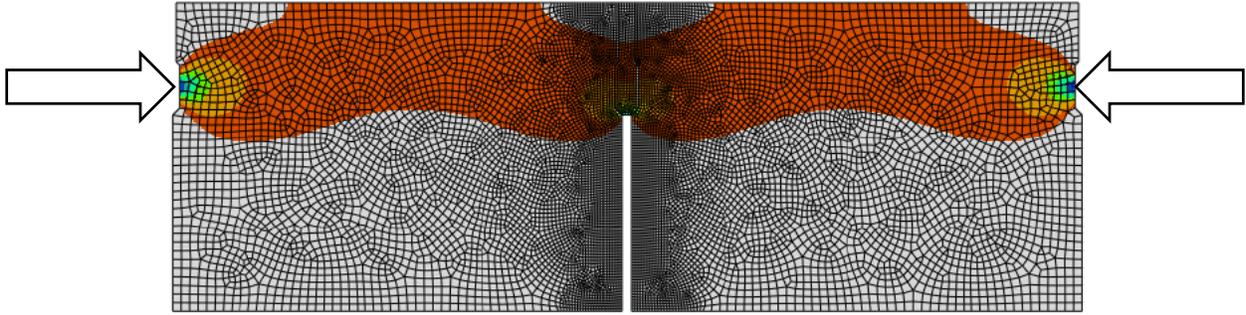
Figure 4.20 Maximum negative principal stress of a partial-depth cementitious grout shear key model under a single post-tensioning force

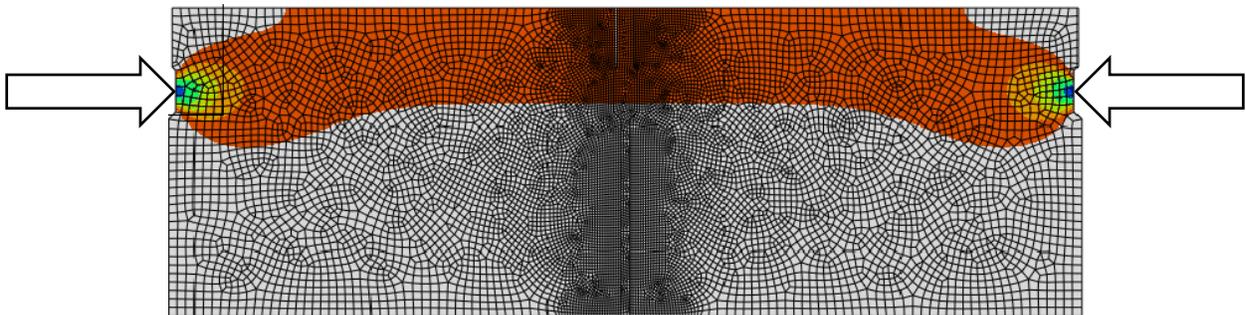
Figure 4.21 Maximum negative principal stress of a full-depth epoxy grout shear key model under one post-tensioning force

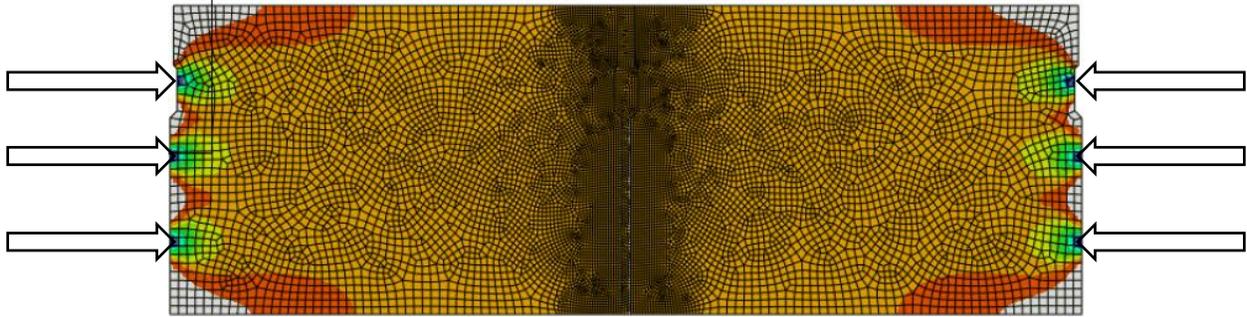
Figure 4.22 Maximum negative principal stress of a full-depth epoxy grout shear key model under three post-tensioning forces

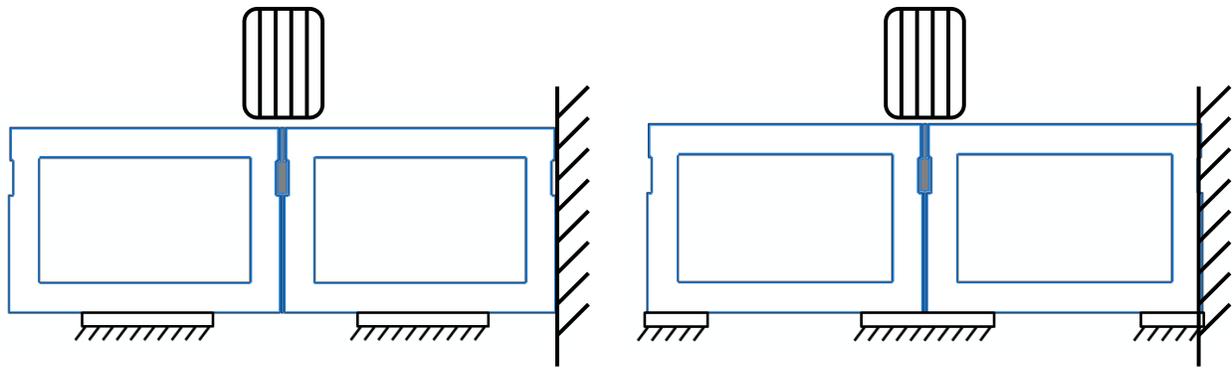
Figure 4.23 a) Bearing pad alternative 1 b) bearing pad alternative 2

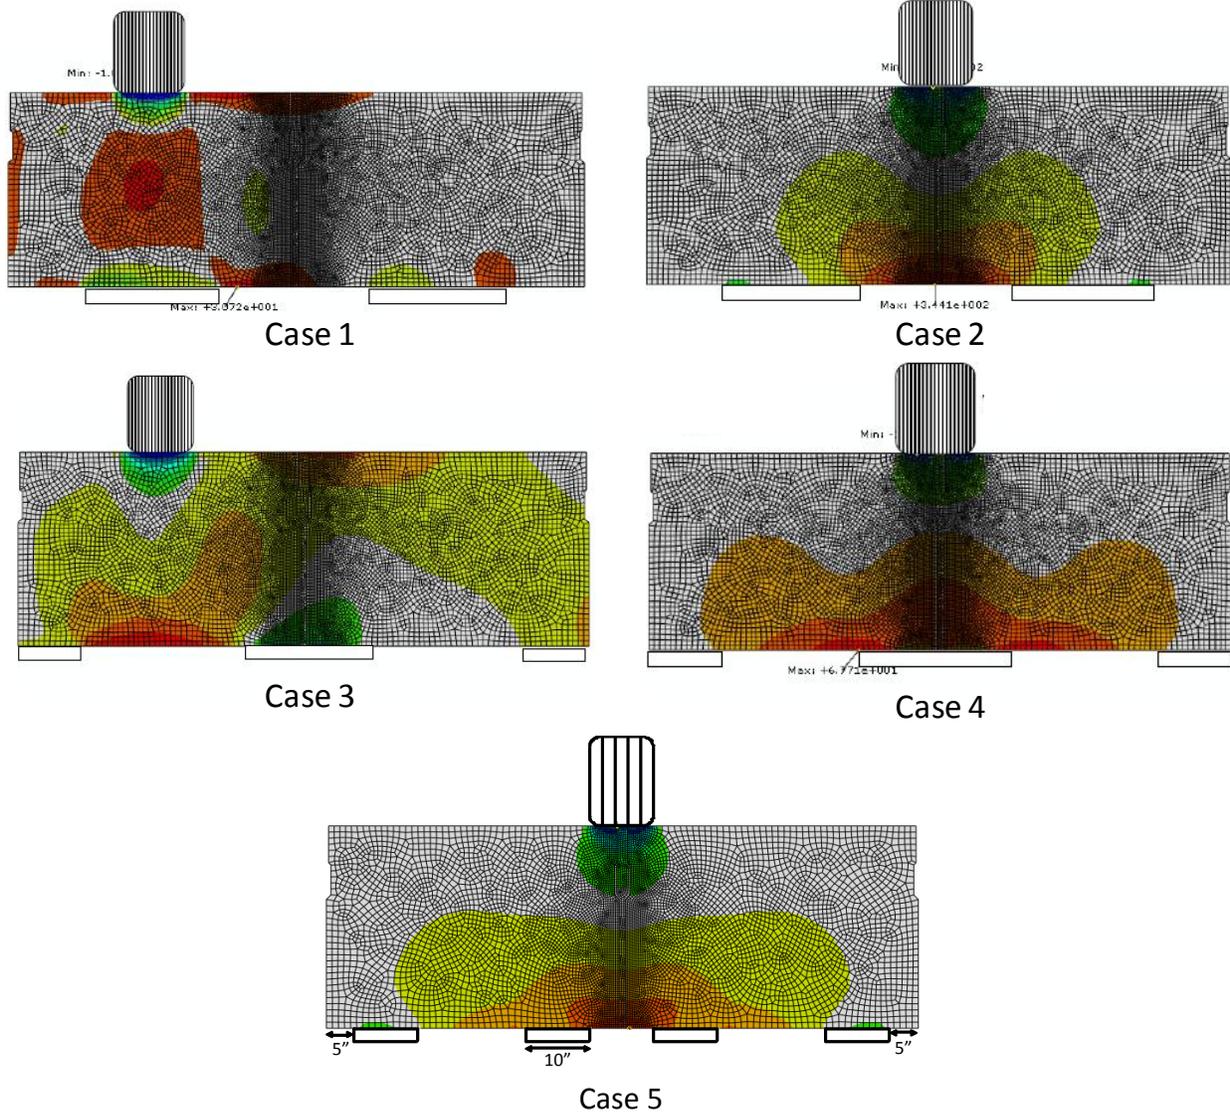
Figure 4.24 Maximum principal stress distribution of five bearing pad models
