Publication No. FHWA-RD-90-052

Aesthetic Bridge Rails, Transitions, and Terminals For Park Roads and Parkways

16. <u>Abstract</u> The objective of this project was to test aesthetic bridge rails for park roads, parkways, and other roads under Federal jurisdiction. Four designs were analyzed and evaluated: the Modified Kansas Corral bridge rail, the Forest Service glulam bridge rail, the Natchez Trace bridge rail, and the aluminum tri-rail bridge rail with sidewalk. Two designs were tested and evaluated: the Forest Service glulam bridge rail and the Modified Kansas Corral bridge rail. Two full-scale crash tests were conducted with each design. The Forest Service glulam bridge rail and the Modified Kansas Corral bridge rail passed both small sedan and pickup truck full-scale tests. Vehicle behavior during and after impact was, in all cases, acceptable. Computer simulation on the Modified Kansas Corral bridge rail and the Natchez Trace bridge rail indicated that the vehicle would be redirected with no vaulting. The Aluminum Tri-Rail bridge rail has a high snagging potential. Both the Modified Kansas Corral and Natchez Trace designs should be submitted for certification as acceptable

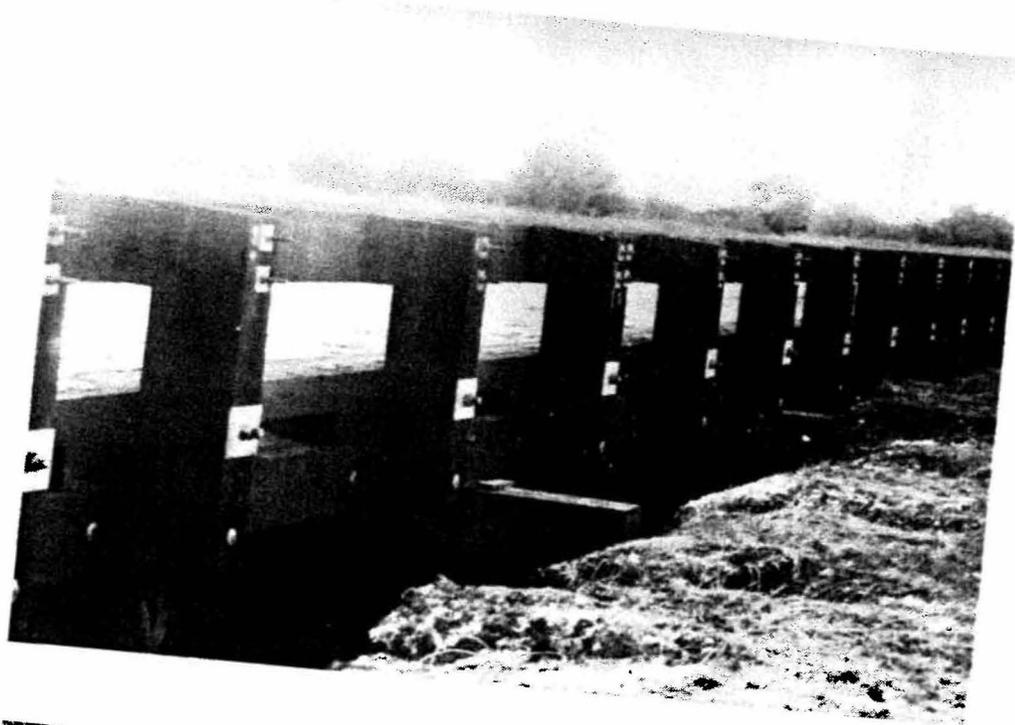
Figure 7a. Test WB-1 pre-test details.

The vehicle used in the test was a 1982 Volkswagen Rabbit. The gross test weight, including the dummy and instrumentation, was 1983 lb (900 kg). Figures 7a and 7b contain photographs of the barrier and test vehicle.

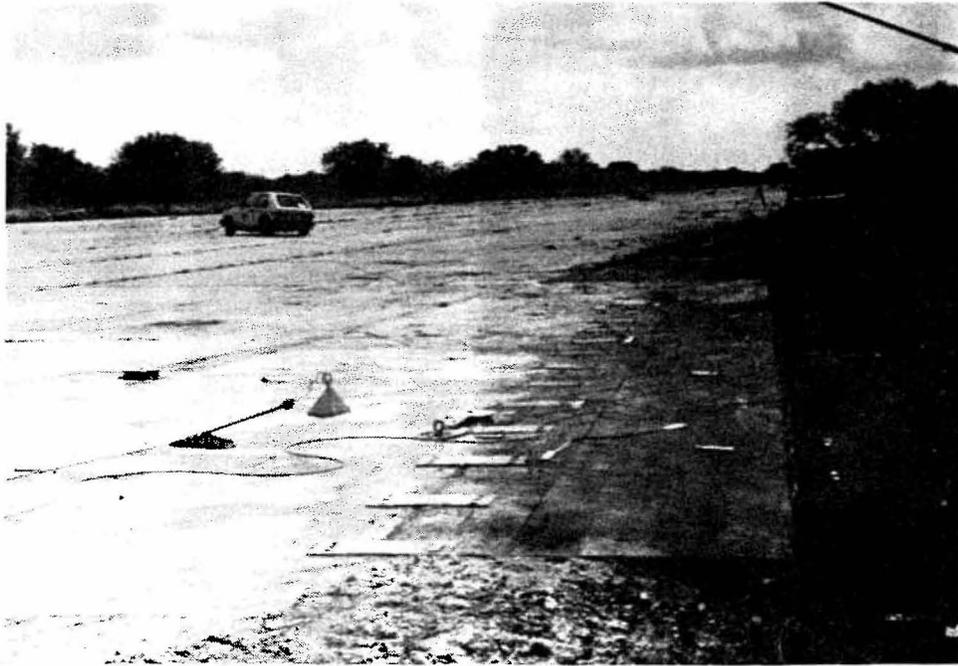
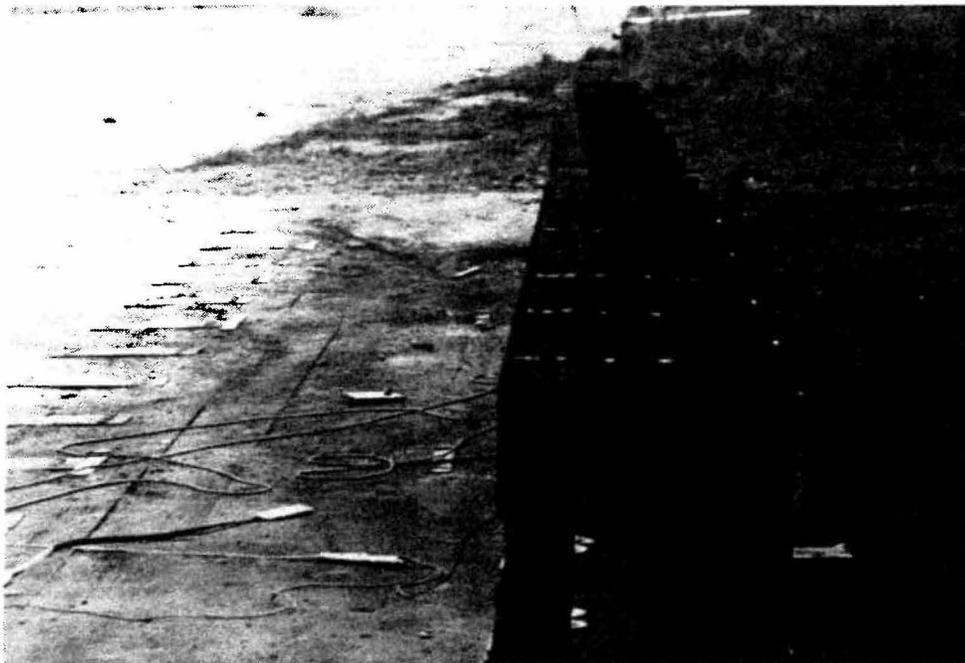
Figure 9a. Test WB-1 post-test details.

Figures 9a through 9c present photographs of damage to the vehicle and barrier. Damage to the barrier consisted of scuff marks and minor gouging on the rail and curb. Inspection of the barrier system revealed no fractured posts or beam members. Observation of the deck showed delamination between the second and third deck timbers in the impact area. The delamination of the deck occurred from the location of post 3 to post 9 with a maximum separation of 0.5 in (1.3 cm) on the top surface of the deck, approximately 3 ft (0.9 m) downstream from post 6. Maximum separation observed on the bottom surface of the deck was 0.1 in (0.3 cm). Several drive spikes in the impact affected area of the deck showed evidence of minor pullout.

Damage to the vehicle consisted of sheet metal deformation of the hood, right front fender, side, and rear fender. The windshield was cracked because of a pillar deformation. Both right side tires were blown out during impact. Vehicle damage was considered commensurate with the severity of the impact. Measurements of vehicle damage are given in table 4.

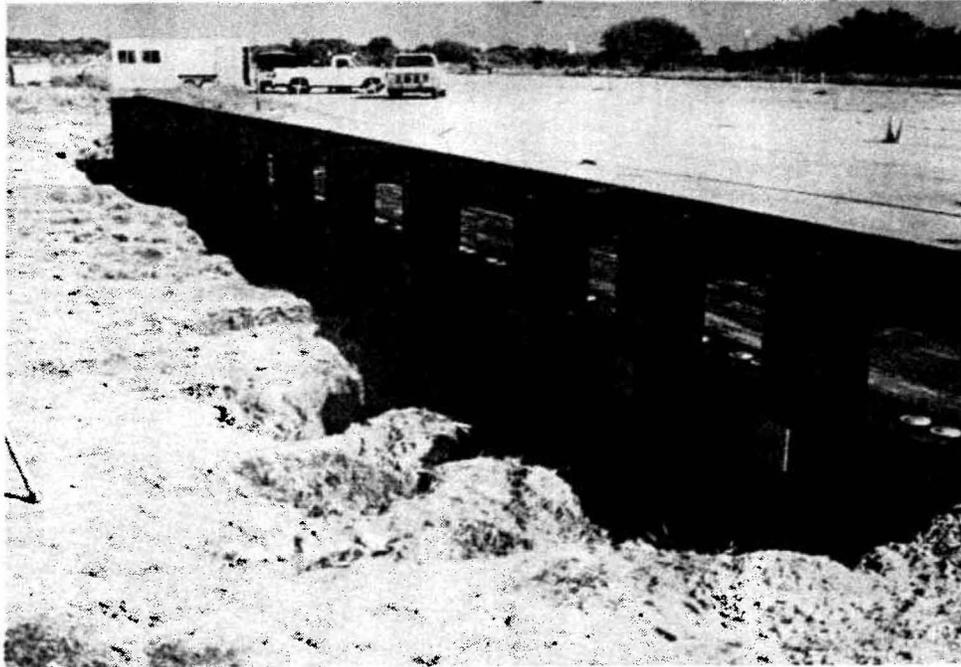
Figure 10a. Test WB-2 pre-test details.

The barrier selected was the same as that used in test WB-1. However, one deck panel with curb/rail was replaced in the impact area to ensure system integrity. The vehicle used was a 1984 Ford F150 pickup truck. The gross test weight, including the dummy and instrumentation, was 5419 lb (2458 kg). Figures 10a and 10b contain photographs of the barrier and test vehicle.

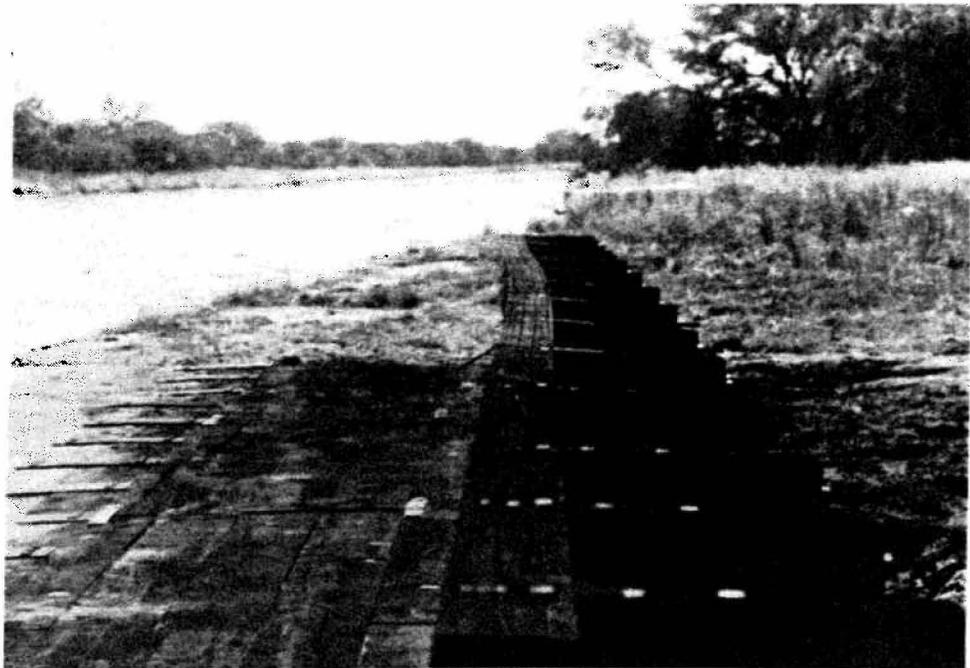
Figure 12a. Test WB-2 post-test details.

Damage to the vehicle consisted of sheet metal deformation of the right front fender, side, and rear fender. The windshield remained intact, and the right front tire was blown out during impact. The tire remained on the wheel during redirection, but became detached during subsequent vehicle retrieval from the runout path. Vehicle damage was considered commensurate with the severity of the impact. Vehicle damage measurements are contained in table 7.

Figures 12a and 12b present photographs of damage to the vehicle and barrier. Damage to the barrier consisted of scuff marks and minor gouging on the rail and curb. Inspection of the barrier system revealed no fractured posts or beam members. Observation of the deck showed delamination between the second and third deck timbers in the impact area. The delamination of the deck occurred from the location of post 3 to post 9 with a maximum separation of 0.8 in (2.0 cm) on the top surface of the deck about 3 ft (0.9 m) downstream from post 6. Maximum separation observed on the bottom surface of the deck was 0.1 in (0.3 cm). Several drive spikes in the impact affected area of the deck showed evidence of minor pullout.

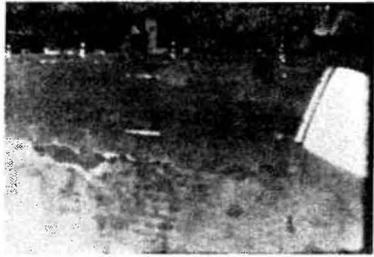
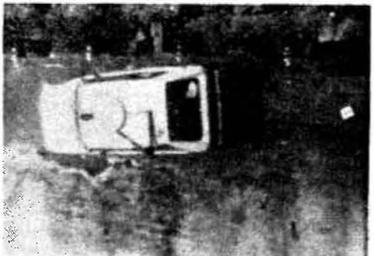
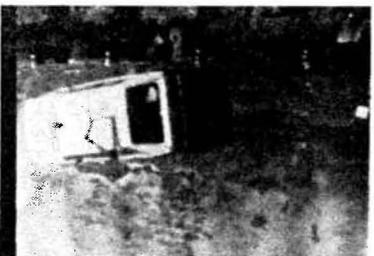
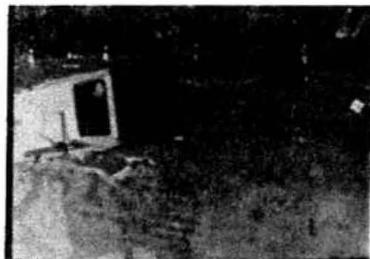
Figure 26. Sequential photographs during impact, test WB-1.

Impact conditions were 59.2 m/h (95.3 km/h) and a 20-degree impact angle. As shown in figure 26, the vehicle impacted the barrier 29 in. (73.7 cm) downstream of Post 5. The vehicle remained in contact with the barrier for 12.5-ft [3.8-m] before redirection at a -12.0 degree angle. During the impact sequence the right front tire/wheel became engaged between the top of the curb and the bottom of the rail (see figure 27). Measurements of the tire/wheel path indicated a maximum of 5 in. (13 cm) of lateral engagement. Since the curb is 12 inches (30.4 cm) wide, there was no propensity for the wheel to snag on a post during impact. No significant pitch, roll, or yaw was noted during impact and redirection. The vehicle came to rest 140 ft (43 m)

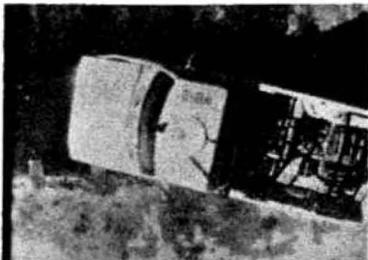
Figure 31. Sequential photographs during impact, test WB-2 (overhead view).

Impact conditions were 47.5 m/h (76.4 km/h) and a 20-degree impact angle. As shown in figure 31, the vehicle impacted the barrier midway between Post 5 and 6. The vehicle remained in contact with the barrier for 15.0-ft [4.6 m] before redirection at a -4.9 degree angle. The vehicle showed no tendency to snag on the curb or posts during the impact sequence. No significant pitch, roll, or yaw was noted during impact and redirection. The vehicle came to rest 130 ft [40 m] downstream of the impact point and 48 feet [15 m] out from the barrier plane. The vehicle brakes were applied at approximately 100 feet [30 m] after impact. Table 17 presents after impact

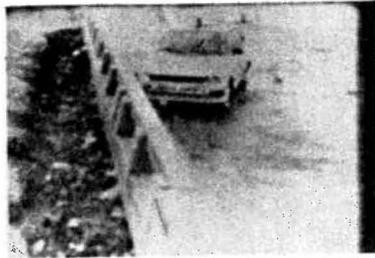
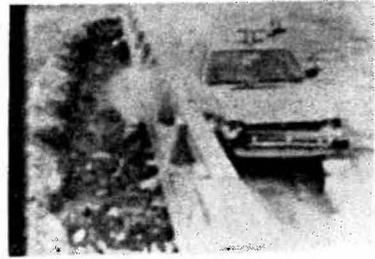
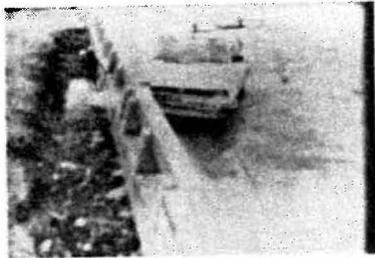
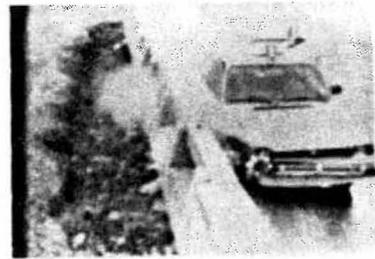
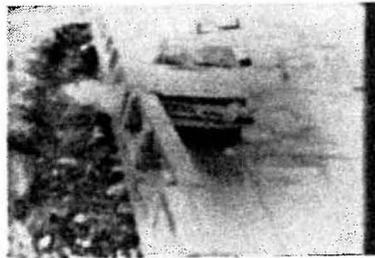
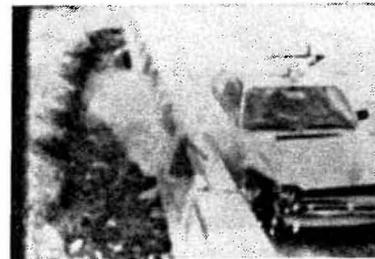
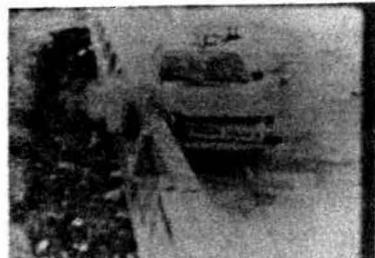
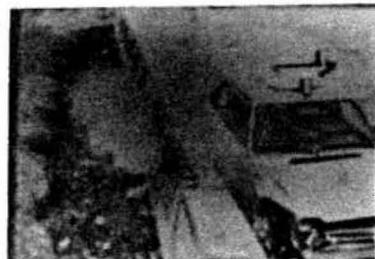
Figure 37. Sequential photographs, test KM-1 (view from downstream).

Impact conditions were 51.0 m/h (82.0 km/h) and a 20.5-degree impact angle. As shown in figures 36 and 37, the vehicle impacted the barrier midway between posts 7 and 8. The vehicle remained in contact with the barrier for 13.8 ft (4.2 m) before redirection at a -3.7 degree angle. During the impact sequence the right front tire/wheel became engaged between the top of the curb and the bottom of the rail and the wheel hub contacted post 8. Although post 8 exhibited minor gouging, observation of the test film showed no significant snag potential. The vehicle remained stable during impact and redirection. The vehicle came to rest 150 ft [46 m] downstream of the impact point and 10.5 ft [3.2 m] out from the barrier plane. The vehicle brakes were not applied after impact. Table 22 presents after impact vehicle trajectory. The barrier did not deflect during impact.
