MONITORING AND MODELING OF PAVEMENT RESPONSE AND PERFORMANCE

TASK A: OHIO

Pooled Fund Project TPF-5 (121)

By
Shad M. Sargand and J. Ludwig Figueroa

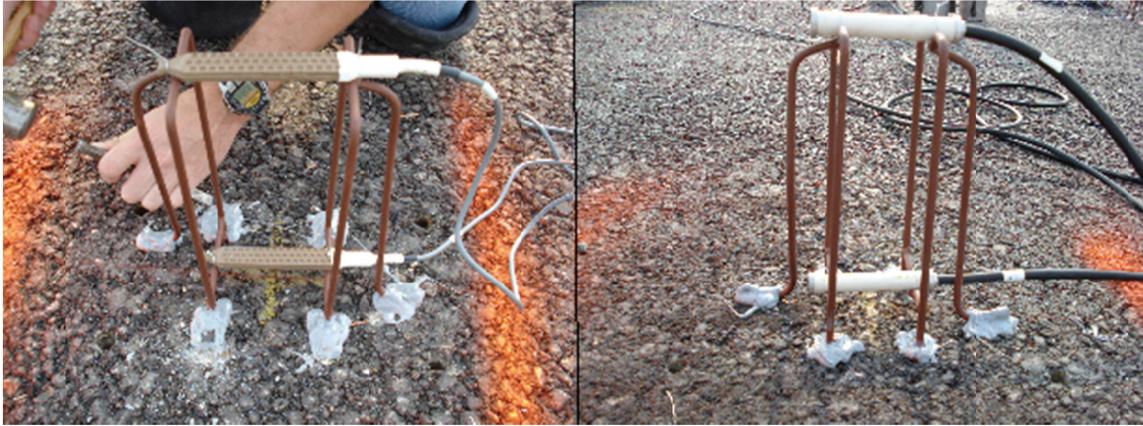
Figure 3.2 Strain Gauges Mounted on Chairs

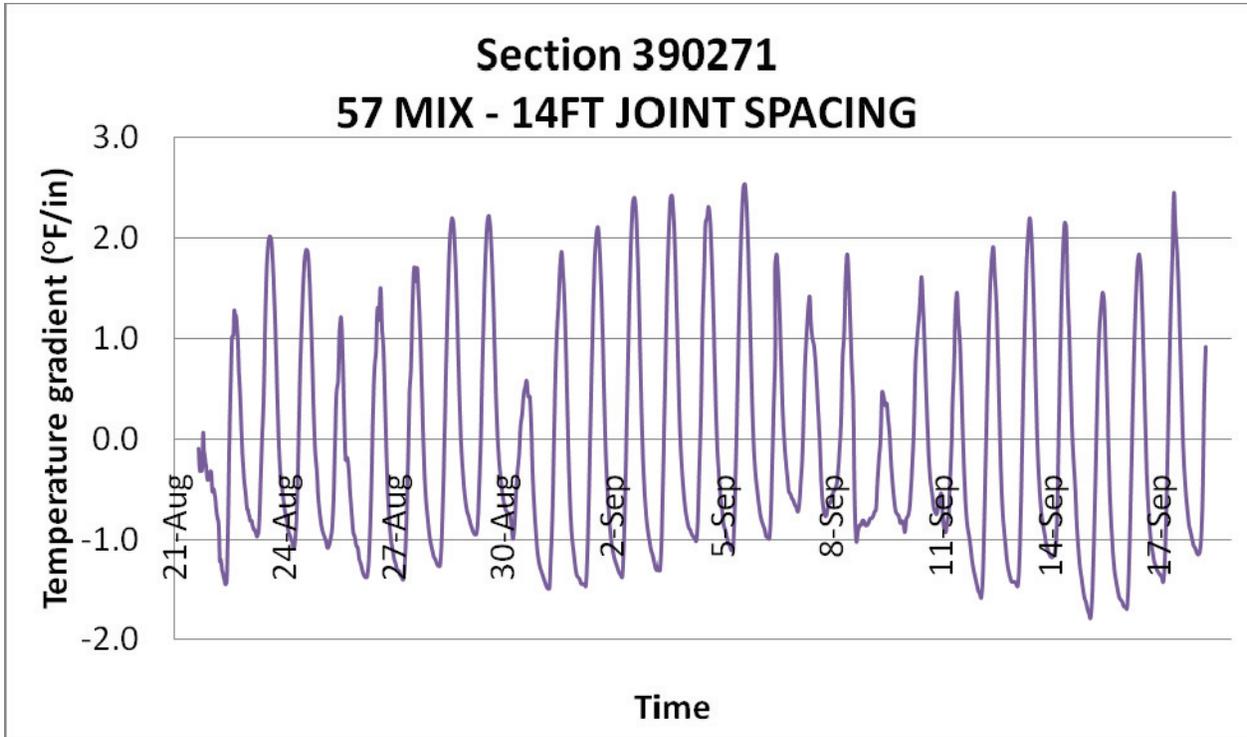
Figure 3.7 – Early Temperature Gradients in Section 271, August-September 2007.

Figures 3.4 – 3.8 show average temperature gradients measured between centerline thermocouples TC1CL and TC4CL starting immediately after concrete was placed in Sections 268, 269, 270, 271 and 272, respectively; these were computed by taking the difference between the two temperatures, those closest to the top and bottom of the slab, and dividing by the distance between the thermocouples, which was 8 in (20 cm). In August, gradients are normally positive (top warmer than bottom), quite large in the afternoon as the hot sun heats the pavement surface, and near zero at night as the surface cools. When the effects of internal warming from hydration of newly placed concrete are added to these cycles, the net effect is to shift the daily cycles down and have negative gradients at night and minimal gradients during the day. As the hydration heat dissipates, the daily cycles rise back to normal. In Sections 268, 269 and 270, five to six days were required for this process to be completed. No obvious signs of hydration appeared in Sections 271 and 272.

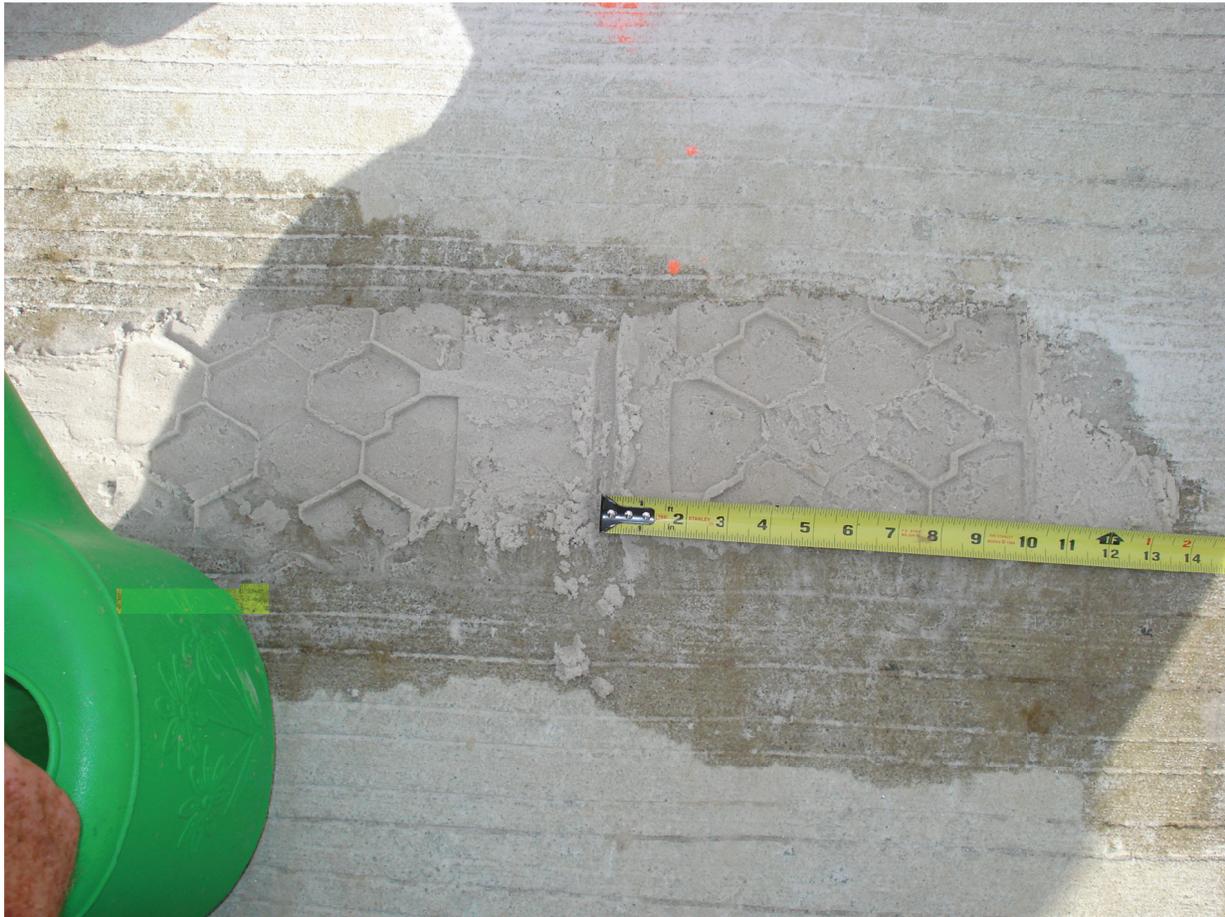
Figure 3.9 – Tire Imprints in Sand

Considering the stiffness of these concrete sections, little difference in response would be expected with the sensors being located anywhere between or under the dual tires.

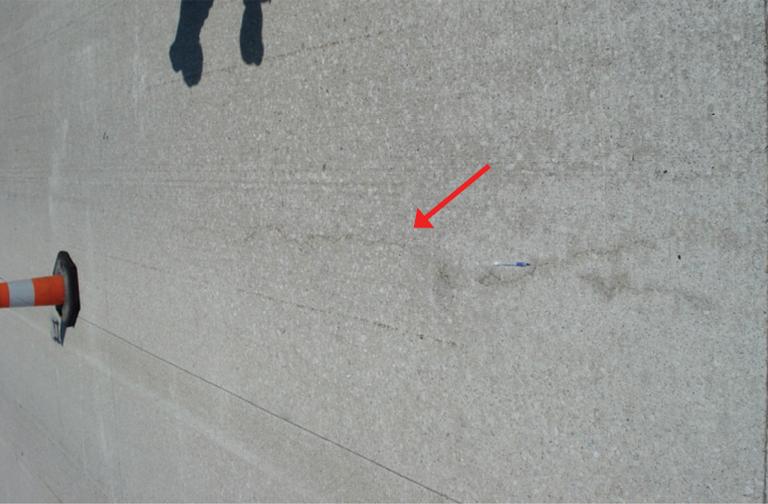
Figure 3.26 – Longitudinal Cracking on PCC Slabs on DEL-23

Visual inspection of the new sections on DEL-23 in June 2009, two years after construction, confirmed that the concrete had experienced premature distresses. Longitudinal cracks approximately two ft (0.61 m) from the longitudinal joints were identified in Sections 390268, 390270, and 290271. Figure 3.26 shows longitudinal cracks in each of those sections. Figure 3.27 shows some additional observed damage, including spalling and transverse cracking on Section 270 and a patch applied on Section 271 at a damaged joint.

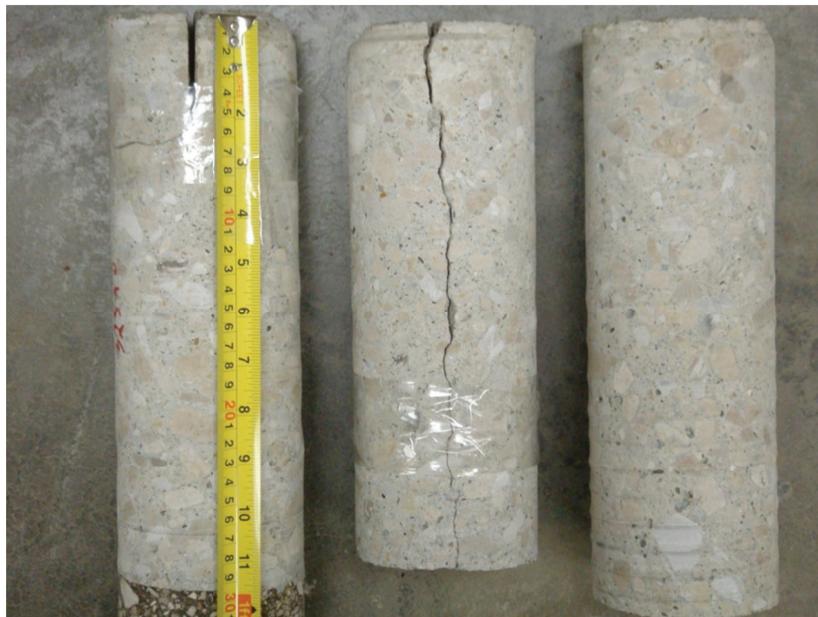
Three core samples were collected from a cracked slab in one of the damaged sections. The first sample came from the longitudinal joint. The core revealed that the saw cut was only 2 in (5.1 cm) deep, with no cracking at the base of the cut. The core showed that the thickness of the pavement was 12 in (30.5 cm). The second sample was taken from the longitudinal crack, located 1.5 ft (46 cm) from the longitudinal joint. Here the core showed that the pavement was 11.25 in (28.6 cm) thick. The third core was near the edge of the pavement, 1 ft (30 cm) from the outside shoulder. The pavement thickness as indicated by this concrete core was 12.25 in (31.1 cm). The compressive strength of this specimen was 5.24 ksi (36.1 MPa). Figure 3.28 shows the three cores.

Figure 3.28 – Concrete Cores from a Cracked Slab on DEL-23

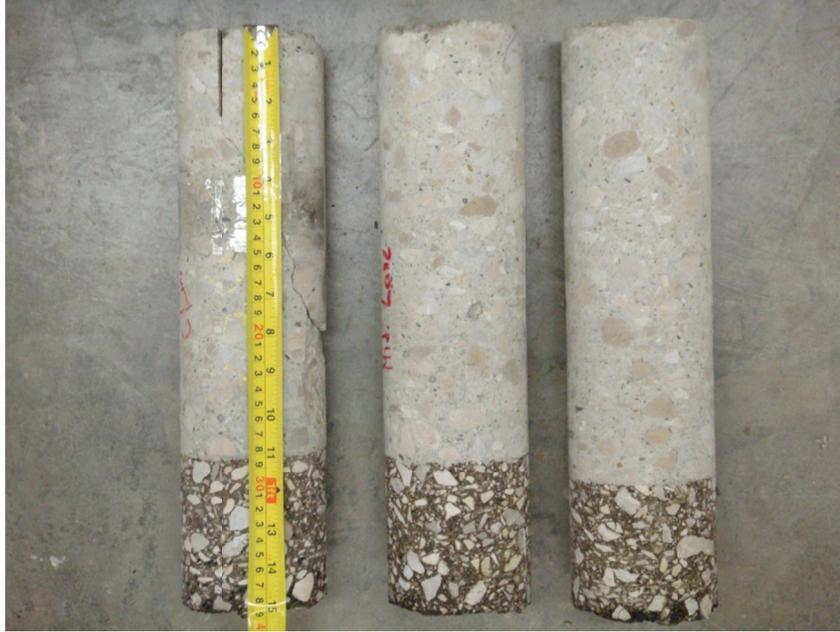
Three samples were taken from a slab in the same section that did not have the surface cracking. The first concrete core came from the longitudinal joint. A 45 degree crack was found under the 2.25 in (5.71 cm) saw cut in the 11.25 in (28.6 cm) thick pavement. The second core, extracted from the middle of the slab, was 11 in (27.9 cm) deep. The compressive strength was 5.45 ksi (37.6 MPa). Finally, the third core, which was 1 ft (30 cm) from the outside shoulder, showed that the pavement was 12 in (30.5 cm) thick. The compressive strength of this specimen was 6.55 ksi (45.2 MPa). Figure 3.29 presents these cores; notice in the left core the crack at 45 degrees starting at the bottom of the saw cut.

Figure 3.29 – Concrete Cores from a Non-Cracked Slab on DEL-23
