The Effectiveness of Vertebrate Passage and Prevention Structures: A Study of Boeckman Road in Wilsonville

**OTREC-RR-10-14
September 2010**

Final Report

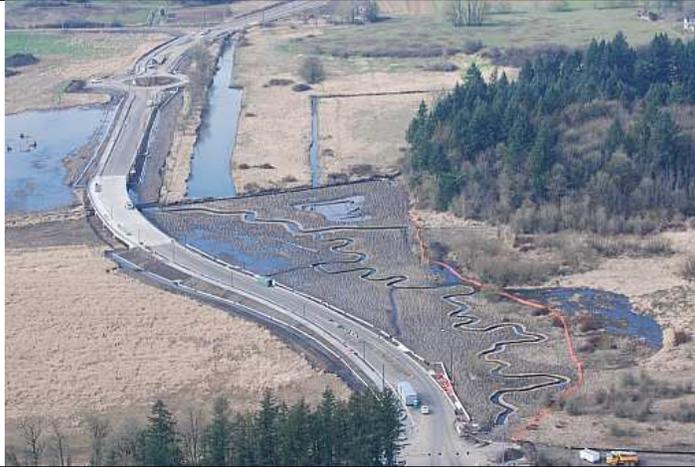
Figure 2.1.2: Aerial photo of Boeckman site during construction. Photo was taken from the east looking west. Research was primarily conducted in the northeastern area of the project (lower right quadrant of photo).

The road extension spans a portion of the Coffee Lake Creek wetlands and is bordered by private farms (west and south), a forested upland island (north) and a corporate park (east) (Figure 2.1.2). The 6,200-acre Coffee Lake Creek drainage basin is a tributary of the Willamette River, which is located approximately 2.5 km south of the study site. Most of the site and surrounding areas are or have been used for agricultural production. These areas have been fallow for some time and, previous to enhancement work conducted through the Boeckman Extension project,

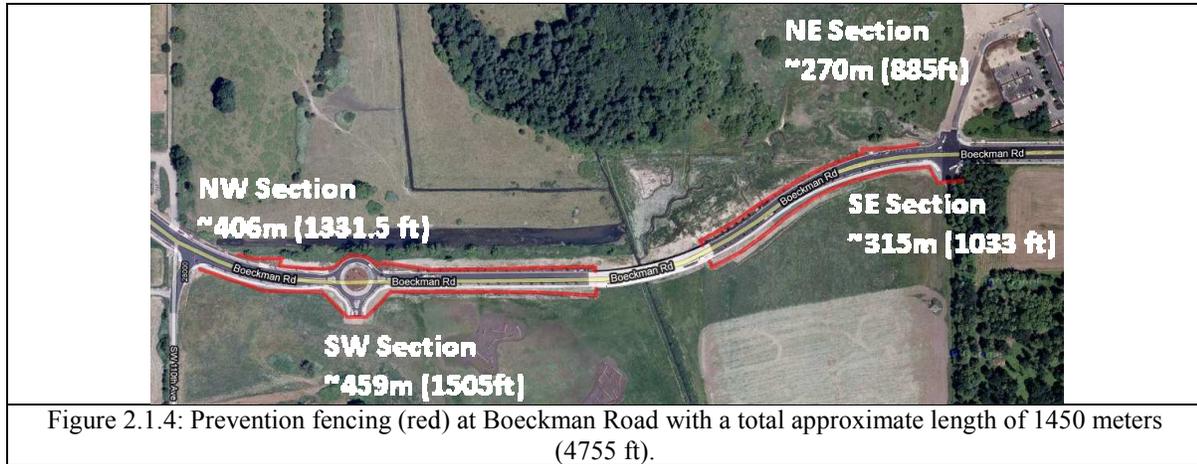
Wildlife passage was taken into great consideration during the extension project. As a result, it includes a bridge ranging from five to nine feet tall and approximately 400 feet in length; two box culverts with a 9 foot span and 4 foot rise; and five 24-inch and six 18-inch-round concrete culverts to facilitate wildlife passage (Figures 2.1.4 - 2.1.10). These features also are designed to help prevent disruption of hydrologic function of the wetland. In addition, prevention fencing is part of the road design and includes a two-foot concrete amphibian wall, with an overhang, topped by a six-foot-tall mammal fence to prevent animals from entering the road surface (Figure 2.1.7 and 2.1.8). The fencing has approximate length of 1450 meters (4755 ft) (Figure 2.1.4). The width of the area over the road within the fencing averages 27 meters (88 ft).

Both 9 by 4 culverts and three of the four 24-inch culverts include grating that allows natural light penetration. In addition to incorporating wildlife passage and prevention structures, the project required restoration and enhancement of the wetland. This enhancement included adding meanders to what had been a straight drainage ditch and planting, in 2008, willows and other vegetation.

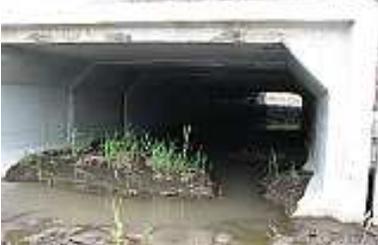
<p>Figure 2.1.5: 9-foot span by 4-foot rise box culvert.</p>	<p>Figure 2.1.6: 24-inch-round concrete culvert.</p>	<p>Figure 2.1.7: Bridge and Boeckman Road looking east.</p>

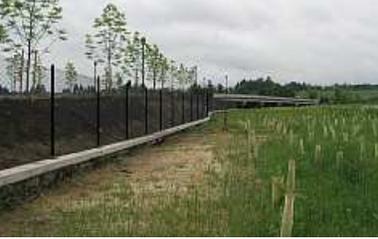
<p>Figure 2.1.8: Chain link mammal fence (6 feet) atop the amphibian/reptile wall (2 feet). Note bridge in background.</p>	<p>Figure 2.1.9: 18-inch-round concrete culvert. Note amphibian/reptile wall with overhanging lip.</p>	<p>Figure 2.1.10: Photo taken from under the bridge passage.</p>

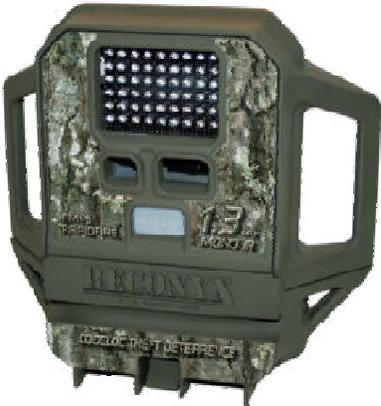
<p>Figure 2.2.1: Reconyx brand motion-detection camera used to monitor wildlife movements.</p>	<p>Figure 2.2.2: Segment of sand-track pad under bridge section 3.</p>

In order to monitor passage use, a combination of sand-track monitoring and motion-detection cameras was used (Figure 2.2.1 and 2.2.2). Sand-track monitoring was conducted on a weekly basis from May to September 2009 under bridge sections 2 and 3 to account for small animals not likely to be captured by the cameras. Similar tracking was conducted in 2008 as well, but is not reported here due to the temporal mismatch with the camera data.

Reconyx brand model RM45 motion-detection, infrared cameras were used to identify vertebrate species using the passage structures as well as to compare passage use to movement across the landscape. Each camera in the surrounding habitat was mounted on a metal fence post, approximately one-third to one-half meter from the ground surface, with a slight angle downward to limit false triggering. Cameras in small passage structures (18-inch and 24-inch) were mounted directly to the concrete and were similarly angled but positioned more closely to the ground (approximately 15cm). The cameras in these culverts therefore were effective at detecting movement of small animals. Cameras located under the bridge were mounted to posts and angled only slightly downward to capture medium and large animals moving across the entire span. As a consequence, cameras under the bridge were much less capable of capturing small animals such as mice, voles, snakes and frogs. To supplement the bridge camera data, sand-track pads were established under bridge sections 2 and 3 and were monitored weekly. Camera flash cards were exchanged and batteries checked on a weekly basis. Collected cards were brought back to the lab and downloaded. Species were then identified and entered into an Access database. Animals' ability to traverse and the presence of standing water near passage structures were assessed and documented on 31 Aug. 2009.

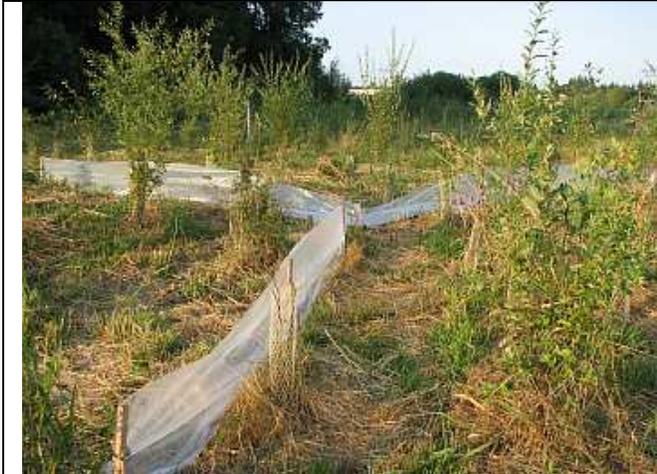
Figure 2.2.4: 100M North Station 1 pit trap array. One bucket is located in the center of the array of plastic sheeting.

Detection of small animal movement was limited with camera monitoring in the surrounding habitat because the angle and proximity to the ground necessary for the cameras to capture small animals would severely limit the range and ability to detect large and medium animal movements. In order to compensate for this shortcoming in camera data on small organisms, we also conducted tag-and-release studies targeted to small mammals. Trapping methods included pit traps (Figure 2.2.4) and Sherman traps (3"x 3.5"x 9" folding aluminum). One of each type of trap was deployed per station for the 100M North, 25M North, 2M North and 2M South transects, for a total of 72 traps. Traps were deployed for three consecutive nights per month during late summer 2009 (31July-2 August, 25-27August, and 21-23September). Traps were baited and opened at dusk, checked at dawn during trapping sessions, and then closed for the day. Voles and mice were tagged using metal ear bands (Figure 2.2.5) with unique identifying numbers, while shrews were released due to their lack of pinnae, which are required for placement of ear tags.

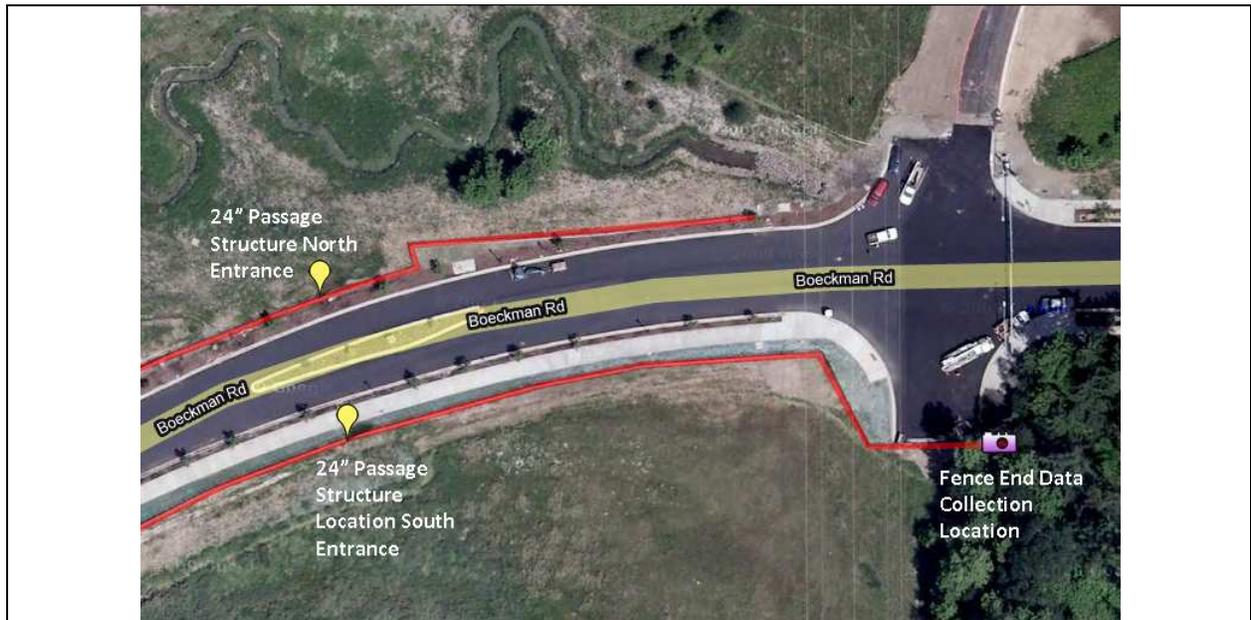
Figure 2.2.6: Fence end monitoring location in relation to fence end (red lines) and nearest passage (24-inch-round concrete culvert).

Camera data collected in passage structures were compared to camera monitoring at the end of the exclusionary fencing (Figure 2.2.6). The direction animals were traveling was noted in order to best determine if the animal was about to, or had just, crossed the road surface.

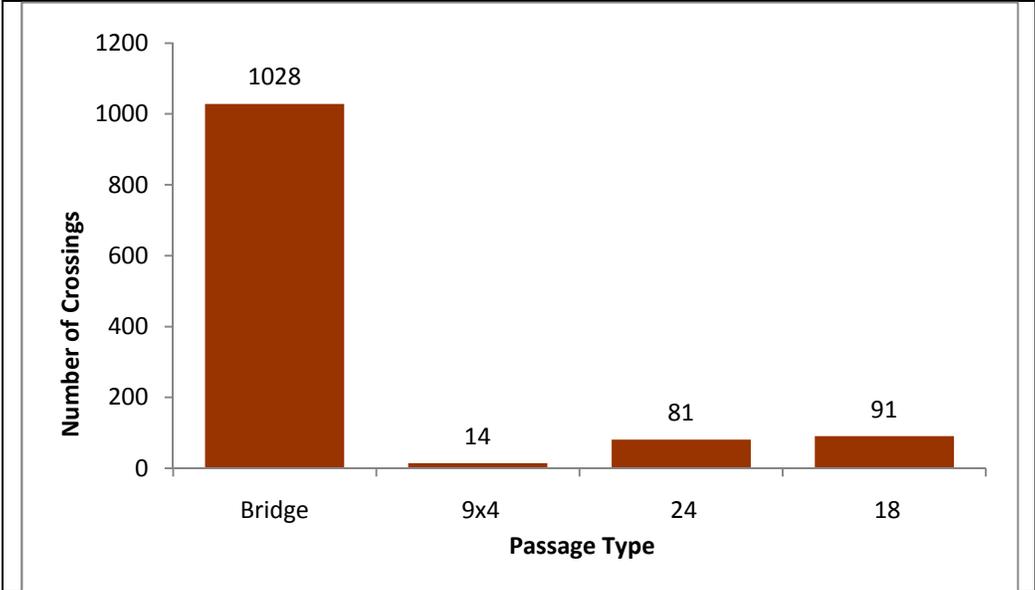
Figure 3.1.2: Number of individual crossing events captured with both motion-detection cameras (July to October 2009) and sand-pad tracking (May to August 2009) in passage structures.

The bridge spans over land were, by far, the most commonly used passage options, accounting for 18 of the 19 species found to use the passages, and for 85% of the total passage detections (sand-track and camera; Table 3.1, Figures 3.1.1, 3.1.2, 3.1.4). The camera-only data also identified the bridge as the most commonly used structure (Figure 3.1.3). The 18-inch round culverts had a similar amount and diversity of usage as the 24-inch round culvert, with both trailing significantly behind the bridge and with, at most, one-fourth of the detections and two-thirds of the species. The 9-foot-by-4-foot box culverts showed low passage use from both datasets. Some passages had standing water even in the dry season and some had blocked access (Table 3.2). Examining the total cost of each passage structure divided by their number of crossings in a four-month period revealed that the 9-by-4 culverts were by far the most expensive for the connectivity they provided (Figure 3.1.5). The bridge crossings were about 2.5 times more expensive than the small, round culverts, but they provided passage to many more species.

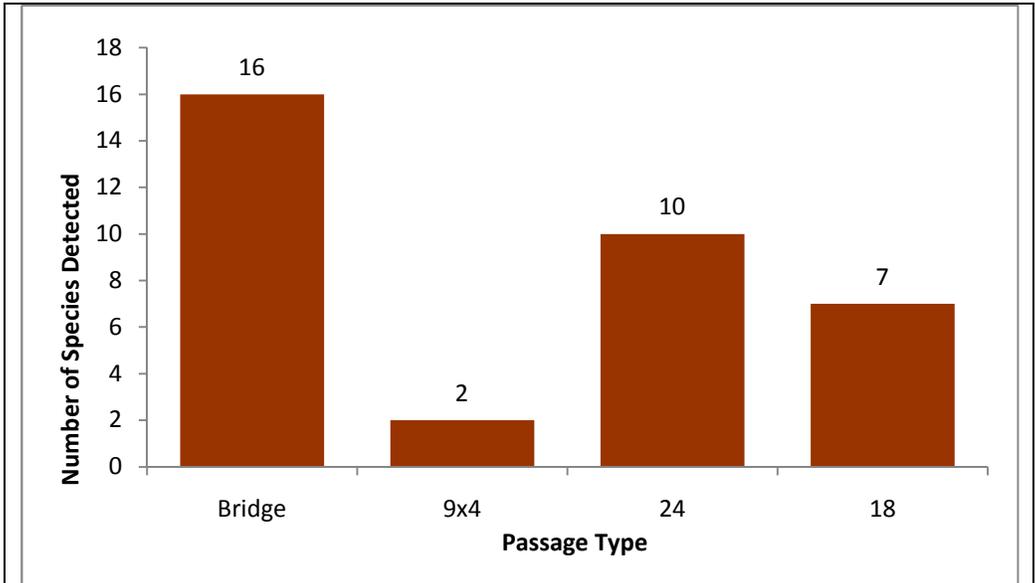
Figure 3.1.3: Number of species detected to be using passage structures. Includes both camera (July to October 2009) and sand-track data (May to August 2009).

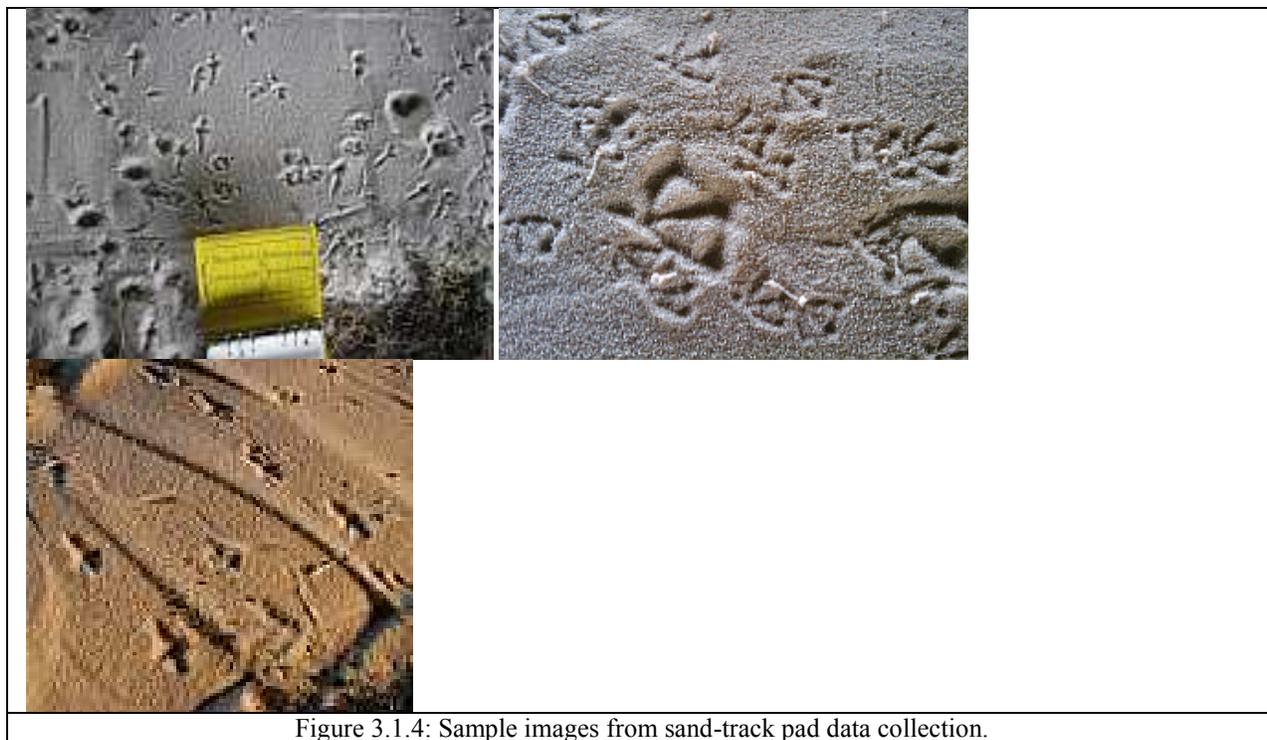
Figure 3.1.4: Sample images from sand-track pad data collection.

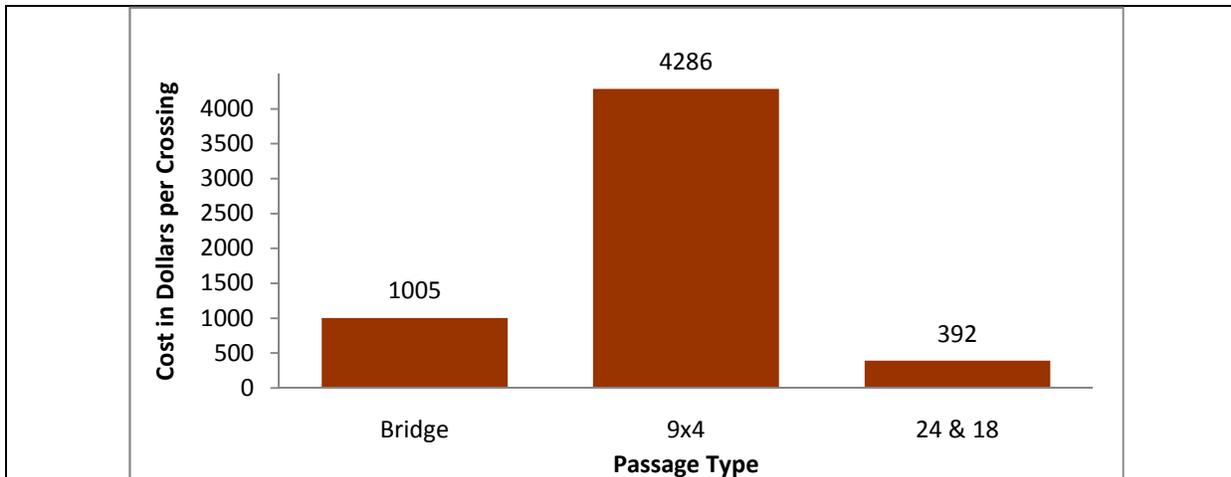
Figure 3.1.5: Number of individual crossing events (camera and sand track data) during a four month monitoring period as a function of passage structure construction cost. Detected crossings were extrapolated to include all passage structures available (includes west half of road project). Assumes all species are of equal value and crossings are limited to the time period of the study (although these structures should last decades), and costs do not factor out construction costs needed for hydrologic connectivity (culverts) or water crossings (bridge).

A potential method for assessing the usefulness of each type of passage is to use the number of crossings per cost of construction (Figure 3.1.5). This simple metric suggested the smallest passages (24-inch and 18-inch) provided the best value per crossing. This assessment, however, did not attempt to consider one species of greater value than another, so species such as voles were ranked equally with deer. Depending on the species in any given area, such as endangered or threatened animals or ones that cause damage to vehicles, the size of an animal may be of more or less concern in regards to maintaining habitat connectivity and/or preserving driver safety. Including a weighting for larger species would greatly increase the priority of an overland bridge extension. Similarly, including diversity of animals rather than just number of passages would strongly favor the bridge. Furthermore the total cost of the passage structures is not necessarily the true cost of providing animal passage, for the Boeckman project specifically a bridge structure would have been constructed regardless of the consideration for wildlife crossings due to the presence of a waterway, but likely would have been much smaller than the current bridge length. While this analysis simply considered the total cost of the structures and gave all animals equal weight a more accurate model would increase the value per crossing.

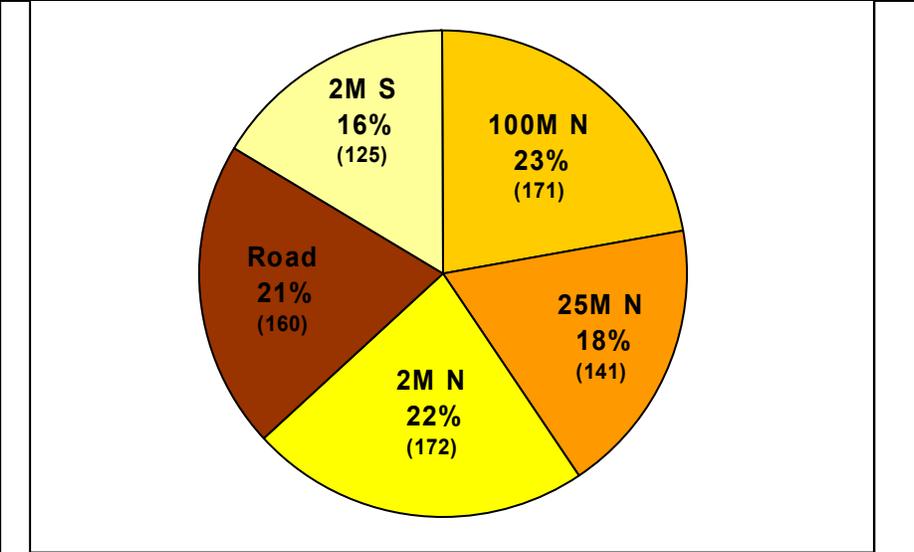
Figure 3.2.1: Percent of animal crossings detected by cameras per transect (excludes small mammals, reptiles, and amphibians due to the low detection probability off-road).

The habitat transects did not differ significantly from the road transect or each other with regard to the number of large and medium mammals detected (Table 3.3, Figure 3.2.1; Generalized linear model: overall model Likelihood ratio $\chi^2 = 375.55$, $df = 39$, $P < 0.001$; transect $\chi^2 = 1.99$, $df = 3$, $P = 0.575$; station [transect] $\chi^2 = 242.66$, $df = 32$, $P < 0.001$; Block $\chi^2 = 54.84$, $df = 4$, $P < 0.001$). Deer were most commonly detected at the 100M transect ($n = 124$ observations) and least commonly detected at the under-road crossings ($n = 72$; Table 3.3, Figure 3.2.2).

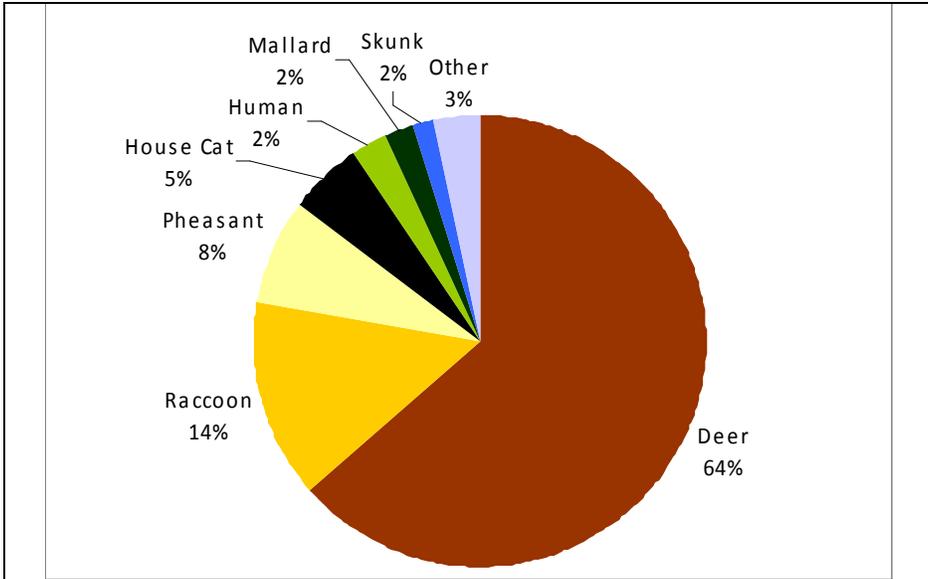
Figure 3.2.2: Percent of total animal activity per species for the transect study, using camera data and excluding small mammals, amphibians and reptiles (due to low capture probability). The 'Other' category includes Great Blue Heron (0.9%) Beaver (0.7%) Virginia Opossum (0.8%) Coyote (0.4%) Nutria (0.4%) and rabbit (0.3%).

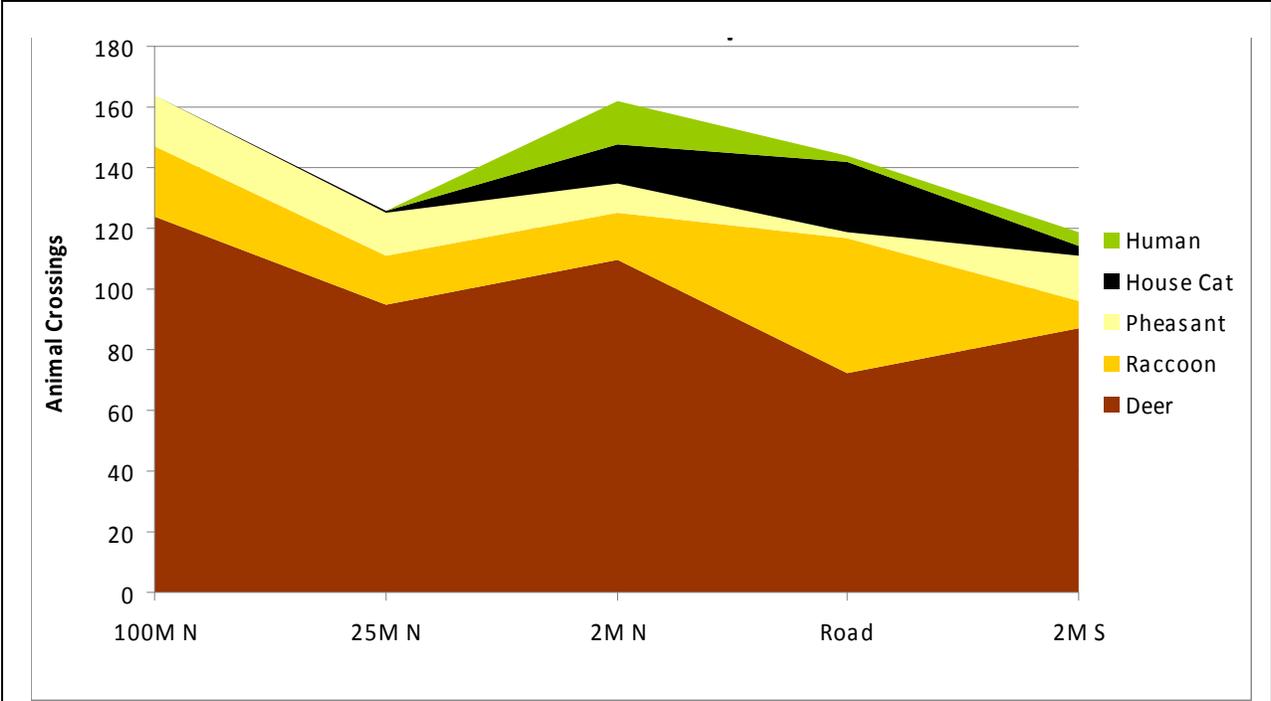
Figure 3.2.3: Total animal activity by transect for the most commonly detected species (camera data): human, house cat, pheasant, raccoon, and deer.

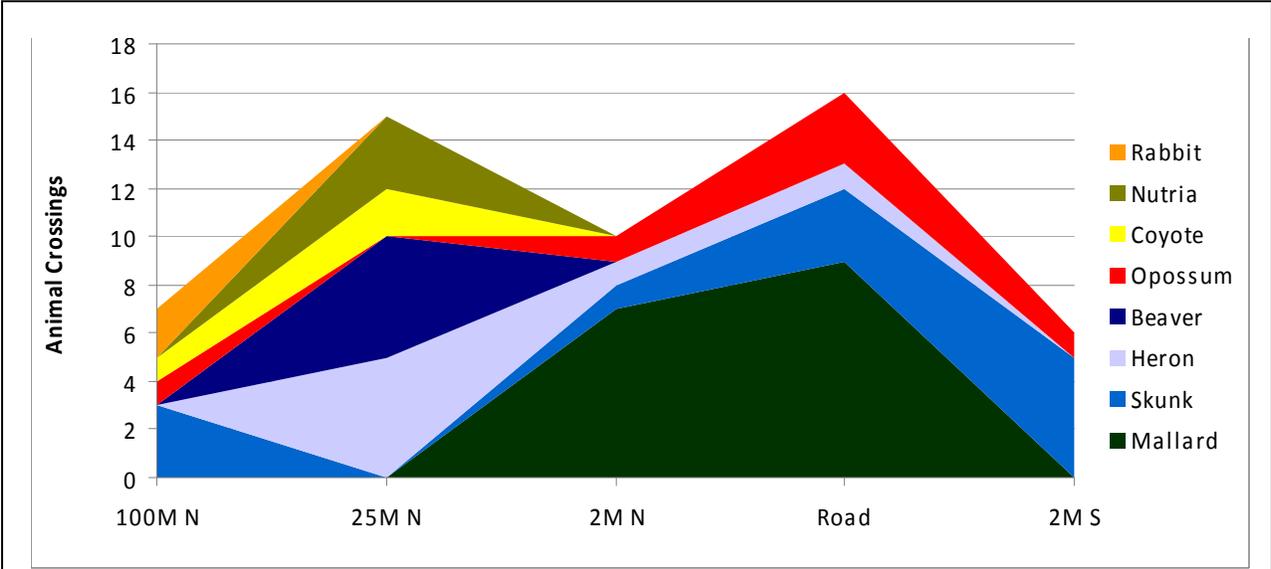
Figure 3.2.4: Total animal activity by transect for the least commonly detected species (camera data): rabbit, Nutria, Coyote, opossum, Beaver, Great Blue Heron (heron), skunk, and Mallard

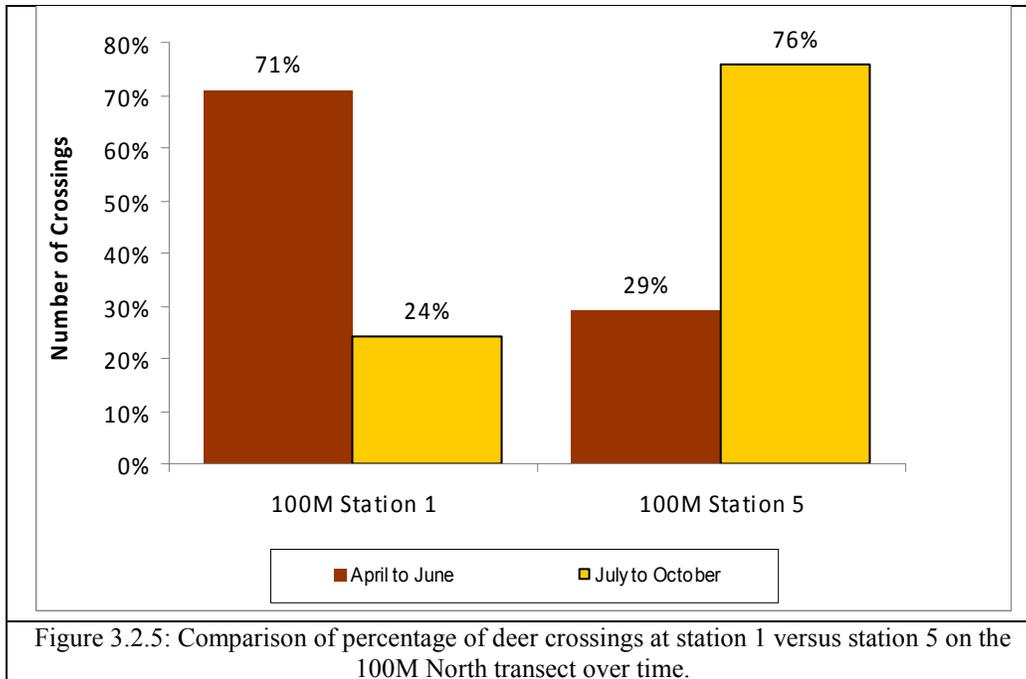
Figure 3.2.5: Comparison of percentage of deer crossings at station 1 versus station 5 on the 100M North transect over time.

Examination of the deer alone provided a contrast to the combined analysis: Deer were detected significantly less often at the road than along the transects in the surrounding habitat (Figure 3.2.3; Generalized linear model: overall model Likelihood ratio $\chi^2 = 433.30$, $df = 39$, $P < 0.001$; transect $\chi^2 = 14.95$, $df = 3$, $P = 0.002$; station [transect] $\chi^2 = 156.50$, $df = 25$, $P < 0.001$; Block $\chi^2 = 45.17$, $df = 4$, $P < 0.001$). The second and fourth most commonly detected species, raccoons and domestic cats, appear to be detected more often near the road (Fig 3.2.3). The least commonly detected species have much higher variation in detected movement by transect: Their movement peaked at the 25M transect, which frequently intersects with meandering waterways (Figure 2.2.2.1), and the road (Figure 3.2.4). Deer shifted their routes over time once the vegetation planted at the site had developed seasonal foliage and grown (Figure 3.2.5).

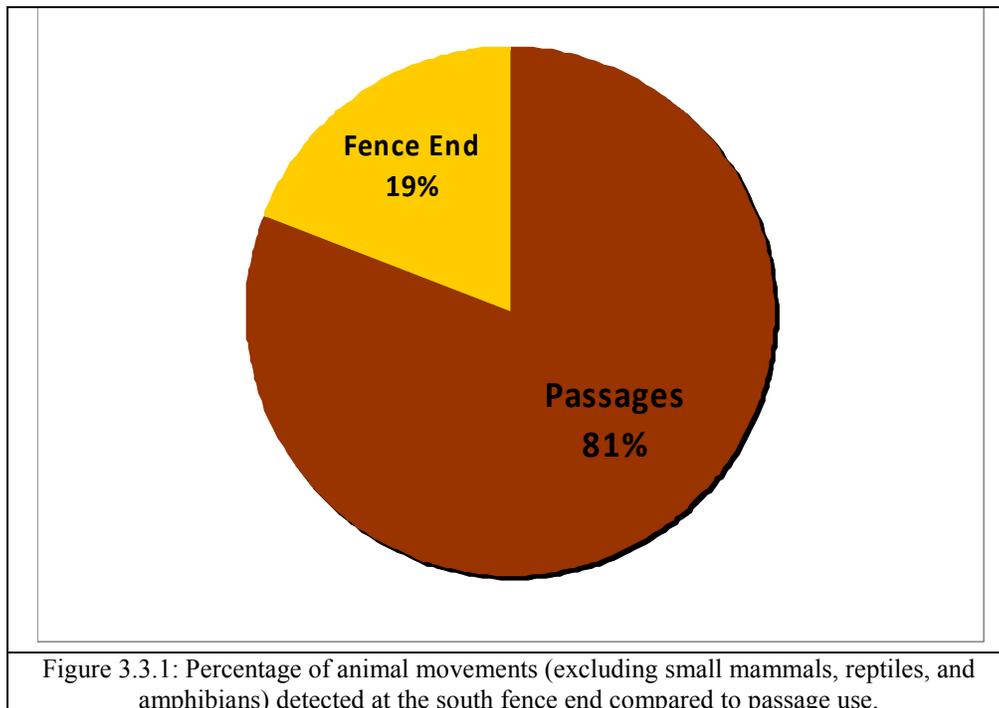
Figure 3.3.1: Percentage of animal movements (excluding small mammals, reptiles, and amphibians) detected at the south fence end compared to passage use.

For medium and large mammals and birds, the species detected with cameras at the passage structures or circumventing fencing, 19% (33) of the 139 individuals were found potentially crossing on the road surface (Figure 3.3.1). While there were other locations further east without fencing where animals could have chosen to cross, the location monitored captured animals following fencing to the end and crossing the road, rather than using passage structures. Nearly equal numbers of opossum and skunk were observed circumvented fencing as were detected using passages. The proportion of deer detected using over-road crossings (23%) is of particular concern for driver safety (Table 3.4).
