Appendix D
M-14 Core Site

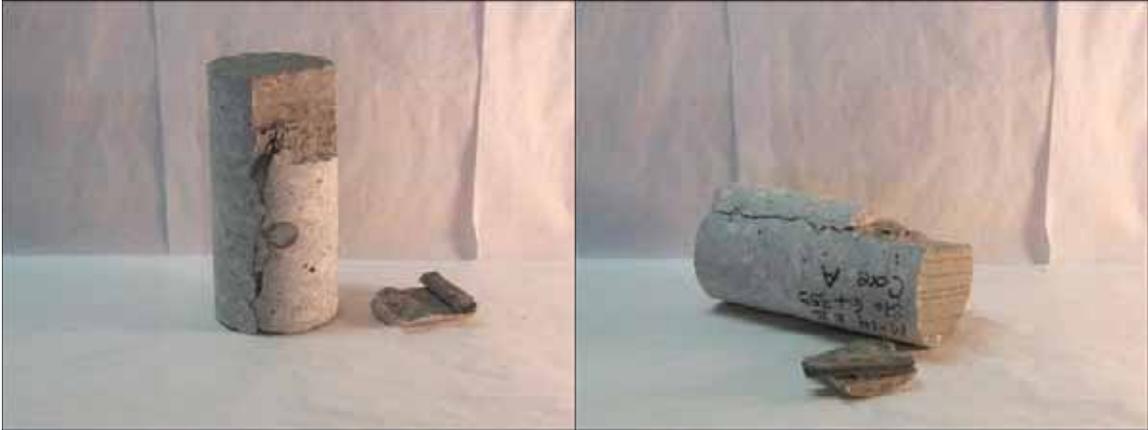
EB M-14, constructed 2000, station 6+353, at joint, core A, (MTU ID 14-01).

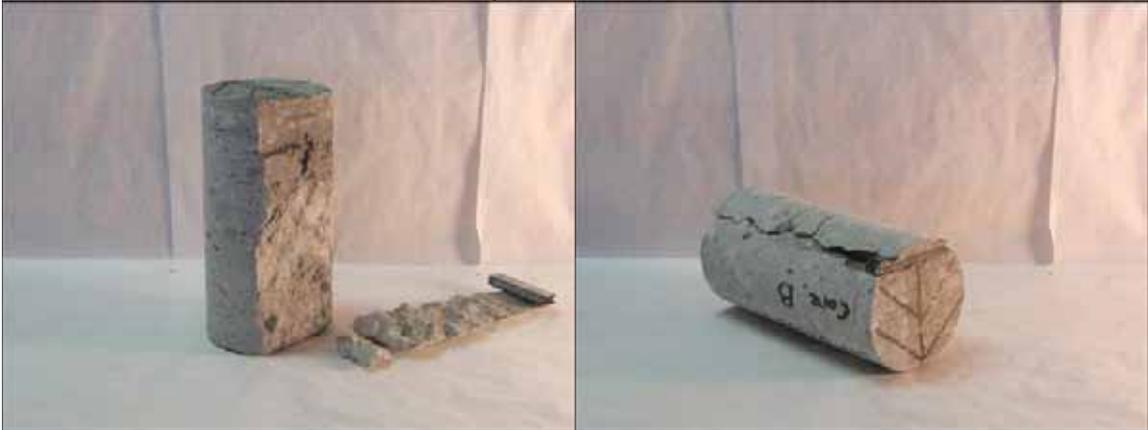
EB M-14, constructed 2000, station 6+353, at joint, core B, (MTU ID 14-02).

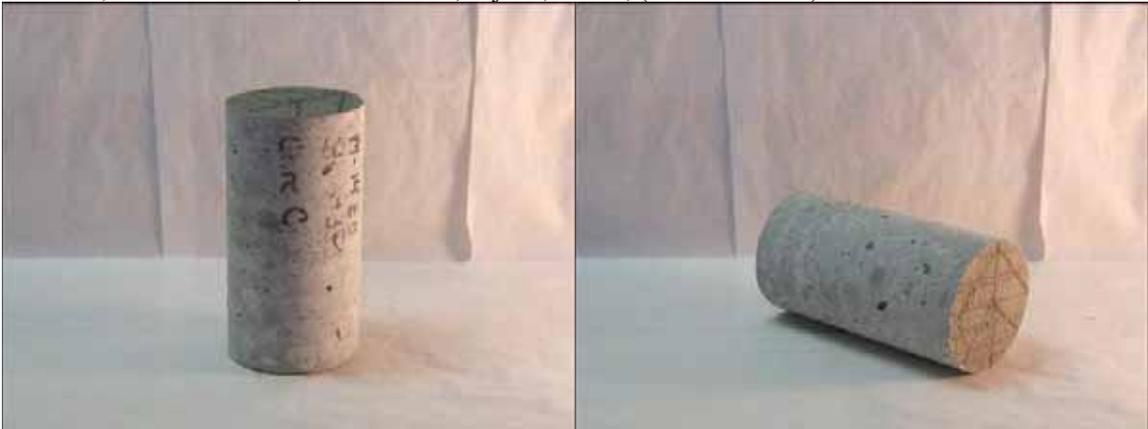
EB M-14, constructed 2000, station 6+353, away from joint, core C, (MTU ID 14-03).

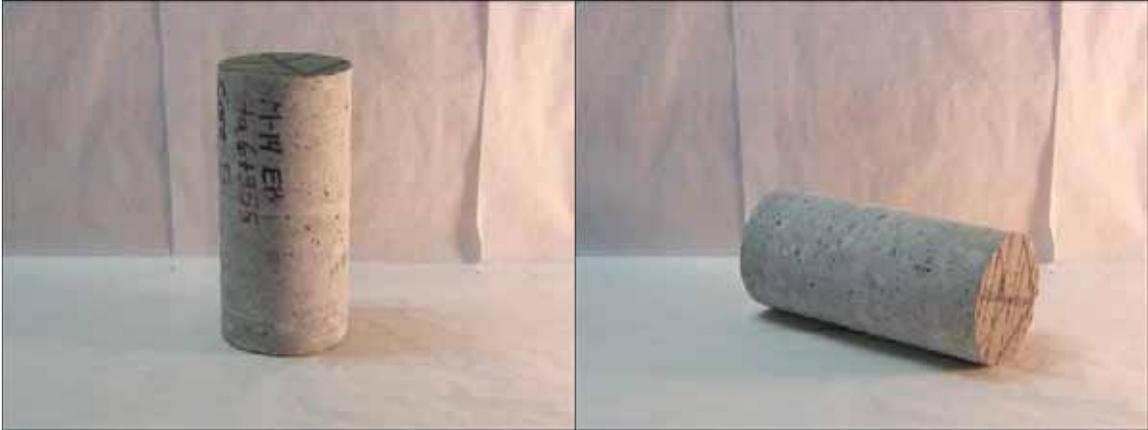
EB M-14, constructed 2000, station 6+355, away from joint, core D, (MTU ID 14-04).

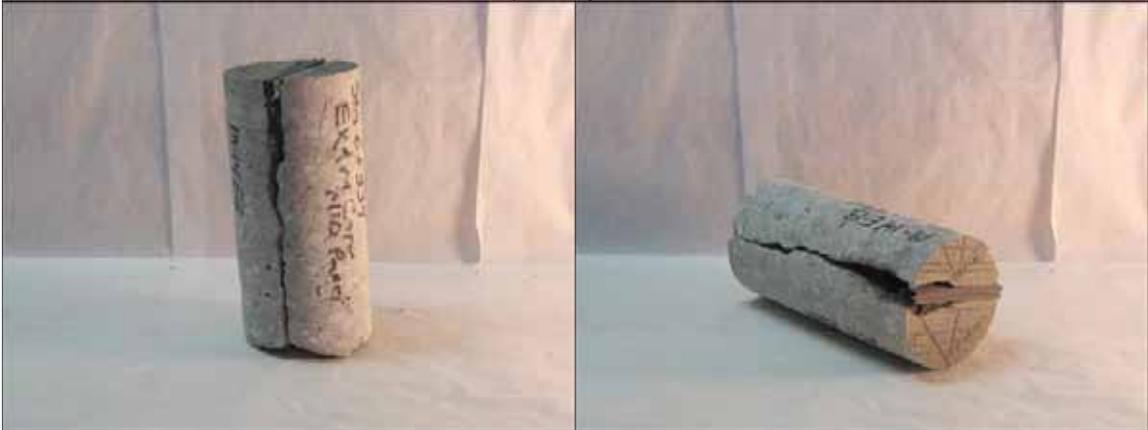
EB M-14, constructed 2000, station 6+334, at joint, core E, (MTU ID 14-05).

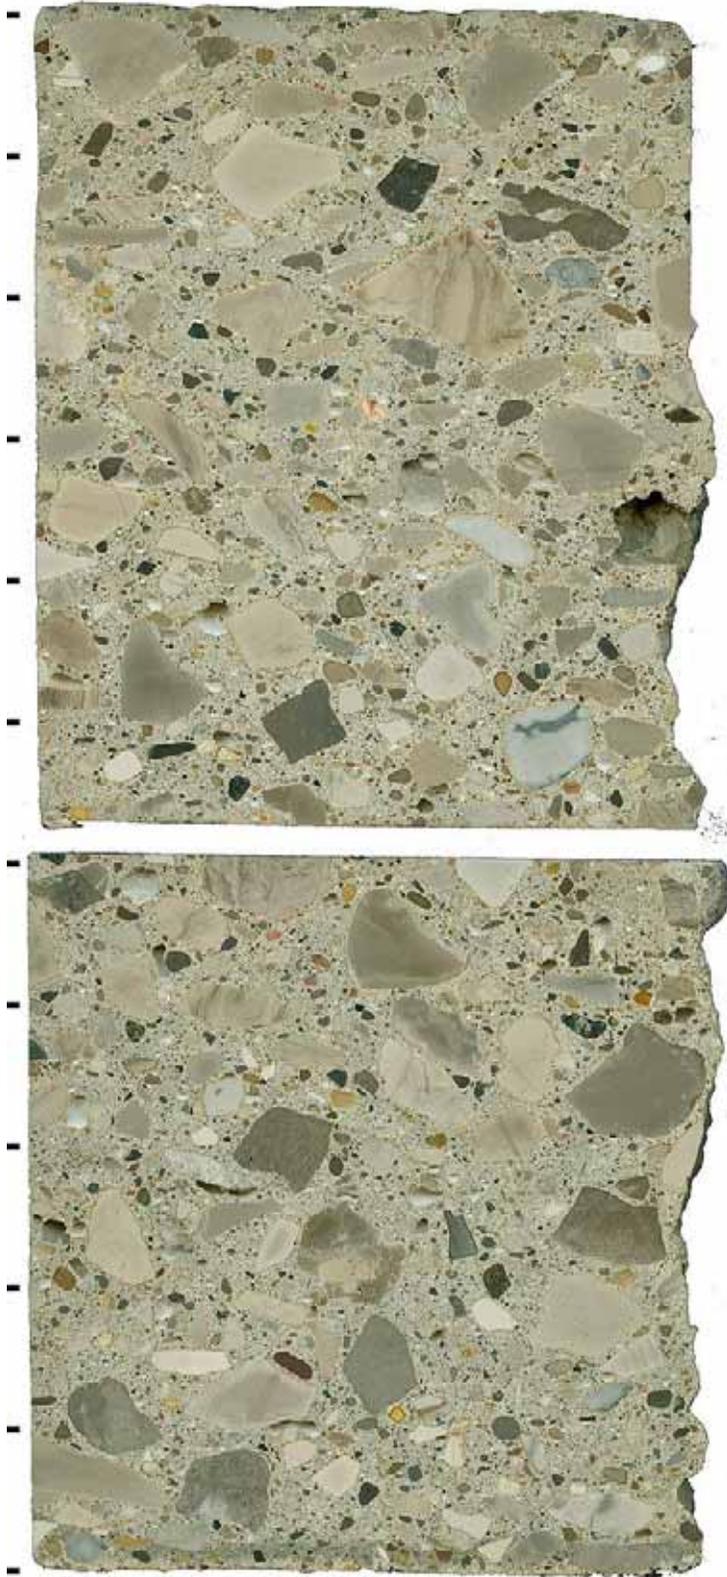
Slabs representing full cross section through pavement, as polished, EB M-14, station 6+353, at transverse joint, core B, MTU ID M14-02, tic marks every inch.

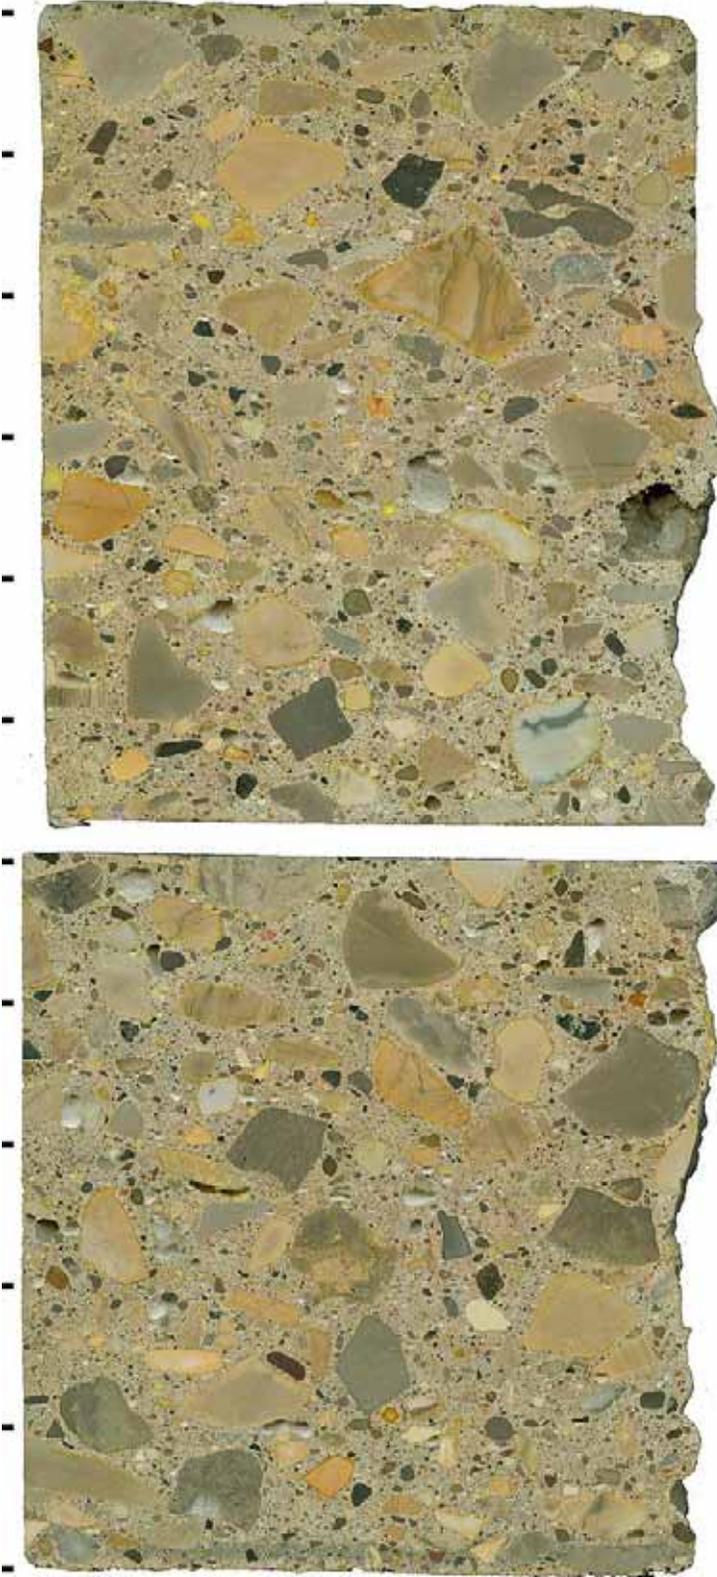
Slabs representing full cross section through pavement, after sodium cobaltinitrite stain, EB M-14, station 6+353, at transverse joint, core B, MTU ID M14-02, tic marks every inch.

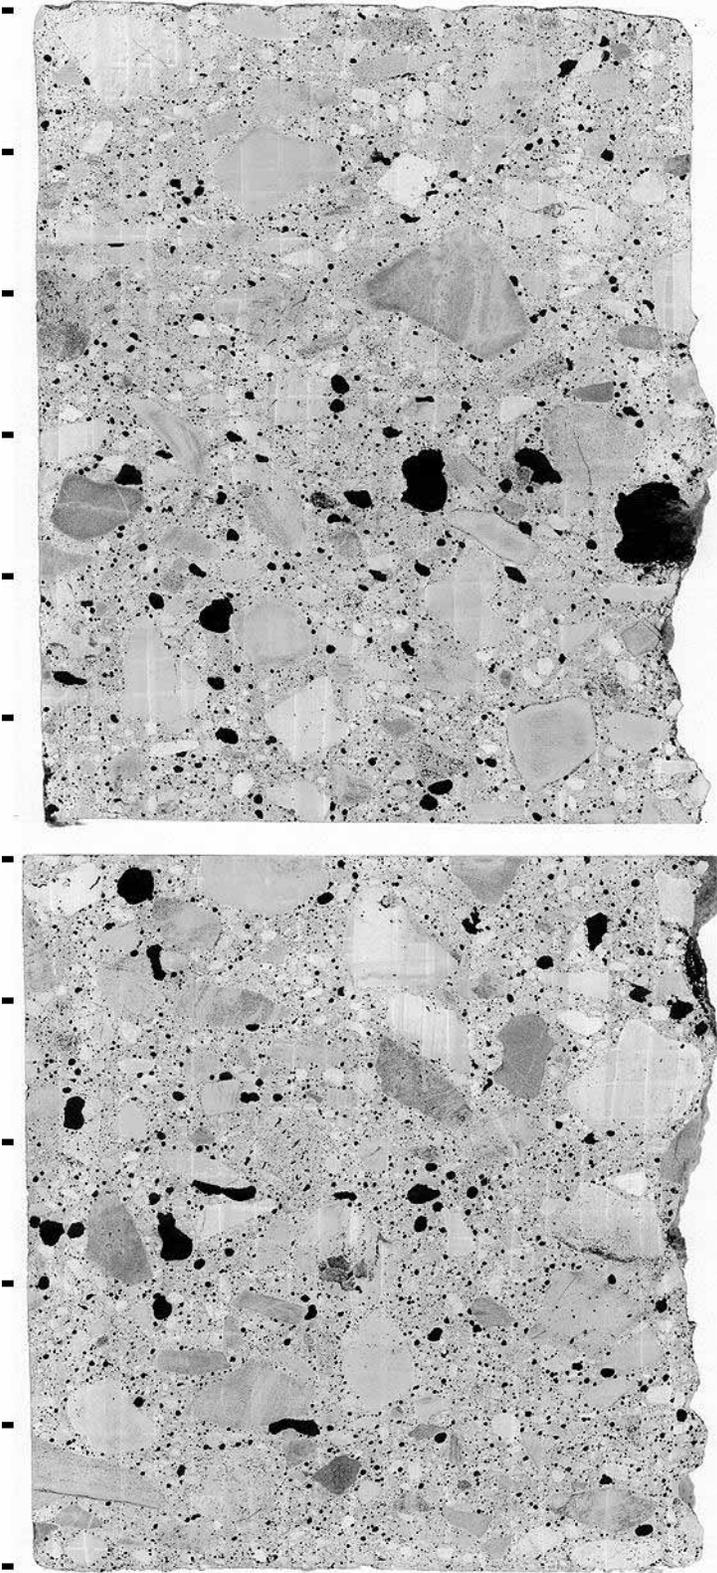
Slabs representing full cross section through pavement, after treatment to enhance air voids and cracks, EB M-14, station 6+353, at transverse joint, core B, MTU ID M14-02, tic marks every inch.

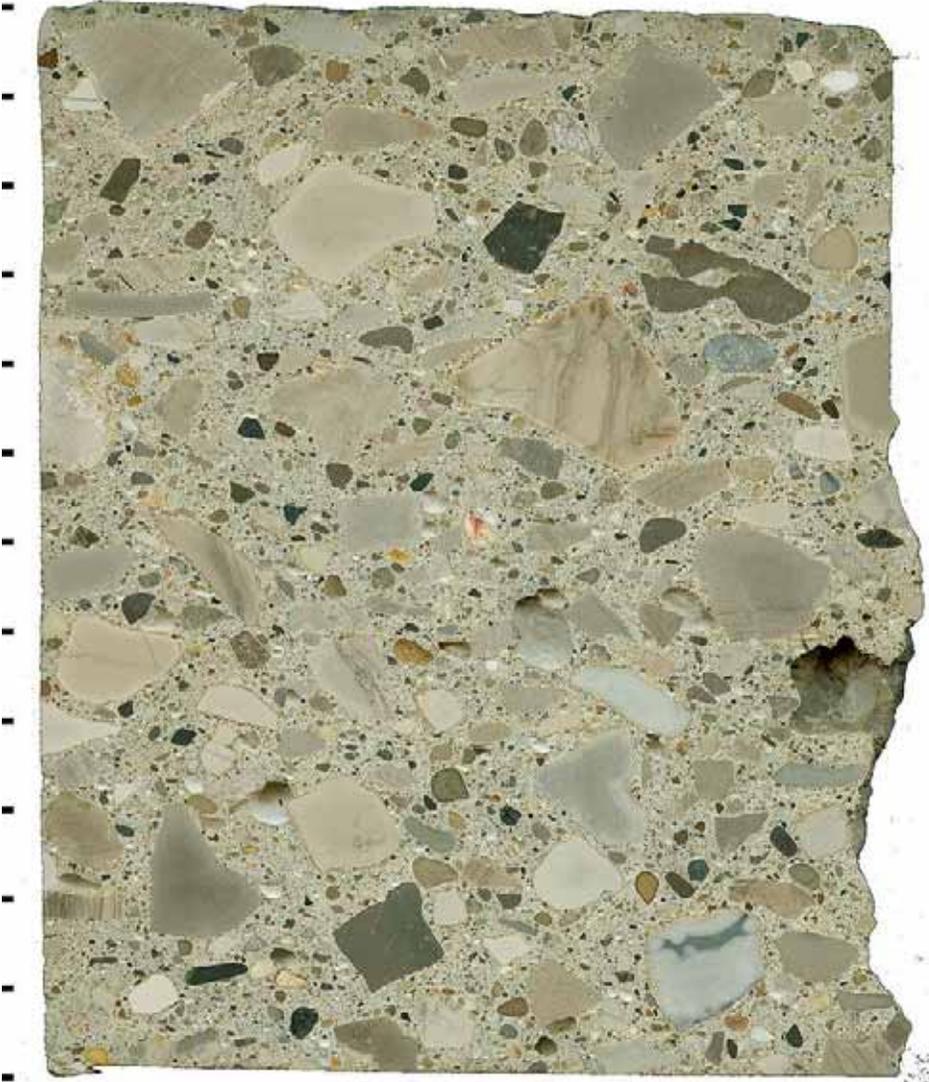
Slab representing cross section through top half of pavement, as polished, EB M-14, station 6+353, at transverse joint, core B, MTU ID M14-02, tic marks every half inch.

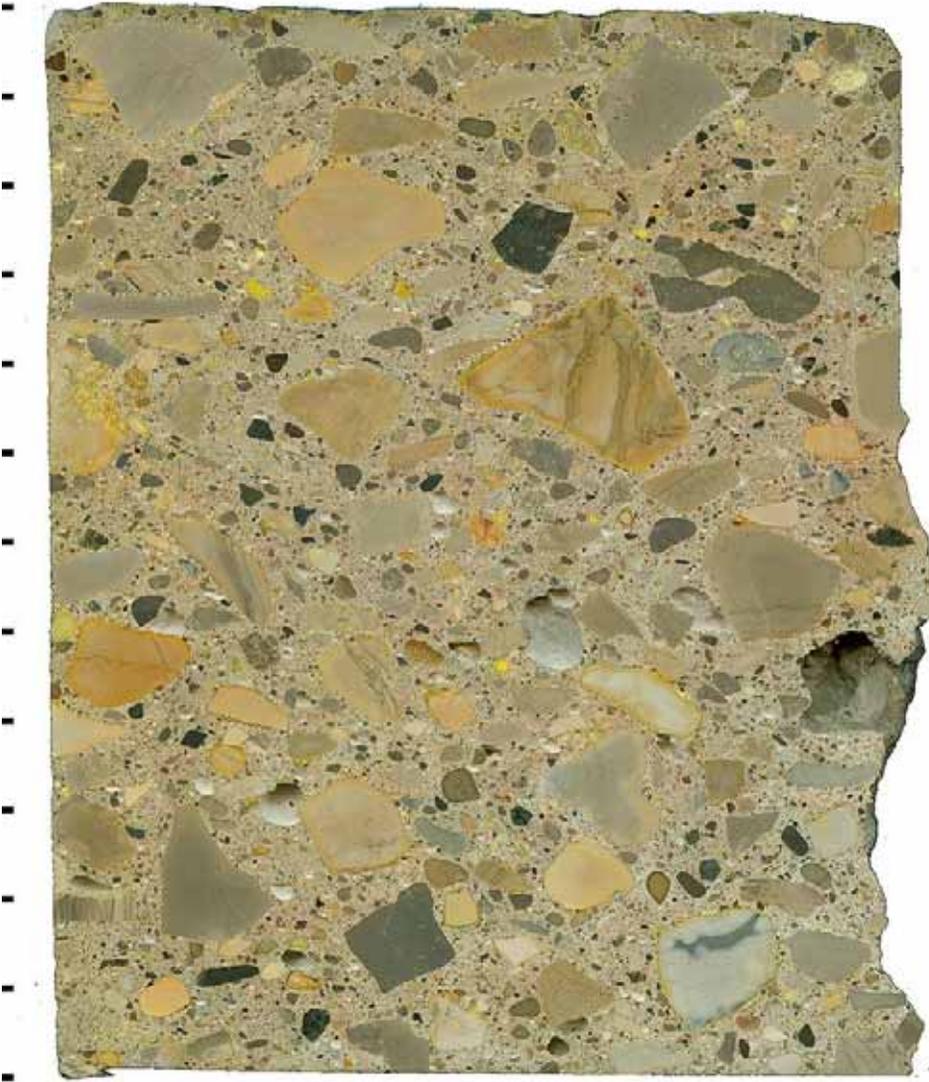
Slab representing cross section through top half of pavement, after sodium cobaltinitrite stain, EB M-14, station 6+353, at transverse joint, core B, MTU ID M14-02, tic marks every half inch.

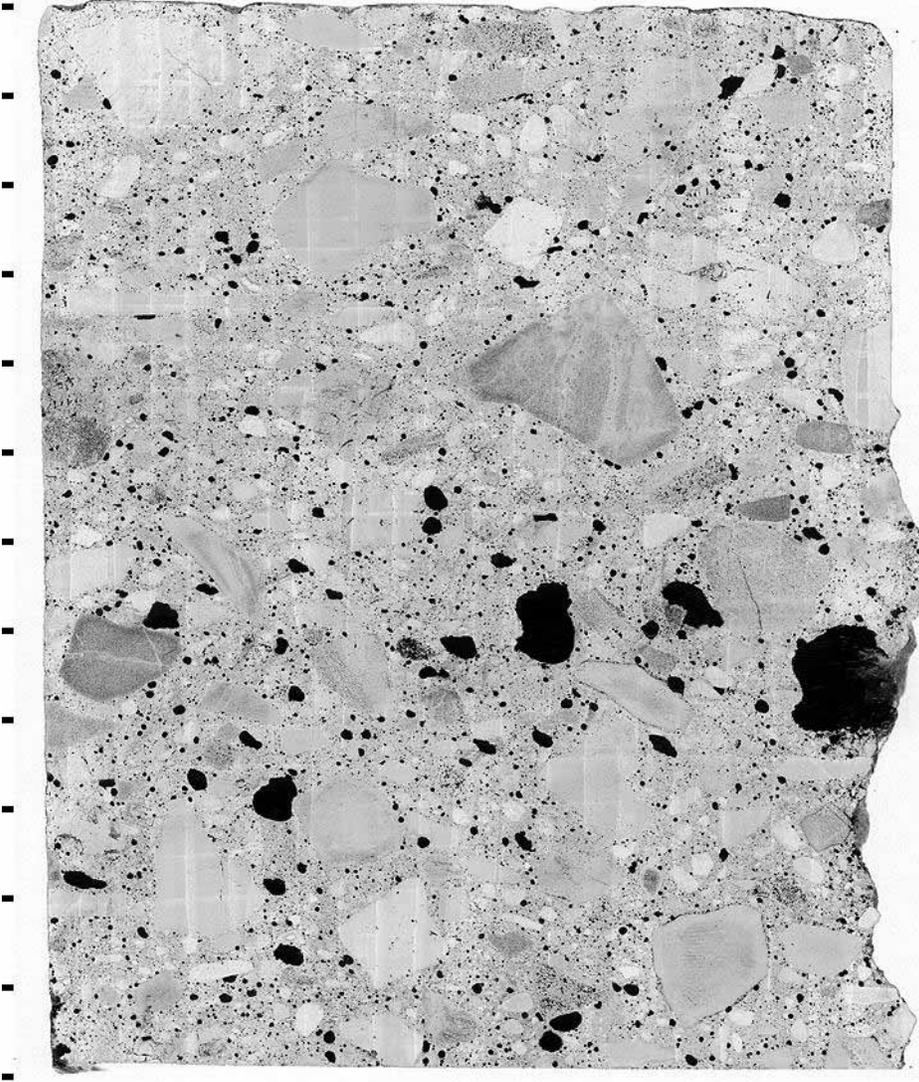
Slab representing cross section through top half of pavement, after treatment to enhance air voids and cracks, EB M-14, station 6+353, at transverse joint, core B, MTU ID M14-02, tic marks every half inch.

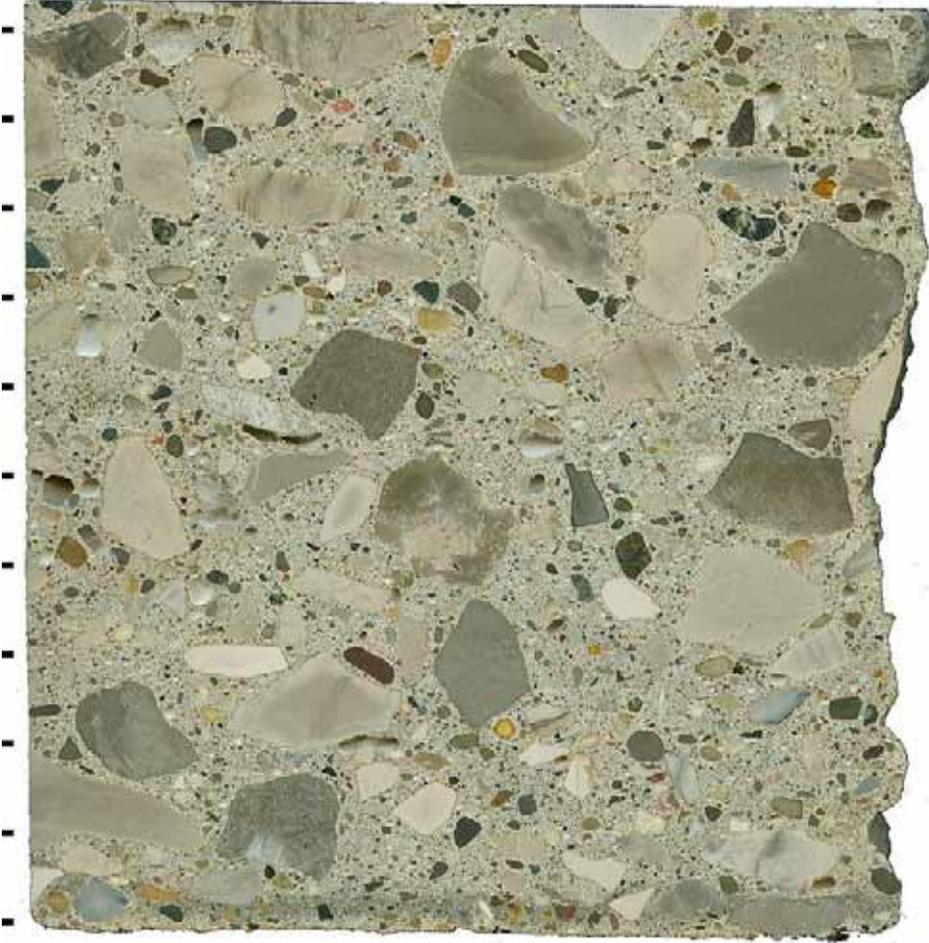
Slab representing cross section through bottom half of pavement, as polished, EB M-14, station 6+353, at transverse joint, core B, MTU ID M14-02, tic marks every half inch.

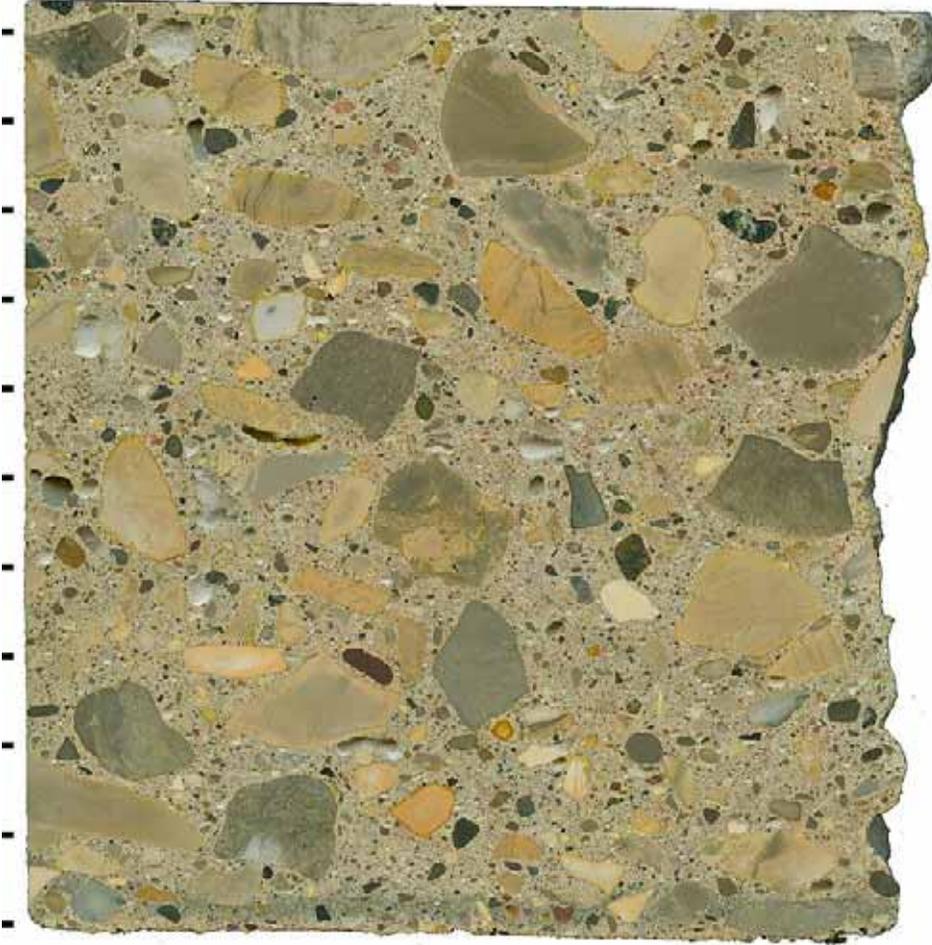
Slab representing cross section through top half of pavement, after sodium cobaltinitrite stain, EB M-14, station 6+353, at transverse joint, core B, MTU ID M59-01, tic marks every half inch.

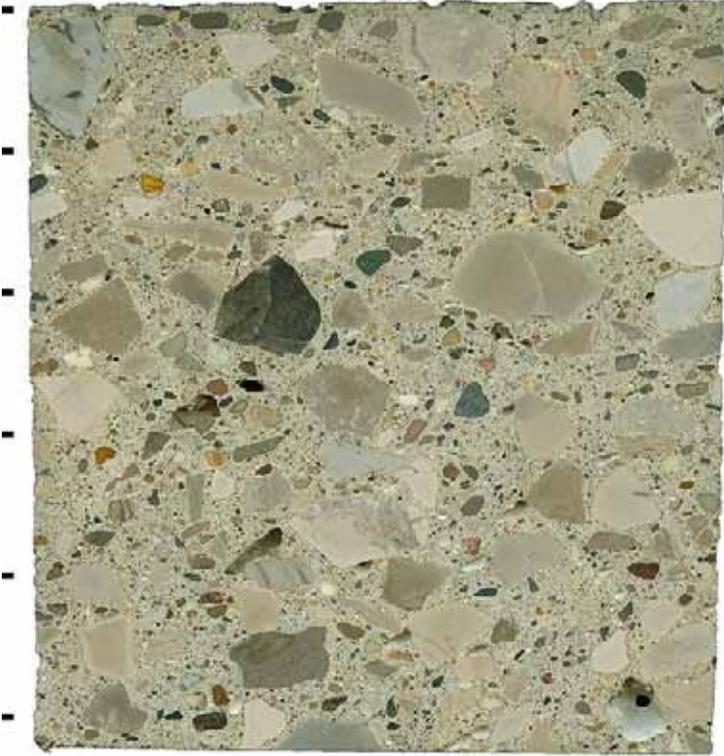
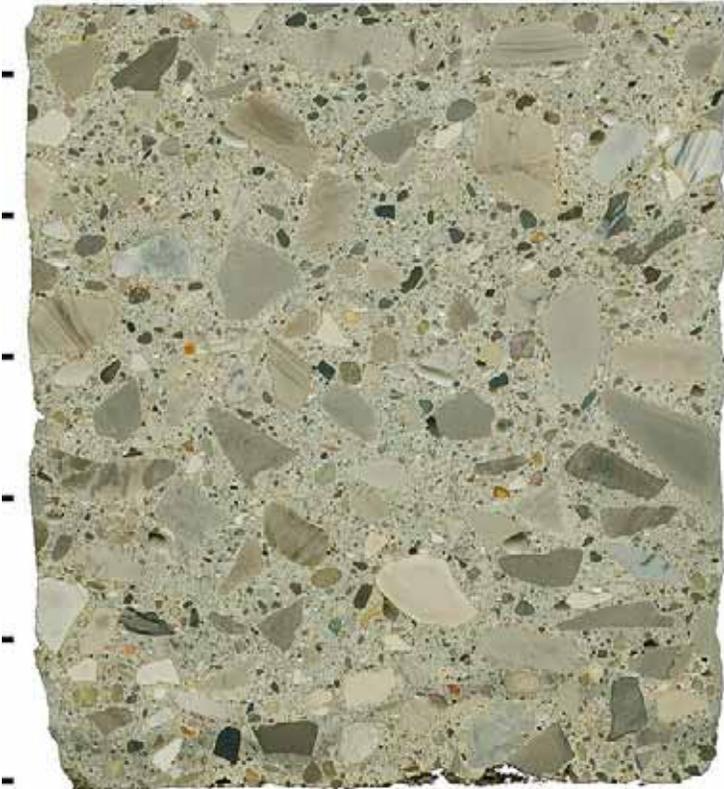
Slabs representing full cross section through pavement, as polished, EB M-14, station 6+353, away from transverse joint, core C, MTU ID M14-03, tic marks every inch.

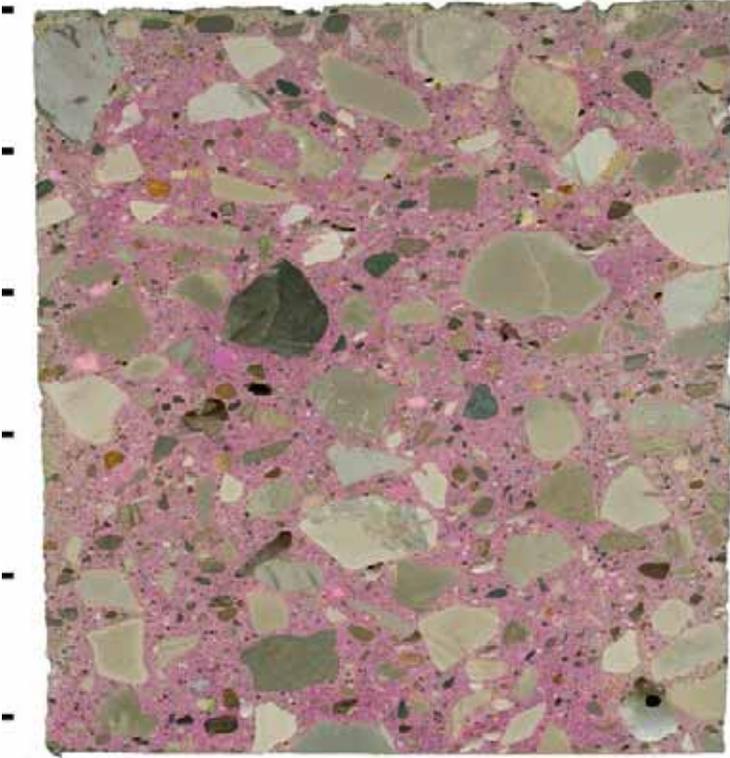
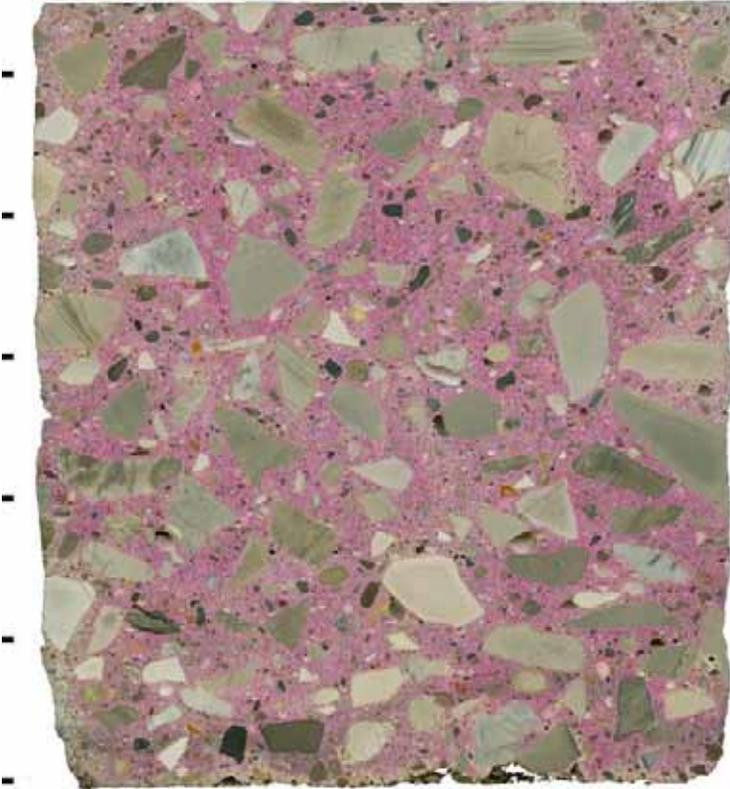
Slabs representing full cross section through pavement, after phenolphthalein stain, EB M-14, station 6+353, away from transverse joint, core C, MTU ID M14-03, tic marks every inch.

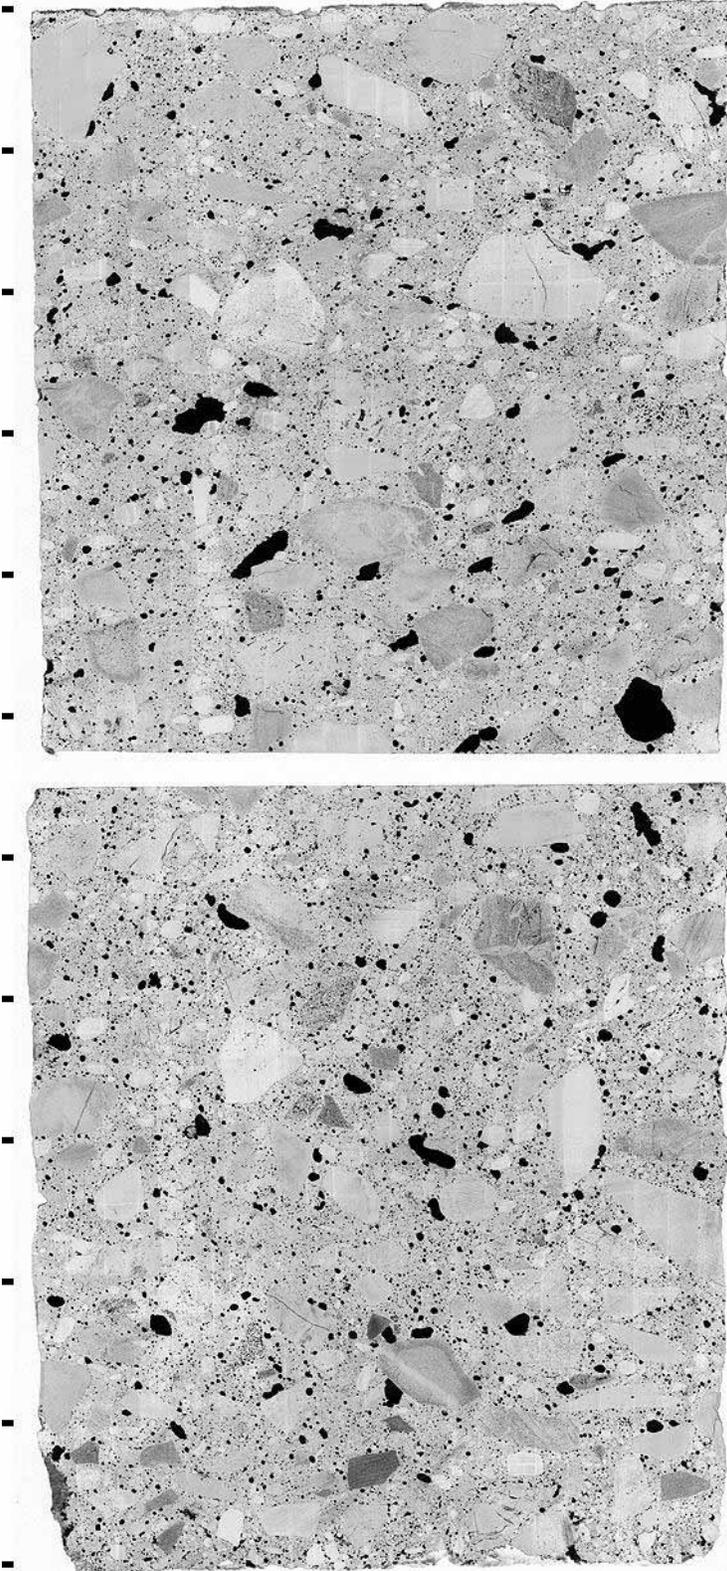
Slabs representing full cross section through pavement, after treatment to enhance air voids and cracks, EB M-14, station 6+353, away from transverse joint, core C, MTU ID M14-03, tic marks every inch.

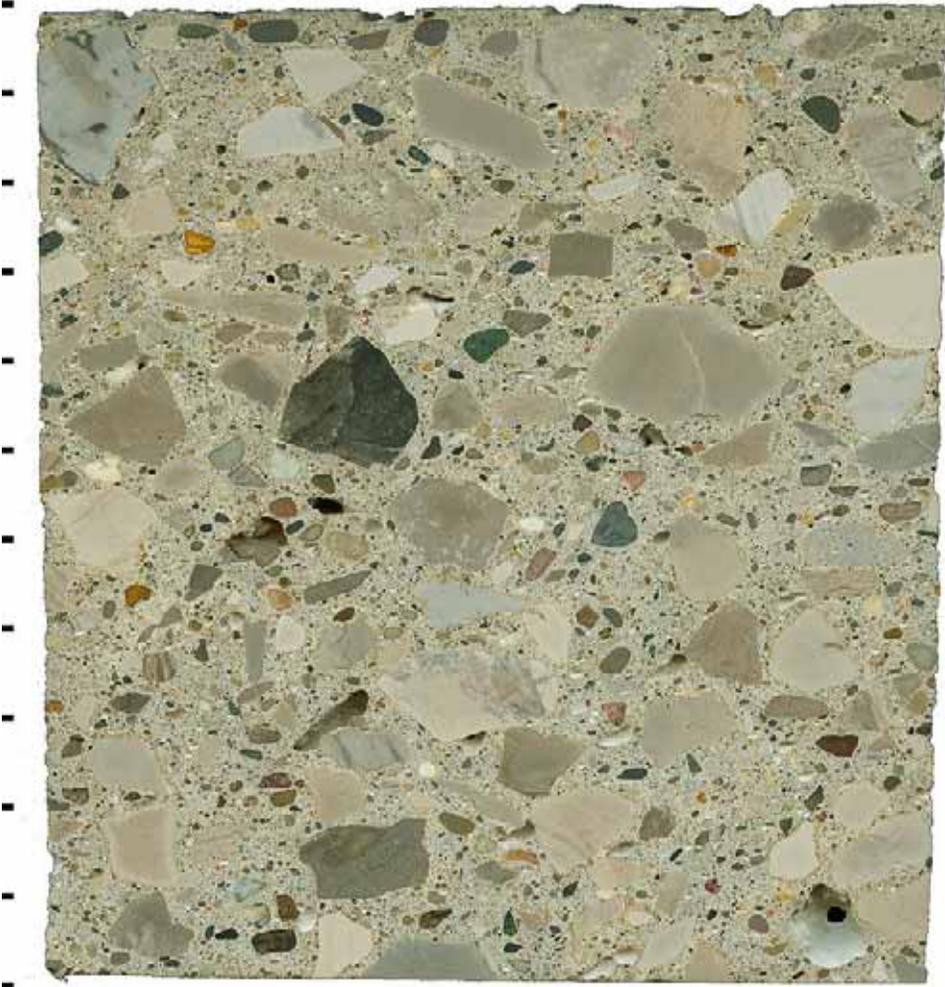
Slab representing cross section through top half of pavement, as polished, EB M-14, station 6+353, away from transverse joint, core C, MTU ID M14-03, tic marks every half inch.

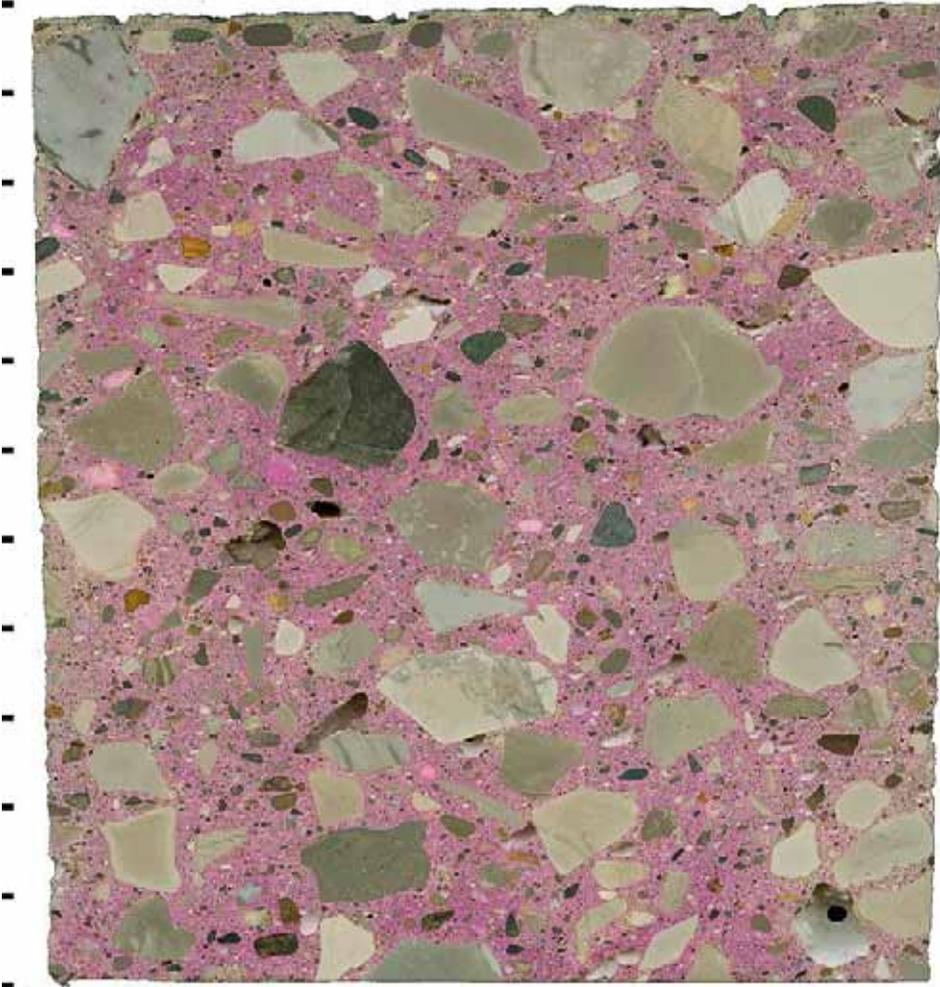
Slab representing cross section through top half of pavement, after phenolphthalein stain, EB M-14, station 6+353, away from transverse joint, core C, MTU ID M14-03, tic marks every half inch.

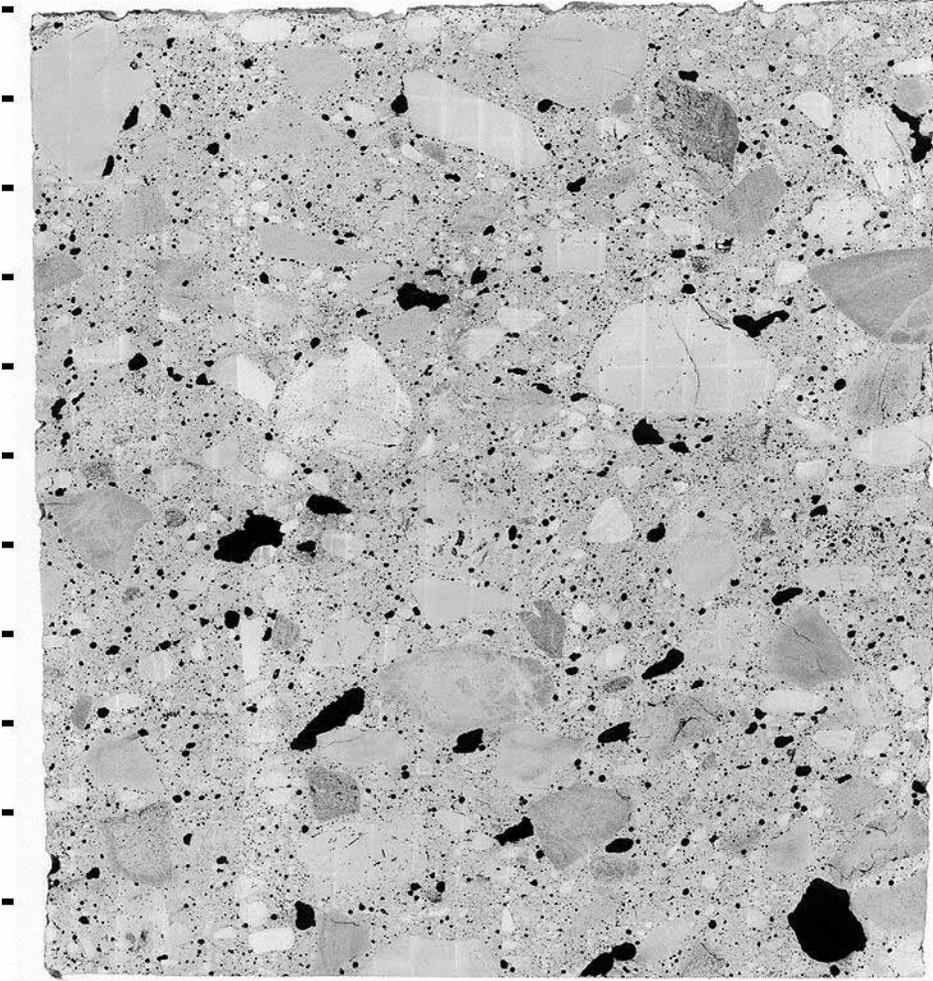
Slab representing cross section through top half of pavement, after treatment to enhance air voids and cracks, EB M-14, station 6+353, away from transverse joint, core C, MTU ID M14-03, tic marks every half inch.

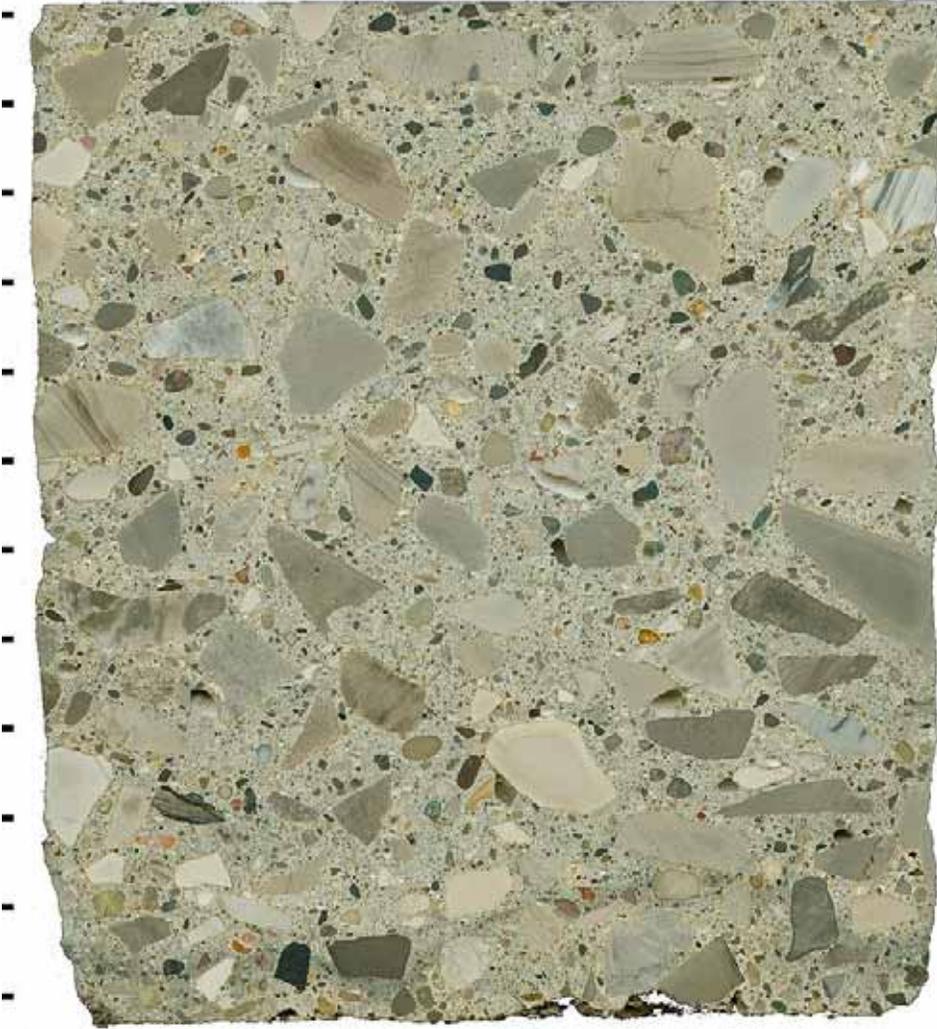
Slab representing cross section through bottom half of pavement, as polished, EB M-14, station 6+353, away from transverse joint, core C, MTU ID M14-03, tic marks every half inch.

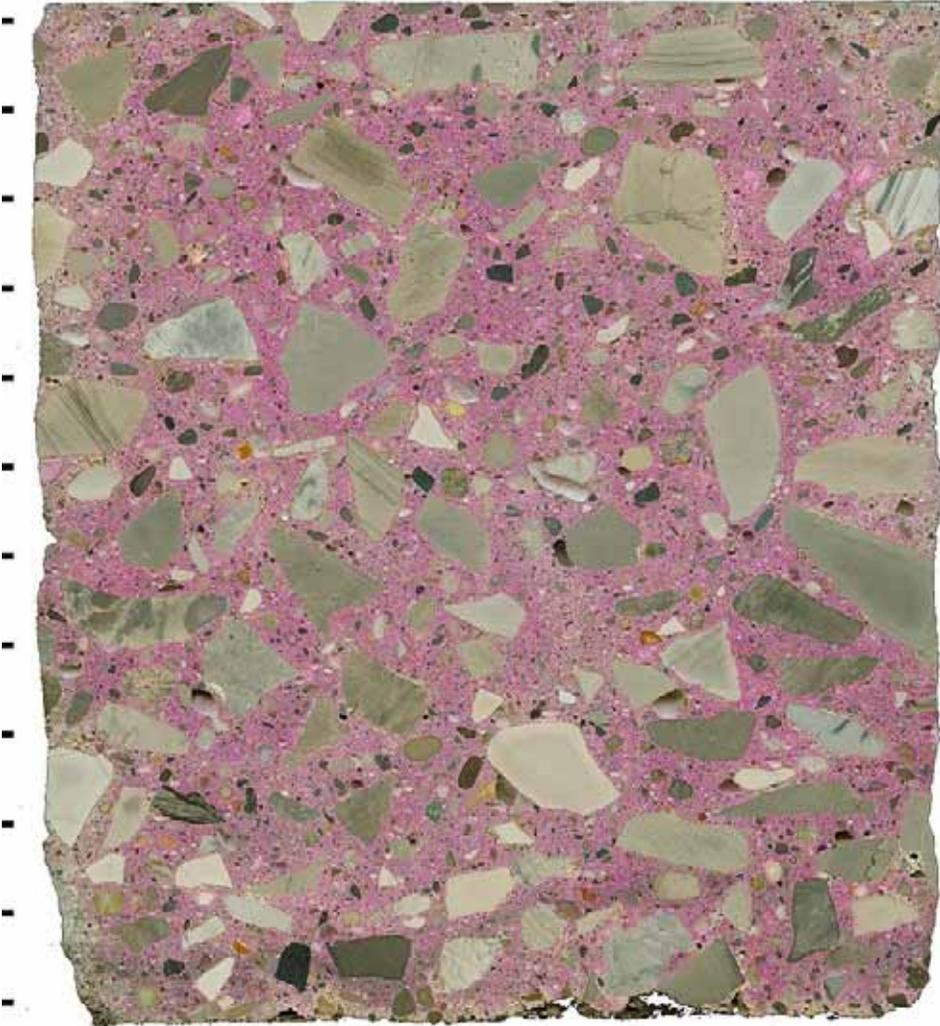
Slab representing cross section through top half of pavement, after phenolphthalein stain, EB M-14, station 6+353, away from transverse joint, core C, MTU ID M14-03, tic marks every half inch.

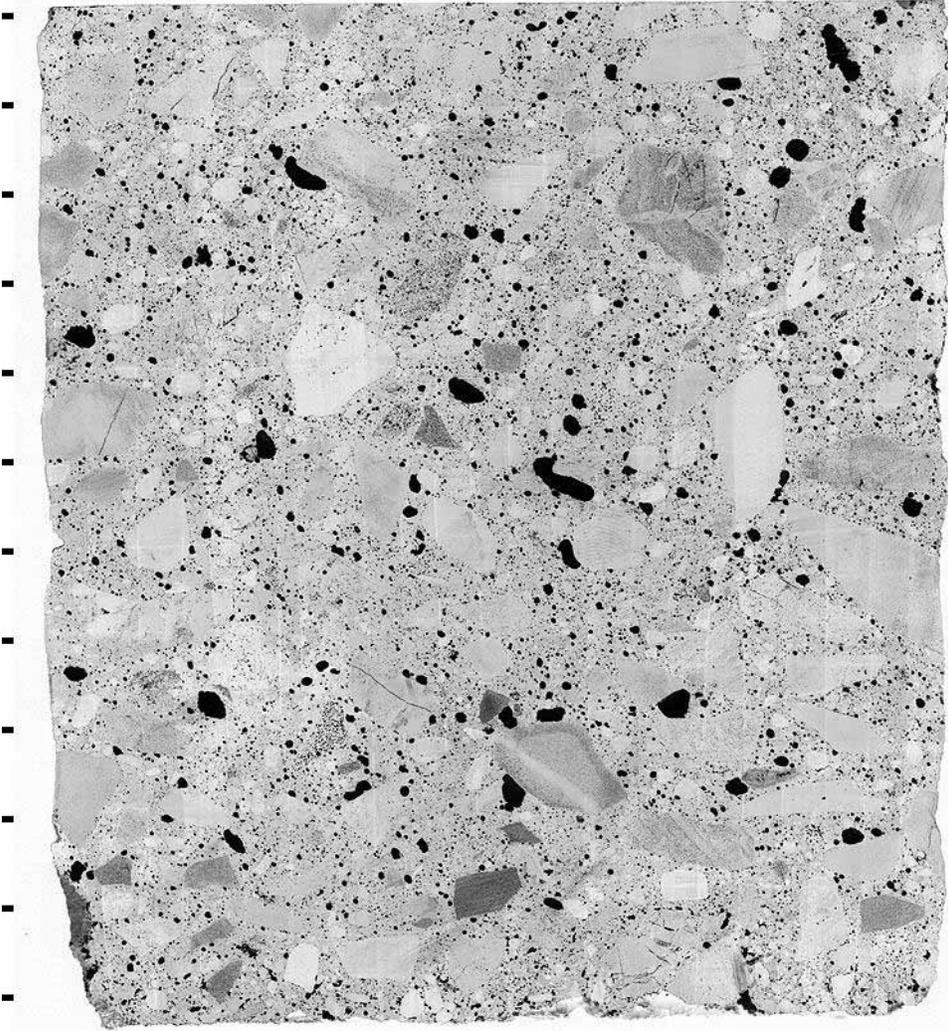
Slab representing cross section through top half of pavement, after treatment to enhance air voids and cracks, EB M-14, station 6+353, away from transverse joint, core C, MTU ID M14-03, tic marks every half inch. EB

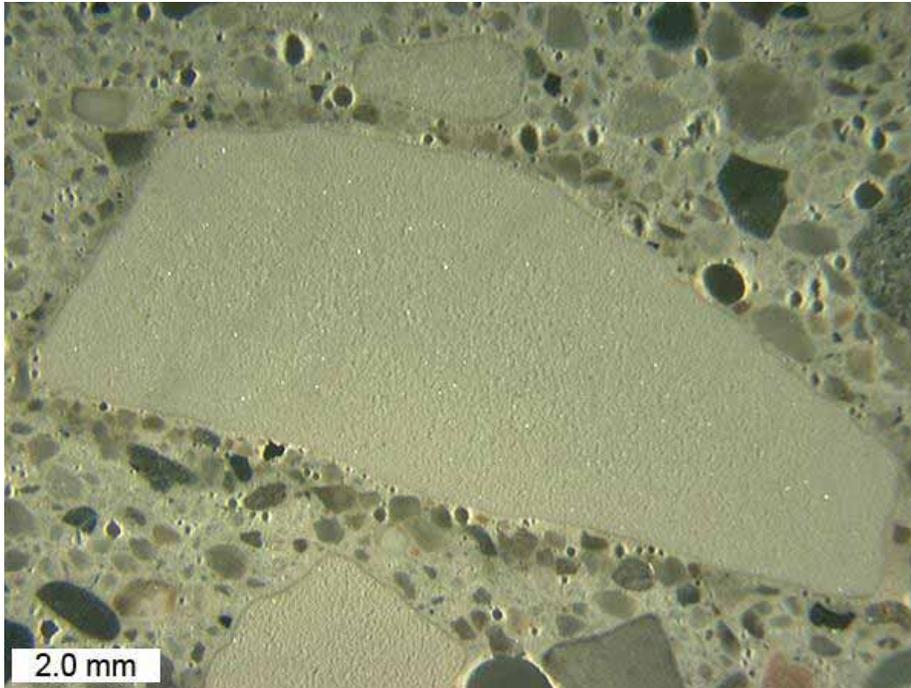
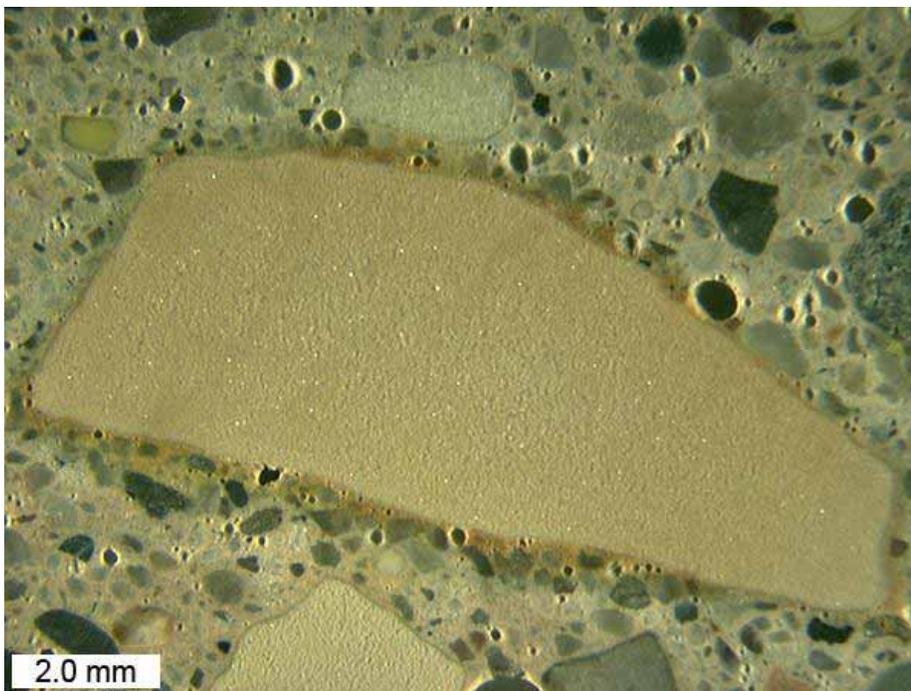
Coarse aggregate particle with darkened rim in contact with the cement paste, without cracking, before and after sodium cobaltinitrite stain, polished slab from SB M-14, at transverse joint, top half of core B, MTU ID M14-02.

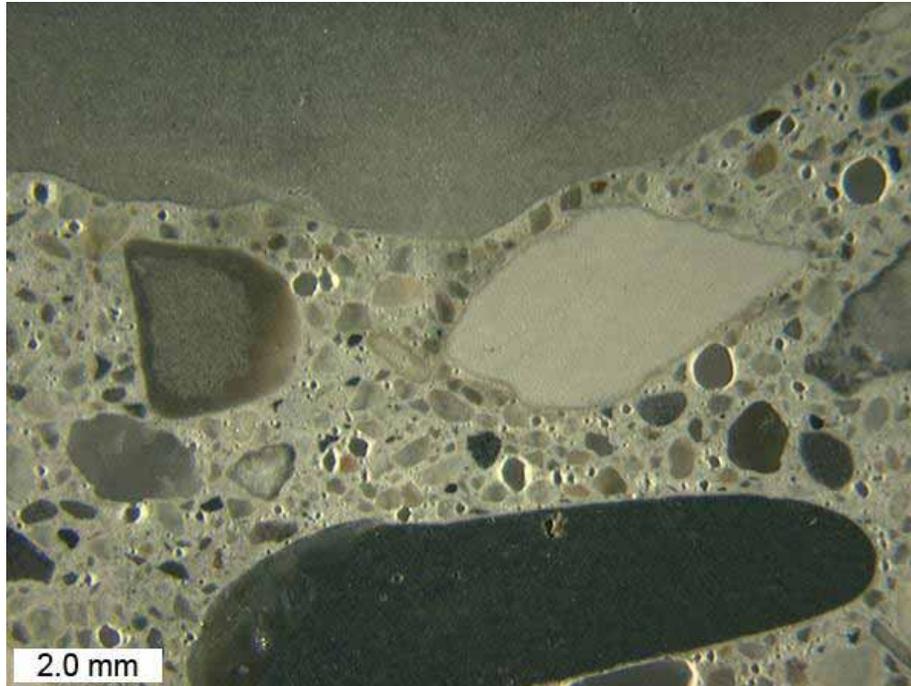
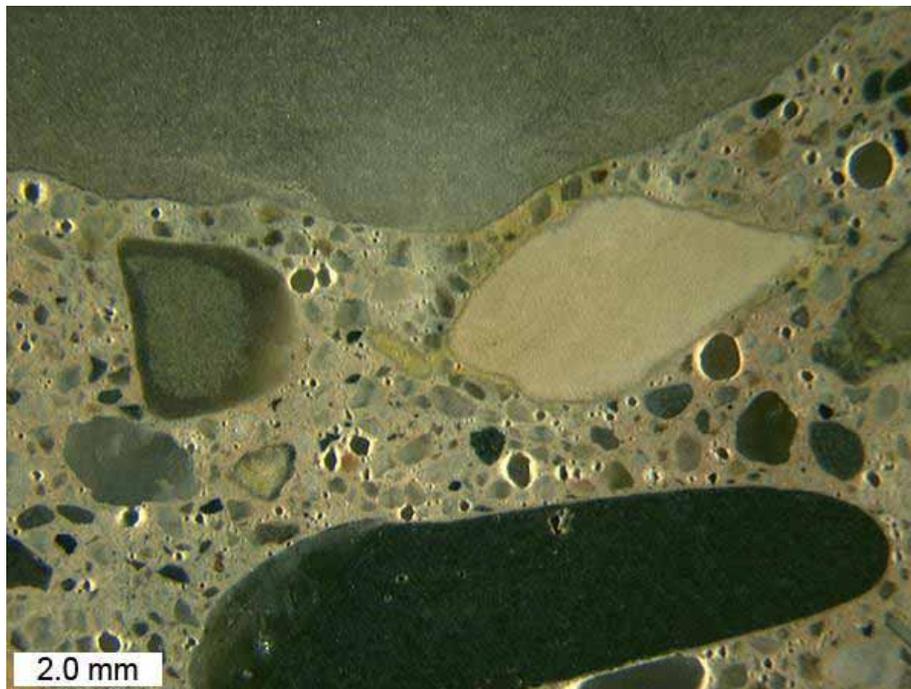
Coarse and fine aggregate particles with darkened rims in contact with the cement paste, without cracking, before and after sodium cobaltinitrite stain, polished slab from SB M-14, at transverse joint, top half of core B, MTU ID M14-02.
