Appendix D
M-14 Core Site

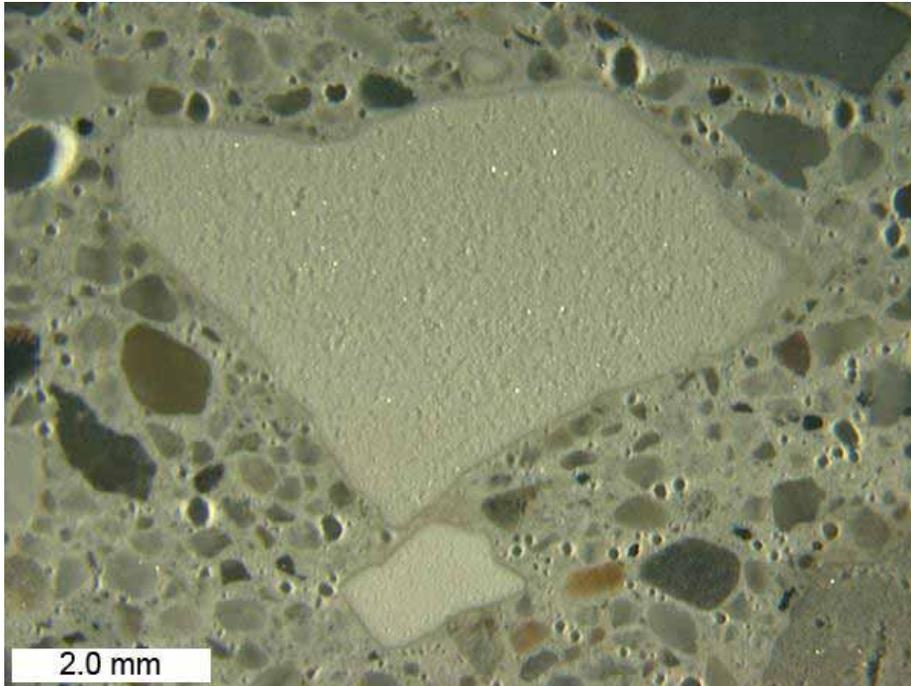
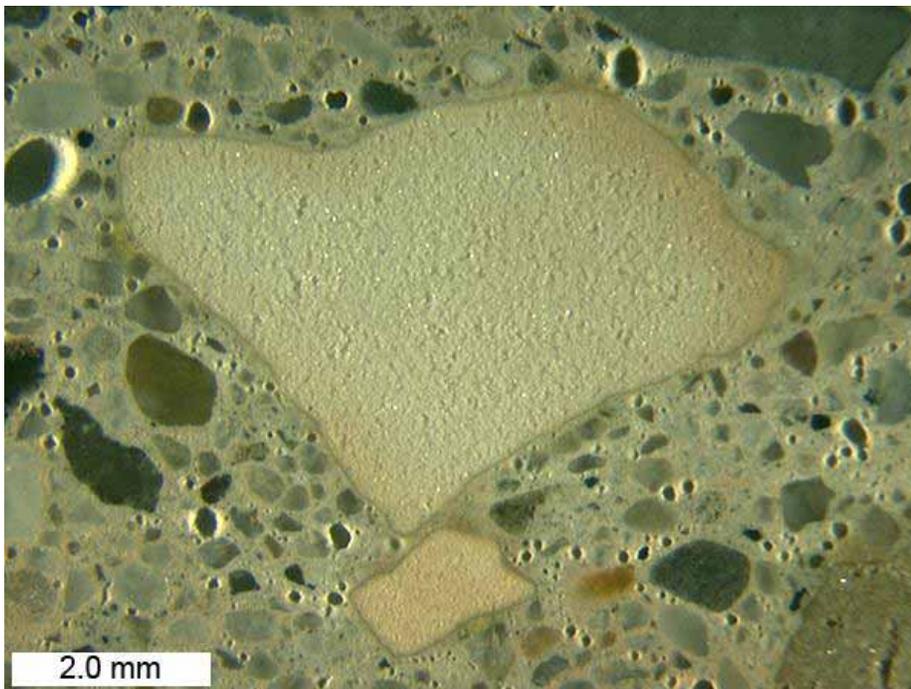
Coarse aggregate particles with darkened rims in contact with the cement paste, without cracking, before and after sodium cobaltinitrite stain, polished slab from SB M-14, at transverse joint, top half of core B, MTU ID M14-02.

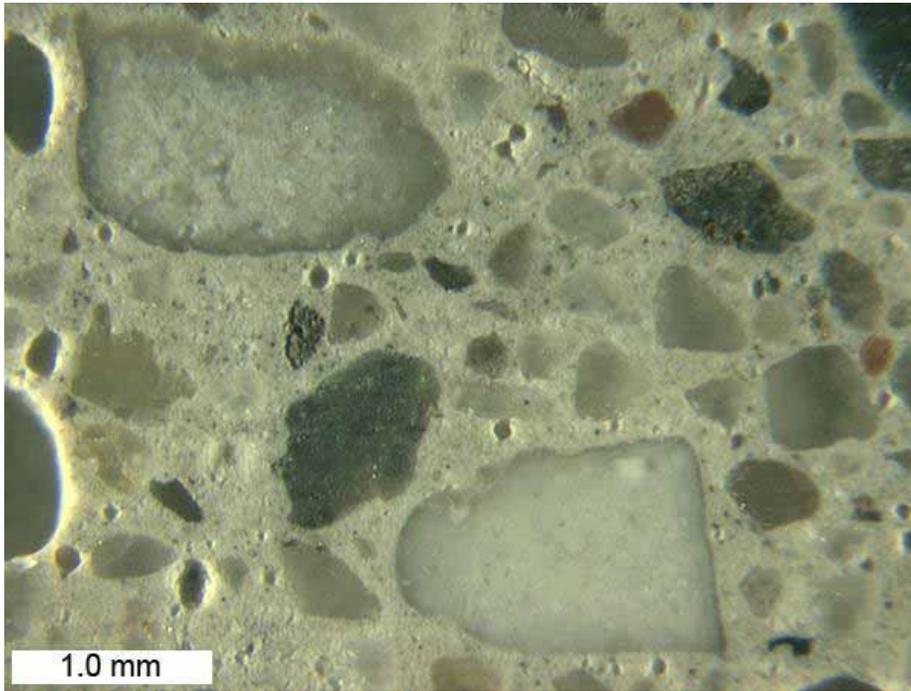
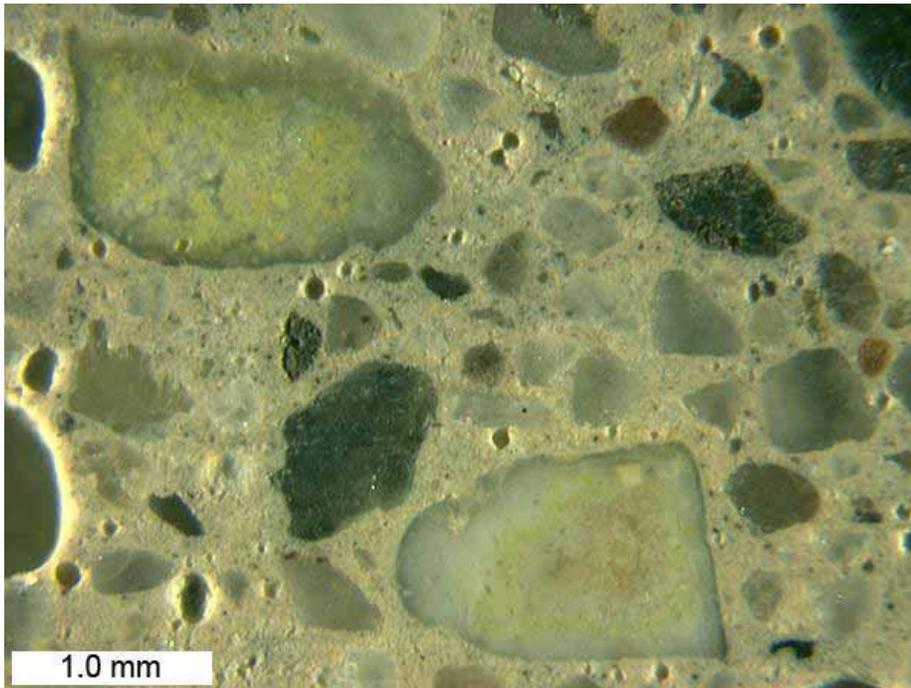
Fine aggregate particles with darkened rims in contact with the cement paste, without cracking, before and after sodium cobaltinitrite stain, polished slab from SB M-14, at transverse joint, top half of core B, MTU ID M14-02.

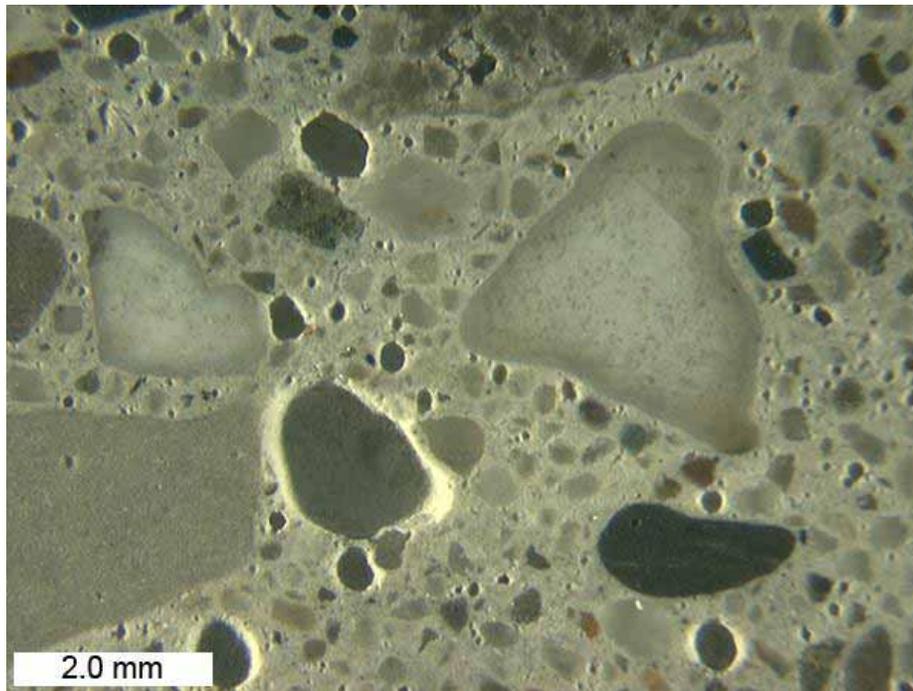
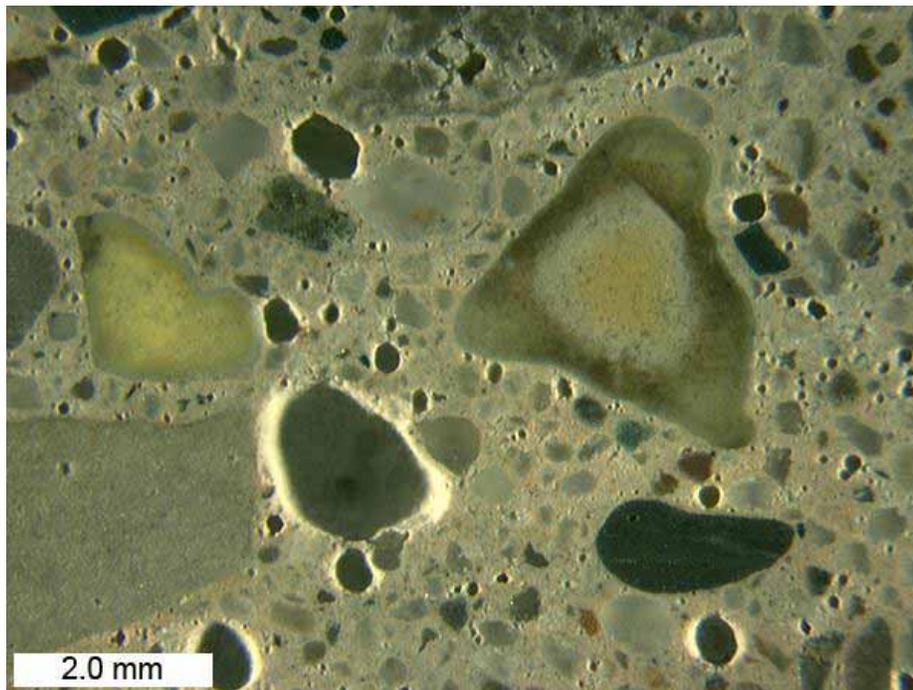
Fine aggregate particles with darkened rims in contact with the cement paste, without cracking, before and after sodium cobaltinitrite stain, polished slab from SB M-14, at transverse joint, top half of core B, MTU ID M14-02.

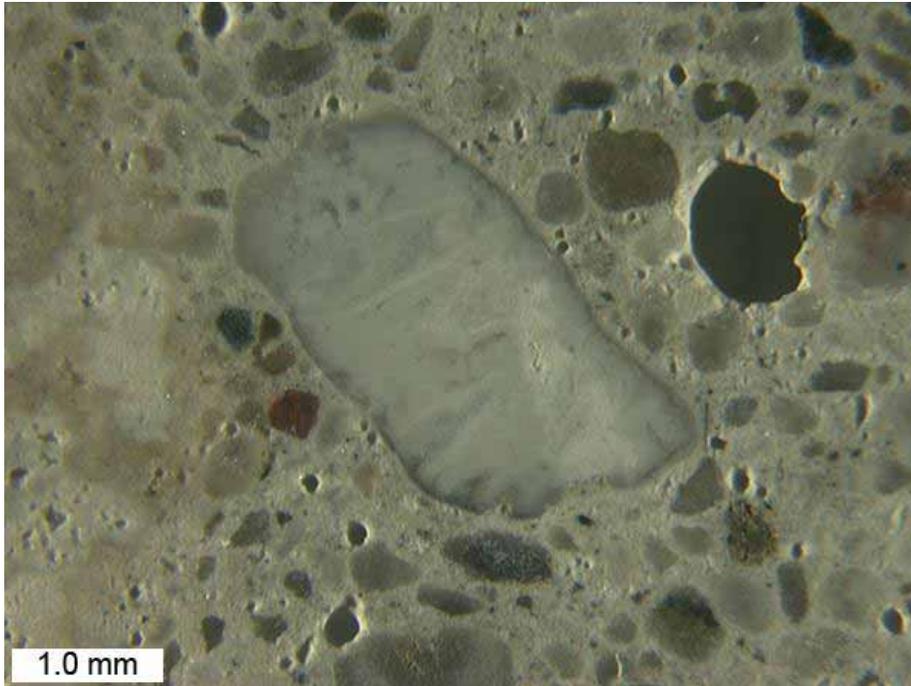
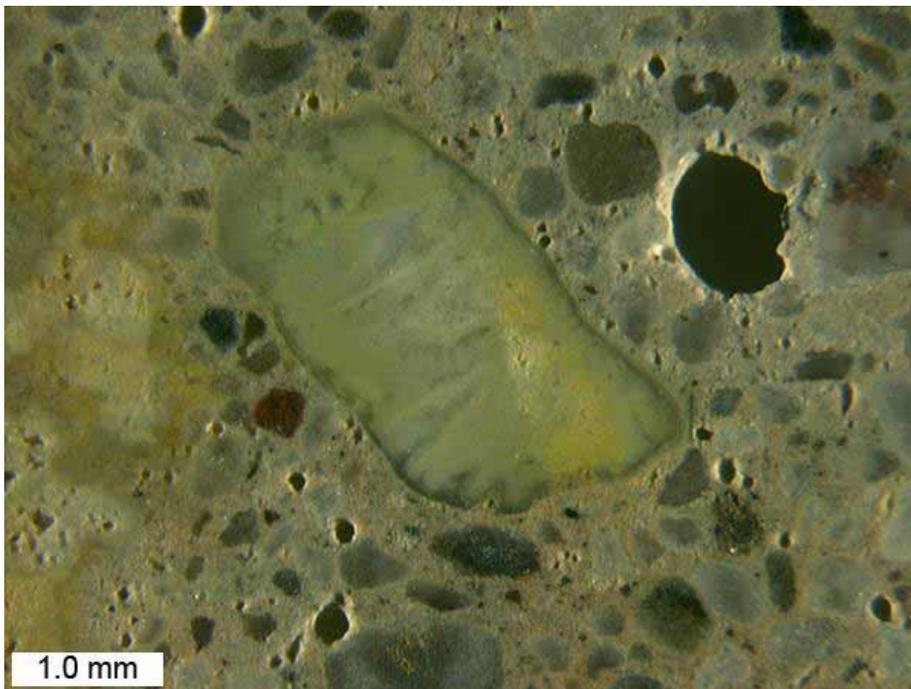
Fine aggregate particles with darkened rims in contact with the cement paste, without cracking, before and after sodium cobaltinitrite stain, polished slab from SB M-14, at transverse joint, top half of core B, MTU ID M14-02.

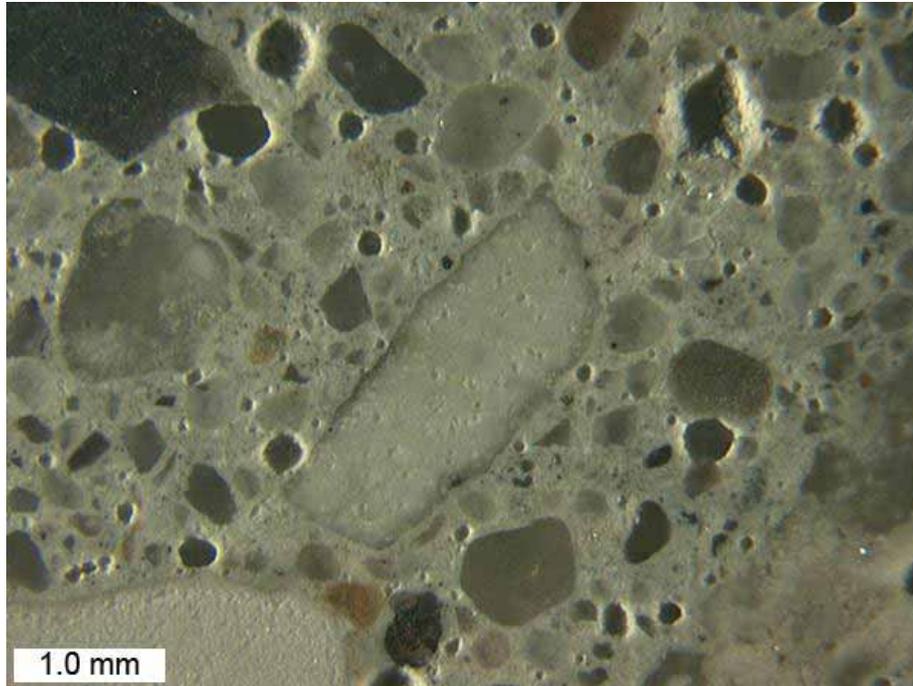
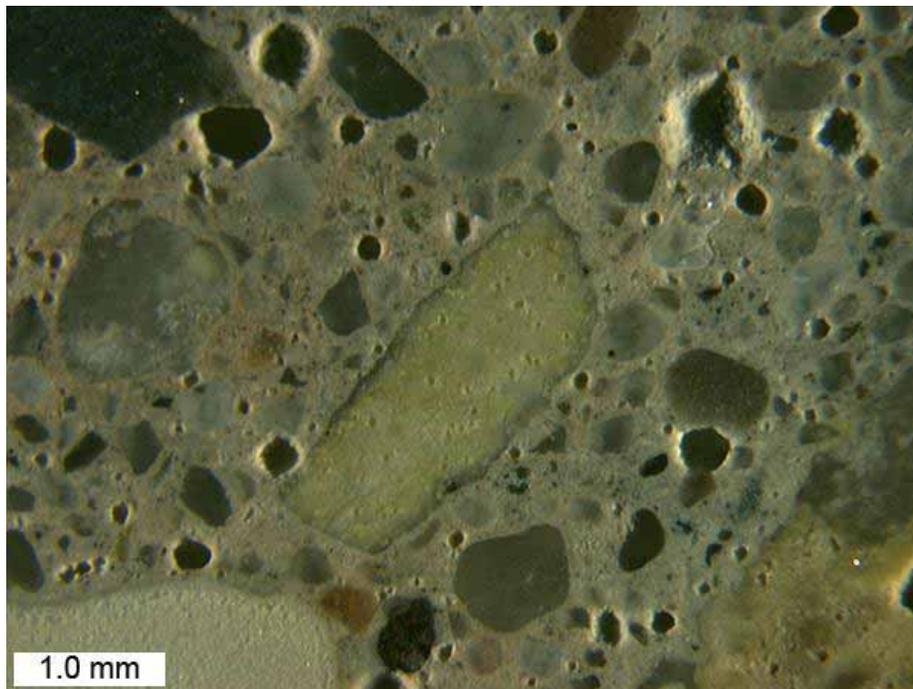
Fine aggregate particles with darkened rims in contact with the cement paste, without cracking, before and after sodium cobaltinitrite stain, polished slab from SB M-14, at transverse joint, bottom half of core B, MTU ID M14-02.

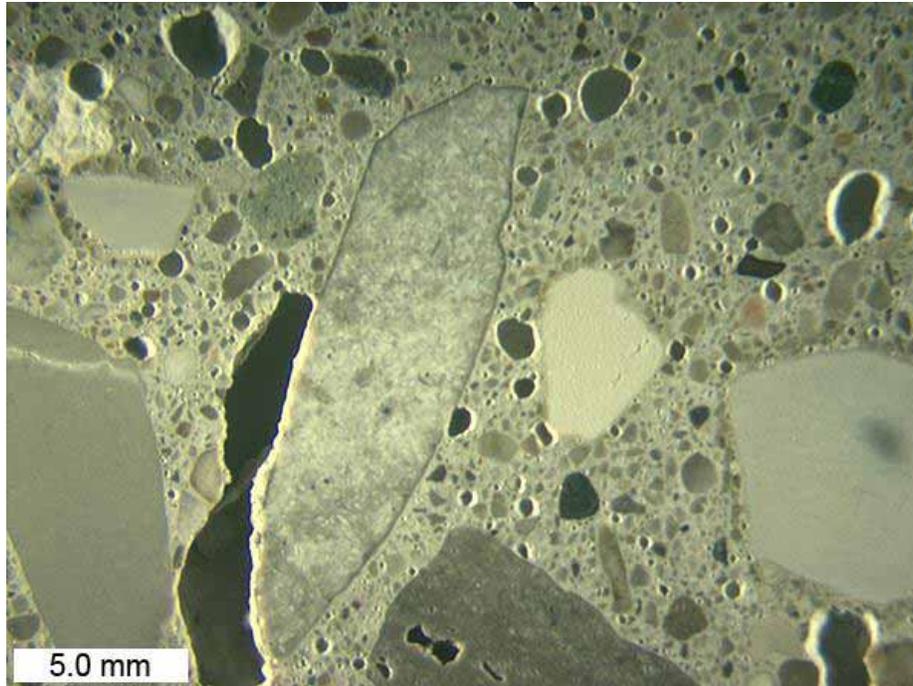
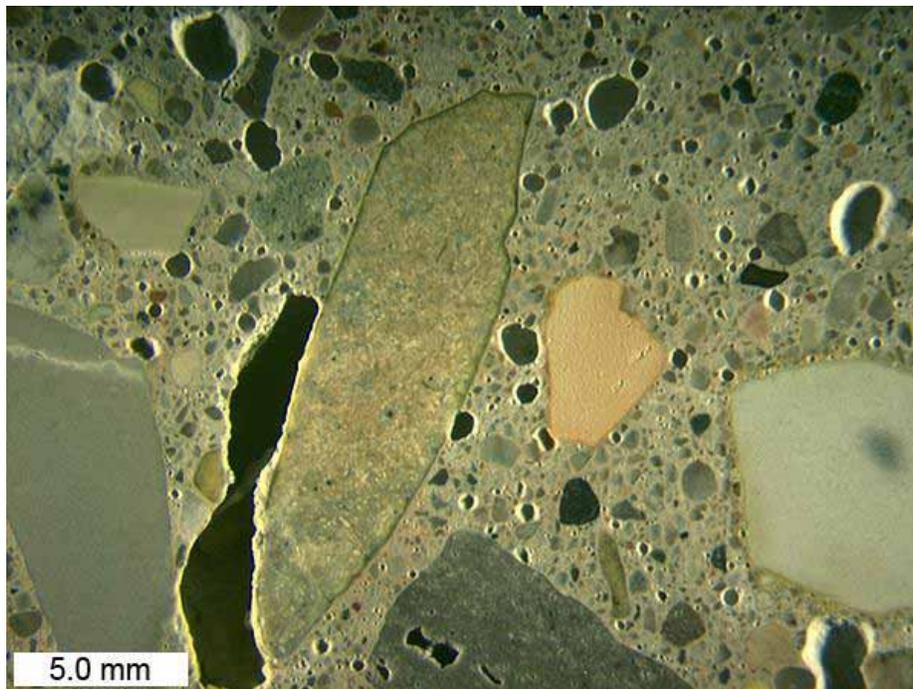
Coarse and fine aggregate particles with darkened rims in contact with the cement paste, without cracking, before and after sodium cobaltinitrite stain, polished slab from SB M-14, at transverse joint, bottom half of core B, MTU ID M14-02.

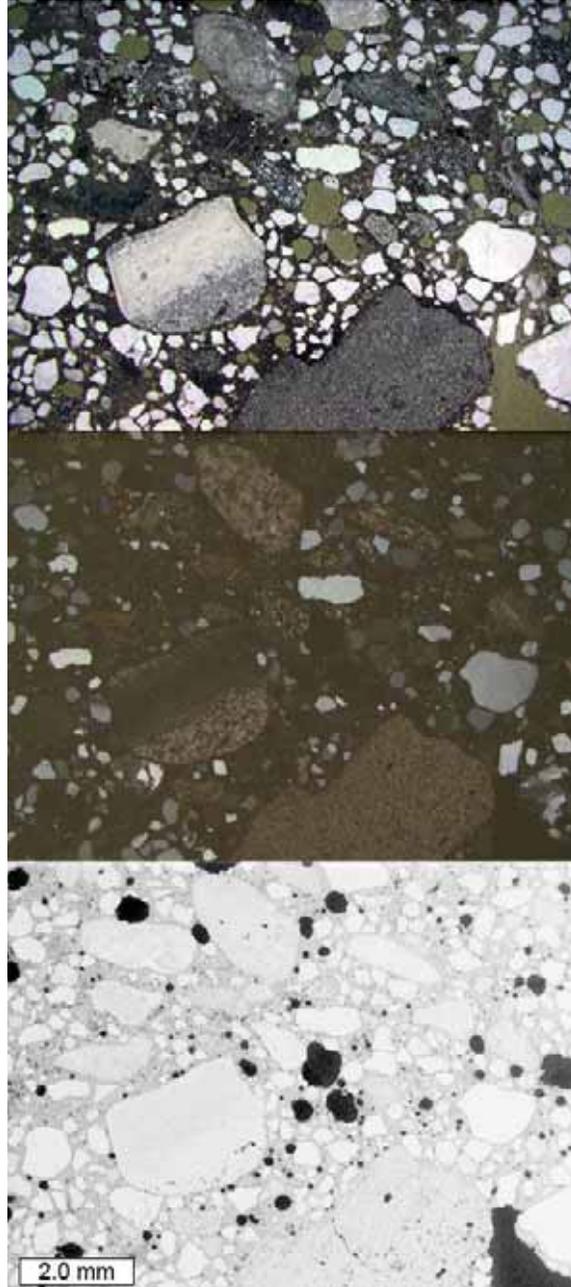
Example of chert particle without signs of deleterious alkali-silica reaction, from thin section prepared from core from M-14, away from joint, MTU ID M14-03. From top to bottom: transmitted light, crossed-polars, and epifluorescent mode images.

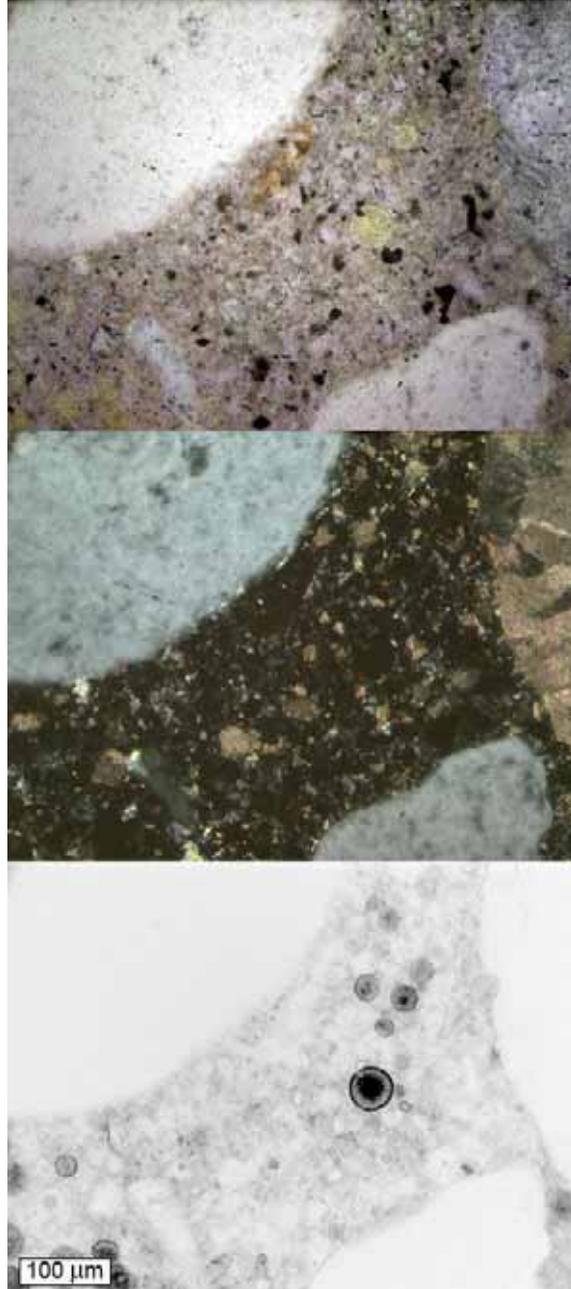
Carbonate dust in cement paste fraction in thin section prepared from core from M-14, away from joint, MTU ID M14-03. From top to bottom: transmitted light, crossed-polars, and epifluorescent mode images.

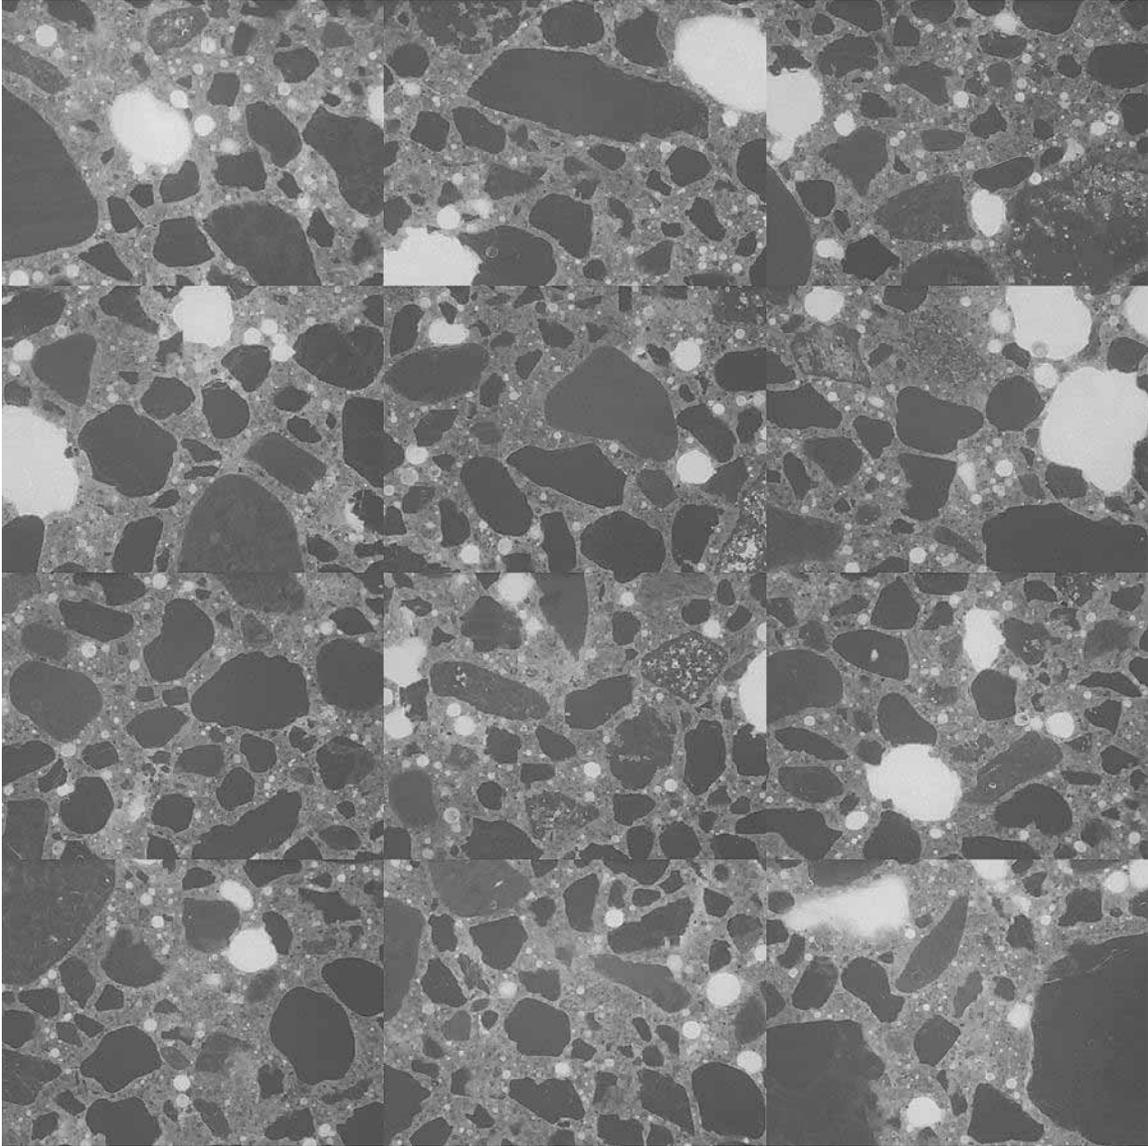
Mosaic of 12 epifluorescent mode images collected from thin sections prepared from core from M-14, away from transverse joint, MTU ID M14-03 (each individual frame measures 2.612 x 1.959 mm).

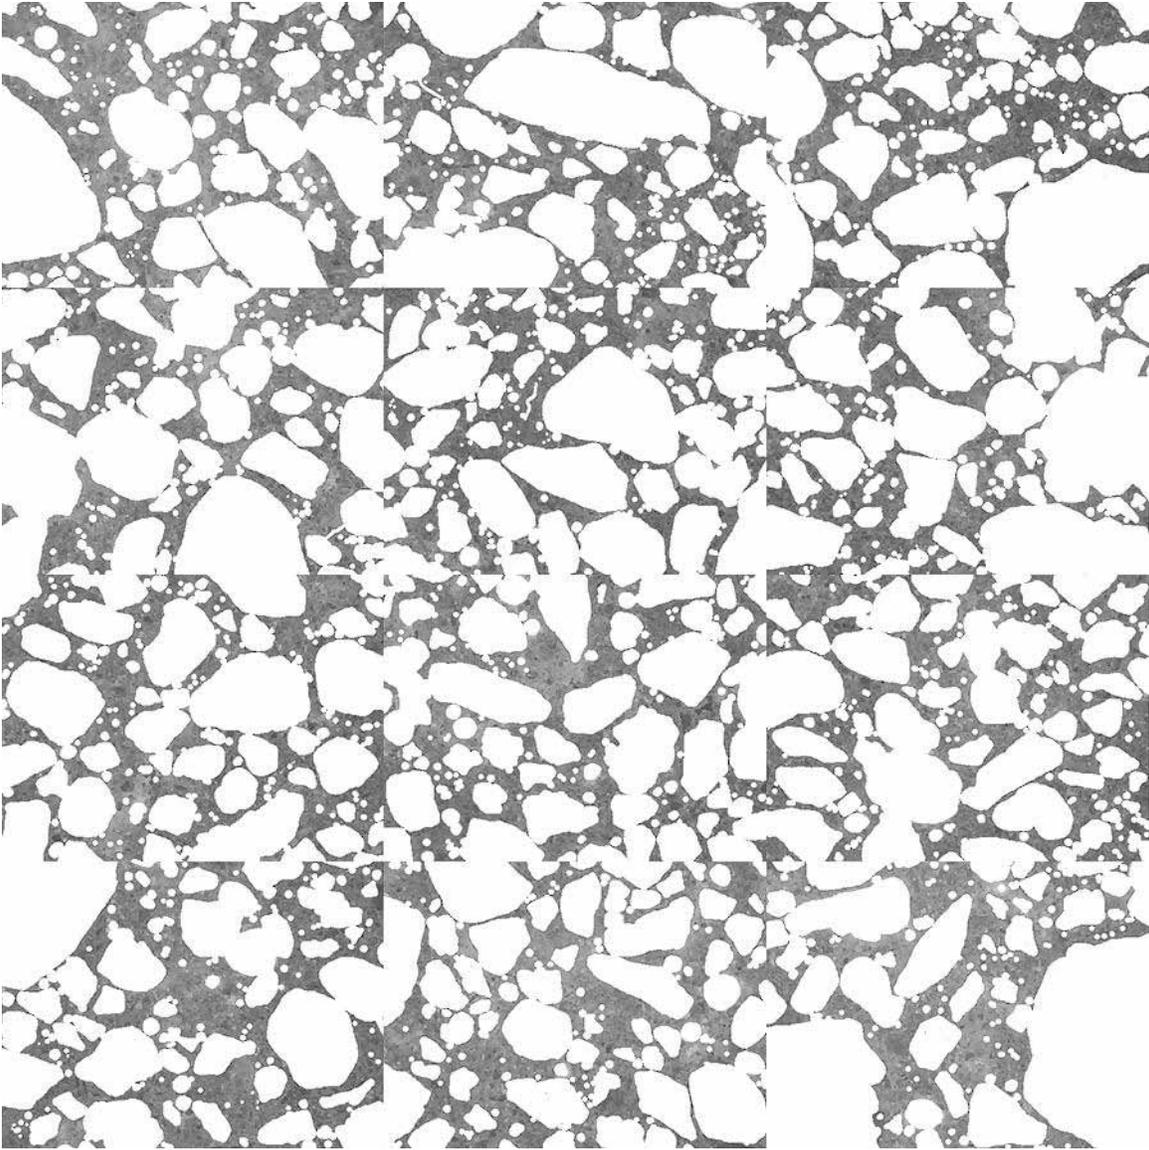
Mosaic of 12 epifluorescent mode images collected from thin sections prepared from core M-14, away from transverse joint, MTU ID M14-03, after masking out air voids and fine aggregate to isolate cement paste (each individual frame measures 2.612 x 1.959 mm).

Average cement paste pixel intensities per frame, and equivalent w/c values (as compared to 28-day moist cured mortar samples) from thin section prepared from core from M-14, away from transverse joint, MTU ID M14-03.

cement paste pixel fluorescence measurements (average intensity per frame)			
84	71	61	77
63	67	68	72
69	67	79	87
equivalent w/c ($y = 0.0044x + 0.0329$)			
0.35	0.40	0.34	0.30
0.37	0.31	0.33	0.33
0.35	0.33	0.32	0.38
