Appendix F
US23 MDOT Aggregate Test Road Sec. B Core Site

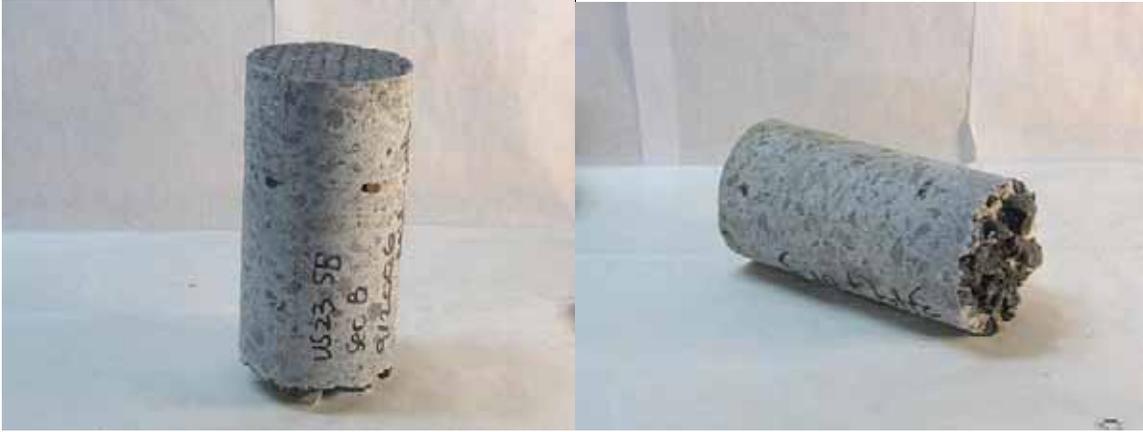
SB US23, section B, station 349+13, mid-slab, (MTU ID 23-06).

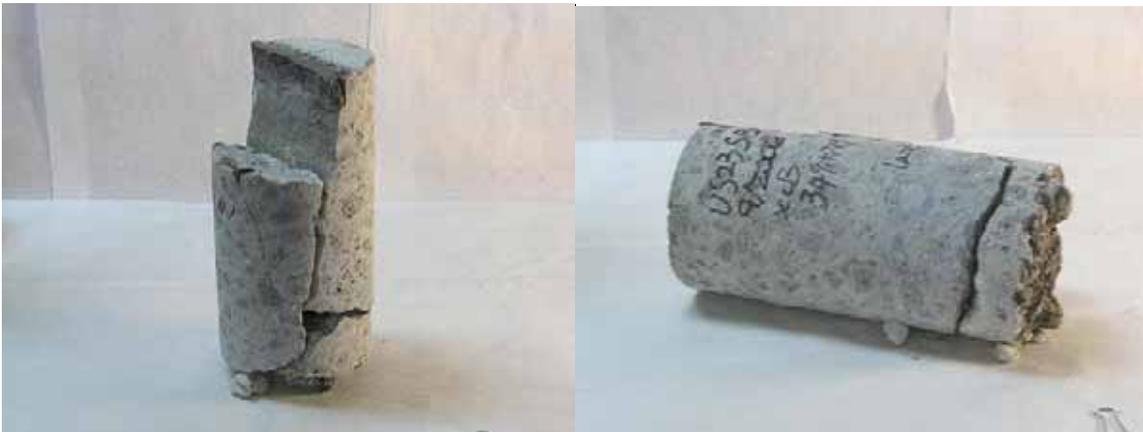
SB US23, section B, station 349+71.9, mid-slab, (MTU ID 23-07).

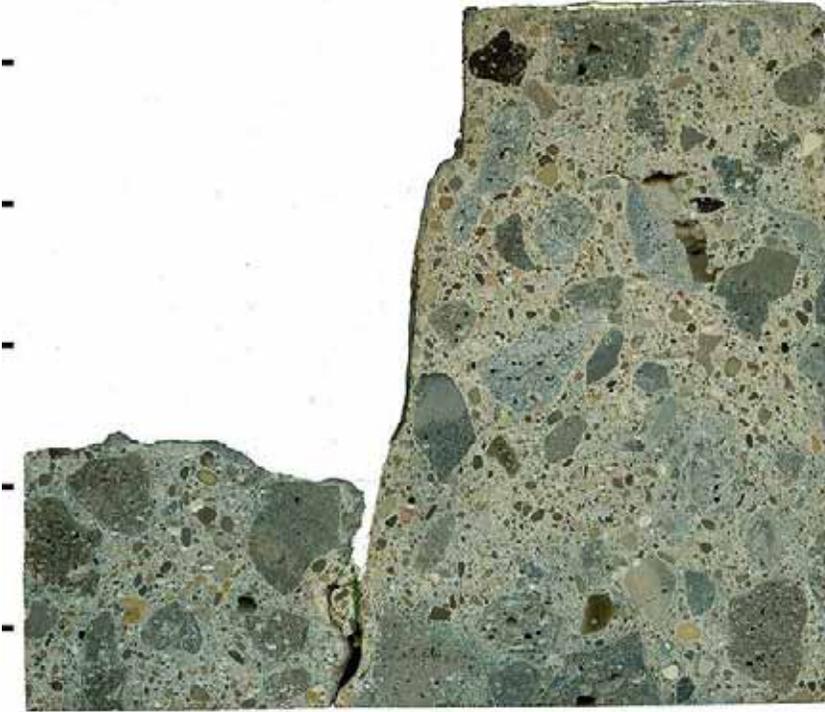
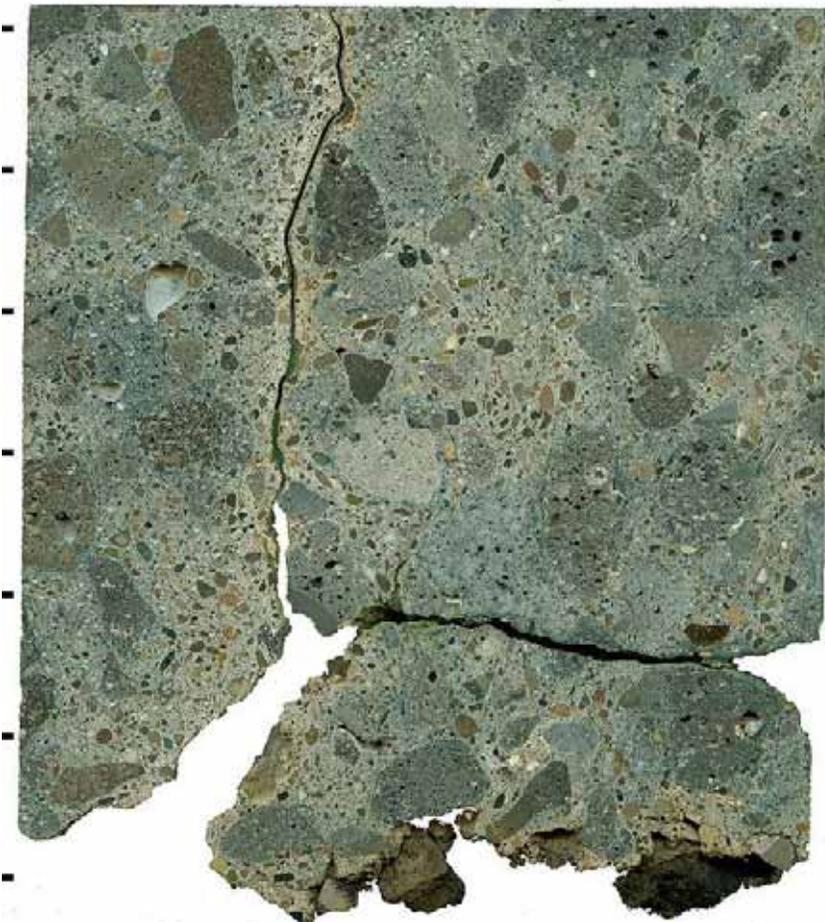
Slabs representing full cross section through pavement, as polished, SB US23, Section B, constructed 1992, station 349+71.9, at longitudinal joint, MTU ID US23-07, tic marks every inch.

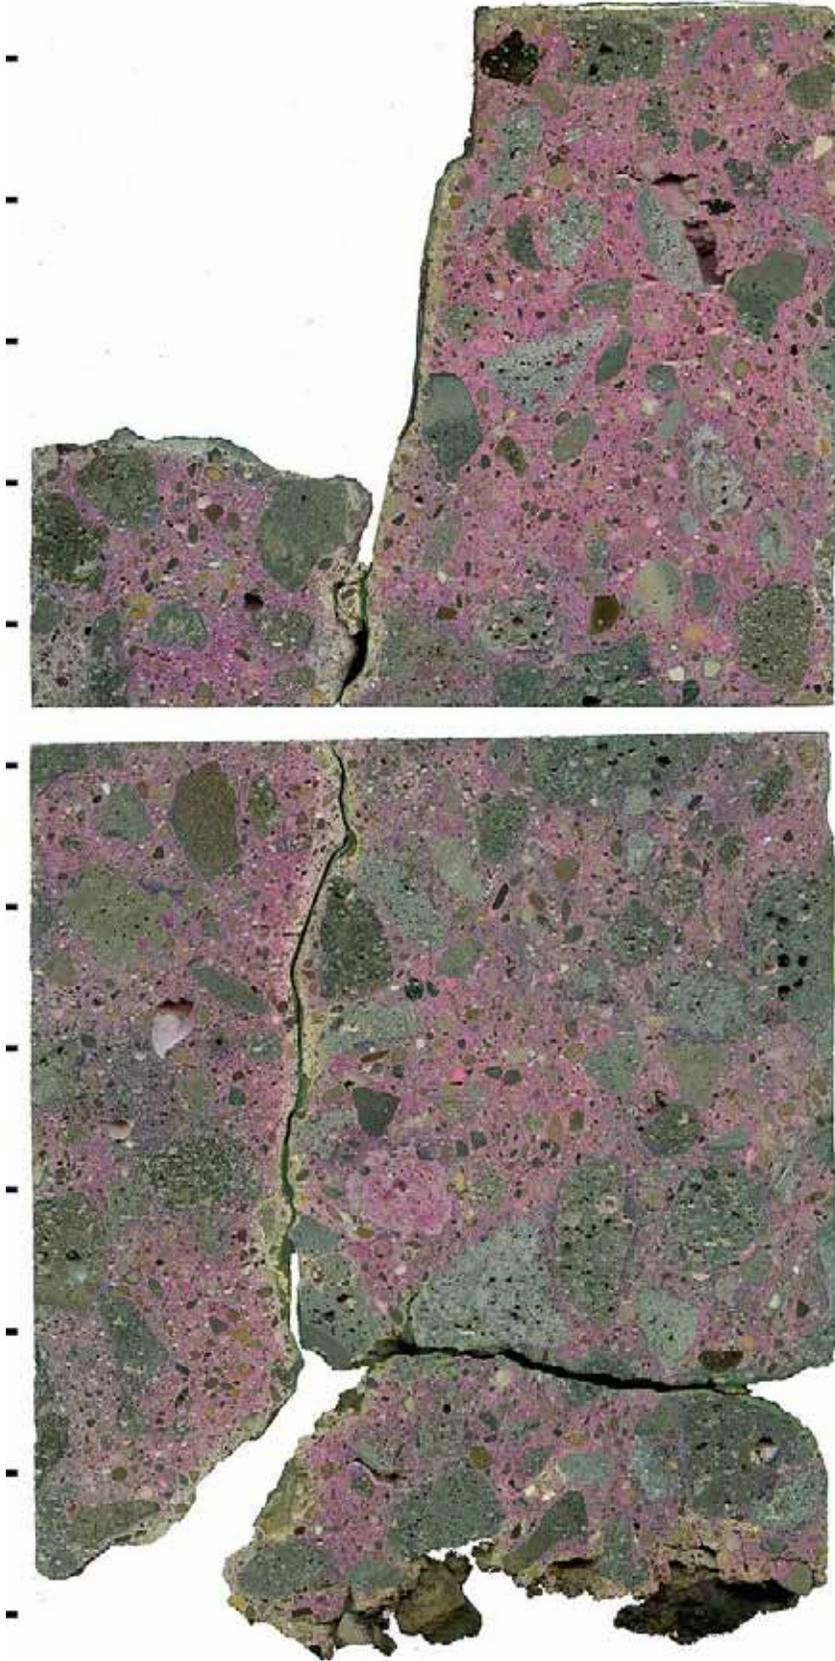
Slabs representing full cross section through pavement, after phenolphthalein stain, SB US23, Section B, constructed 1992, station 349+71.9, at longitudinal joint, MTU ID US23-07, tic marks every inch.

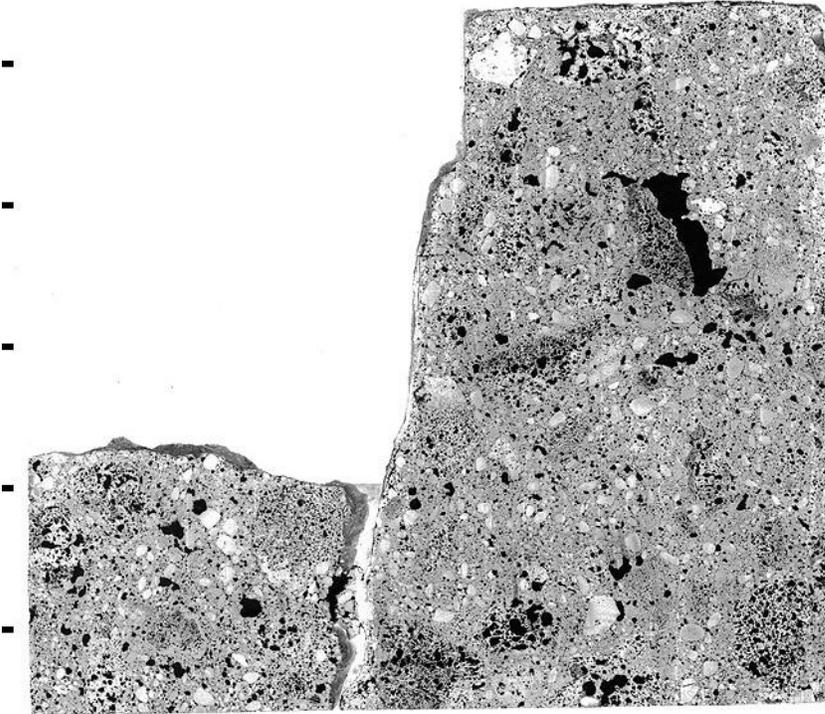
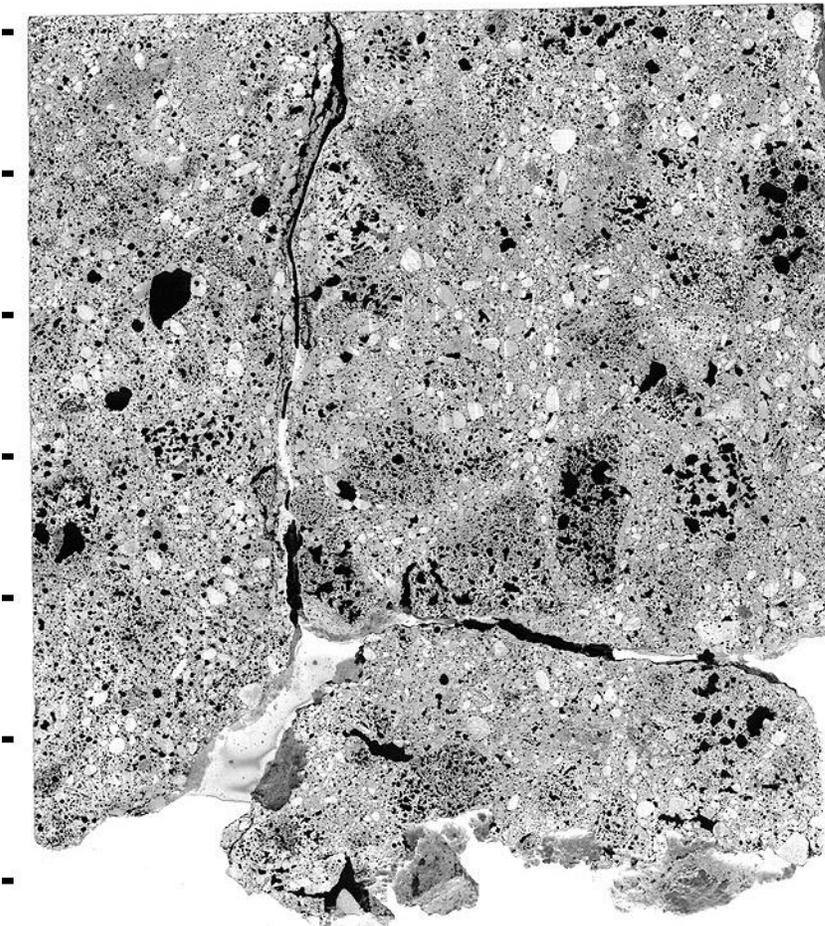
Slabs representing full cross section through pavement, after treatment to enhance air voids and cracks, SB US23, Section B, constructed 1992, station 349+71.9, at longitudinal joint, MTU ID US23-07, tic marks every inch.

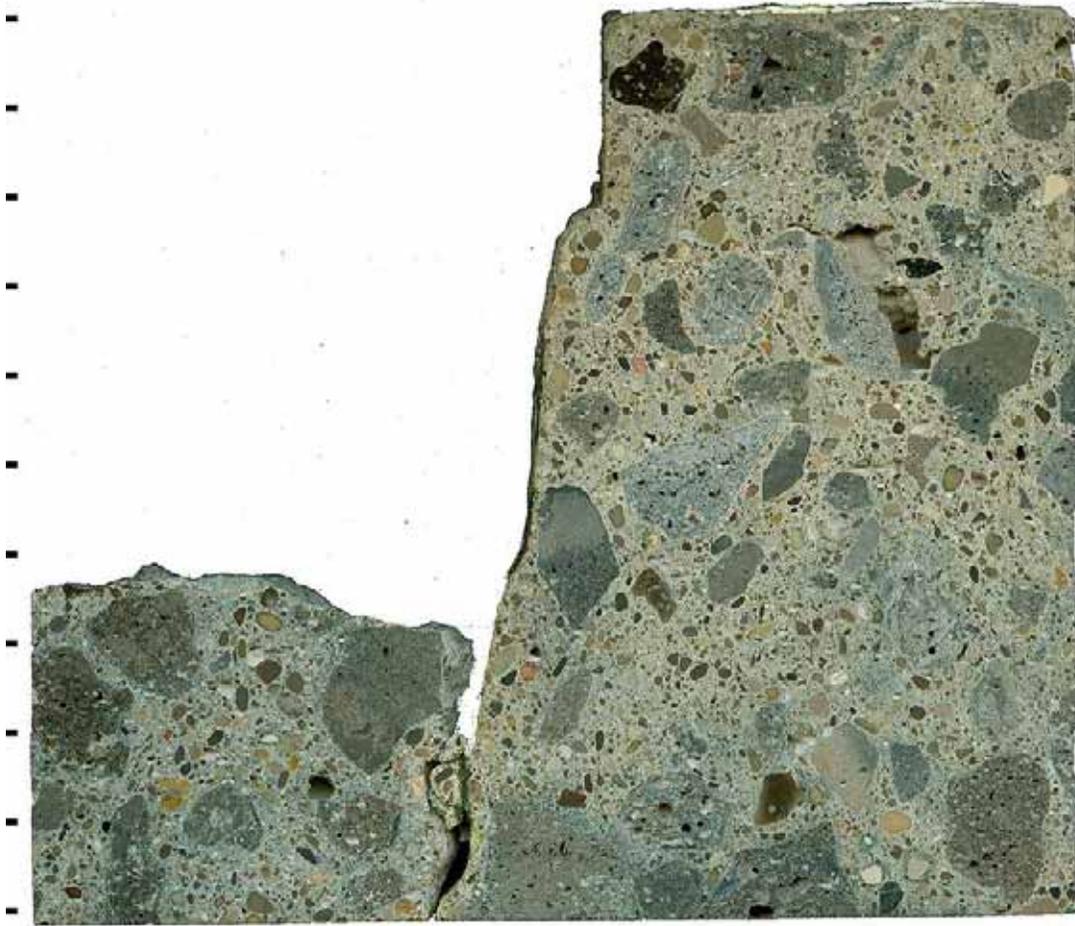
Slab representing cross section through top half of pavement, as polished, SB US23, Section B, constructed 1992, station 349+71.9, at longitudinal joint, MTU ID US23-07, tic marks every half inch.

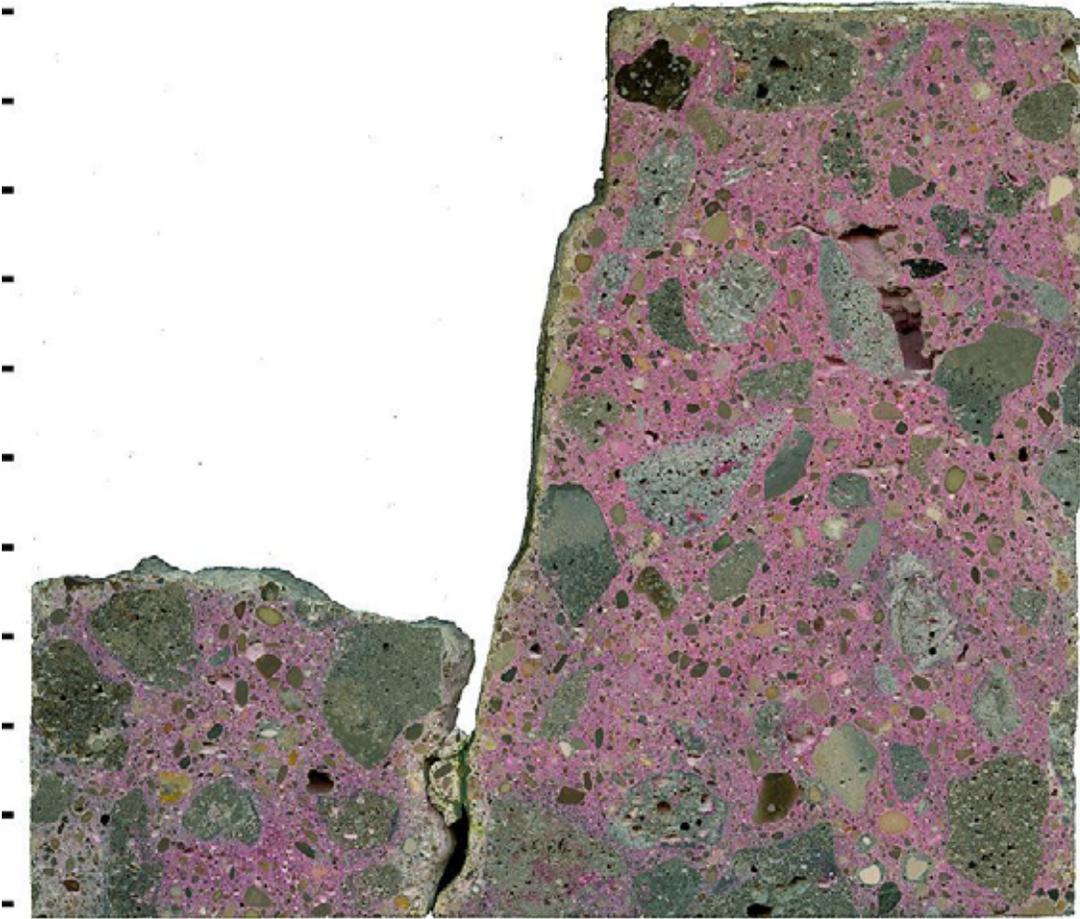
Slab representing cross section through top half of pavement, after phenolphthalein stain, SB US23, Section B, constructed 1992, station 349+71.9, at longitudinal joint, MTU ID US23-07, tic marks every half inch.

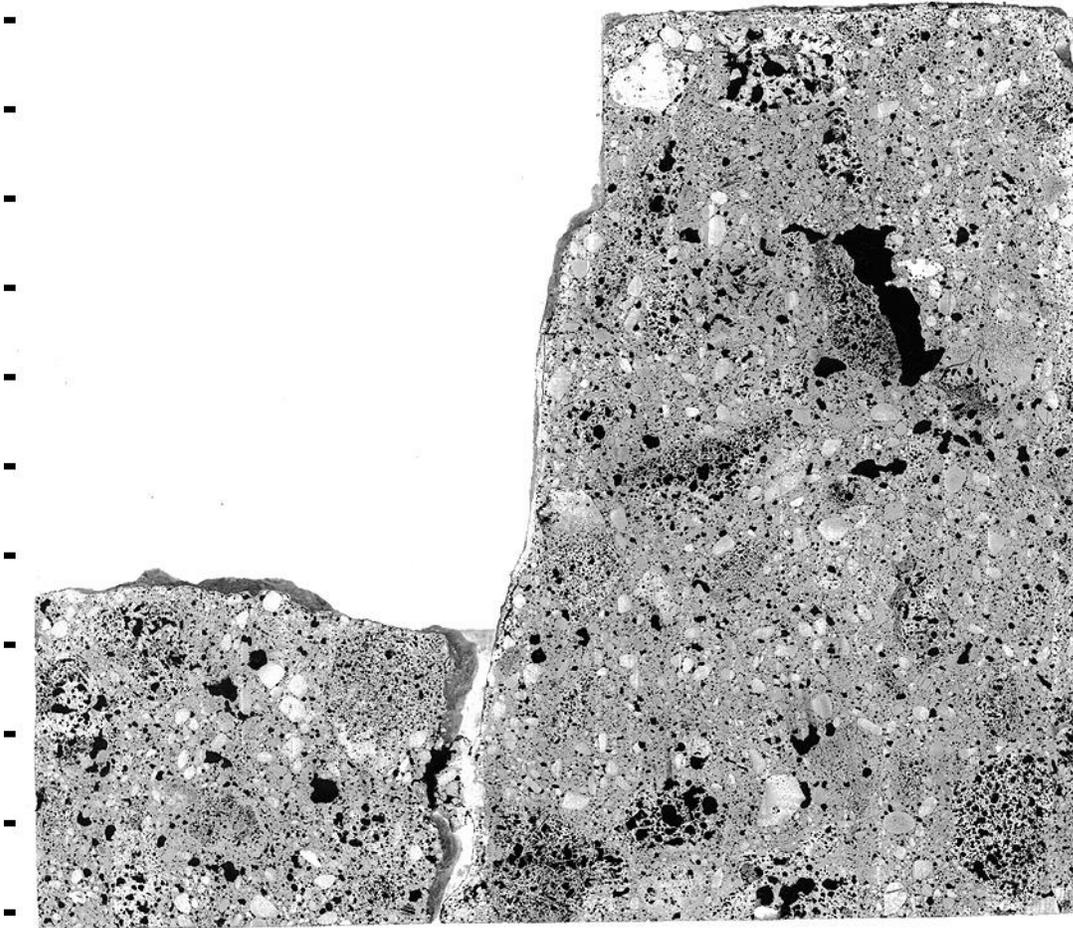
Slab representing cross section through top half of pavement, after treatment to enhance air voids and cracks, SB US23,Section B, constructed 1992, station 349+71.9, at longitudinal joint, MTU ID US23-07, tic marks every half inch.

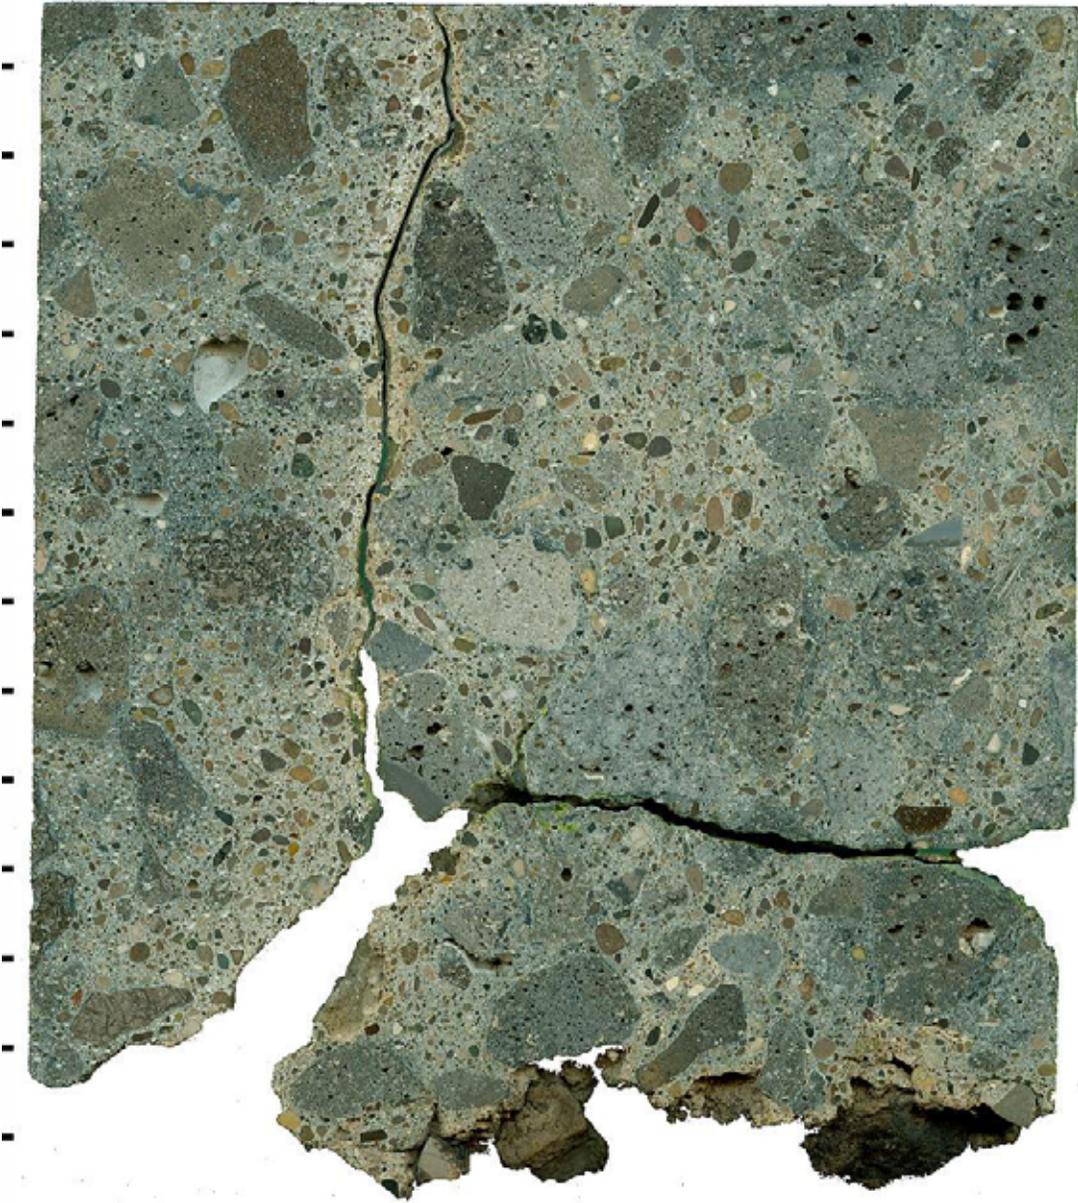
Slab representing cross section through bottom half of pavement, as polished, SB US23, Section B, constructed 1992, station 349+71.9, at longitudinal joint, MTU ID US23-07, tic marks every half inch.

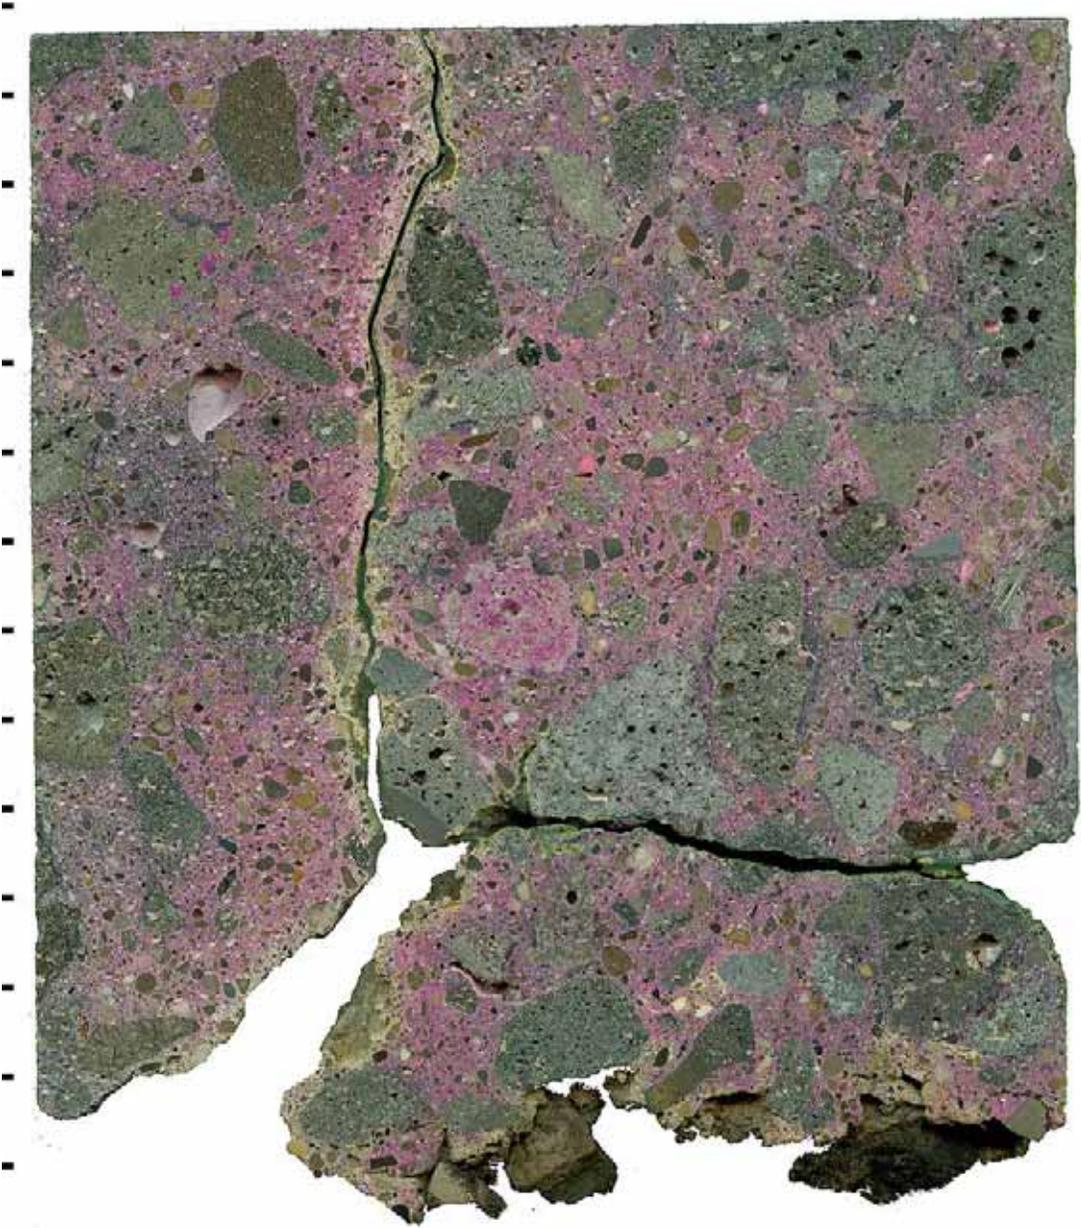
Slab representing cross section through top half of pavement, after sodium cobaltinitrite stain, SB US23, Section B, constructed 1992, station 349+71.9, at longitudinal joint, MTU ID US23-07, tic marks every half inch.

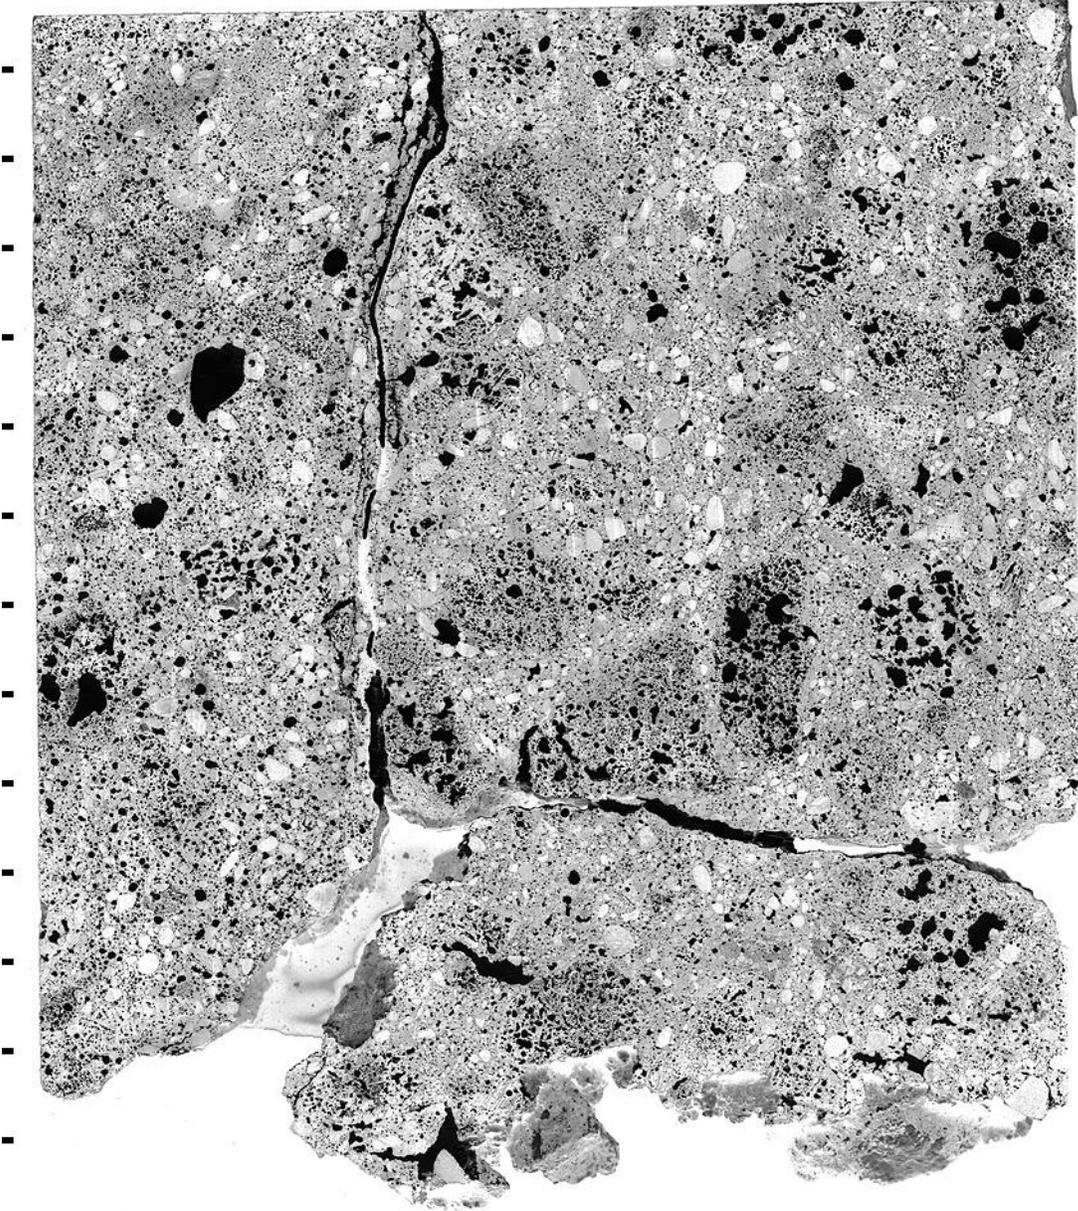
Slab representing cross section through top half of pavement, after treatment to enhance air voids and cracks, SB US23, Section B, constructed 1992, station 349+71.9, at longitudinal joint, MTU ID US23-07, tic marks every half inch.

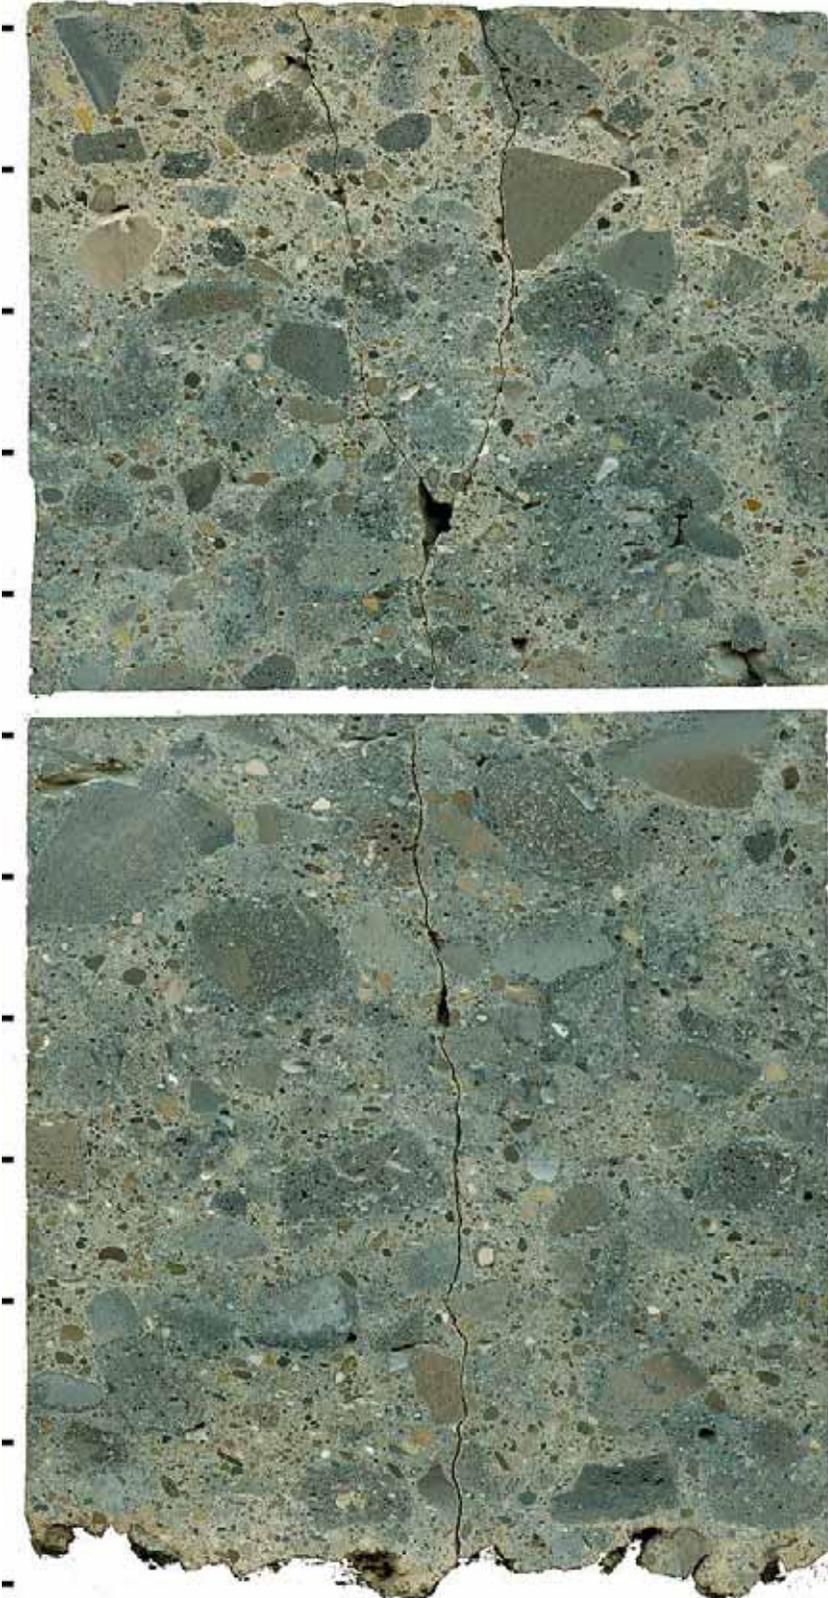
Slabs representing full cross section through pavement, as polished, SB US23, Section B, constructed 1992, station 349+13, away from transverse joint, MTU ID US23-06, tic marks every inch.

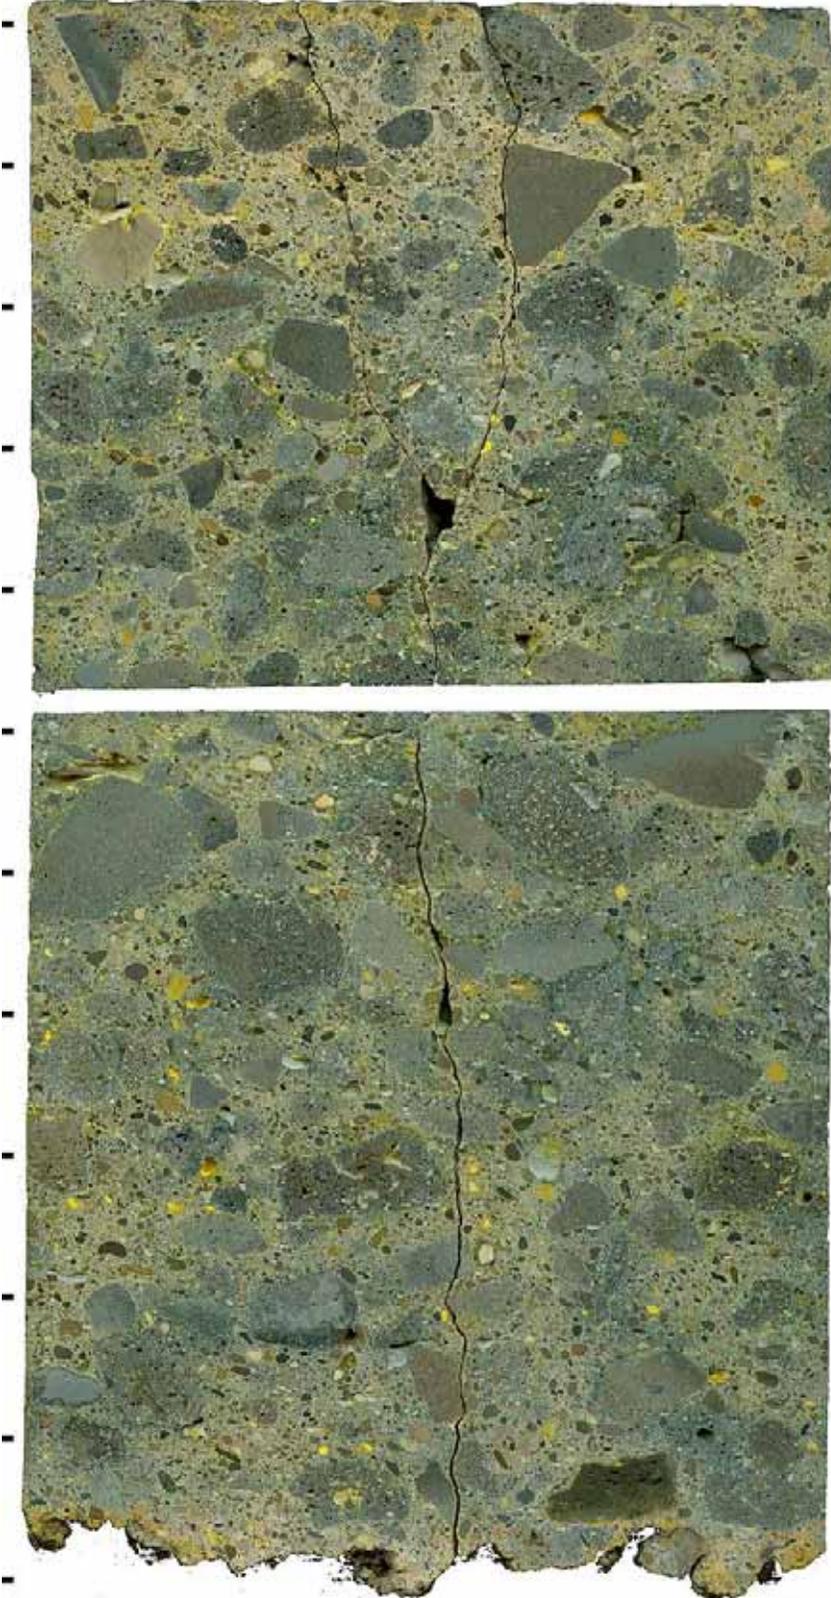
Slabs representing full cross section through pavement, after sodium cobaltinitrite stain, SB US23, Section B, constructed 1992, station 349+13, away from transverse joint, MTU ID US23-06, tic marks every inch.

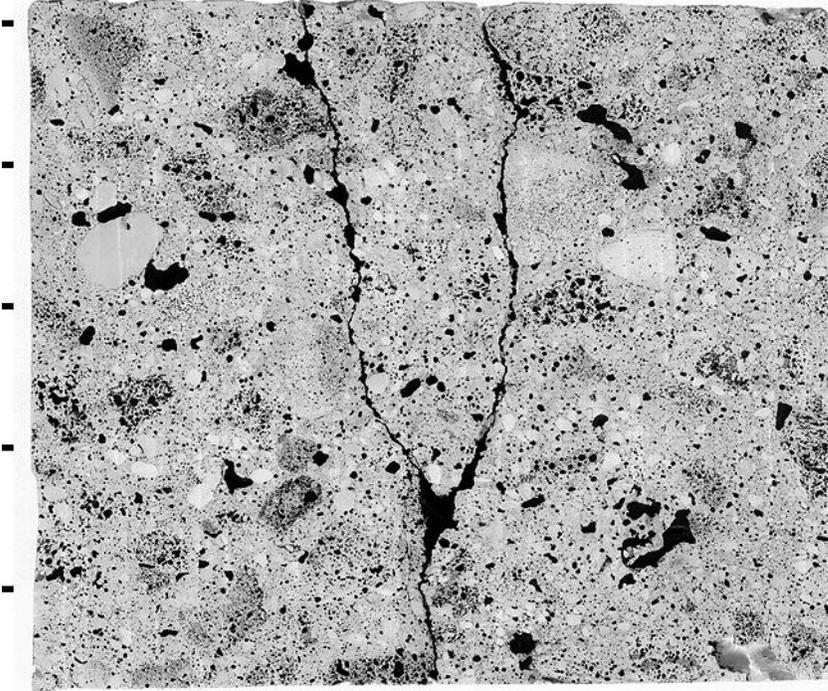
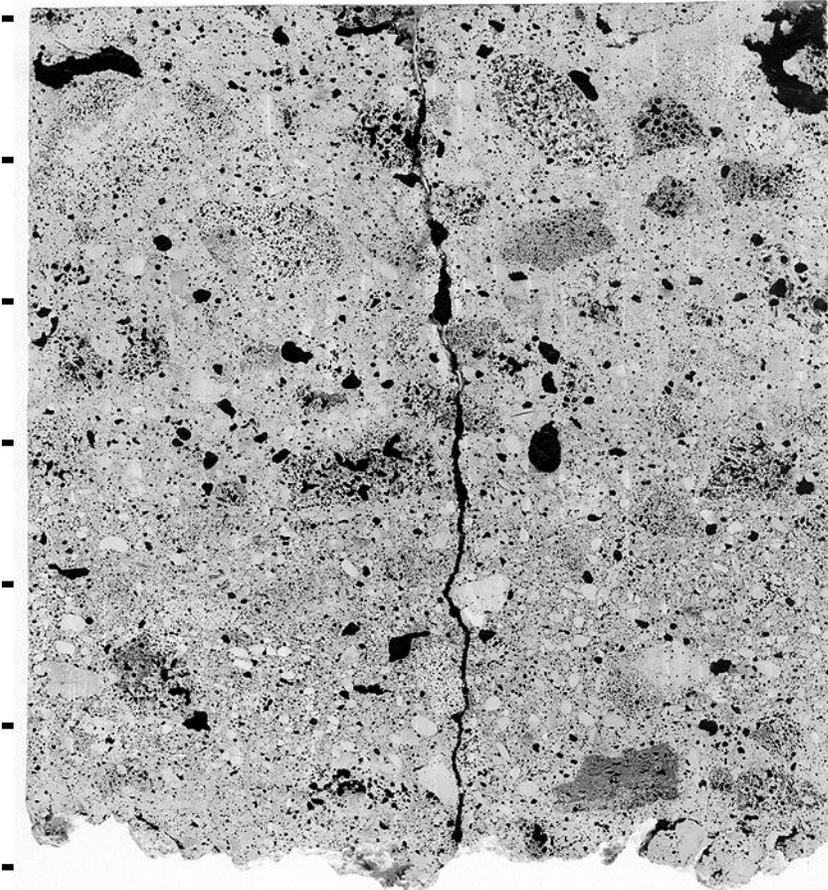
Slabs representing full cross section through pavement, after treatment to enhance air voids and cracks, SB US23, Section B, constructed 1992, station 349+13, away from transverse joint, MTU ID US23-06, tic marks every inch.

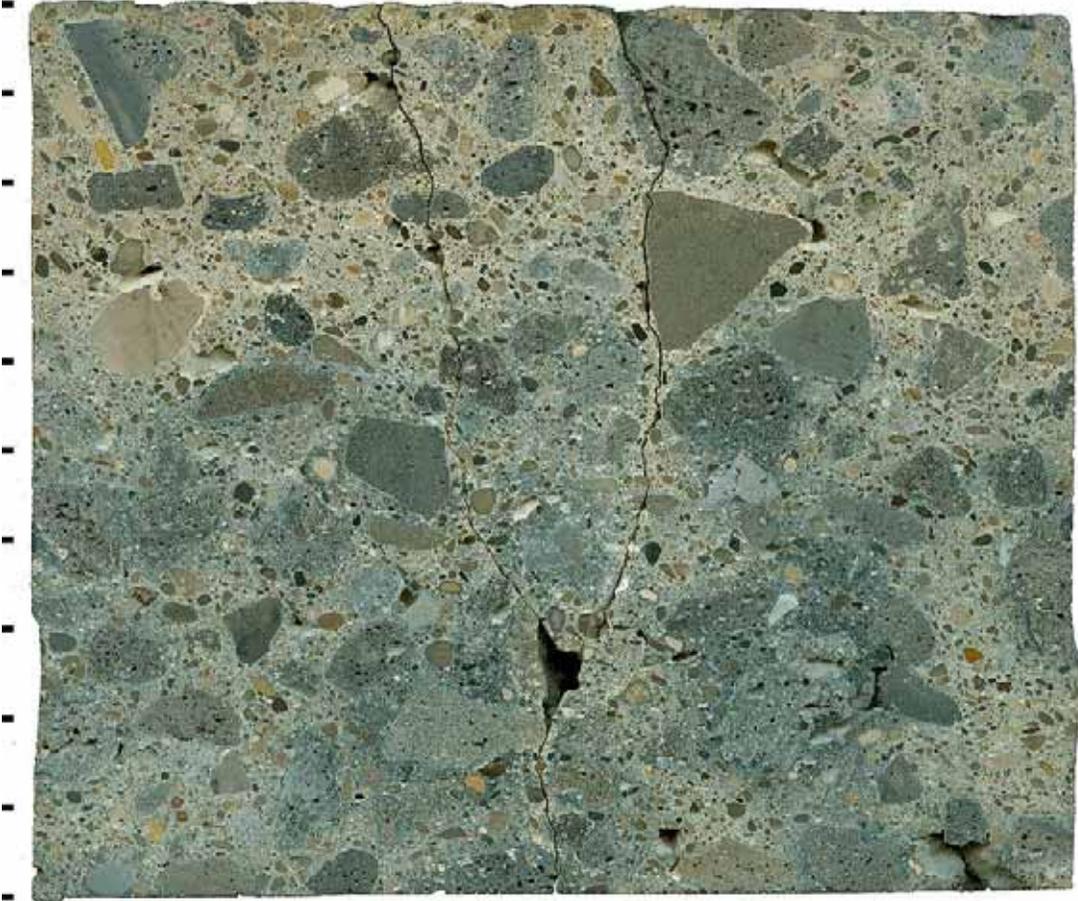
Slab representing cross section through top half of pavement, as polished, SB US23, Section B, constructed 1992, station 349+13, away from transverse joint, MTU ID US23-06, tic marks every half inch.

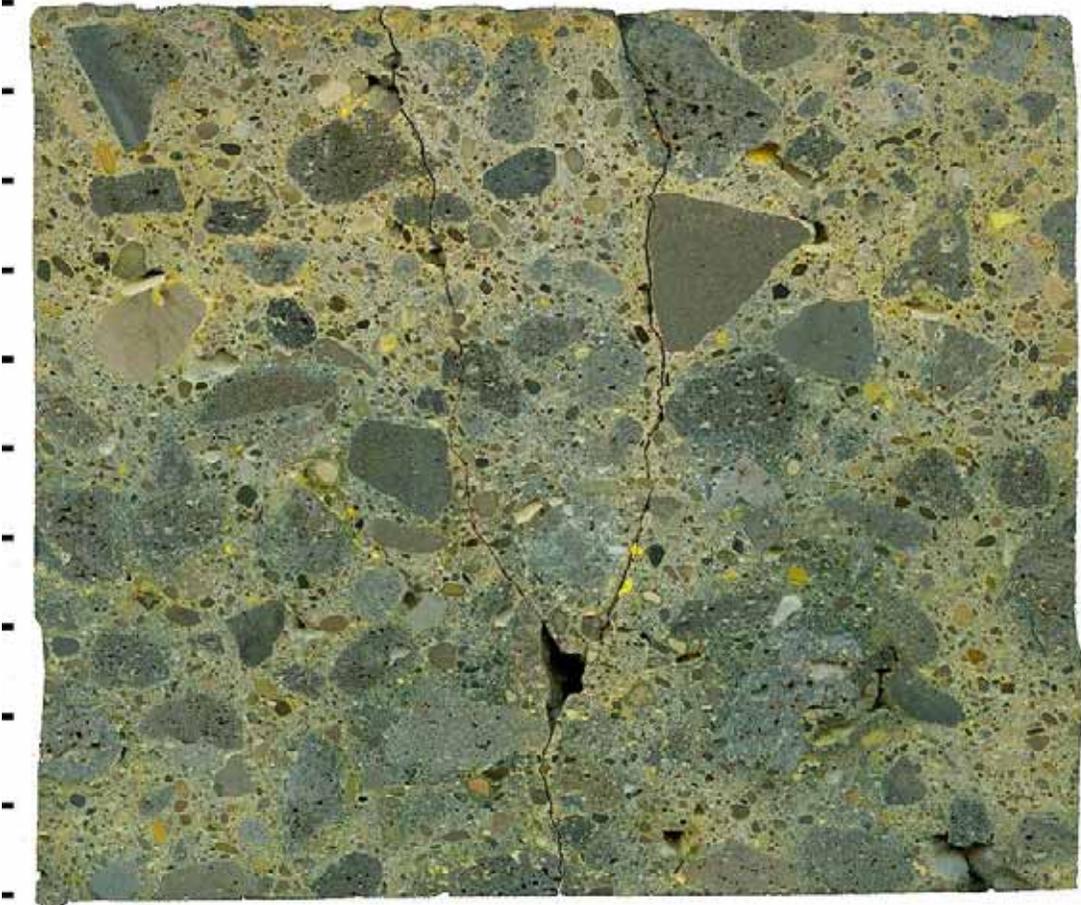
Slab representing cross section through top half of pavement, after sodium cobaltinitrite stain, SB US23, Section B, constructed 1992, station 349+13, away from transverse joint, MTU ID US23-06, tic marks every half inch.

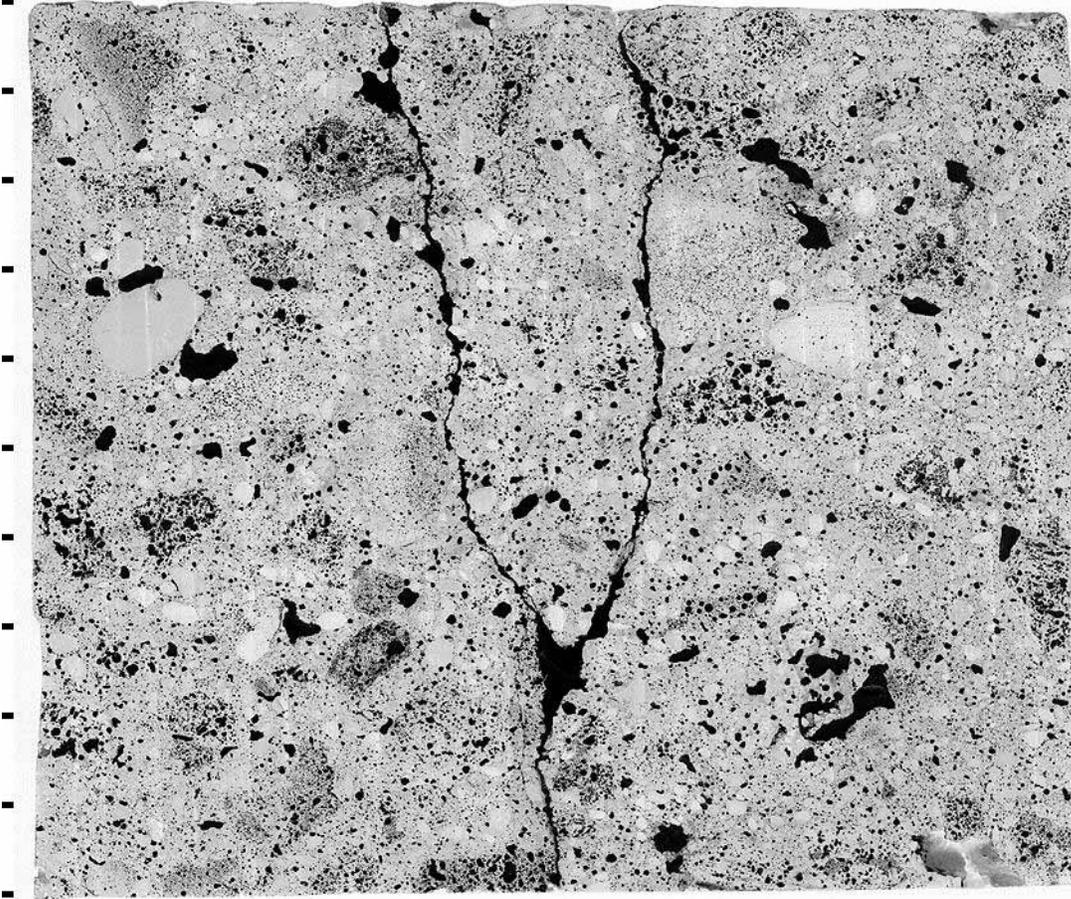
Slab representing cross section through top half of pavement, after treatment to enhance air voids and cracks, SB US23, Section B, constructed 1992, station 349+13, away from transverse joint, MTU ID US23-06, tic marks every half inch.

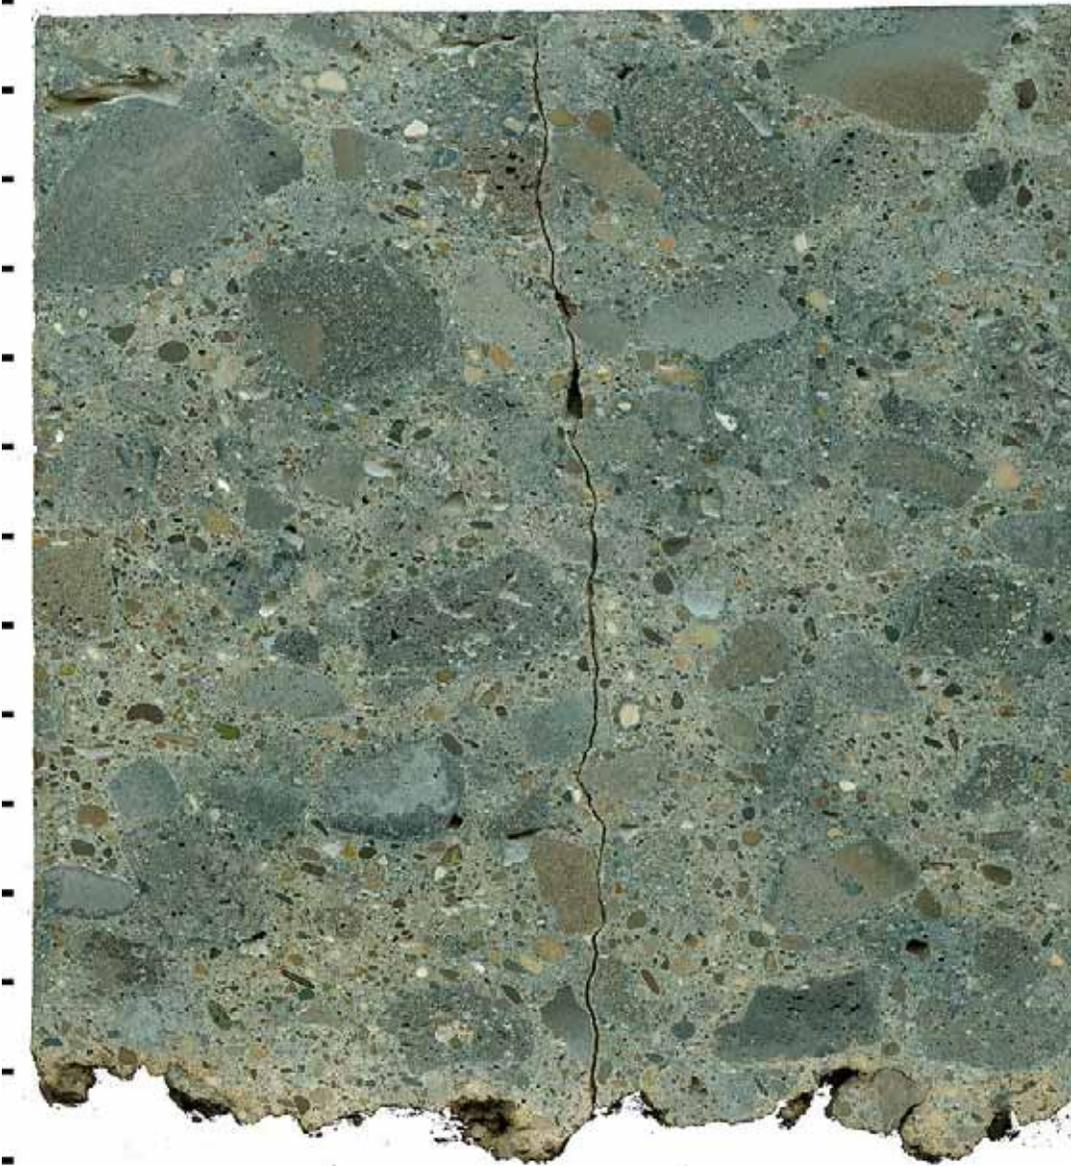
Slab representing cross section through bottom half of pavement, as polished, SB US23, Section B, constructed 1992, station 349+13, away from transverse joint, MTU ID US23-06, tic marks every half inch.

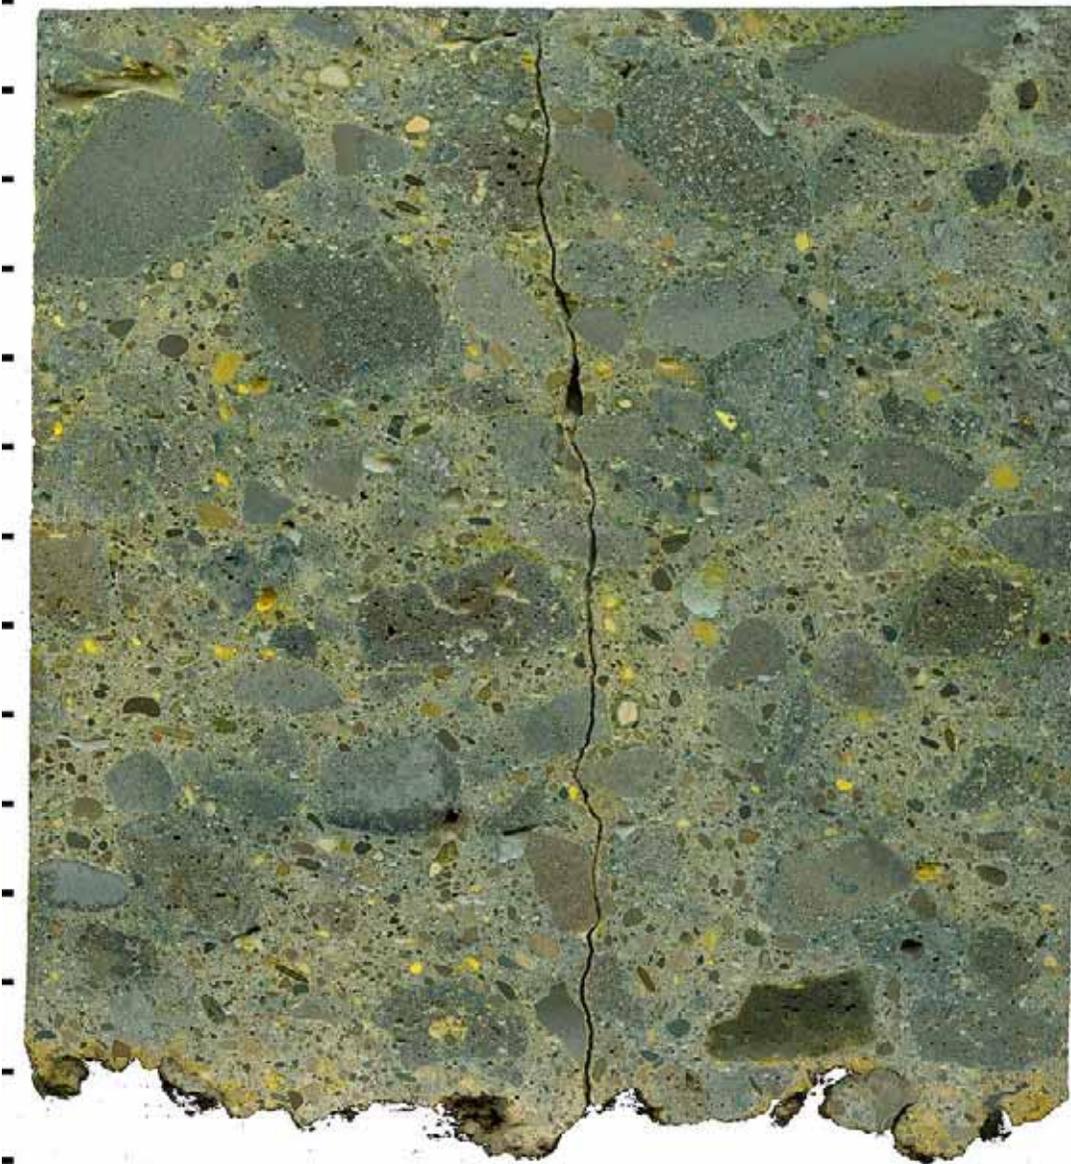
Slab representing cross section through top half of pavement, after sodium cobaltinitrite stain, SB US23, Section B, constructed 1992, station 349+13, away from transverse joint, MTU ID US23-06, tic marks every half inch.
