Appendix F
US23 MDOT Aggregate Test Road Sec. B Core Site

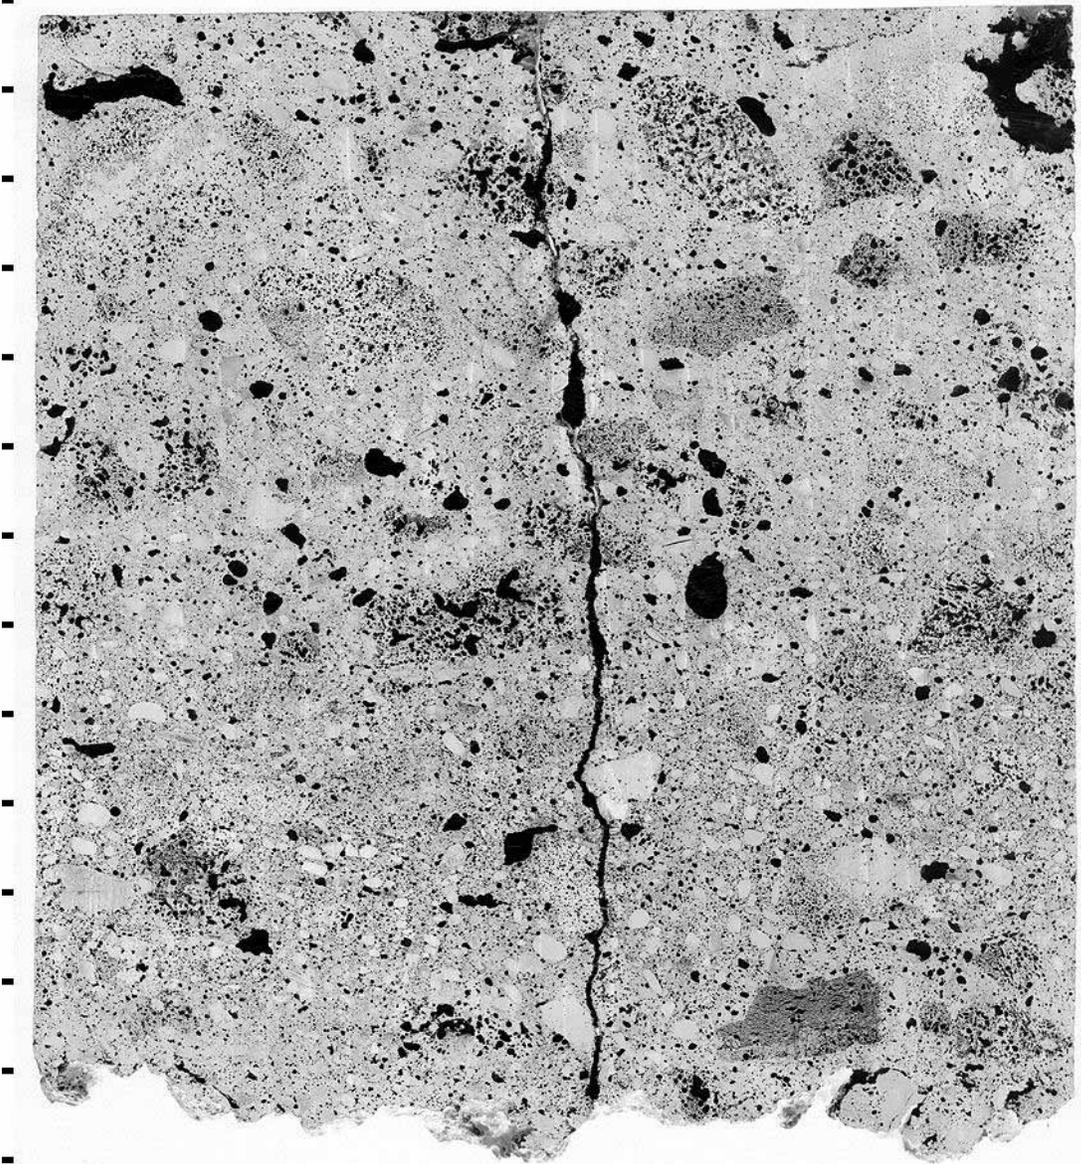
Slab representing cross section through top half of pavement, after treatment to enhance air voids and cracks, SB US23, Section B, constructed 1992, station 349+13, away from transverse joint, MTU ID US23-06, tic marks every half inch.

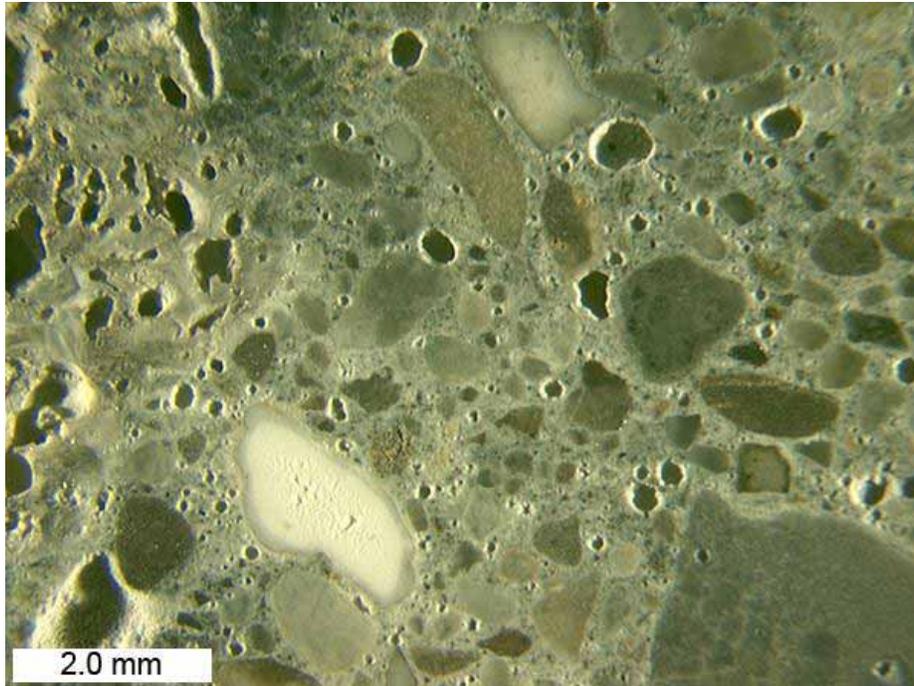
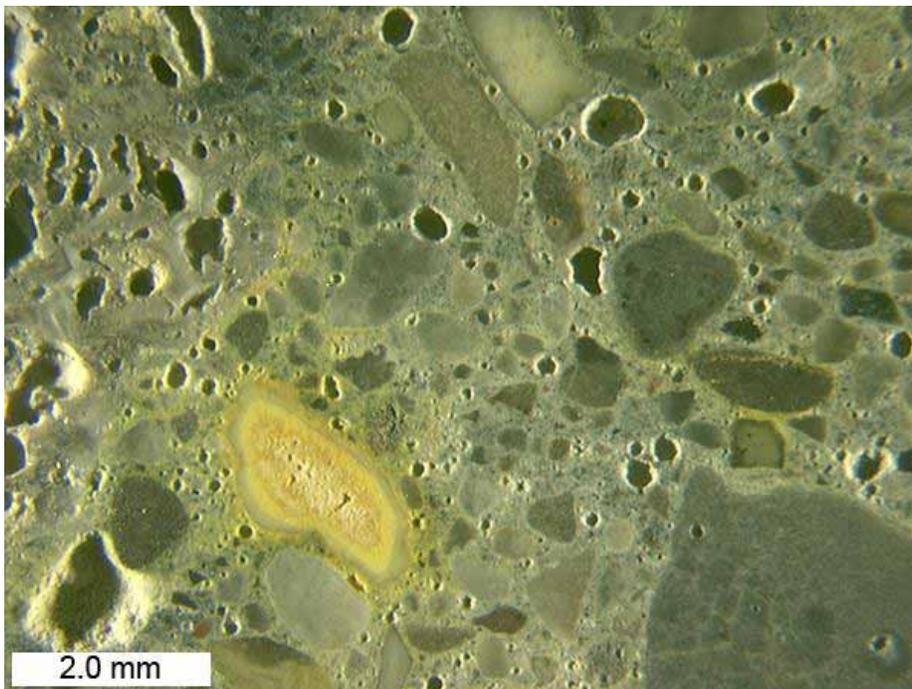
Alkali silica reaction in fine aggregate and associated cracking, before and after sodium cobaltinitrite stain, polished slab from SB US23, Section B, constructed 1992, at longitudinal joint, bottom half of core, MTU ID US23-07.

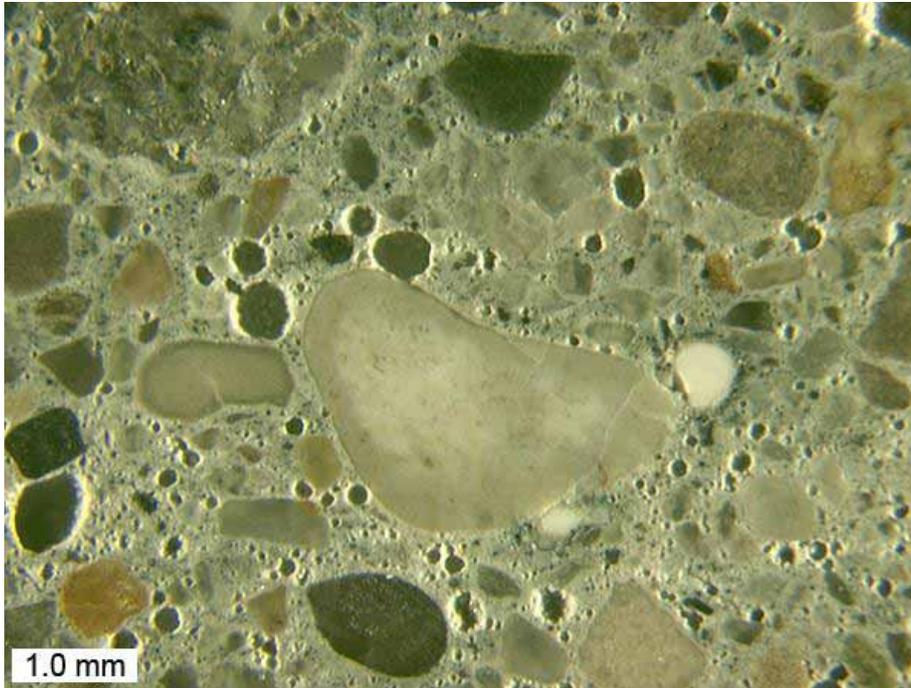
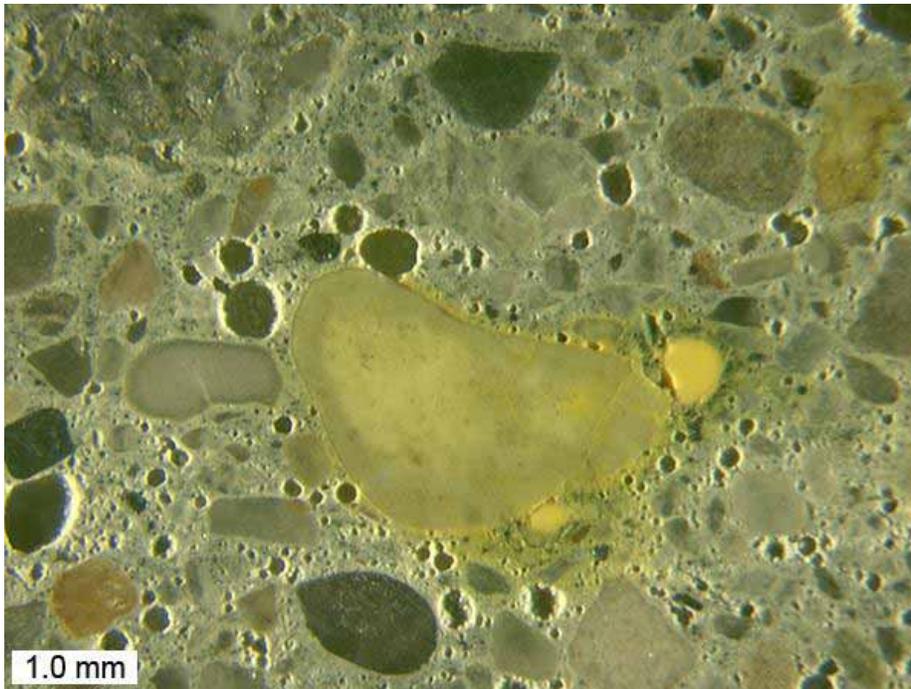
Alkali silica reaction in fine aggregate with associated cracking and reaction product filled air voids, before and after sodium cobaltinitrite stain, polished slab from SB US23, Section B, constructed 1992, at longitudinal joint, bottom half of core, MTU ID US23-07.

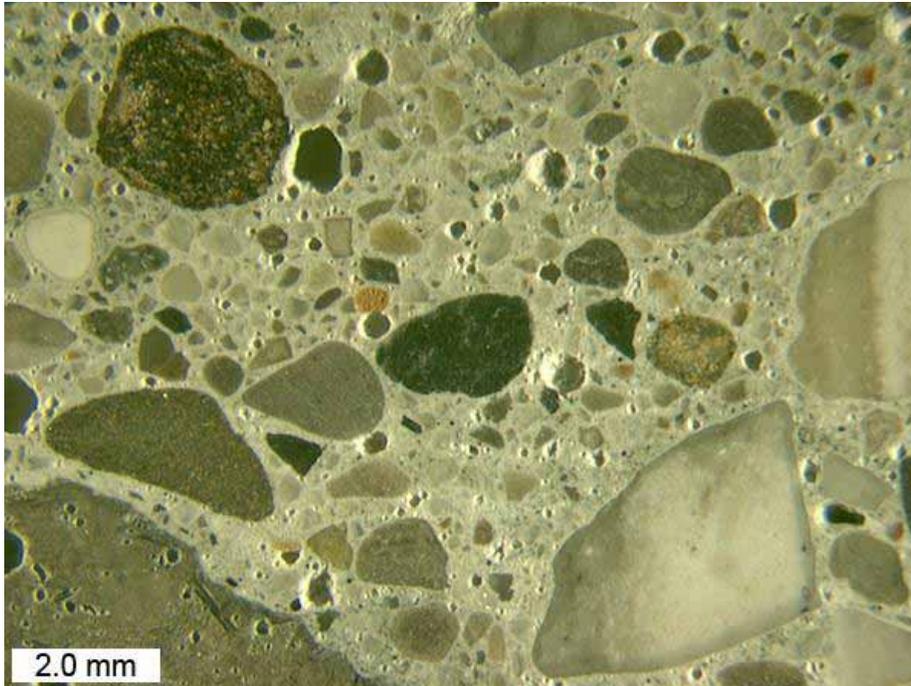
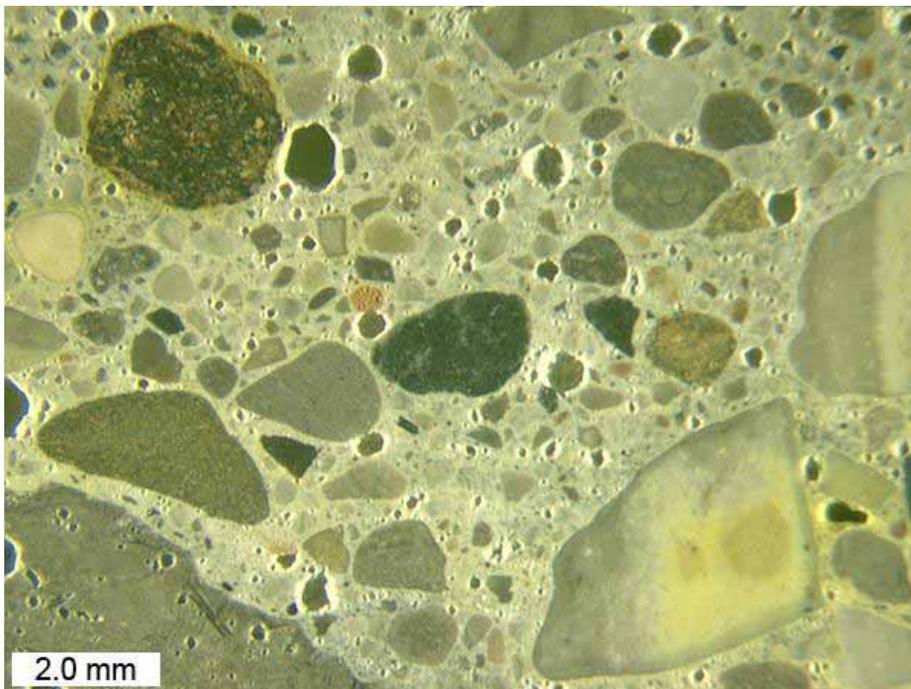
Alkali silica reaction in fine aggregate, without cracking, before and after sodium cobaltinitrite stain, polished slab from SB US23, Section B, constructed 1992, away from joint, top half of core, MTU ID US23-06.

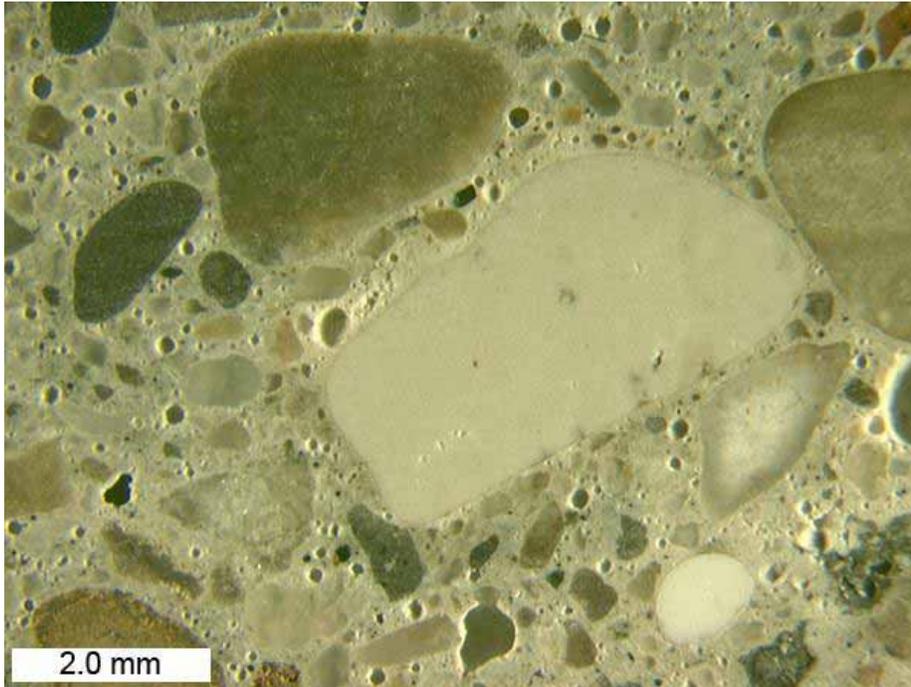
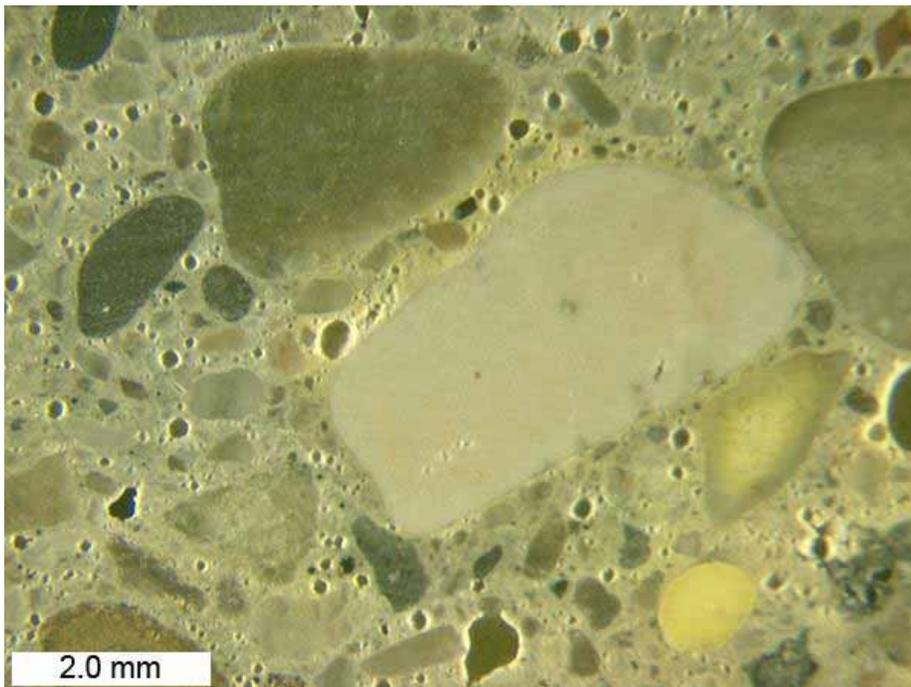
Fine aggregate particles with darkened rims in contact with the cement and alkali silica reaction product filled air void, before and after sodium cobaltinitrite stain, polished slab from SB US23, Section B, constructed 1992, away from joint, top half of core, MTU ID US23-06.

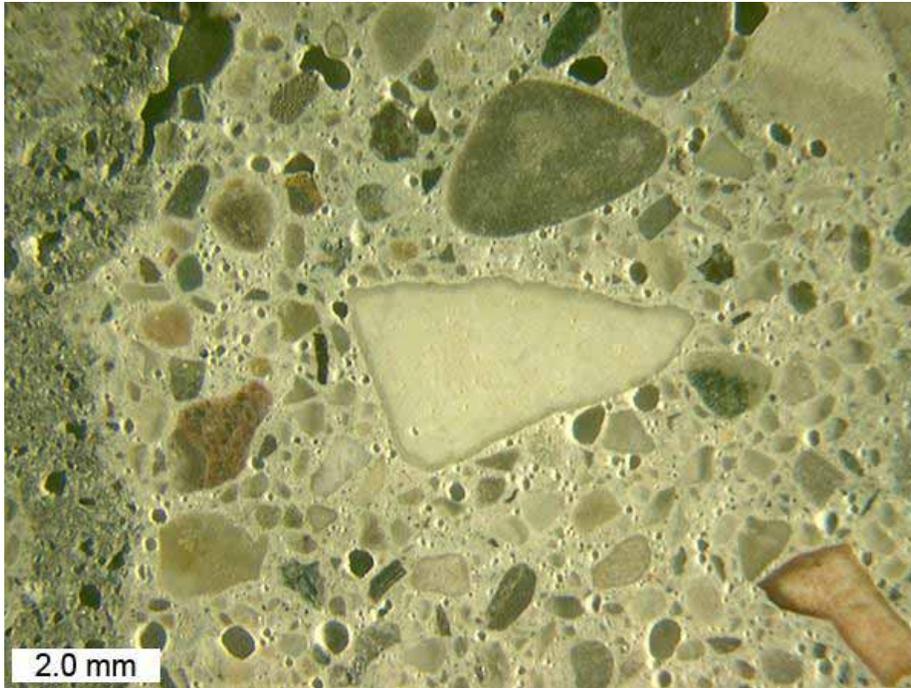
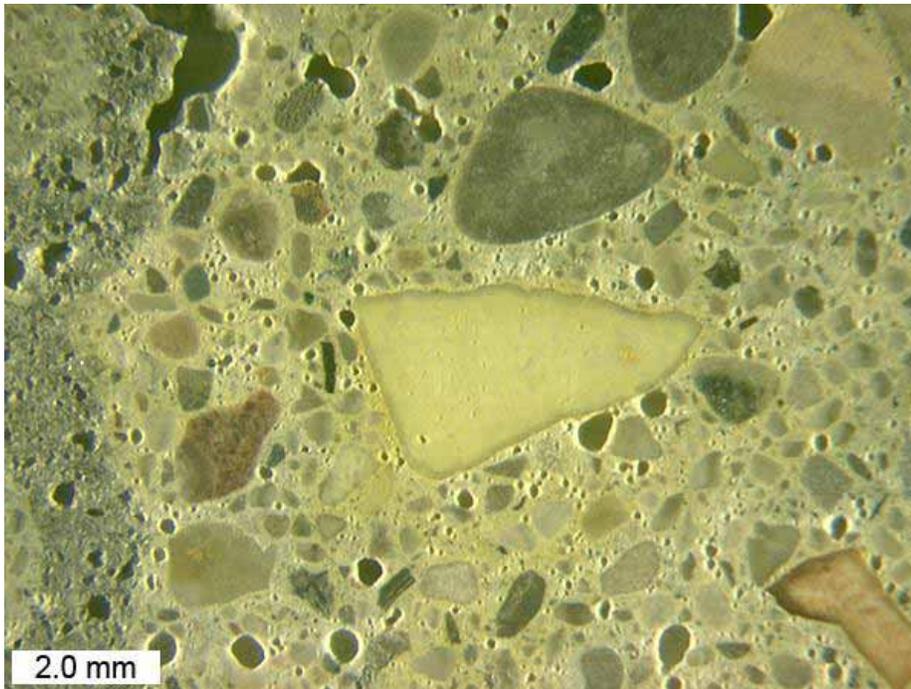
Fine aggregate particles with darkened rims in contact with the cement paste, before and after sodium cobaltinitrite stain, polished slab from SB US23, Section B, constructed 1992, away from joint, top half of core, MTU ID US23-06.

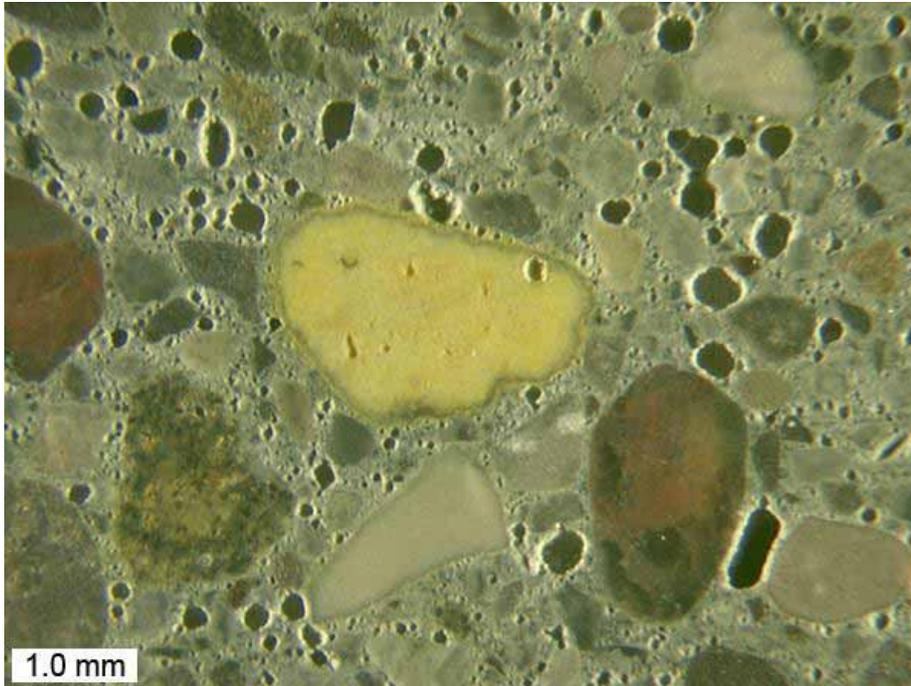
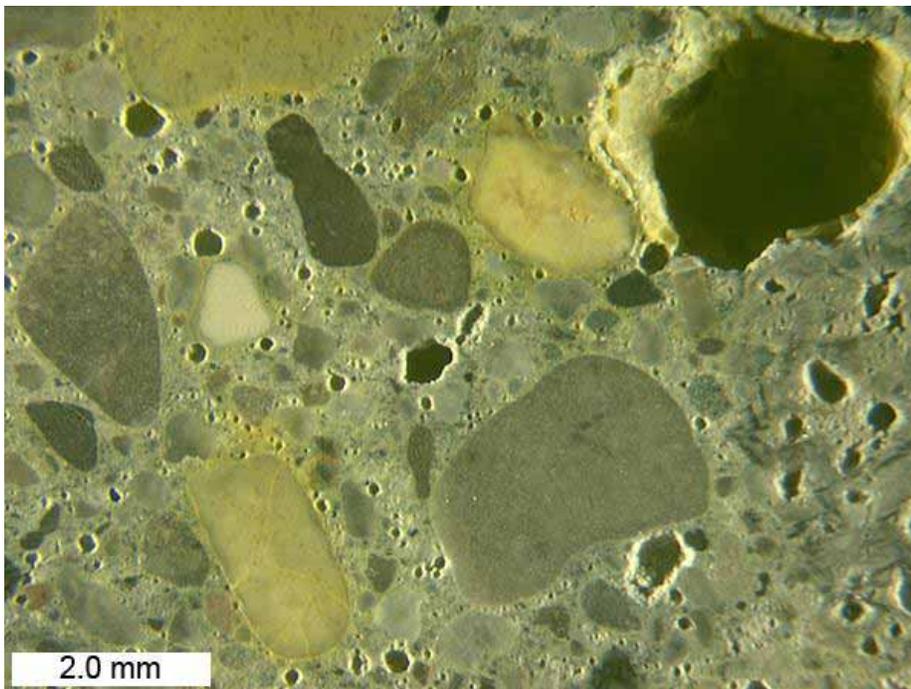
Examples of alkali silica reaction in fine aggregate, without cracking, after sodium cobaltinitrite stain, polished slab from SB US23, Section B, constructed 1992, away from joint, bottom half of core, MTU ID US23-06.

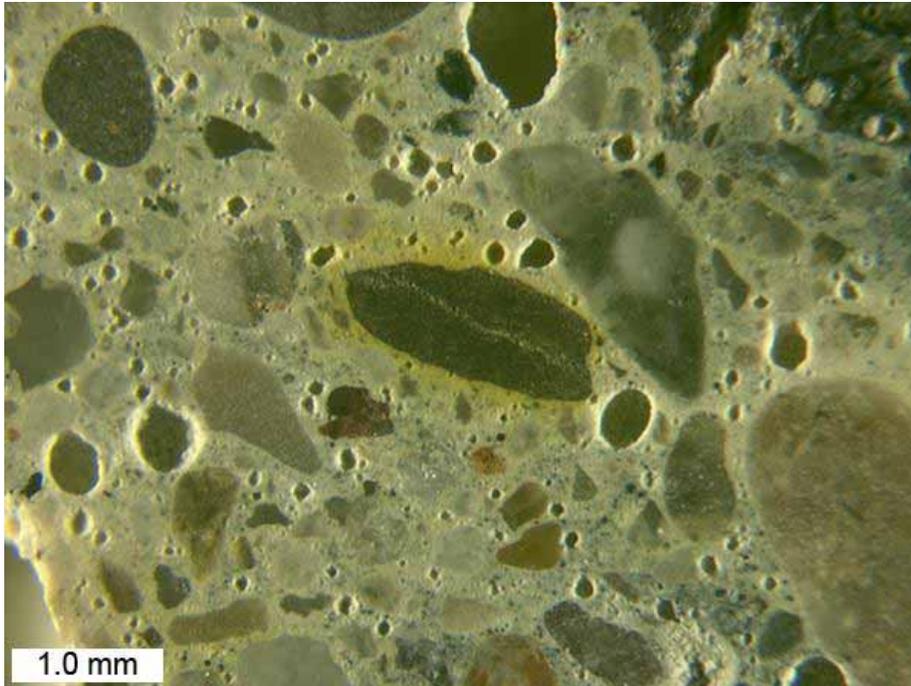
Examples of alkali silica reaction in fine aggregate, with cracking, after sodium cobaltinitrite stain, polished slab from SB US23, Section B, constructed 1992, away from joint, top half of core, MTU ID US23-06.

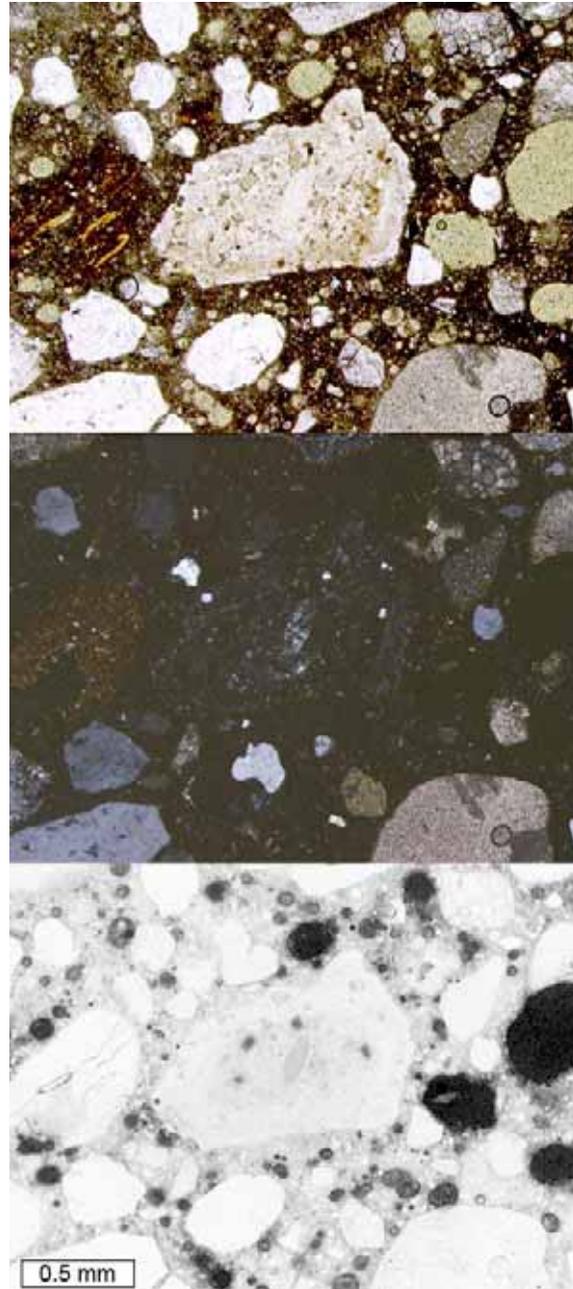
Example of chert particle, and brown siltstone particle, both without signs of deleterious alkali-silica reaction, from thin section prepared from core from US23, Section B away from joint, MTU ID US23-06. From top to bottom: transmitted light, crossed-polars, and epifluorescent mode images.

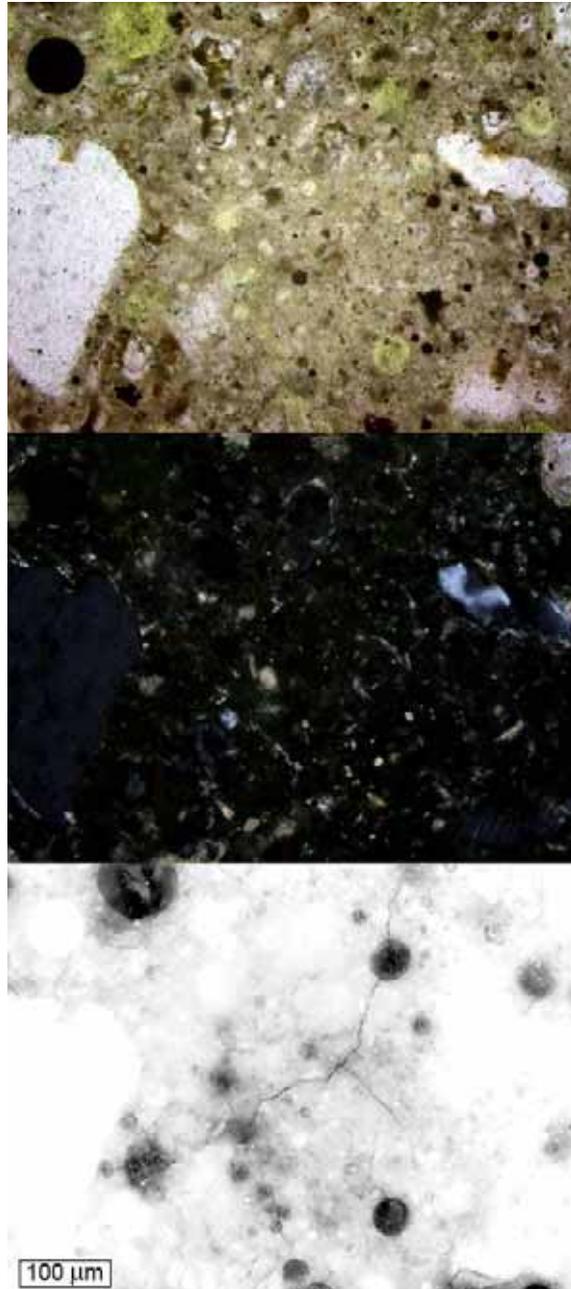
Fly ash in cement paste fraction in thin section prepared from core from US23, Section B at longitudinal joint, MTU ID US23-07. From top to bottom: transmitted light, crossed-polars, and epifluorescent mode images.

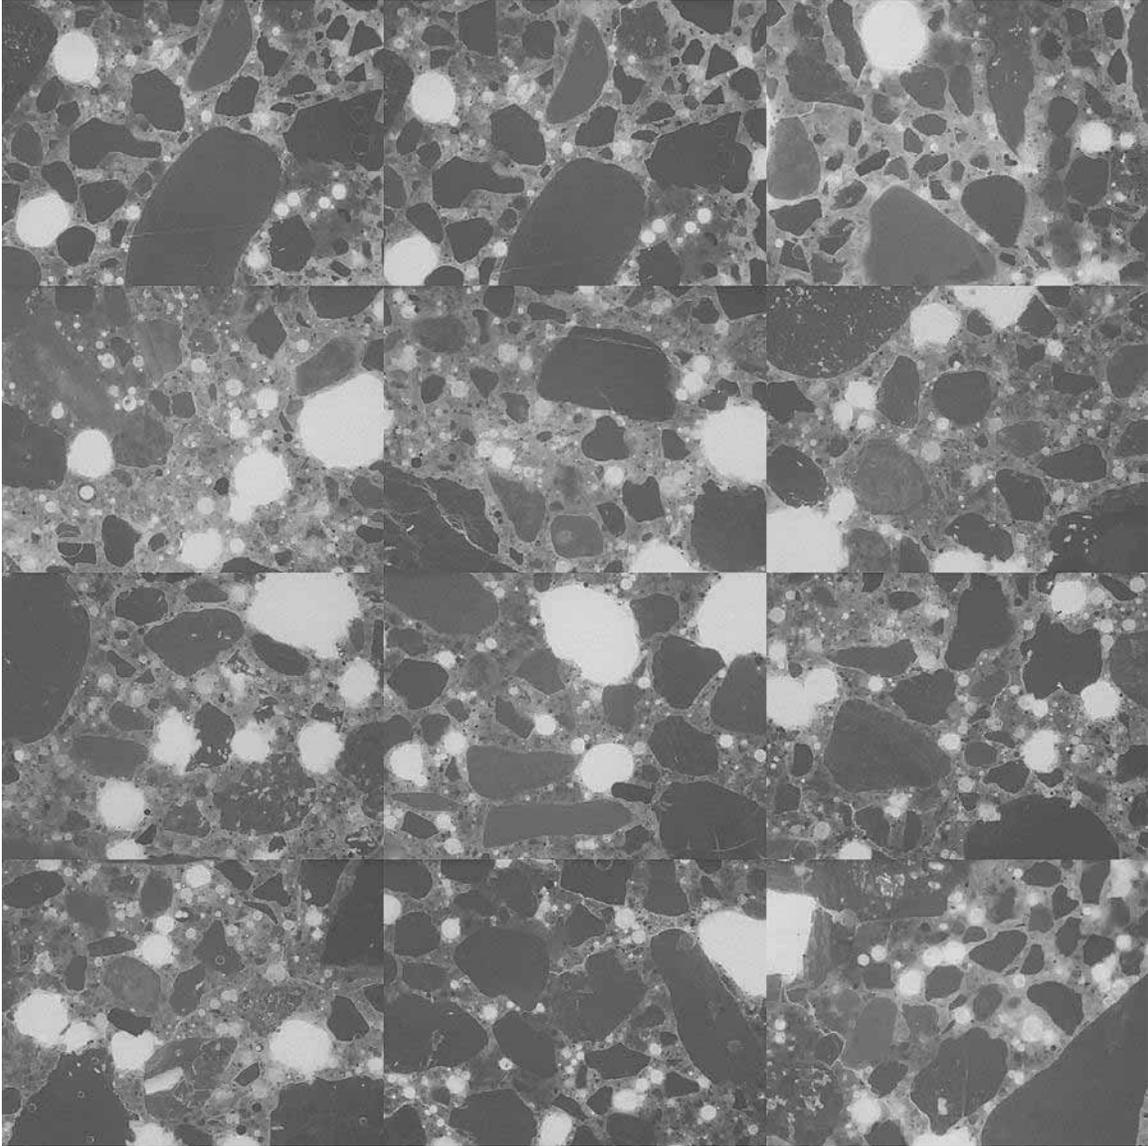
Mosaic of 12 epifluorescent mode images collected from thin sections prepared from core from US23, Section B, away from transverse joint, MTU ID US23-06 (each individual frame measures 2.612 x 1.959 mm).

Average cement paste pixel intensities per frame, and equivalent w/c values (as compared to 28-day moist cured mortar samples) from thin section prepared from core from US23, Section B, away from transverse joint, MTU ID US23-06.

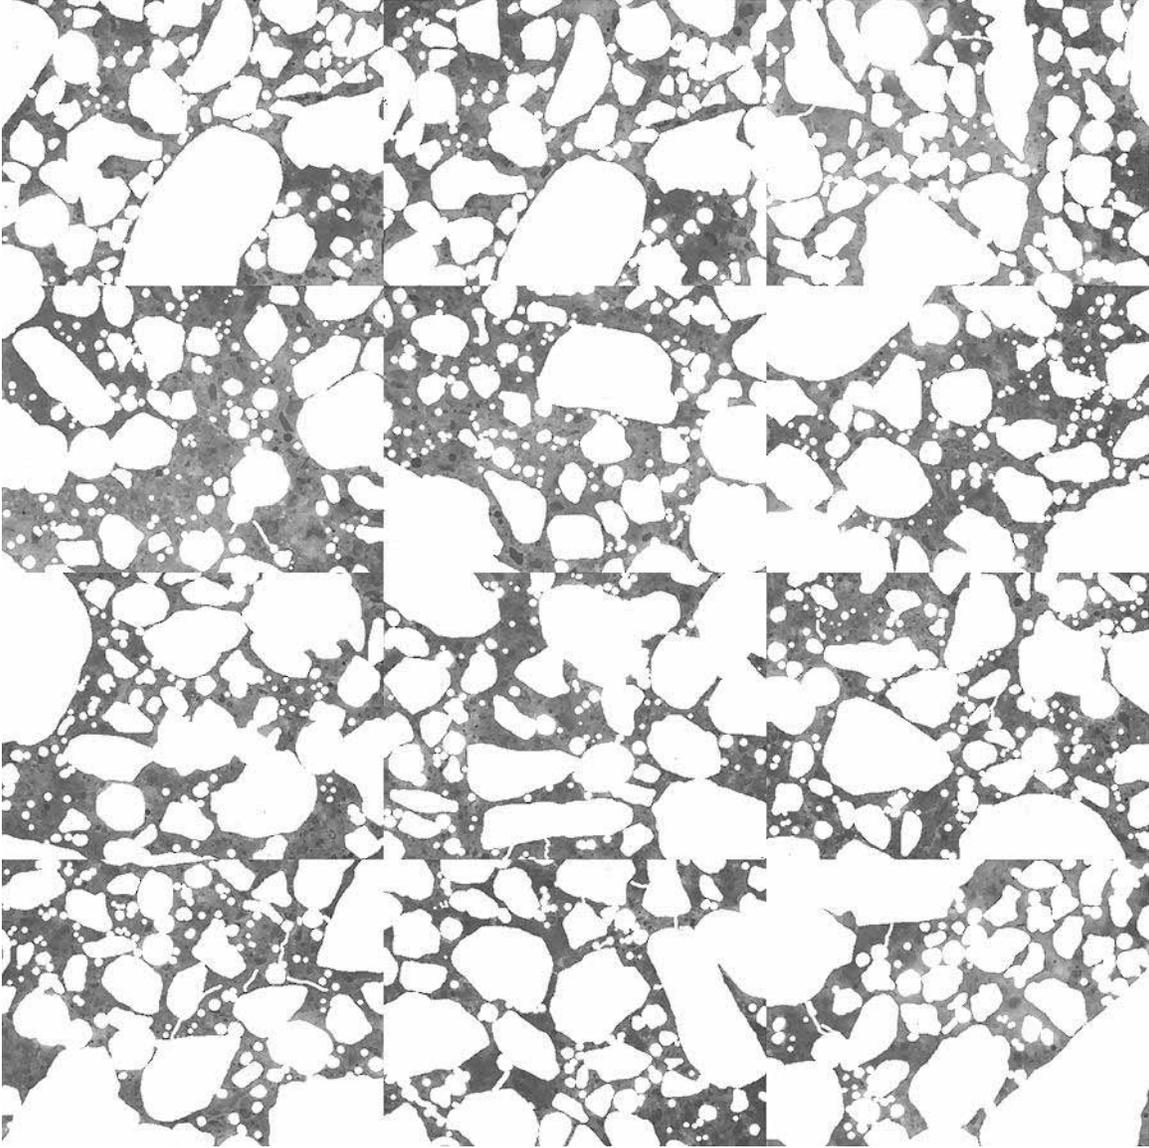
Mosaic of 12 epifluorescent mode images collected from thin sections prepared from core US23, Section B, away from transverse joint, MTU ID US23-06, after masking out air voids and fine aggregate to isolate cement paste (each individual frame measures 2.612 x 1.959 mm).
