**EVALUATION OF THIN OVERLAYS
FOR BRIDGE DECKS**

Final Report

SPR 304-431

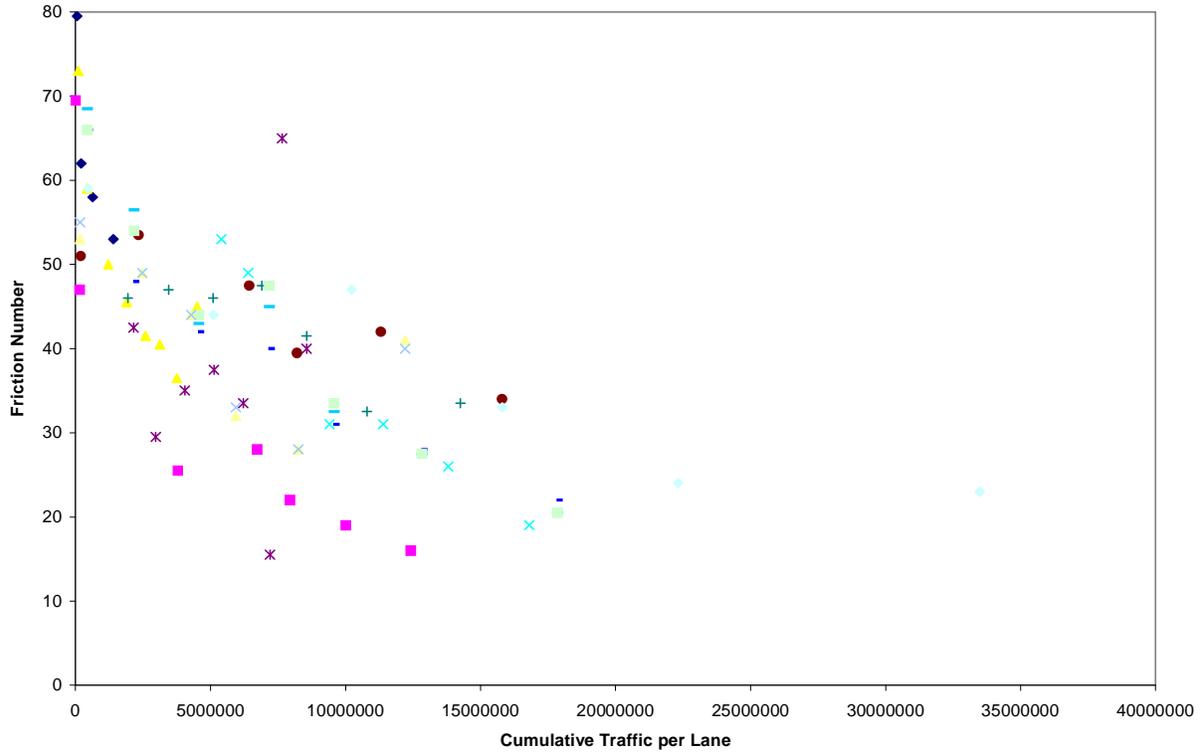
Figure 1.1: In-service skid resistance of thin epoxy overlays.

Sprinkel et al. 1993). None of these comparisons were designed to make a direct comparison of the specific overlay products. Wilson and Henley summarized 10 years of experience with epoxy and methyl methacrylate (MMA) overlays in Washington State. According to the investigation, MMA overlays retain skid resistance better than epoxy overlays over time. However, the skid resistance of epoxy overlays starts higher than MMA. This general behavior is illustrated in Figures 1.1 and 1.2 for six different epoxy products and five different MMA products based on the Washington data.

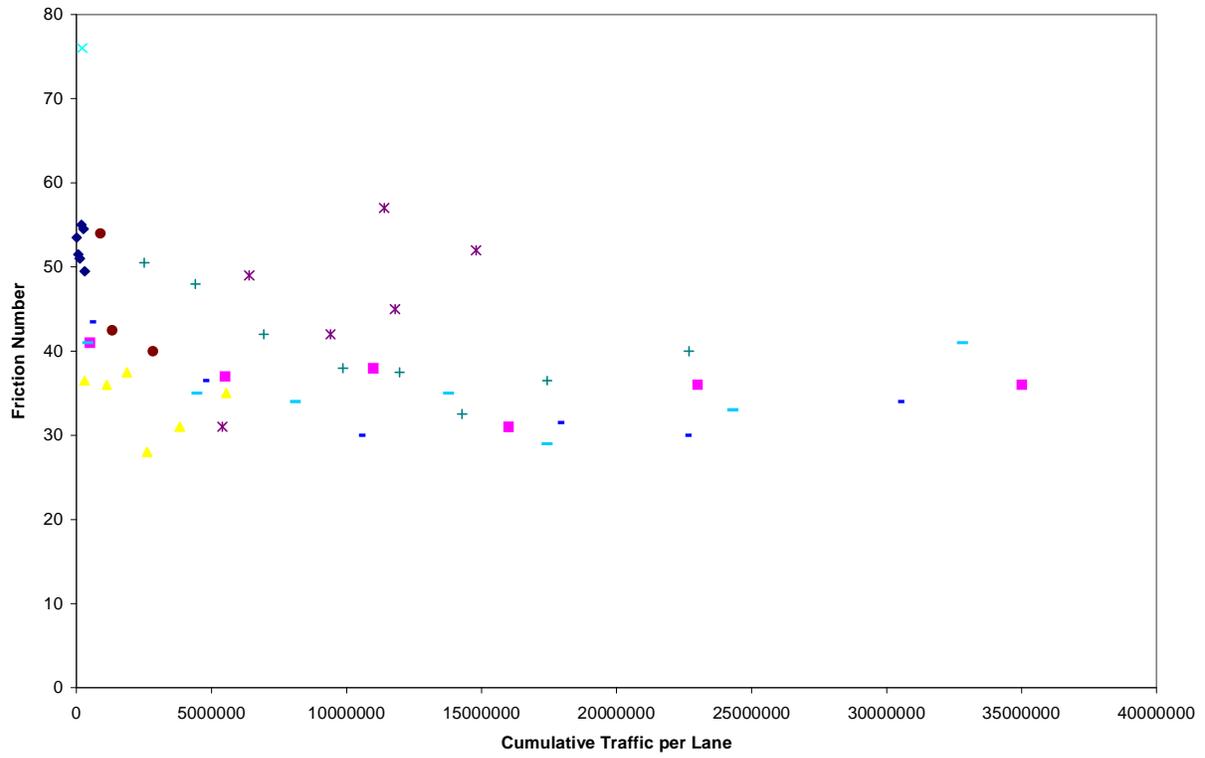
Figure 1.2: In-service skid resistance of thin MMA overlays.

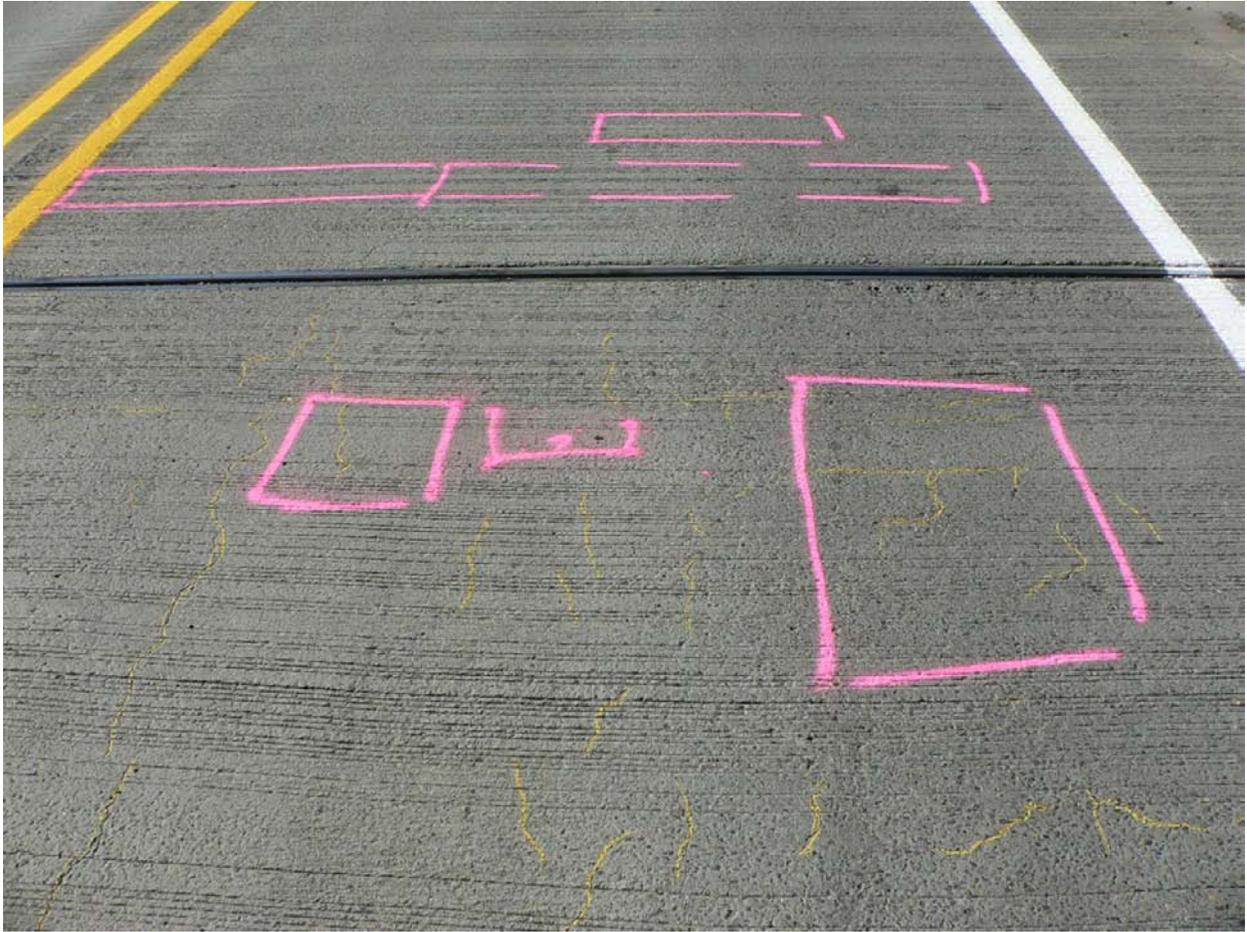
Figure 2.1: Highlighted cracks and marked delaminations.

Prior to installation, ODOT mapped the locations of joints, drains, major cracks, and delaminations for each section. Most sections showed substantial cracking, in which case, the cracks in an area extending across the width of the lane and 5-foot along the lane were highlighted and photographed in order to document the degree of cracking. The pre-installation section maps are shown in Appendix A. The section locations and the respective products are shown in Table 2.1. A photograph of the highlighted cracks from Section E is shown in Figure 2.1. Delaminated areas delineated with paint are also shown in the photograph.

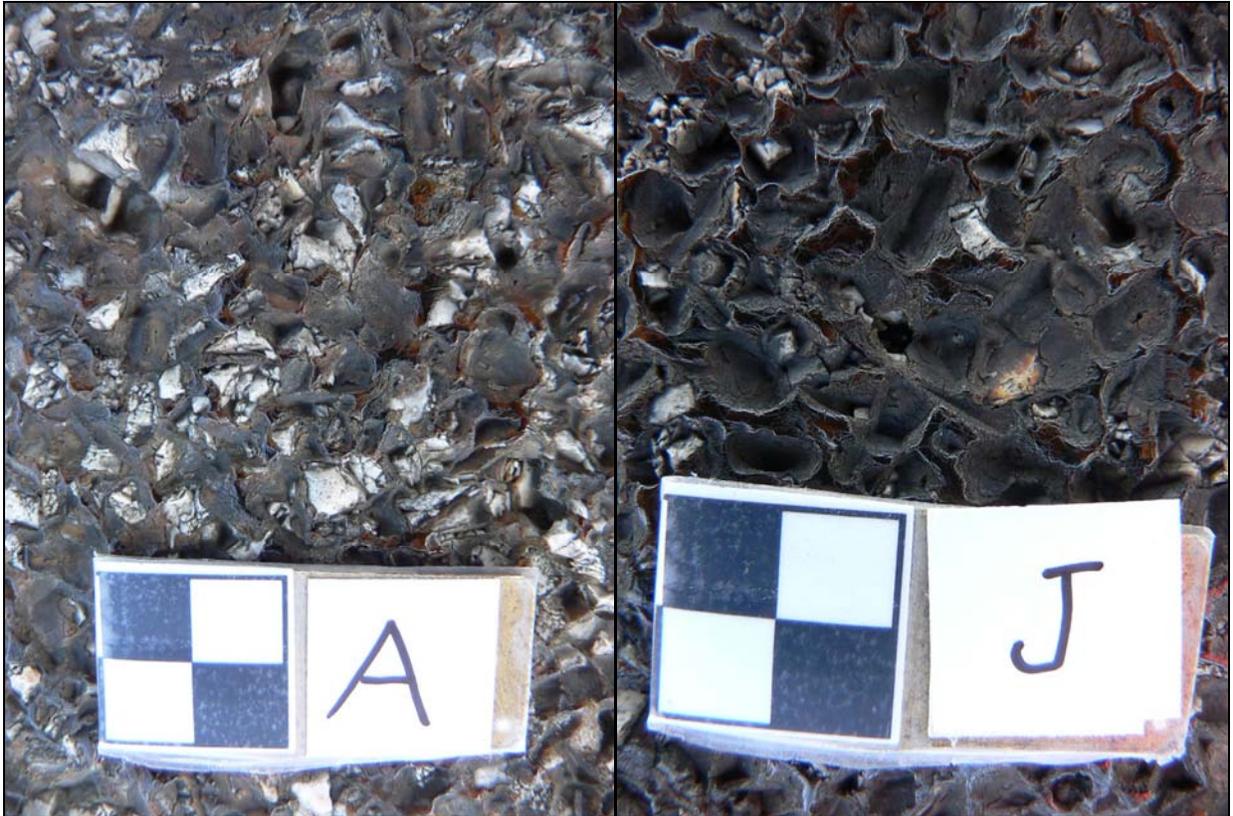
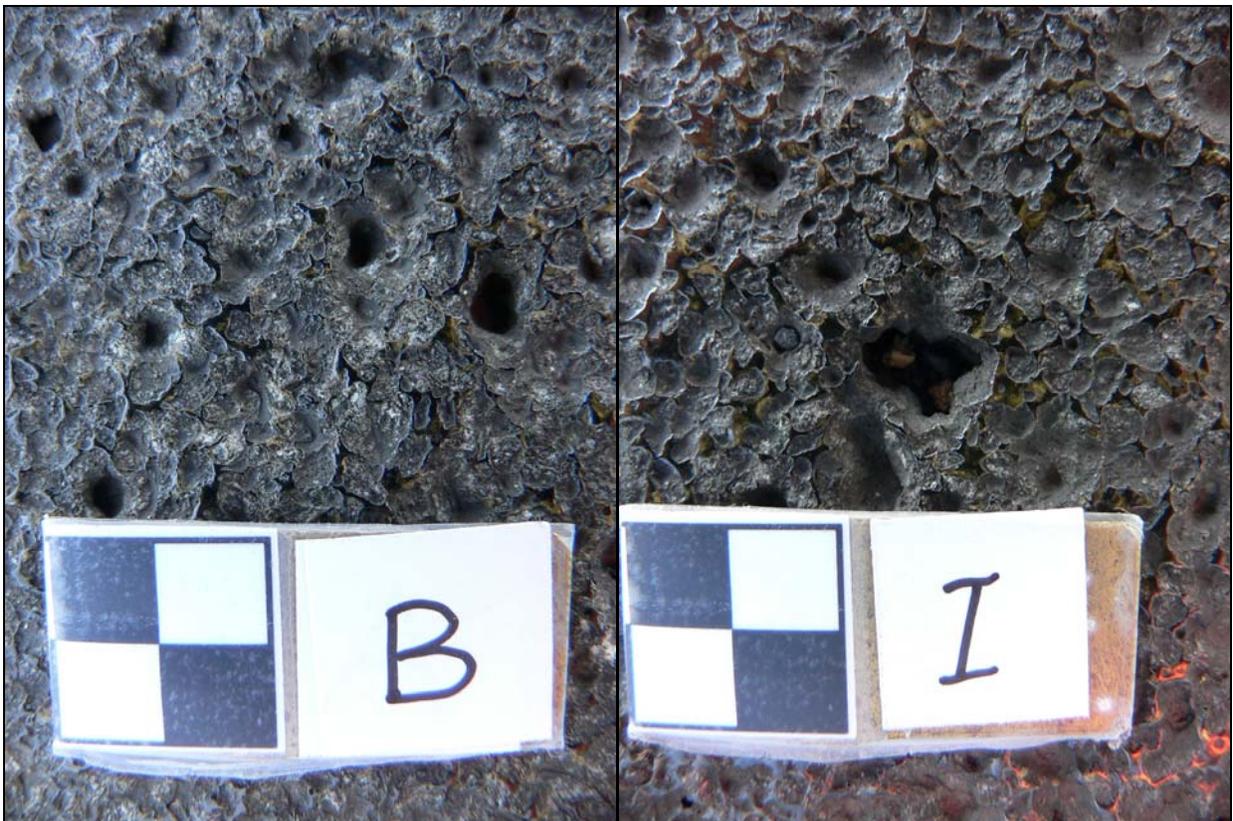
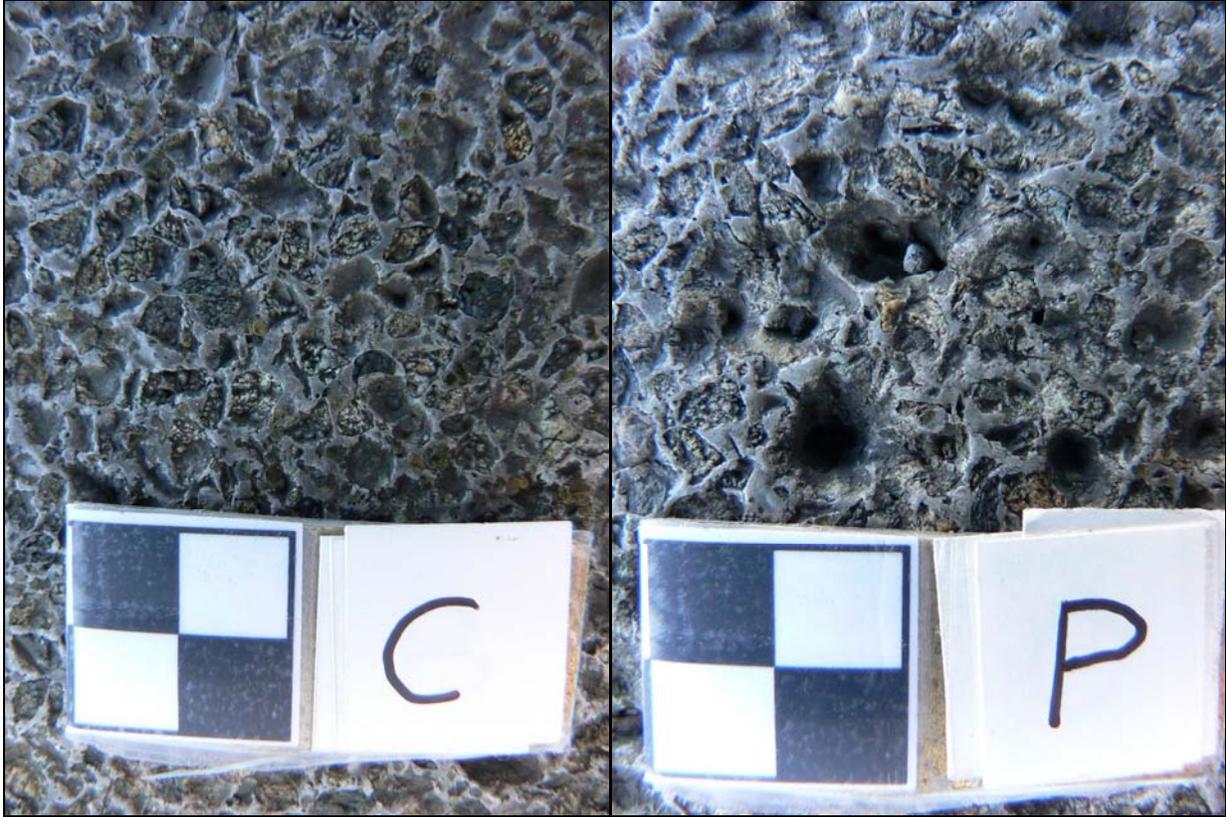
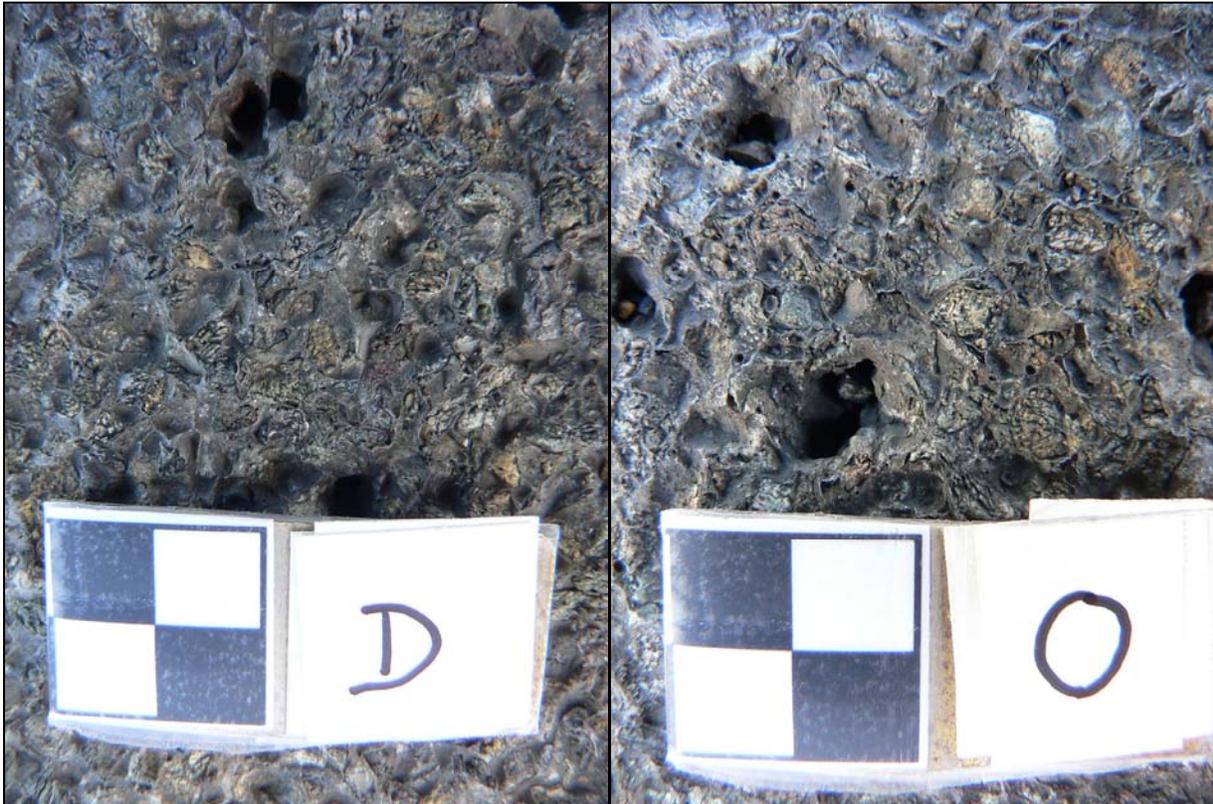
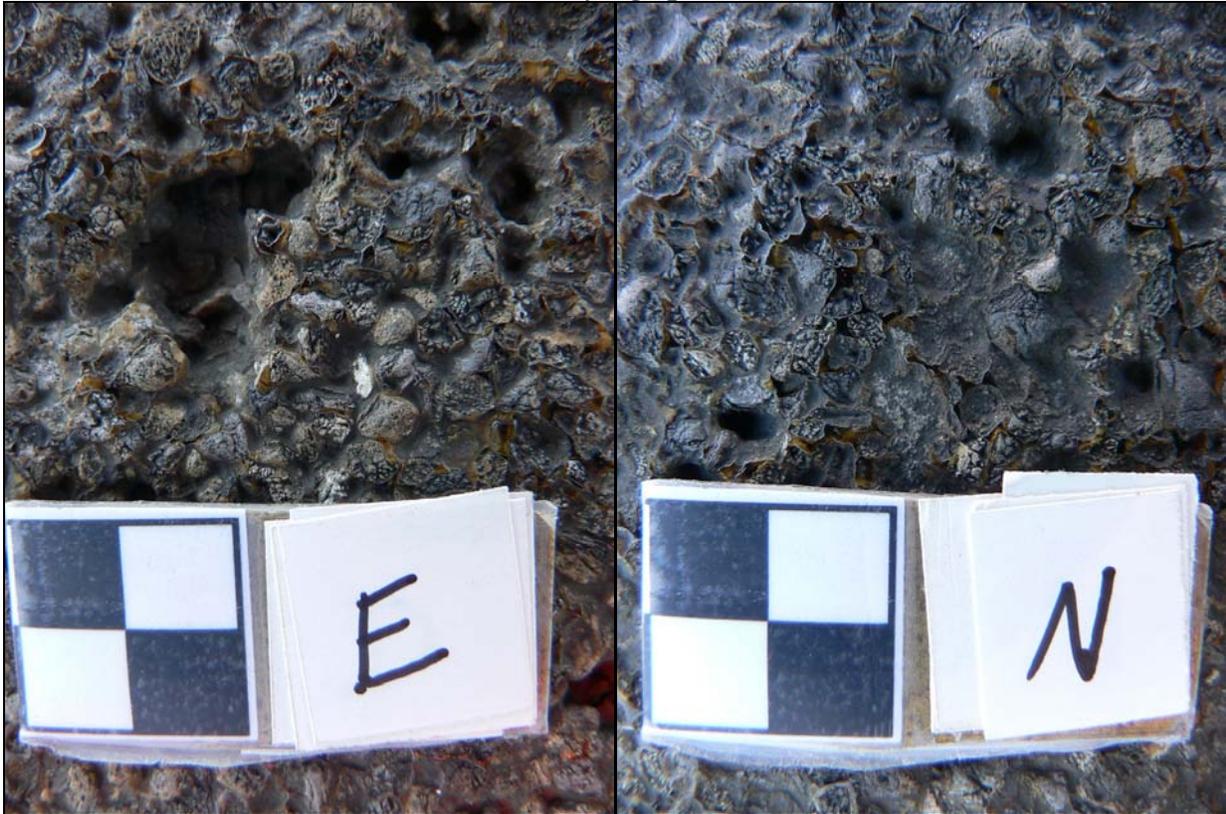
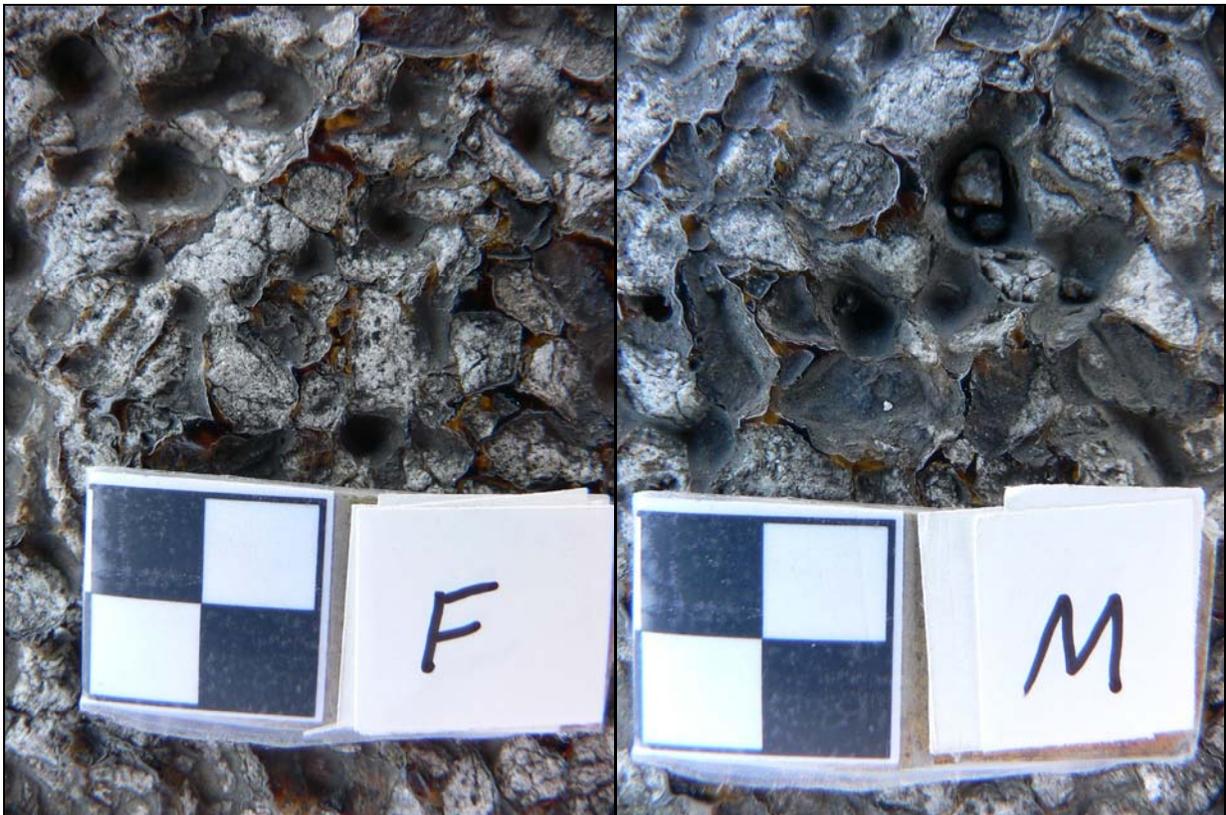
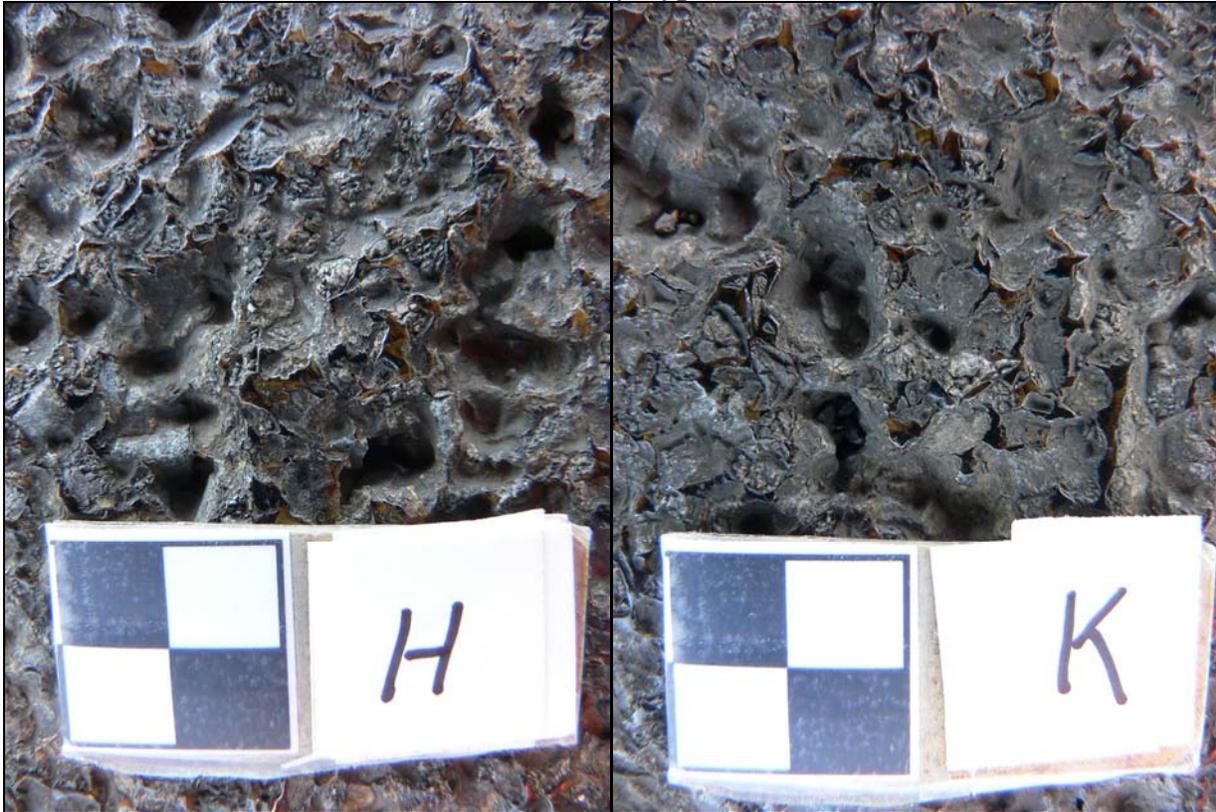
Figure 3.1: Surface condition of overlays at interim inspection. The small squares in the scale are 0.25 in. The left photos are from the bridge at Newberg and the right photos are from the bridge at McMinnville.

Safetrack HW and Tyregrip showed evidence of wearing through to the concrete. Flex-O-Lith also showed wear-through in one part of one section, but this was attributed to insufficient overlay thickness due to the contractor running out of resin during installation. Subsequent comparisons in this report do not show Flex-O-Lith exhibiting wear-through.

A common feature shown in the photographs of Figure 3.1 was voids in the overlays presumably from missing aggregate. No attempt was made to investigate the mechanism for the void formation (e.g., aggregate pull-out, aggregate crushing); however, some photographs showed aggregate that appeared highly fractured. The presence of fractured aggregate indicates that aggregate crushing may be one cause of the voids.

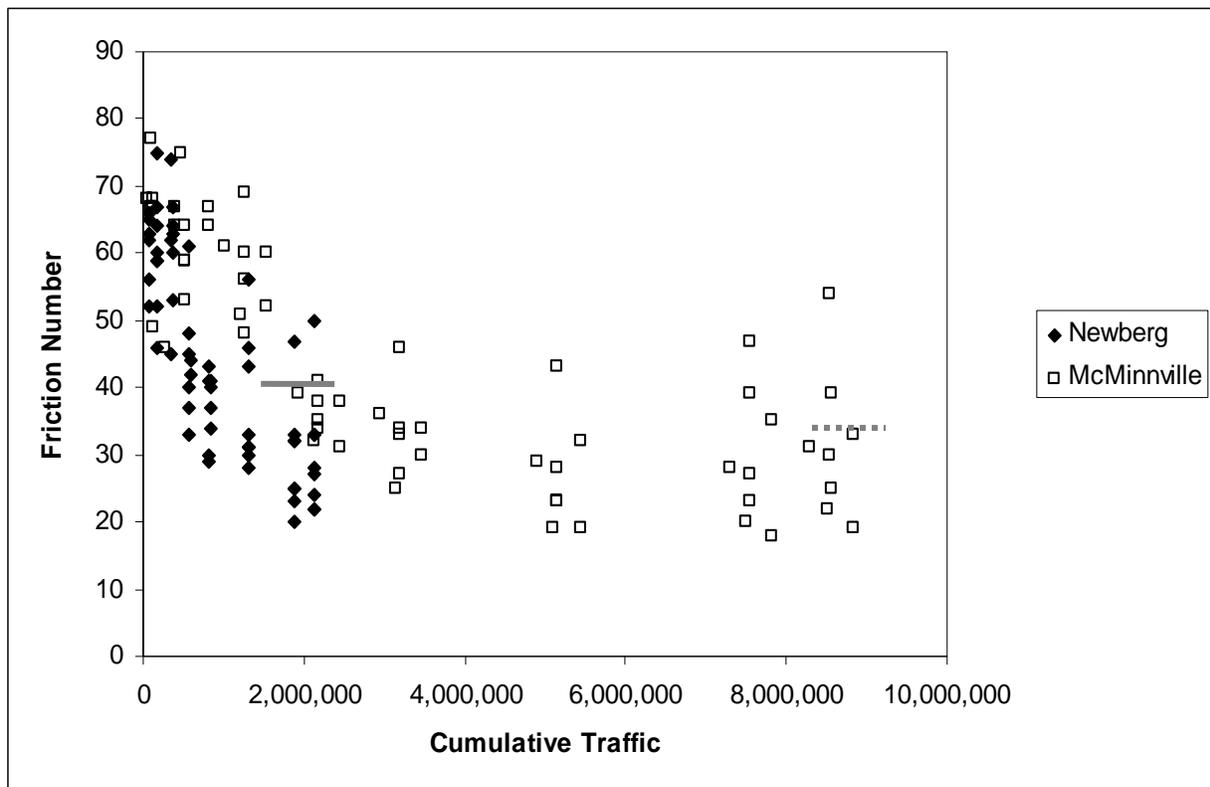
Figure 4.1: Combined skid testing results for all overlay systems. The solid and dashed horizontal lines show the friction number of the concrete for the last set of measurements at Newberg and McMinnville, respectively.

The overlays at Newberg were prone to more rapid decrease in friction number than those at McMinnville as shown in Figure 4.1. However, trucks made up a higher fraction of the traffic at Newberg (0.086) than at McMinnville (0.047). Also, the posted speed at Newberg was 55 mph compared to 35 mph at McMinnville. The effects of speed and fraction of trucks on friction number could not be extracted from the data.

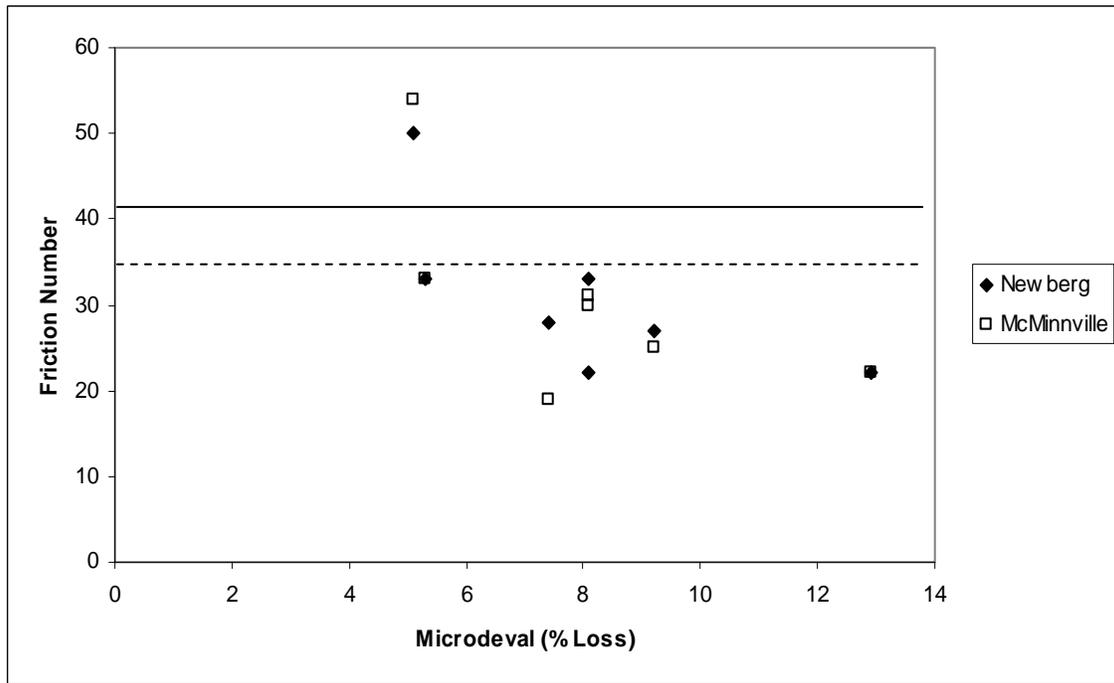
Figure 4.2: Comparison of skid resistance and aggregate abrasion resistance test results. The friction numbers are from the last set of skid tests where Newberg cumulative traffic ranged from 2,131,000 to 2,137,000 and McMinnville cumulative traffic ranged from 8,299,000 to 8,831,000. The solid and dashed horizontal lines show the concrete friction numbers at Newberg and McMinnville, respectively.

The aggregate properties measured in the laboratory did not provide good predictors of field performance. The most likely aggregate property to correlate with skid resistance, aggregate abrasion resistance measured with Microdeval, had little influence as shown in Figure 4.2. Similarly, system (resin + aggregate) abrasion resistance had little correlation with skid resistance as shown in Figure 4.3. The figures also show that only one overlay system, Tyregrip, had friction numbers greater than that of the concrete on the respective bridges.

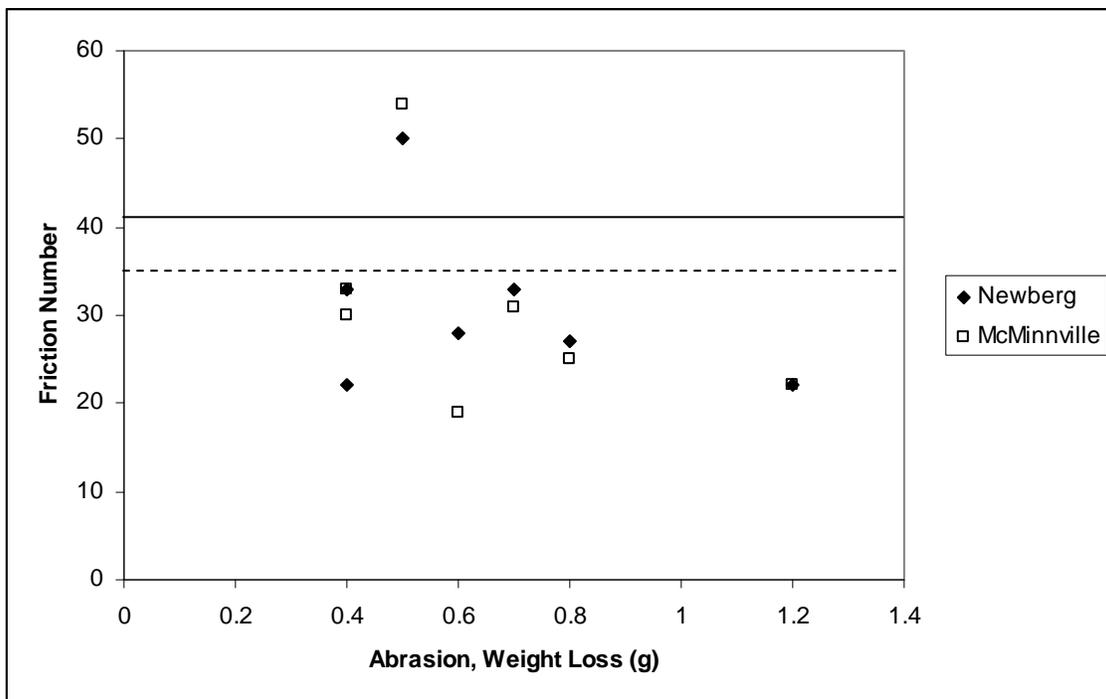
Figure 4.3: Comparison of skid resistance and system abrasion resistance test results. The friction numbers are from the last set of skid tests where Newberg cumulative traffic ranged from 2,131,000 to 2,137,000 and McMinnville cumulative traffic ranged from 8,299,000 to 8,831,000. The solid and dashed horizontal lines show the concrete friction numbers at Newberg and McMinnville, respectively.

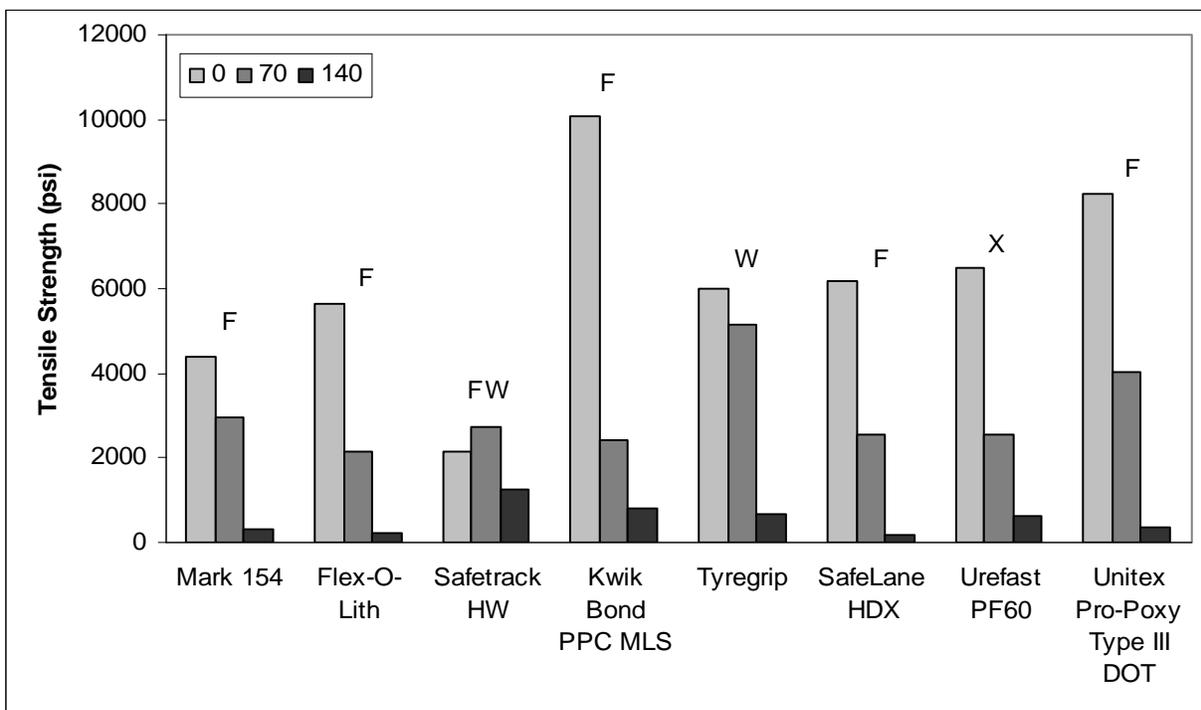
Figure 4.4: Comparison of the tensile strengths of the resins at 0, 70, and 140°F. “F” indicates systems that had friction numbers less than the concrete. “W” indicates systems that have worn through to the concrete. “X” indicates a system that failed early in the evaluation.

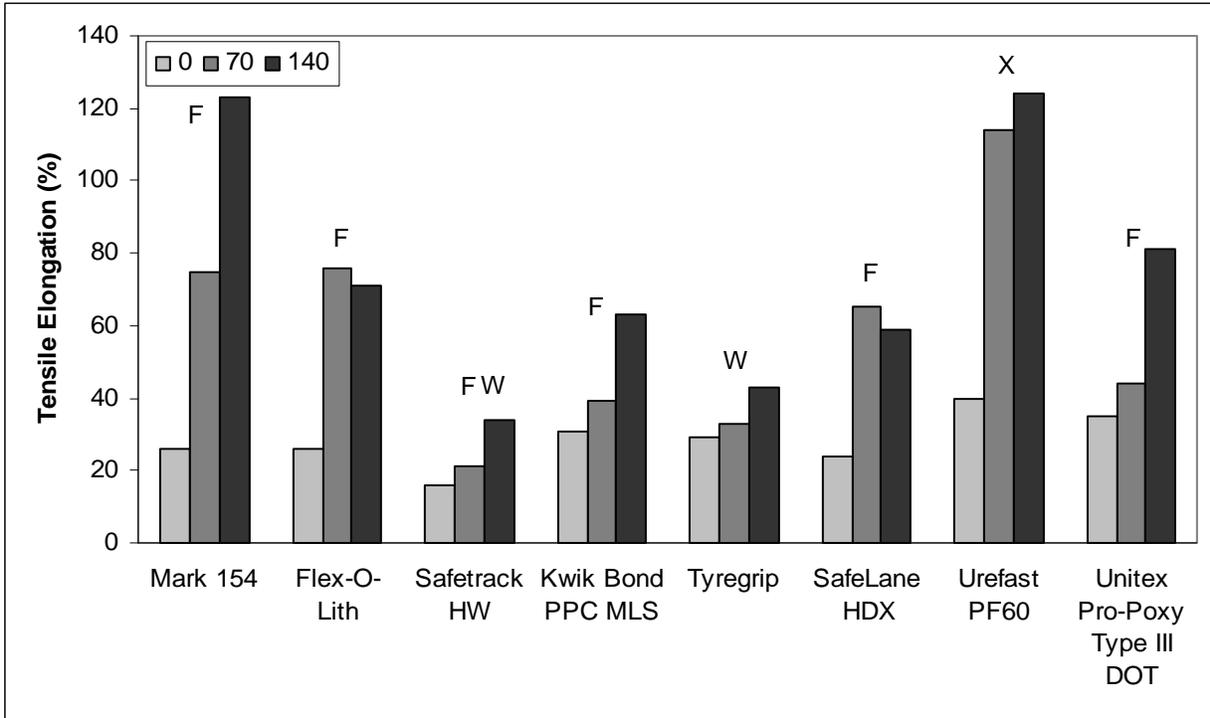
Figure 4.5: Comparison of the tensile elongations of the resins at 0, 70, and 140 °F. “F” indicates systems that had friction numbers less than the concrete. “W” indicates systems that have worn through to the concrete. “X” indicates a system that failed early in the evaluation.

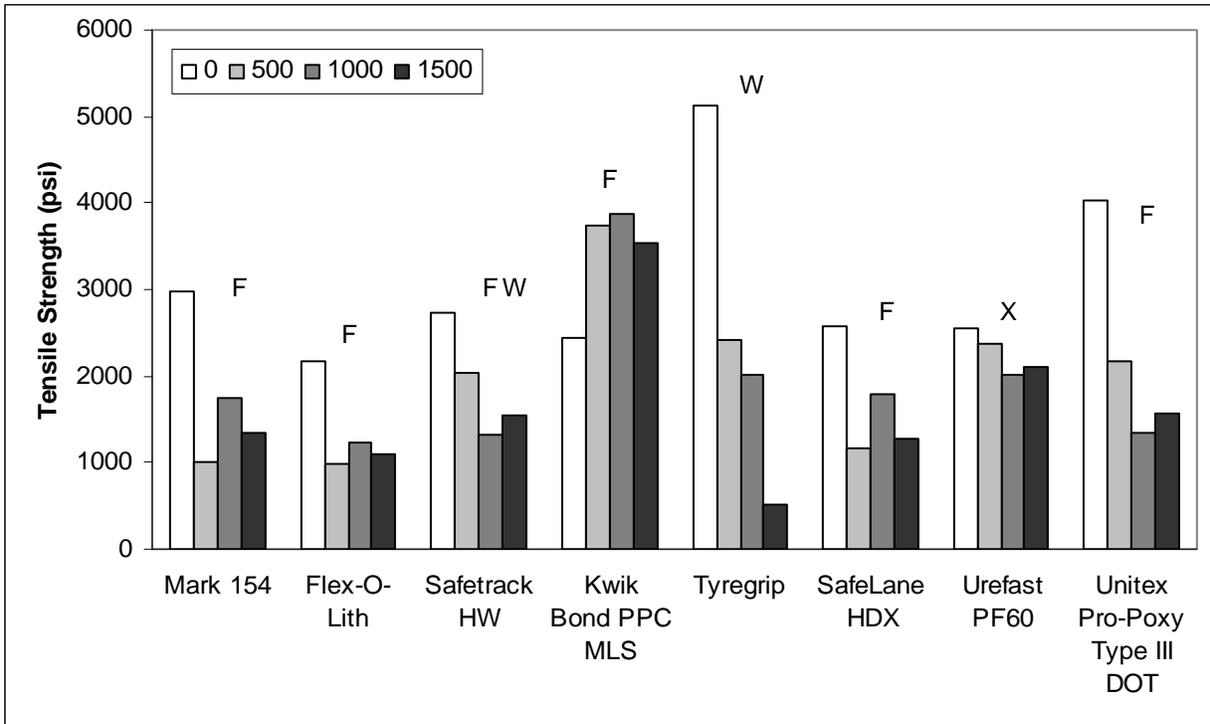
Figure 4.6: Comparison of the tensile strengths of the overlay resins after simulated sunlight exposure of 0, 500, 1000, and 1500 hours. “F” indicates systems that had friction numbers less than the concrete. “W” indicates systems that have worn through to the concrete. “X” indicates a system that failed early in the evaluation.

Most resins showed some reduction in tensile strength due to simulated sunlight exposure as shown in Figure 4.6. However, only Tyregrip showed continued reduction in tensile strength with increased exposure time. Four of the resins showed relatively large reductions of elongation after exposure, but, with the exception of Tyregrip and Kwik Bond, the elongation did not decrease appreciably with continued exposure (Figure 4.7). The general trend of degradation occurring mostly after initial exposure may be due to the fact that the surface deteriorates but protects the interior of the specimen. In service, however, a deteriorated surface could be worn away exposing a fresh surface for further deterioration. This would occur around an aggregate particle until there was not enough resin to keep the particle in place.

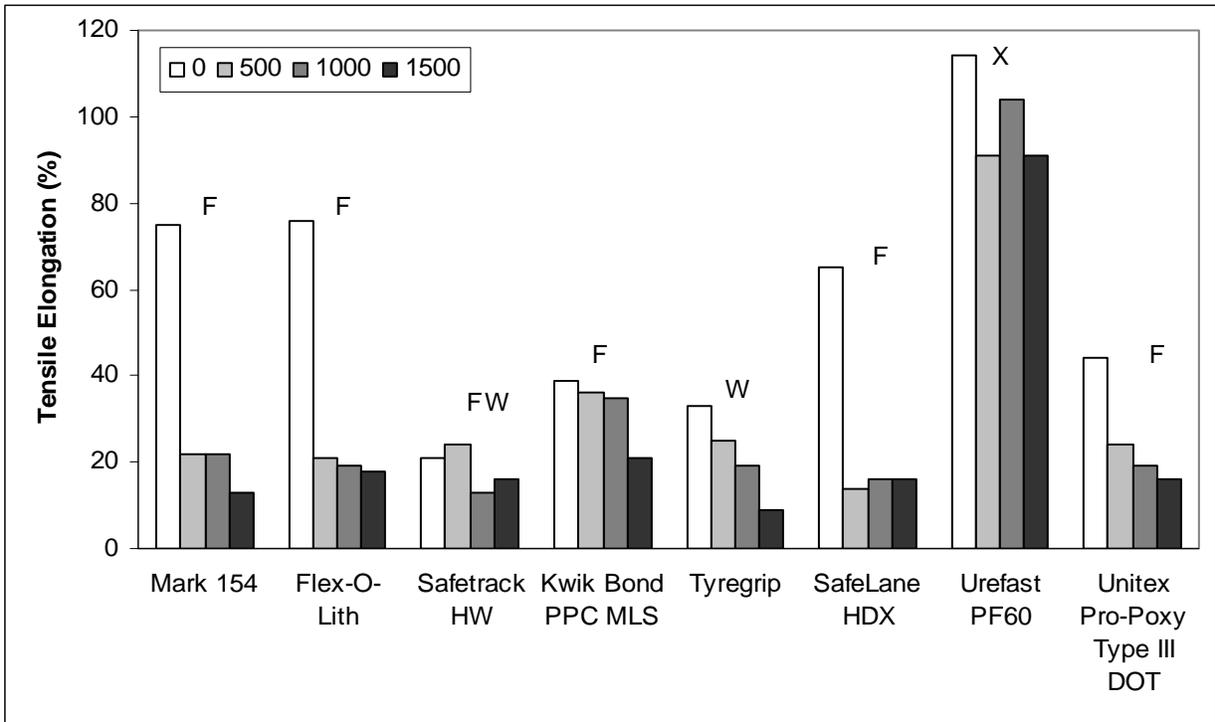
Figure 4.7: Comparison of the tensile elongations of the overlay resins after simulated sunlight exposure of 0, 500, 1000, and 1500 hours. “F” indicates systems that had friction numbers less than the concrete. “W” indicates systems that have worn through to the concrete. “X” indicates a system that failed early in the evaluation.

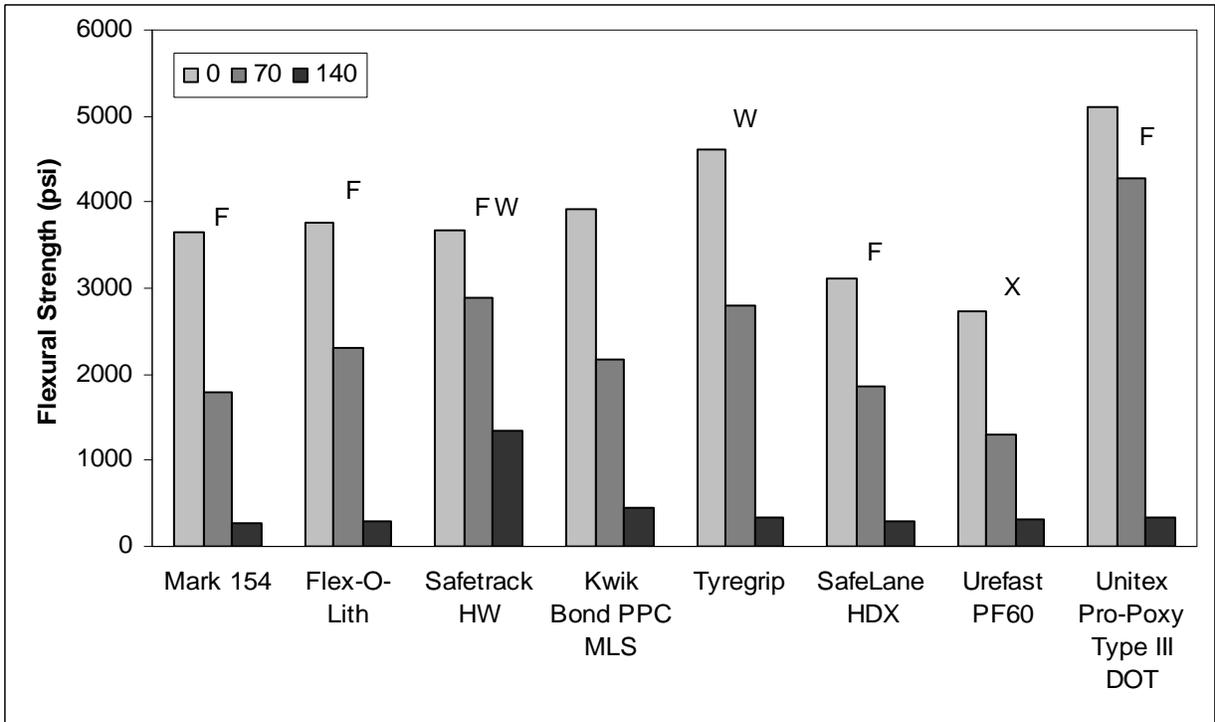
Figure 4.8: Comparison of the flexural strengths of the overlay systems at 0, 70, and 140 °F. “F” indicates systems that had friction numbers less than the concrete. “W” indicates systems that have worn through to the concrete. “X” indicates a system that failed early in the evaluation.

The flexural and compressive strength of the overlay systems in the temperature range of 0°F to 140°F followed the expected trend of decreased strength as the temperature increases (Figures 4.8 and 4.9). Though the strengths are substantially lower at 140°F, none of the systems on the bridges showed evidence of shoving that would indicate hot weather deformation.

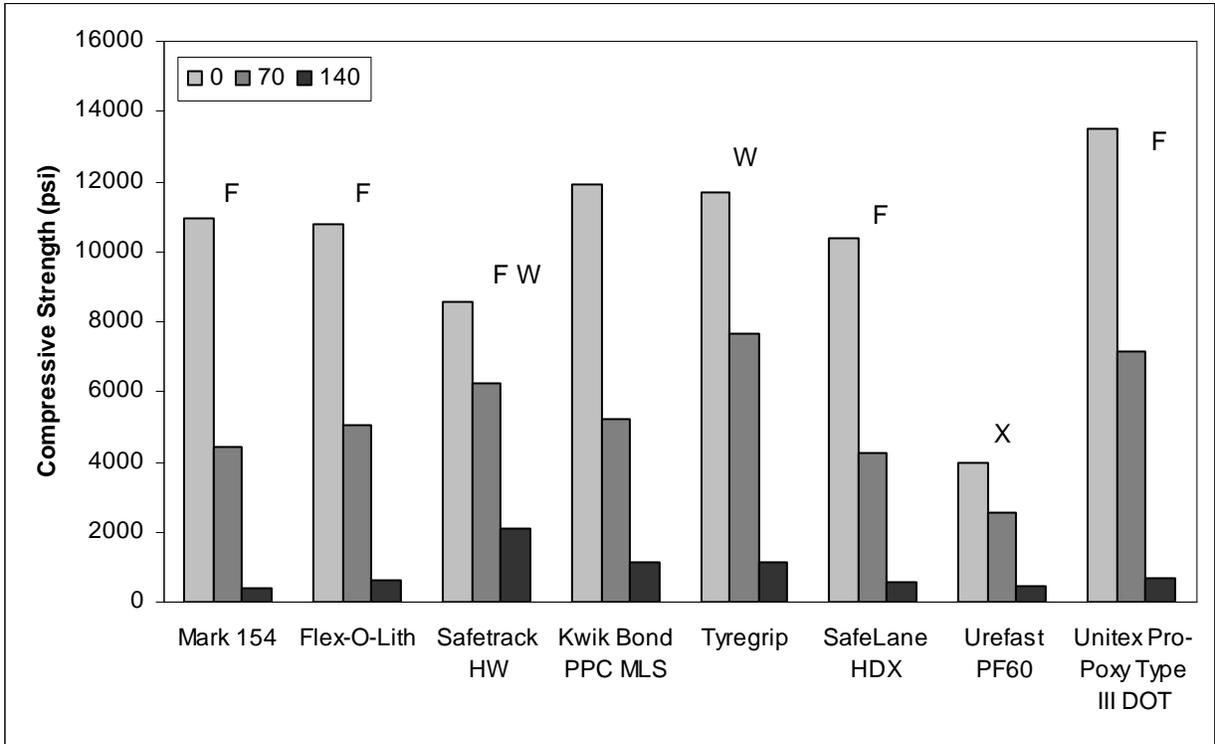
Figure 4.9: Comparison of the compressive strengths of the overlay systems at 0, 70, and 140 °F. “F” indicates systems that had friction numbers less than the concrete. “W” indicates systems that have worn through to the concrete. “X” indicates a system that failed early in the evaluation.
