1. Report No. SWUTC/10/476660-00019-1		2. Government Accession No.		3. Recipient's Catalog No.	
4. Title and Subtitle USE OF MICRO UNMANNED AERIAL VEHICLES FOR ROADSIDE CONDITION ASSESSMENT				5. Report Date December 2010

USE OF MICRO UNMANNED AERIAL VEHICLES FOR ROADSIDE CONDITION ASSESSMENT

Project 476660-00019-1
Project Title: Use of Micro Unmanned Aerial Vehicles (MUAVs) for
Roadside Condition and Inventory Surveys

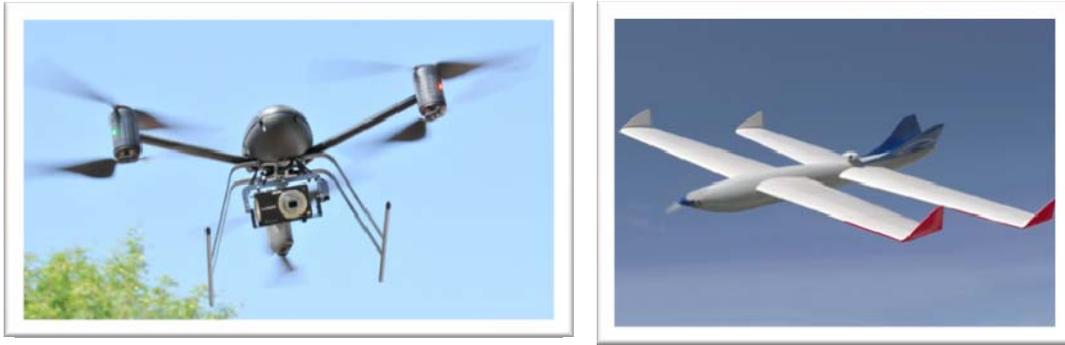
Generally, there are two major types of MUAVs: plane-configured and helicopter-configured. Examples of these MUAV types are shown in Figure 2-1.

Figure 2-1. Helicopter-configured (Left) and Plane-configured (Right) MUAVs.

A plane-configured MUAV mimics a single-propeller aircraft. These MUAVs have the ability to fly in a straight-line path and must be designed to obey the same laws of aerodynamics that apply to regular aircrafts. The wingspan on this type of MUAV can vary from 12 inches up to 4 feet, depending on application. A helicopter-configured MUAV utilizes upward thrust induced by a single or multiple propellers to maneuver in flight. The typical size for helicopter-configured MUAV is approximately 2-3 feet diametrically. However, recent research projects have used nanotechnology to produce an insect-sized helicopter-configured MUAV (Newcome 2004). Advantages of plane-configured over helicopter-configured MUAVs include:

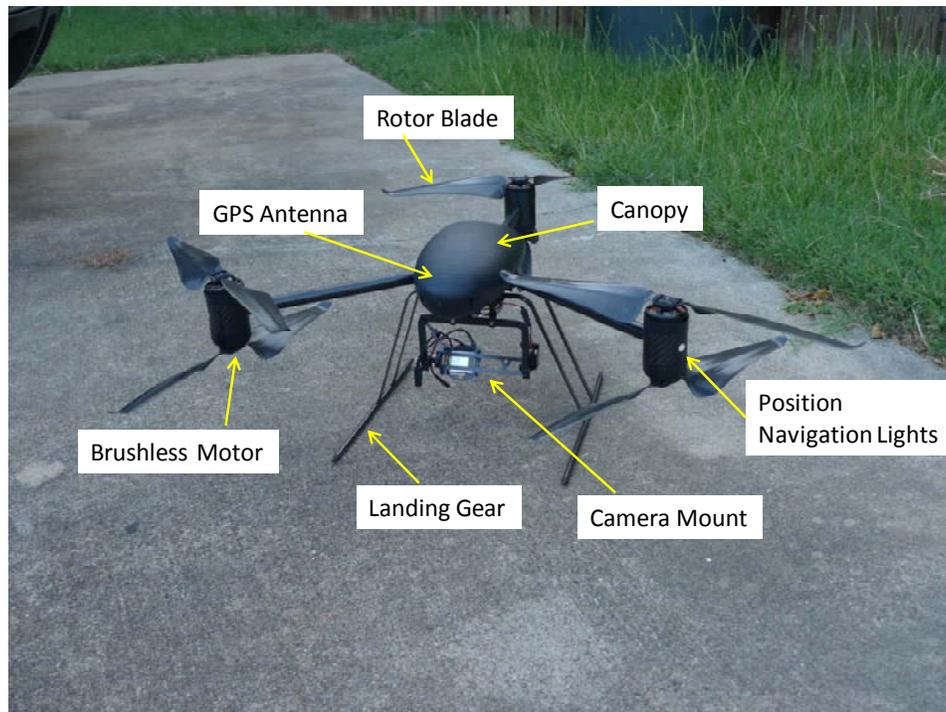
Figure 3-5. Main Components of MUAV Used in Field Experiments.

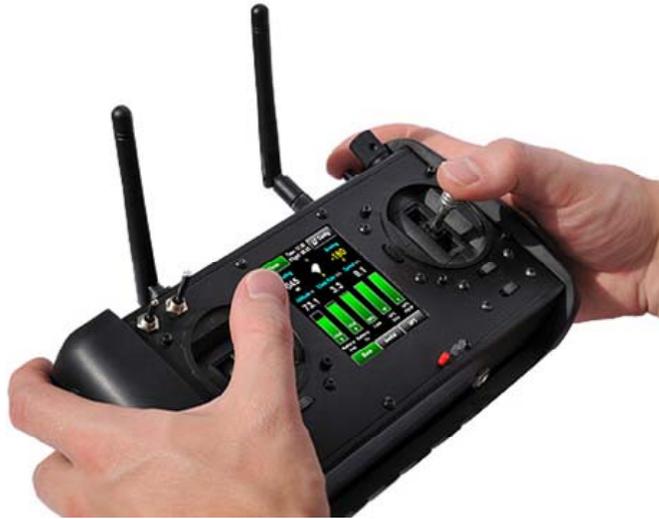
Figure 3-6. Handheld Flight Controller.

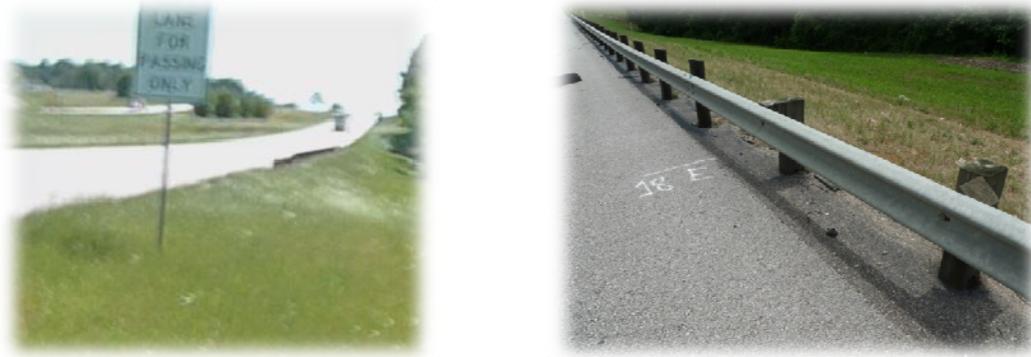
Figure 4-10. False Readings Example 1: MUAUV-Captured Image Missed Guard Rail (Left Image); On-site Inspection Captured Guard Rail (Right Image).

For this study, a false reading is a case where an asset is rated incorrectly using the MUAV-captured images. There are two types of false reading that occurred in this study. The first type occurred when an asset in a sample unit was observed and rated in the visual inspection, but was missed in the MUAV inspection. The second type occurred when the MUAV captured an image of an asset, but it could not be properly rated due to lack of visibility or clarity of images.

Out of the 10 sample units that were surveyed, there were 14 total false readings that affected the outcome of the MUAV rating process. Fifty percent of these false readings occurred when rating ditches and front slopes. The remaining 50 percent of false readings occurred when the MUAV failed to capture a specific asset due to lack of visibility or clarity of images. Figure 4-10 shows an example false MUAV reading. This example was taken from the last image in the video that the MUAV captured for Sample Unit No. 2. The image taken on-site shows that the guard rail is included in the sample unit. The MUAV was unable to capture the image of the guard rail due to obstructions from trees and signage, coupled with uncontrollable winds that prevented the MUAV from maneuvering around these obstacles. Since the MUAV missed the guard rail (which met all performance standards), the other standards that received a failing rating carried larger impact on the overall condition of the sample unit, lowering the SUS rating obtained from the MUAV-captured images.
