**Final Report  
TNW2010-13**

Road Stabilization and Drainage Improvements in North Potosi, Bolivia - Improving  
Access to Markets, Clinics, Schools, and Facilitating Future Development

# Road Stabilization and Drainage Improvements in North Potosi, Bolivia

**Engineers Without Borders**  
University of Washington Chapter  
(EWB-UWS)

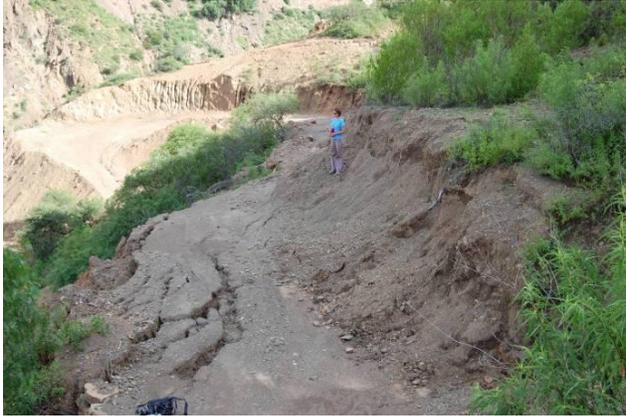
The original road was built less than ten years ago and was designed for very low-volume, single vehicle traffic, with virtually no features to ensure proper drainage. The construction used the basic cut-and-fill method with a D8 bulldozer. The road is very narrow, with very steep upslopes and downslopes at many locations. As a result, the soil is unstable and rockslides are common, especially during the rainy season, when the region is often subject to large flash floods that cause road erosion and can make the road impassable. Examples of this erosion and instability are shown in Figures 1 and 2.

**Figure 1: Major erosion and rutting along roadway before implementations**

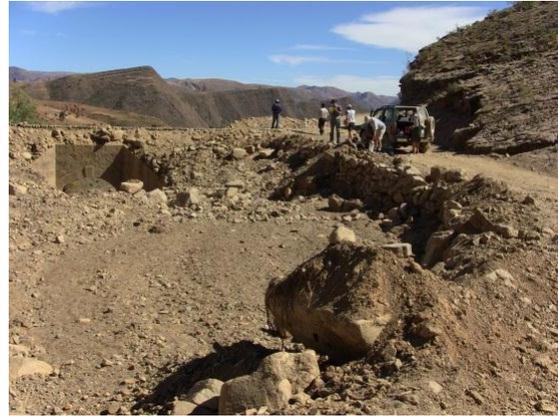
**Figure 2: El Truncal before implementation with erosion clearly visible**

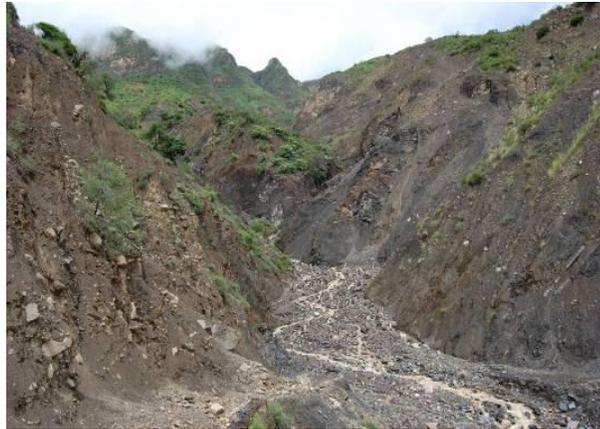
This site, where the road crosses the Tarcuni River, was the largest and most important site in the project. The river drains a large watershed and, at full force,

can move boulders the size of a sedan. The erosion at Tarcuni after only a mild storm is shown in Figure 3.

Figure 3: Tarcuni during the rainy season with stream and debris crossing perpendicular to roadway

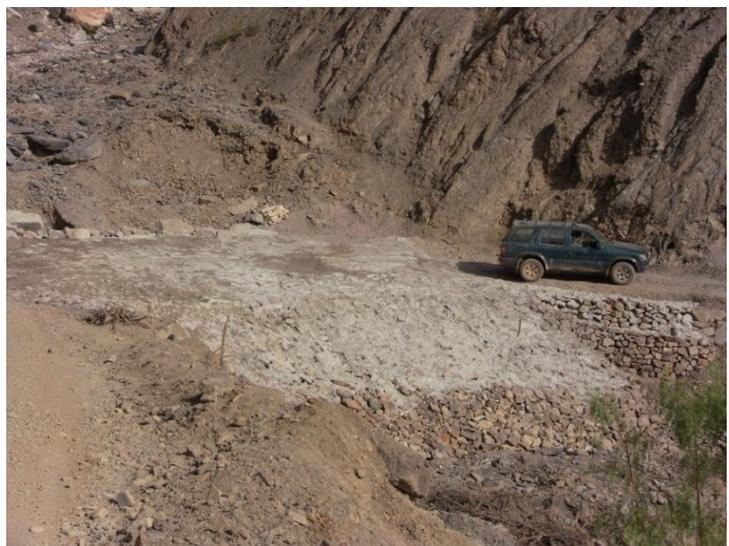
The design at Tarcuni, depicted in Figure 4, consisted of:

- A three tiered gabion wall placed about 3.5 meters from the road
- Rocks reinforced by flat gabions, attached to each tier of gabion wall, between the wall and the road
- A 2:1 slope of large rocks on top of the gabion wall
- A large armored crossing on the surface of the road

The gabion wall and 2:1 rock slope should provide a massive support that will prevent the entire road from washing out. The armored surface of the road should maintain a better driving surface throughout the rainy season.

Figure 4: The robust design at Tarcuni, after laying concrete

1. Construction footprint was excavated with a backhoe, and site preparation was finished with hand tools
2. Gabion baskets were assembled and placed, and flat gabions were attached to the backs of baskets.
3. Rocks were filled inside baskets first, and then on top of flat gabions.
4. 30-cm-thick layer of sand and gravel was placed between road and rock layer.
5. Rocks were placed in front of baskets, up to basket level, then sloping down to ground.
6. Process was repeated for next two levels of gabion baskets and flat gabions. Rocks on both sides of the gabions were added before next layer.

7. Surface of the road was leveled and graded.
8. Layer of dirt and sand placed on road surface, and then large, flat rocks placed on top.
9. A cordon was dug around the outside perimeter of the armored crossing, with large rocks placed 30 cm into the ground to protect the edges of the armored crossing.
10. Concrete was mixed and placed between flat rocks.
11. Concrete was placed on top of rock slope to provide a more cohesive layer protecting the gabions.
12. Concrete cured and dried

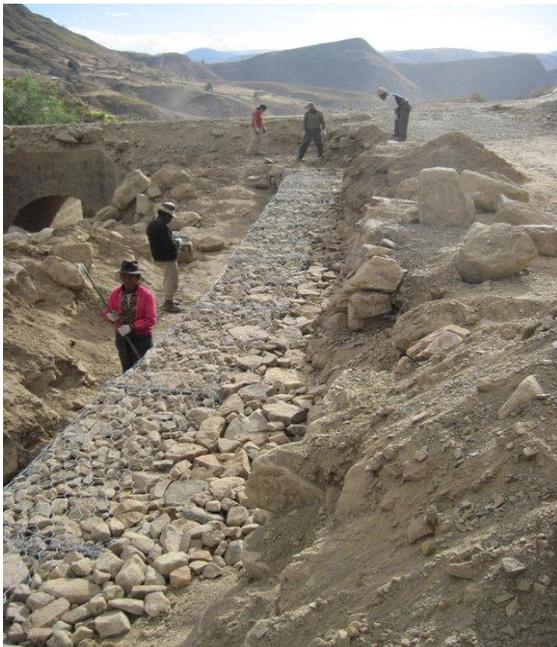
**Figure 5: Llut'arans completing the first layer of gabions at El Truncal.**

- A two tiered gabion wall adjacent to the road, with an 11-gabion bottom layer and a 16-gabion top layer, offset about 10-20 centimeters. This wall is shown in Figure 5.
- A 16-m wall of boulders moved into location by the backhoe
- A slight re-grading of the flow channel

The first layer of the wall consisted of 11 gabions, properly filled and tied together; the second layer of 16 gabions was placed on top of the 11 gabions and was offset by 10-20 cm in a stair-like pattern. The wall rose above the level of the road by 10 cm. After all gabions were constructed and placed, the backhoe was used to backfill the wall with rock for more support along the road, and

to clear the mounds of rock debris out of the flow path in front of the wall. The 16-meter wall was constructed using the backhoe. The excavation extended approximately 16 meters along the road and 0.5 meters in depth. Large rocks (about 1 meter in diameter) were then placed in the excavated area. Tuquizans then filled the gaps with smaller rock.

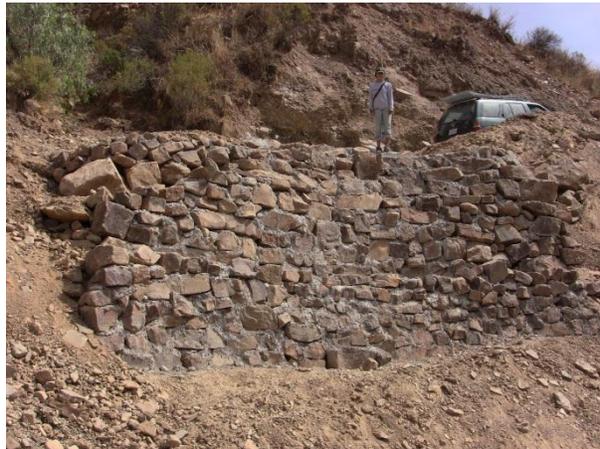
- Two armored crossings, at both places where the water crosses, one of which is detailed in Figure 6.
- A three tiered, cemented drywall to reinforce under the upper armored crossing, detailed in Figure 7.

Figure 6: The completed cemented drywall

The upper armored crossing was approximately two meters long and four meters wide. The backhoe was used to excavate both armored crossings. Flat rock was then placed into the armored crossings and stabilized with concrete. The lower armored crossing was two meters long and three meters wide. The cemented drywall was about four meters long and had three tiers of tapered levels to support the top level, which connected to the armored crossing via rock and concrete. All rock for this site was collected near the site.

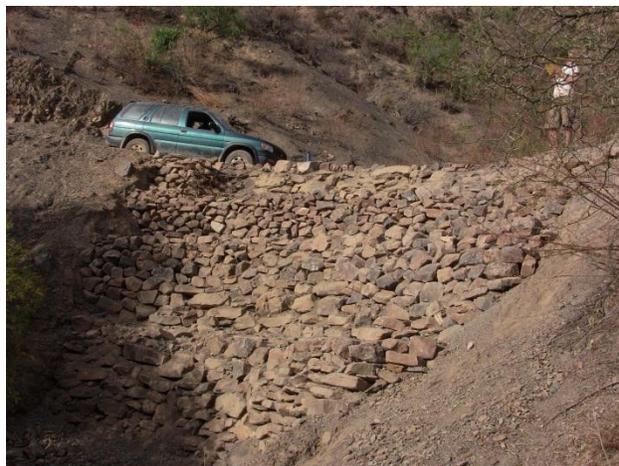
At this site, Tuquizans complained of difficult driving conditions during the rainy season. The edge of the downslope erodes with heavy rainfall, narrowing the road and making driving precarious. Rain discharge also creates ruts along this patch of road (about 15 m long and 4.5 m wide). These ruts, along with loose, muddy soil, cause trucks to get stuck and have to be freed using shovels, pickaxes and ropes.

The construction at this site consisted of installing a 15-m cemented drywall. The wall was built on the downslope and had two tiers. The bottom tier was 2.5 m high, while the top was 1.5 m high. The completed wall is shown in Figure 8.

Figure 8: The 2-tiered cemented dry-wall

1. Excavating the bottom tier and making a footpath for wheelbarrows
2. Placing the largest boulders on bottom and laying concrete on top
3. Continuing with large cobbles and thin layers of concrete
4. Excavating slightly for the second tier, and continuing the pattern.

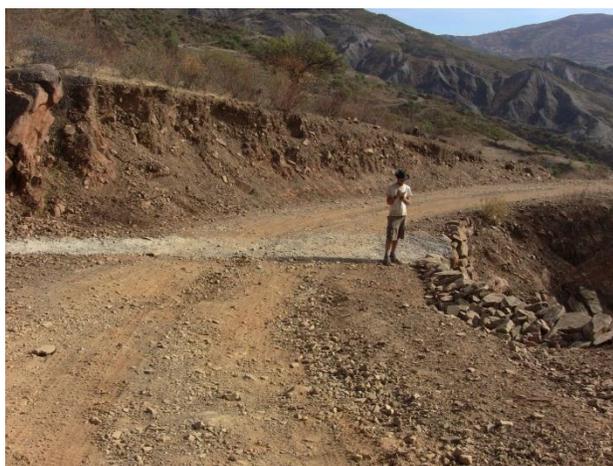
At one location along the Yanayan section, and at the Molle site near Tuquiza, small armored crossings were built at places where water crosses the road and erodes the edges of the road or creates ruts down the road. The purpose of these armored crossings is to direct the water flow across the road efficiently, reducing erosion and eliminating standing water on the roadway. These armored crossings were approximately 2 meters in length. The armored crossing near Yanayo was simply a widening of a 1-meter armored crossing created on the previous implementation trip. A typical crossing is shown in Figure 9.

Figure 9: The completed armored crossing near Yanayo Grande

1. Digging into the road to create the trench for the armored crossing (by backhoe or hand-labor)
2. Placing large flat rocks along the trench
3. Mixing and placing concrete on top of the trench, spreading a thin layer over and in between the rocks.
4. Curing the concrete for approximately 3 days
