Publication No. FHWA-RD-93-118

July 1994

Testing of Small and Large Sign Support Systems FOIL Test Number: 92F037

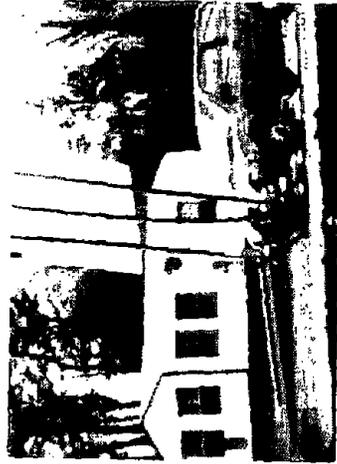
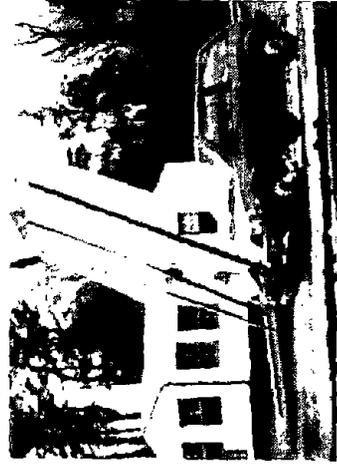
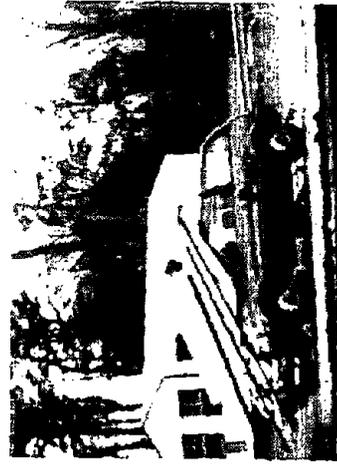
Figure 3. Test photographs during impact, test 92F037.

The bumper made contact with all three sign posts and they began to collapse. The u-channel legs began to bow away from the vehicle. The u-posts began to plow through the strong soil, however the resistive force of the soil did not allow the posts to continue to plow through it. The force builds at the point of contact and the left post failed at 0.016 s. Left post failure was followed by the left post's grade-2 splice bolts failing at 0.024 s. The left post was aligned with the left bumper support of the vehicle which caused the post failure. Crush of the vehicle did not allow failure of the center or right u-post early in the impact event. The right post failed approximately 38 in (965.2 mm) above ground and at 0.038 s. Failure above the bumper level was due to sign post being fastened to the anchor at the bottom and the mass of the large sign panel on the top. The sign post bent as far as possible then broke about half way up the sign post. The vehicle continued to flatten the right stub and the grade-2 bolts failed at 0.042 s. The center post began to wrap around the front end of the vehicle and the center post splice bolts failed as the vehicle tried to force the sign post through the soil. The center post was wrapped around the front end of the vehicle and eventually fractured at 0.090 s. The remainder of the sign system fell on top of the vehicle making contact with the hood, windshield and roof. The contact cracked the windshield along the roof-windshield joint. The contact occurred at 0.430 s.
