Forensic Investigation of AC and PCC Pavements with Extended Service Life

Volume 2: Petrographic Examination of PCC Core Samples at Lankard Materials Laboratory

Report FHWA/OH-2010/004B

September 2010

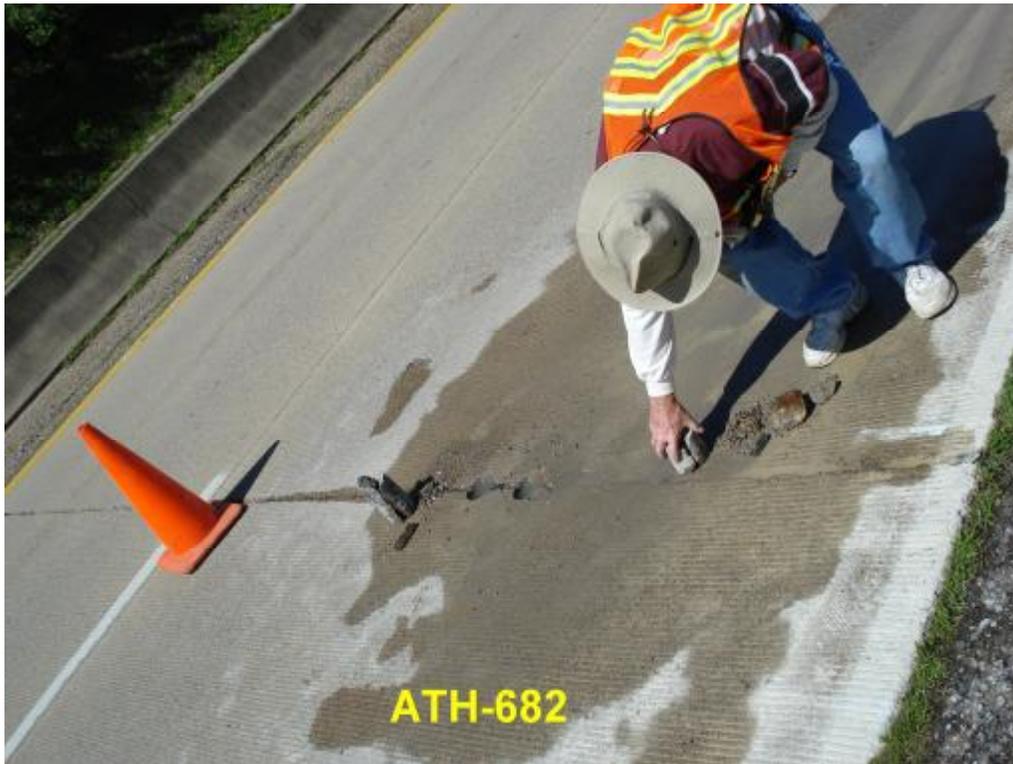
Figure 3. Coring through a control joint on State Route 682 in Athens County, Ohio in May, 2009. This pavement received an “Average” Performance Rating.

The PCC cores were taken by Ohio University personnel. An example of the coring operation on a control joint site and a mid-slab crack site is shown in Figures 3 and 4 respectively.

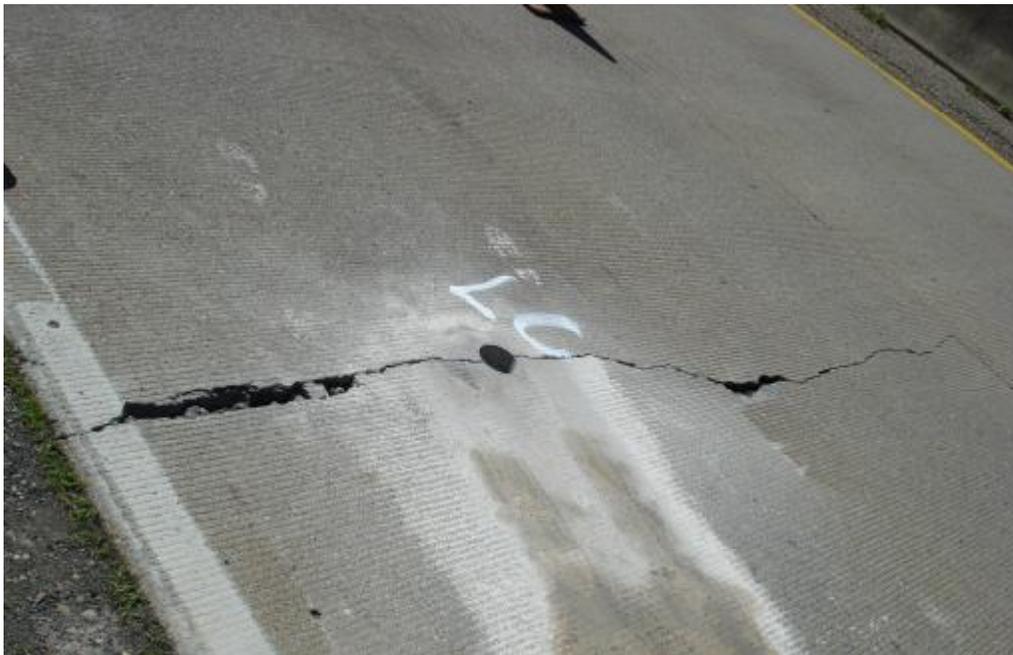
Figure 4. Coring through a mid-slab crack on State Route 682 in Athens County, Ohio in May, 2009. This pavement received an “Average” Performance Rating.

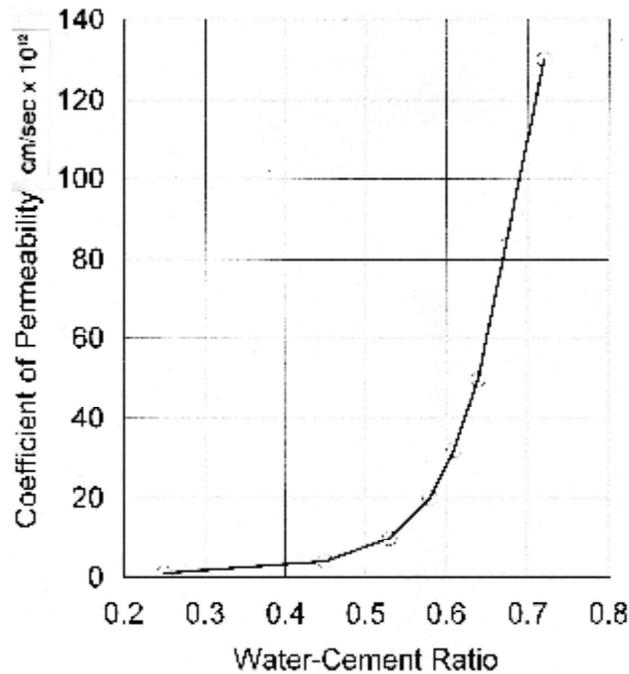
Figure 6. The effect of water-cement ratio on the permeability of mature hardened portland cement paste (Powers et. al. 1954).

Figure 6 shows the effect of water-cement ratio on the permeability of mature hardened portland cement paste. At a w/cm at or below 0.45, hardened portland cement paste has a very low permeability, which is an important feature regarding the freeze/thaw durability of concretes exposed in a severe weather environment. Low permeability is also an important feature of concretes regarding the ingress of chloride-laden waters, which may come into contact with embedded steel dowels or mesh.

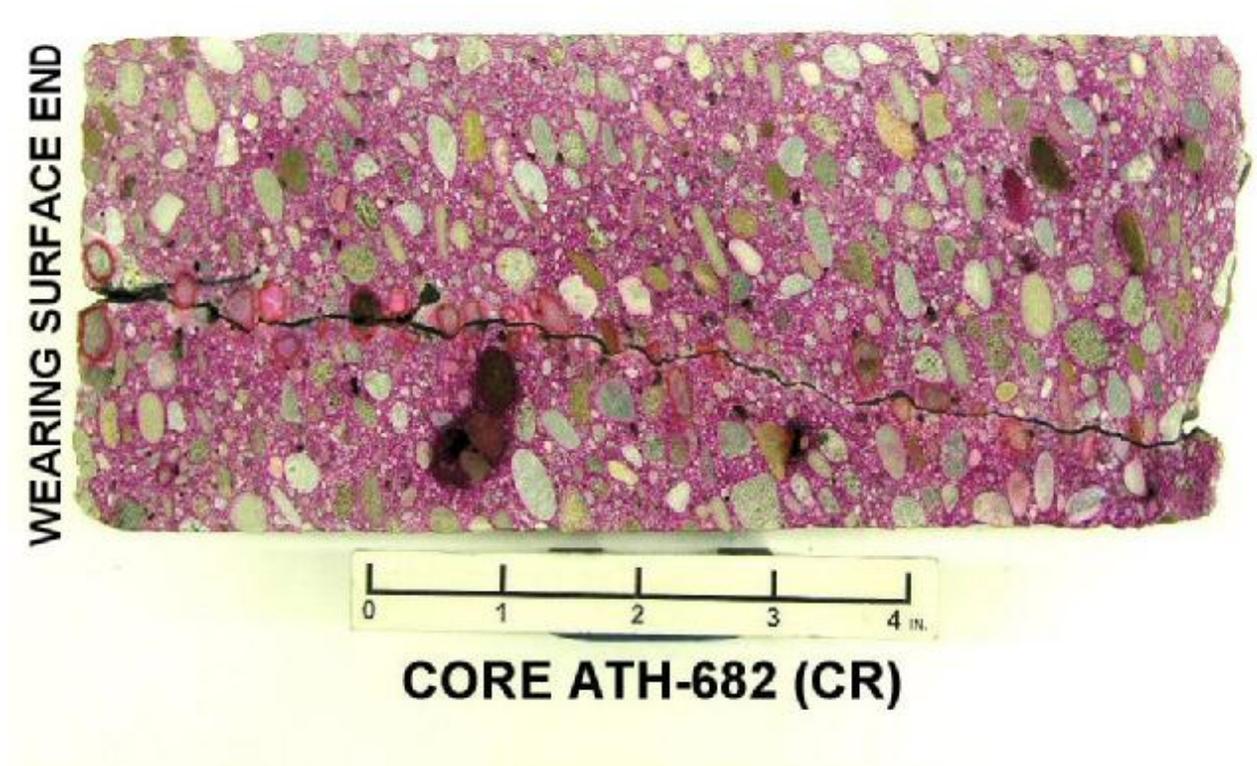
Figure 7. Saw-cut surface of Core ATH-682 (CR) following the application of the phenolphthalein pH indicating solution. No carbonation has occurred in the red colored area (essentially the entire thickness of the core).

Figure 7 shows a saw-cut surface of the core from State Route 682 in Athens County, Ohio [ATH-682 (CR)] following the application of the phenolphthalein solution. The saw-cut is perpendicular to the plane of the pavement wearing surface. No carbonation has occurred in the cementitious phase in those portions of the surface that are red in color. In this core only portions of the topmost 0.5 mm thickness of the wearing surface are carbonated.

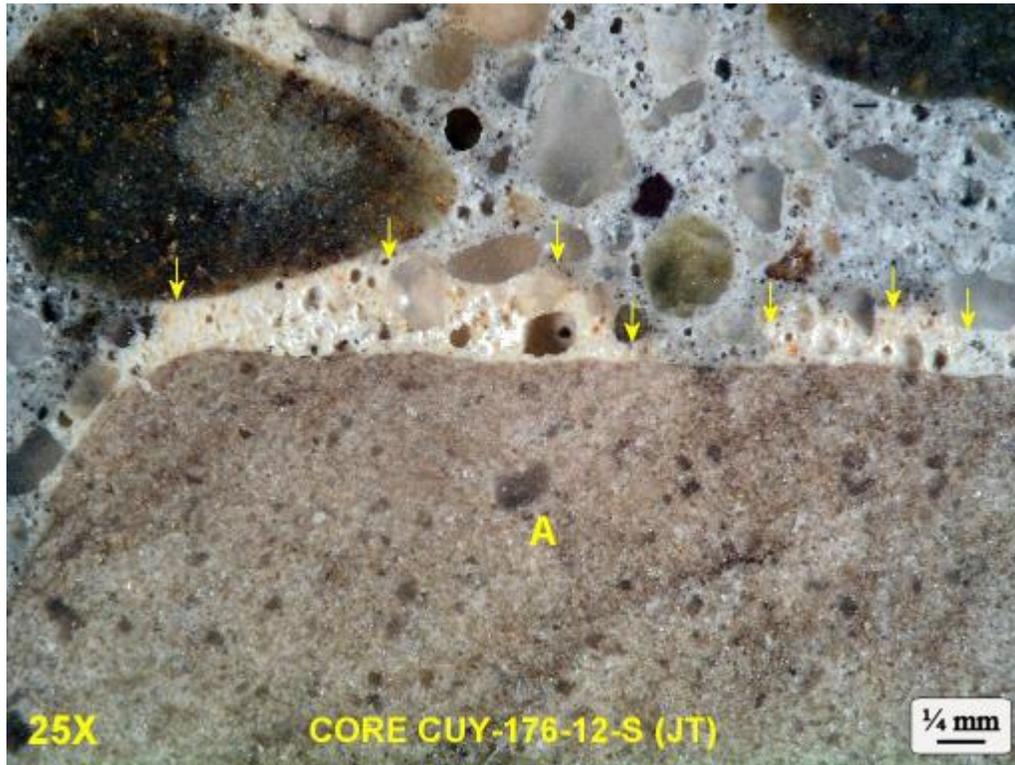
Figure 8. Lapped surface (25X) of Core CUY-176-12-S (JT) showing a region of elevated w/cm cement paste (below the arrows) in contact with a limestone coarse aggregate particles (A).

One possible explanation for this microstructural feature is as follows. Coarse aggregate particles are often in the saturated condition when they are introduced into the concrete. Once the concrete has been placed, the temperature within the concrete rises due to the exothermic cement hydration reactions. As the absorbed water in the aggregate particles heats up, it expands. As there is no new empty volume within the aggregate particle to accept this new increased water volume, the excess water moves out into the concrete. If the concrete is still in a fluid state, the excess water can enter the cement paste that is in contact with the aggregate particle and increase its w/cm.

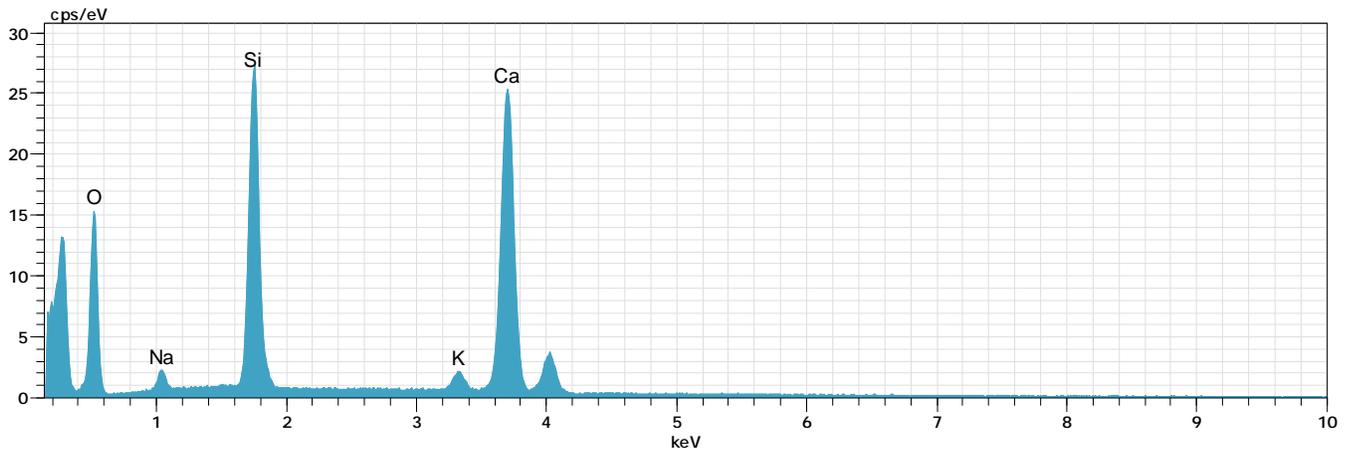
Figure 9. EDX spectrum (20X) of alkali-silica gel excavated from Core TUS-39.

Model JSM-840A SEM). Figure 8 shows the EDX spectrum (20X) of suspected ASR material excavated from Core TUS-39 (Tuscarawas County State Route 39 – 1990 pavement project). This is a typical pattern for alkali-silica gel, showing a dominance of calcium and contributions of the alkali elements sodium (Na) and potassium (K).

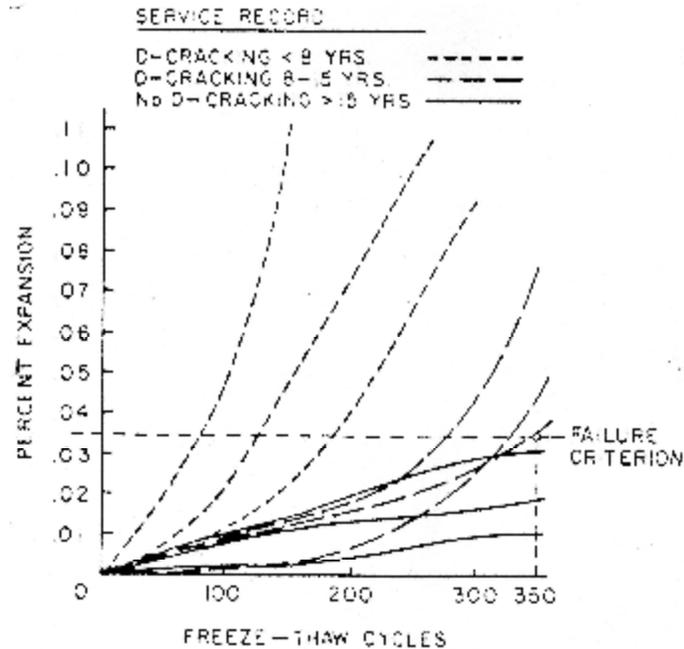
Figure 10. Relationship between aggregate service record for sources of Ohio carbonate coarse aggregate sources and the expansion of air-entrained concrete beams containing the aggregates in laboratory freezing and thawing tests. (Stark, 1976)

Historically and currently there have been problems with D-cracking in some of the coarse aggregate sources in Ohio. The Portland Cement Association conducted an extensive study of this phenomenon for ODOT in the 1970s (Klieger and Stark, 1974 and Stark, 1976). The proneness of a given aggregate source to D-Cracking was quantified by subjecting air-entrained concrete beam specimens to freezing and thawing cycles and measuring permanent expansions in the beams as a

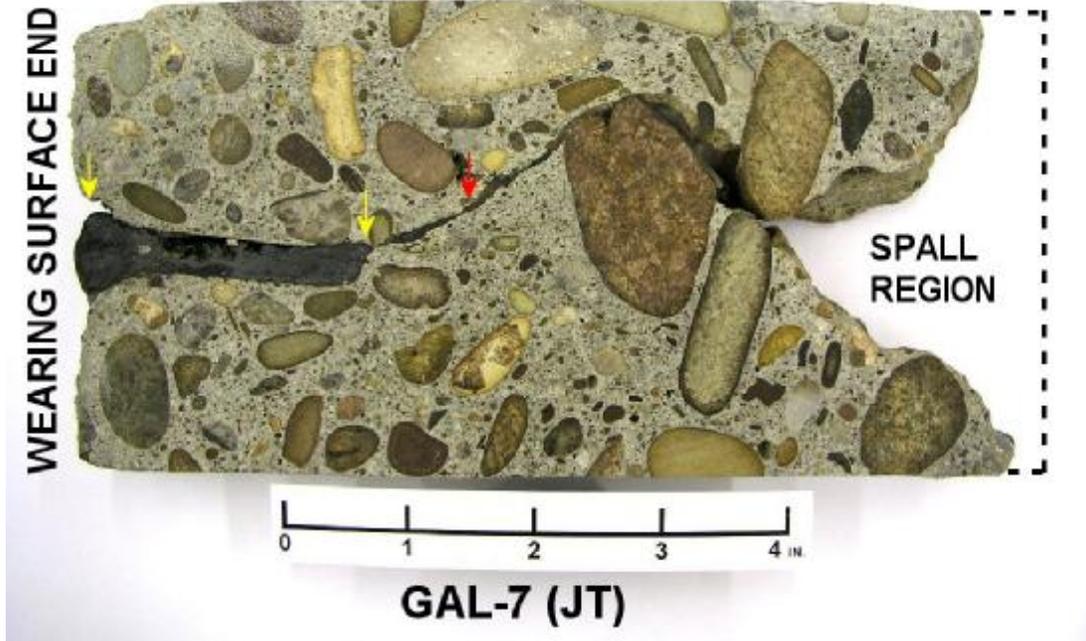
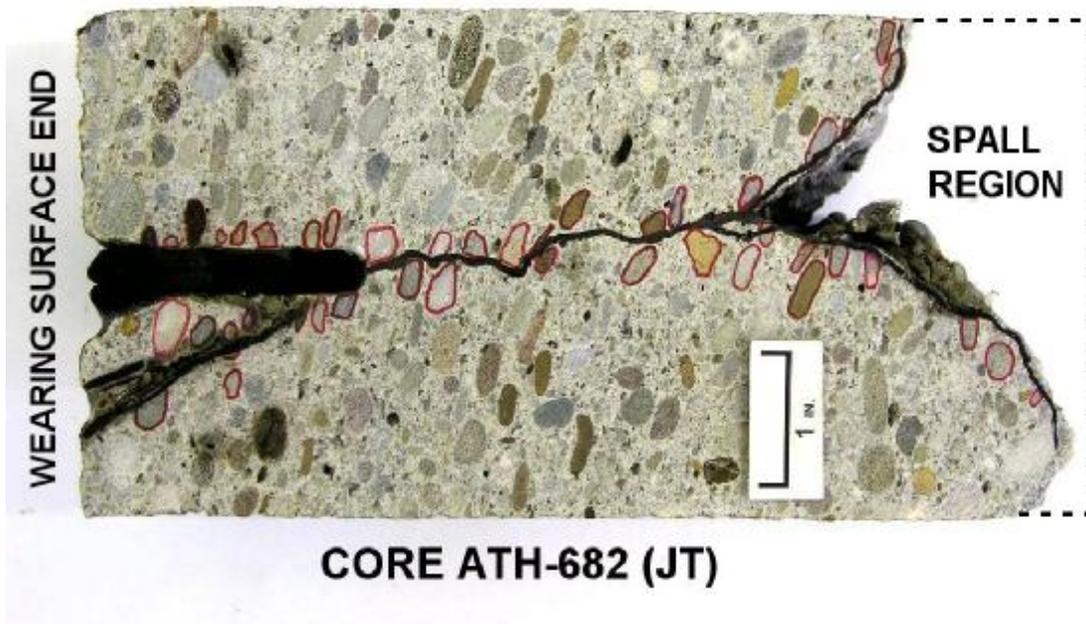
Figure 13. Section views of Joint Cores GAL-7 (JT) and ATH- 682 (JT) showing cone-shaped regions of spalling in the bottom of the cores. The Gallia County pavement has been in service for 63 years; the Athens County pavement for 33 years.

Examples of this cone fracture pattern, which is diagnostic of this type of freeze/thaw related distress are shown in Figure 13 for Joint Cores GAL-7 and ATH-682. The Gallia County pavement has been in service for 63 years and the Athens county pavement for 33 years. Both of these concretes contain a siliceous gravel, which includes some sedimentary rock types.

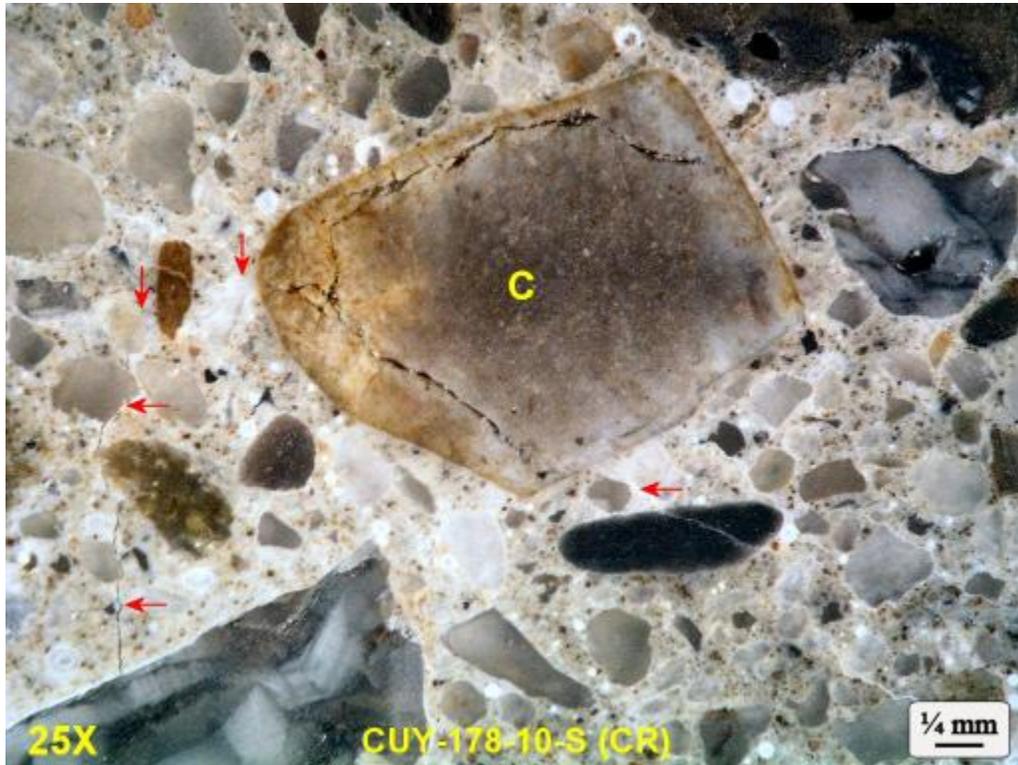
Figure 14. Lapped section view (25X) of Core CUY-176-10-S (CR) showing a reacted chert aggregate particle (C) from the sand phase of the concrete. Cracks in the chert particle have advanced a short distance into the adjacent cementitious phase of the concrete (arrows).

All but one of the pavement concrete sands contain chert, ranging from the third most abundant constituent to the ninth most abundant. Chert is one of the silica minerals that is known to be potentially alkali-silica reactive. The same criterion used to rate the extent and occurrence of alkali-silica reaction activity for the coarse aggregates was used for the fine aggregate phases of the pavement concretes. Only five of the concretes showed any evidence of alkali-silica reaction activity, which was limited to only a few chert particles (or in two cases to siltstone particles). An example of a reacted chert particle is shown in Figure 14, which is a 25X view of a lapped surface

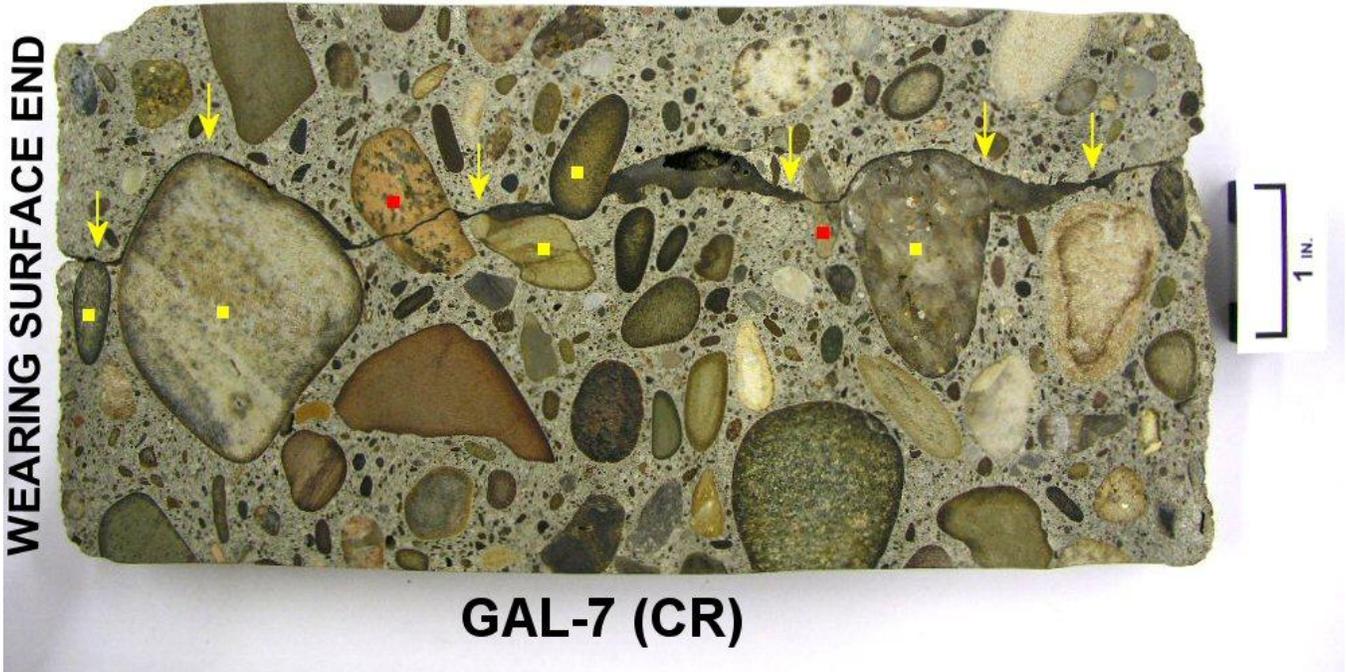
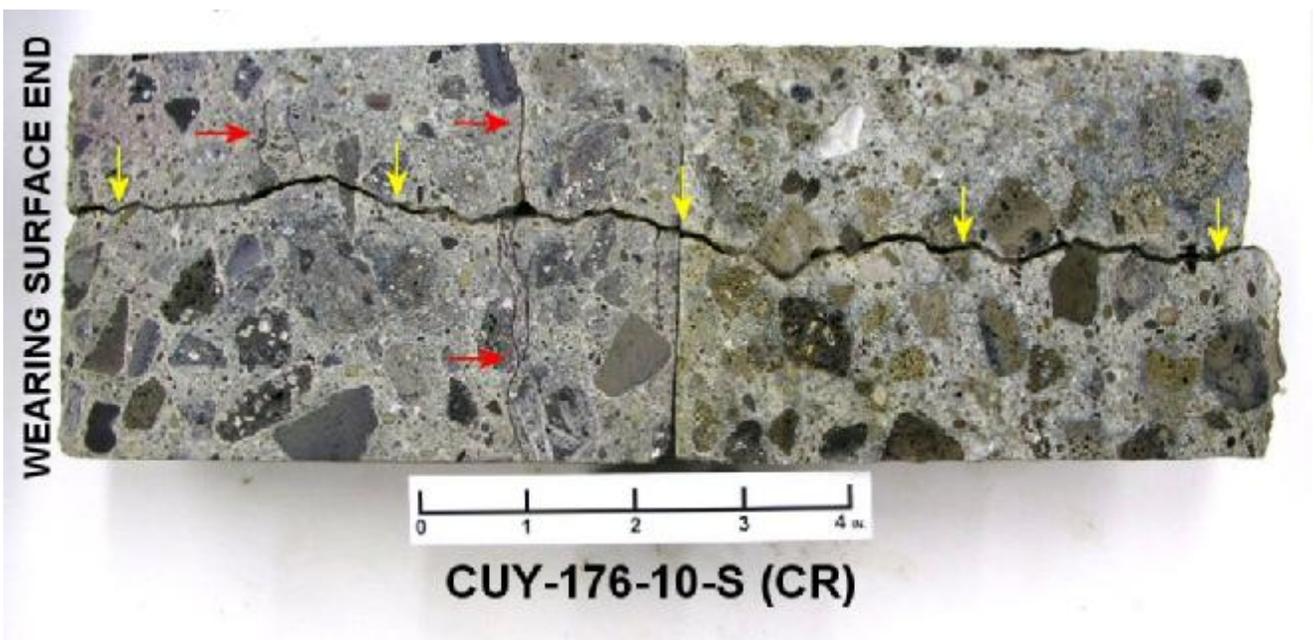
Figure 15. Lapped section views perpendicular to the plane of the wearing surface of Cores GAL-7 (CR) and CUY-176-10-S (CR). Both cores were taken through a mid-slab crack (yellow arrows). The coarse aggregate in the GAL-7 core is a 2 in. maximum size siliceous gravel. The red arrows in the bottom photograph point to horizontal cracks that pass through the cementitious matrix phase and around the slag coarse aggregate particles in the CUY-176-10-S (CR) core.

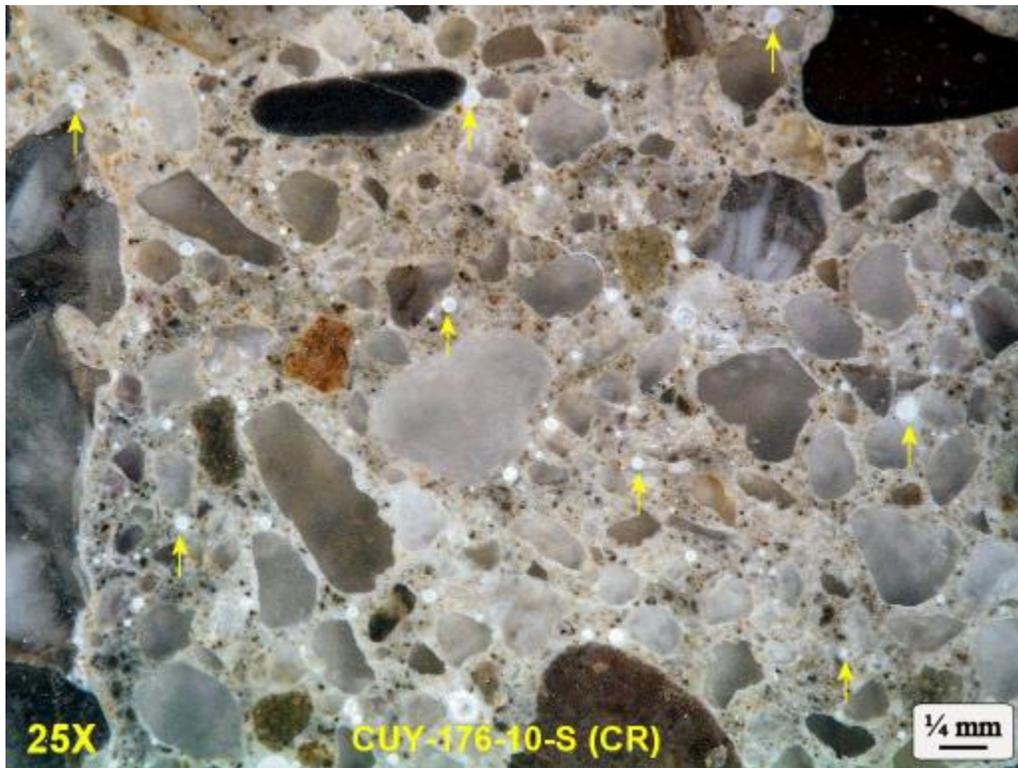
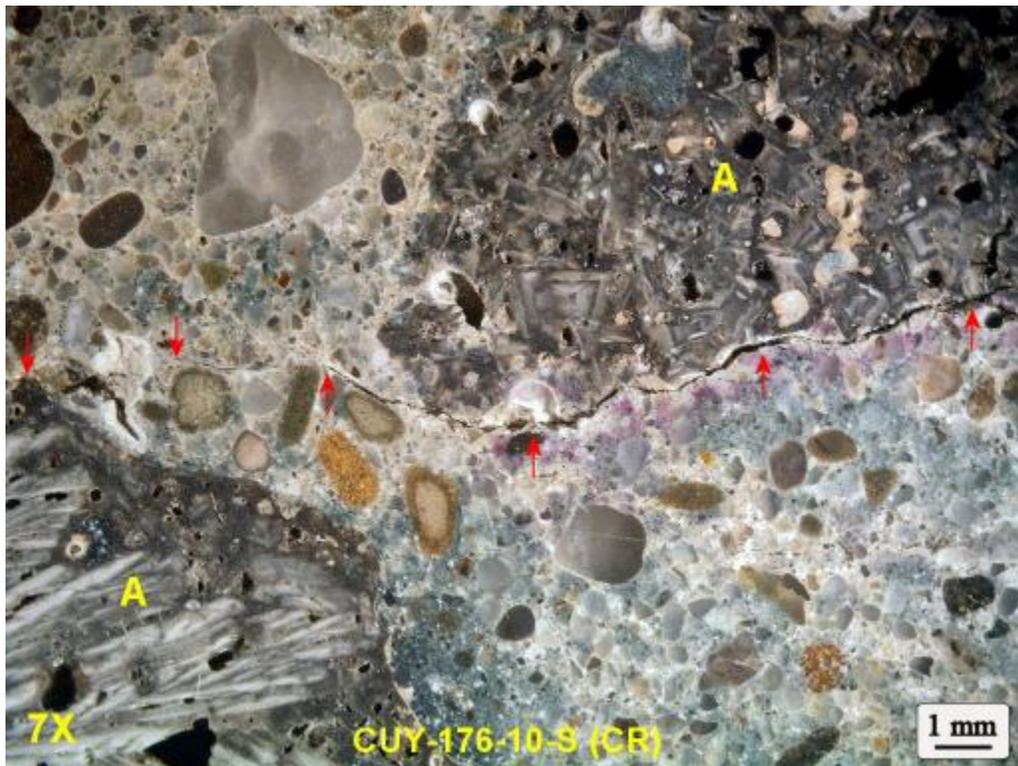
Figure 16. Lapped section views (7X and 25X) perpendicular to the plane of the wearing surface of Core CUY-176-10-S (CR). The yellow arrows in the top photograph point to a few of the entrained air voids that are filled with secondary deposits. The red arrows in the bottom photograph point to a crack in the cementitious matrix that passes around two of the slag coarse aggregate particles (A).

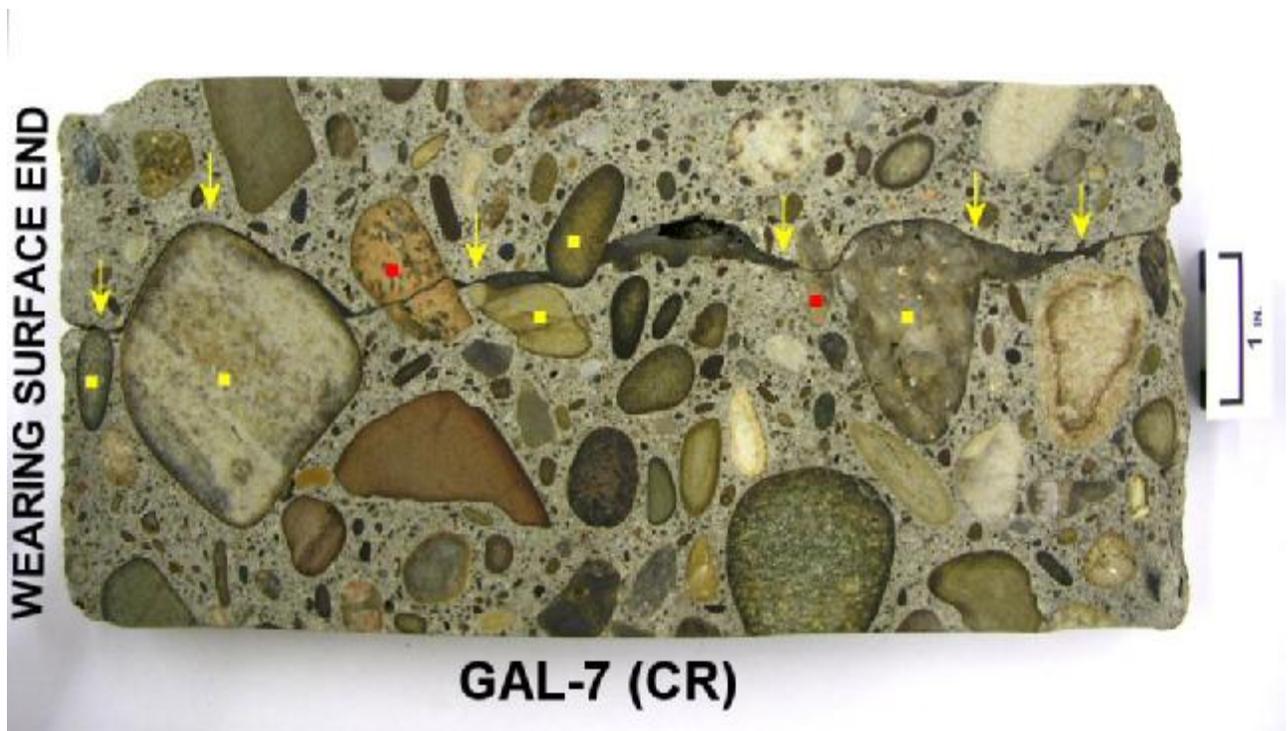
Figure 17. Lapped surface of Core GAL-7 (CR) showing the full depth (8 in.) mid-slab crack.

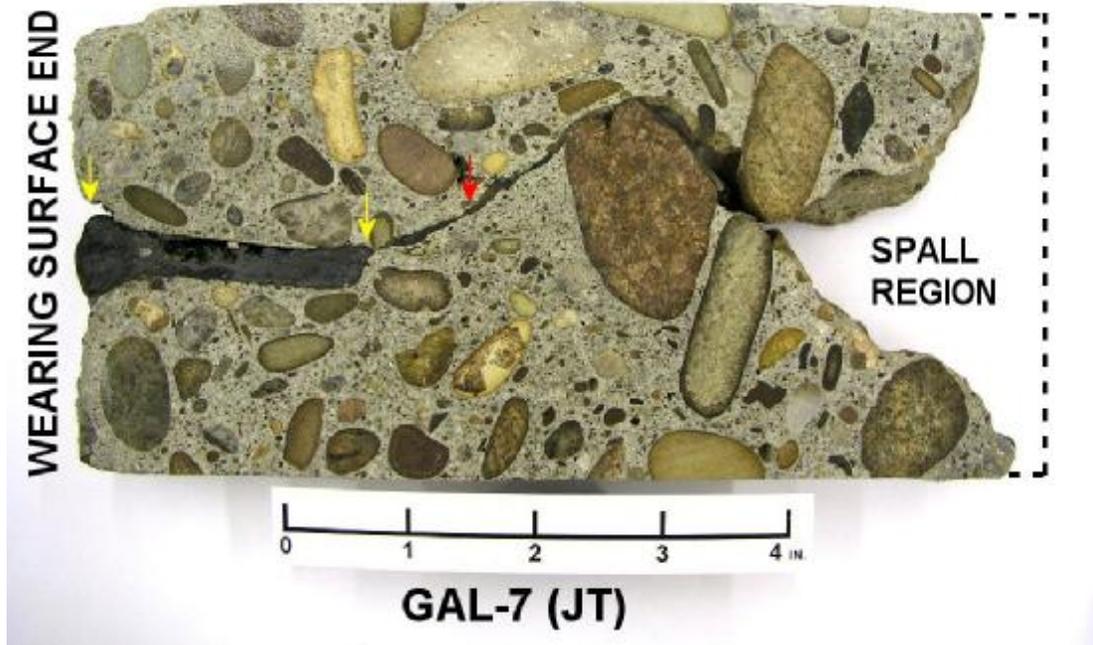
Figure 18. Lapped surface of Joint Core GAL-7 (JT).

The control joint spacing on this 1946 ODOT pavement project is 40 ft. The joints were formed (not saw-cut) and the smooth dowels used have a diameter of $\frac{3}{4}$ in. A photograph of a lapped surface of Joint Core GAL-7 (JT) is shown in Figure 18.

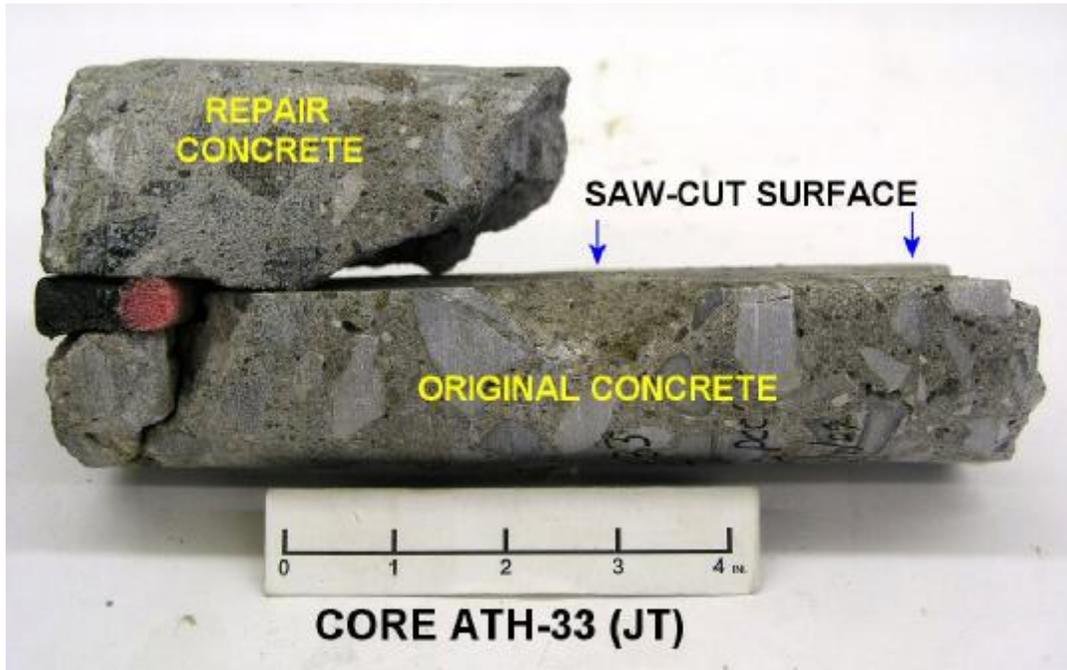
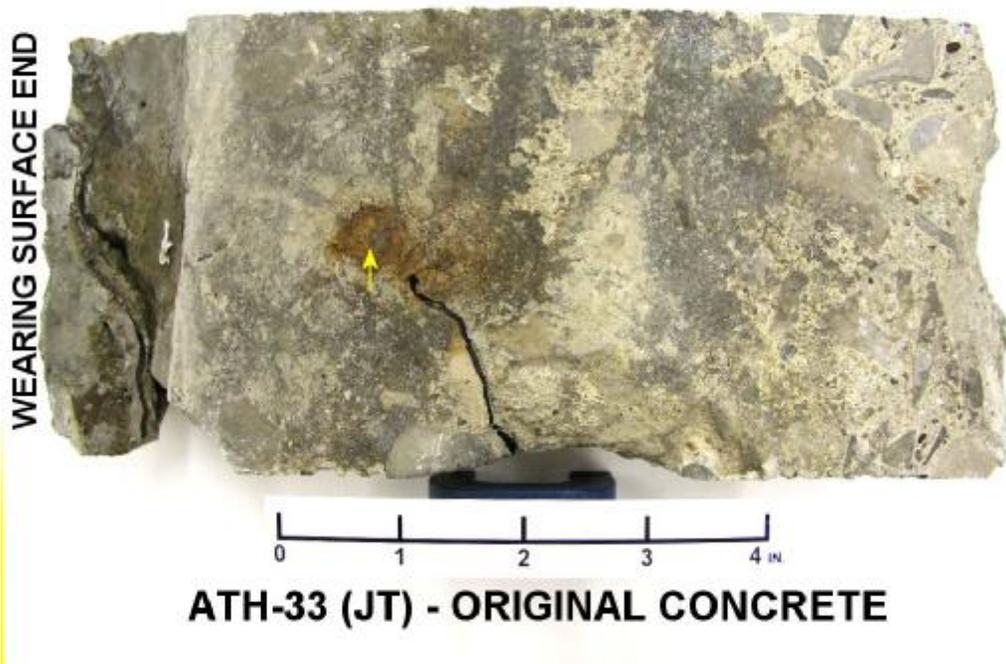
Figure 19. Two views of the control joint core taken from the pavement on Athens County US Route 33. The current joint is a replacement that was installed in 1999 in this 51 year old pavement (original construction 1958). The arrow in the bottom photograph points to a steel mesh layer, which shows light corrosion on the saw-cut surface of the original concrete. A crack originating at the mesh is highlighted with a black marking pen.

Virtually the entire original 9 in. (23 cm) thickness of the original concrete is still intact in the joint core. The bottom half of the repair concrete was received as rubble. There are heavy secondary deposits in the air voids in both the original and the repair concrete. The coarse aggregate in both of the concretes is a 1 in. maximum size limestone, but from two different sources. As shown in the top photograph of Figure 19 the fracture plane defining the bottom end surface of the intact piece of the repair concrete has a diagonal orientation relative to the plane of the wearing surface. This “cone” shape of the distressed material in the bottom of the pavement is characteristic of the D-cracking type of distress. Similar distress has not occurred in the original concrete, which strongly indicates that the cracking and spalling in the repair concrete is primarily due to high expansions of saturated coarse aggregate particles during freezing events. The fact that the original pavement concrete on one side of the joint is still fully intact strongly indicates that the coarse aggregate in the original concrete has good, freeze/thaw resistance. In fact the disintegration and slumping of the repair concrete may explain the presence of the diagonal crack (and incipient spall) in the top 1 inch or so of the original concrete (Figure 19) from a loss of support.

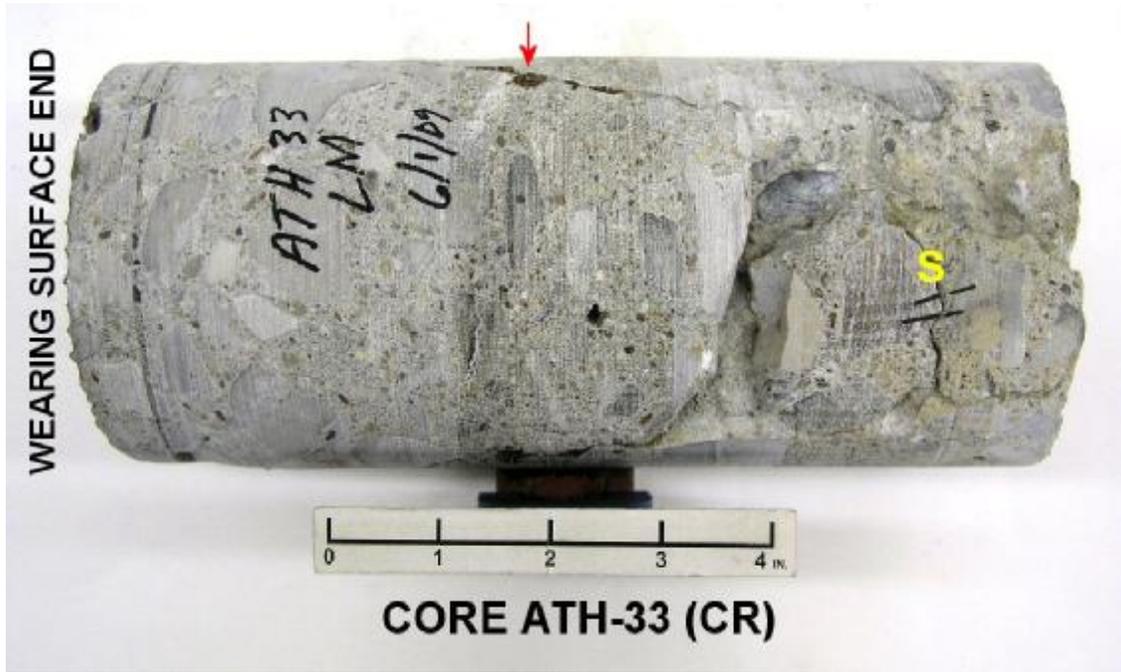
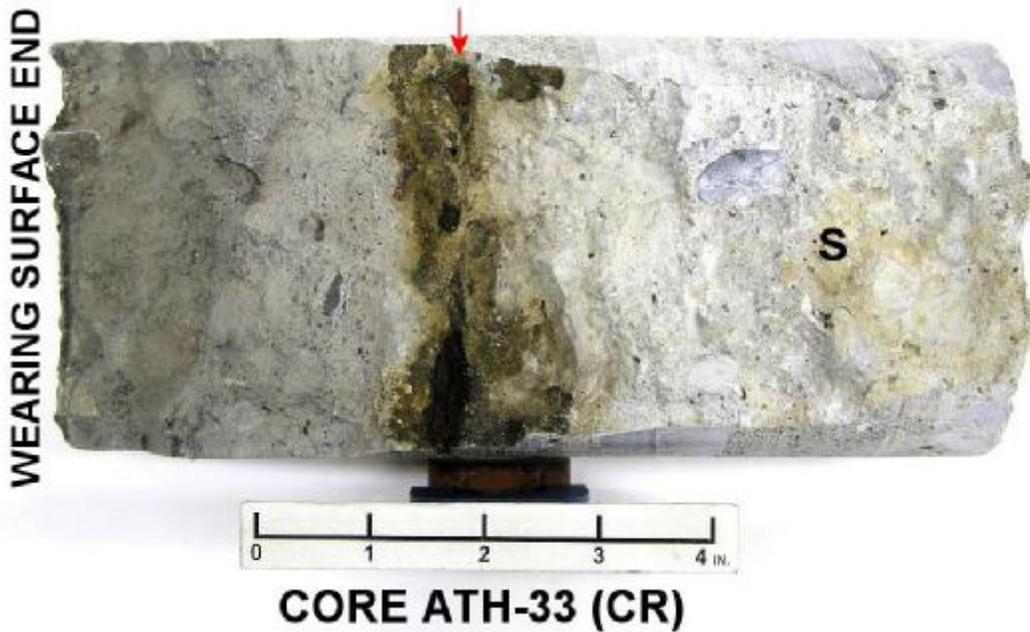
Figure 20. Two views of the mid-slab crack core taken from the pavement on Athens County US Route 33. The top photo is the core in its as-received condition. The arrow points to the steel mesh strand (corroded) that is contained in the crack plane. The cover over the mesh is 3 ¾ in. Spalled pieces of the core are shown in the area marked “S”.

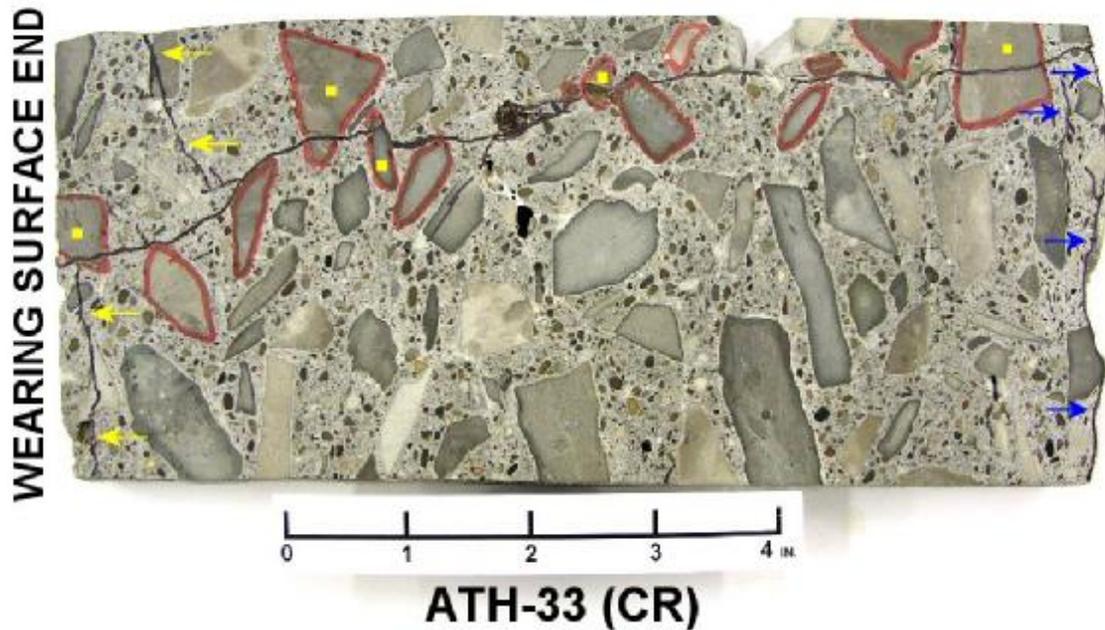
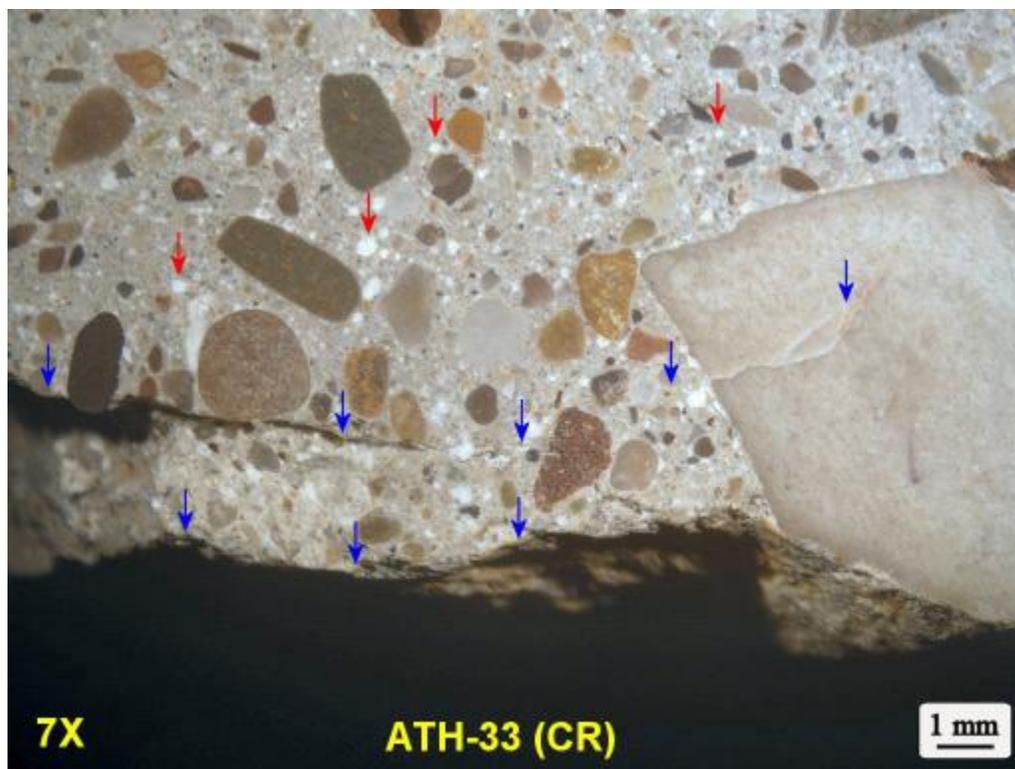
Figure 21. Two views of the mid-slab crack core taken from the pavement on Athens County US Route 33. The mid-slab crack passes through some of the coarse aggregate particles in its path (yellow dots). Horizontal cracks near the wearing surface terminate at the mid-slab crack (yellow arrows). The blue arrows point to cracks at and near the bottom end surface of the core. The red arrows point to a few of the numerous entrained air voids that are filled with white secondary deposits.

- Many of the entrained air voids are filled with white secondary deposits (primarily ettringite). This feature is most prevalent in concrete adjacent to the mid-slab crack, and in the concrete near the top and bottom end of the core. An example is shown in the bottom photograph of Figure 21.

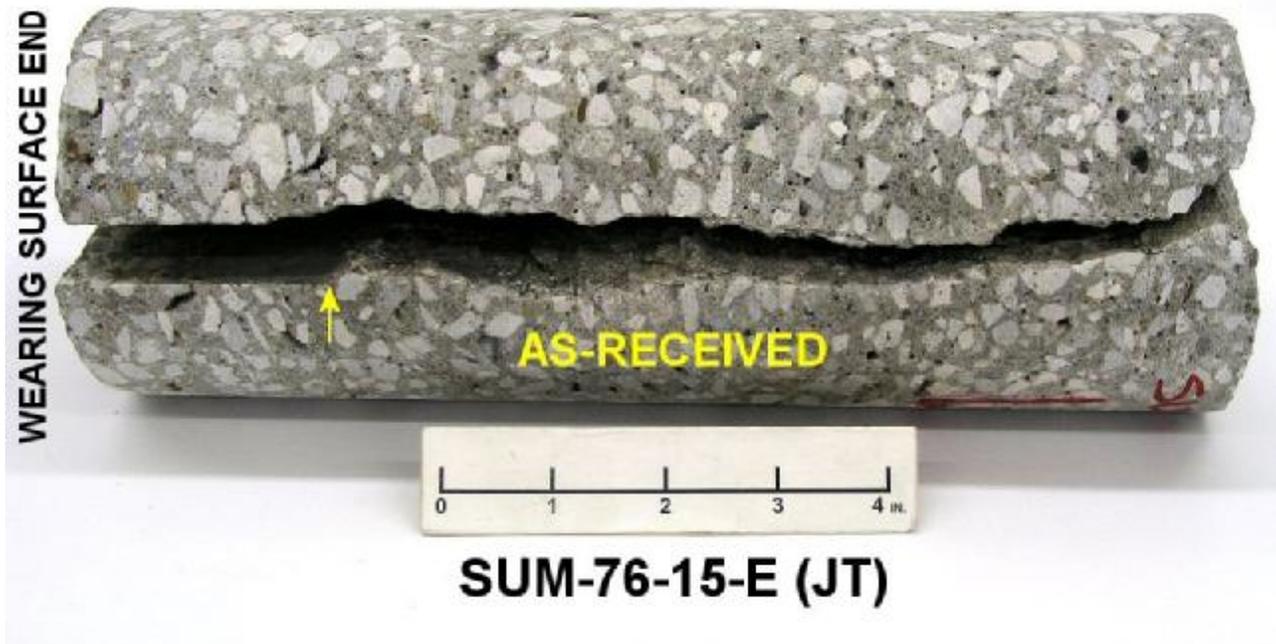
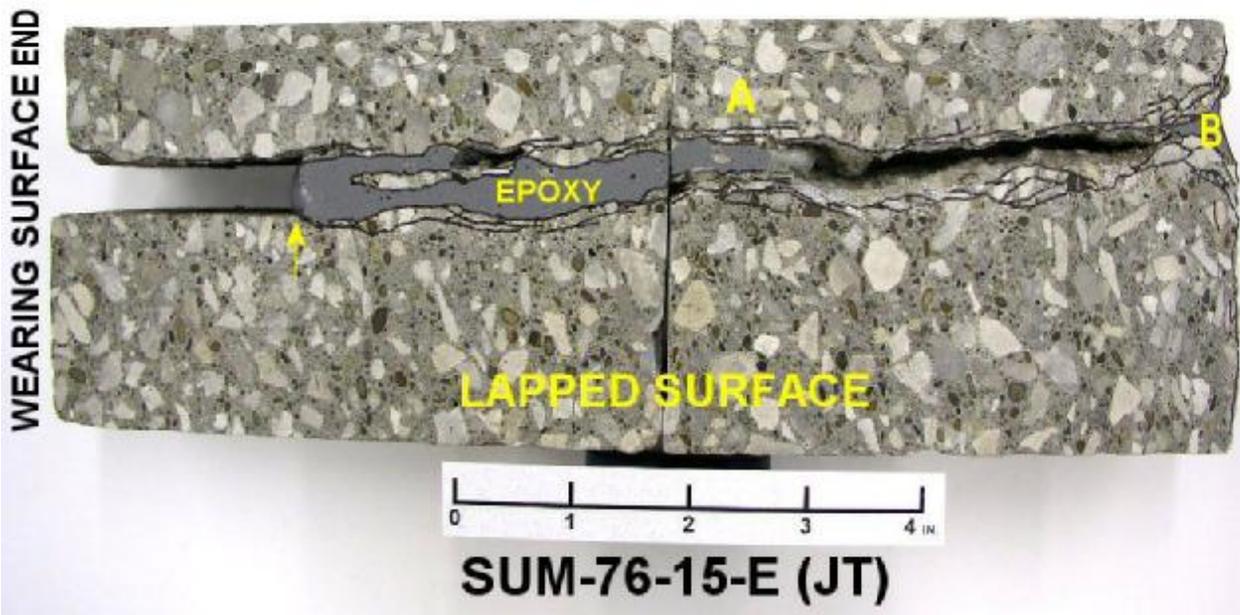
Figure 22. Two views of the core taken through a control joint on the Summit County Interstate 76 pavement project (Core SUM-76-15-E [JT]). The arrow points to the bottom of the joint saw-cut. The letters “A” and “B” identify sites of the enlarged views shown in Figure 23.

- The cracks are present throughout the length of the core below the saw-cut.
- Through most of the length of the core the crack planes are parallel to the original control joint fracture plane.
- Within the bottom 1 in. or so of the core the cracks bend abruptly to become parallel to the ground surface.
- The cracks typically pass through the coarse aggregate particles and some of the fine aggregate particles. Within a given aggregate particle there are often multiple cracks and the cracks fracture planes are parallel (see top photo in Figure 23).

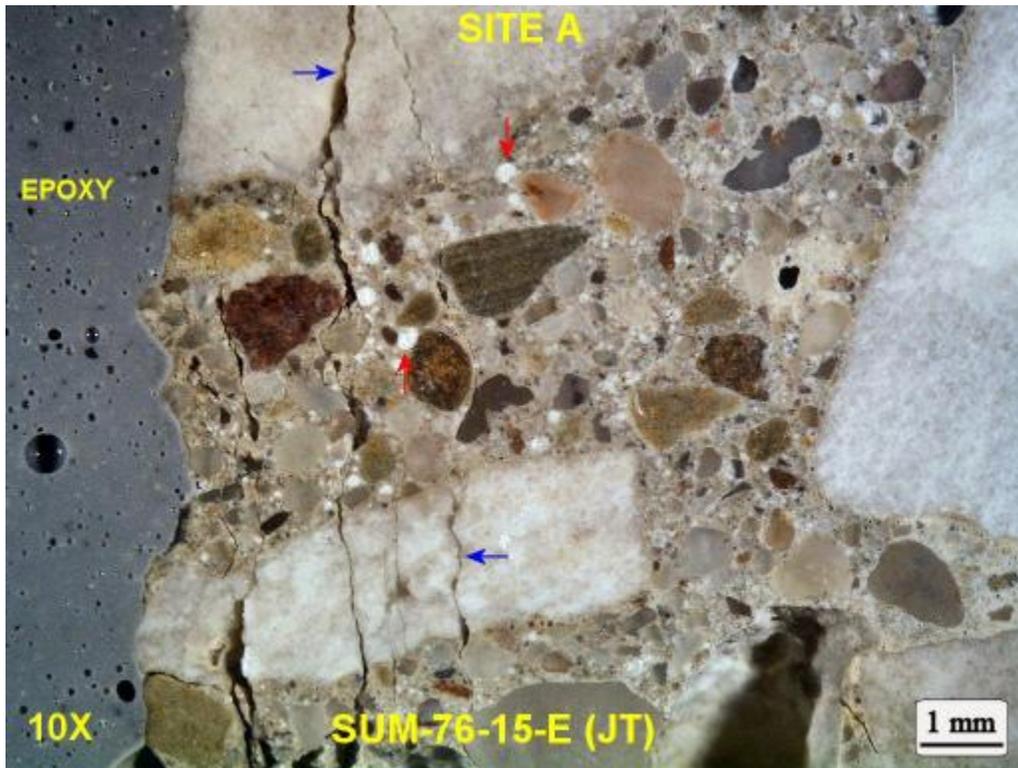
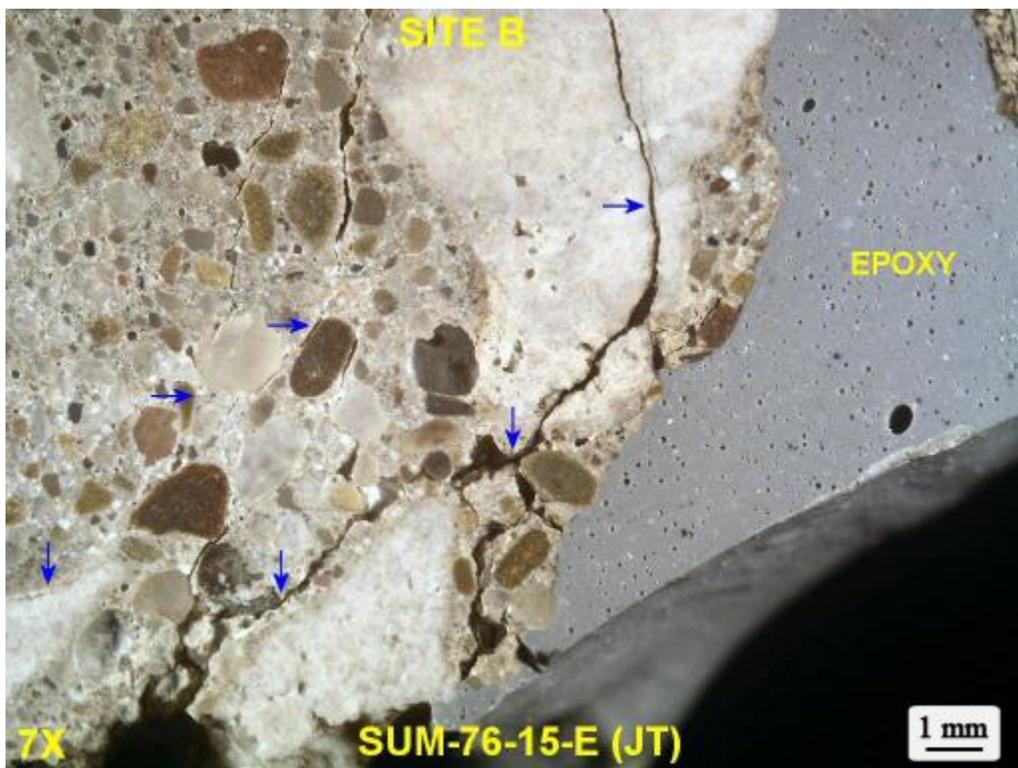
Figure 23. Two enlarged views (7X and 10X) of a lapped surface of Core SUM-76-15-E (JT) showing peripheral cracking (blue arrows) in the concrete adjacent to the joint crack fracture plane. The red arrows point to two of the numerous entrained air voids that are filled with white secondary deposits. Sites A and B are identified in Figure 11.
