Forensic Investigation of AC and PCC Pavements with Extended Service Life

Volume 2: Petrographic Examination of PCC Core Samples at Lankard Materials Laboratory

Report FHWA/OH-2010/004B

September 2010

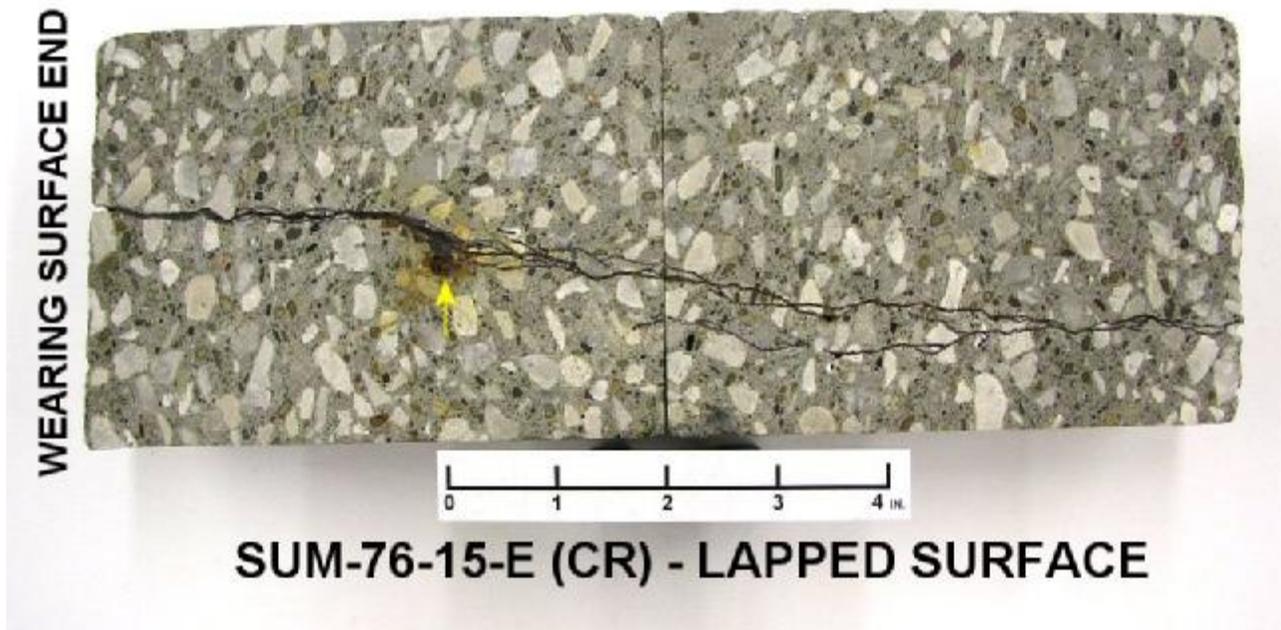
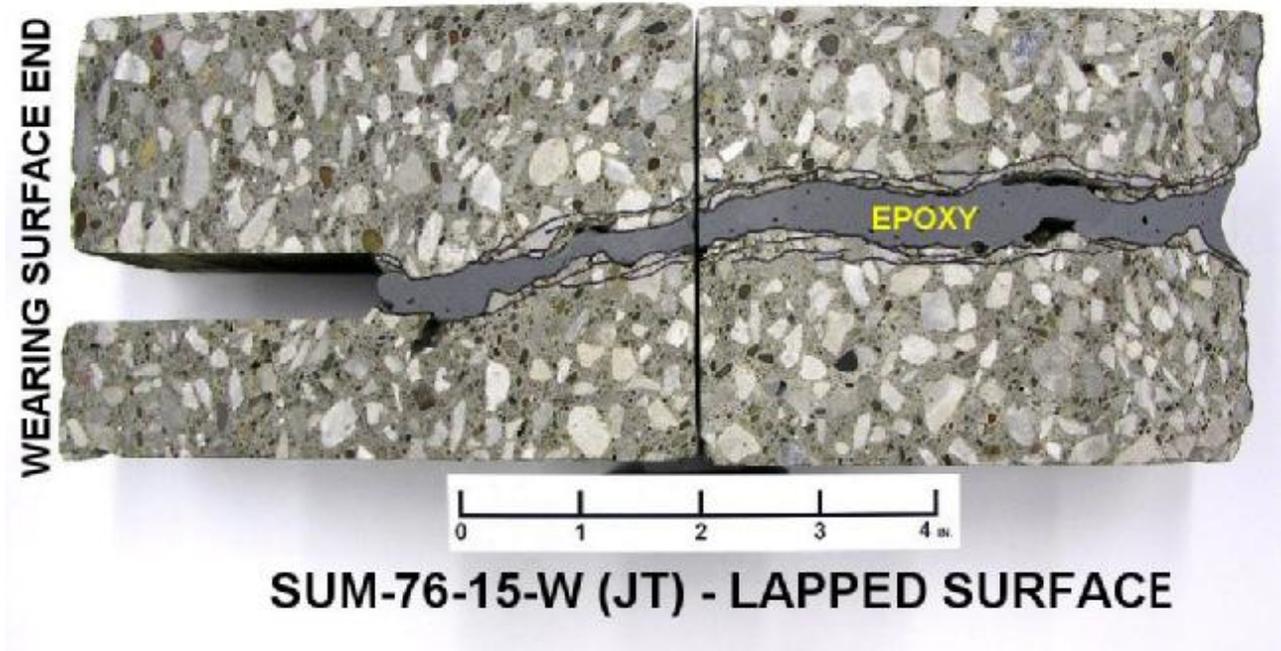
Figure 24. The top photograph is a lapped surface of the mid-slab crack core from the eastbound Summit County I-76 project [Core SUM-76-15-E (CR)]. Cracks in the core are marked with a black marking pen. The arrow points to a steel mesh strand which shows mild corrosion activity. The bottom photograph is a lapped surface of the joint core from the westbound Summit County I-76 project [Core SUM-76-15-W (JT)]. Cracks in the core are marked with a black marking pen.

A lapped surface of the control joint core taken in the westbound lane of I-76 in Summit County [SUM-76-15-W (JT)] is shown in the bottom photograph of Figure 24. The features and nature of the cracking and associated spalling of material in the westbound joint core are very similar to those observed and described previously in the eastbound joint core. The estimated material loss for the eastbound Summit County joint core is 5 percent, compared to a comparable 7 percent for the westbound joint core.

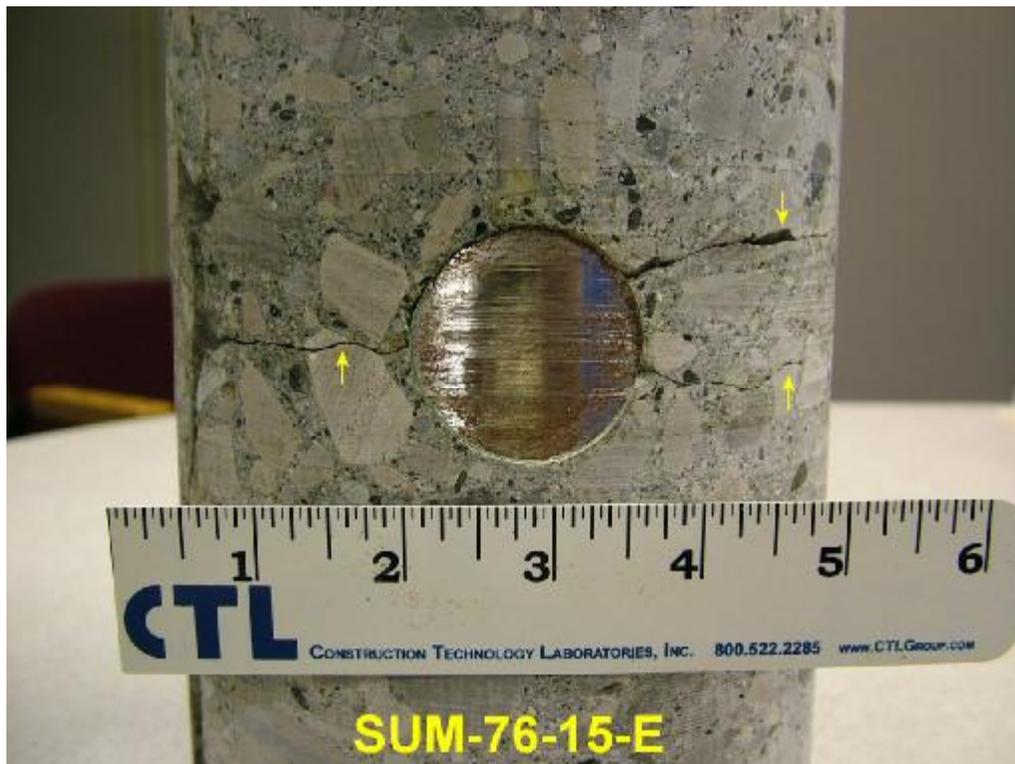
Figure 25. One of the cores taken from a control joint on the eastbound lanes of the Summit County I-76 project showing what is being referred to as “horizontal cracking” at the dowel level. This type of cracking is not present in the joint cores taken from the westbound I-76 lanes.

The primary factor leading to a lower pavement performance rating for the eastbound pavement project is the presence of mid-slab cracking. No mid-slab cracking is present in the westbound lanes. During the coring on this Summit County project it was observed that cracks were present at the level of the dowels in the control joint concrete in the eastbound pavement. The crack planes are parallel to the ground as shown in Figure 25. The cracks are being referred to here as “horizontal cracking”. These cracks are not present in the westbound joint cores.

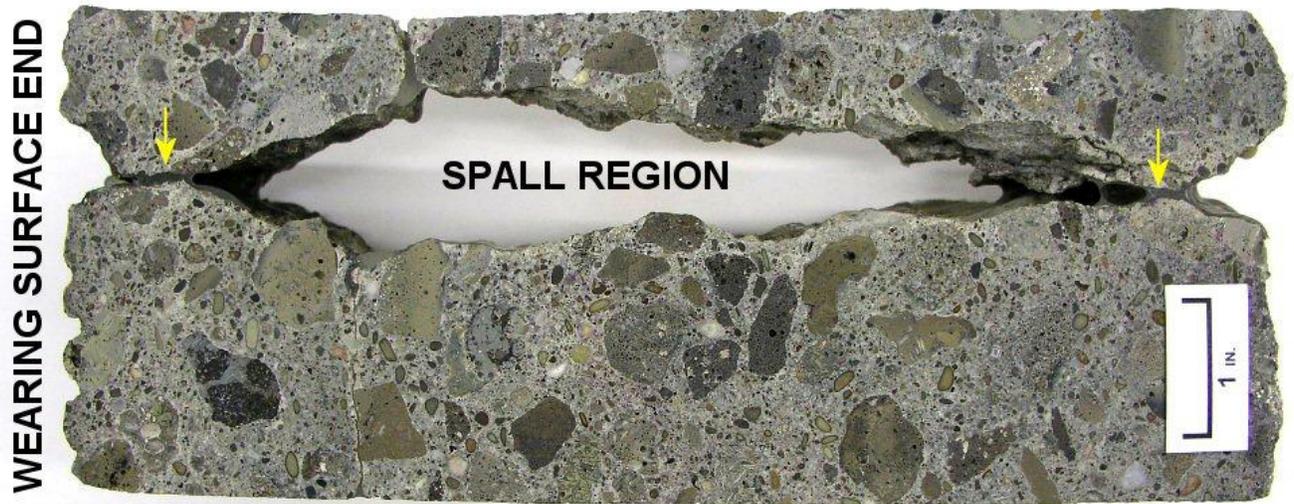
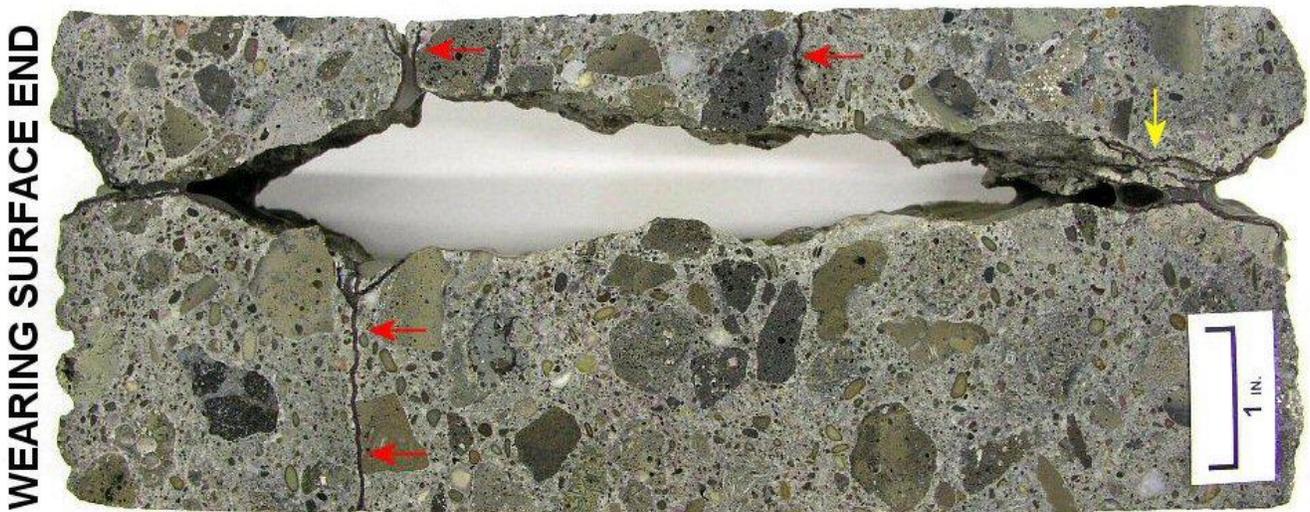
JEF-7 (CR)

The red arrows in the bottom photograph of Figure 27 point to horizontal fractures in the JEF-7 mid-slab crack core. The fracture planes of these cracks are parallel to the plane of the core wearing surface. These are single, sharp cracks which intersect the spall region at a right angle. It is conjectured that these cracks form as a result of repeated traffic impacts at the site of the mid-slab crack. The disintegration of the concrete lying along the mid-slab crack plane translates into a loss of support for the overlying portion of the pavement slab. It is as if there is a void there of the size shown in Figure 27. This condition means that the top portion of the pavement concrete is cantilevered due to the undercut of the spall zone. Eventually, under traffic loads, the concrete cracks as shown in the bottom photograph of Figure 27 (red arrows)

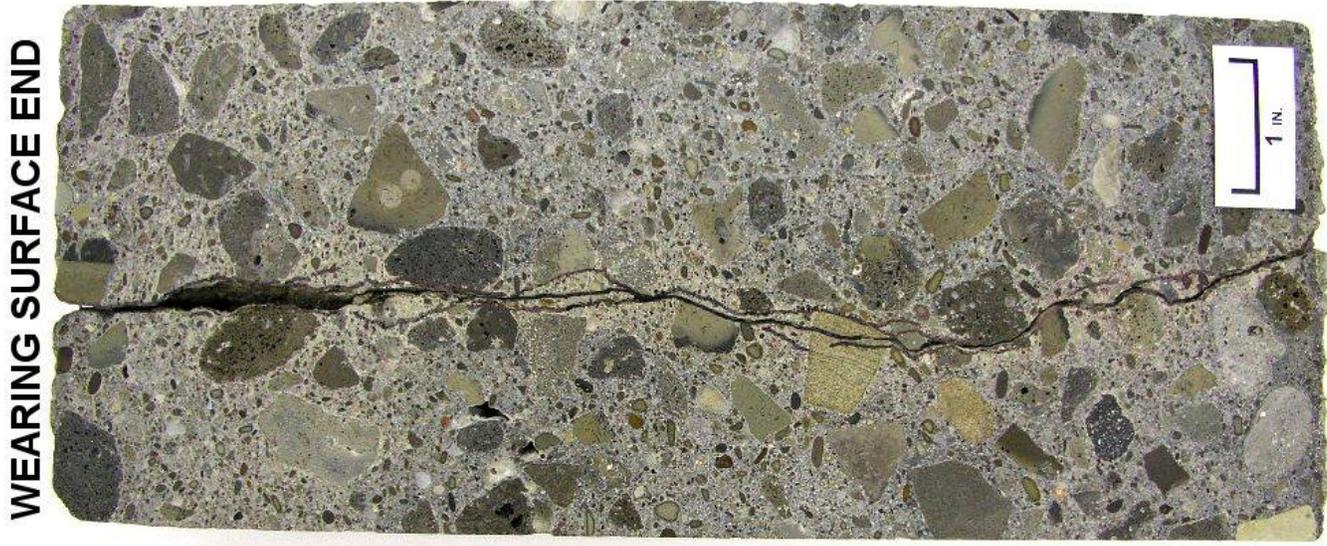
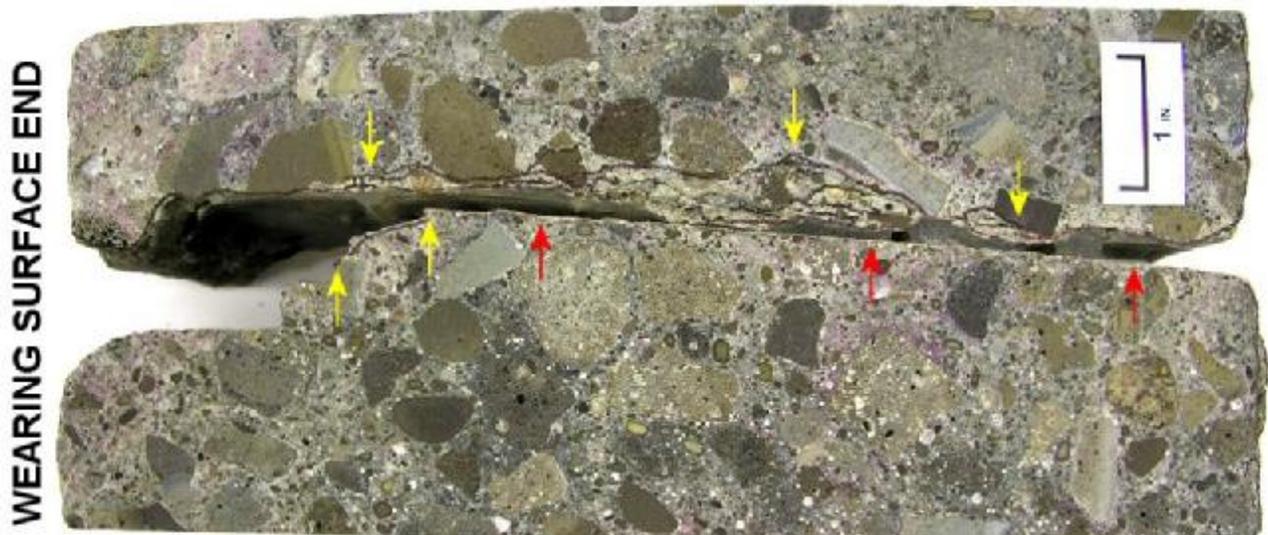
JEF-22 (JT)

One unusual aspect of the joint core from the Jefferson County US Route 22 joint core is that the joint is formed, rather than saw-cut. The feature is shown by the red arrows in the bottom photograph of Figure 28, and indicates that this is a construction joint, not a control joint. In referring to this photograph it is seen that the concrete on one side of the joint is cracked, while that on the other side of the joint is not cracked. The concrete on either side of the joint is from two different batches. Relative to the un-cracked concrete, the cracked concrete has a higher air void content and the overall size (diameter) of the voids is smaller. In both concretes the majority of air voids are either partially or fully in-filled with white secondary deposits (primarily fibrous ettringite). This infilling is more extensive in the cracked concrete than in the un-cracked concrete. The implications of this condition have not yet been worked out.

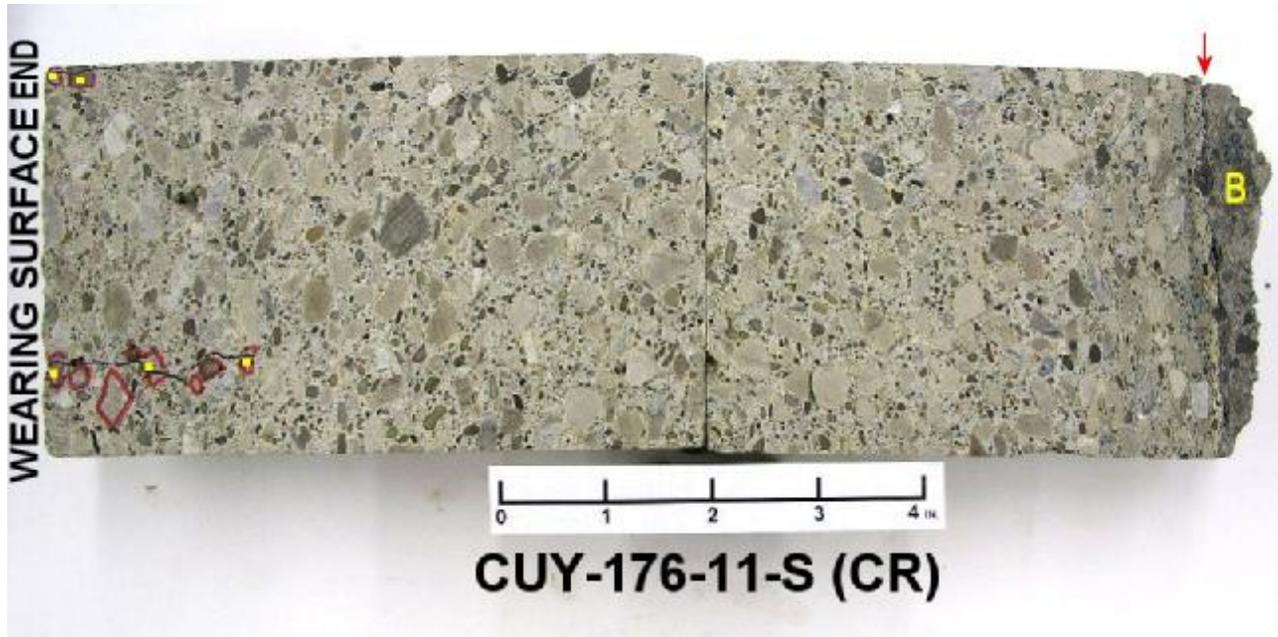
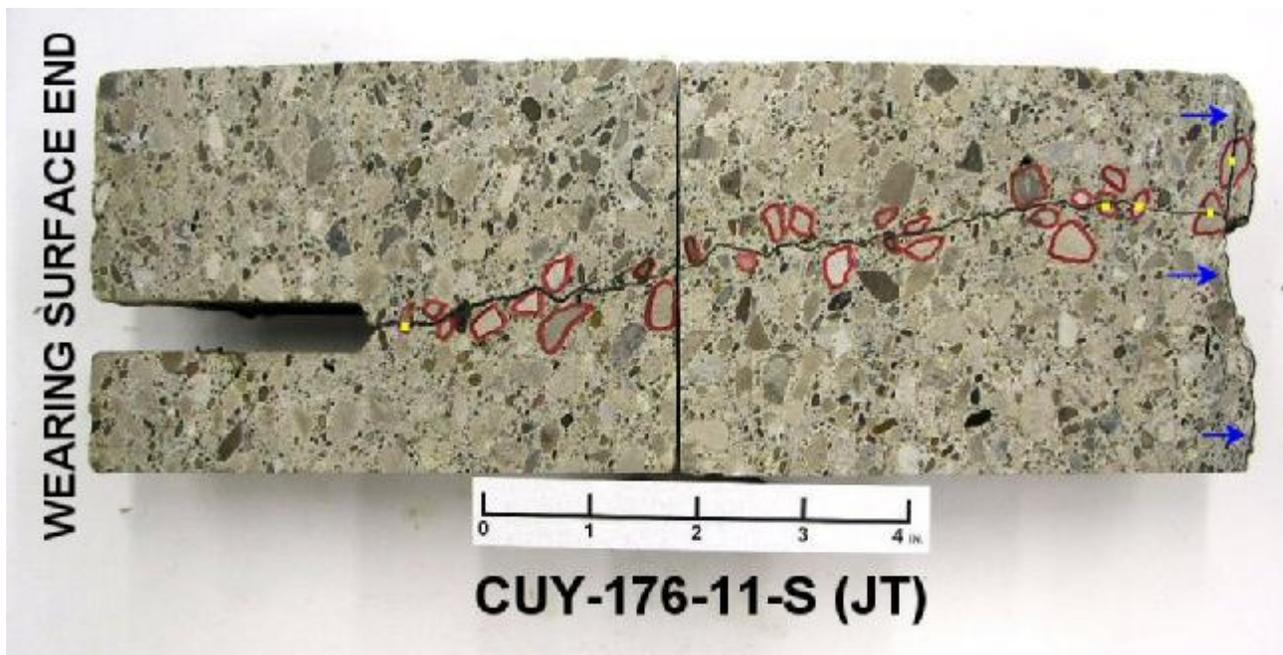
Figure 29. Lapped section view of Cuyahoga County State Route 176 cores taken from a slab mid-point (top photograph) and over a control joint at Mile Marker 11-South (bottom photo). Cracks in the cores are highlighted with a black marking pen. Coarse aggregate particles in the path of the cracks are outlined with a red pen. The yellow dots identify aggregate particles through which the crack passes. The blue arrows point to a fracture plane that forms the bottom surface of the joint core. The “B” label identifies slag base material adhered to the pavement concrete.

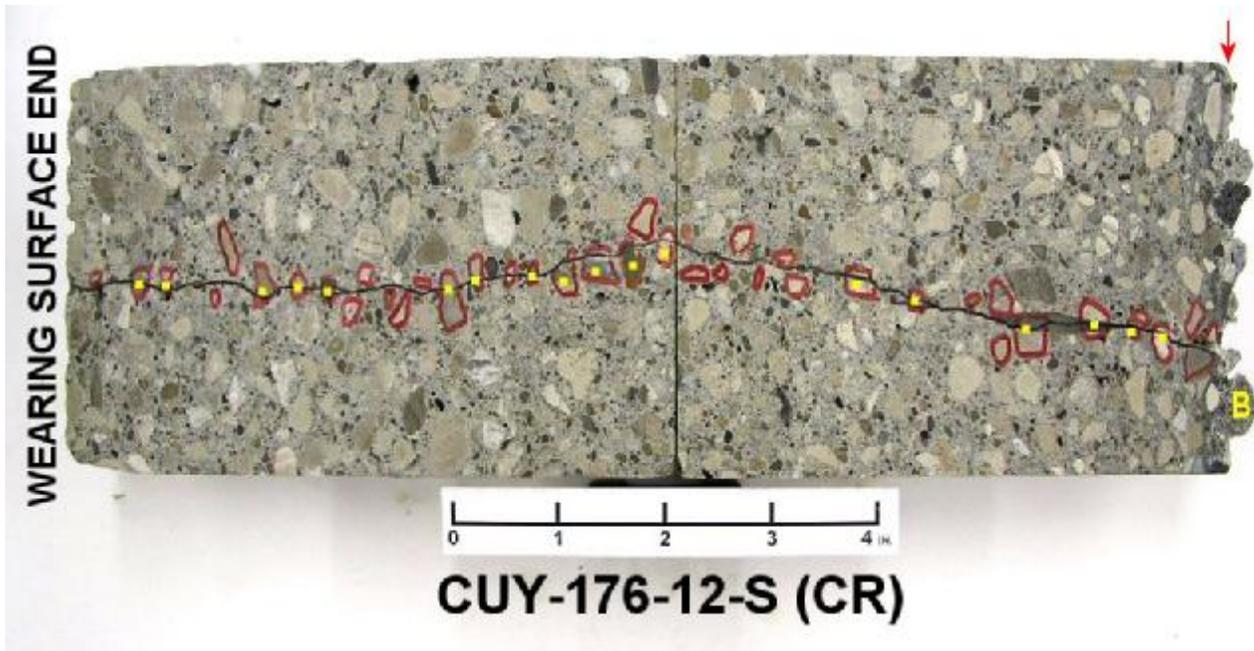
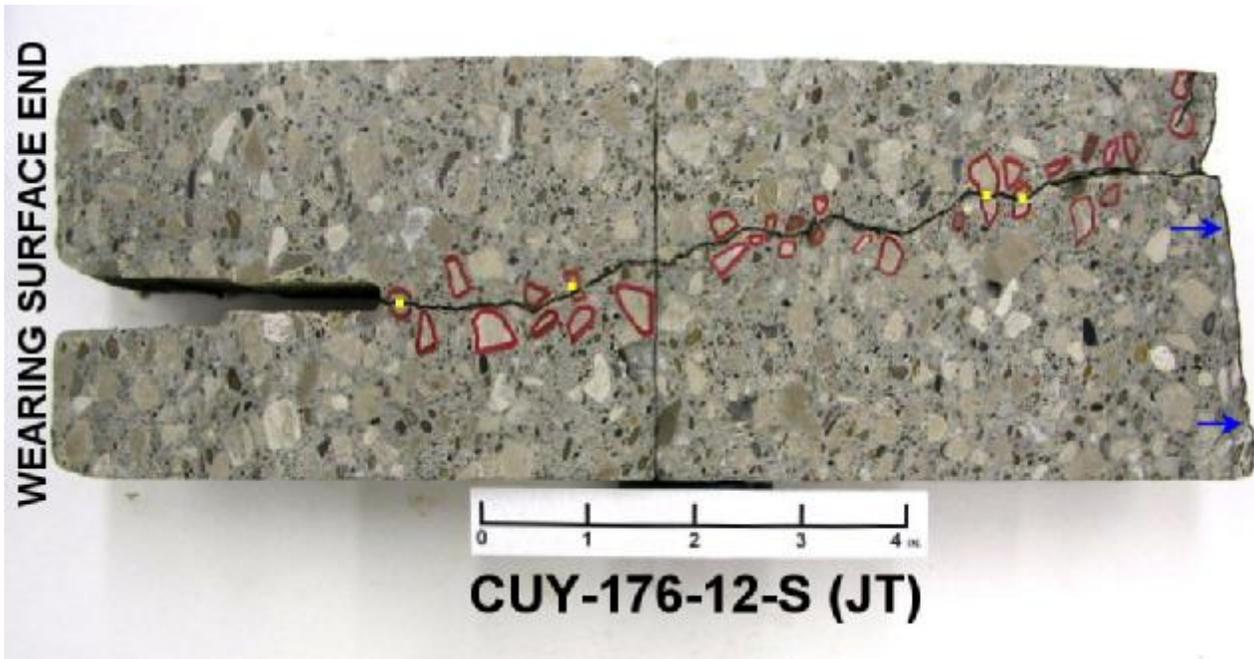
Figure 30. Lapped section view of Cuyahoga County State Route 176 cores taken over a mid-slab crack (top photograph) and over a control joint at Mile Marker 12-South (bottom photo). Cracks in the cores are highlighted with a black marking pen. Coarse aggregate particles in the path of the cracks are outlined with a red pen. The yellow dots identify aggregate particles through which the crack passes. The blue arrows point to a fracture plane forming the bottom end surface of the core. The “B” label identifies slag base material adhered to the pavement concrete.

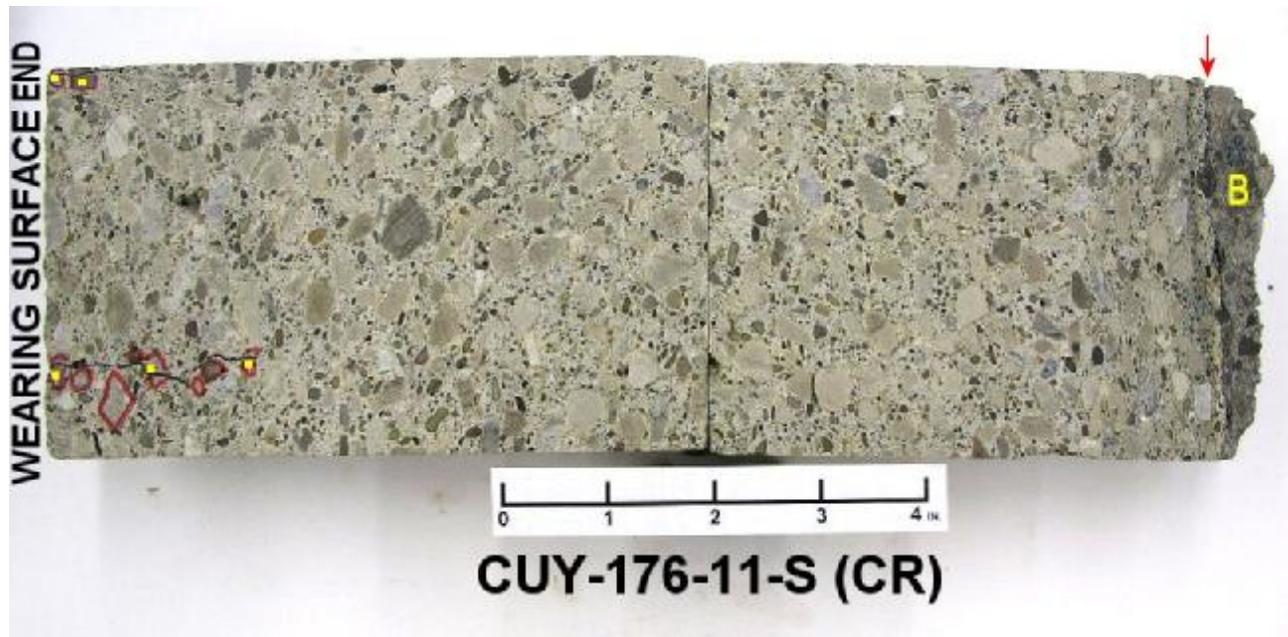
Figure 31. Lapped surface view of Core CUY-176-11-S, which was taken at the mid-point of a pavement slab on this project. This project did not show any full depth mid-slab cracking. There are two shallow vertical cracks in the top portion of the core, which have been highlighted with a black marking pen. The 310 T2 slag aggregate base material (B) is adhered to the pavement concrete.

As shown in Figure 31 the slag aggregate base has solidified and a thin layer of the solidified base is bonded to the pavement concrete. The solidification of the slag base is not unexpected as fine particles of the slag can react with water to provide cementitious hydrate binding phases similar to those in portland cement. In effect, the base becomes a weak substrate concrete that is bonded to the pavement concrete.
