Evaluation of Geofabric in Undercut on MSE Wall Stability

Prepared for the
Ohio Department of Transportation
Office of Research and Development

State Job Number 134396

April, 2011

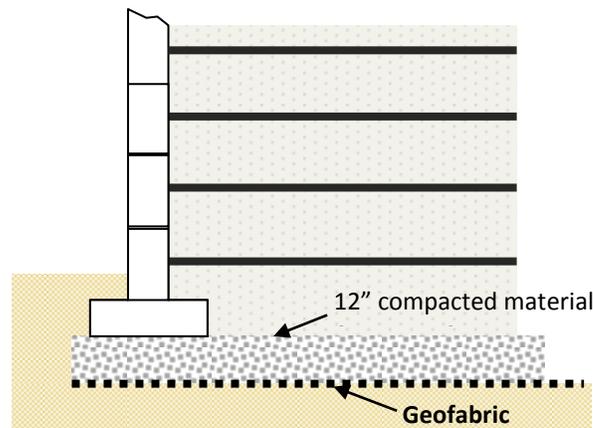
Figure 1: Placement of *Geofabric* at the MSE wall undercut.

Compaction of granular base materials at sites with fine grained native soils often causes unwanted material loss due to penetration. In 2007, ODOT began placing geofabrics in the undercut of MSE walls at the interface of the native soil and the aggregate fill (Figure 1) to facilitate construction. It is probable that the sliding resistances of the retaining walls are affected by this practice. At this time, it is unknown how the frictional resistances at the base of the MSE walls change by the addition of geofabrics at the soil/stone interface and, if the factor of safety (FS) against sliding failure is compromised. It is essential to verify the reliability of this practice because serious financial and safety consequences could result if these walls should fail.

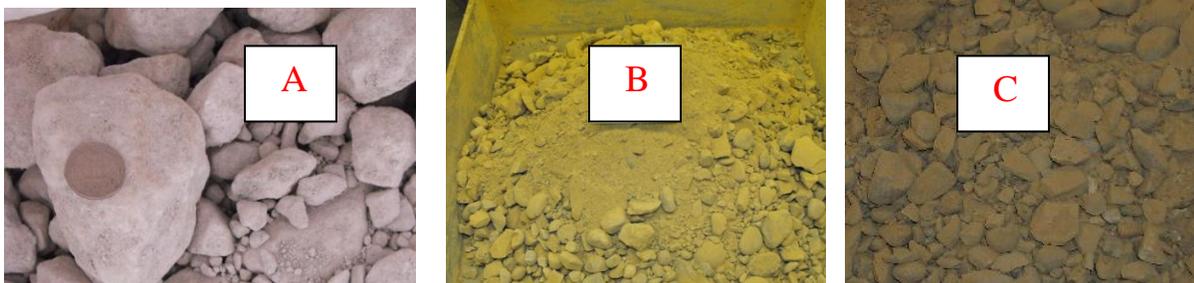
Figure 2: Granular material obtained from ODOT construction sites.

Since Type C granular material contains up to 3 inch aggregates, the large scale shear was chosen. However, with the 12 inch shear box, only the portion of the Type C material passing through a one inch sieve could be used to comply with the ASTM standards. Because of inadequate sample volume of aggregate A passing through 1 inch sieve, it was combined with aggregate B after all the tests related to it were completed, and named Stone AB.

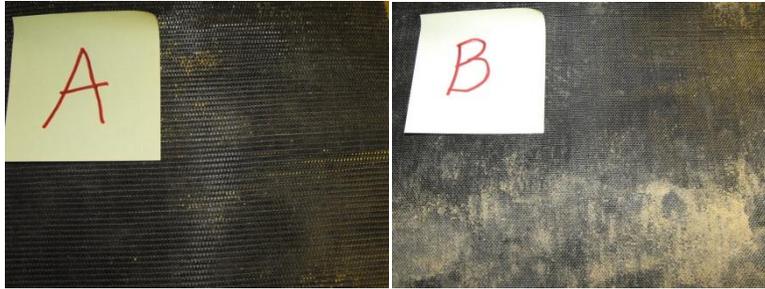
Figure 3: Textured Geofabrics A and B used in the research.

Two textured geofabrics, *Geofabric A* and *Geofabric B* were used in the study. *Geofabric A* was obtained from the Berea and Boston Heights, Ohio, sites. *Geofabric B* was obtained from Wilmington, Ohio, site. Specifications of these geofabrics are provided in Appendix B.

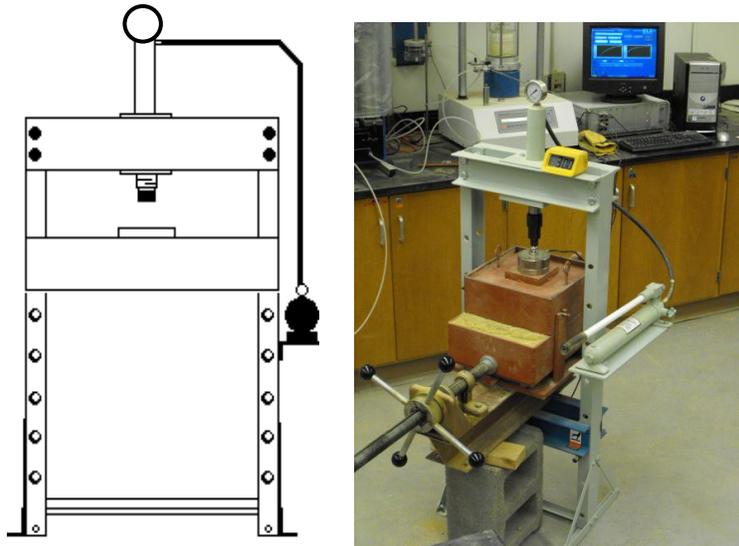
Figure 5: Hydraulic press frame. Figure 5A: Fully assembled photo of LSDS device.

A Large Scale Direct Shear Apparatus (LSDS) with 12 inch square shear box was designed according to ASTM D 5321-08 specifications (Figure 5A). The shear boxes were fabricated at the Cleveland State University machine shop with one inch thick steel plates and mounted on a *Dake Hand Hydraulic Press utility H-frame* with 16 ton capacity (Figure 5). The specifications of the hydraulic press are given in *Appendix A*. The hydraulic press allows a high vertical pressure on the sample during testing. The top shear box was stationary while the bottom shear box had a larger length (15") in the direction of the shear, and mounted on smooth sliding rails. Because of the larger dimension of the bottom shear box, the contact area during the shearing process remained constant and no area correction was required during shear stress calculations.

The lateral force was applied to the bottom box with a manual screw system. The strain rates were maintained between 0.1 to 0.04 inch/min. A digital displacement transducer was attached to this box for measuring the horizontal displacement and a S-type load cell was used to measure the sliding resistance developed at the top shear box. A disc type Loadstar load cell was used for measuring the vertical applied load on the top plate. The load and displacement data was continuously recorded by an *ELE data acquisition* system during the test.

The heights of top and bottom shear boxes were 5 and 4 inch respectively. A one inch thick rigid steel plate was used for applying normal pressure on the top surface of the sample placed in the top shear box.

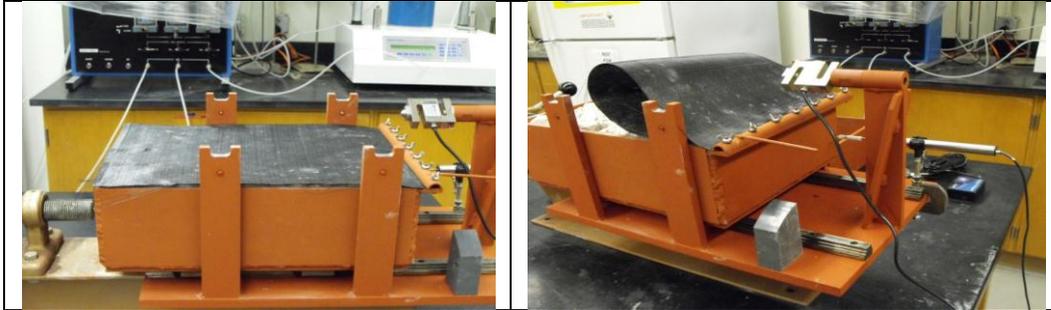
Figure 6: The geofabric assembly with seven wing-nuts to the bottom shear box.

During the direct shear tests, the geofabrics were oriented such that the shear force was applied across the grains. This was the prevailing ODOT practice of the geofabric placement at the MSE wall undercuts. For assembly in the shear box, the geofabrics were cut carefully to a measured size so that they extended over the edges of the bottom shear box, and securely clamped with seven wing-nuts to the bottom shear box (Figure 6).

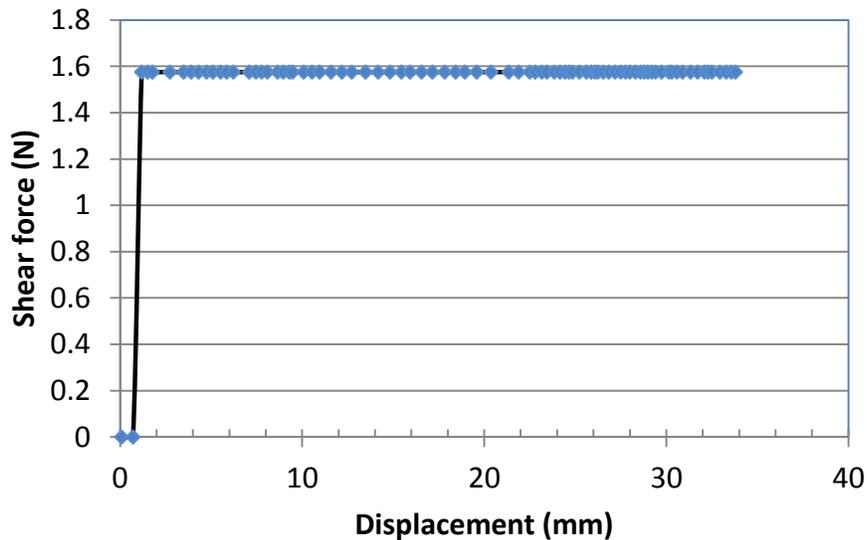
Figure 7: Calibration curve of Large Scale Shear Apparatus for internal frictional resistance.

To determine the system friction, the box assembly was sheared empty with geofabric assembled between the two shear boxes, but without any normal force. Under such conditions, minimal resistance was observed between the shear boxes during the calibration test (Figure 7) and was neglected during shear stress calculations.

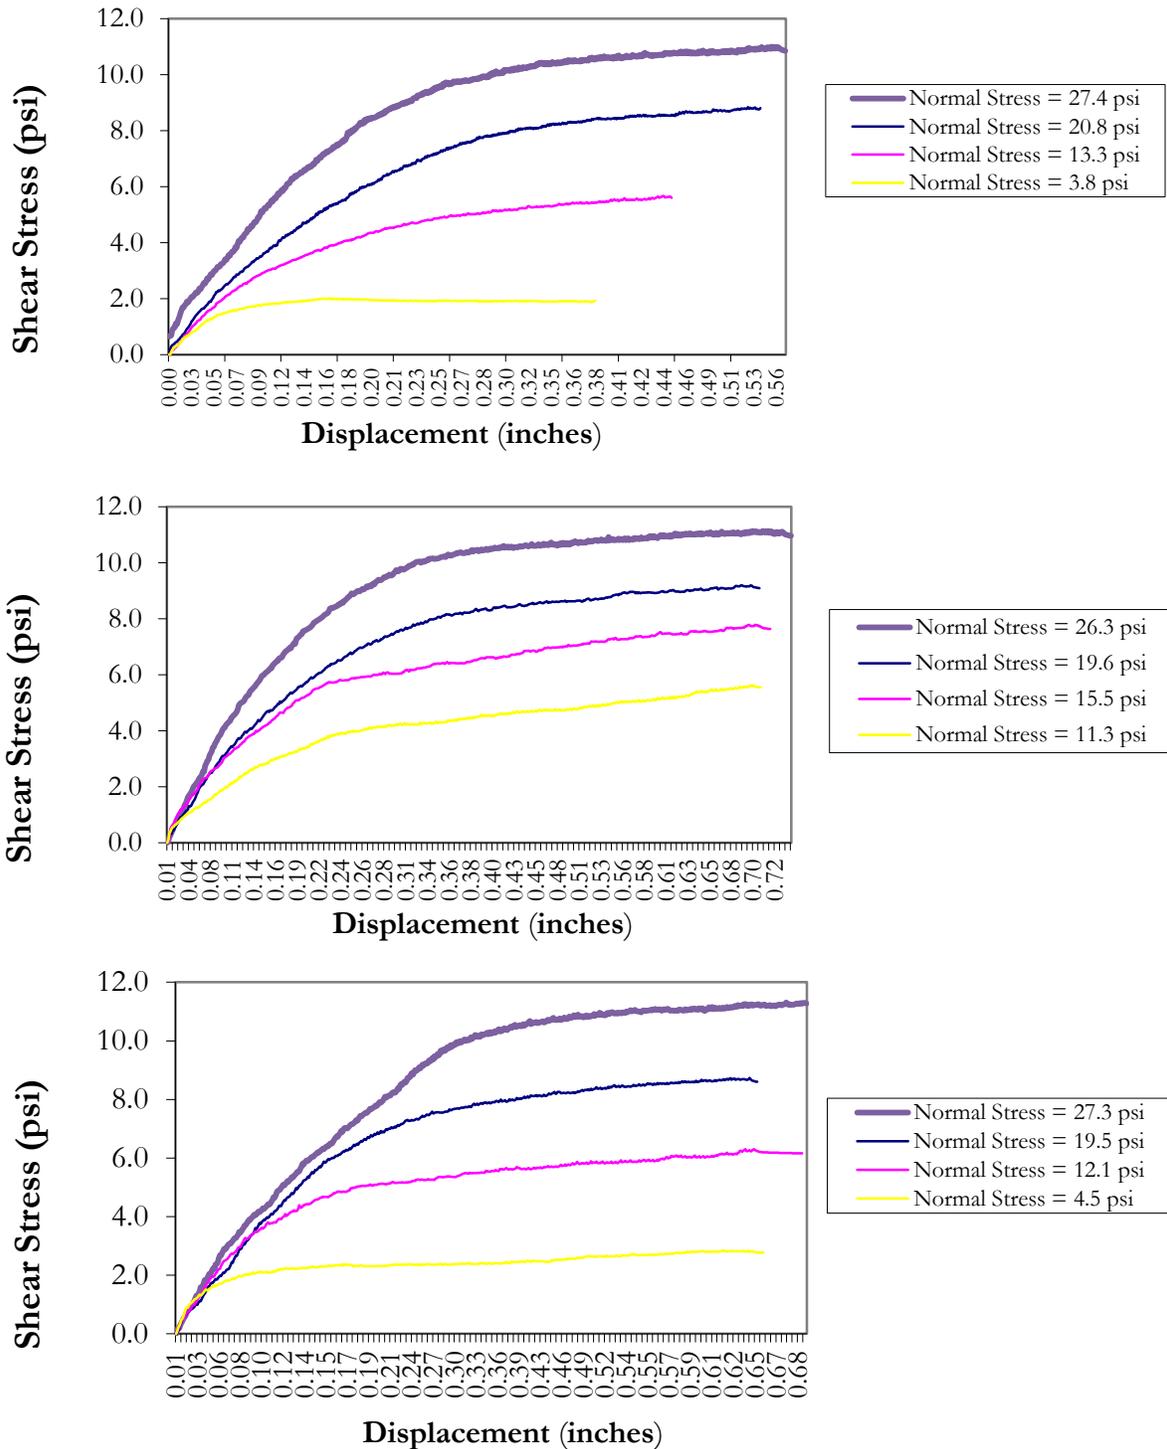
Figure 8: Shear stress vs. displacement for Soil A at bottom, Stone B on top and Geofabric A at interface for TRIALS-1, 2 and 3 respectively.

The shear stress vs. displacement graphs of *Geofabric A/ Stone B* interface are shown in Figure 8. It is noted that the shear stress did not peak to indicate failure. This is consistent with

behavior of the geofabric interface shear tests reported in literature. The peak shear stress was considered as the failure stress in each case.

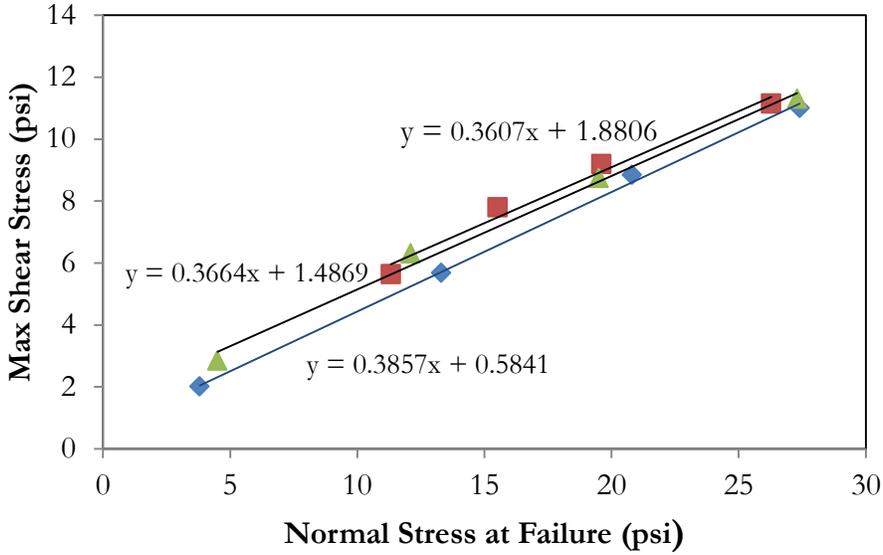
Figure 9 A: Maximum shear stress vs. normal stress for *Geofabric A/ Stone B* interface.

The plots of maximum shear stress vs. normal stress for the *Geofabric A/Stone B* interface are shown in Figures 9-A. A linear best fit trend line was drawn with *excel spreadsheet* for each case, where y represented shear stress and x represented normal stress. Using the best fit line, the slope angle was calculated as the interface friction angle. A summary of the results are given in Table 3.

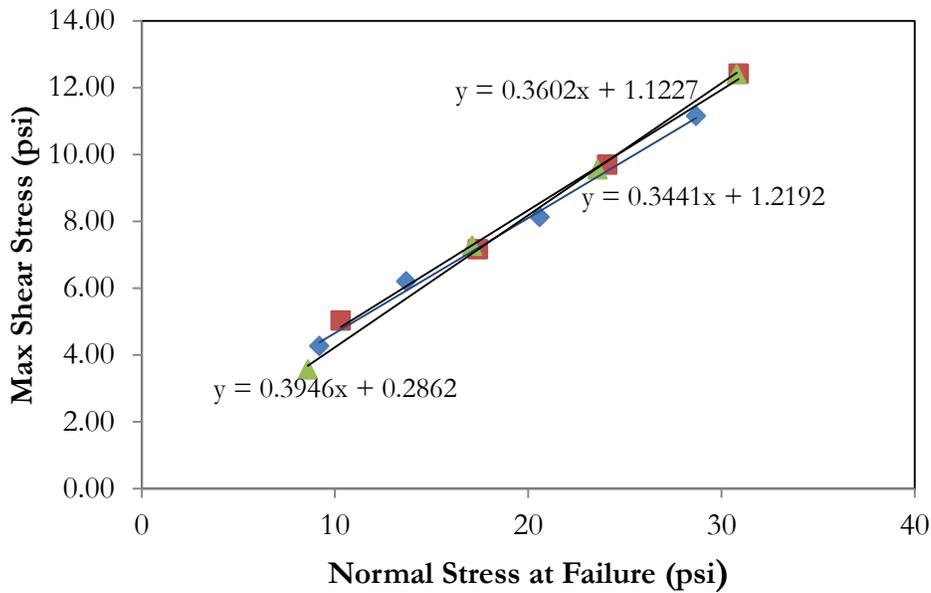
Figure 9 B: Maximum shear stress vs. normal stress for *Geofabric A/ stone C* interface.

Similarly, the shear parameters were determined for *Geofabric A/ Stone C* (Figure 9B), *Geofabric A/ Stone AB* (Figure 9C) interfaces.

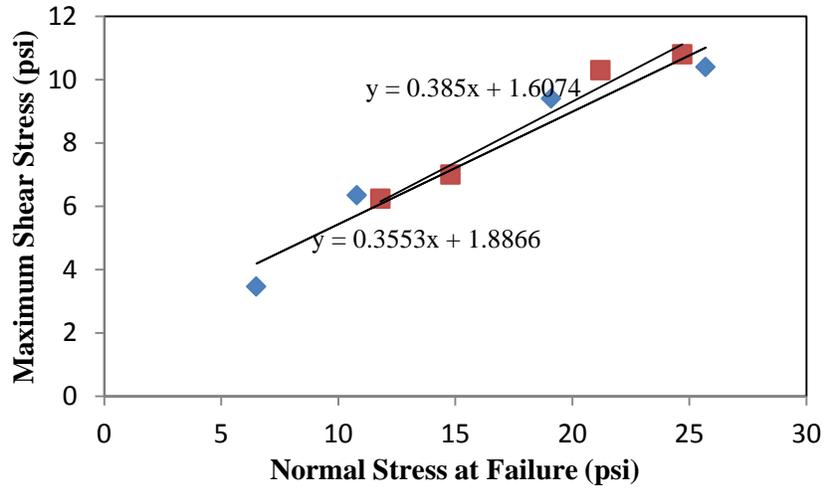
Figure 9 C: Maximum shear stress vs. normal stress for *Geofabric A/ Stone AB* interface.

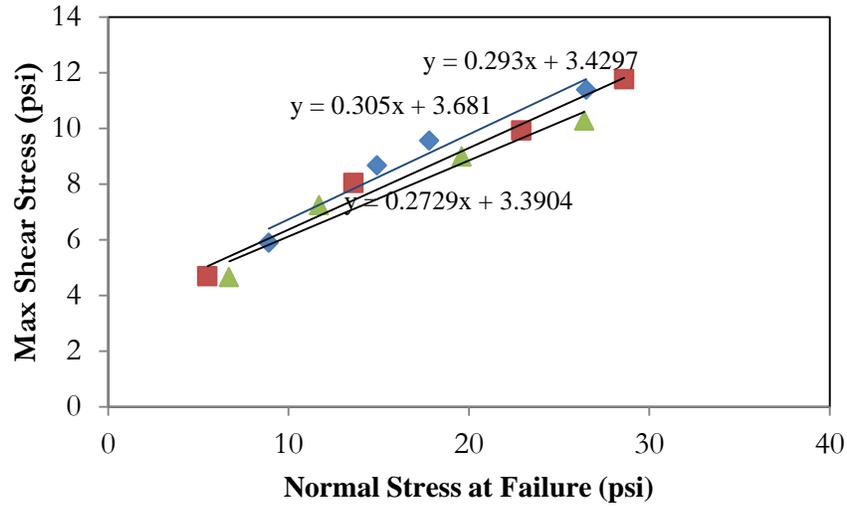
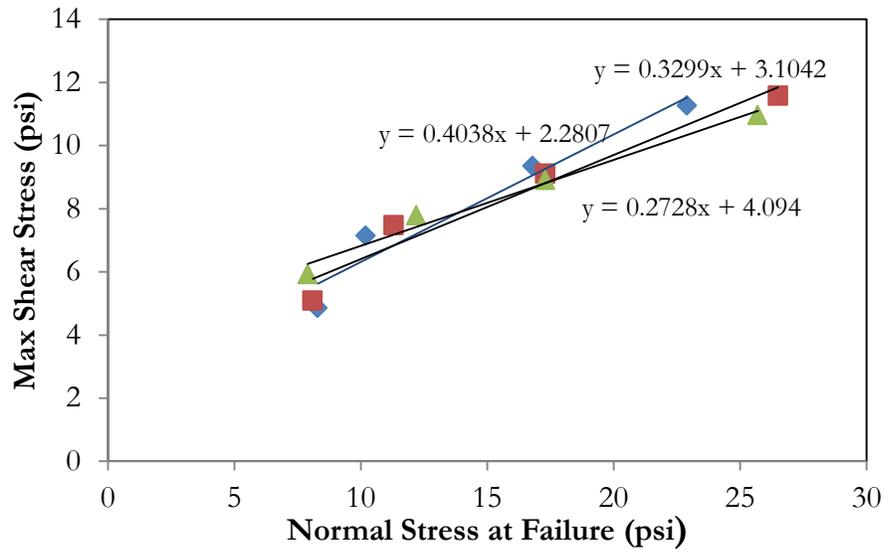
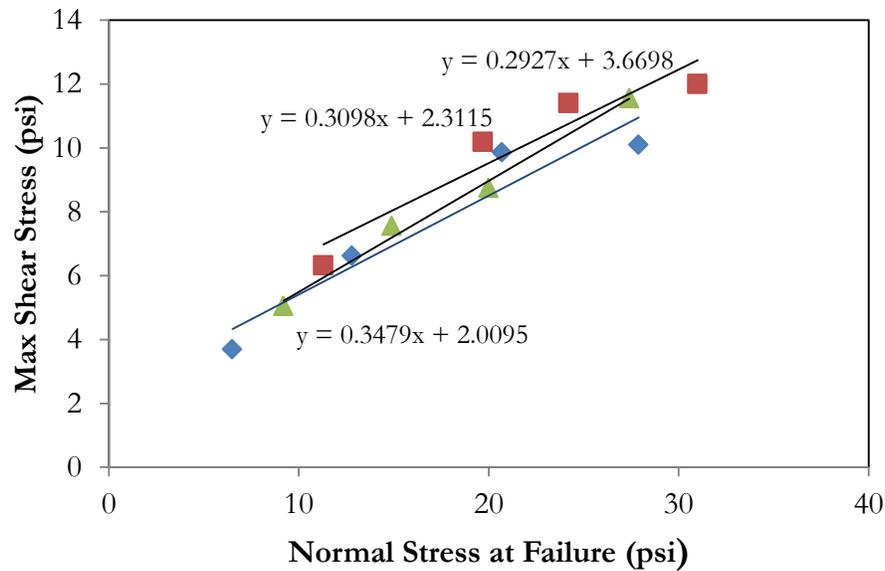
Figure 10 A. Maximum shear stress vs. normal stress for *Soil A / Stone B* interface.

Figure 10 B: Maximum shear stress vs. normal stress for *Soil A / Stone C* interface.

Figure 10 C: Maximum shear stress vs. normal stress for *Soil A / Stone AB* interface.

The LSDS test results of Soil A interface with Stones B, C and AB are shown in Figures 10 A,B and C. The summary of these results are given Tables 4 and 5.

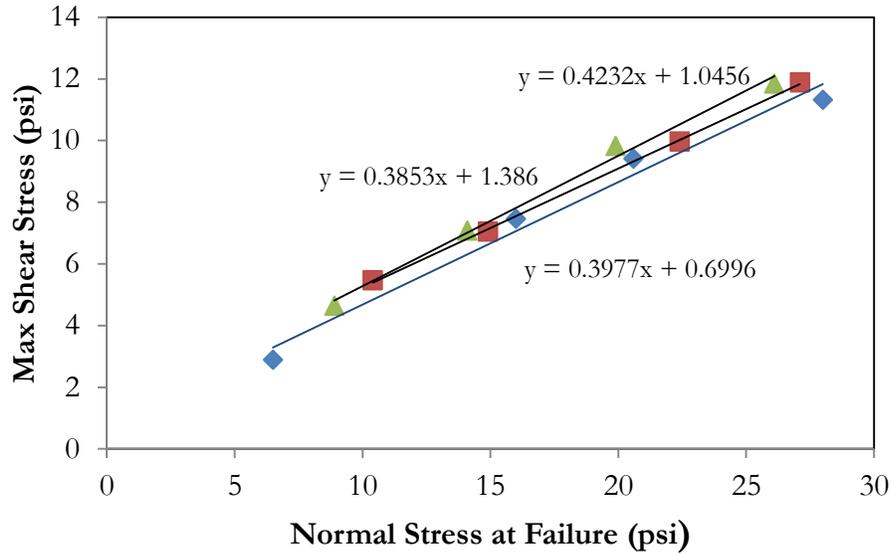
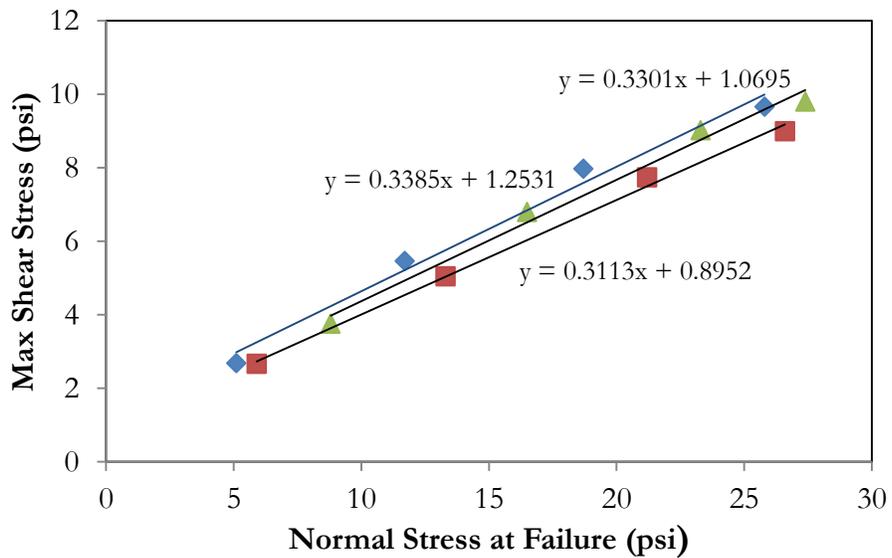
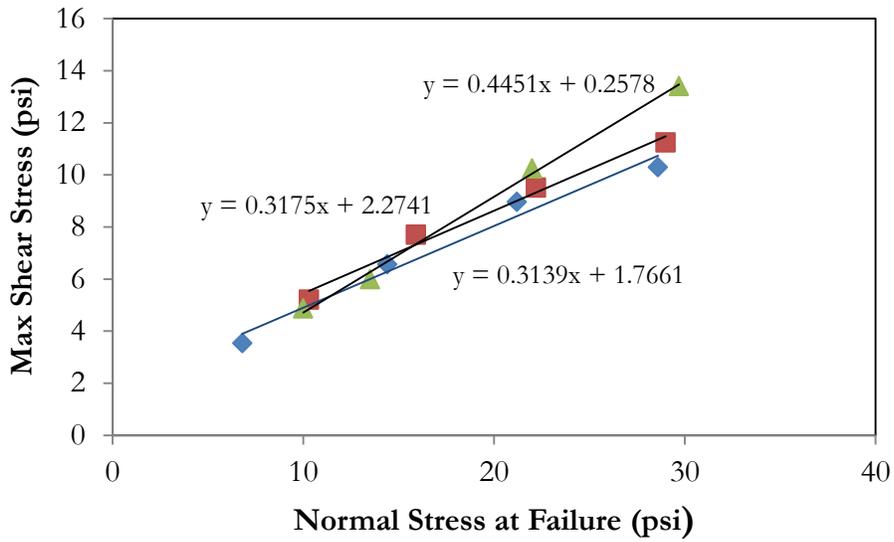
Figure 11 A: Maximum shear stress vs. normal stress for *Geofabric B / Stone B* interface.

Figure 11 B: Maximum shear stress vs. normal stress for *Geofabric B / Stone C* interface.

Figure 11 C: Maximum shear stress vs. normal stress for *Geofabric B / Stone AB* interface.

The LSDS tests were repeated to determine the shear parameters between *Geofabric B* and Stones B, C and AB. The results of these tests are shown the Figures 11 A, B and C, and summaries provided for comparison in Tables 6,7 and 8.

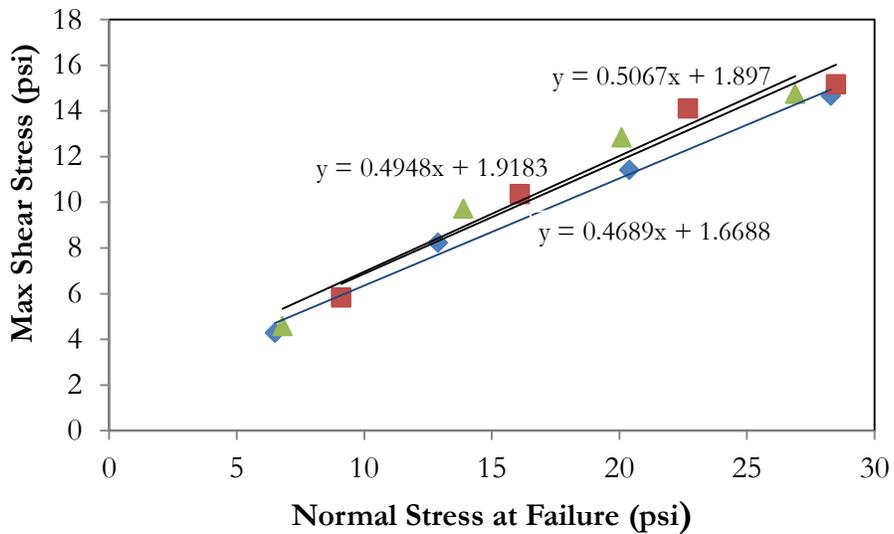
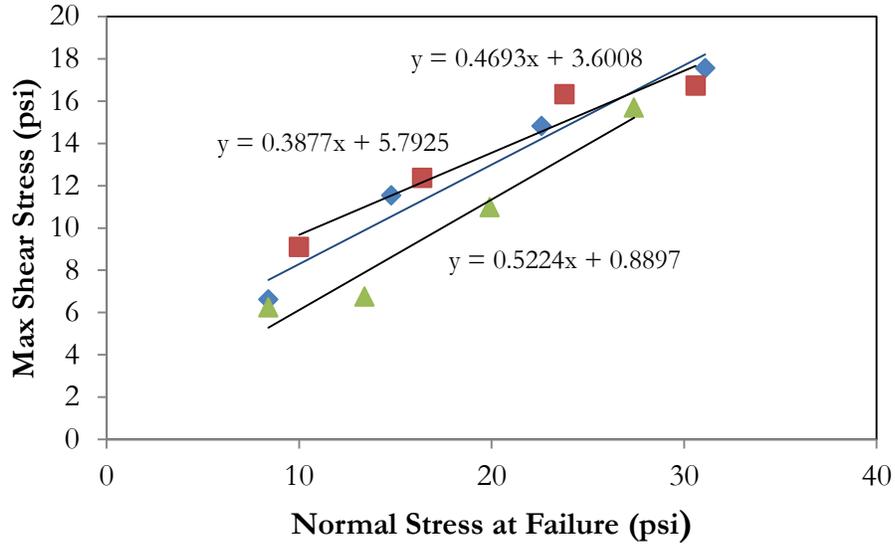
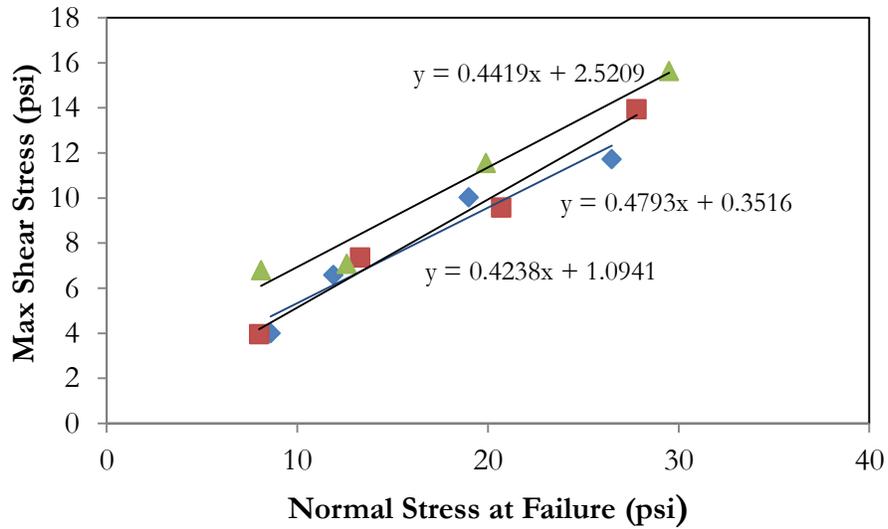
Figure 12 A: Maximum shear stress vs. normal stress for Soil B / Stone B interface.

Figure 12 B: Maximum shear stress vs. normal stress for Soil B / Stone C interface.

Figure 12 C: Maximum shear stress vs. normal stress for Soil B / Stone AB interface.

The tests results for Soil B compacted in the bottom and interchanging Stones B, C and AB in the top shear box are shown in Figures 12 A, B and C. These tests were conducted without any geofabric at the interface. The results of these tests are summarized in Tables 9-14. For comparison purposes the results of geofabric/stone interfaces are also shown in the tables.

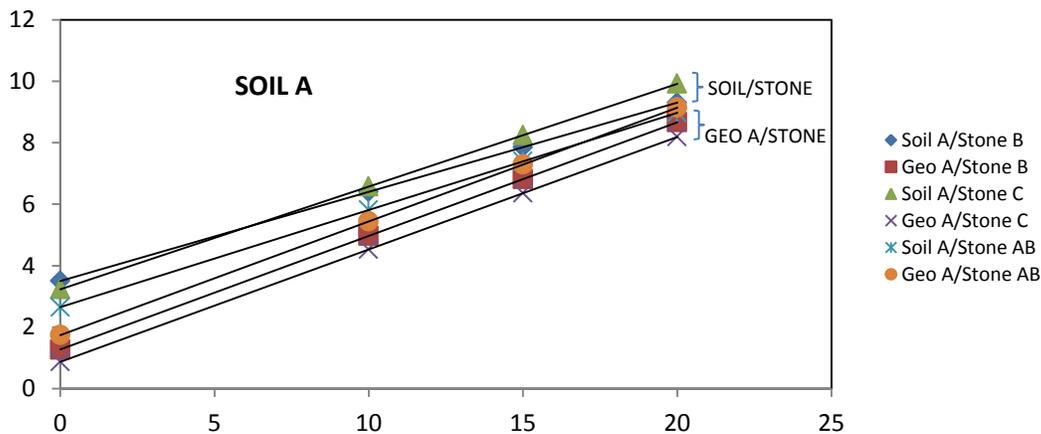
Figure 13: Comparison of maximum shear stress of Soil A interface with stone and *Geofabric A*.

For comparison purpose, the failure envelopes of *Soil A/stone* and *Geofabric A/stone* interfaces are shown in Figure 13. It is observed that the failure envelopes for the *Geofabric A/stone* interfaces were lower than the *Soil A/stone* interfaces indicating that the *Geofabric A* had slightly diminished the shear resistance.

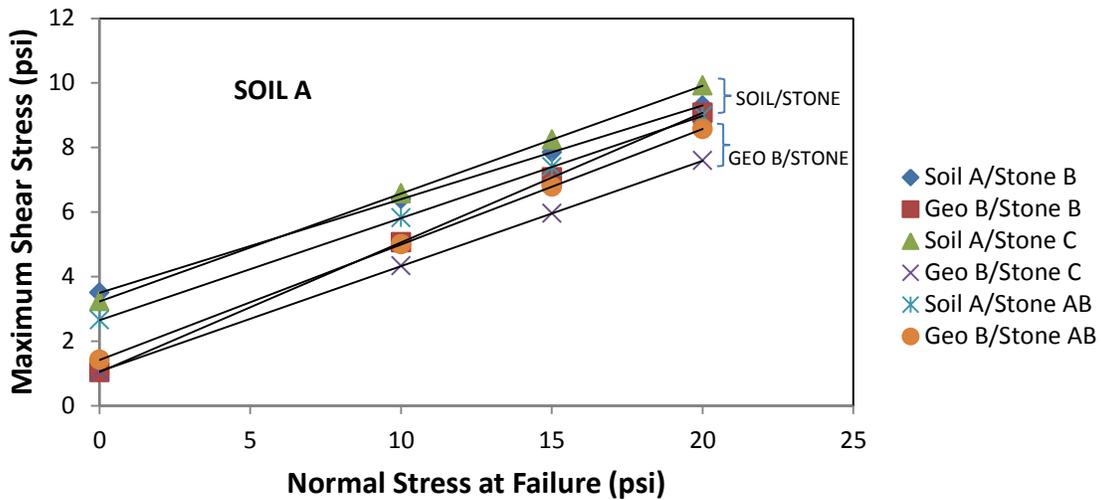
Figure 14: Comparison of maximum shear stress of Soil A interface with stone and *Geofabric B*.

In case of *Geofabric B*, the average friction angles for Stones B, C and AB were 21.89, 18.08 and 19.67 degrees, and the adhesion values were 1.04, 1.06 and 1.42 psi, respectively. The net effect on shear strength is shown in Table 16. It can be seen that in two instances the shear strength had decreased (20% for Stone C and 2% for Stone AB) while on one instance it had increased slightly (3%). The comparison of failure envelopes are shown in Figure 14. The shear behavior of *Geofabric B* with stone interface was very similar to that of *Geofabric A*.

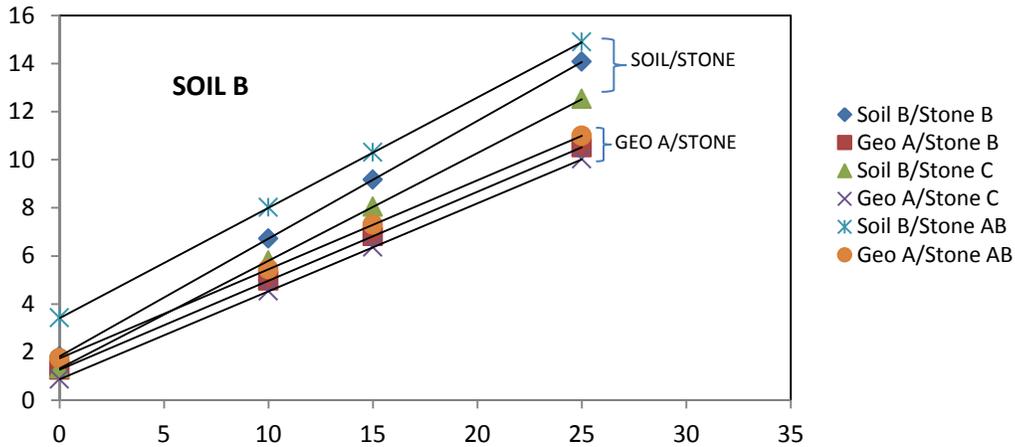
Figure 15: Comparison of maximum shear stress of Soil B interface with stone and *Geofabric B*.

For comparison purpose, the failure envelopes of the *Soil B/ stone*, *Geofabric A/stone* and *Geofabric B/stone* are shown in figures 15 and 16. It is evident that the *Soil B/stone* interface shear parameters were notably higher than those of the *geofabric/stone* interfaces.

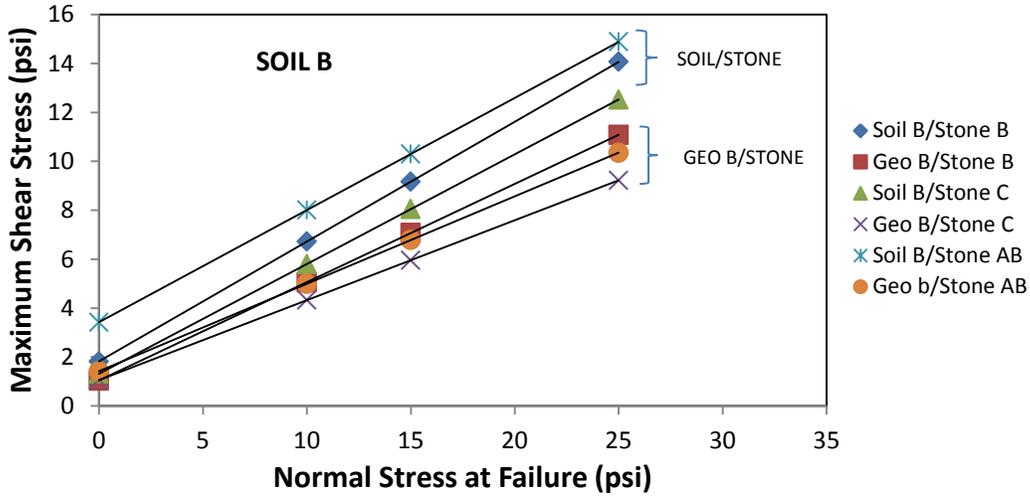
Figure 16: Comparison of maximum shear stress of Soil B with stone and Geofabric B interface.
