**EFFECT OF WARNING SIGNS ON CURVE OPERATING SPEEDS**

Research Report  
KTC-05-20/SPR-259-03-1F

# **Effect of Warning Devices on Curve Operating Speeds**

August 2005

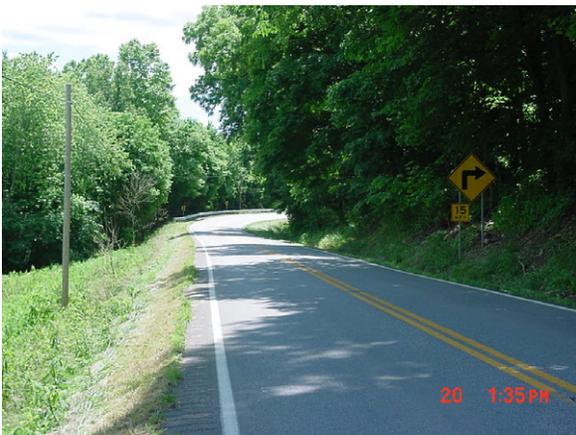
The existing Horizontal Alignment sign with speed plaque was already in place at all sites; therefore, it was not changed (Figures 1 and 2).

**Figure 1.** Lee Co. – Existing conditions      **Figure 2.** Greenup Co. – Existing conditions

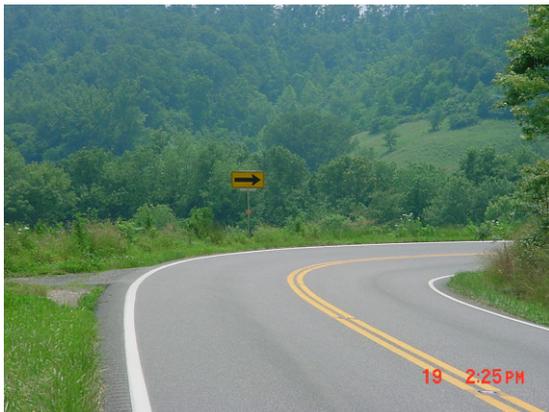
**Figure 3.** Greenup Co. – Large Arrow

The Large Arrow sign was used on the outside of the curve in 2 locations (Lee County and Greenup County) at a right angle to the oncoming traffic (Figures 3 and 4).

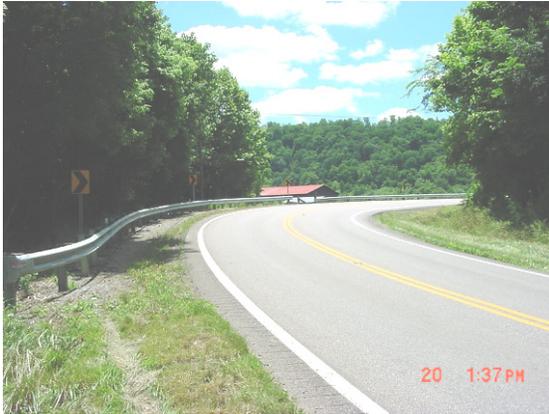
**Figure 5.** Lee Co. – Chevrons

Three existing chevron alignment signs were in place on the outside of the curve at the Henry County site, but three more were added in advance of the existing chevrons to accentuate the curve. Additional chevron signs were used because the MUTCD

recommends that at least two signs should be visible to the driver at all times and the availability of sufficient distance to provide the driver with adequate reaction time. Neither of these two stipulations was followed so the situation was corrected with the additional signs. The existing chevron signs at the Lee and Greenup County sites were satisfactorily placed to allow at least two chevrons to always be visible; therefore, no additional chevrons were used (Figures 5 and 6).

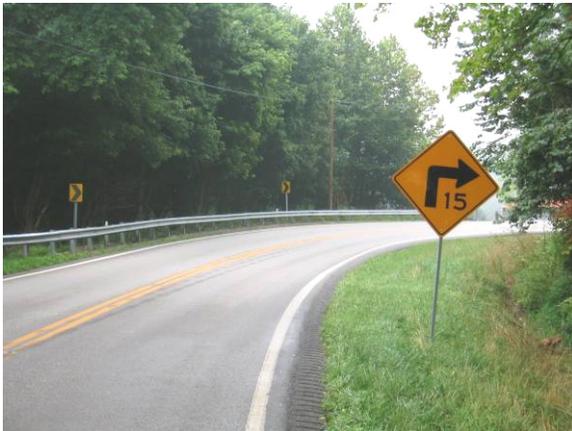
**Figure 7.** Lee Co. – New combination sign

The combinational Horizontal Alignment/Advisory Speed sign was used at all three sites (Figures 7 and 8). The MUTCD states that this sign should supplement other warning signs and should be placed at the point of curvature. Therefore, this sign was located after the existing curve warning sign with speed plaque at the point of curvature for all sites.

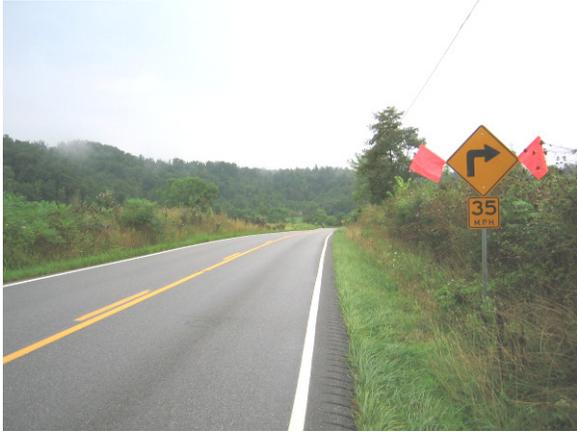
**Figure 9.** Greenup Co. – Warning sign with flags

The existing warning sign with flags was used at all three study sites. Two flags were attached to the top portion of each sign (Figures 9 and 10).

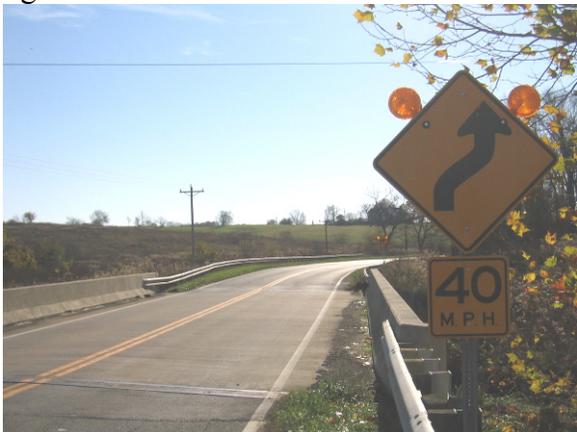
Flashing lights were attached first to the existing warning sign (Figure 11). The following week, the new combination sign was installed again and flashing lights were used on the sign as well as the existing new combination sign (Figure 12). The flashing lights were 6-inch lights that flashed only at night.

**Figure 11.** Henry Co. – Existing warning sign with flashing lights

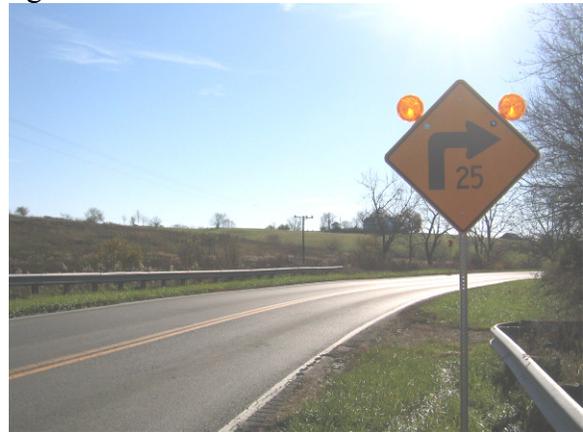
**Figure 12.** Henry Co. – New combination sign with flashing lights

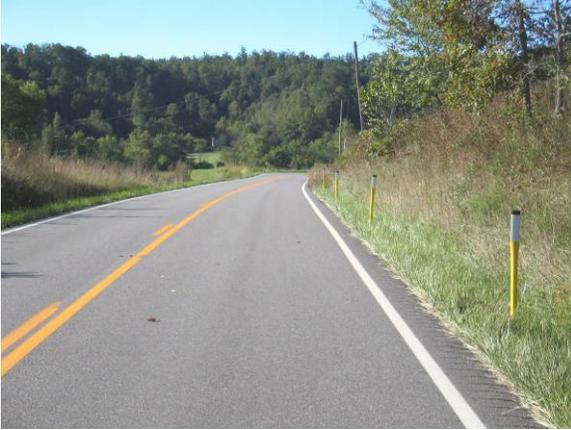
**Figure 13.** Greenup Co. – Post delineators

Post delineators were used at all three study sites (Figures 13 and 14).

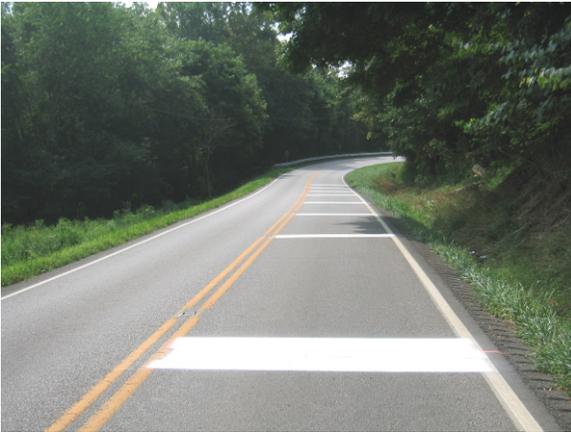
**Figure 15.** Lee Co. – Transverse lines

Transverse lines were used at all three site locations (Figures 15 and 16). However, the number of lines and spacing between lines differed from site to site because of the different degree of curvature and available approach tangent. In the Lee County site, 15 transverse lines were applied because of a short approach tangent. In the other two sites 24 lines were used. The lines were used only in the tangent sections leading up to the curve to avoid the potential of reduced friction while in the curve, particularly during wet conditions.

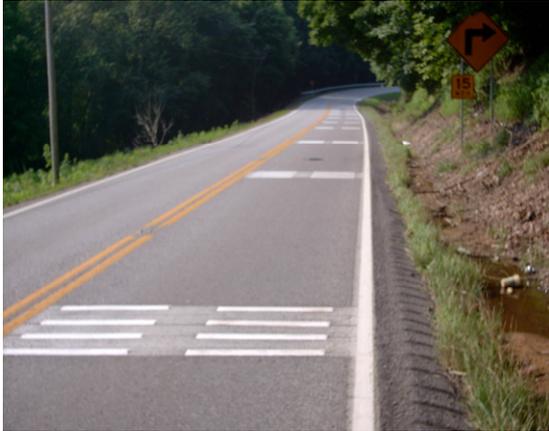
**Figure 17.** Lee Co. – Rumble strips

One year later, the transverse lines were tested again at all three sites to determine their effect over an extended period of time and provide a current basis for comparisons for the new treatments. Then rumble strips were placed on top of the transverse lines to enhance their visibility and simultaneously produce a rumbling sound and vibration to the drivers. The rumble strips consisted of 3 or 4 strips of thermoplastic placed across either the entire lane or the portion of the lane which would be crossed by a vehicle's wheels (Figures 17 and 18).

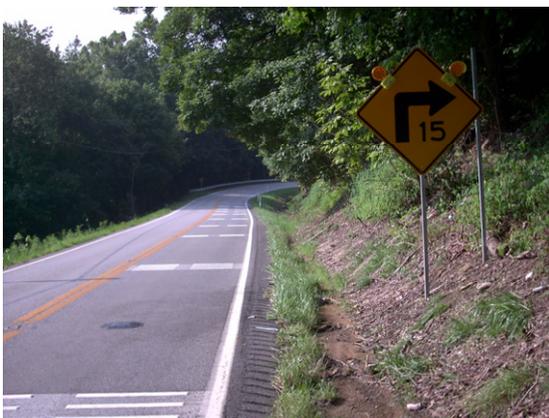
**Figure 19.** Lee Co. – Combination

The final treatment tested was a combination of the reinstallation of the new combination sign, flashing lights on both signs, post delineators in conjunction with the rumble strips overlaid on the transverse lines. The results of the research conducted in the previous year identified each of the treatments noted above as having a significant or a promising impact in affecting operating speeds. It was thus assumed that there may be a collective or additive effect if all treatments were used simultaneously. Therefore all treatments were combined and tested at all 3 locations (Figures 19 and 20). The rumble strips were applied only to 12 stripes starting at the point of curvature and proceeding backward on the tangent. The underlying expectation here was that all these treatments applied together would have a greater effect in alerting the driver to reduce their speeds than the use of any one method by itself. The new sign, flashing lights and post delineators were all placed in the same manner as they had been in the previous treatments.

9. The new combination Horizontal Alignment/Advisory Speed sign replaced the existing warning sign. Two 6-inch flashing lights were mounted on the upper portion of the sign and they were visible to drivers only at night. Post delineators were placed on the inside of the curve at 50-foot intervals from the point of curvature to the end of the curve. The rumble strips placed during the previous trial remained in place during this measurement as well.<sup>2</sup>

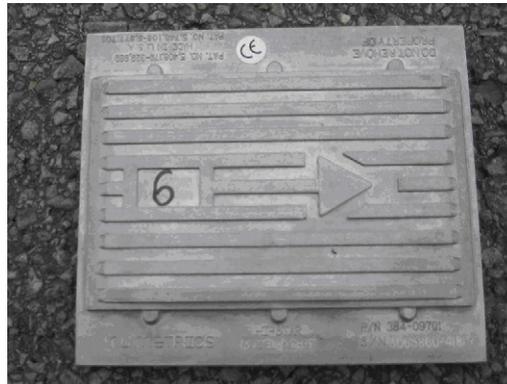
**Figure 21.** HI-STAR unit.

The speeds for this project were measured with HI-STAR Vehicle Magnetic Imaging Traffic Analyzers (Model NC-97). The HI-STAR devices are small sensors that are

installed in the center of a travel lane and require no physical contact from vehicles to measure and record speeds (Figure 21). HI-STAR counters use vehicle magnetic imaging (VMI) to detect vehicles as they move through the earth's magnetic field. The metal from cars interferes with the magnetic field and this disturbance creates electrical signal changes in the HI-STAR sensors. This process allows the HI-STAR devices to accurately measure vehicle speeds and volumes.

The HI-STAR devices also came equipped with a computer analysis program, Highway Data Management (HDM). One of the primary functions of this software was to program the devices before each data collection exercise. HDM allows the user to set up a starting and ending time for the devices. The software also had many graphical and analytical assets, which could be used to evaluate the data. Another unique function of the HDM software is that it had the capability to track individual vehicles throughout a system of several in-line counters.

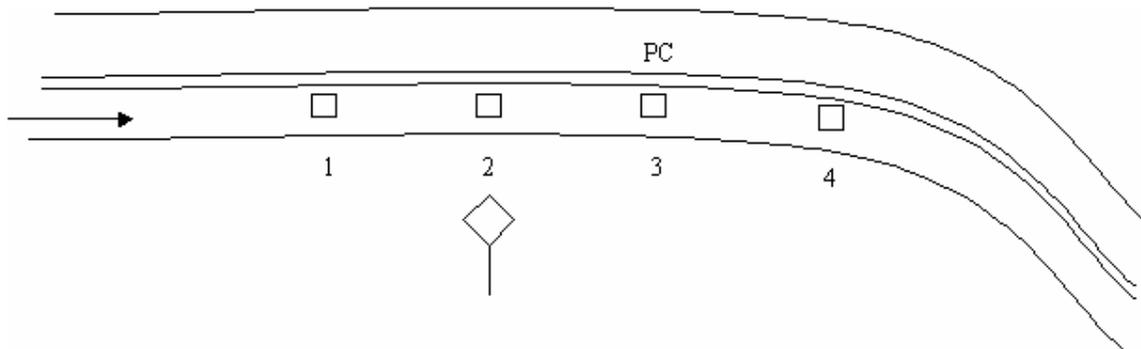
**Figure 22.** Typical right curve with measurement locations

Figure 22 shows the typical layout for the location of the speed measuring devices. Device 2 was placed at the existing warning sign and it was approximately the mid point between devices 1 and 3. Device 3 was placed at the approximate point of curvature, and device 4 was in the curve. The distances for each are noted in Table 2.

Site	Distance between devices (ft)		
	1-2	2-3	3-4
Lee	200	215	370
Greenup	400	400	435
Henry	250	250	250
