HIGHWAY-RAILWAY AT-GRADE CROSSING STRUCTURES: LONG-TERM SETTLEMENT MEASUREMENTS AND ASSESSMENTS

KTC-09-06/FR 136-04-3F

Highway-Railway At-Grade Crossings: Long-Term Settlement Measurements and Assessments

May 2009

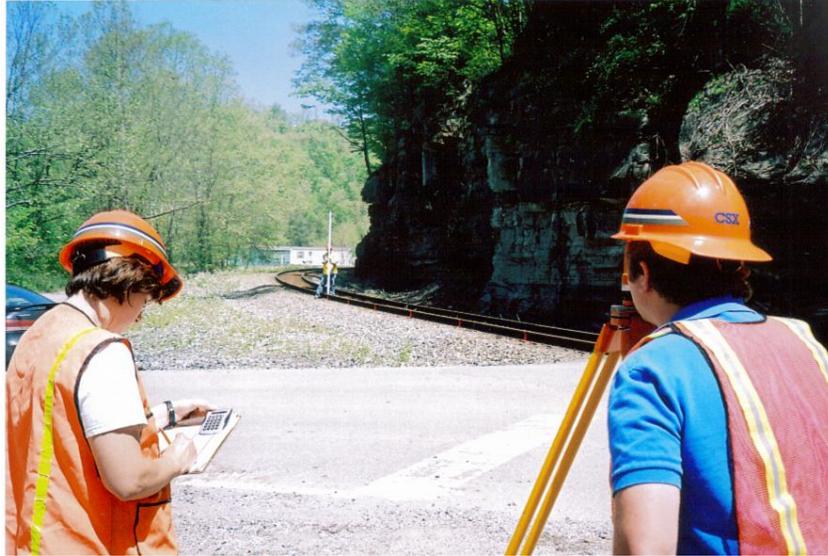
Figure 2.1a Procedure for top-of-rail profile measurements.

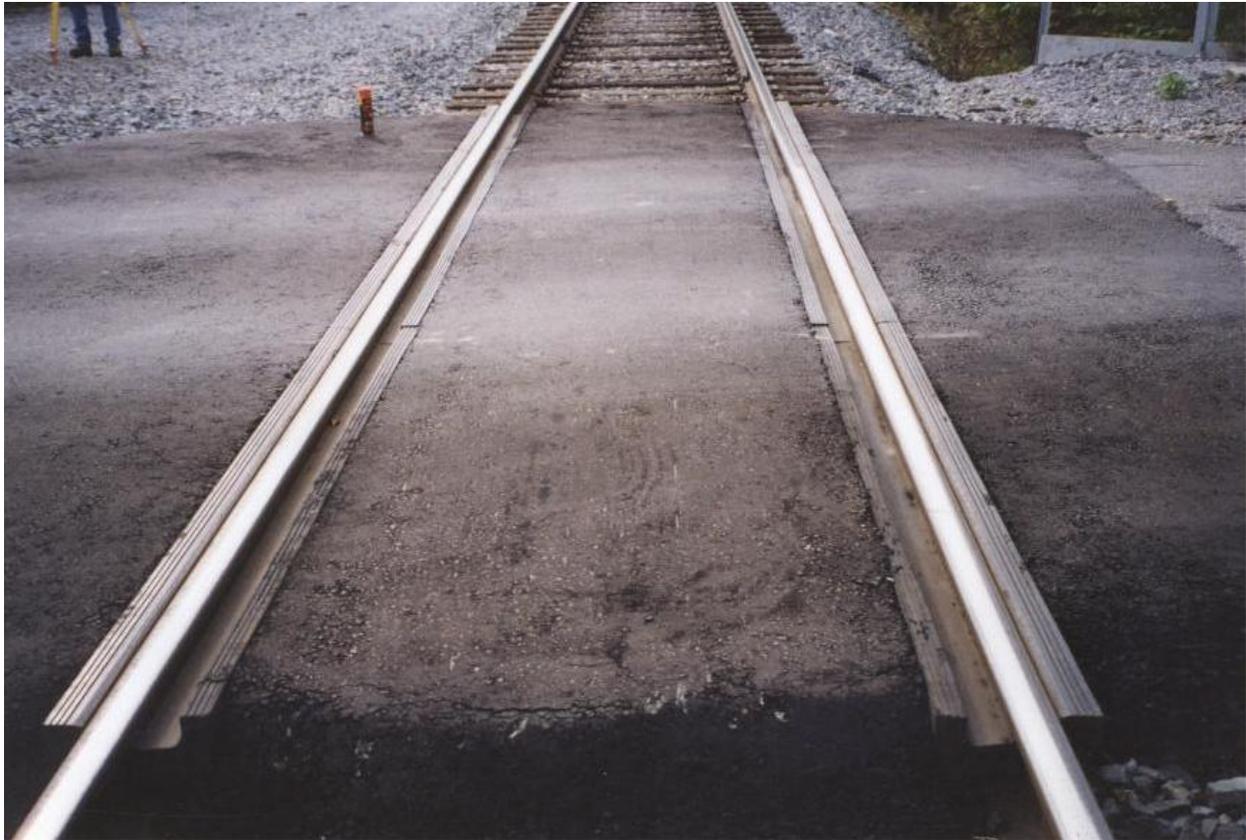
Figure 2.1c Representative Cincinnati Subdivision crossing (Flag Spring) without underlayment.

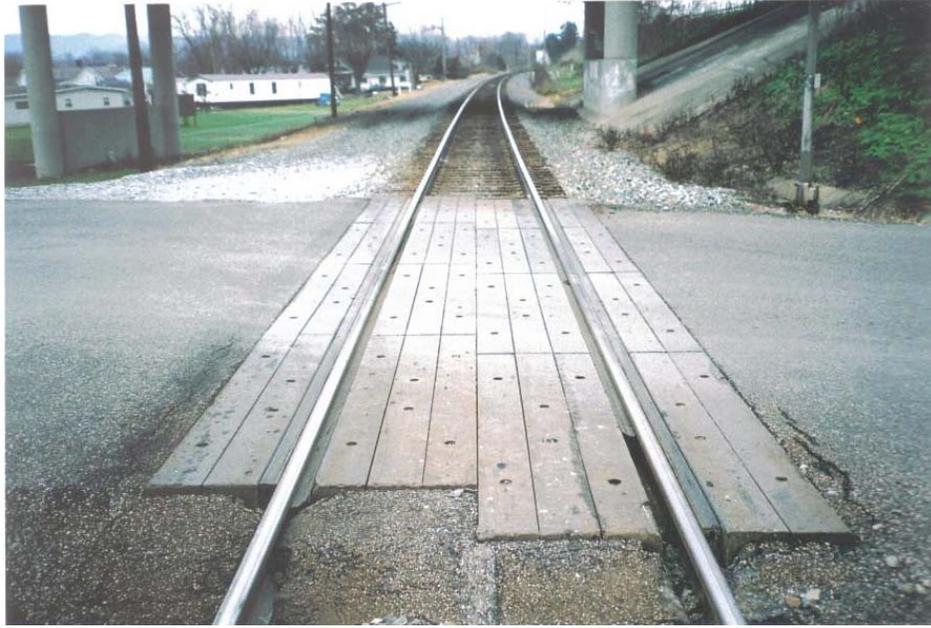
Figure 2.1d Representative Cincinnati Subdivision crossing (South Portsmouth) with underlayment.

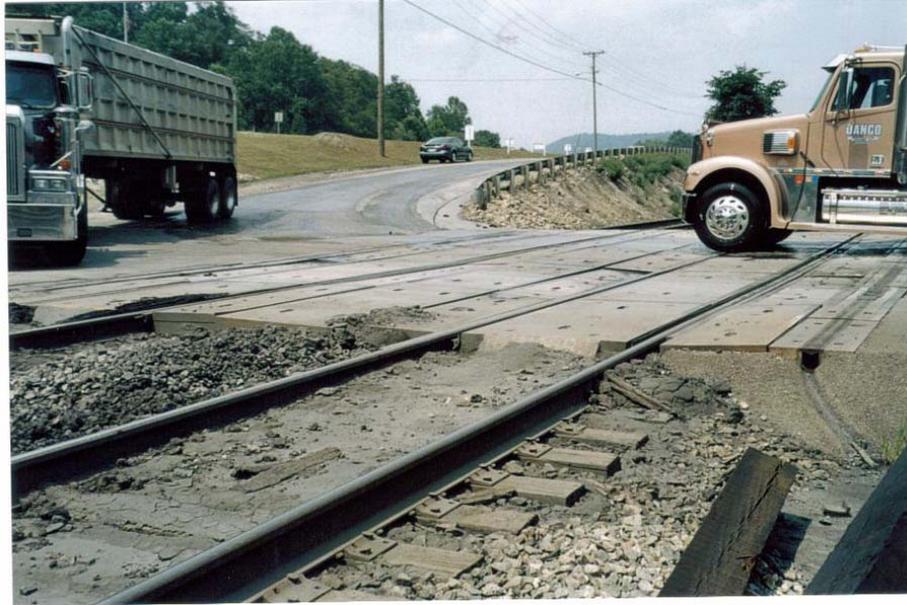
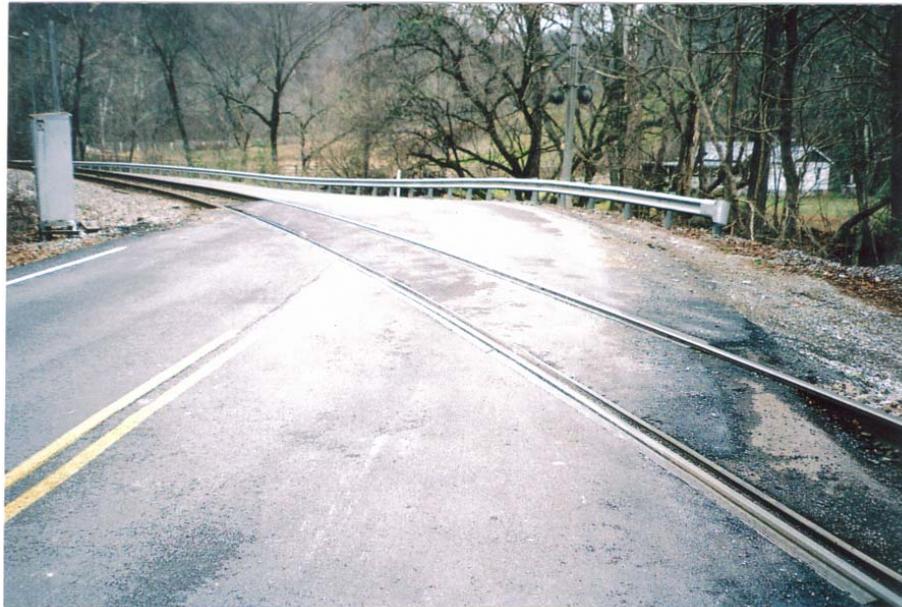
Figure 2.1e Representative Big Sandy Subdivision crossing (KY Coal Terminal) and Rockhouse Subdivision crossing (No Name, KY 7) both with underlayment.

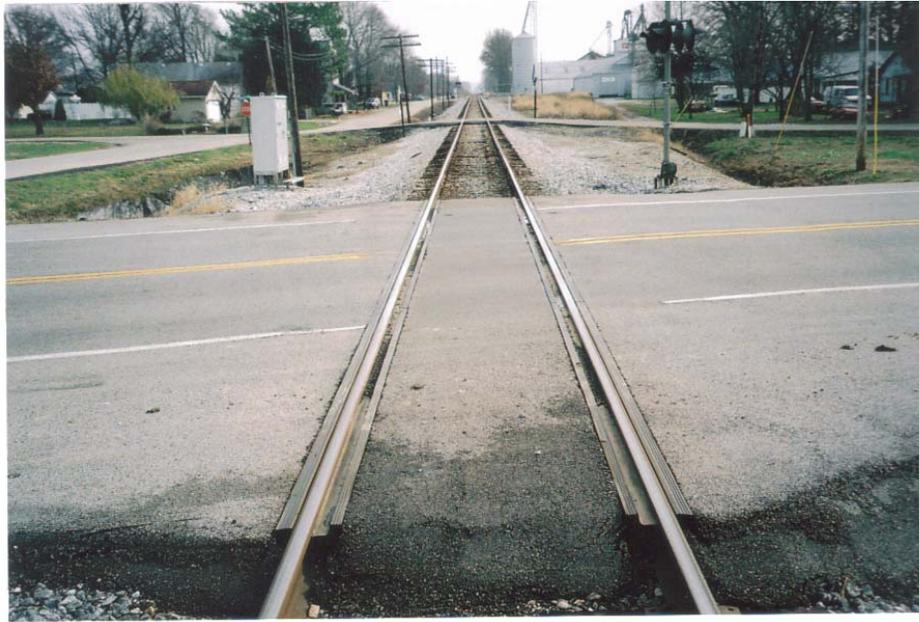
Figure 2.1f US 60 (Stanley) crossing with underlayment.

The other 16 crossings contain asphalt underlayments. These are on three major and two minor rail mainlines. Four are located on the Cincinnati Subdivision. A representative crossing with underlayment is shown in Figure 2.1d. Most of the others are located on heavy tonnage coal-hauling rail lines in Eastern Kentucky. These also accommodate high volumes of highway traffic and trucks. The combined rail and highway loadings on several of the crossings are considered to be the most severe in the state. A representative crossing is shown in Figure 2.1e. The three crossings on relatively light tonnage rail lines have very high highway traffic volumes. One of these is in Western Kentucky (see Figure 2.1f); the other two are in Michigan.

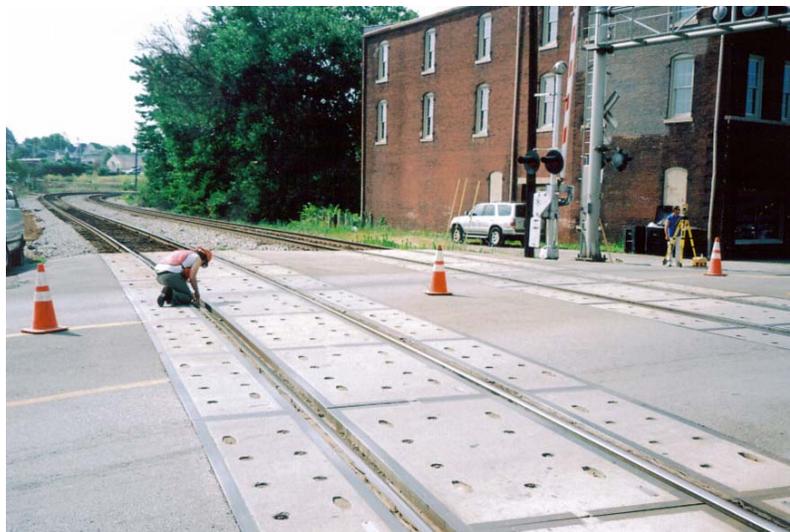
Figure 3.1a Procedure and locations for longitudinal highway profile measurements.

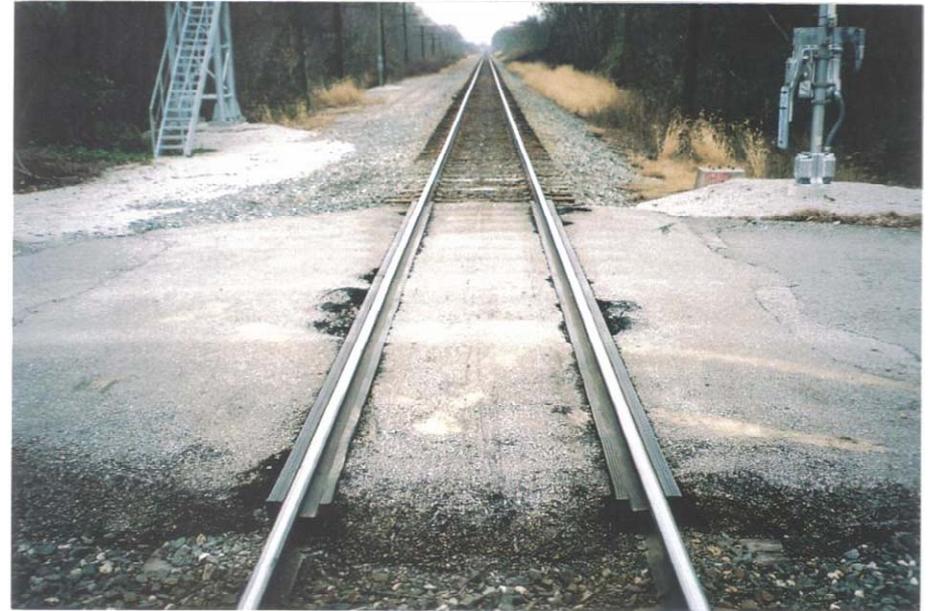
Top-of-Rail Settlements

Dam (No Underlayment)

Average Asphalt/Approach Settlement for DAM (no underlayment)

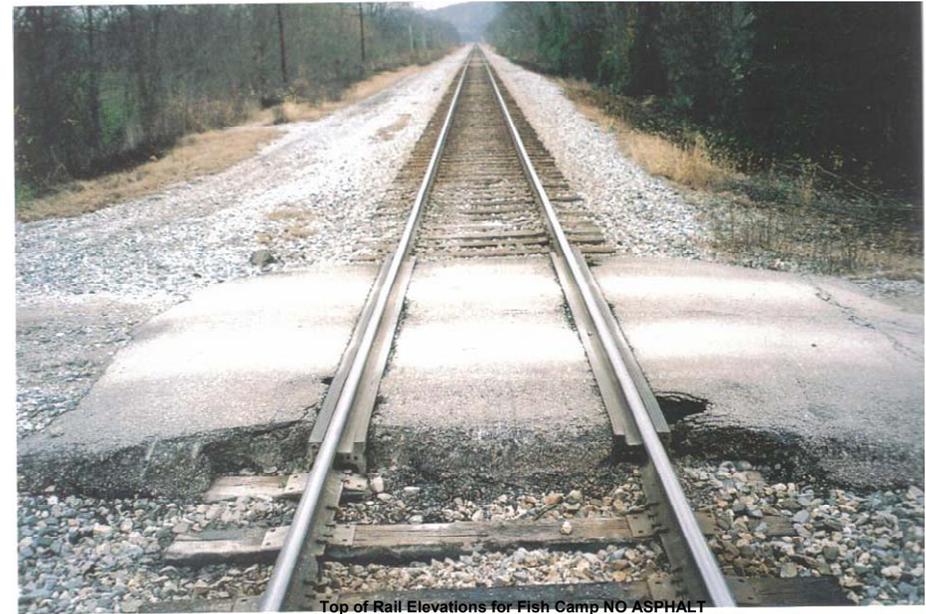
Fish Camp (No Underlayment)

(46 month data inconclusive due to a track surfacing affecting the elevation datum)

Average Asphalt/Approach Settlement for Fish Camp (no underlayment)

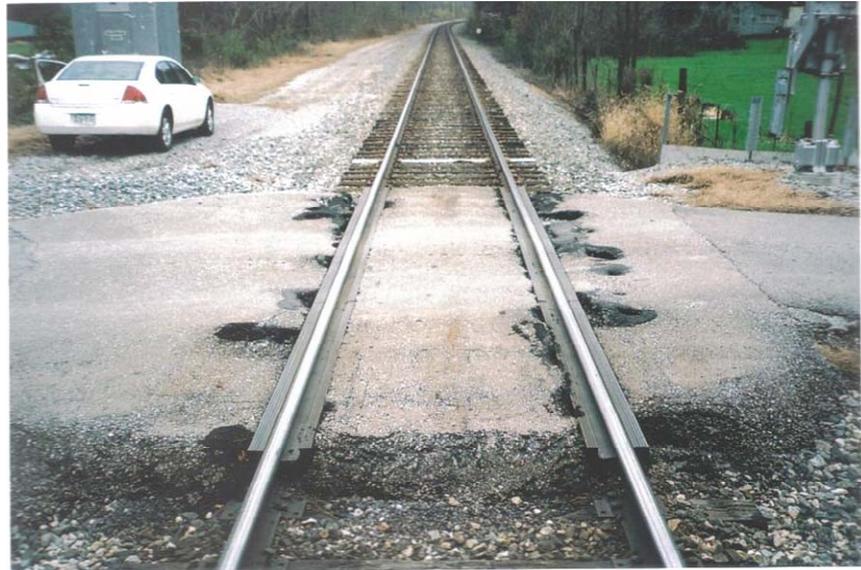
Flag Spring (No Underlayment)

(Only used 33 month data to be consistent with the other three non-underlayment crossings)

Average Asphalt/Approach Settlement for Flag Spring (no underlayment)

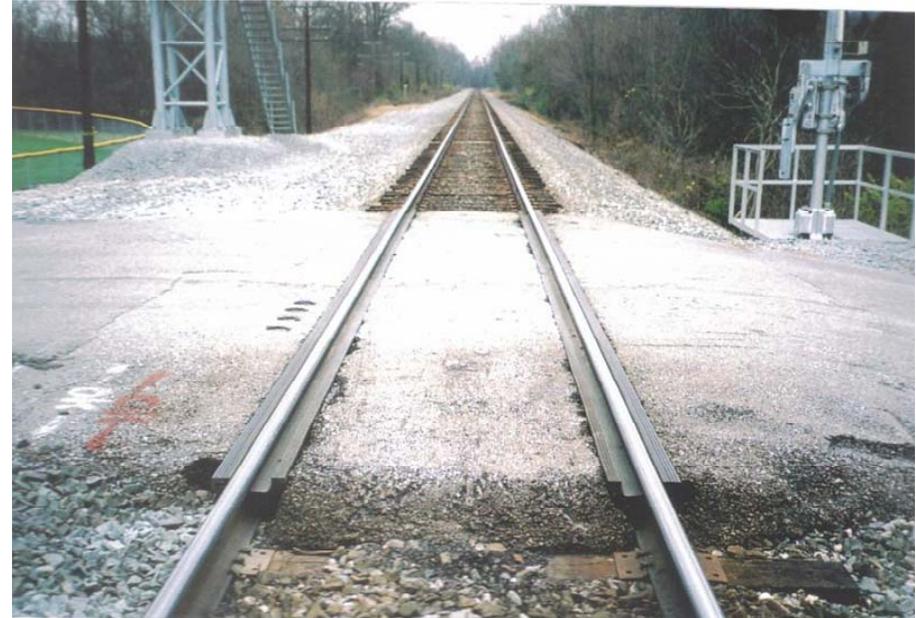
Union Street (No Underlayment)

Top of Rail Elevations for Union Street NO ASPHALT

Average Asphalt/Approach Settlement for Union St. (no underlayment)

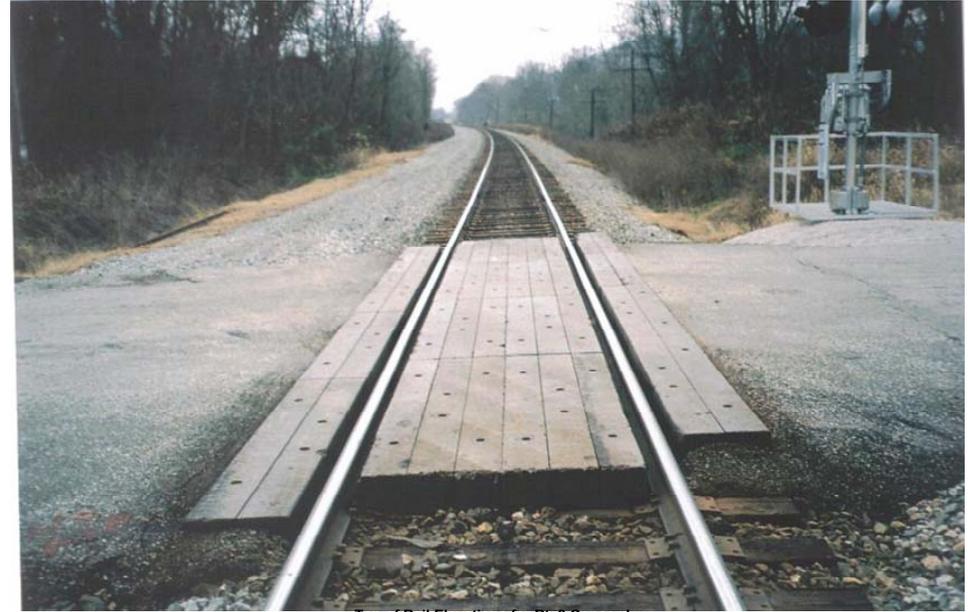
Figure A.5

Rt. 8 Concord

Top of Rail Elevations for Rt. 8 Concord

Average Asphalt/Approach Settlement for Rt. 8 Concord

Similar to the previously mentioned crossings on the Cincinnati Subdivision, these four crossings were installed during the 2002 timbering and surfacing operation. Unlike the other crossings in the Cincinnati Subdivision, these contained an asphalt underlayment. Each of these four crossings received a different surface for comparative and experimental purposes. These crossings on the CSXT line carry 38 MGT of traffic each year and after five years of service show no signs of fatigue, cracks or failure. Figures A.5 through A.8 contain the settlement data and plots.

After 42 months, the average settlement was 1.53 in. for the approaches and 0.53 in. for the crossings. As stated earlier, the approach settlement for these four crossings is comparable to the crossing with an all-granular trackbed, however, the crossing settlement is significantly less. These differences between the crossings performance should be noted because they are similar in many ways. The crossings carry the same amount of train traffic and the highway traffic is minimal. In places such as the approaches where the track was only supported by ballast, the settlement is similar to the crossings with no underlayment. However, through the crossing surface where an underlayment was utilized for additional support, the settlement was significantly less indicating that the added stability prevented the track from such large settlements.

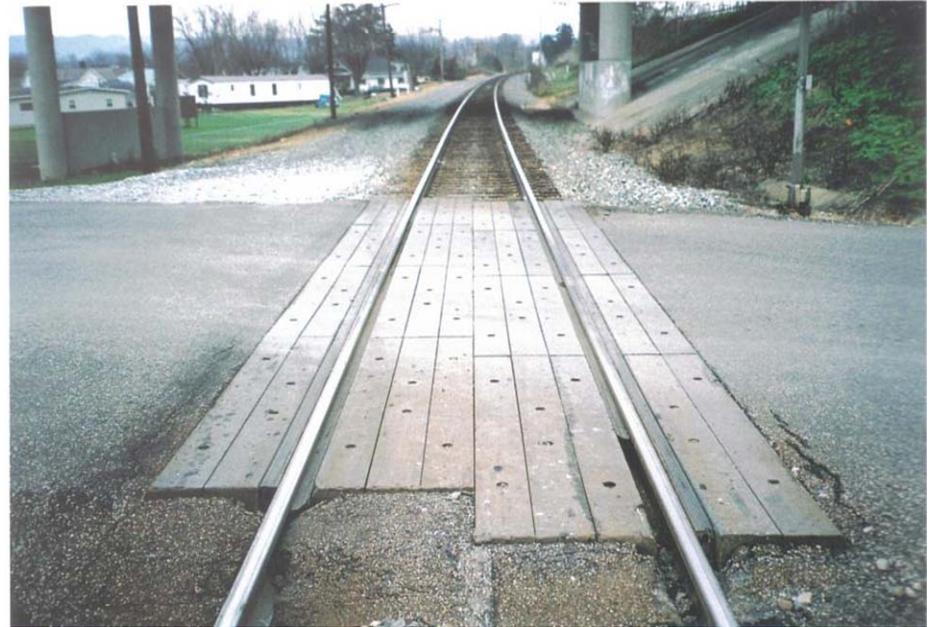
Top-of-Rail Settlements South Portsmouth

Top of Rail Elevations for South Portsmouth

Average Asphalt/Approach Settlement for South Portsmouth

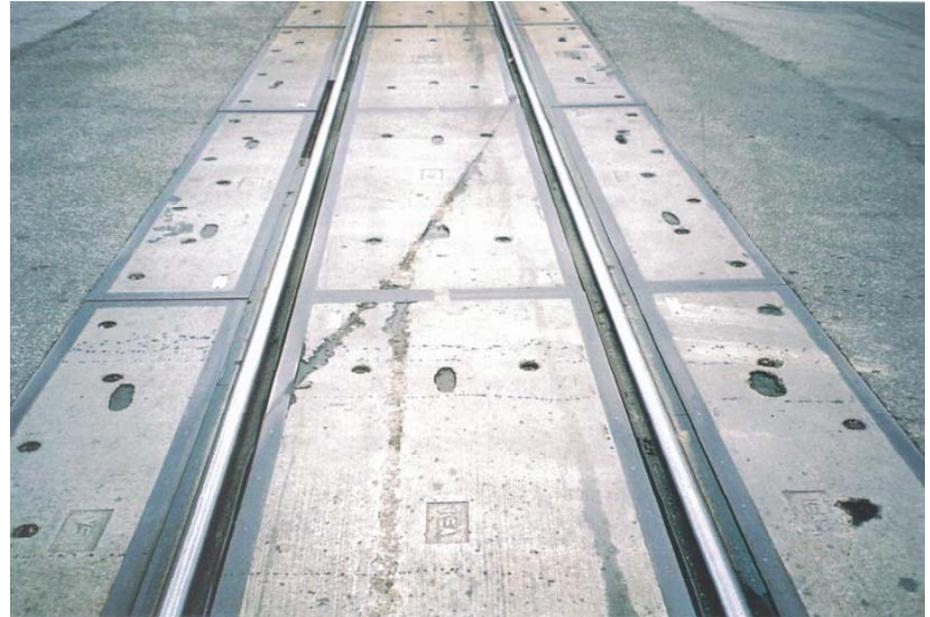
Figure A.7

Top-of-Rail Settlements Vanceburg- Main Street

Average Asphalt/Approach Settlement for Vanceburg - Main Street

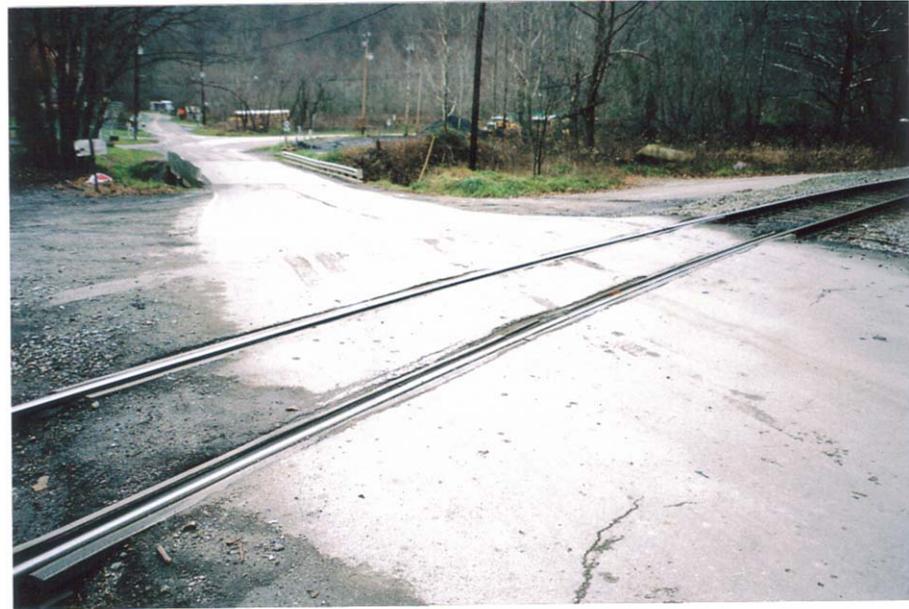
Colson

Average Asphalt/Approach Settlement for Colson

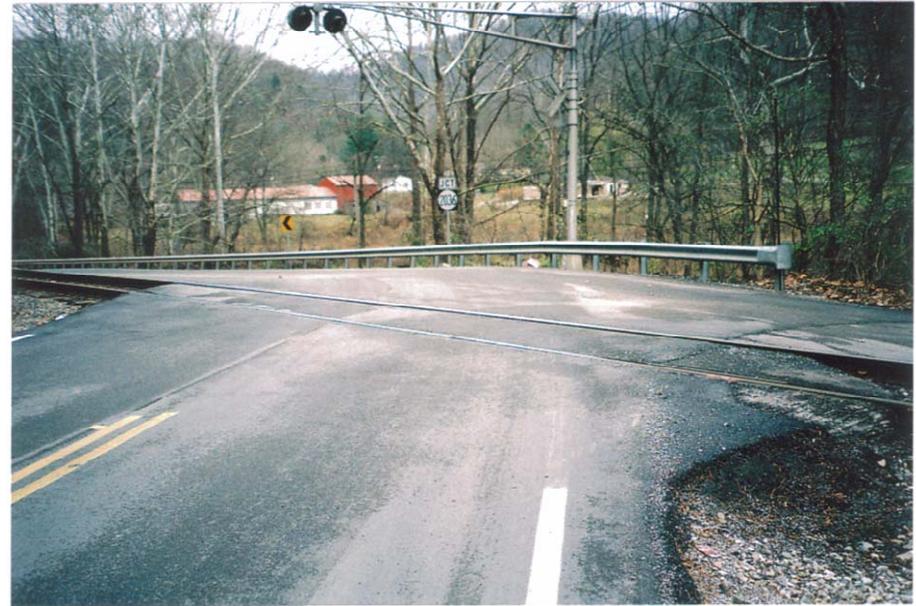
Indian Bottom Church

Average Asphalt/Approach Settlement for Indian Bottom Church

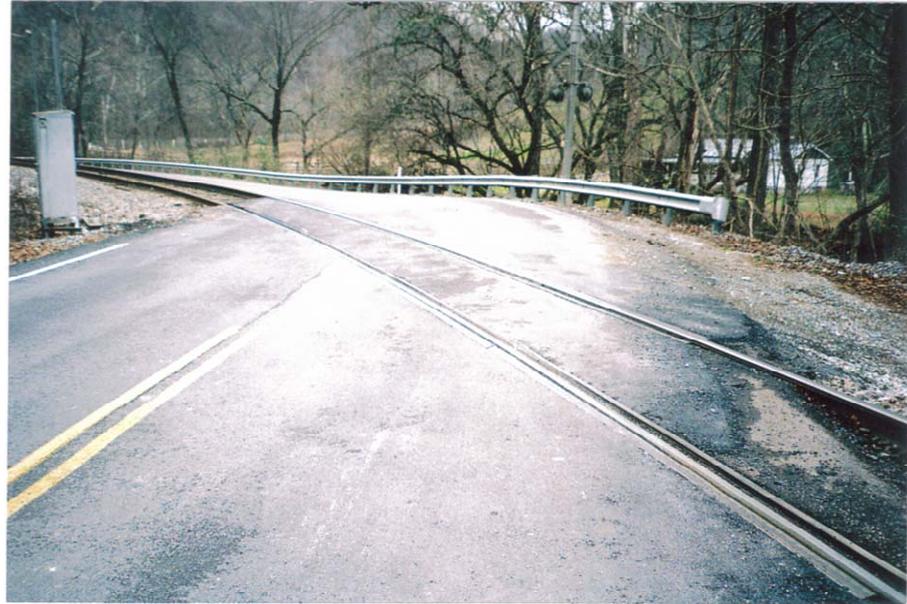
No Name

Average Asphalt/Approach Settlement for No Name

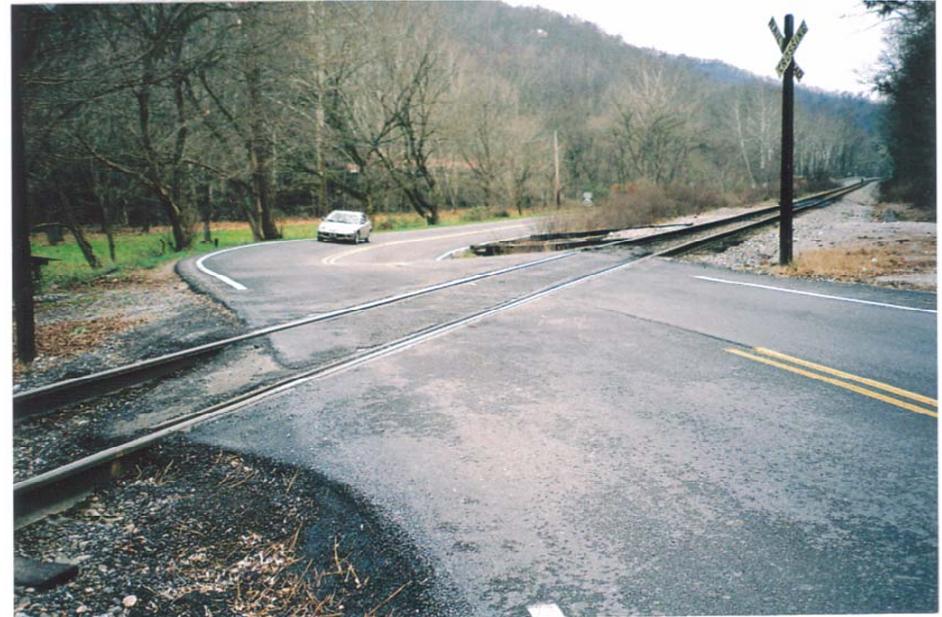
Figure A.11

Top-of-Rail Settlements Old Letcher School

Average Asphalt/Approach Settlement for Old Letcher School

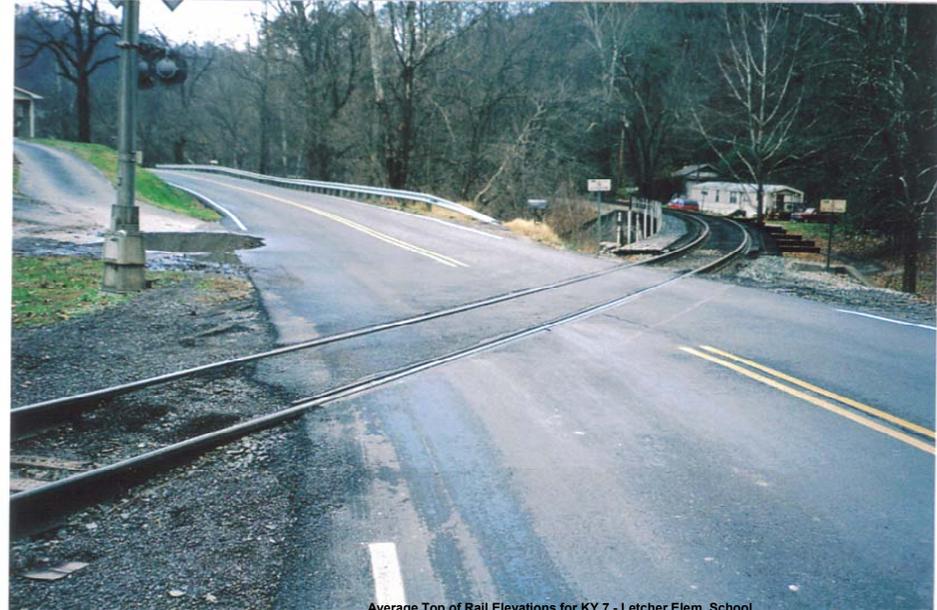
Letcher School

Average Top of Rail Elevations for KY 7 - Letcher Elem. School

Average Asphalt/Approach Settlement for Letcher Elem. School (OVG 272.12)

The crossing at Letcher Elementary School, OVG 272.12, was installed August 2, 2005. Due to this crossings proximity to a railroad bridge, it was not possible to raise the crossing. As a result of these circumstances, the existing highway approaches were higher than the crossing, causing a low, rough point in the roadway. During the 2006 KY 7 resurfacing program the approaches were milled and replaced and are now smooth. This crossing receives 2580 ADT with 13% trucks and during 21 months of service the approaches and crossing settled 0.76 in. and 0.25 in. respectively.

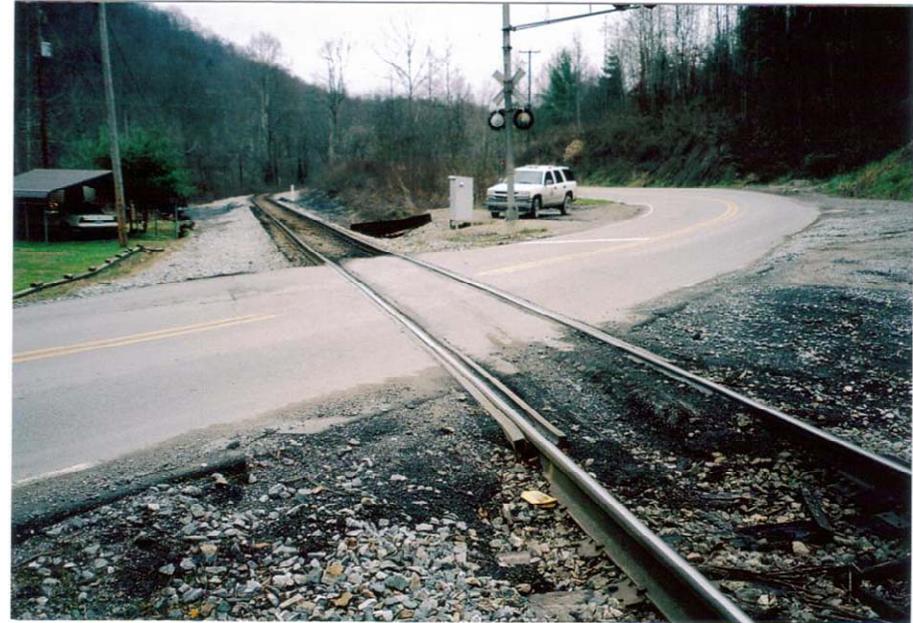
Thornton Gap

(Data inconclusive due to derailment near the crossing 9 months after installation, subsequent surfacing affected elevation datum, data omitted from analysis)

Average Top of Rail Elevations for KY 7 Thornton Gap

Average Asphalt/Approach Settlement for Thornton Gap

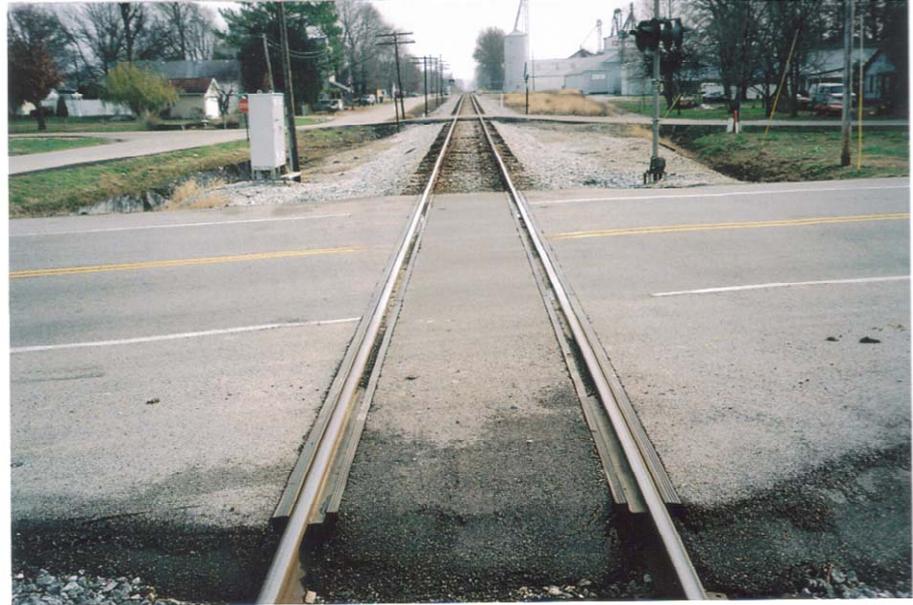
Average Asphalt/Approach Settlement for US 60 Stanley

Average Top of Rail Elevations for US 60 Stanley

One crossing was studied on the LH&StL Subdivision of the CSXT line in Western Kentucky which carries a heavy amount of highway traffic and a moderate 8 MGT of rail traffic each year. This crossing was rehabilitated in May of 2002, prior to a timbering and surfacing operation. The old crossing was removed and replaced with a rubber seal/asphalt surface. The initial rail traffic included the tie change-out equipment as it passed by immediately after bolting the new track panel to the existing track. This crossing remains very smooth for the heavily trafficked 60 mile-per-hour traffic it is exposed to. Typically, rubber seal/asphalt surfaces are not predicted to perform well under such circumstances, however, this crossing shows no signs of fatigue and remains smooth. Figure A.15 contains the settlement data and plot.

KYDOT District 2 personnel provided traffic control as well as the asphalt paving. This crossing has been monitored by Top-of-Rail studies for 54 months, in this time the approaches have settled 0.93 in. and the crossing has settled 0.45 in. This result is consistent with other crossings, which illustrates the additional support from the underlayment is preventing premature wear to the crossing surface.

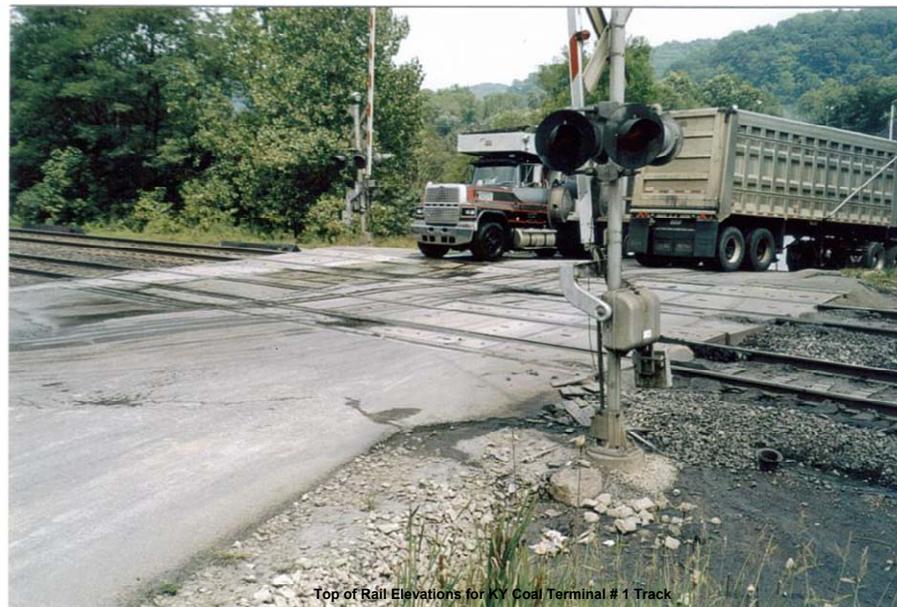
KY Coal Terminal Track #1

Average Asphalt/Approach Settlement for KY Coal Terminal #1

The KY Coal Terminals crossing is a section of double track in the Big Sandy Subdivision at CMG 6.6. These tracks carry 45 MGT and serve as a private access to a coal unloading facility. Due to the extreme loadings, these crossings have a history of rapidly deteriorating. On a typical weekday, in addition to service traffic, approximately 500 coal trucks at or above the legal extended weight of 126,000 lbs. cross these tracks. With these large loadings it can be stated that this is one of the heaviest loaded rail/highway crossings in the state. Previous attempts to establish a long-life smooth crossing have not been successful, however, since the implementation of the asphalt underlayment and concrete crossing panels the crossing has required no maintenance and shows no signs of deterioration.

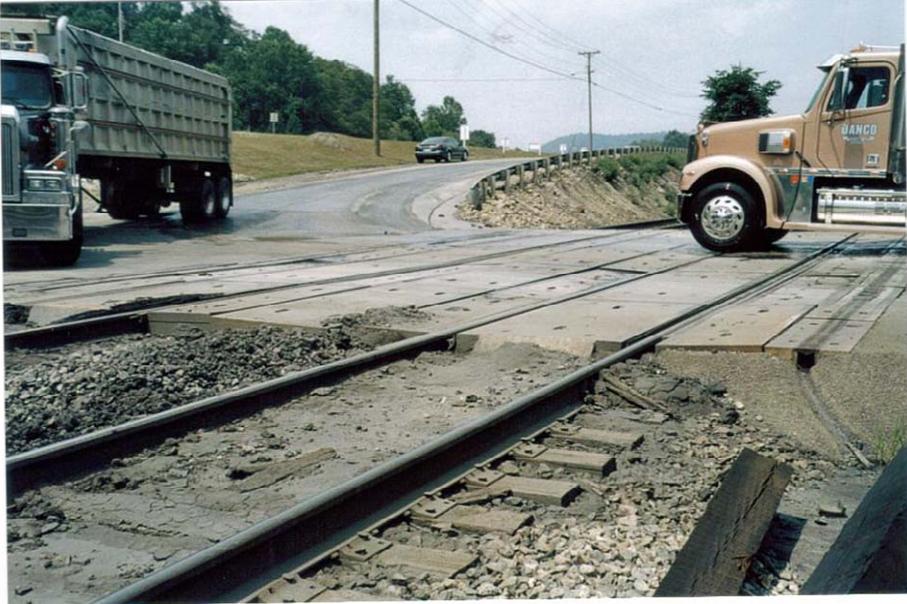
KY Coal Terminal Track #2

Average Asphalt/Approach Settlement for KY Coal Terminal #2

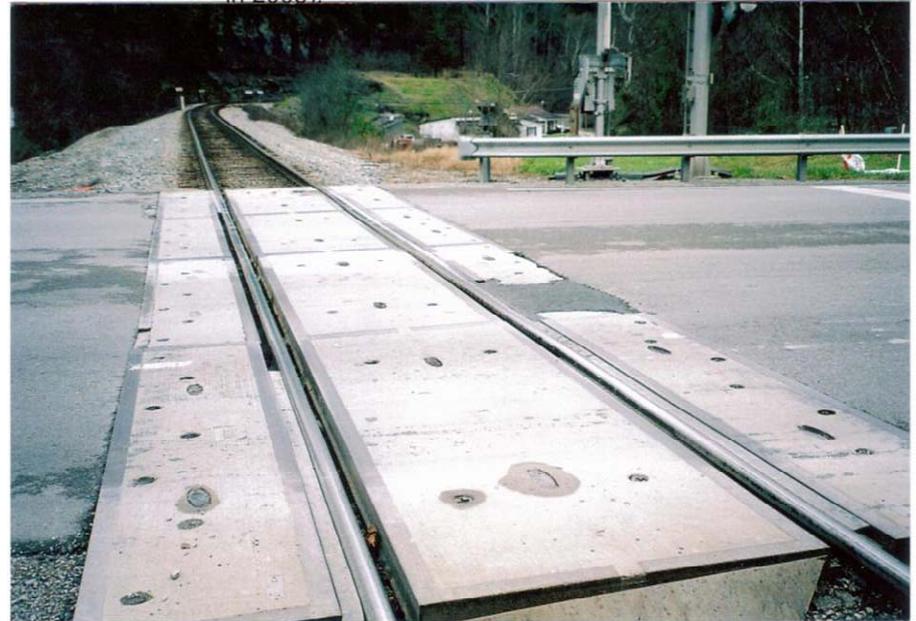
KY 15-Isom

Average Asphalt/Approach Settlement for KY 15 Isom

KY 15 crossing at Isom, OVG 276.4, is a 60 MPH highway located on the Rockhouse Subdivision and is the primary highway route serving southeastern Kentucky. This crossing was rehabilitated November 6, 2002. This rail line carries 21 MGT and the highway carries 9440 ADT. The Isom crossing carries 13% loaded coal trucks in addition to local traffic. Much like previously mentioned crossings, Isom routinely required maintenance in order to service the deteriorating crossing surface which posed as a safety risk to the traveling public. During the installation procedure KYDOT District 12 provided traffic control and the asphalt for the approaches and underlayment. After four years, the metal encasement for one of the field side concrete panels loosened and the impact cracked and deteriorated the concrete panel. Despite recent cracks found in the concrete panels after the installation of an underlayment the crossing remains smooth. After 37 months of service, the approaches settled 2.10 in. and the crossing settled 1.17 in.

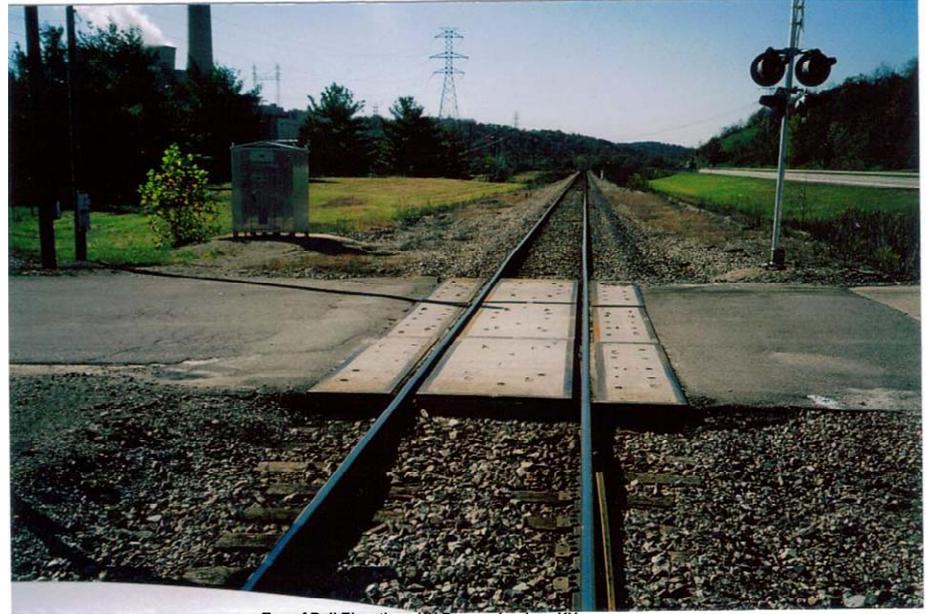
Figure A.18

Top-of-Rail Settlements Kentucky Power- Louisa

Top of Rail Elevations KY Power - Louisa, KY

Average Asphalt/Approach Settlement for KY Power

KY Power Louisa is a private crossing in the Rockhouse Subdivision on single track 45 MGT line several miles south of KY Coal Terminal crossing. It was rehabilitated in 2002 with a concrete surface, new track panel and asphalt underlayment. The crossing had been cribbed out, surfaced and renewed with a rubber seal and asphalt surface in 2000. The rapid deterioration was attributed to mud and fouling, which is prevalent in this area. In addition to these conditions, when the concrete panel was installed the tie spacing did not match the holes for the lag screws, resulting in panels which were always loose. The rail approaches beyond the underlayment have displayed signs of significant pumping and require surfacing. Despite heavily loaded coal trucks as the primary traffic the crossing is performing well. During the 37 months of service, the approaches have settled 1.35 in. and the crossing has settled 0.59 in.

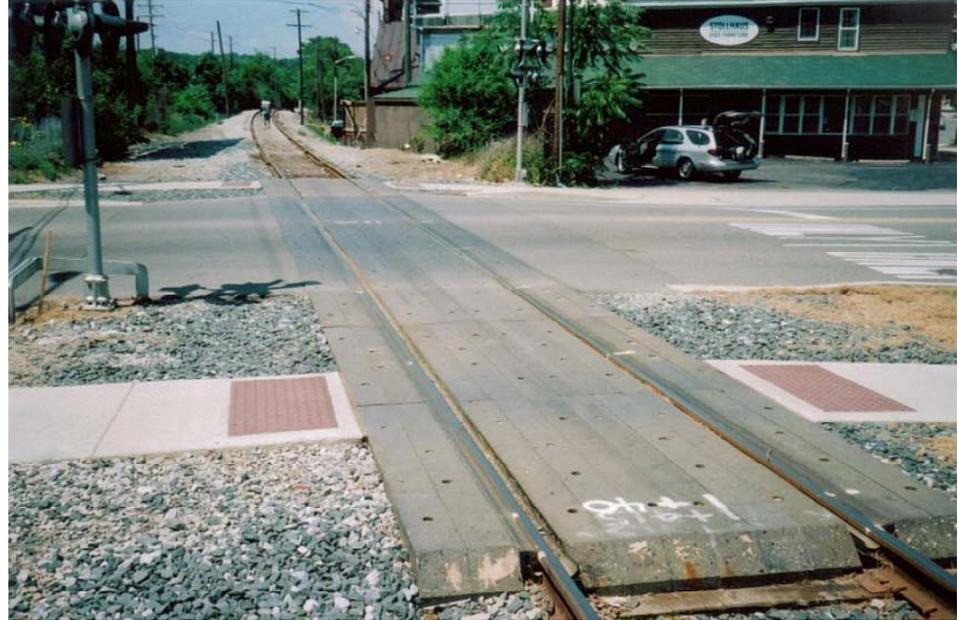
Liberty Street – Ann Arbor, MI

Top of Rail Elevations for Liberty Street - Ann Arbor, MI

Average Asphalt Settlement for Liberty Street - Ann Arbor, MI

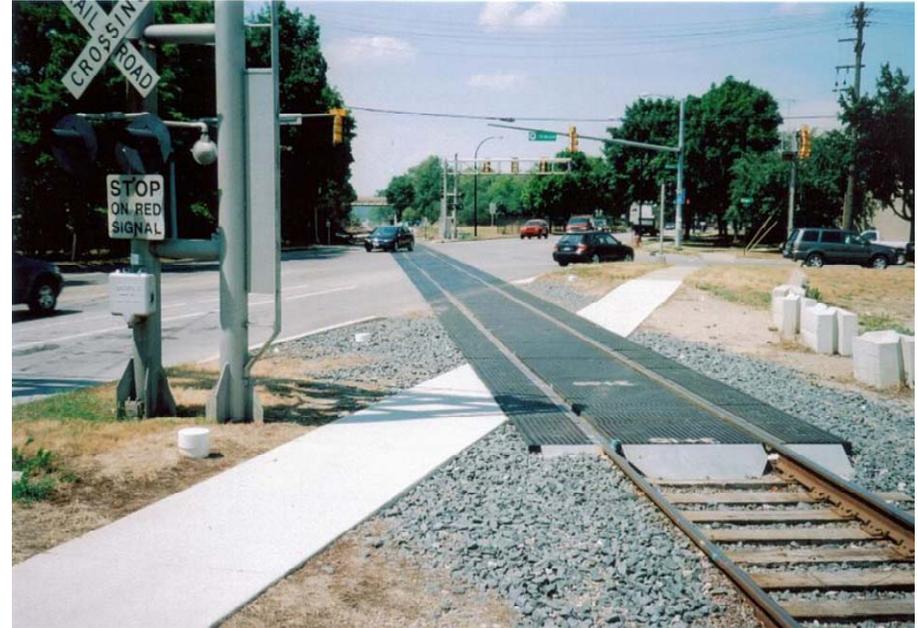
State Street – Ann Arbor, MI

Average Asphalt Settlement for State Street-Ann Arbor, MI

State Street connects the University of Michigan with downtown Ann Arbor. The crossing contains four lanes of highway traffic on a skew. During rehabilitation, the old crossing surface was removed and replaced with a full depth rubber crossing in addition to the asphalt underlayment. This crossing has also settled 0.31 in. after 24 months.

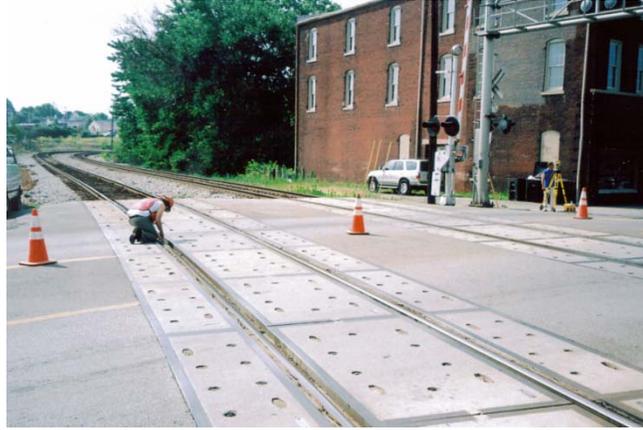
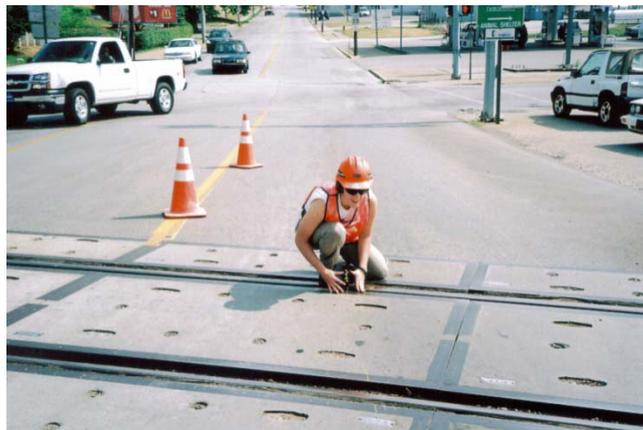
Figure B.1b: View of Total Stationing Procedure

In order to develop a plot of changes over time due to settlement, vertical deviations in the roads surface were found. It is assumed that the crossing approaches were smooth when installed, and the only deformations would be due to settlement. To determine these points, a rod was used and laid flat against the ground surface measuring from the beginning to the end of the wheel path. A point where the rod does not lay flat indicates a change in slope, this position is marked and recorded by the total station. In some cases, where the crossing was recently paved and still smooth, readings were taken at intervals equivalent to the length of the rod to ensure a representative profile was established.

Although this method is considered accurate, this is a time consuming and meticulous procedure and one traffic lane must be closed for several hours while measurements are taken.

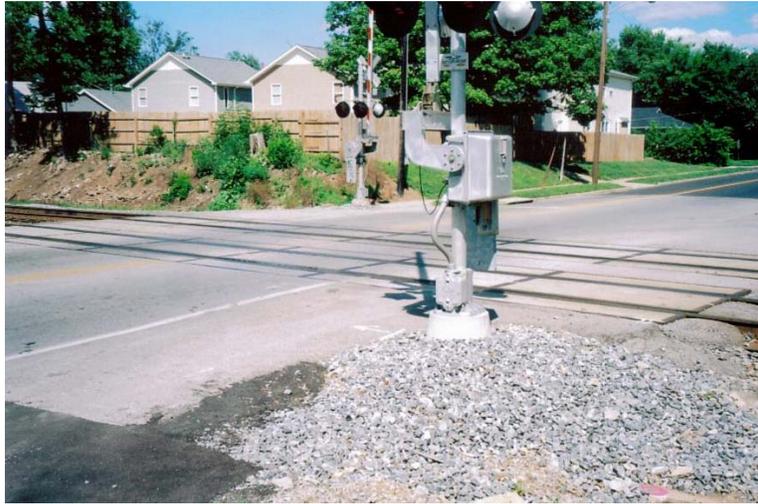
Figure B.2a: View of Waller Avenue Crossing

Pictures of each of these crossing can be seen in Figures B.2a – B.2d.

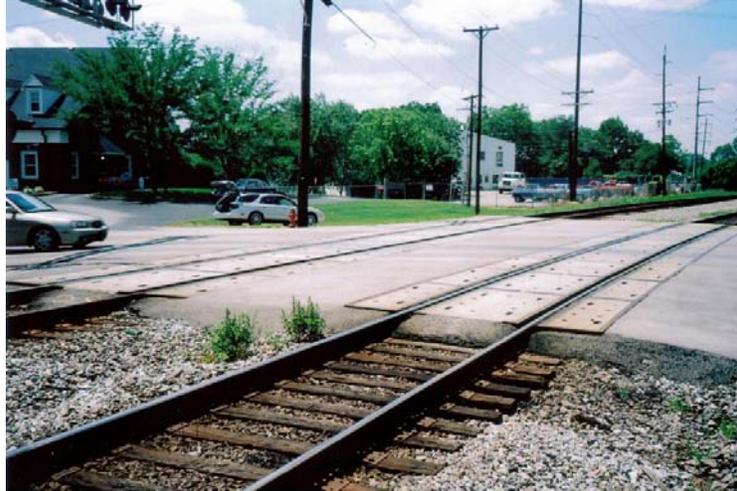
Figure B.2c: View of Main Street – Winchester Crossing

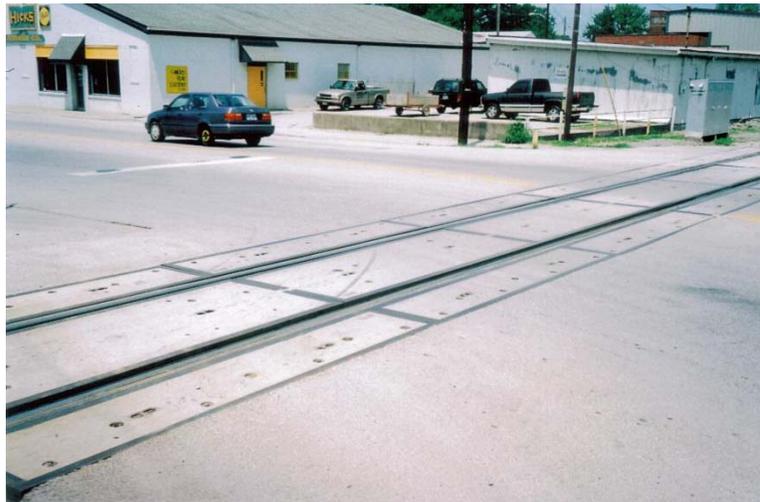
Figure B.2d: View of Main Street - Richmond Crossing

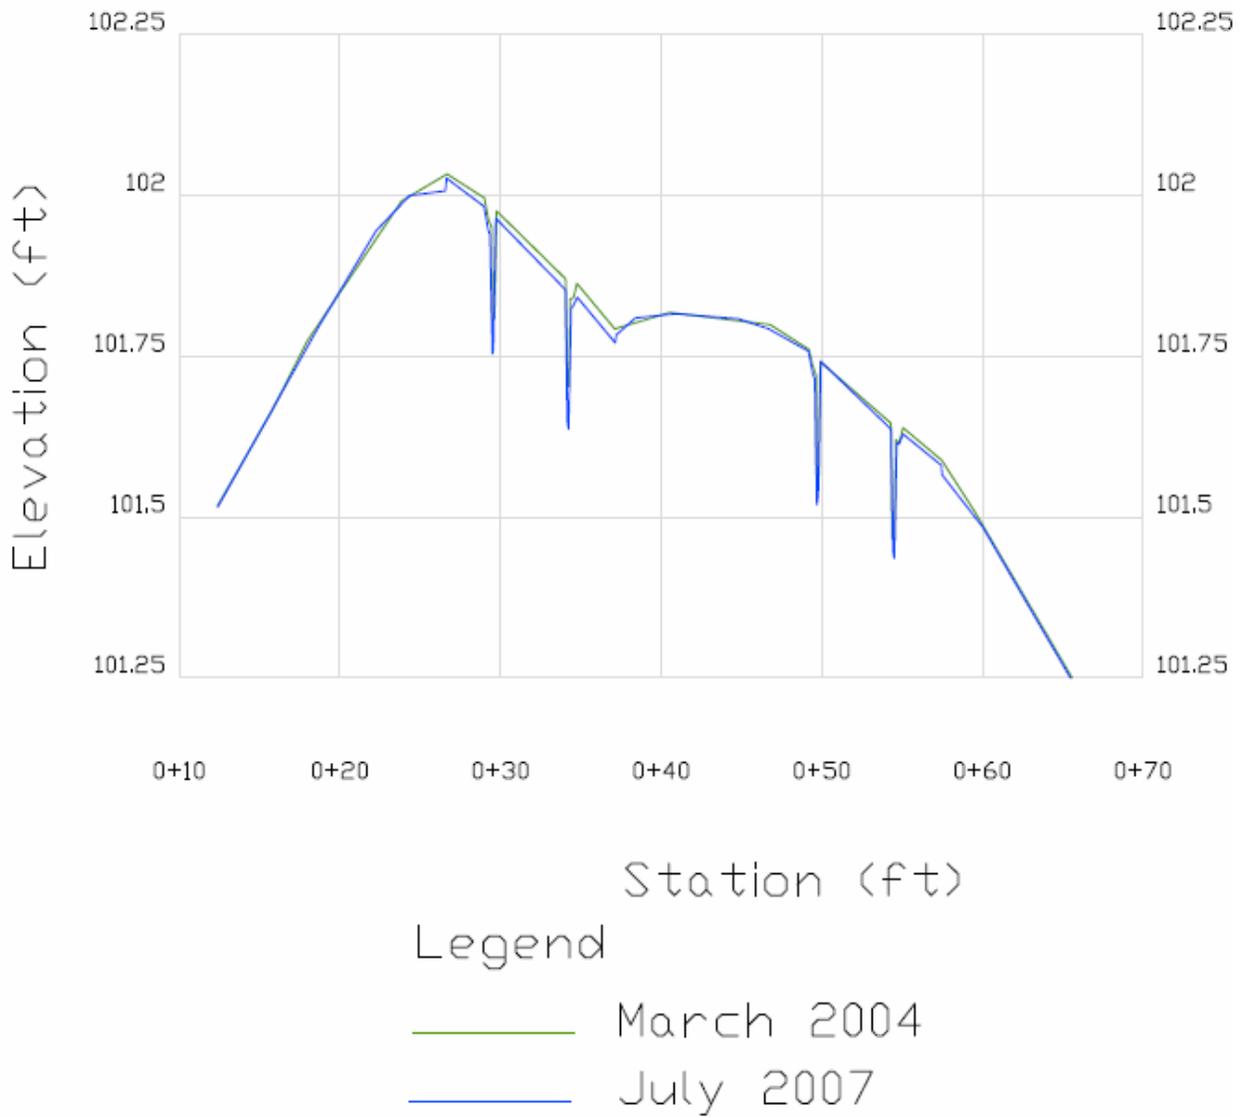
Westbound Inside Wheelpath Main Street - Winchester

Eastbound Outside Wheelpath
Main Street - Winchester
Installed November 2003

Eastbound Inside Wheelpath
Main Street - Winchester
Installed November 2003

Unlike the previously mentioned crossings, Winchester was not surveyed prior to rehabilitation so comparison to previous surface condition is not possible. Profiles of the crossings can be seen in Figures B.7a-B.7d. Also, it should be noted that the first longitudinal survey was not performed until four months after the underlayment was installed. This is significant because much of the consolidation that occurs in the track occurs soon after construction. The train consolidates the newly placed ballast and trackbed as it passes over the track. Therefore, it can be inferred that the results of the survey are not complete since a considerable amount of the settlement occurred prior to the study.
